APPENDIX C.2

GEOTECHNICAL INSPECTIONS

APPENDIX C.2.1
2017 GEOTECHNICAL INSPECTION NO. 1

RE: Submission of 2017 Geotechnical Inspection Report No. 1 (Aug. 2017)

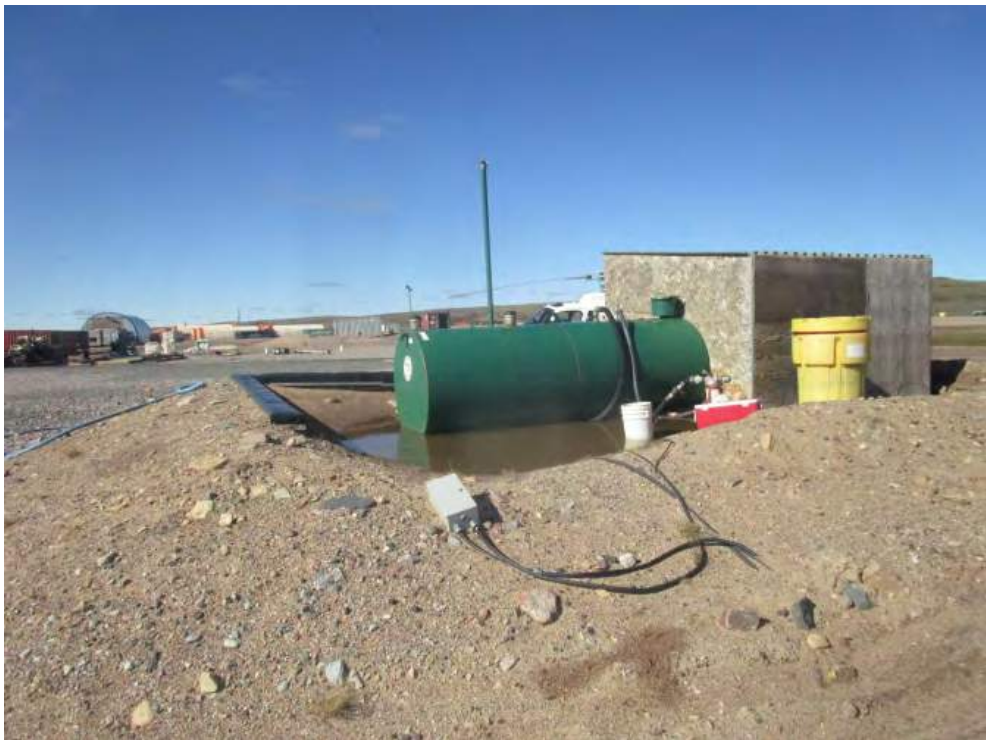
6. Helicopter Fuel Tank Containment

A review of the exterior and the top of the berms showed no sign of cracking or settlement which would indicate stress within the structure.

The structure is considered to be stable in its present condition and contains water that attests to its integrity.

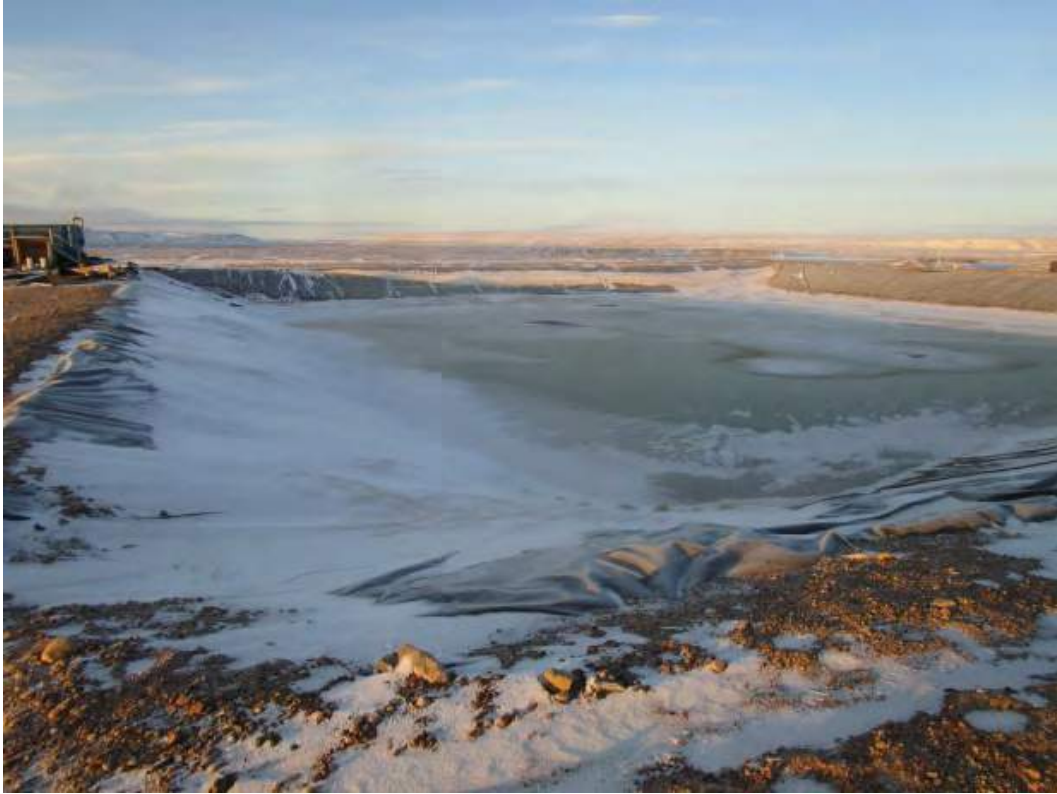
5. PWSP 3

These settlements appear to be settlements within the one metre \pm active layer above the permafrost and are of little concern as the PWSP's are temporary structures and the settlements have no effect on the dyke stability.

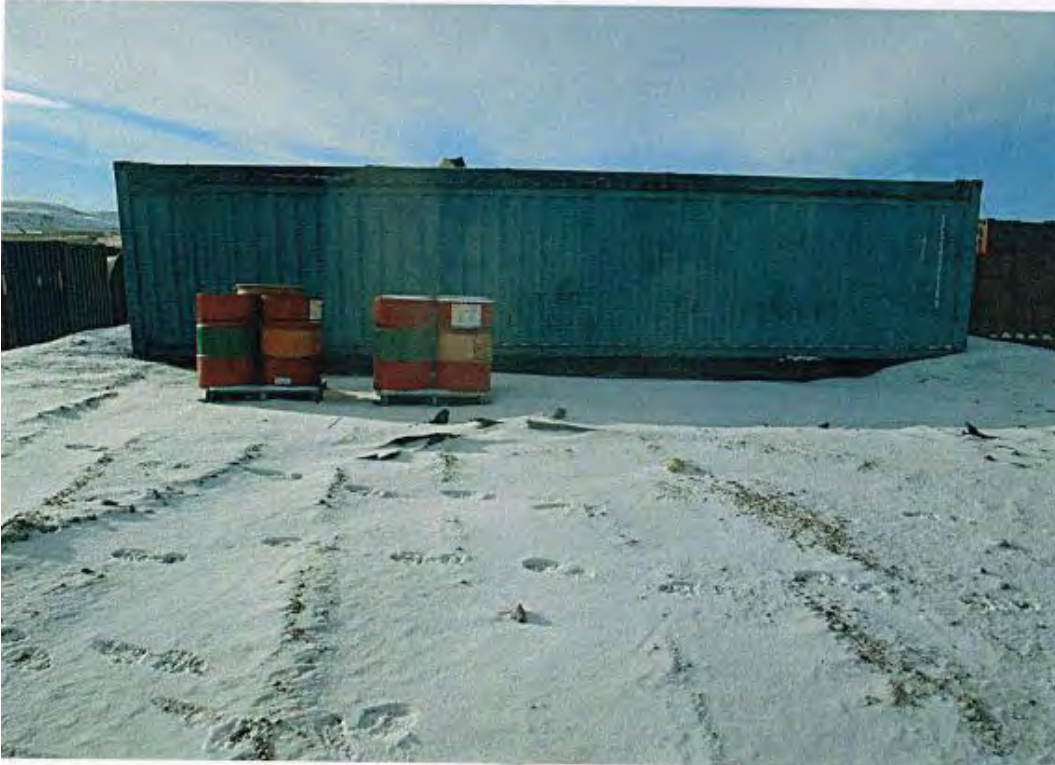
21. Hazardous Waste Storage (MP-HWB-3)

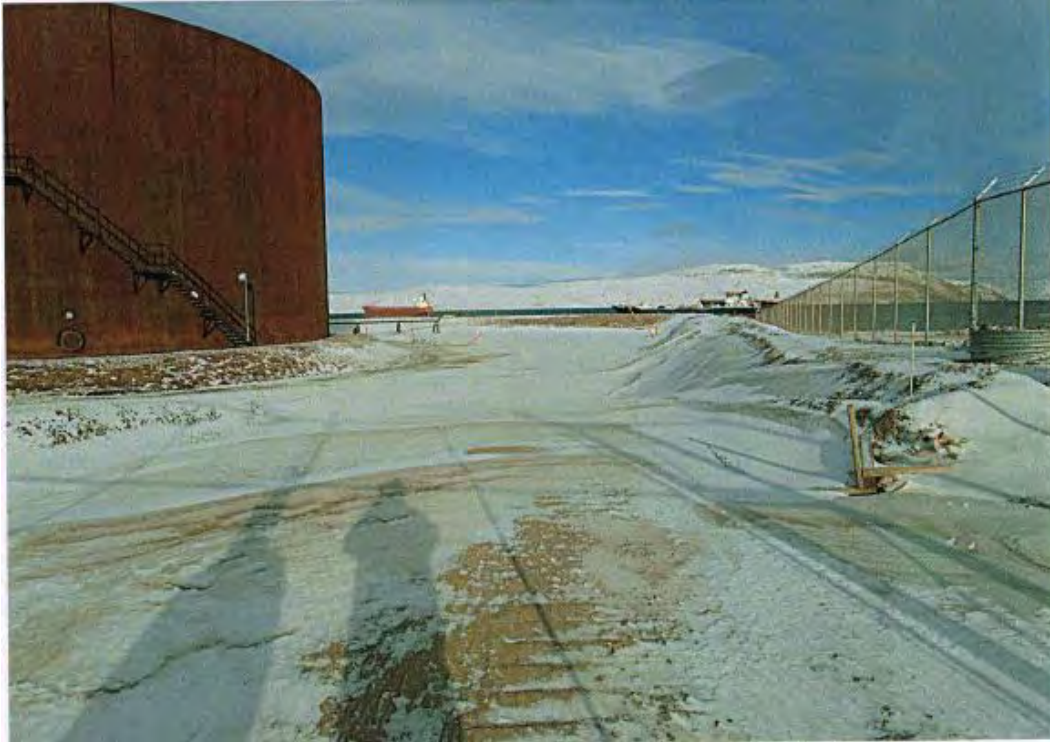
23. Fuel Tank Farm (MP-03)

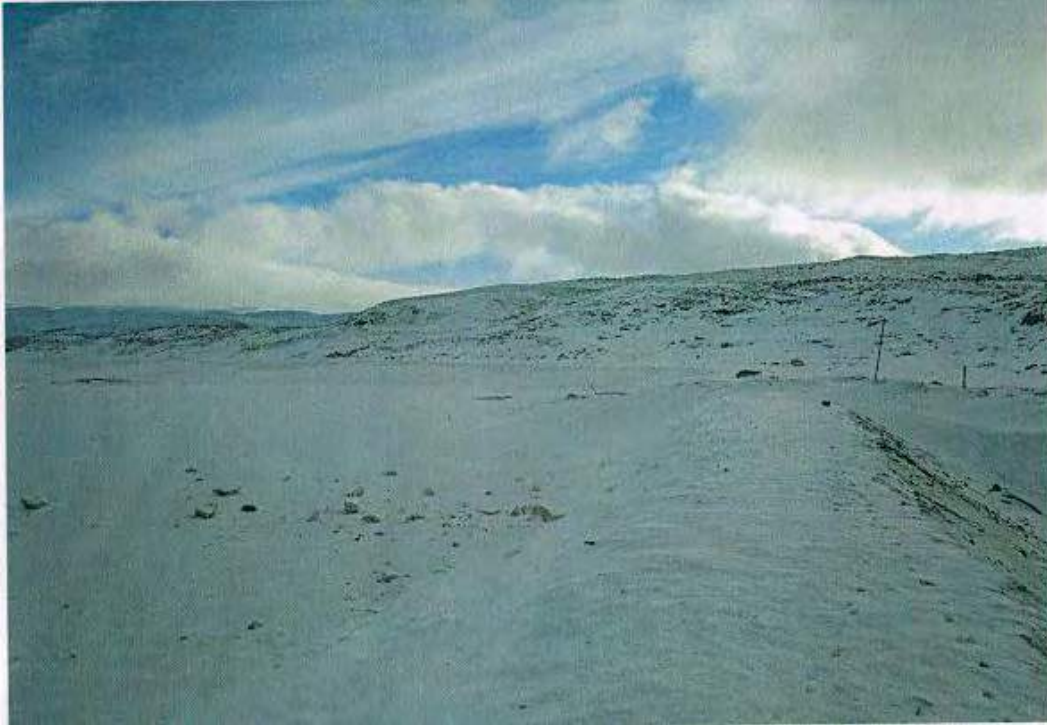
25. Land Farm Containment (MP-04)

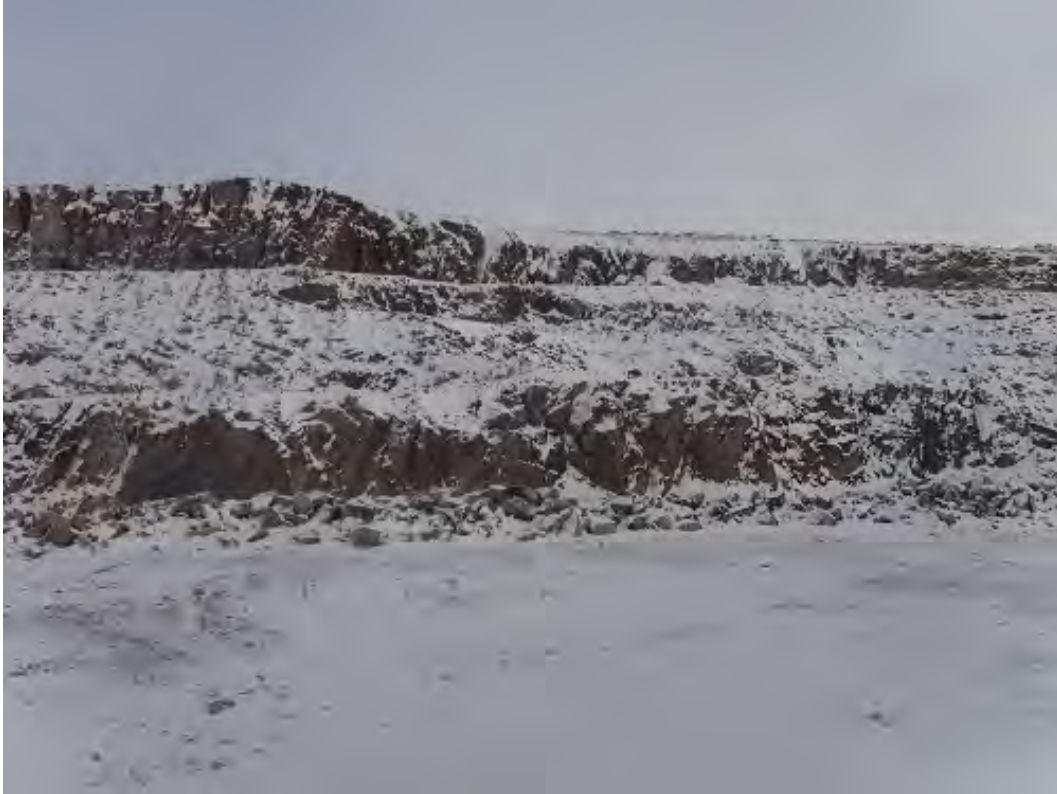
27. Milne Inlet Quarry (Q1)

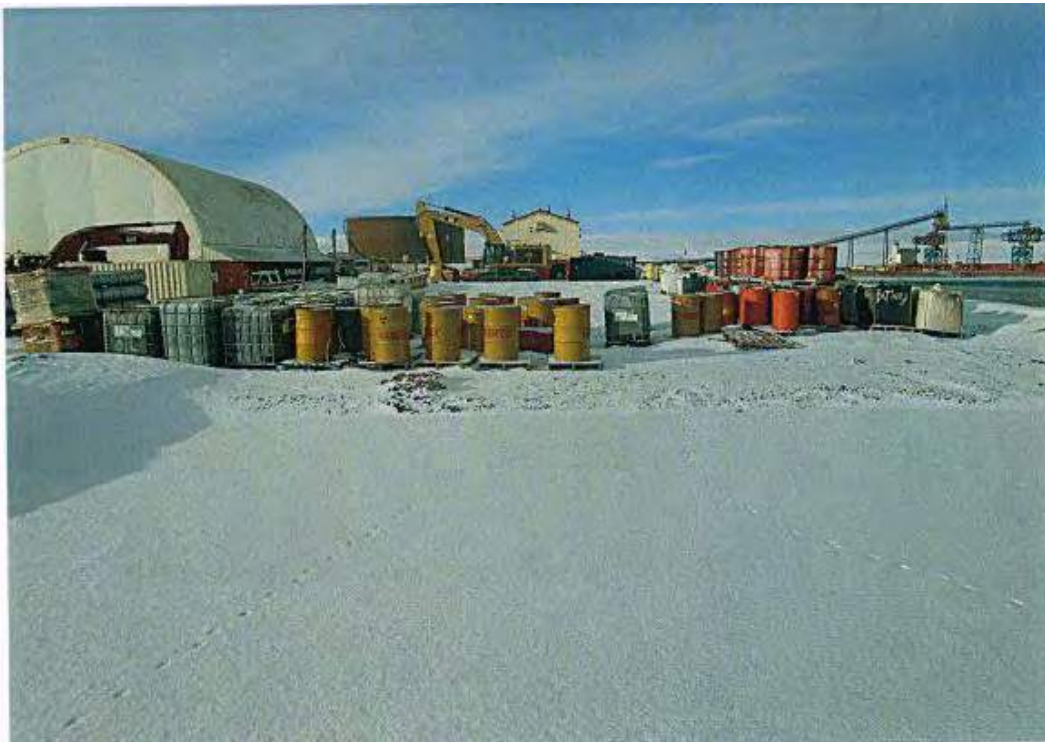
28. Loading Area Containment Storage (MP-HWB-1)

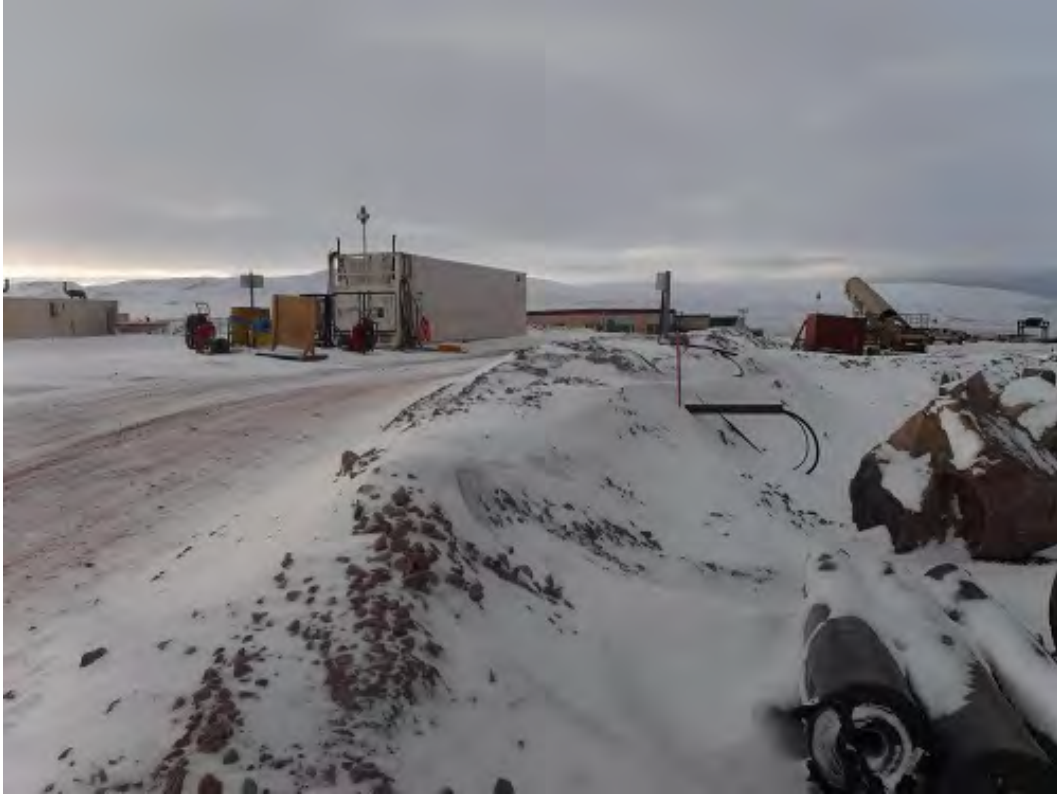
29. Fueling Facility Containment

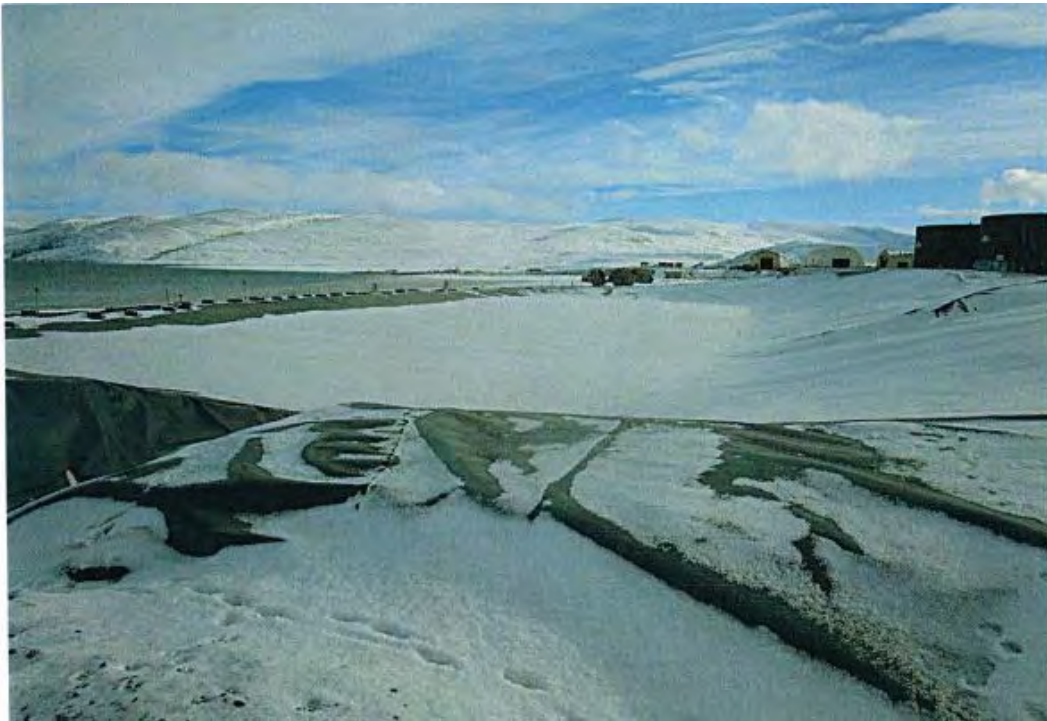
The two inlets to the pond have very recently been upgraded and the enviroliner has been repaired at these locations. This was performed at the end of July, 2017.

We have concerns over the stability of the liner on this pond and recommend the possibility of further tire ballast over the liner which appears possibly subject to wind damage. This shall provide a function for used tires

30. Milne Port Ore Stockpile Sedimentation Pond East (MP-05)

We recommend review of the use of a ballast (possibly tires) on the exposed liner at the dyke to prevent wind uplift.

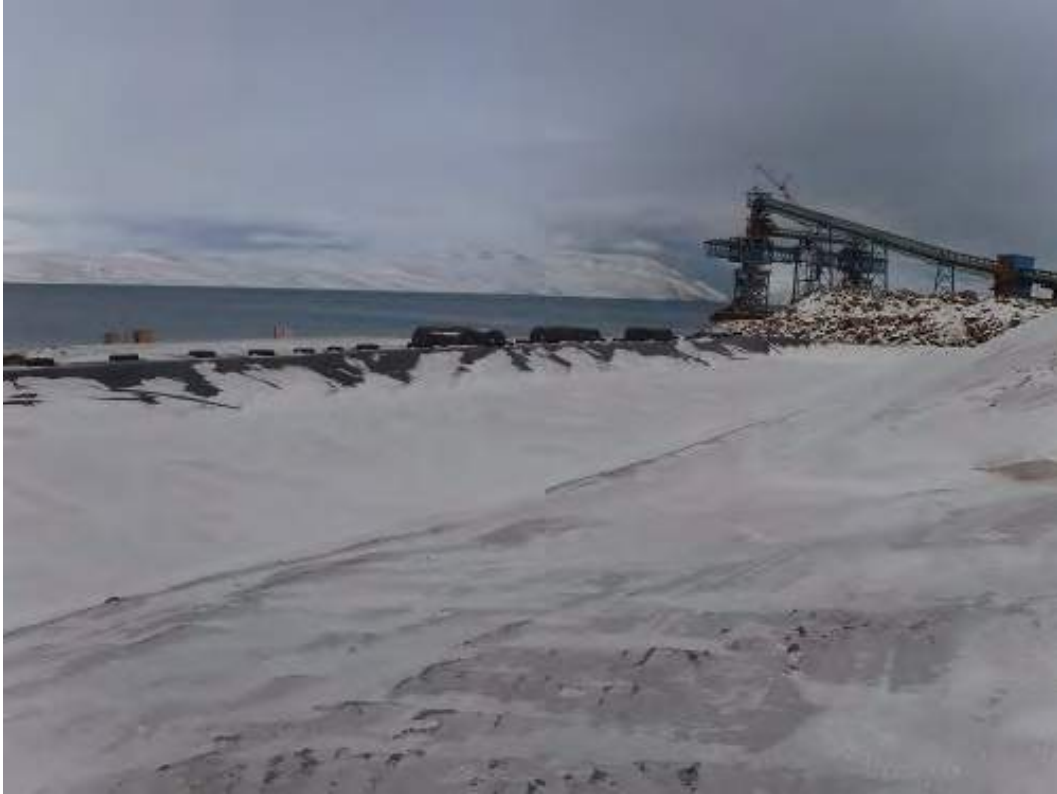
The construction of this sedimentation pond for drainage from the west side of the site is now complete with repairs recommended in our report of last year having been completed.

The inlet where the inlet where possible water infiltration was occurring was addressed at the end of July, 2017, and the inlet has been reconstructed.

We have some concern over the stability of the liner on this pond as we have with the east pond and further recommend that used tire ballast be considered.

31. Milne Port Ore Stockpile Sedimentation Pond West (MP-06)

We have no concerns other than that of possible wind damage to the liner and recommend the use of tires as ballast.

We recommend that the ditch that conducts water from the east side of the pond be reviewed to ensure water is conducted to the pond readily.

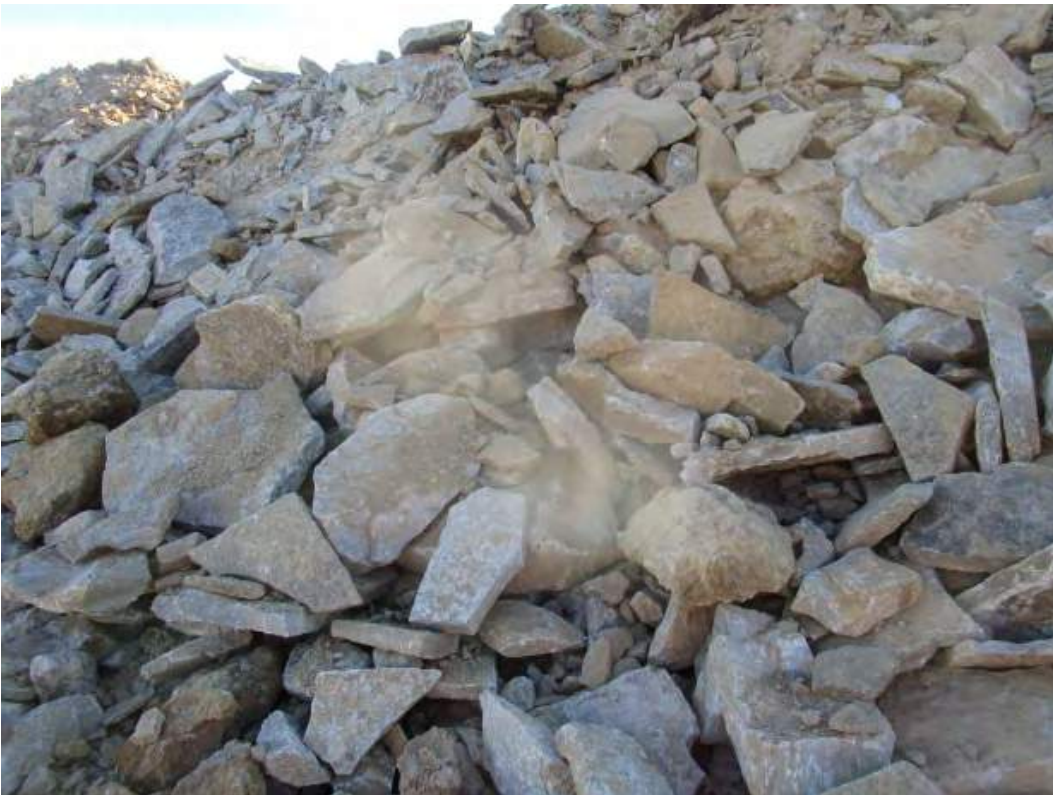
35. Typical Rock Used as Fill from km 76

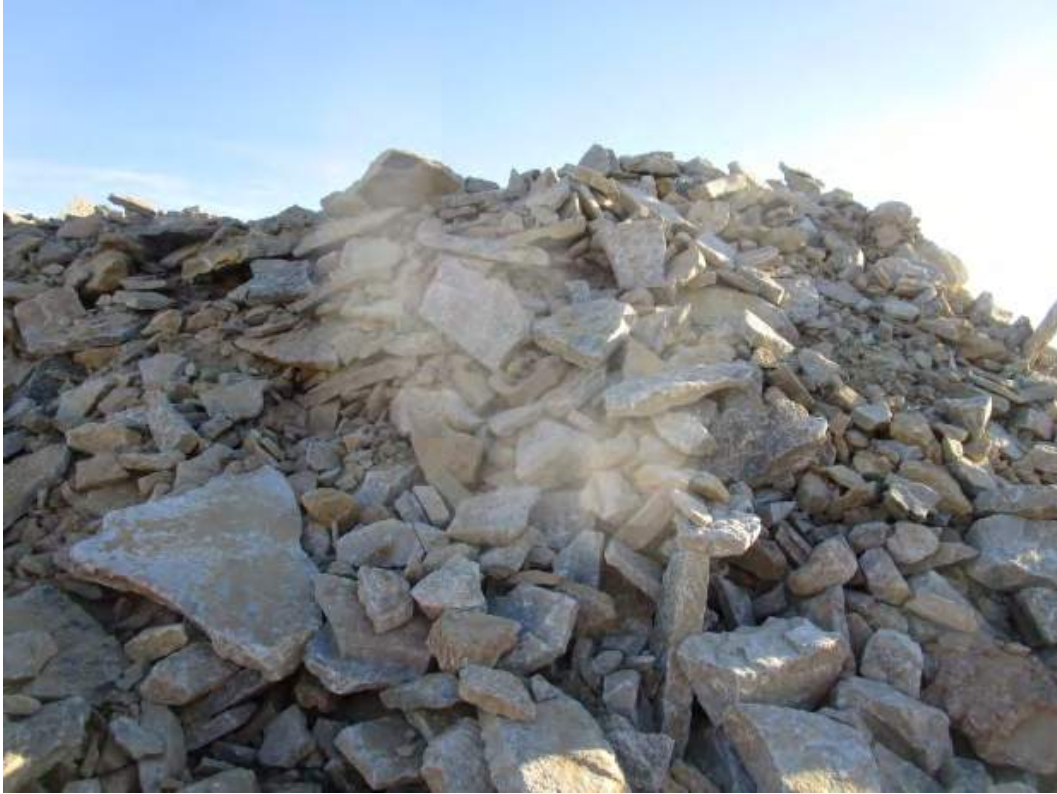
36. Typical Rock Used as Fill from km 76

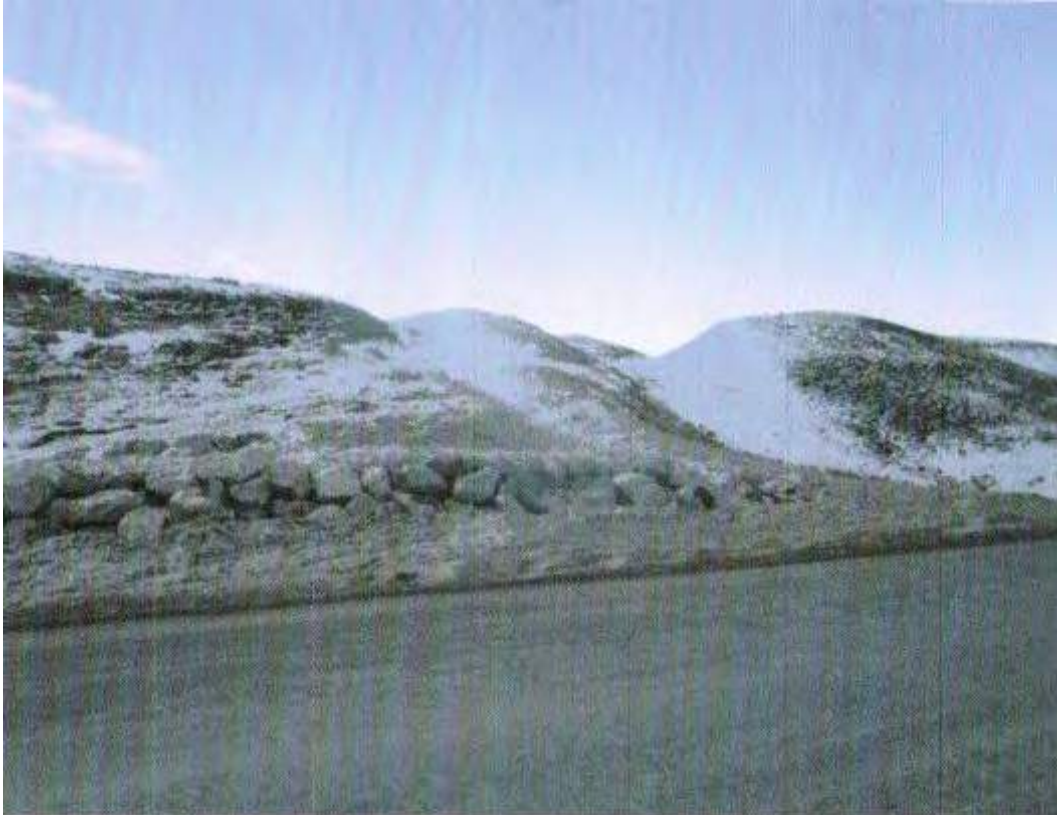
37. Armor Stone Used in Road Cut Area km 91

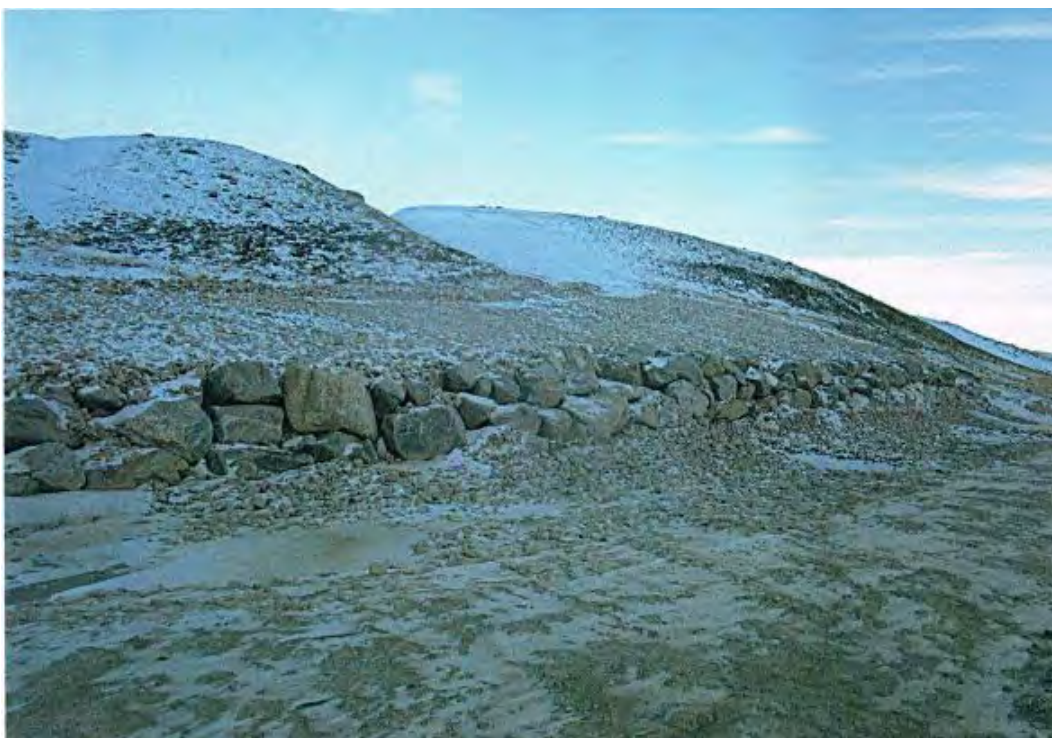
38. Armor Stone Used in Road Cut Area km 91
