### **GEOTECHNICAL INSPECTIONS**

**APPENDIX C.2.1**  
**GEOTECHNICAL INSPECTION**  
**JULY/AUGUST 2018**

**RE: Submission of 2018 Geotechnical Inspection Report No. 1 (Jul/Aug. 2018)**

FIRST INSPECTION OF TWO

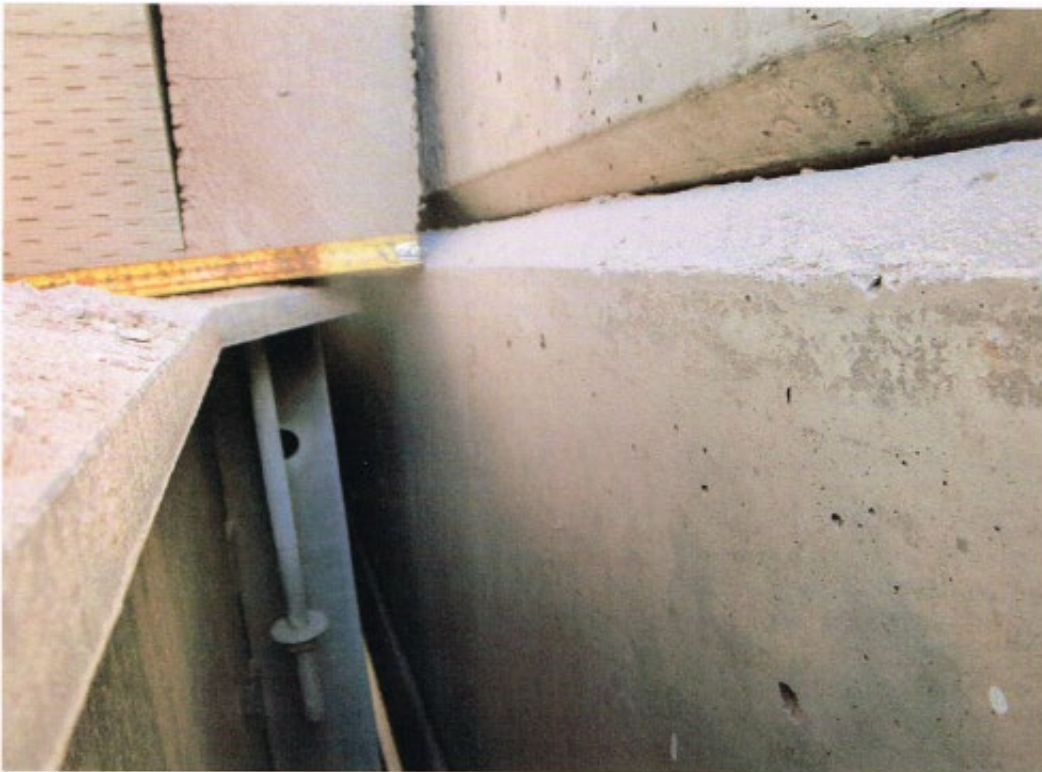
**Photo 2 - North Abutment - NE Corner**

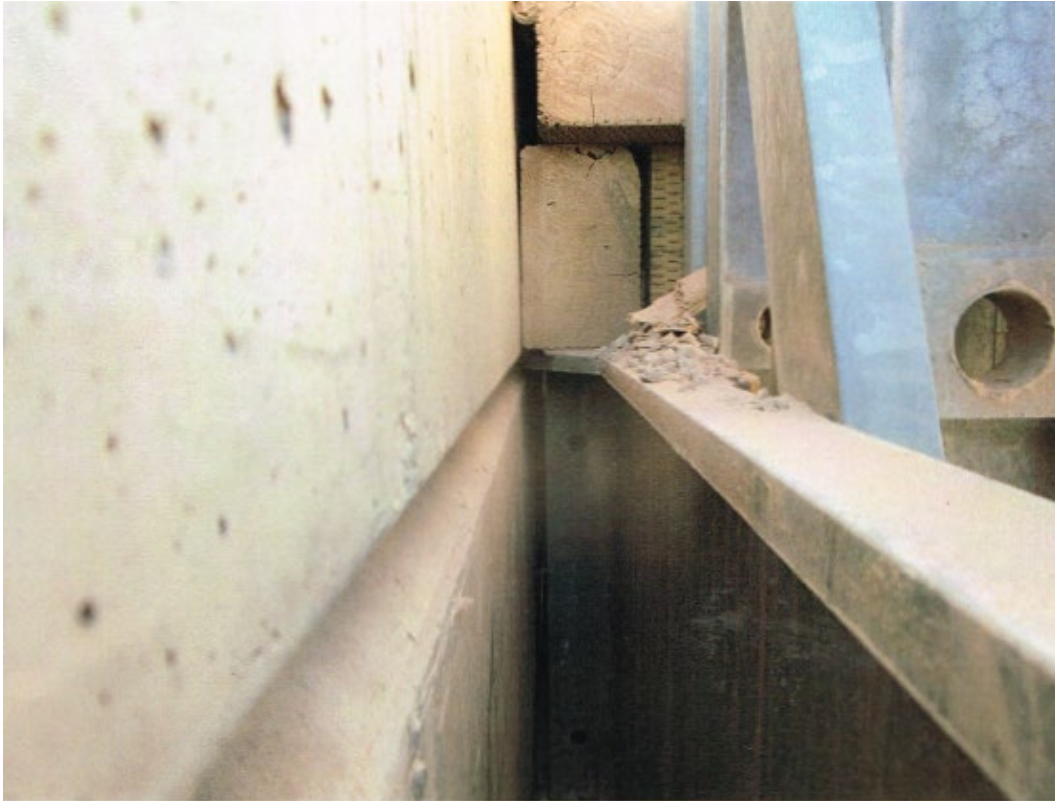
**Photo 3 - South Abutment - SE Corner**

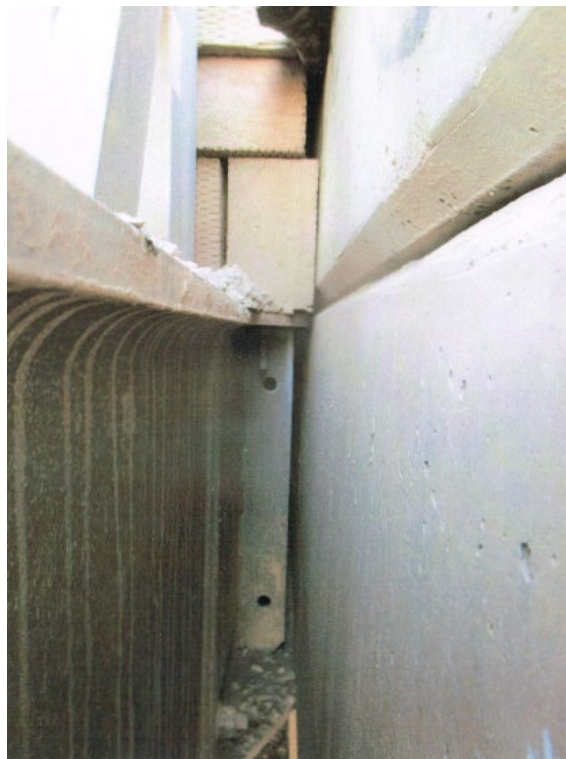
**Photo 4 - South Abutment - SW Corner**

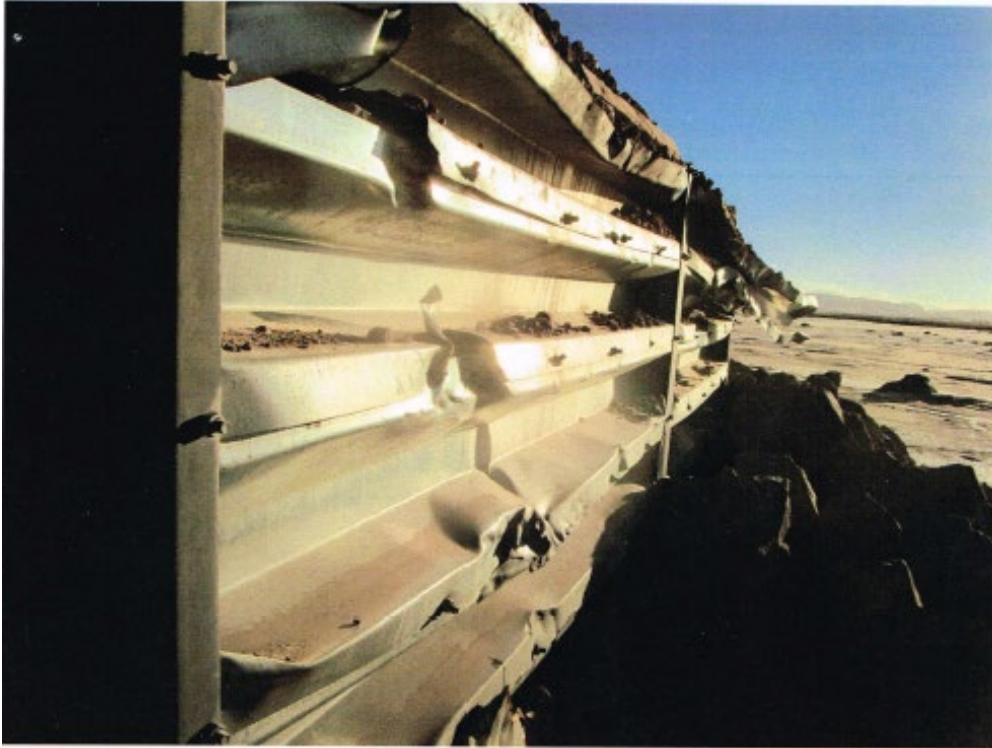
**Photo 5 - North Abutment (Former Shipping Container Bridge)**

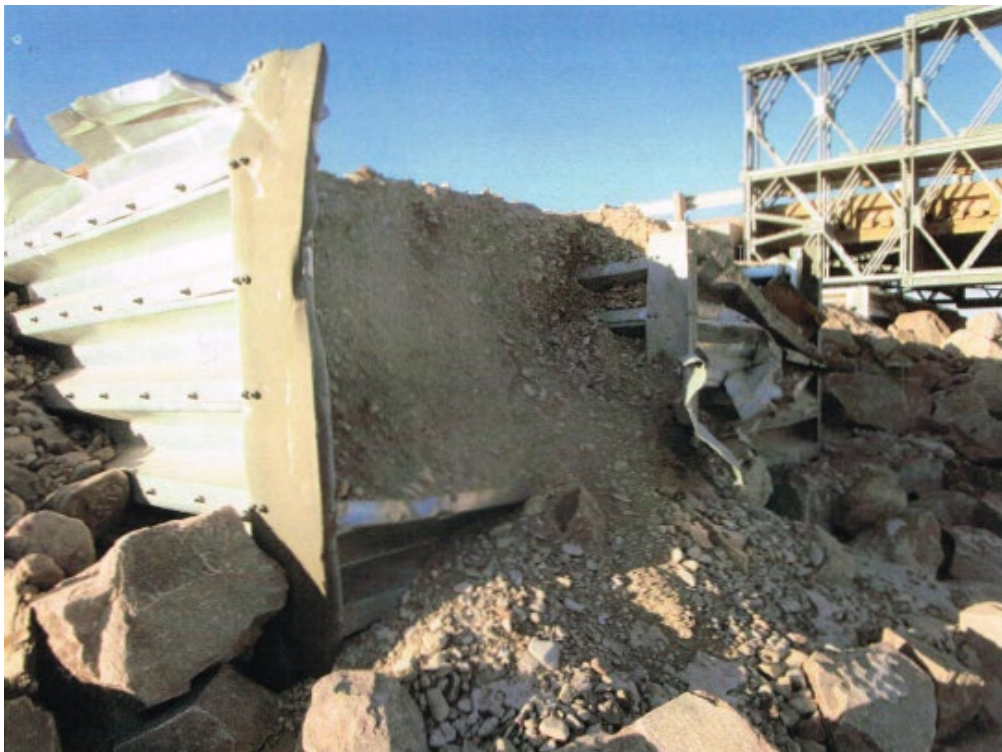
**Photo 6 – South Abutment (Former Shipping Container Bridge)**

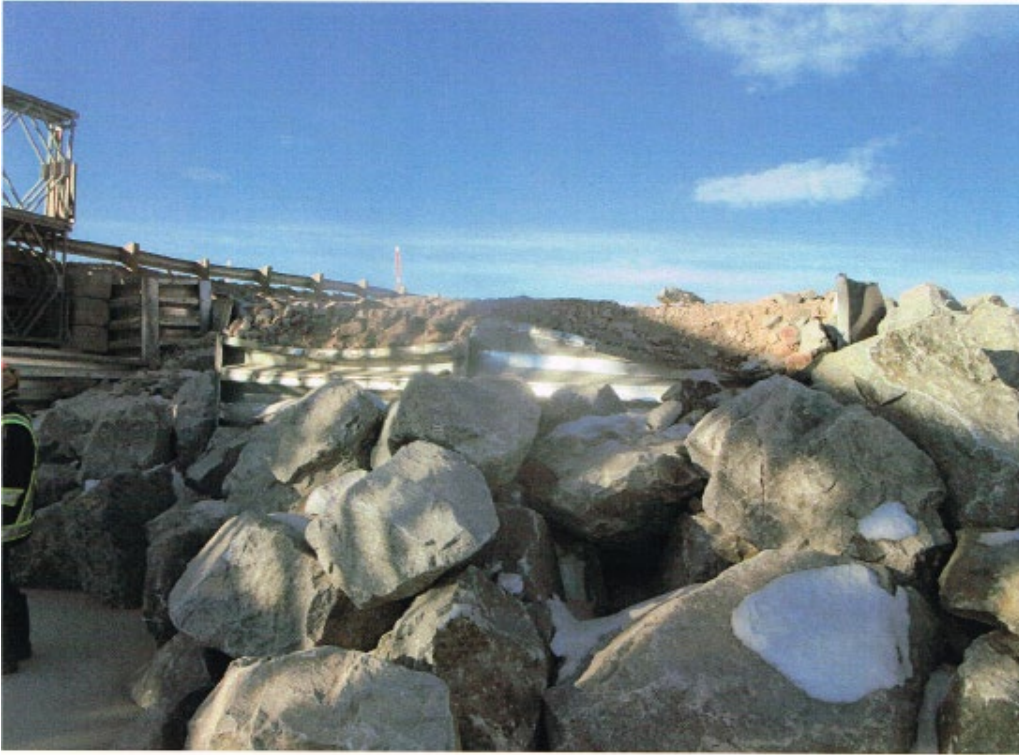
**Photo 3 - North Abutment (Former Shipping Container Bridge)**

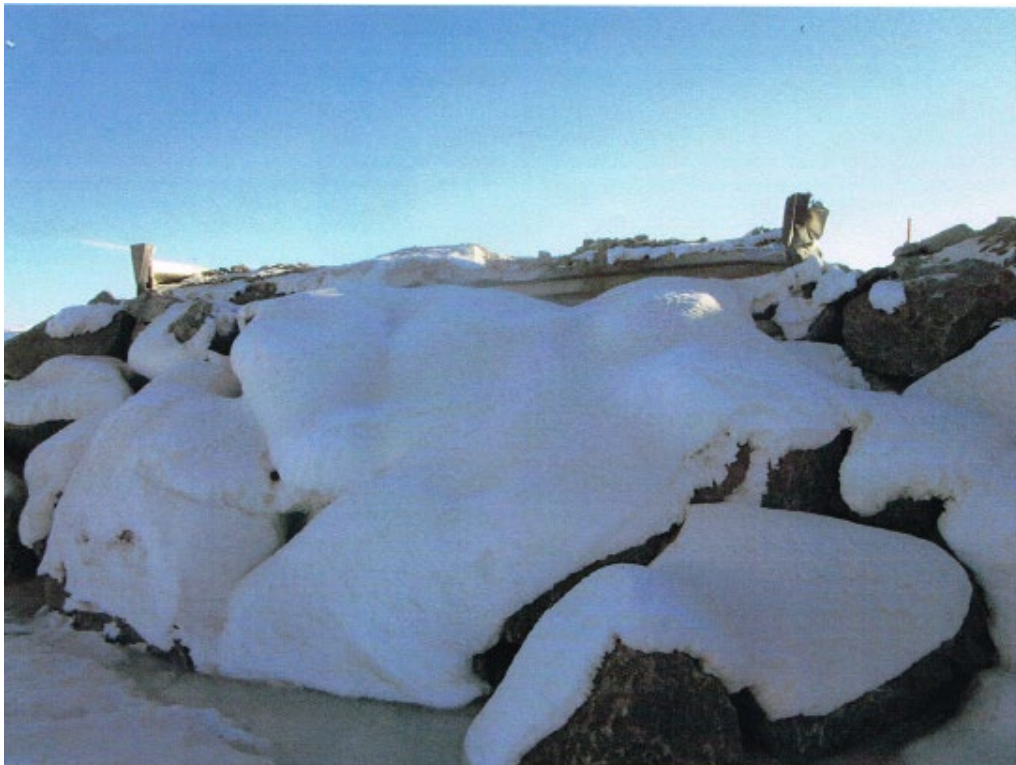
**Photo 4 - South Abutment (Former Shipping Container Bridge)**

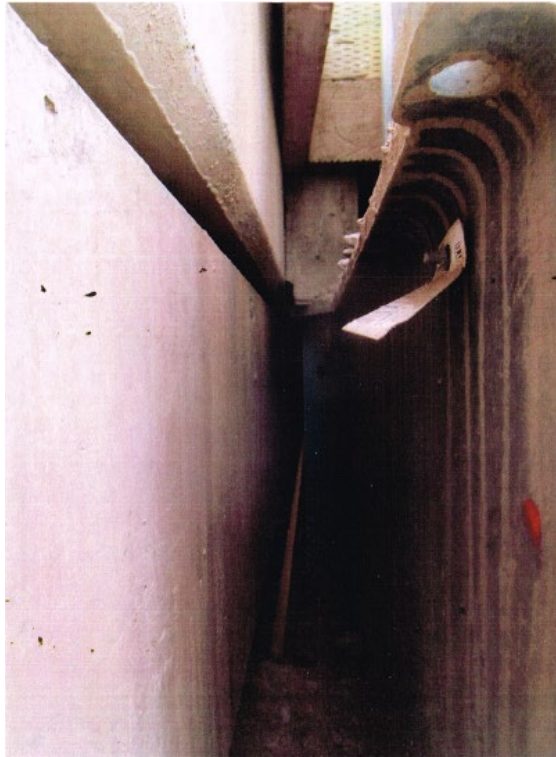
**Photo 3 - South Abutment – SE Corner**

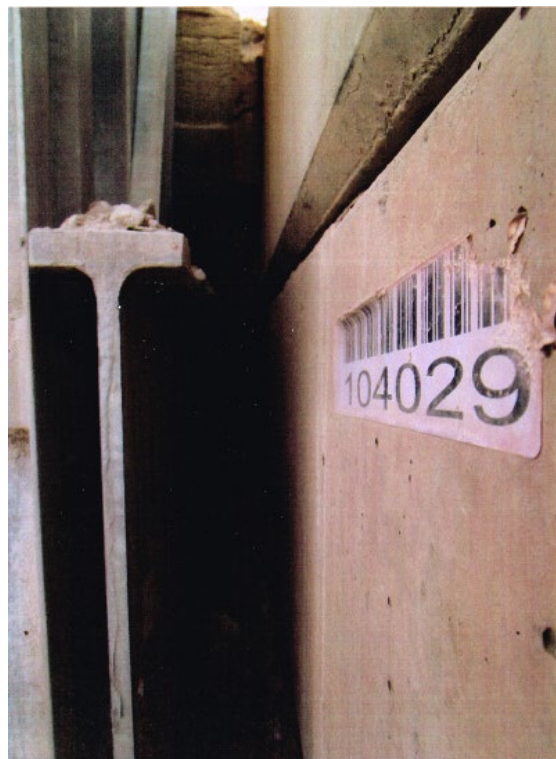
**Photo 4 - South Abutment – SW Corner**

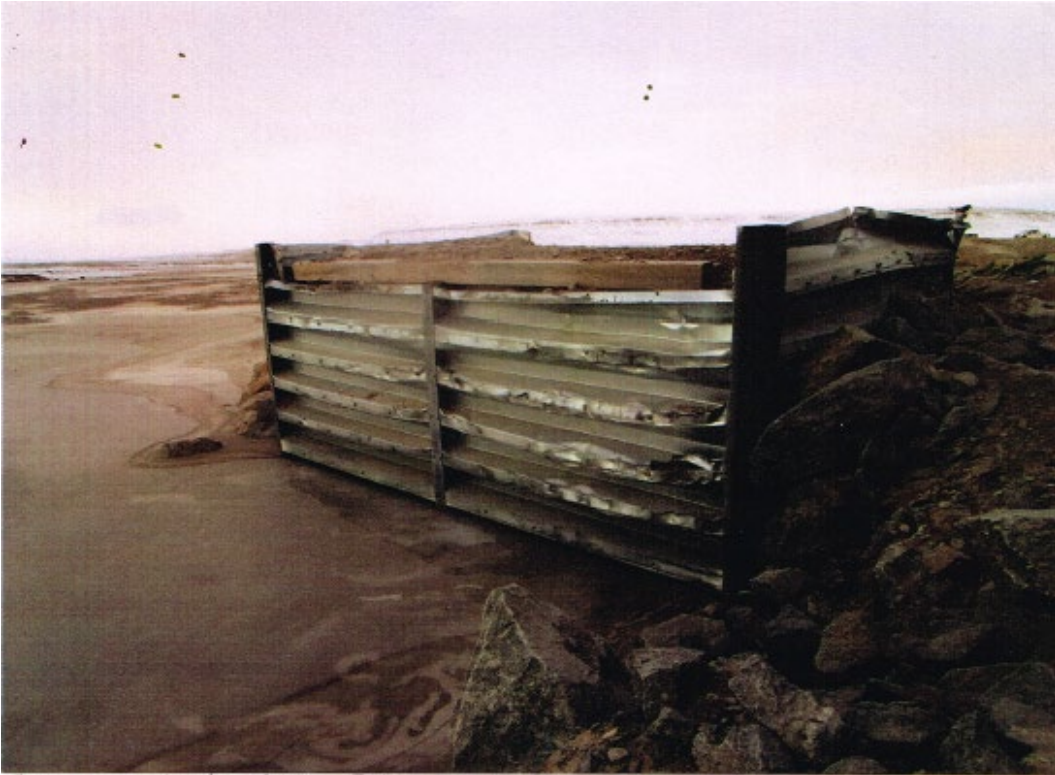
**Photo 5 – North Abutment (Former Shipping Container Bridge)**

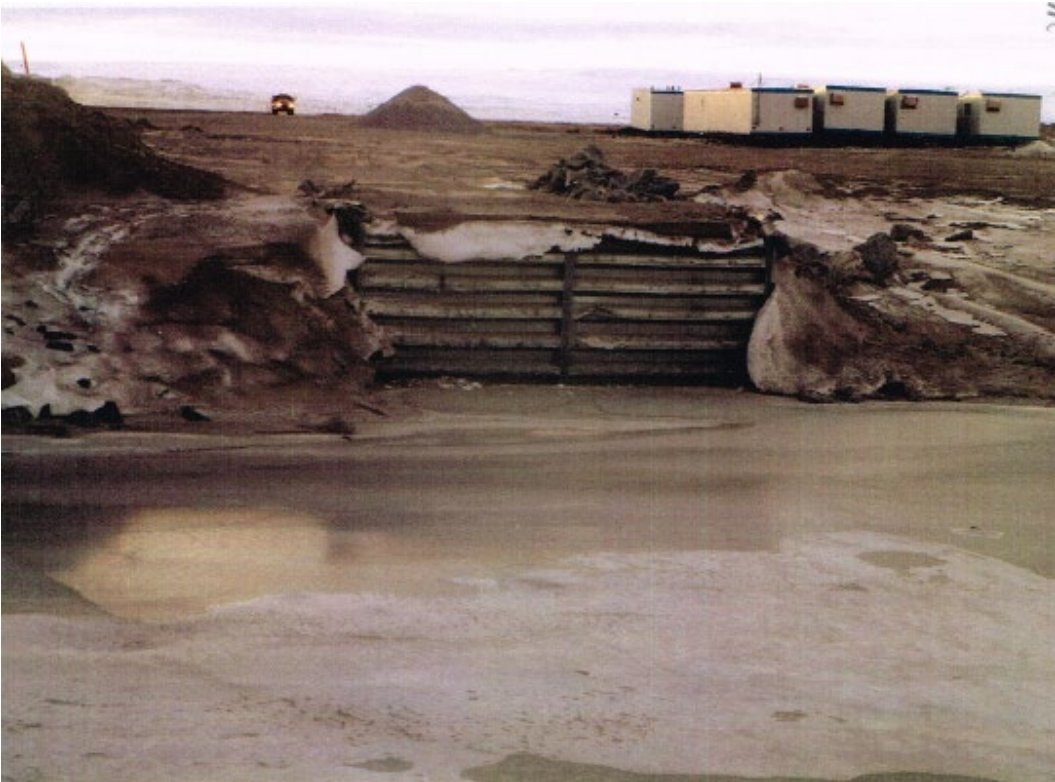
**Photo 6 – South Abutment (Former Shipping Container Bridge)**

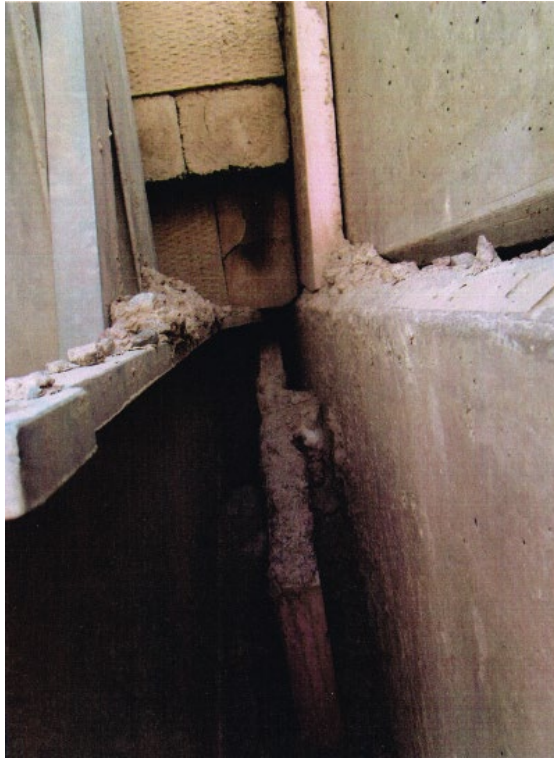
**Photo 1 - North Abutment - NE Corner**

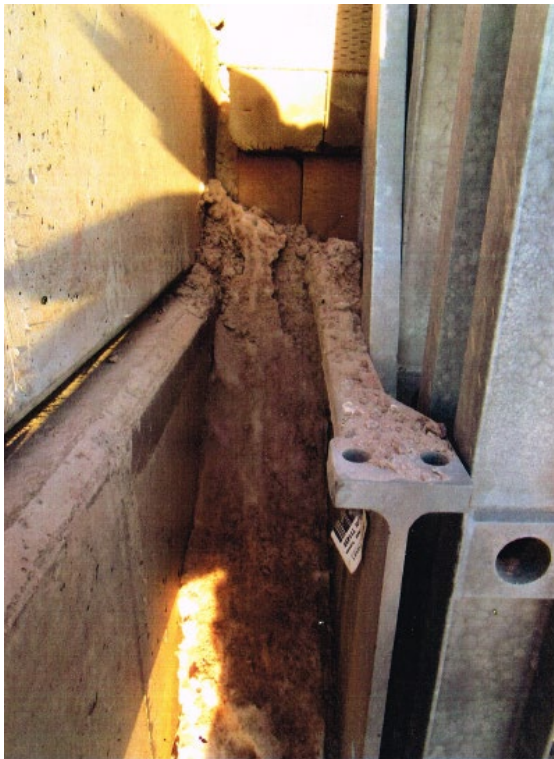
**Photo 2 - North Abutment - NW Corner**

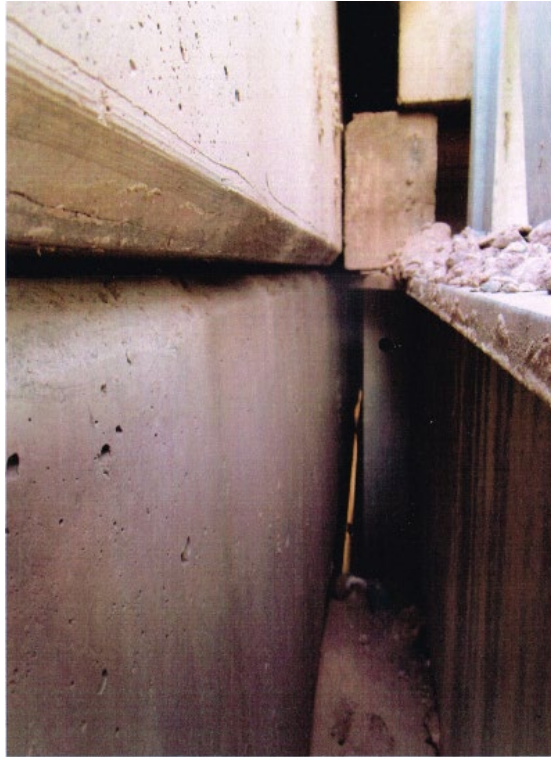
**Photo 3 - South Abutment – SE Corner**

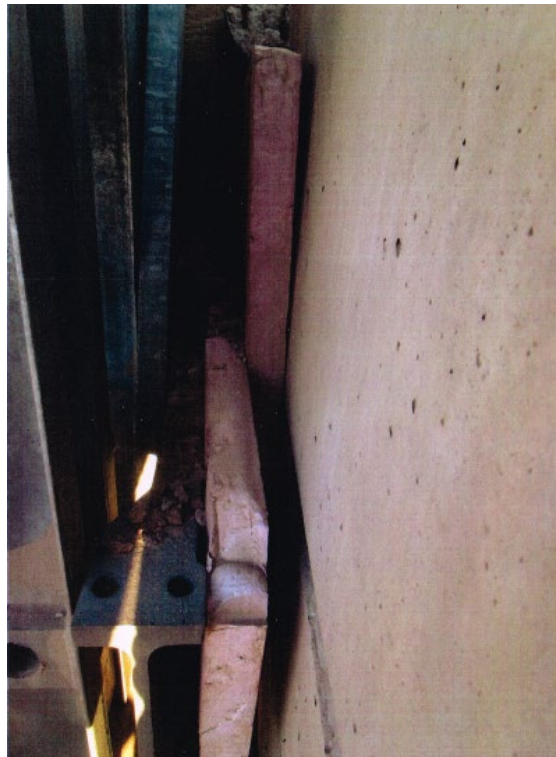
**Photo 4 - South Abutment – SW Corner**
