Geotechnical Inspection Report

RE: Submission of 2019 Geotechnical Inspection Report No. 1 (July 2019)

Annual Geotechnical Inspections – 2019 Report 1. Mary River Iron Mine Complex – Nunavut

Annual Geotechnical Inspections – 2019 Report 2. Mary River Iron Mine – Nunavut

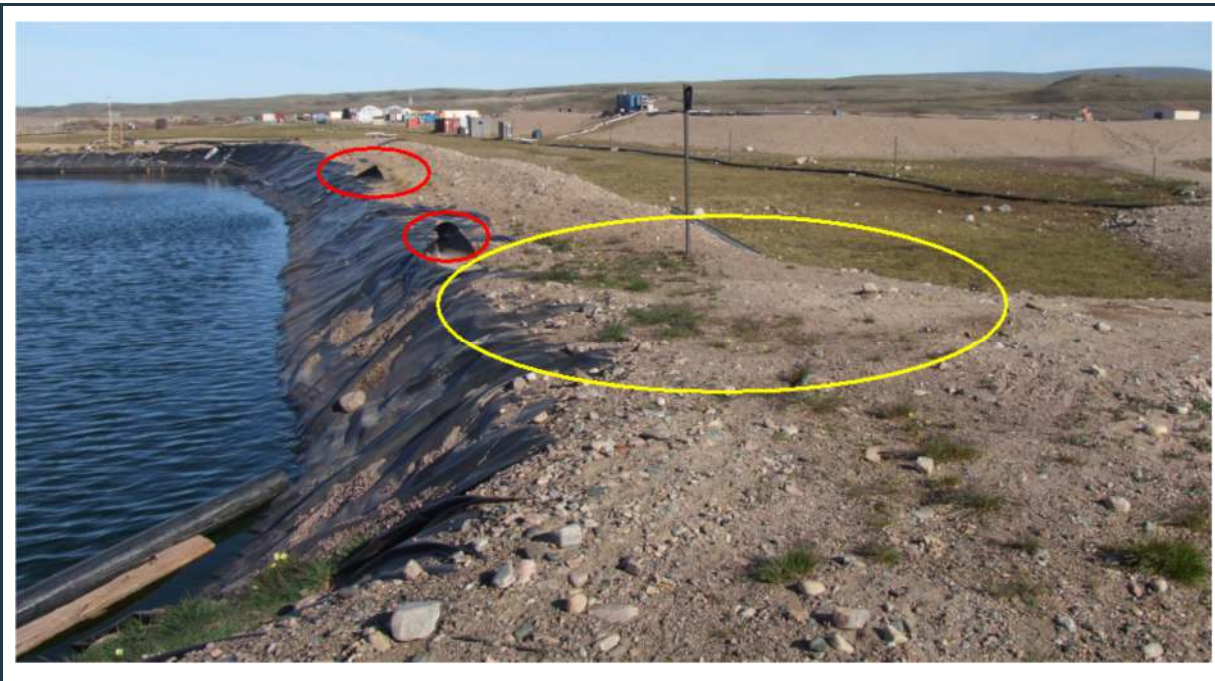
The berms around the ponds generally comprise granular soils (sand and gravel), supporting High Density Polyethylene (HDPE) geomembrane liners. The liners are secured in anchor trenches on the crest of the berms, and no damage is visible on the membranes on the upstream face of the slopes. However, there are some minor damages visible on the liners on the crest of the berms (above the maximum water/freeboard line) at a few locations, as shown in Figure 7 (see red circles). These minor damages should be repaired as part of the regular maintenance program.

Figure 7: PWS pond #1 – Lower crest elevation (yellow circle) and damages to the liner (red circles)

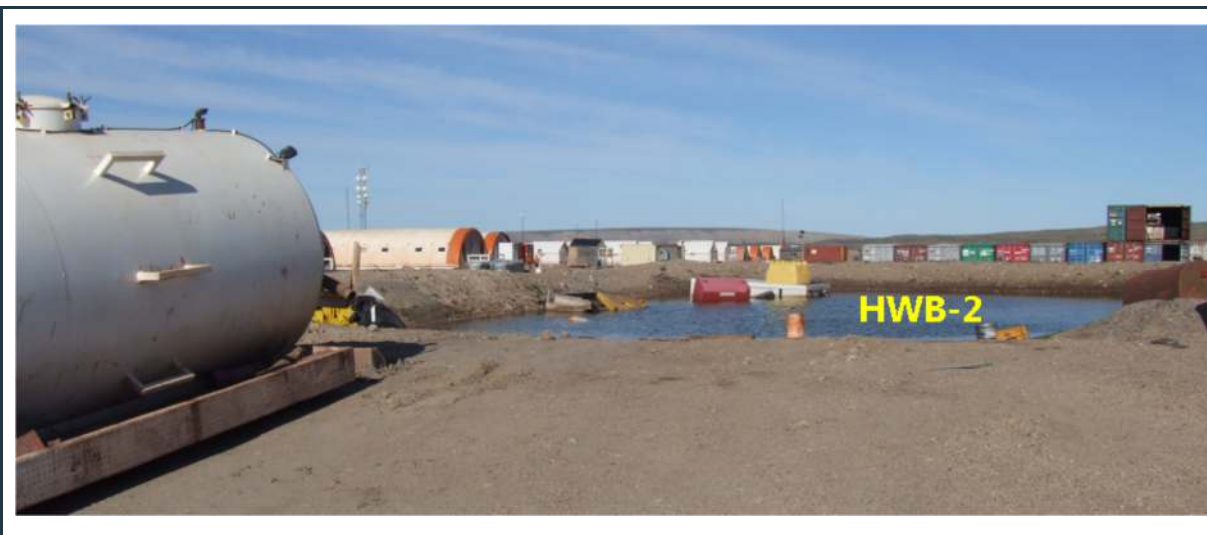
As shown in Figure 12, the perimeter berm appears to be stable. The presence of water visible within the pond demonstrates that the liner is intact. No visible seepage from the pond was noted around the berm, and the pond operates as intended.

Figure 12: View of HWB-2

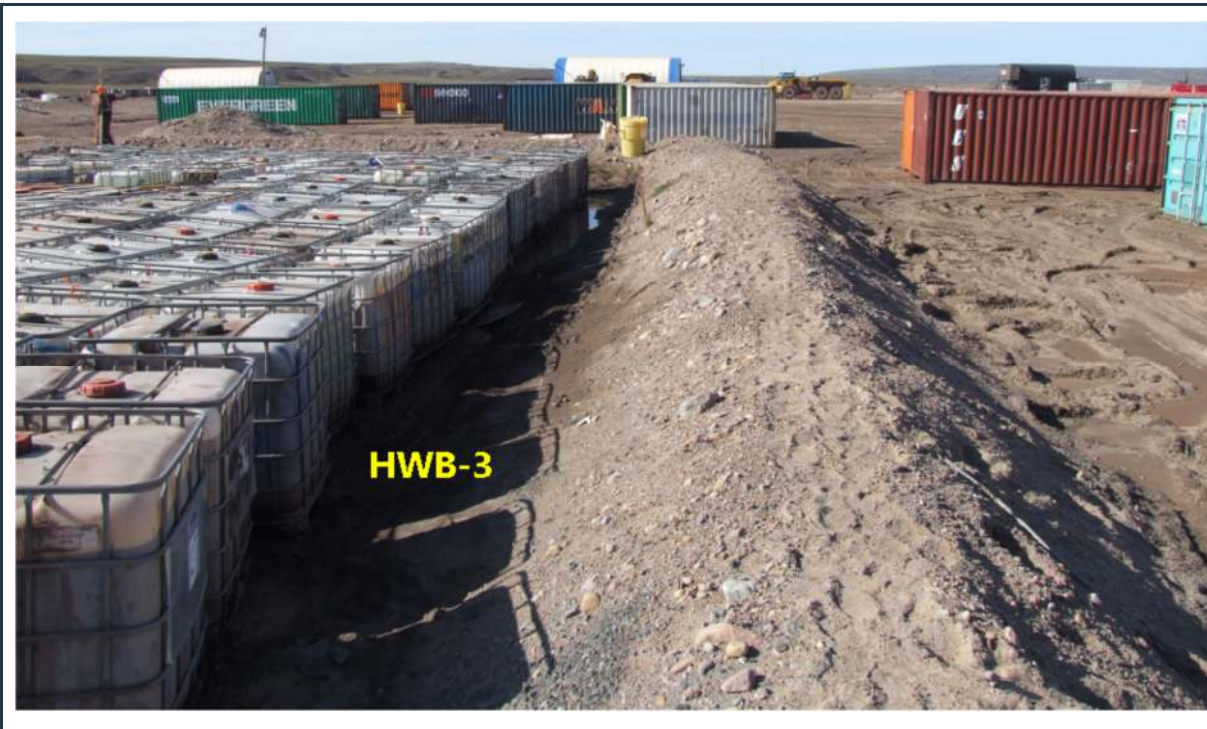
These cells are located side-by-side and were called in previous reports as "Fuel Containment" cells. As shown in Figures 13 and 14, there are predominantly contaminated waste (HWB-3) and fuel barrels (HWB-4) stored in these two cells.

The photographs of the cells attest stable berm condition, and good liner performance (e.g., ponded water in Figure 14). However, it is also shown on the images that foot traffic had caused disturbance on the slopes of the berms and that should be avoided. Furthermore, access points into the cells should be limited and foot traffic on the berms, particularly on their slopes, should be minimized. Furthermore, damaged wood pallets (shown in Figure 14) with nails sticking out of them, should be stored in a designated area, in order to minimize the possibility of liner damage by the nails.

Figure 13: View of HWB-3

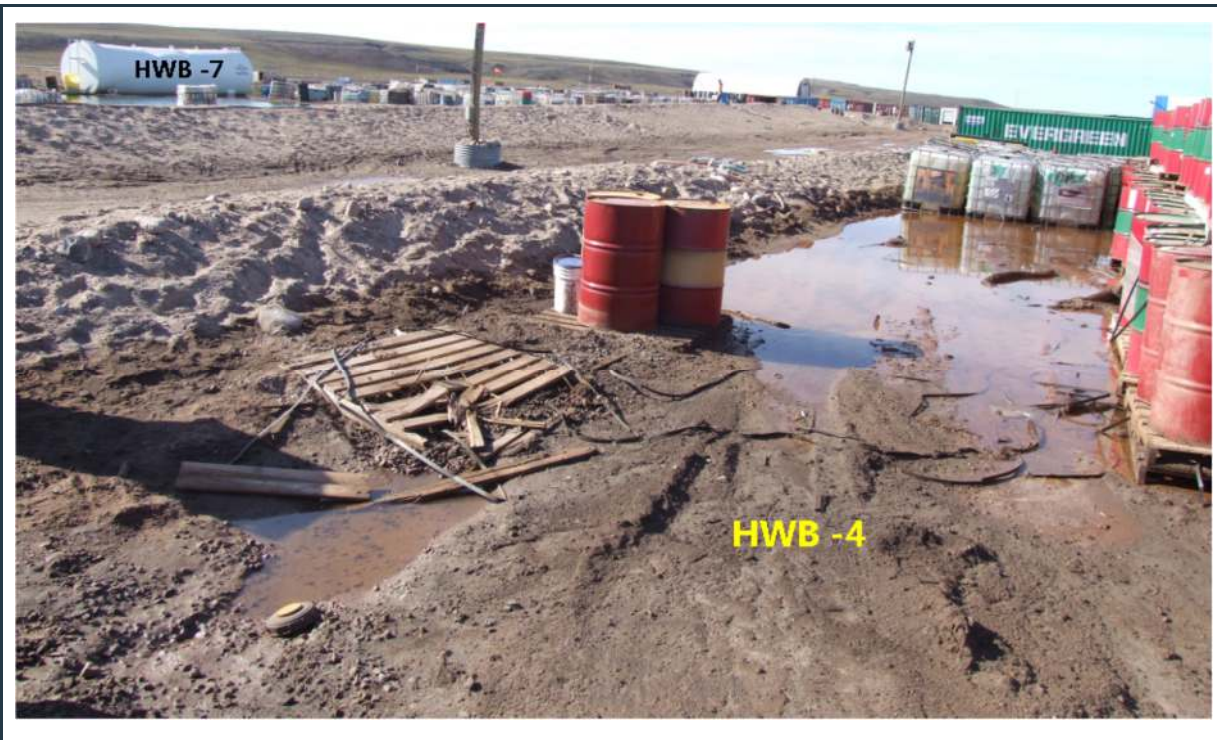
Figure 14: View of HWB-4

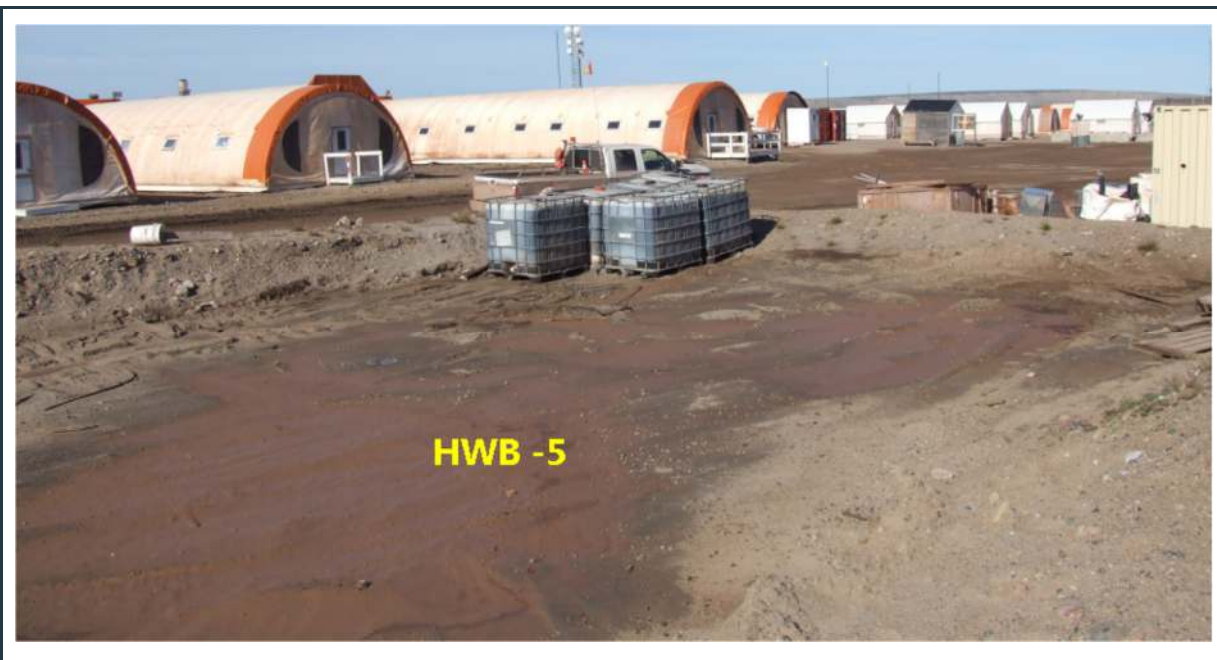
As shown in Figure 15, there are a few totes of lubricants currently stored in this cell. The berms around the cell appear to be stable and there is no visible liner damage. As recommended above, foot and truck traffic on the slopes and the crest of the berm should be prohibited with controlled / ramped access points (preferably one) provided for the skid-steers to dispose designated materials in the cell.

Figure 15: View of HWB-5

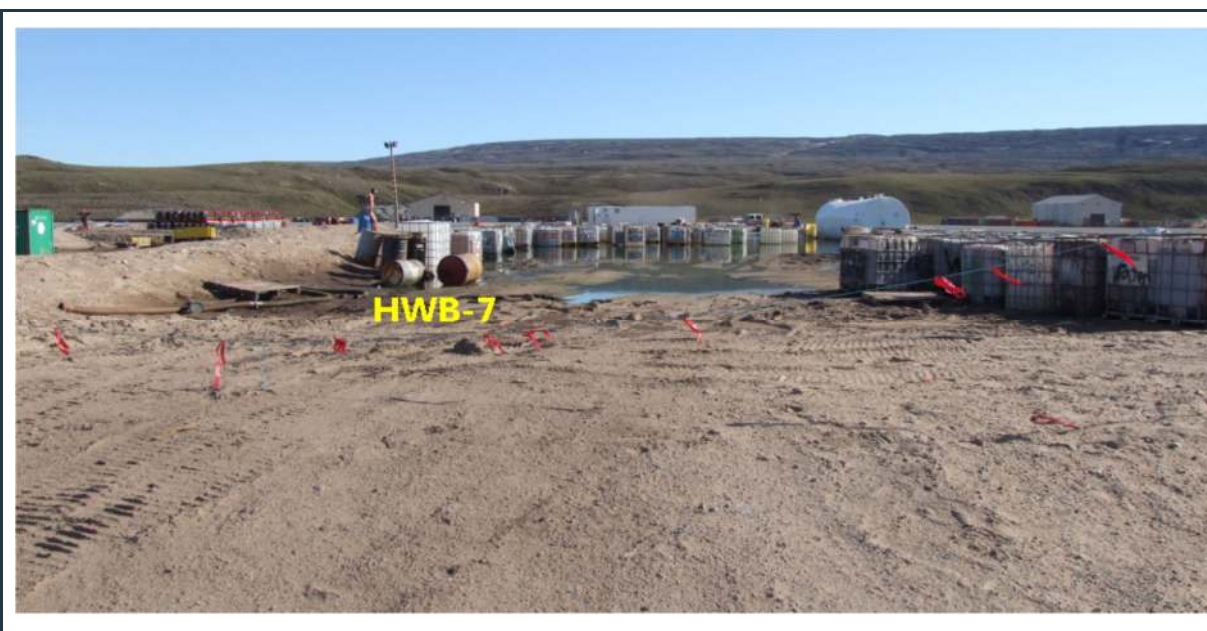
Based on information from historic reports, the HWB-7 cell was a bulk fuel storage facility in the past. Currently it is used to store fuel barrels, lubricant totes and a large fuel tank, as shown in Figures 18 and 19. The perimeter berm around three sides of the cell appears to be stable and the visible water within the cell supports adequate liner performance. There is a ramp along the fourth side of the cell (with appropriately high elevation at its highest end) to provide truck access into the cell.

Figure 19: View of HWB-7

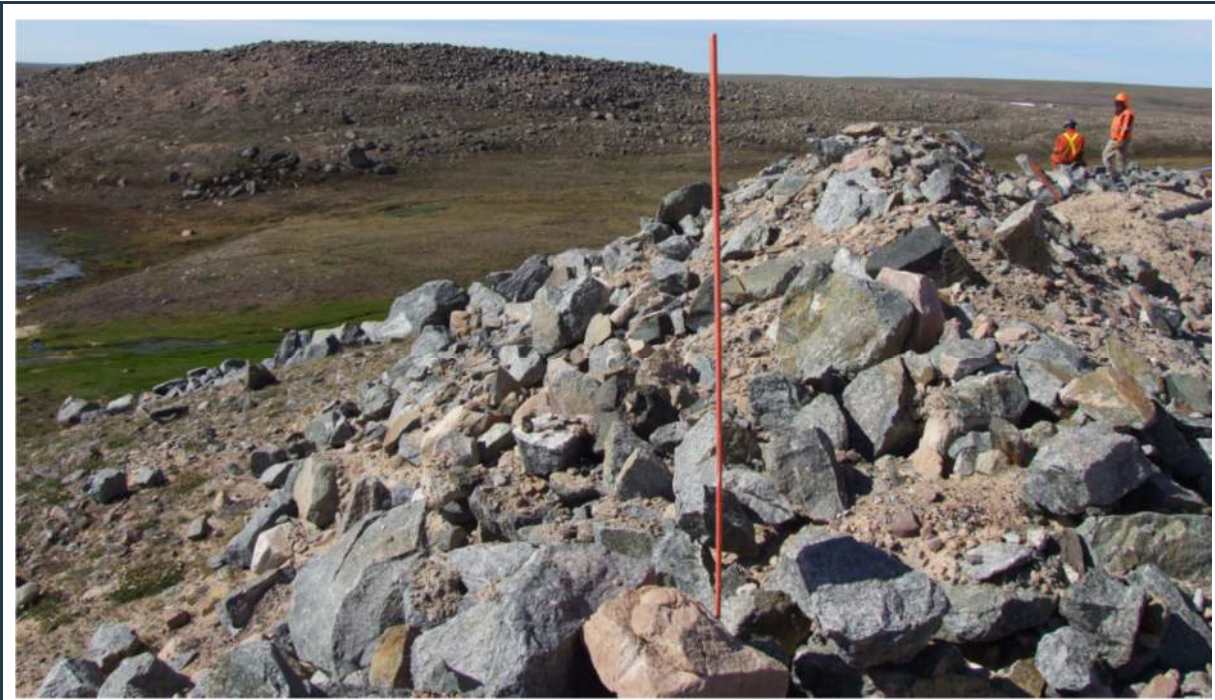
Figure 40: Water discharge area. Stable slope, comprising a mix of crushed rock and soils.

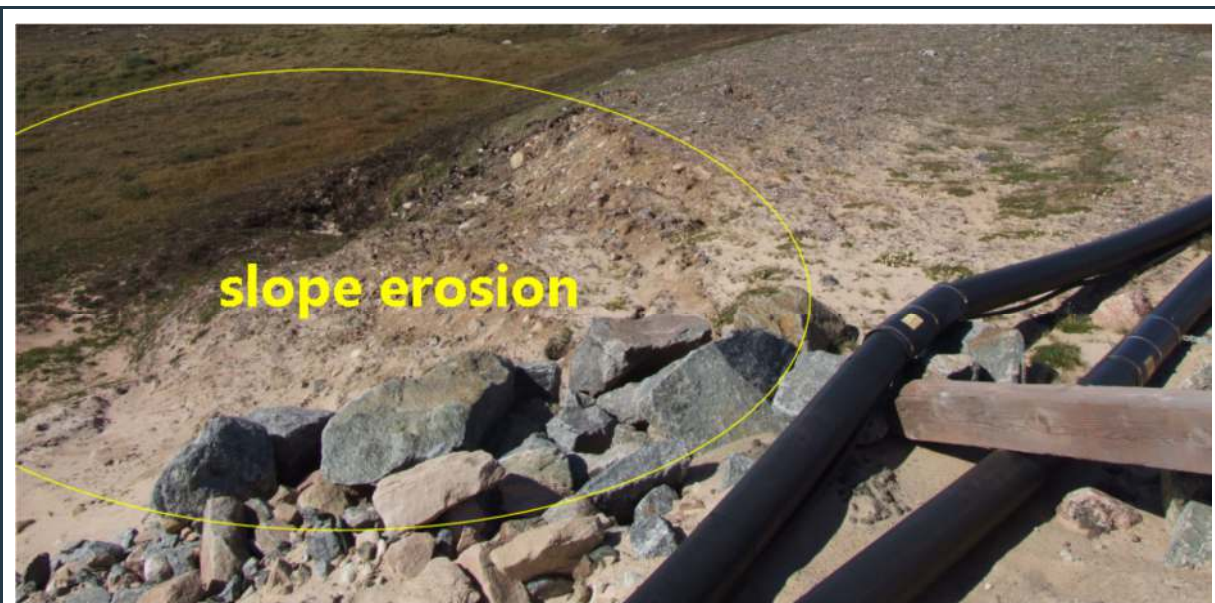
Figure 41: Minor slope erosion adjacent to the water discharge area.

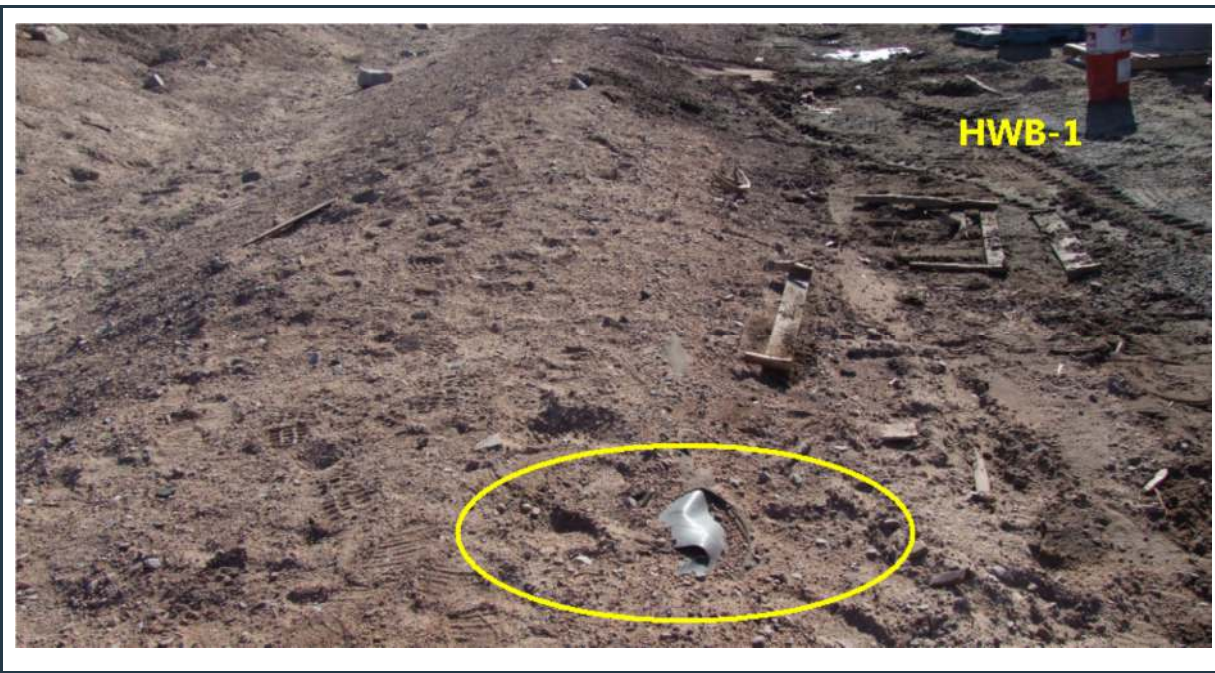
Figure 43: Ripped geotextile and exposed liner at the HWB-1 cell

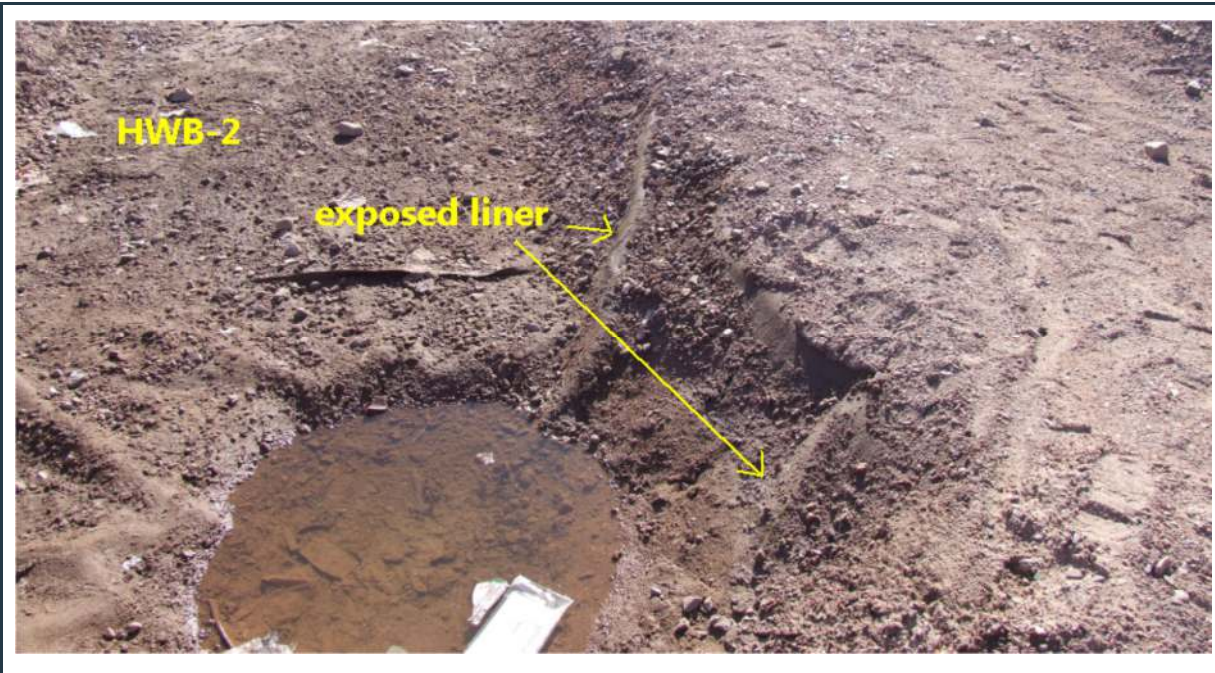
Figure 44: Small area of ponding water within the HWB-2 cell with locally exposed liner

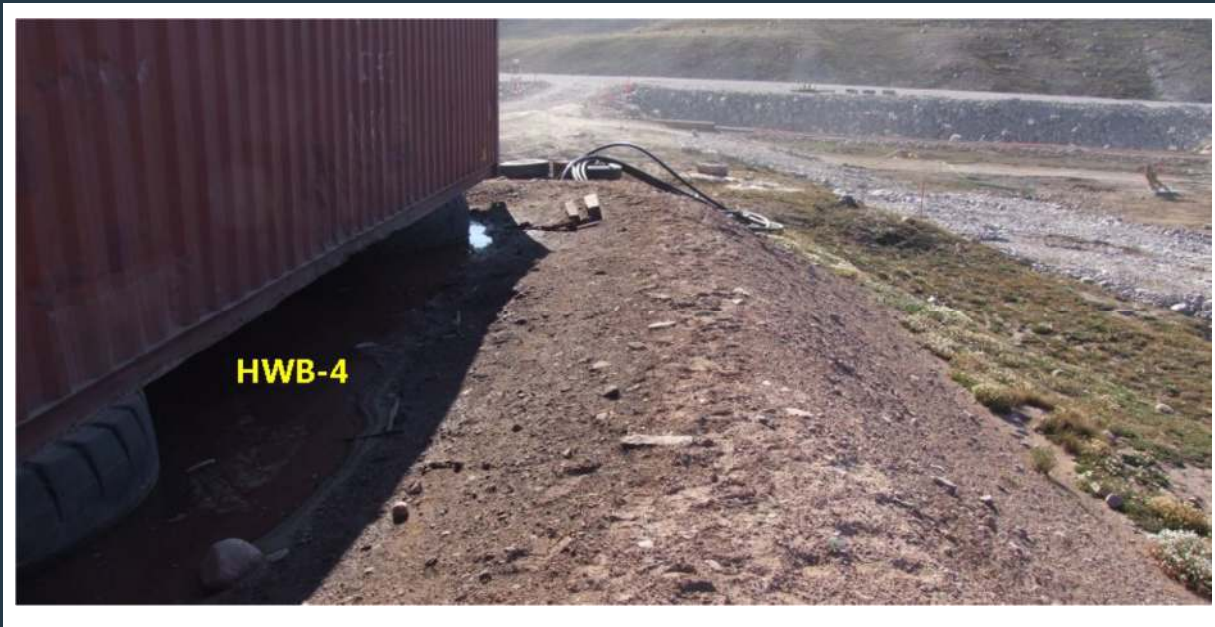
Figure 46: Stable berm at the HWB-4 pond

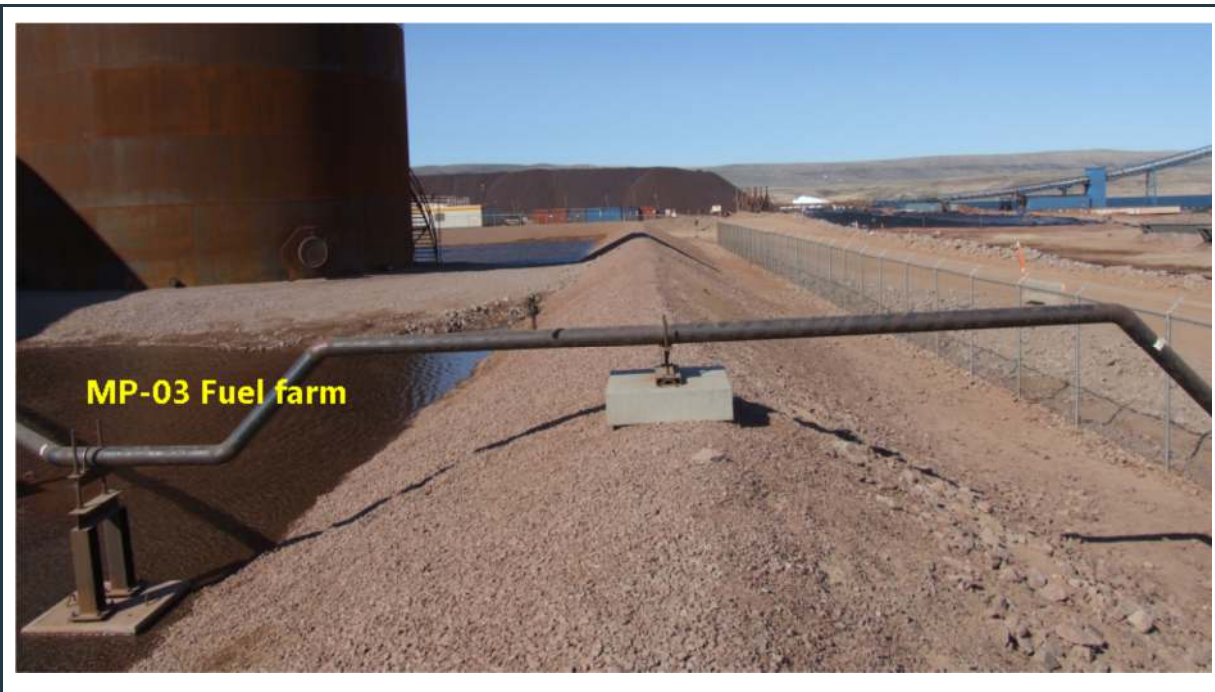
Figure 51: View of stable, well maintained berms around the MP-03 fuel tank farm

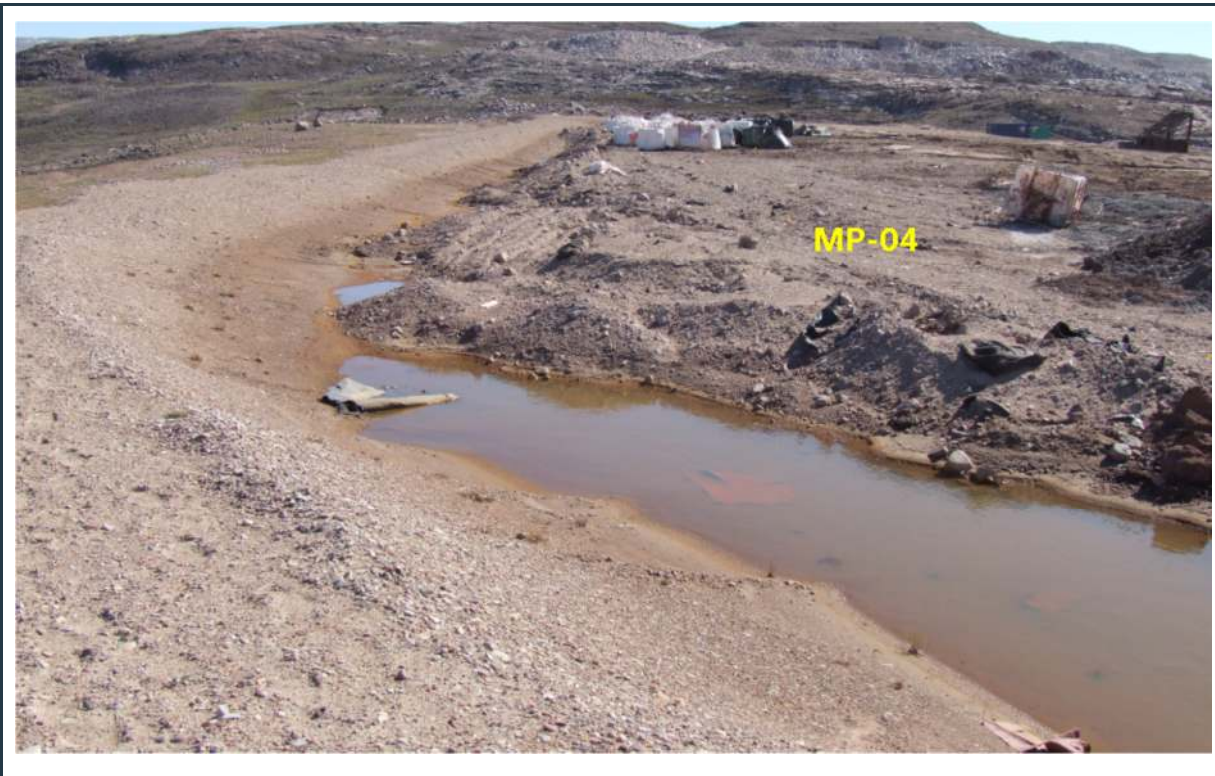
Figure 52: View of the waste and the stable berm at the MP-04 landfarm

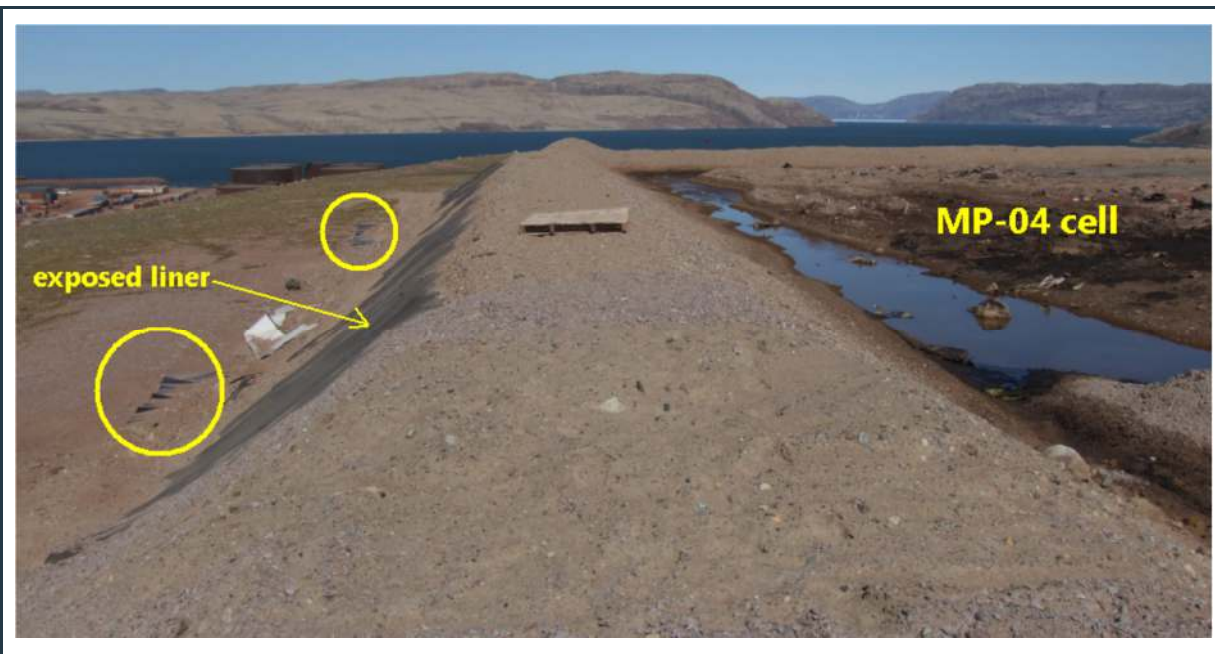
Figure 53: Stable berm at the MP-04 landfarm with exposed liner on the downstream face of the berm

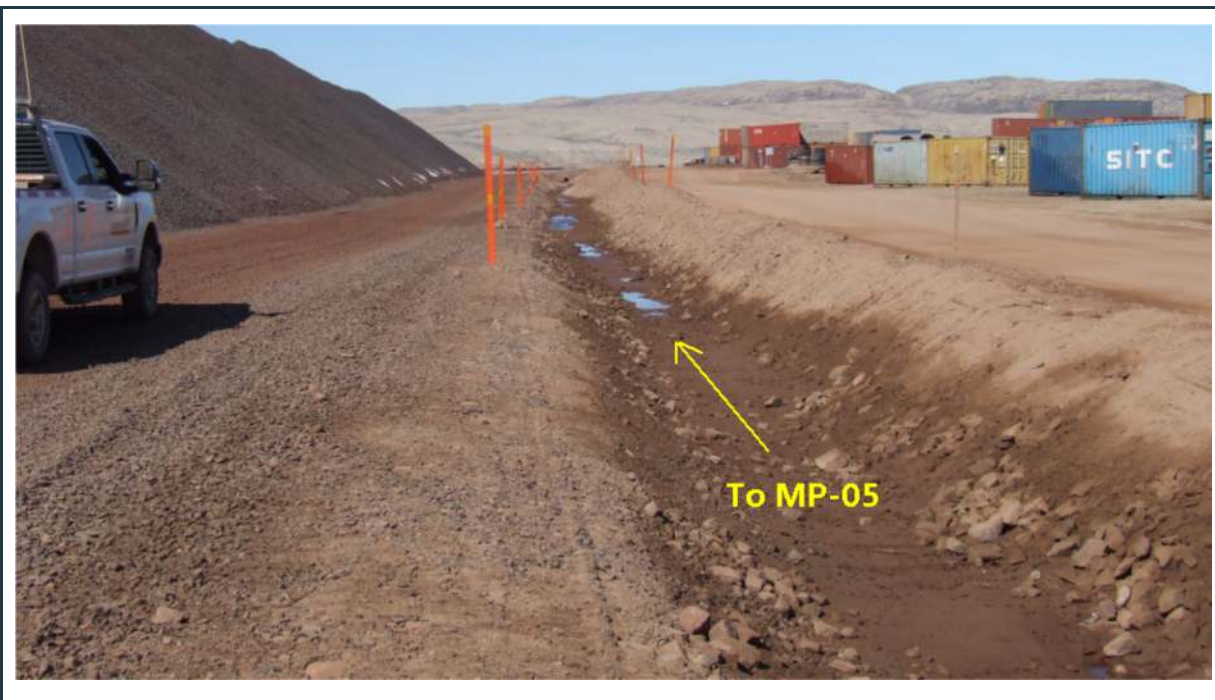
Figure 57: Surface water collection ditch adjacent to stored, crushed ore (leading to the MP-05 pond)

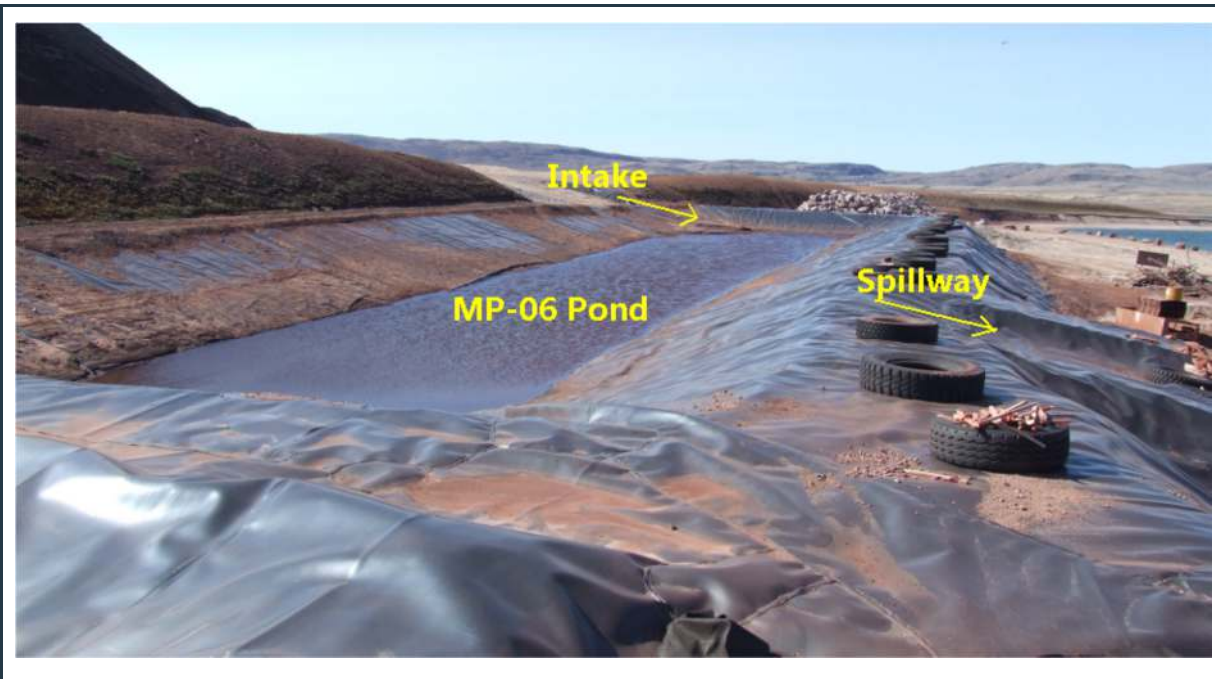
Figure 58: View of the MP-06 pond at the front of the north-west corner of the ore stockpile

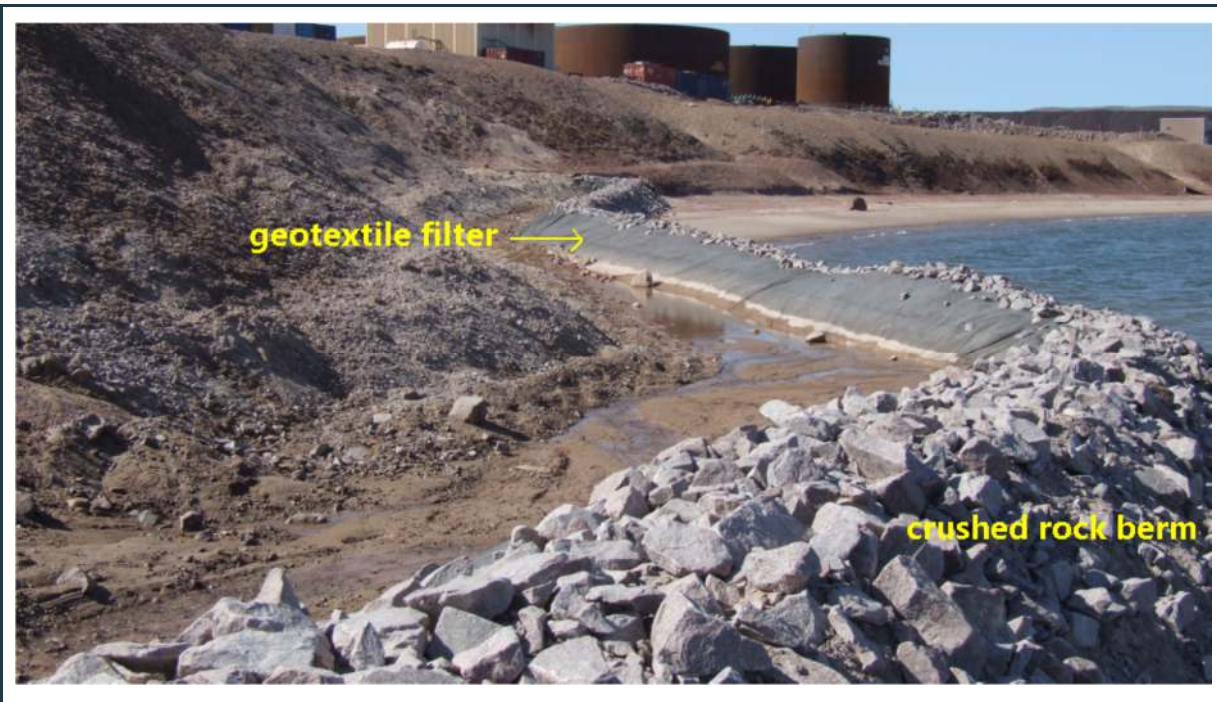
The freight dock check dam is a newly constructed structure comprising a crushed rock fill berm with geotextile cover on its upstream slope, as shown in Figure 61. This structure collects fine-grained soil particles (silt and clay) that may erode down from the port site and from the adjacent slope located along the bay's shore, approximately at the front of the HWB-1 pond. The berm/dam appears to be stable for intended purpose. It is suggested, however, that its condition be monitored during ice formation in the bay and check its resistance against the impact of ice forces.

Figure 61: View of the freight dock check dam/berm with geotextile filter on the upstream face of the crushed rock berm, to retain silt

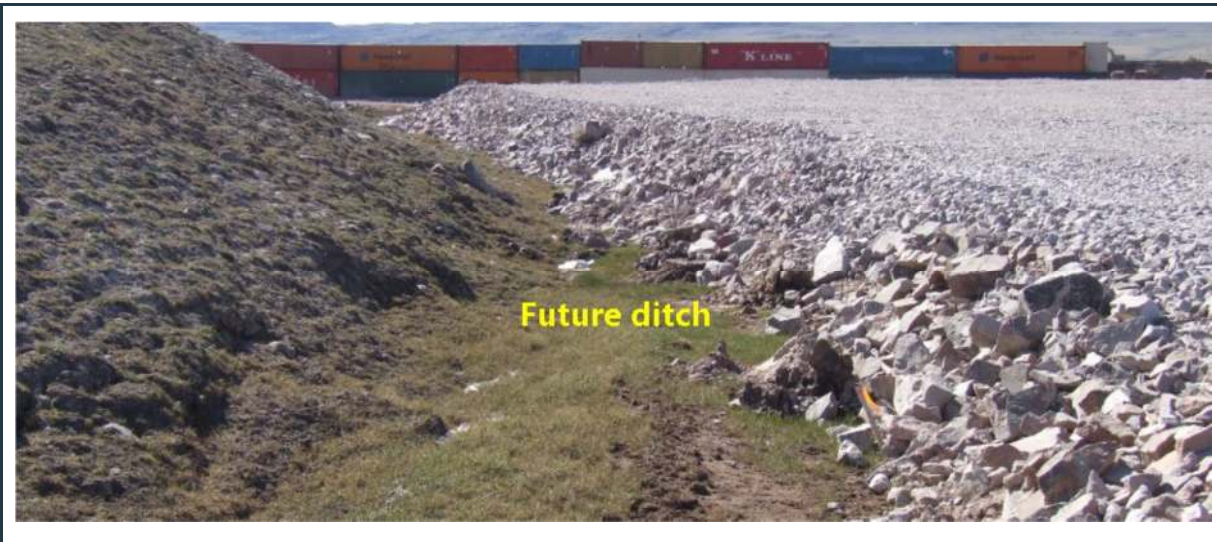
There are several water collection drainage ditches (listed above), most of them still under construction or improvement, as shown in Figures 62 to 67. These open ditches are excavated somewhat into the native soils and then their sides and inverts receive erosion protection layers composed of fine crushed rock. It was noted during the inspection that geotextile have been used wherever the native subgrade composed of fine-grained material to prevent migration of fines into the rockfill. The condition of these ditches should be monitored, particularly prior to the spring freshet, and any potential slope deterioration should be rectified prior to the anticipated increased flow during the thaw period of the year.

Figure 62: Future "P-SWD-3 LP2" surface water collection ditch – under construction

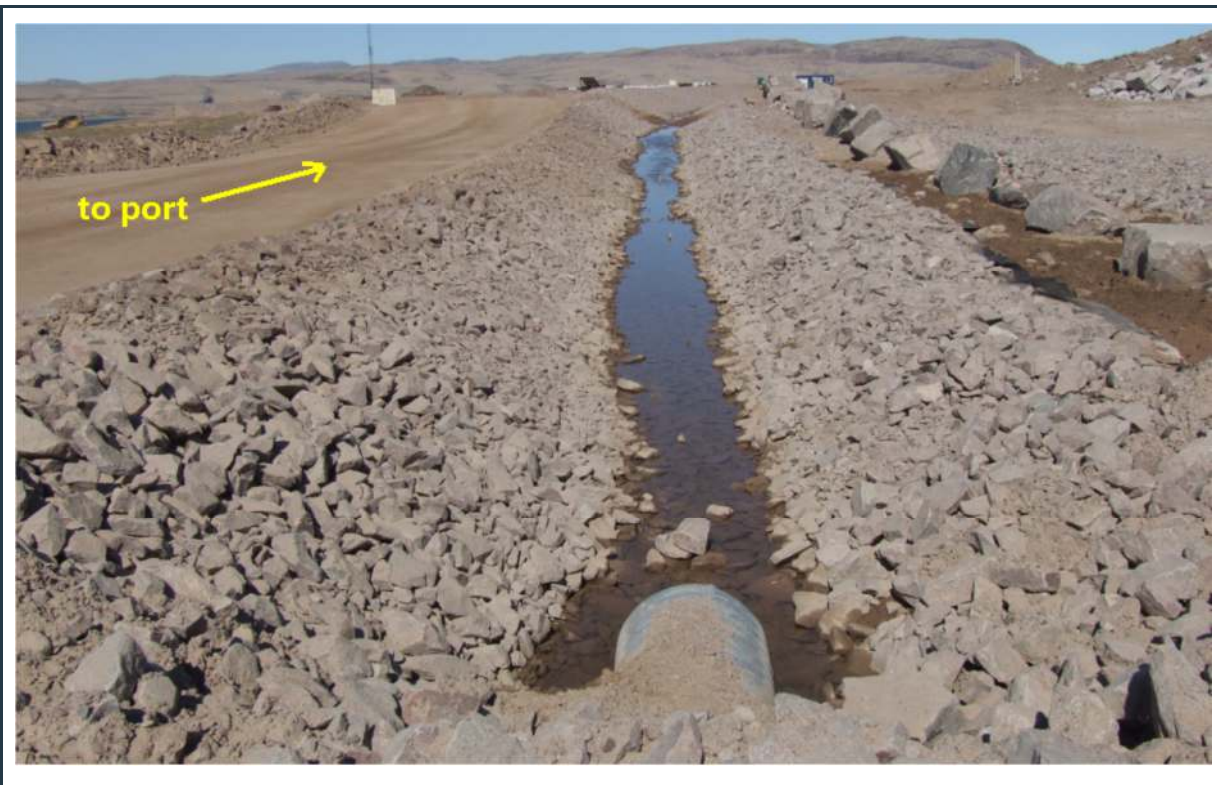
Figure 63: P-SWD-5 Q1 North surface water collection ditch

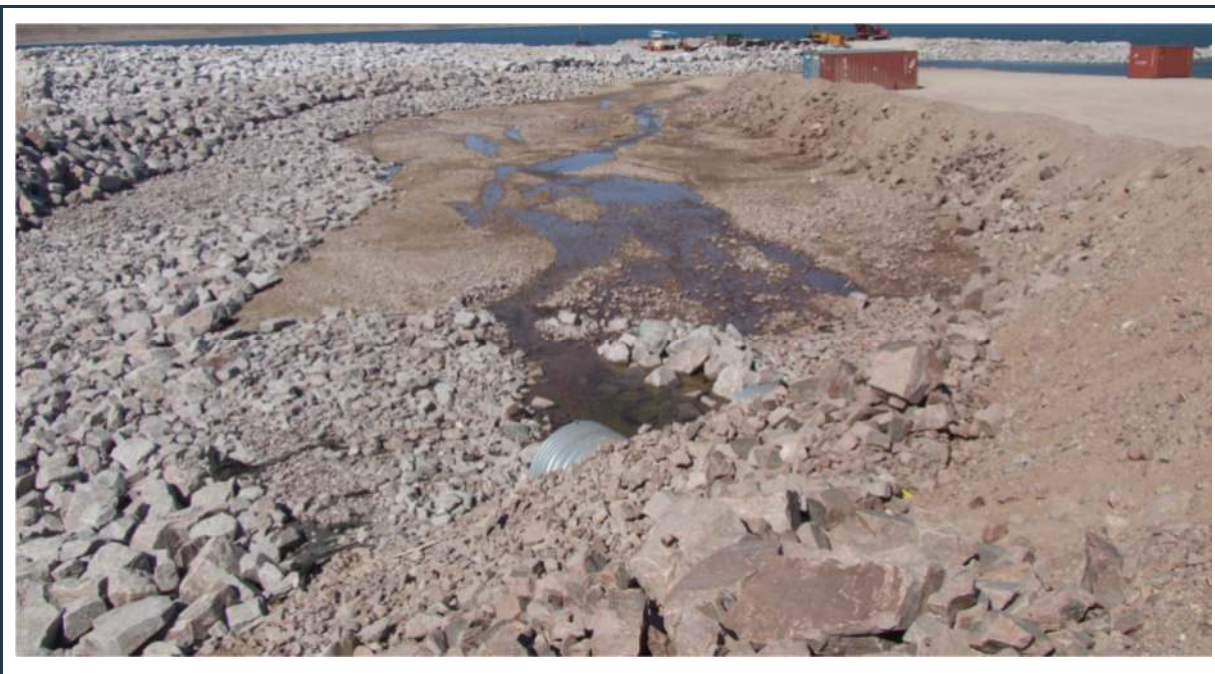
Figure 65: P-SWD-7 surface water collection ditch adjacent to the new freight dock (under construction)

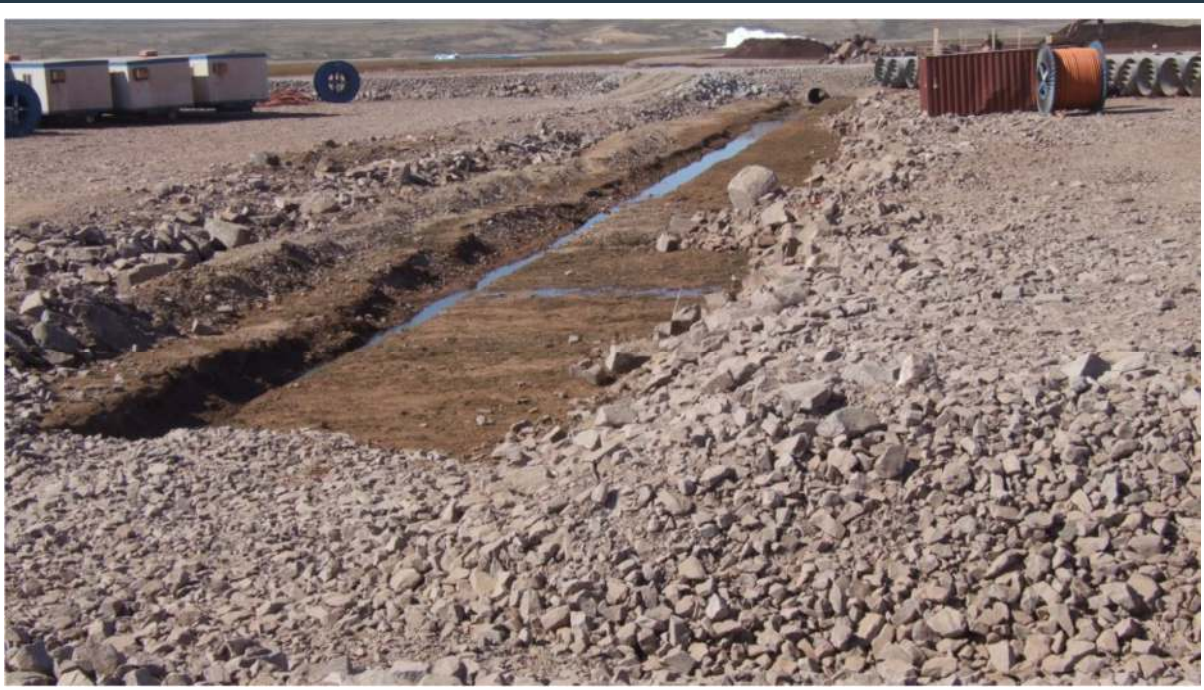
Figure 66: W13-W14 surface water collection ditch (under construction)

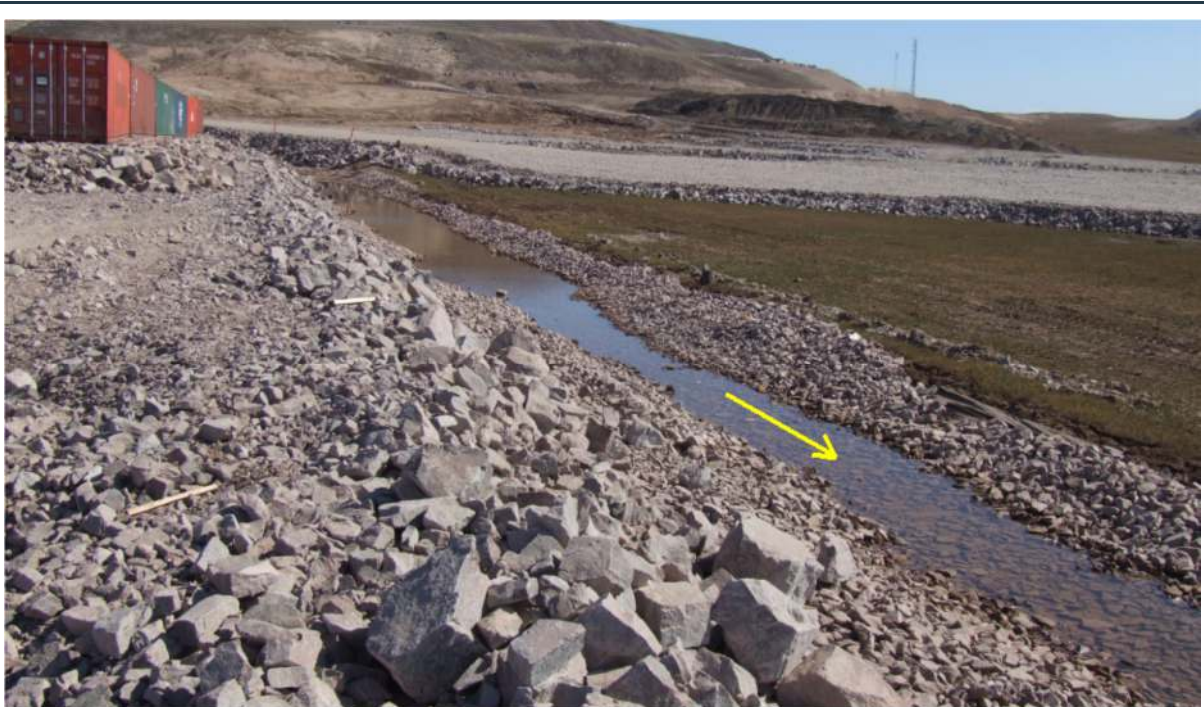
Figure 67: 380 M surface water collection ditch (under construction)

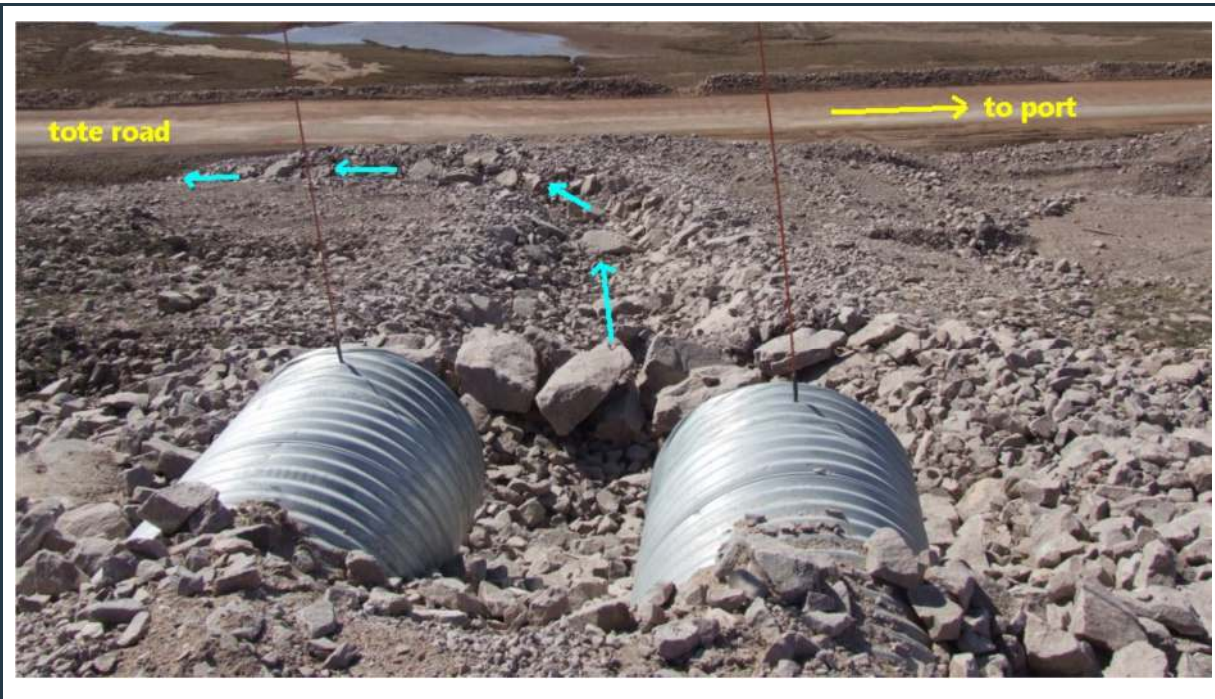
Figure 68: Culverts and drainage ditch, conveying surface water from higher elevation toward the road

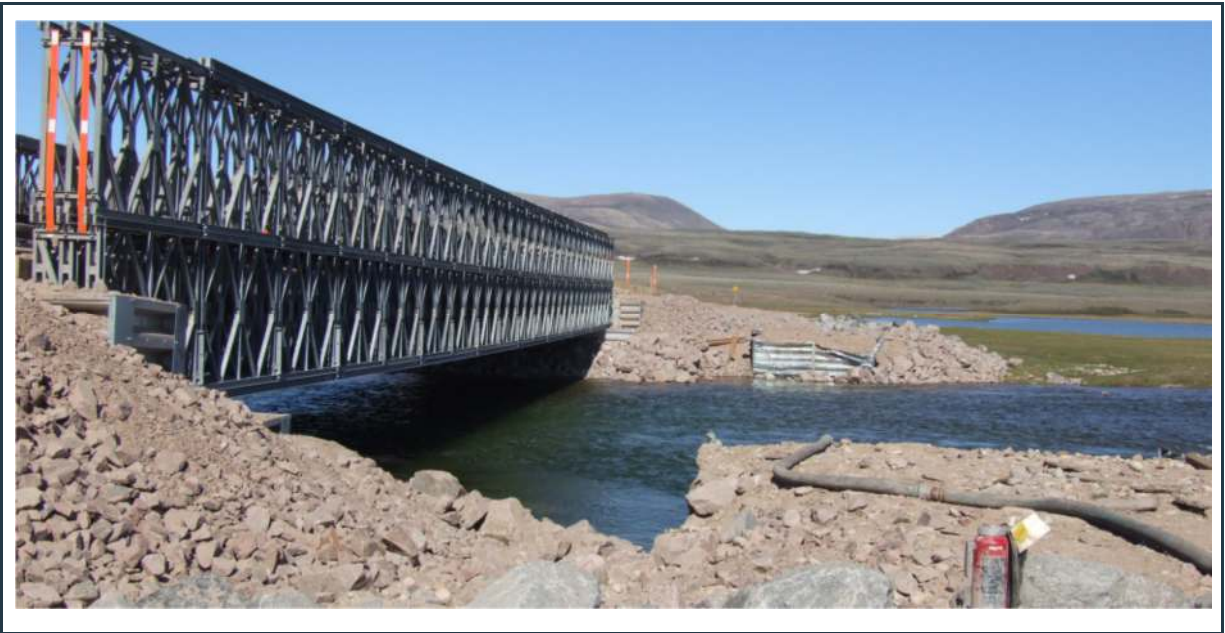
As shown in Figures 72 to 75, the abutments of this bridge are stable and no scour in the river-bed was noted during the site visit. The abutments show no differential settlement or any structural discrepancy, like cracking on the foundation concrete. There are two historic abutments, located immediately adjacent to the "new" ones. The metal front and wing walls of both "old" abutments have suffered damages in the past, particularly the south abutment, as shown in Figure 75. That image also shows that a pump is operated on the top of the abutment, supplying water to the water trucks from the river (used for dust control on the road).

Figure 72: View of bridge 17 (17 km from the port), looking north-east

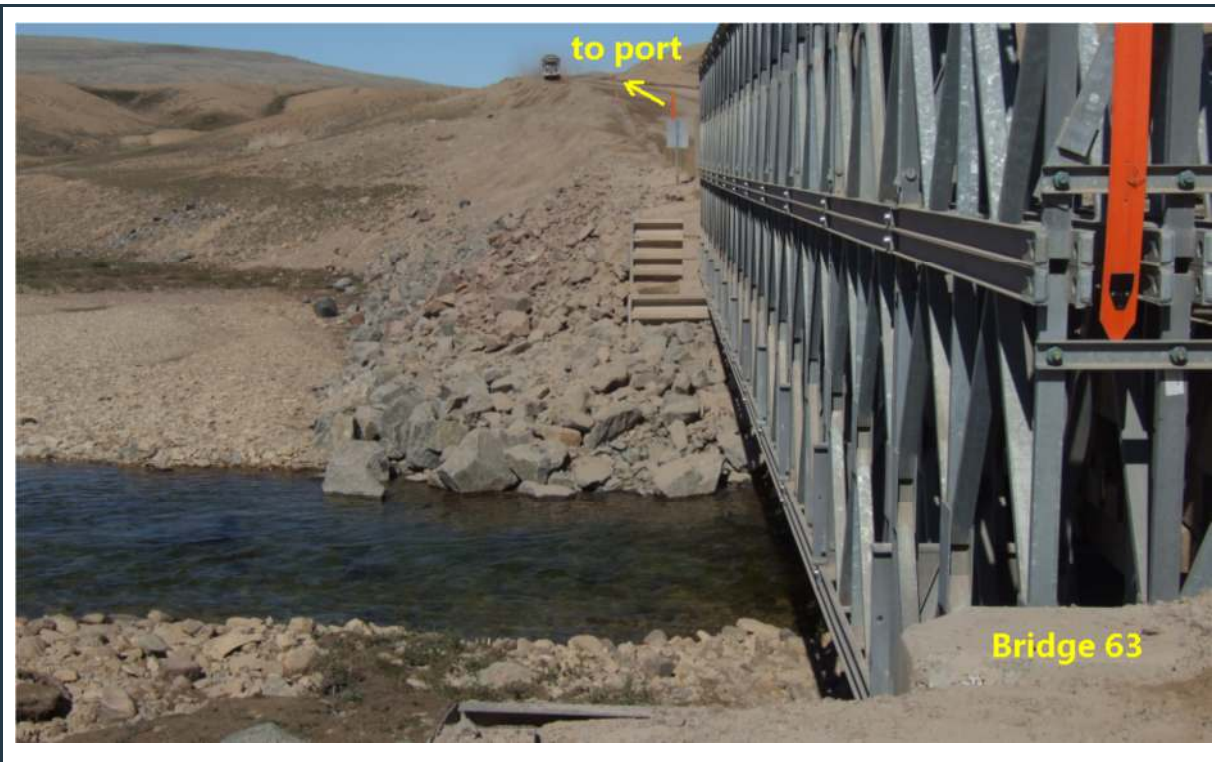
As shown in Figures 76 to 78, the abutments of this bridge are stable and no scour in the river-bed was noted during the site visit. The abutments show no differential settlement or any structural discrepancy like cracking on the foundation concrete. The wing-wall at the north-west abutment appears to be short and minor erosion of the road fill was noticed (Figure 78). At that location a metal section should be added to the wing-wall or alternatively some rock-fill be placed there to prevent soil erosion from the road into the river.

Figure 76: View of bridge 63, looking north
