Geotechnical Inspection Report

RE: Submission of 2019 Geotechnical Inspection Report No. 1 (July 2019)

Annual Geotechnical Inspections – 2019 Report 1. Mary River Iron Mine Complex – Nunavut

Annual Geotechnical Inspections – 2019 Report 2. Mary River Iron Mine – Nunavut

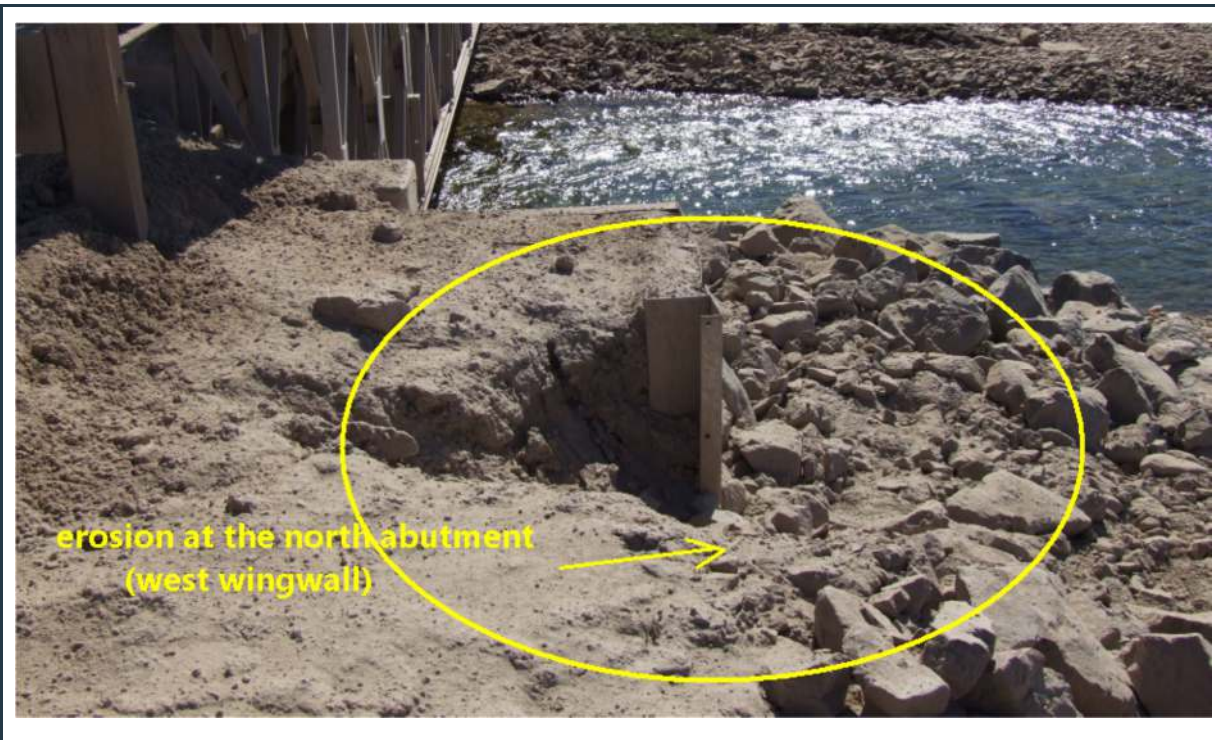
As shown in Figures 76 to 78, the abutments of this bridge are stable and no scour in the river-bed was noted during the site visit. The abutments show no differential settlement or any structural discrepancy like cracking on the foundation concrete. The wing-wall at the north-west abutment appears to be short and minor erosion of the road fill was noticed (Figure 78). At that location a metal section should be added to the wing-wall or alternatively some rock-fill be placed there to prevent soil erosion from the road into the river.

Figure 78: Minor erosion at the north-west wingwall at bridge 63

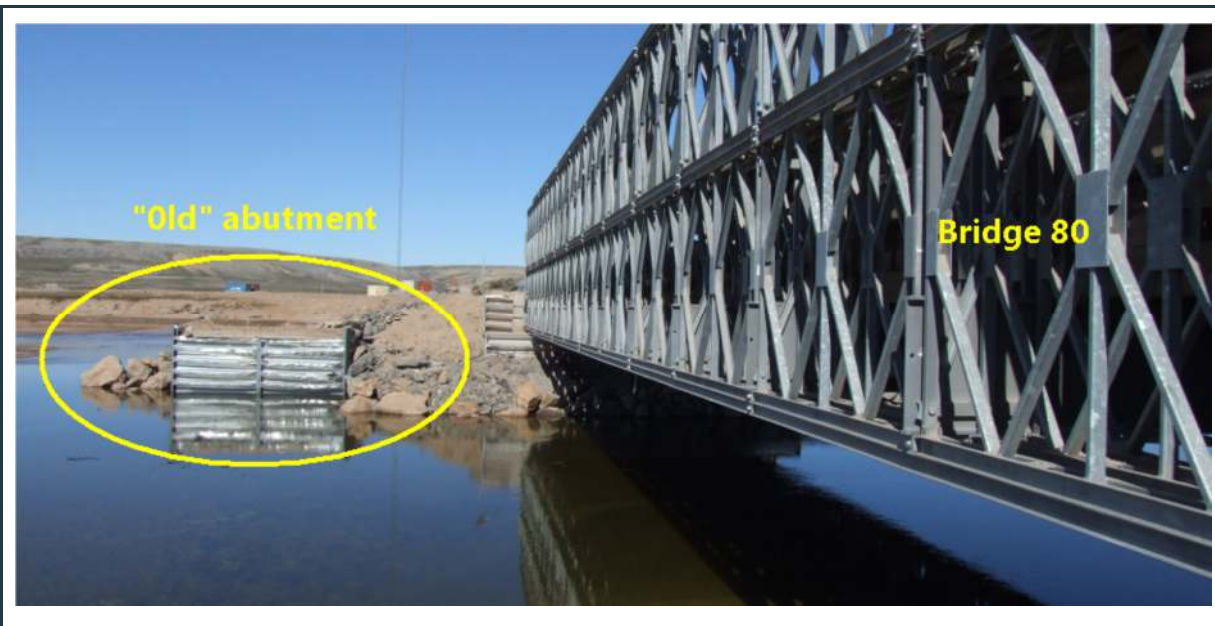
As shown in Figure 79, the abutments of this bridge are stable and no scour in the river-bed was noted during the site visit. The abutments show no differential settlement or any structural discrepancy like cracking on the foundation concrete.

Figure 79: View of bridge 80 with one of the old abutments, looking north

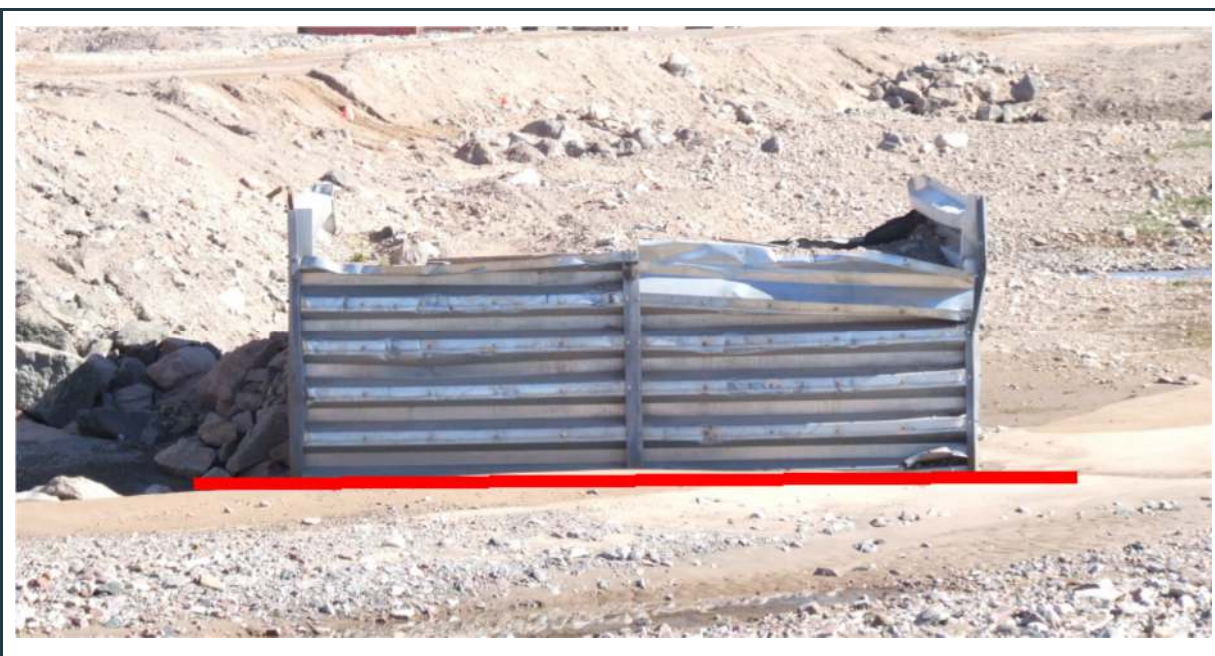
As shown in Figure 80 and 81, the abutments of this bridge are stable and no scour in the river-bed was noted during the site visit. The abutments show no differential settlement or any structural discrepancy like cracking on the foundation concrete.

Figure 81: One of the "old" abutments at bridge 97. The section above the red-line may be removed, but the removal is not necessary.

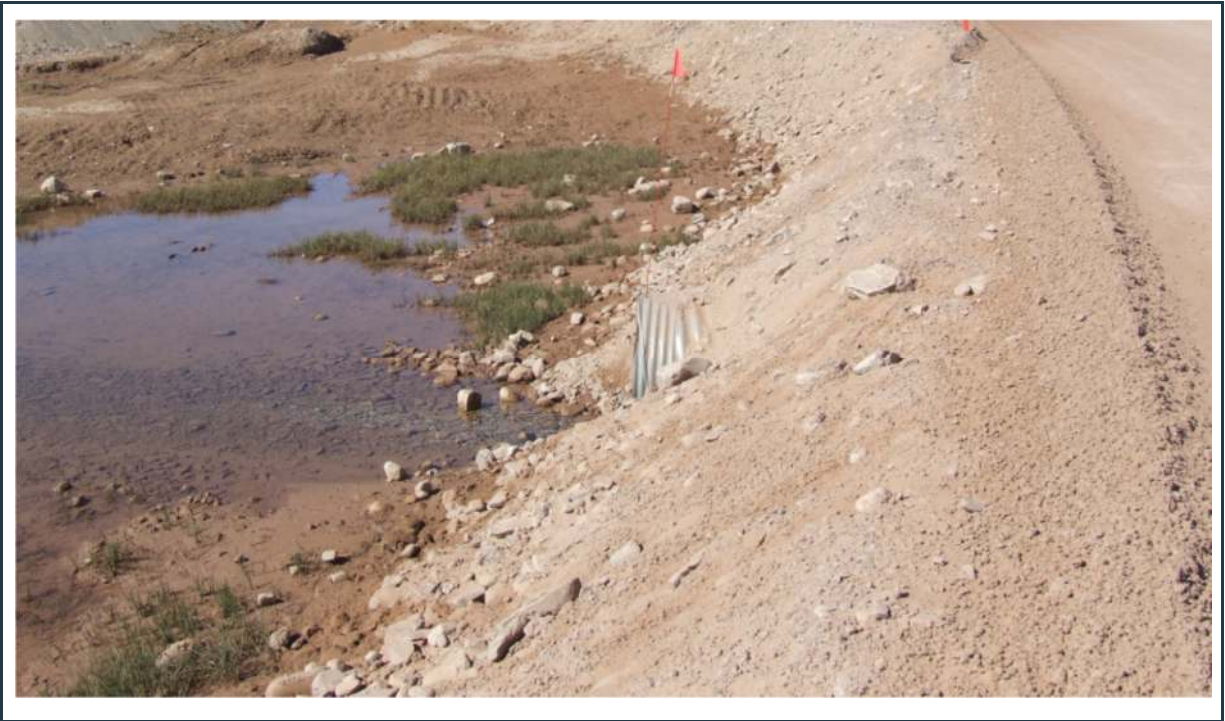
Figure 82: View of culvert 076 (outlet)

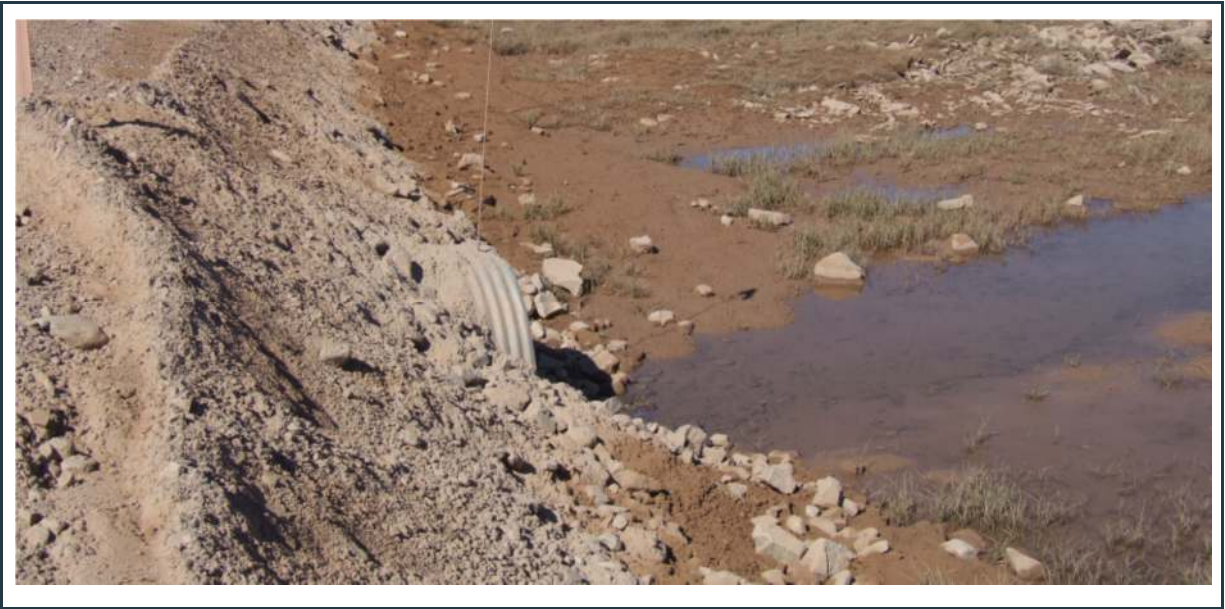
Figure 83: View of culvert 076 (inlet)

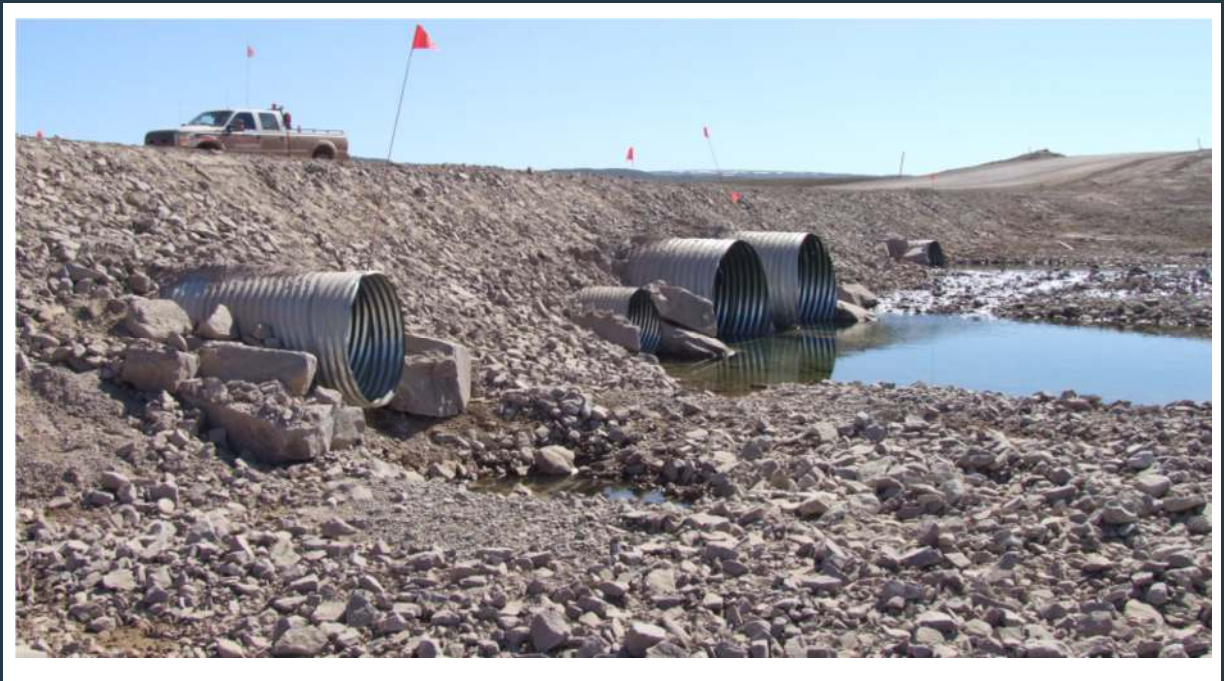
Figure 84: View of culvert(s) 078 (outlet)

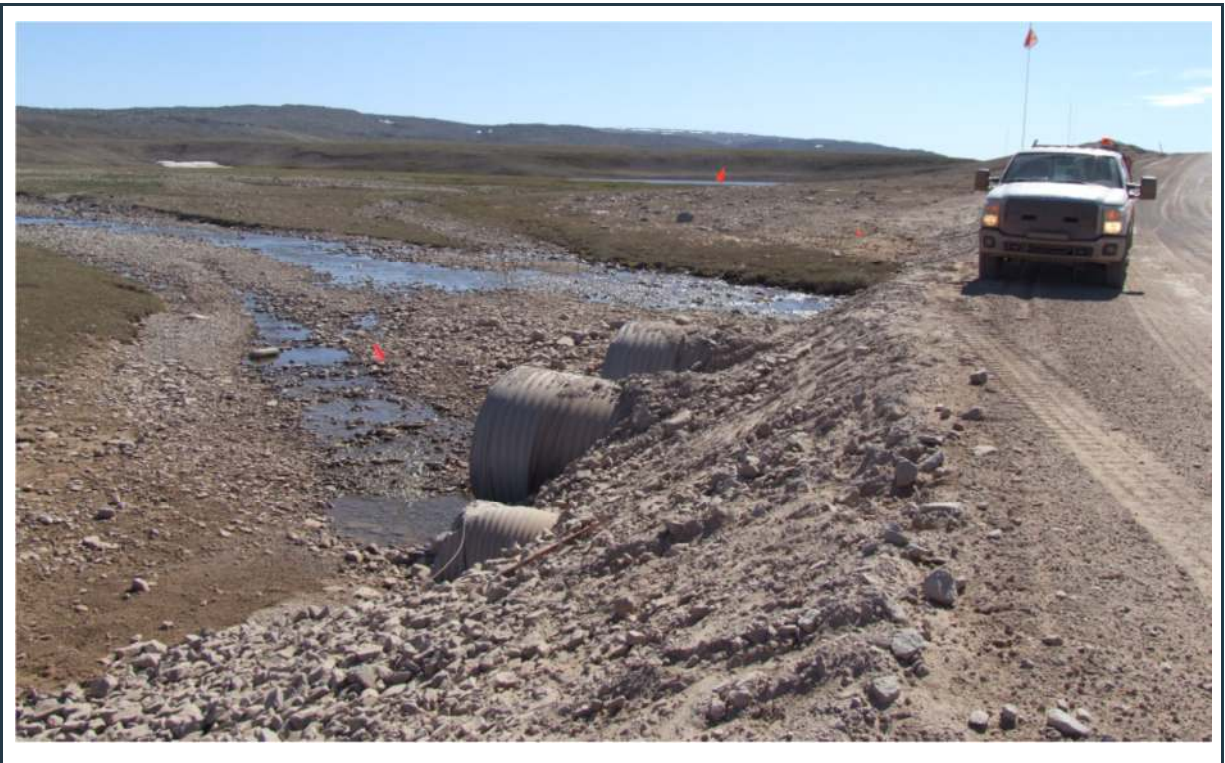
Figure 85: View of culvert(s) 078 (inlet)

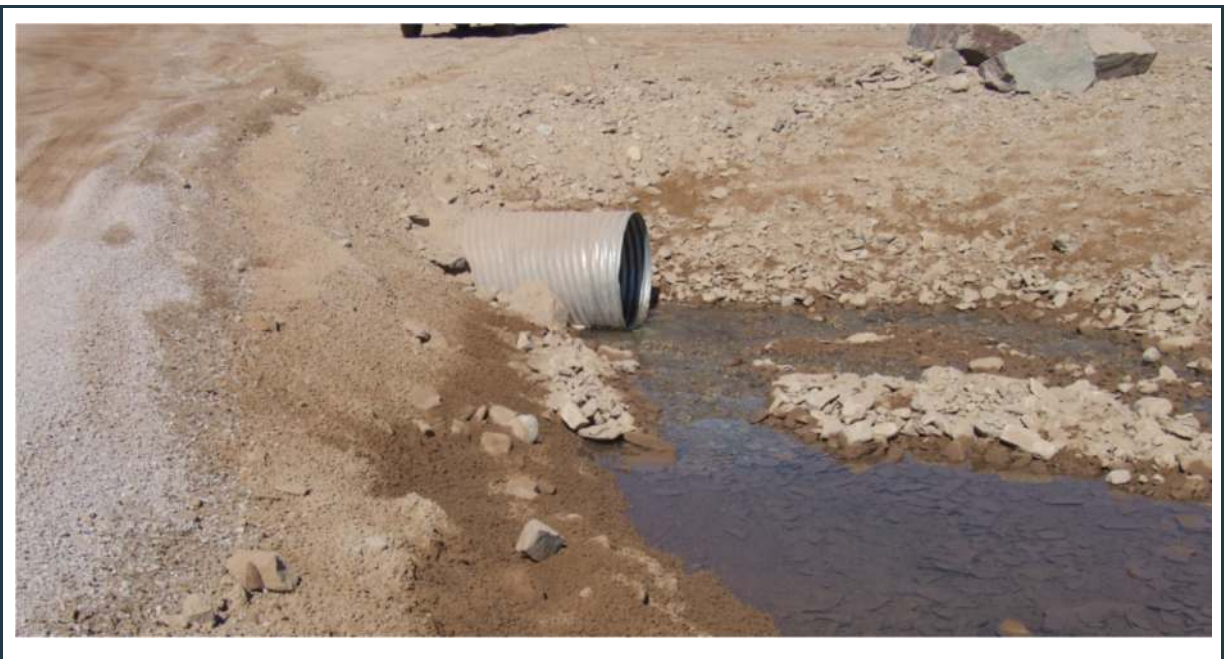
CV-083 (Figures 86 and 87): The outlet of this culvert appears to be short. It should be extended by about 1.5 m and the adjacent road embankment shall be upgraded to a more stable slope with the placement of crushed stone. Crushed rock fill should also be placed adjacent to the culvert at its inlet, to prevent erosion of the road embankment by the flowing water in the creek. Improvement of the creek's alignment at the front of the inlet is also recommended (minimize water flow parallel with the embankment at its toe, to prevent toe erosion and subsequent potential slope instability).

Figure 87: View of culvert 083 (inlet)

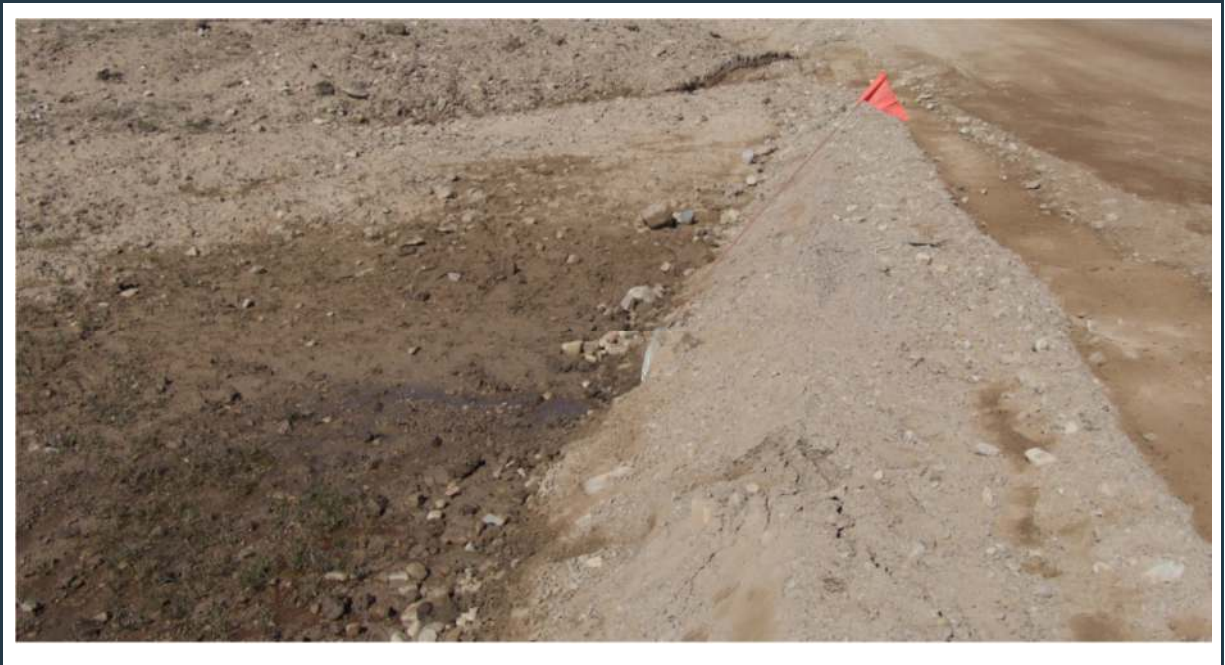
CV-107 (Figures 92 and 93): Both ends of this culvert are short, particularly at the inlet side. Consideration shall be given to replace this culvert with a longer and somewhat larger pipe. It is visible in Figure 93 that the inlet's invert is currently located above the water level, resulting in ponding water at the front of the inlet. A larger and longer pipe would facilitate uninterrupted flow of water from upstream to the other side of the road.

Figure 92: View of culvert 107 (outlet)

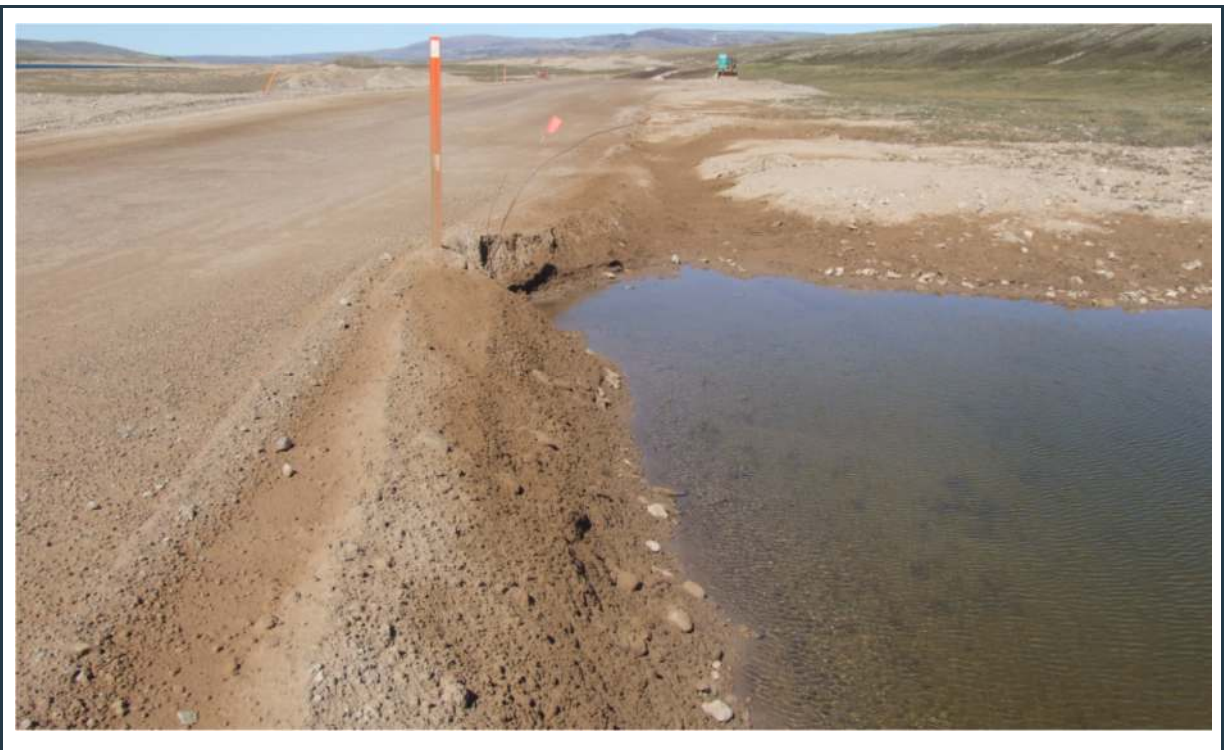
Figure 93: View of culvert 107 (inlet). Extension of the culvert is required.

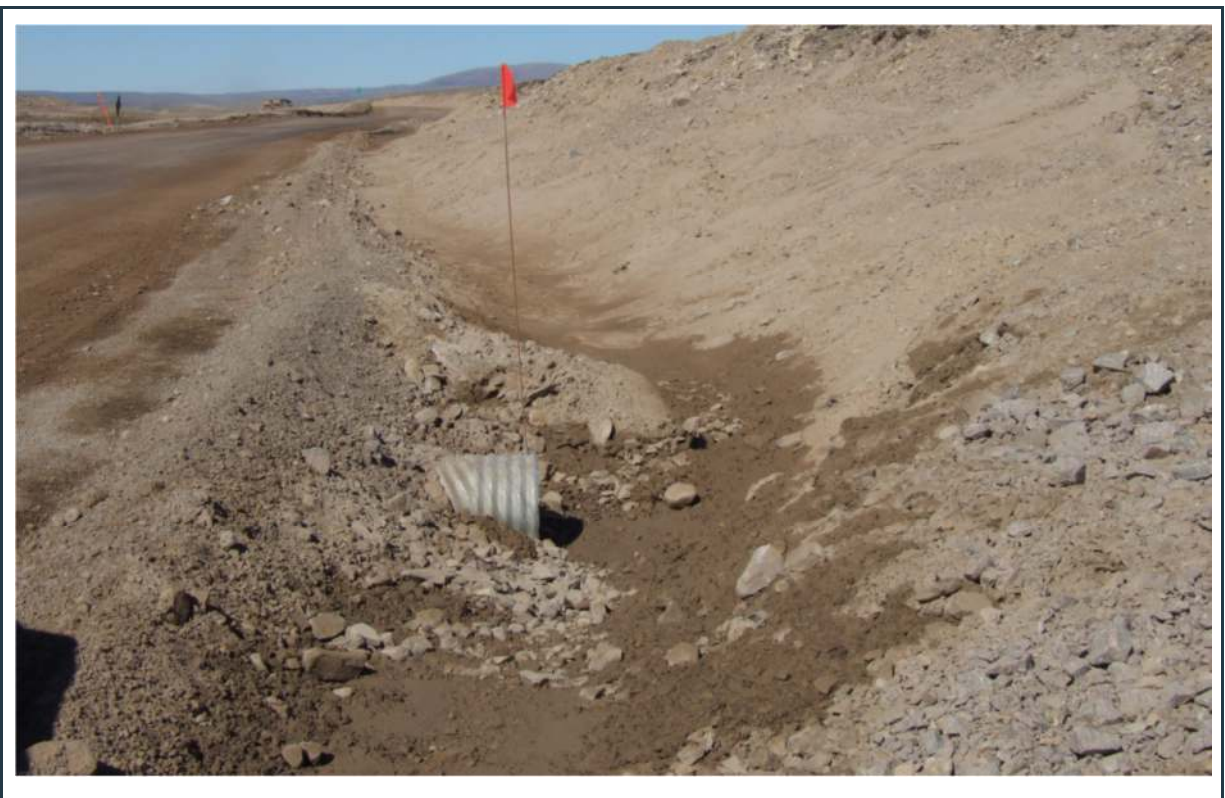
Figure 95: View of culvert 110A (inlet) in good condition

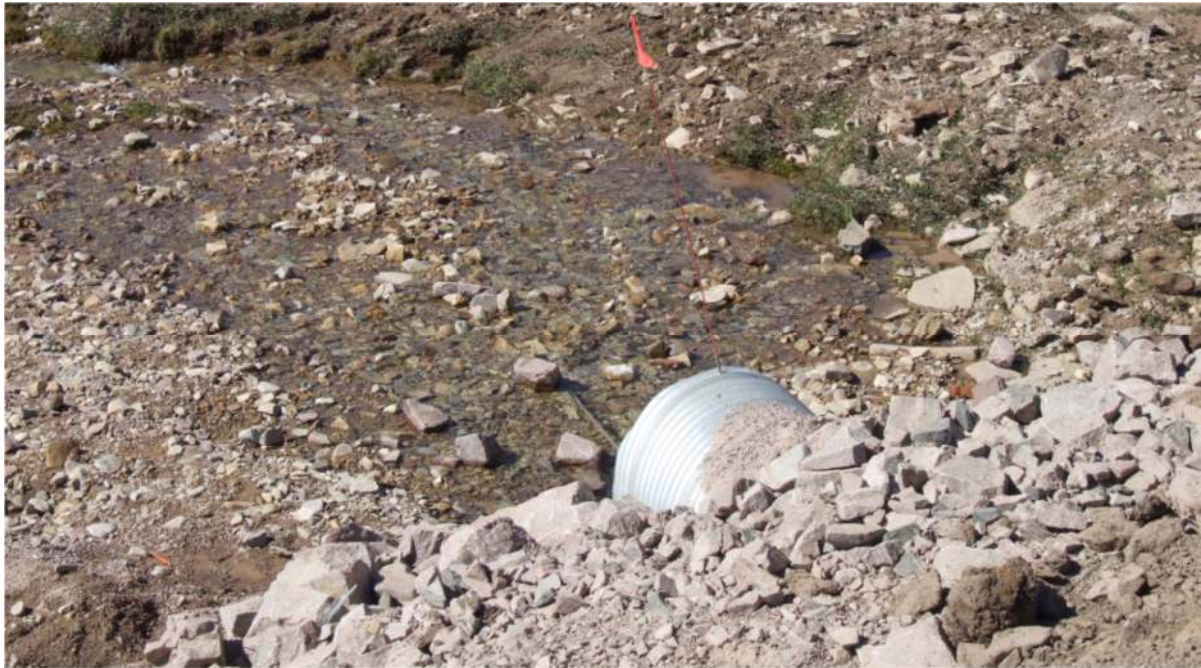
Figure 96: View of culvert 111 (outlet)

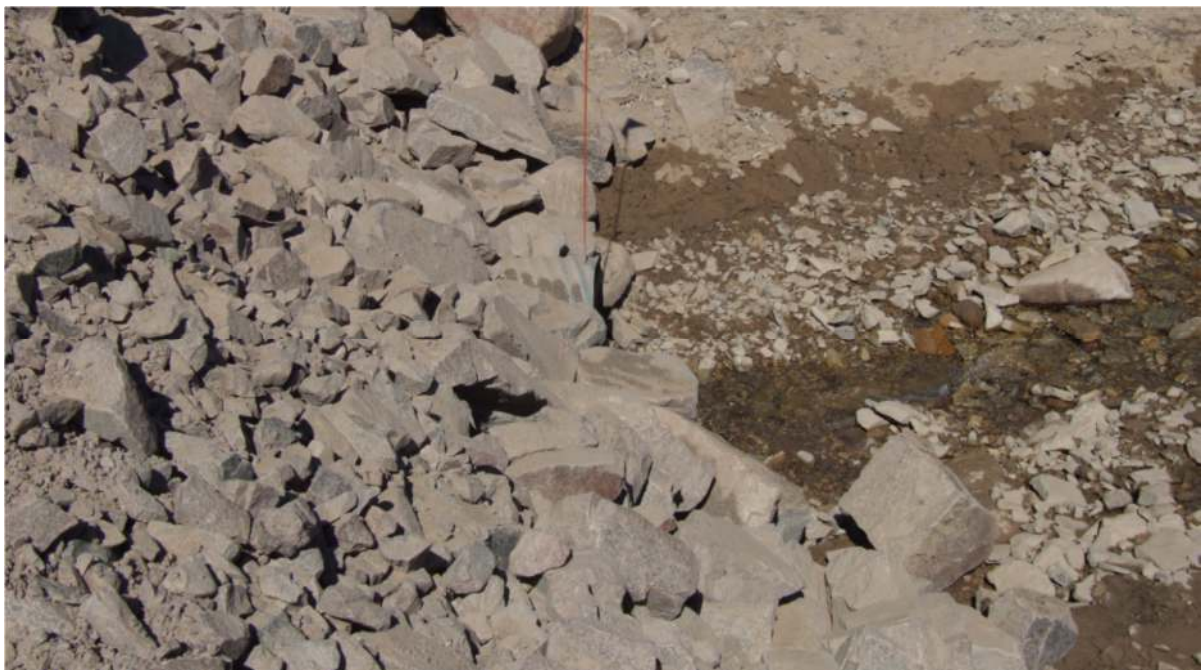
Figure 97: View of culvert 111 (inlet)

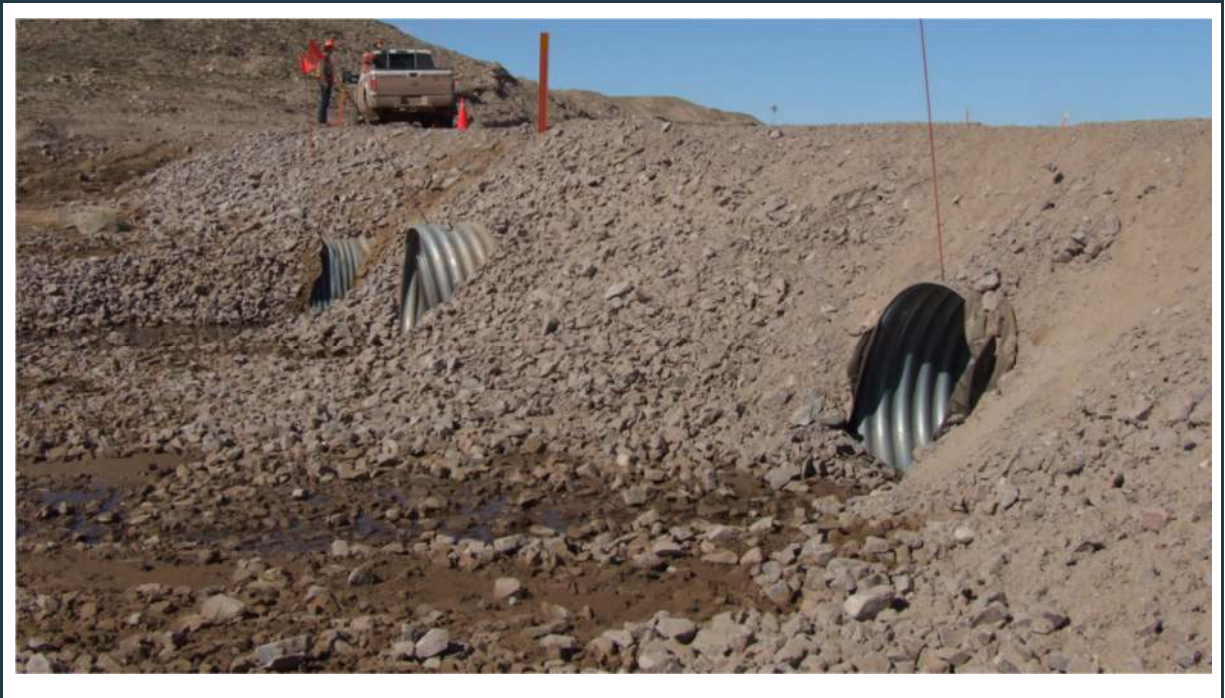
Figure 98: View of culvert(s) 112D (outlet)

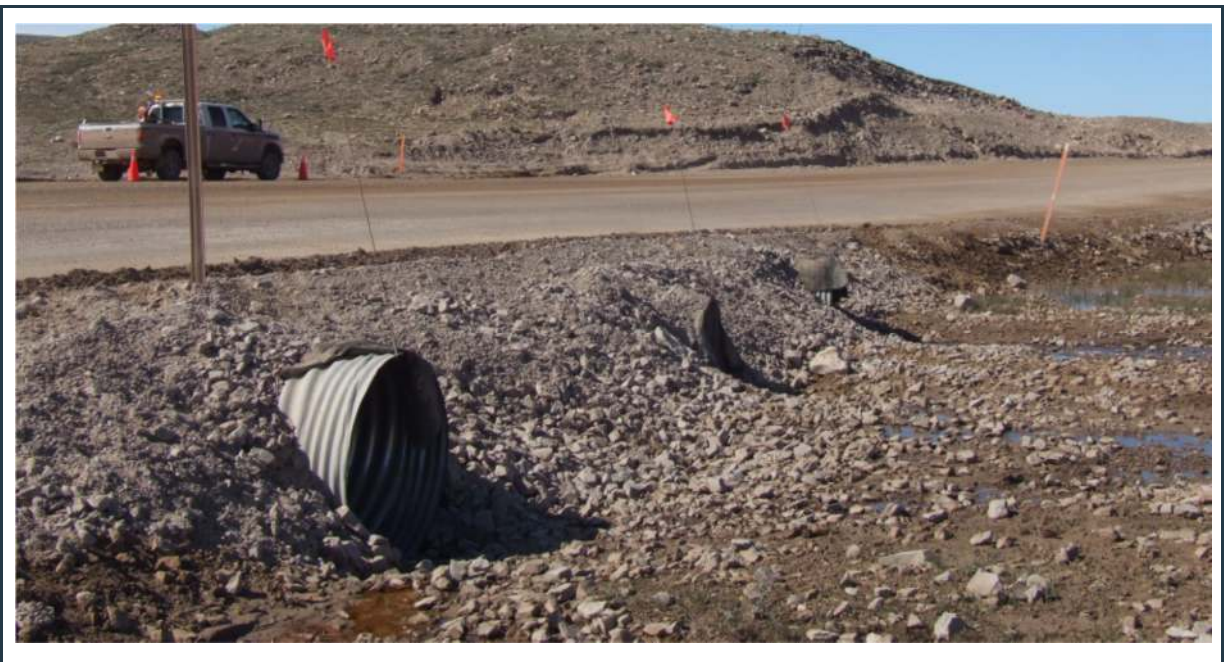
Figure 99: View of culvert(s) 112D (inlet)

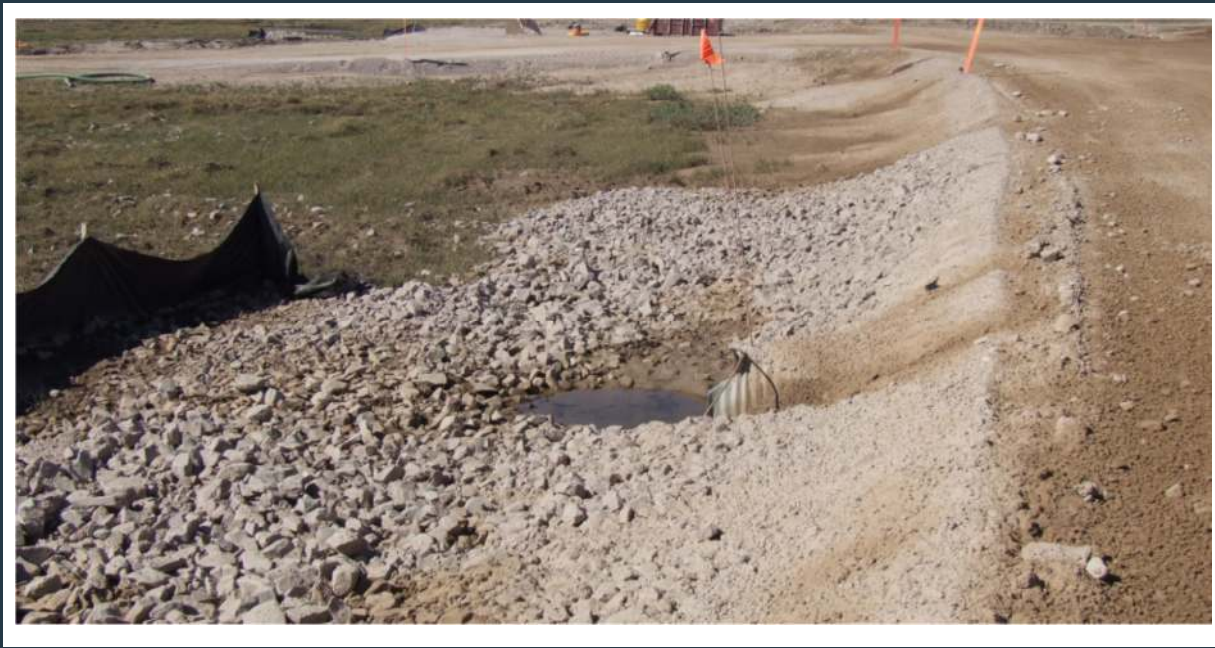
Figure 102: View of culvert 202 (outlet)

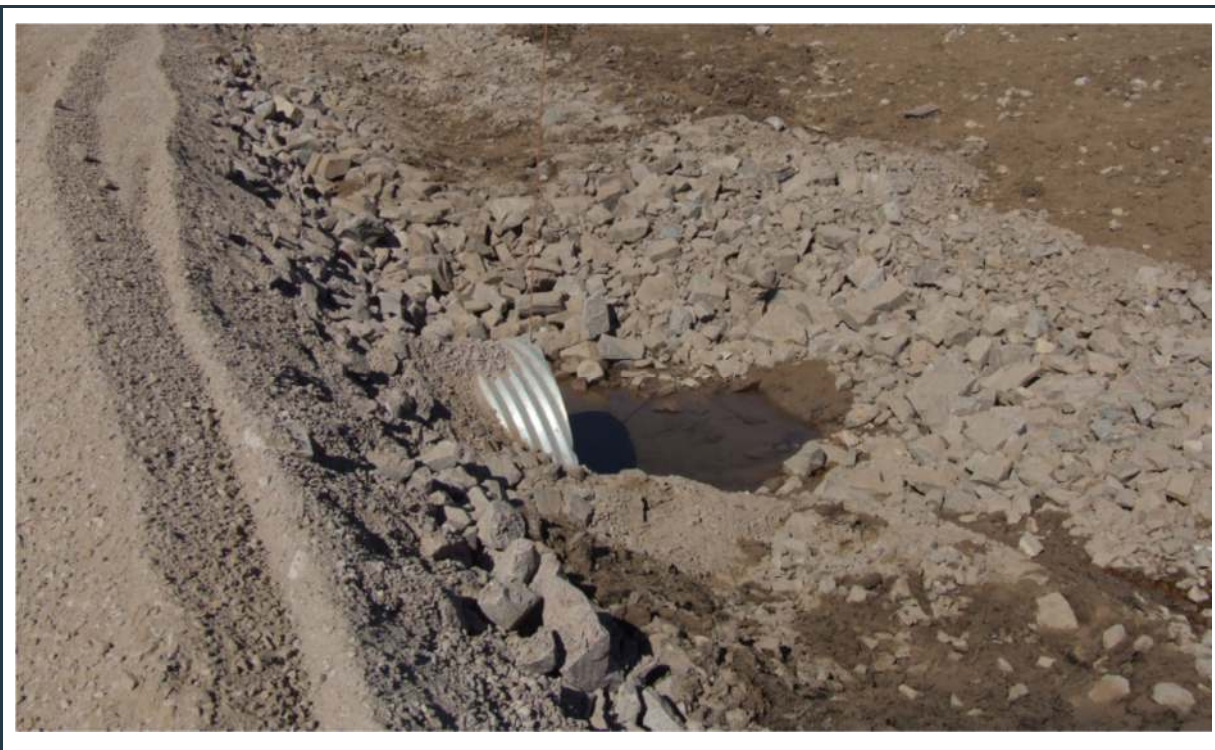
Figure 103: View of culvert 202 (inlet)

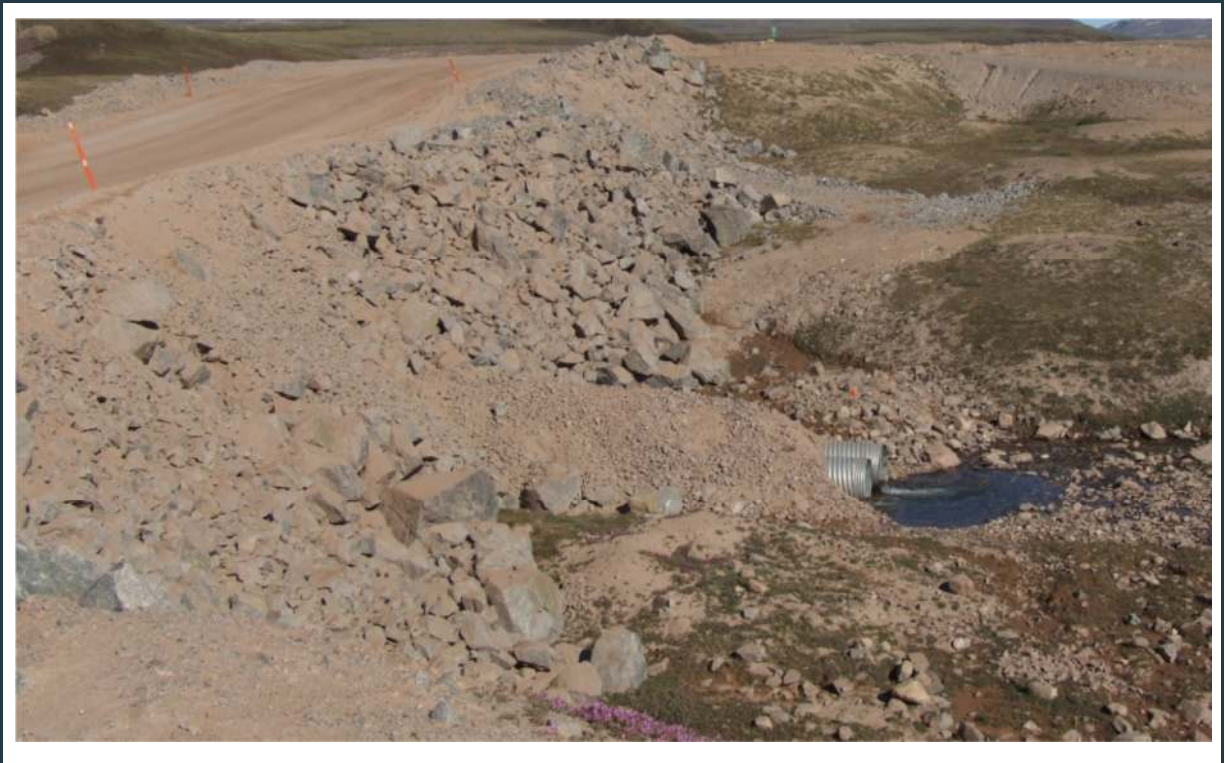
Figure 104: View of culvert 225 (outlet)

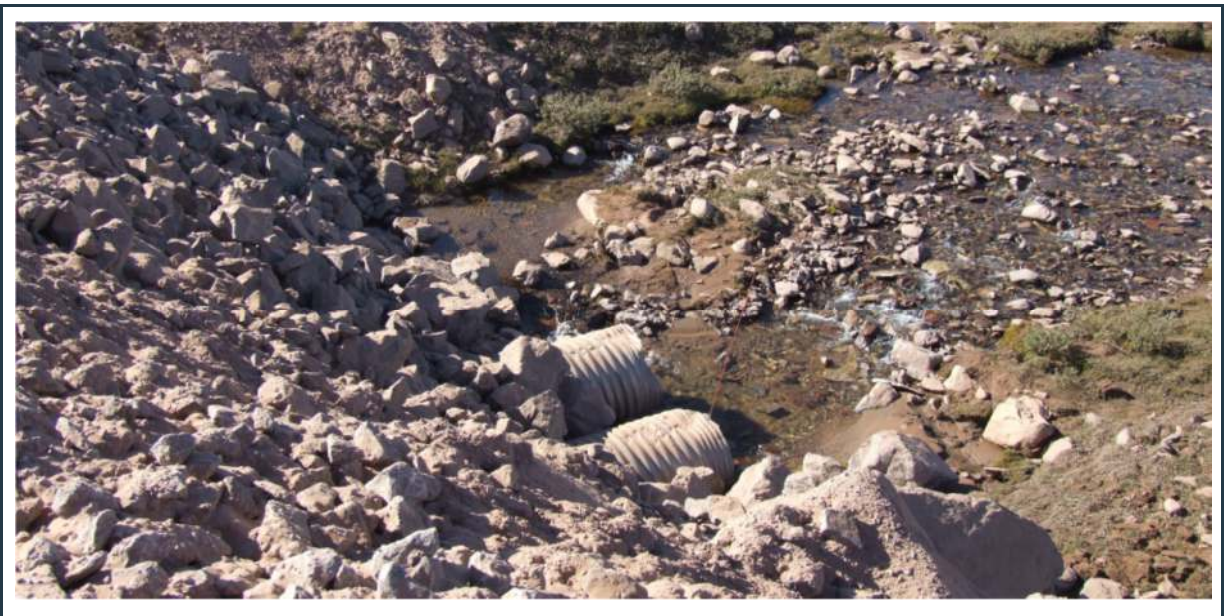
Figure 105: View of culvert 225 (inlet)

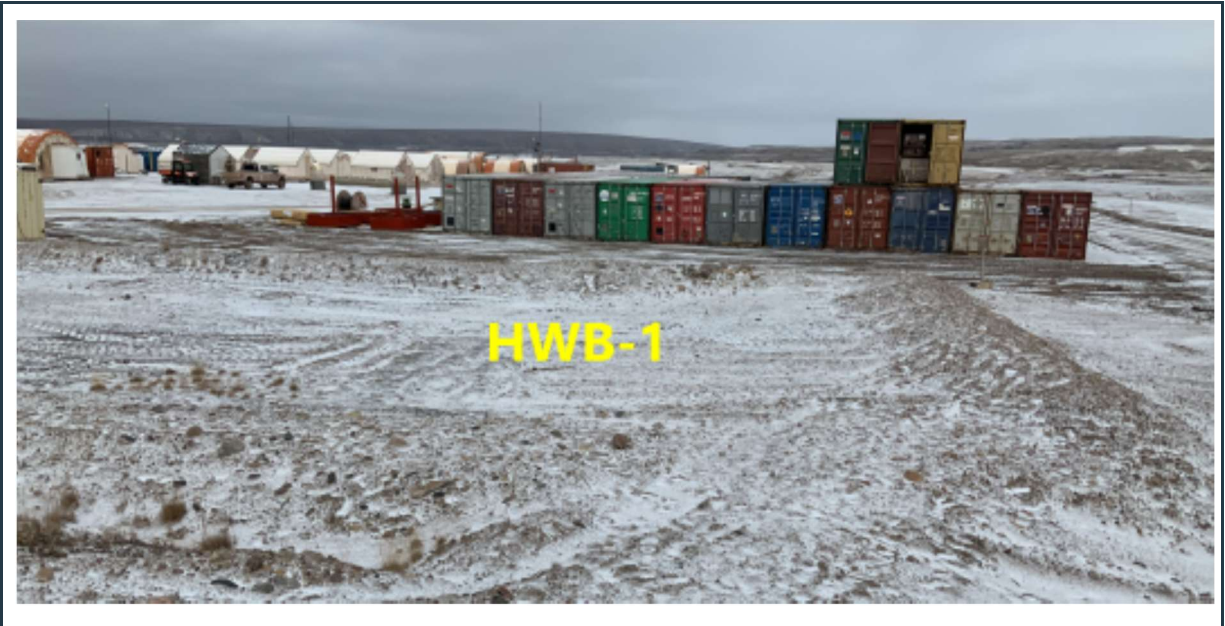
a) HWB-1

Note that due to potential liner damage, Mine Site HWB-1 is currently not used and has been left empty. This facility will not be used for the storage of hazardous waste or substances until it has been repaired. Alternatively, this facility may be decommissioned.

This cell is currently empty, with no water or ice visible within the cell (Figure 9). Based on information obtained during the June 27 to July 2, 2019 visit, it is understood that potential liner damage was suspected here, and consequently no material is stored in the cell.

Figure 9: View of HWB-1 – Currently this cell is empty.

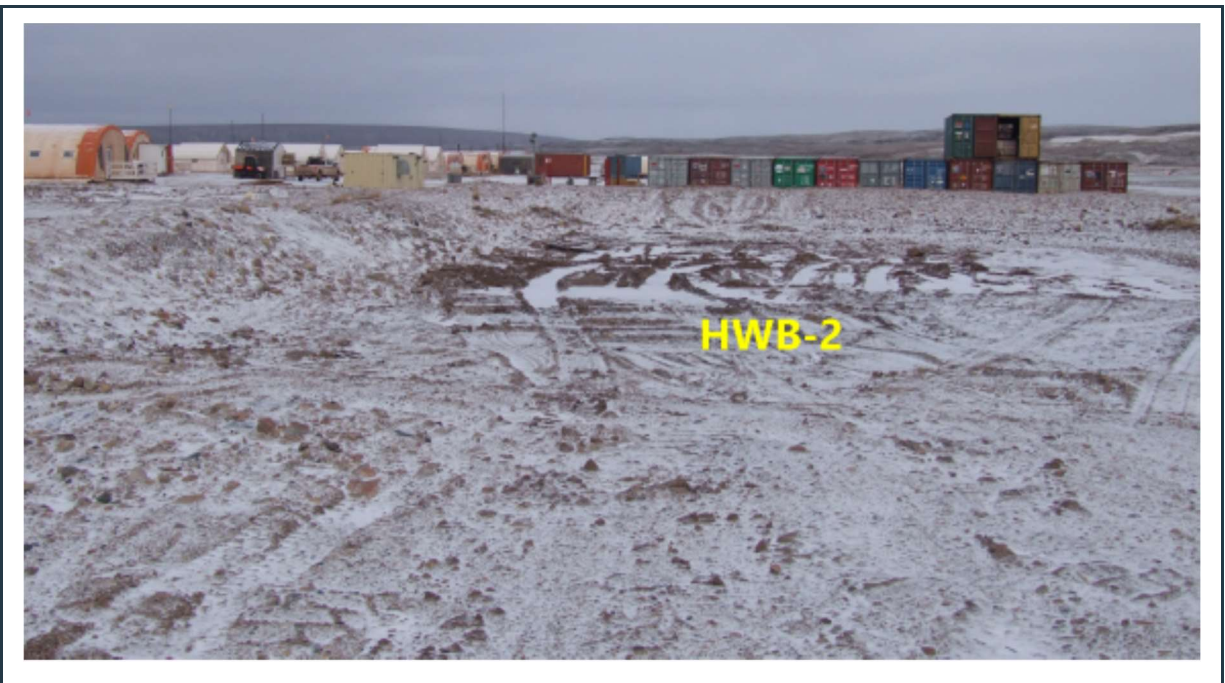
b) HWB-2

As shown in Figure 10, the perimeter berm around the HWB-2 cell appears to be stable. All previously stored materials have been removed and hence, no waste is currently stored in the cell.

Figure 10: View of HWB-2 – Currently the cell is empty.

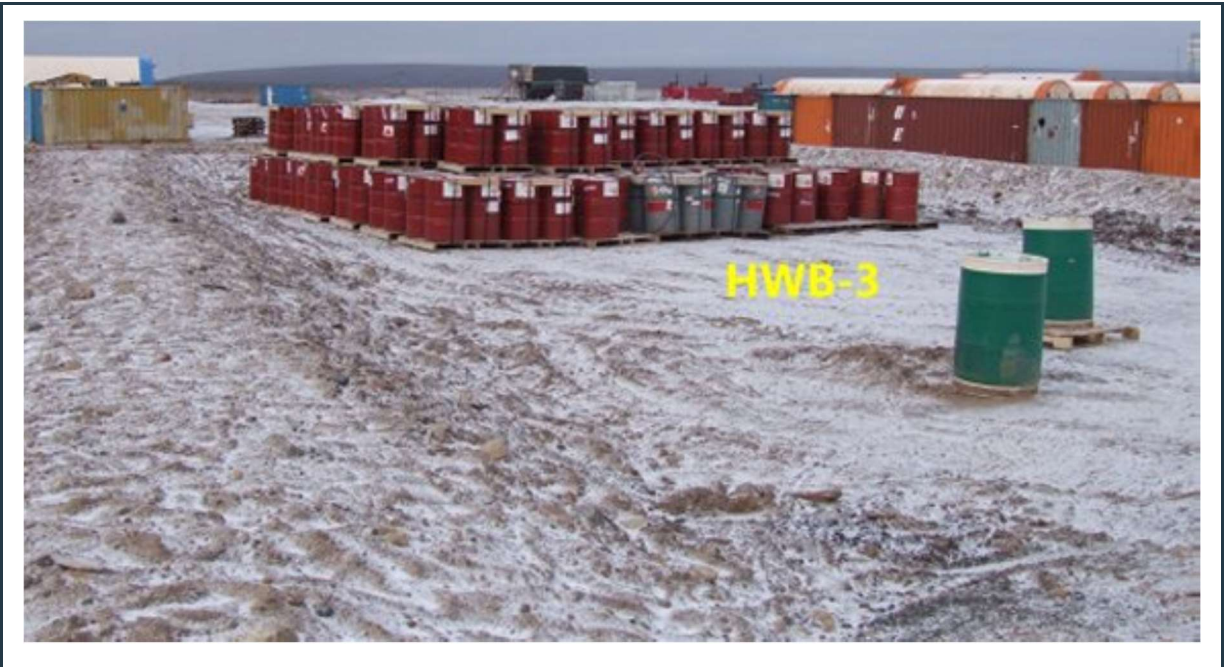
These cells are located side-by side and were called, in previous reports, "Fuel Containment" cells. As shown in Figures 11 and 12, there are only fuel barrels visible now in these two cells, stored on wooden pallets. The berms are stable and there is no visible liner damage in these cells. As recommended in the August 31, 2019 report, all damaged wood pallets and other debris have been removed from the cells to prevent potential damage to the liners.

Figure 11: View of HWB-3, with fuel barrels stored on wooden pallets.

- Mine Site Hazardous Waste Berms (HWB) HWB-3 and HWB-4: Removed damaged wood pallets and other debris from the cells to prevent potential damage to the liners.

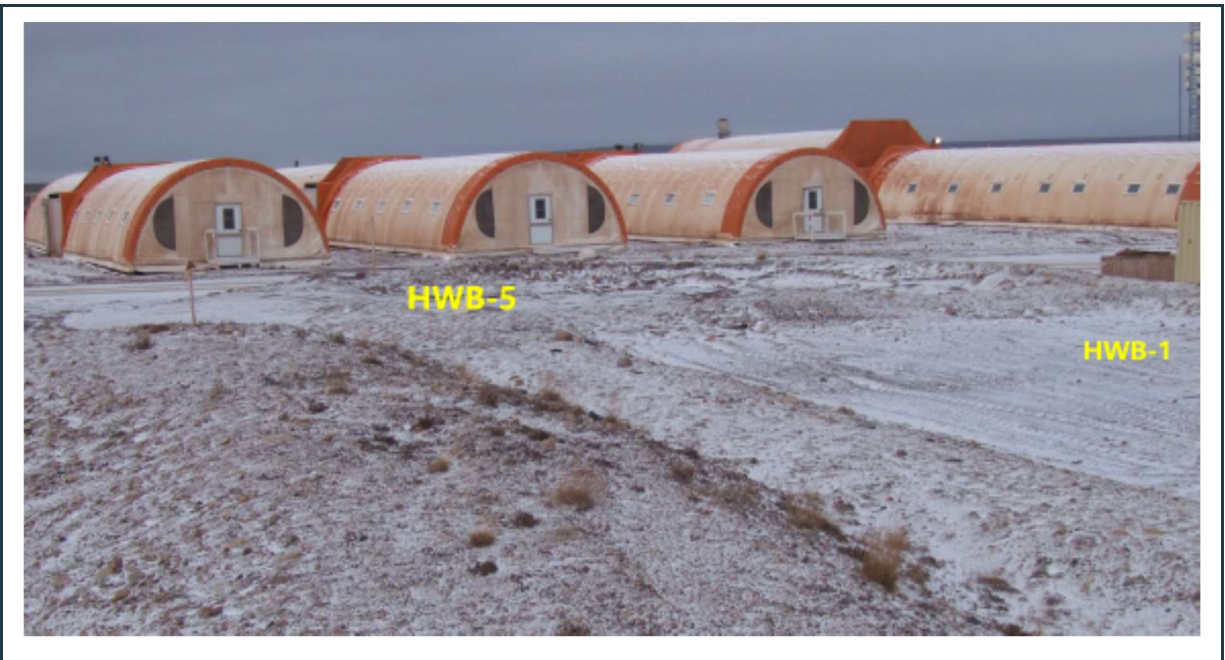
d) HWB-5

As shown in Figure 13, this cell is currently empty. The few totes of lubricants that were visible during the June 27 to July 2, 2019 inspection, have been removed from the cell. As pointed out in the earlier report, the berms around the cell appear to be stable and there is no visible liner damage.

Figure 13: View of HWB-5, located immediately adjacent to HWB-1. Both cells are currently empty.

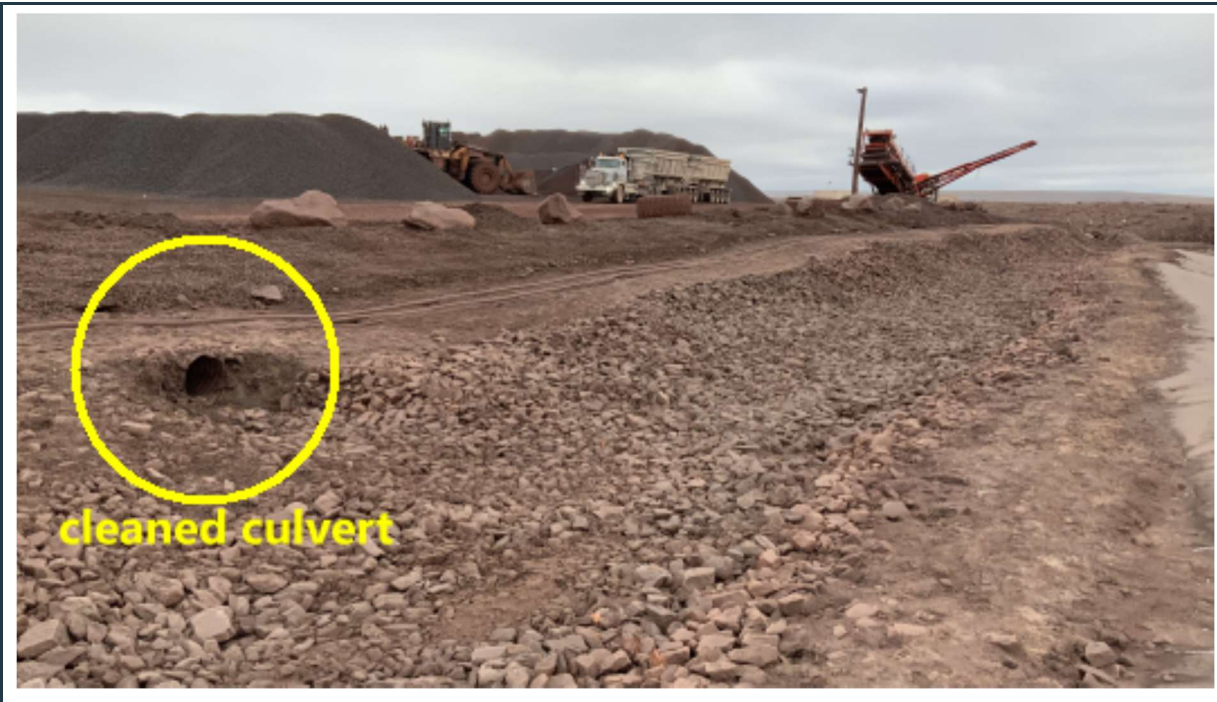
Figure 19: Surface water collection ditch, with recently cleaned culvert.

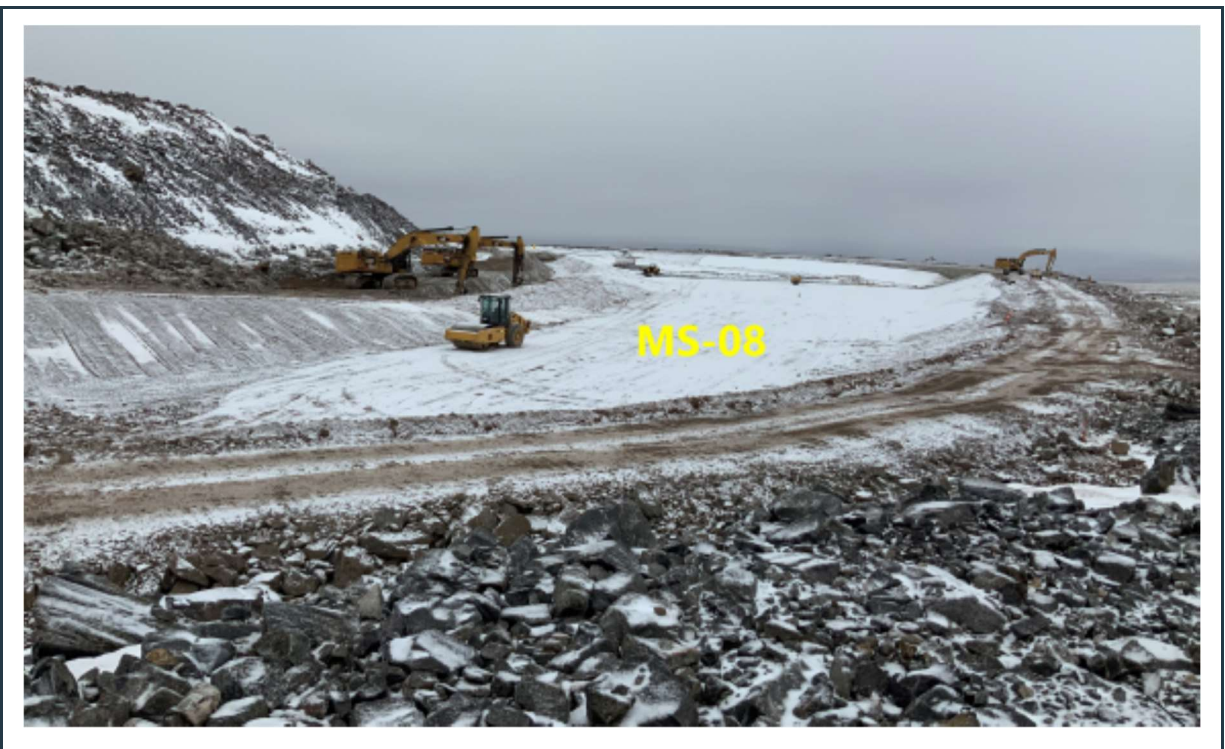
Figure 24: Construction of the new MS-08 pond, immediately adjacent to the waste rock dump.

- MS-08: Upgraded surface contact water drainage ditches around the waste rock dump and reconstructed the MS-08 sedimentation pond, including removing the existing liner and repairing the subgrade.
