Geotechnical Inspection Report

RE: Submission of 2019 Geotechnical Inspection Report No. 1 (July 2019)

Annual Geotechnical Inspections – 2019 Report 1. Mary River Iron Mine Complex – Nunavut

Annual Geotechnical Inspections – 2019 Report 2. Mary River Iron Mine – Nunavut

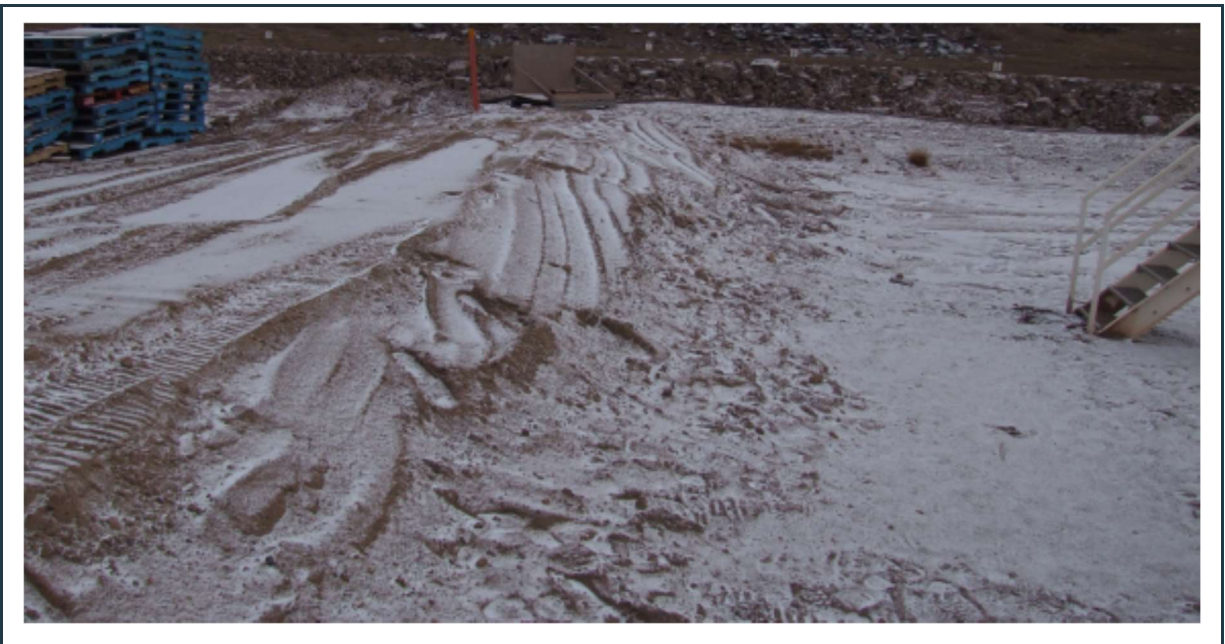
Figure 30: Recently placed granular fill on the berm's crest, to protect the previously exposed liner.

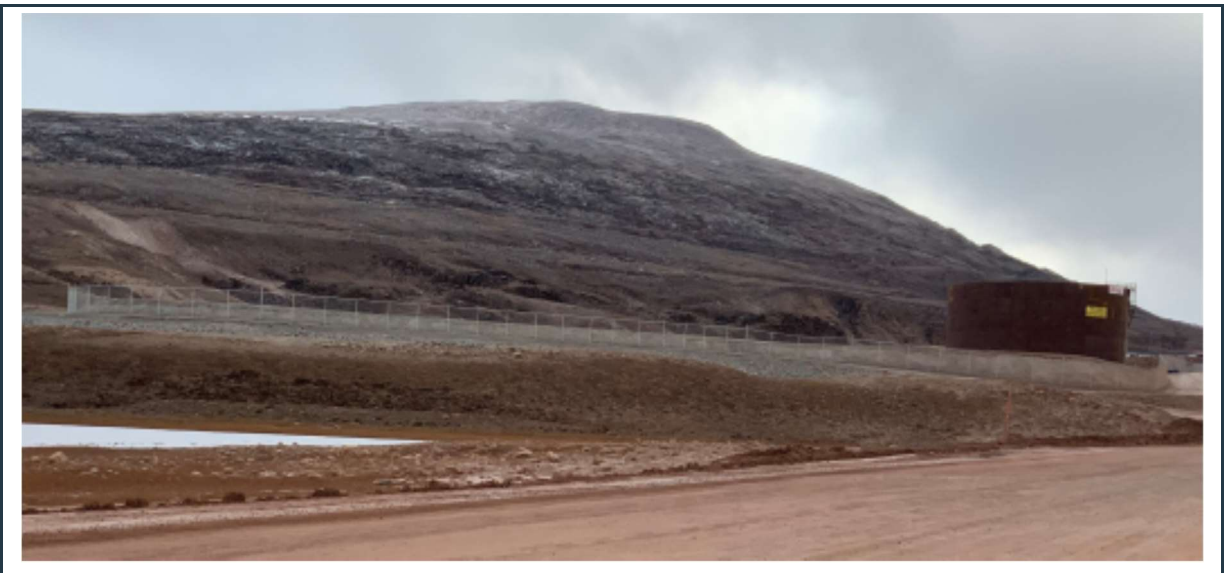
Figure 32: View of the recently completed new fuel storage.

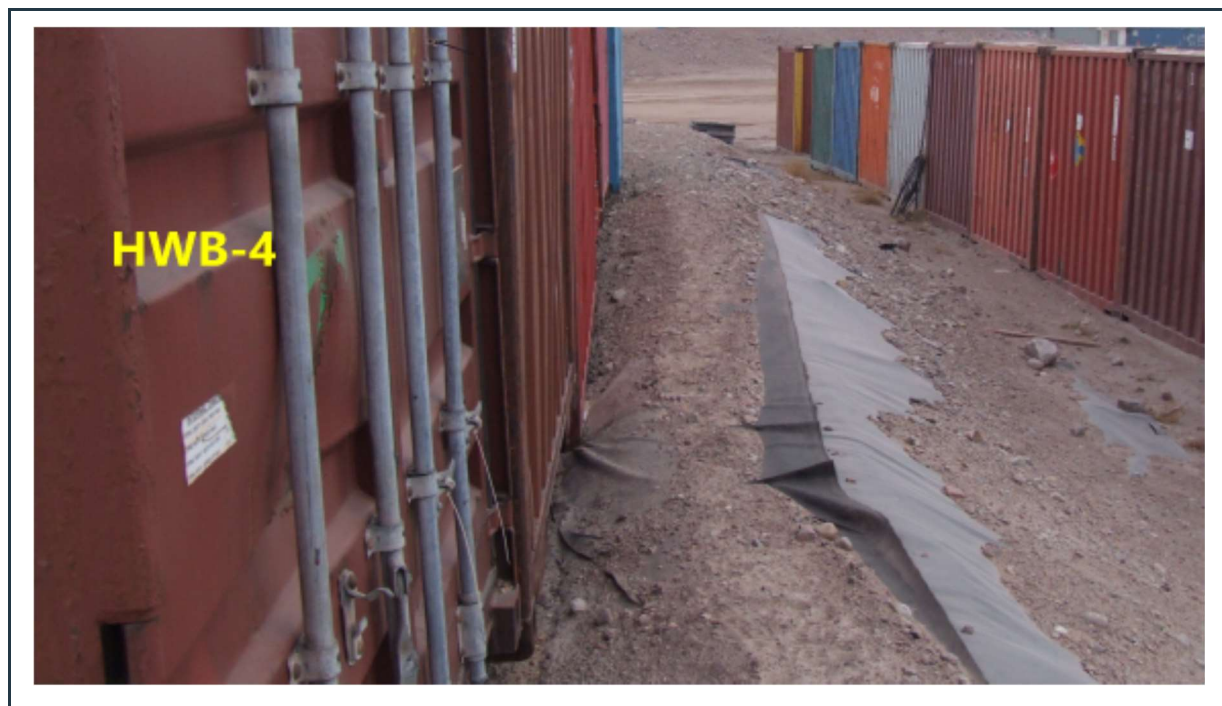
d) HWB-4

Figure 43: Perimeter berm at the HWB-4 cell, with exposed geotextile and liner.

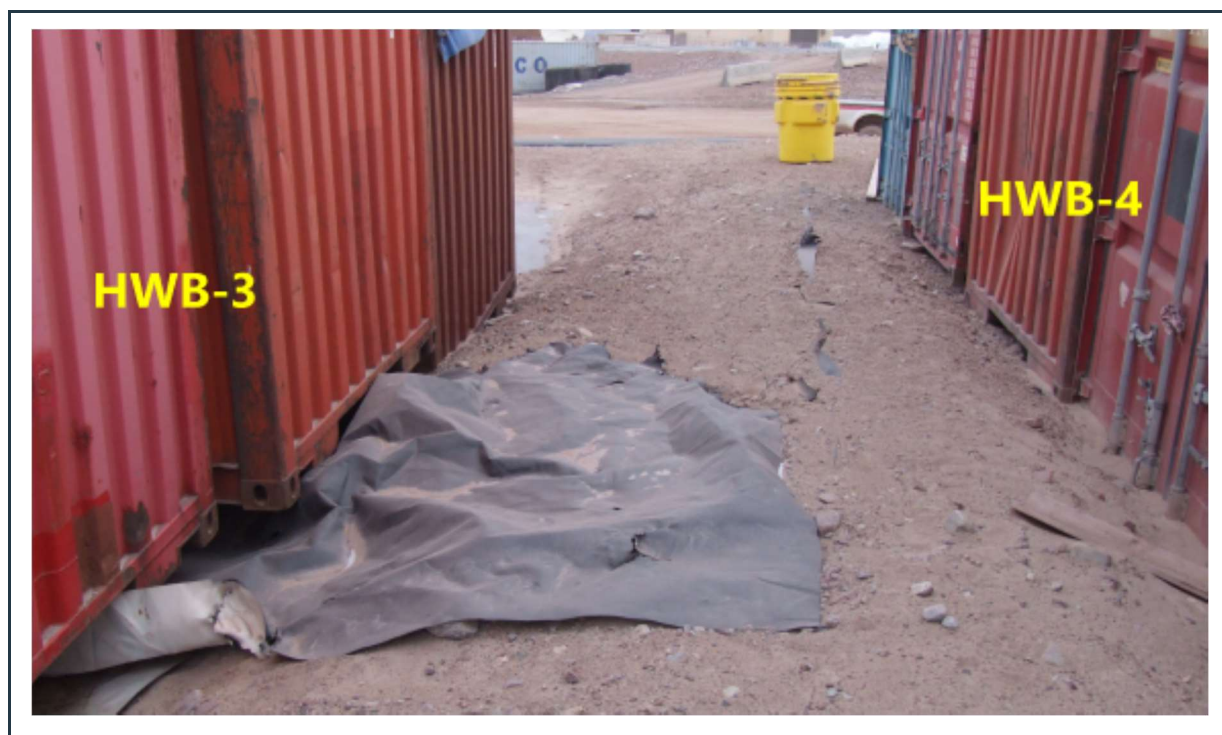
Figure 44: Exposed liners between the HWB-3 and HWB-4 cells.

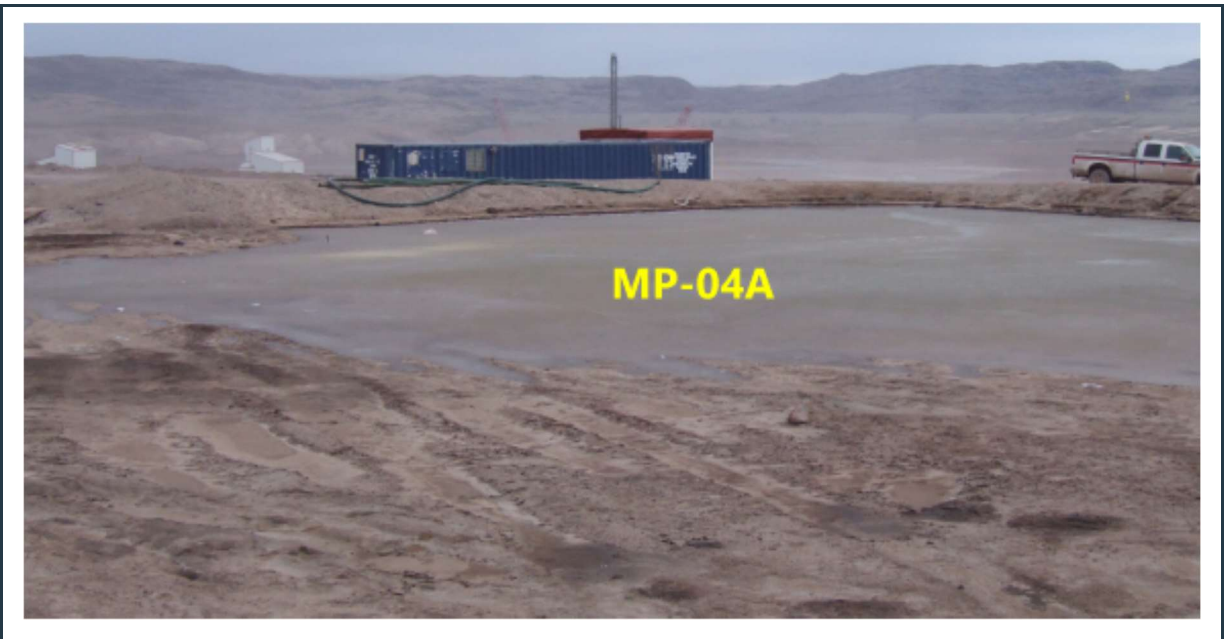
Figure 49: Stable berms and frozen water at the MP-04A contaminated snow dump.

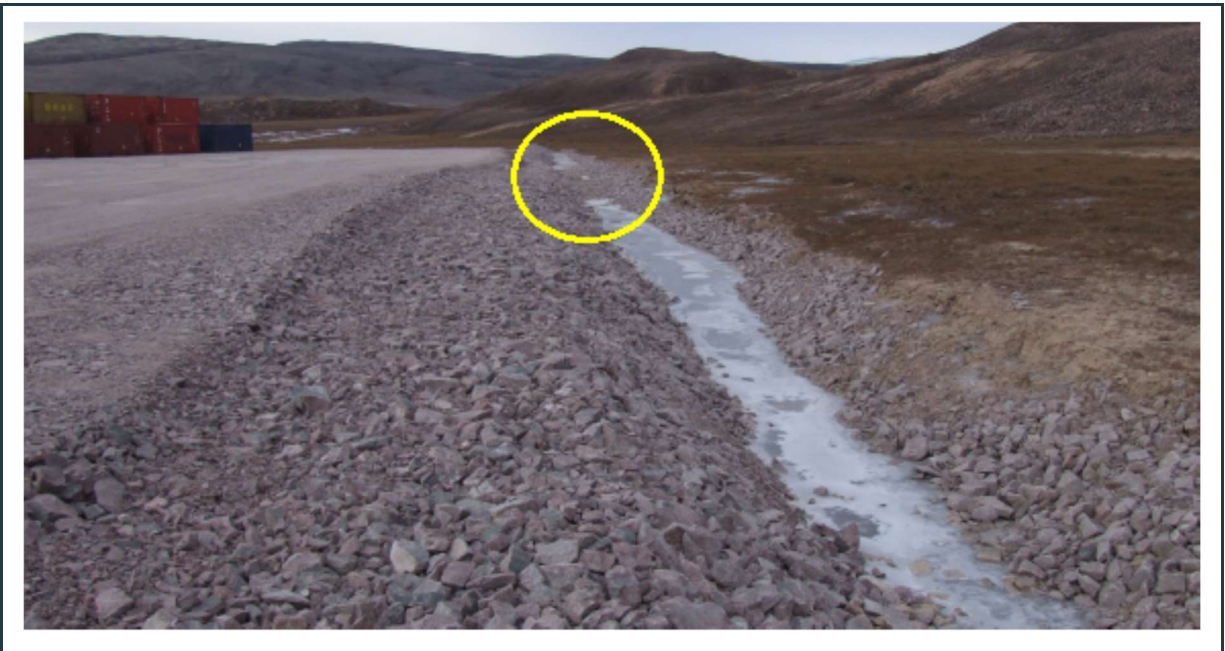
There are several water collection drainage ditches (listed above), most of them still under construction or continuous improvement, as shown in Figures 53 to 58. These open ditches are excavated partly into the native soils with their sides and inverts lined with erosion protection layers composed of fine crushed rock from the local quarry. It was noted during the inspection that geotextile have been used in areas where the native soil subgrade was composed of fine-grained material to prevent migration of fines into the voids of the rockfill. It is recommended that the condition of these ditches be monitored, particularly prior to the spring freshet, and that any slope deterioration be rectified to ensure an unobstructed functionality of the ditches. One such obstruction, a consequence of ditch side slope failure observed at the LP2 drainage ditch (see yellow circle in Figure 53) will require repair ahead of the spring freshet.

Figure 53: View of the LP2 surface water collection ditch – still under construction.

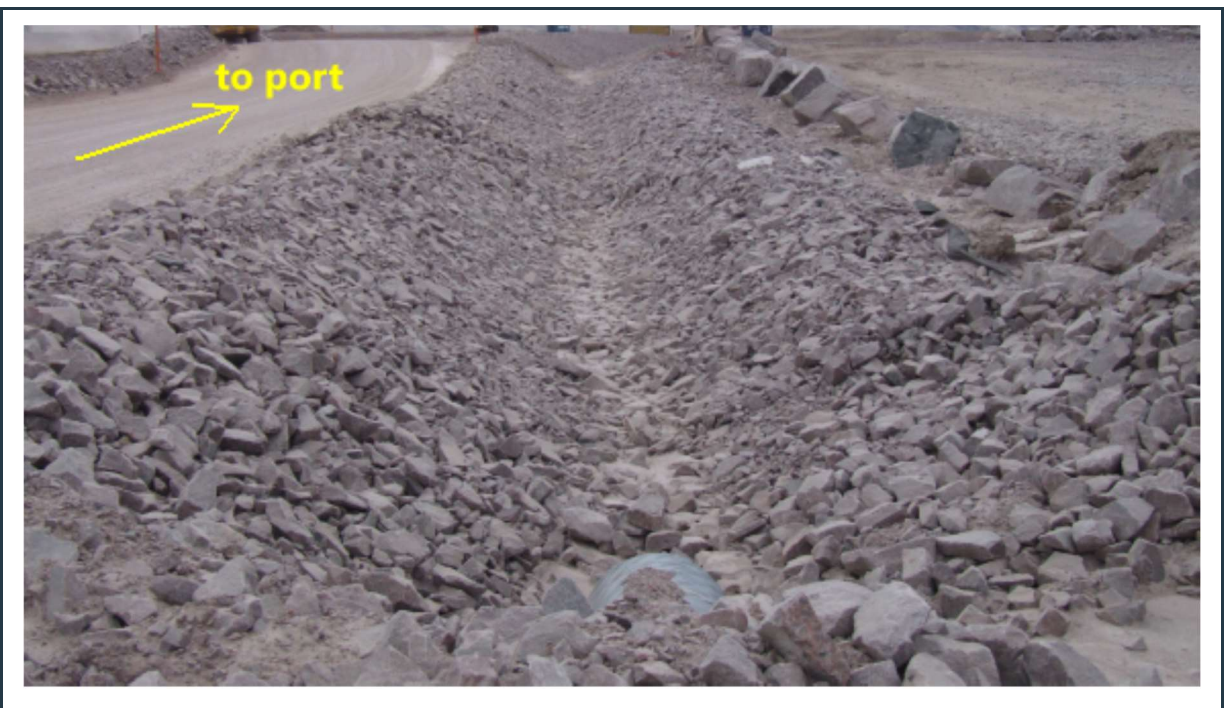
Figure 54: Well maintained "P-SWD-5 Q1 North" surface water collection ditch.

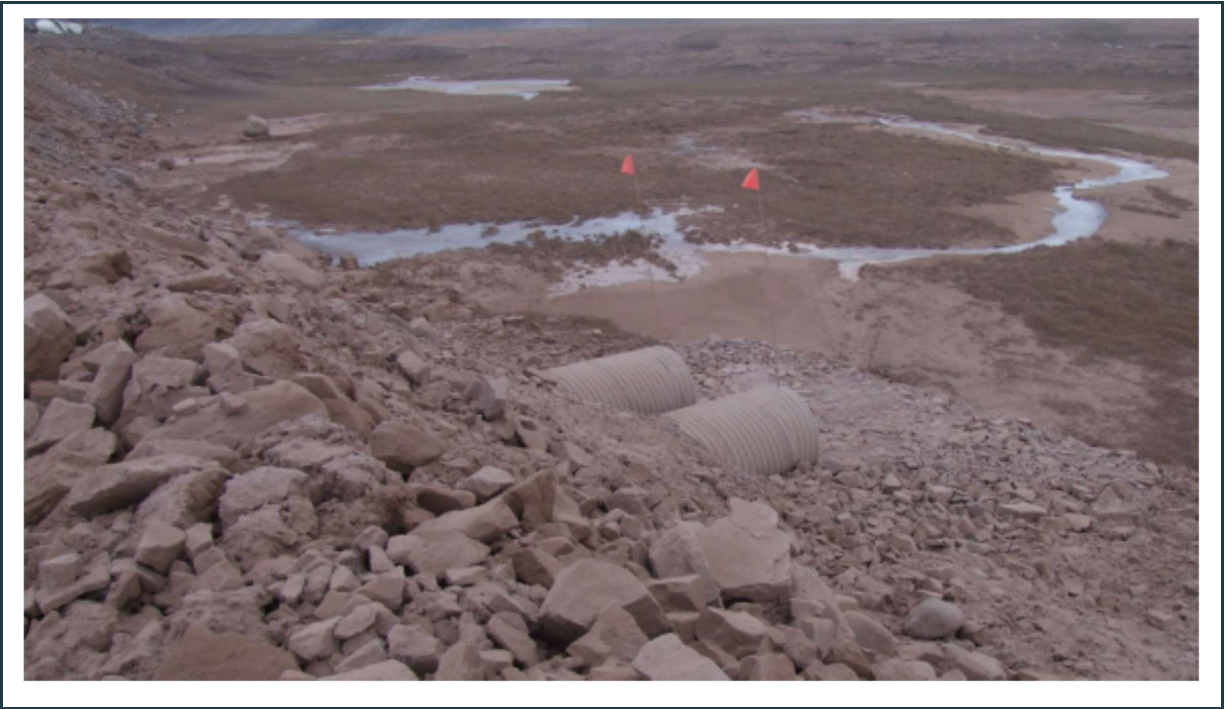
Surface water from higher elevation around the rock quarry is collected in drainage ditches and conveyed down the slope through corrugated galvanized steel culverts, installed under the quarry road and then under the Tote Road. The water in the ditches is then conveyed to small natural ponds, located along the west side of the Tote Road, as shown in Figure 59. As reported earlier, the fill in the area (road embankment and slope cover) comprises crushed rock fill, and therefore a portion of the surface water have the tendency to bypass the two culverts beneath the Tote Road embankment (through-flow) and finds its way to the nearby ponds (see Figure 59) in open, shallow channels. The flow of such water may

Figure 59: Water seepage through and beneath the road embankment near the tote road culverts.

soften the original native subgrade beneath the road embankment and potentially destabilize the road embankment. As recommended in the August 31, 2019 inspection report, and to increase the stability of the Tote Road's embankment in the affected areas, construction of a rock fill toe berm is recommended along the affected sections (approximately 50 m south and north from the twin culverts, shown in Figure 59) of the Tote Road.
