Km106 Run of Mine Stockpile & Sedimentation Pond

MARY RIVER PROJECT

Construction Summary Report

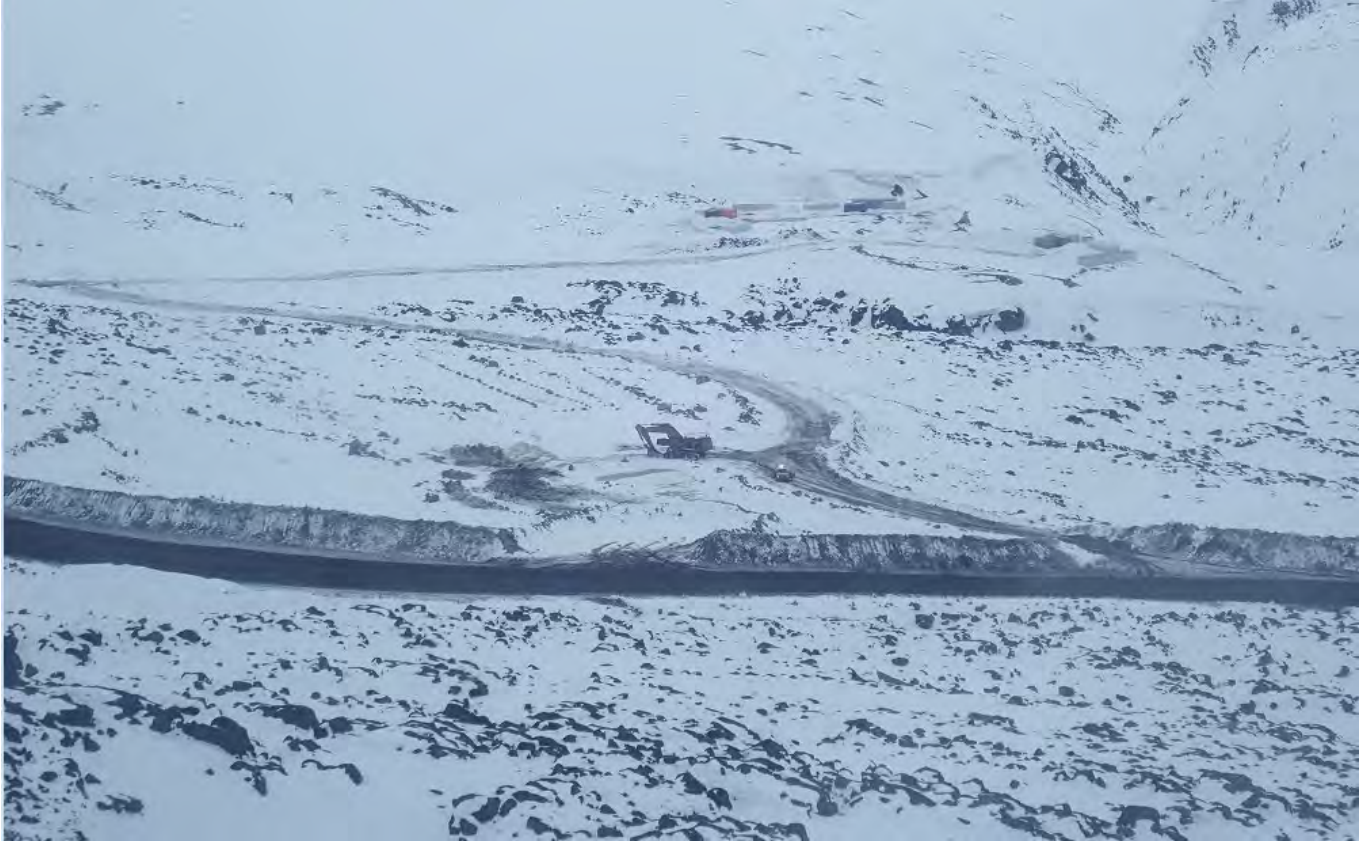
Aerial Photo – June 1, 2020 (Pre-Construction)

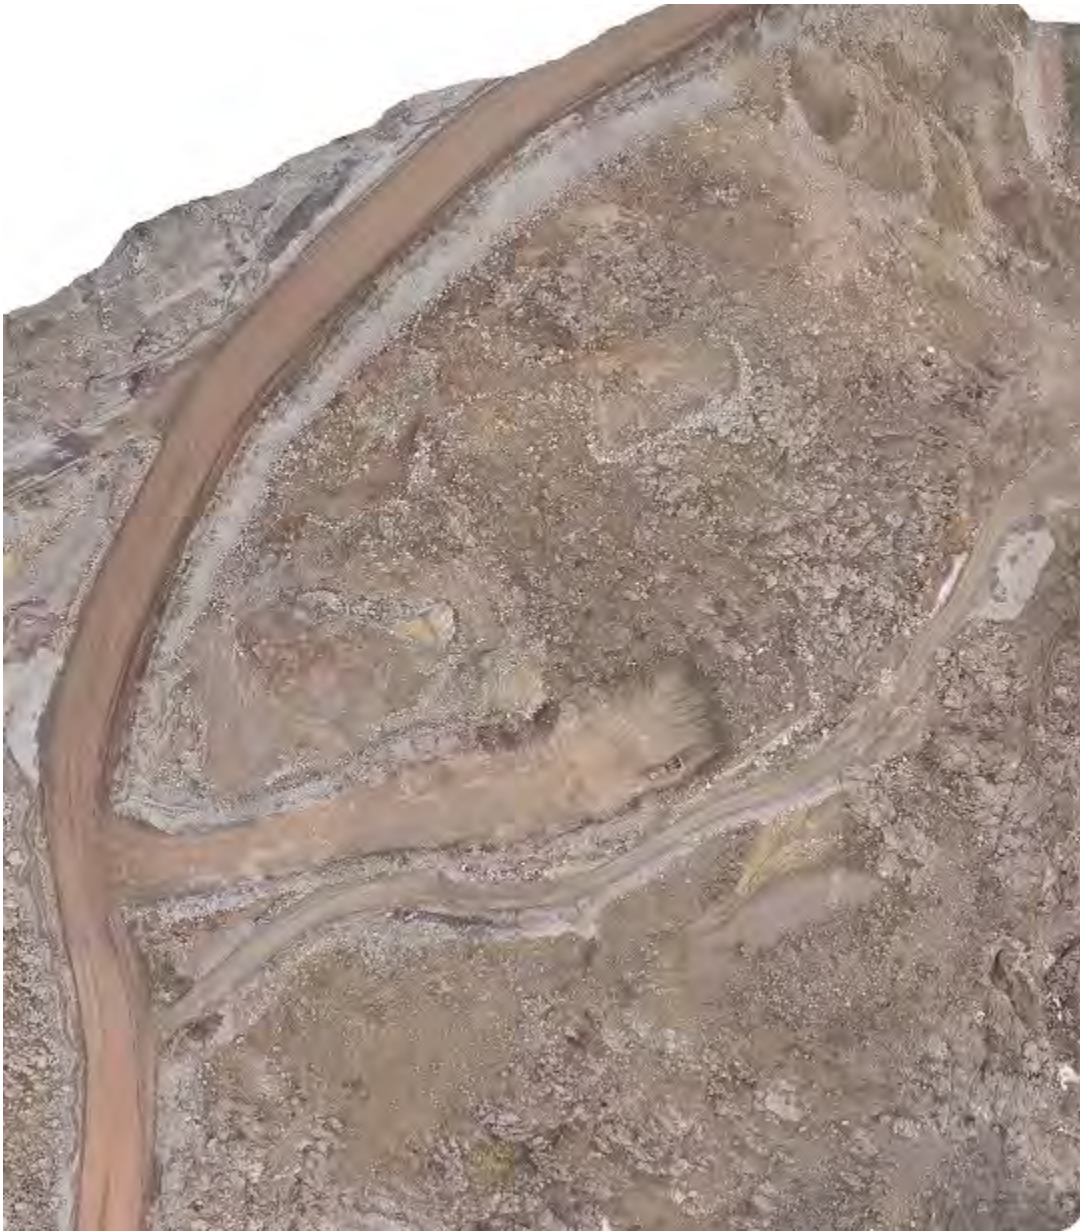
Aerial Photo – June 22, 2020 (Construction Start)

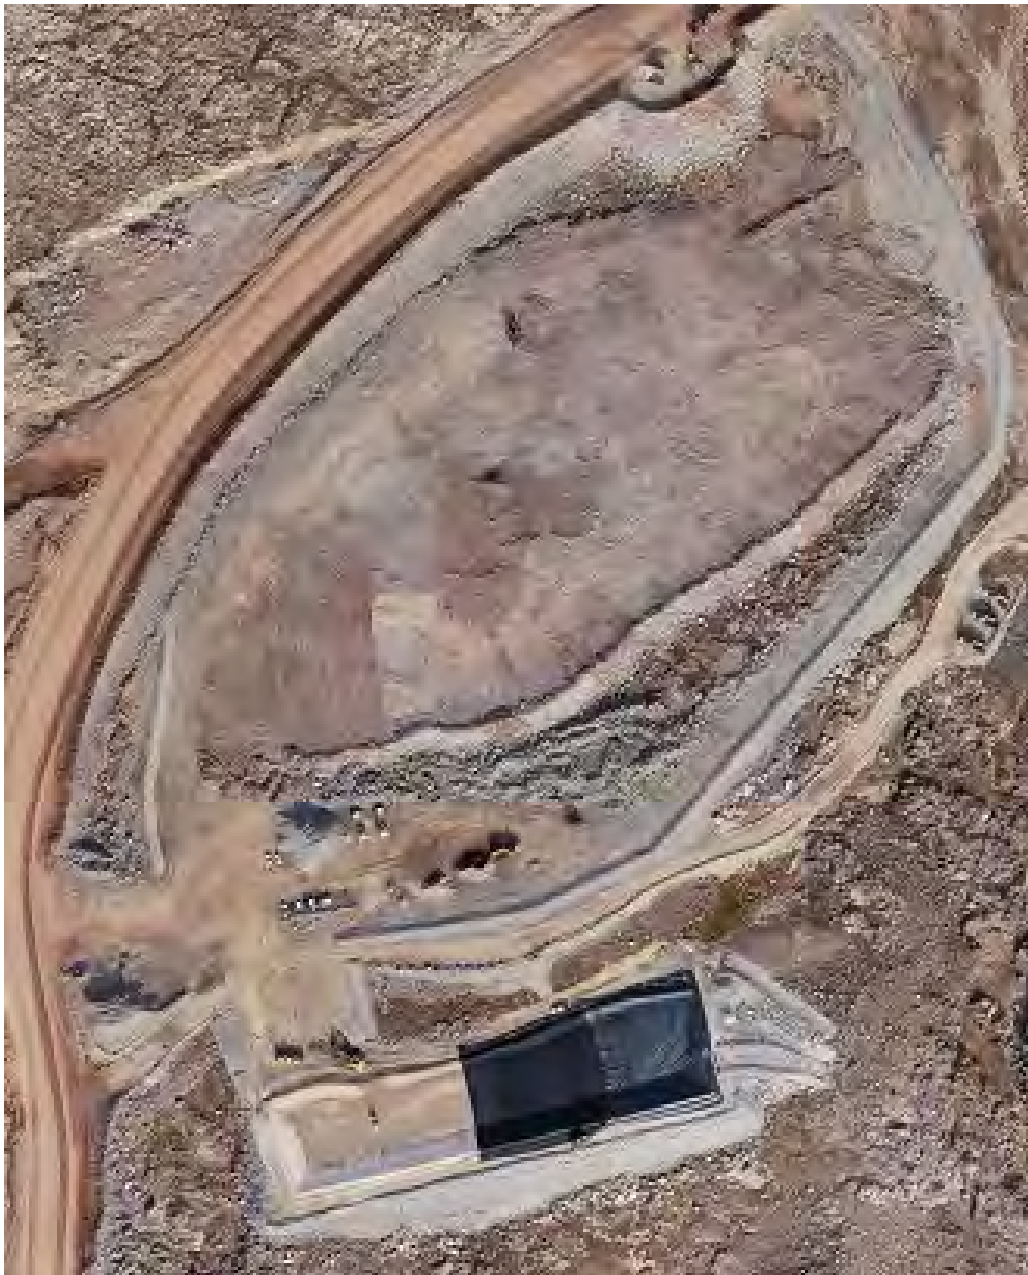
Aerial Photo – September 6, 2020 (Liner Installation)

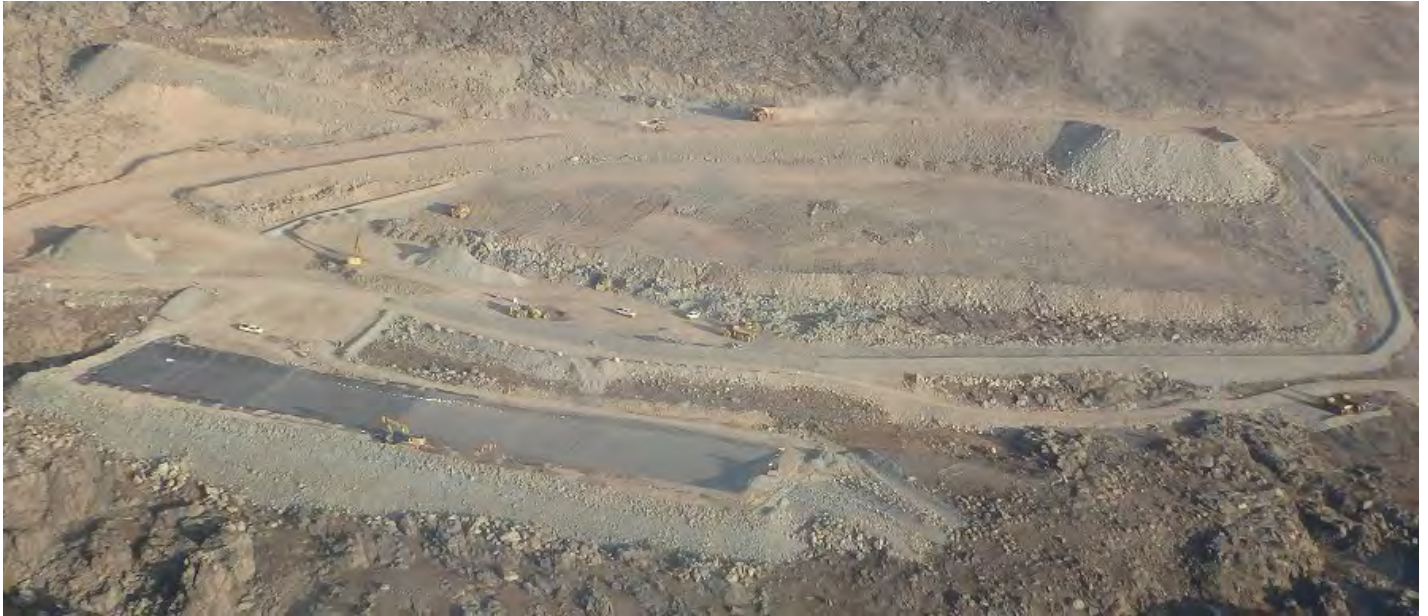
Aerial Photo – September 9, 2020 (Post Liner Installation)

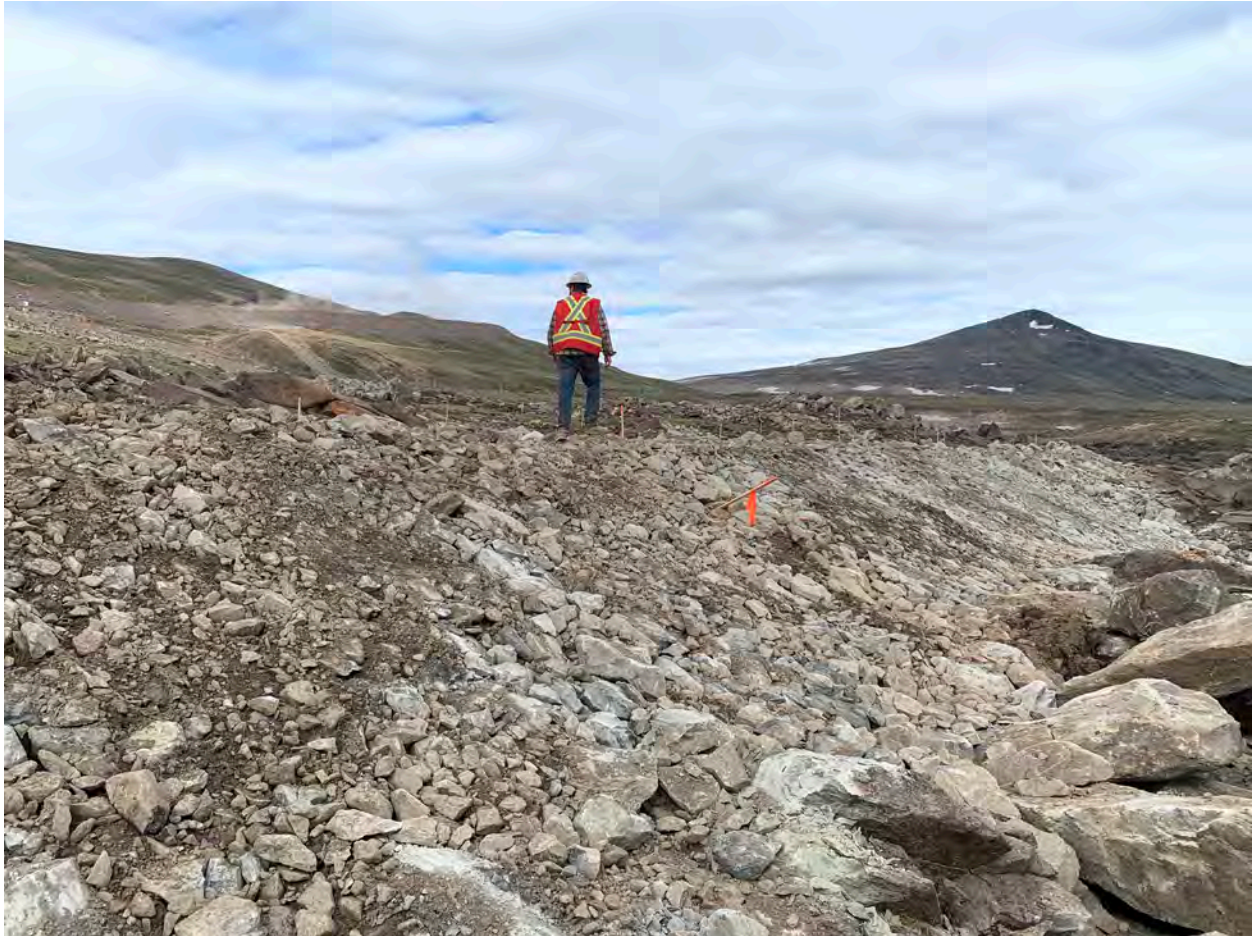
4th Layer of Berm Rise – 5Jul20

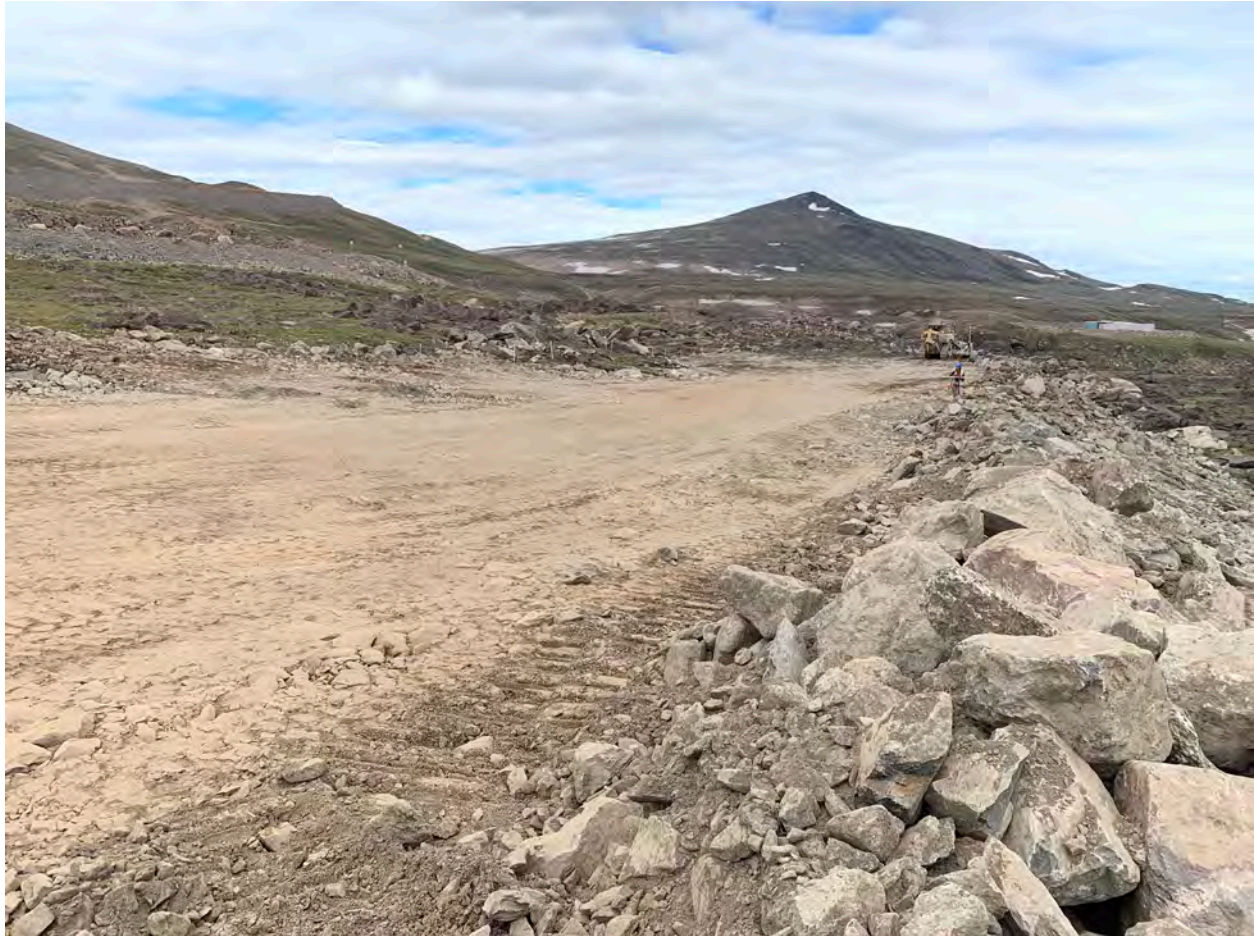
Top of 4th Layer of ROQ on Berm - 5Jul20

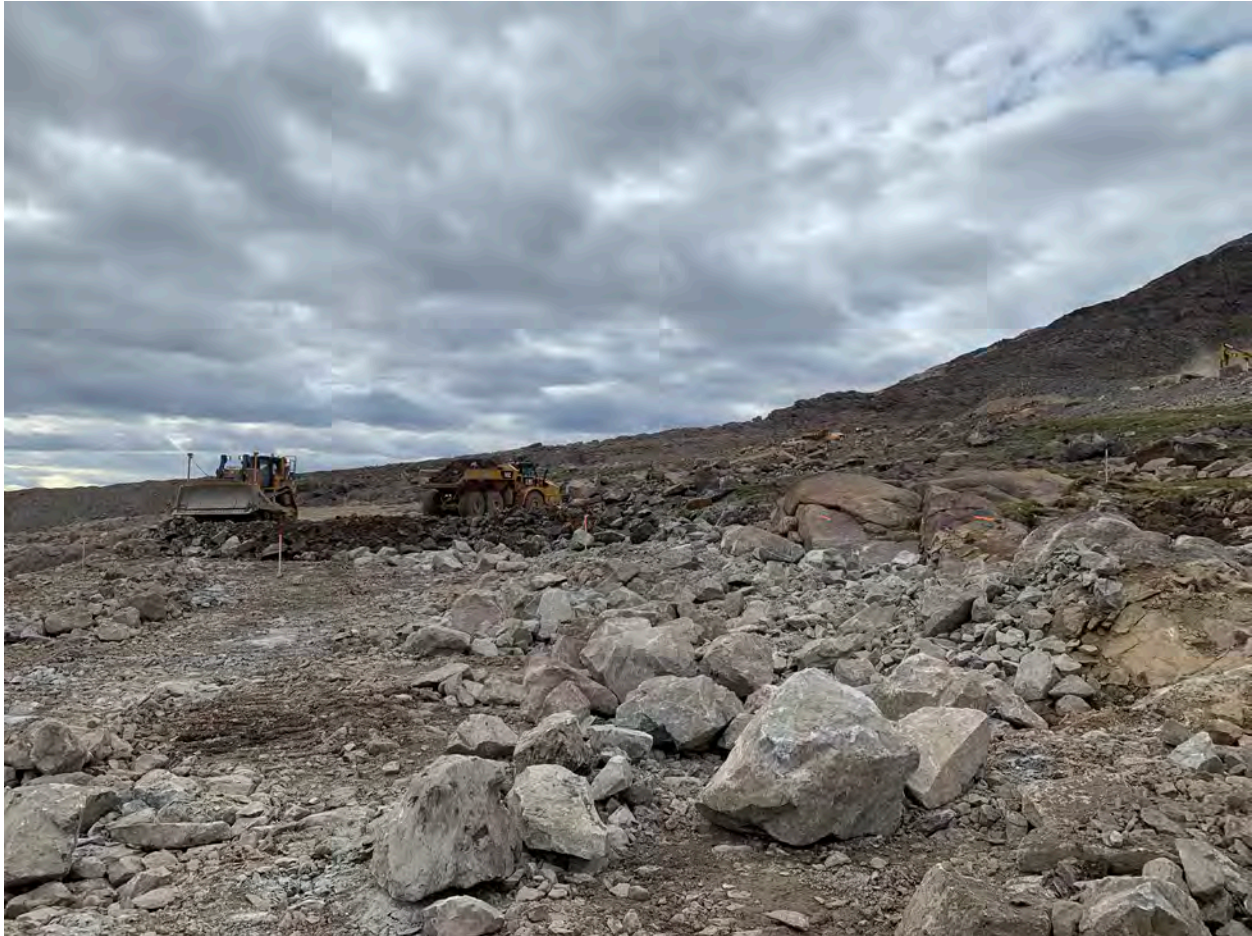
Berm ROQ Placement - 5Jul20

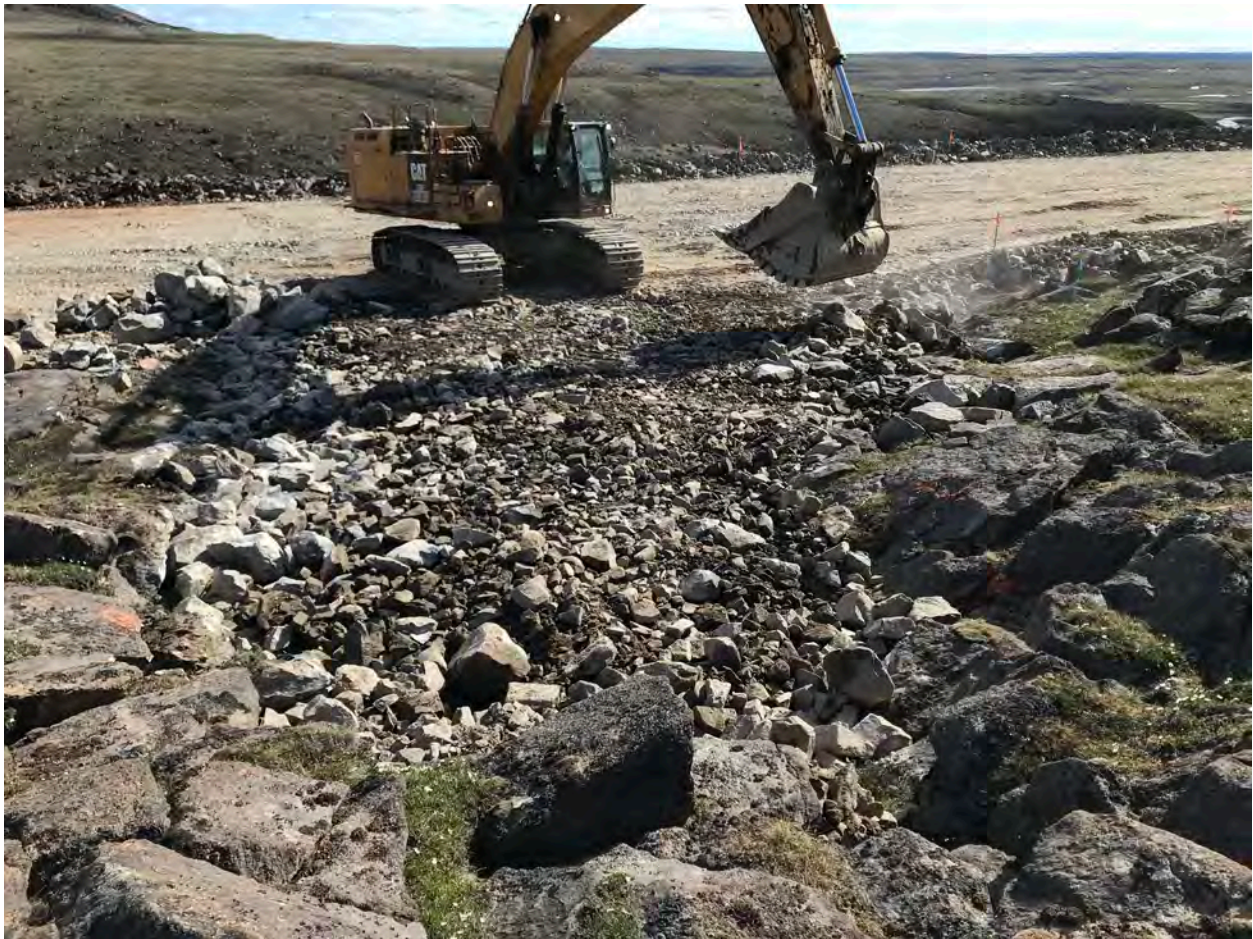
Filling in a Crevice with ROQ and 150mm minus – 7Jul20

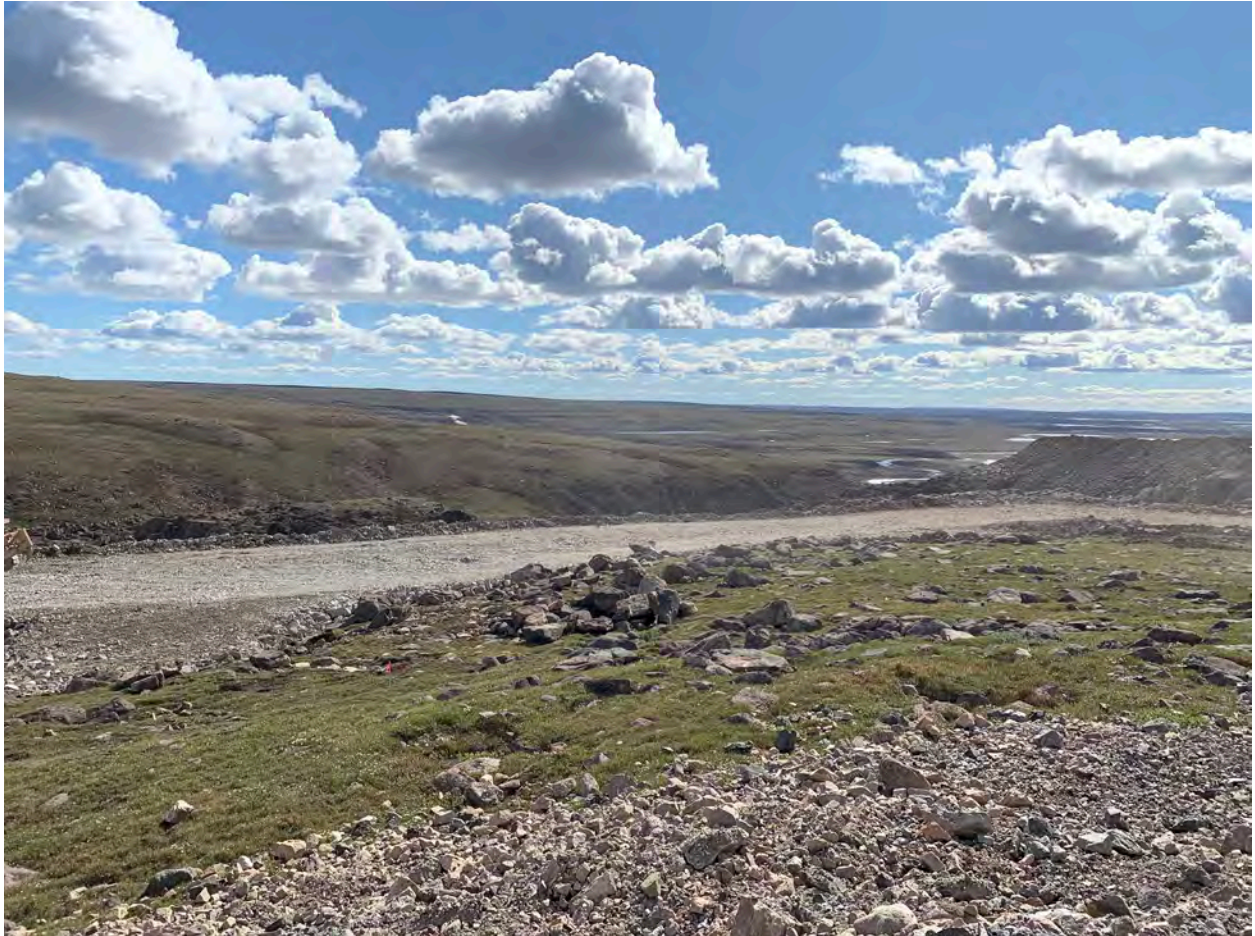
Pond Bottom Original Ground - 9Jul20

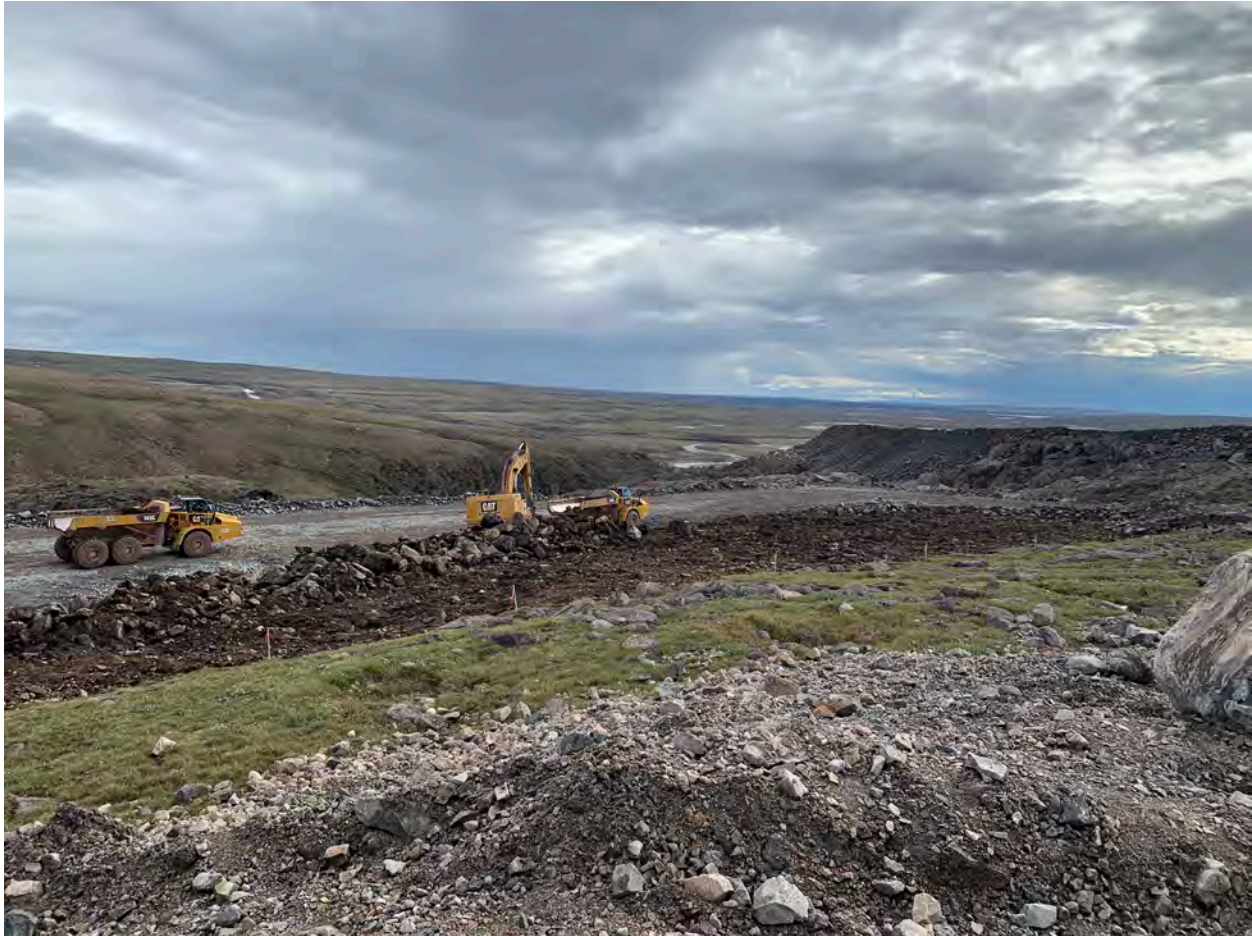
Pond Bottom Original Ground Preparation - 10Jul20

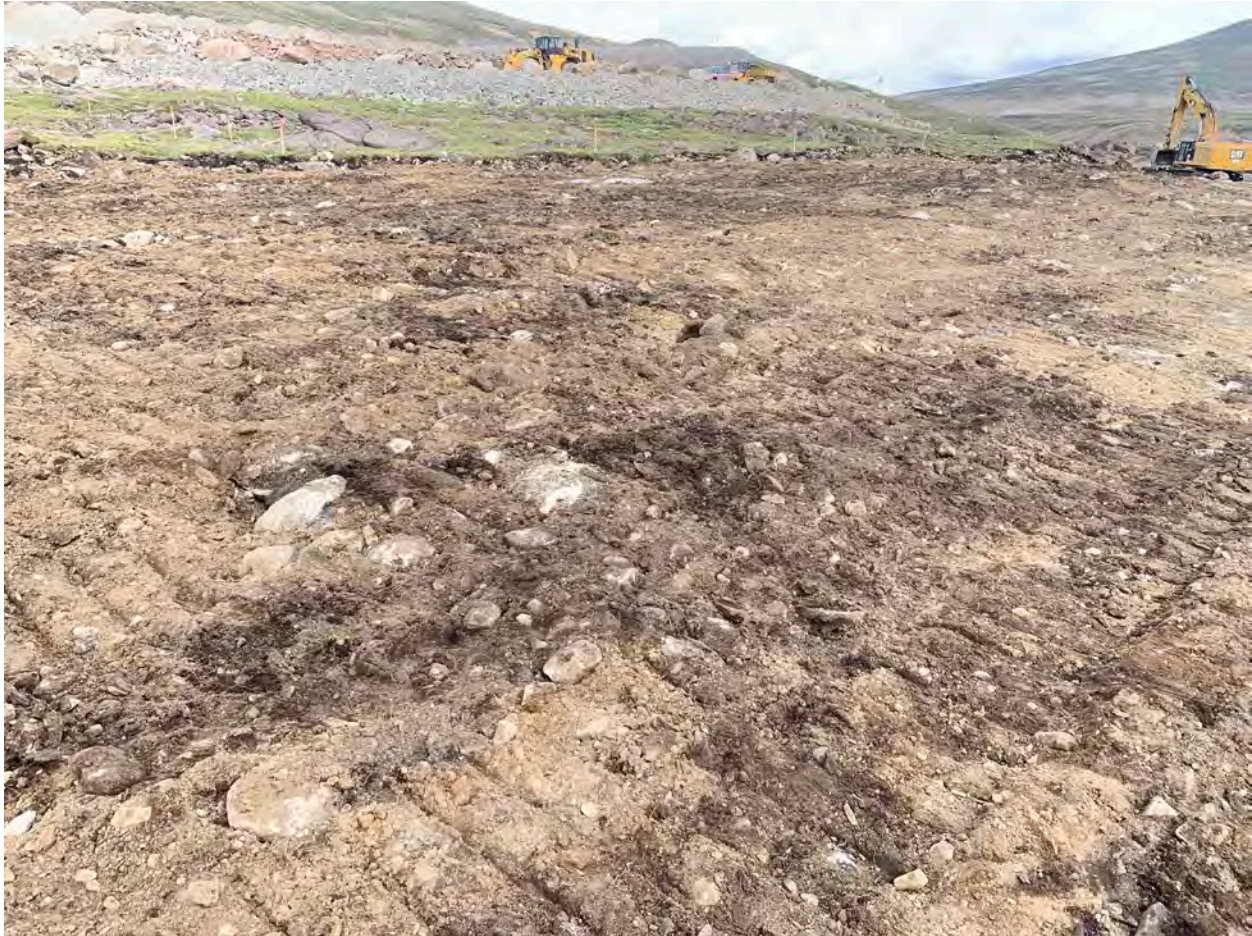
Pond Bottom Original Ground Preparation - 11Jul20

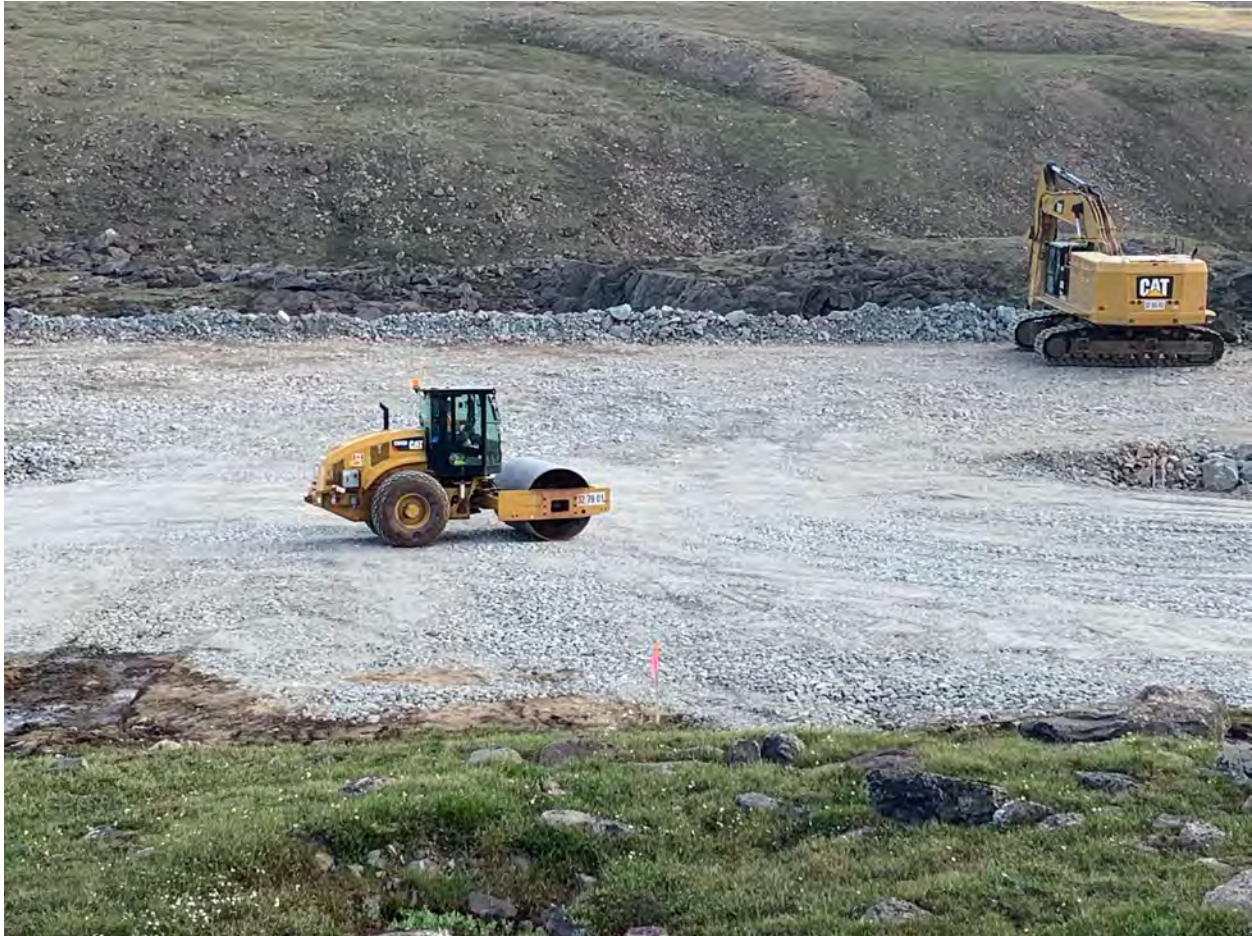
Placing 32mm minus layer on Pond Bottom - 12Jul20

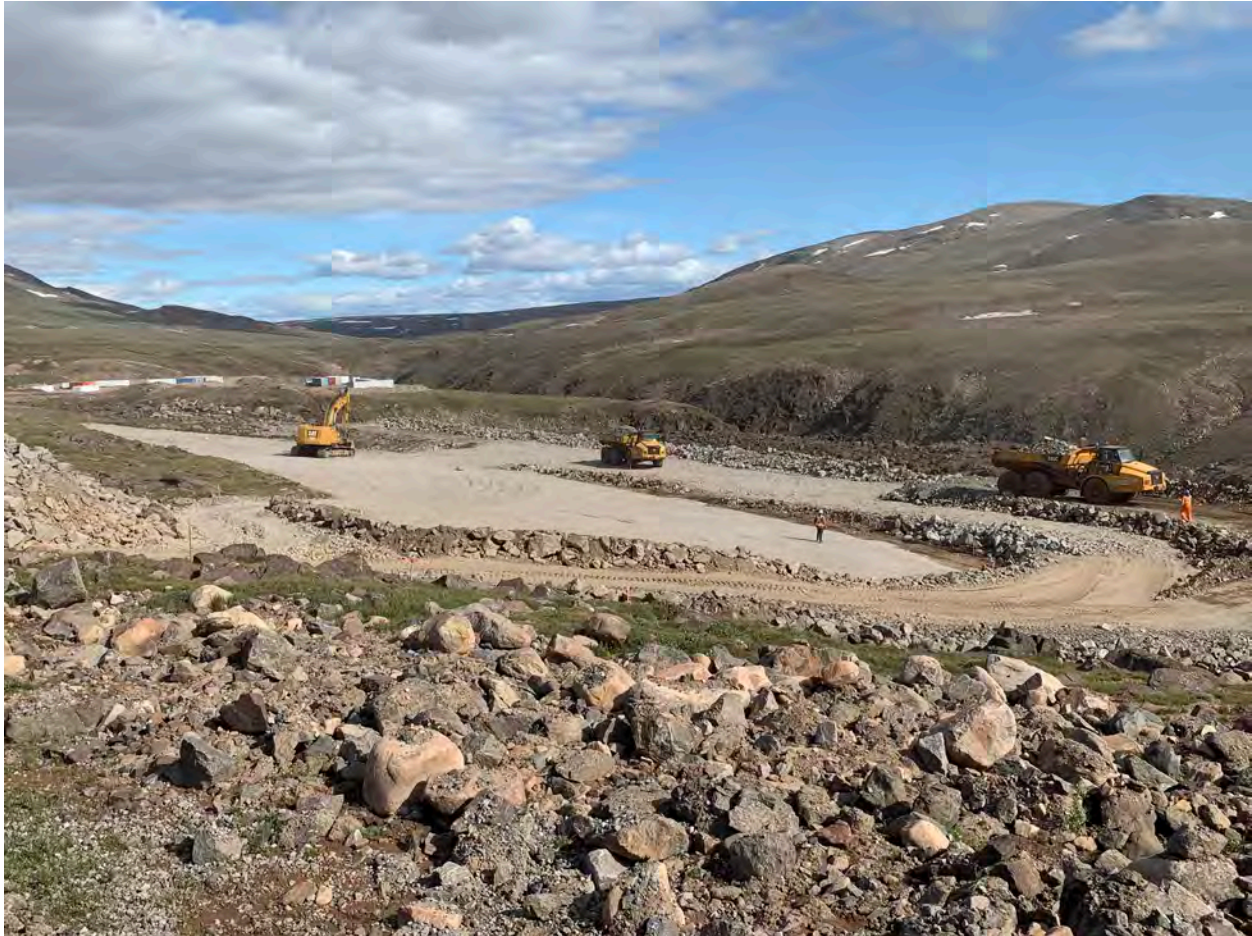
Placing ROQ on Berm and Placing 32mm minus Pond Bottom Layer - 13Jul20

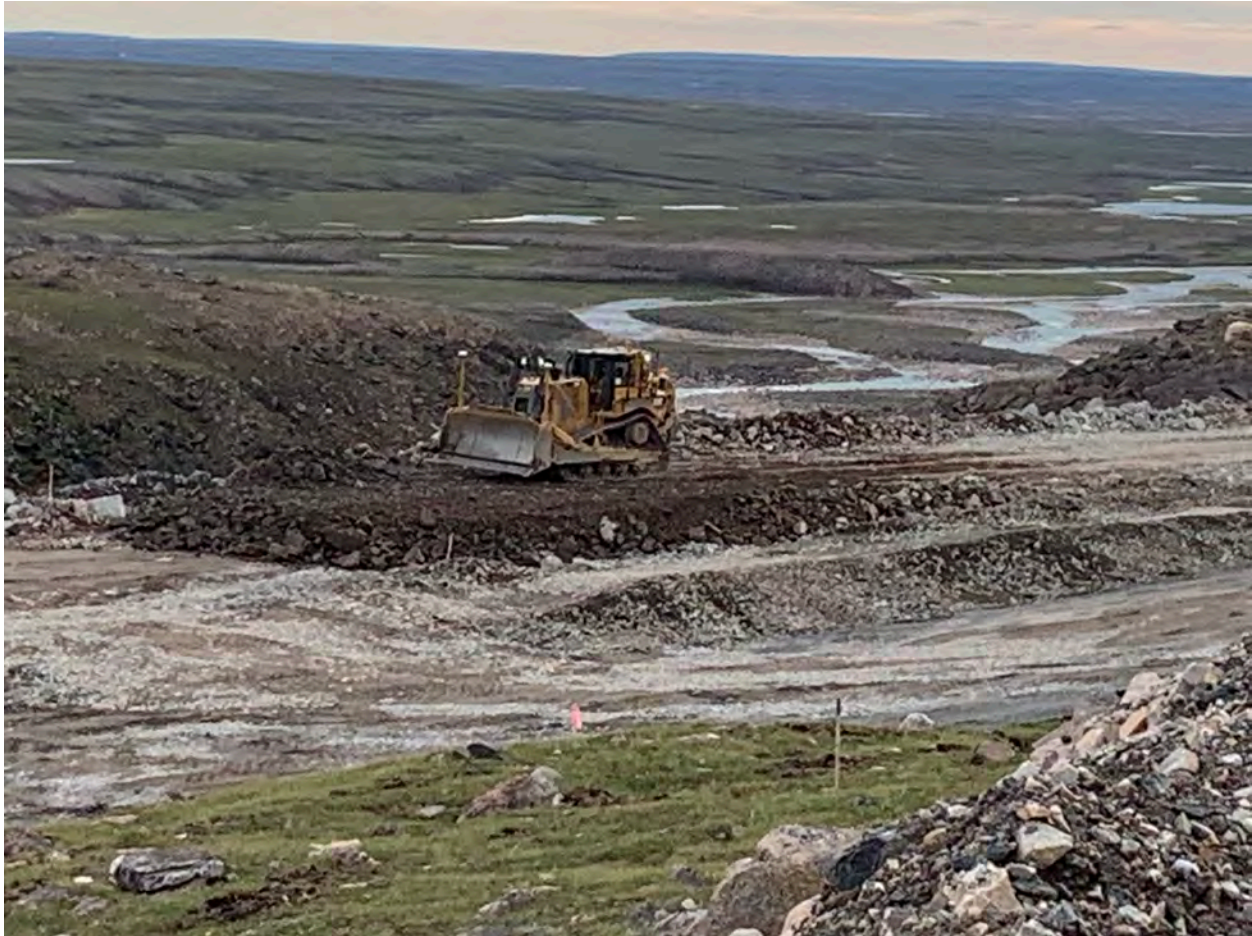
Placing ROQ in Layers on Berm - 15Jul20

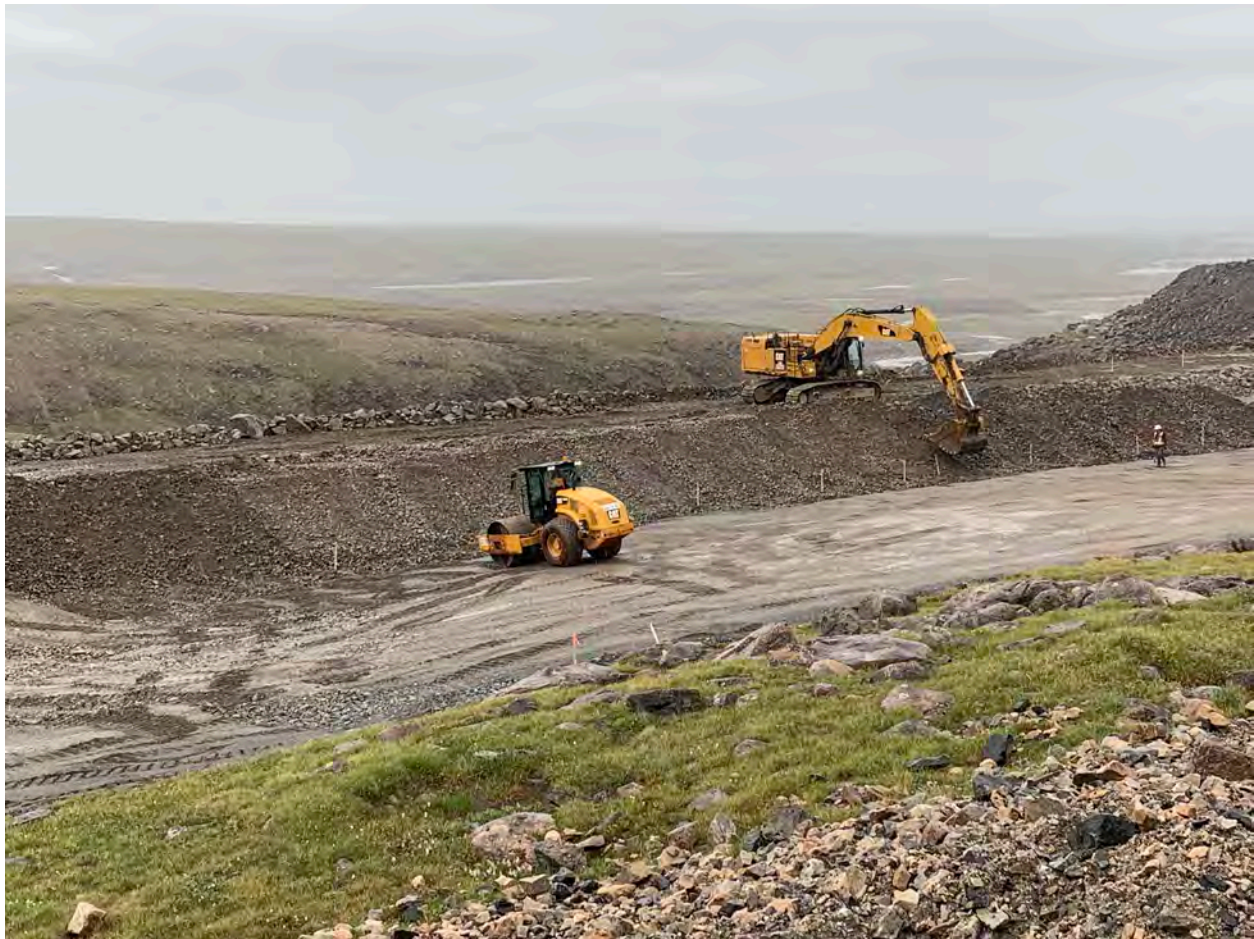
Placement of 150mm Minus on Upstream Side of Berm - 17Jul20

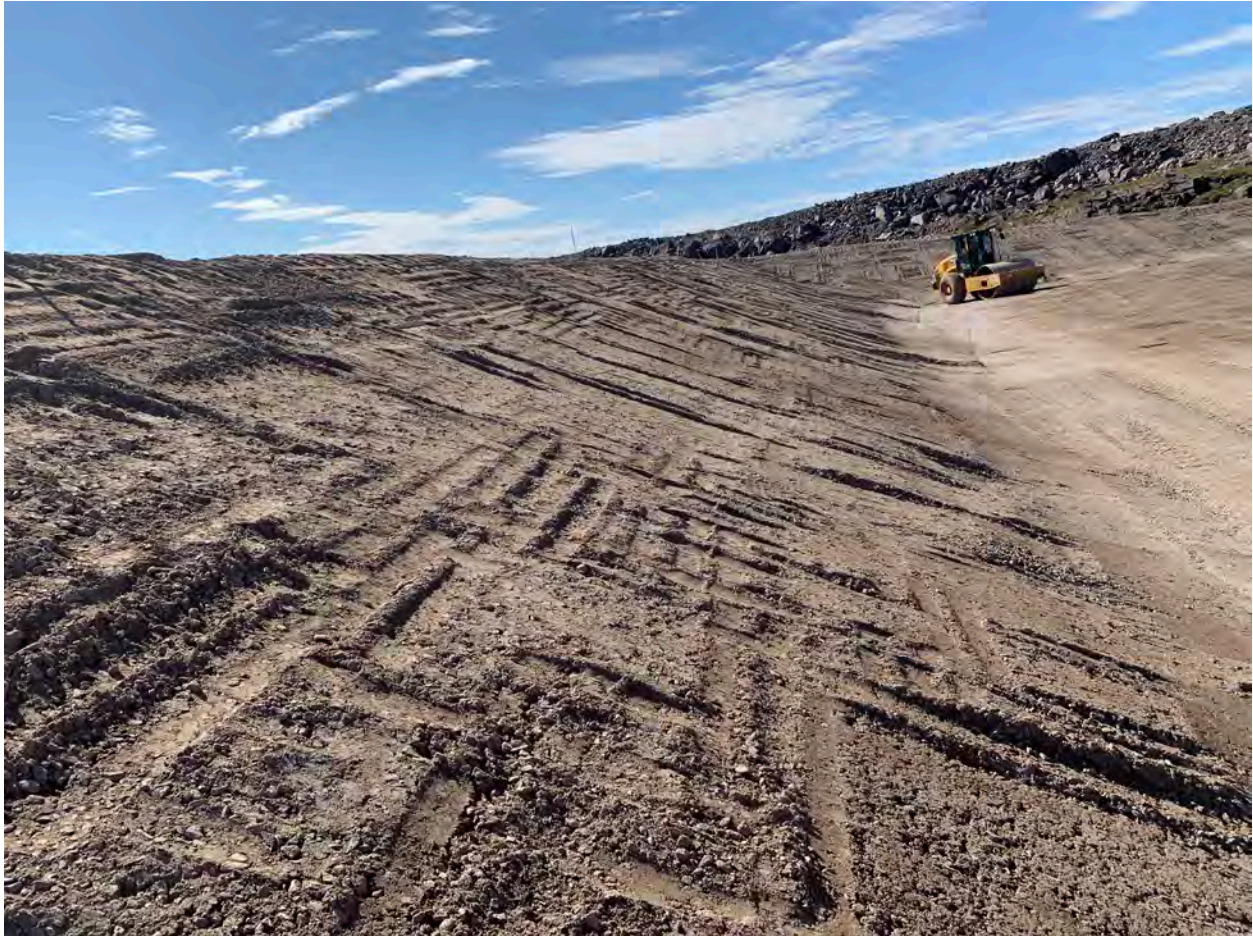
Placement of Intermediate Bedding Prior to Compaction - 19Jul20

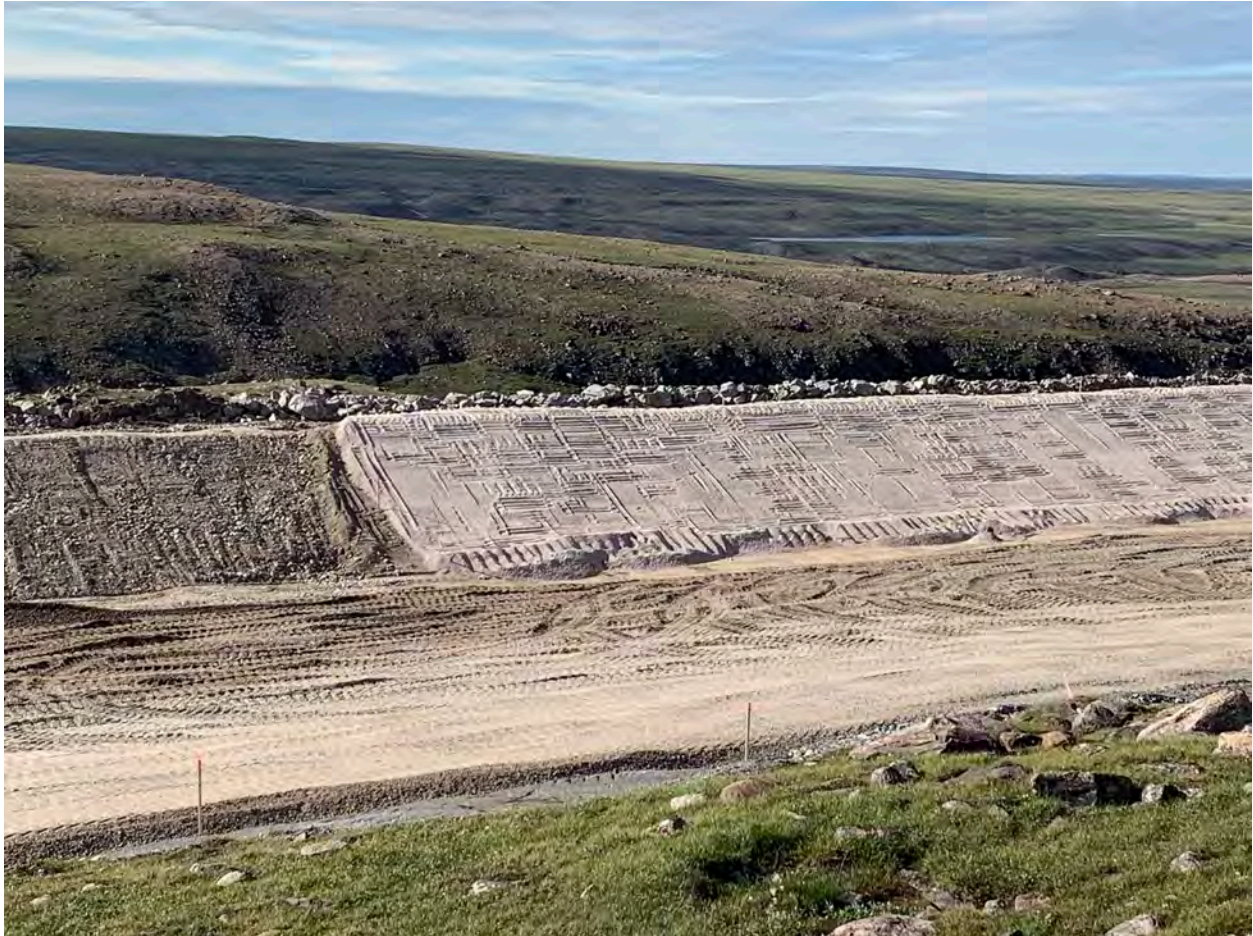
Placement of Intermediate Bedding - 20Jul20

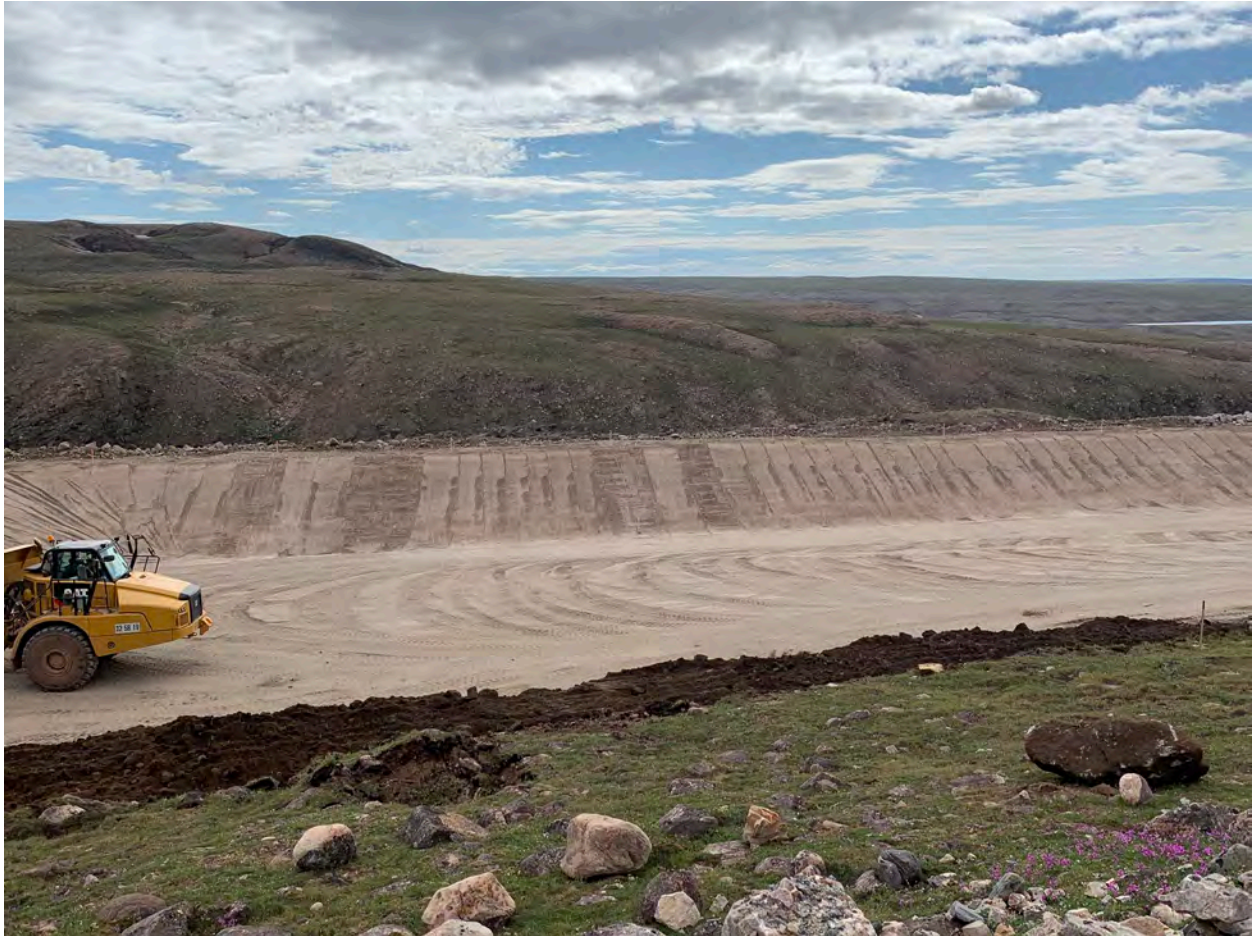
Preparing North Liner Anchoring - 21Jul20

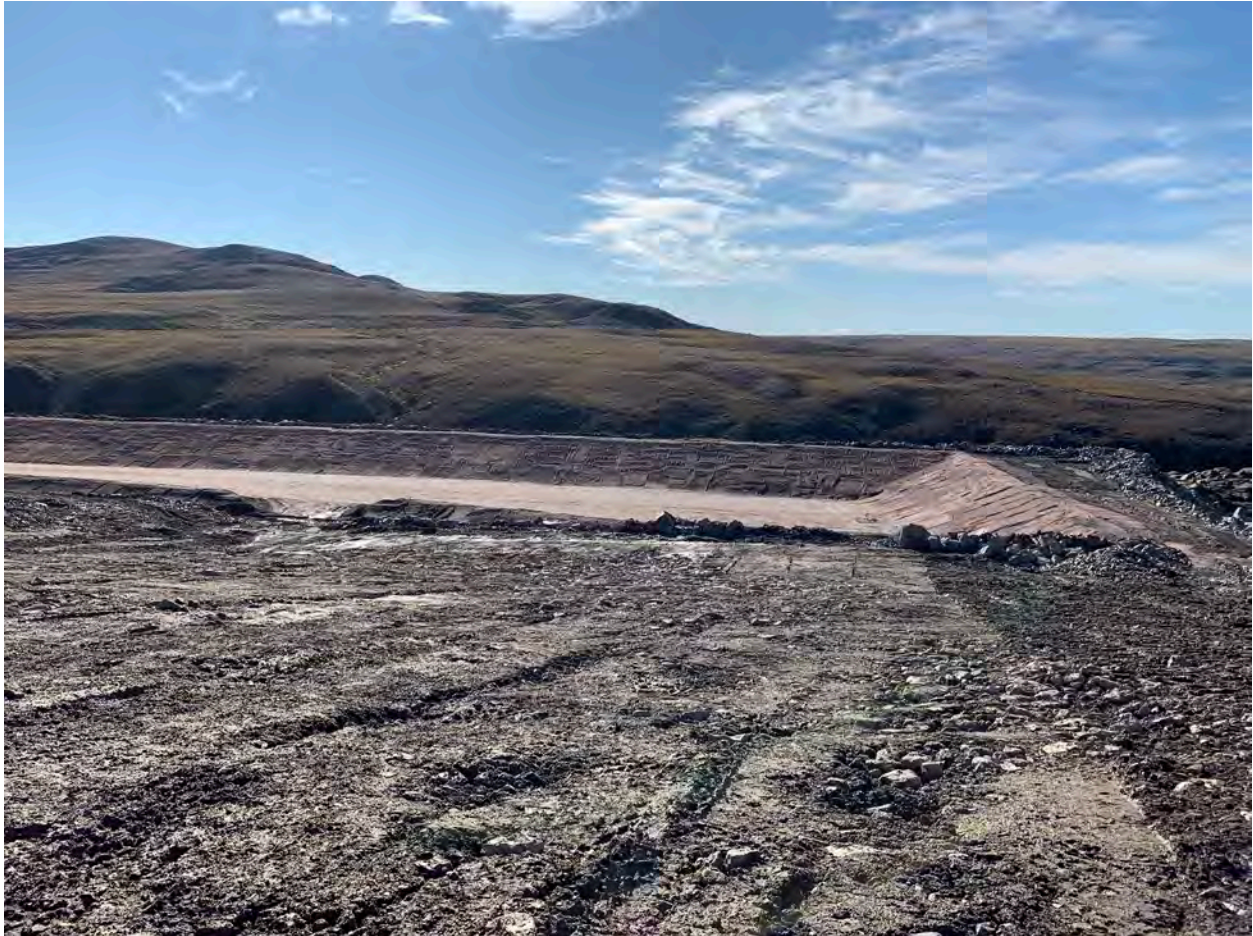
Pond Inlet Grading – 8Aug20
