Km106 Run of Mine Stockpile & Sedimentation Pond

MARY RIVER PROJECT

Construction Summary Report

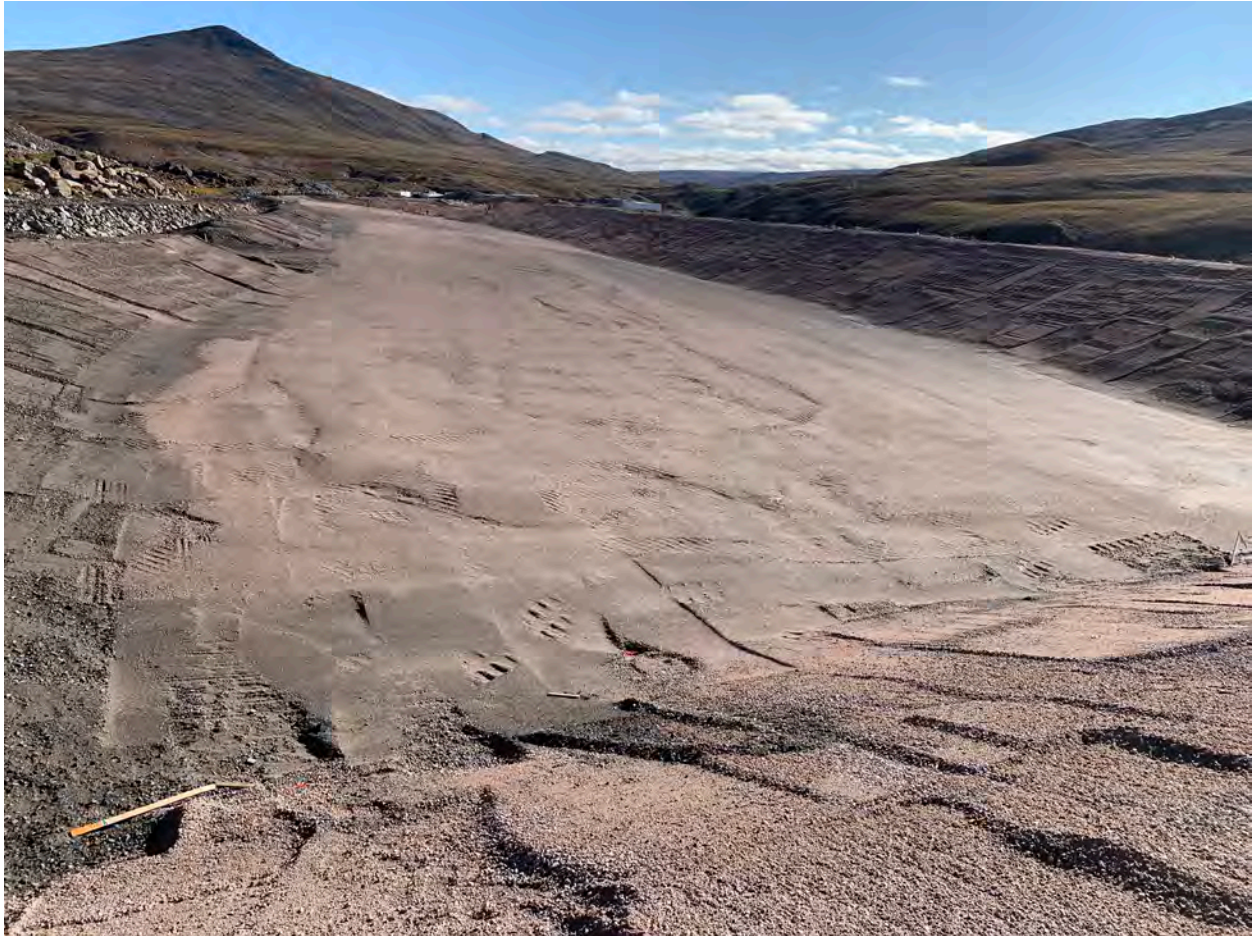
Placement of Intermediate Bedding - 20Aug20

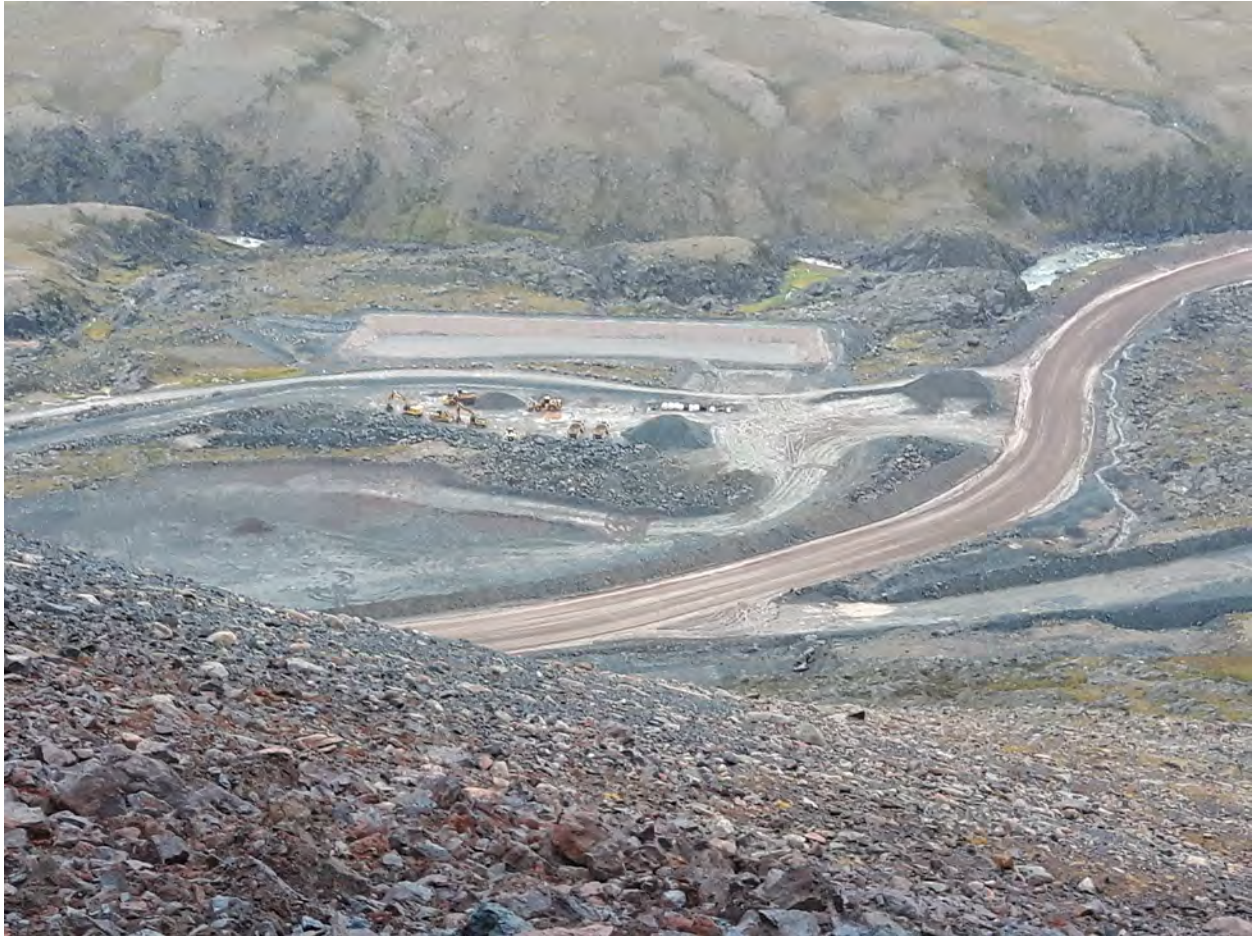
Photo – Project Extends Construction Activity - 22Aug20

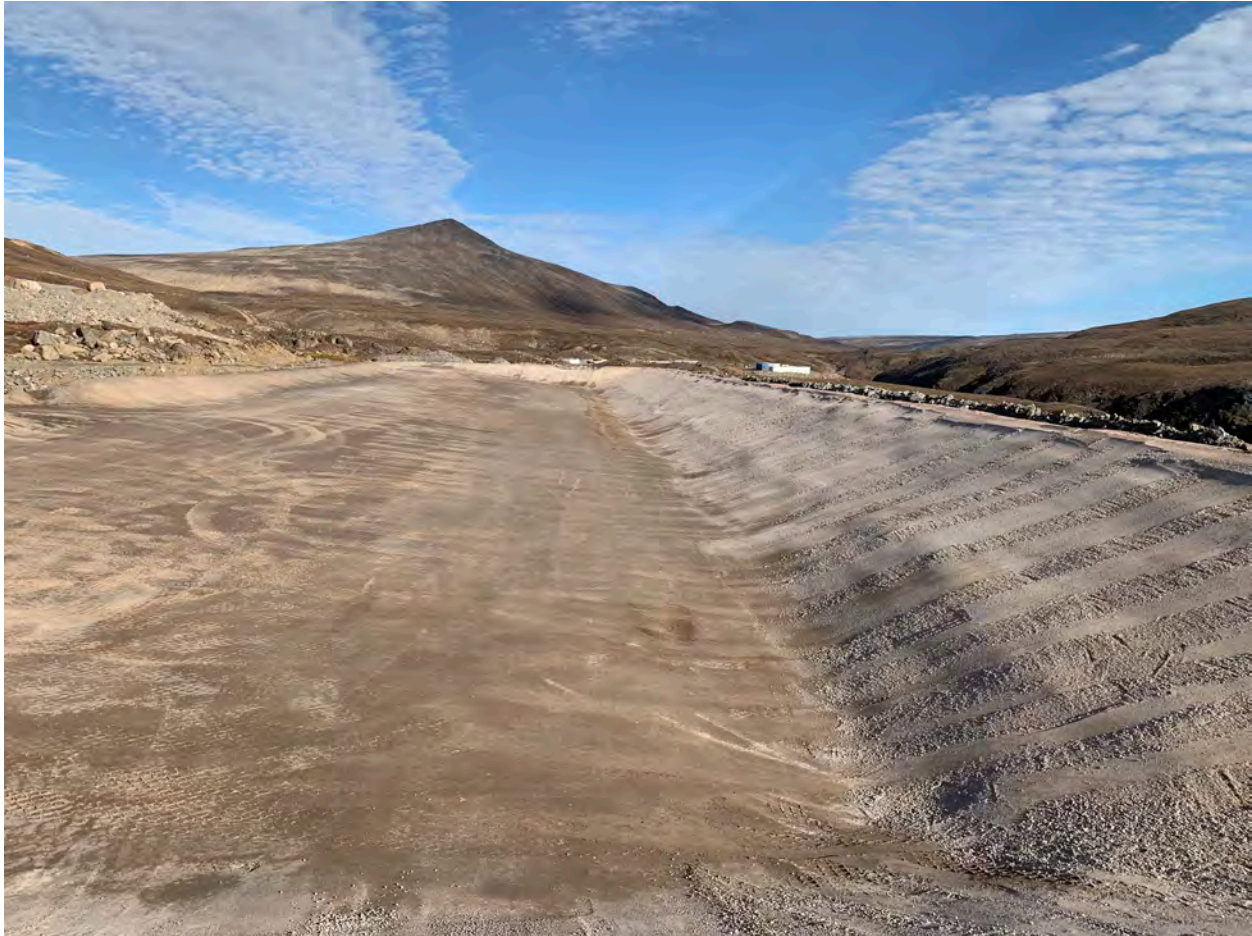
Completed Intermediate Bedding on Pond Bottom - 2Sep20

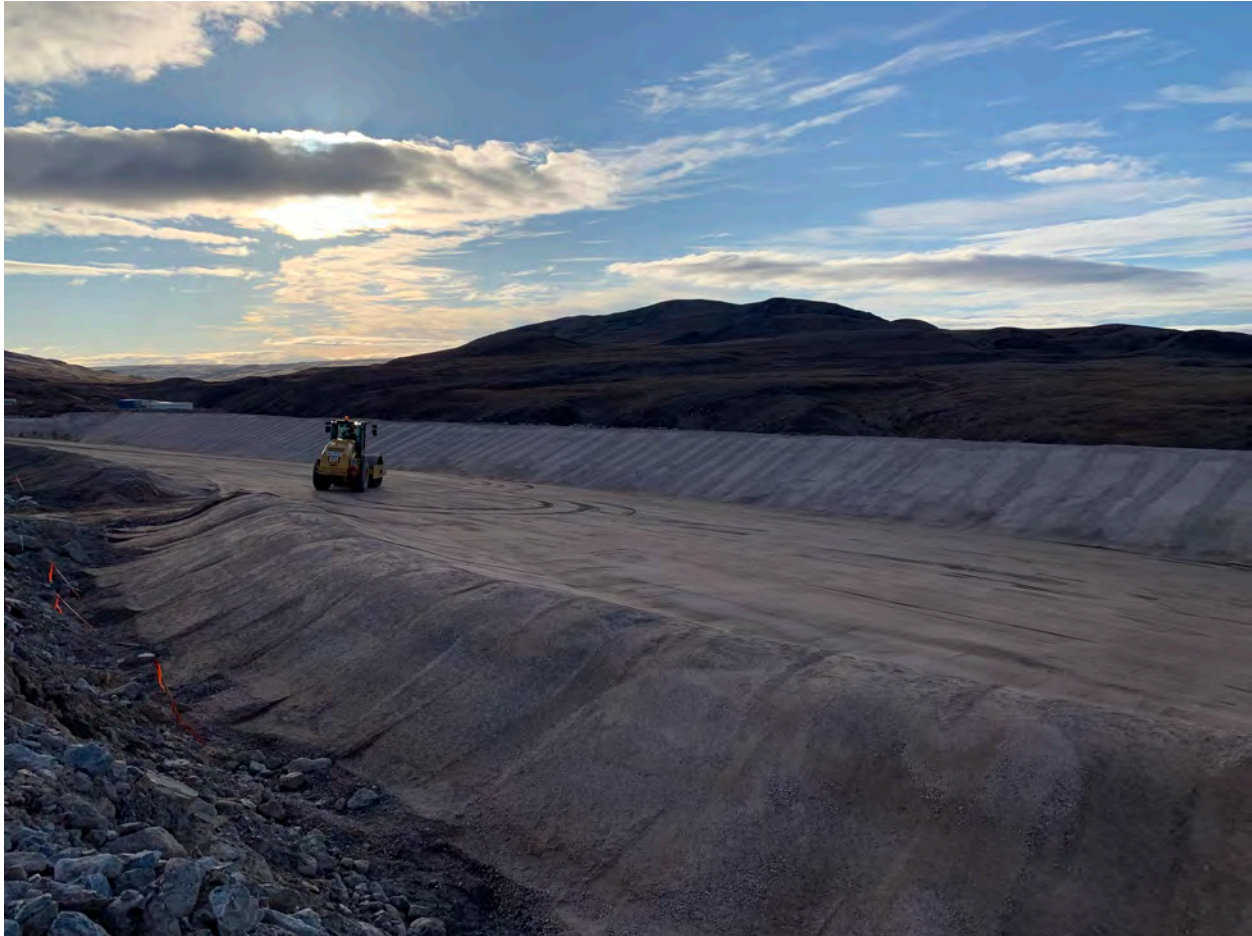
Compacting Intermediate Bedding - 3Sep20

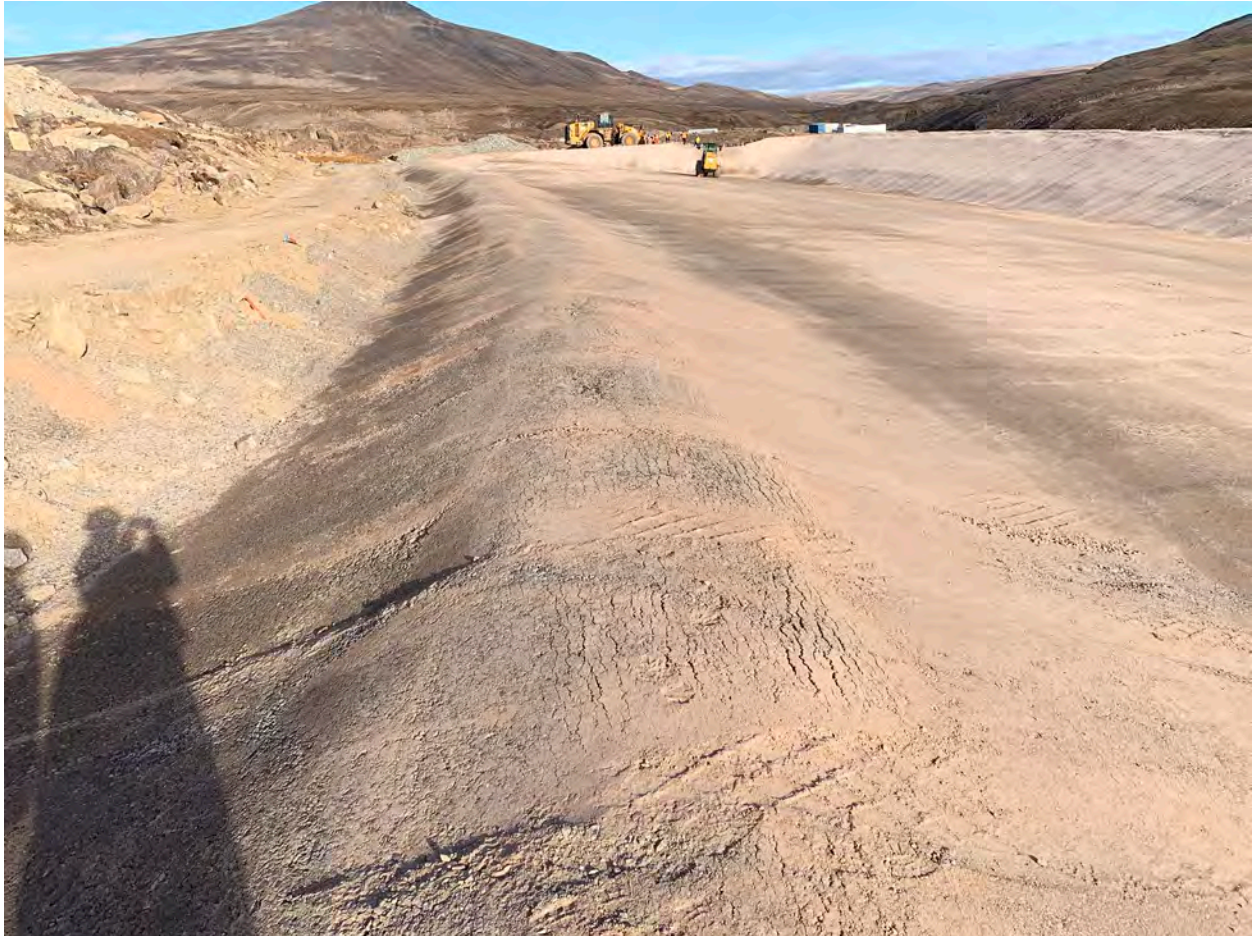
Photo of Completed Intermediate Bedding - 4Sep20

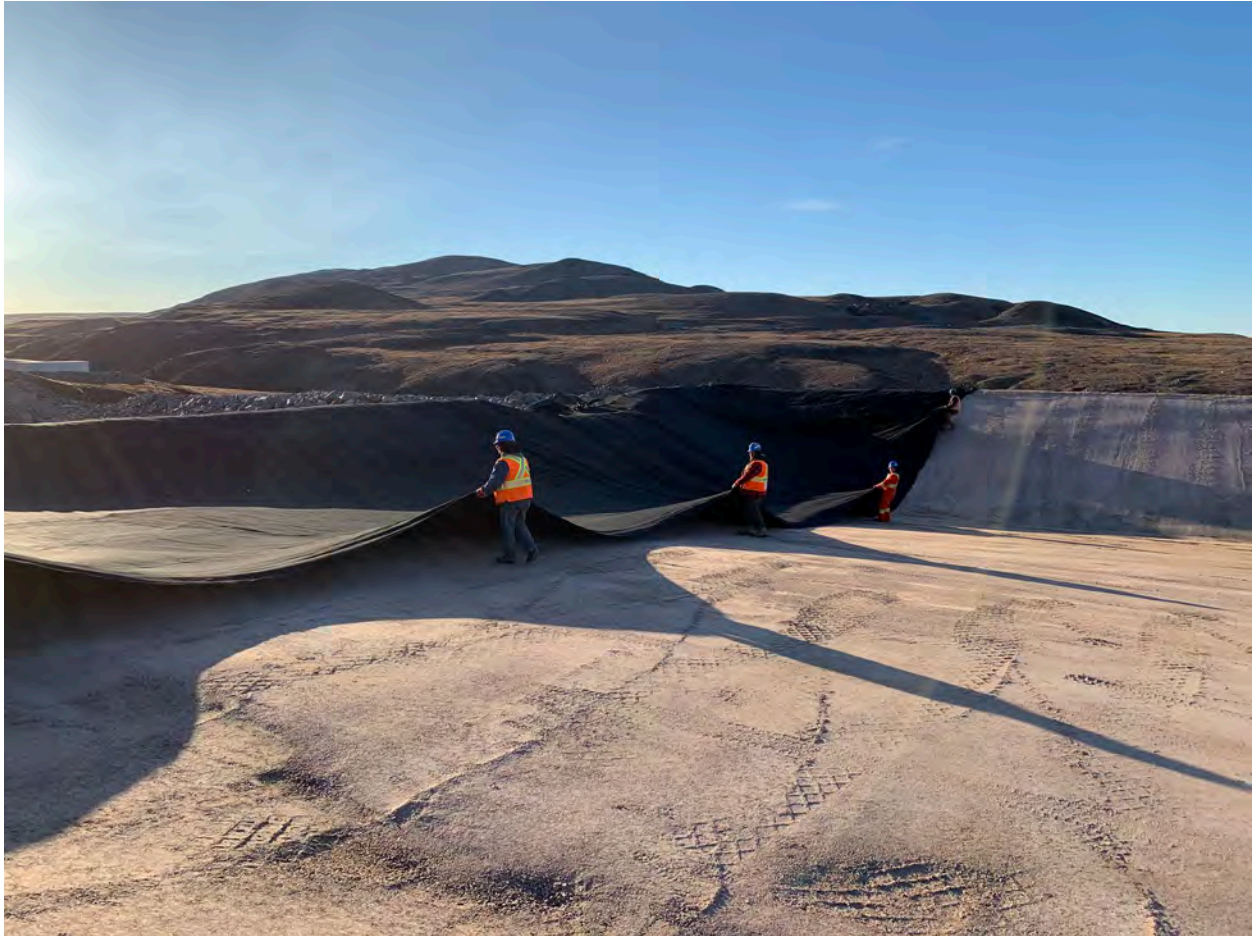
Deploying Geotextile Fabric - 5Sep20

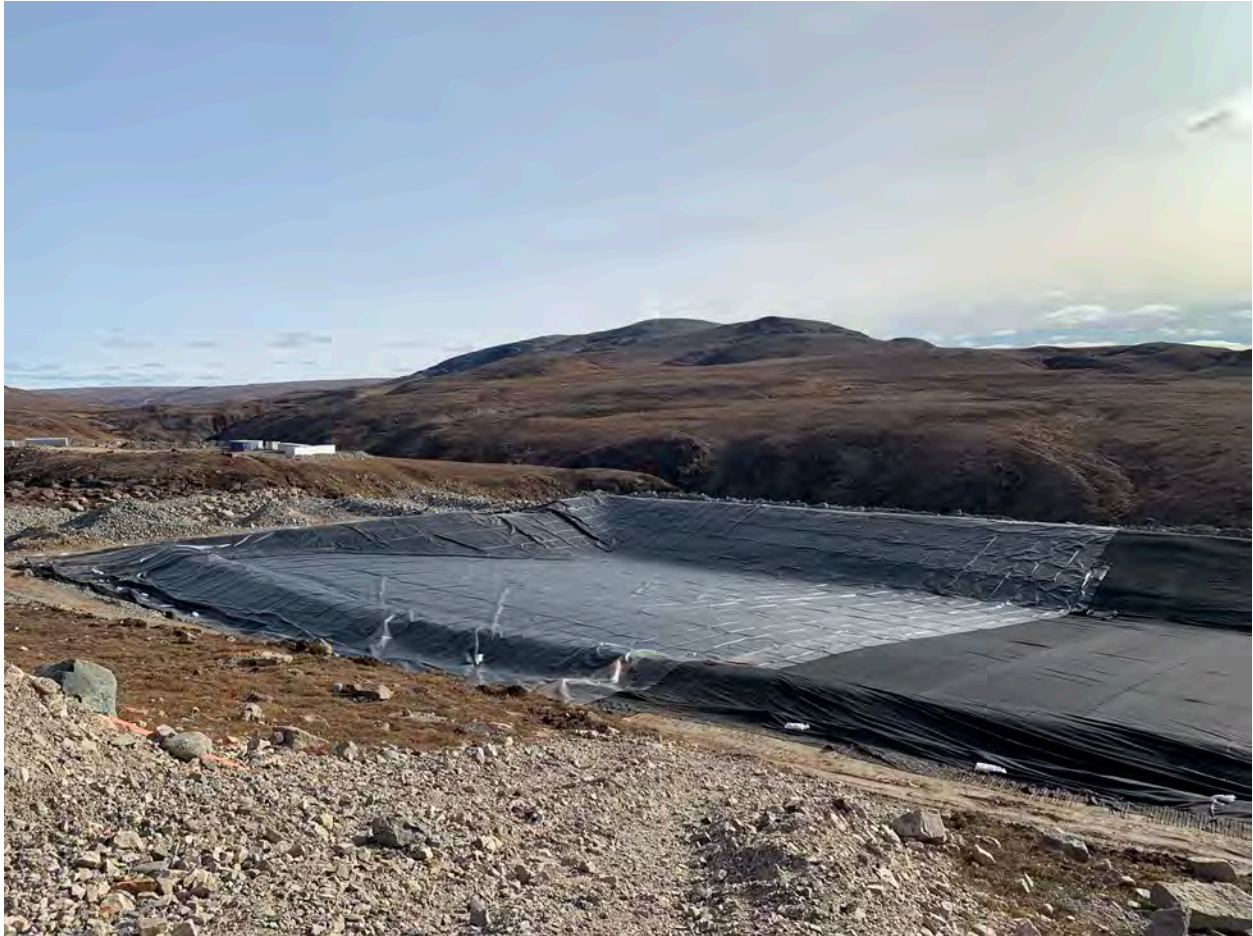
Deploying 1st Liner Panel - 5Sep20

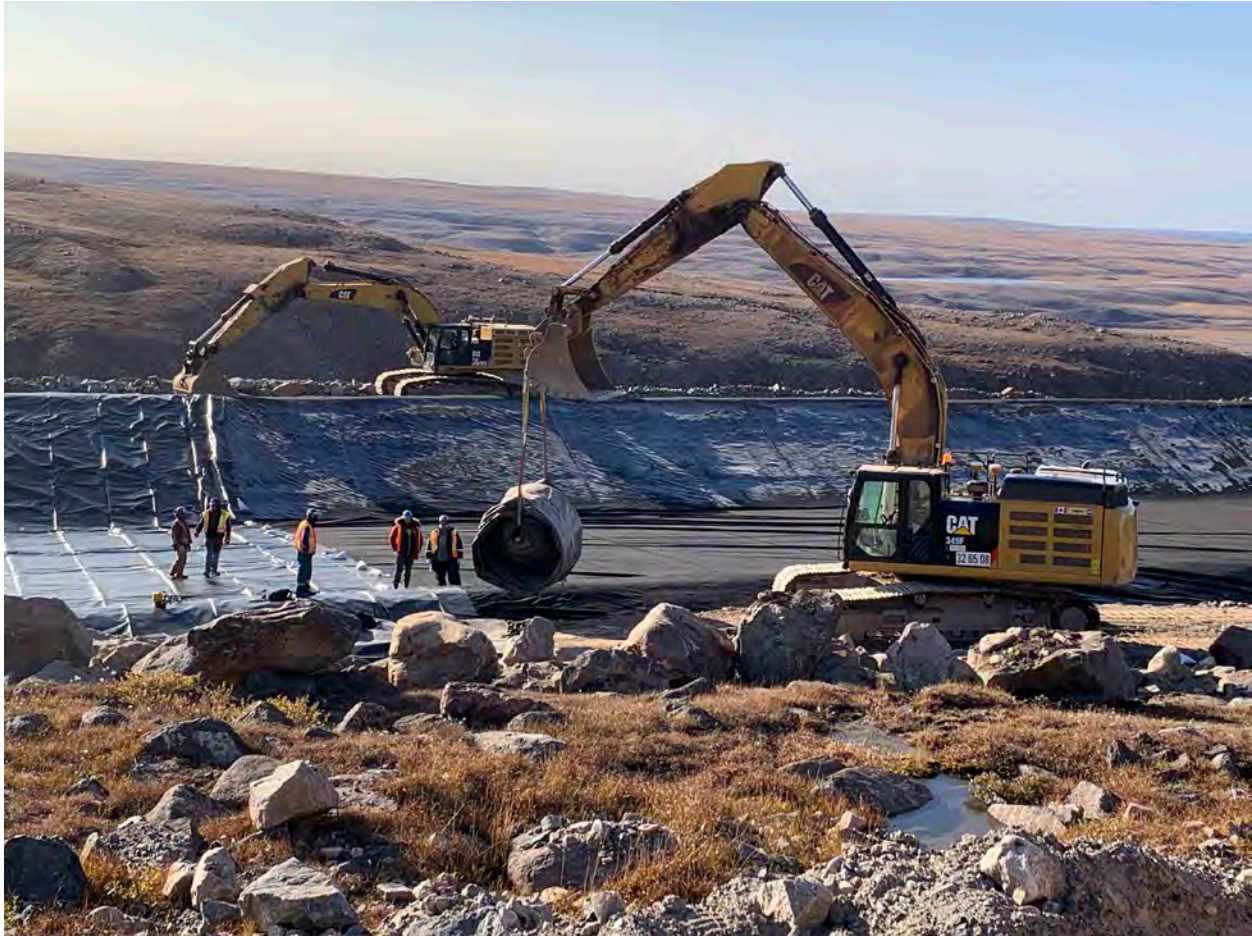
Deploying 2nd Liner Panel - 6Sep20

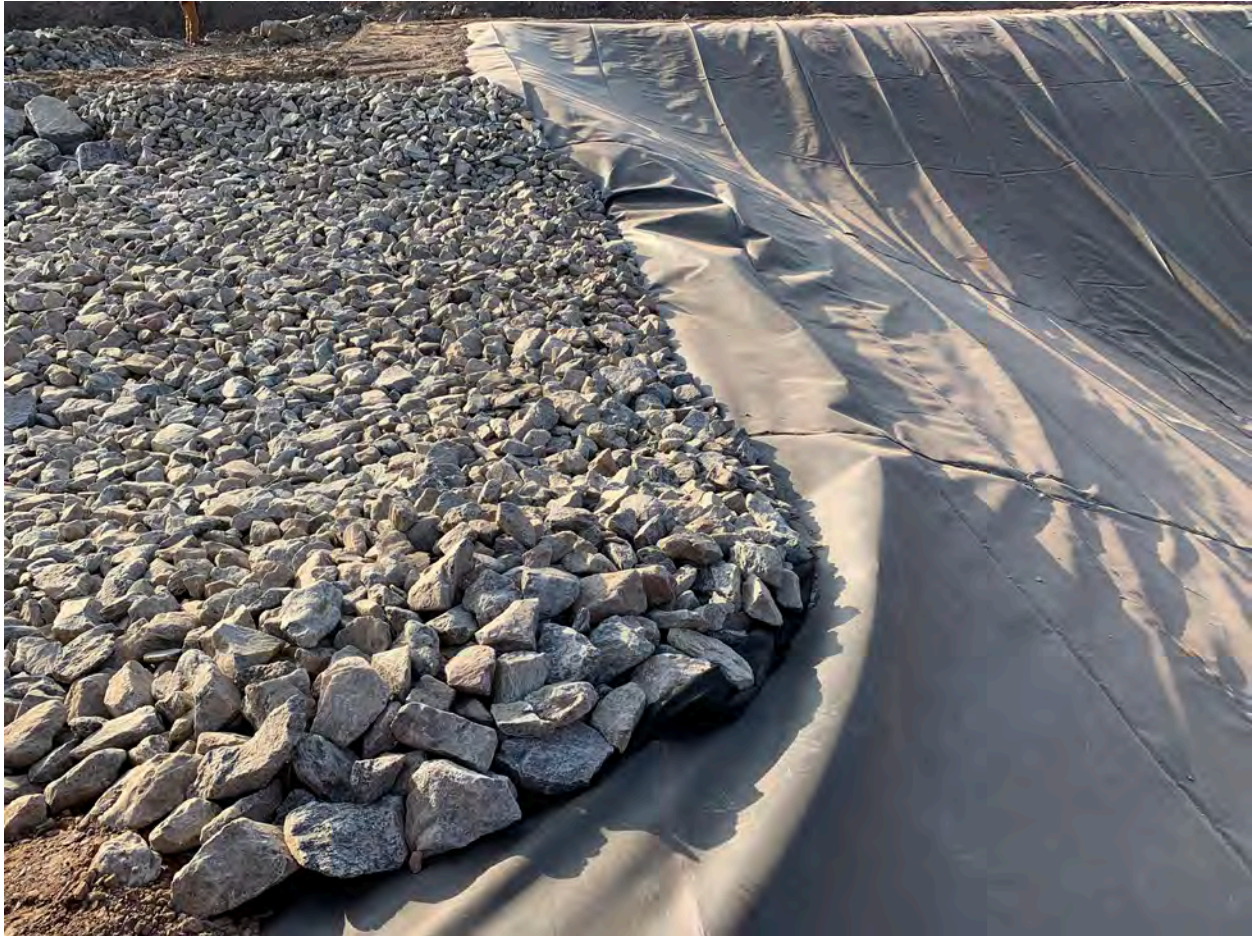
Photo of Spillway and Liner Transition - 9Sep20

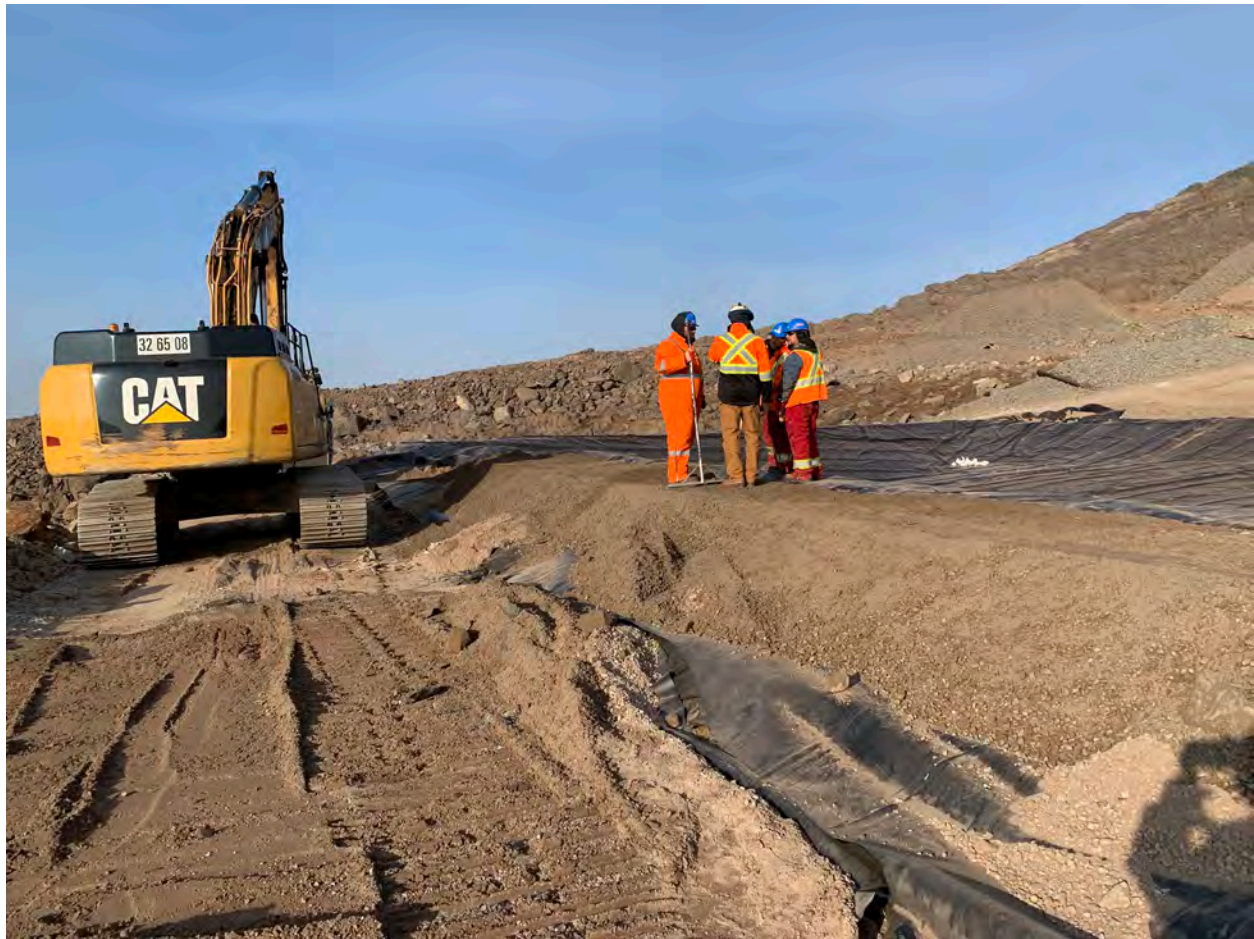
Backfilling Liner with $\frac{3}{4}$ " minus Material in Anchor Trench - 9Sep20

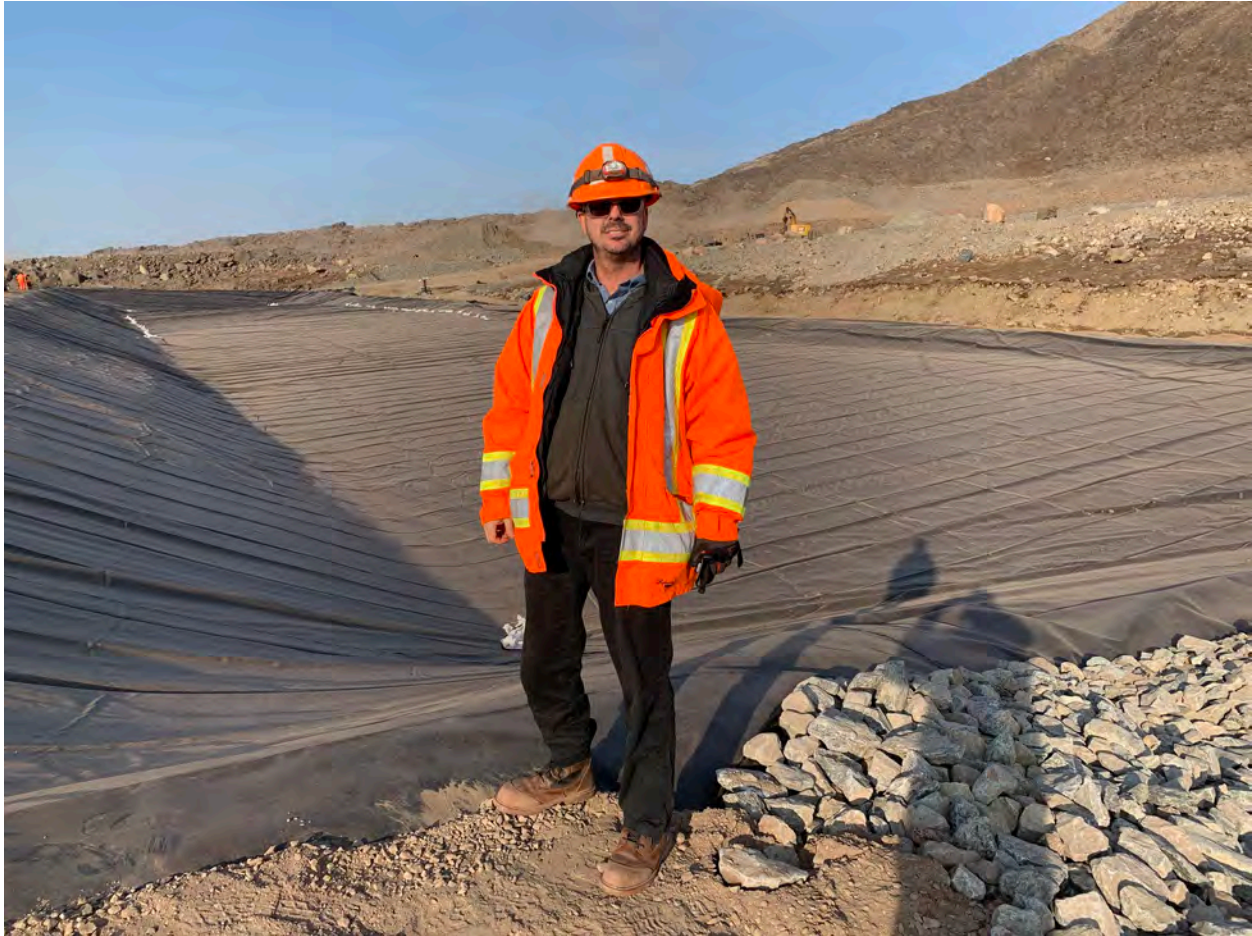
Completed Liner Installation - 10Sep20

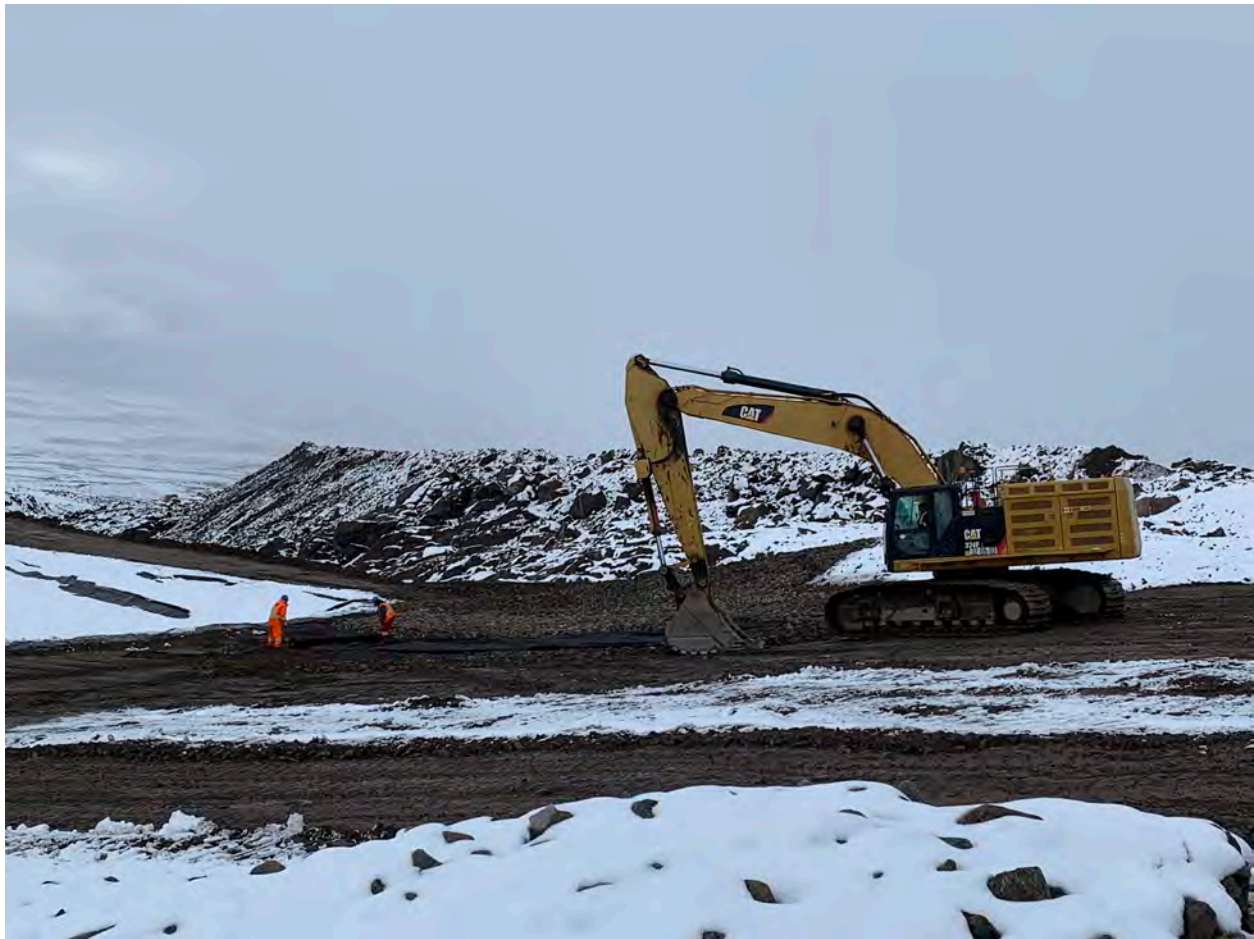
Placing Geotextile Fabric and Fine Riprap at Inlet - 12Sep20

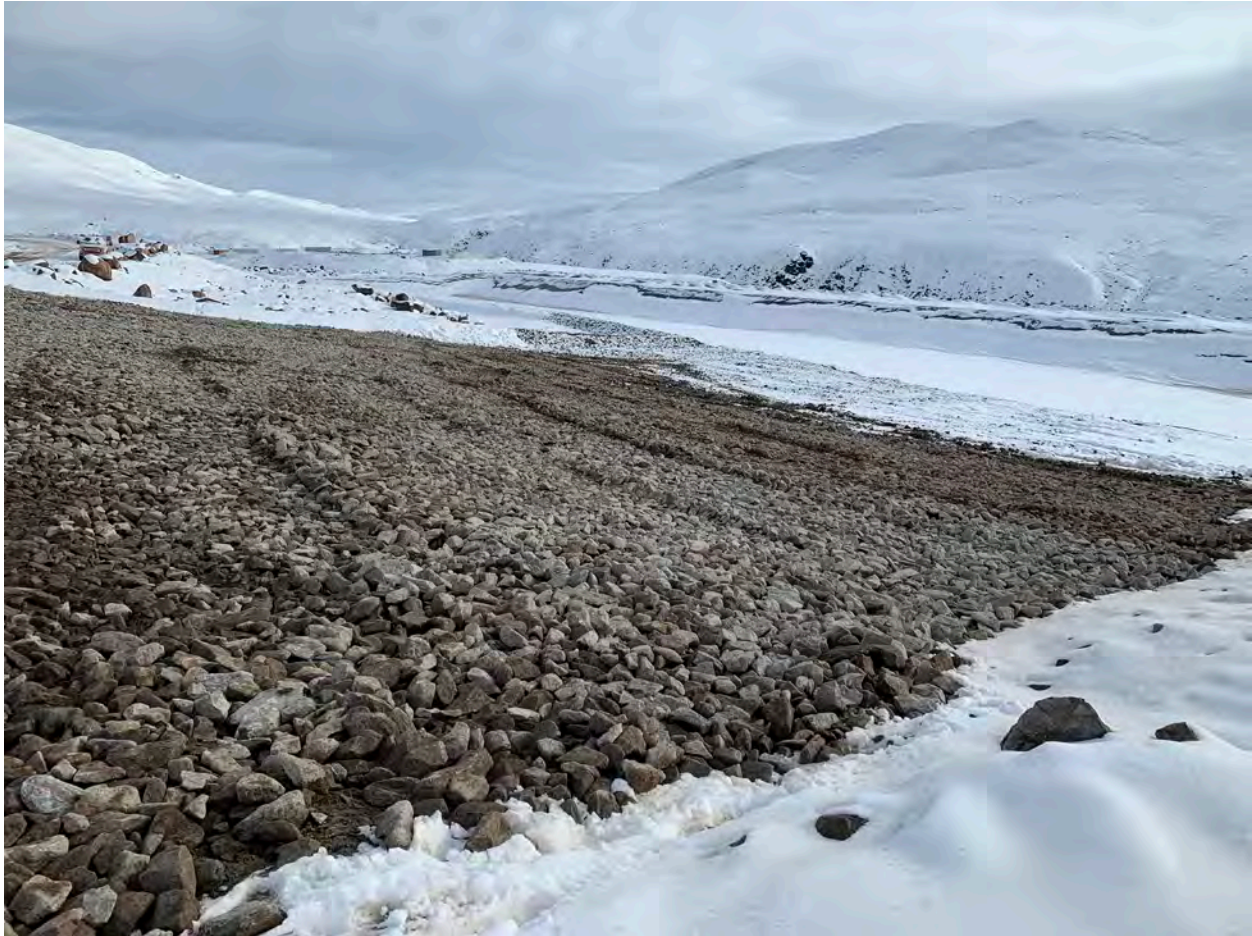
Completed Fine Riprap Placement at Inlet - 16Sep20

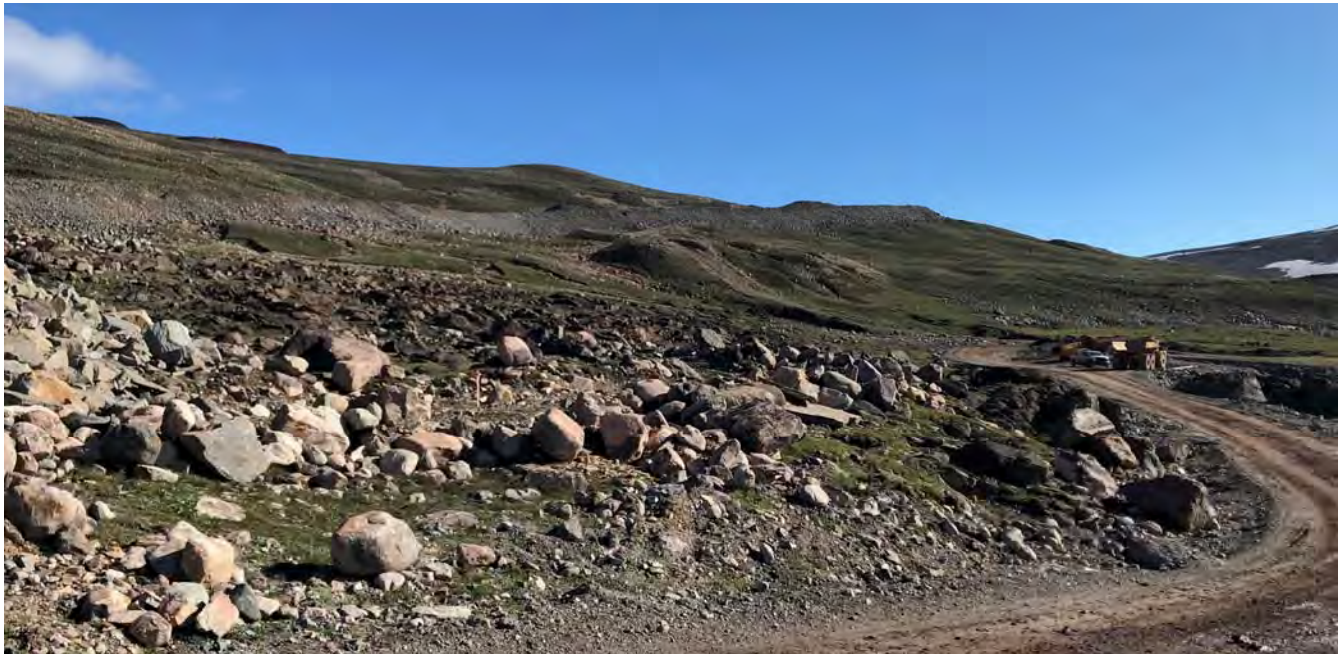
Location of Diversion Berm Where High Point Prevent Drainage Along Design Alignment
