APPENDIX C.2

Geotechnical Inspection Reports

RE: Submission of 2019 Geotechnical Inspection Report No. 1 (July 2020)

Wood Environment & Infrastructure Solutions (Wood), has completed the first geotechnical field inspection of 2020 at the Mary River Iron mine complex, which is a condition of the Type "A" Water License No: 2AM-MRY1325 – Amendment No.1 ("Water License").

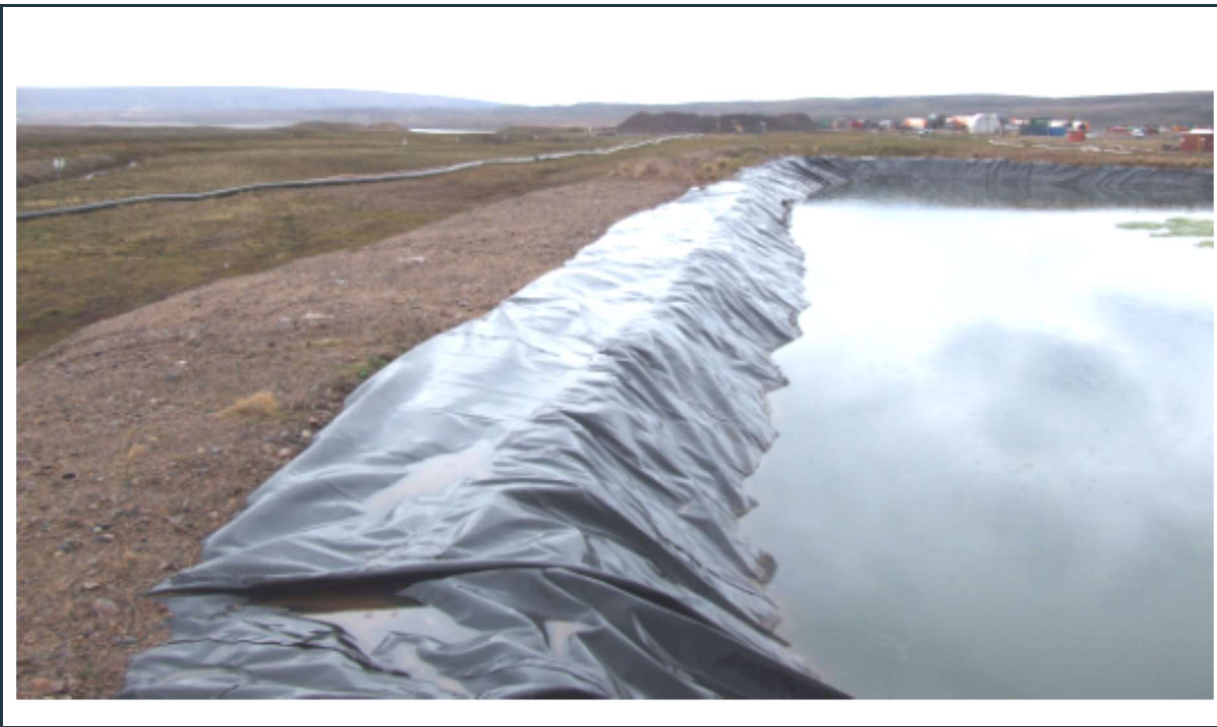
Figure 8: PWS pond #1. Well maintained perimeter berm and liner (note some floating ice in the pond).

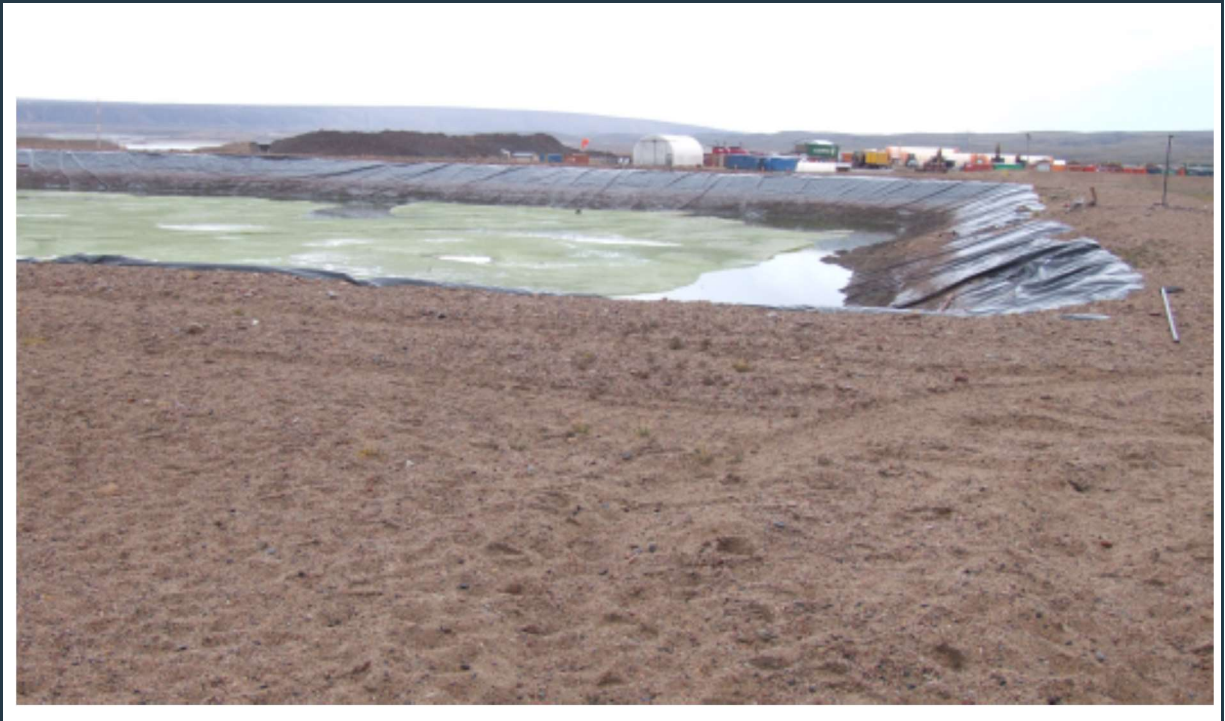
Figure 9: PWS pond #2 – Berm and liner in good condition. The water was recently lowered, and ice still visible in the pond.

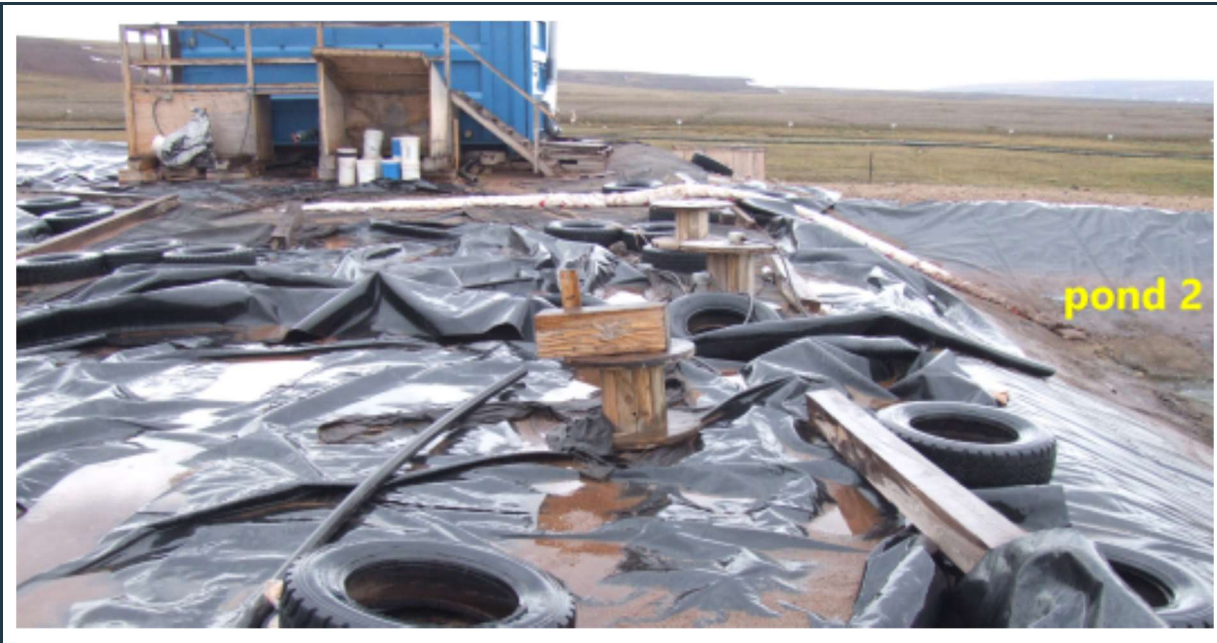
As pointed out above, the berms appear to be structurally stable, and no visible wet downstream slopes and toe seepage was noted. However, as shown in Figure 11, the surface appearance was not found to be orderly at the front of the water discharge pipes at the middle of the south-western perimeter berm at its juncture with the central berm between Ponds #2 and #3. Namely, heavily wrinkled surficial liner was observed to cover the crest at this location and at the junction.

Figure 11: PWSP #2 and #3 – Untidy conditions at the water discharge point between ponds #2 and #3.

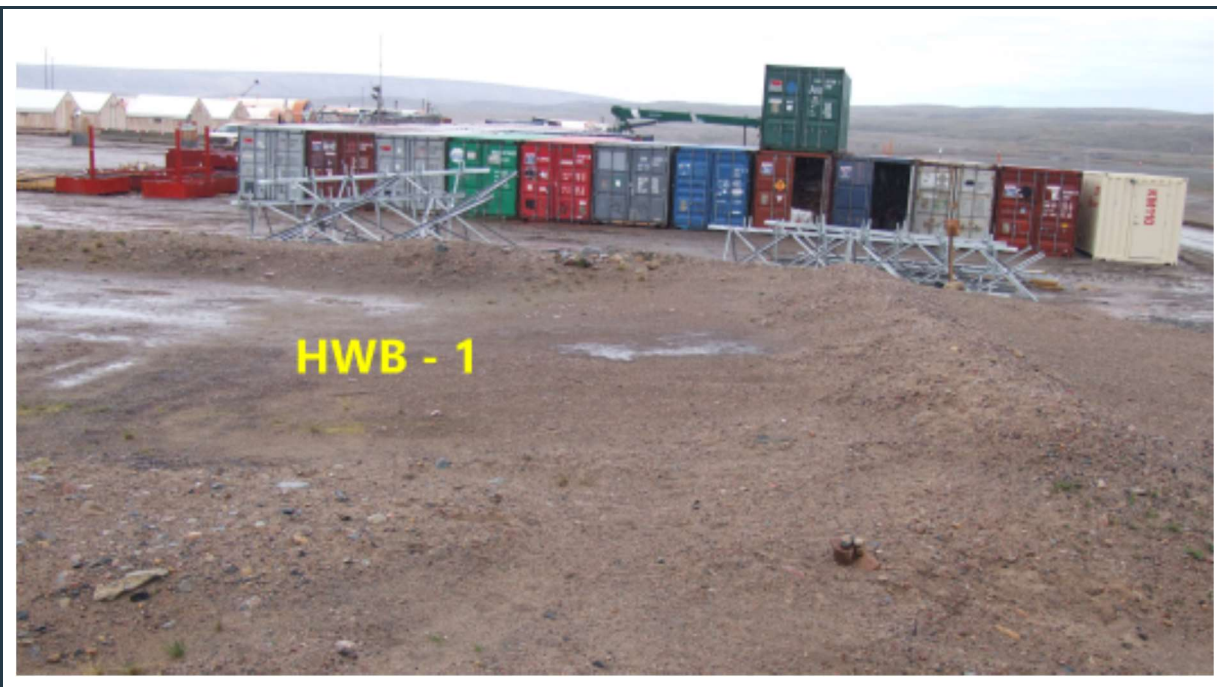
This cell is currently empty, as shown in Figure 12. Based on information obtained during the 2019 summer inspection, concerns had been raised in the past to suspected liner damage within this cell, and consequently no material is stored in this cell.

Figure 12: View of HWB-1 – Currently this cell is empty.

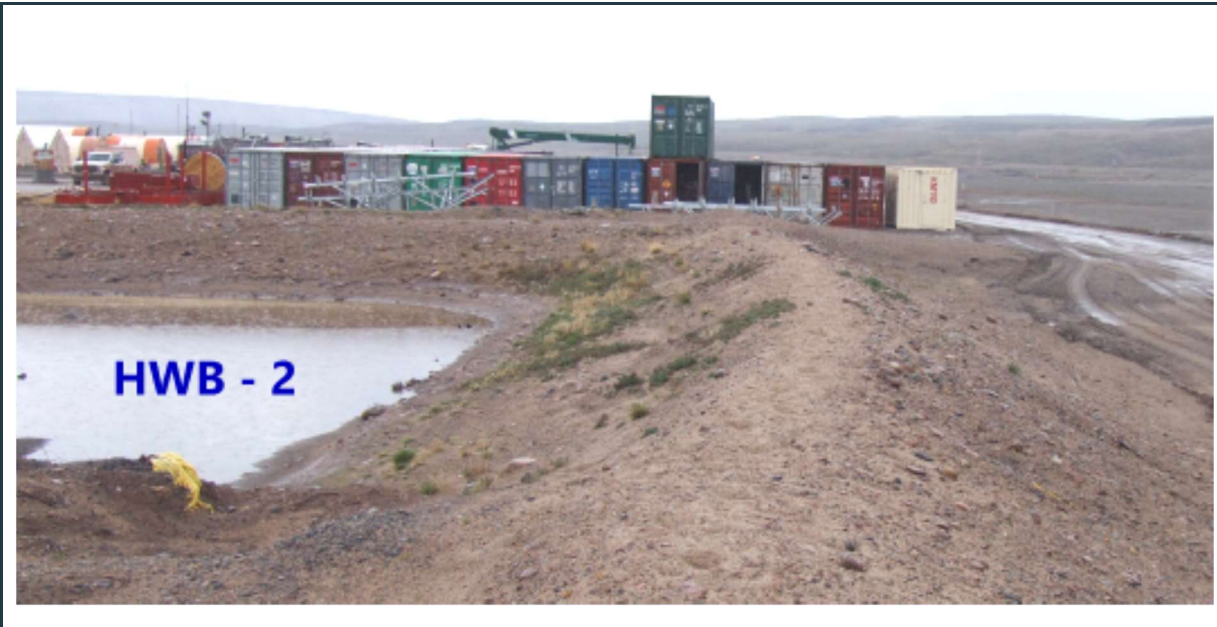
As shown in Figure 13, the perimeter berm around this cell appears to be stable. The presence of water visible within the cell demonstrates that the liner is intact. No visible seepage from the cell was noted around the berm, and the cell operates as intended, although no material is currently stored here.

Figure 13: View of the stable berm at HWB-2. Other than some plastic, the cell is currently empty.

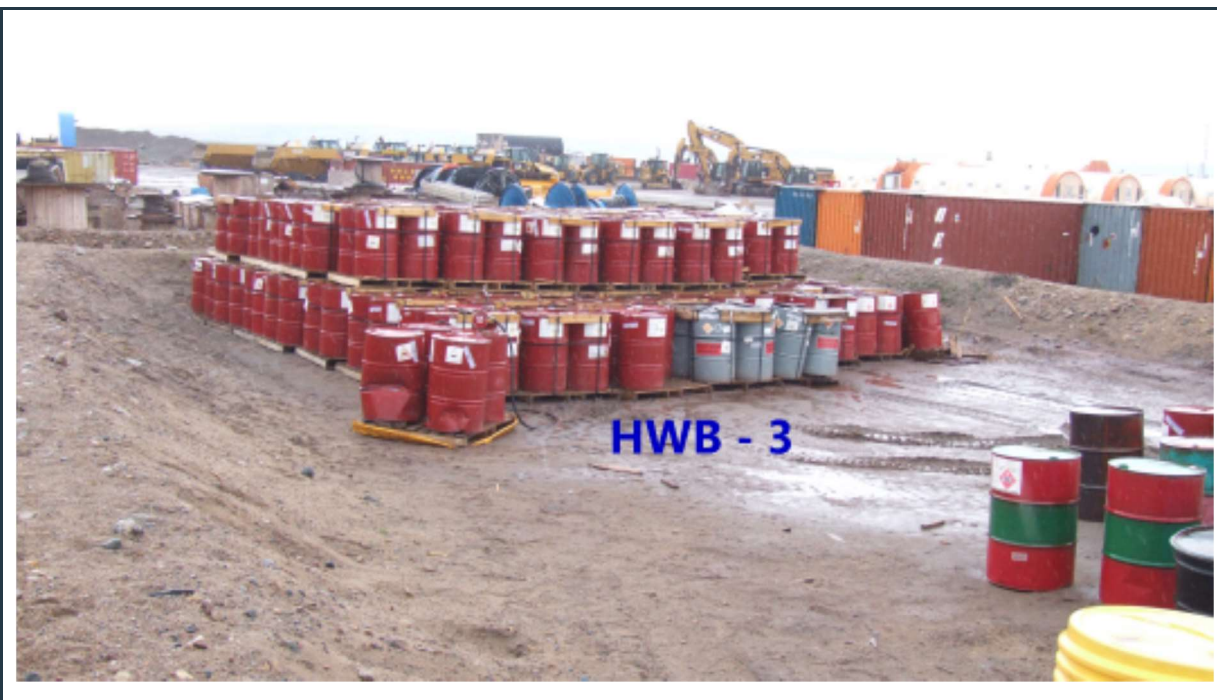
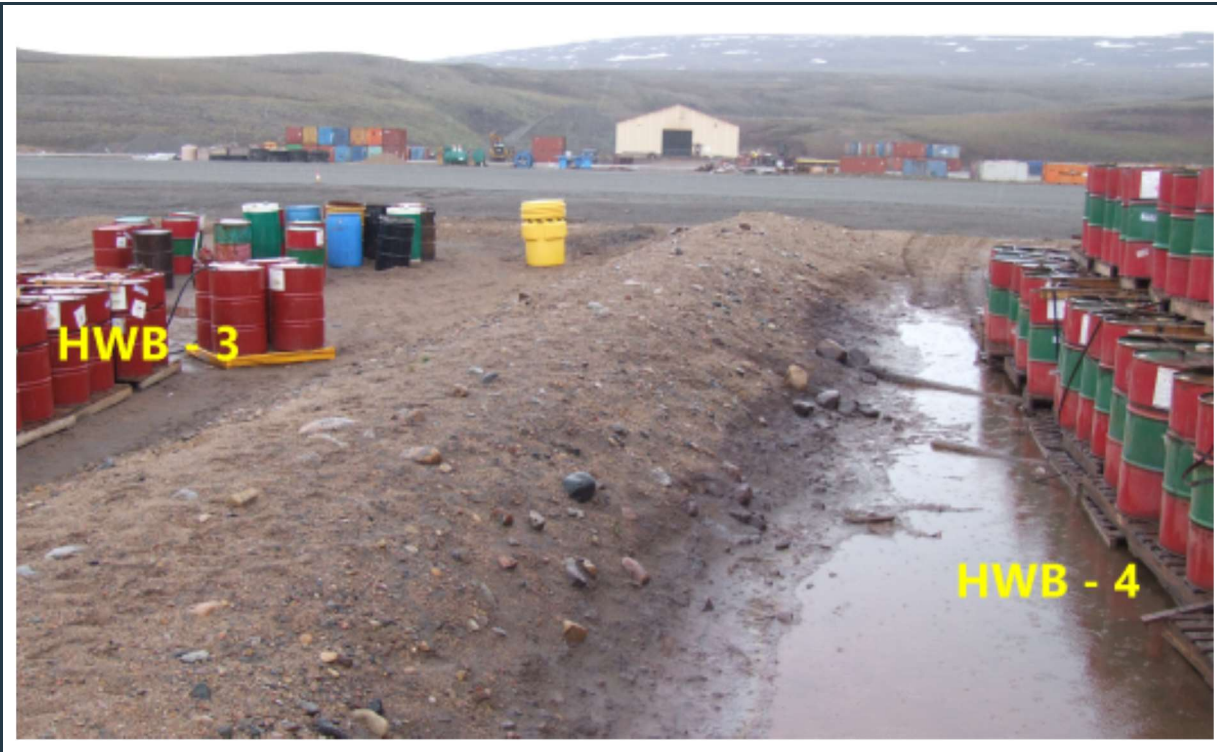
These cells are located side-by-side and were called in previous reports as "Fuel Containment" cells. As shown in Figures 14 and 15, currently there are fuel barrels stored on wooden pallets in both cells.

Figure 14: View of stable berms and the stored fuel barrels in HWB-3.

Figure 15: View of HWB-4 next to HWB-3, with jetfuel barrels stored on wooden pallets.

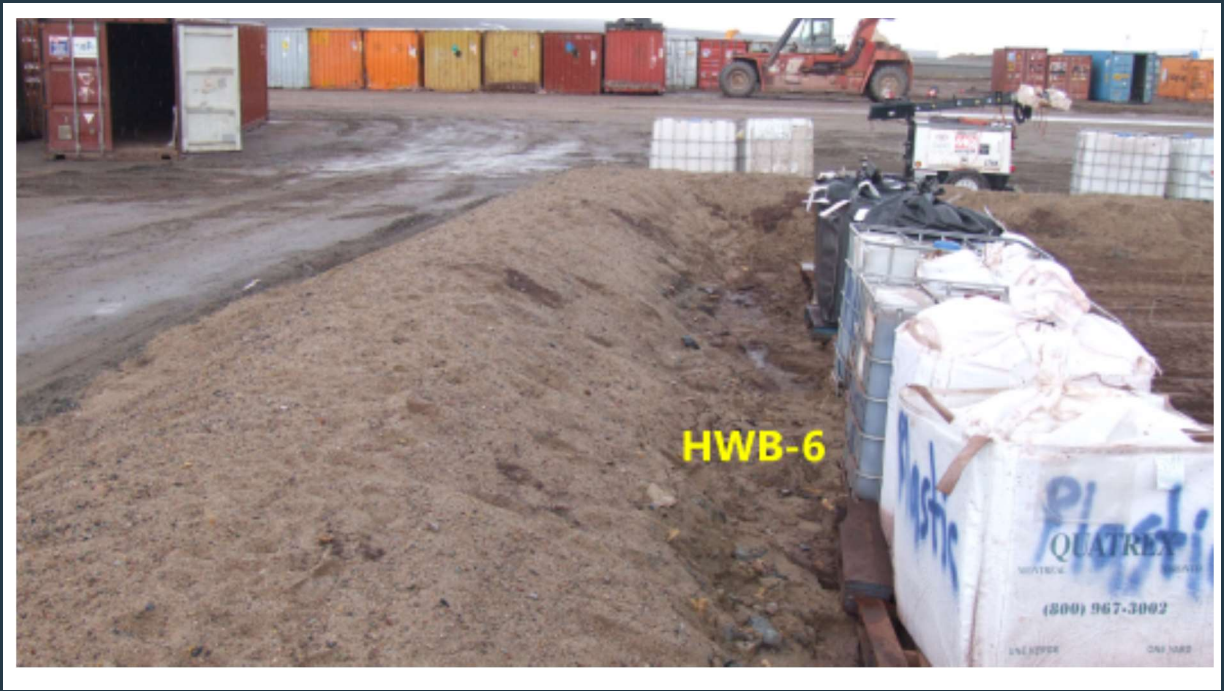
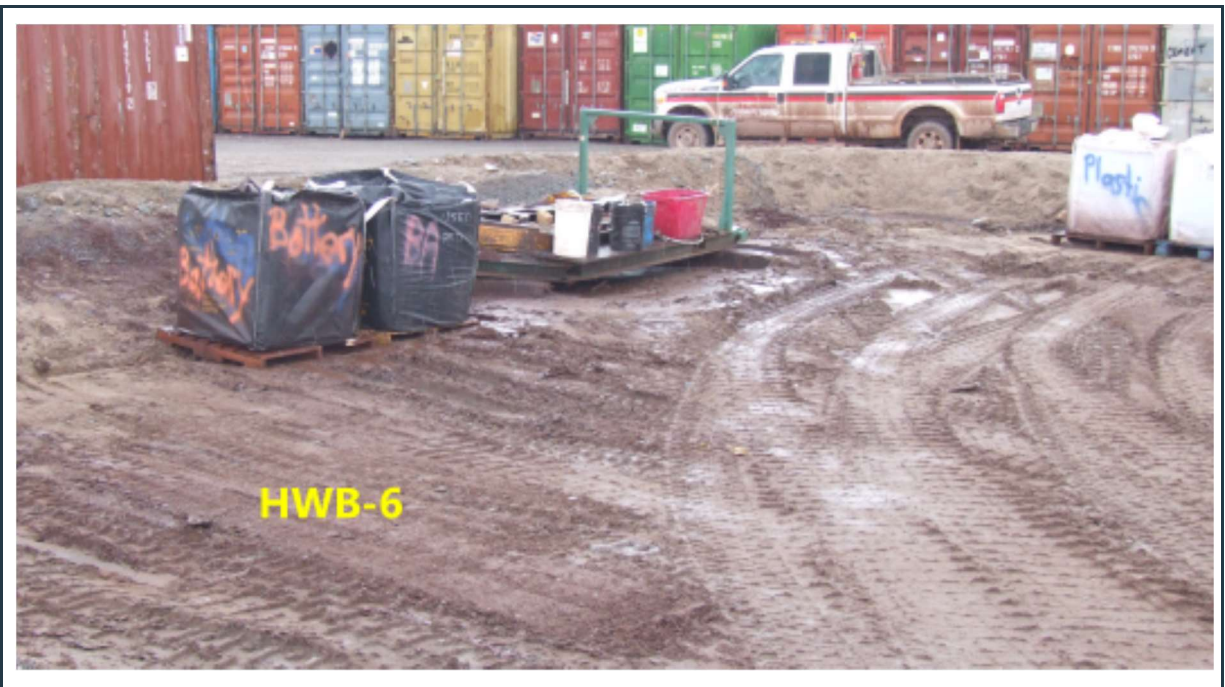
The HWB-6 cell was in poor condition during the 2019 summer inspection. However, as shown in Figures 17 and 18, extensive rehabilitation of this cell has recently been completed. The berms have been regraded, stabilized and the floor of the cell covered with granular fill. Currently, there are a few waste cubes on wood pallets stored in the cell, located adjacent to the incinerator.

Figure 17: View of the recently upgraded stable berm around HWB-6.

Figure 18: View of HWB-6. Note the well maintained “floor” (protecting the liner) within the cell.

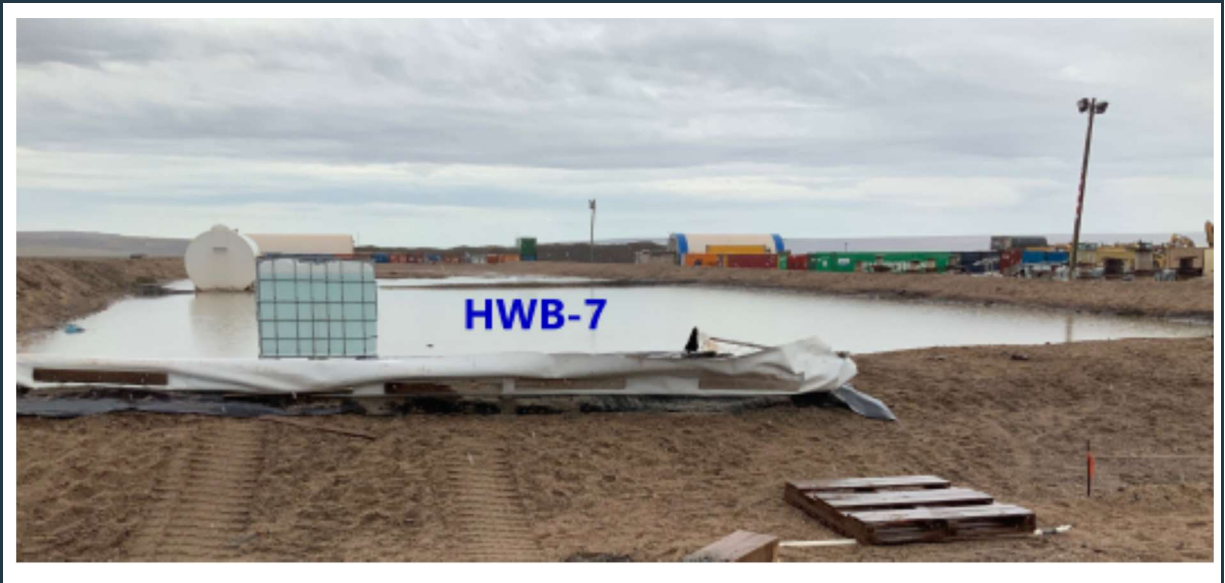
HWB-7 cell was a bulk fuel storage facility in the past. Currently, only one large fuel tank is stored in the cell, as shown in Figure 19. The perimeter berms around the cell appear to be stable and the visible water (rain and melted snow) within the cell is indicative of adequate liner performance.

Figure 19: View of the large HWB-7, with only one fuel tank stored in this cell.

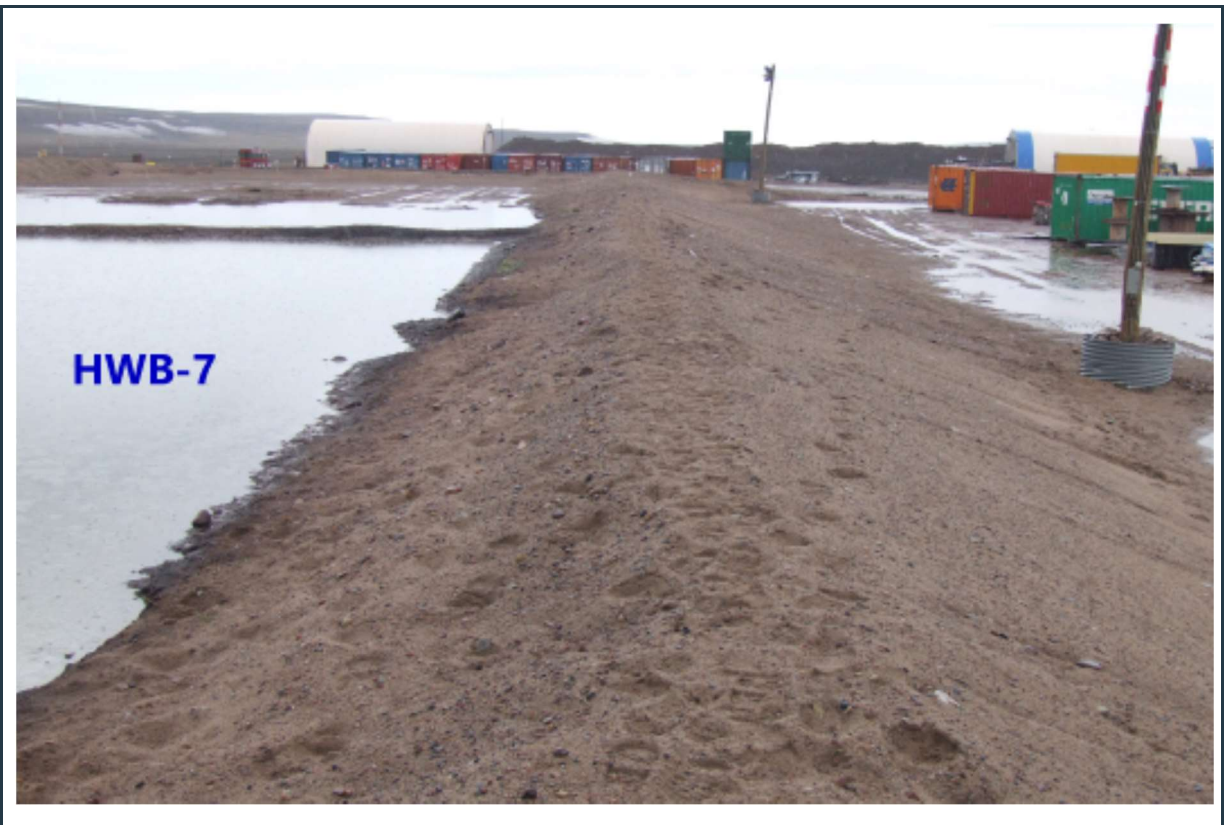
Figure 20: View of the stable berm around the HWB-7 cell.

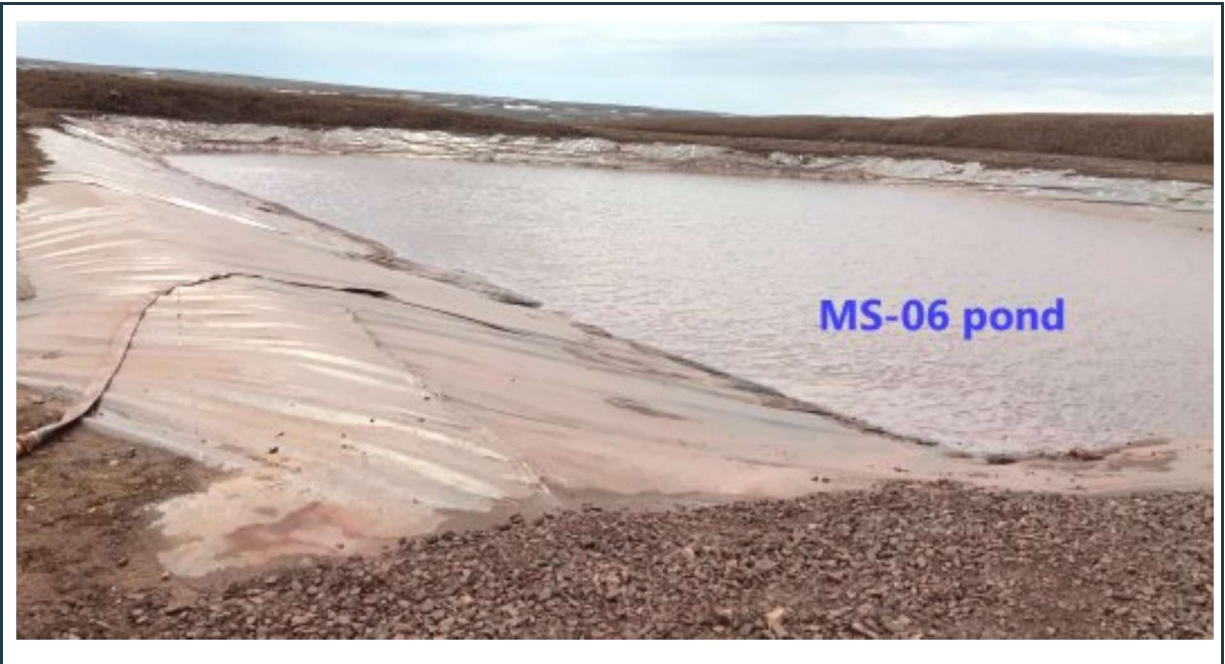
Figure 21: MS-06 surface-water collection pond with stable berms and intact liner.

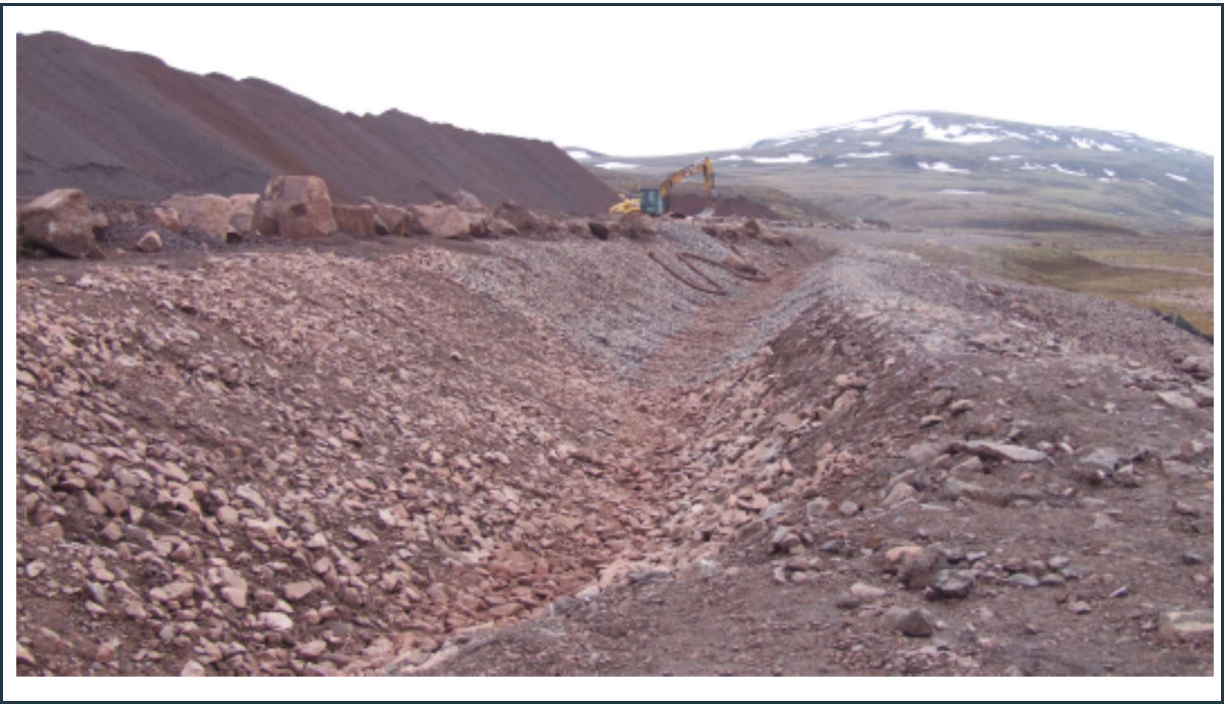
Figure 22: Well maintained surface-water collection ditch around the crusher plant, leading to MS-06.

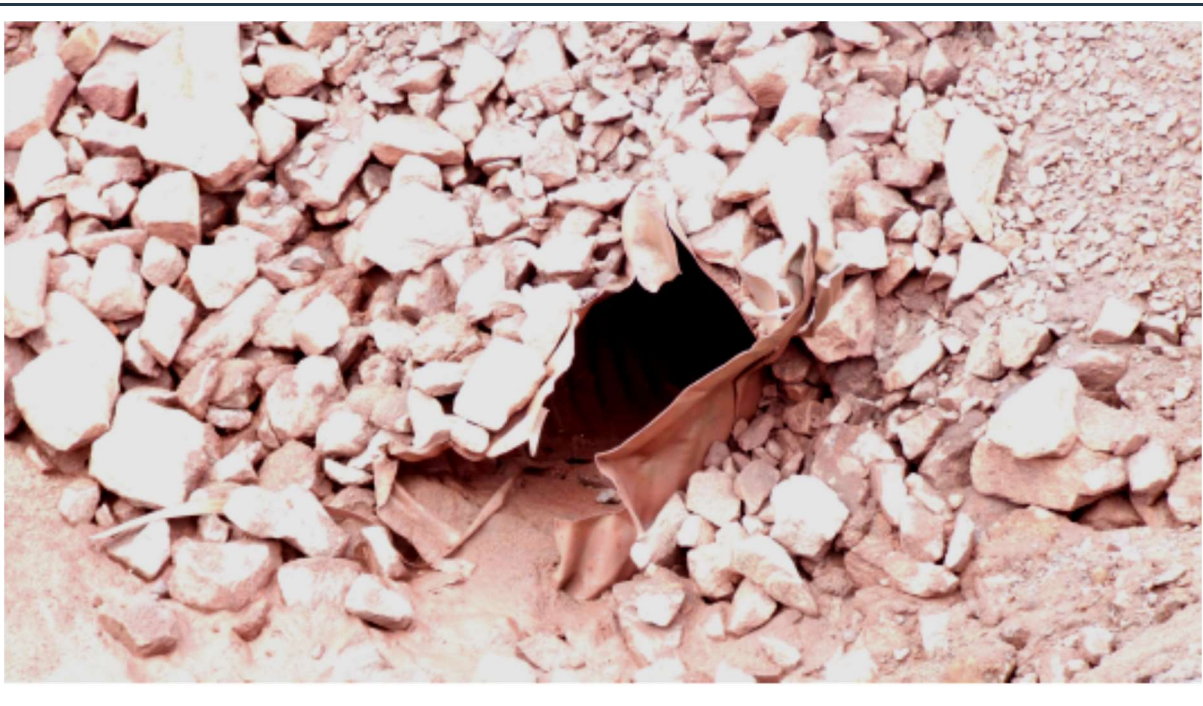
Figure 24: The other end (inlet) of the culvert shown in Figure 23.

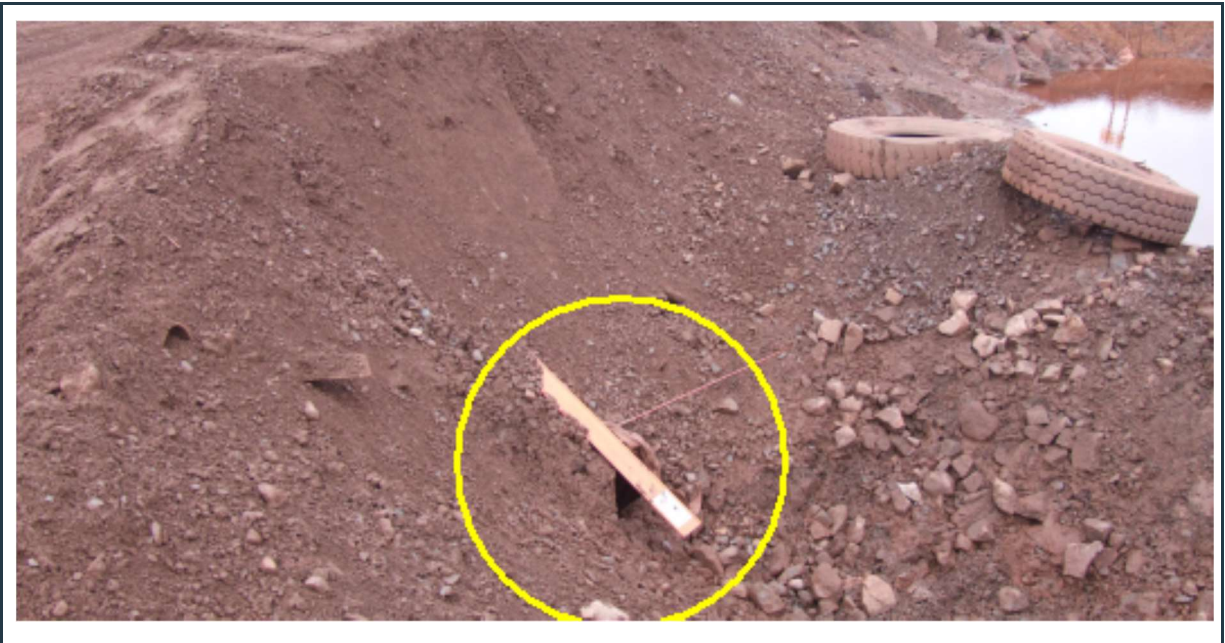
Figure 25: Partially clogged inlet of a culvert, located under the access road next to the truck weighing scale. It drains surface-water from the crusher area to the MS-06 pond.

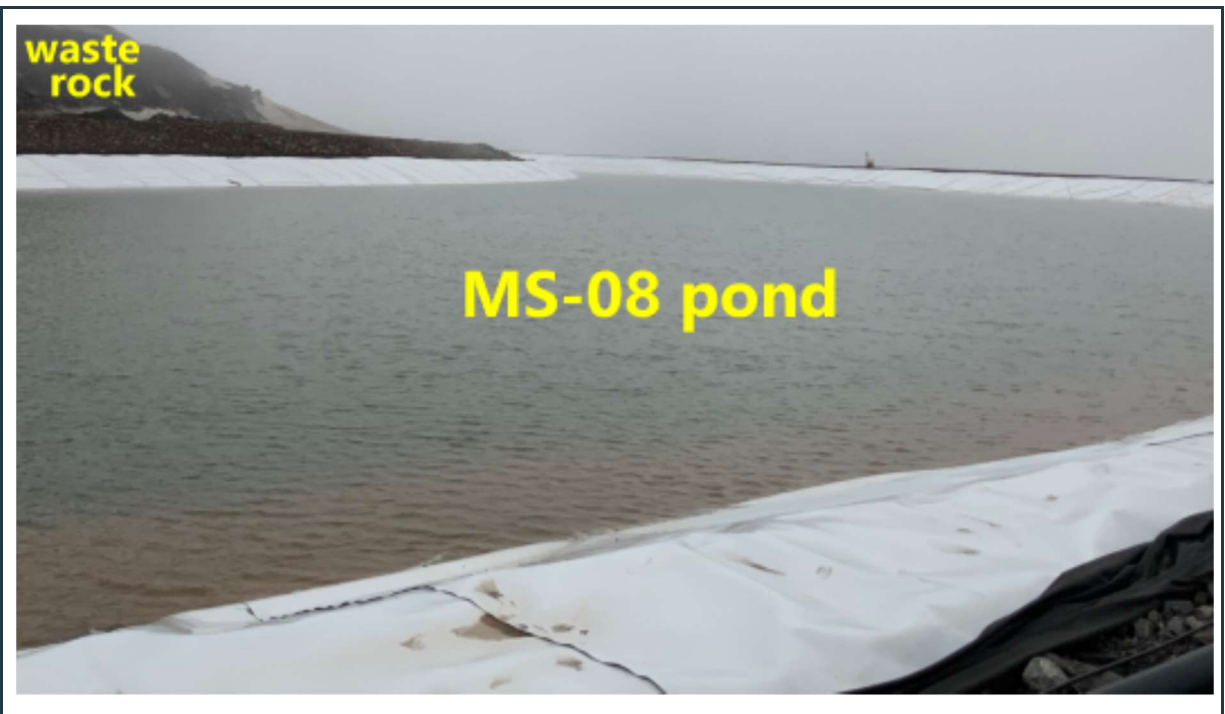
Figure 26: View of the recently completed enlarged MS-08 pond, downstream of the waste rock dump

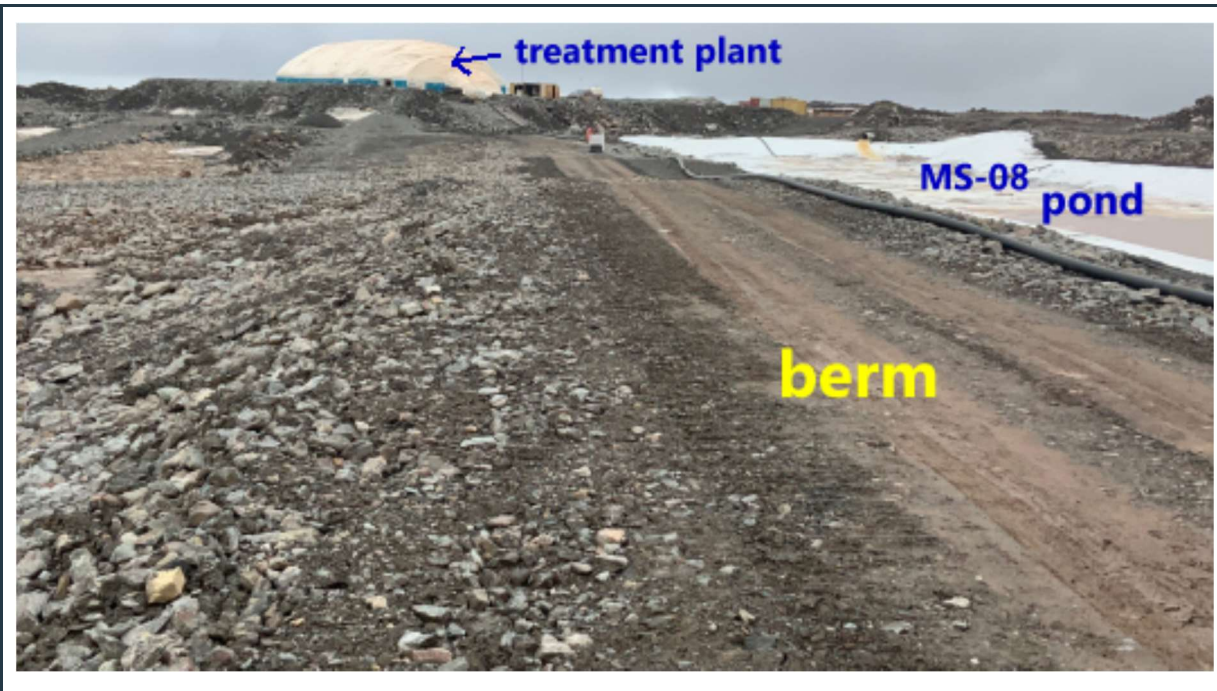
Figure 27: View of the new, robust berm with shallow side-slopes around the MS-08 pond

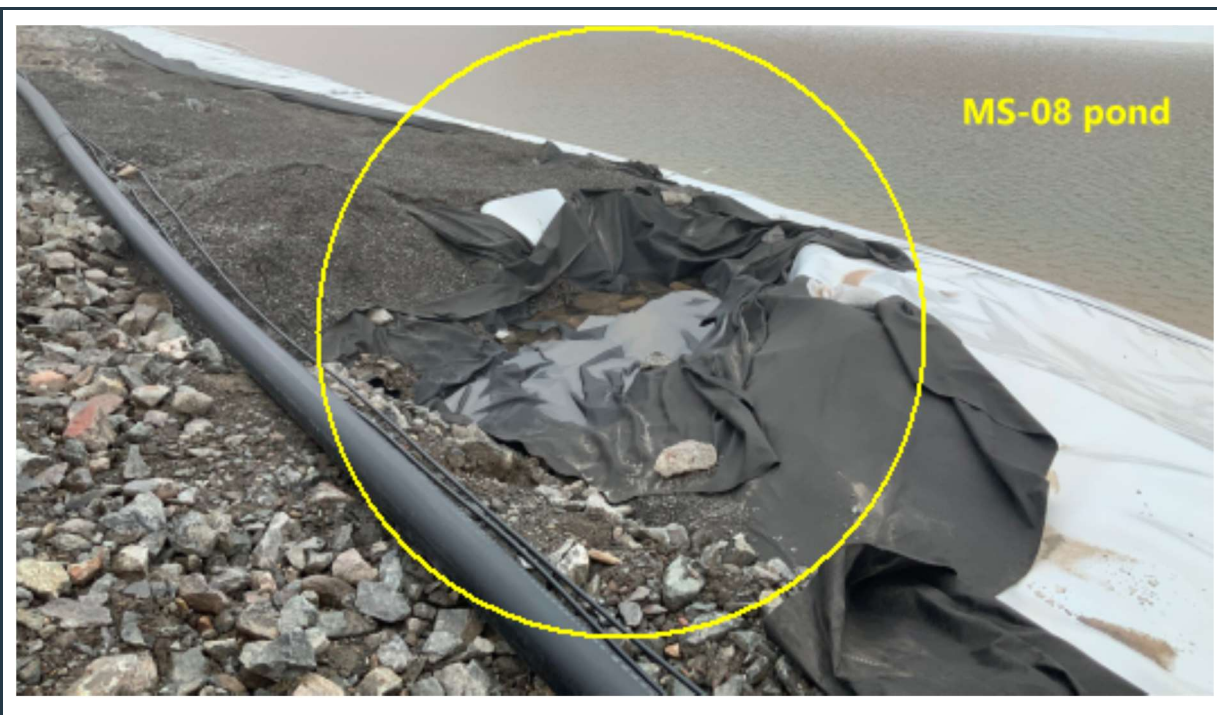
Figure 28: Area of minor fine-soil migration into the underlying rock fill at the northern section of the berm. The geotextile should be rearranged and the hole filled with fine crushed aggregate.

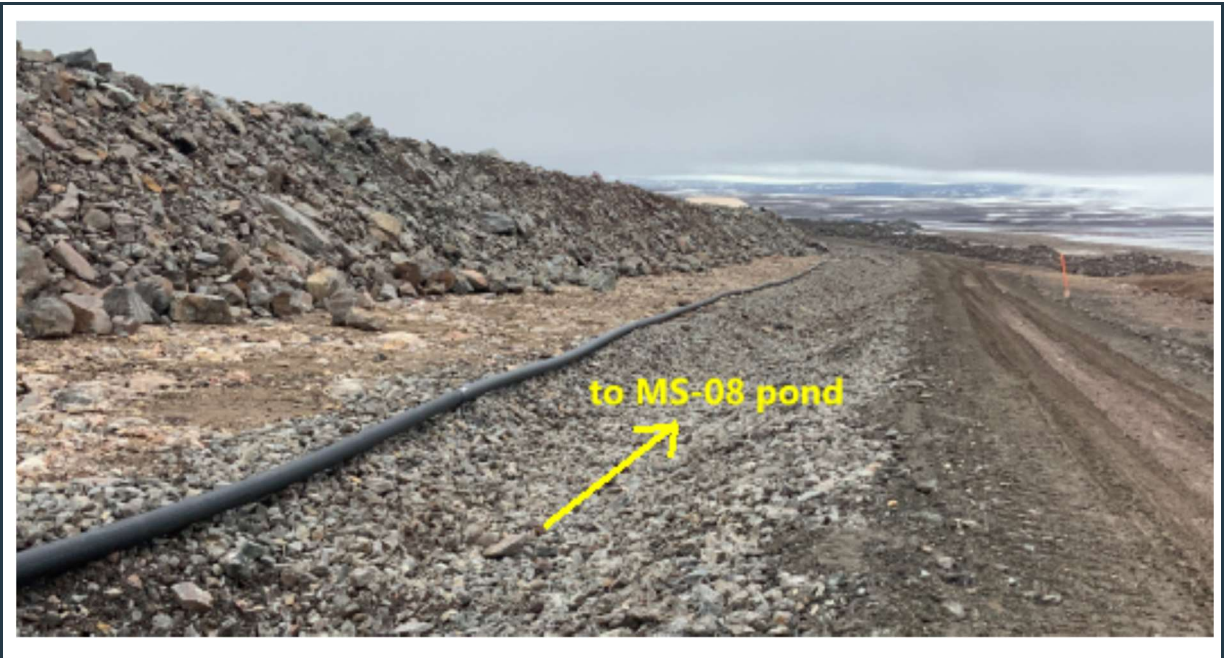
Figure 29: Well-maintained drainage ditch along the east side of the waste rock dump

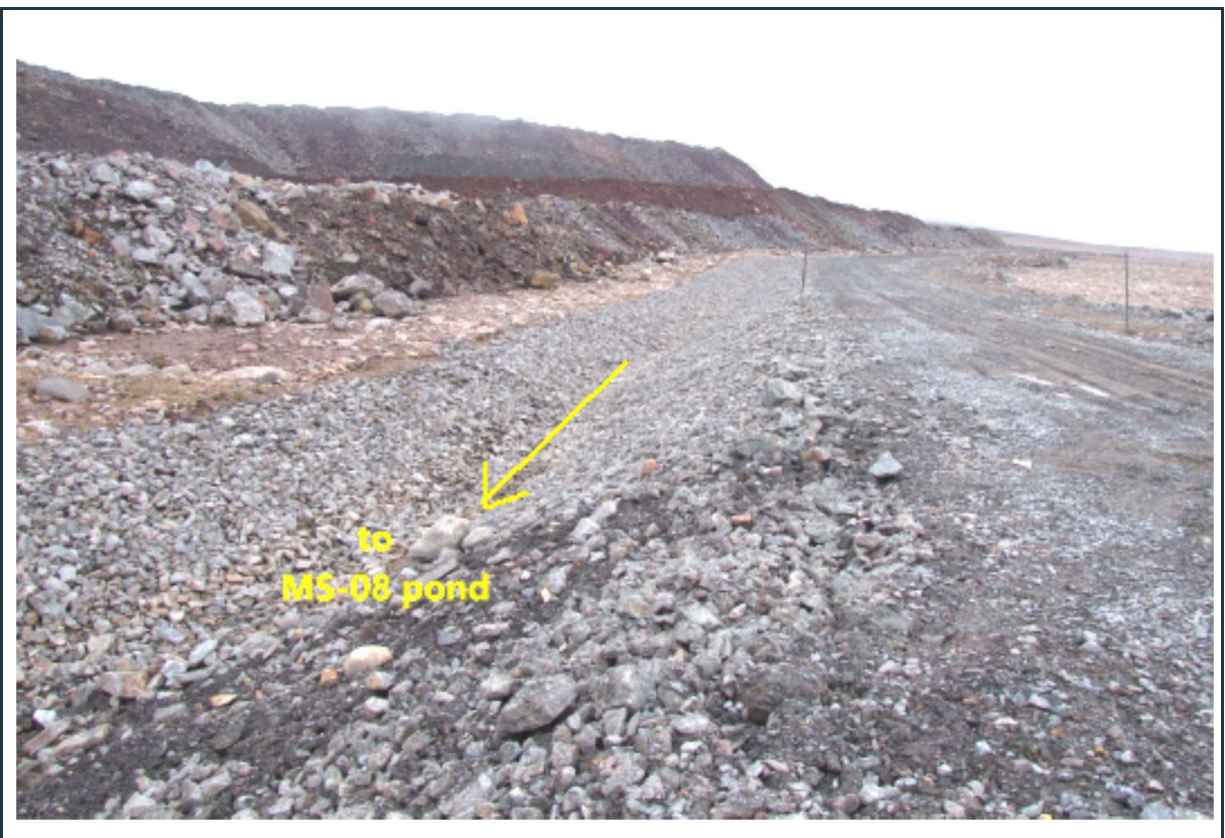
Figure 30: Well-maintained drainage ditch along the west side of the waste rock dump

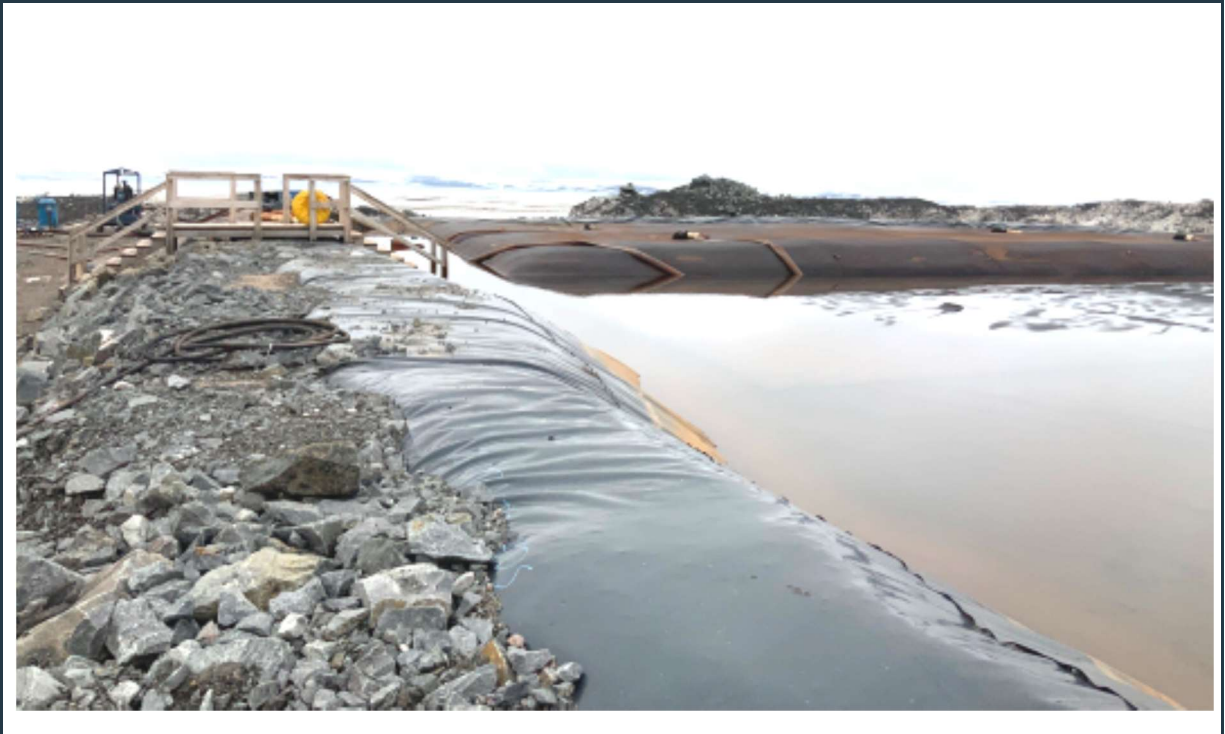
As pointed out above, the water from the pond is pumped to the nearby designated facility for treatment. There is a lined treatment cell in a good condition located immediately next to the plant with confined stable perimeter berms, as shown in Figure 31.

Figure 31: Water treatment pond adjacent to the waste rock dump and MS-08

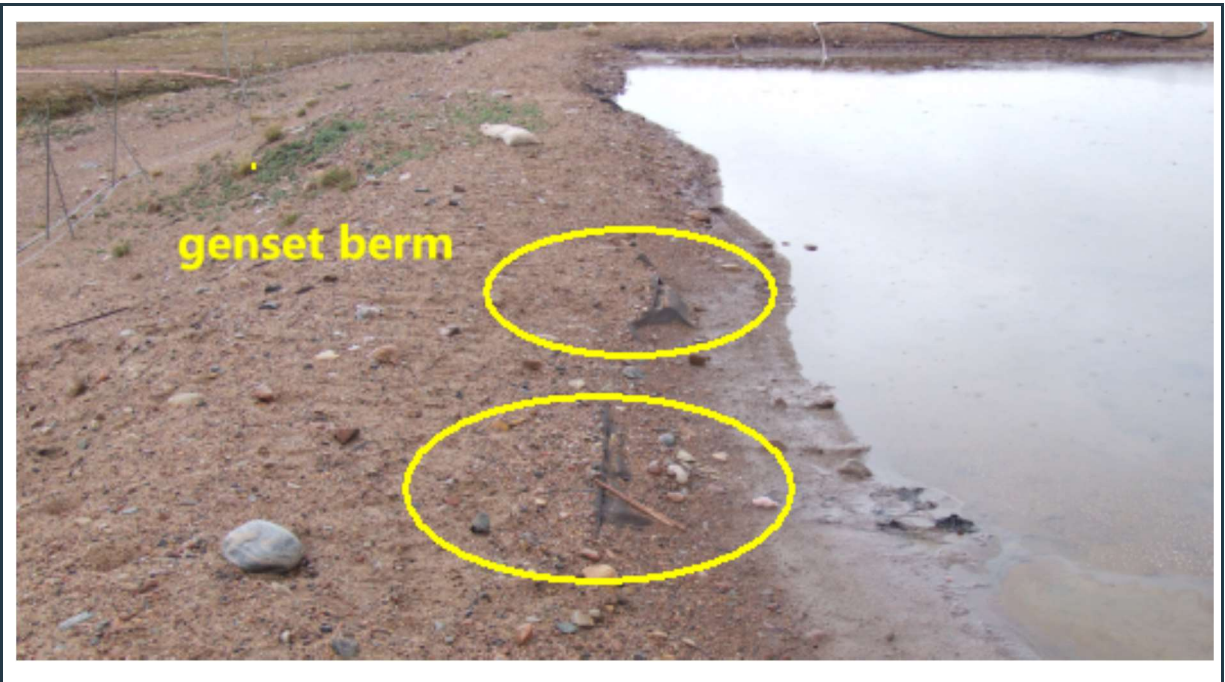
Figure 32: View of the berm near the generator, with exposed geotextile and liner at a few locations.

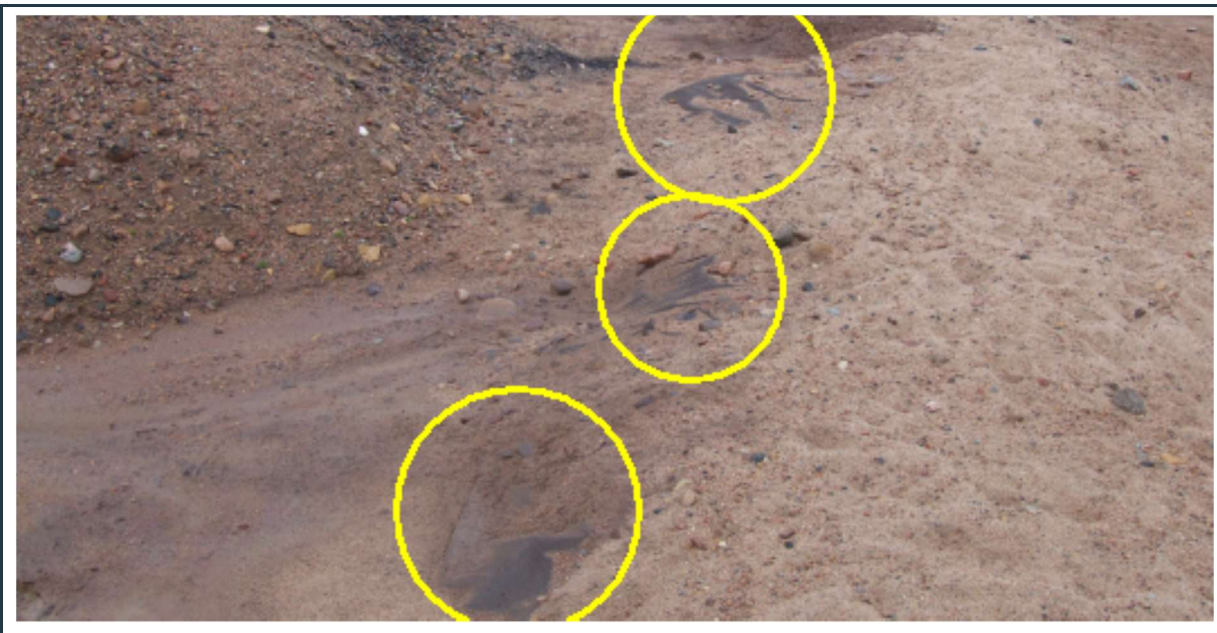
Figure 34: View of the south-east berm that needs to be repaired (raised and regraded). Note the exposed geotextile and liner that shall be covered with sand/gravel during berm rehabilitation.

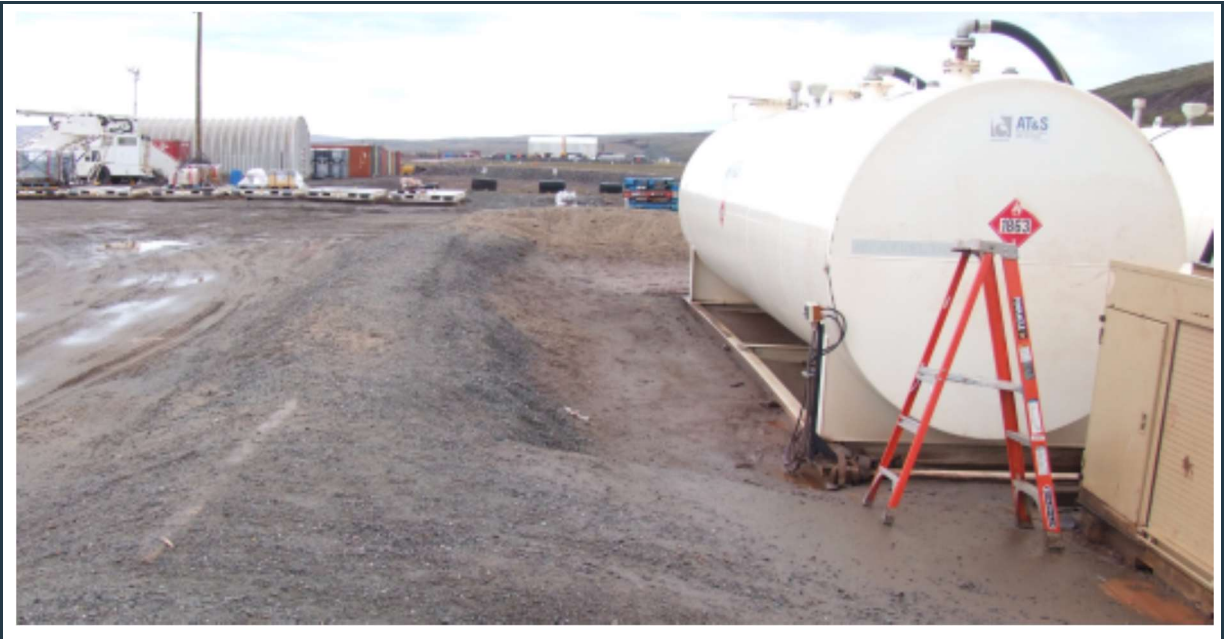
Figure 35: View of the well-maintained berm at the jetfuel storage cell.

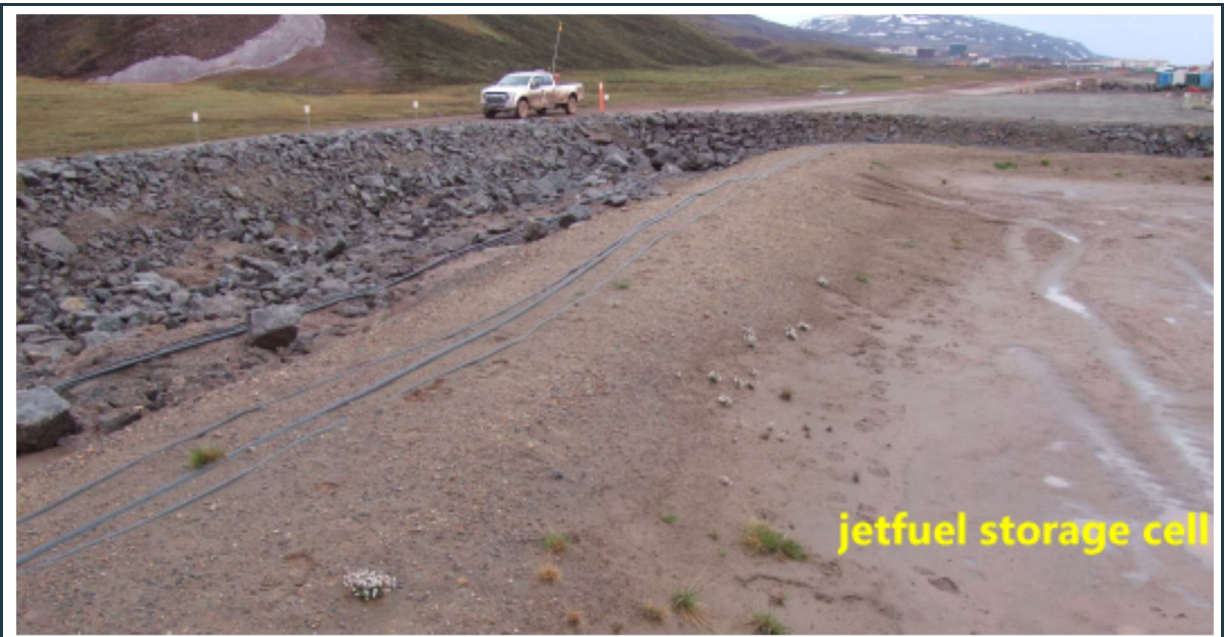
Figure 36: View of the jetfuel farm's double berm system (note the additional crushed rock berm between the cell's perimeter berm and the tote road/parking lot).
