APPENDIX C.2

Geotechnical Inspection Reports

RE: Submission of 2019 Geotechnical Inspection Report No. 1 (July 2020)

Wood Environment & Infrastructure Solutions (Wood), has completed the first geotechnical field inspection of 2020 at the Mary River Iron mine complex, which is a condition of the Type "A" Water License No: 2AM-MRY1325 – Amendment No.1 ("Water License").

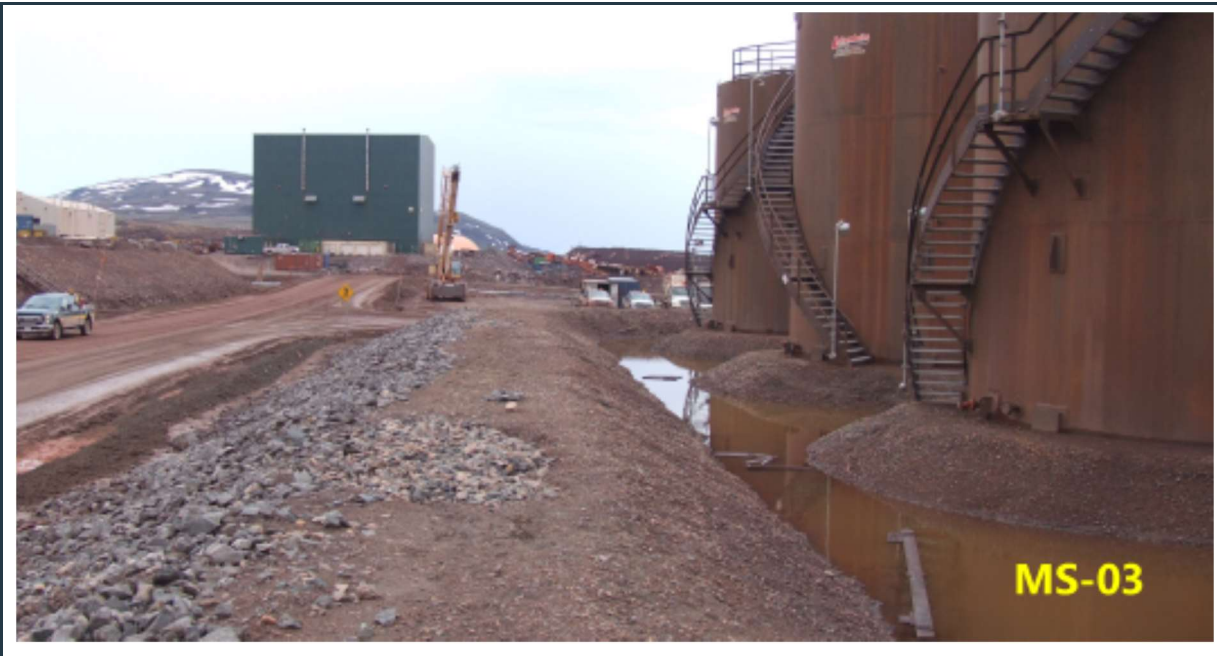
Figure 37: View of the MS-03 diesel fuel farm. Note some floating debris that should be removed.

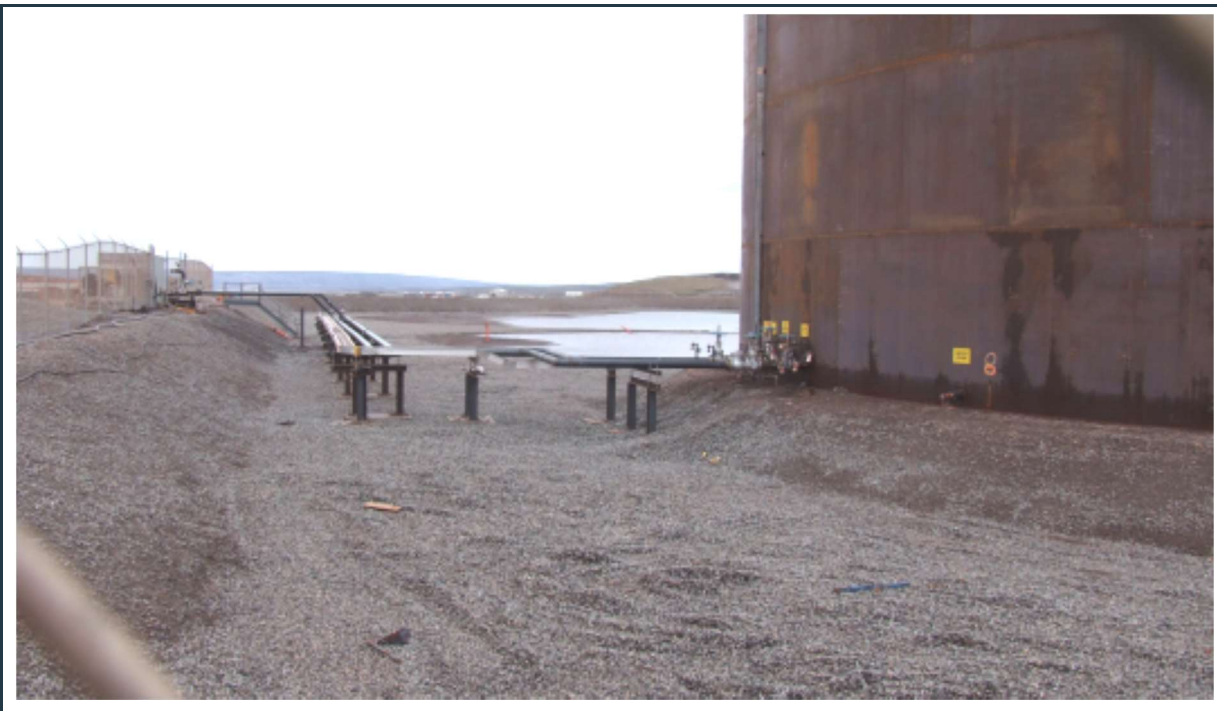
Figure 38: View of the recently completed fuel tank farm with well-constructed stable perimeter berms.

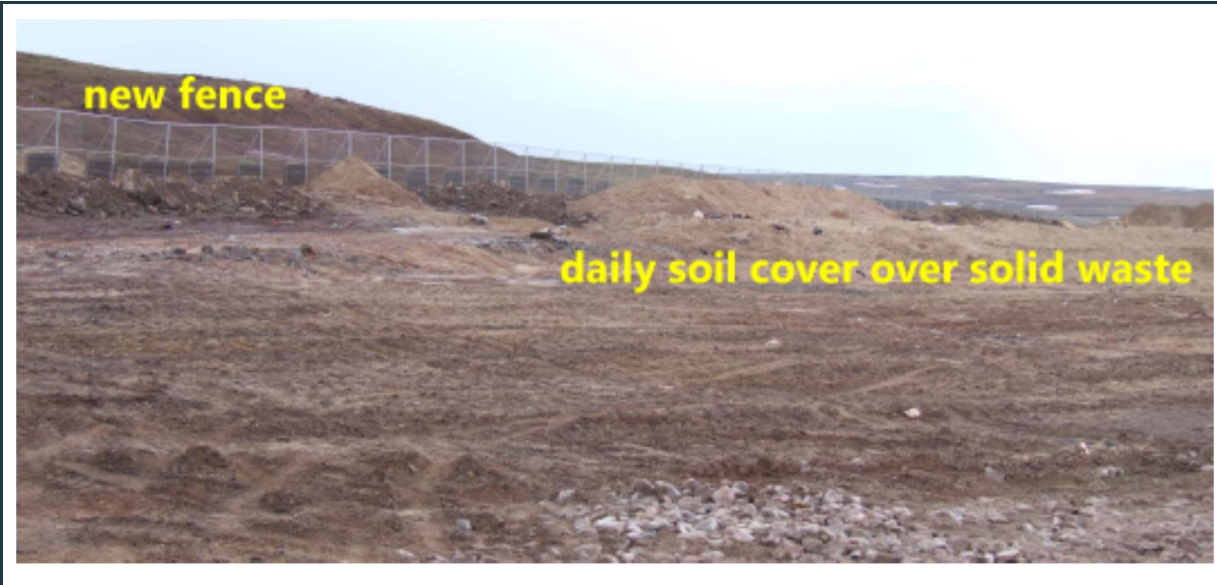
Figure 39: Solid waste landfill facility (note the recently installed perimeter fence).

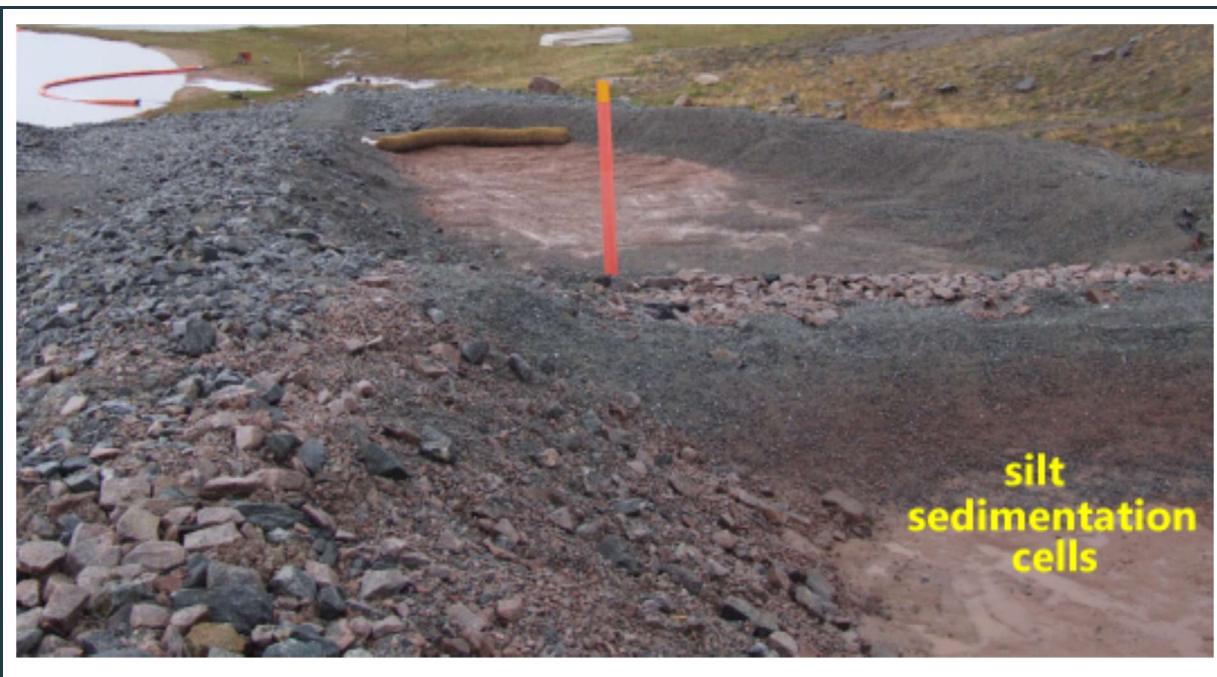
Figure 40: CLSP check dams and berms, forming efficient silt sedimentation cells

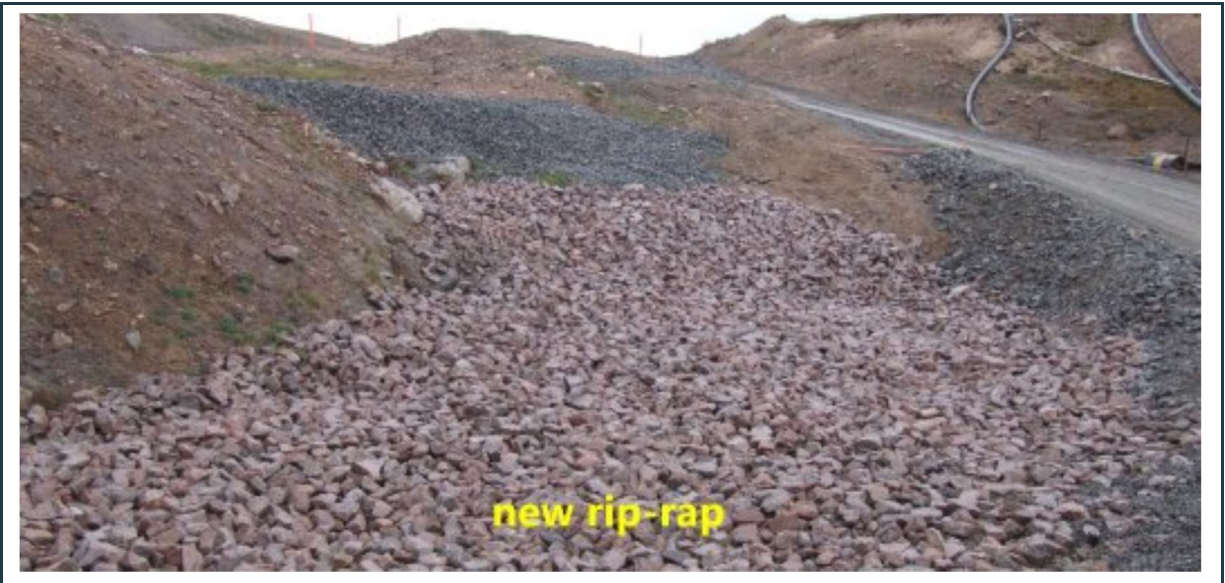
Figure 41: Recently placed rip-rap in one of the cells to prevent erosion of the channel floor at the critical vertical drop in elevation along the chain of sedimentation cells.

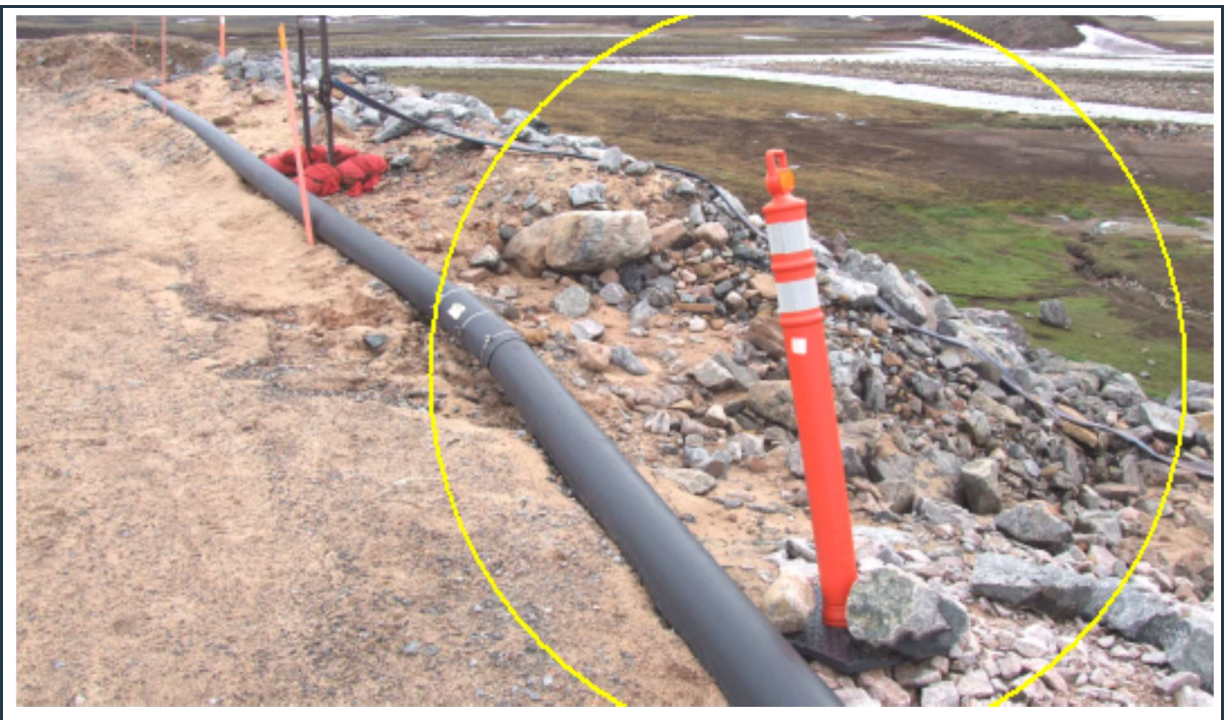
Figure 42: Minor crest/slope erosion (cobbles and boulders rolling down the slope) at the water discharge area. Placement of rock fill is required here to improve slope integrity and prevent erosion.

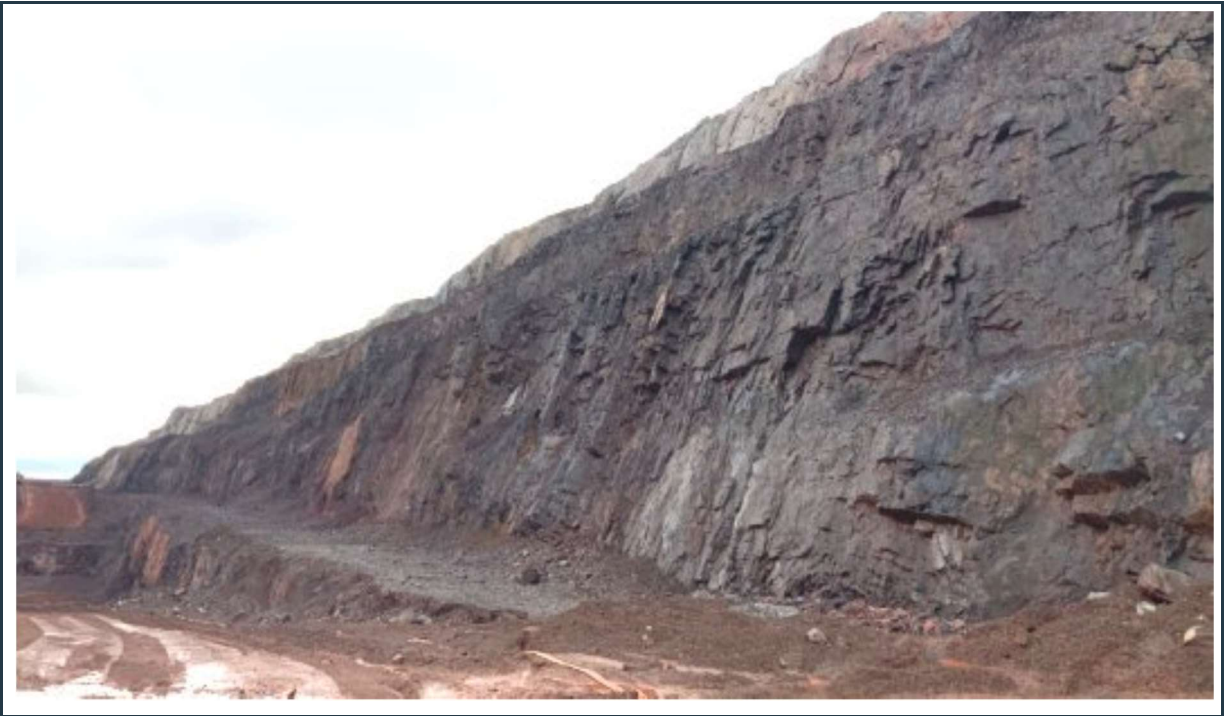
Figure 43: Stable pit-wall in the area of deposit-1.

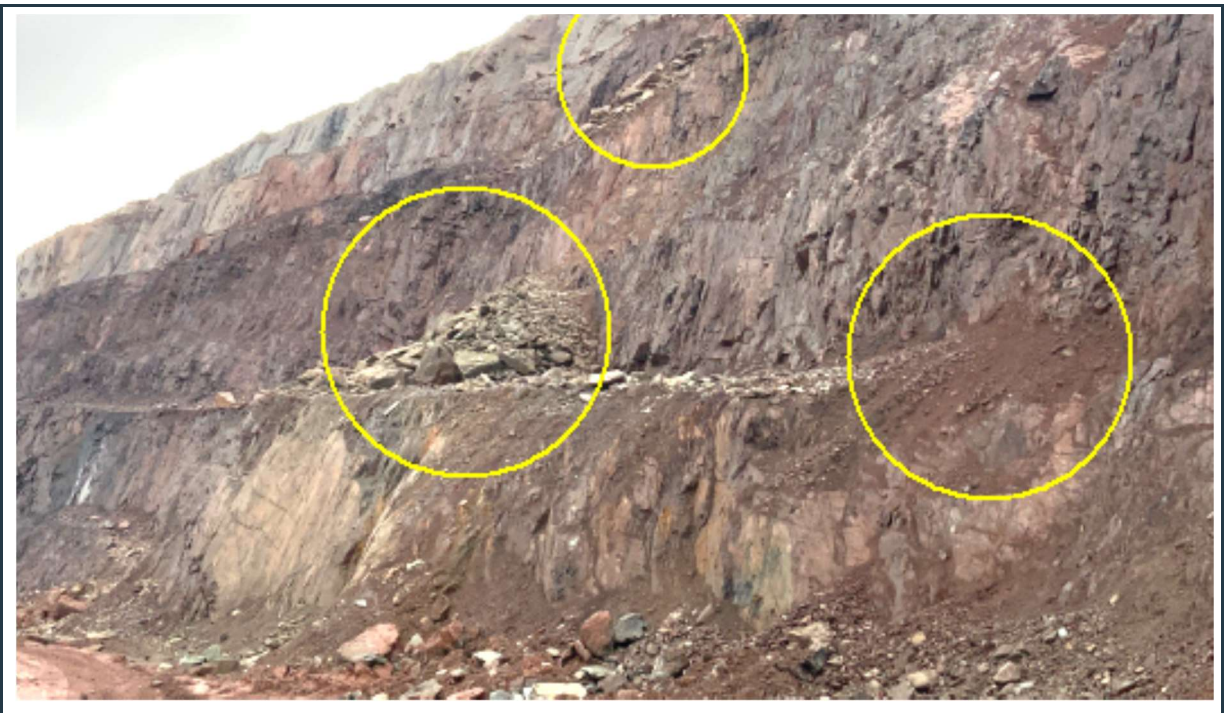
Figure 44: Minor weathering and pit-wall erosion in the area of deposit-1.

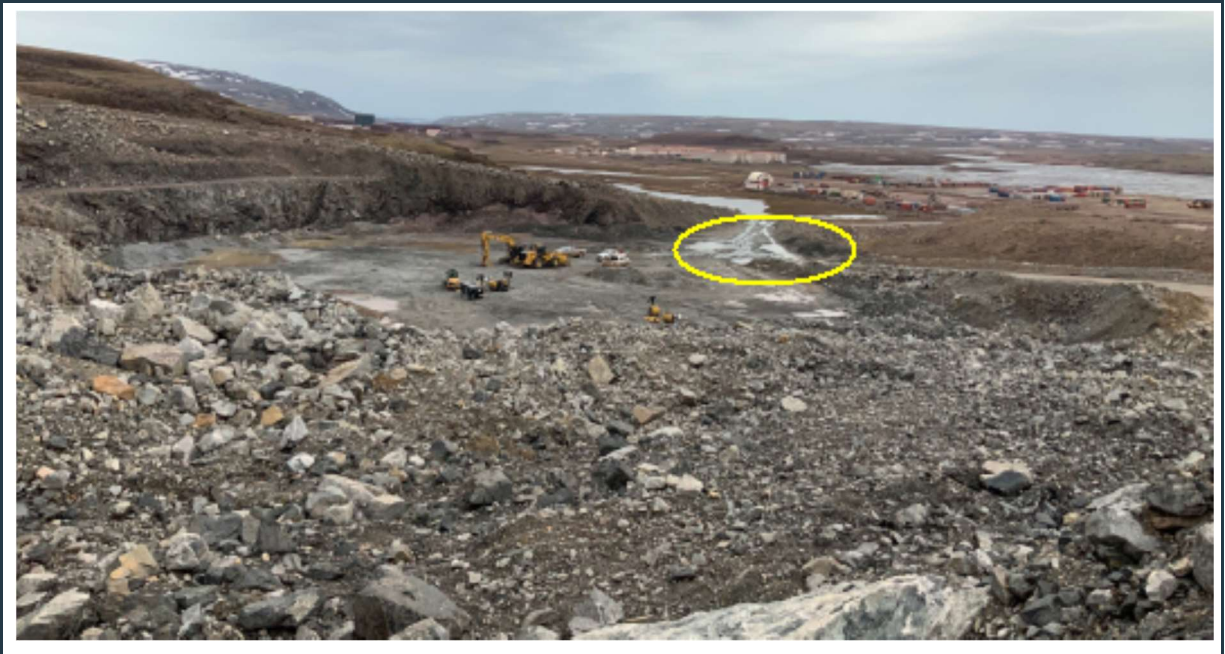
Figure 45: View of QMR2 quarry with poor surface water control area marked by the yellow circle.

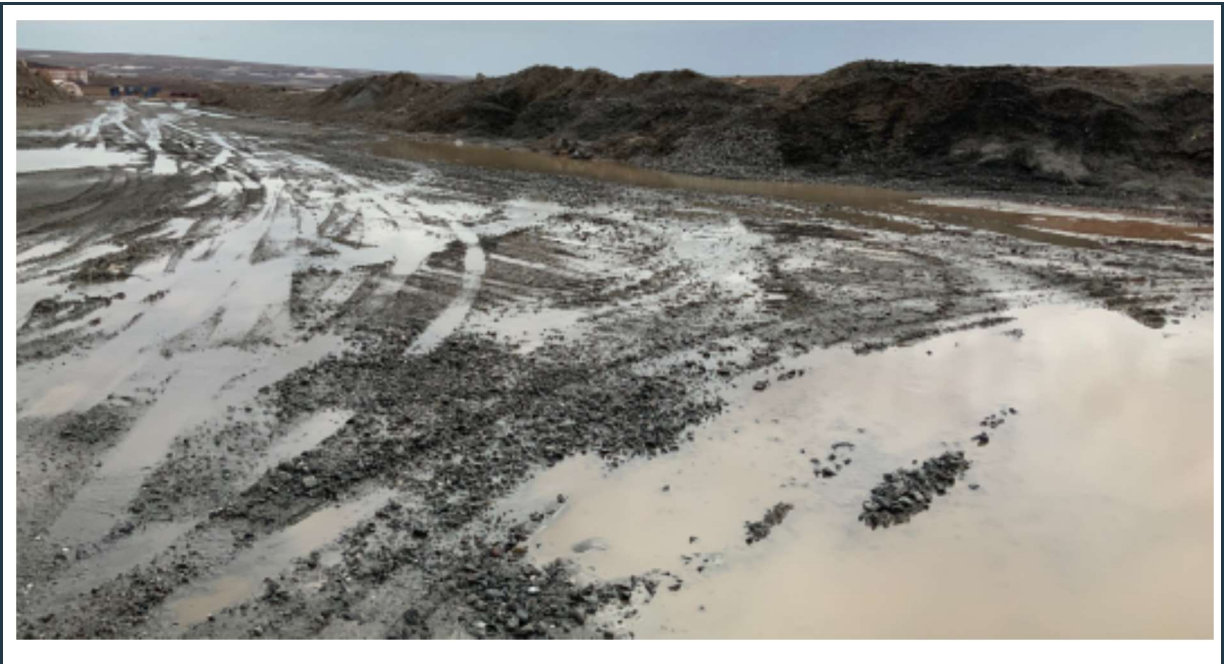
Figure 47: Poor surface water control at the main level of QMR2 quarry (enlarged from Figure 45).

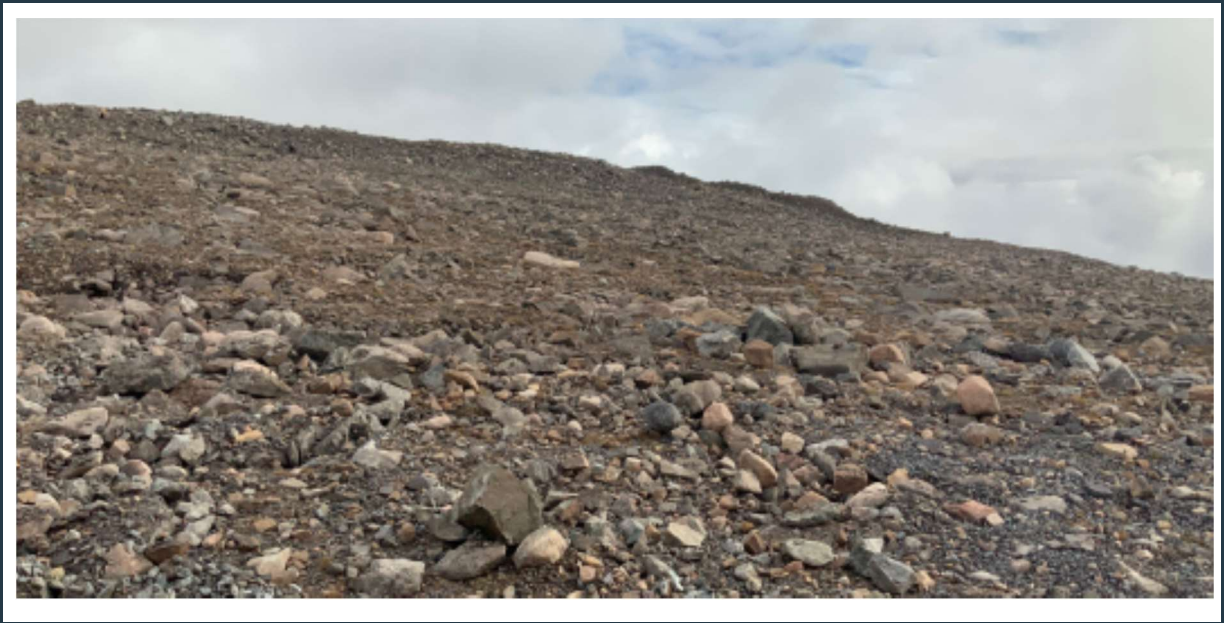
Figure 49: View of the northern slope of the future D1Q1 quarry.

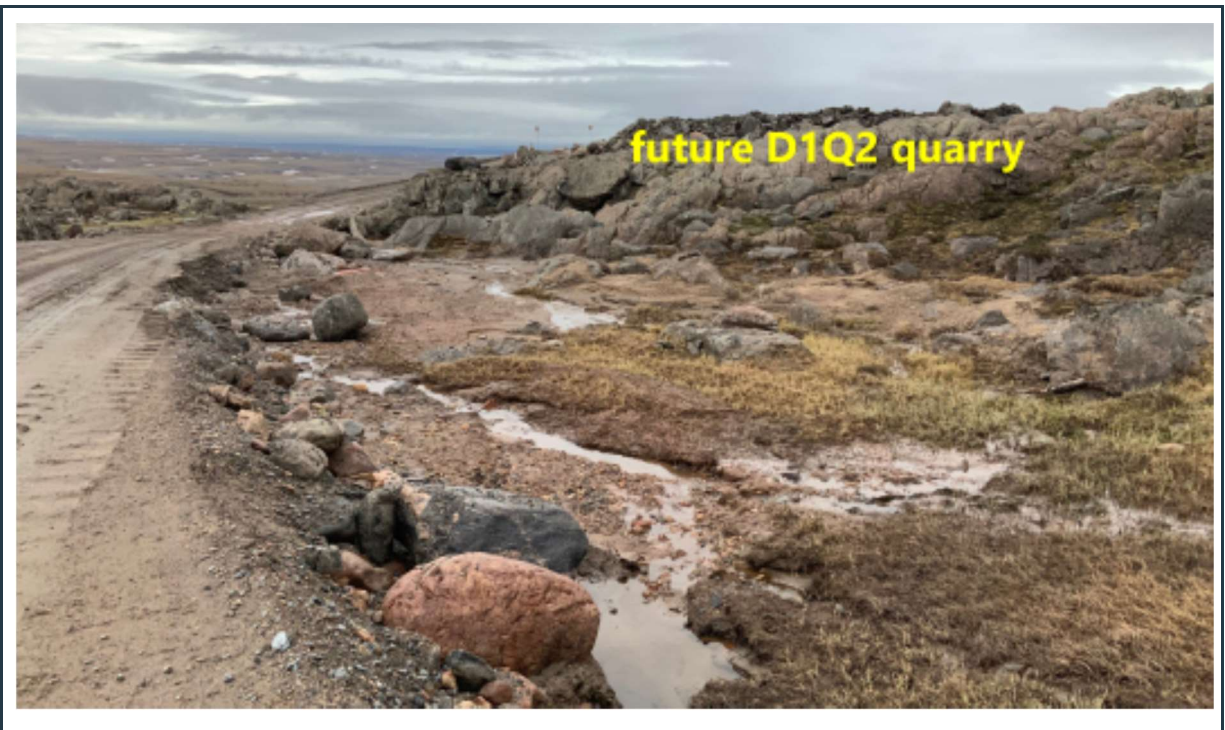
Figure 50: View of the southern section of the future D1Q2 quarry.

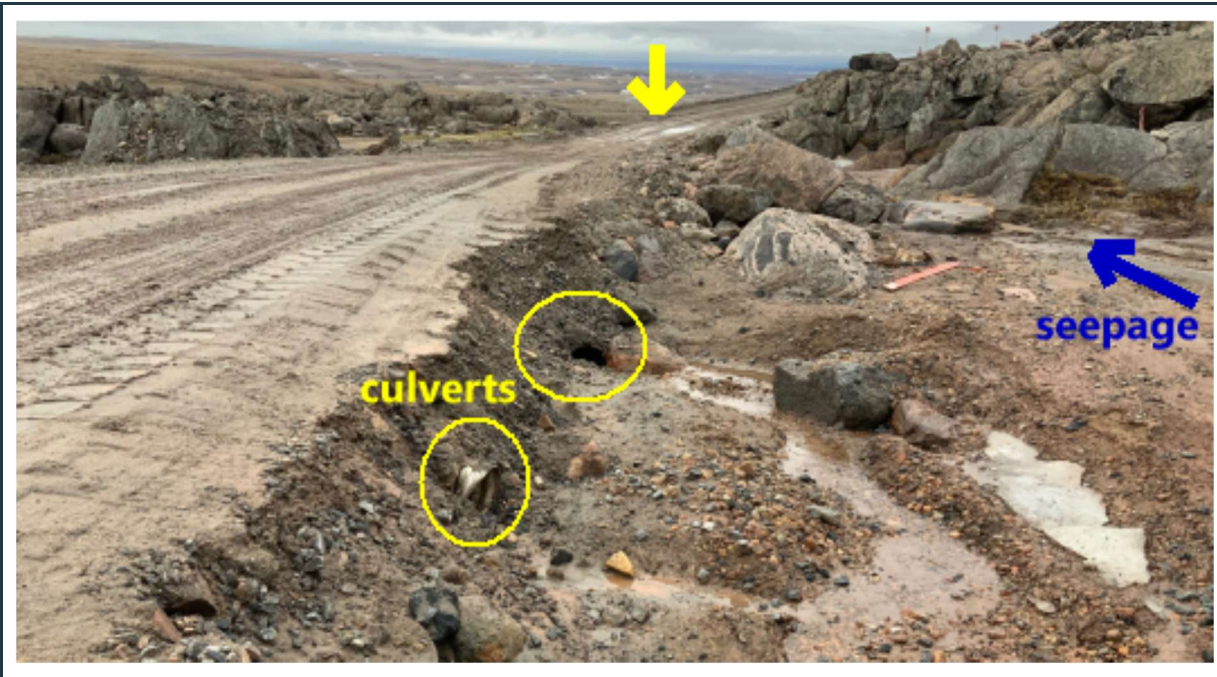
Figure 51: Existing culverts installed at the wrong place (yellow circles). New culvert required at the yellow arrow to prevent serious road problems in the future. Blue arrow indicates below grade seepage.

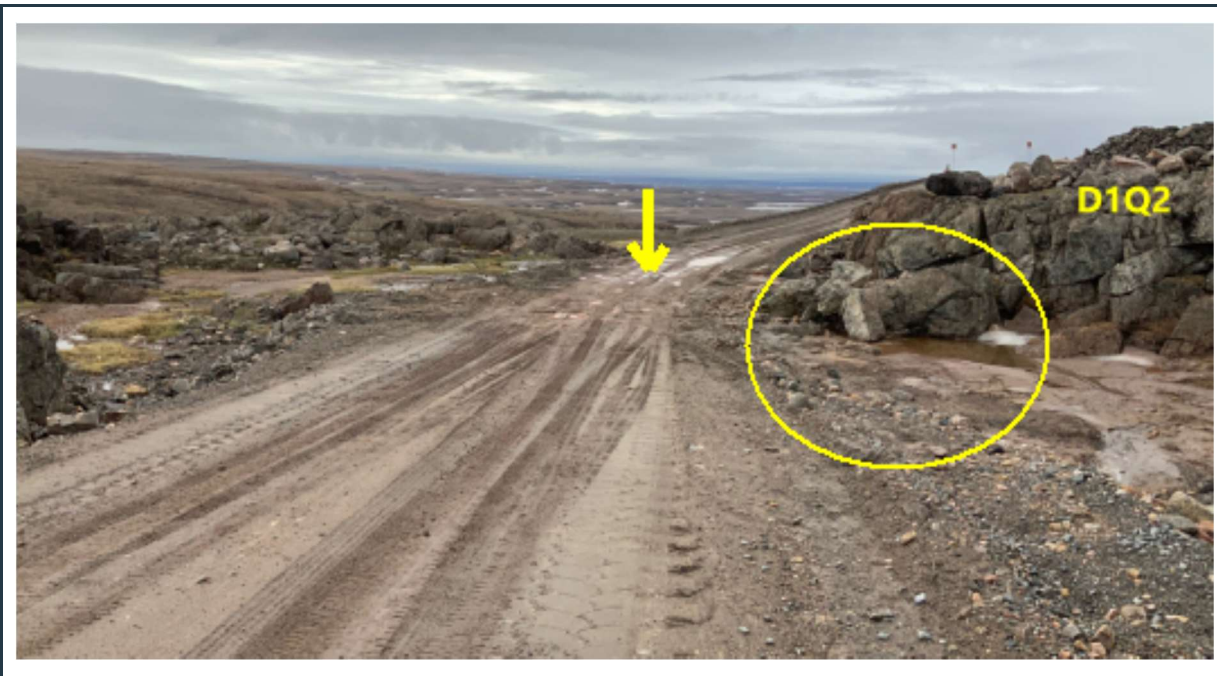
Figure 52: Ponding water at the edge of the future D1Q2 quarry. Culvert is required at the low point of the road and the road grade should be raised in the area above the culvert.

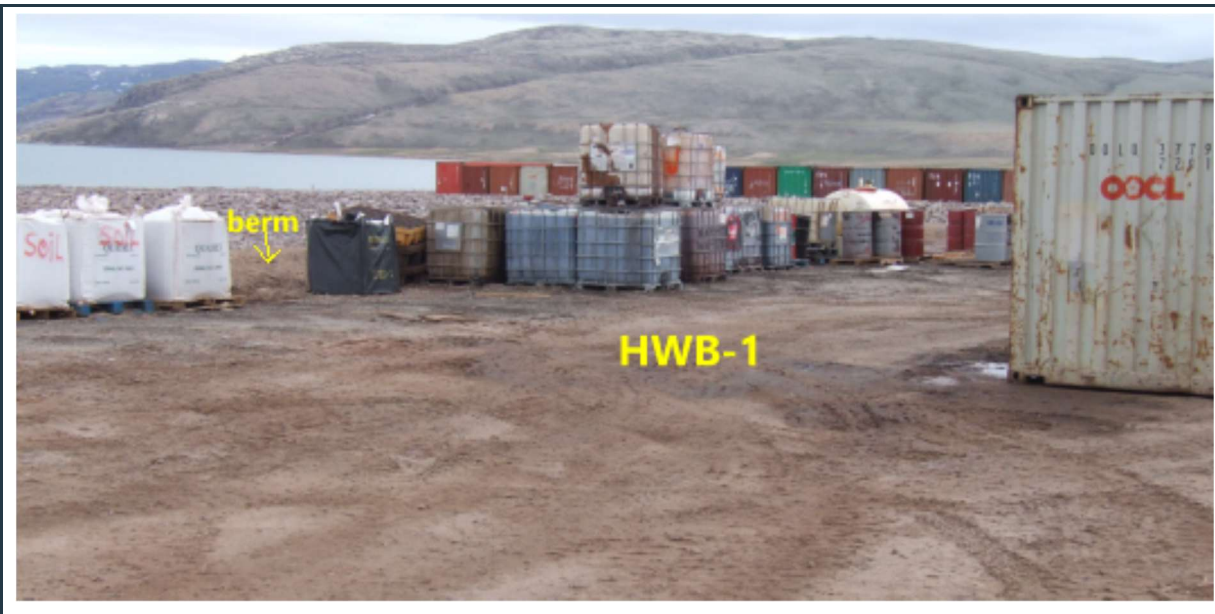
Figure 53: View of the well organized interior of the HWB-1 cell.

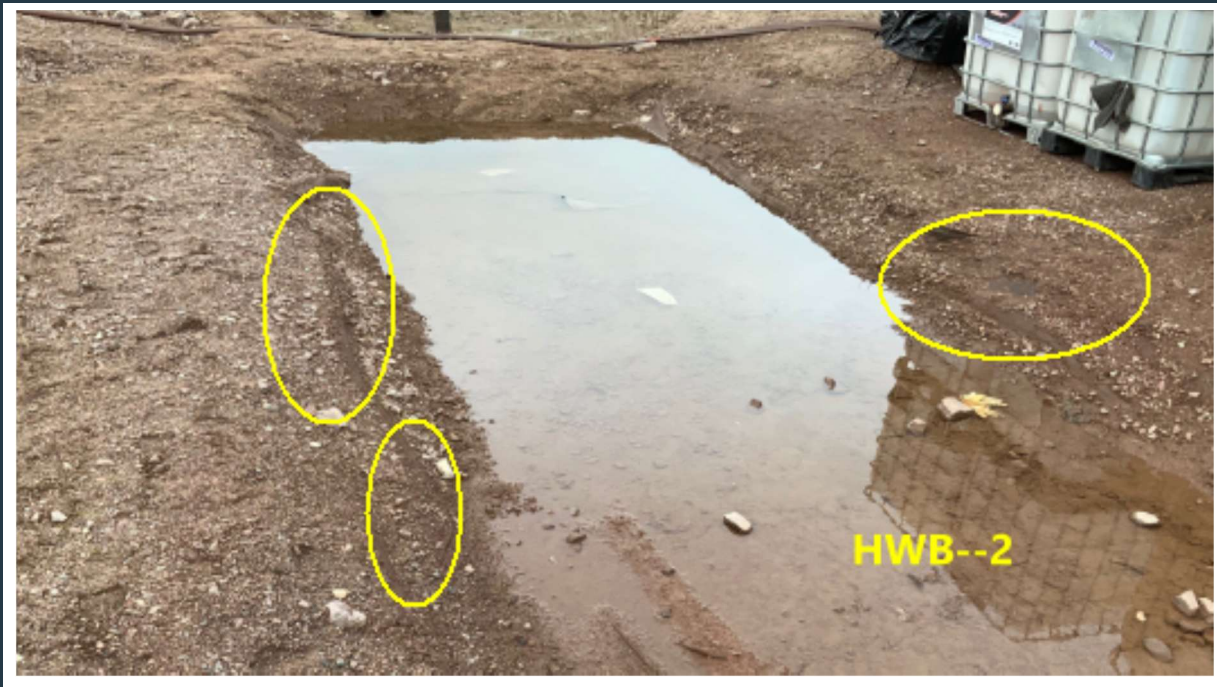
Figure 55: Ponding water in the empty HWB-2 cell with locally exposed geotextile and liner. Empty containers stored immediately adjacent to the cell.

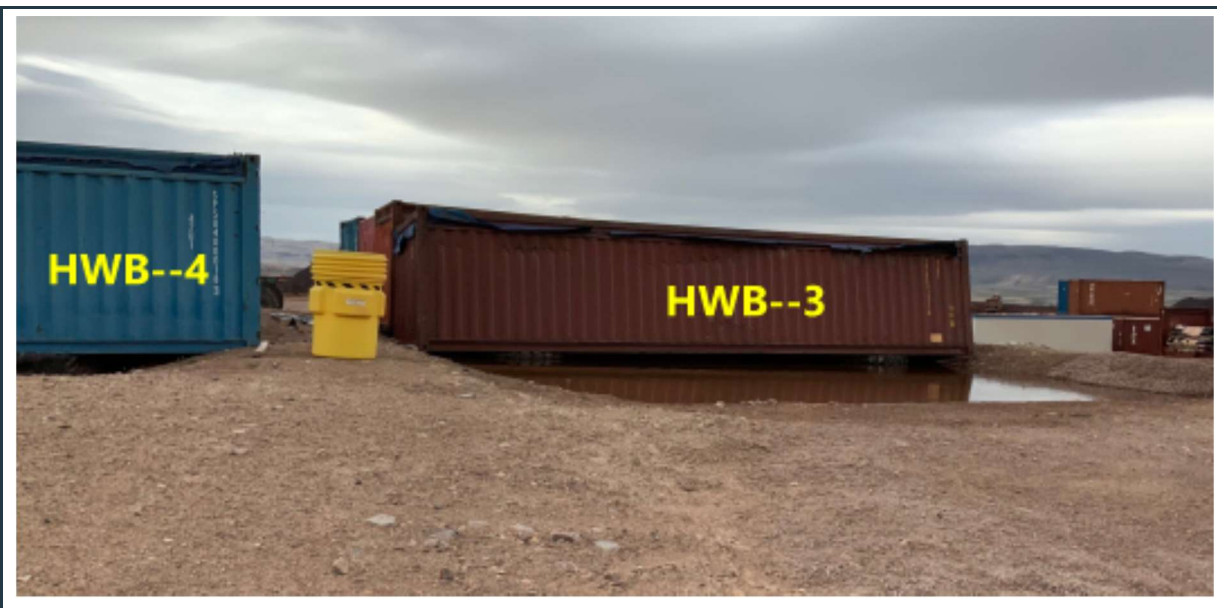
Figure 56: View of the HWB-3 and HWB-4 twin cells, containing solid waste in shipping containers.

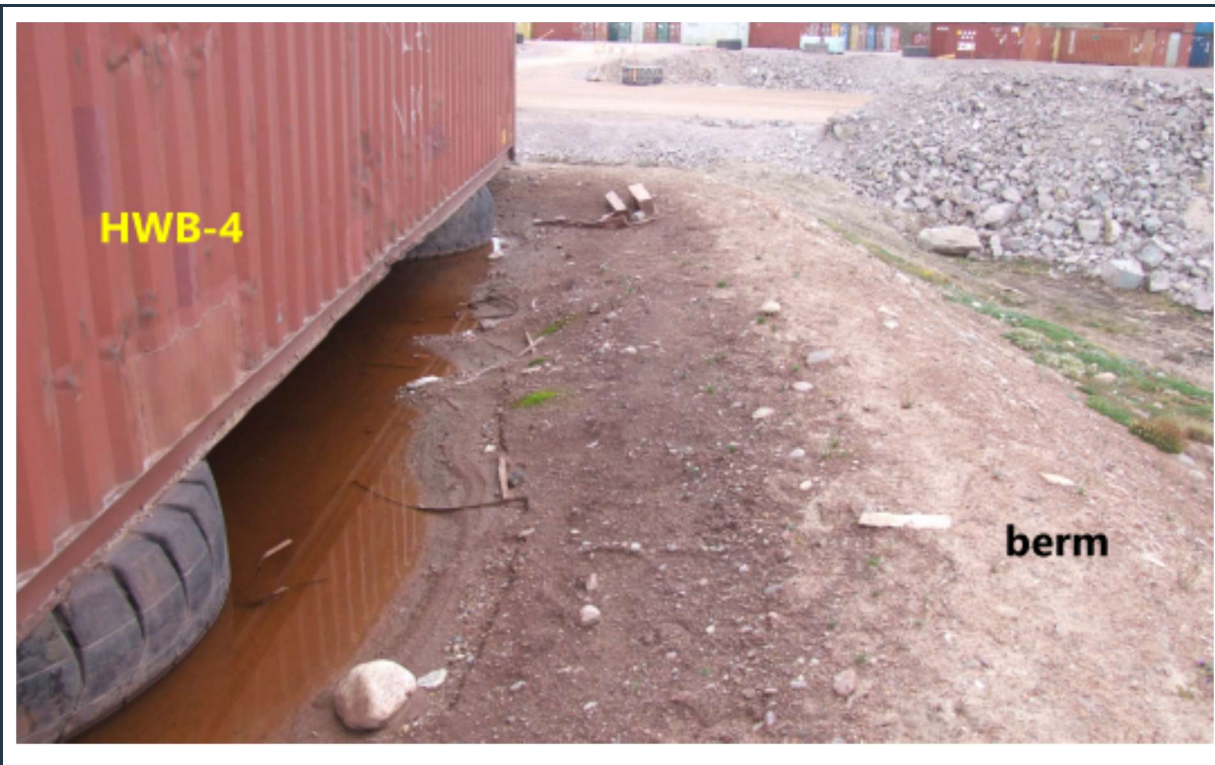
Figure 57: Stable berm around, and ponding water within the HWB-4 cell.

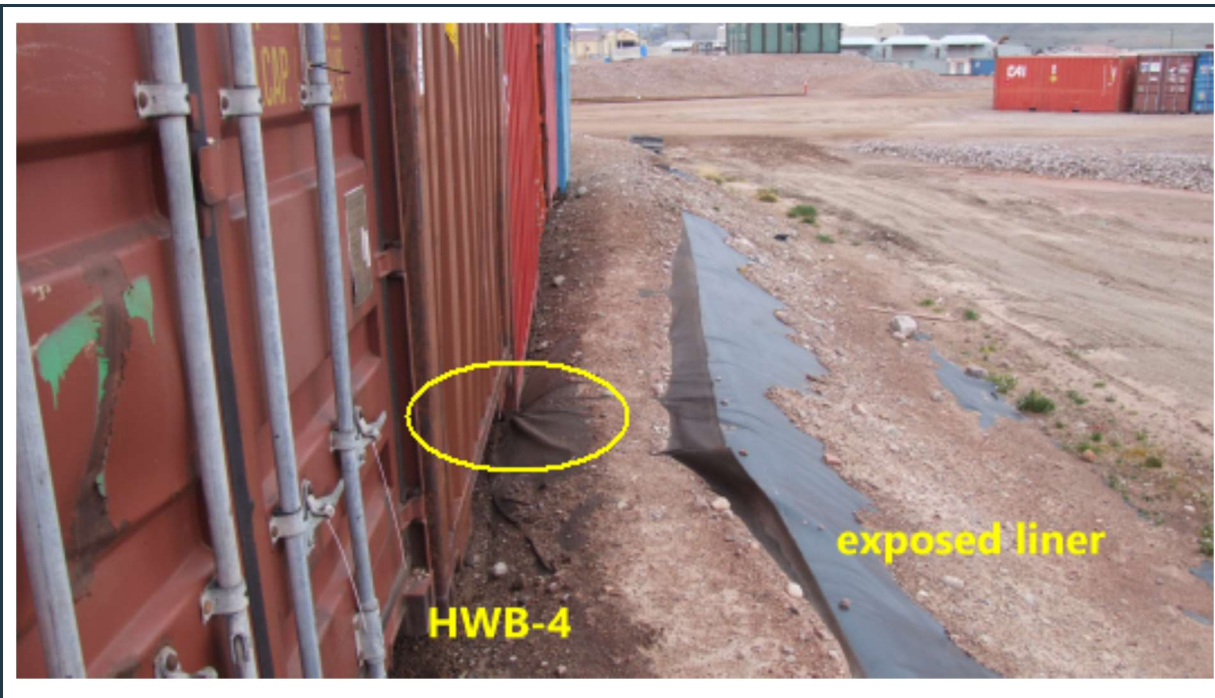
Figure 59: Exposed geotextile and liner at the HWB-4 cell, with location of potential damage to liner.

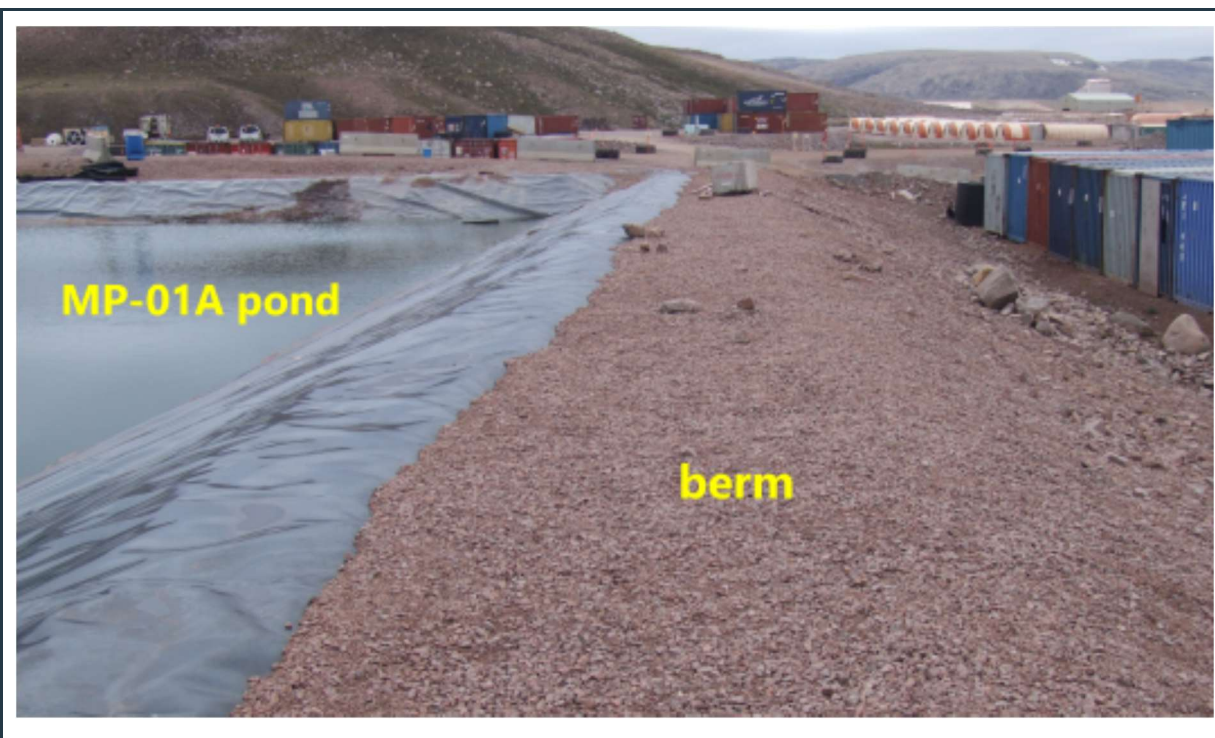
Figure 60: Berms in excellent condition with stable slopes around the MP-01A pond.

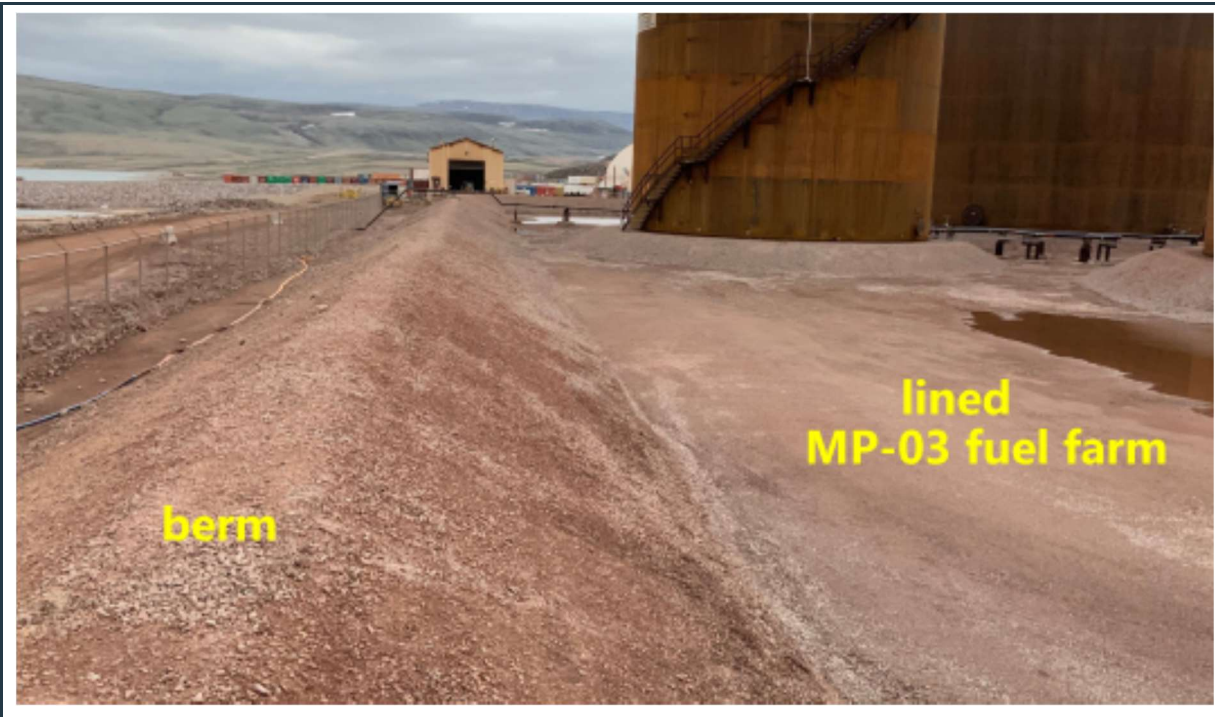
Figure 61: View of stable, well maintained berms around the MP-03 fuel tank farm.

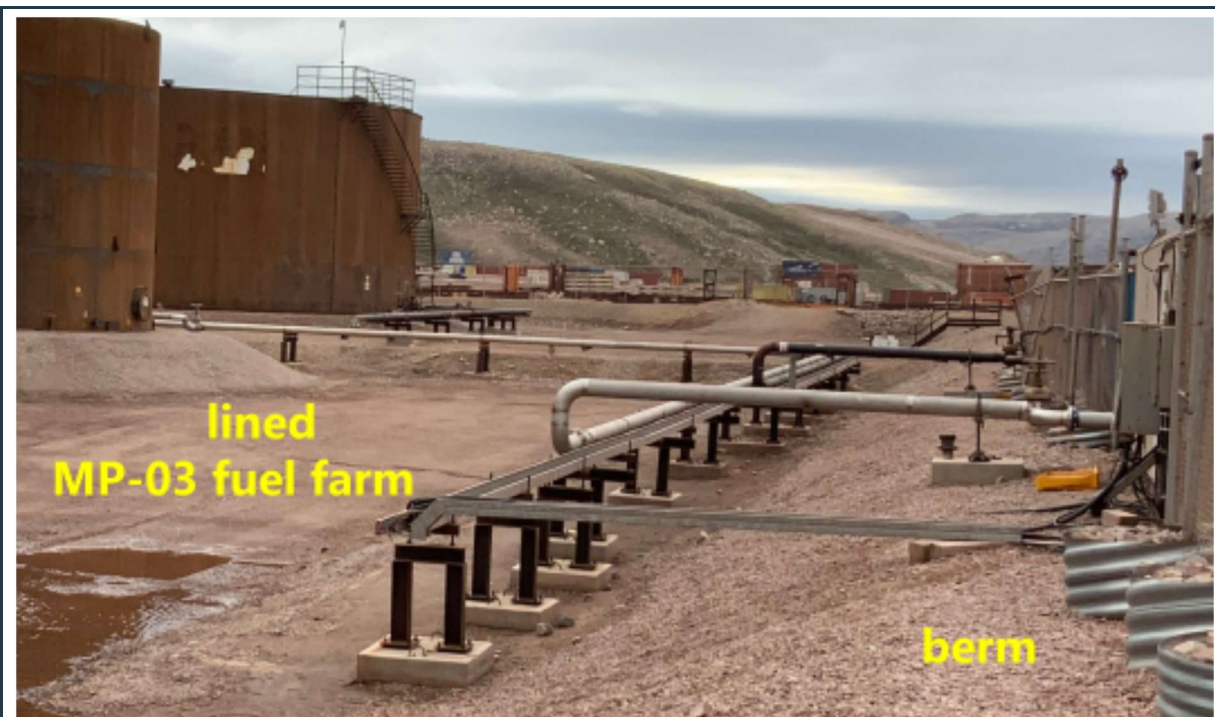
Figure 62: View of stable, well maintained berms around the MP-03 fuel tank farm.

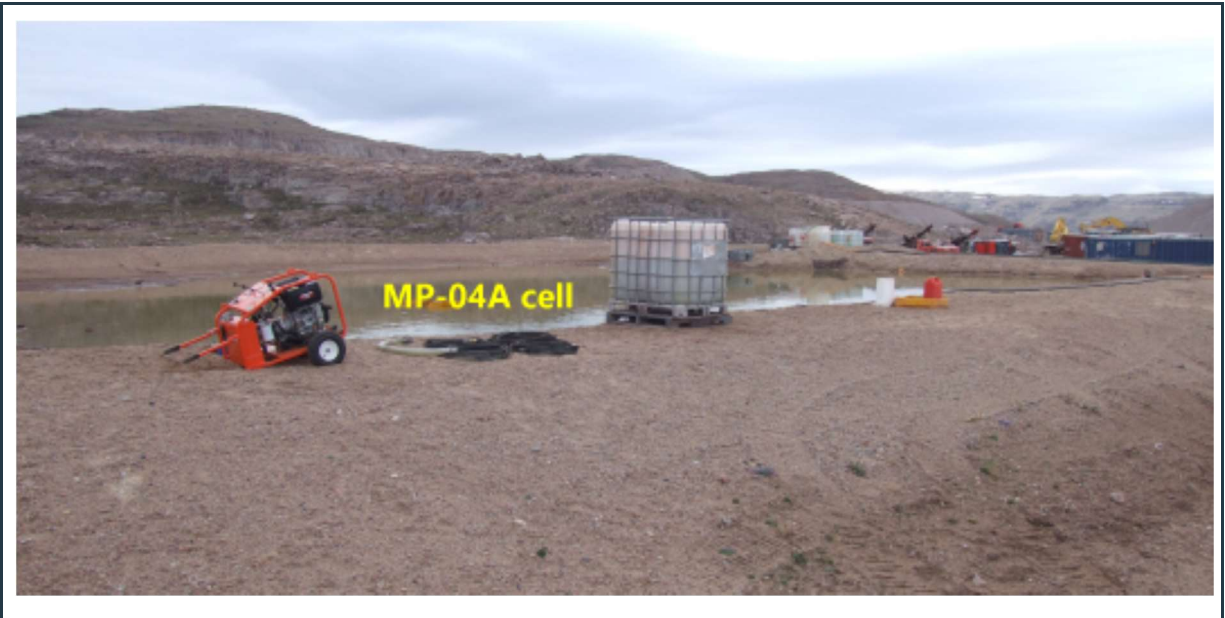
MP-04A is a smaller cell used generally for the disposal of contaminated snow. This pond was constructed immediately adjacent to the MP-04 landfarm cell, shown in Figure 65. No seepage from the cell was noted anywhere around the pond; however, exposed liner was visible at the access ramp to the cell, as shown

Figure 65: View of the MP-04A contaminated snow dump cell with stable berms.

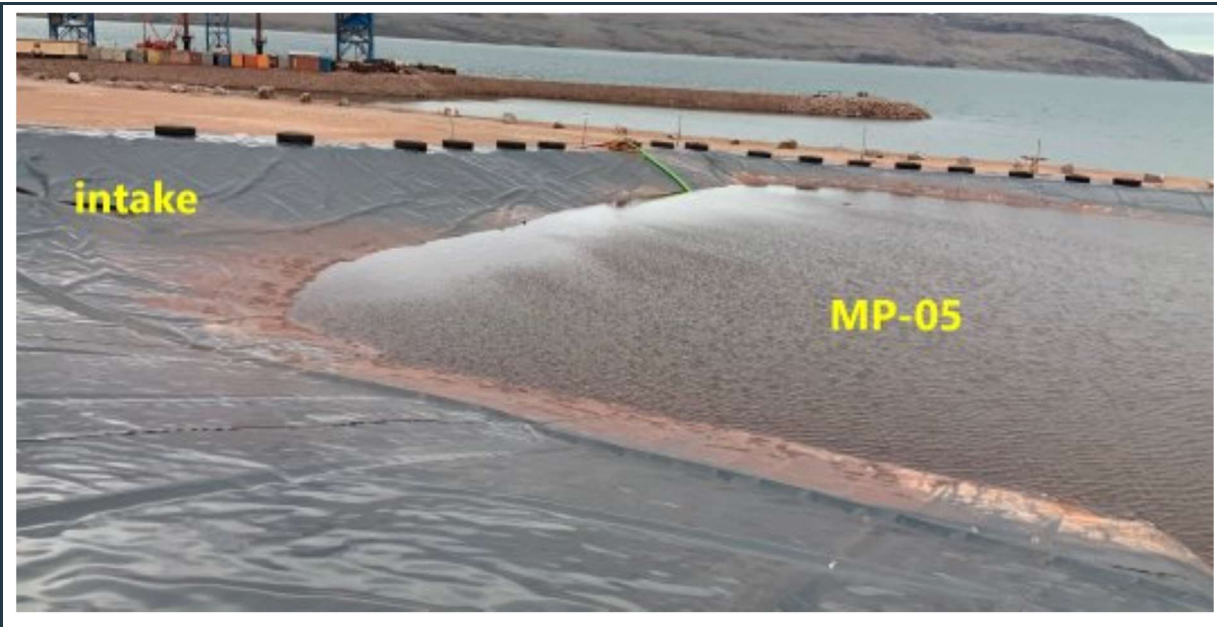
The MP-05 settling pond is located adjacent to the north-east corner of the stockpile, while MP-06 has been constructed at the north-west corner. Both settling ponds are in excellent condition with stable, well maintained berms and intact geomembrane liners, as shown in Figures 67, 70 and 71.

Figure 67: View of stable berms at the MP-05 settling pond (north-east corner of the ore stockpile).

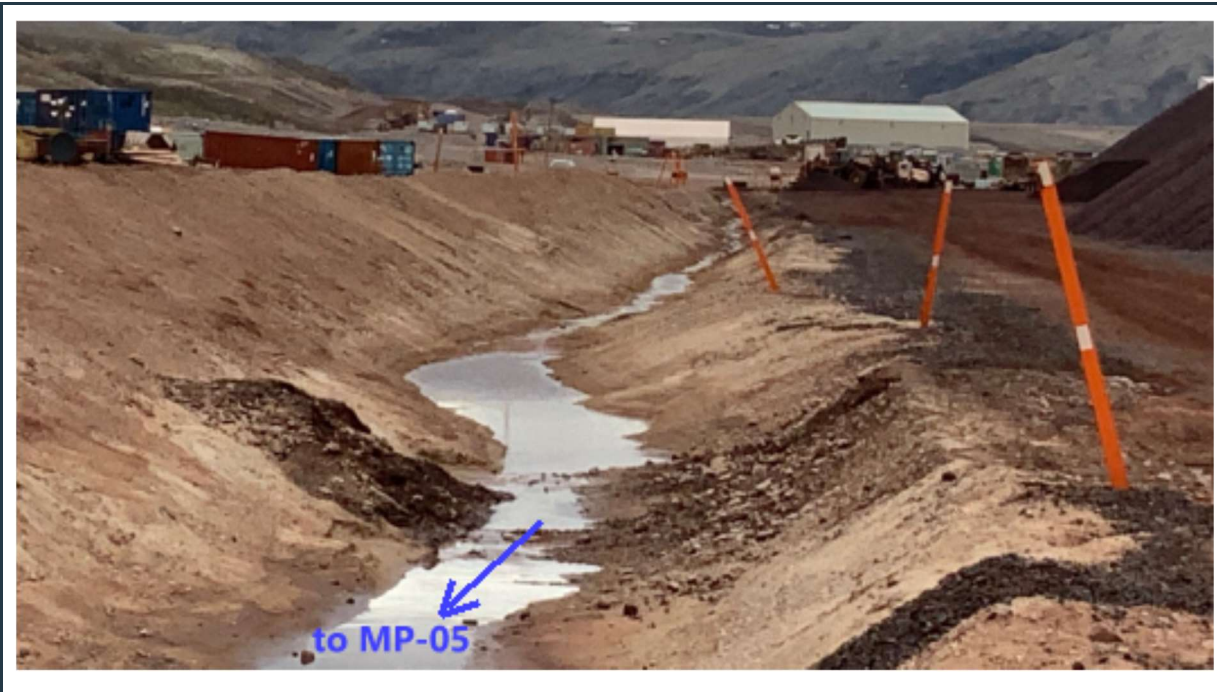
No instability, erosion or settlement was noted at the berms and no toe seepage from the pond is visible anywhere around the ponds' perimeter. The surface water from around the stockpile is collected in generally well-maintained drainage ditches. Minor liner damage: however, was noted on the slope of the southern intake channel to the pond, as shown in Figure 68. Also, erosion on the slope of the drainage ditch to the MP-05 pond was noted at one location, shown in Figure 69. It was recommended that the liner and erosion damage should be repaired as soon as possible.

Figure 69: Surface water collection ditch adjacent to the crushed ore storage, draining to MP-05 pond.

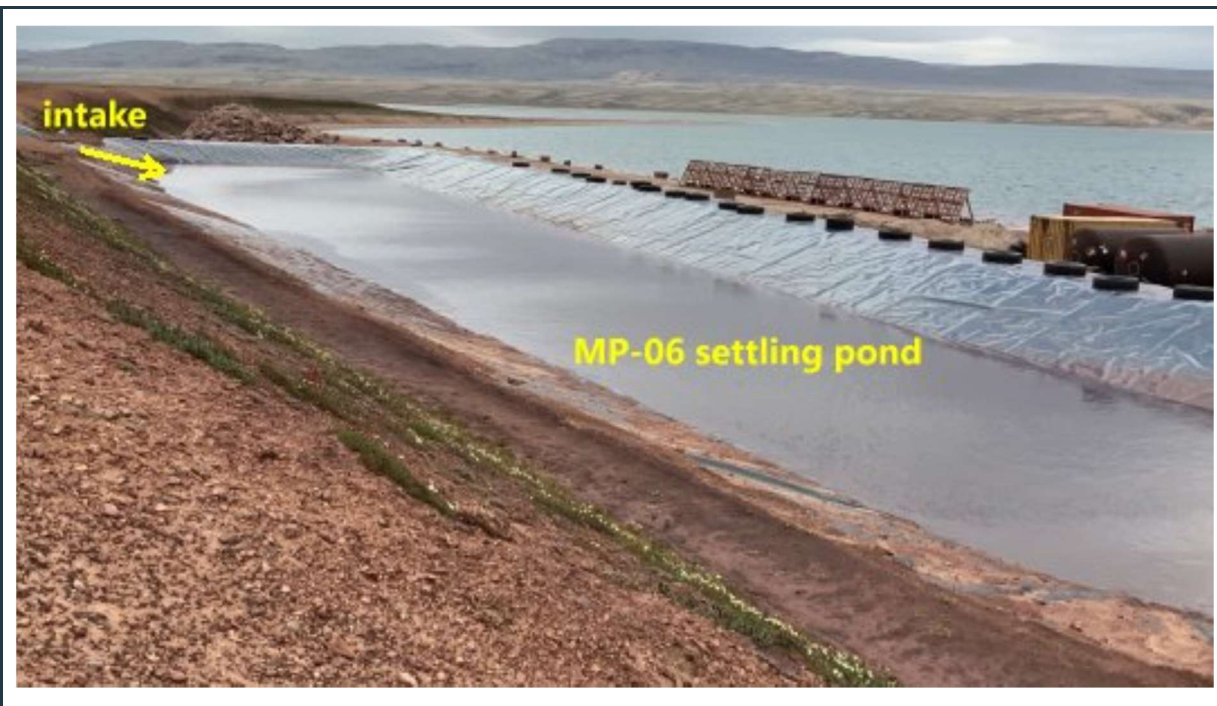
The MP-06 settling pond (Figure 70) is divided into two parts by a liner-covered internal berm and the northern cell is called the "overflow pond" (Figure 71). Both settling ponds have emergency spillways and the water level in both ponds was well below the spillways' inverts at the time of the inspection. The stable berms around the ponds are in excellent condition and no seepage was noted from the cells. The drainage ditch to the MP-06 pond is in excellent condition, as shown in Figure 72.

Figure 70: View of the lined MP-06 pond with stable berms (north-west corner of the ore stockpile).
