APPENDIX C.2

Geotechnical Inspection Reports

RE: Submission of 2019 Geotechnical Inspection Report No. 1 (July 2020)

Wood Environment & Infrastructure Solutions (Wood), has completed the first geotechnical field inspection of 2020 at the Mary River Iron mine complex, which is a condition of the Type "A" Water License No: 2AM-MRY1325 – Amendment No.1 ("Water License").

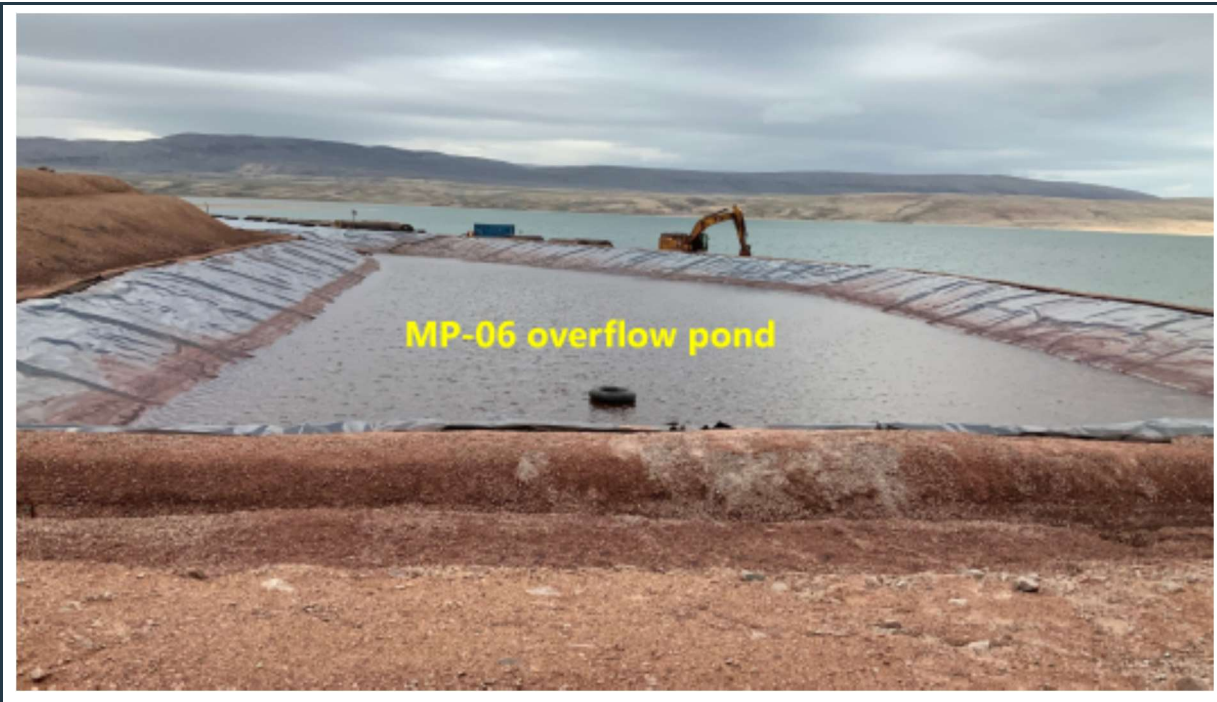
The MP-06 settling pond (Figure 70) is divided into two parts by a liner-covered internal berm and the northern cell is called the "overflow pond" (Figure 71). Both settling ponds have emergency spillways and the water level in both ponds was well below the spillways' inverts at the time of the inspection. The stable berms around the ponds are in excellent condition and no seepage was noted from the cells. The drainage ditch to the MP-06 pond is in excellent condition, as shown in Figure 72.

Figure 71: View of the lined MP-06 overflow pond, with stable berms.

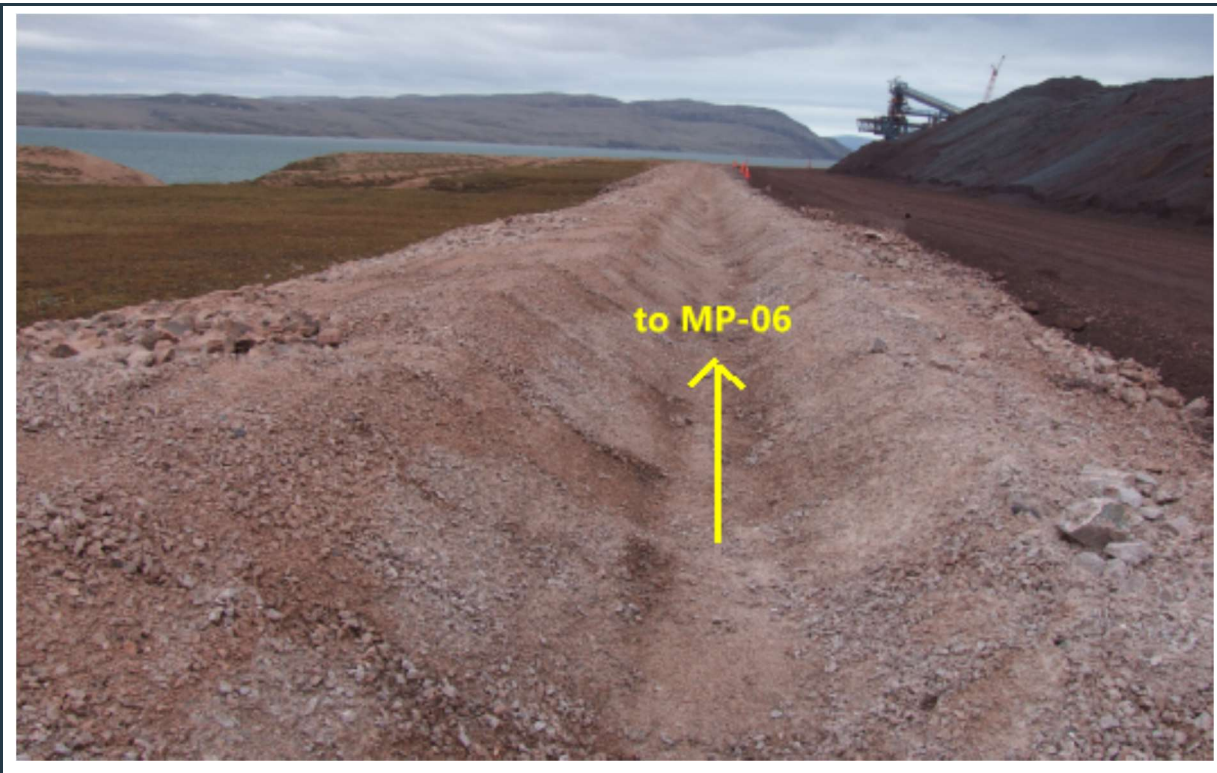
Figure 72: Surface water collection ditch adjacent to the crushed ore storage, draining to MP-06 pond.

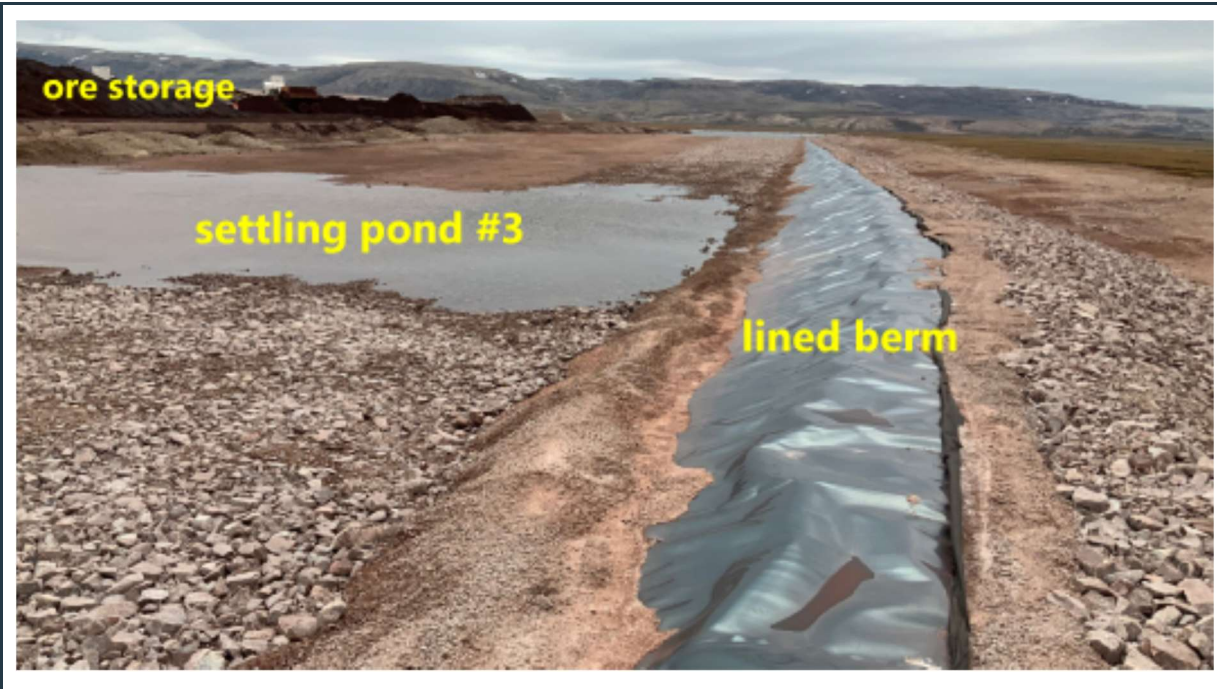
This settling pond was recently constructed west of the ore storage area, as shown in Figure 5. The pond is surrounded along three sides with a stable, lined berm and contains two sumps, as shown in Figures 73 and 74. The geomembrane and protective geotextile on the internal slope of the berm extend 2.5 m below

Figure 73: View of the lined, stable berm along the west side of settling pond #3.

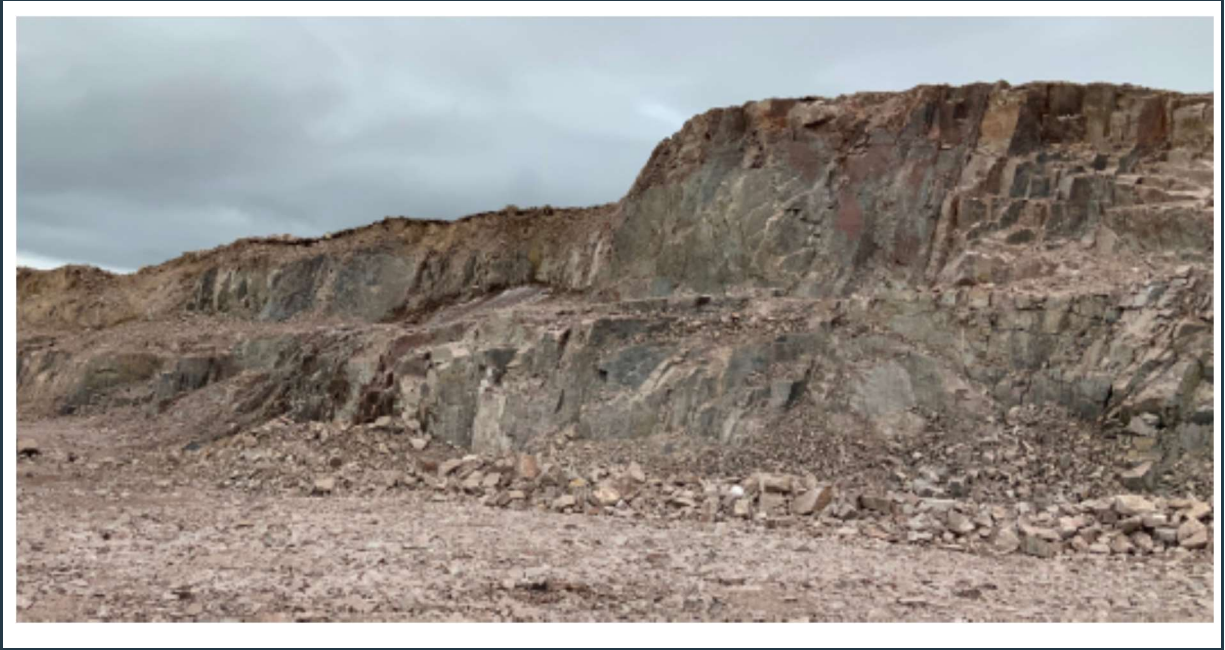
No activity was noted in the Q01 quarry at the time of the inspection. The rock slopes in the quarry appeared to be stable conditions, as shown in Figure 75. Surface water is collected and drained well, into nearby drainage ditches.

Figure 75: View of stable highwalls in the Q01 quarry.

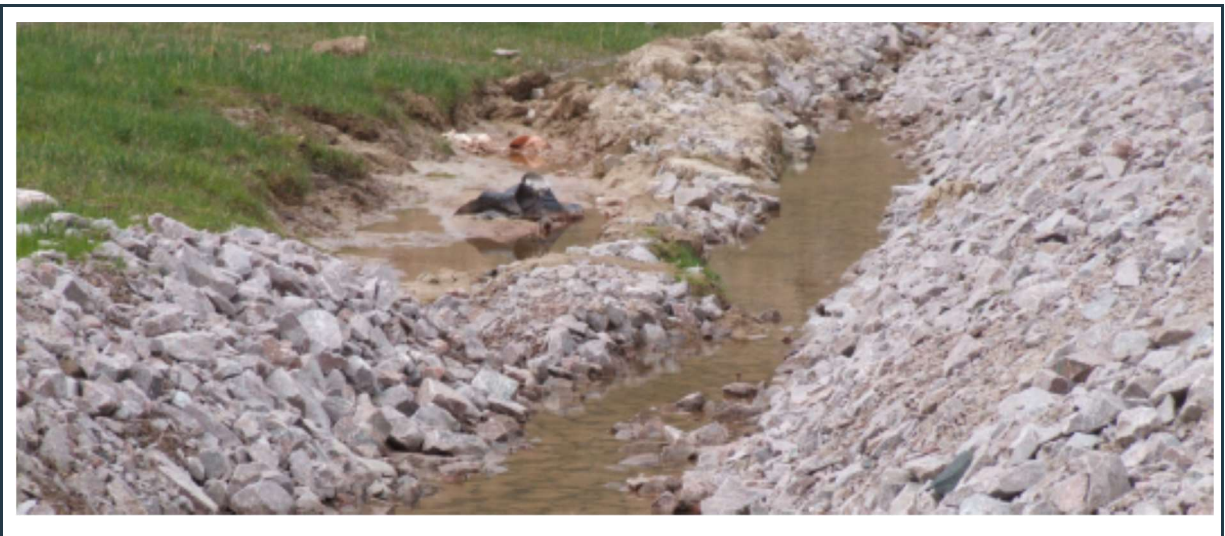
- Sloughing of the sides of ditch P-SWD-3, adjacent to the LP2 laydown area, is visible at many locations along the ditch, as shown in Figures 76 and 77. The sloughing is a result of uncontrolled sheet-flow of surface water, drained into this area by the P-SWD-5 ditch. It is suggested that the two ditches be connected by one drainage ditch to eliminate the development of sheet-flow from the current end of the P-SWD-5 toward the P-SWD-3 ditch.

Figure 76: View of the “P-SWD-3 surface water collection ditch with failing side slope. The sloughing is caused by the uncontrolled water flow into the ditch along its alignment (see the next image).

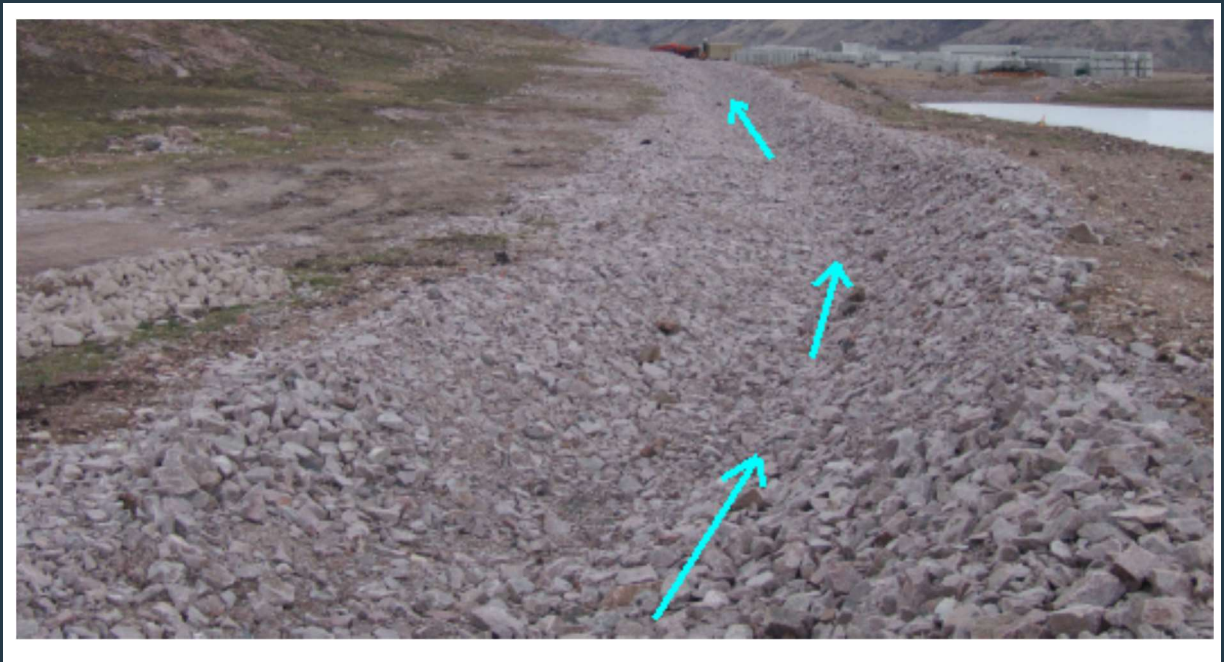
Figure 79: View of the well maintained P-SWD-6 - "Q01 South" surface water collection ditch.

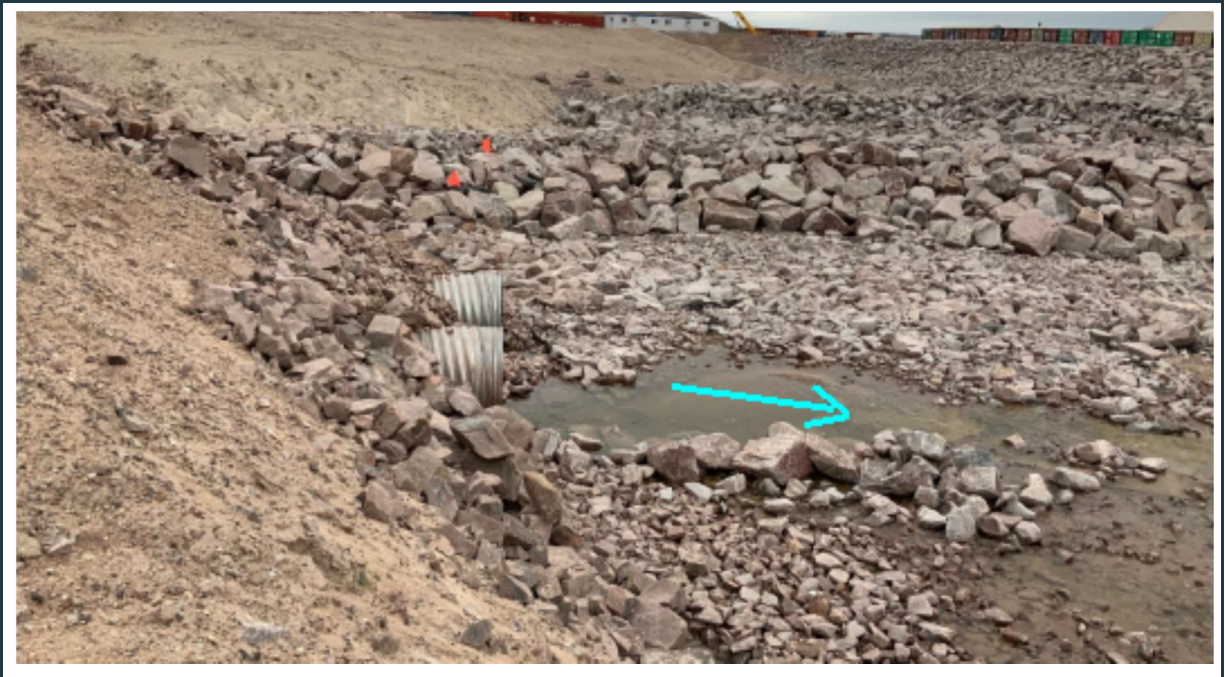
Figure 81: View of the P-SWD-7 surface water collection ditch and culverts (outlet).

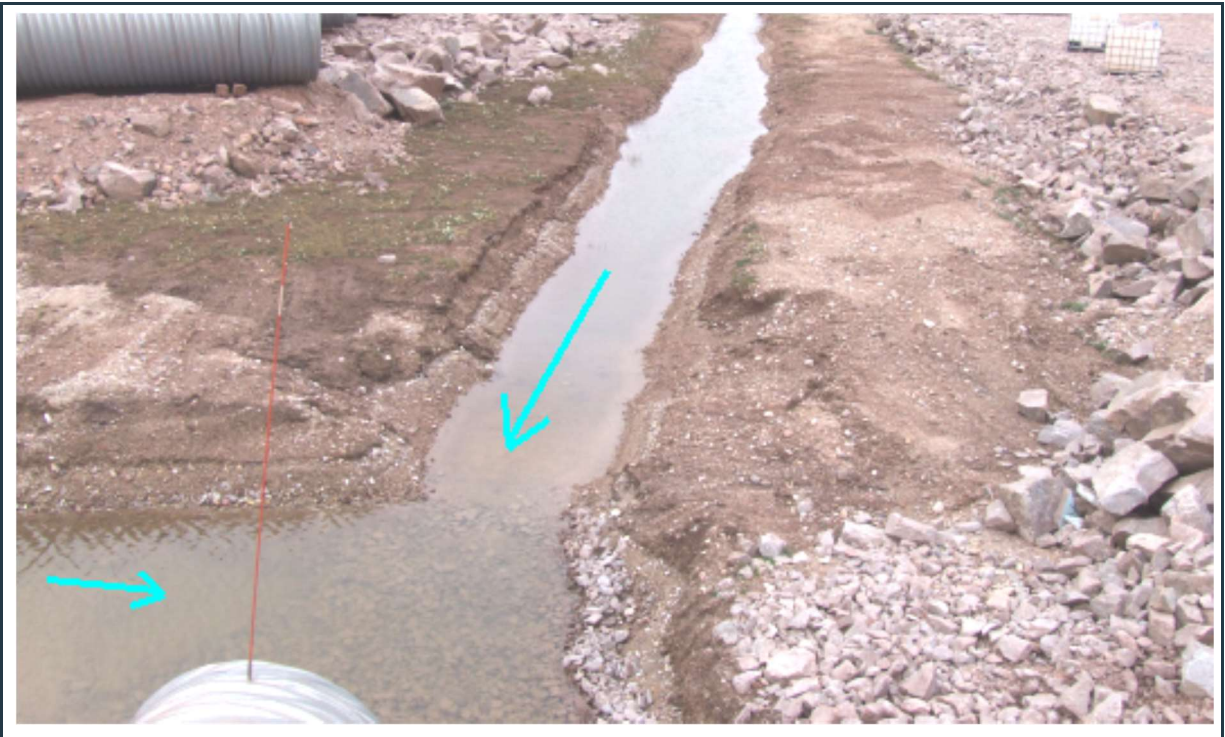
Figure 82: View of the W3/W14 surface water collection ditch and culvert inlet.

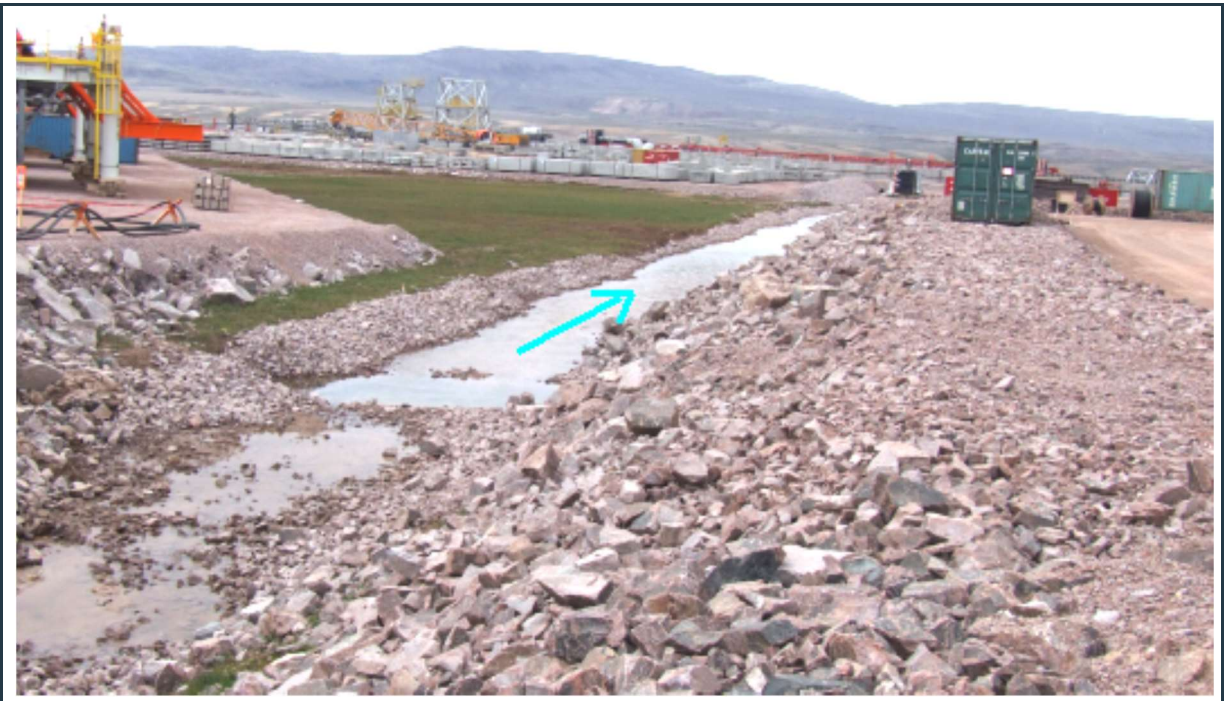
- Minor sloughing of the riprap in the 380M ditch was also visible that should be repaired (Figure 83).
- The P-SC drainage ditch is still under construction. The riprap on the slope at a culvert in that ditch should be rectified, and the culvert should be shortened at this location to facilitate uninterrupted flow of water within the ditch (Figure 85).

Figure 83: View of the south section of the 380 M surface water collection ditch, with minor riprap sloughing/rolling in the foreground.

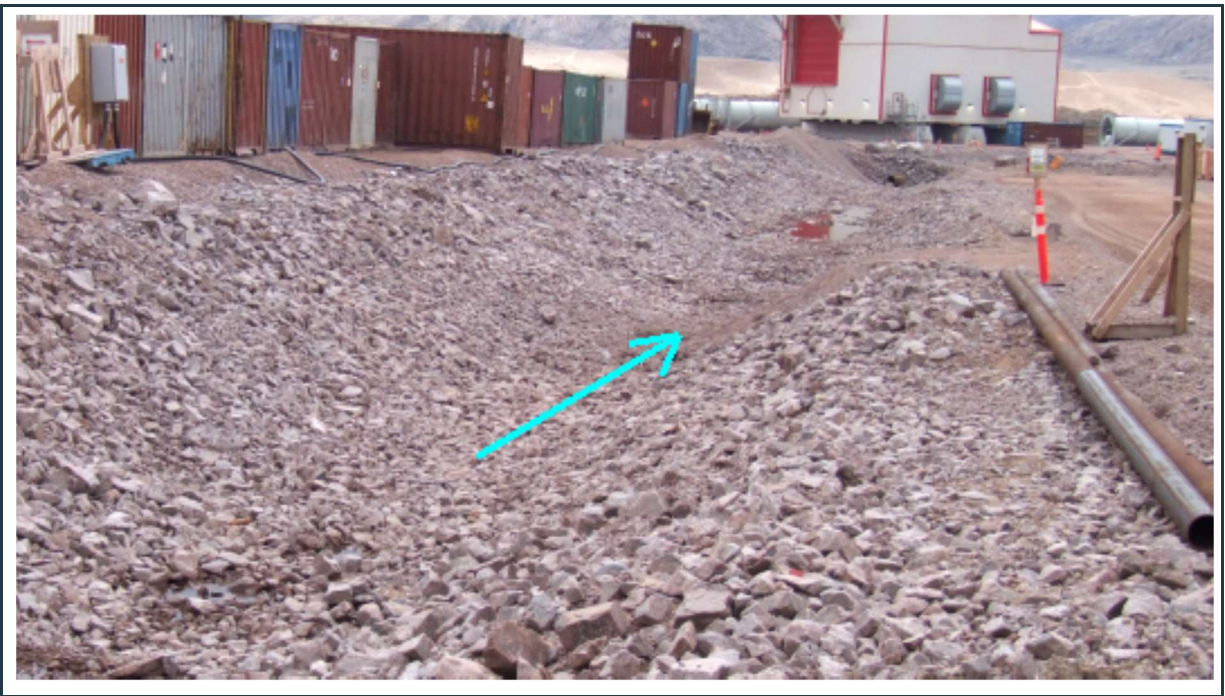
Figure 84: View of the east section of the 380 M surface water collection ditch, in good condition.

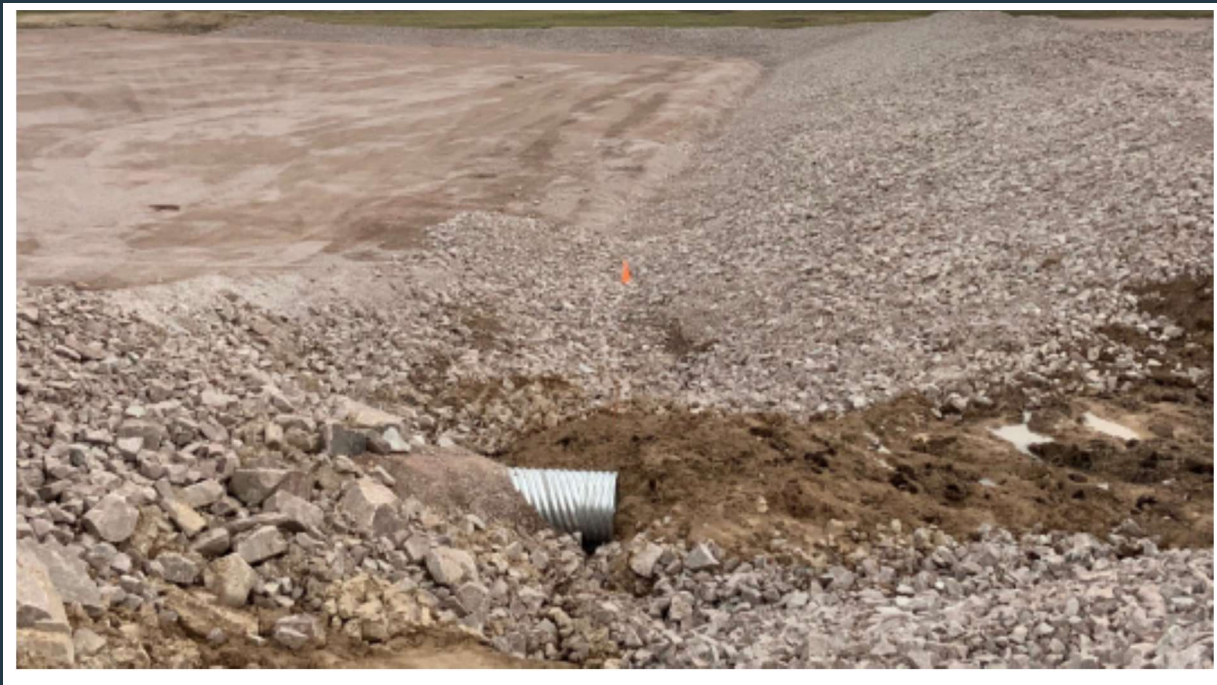
Figure 85: View of the P-SC surface water collection ditch and culvert (still under construction).

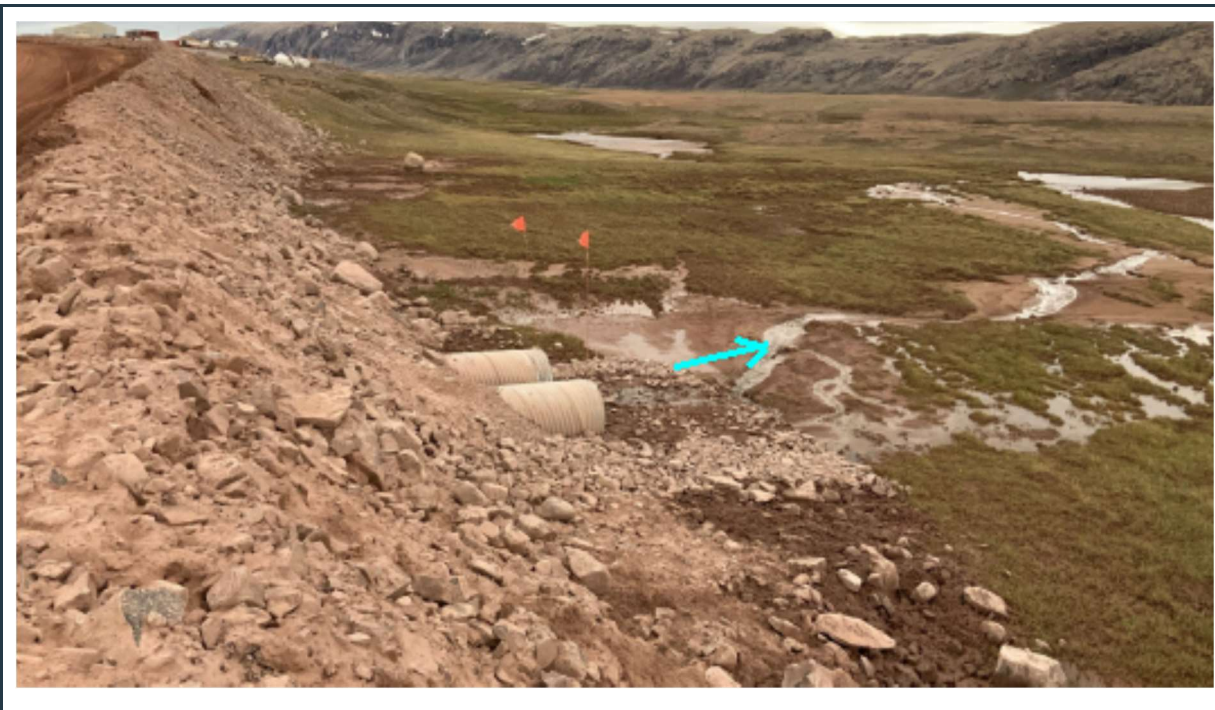
Figure 88: View of twin culverts, draining surface water under the tote road (outlet).

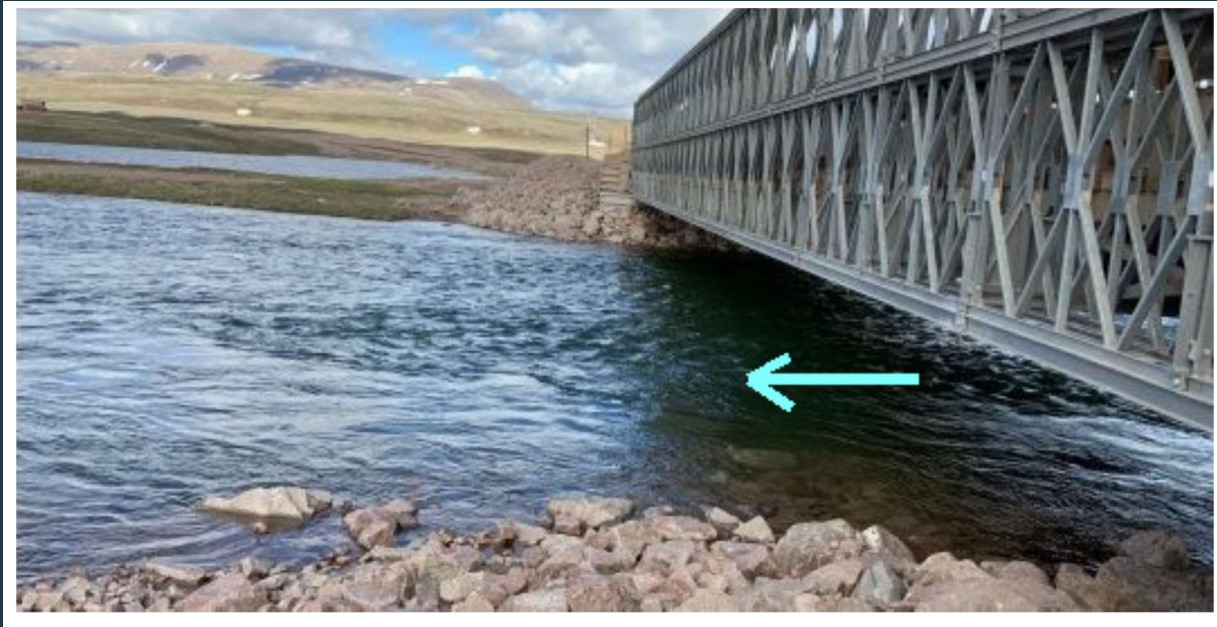
Figure 89: View of "bridge 17", looking north-east. Note the rip-rap scour protection.

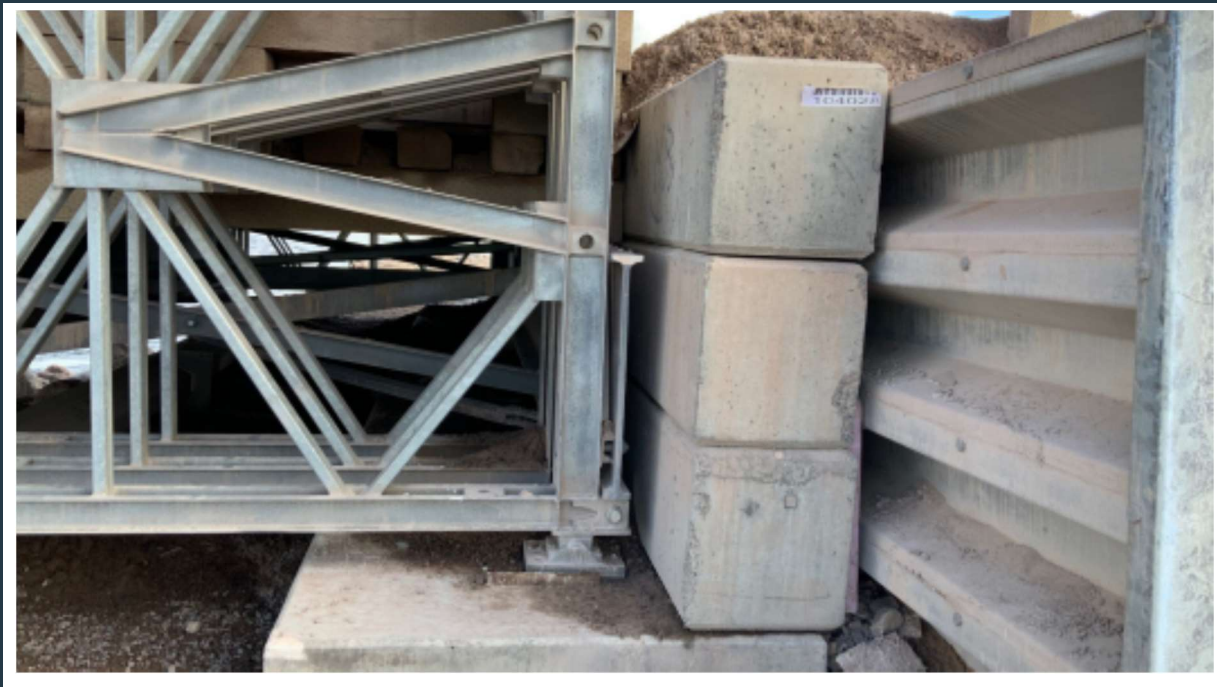
Figure 90: Foundation and abutment conditions at the south-west abutment of bridge 17.

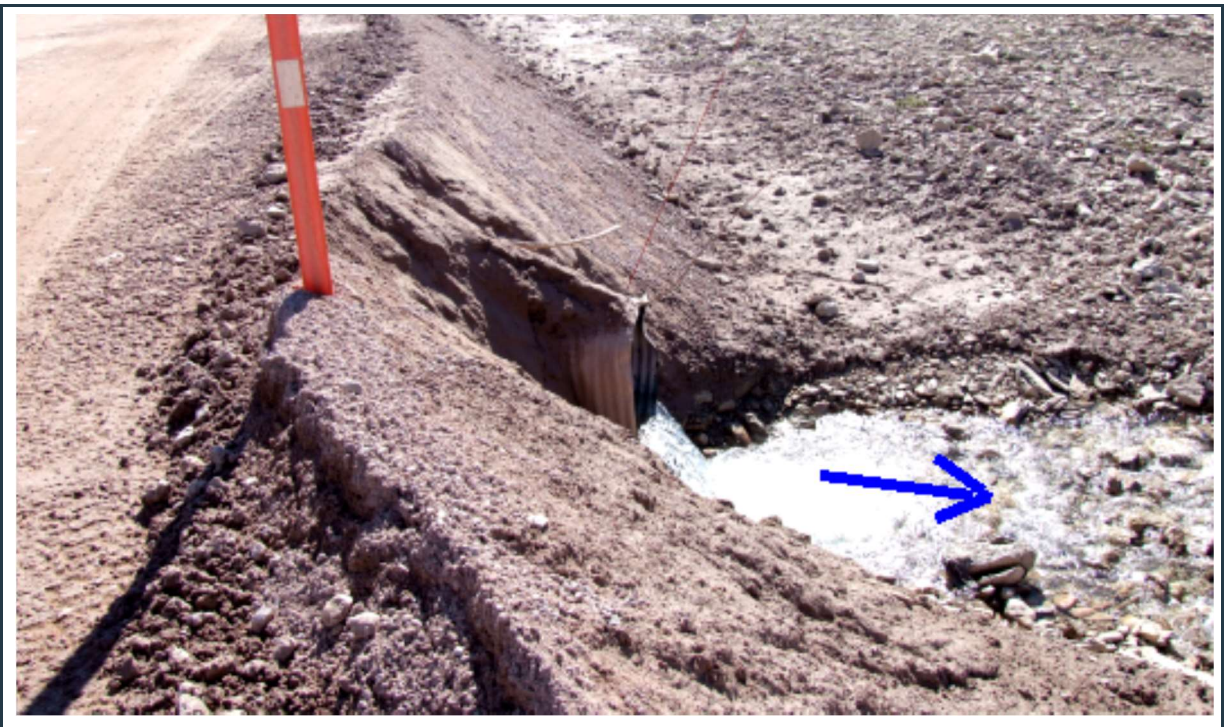
Figure 102: View of culvert 083 (outlet), with some slope erosion around the culvert.

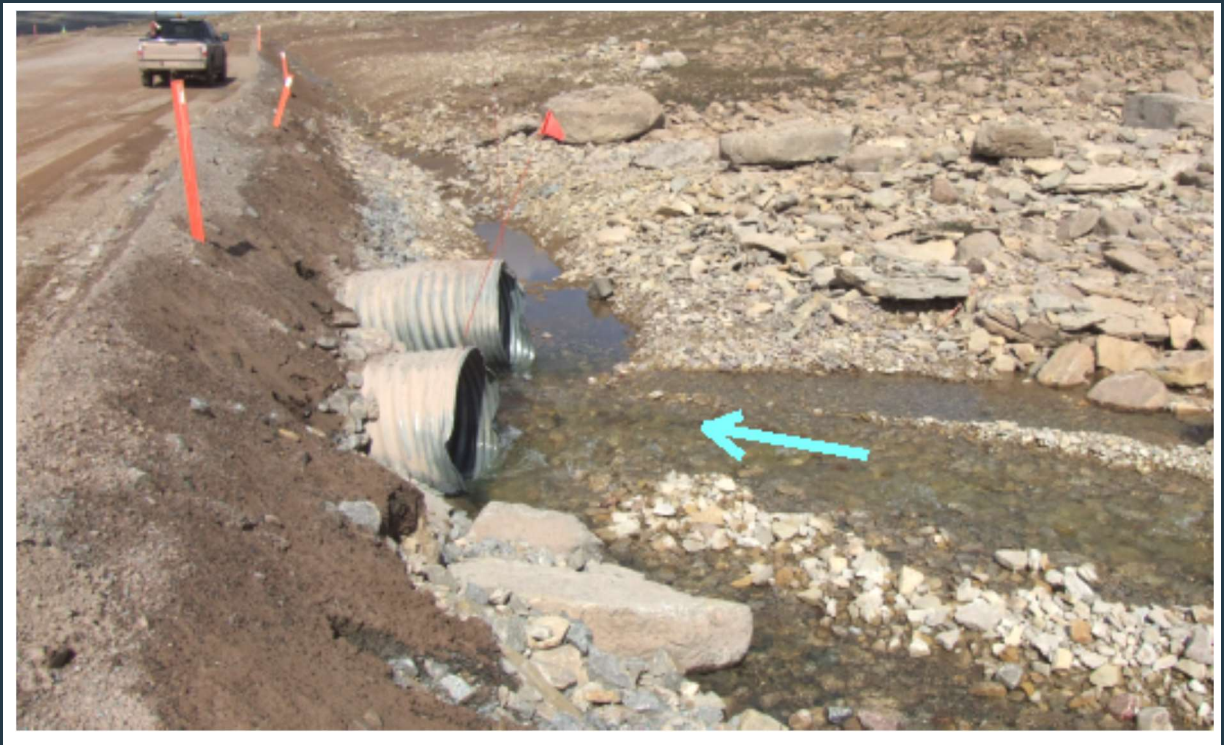
Figure 103: View of culvert(s) 094 (inlet) in good condition.

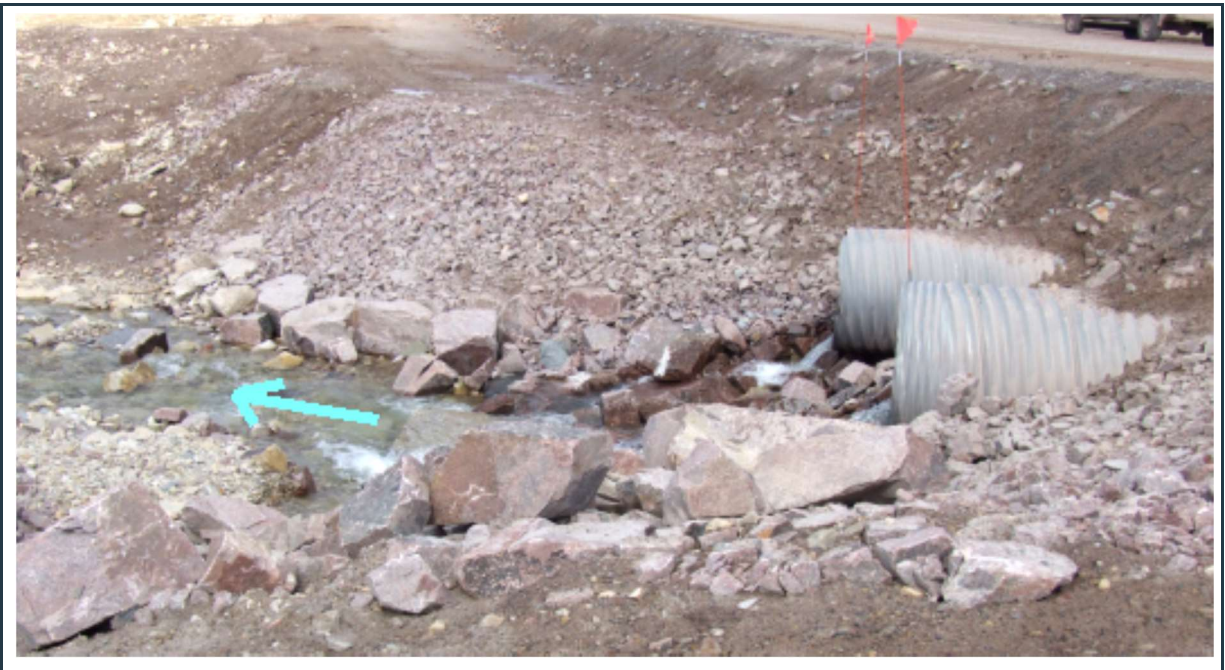
Figure 104: View of culvert(s) 094 (outlet) in good condition.

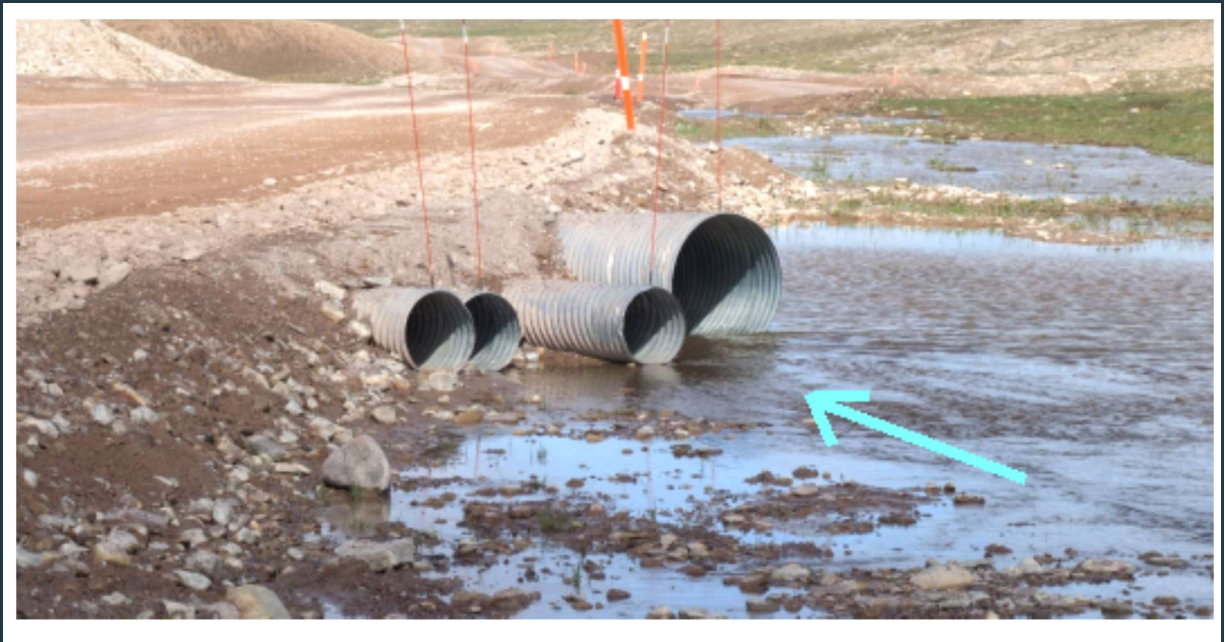
Figure 105: View of culvert(s) 102 (inlet) in good conditions.

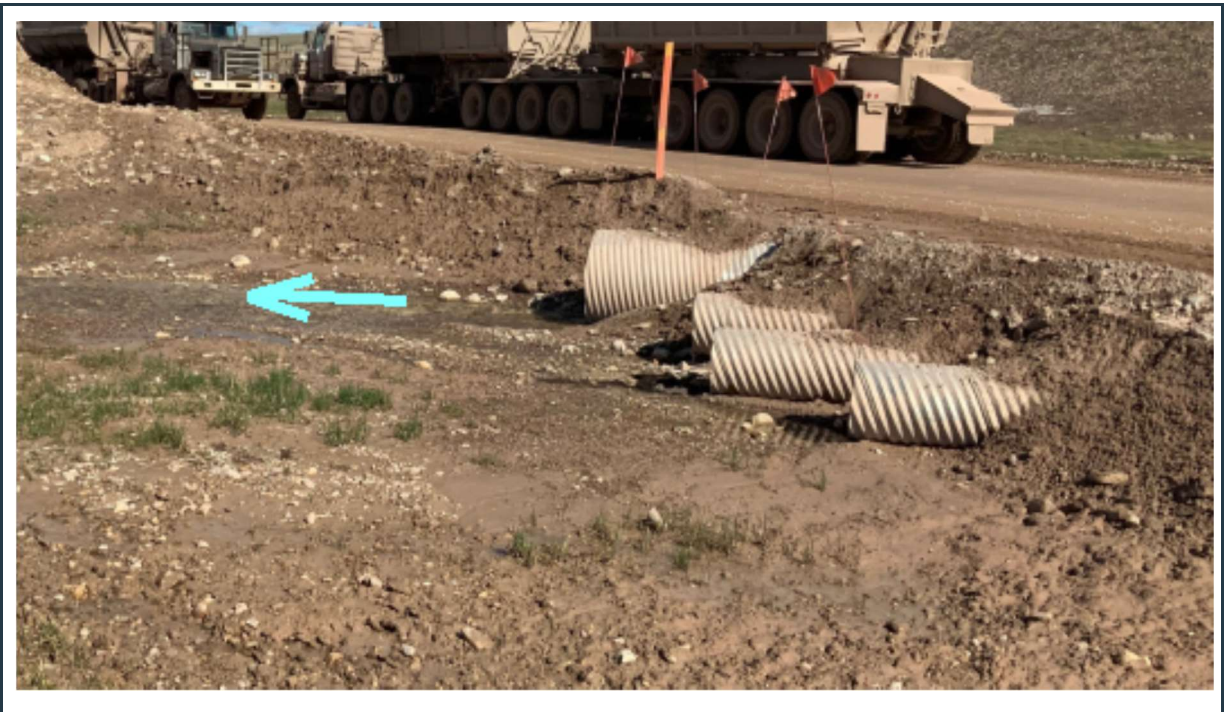
Figure 106: View of culvert(s) 102 (outlet) in good conditions.

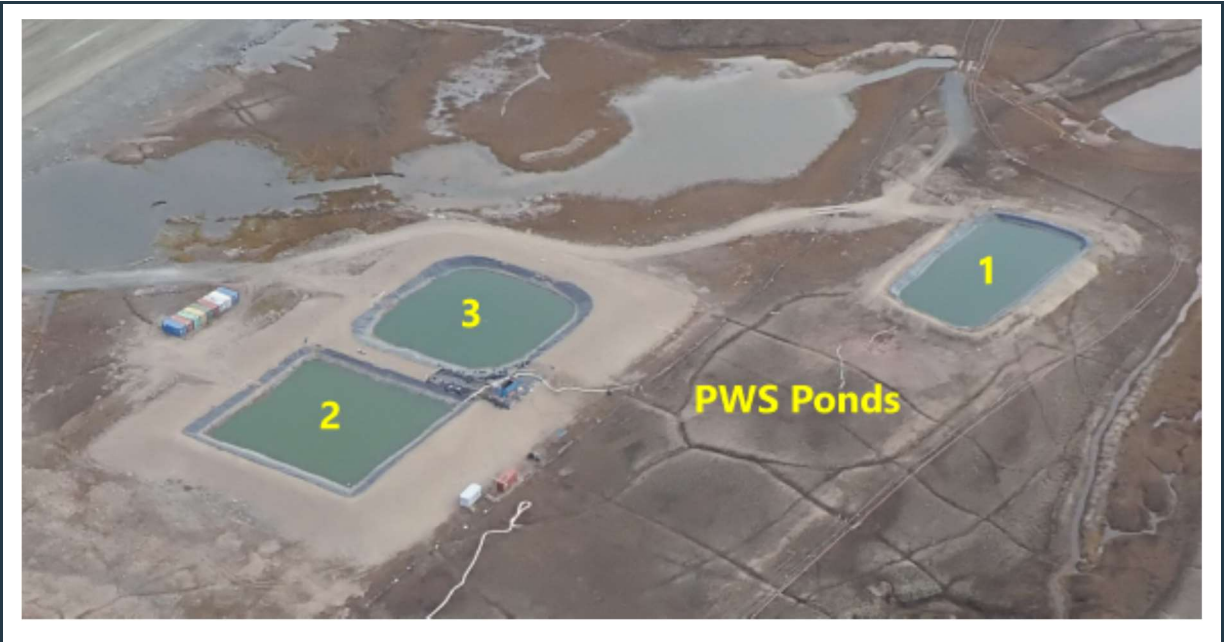
Figure 9: Aerial view of the stable berms around the three PWS ponds.

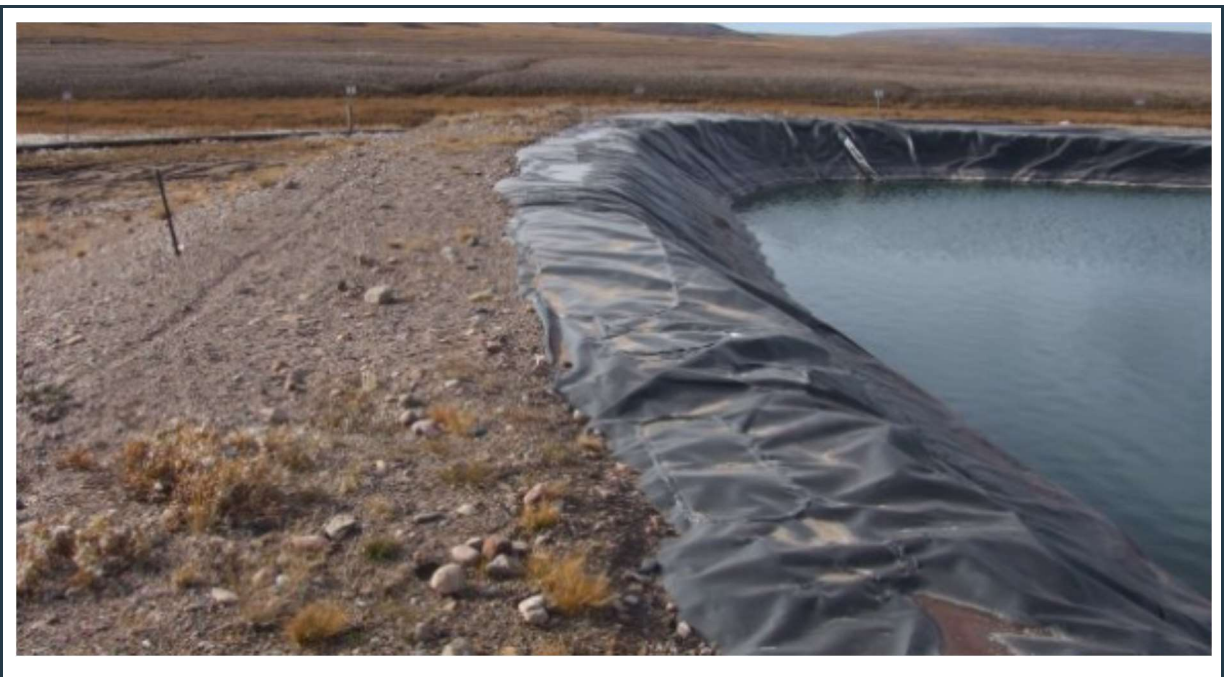
Figure 10: PWS pond #1. Well maintained stable perimeter berm and liner.

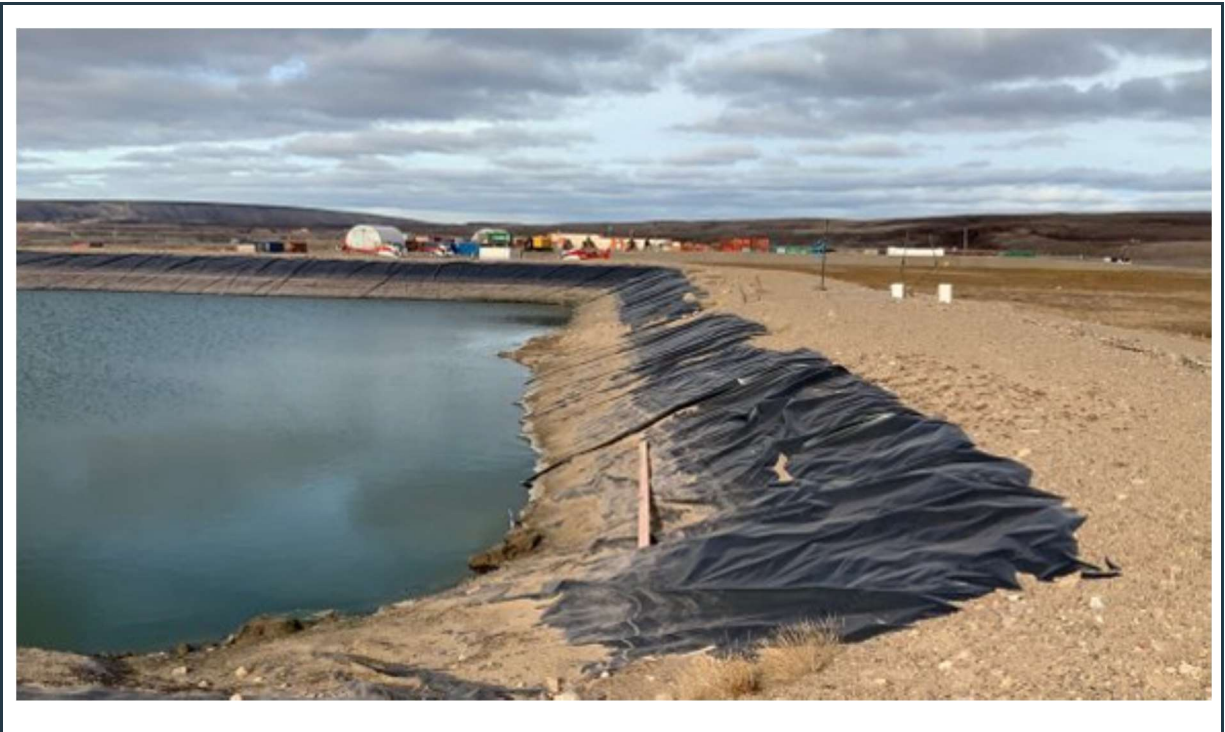
Figure 11: PWS pond #2 – Stable berm around the pond. The water was lowered in the summer.

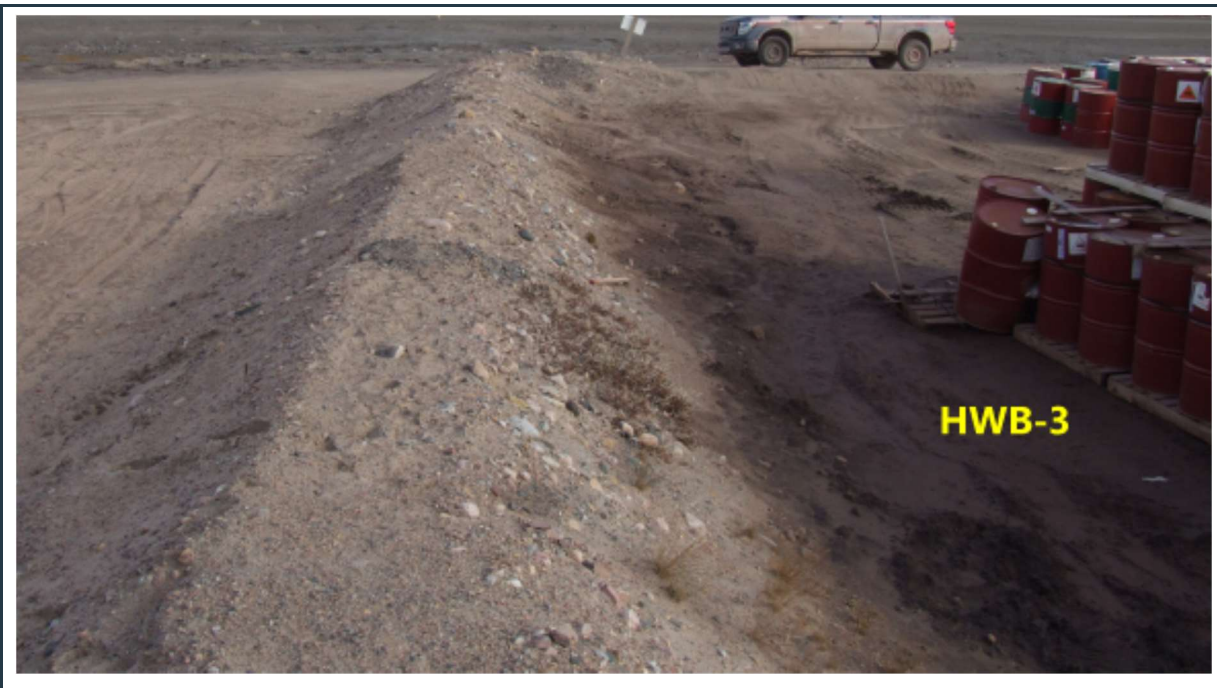
Figure 15: View of stable berms and the stored fuel barrels in HWB-3.

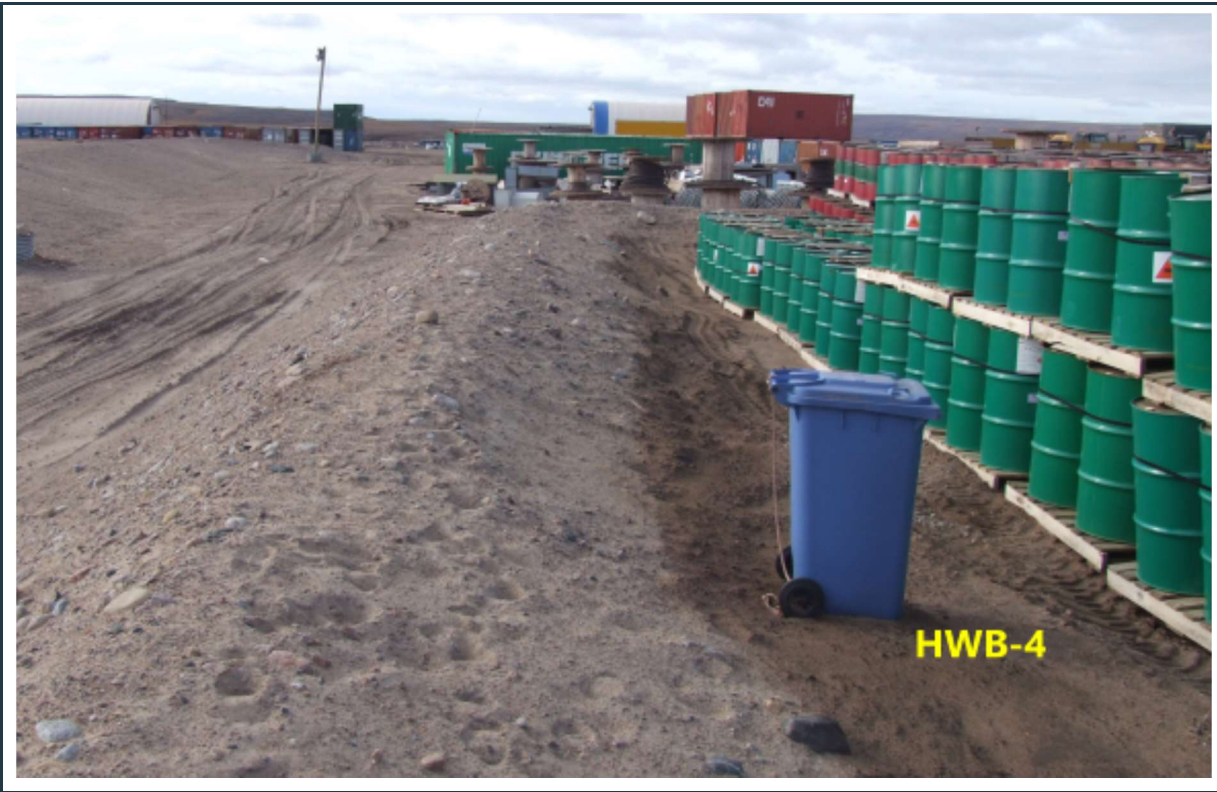
Figure 16: View of stable berms at HWB-4 next to HWB-3, with jet-fuel barrels stored on wooden pallets.

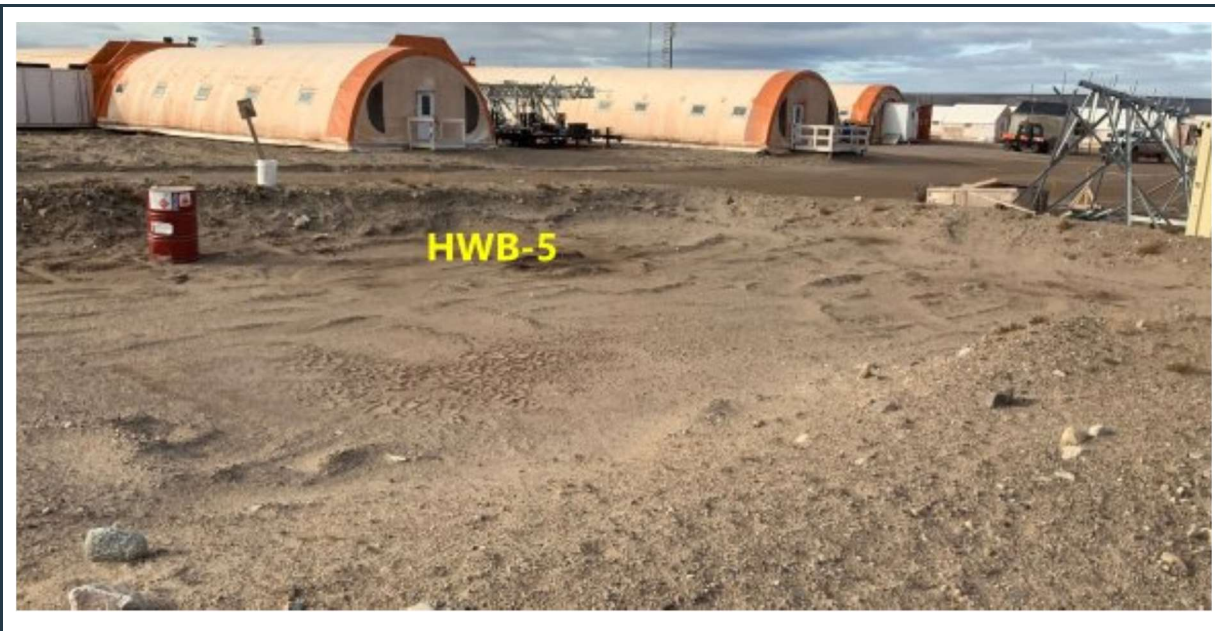
d) HWB-5

Figure 17: View of the HWB-5 berms. Only one fuel barrel stored in the otherwise empty cell.

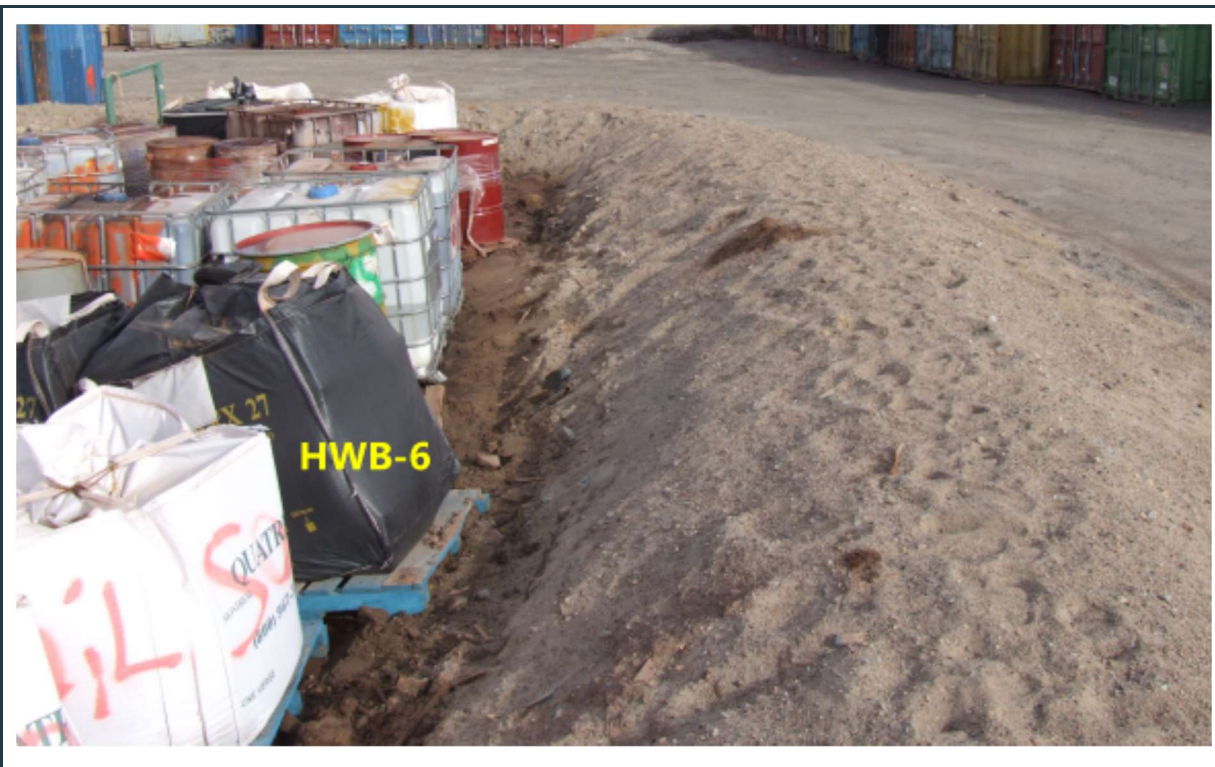
e) HWB-6

Figure 18: View of the recently upgraded stable berm around HWB-6.
