APPENDIX C.2

Geotechnical Inspection Reports

RE: Submission of 2019 Geotechnical Inspection Report No. 1 (July 2020)

Wood Environment & Infrastructure Solutions (Wood), has completed the first geotechnical field inspection of 2020 at the Mary River Iron mine complex, which is a condition of the Type "A" Water License No: 2AM-MRY1325 – Amendment No.1 ("Water License").

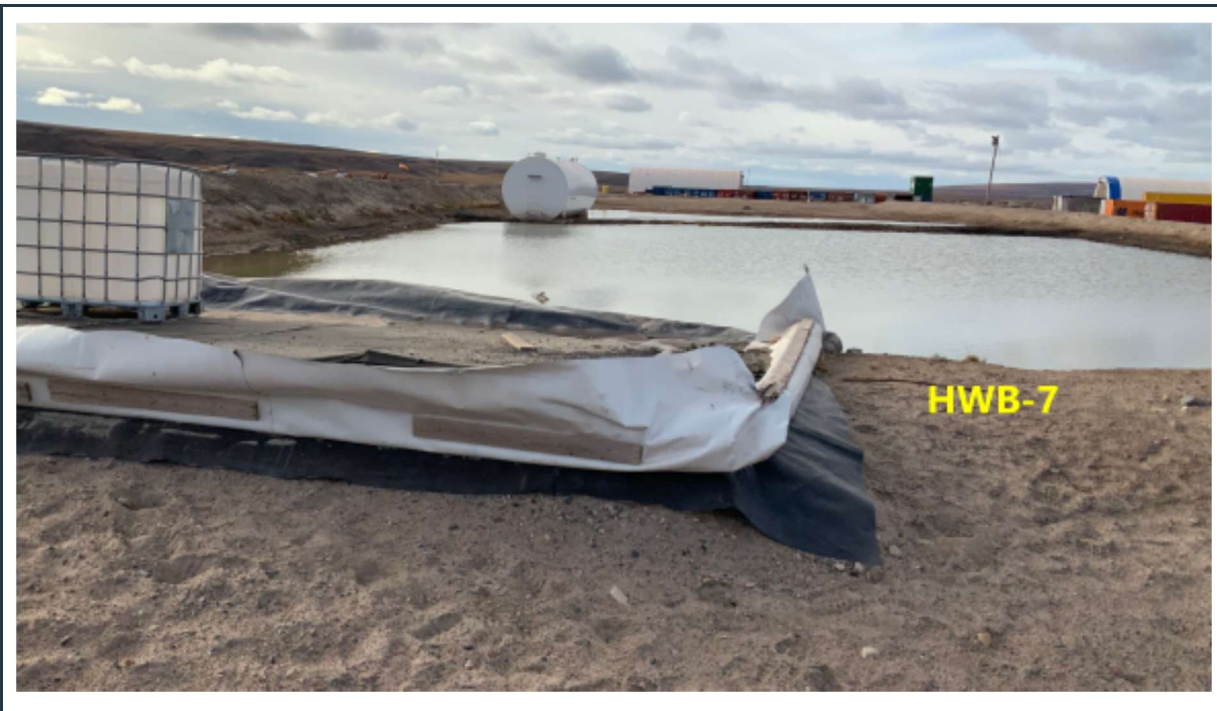
Figure 19: View of the large, flooded HWB-7 cell, with only one fuel tank stored.

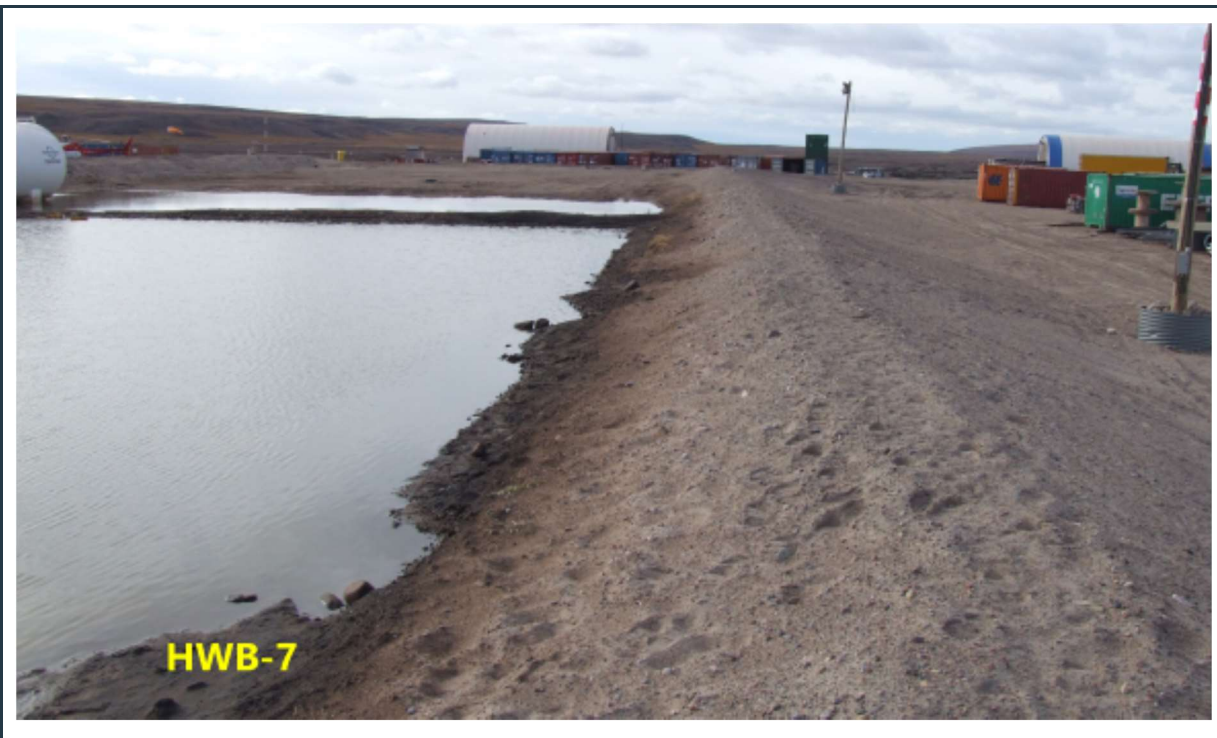
Figure 20: View of the robust, stable berms around the HWB-7 cell.

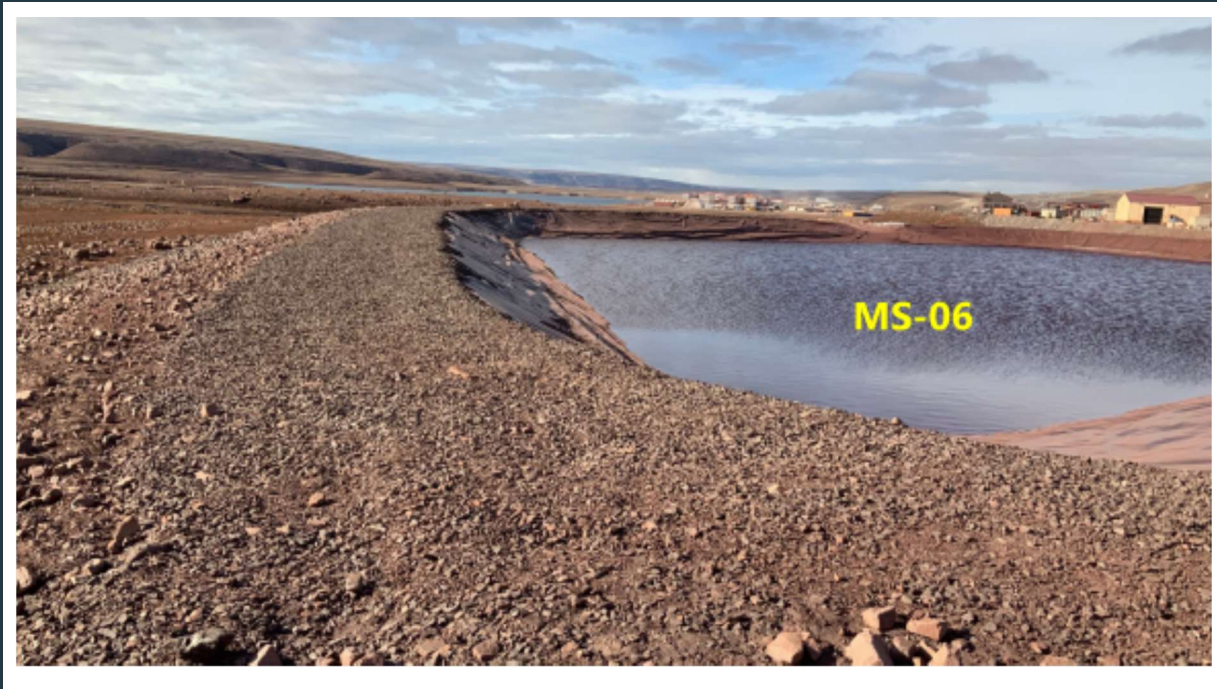
Figure 21: MS-06 surface-water collection pond with robust, stable berms and intact liner.

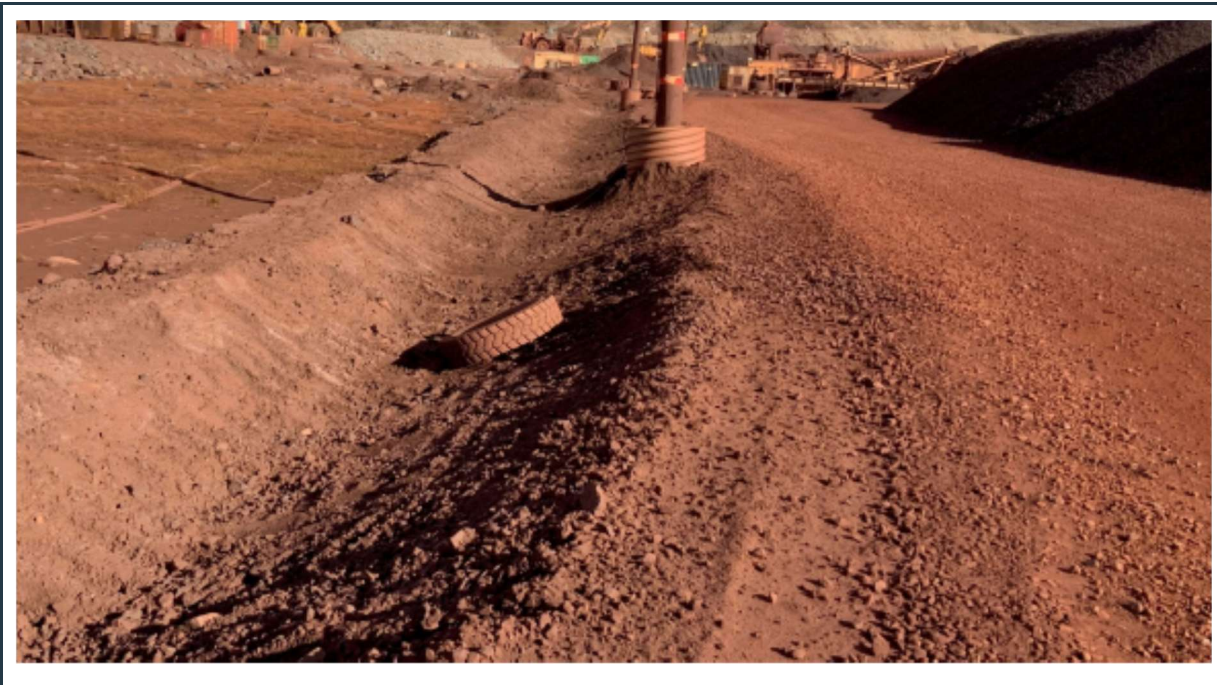
Figure 22: Well maintained surface-water collection ditch next to the crusher plant, leading to MS-06.

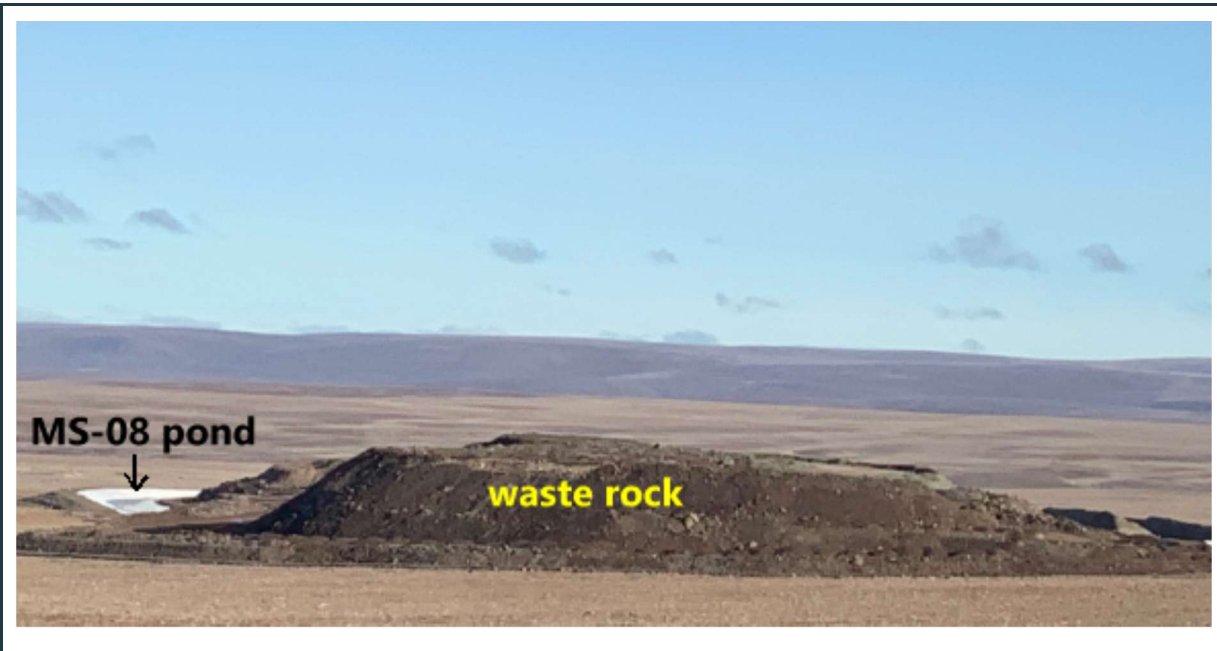
Figure 23: View of the MS-08 pond at the waste rock facility.

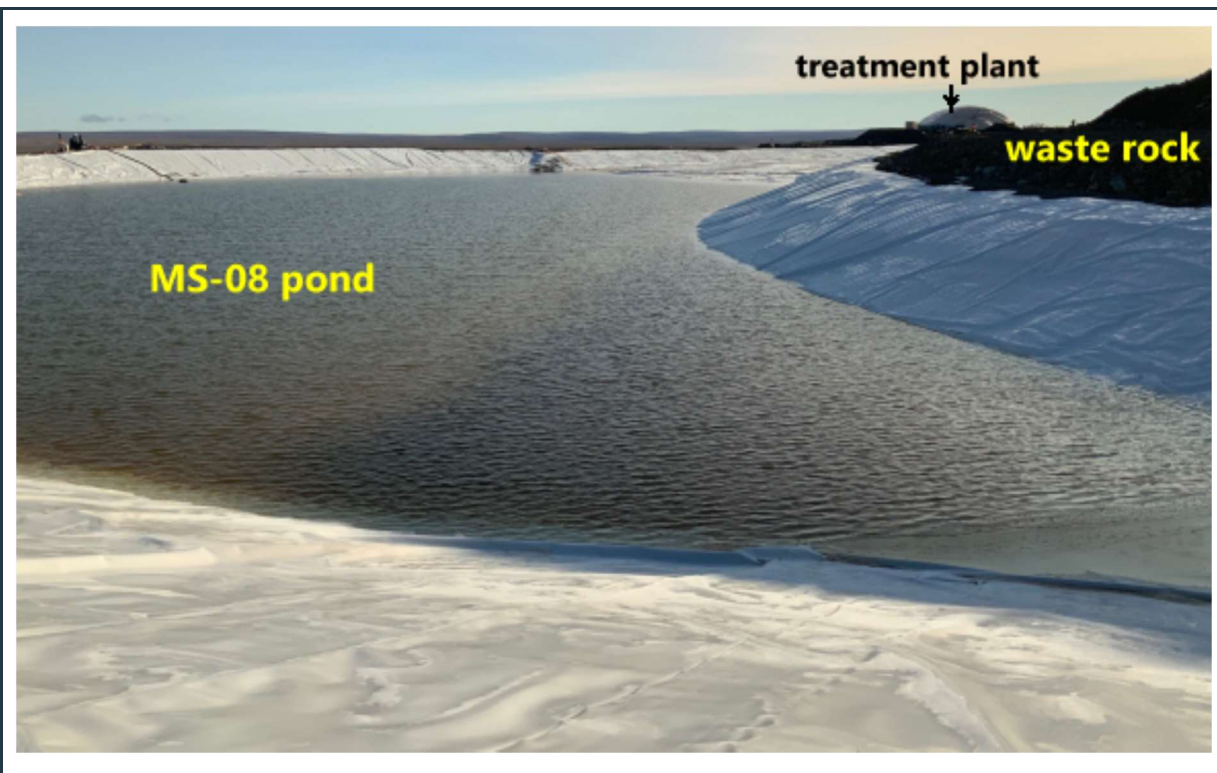
Figure 24: View of the robust, stable berm around the MS-08 pond with shallow slopes and intact liner.

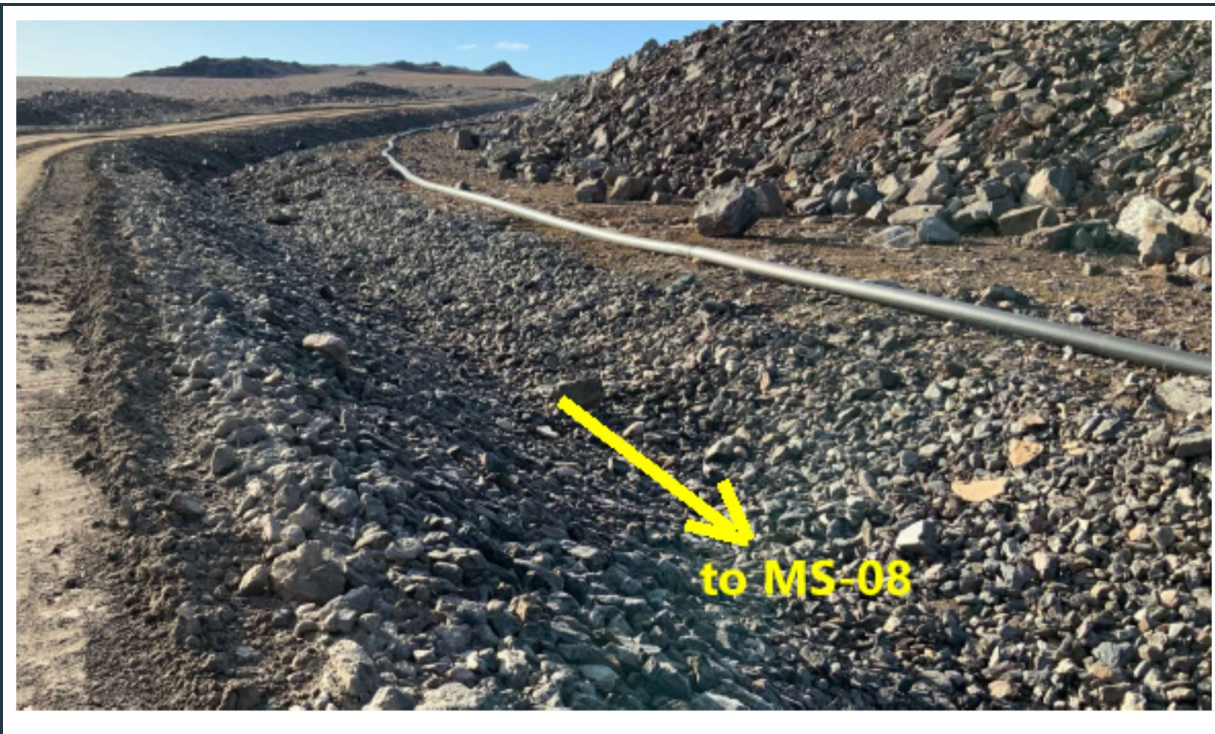
Figure 25: Well-maintained drainage ditch around the east side of the waste rock facility.

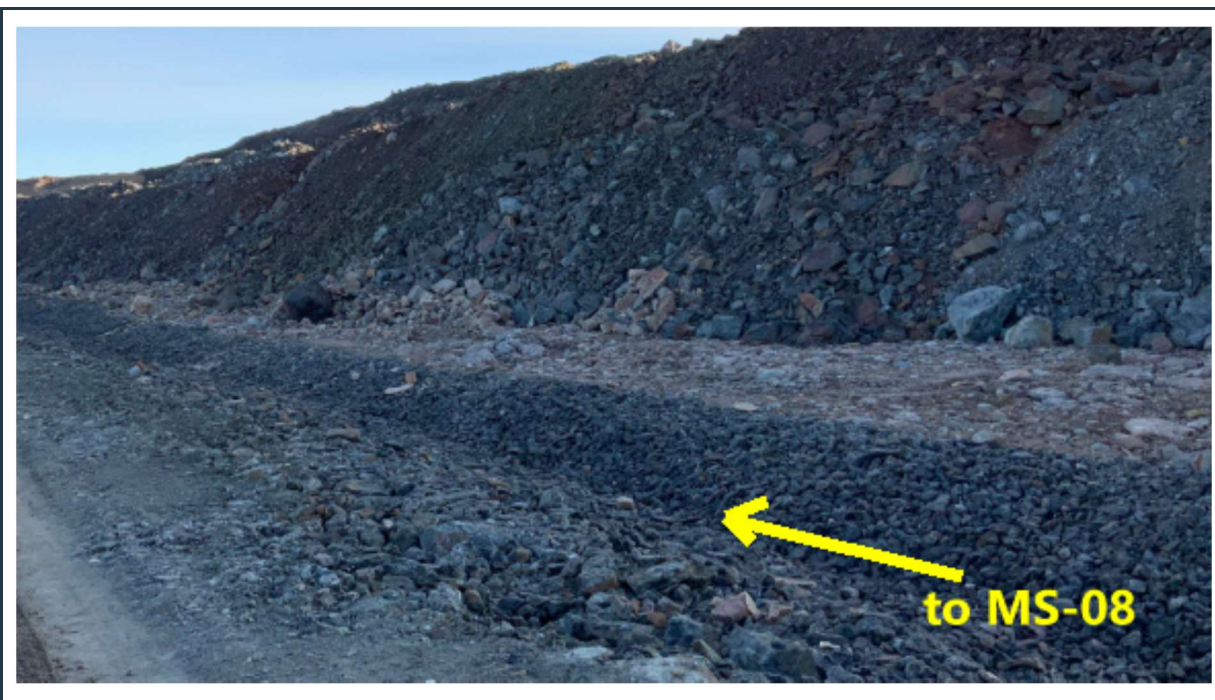
Figure 26: Well-maintained drainage ditch along the west side of the waste rock facility.

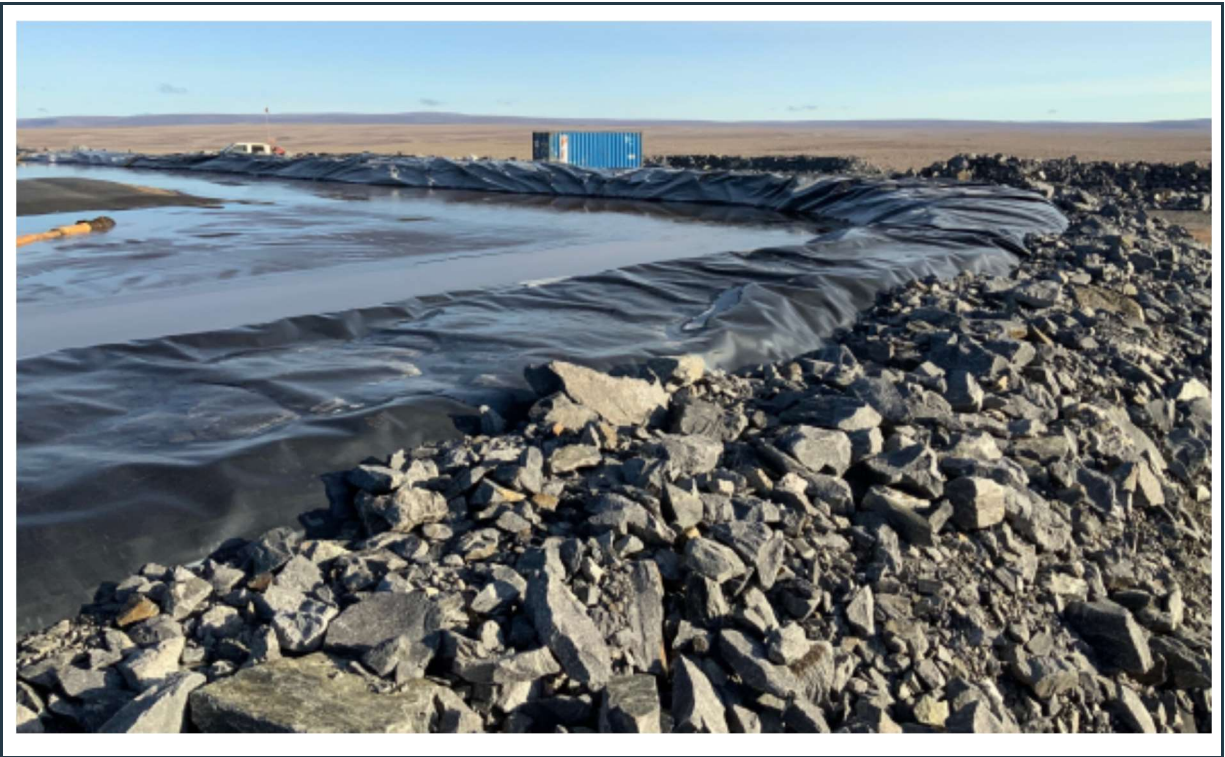
Figure 27: Stable rock fill berm at the water treatment pond adjacent to the waste rock facility.

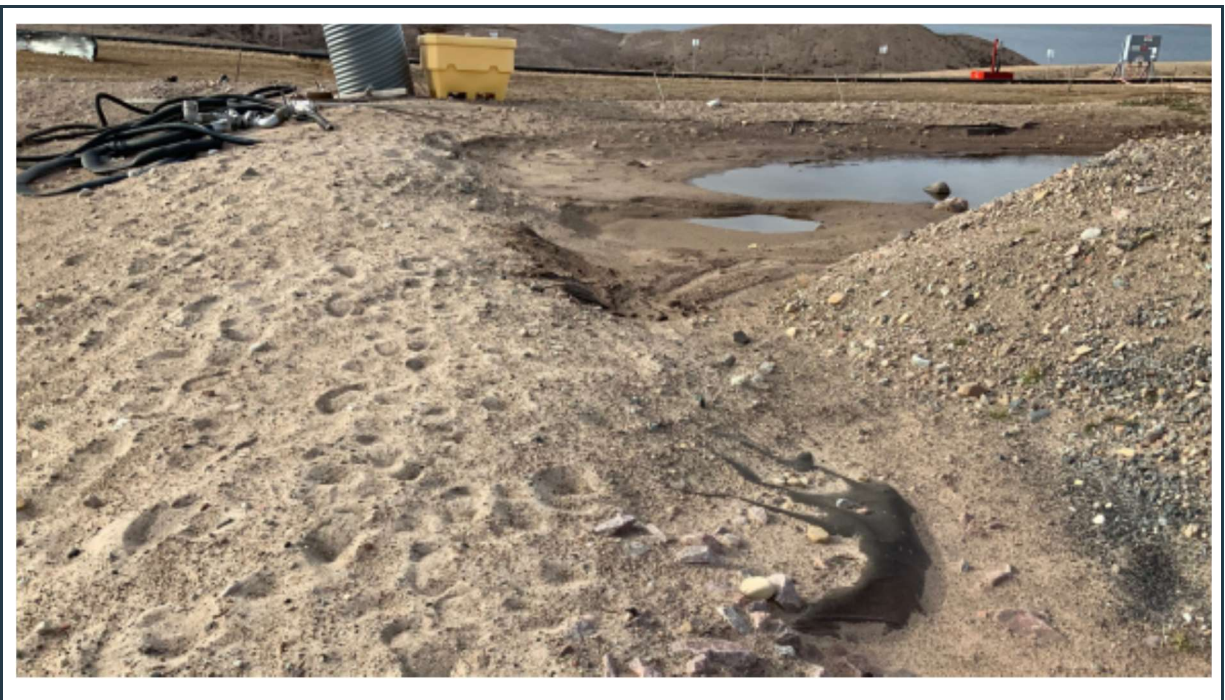
Figure 28: View of the generator fuel berm with exposed geotextile at a few locations.

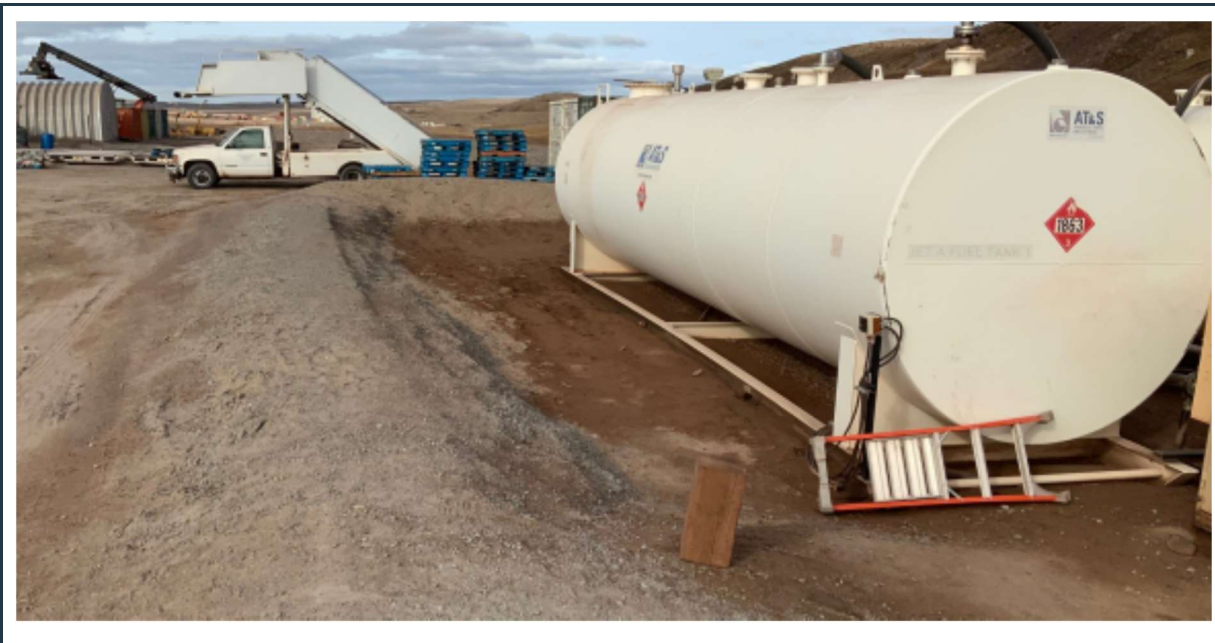
Figure 30: View of the well-maintained berm at the jet-fuel storage facility.

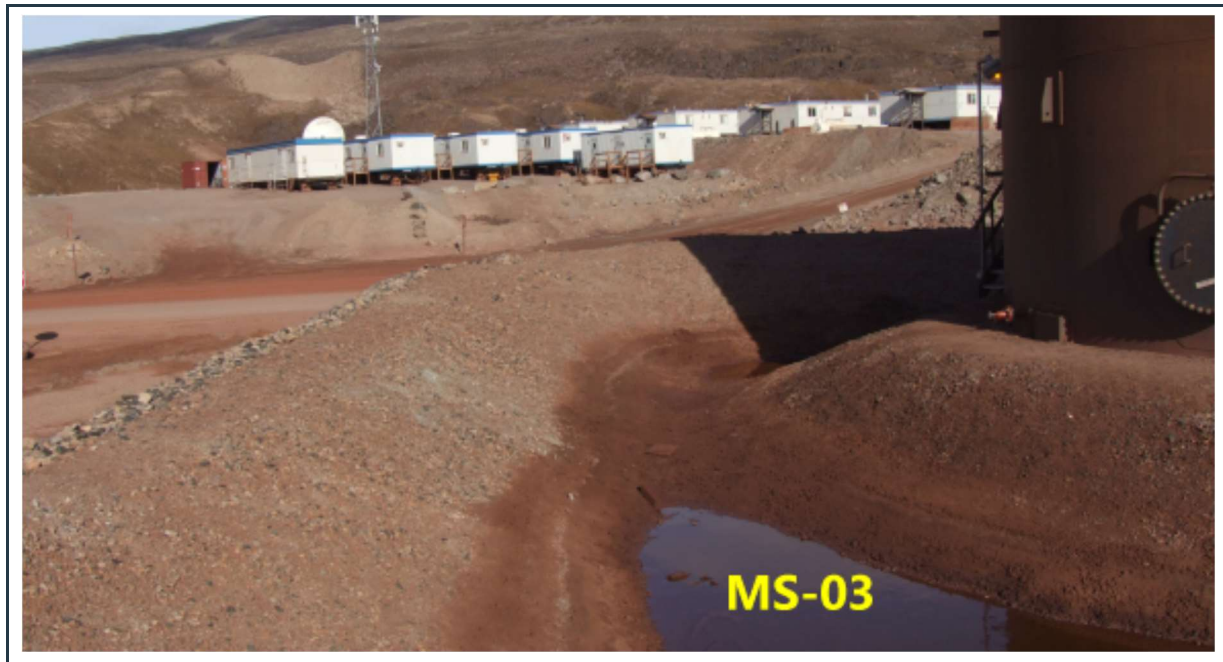
Figure 31: View of the well-maintained stable berm around the MS-03 diesel fuel farm.

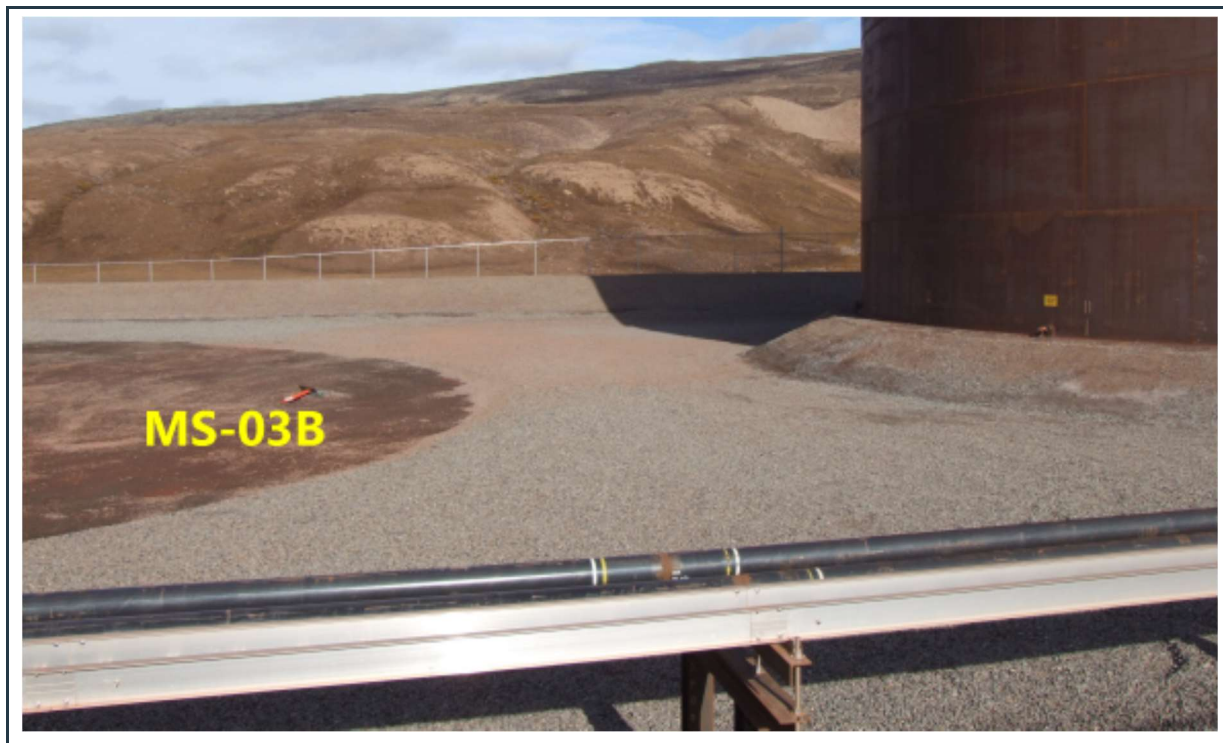
Figure 32: View of the recently completed fuel tank farm with well-constructed stable perimeter berms.

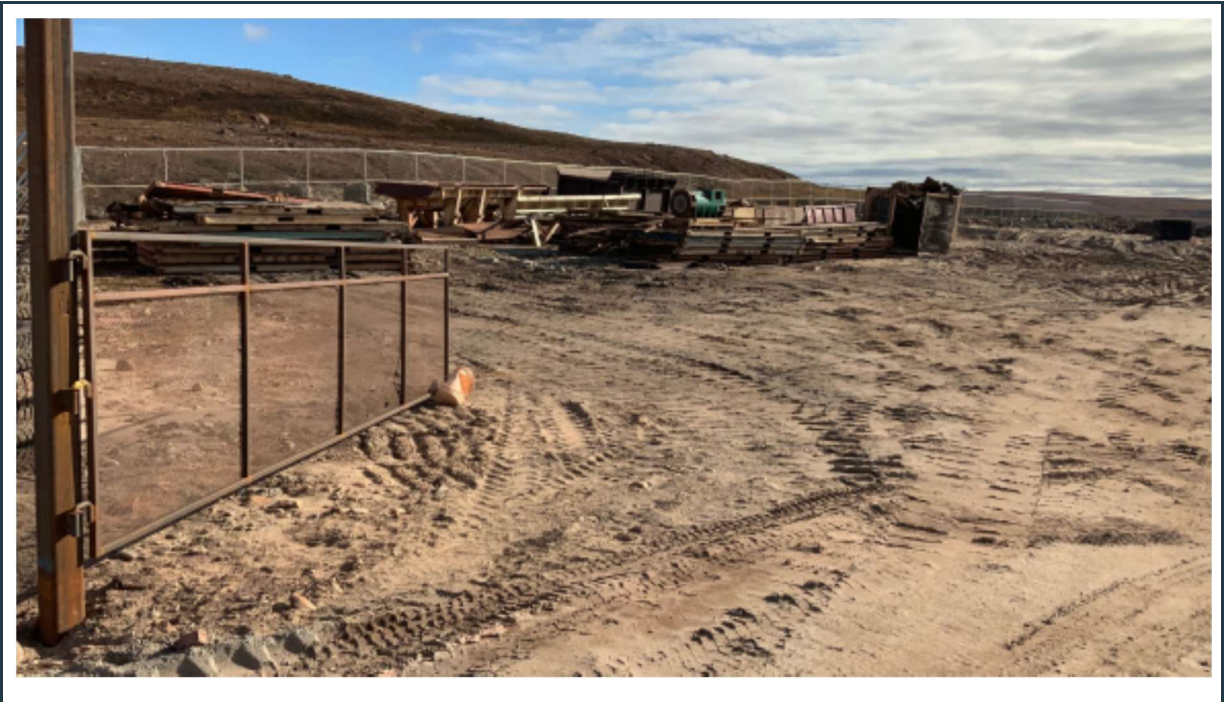
Figure 33: Solid waste landfill facility with new perimeter fence and gate.

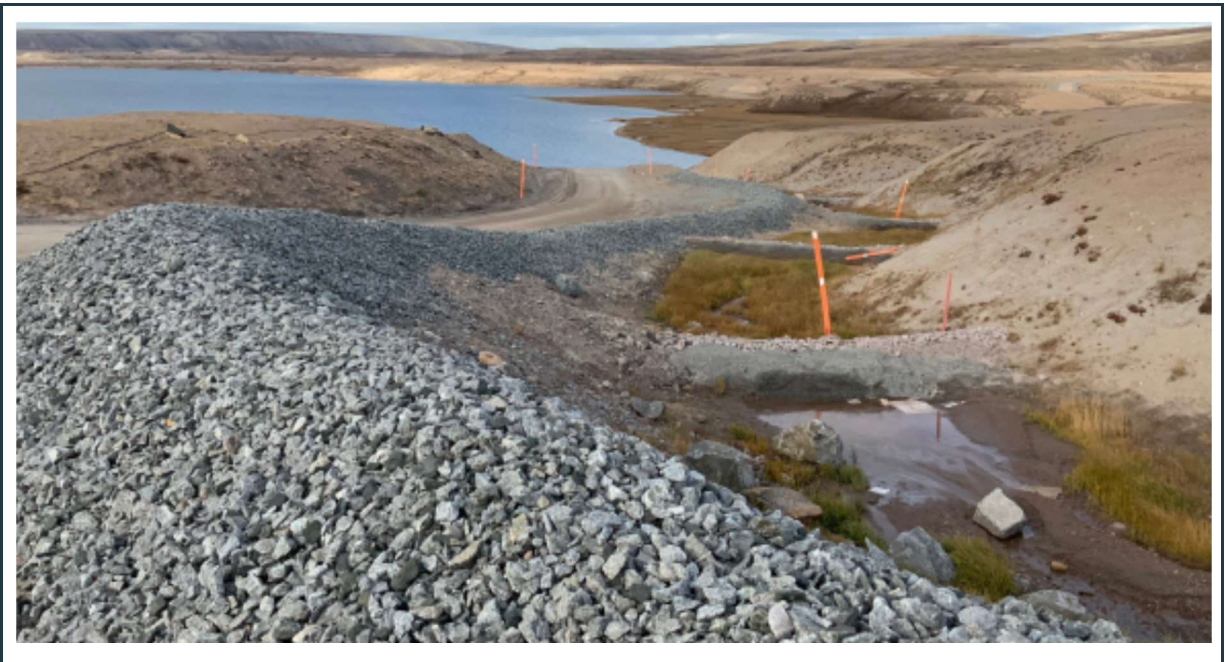
Figure 34: Camp Lake check dams and berms, forming efficient silt sedimentation cells

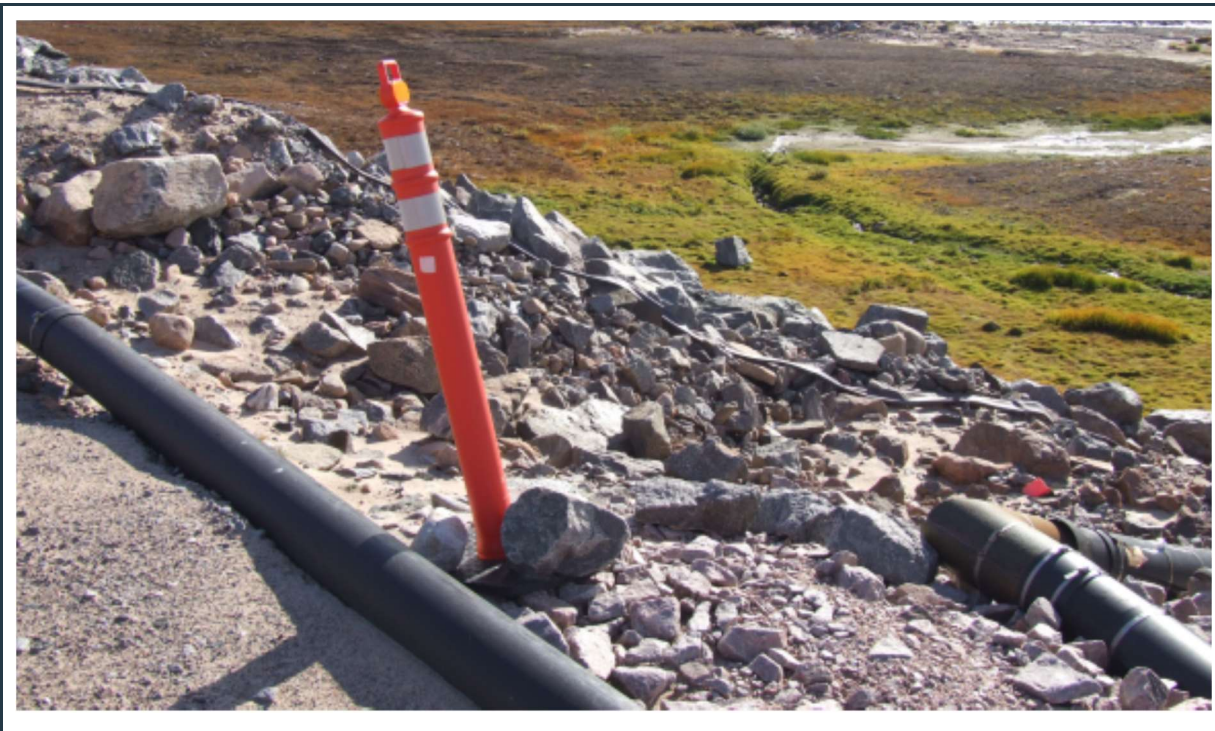
Figure 35: Minor slope erosion (cobbles and boulders rolling down the slope) at the water discharge area.

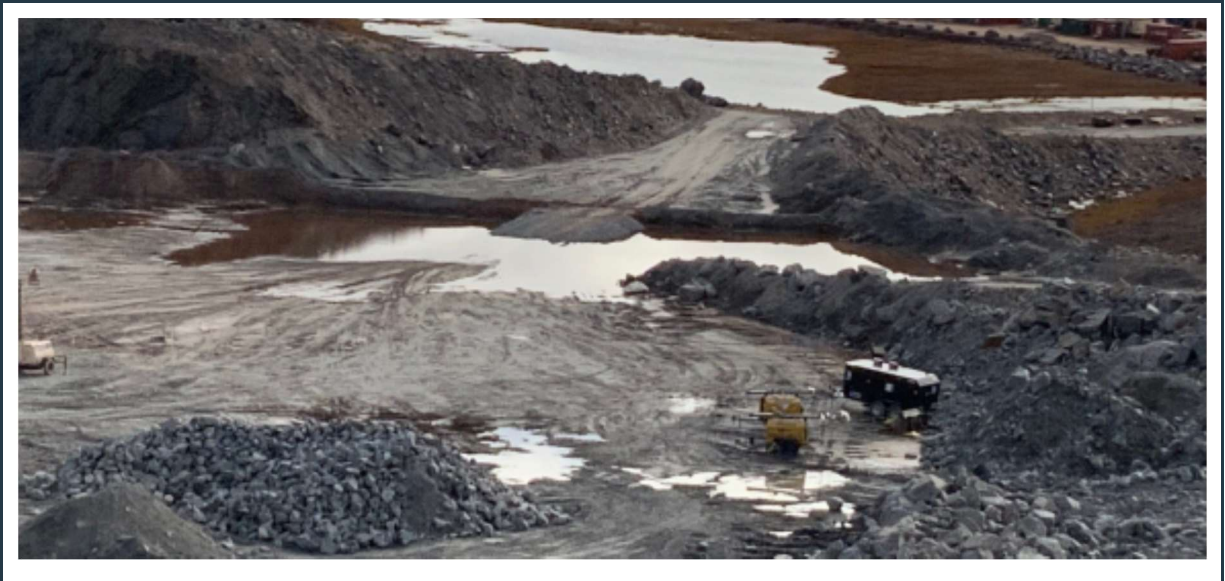
There was no activity noted in the QMR2 rock quarry (Figure 37) at the time of the September 2020 inspection. The exposed slopes (rock face) in the quarry appeared to be in stable condition overall, with few localized fall hazards (no changes since the 2020 June inspection). Such hazards, represented by the presence of weak veins within the pit walls, loose boulders, and rock wedges prone to skidding down to the toe of the slope (Figure 38). Boulders placed along the slope toes prevent traffic from accessing the toe of the rock wall.

As shown in Figure 37, the lowest plateau of the quarry still exhibits poor surface water control and therefore ponding rainwater covers a section of the quarry's main level. Although a recently constructed berm, placed across the head of the access road, apparently prevents the water from flowing down on

Figure 37: View part of the QMR2 quarry with area that still requires a more efficient surface water control. Rainwater should be properly drained from the traveled areas of the quarry.

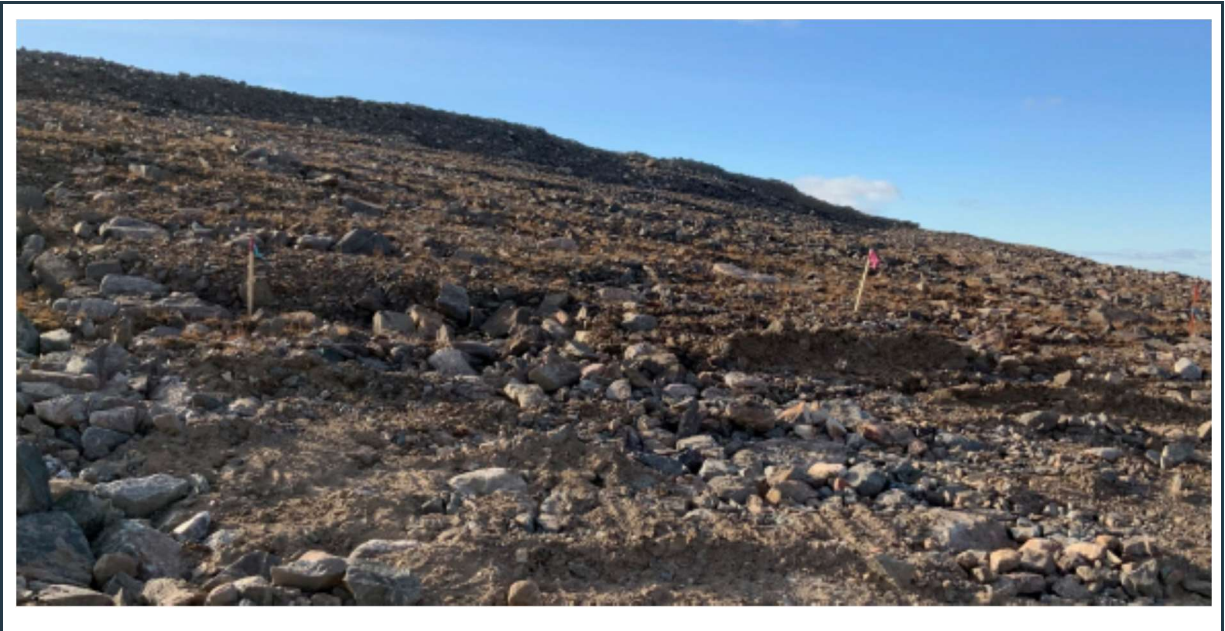
The proposed D1Q1 rock quarry will be a source of crushed aggregate in the future. Currently, the designated area is undeveloped, with no road or any excavation activity at this particular location. As shown in Figure 39, the gentle slope in the area is covered by cobbles and boulders that will be mined and crushed for future use.

Figure 39: View of the northern slope of the future D1Q1 rock quarry (currently undeveloped).

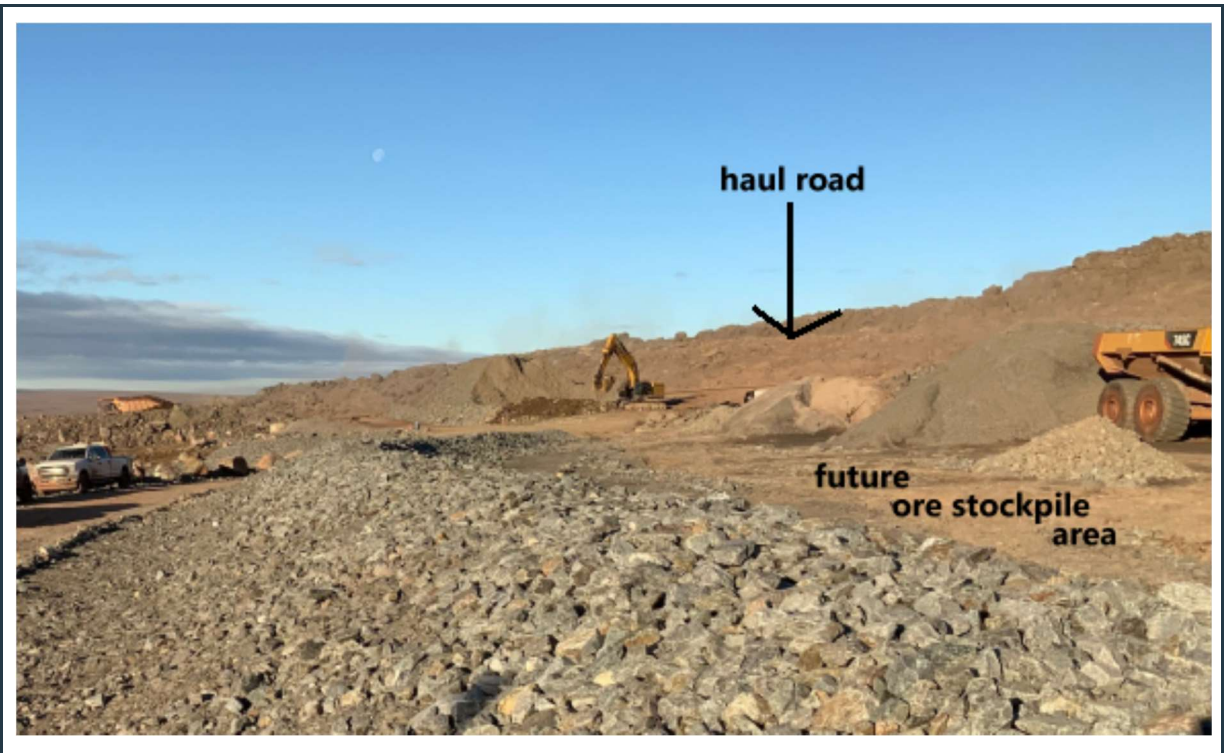
The area previously considered as future D1Q2 rock quarry is now under development as an ore stockpile. As shown in Figure 5, the selected area is located south of the "deposit-1" open pit, along the east side of the ore haul road. Preparation of the ore storage area and placement of diversion and drainage control berms were in progress at the time of the September 2020 inspection, as shown in Figure 40.

Figure 40: View of the proposed ore stockpile area, adjacent to the haul road.

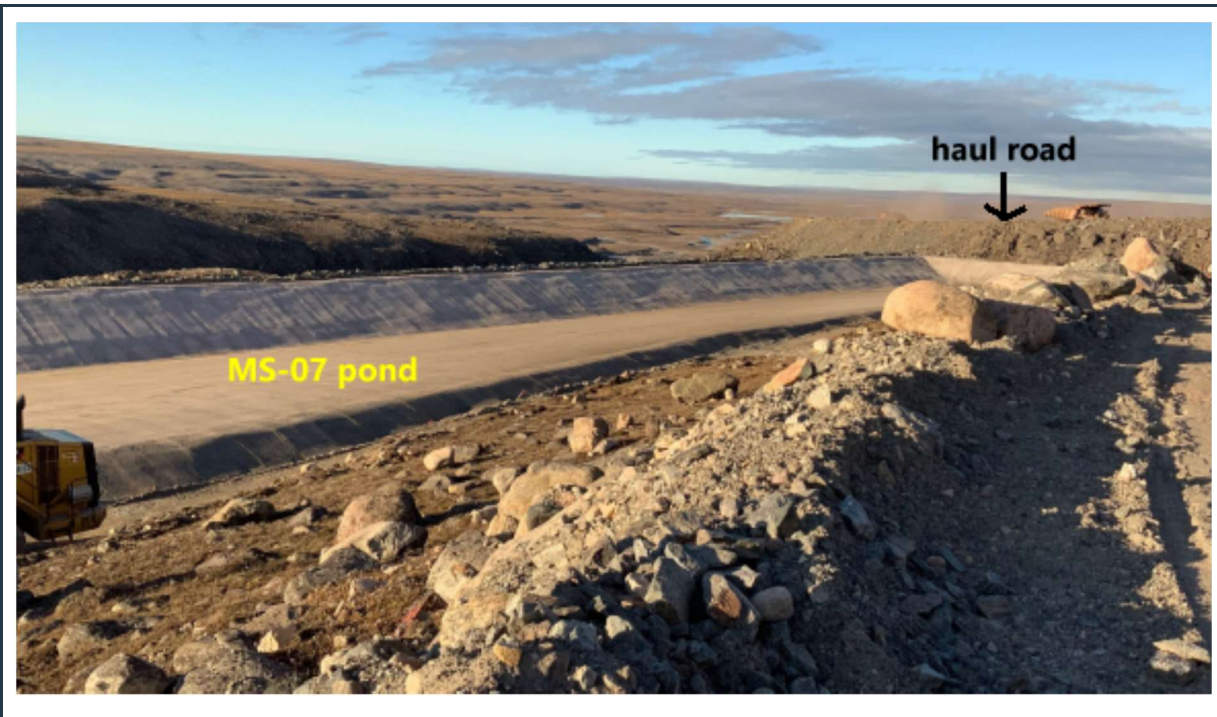
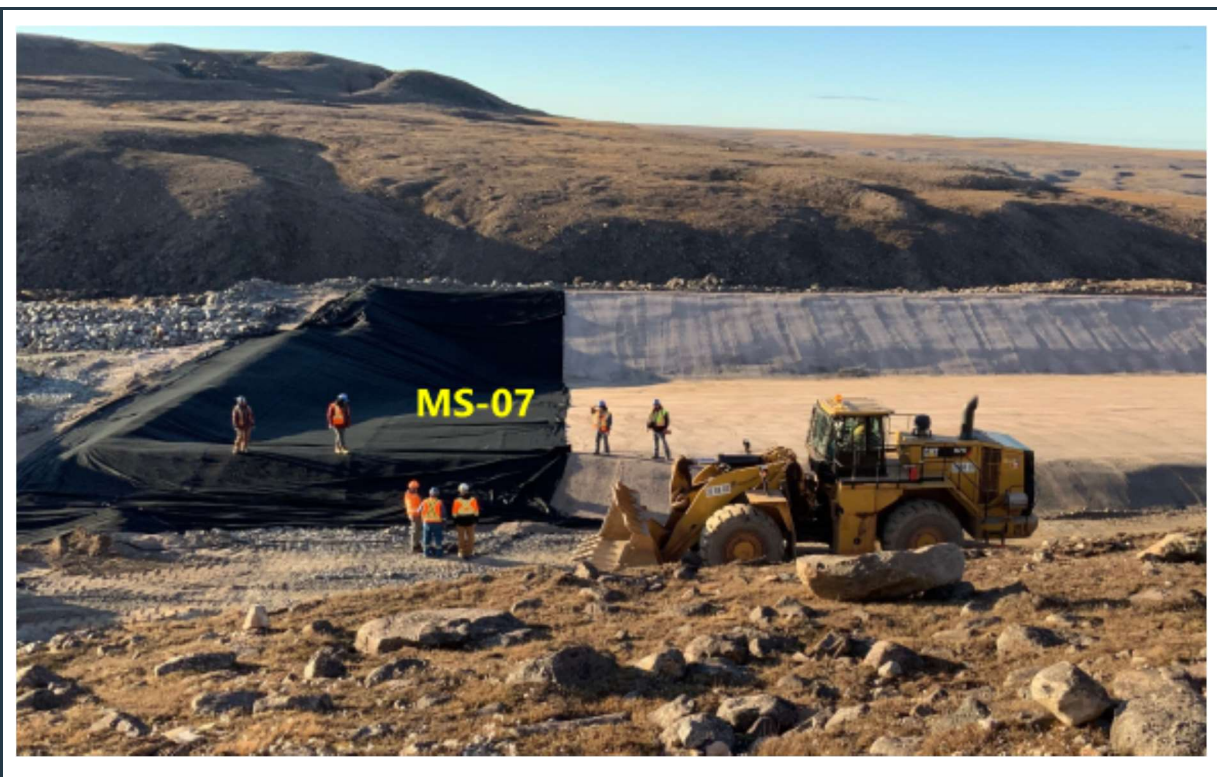
In addition to the earthwork for the KM 106 ore storage facility, construction of a new sedimentation control pond (MS-07) was in progress at the time of the September 2020 inspection. As shown in Figures 41 and 42, the perimeter berm around the future pond has already been completed as per design specifications. Figure 42 shows the area where placement of geotextile was in progress over well-prepared granular subgrade across the base of the pond and on the upstream slopes of the berms. According to design details (prepared by Knight Piésold Ltd in 2019), geomembrane liner will be installed over the geotextile and anchored into trenches on the crest of the perimeter berm.

Figure 41: Construction of the MS-07 pond is in progress south of the proposed ore stockpile area.

Figure 42: Construction of the MS-07 pond is in progress south of the proposed ore stockpile area.

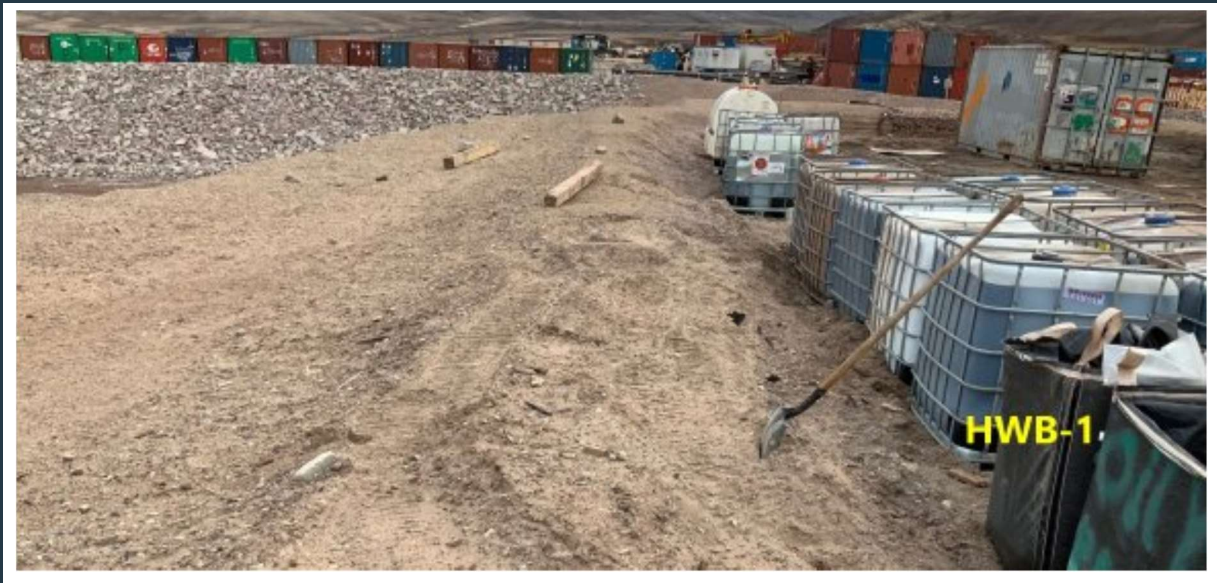
a) HWB-1

The HWB-1 cell covers a relatively large area, surrounded by stable perimeter berm, constructed of granular fill material, as shown in Figure 43, in Appendix B. The stored materials in the cell appear to be well organized and predominantly contain cubes of lubricants stored on wooden pallets and one shipping container. Ponding water was visible across the deeper area of the cell, indicating that the liner within the cell is intact. No seepage from the cell was visible around the downstream toes of the perimeter berm. However, some disturbance at a few locations on the crest of the sea-side berm was noted, as shown in Figure 43. It is recommended that the disturbed areas of the berm (generally caused by foot traffic) on the slopes and crest be re-graded manually as part of the maintenance program.

Figure 43: View of the, stable berm around the HWB-1 cell.

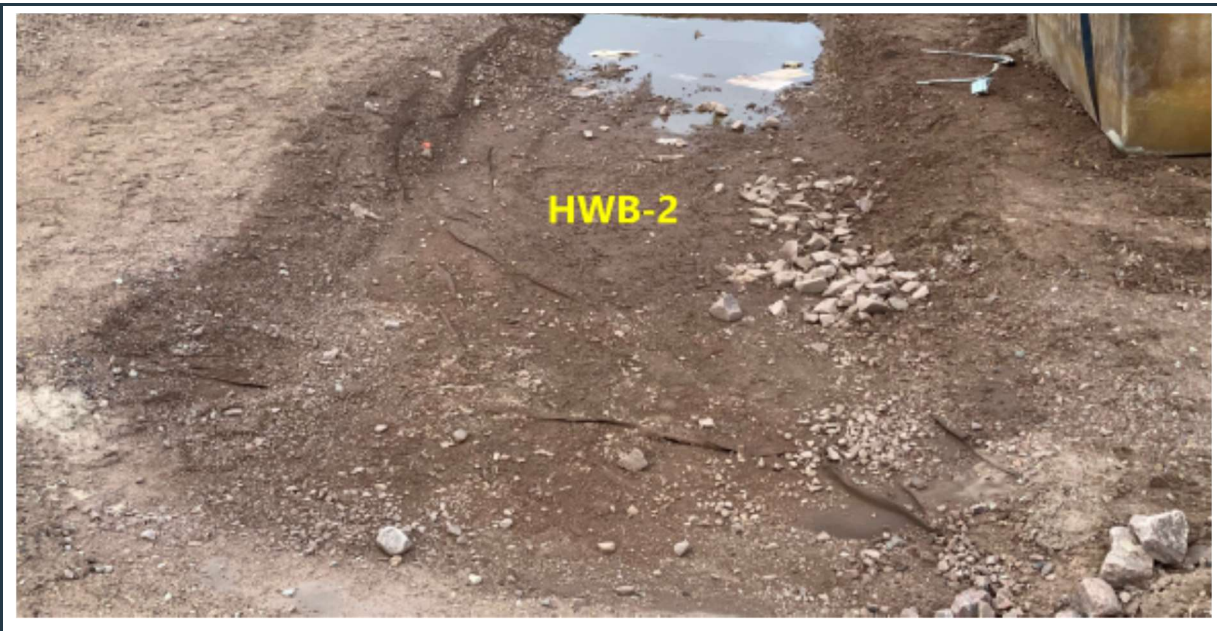
b) HWB-2

The HWB-2 is a small cell that is currently empty, except rainwater ponding within a portion of the cell. Exposed geotextile and liner were noted in a small area, as shown in Figure 44. It is recommended that the exposed liner/geotextile areas be covered with a protective layer of soil (clean sand and gravel) during cell maintenance.

Figure 44: Ponding water in the empty HWB-2 cell with locally exposed geotextile and liner. Empty containers stored immediately adjacent to the cell.
