APPENDIX C.2

Geotechnical Inspection Reports

RE: Submission of 2019 Geotechnical Inspection Report No. 1 (July 2020)

Wood Environment & Infrastructure Solutions (Wood), has completed the first geotechnical field inspection of 2020 at the Mary River Iron mine complex, which is a condition of the Type "A" Water License No: 2AM-MRY1325 – Amendment No.1 ("Water License").

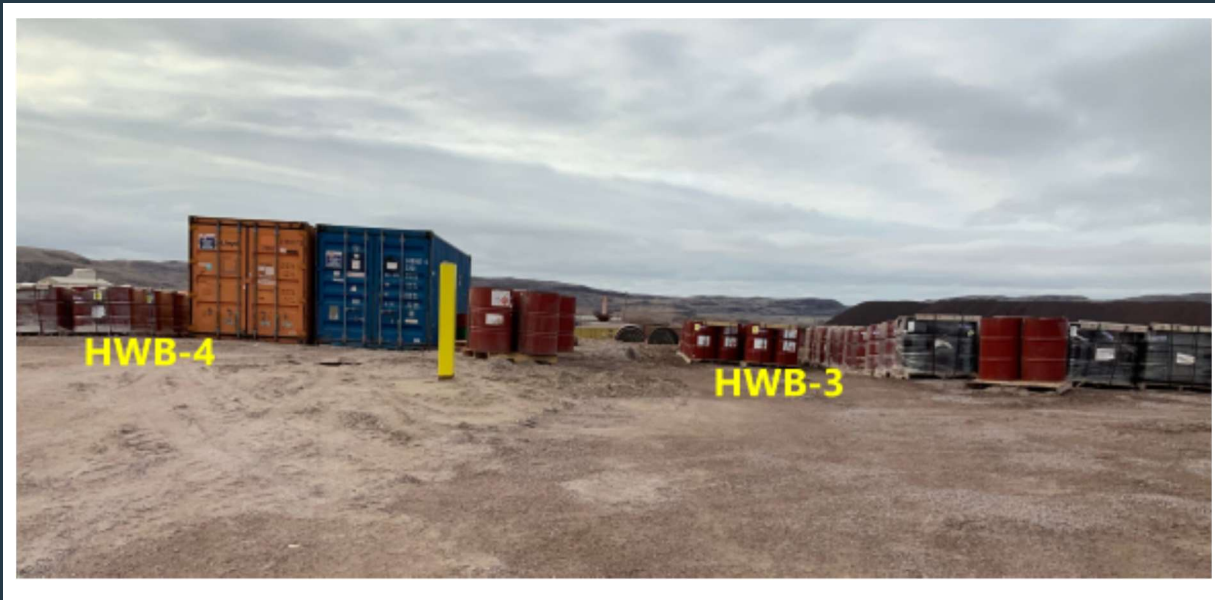
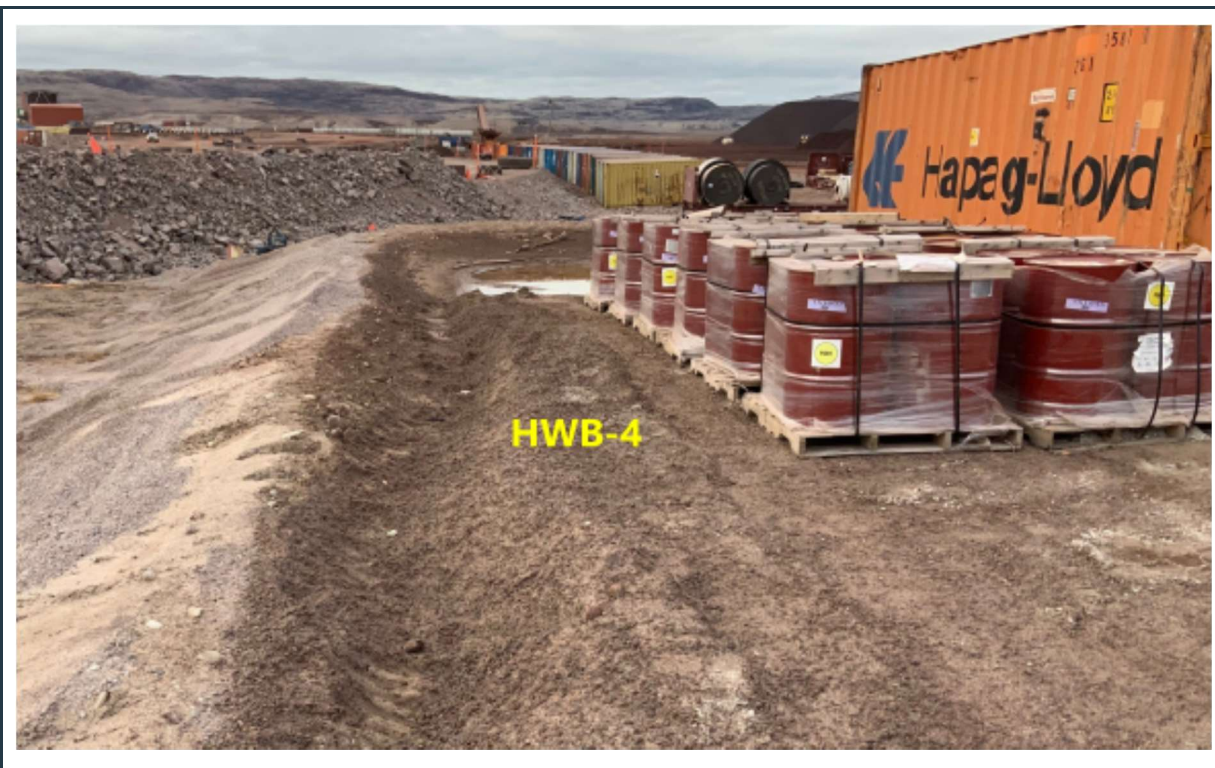
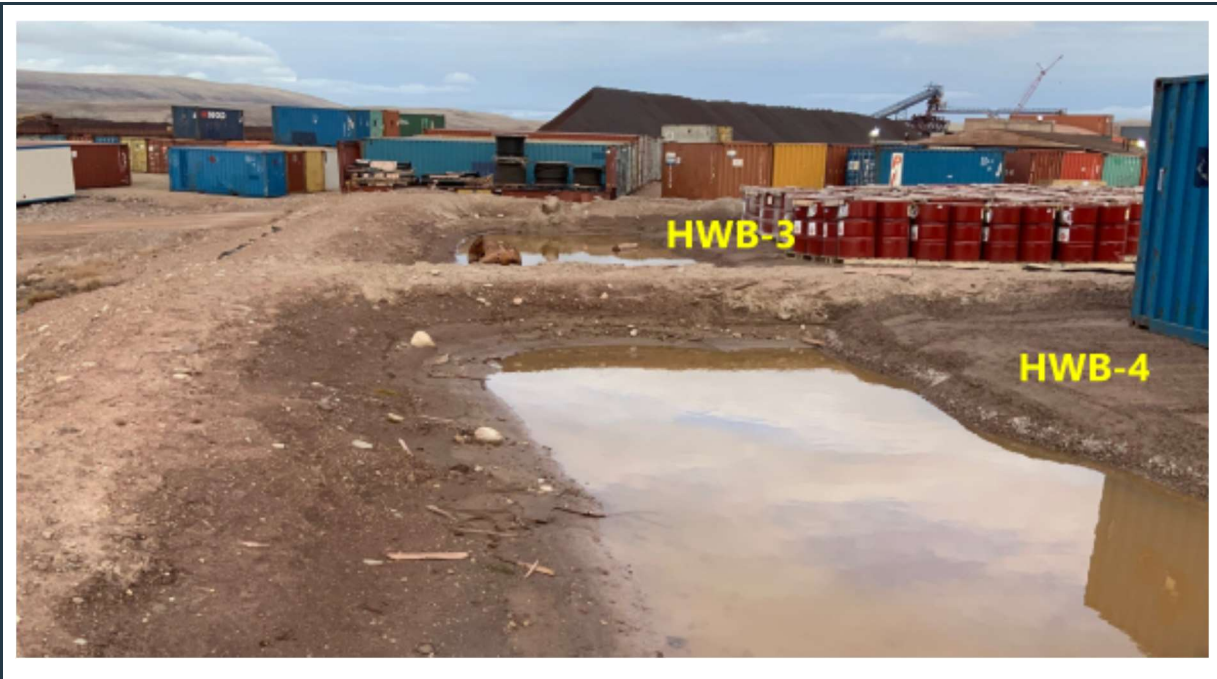
The HWB-3 and HWB-4 cells are located immediately next to each other (twin-cells), as shown in Figures 45 to 47. These cells contained only shipping containers in the past; however, the cells have been recently emptied and refurbished. At the time of the September 2020 inspection, the cells contained fuel barrels on wooden pallets, with only two shipping containers present in HWB-4. Some of the berms around the cells have been regraded and appear to be in stable condition with no indication of slope movements or settlement. Ponding water at the back of the cells indicate that the liner within the ponds are intact. As shown in the relevant images, new granular fill was placed across the floor of the cells, providing additional protection to the liner.

Figure 45: View of the HWB-3 and HWB-4 cells, containing fuel barrels and two shipping containers.

Figure 46: Upgraded stable berm and ponding water within the reconstructed HWB-4 cell.

Figure 47: Stable berms around and ponding water within the HWB-3 and HWB-4 cells.

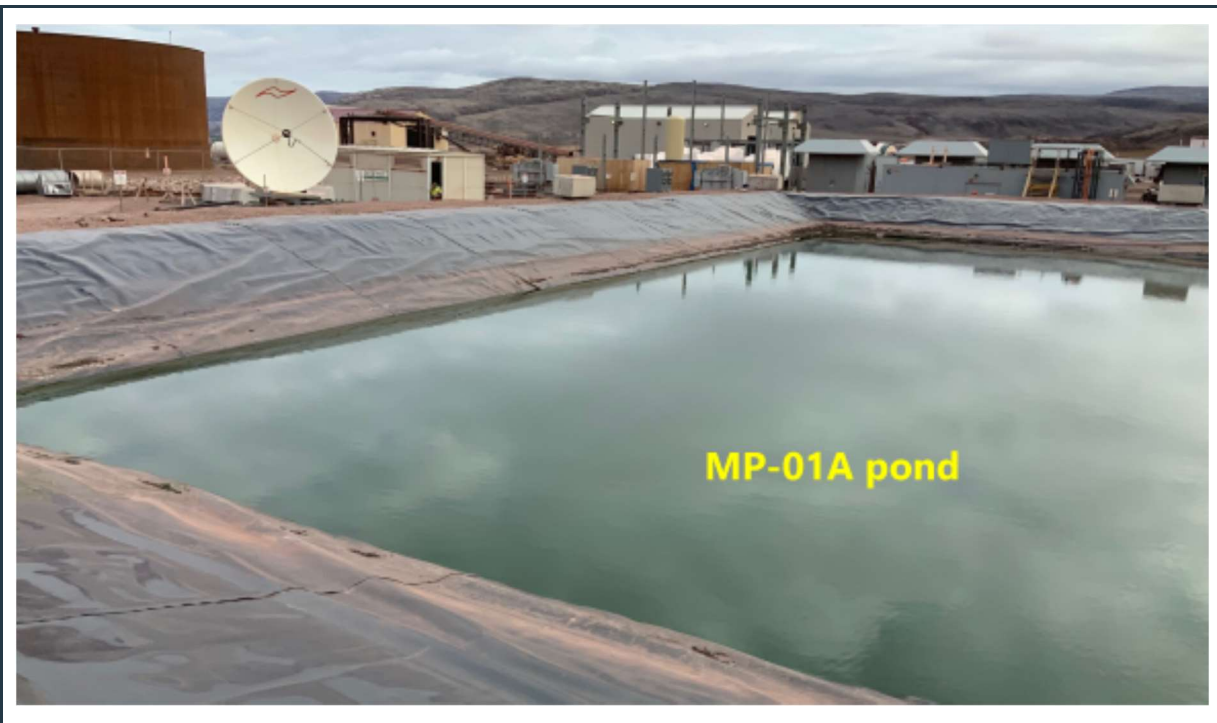
The MP-01A polishing waste stabilization pond is located immediately south of the MP-03 fuel tank farm. As shown in Figure 48, the berm around the well-maintained pond is in excellent condition and the liner appear to be intact. No sign of slope instability, settlement or seepage from the pond was noted during the field inspection.

Figure 48: Berms and liner in excellent condition with stable slopes around the MP-01A pond.

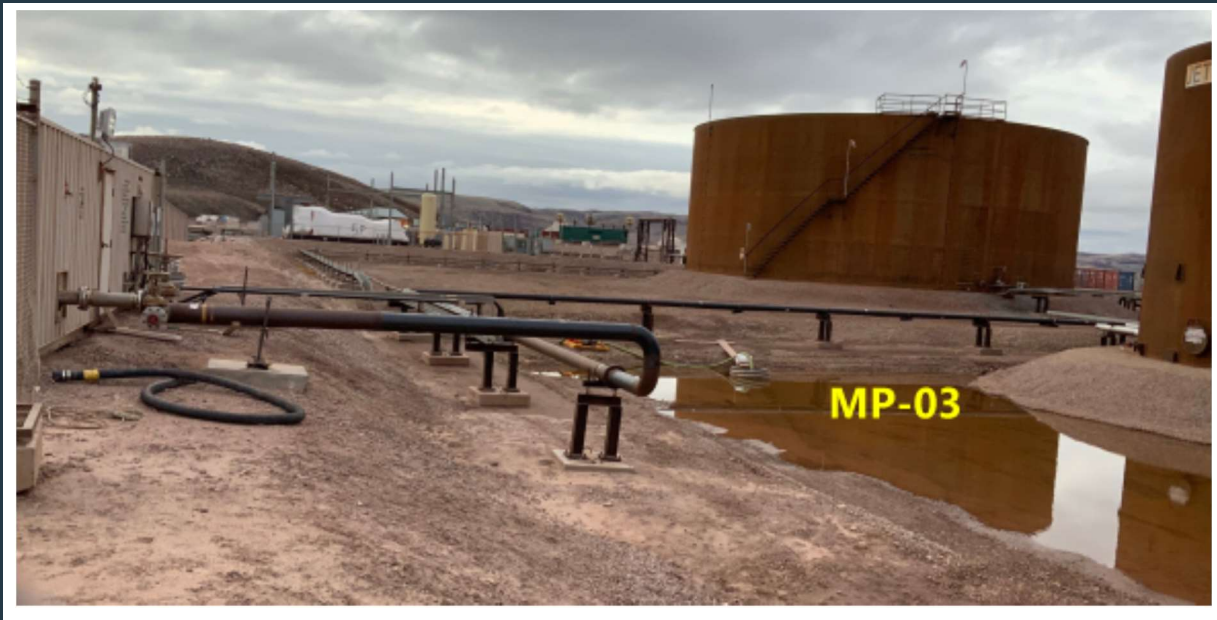
The MP-03 fuel tank farm occupies a large area in the center of the Milne Inlet port site. As shown in Figure 49, the stable berms around the facility are well maintained and are in excellent condition. The visible ponding rainwater within the internal cells of the fuel farm is an indication of proper liner functionality. The facility is fenced in and no indication of berm instability or seepage was noted on and around the berms, comprising compacted granular materials.

Figure 49: View of the stable, well-maintained berms around the MP-03 fuel tank farm.

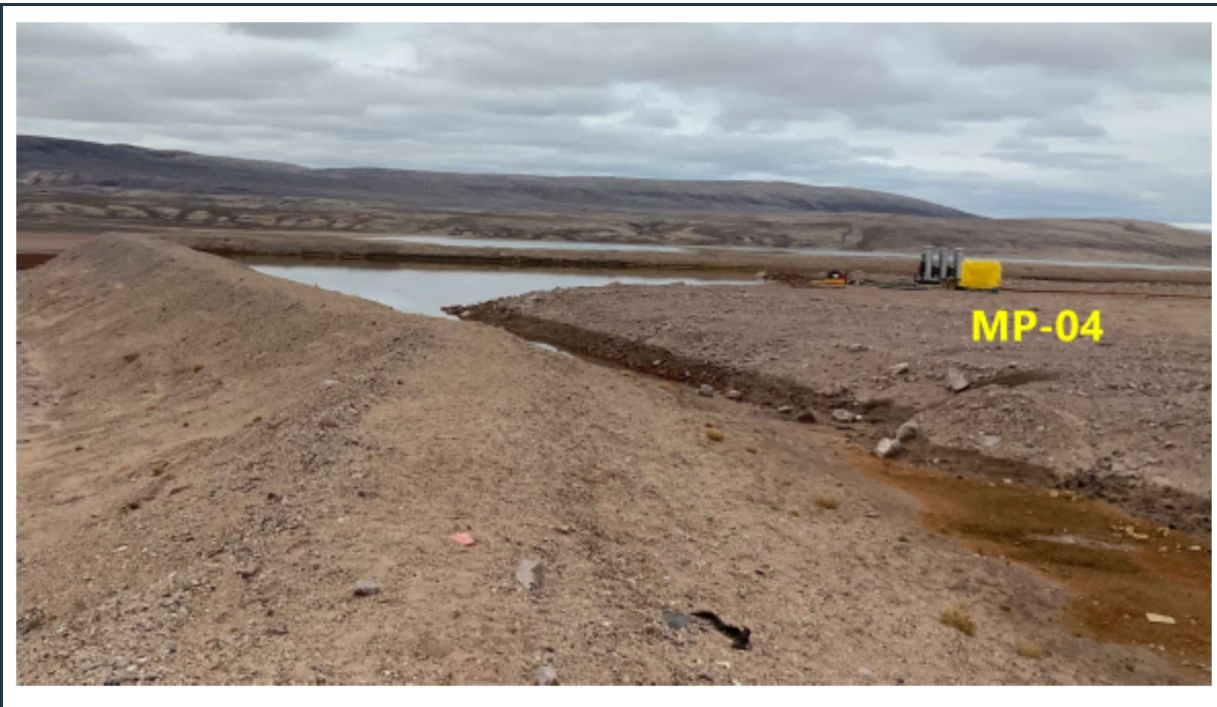
Figure 50: View of stable berm at the MP-04 landfarm, with covered waste and ponding water within the cell.

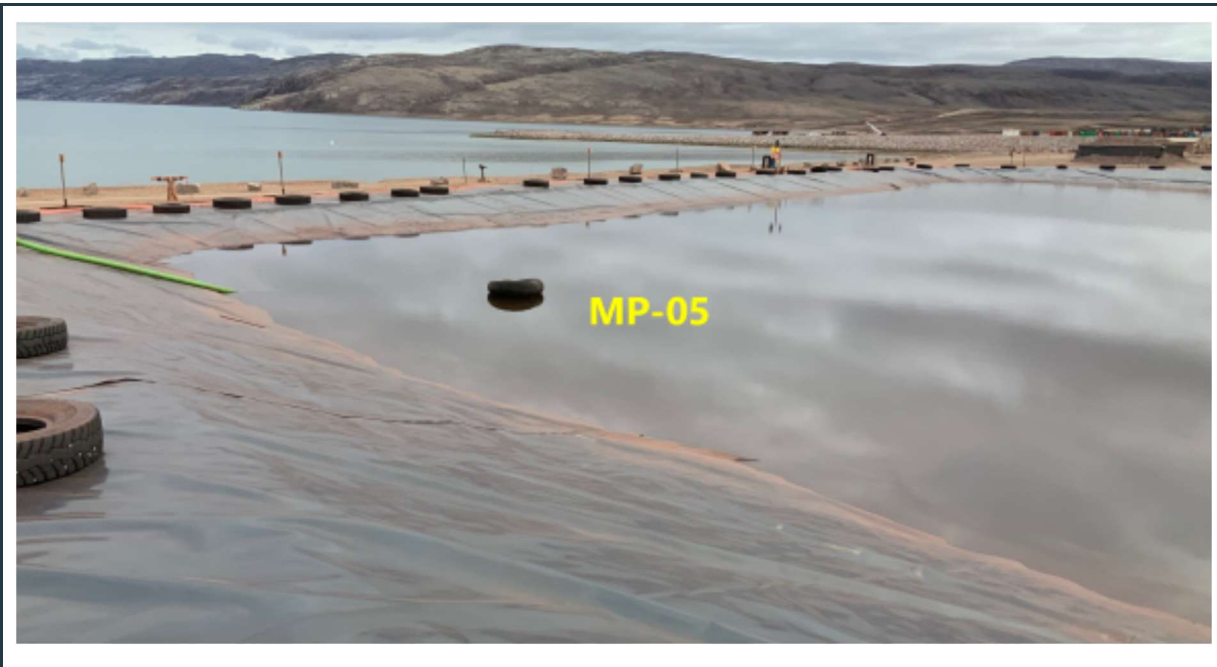
Figure 53: View of the stable berms at the MP-05 settling pond (north-east corner of the ore stockpile).

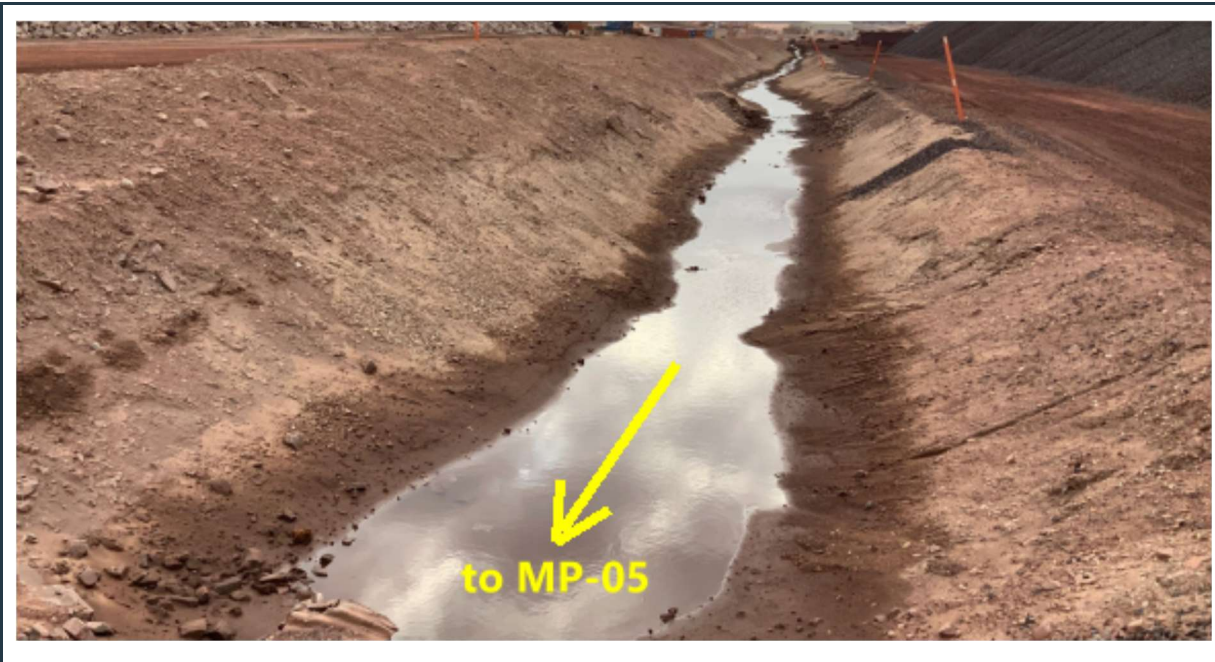
Figure 55: Surface water collection ditch adjacent to the crushed ore storage, draining to MP-05 pond.

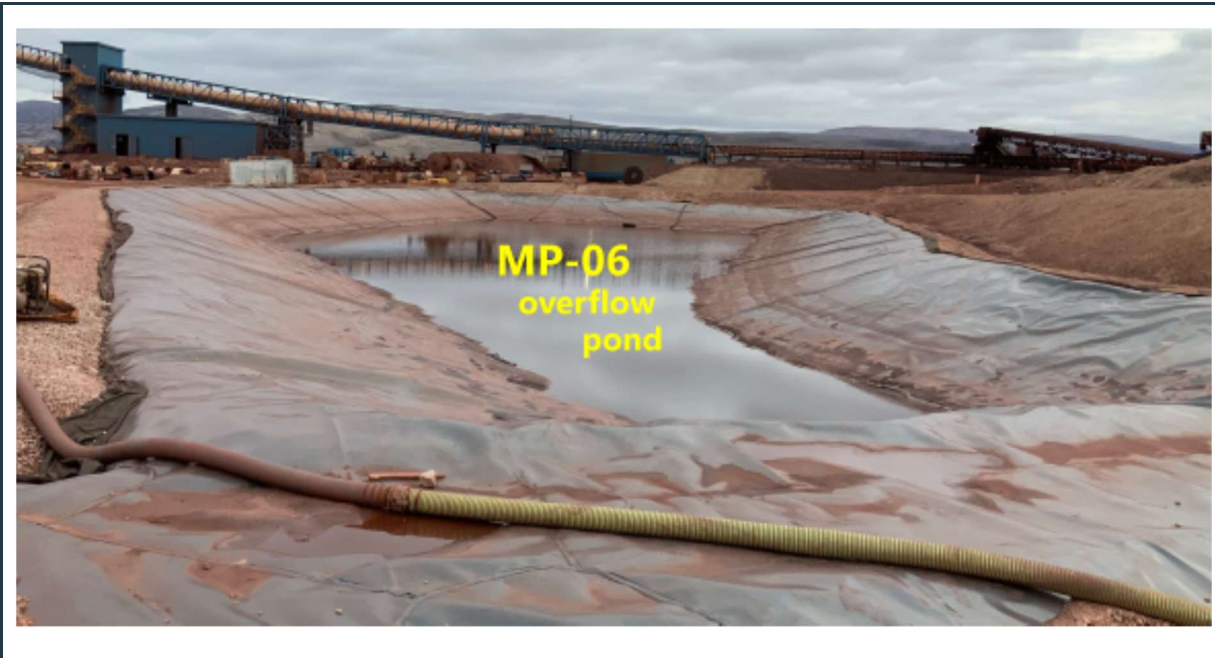
Figure 57: View of the lined MP-06 overflow pond, with stable berms.

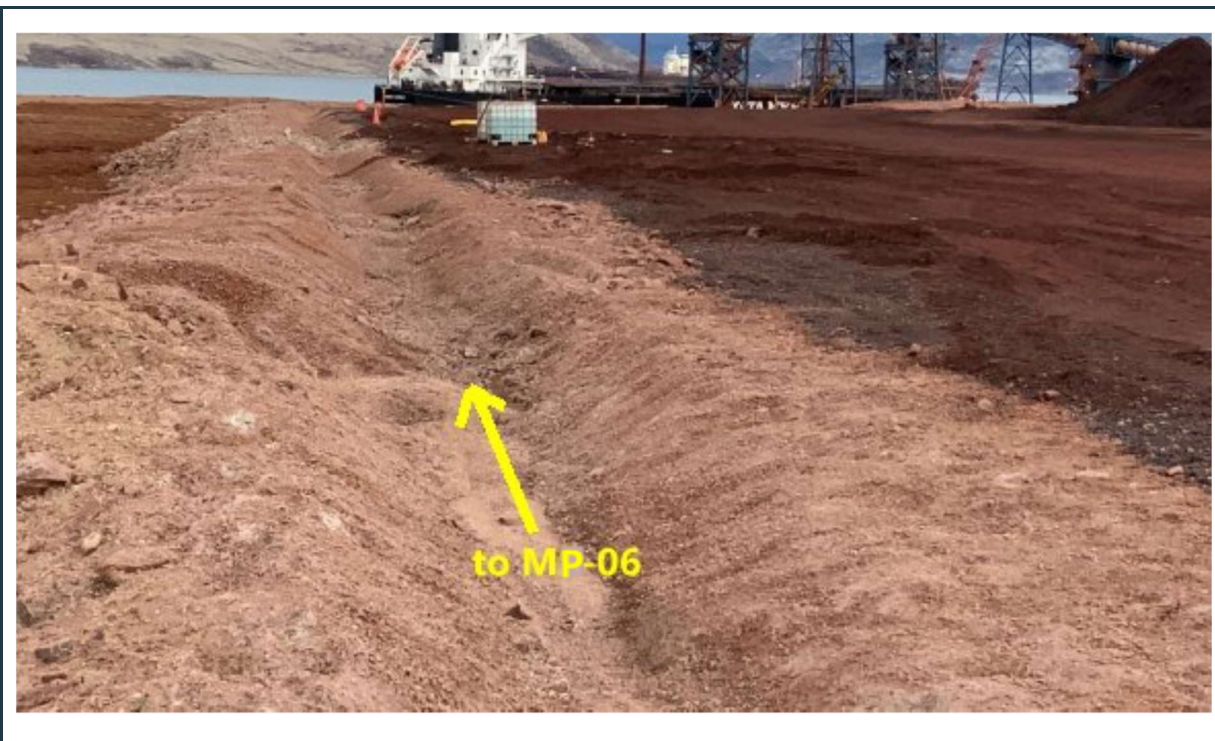
Figure 58: Surface water collection ditch adjacent (west) to the crushed ore storage area, draining to the MP-06 pond.

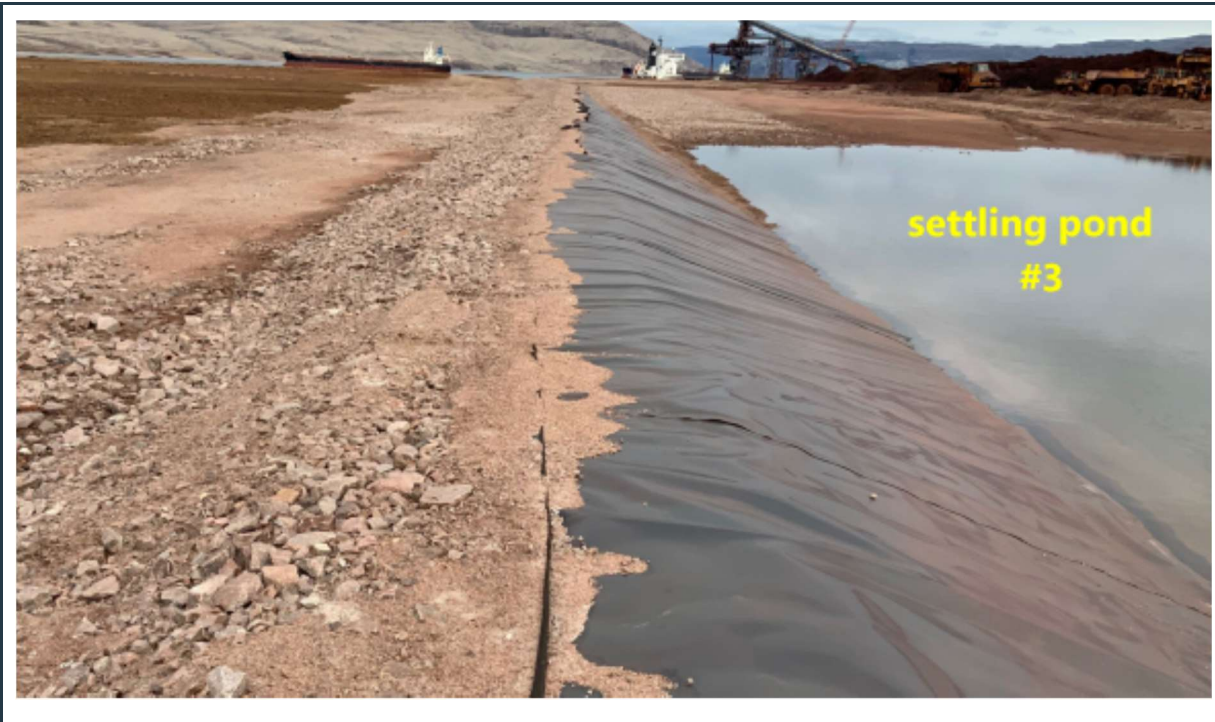
Figure 59: View of the lined, stable berm along the west side of settling pond #3.

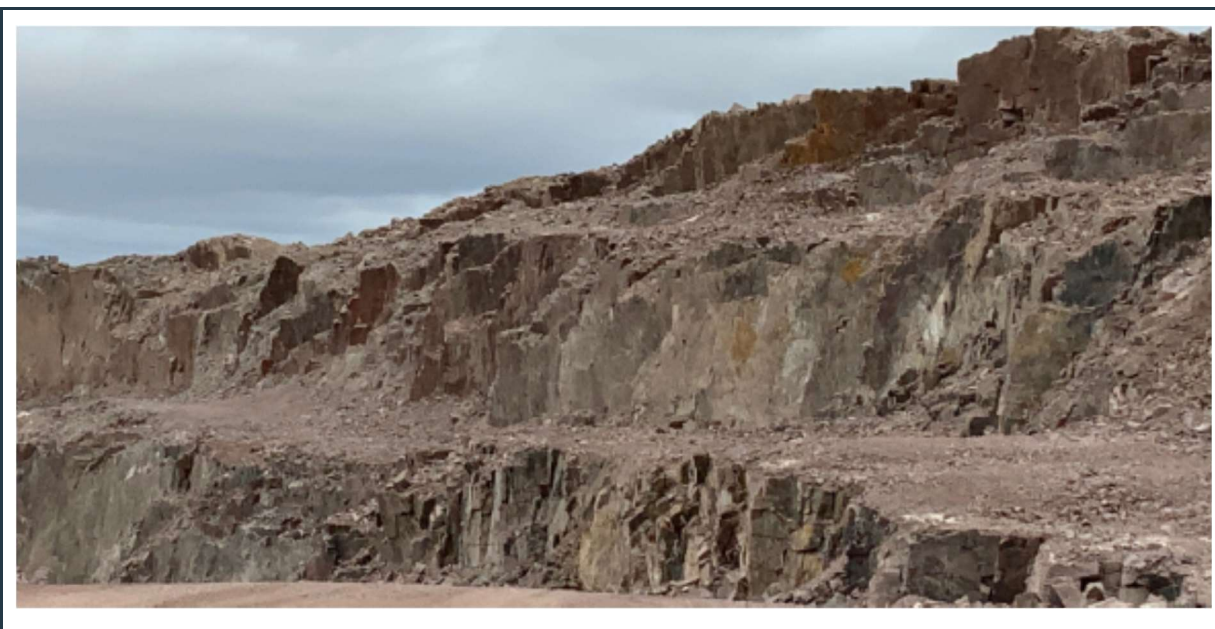
Figure 60: View of stable highwalls with minor weathering and bench erosion in the Q01 rock quarry.

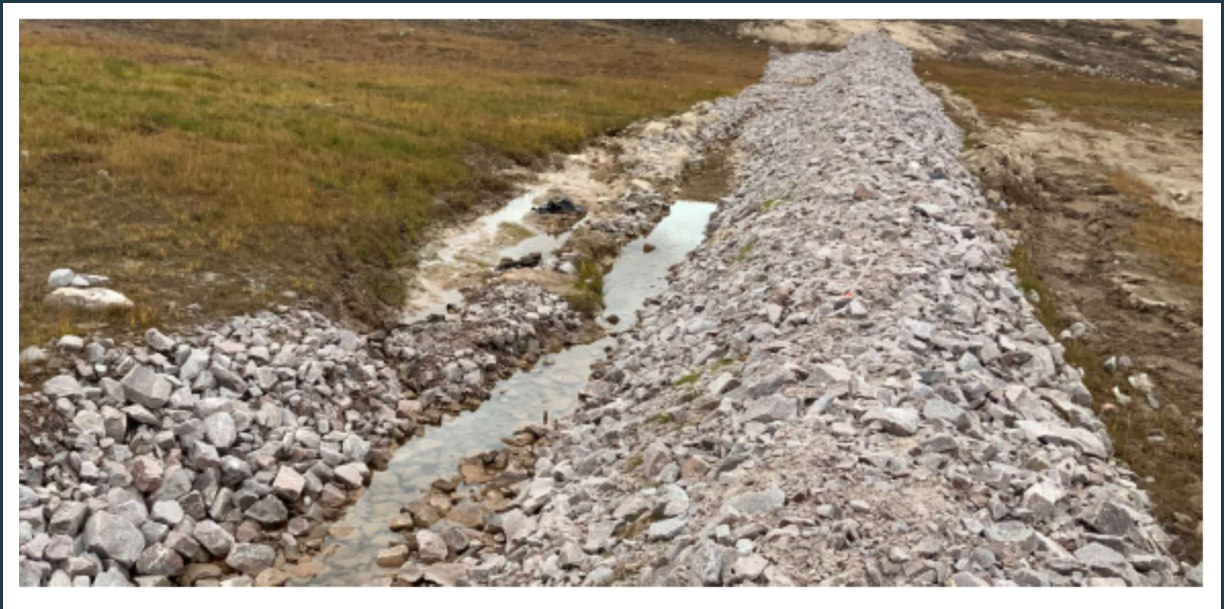
Figure 61: View of the “P-SWD-3 surface water collection ditch with failing side slope. The sloughing is caused by the uncontrolled water flow into the ditch along its alignment (see the next image).

- Open drainage ditches across the Mary River and Milne Inlet sites are generally in good condition with some erosion and slope sloughing visible at a few locations. As part of a more frequent maintenance program the eroded sides of the ditches should be repaired/regraded.

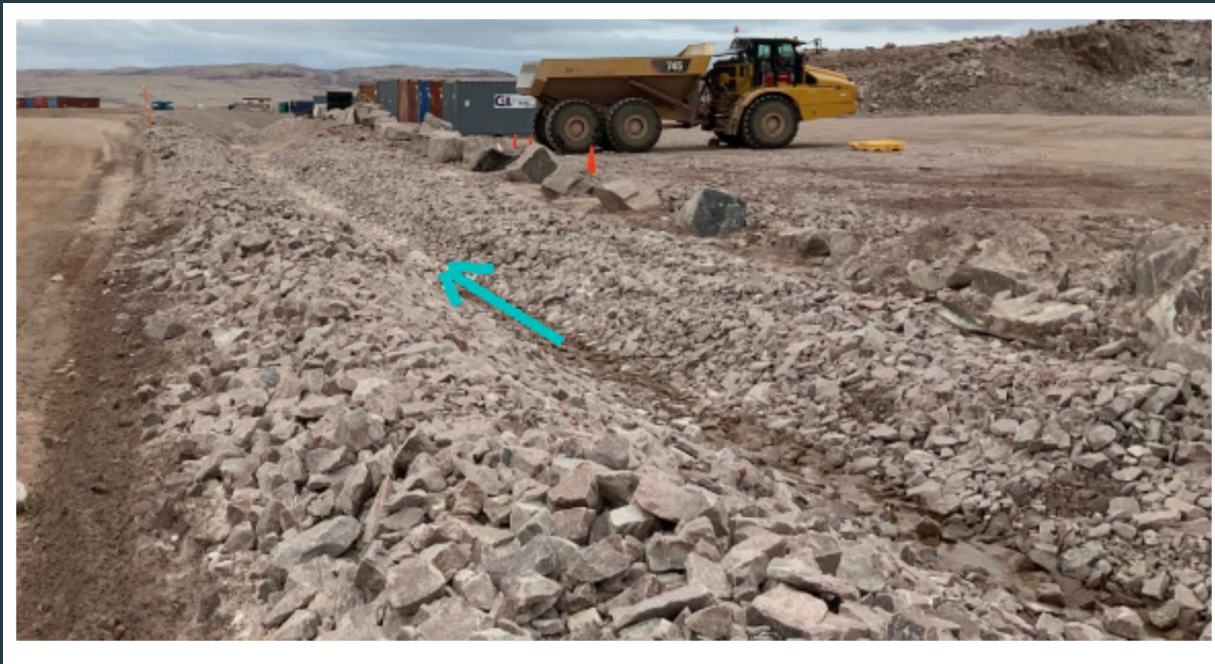
Figure 63: P-SWD-5 – "Q01-North" surface water collection ditch.

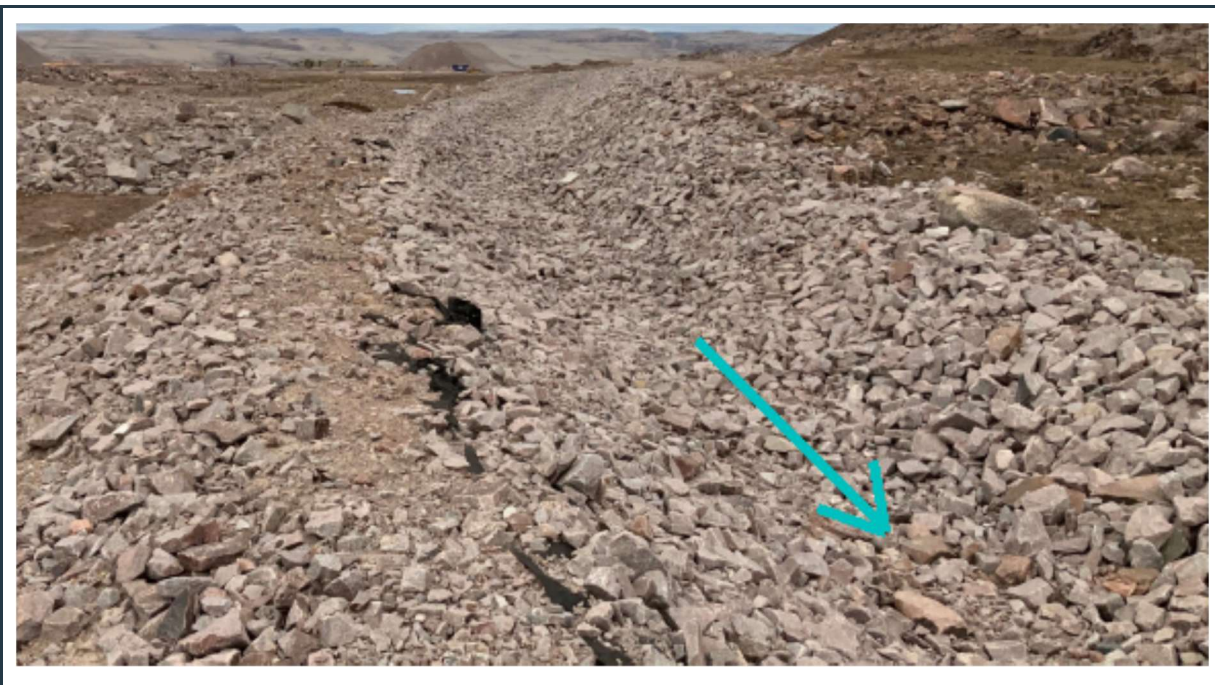
Figure 64: View of the well maintained P-SWD-6 - "Q01 South" surface water collection ditch.

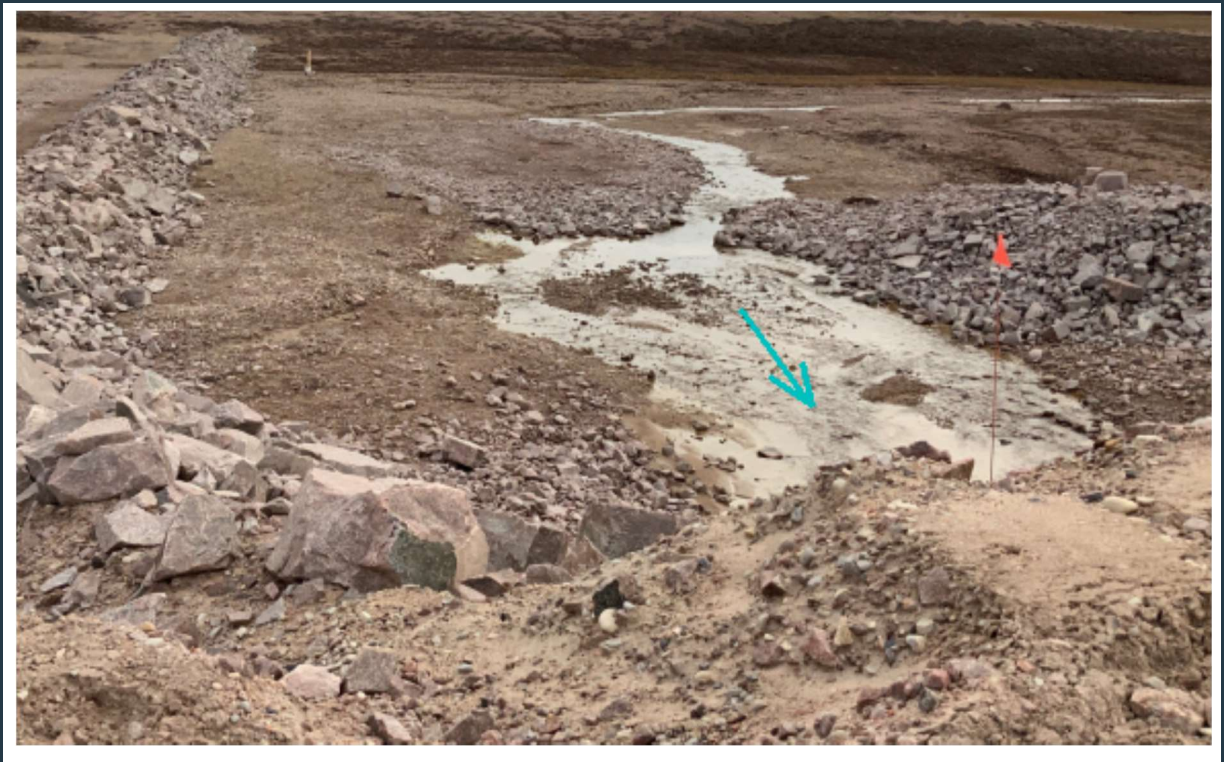
Figure 65: View of the P-SWD-7 surface water collection ditch and culverts (inlet).

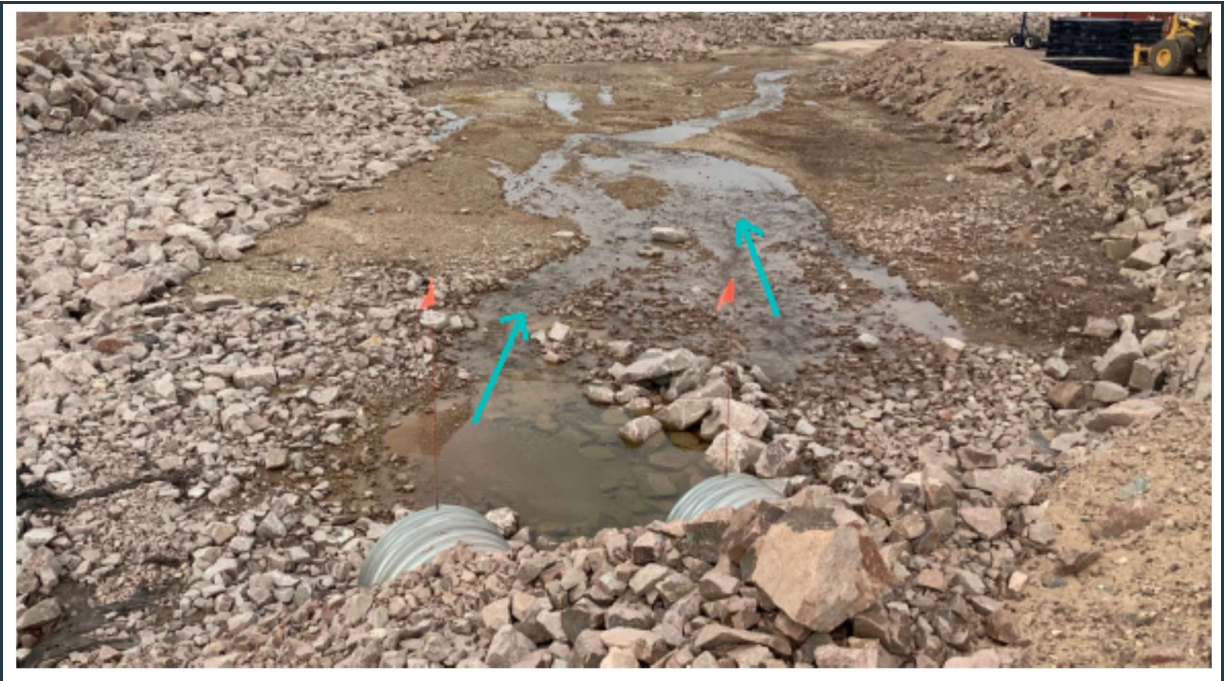
Figure 66: View of the P-SWD-7 surface water collection ditch and culverts (outlet).

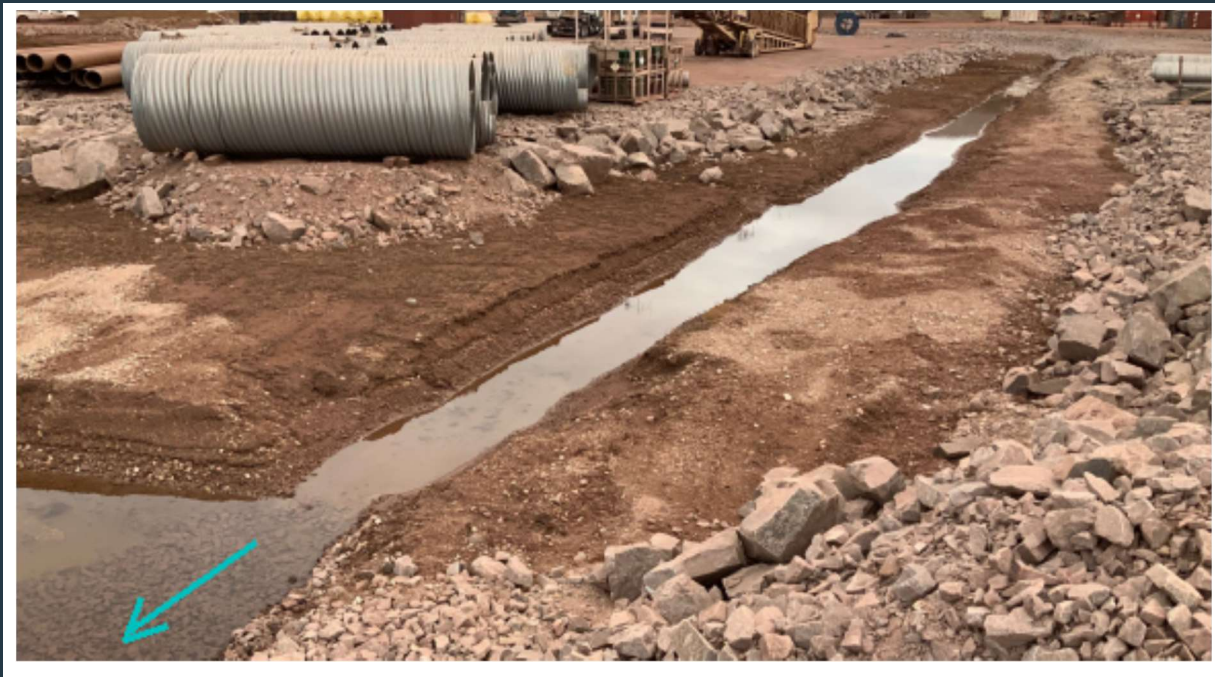
Figure 67: View of the W3/W14 surface water collection ditch.

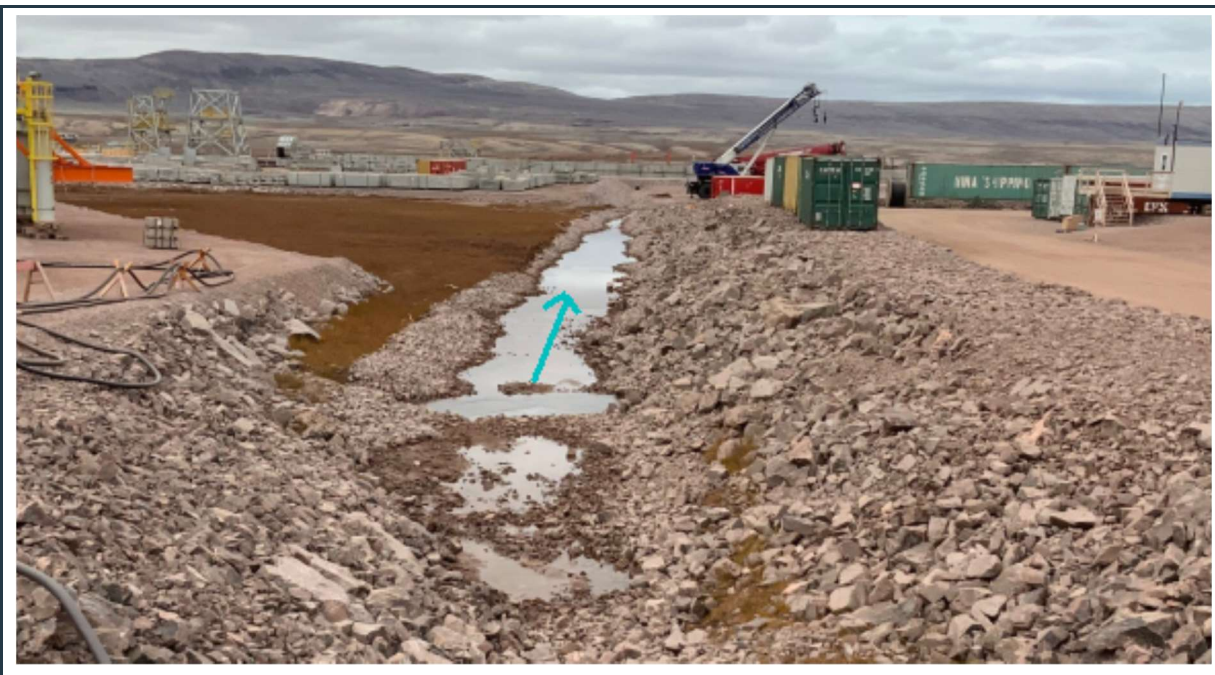
Figure 68: View of the south section of the 380 M surface water collection ditch.

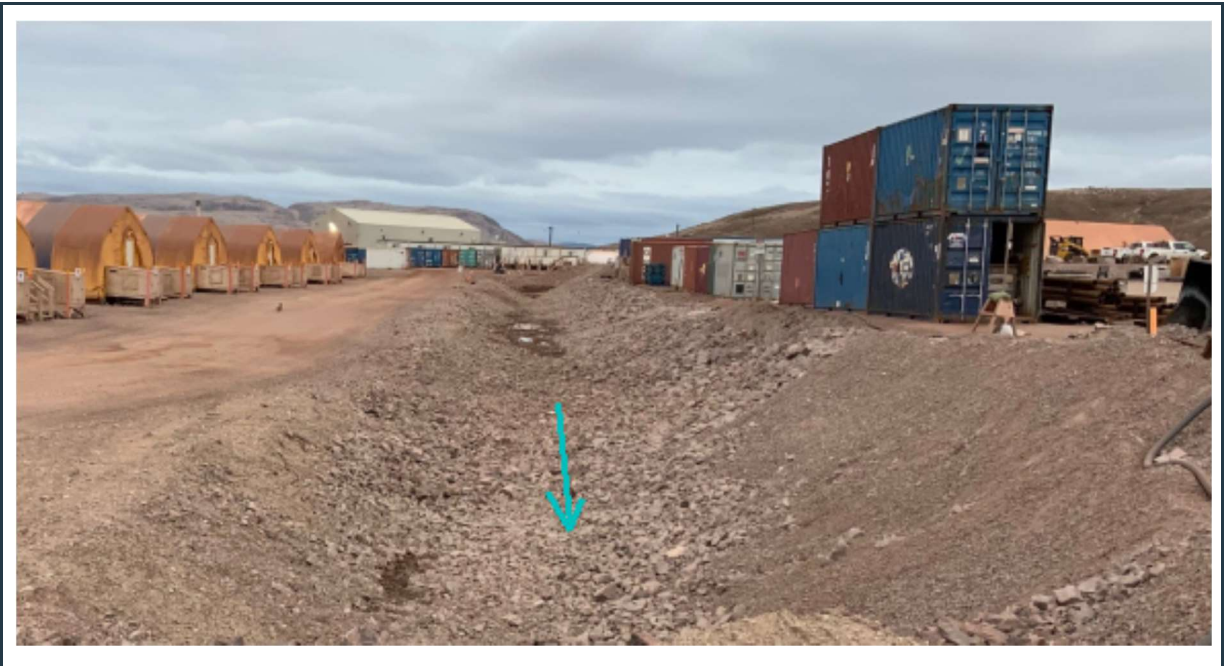
Figure 69: View of the east section of the 380 M surface water collection ditch, in good condition.

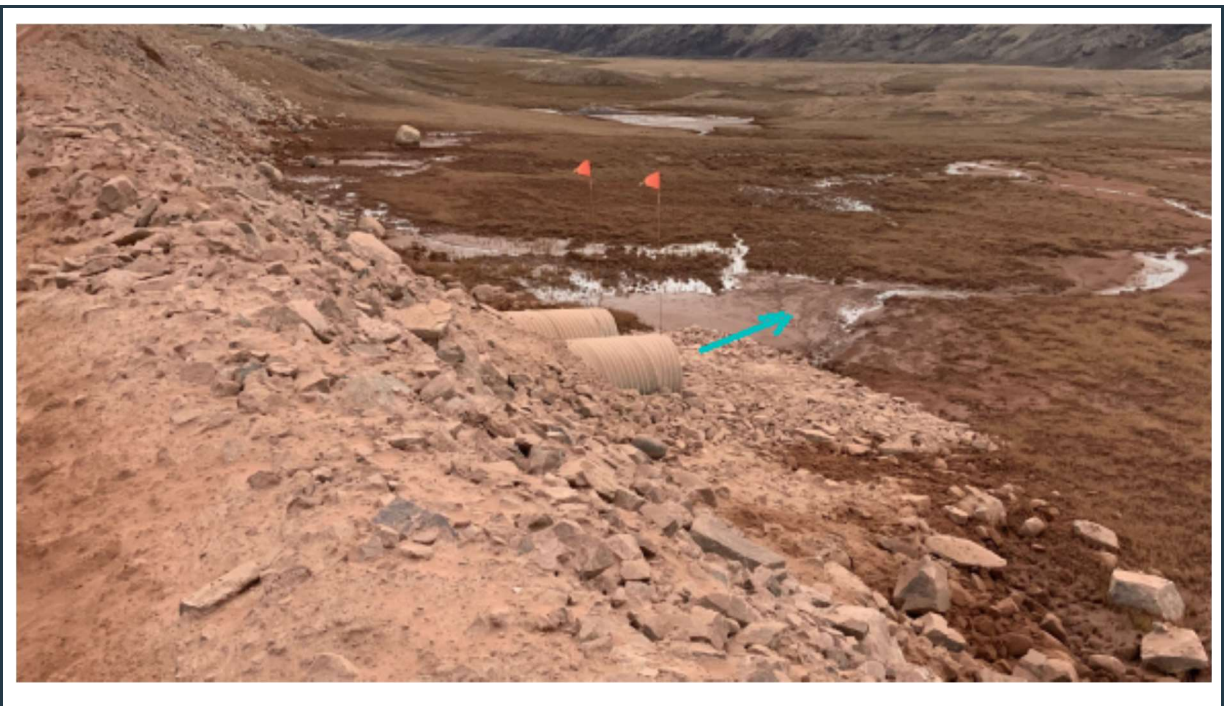
Figure 72: View of twin culverts, draining surface water from the quarry under the tote road (outlet).

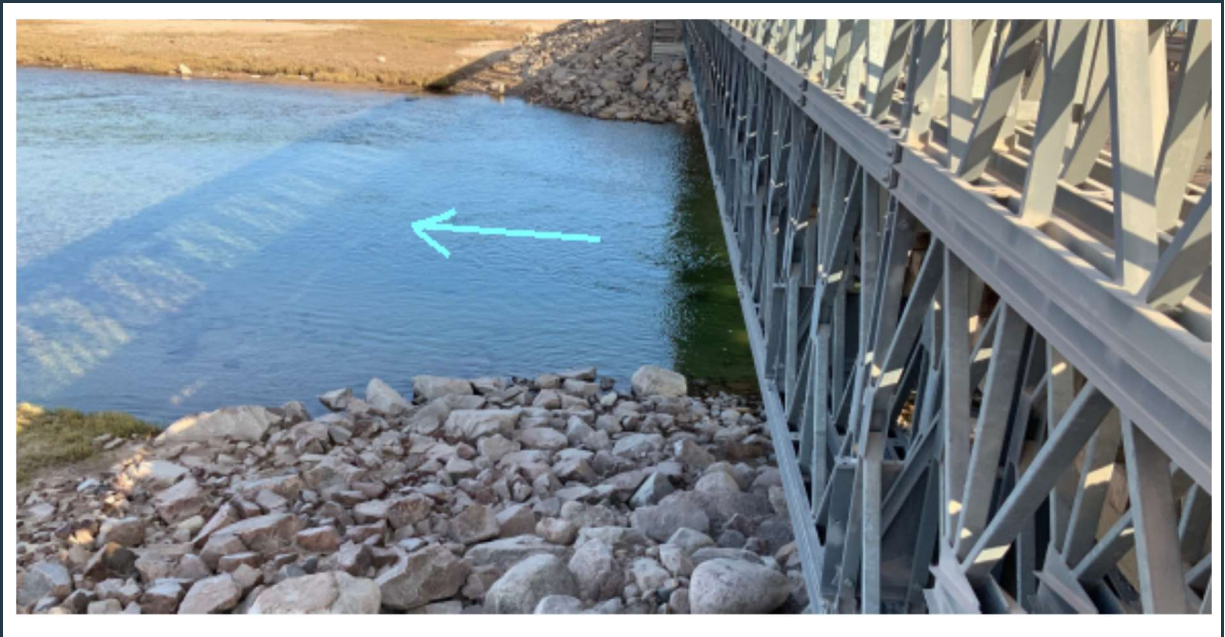
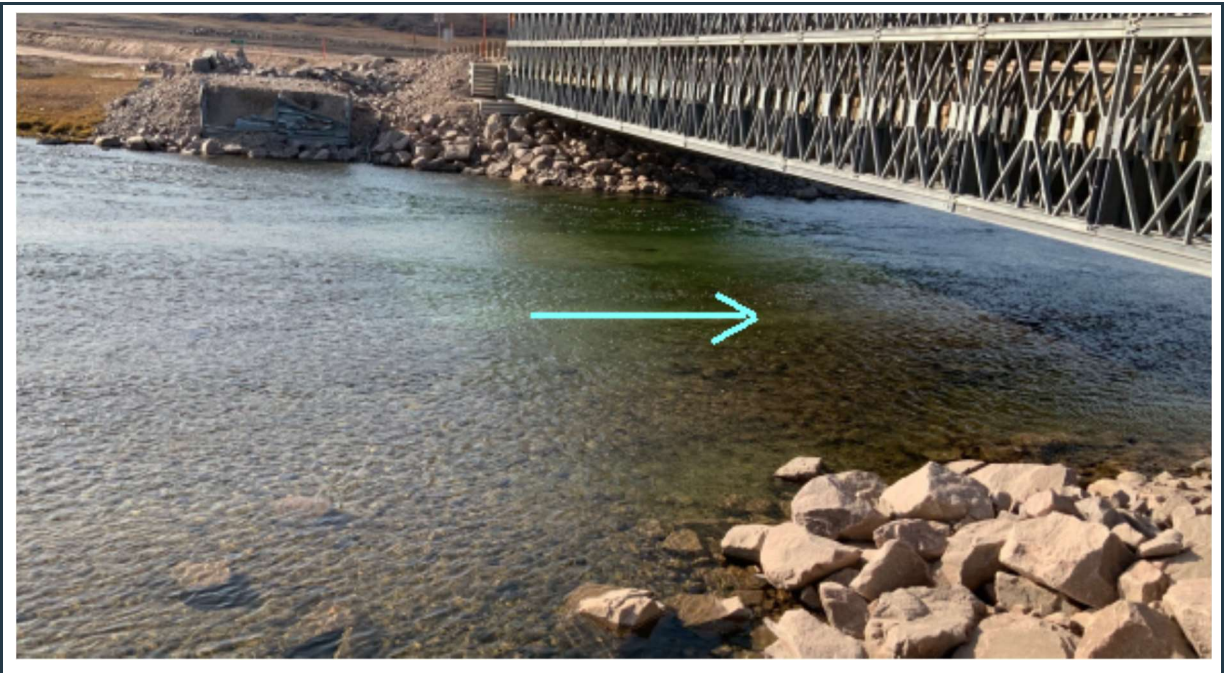
As shown in Figures 73 and 74, the abutments of this bridge are stable and no scour in the riverbed around the abutments was noted during the recent site visit in September. The abutments show no visible differential settlement or any structural discrepancy like deterioration of the foundation concrete. There are two historic abutments located immediately adjacent to the "new" ones. The metal front and wing walls of both "old" abutments have suffered some damages in the past, particularly the south abutment. To maintain the stability of the currently used bridge abutments it was recommended during the 2019 inspection that the two old (somewhat damaged) abutments should be kept in place since they provide additional support to the adjacent new abutments.

Figure 73: View of the north side of "bridge 17". Note the rip-rap scour protection at the abutments.

Figure 74: View of the south side of "bridge 17". Note the rip-rap scour protection at the abutments.

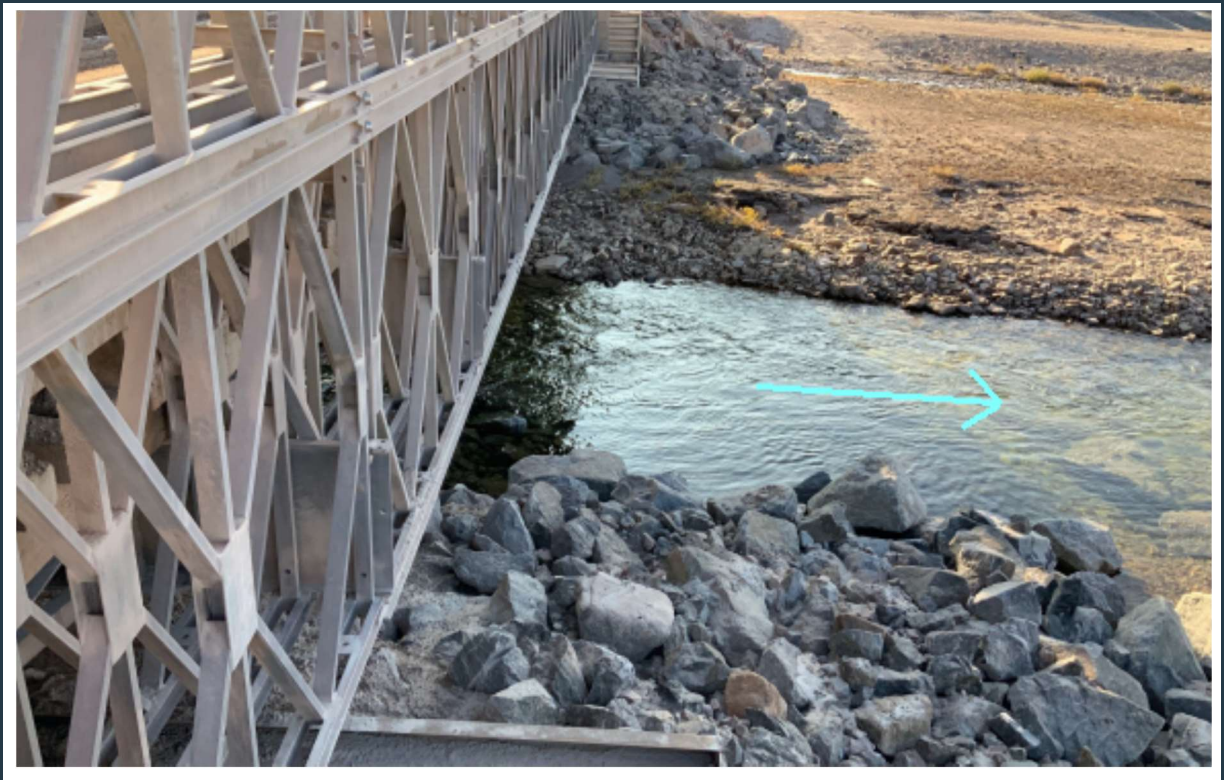
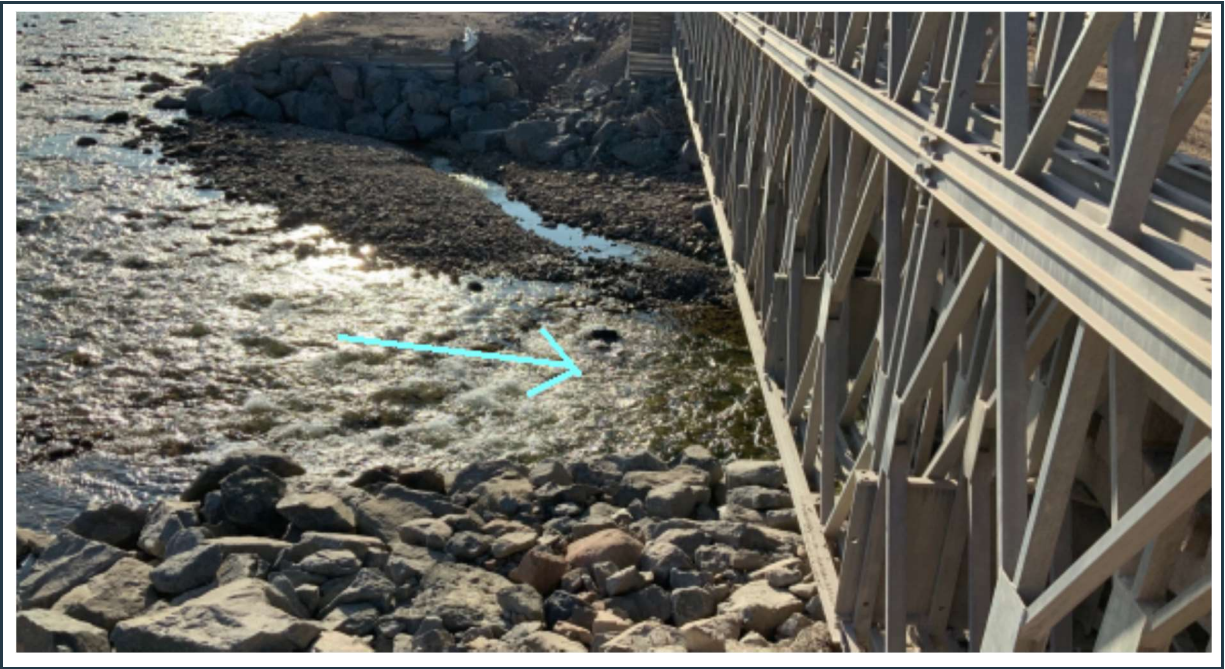
As shown in Figures 75 and 76, the abutments of this bridge are stable and no scour in the riverbed was noted during the recent site visit. The abutments show no visible differential settlement or any structural discrepancy like cracking on the foundation concrete. Similar to bridge 17, there are two historic abutments, located immediately adjacent to the "new" ones and damage to the metal front and wing walls of both old abutments are visible. In order to maintain the stability of the currently used bridge abutments, the two old abutments should be kept in place since they provide support to the adjacent currently used abutments.

Figure 75: View of the west side of bridge 63, looking south. Note the low flow and stable abutments.

Figure 76: View of the east side of bridge 63, and one of the old abutments, looking south.
