APPENDIX C.2

Geotechnical Inspection Reports

RE: Submission of 2019 Geotechnical Inspection Report No. 1 (July 2020)

Wood Environment & Infrastructure Solutions (Wood), has completed the first geotechnical field inspection of 2020 at the Mary River Iron mine complex, which is a condition of the Type "A" Water License No: 2AM-MRY1325 – Amendment No.1 ("Water License").

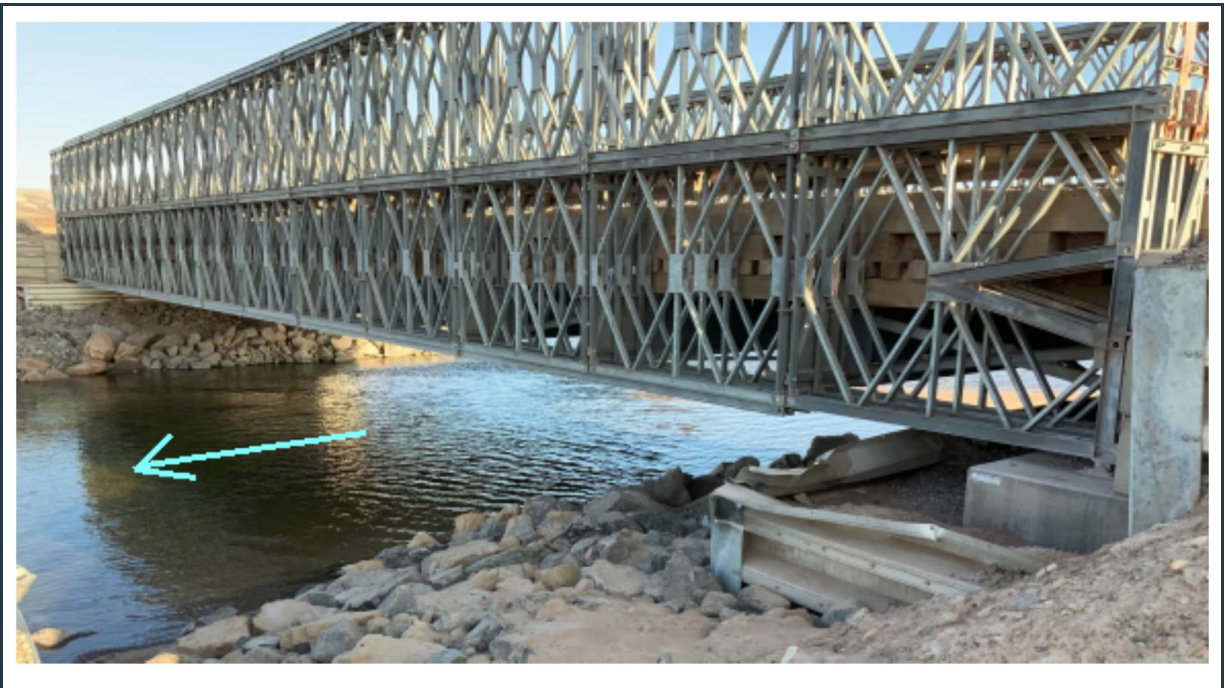
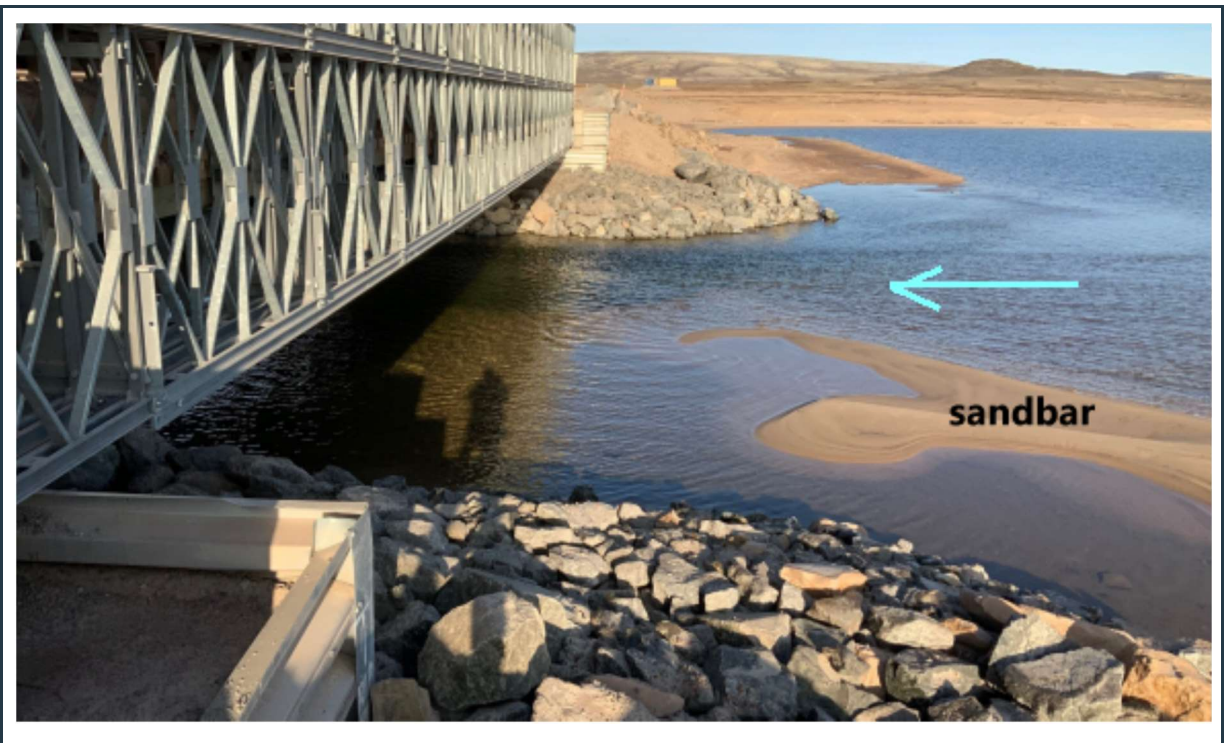
As shown in Figures 77 and 78, the abutments of this bridge are stable and no visible scour in the riverbed was noted during the recent site visit. The abutments show no differential settlement or any structural discrepancy like cracking on the foundation concrete. However, the water level in the river at this bridge was somewhat lower than during the 2020 June inspection. As a result, a long sandbar became visible in the riverbed at the south-east side of the south abutment of the bridge. The formation of such sandbars, immediately upstream of the bridge, may result in contraction scour beneath the bridge that can occur at the abutments as a result of the reduction in the river channel's cross-sectional area that may occur due to the deposition of sand and gravel into a sandbar by the river during low flow. The reduction in channel's cross section may result in scouring, due to an increase in flow velocity. This in turn could render sediments located at the front and beneath the foundation of the abutments unstable. As pointed out above, there is no indication of scour yet; however, the potential increase in size of the sandbar should be monitored. Should the river bring and deposit more sand and gravel at the sandbar in the future, removal of the sandbar may become necessary.

Figure 77: View of the west side of bridge 80.

Figure 78: View of bridge 80, looking north. Note the sandbar in the river, blocking some of the flow.

- The abutments at the four inspected bridges appear to be in good condition and no scour in the riverbed around the abutments were noted at the time of the site visit in September. Sandbar development was noted at bridge 80 (near the north-east corner of the south abutment) which should be monitored and may need to be removed should its size continue to increase.

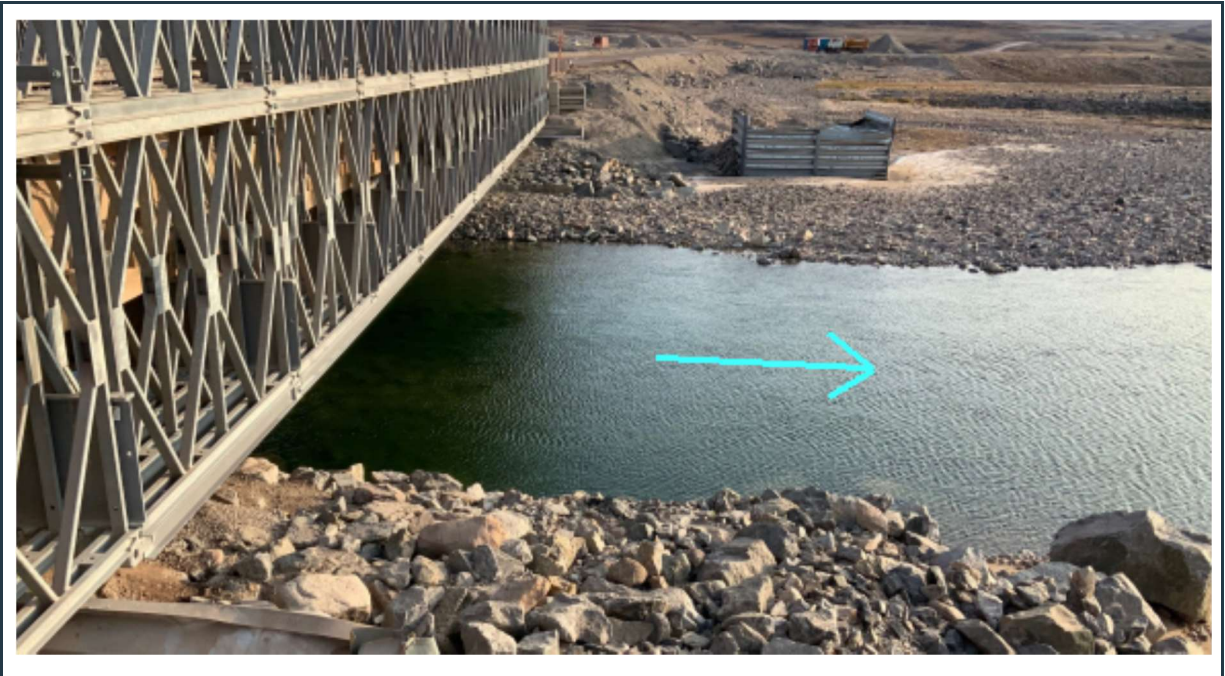
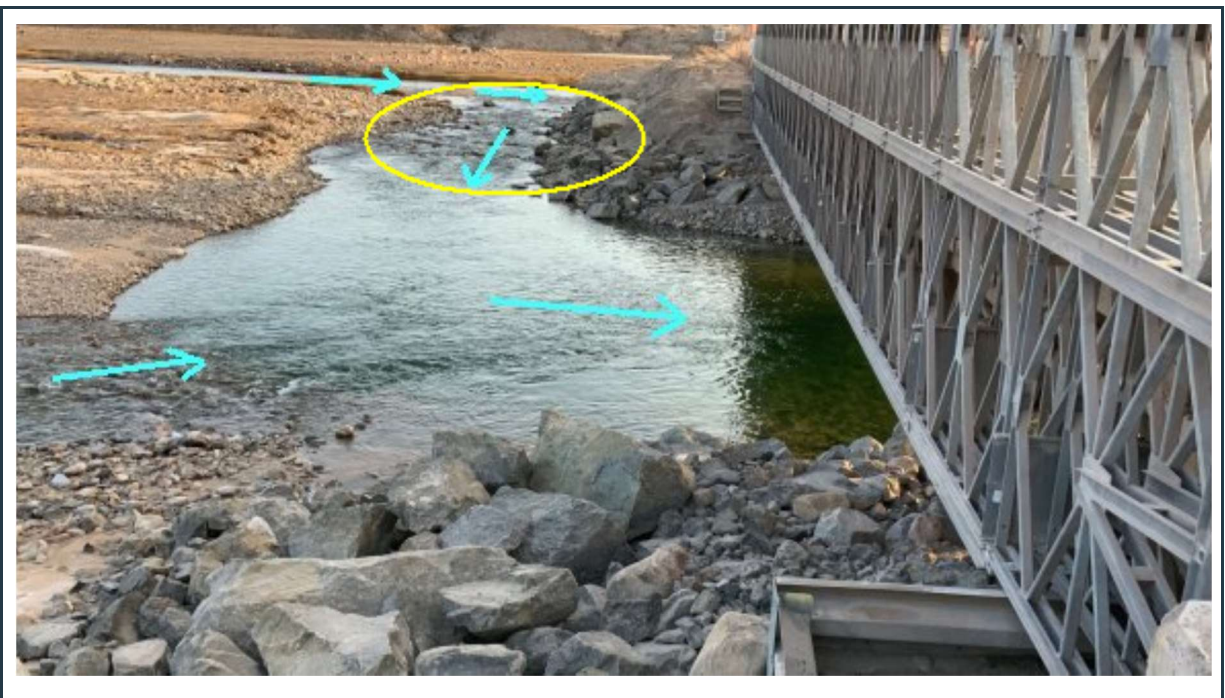
As shown in Figures 79 and 80, the abutments of this bridge appear to be stable and no scour in the riverbed was noted during the site visit. The abutments show no differential settlement or any structural discrepancy like cracking on the foundation concrete. There are two culverts installed under the tote road just south of the bridge, to convey some of the water in the river channel to the west side of the tote road (bypassing the bridge, as shown in Figure 8). Due to the local topography of the riverbed, some of the water flows from the front of the culverts toward the bridge immediately adjacent to the toe of the south approach embankment. No scour at the toe of the embankment was noted, however, the flow and its potential impact on the stability of the embankment should be closely monitored in the future.

Figure 79: View of the west side of bridge 97, with one of the old abutments in the background.

Figure 80: View of two abutments and the east side of bridge 97. Note the flow of water at the toe of the south abutment between the side-culverts and the bridge (yellow circle and also in Figure 8).

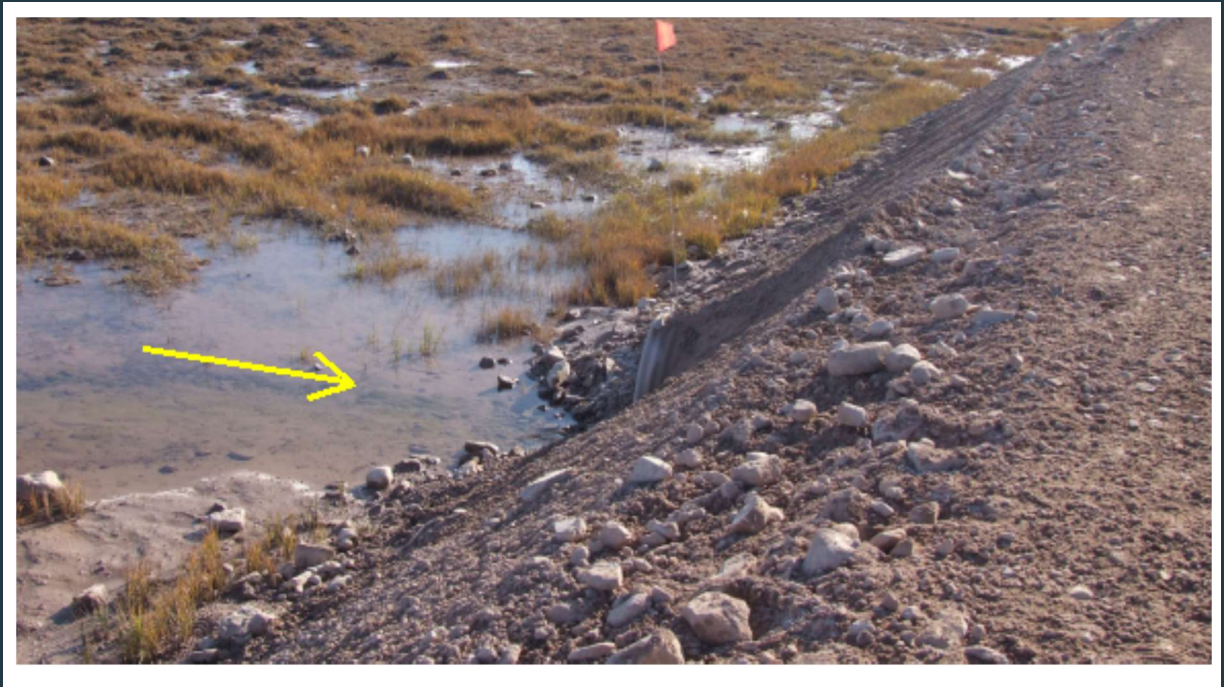
Figure 81: View of culvert 076 inlet (looking south).

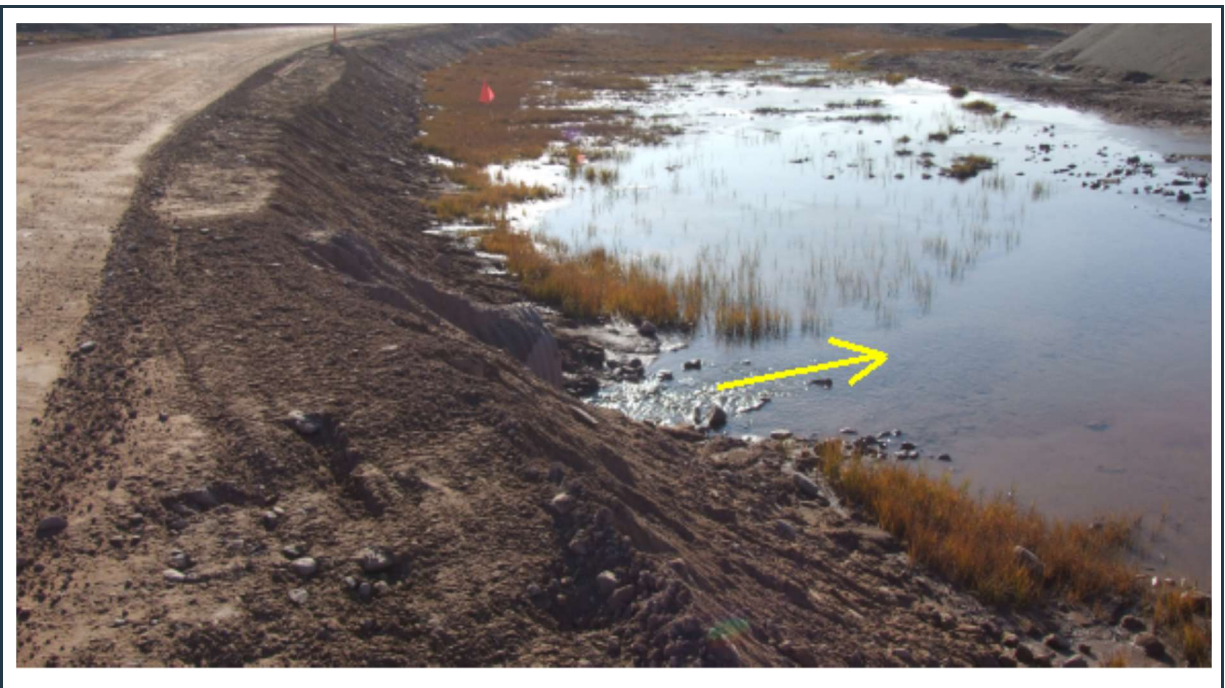
Figure 82: View of culvert 076 outlet (looking south).

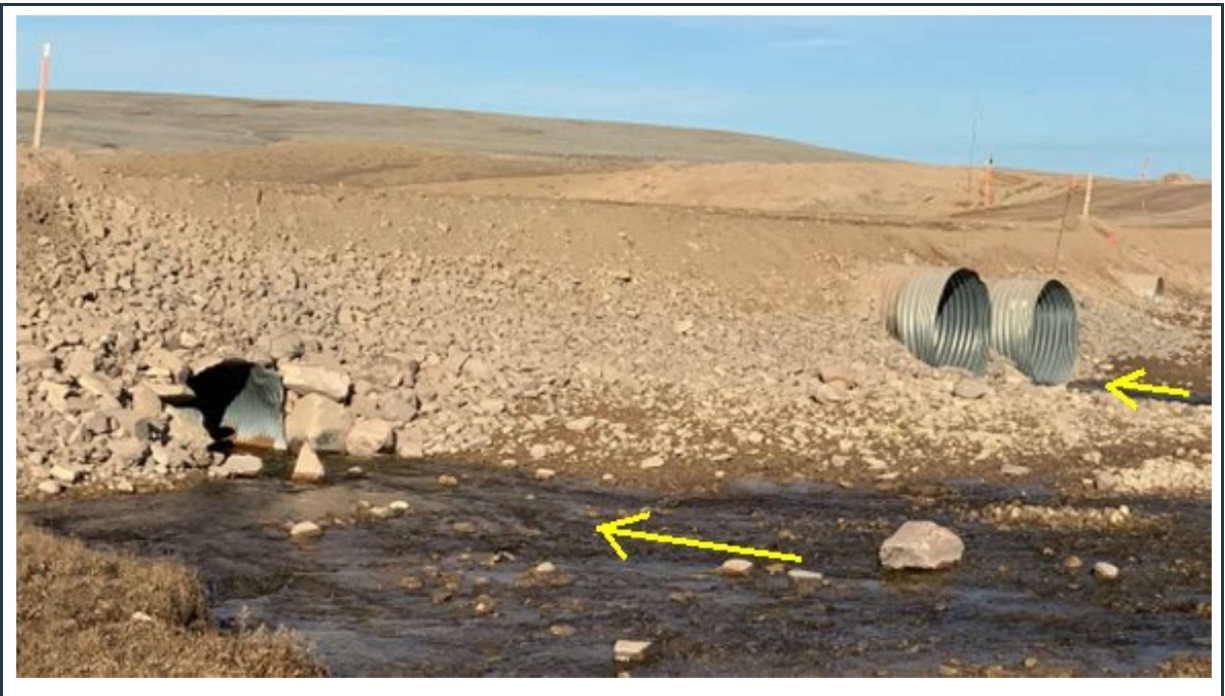
CV-078 (Figures 83 and 84): The outlet end of one of the four culverts (second from the north) at this location is damaged slightly, although the “cut” at the top of the corrugated pipe has no effect on the flow within the pipe at this stage. However, the outlet end of this culvert may need to be removed (cut) if the damaged part would impede the flow of water in the future.

Figure 83: View of culvert(s) 078 inlet (looking north-west).

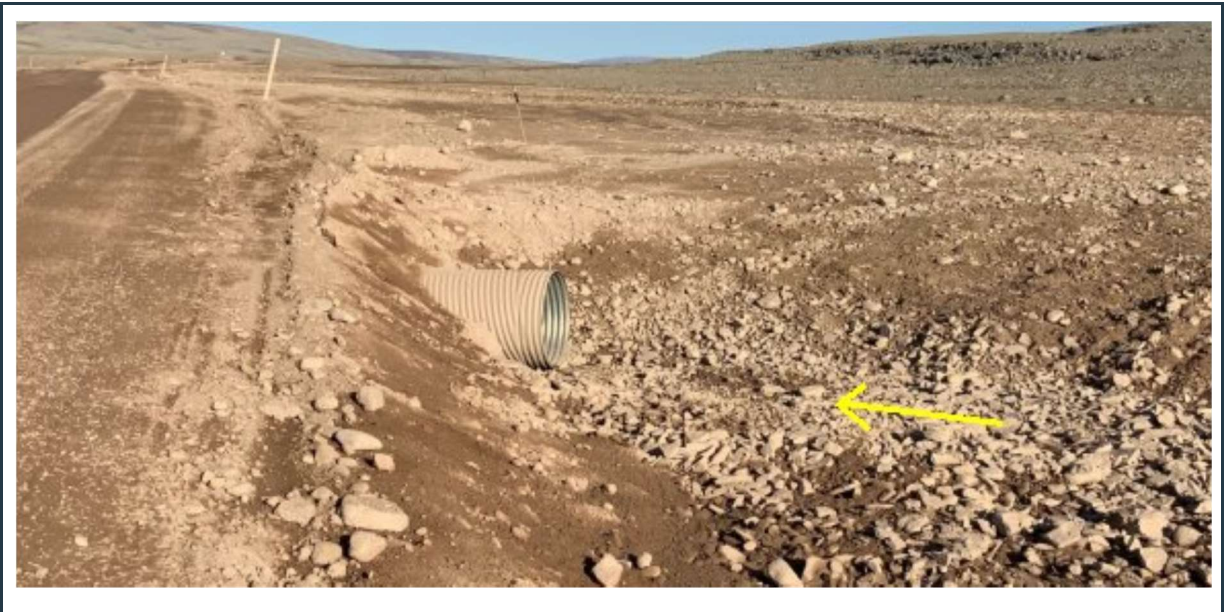
CV-083 (Figures 85 and 86): The outlet of this culvert appears to be somewhat short. As a result, erosion of the road embankment is visible around the culvert pipe. It should be extended by about 1.5 m and the slope of the adjacent road embankment shall be covered by the placement of crushed rock riprap around the culvert. Improvement of the creek’s alignment at the front of the inlet is also recommended (minimize water flow parallel with the embankment at its toe to prevent erosion and subsequent potential slope instability at the road embankment).

Figure 85: View of culvert 083 inlet (looking north). No flow was noted at the time of the inspection.

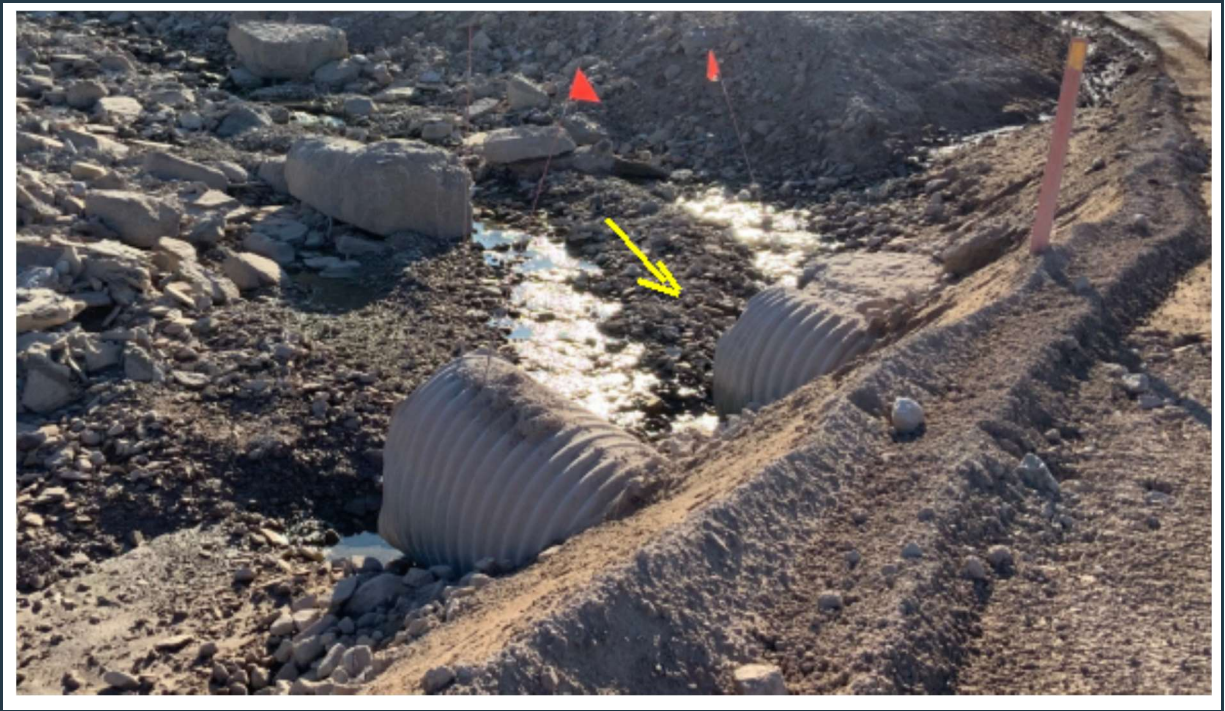
Figure 87: View of culvert(s) 094 inlet, in good condition (looking south).

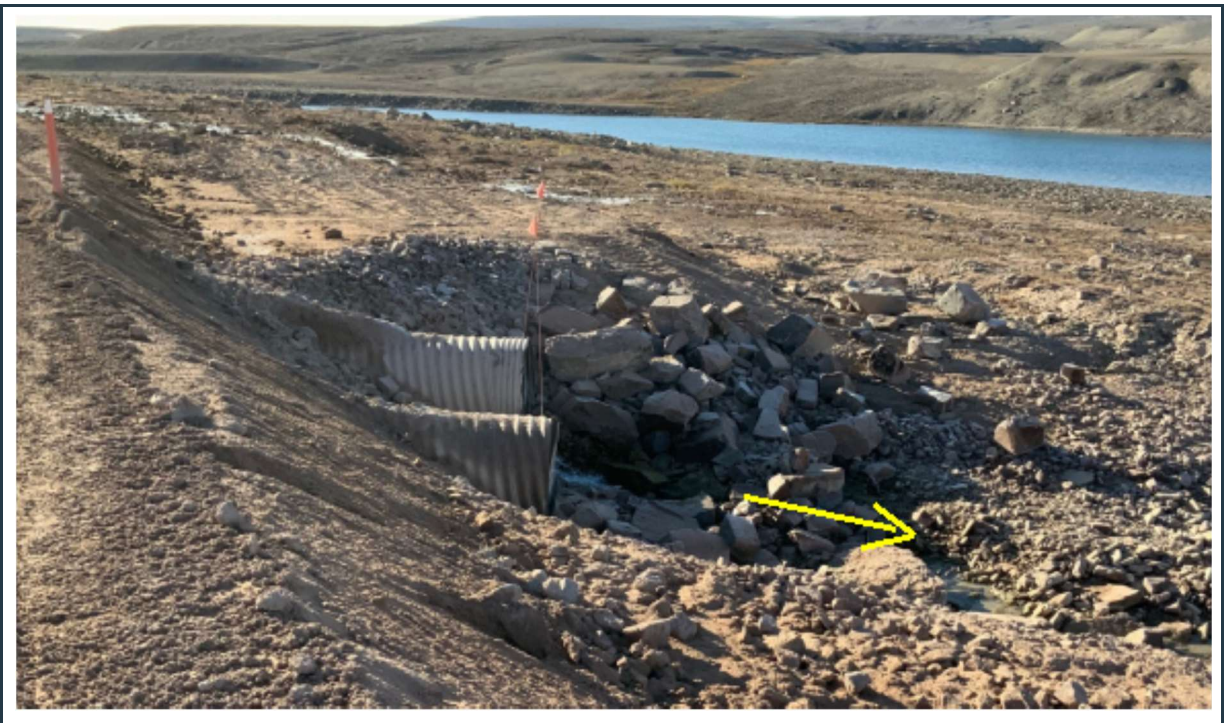
Figure 88: View of culvert(s) 094 outlet, in good condition (looking south).

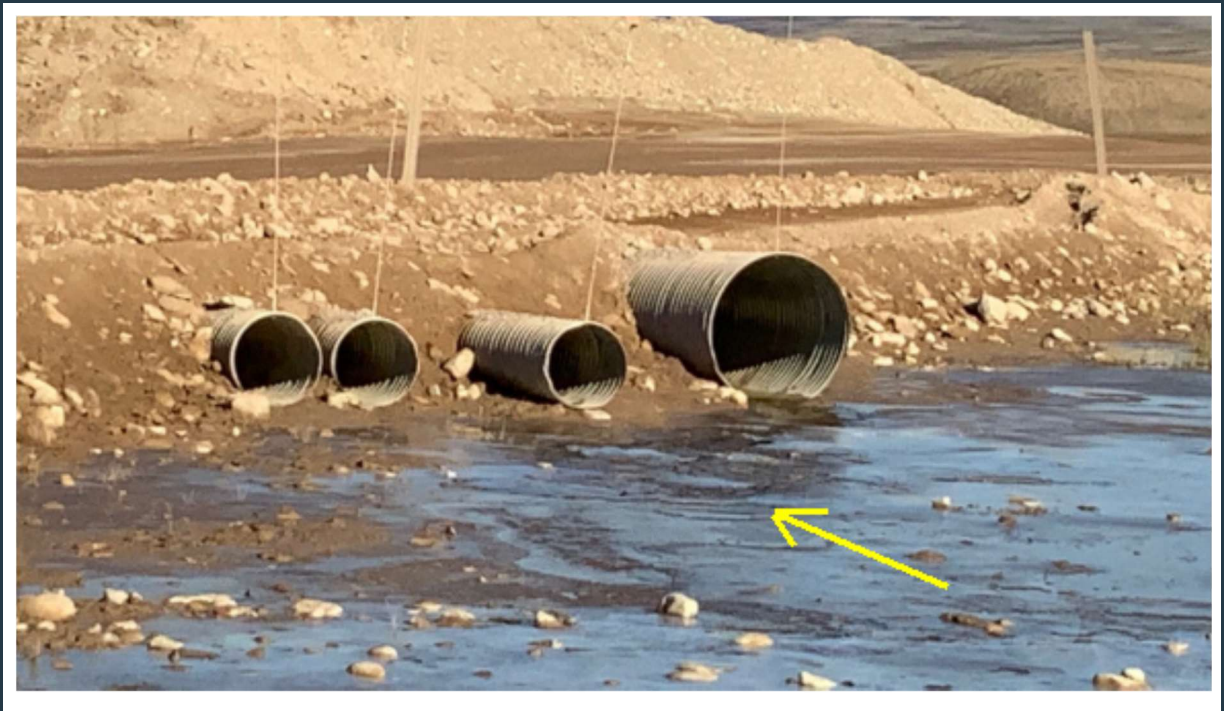
Figure 89: View of culvert(s) 102 inlets in good condition (looking west).

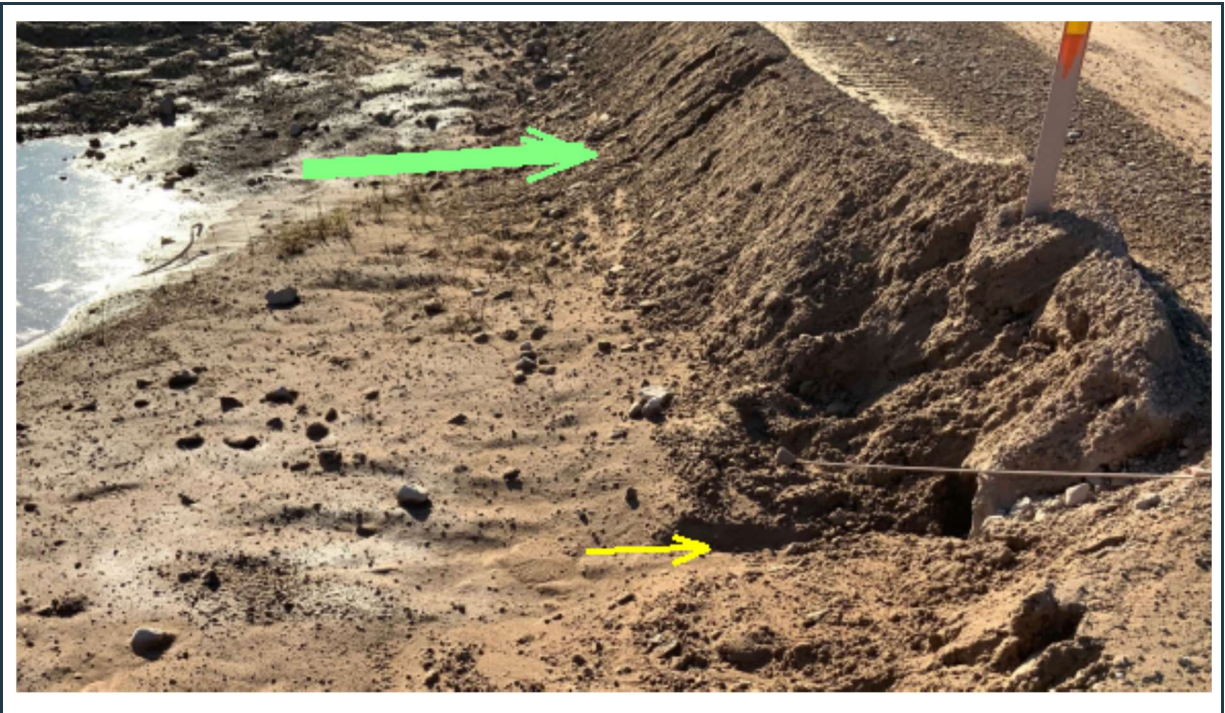
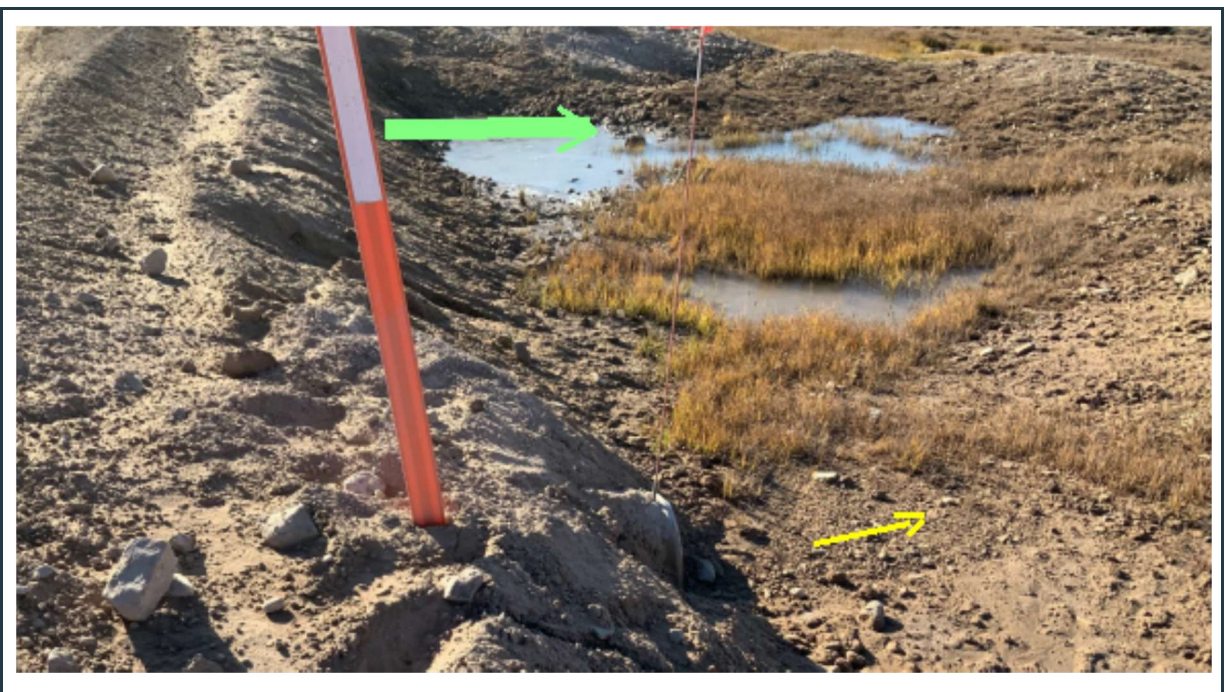
CV-107 (Figures 91 and 92): This is a short, small diameter culvert that was installed at somewhat higher elevation instead of the lowest point of the native ground in the area. Consideration shall be given to replace this culvert with a longer and somewhat larger pipe a few meters south of the current location, as

Figure 91: View of culvert 107 inlet (looking south). See detailed comments in the report.

Figure 92: View of culvert 107 outlet (looking south). See detailed comments in the report.

shown by the green arrows on the two relevant images (Figures 91 and 92). The arrows mark the location of the lowest point of the drainage channel in the area, where the culvert would be able to convey the surface water more efficiently from one side of the road to the other.

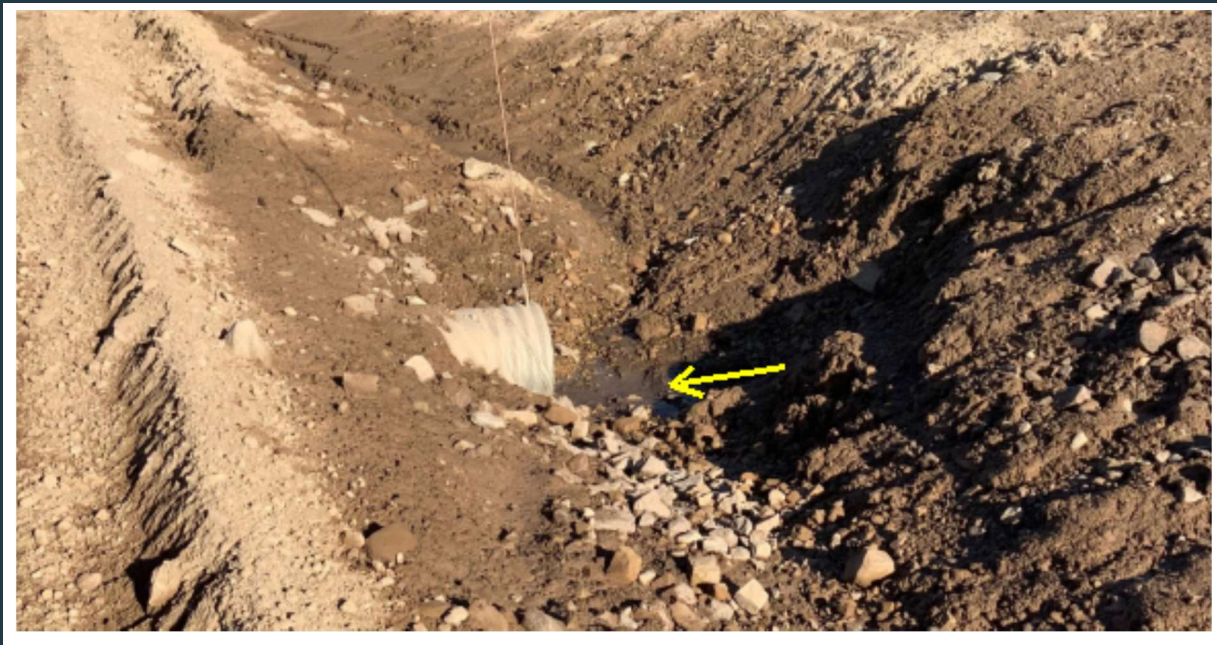
Figure 93: View of culvert 110A inlet (looking north).

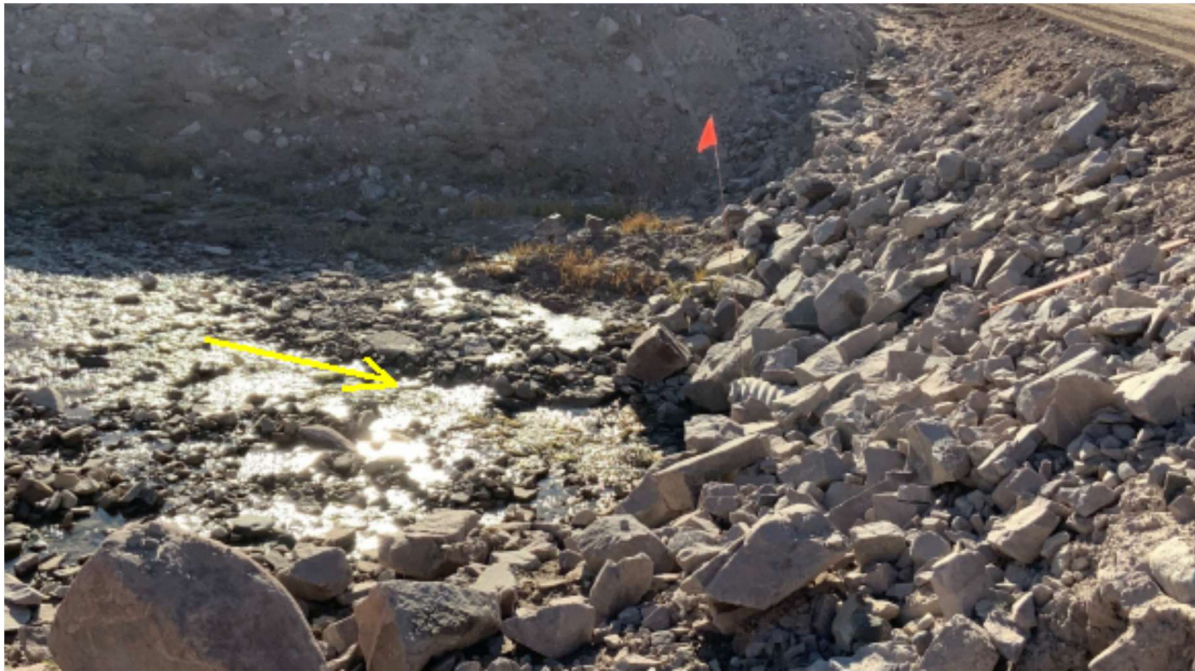
Figure 95: View of culvert 111 inlet (looking south).

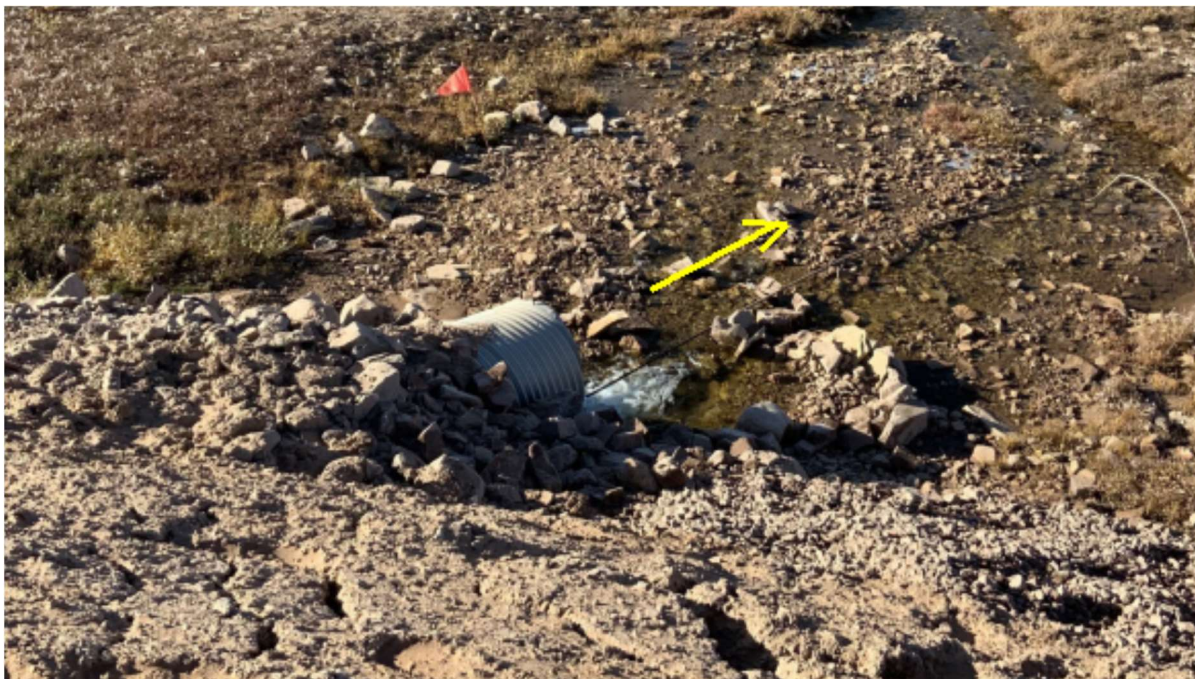
Figure 96: View of culvert 111 outlet (looking west).

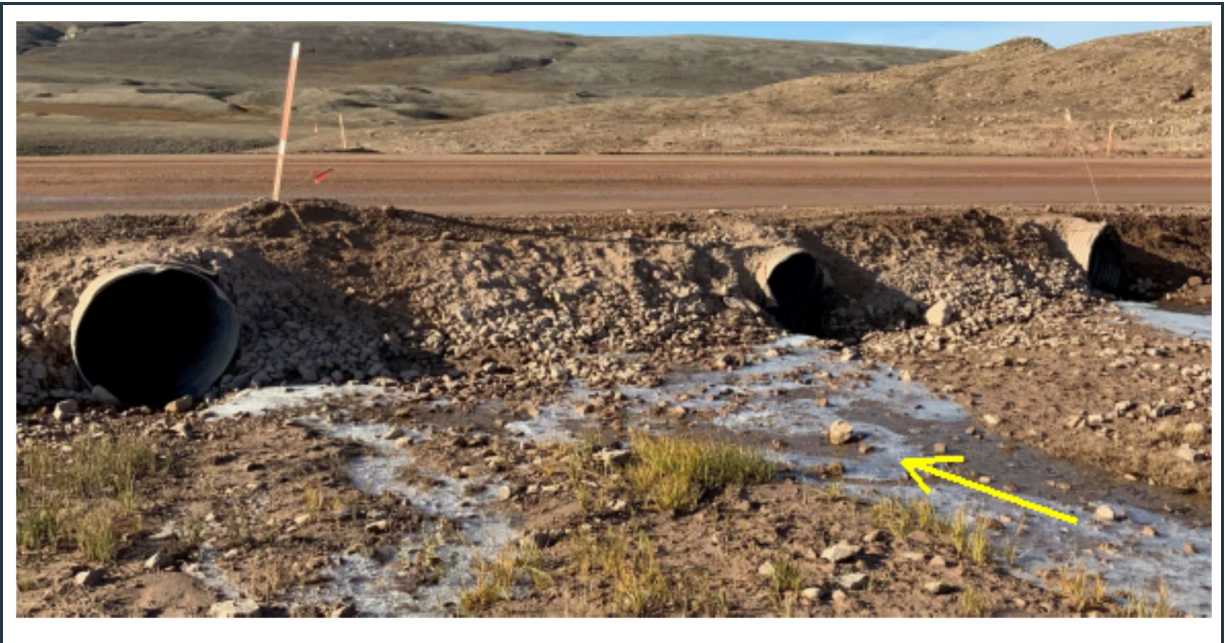
Figure 97: View of culvert(s) 112D inlets (looking west). Thin ice was already visible in the creek during the first week of September.

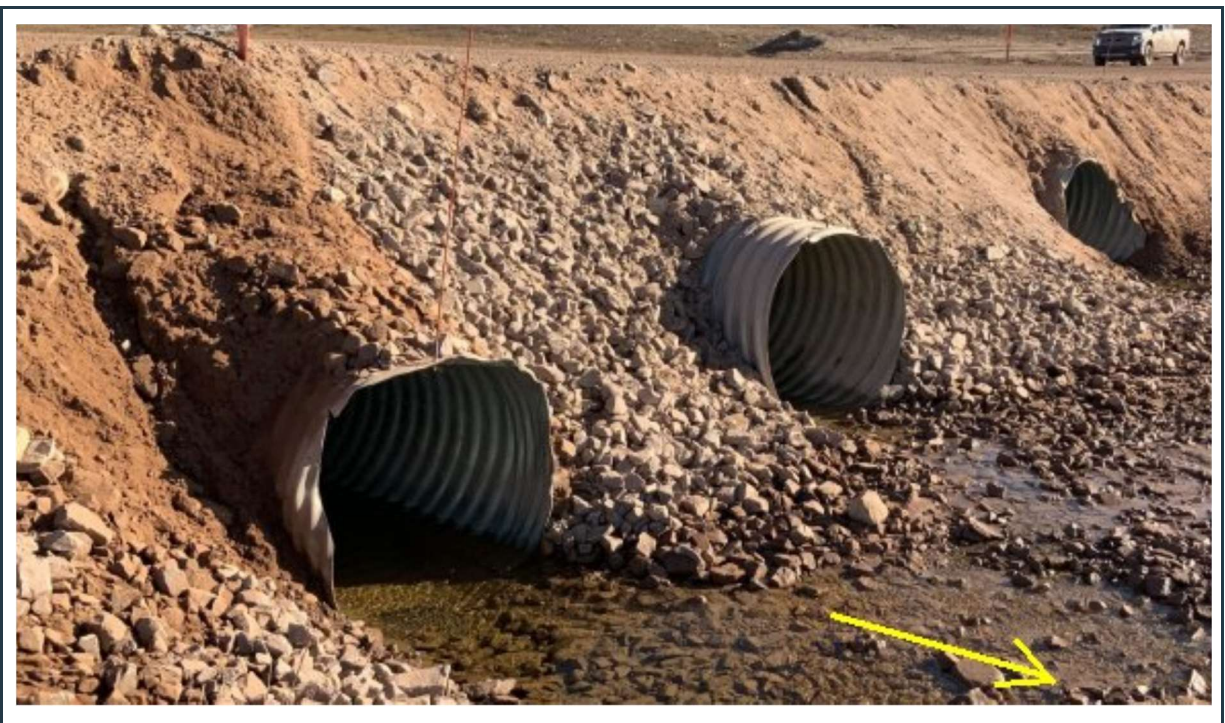
Figure 98: View of culvert(s) 112D outlets (looking south-east).

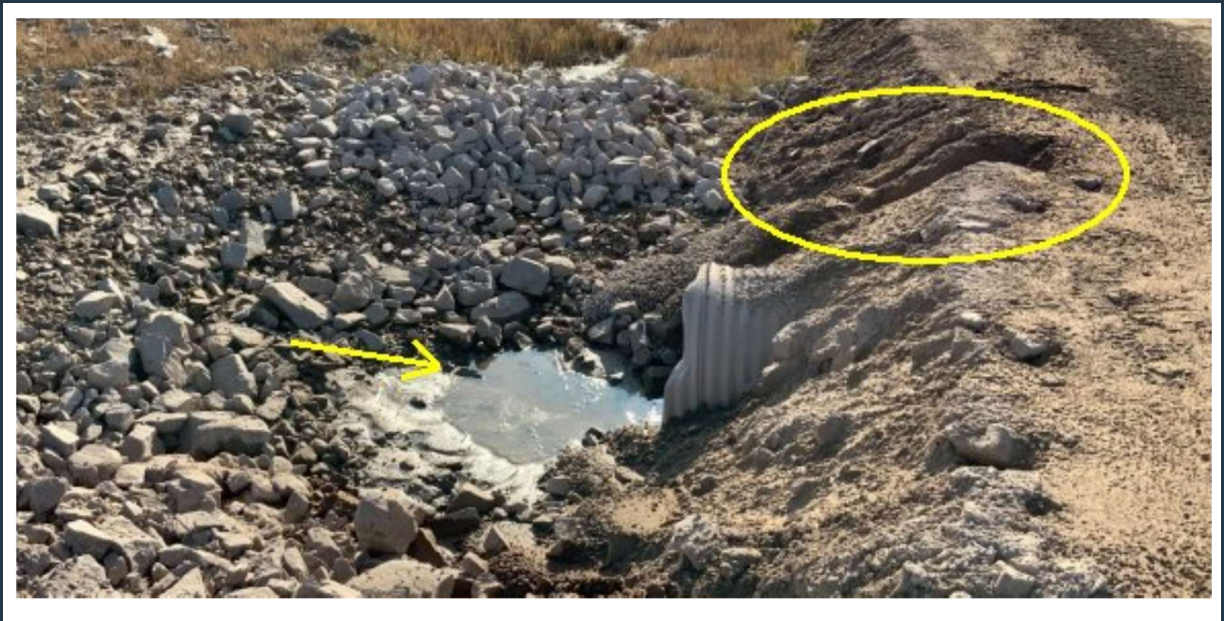
k) CV-202

Figure 101: Culvert 202 inlet (looking south). Note the slope erosion at the edge of the road, adjacent to the culvert (yellow circle).

CV-202 (Figures 101 and 102): There are two problems with this culvert. At the inlet end of the pipe, there is some erosion visible immediately adjacent to the pipe, which should be rectified by filling the eroded rill with compacted soil and should be covered with crushed rock fill. The second issue is visible at the outlet end of the pipe, where its invert is located below the floor of the flow channel. The rock fill at the front of the pipe outlet should be regraded and uninterrupted flow from the culvert should be provided.

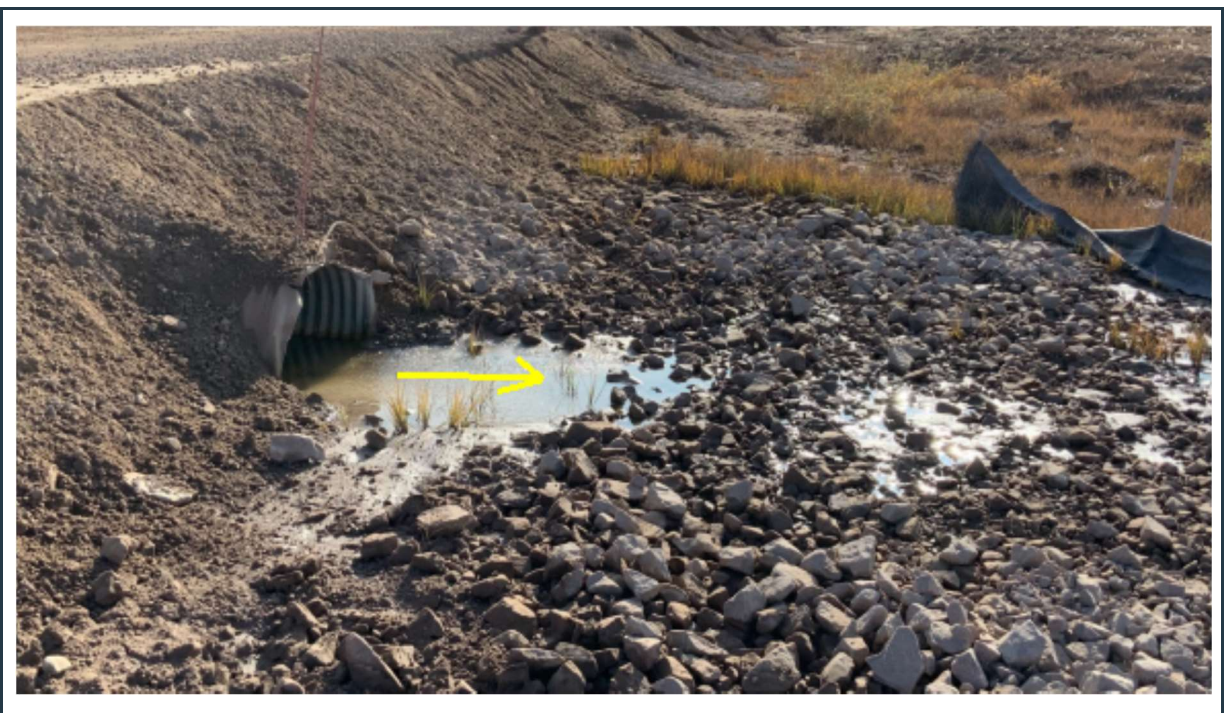
Figure 102: View of culvert 202 outlet (looking south). Flow of water is blocked by the crushed rock fill.

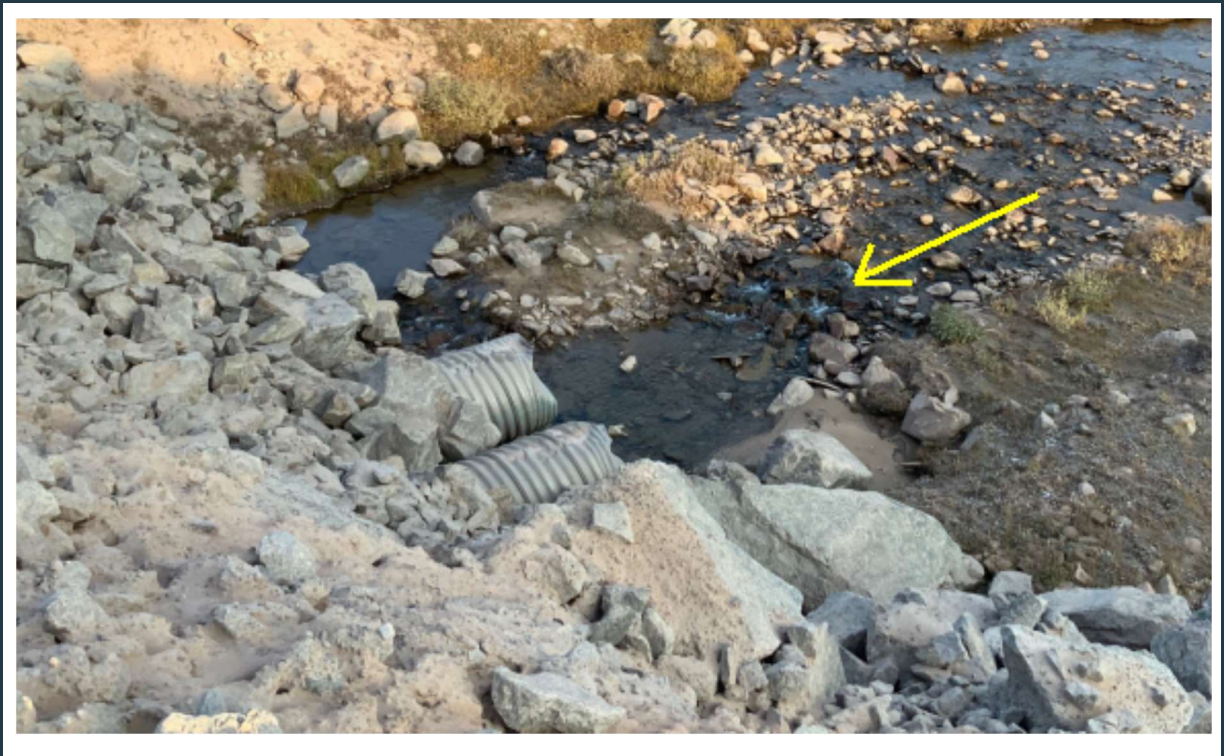
I) CV-225

Figure 103: View of culvert(s) 225 inlets (looking north-east).

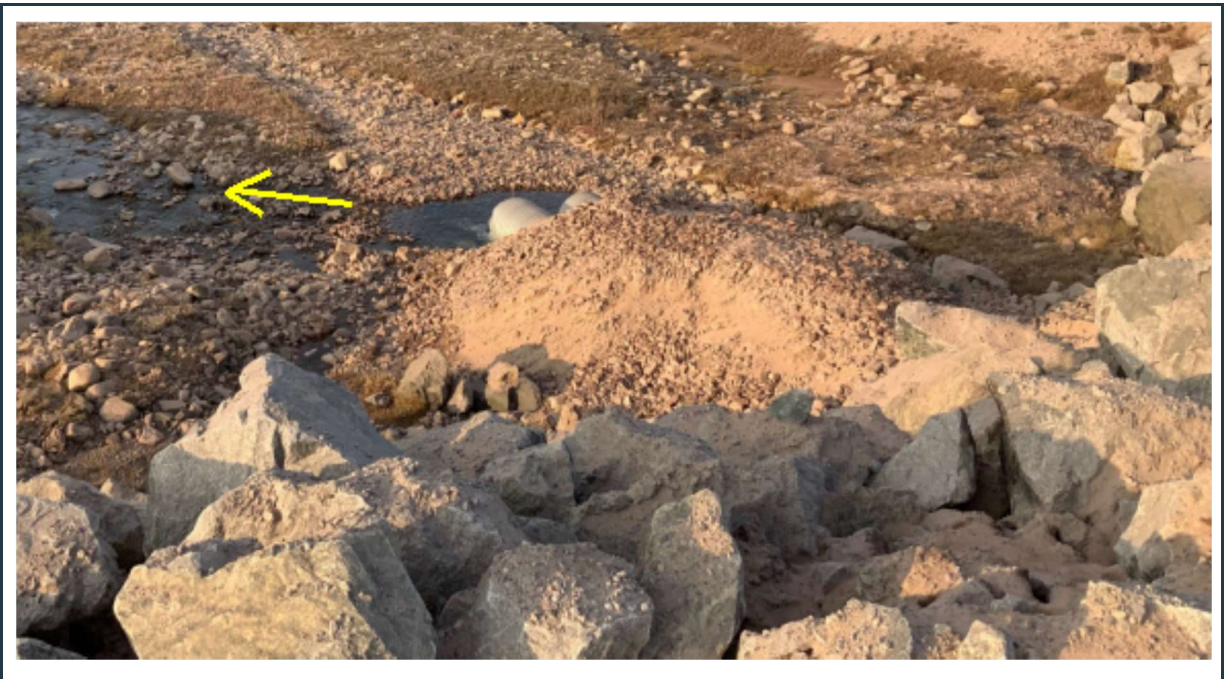
Figure 104: View of culvert(s) 225 outlets (looking west).
