## **APPENDIX C**

### **Construction Summary Letters**

## **RE: Construction Summary of BG-04 Remedial Measures**

## BG-04 AS-BUILT PHOTO LOG

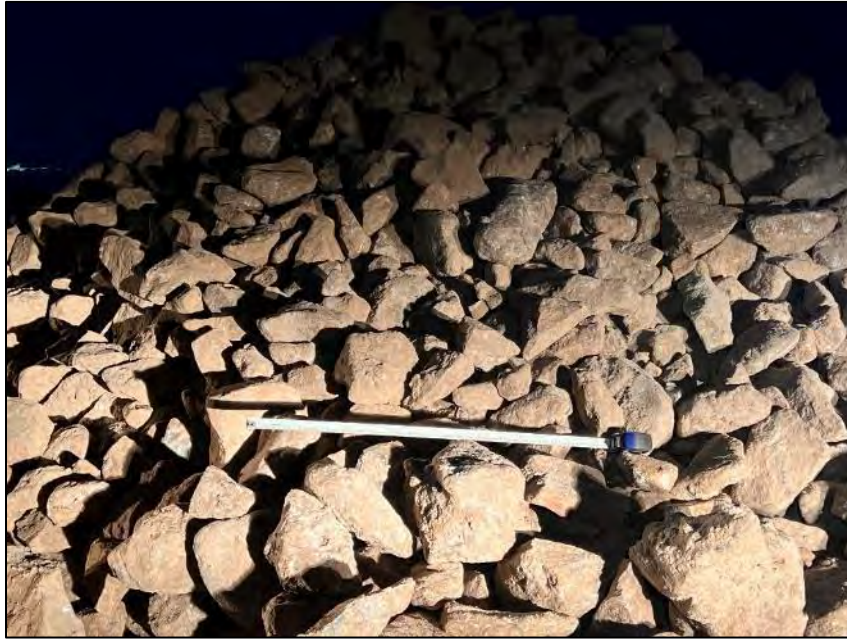
**PHOTO 25.** Material Stockpile - Fine Riprap - km 94 Laydown - Looking Southeast (April 09, 2024).

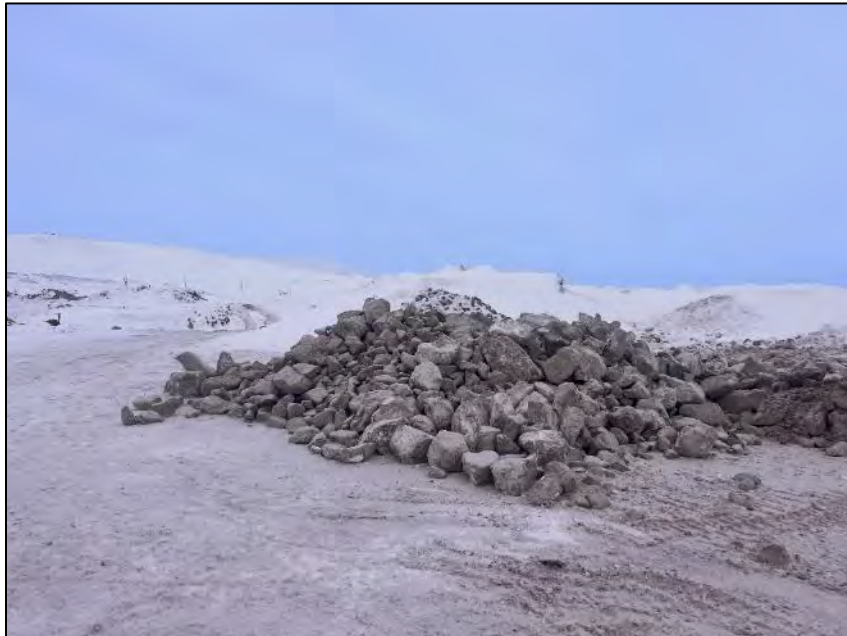
**PHOTO 26.** Material Stockpile - Coarse Riprap - km 94 Laydown - Looking Southwest (April 03, 2024).

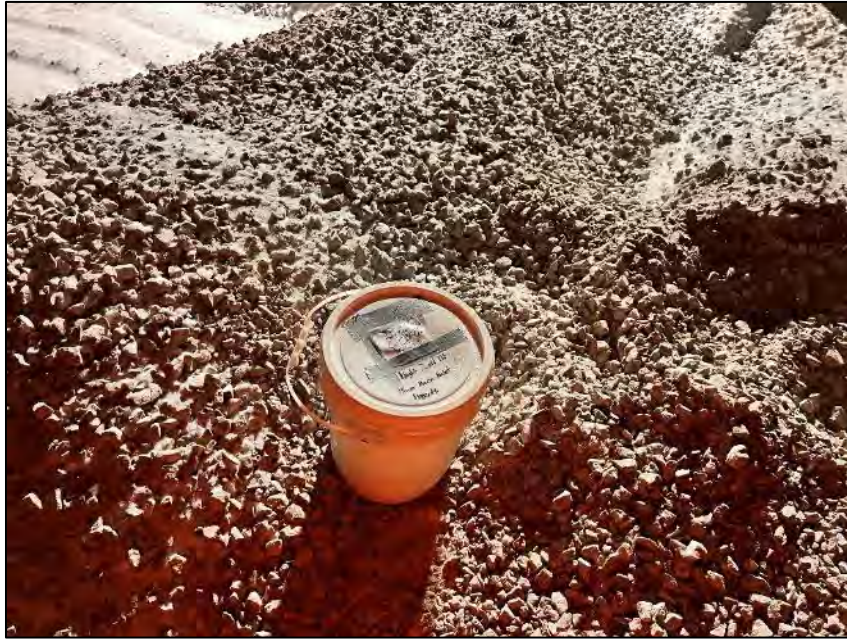
**PHOTO 27.** Material Stockpile - Culvert Backfill - km 94 Laydown - Looking South (March 31, 2024).

- **Culvert Backfill** - Culvert Backfill material consisted of 32 mm minus material that was crushed and screened at the aggregate quarry located at the Milne Inlet Port. The material was backhauled to the km 80 laydown area on the Tote Road using Baffinland's ore hauling trucks (OHTs). Particle size gradations from laboratory tests show that the processed material met the material specifications, as shown on Figure 1.

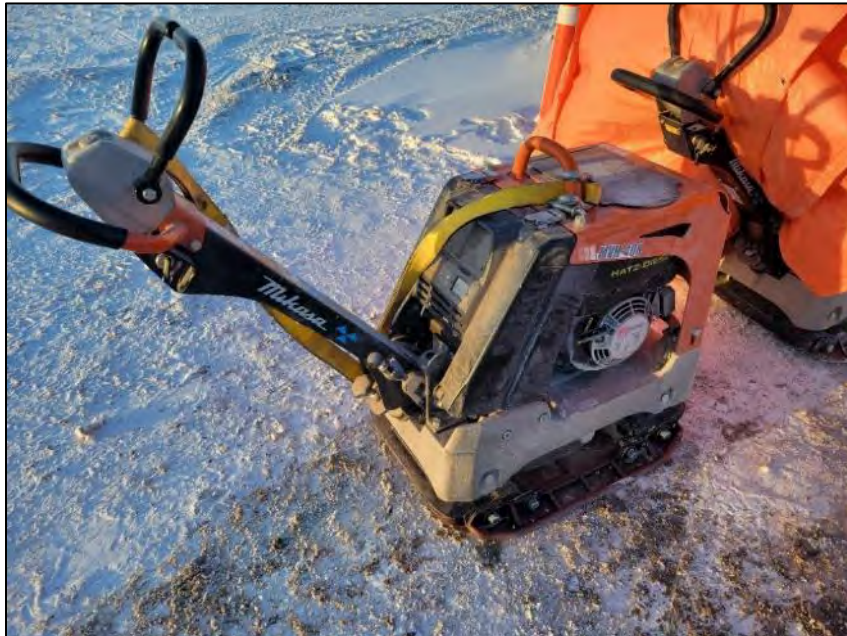
**PHOTO 28.** Equipment - Mikasa MVH408 1000 lb Plate Compactor - km 60 Laydown (March 05, 2024).

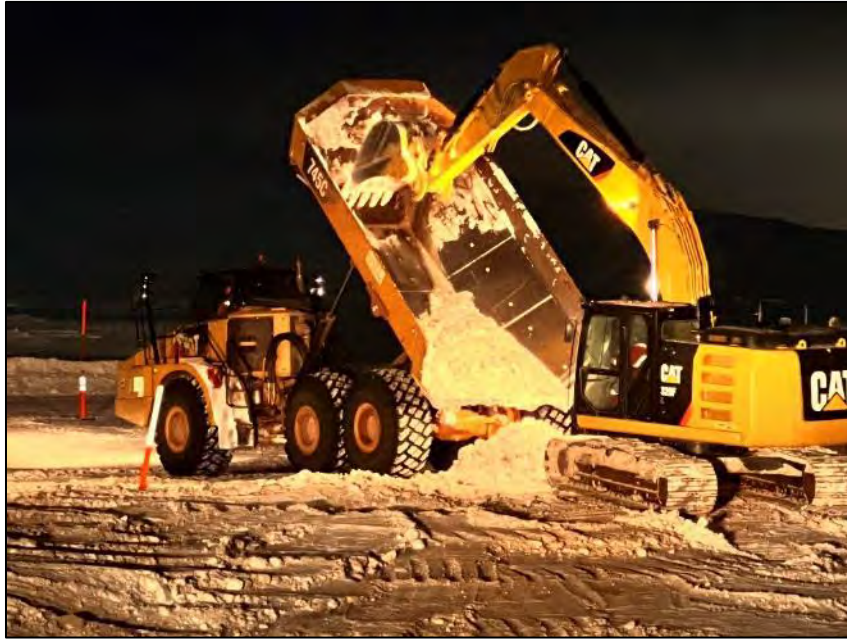
**PHOTO 29.** Equipment - CAT 745C articulated dump truck - km 60 Laydown (April 09, 2024).

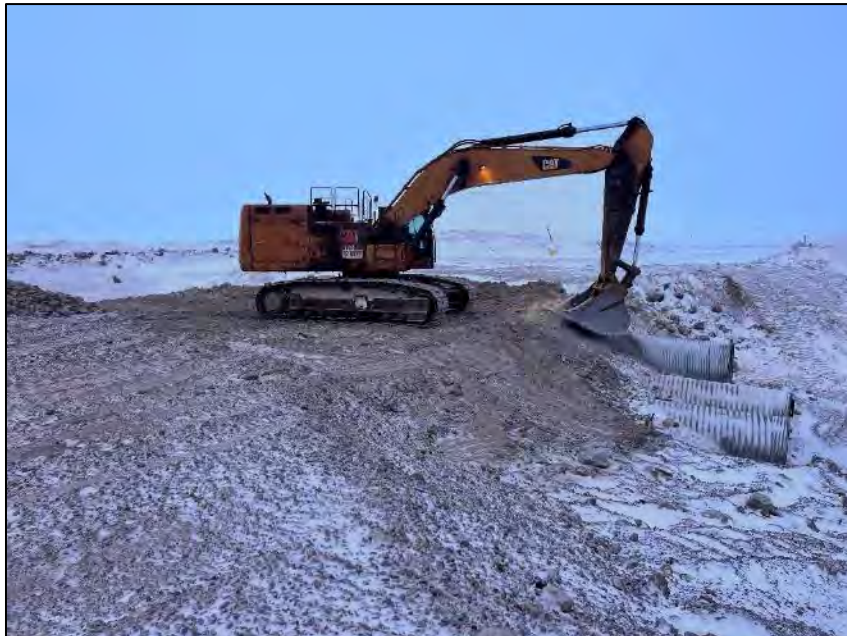
**PHOTO 30.** Equipment - CAT 374F Excavator - km 94 Laydown - Looking East (April 08, 2024).

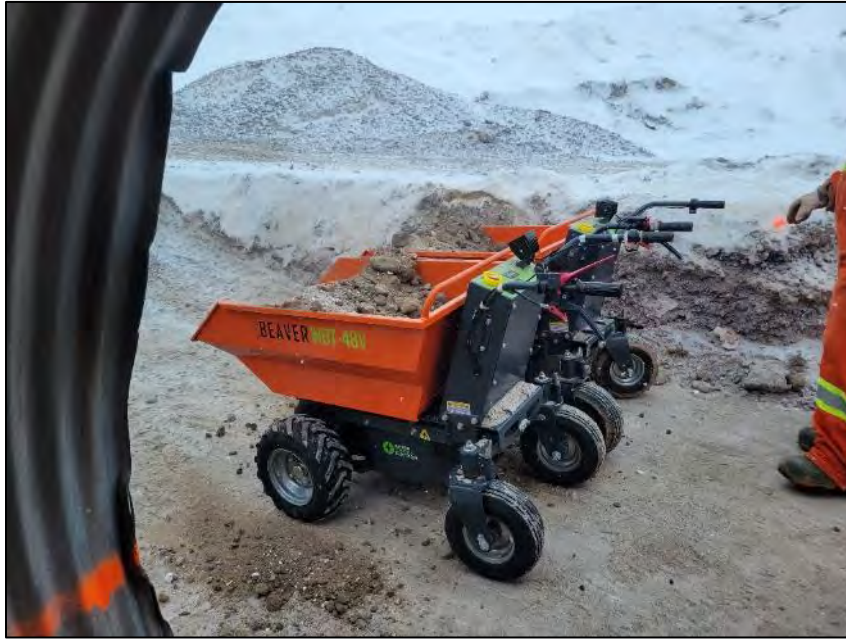
**PHOTO 31.** Equipment - Ducar Motorized Wheelbarrow loaded with Coarse Riprap - CV-059 (April 04, 2024).

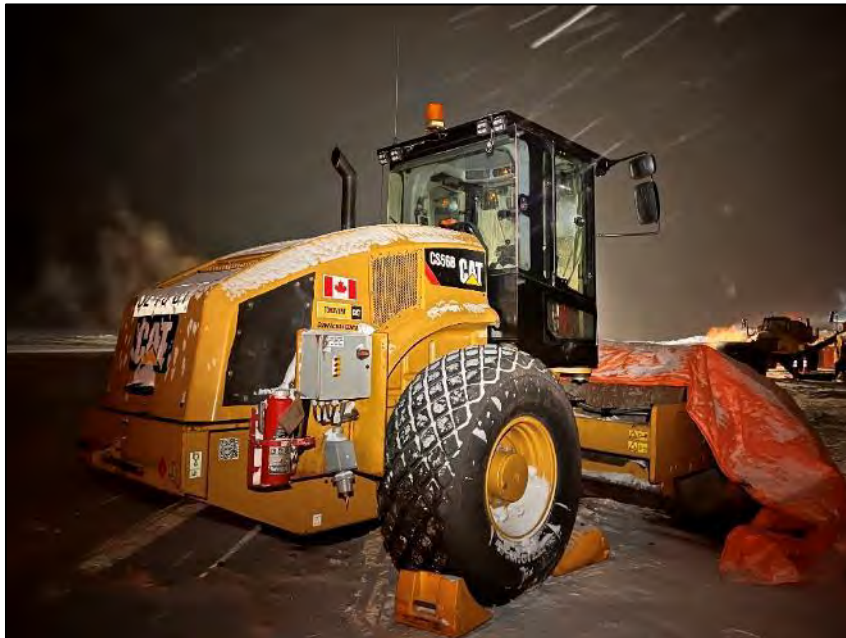
**PHOTO 32.** Equipment - CAT CS56B Smooth Drum Compactor (March 02, 2024).

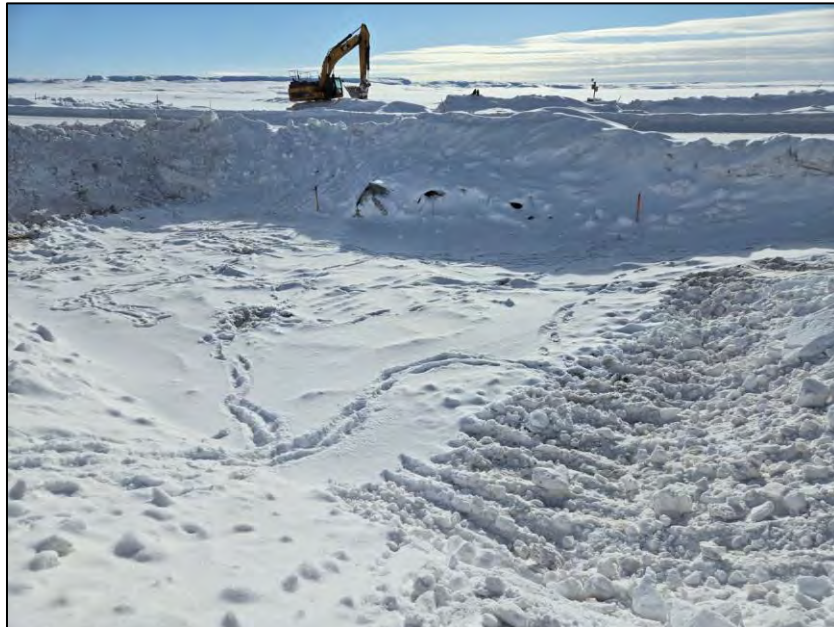
**PHOTO 4.** Prior to Construction - Vantage Point 3 - Upstream Side of Crossing - Looking North  
(April 03, 2024).

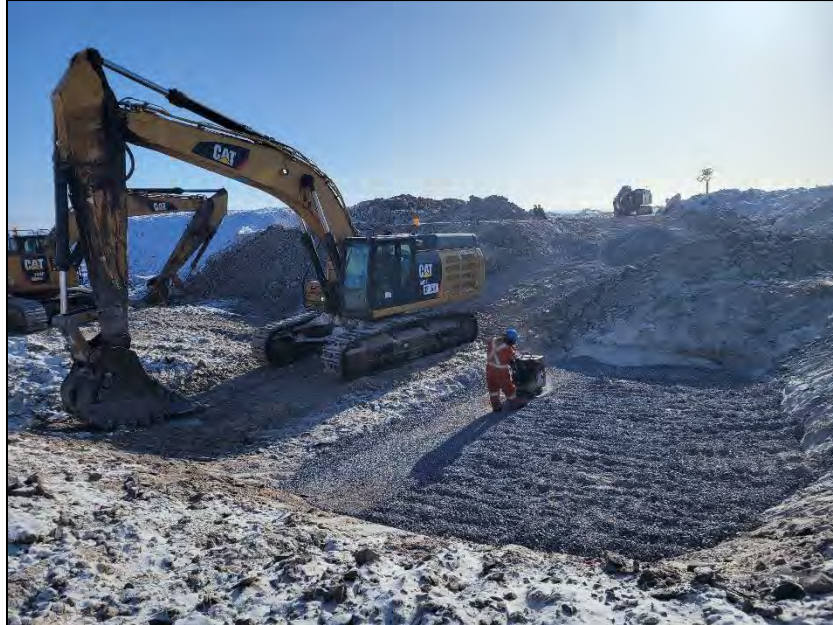
**PHOTO 10.** During Construction - Vantage Point 4 - Placement and Compaction of Culvert Backfill Material - Upstream inlet - Looking Northeast (April 19, 2024).

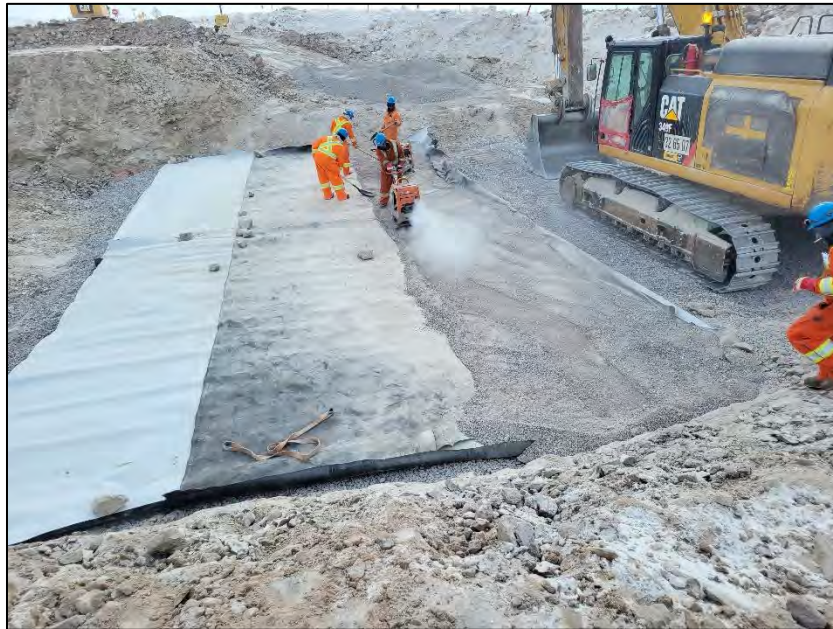
**PHOTO 13.** During Construction - Vantage Point 3 - Compaction of 3/4 inch Material in Plug Trench - Looking West (April 20, 2024).

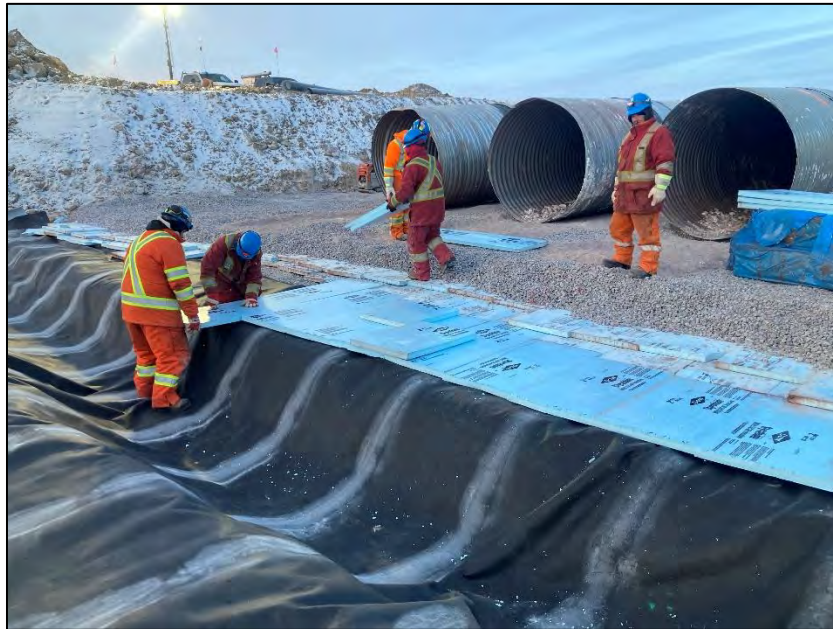
- Insulation - 50 mm thick Styrofoam™ Highload 60 Extruded Polystyrene Insulation was stored at the km 80 laydown. Two layers of insulation (total thickness of 100 mm) was installed across the foundation beneath the culverts.

**PHOTO 15.** During Construction - Vantage Point 1 - Placement of Insulation - Road Crossing - Looking Northeast (April 23, 2024).

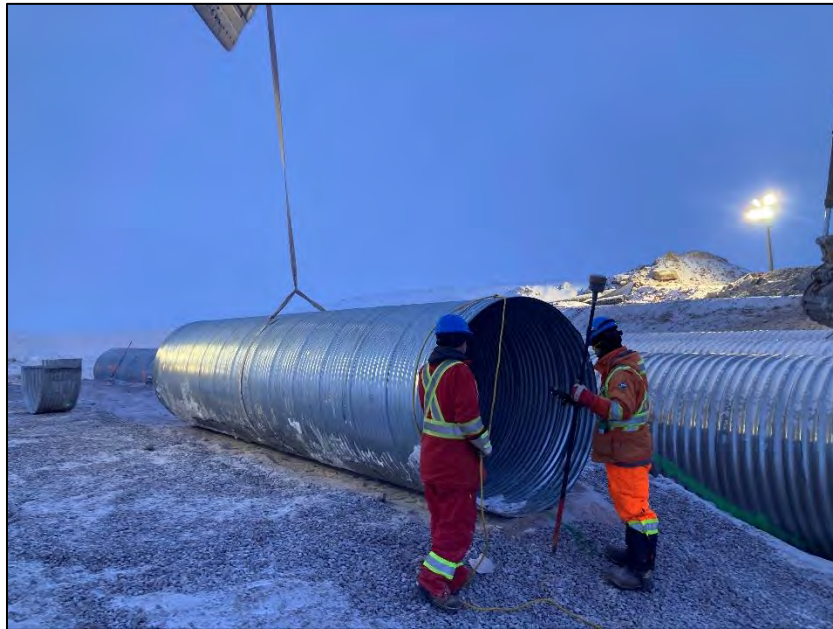
**PHOTO 17.** During Construction - Vantage Point 3 - Placement of segment of 1.8 m diameter corrugated steel pipe high flow culvert - Looking Northeast (April 25, 2024).

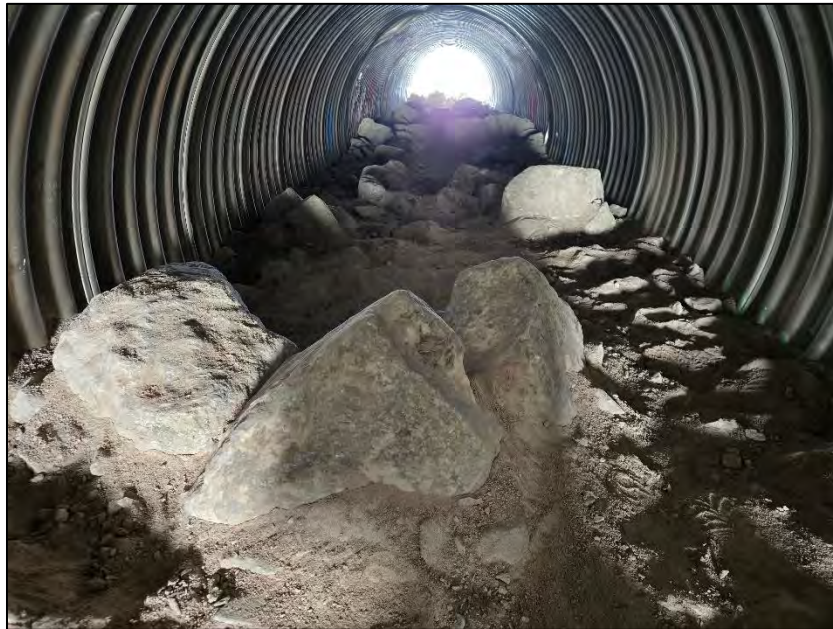
**PHOTO 19.** During Construction - Placement of Boulder Clusters in Low Flow Culvert - Looking North (May 01, 2024).

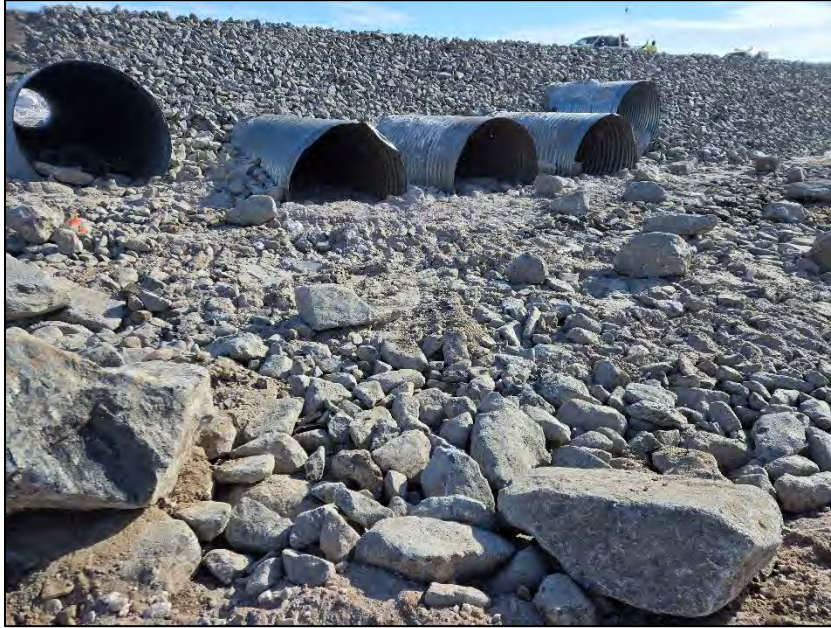
**PHOTO 21.** Following Construction - Vantage Point 2 - Completed north (outlet) apron with Coarse Riprap and Stream Substrate Material - Looking Northwest (May 04, 2024).

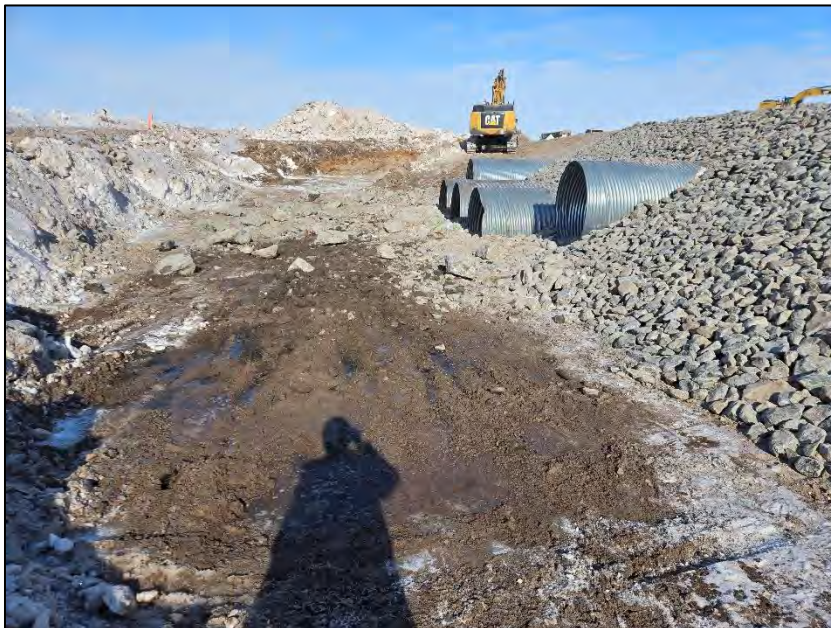
**PHOTO 22.** Following Construction - Vantage Point 3 - Completed south (inlet) apron with Coarse Riprap and Stream Substrate Material - Looking Northwest (May 04, 2024).

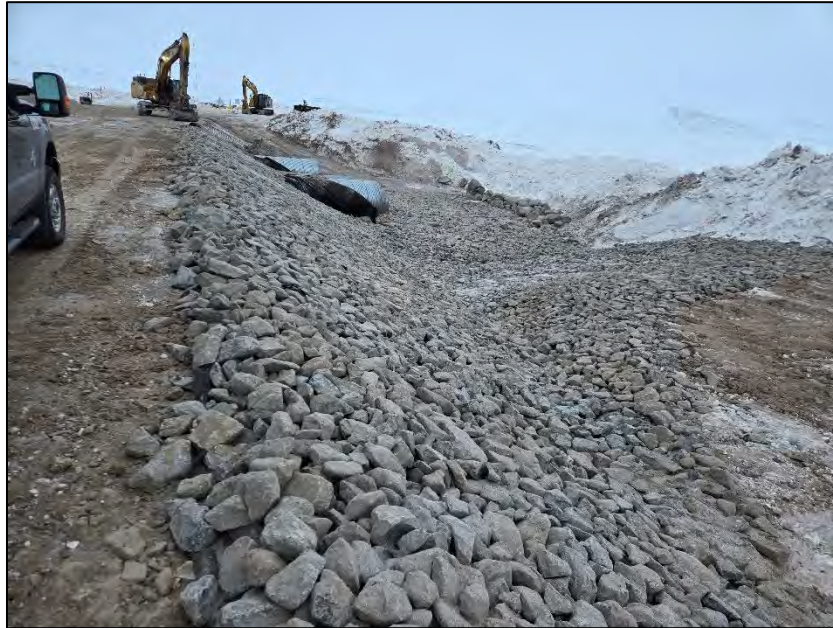
**PHOTO 23.** After Vantage Point 2 - Completed Downstream Outlet Apron and Slope Stabilization - Downstream Outlet Area - Looking North (May 03, 2024).

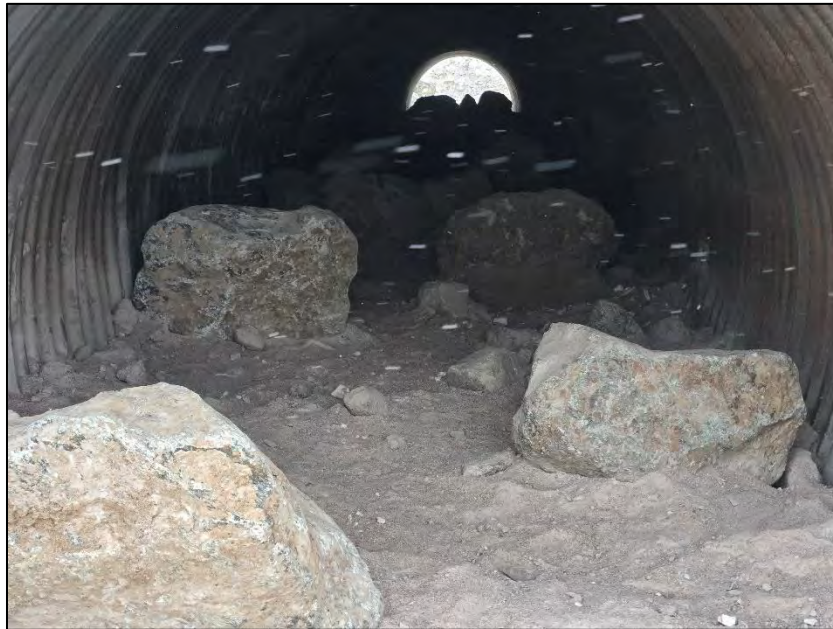
**PHOTO 25.** Following Construction - Completed placement of boulder clusters and coarse riprap and stream substrate material within the interior of the low flow culvert (May 03, 2024).

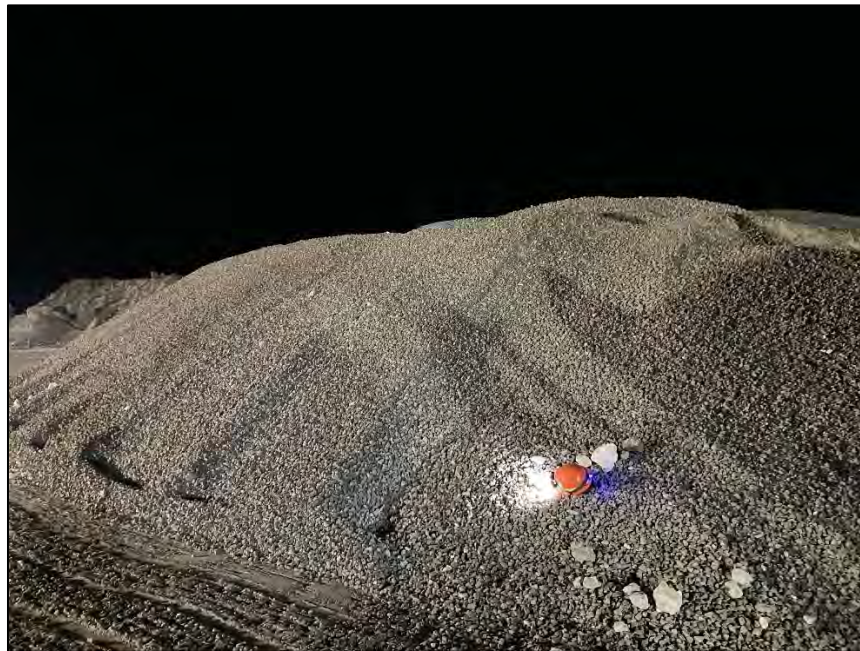
**PHOTO 26.** Material Stockpile - 32 mm minus Culvert Backfill Material - km 60 Laydown - Looking Northeast (March 10, 2024).

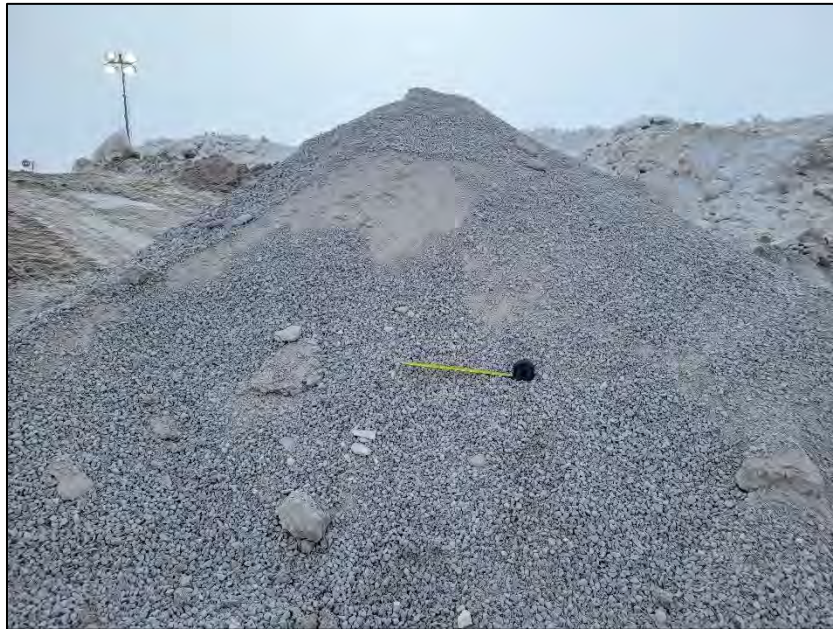
**PHOTO 27.** Material Stockpile - Culvert Bedding Material - km 80 Laydown - Looking North (April 20, 2024).

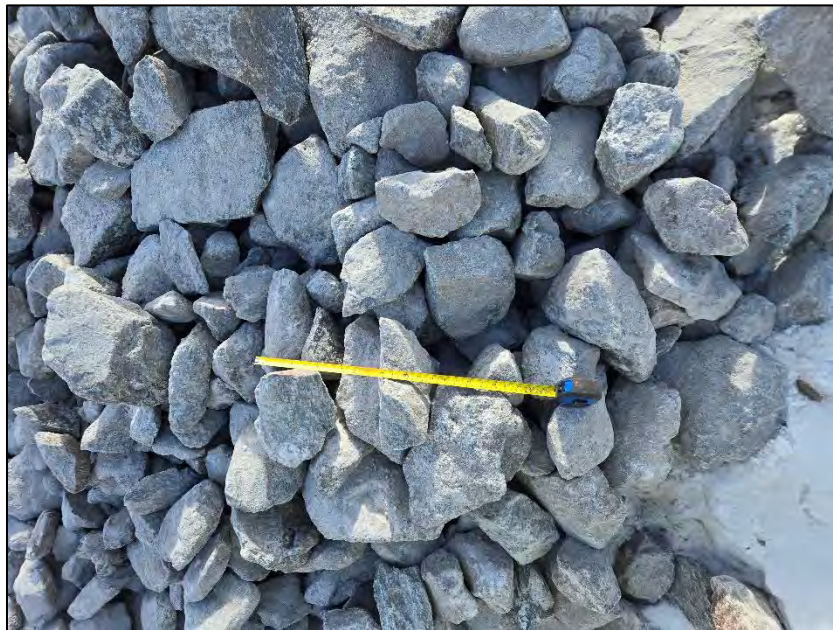
**PHOTO 28.** Material Stockpile - Fine Rip Rap - km 80 Laydown (May 01, 2024).

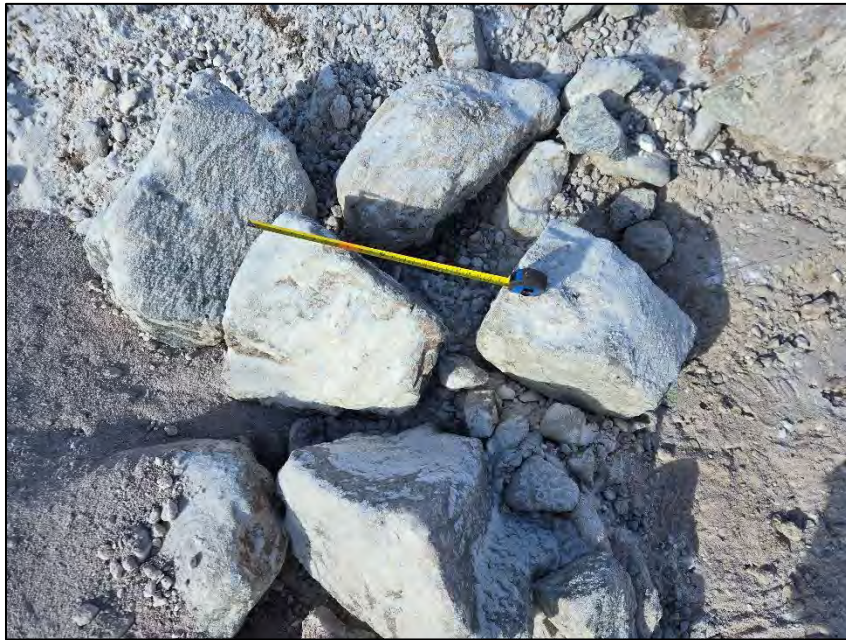
**PHOTO 29.** Material Stockpile - Coarse Rip Rap - km 80 Laydown (May 01, 2024).

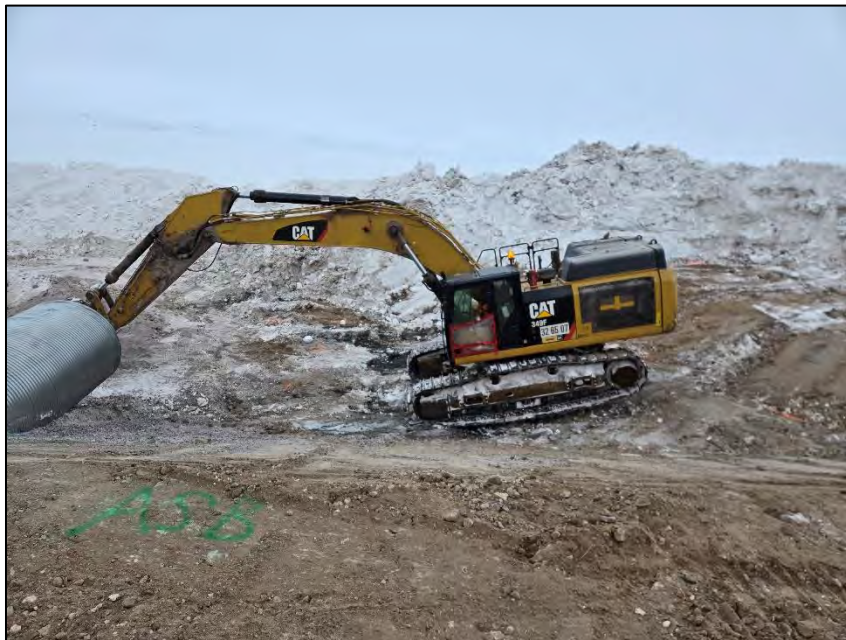
**PHOTO 30.** Equipment - CAT 349F Excavator - km 60 Laydown - looking East (May 02, 2024).

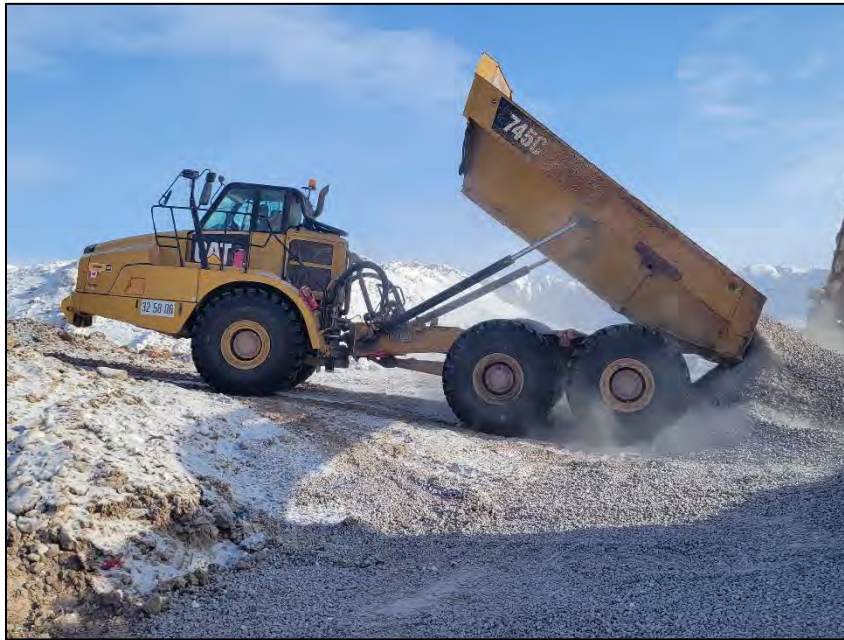
**PHOTO 31.** Equipment - CAT 745C articulated dump truck - km 80 Laydown (April 23, 2024).

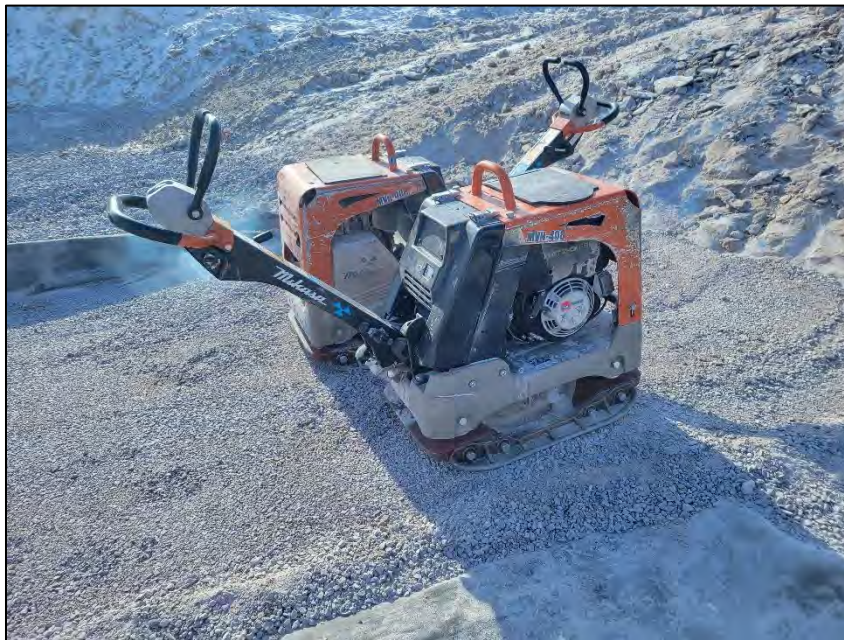
**PHOTO 32.** Equipment - Mikasa MVH408 1000 lbs Plate Compactor - km 80 Laydown (April 20, 2024).

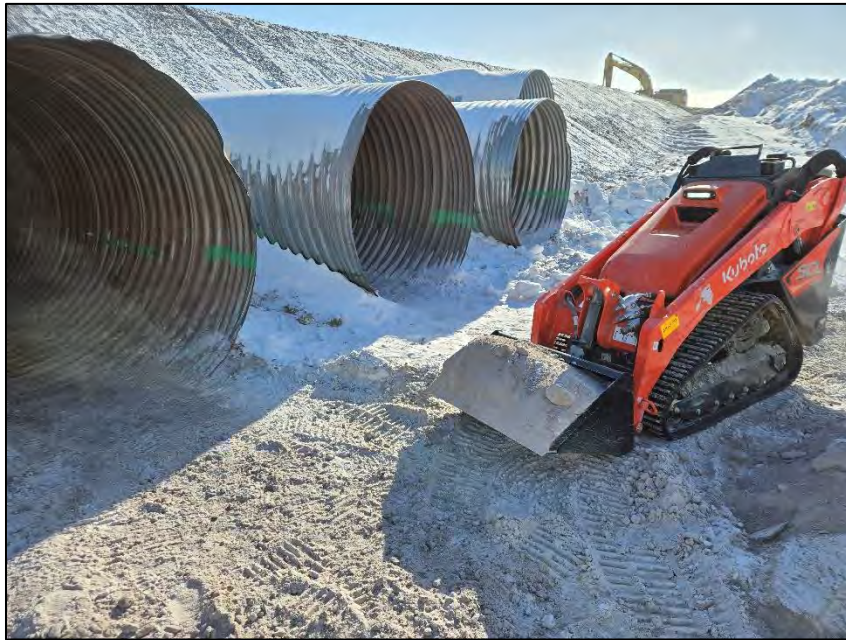
**PHOTO 33.** Equipment - Kubota SCL 100 Stand On Compact Loader - km 80 laydown (May 01, 2024).

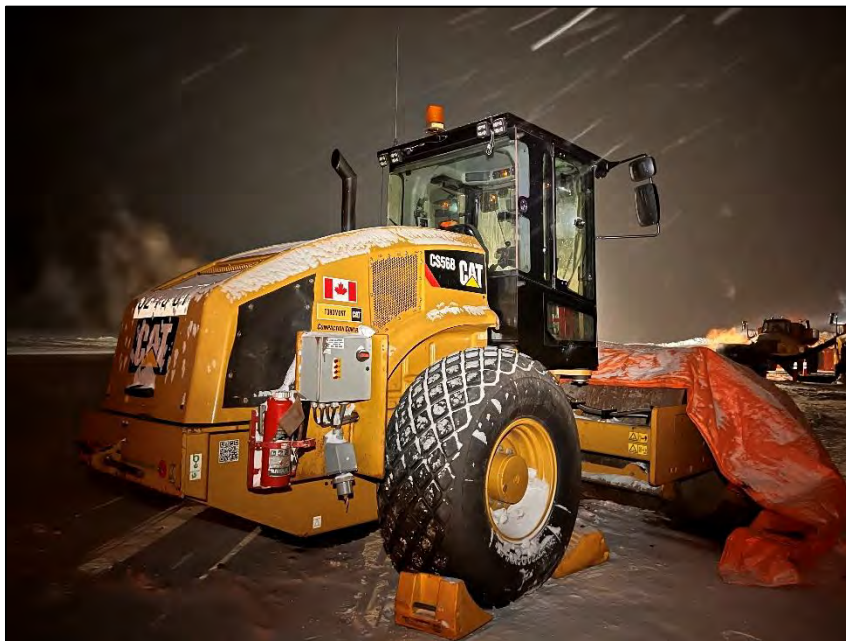
**PHOTO 34.** Equipment - CAT CS56B Smooth Drum Compactor (March 02, 2024).
