CONSTRUCTION SUMMARY REPORT ROUND CSP CULVERTS – FEBRUARY TO MAY 2024

APPENDIX E Design Change Forms

MARY RIVER - TOTE ROAD ROUND CSP CULVERTS

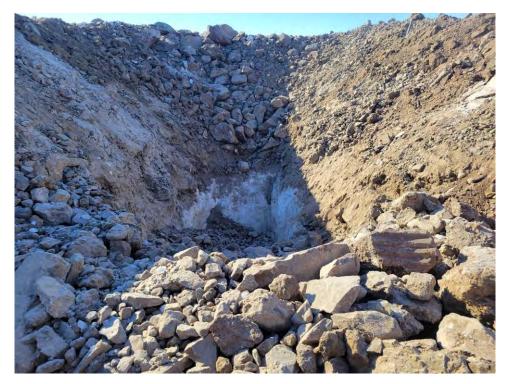
Drilling and blasting at CV-216 during the week of April 8, 2024 exposed massive ice in the northeast portion of the culvert excavation (Photos 1 and 2). Following the discovery of the massive ice on April 12, 2024, Baffinland halted excavation and informed KP. KP reviewed the photos and survey of the massive ice in relation to the design and developed the design change details illustrated on Figure 1.

Photo 1 Looking at the Initial Discovery of Massive Ice at CV-216

The proposed design change for CV-216 consists of over-excavation of the massive ice below the culvert and the installation of fill and insulation to minimize the impacts of ambient temperatures and heat laden water flows on the ice beneath the culvert foundation (i.e. minimize potential for thawing).

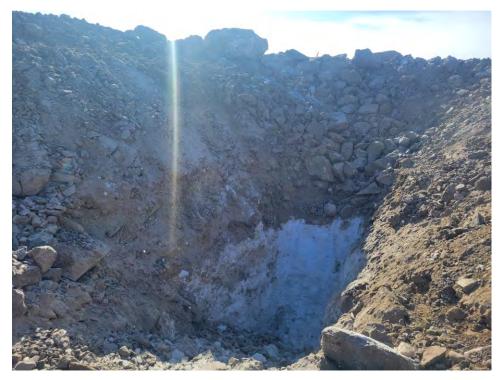
Photo 2 Looking at the Massive Ice after further excavation at CV-216

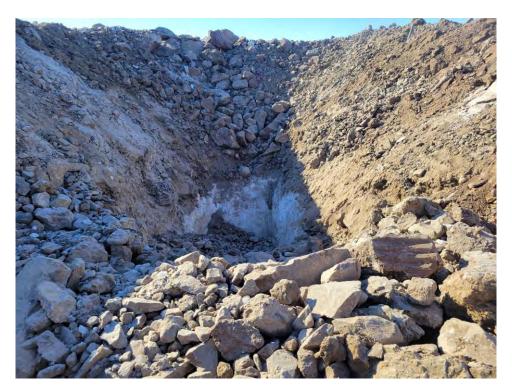
Drilling and blasting at CV-216 during the week of April 8, 2024 exposed massive ice in the northeast portion of the culvert excavation (Photos 1 and 2). Following the discovery of the massive ice on April 12, 2024, Baffinland halted excavation and informed KP. KP reviewed the photos and survey of the massive ice in relation to the design and developed the design change details illustrated on Figure 1.

Photo 1 Looking at the Initial Discovery of Massive Ice at CV-216

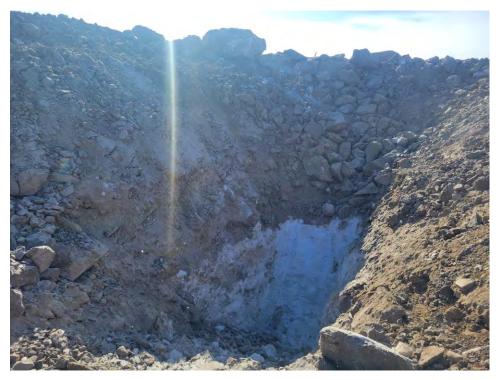
Photo 2 Looking at the Massive Ice after further excavation at CV-216

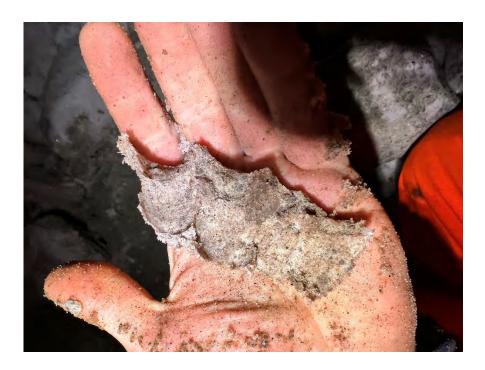
Photo 4 Sample of the snow and stream substrate material mix from hole in Photo 3

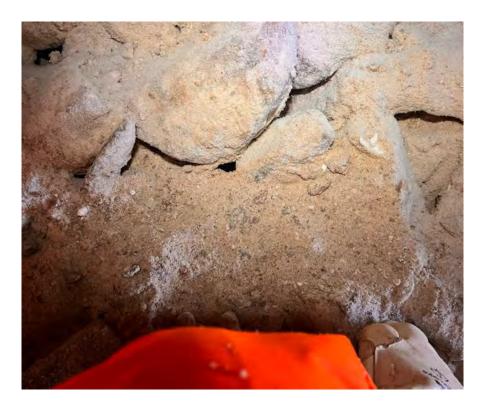
Photo 5 Snow mixed in with the Culvert Infill Material at BG-04 culvert

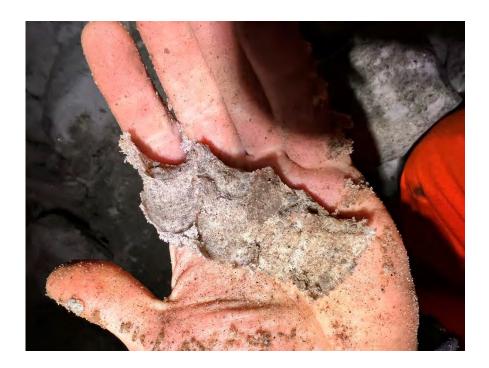
Photo 4 Sample of the snow and stream substrate material mix from hole in Photo 3.

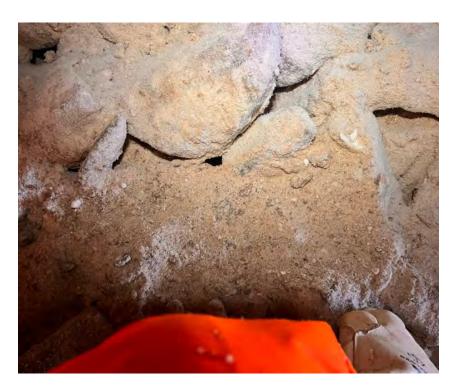
Photo 5 Snow mixed in with the Culvert Infill Material at BG-04.

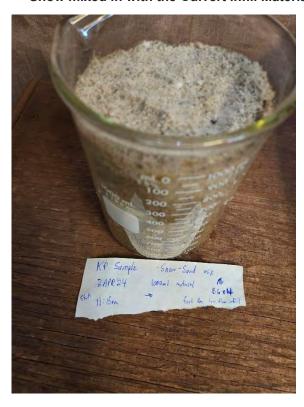
One (1) sample was collected from the identified area of the two (2) low flow culverts at BG-04 on April 3 and allowed to thaw to estimate the volume of snow/ice within the sample. The results indicated that greater than 50% of the volume of the material similar to natural stream substrate (finer portion of the matrix) was comprised of snow/ice (See Photo 6 and 7).

Photo 6 April 3rd Culvert Infill Sample Before Melting.

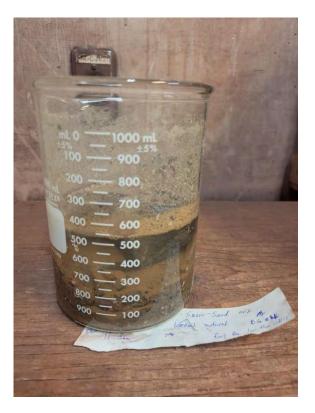
Photo 7 April 3rd Culvert Infill Sample After Melting.

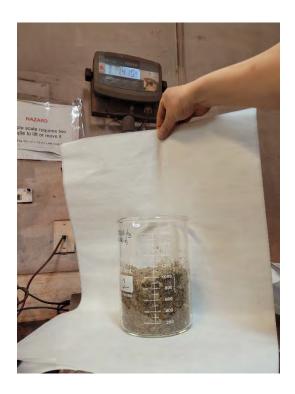
To confirm the observations and initial test results, an additional eight (8) samples were collected on April 9 from the identified non-conforming material in the two low flow culverts at BG-04. Four of the samples were delivered to the on-site ALS laboratory for moisture content testing, and four duplicate samples were retained by KP for comparison. The results of all eight samples indicate that approximately 80% of the volume of the natural stream substrate (finer portion of the matrix) samples consisted of snow and/or ice (See Photos 8 to 18).

Photo 11 Sample 01 prior to melting of snow and ice.

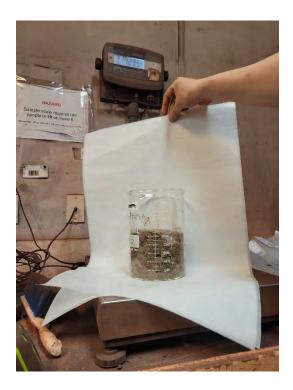
Photo 13 Sample 02 prior to melting of snow and ice.

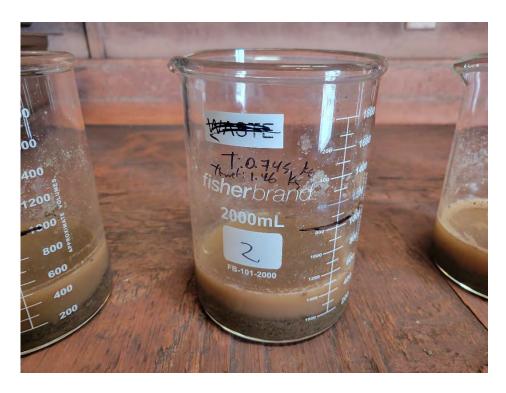
Photo 14 Sample 02 results after melting of snow and ice.

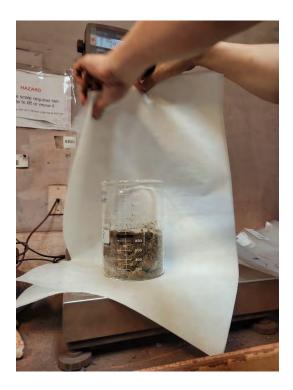
Photo 15 Sample 03 prior to melting of snow and ice.

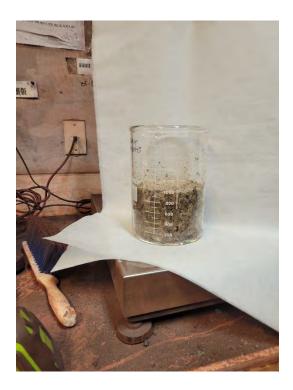
Photo 17 Sample 04 prior to melting of snow and ice.

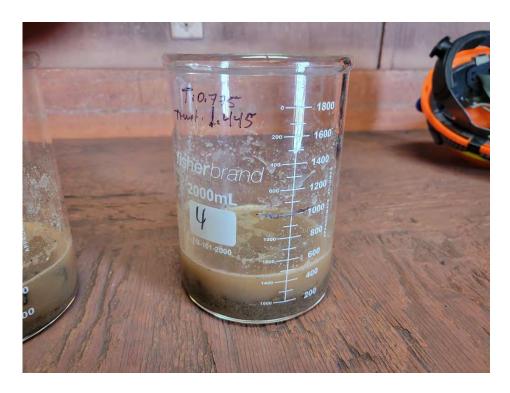
Photo 18 Sample 04 results after melting of snow and ice.

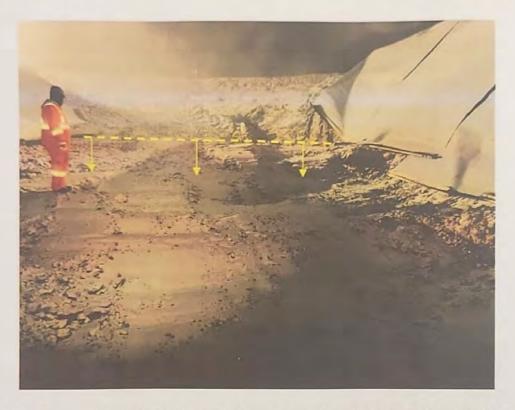
Photo 5 Approximate Subgrade Acceptance Area. Photo taken March 4, 2024.

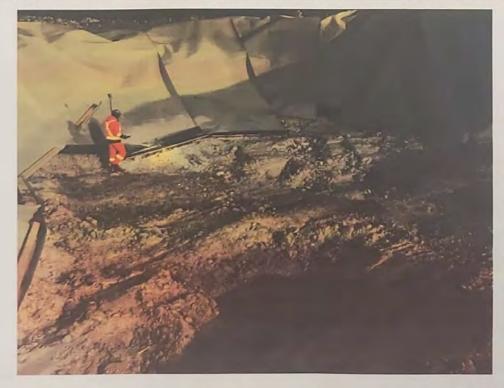
Photo 6 Approximate Foundation Acceptance Area. Photo taken March 4, 2024.

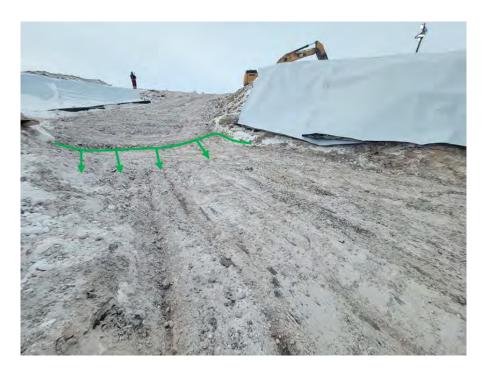
Photo 1: Approximate Foundation Acceptance Area - Section 1, indicated in green. Photo taken March 11, 2024.

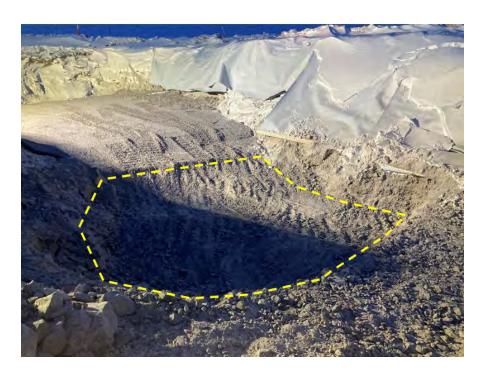
Photo 2: Approximate Foundation Acceptance Area - Section 2, outlined in yellow. Photo taken March 13, 2024.

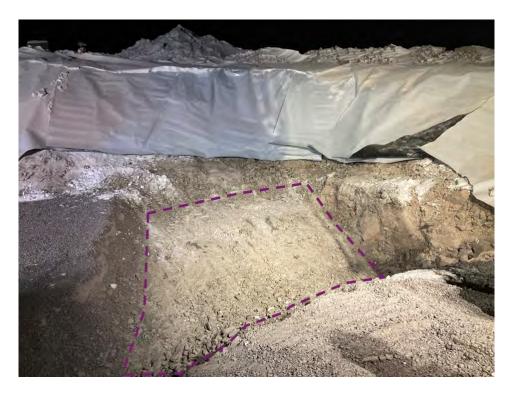
Photo 3: Approximate Foundation Acceptance Area - Section 3, outlined in purple. Photo taken March 14, 2024.

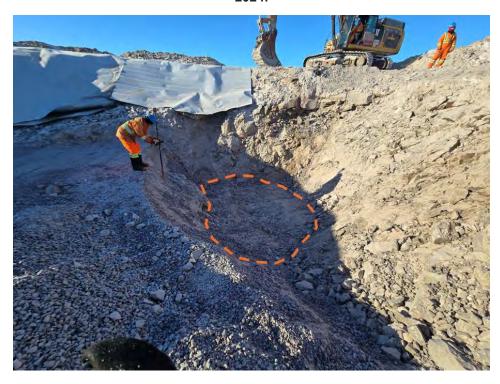
Photo 4: Approximate Foundation Acceptance Area - Section 4, outlined in orange. Photo taken March 15, 2024.

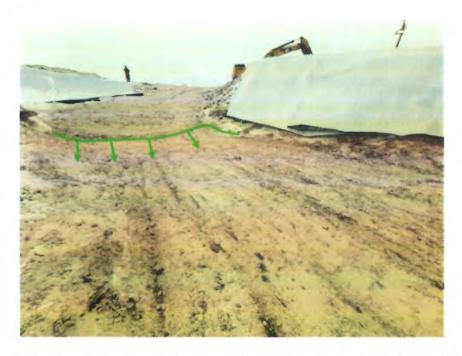
Photo 1: Approximate Foundation Acceptance Area - Section 1, indicated in green. Photo taken March 11, 2024.

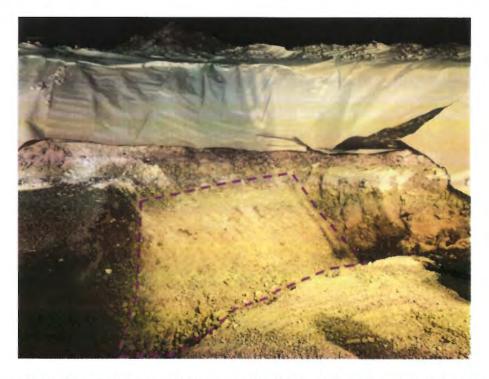
Photo 3: Approximate Foundation Acceptance Area - Section 3, outlined in purple. Photo taken March 14, 2024.

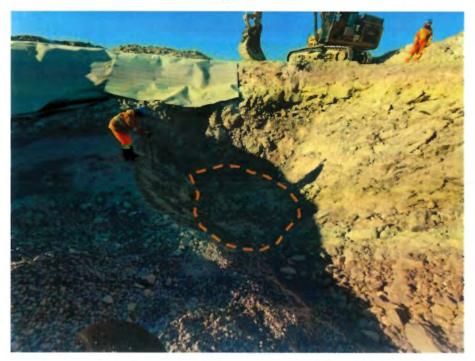
Photo 4: Approximate Foundation Acceptance Area - Section 4, outlined in orange. Photo taken March 15, 2024.

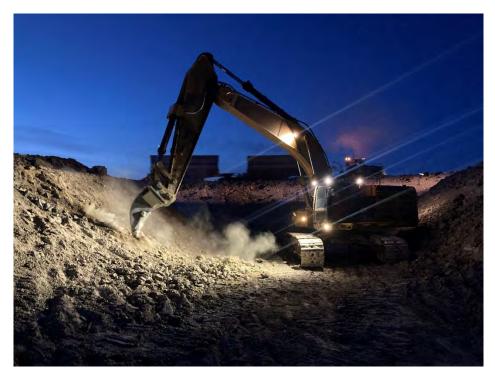
Photo 1 Ripping excavation surface for foundation preparation at BG-04. Photo taken March 26, 2024.

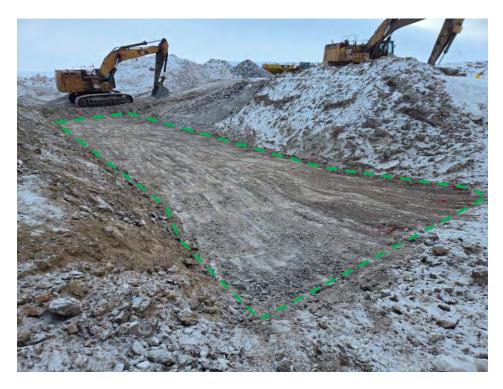
Photo 2 Prepared foundation surface at BG-04 highlighted in green. Photo taken March 28, 2024, looking south.

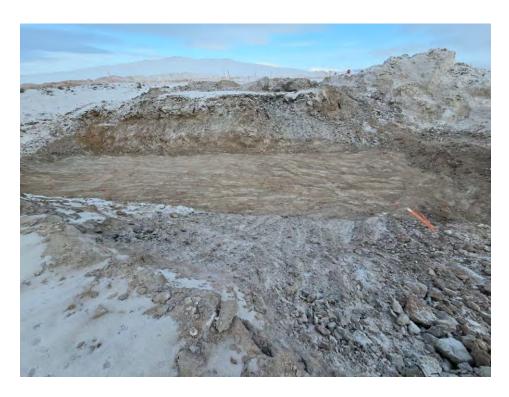
Photo 3 Prepared foundation surface at BG-04. Photo taken March 28, 2024, looking east.

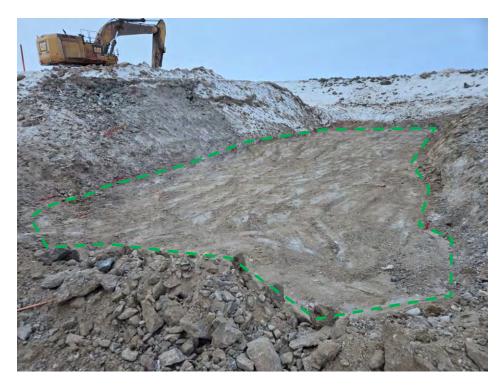
Photo 4 Prepared foundation surface at BG-04. Photo taken March 28, 2024, looking north.

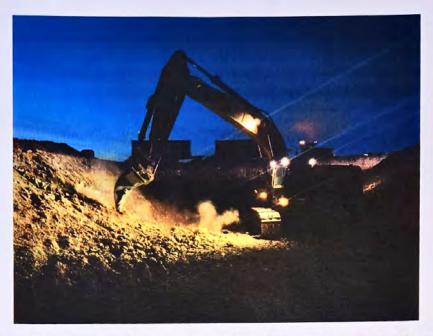
Photo 1 Ripping excavation surface for foundation preparation at BG-04. Photo taken March 26, 2024.

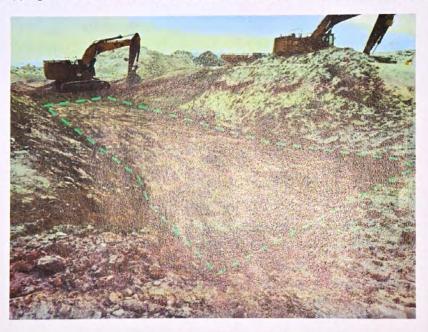
Photo 2 Prepared foundation surface at BG-04 highlighted in green. Photo taken March 28, 2024, looking south.

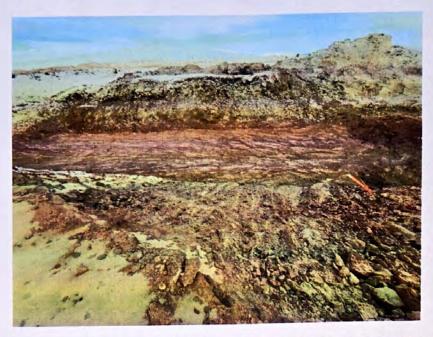
Photo 3 Prepared foundation surface at BG-04. Photo taken March 28, 2024, looking east.

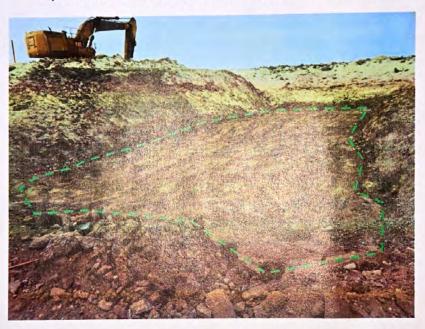
Photo 4 Prepared foundation surface at BG-04. Photo taken March 28, 2024, looking north.

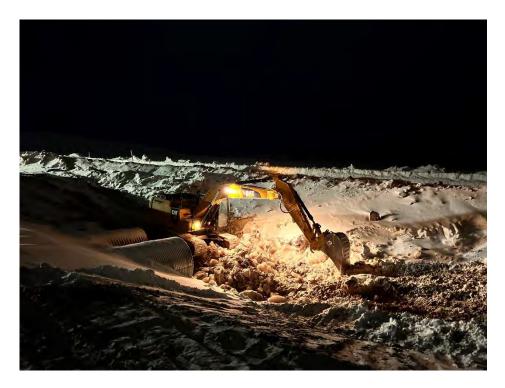
Photo 1 Ripping excavation surface for foundation preparation at BG-04. Photo taken April 10, 2024.

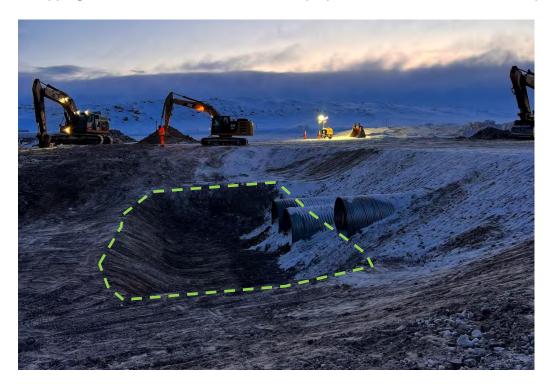
Photo 2 Prepared foundation surface of outlet at BG-04 highlighted in green. Photo taken April 10, 2024, looking north-west.

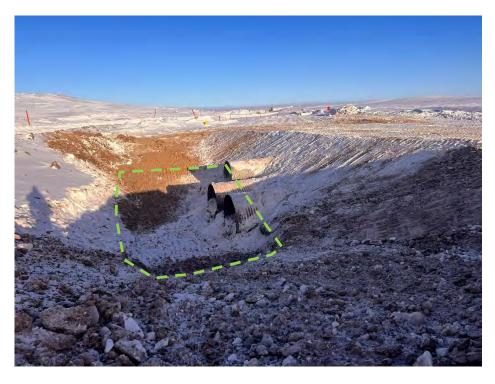
Photo 3 Prepared foundation surface of inlet at BG-04 highlighted in green. Photo taken April 10, 2024, looking east.

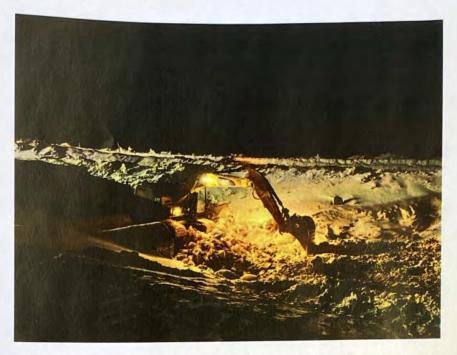
Photo 1 Ripping excavation surface for foundation preparation at BG-04. Photo taken April 10, 2024.

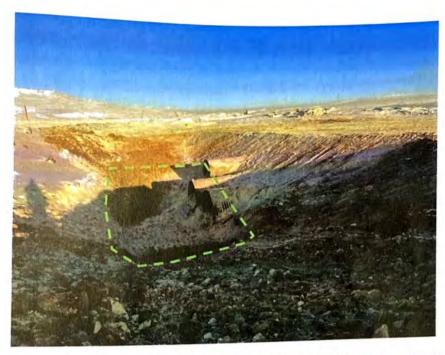
Photo 3 Prepared foundation surface of inlet at BG-04 highlighted in green. Photo taken April 10, 2024, looking east.
