June 10th – June 12th, 2024, Environmental Inspection

RE: Baffinland Iron Mines Corporation's Mary River Project – Qikiqtani Inuit Association September 2024 2nd Annual Site Inspection Findings and Recommendations

Baffinland Mine Site Investigations APPENDIX A - PHOTOGRAPHS

Baffinland Mine Site Unscheduled Environmental Investigation

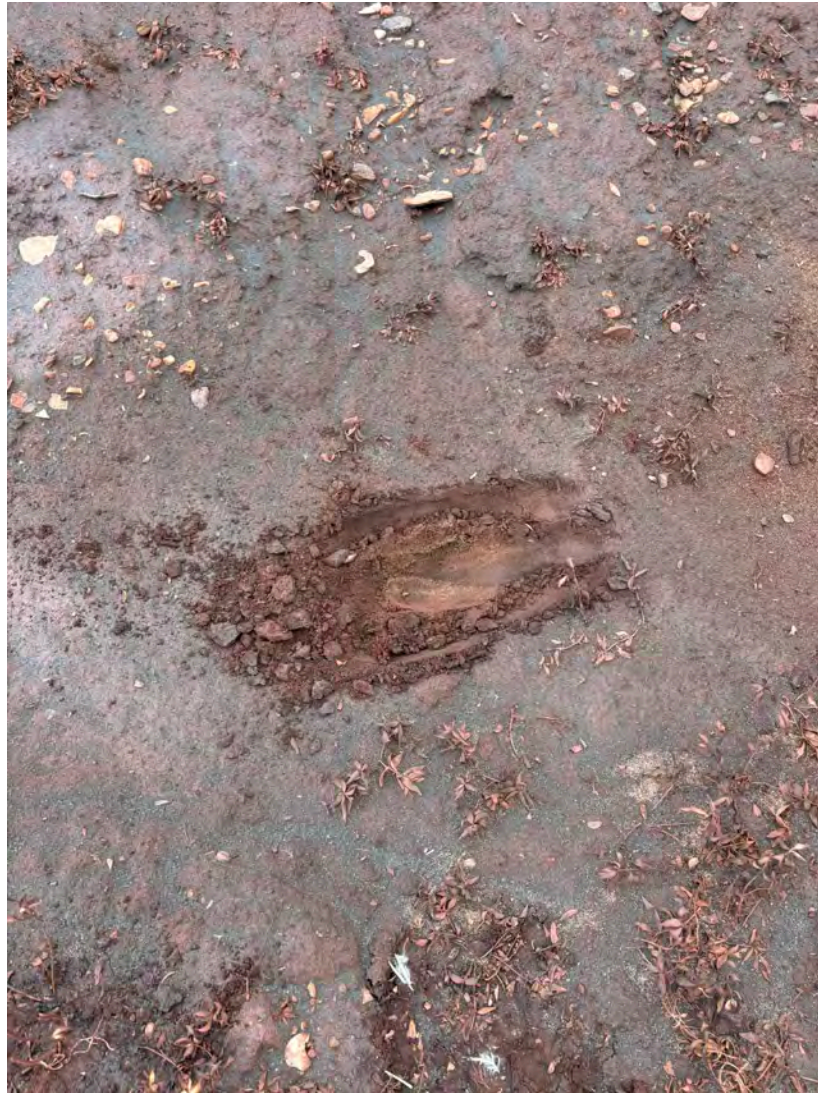
Photo 21 – Milne Port beach sample location (Sep 2024).

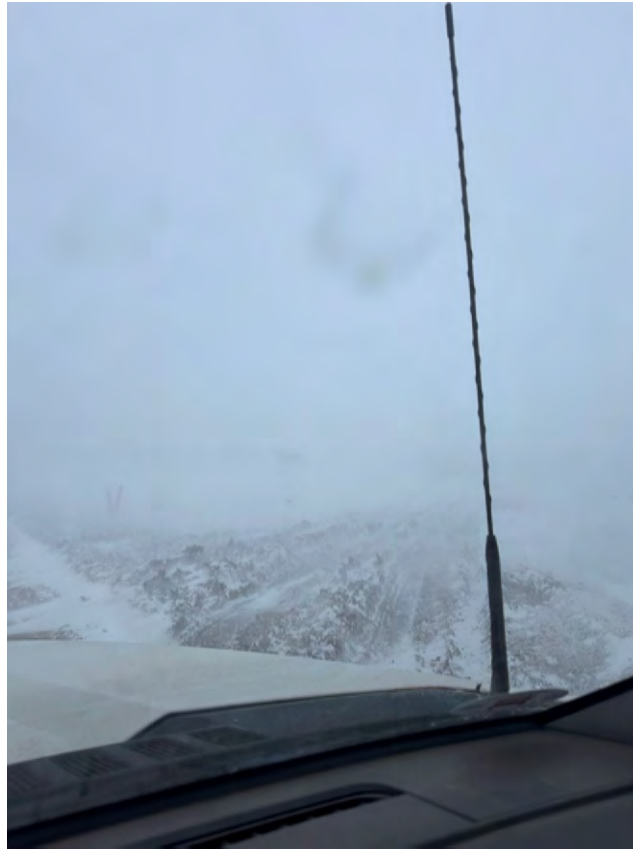
Photo 1 – White out conditions at the Waste Rock Facility that prevented access (Oct 2nd, 2024).

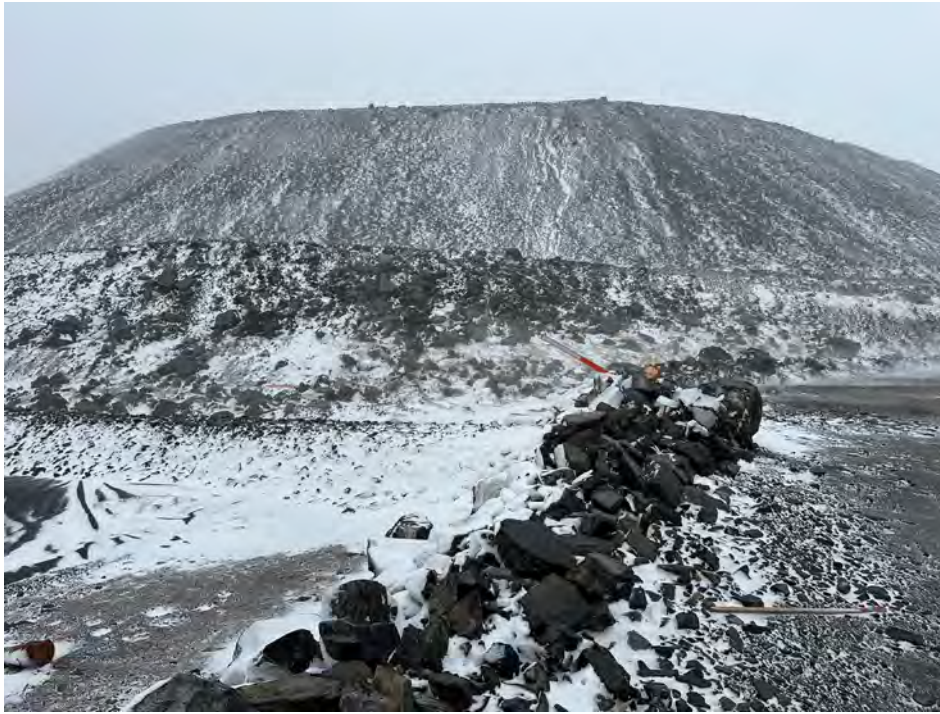
Photo 3 – KM106 Stockpile (Oct 2nd, 2024).

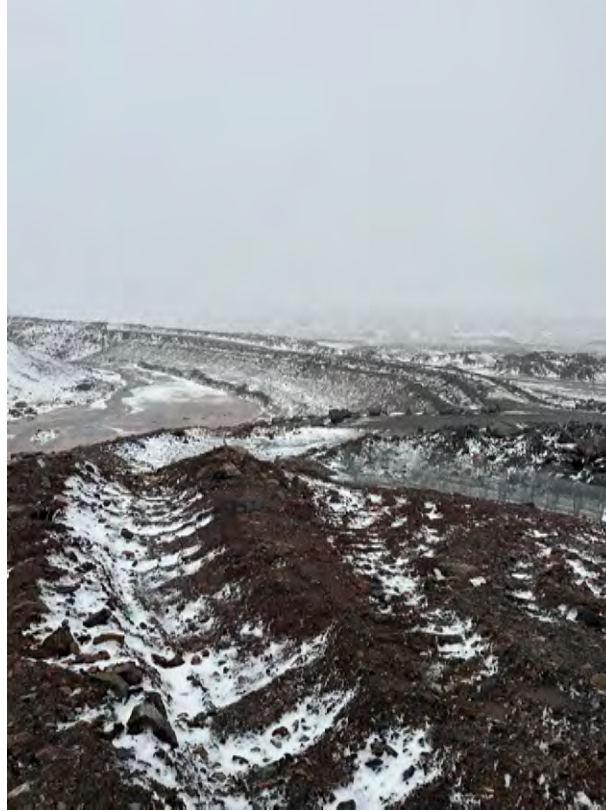
Photo 5 – Runoff collection upstream of KM105 Pond, turbidity is noticeable (Oct 2nd, 2024).

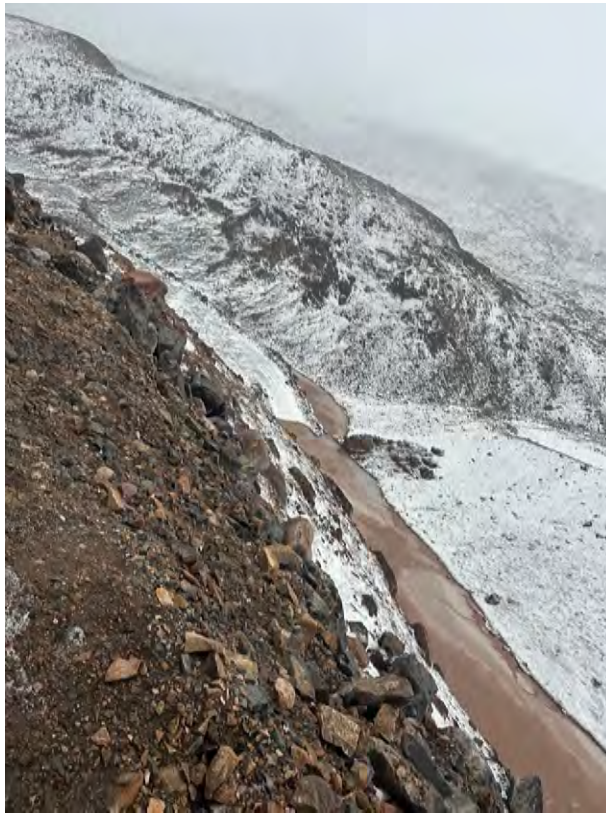
Photo 6 – Collection area upstream of KM105 Pond, turbidity is noticeable (June 10, 2024).

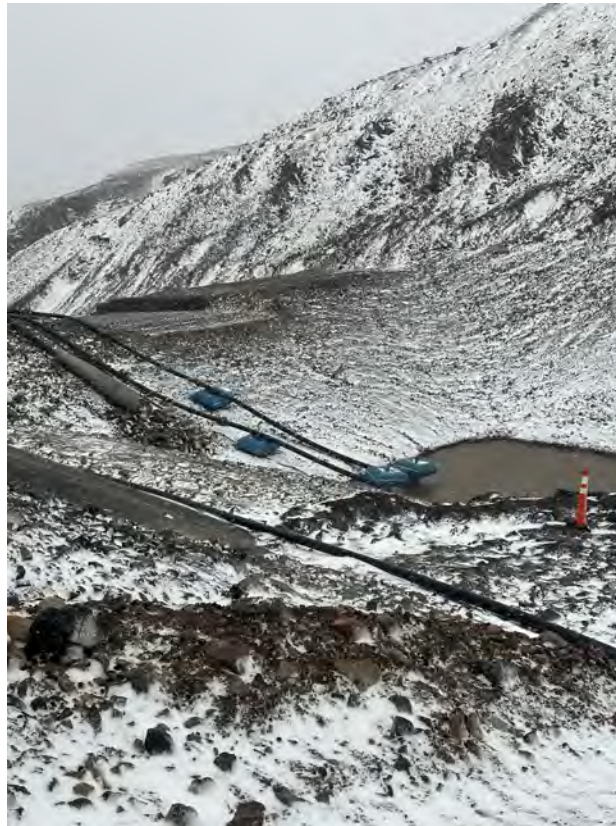
Photo 7 – KM105 Pond (Oct 2nd, 2024).

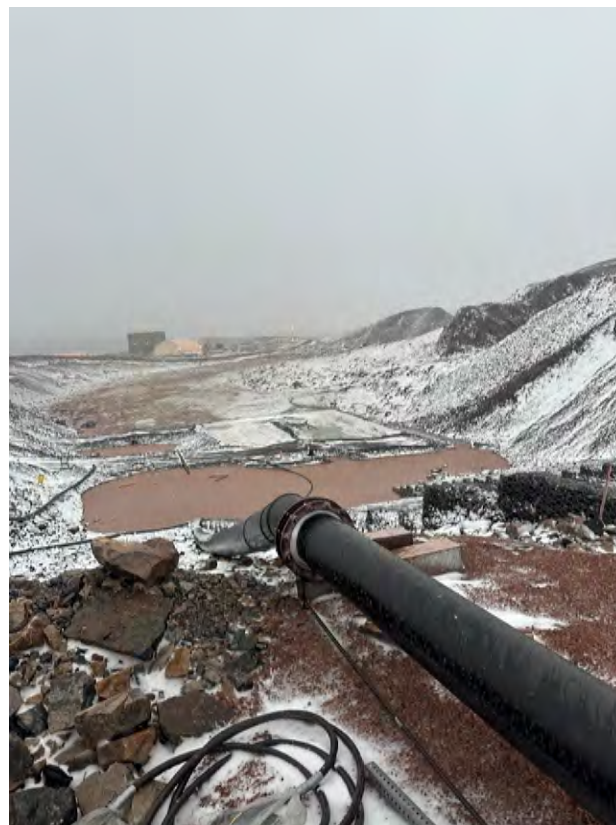
Photo 8 – KM105 Dam looking downstream towards Sailiivik Camp (Oct 2nd, 2024).

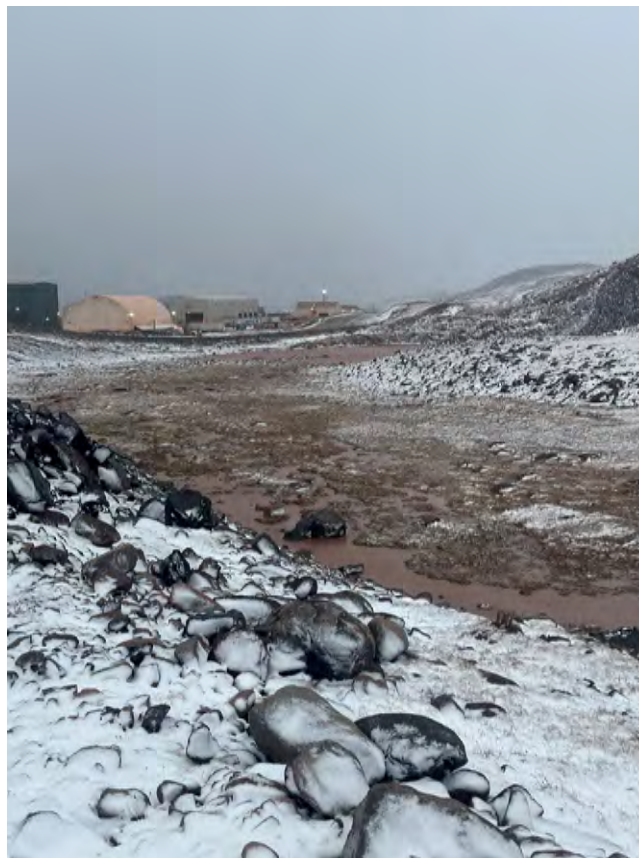
Photo 10 – Tundra below KM105 Dam (Oct 2nd, 2024).

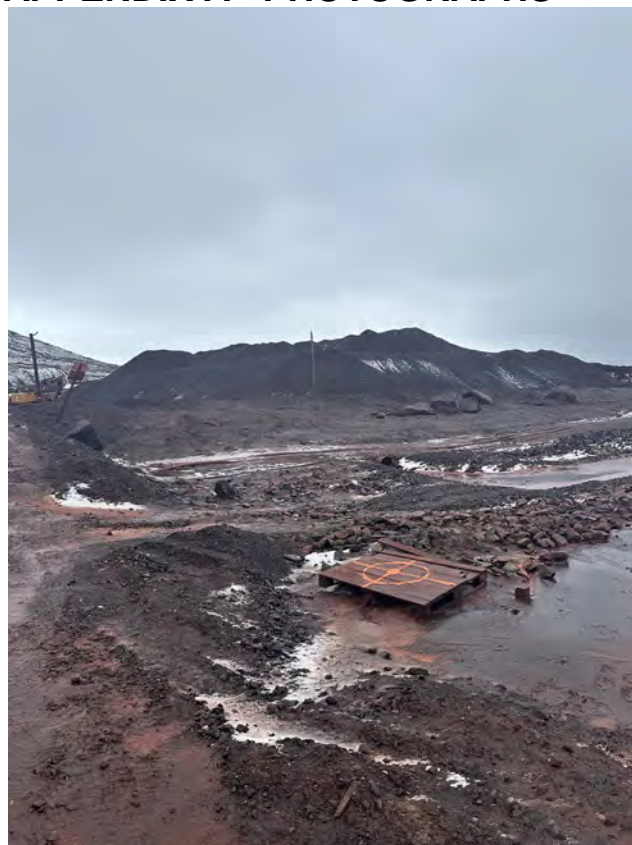
Photo 11 – Stockpile at the crusher pad. (Oct 2nd, 2024).

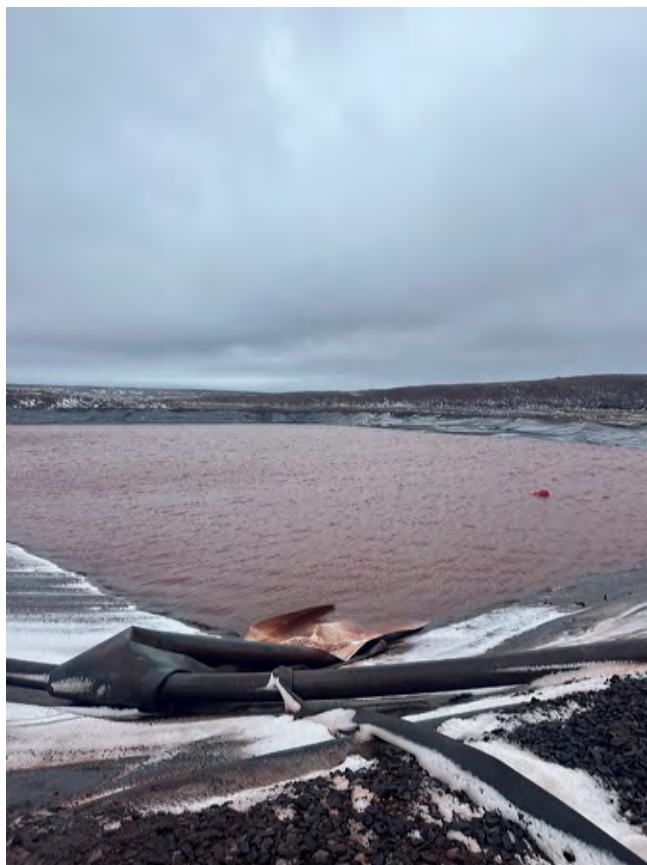
Photo 12 – Crusher Pond (Oct 2nd, 2024).

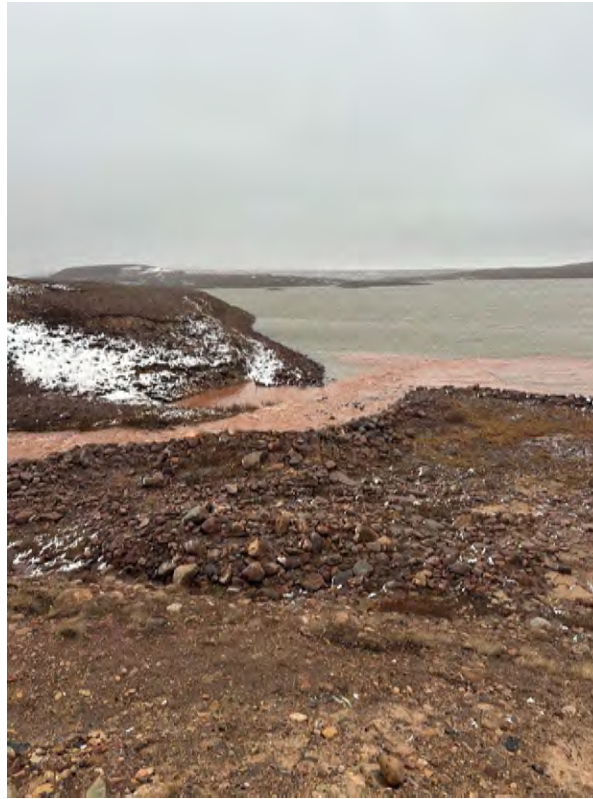
Photo 13 – Sheardown Tributary entering Sheardown Lake. The water is noticeable turbid in the tributary and lake (Oct 2nd, 2024).

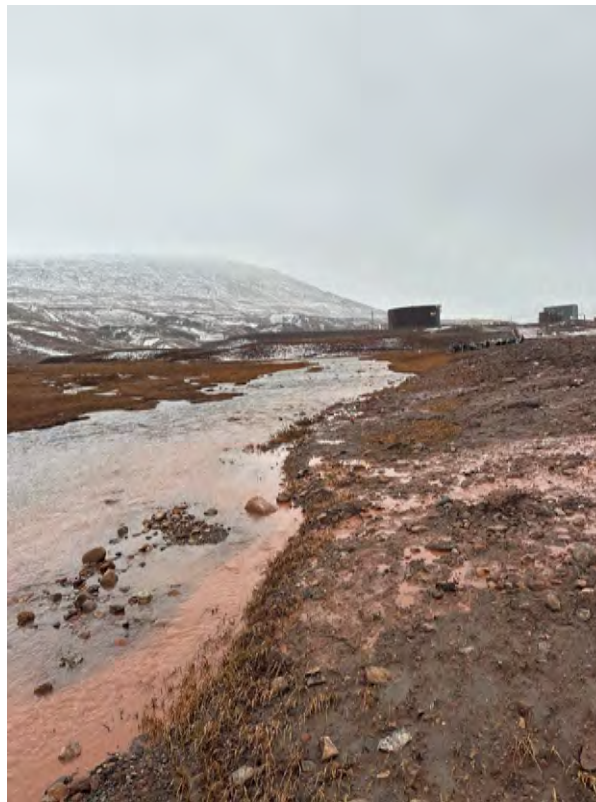
Photo 14 – Runoff from the road behind Sailiivik Camp entering Sheardown Tributary (Oct 2nd, 2024)

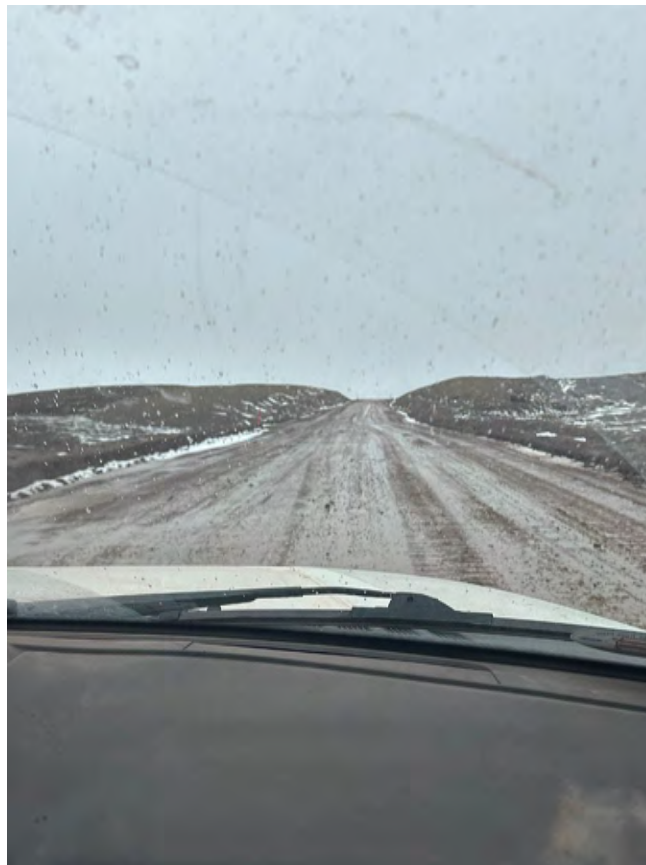
Photo 16 – Status of the Tote Road (Oct 2nd, 2024)

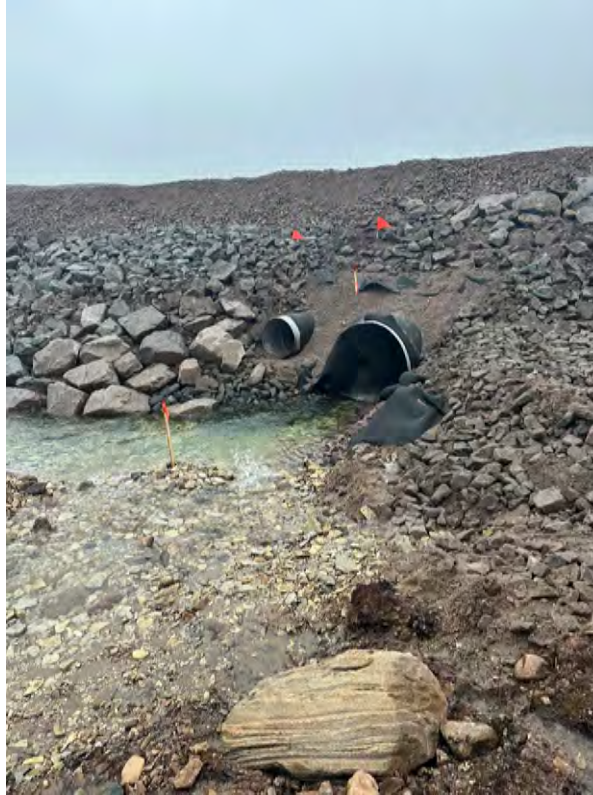
Photo 17 – Culvert replacement at ~KM63.5 (Oct 2nd, 2024).

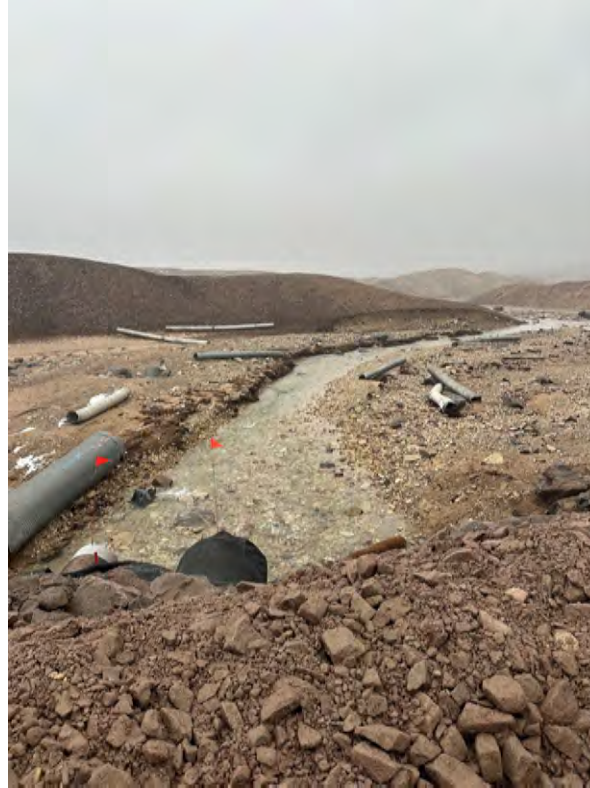
Photo 19 – Culverts scattered across the landscape at KM63.5 (Oct 2nd, 2024).

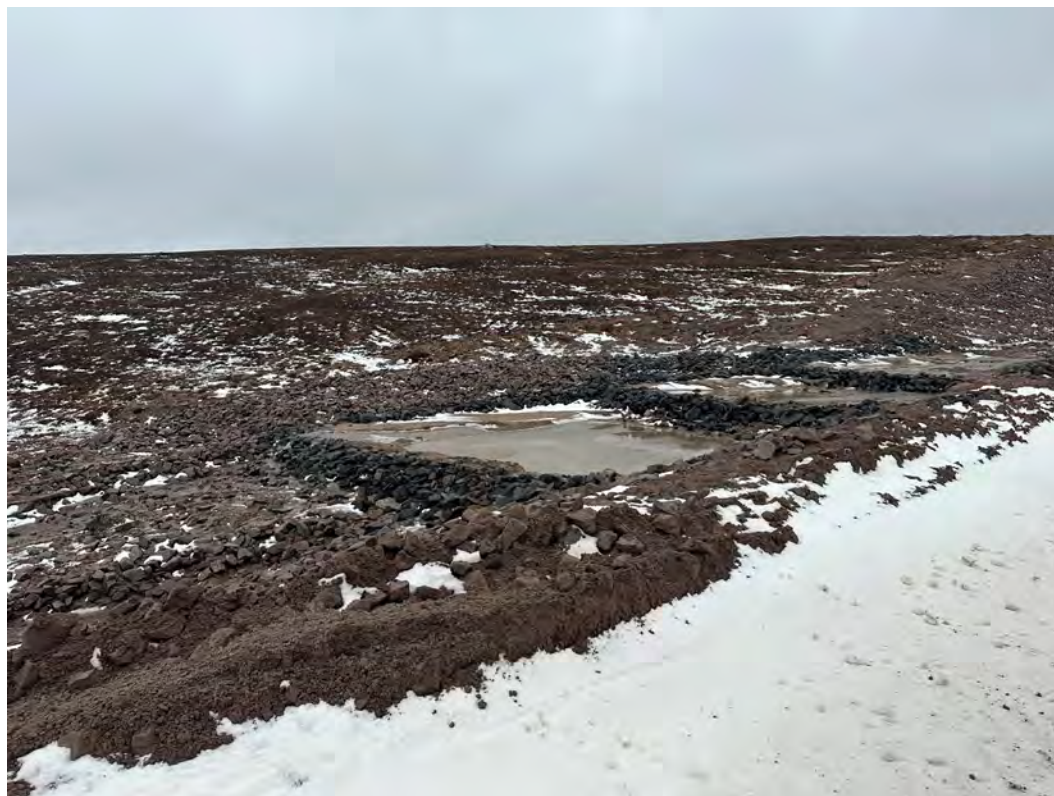
Photo 22 – Check dam at KM72 Dip (Oct 2nd, 2024).

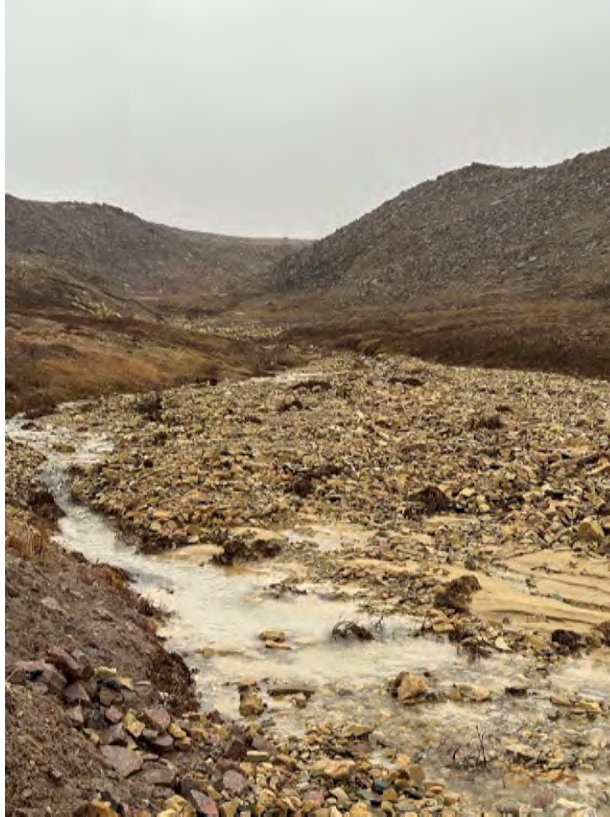
Photo 23 – KM86 washout event deposited high quantities of material and altered the natural watercourse (Oct 2nd, 2024).

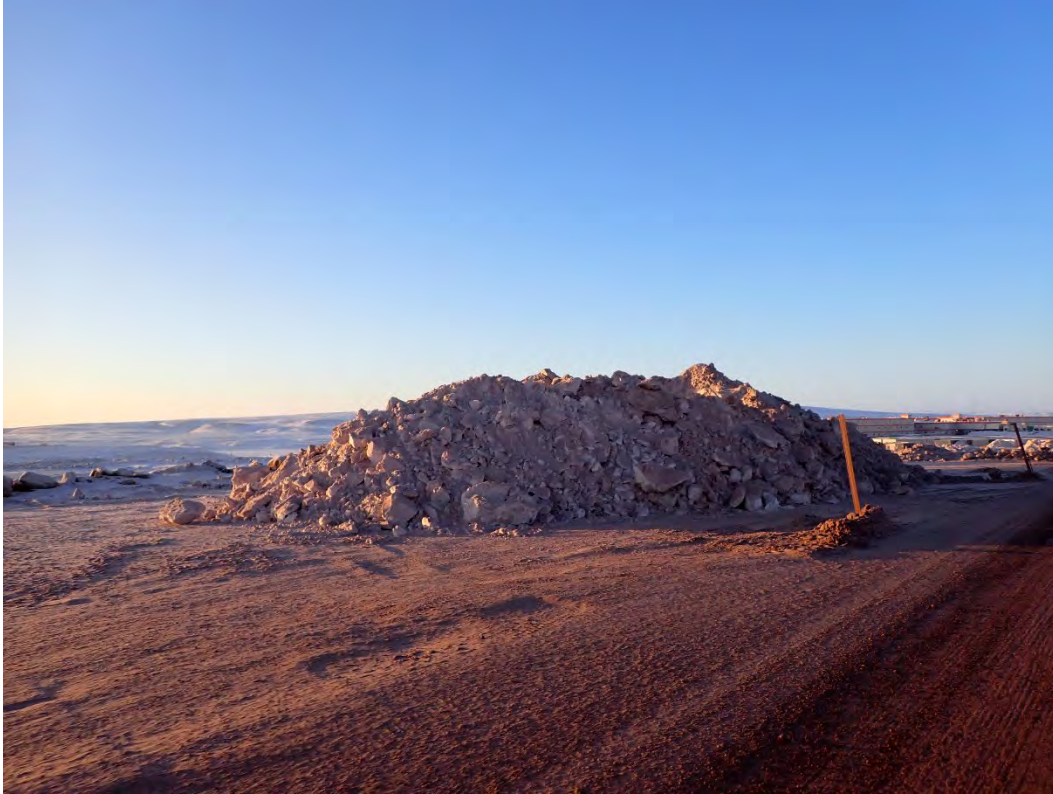
Photo 1 – Temporary snow stockpile immediately south of the mine road to be removed in order to ensure no sediment be deposited into Sheardown Lake Tributary - February 9, 2025

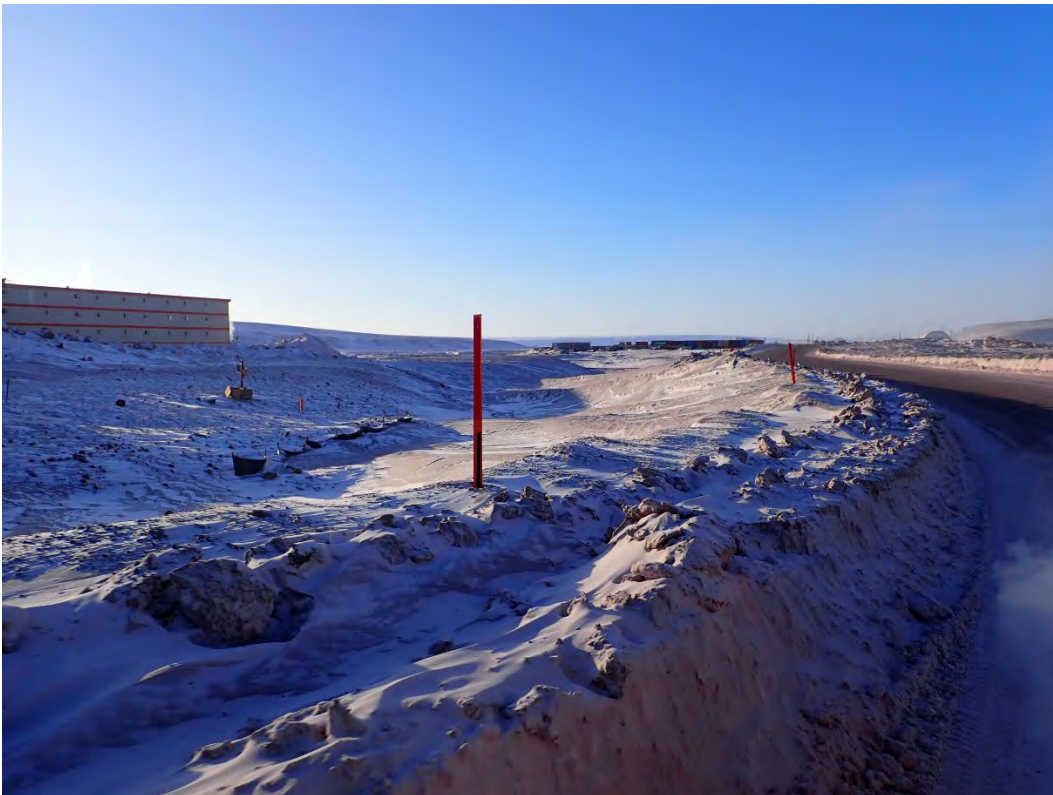
Photo 2 – Sheardown Tributary North of Sailiivik Camp showing clear delineation of road and no snow pushed into the stream channel – February 9, 2025

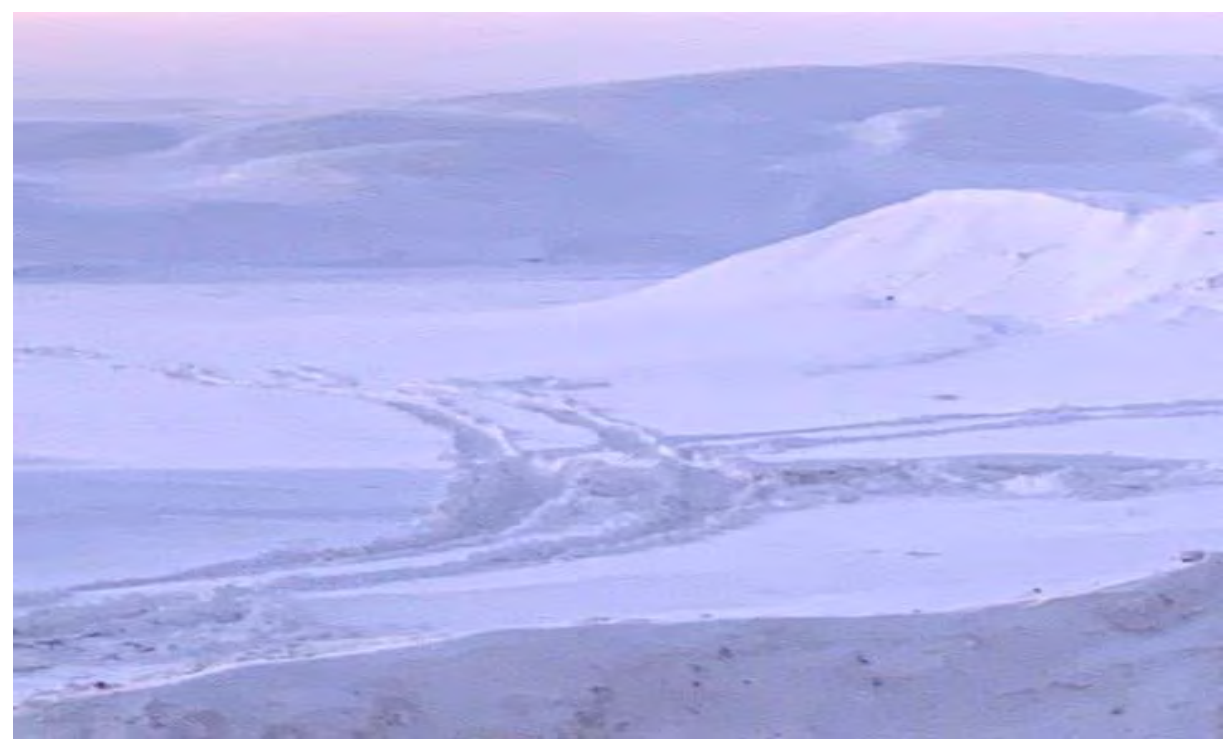
Photo 3. KM 63.5, excavator tracks leading out to retrieve culverts down stream of crossing, 2024-11-28

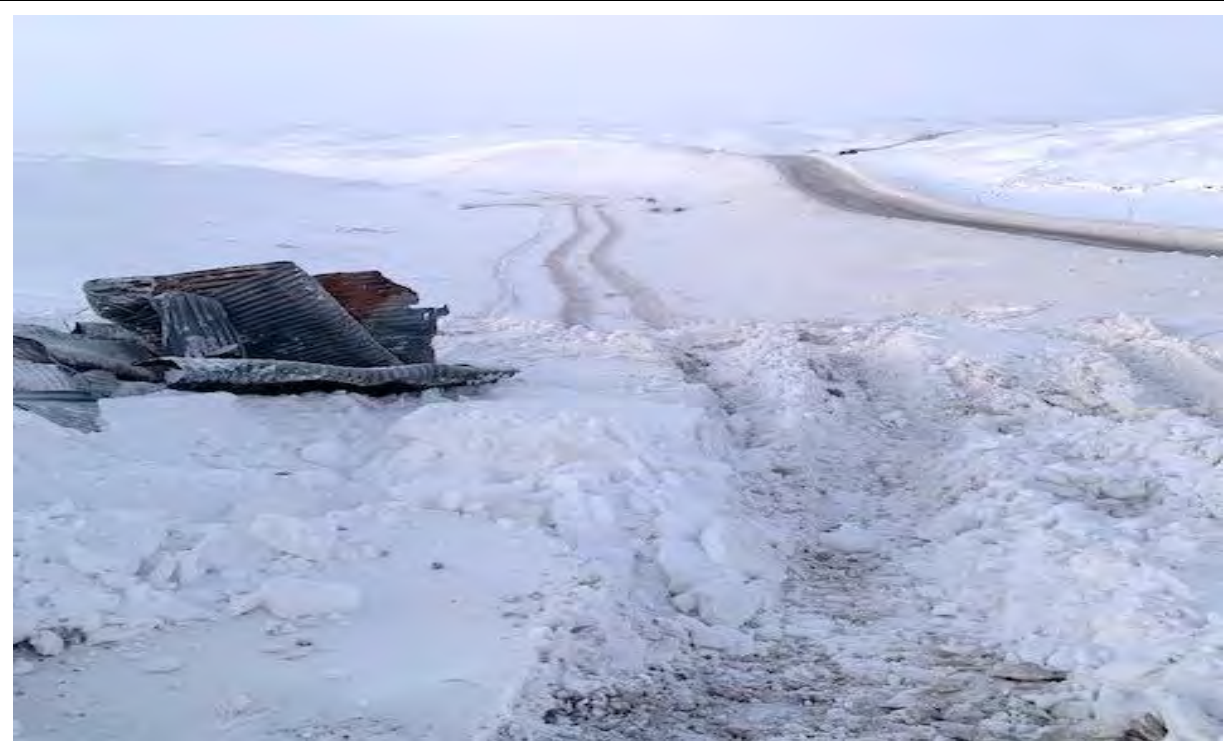
Photo 4. KM 63.5, Culverts retrieved from watercourse, staged next to Tote Road for pick-up and final disposal, 2024-11-28

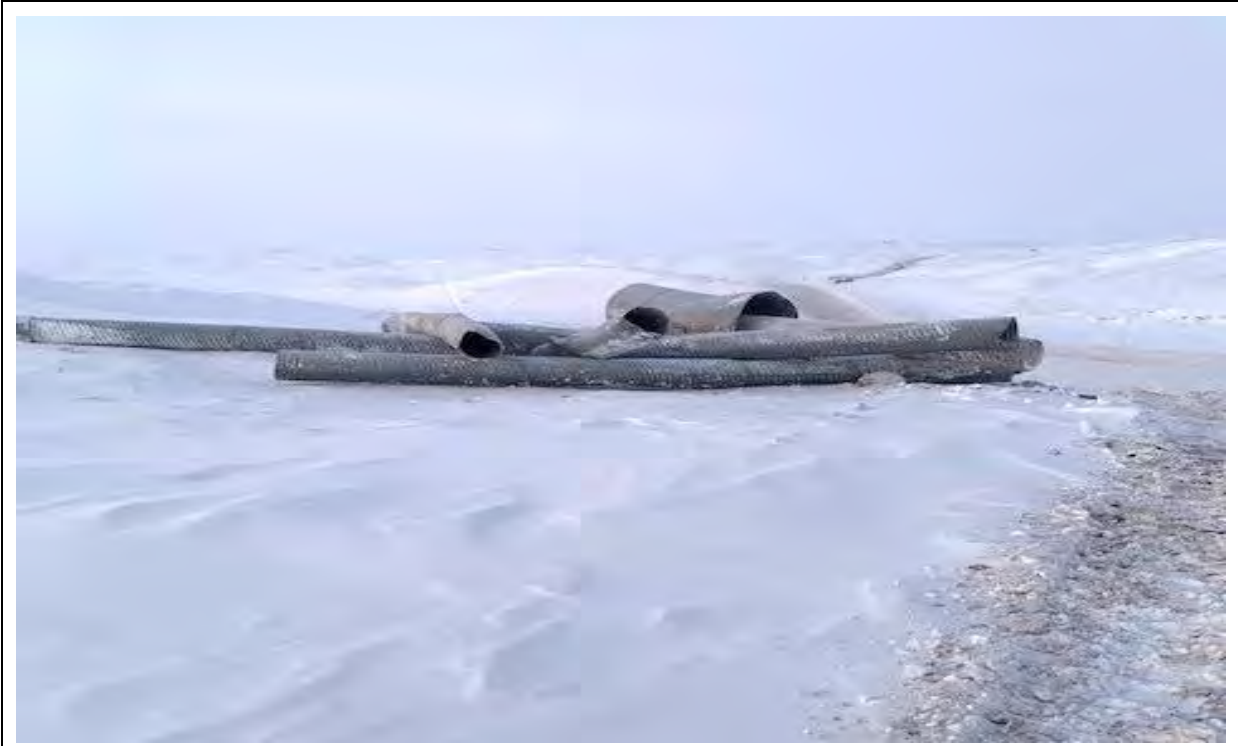
Photo 5. KM 63.5, Culverts retrieved from watercourse, staged next to Tote Road for pick-up and final disposal, 2024-11-28

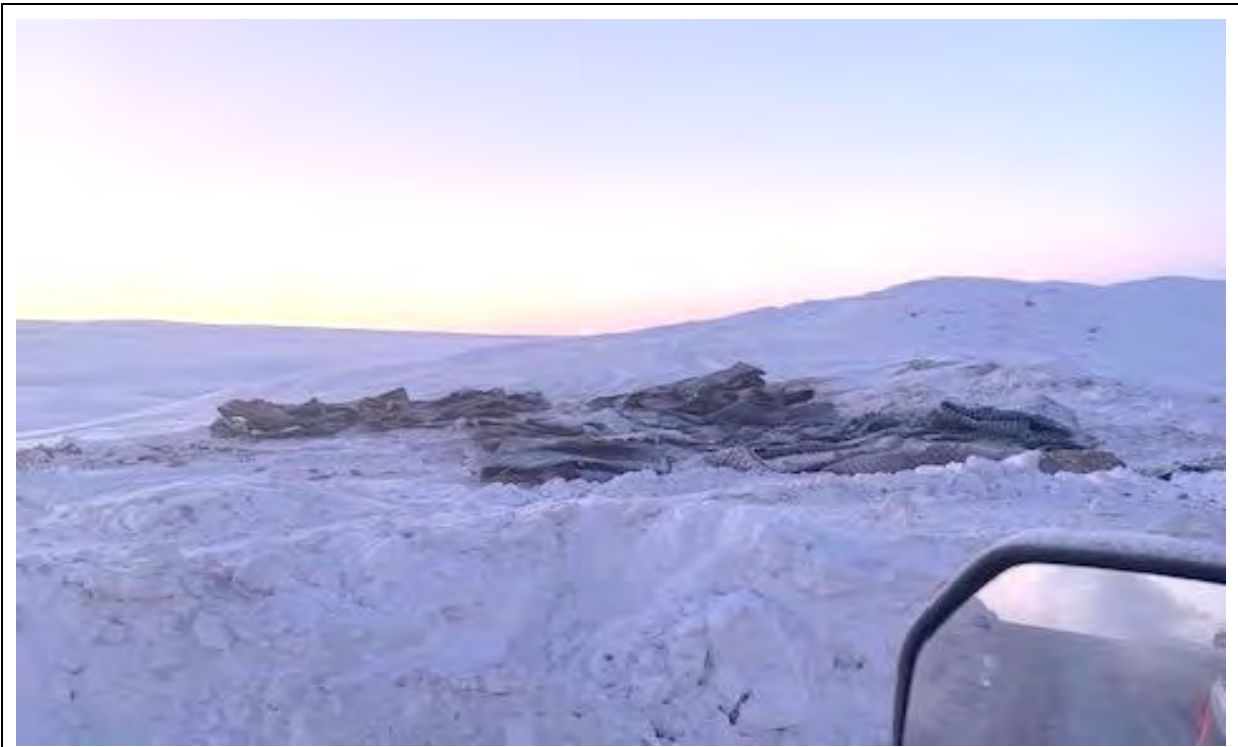
Photo 6. KM 63.5, Culverts retrieved from watercourse, staged next to Tote Road for pick-up and final disposal, 2024-11-28

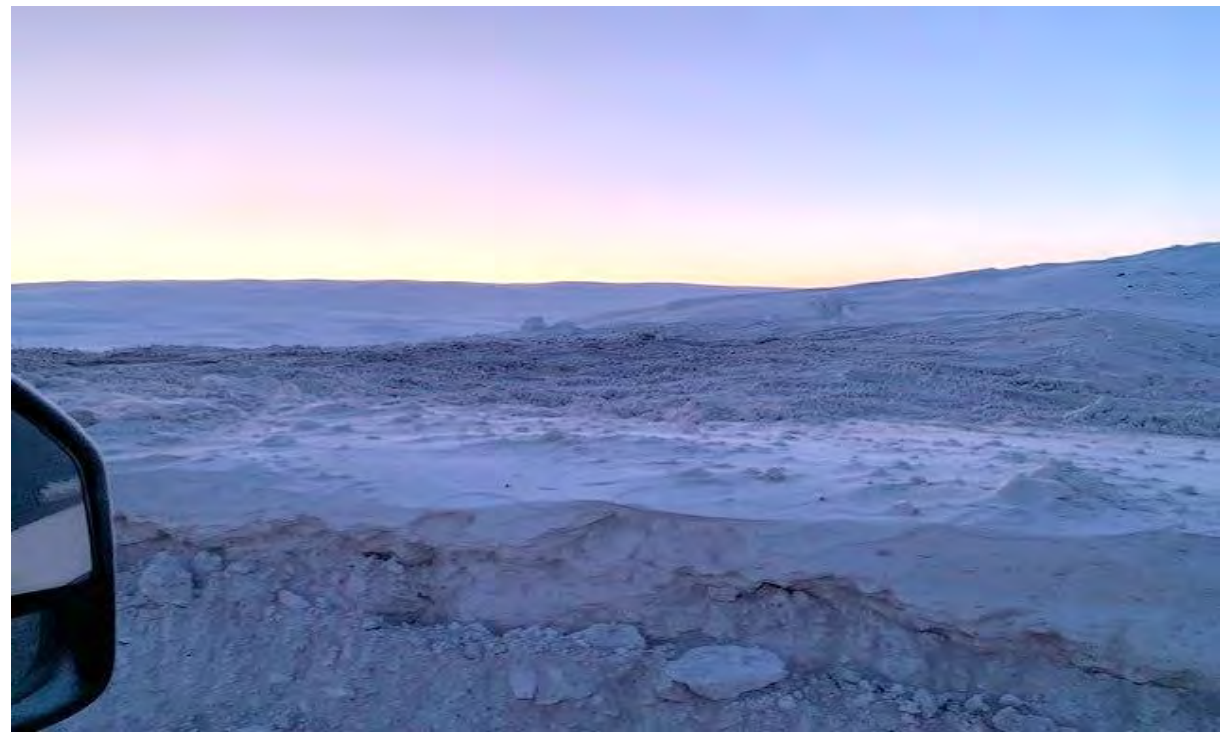
Photo 7. KM 63.5, Culvert staging area empty, after transporting culvert debris for disposal, 2024-11-29
