Water Licence Inspection Report

Authorization	Representative
Baffinland Iron Mines	William Bowden/Scott Klingmann
Authorization No. / Expiry	Representative's Title
2AM-MRY1325 June 10, 2025	Sr. Environnemental Superintendent/Mine Manager
Inspection Date: January 8, 2025	Inspector: Omer Pasalic
Activities Inspected	
<input type="checkbox"/> Camp, Commercial <input type="checkbox"/> Drilling <input type="checkbox"/> Mining <input type="checkbox"/> Construction <input type="checkbox"/> Reclamation <input type="checkbox"/> Fuel Storage <input type="checkbox"/> Roads/Hauling <input type="checkbox"/> Winter Hauling <input type="checkbox"/> Camp, Private <input checked="" type="checkbox"/> Other Waste Rock Facility/Follow up on the items of concern identified during October 23, 2024 inspection

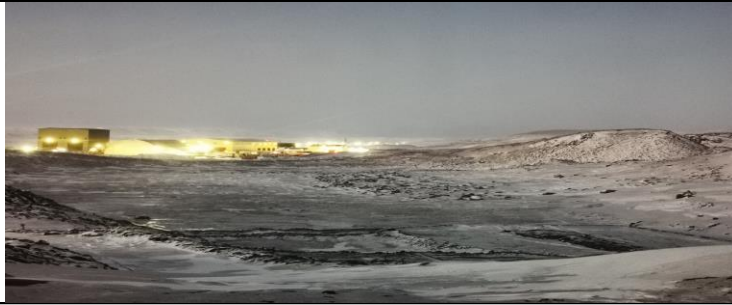
Photo No. 2	Lat/Long (DD.MM.SS.SS, NAD83)
--------------------	--------------------------------------

Photo from the inside of the facility

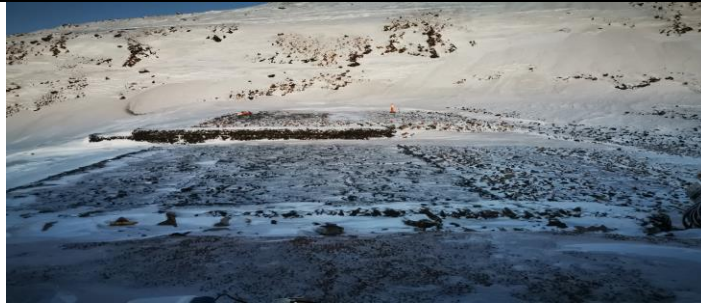
Photo from the inside of the facility

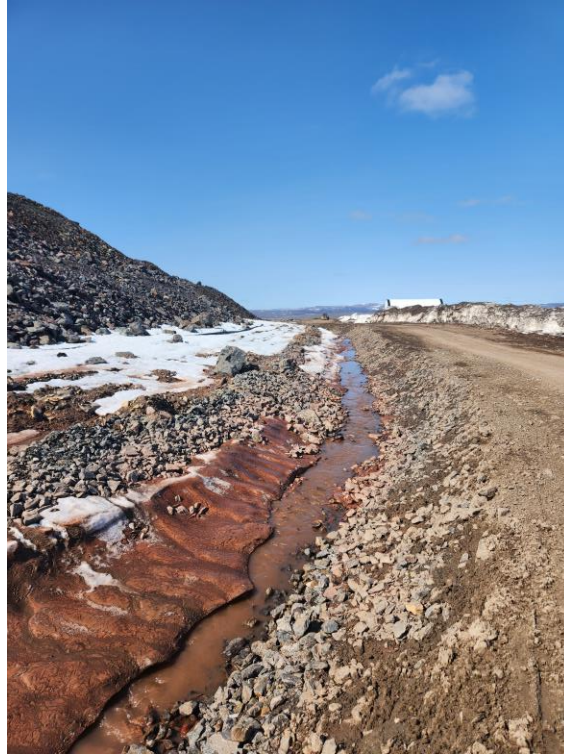
Photo No. 1
Photo

Description:
View of water runoff from the Waste Rock Facility flowing down to the Surface Water Management Pond. Photo was taken on the East side.

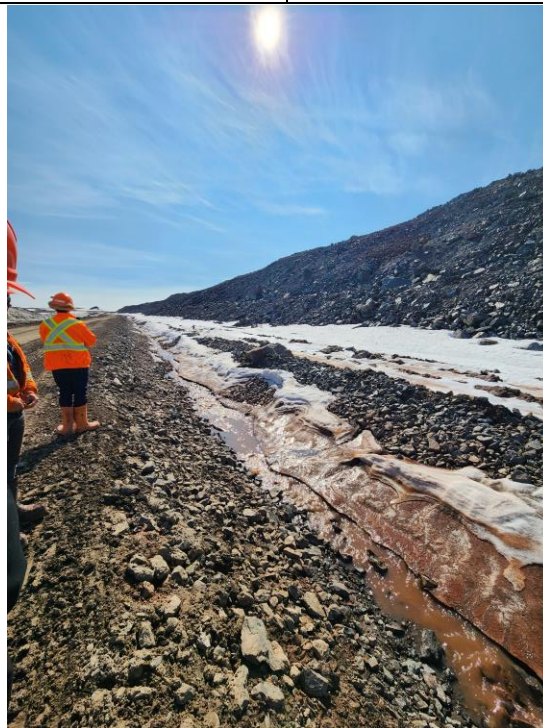
Photo No. 2
Photo

Description:
Another view of the water runoff coming from upstream.

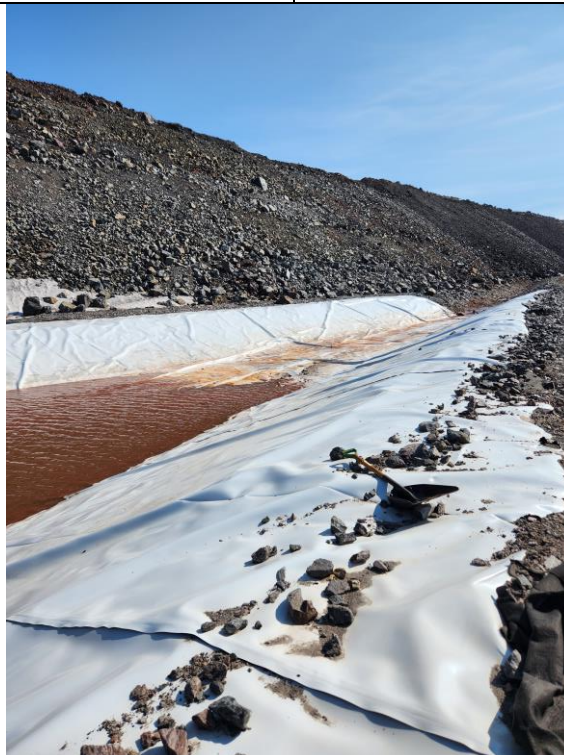
View of surface water runoff entering the management pond from the West side.

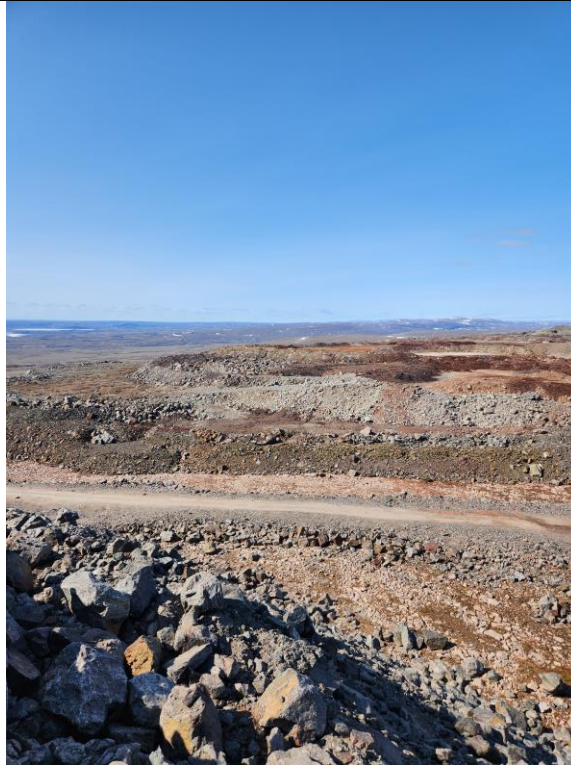
Photo of the Waste Rock Facility facing North.

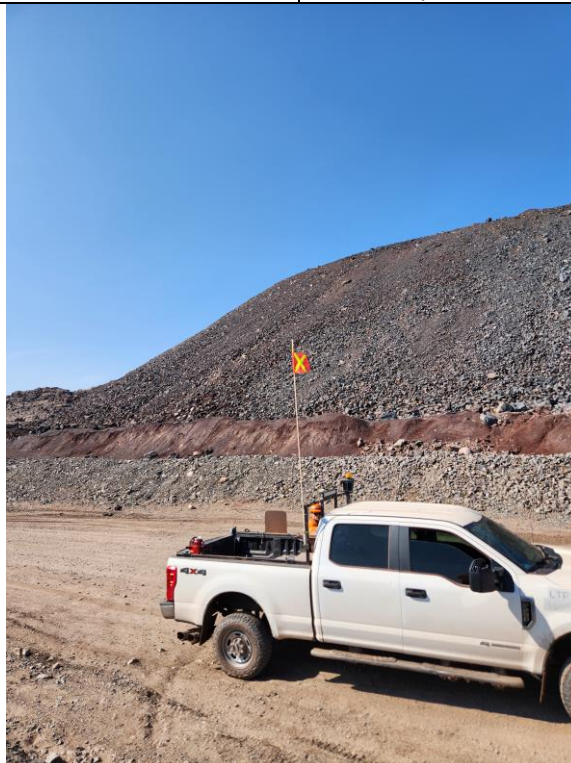
Photo of the KM106 Ore Stockpile.

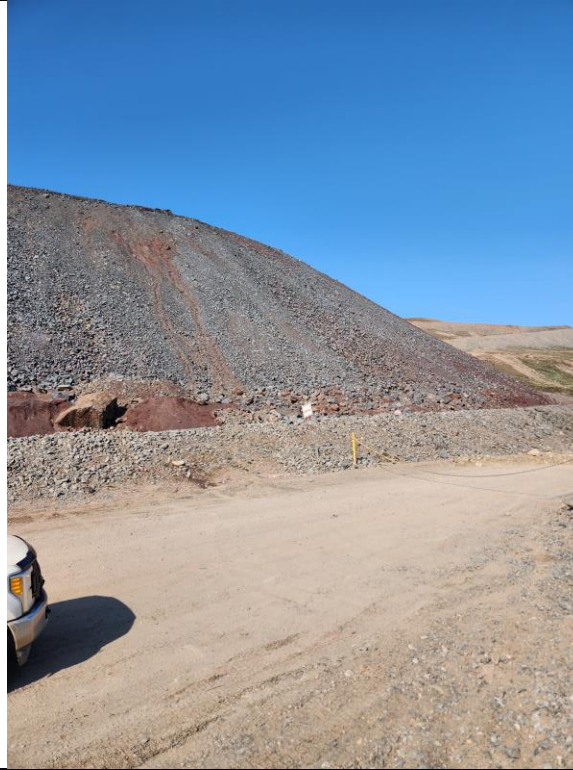
Another view of the ore stockpile.

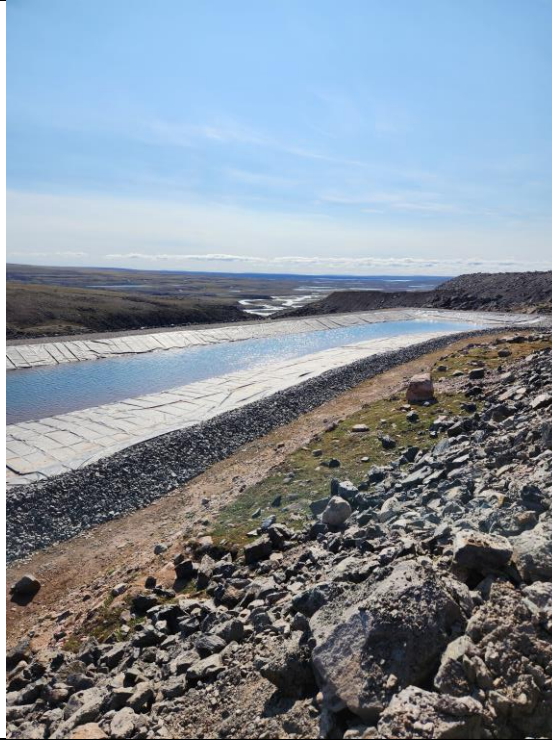
Photo showing the Surface Water Management Pond that collects water from the KM106 Ore Stockpile.

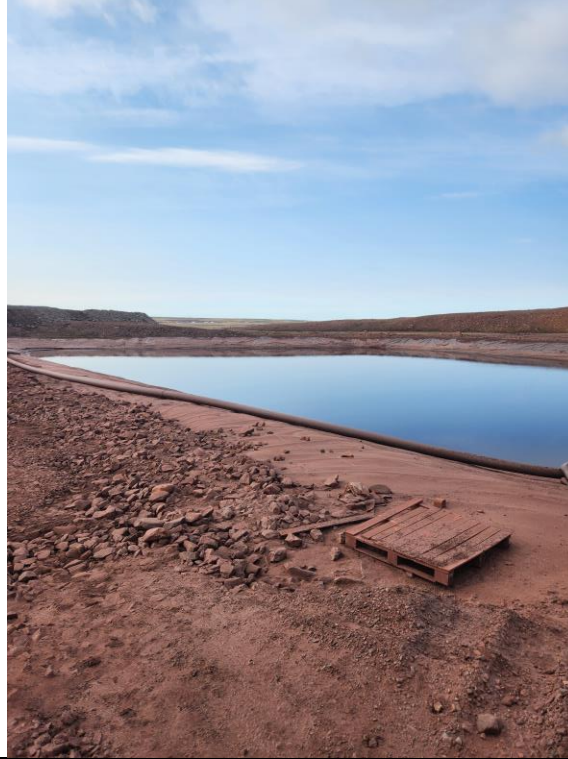
Surface Water Management Pond for the Crusher Pad.

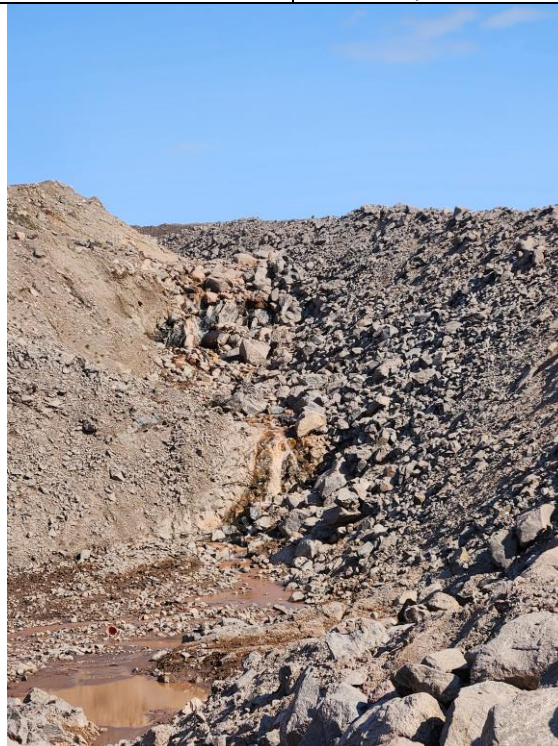
Photo showing water entering the KM105 Dam. A series of ditches carry the water from the mine/deposit and into the dam structures to treat water prior to exiting into the environment.

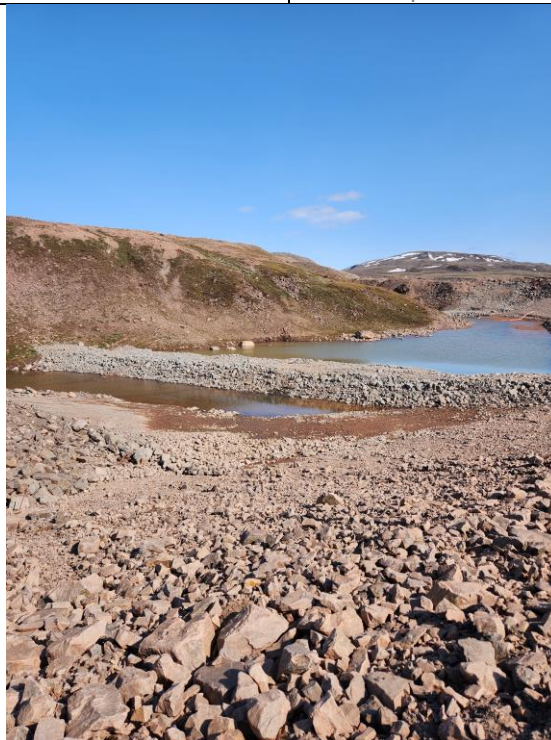
Another check dam to help with the sedimentation levels prior to reaching the dam.

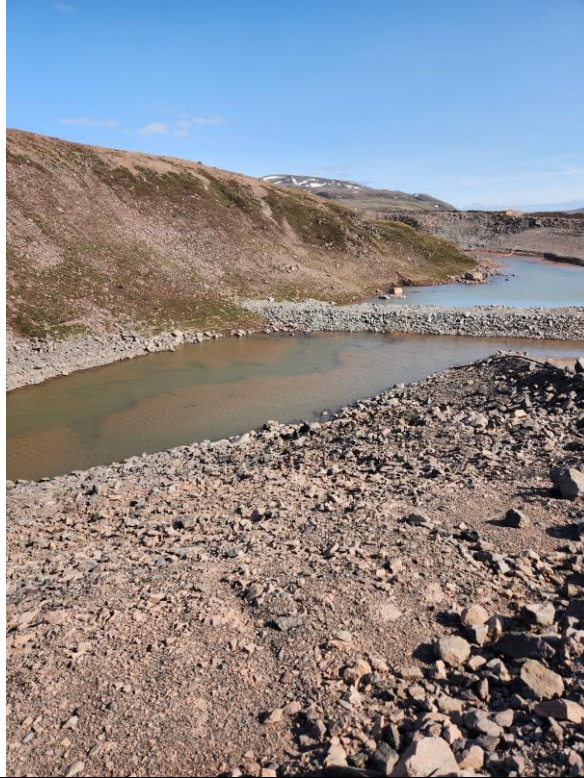
Photo showing water quality after the initial treatment of the check dams.

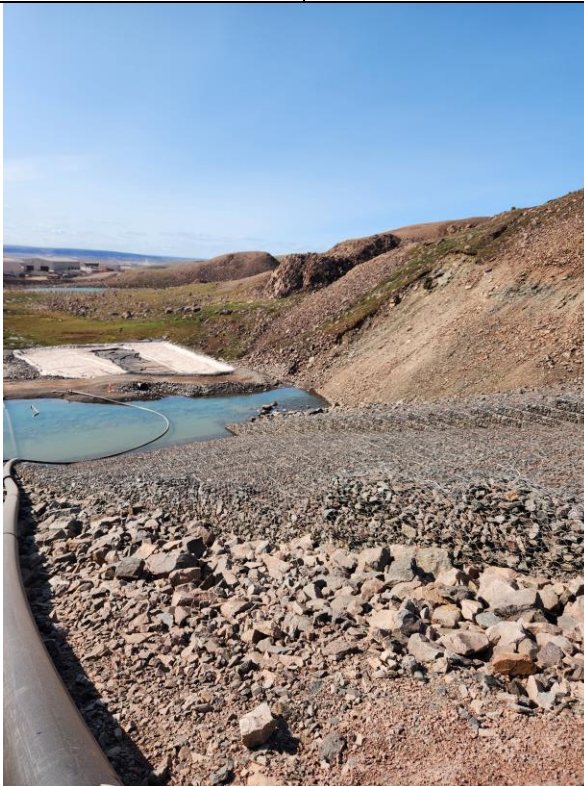
KM105 dam facing West.

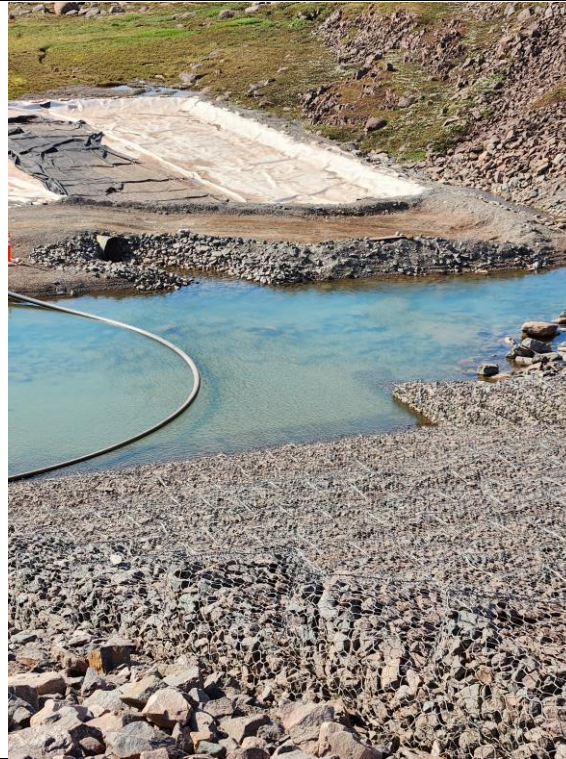
Water quality improving significantly after the dam.

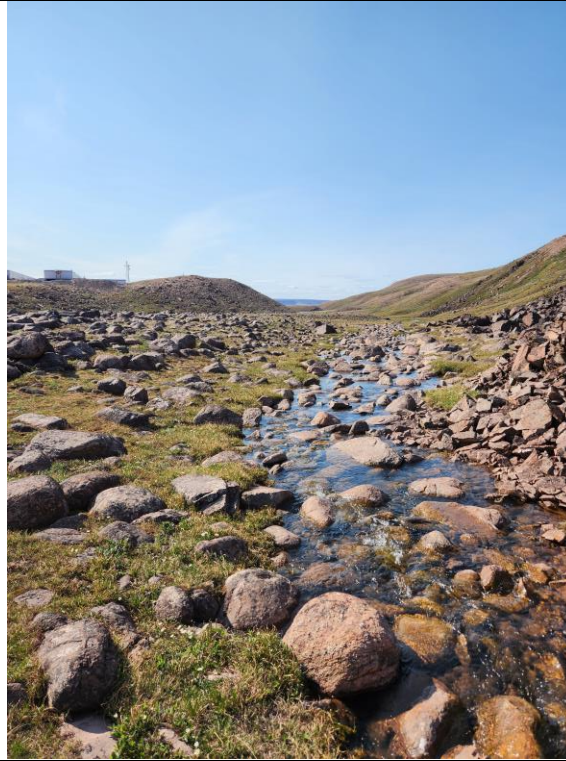
Photo of treated water being released back into the environment after treatment.

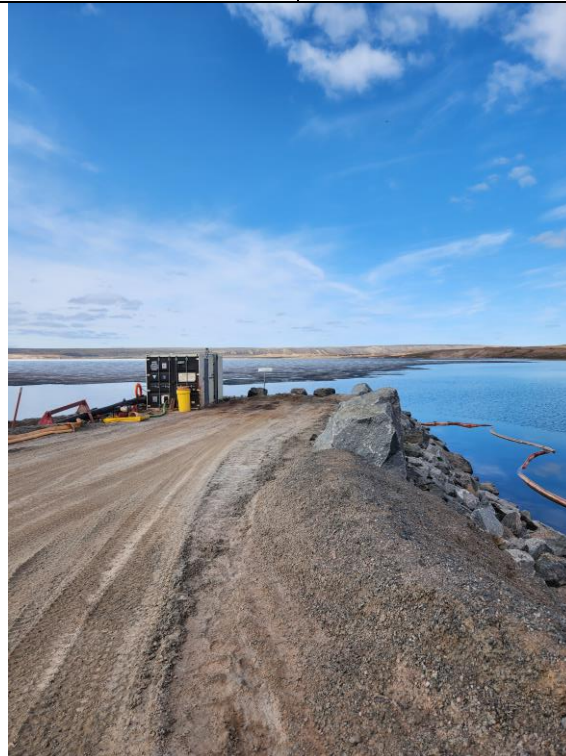
Photo of Water Intake Station at Camp Lake. Water is withdrawn from here to supply water for the Mary River Mine Site.

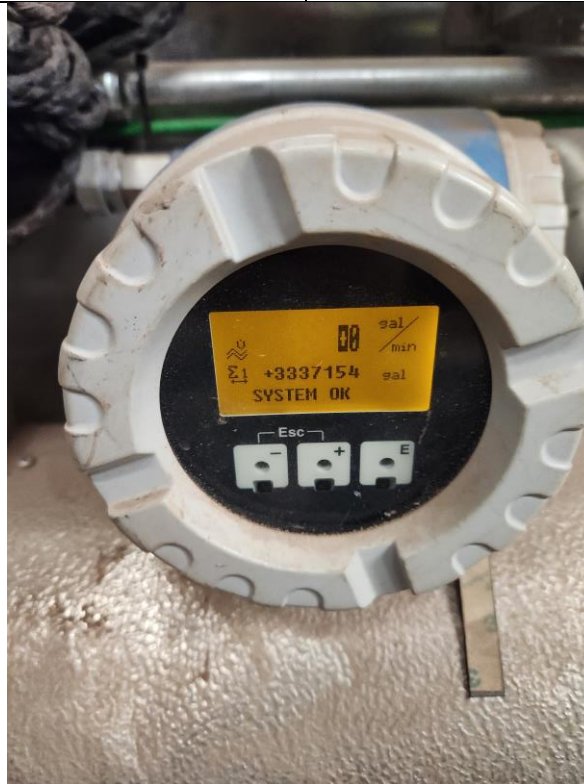
Photo of flow meter at the Jetty,

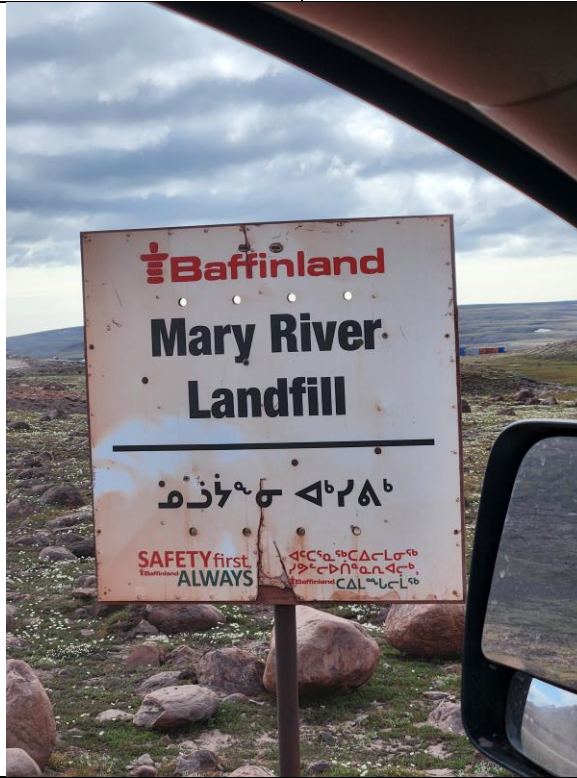
Proper signage was observed at the Mary River Landfill.

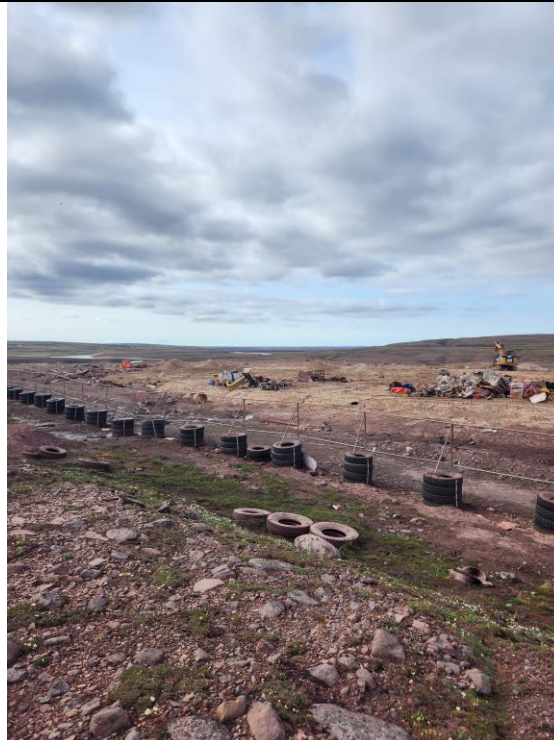
Photo of the landfill facing South.

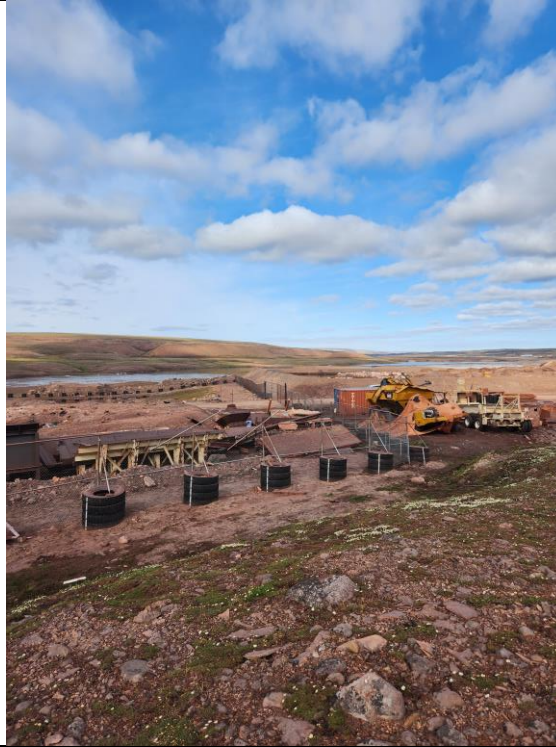
Photo of landfill facing West.

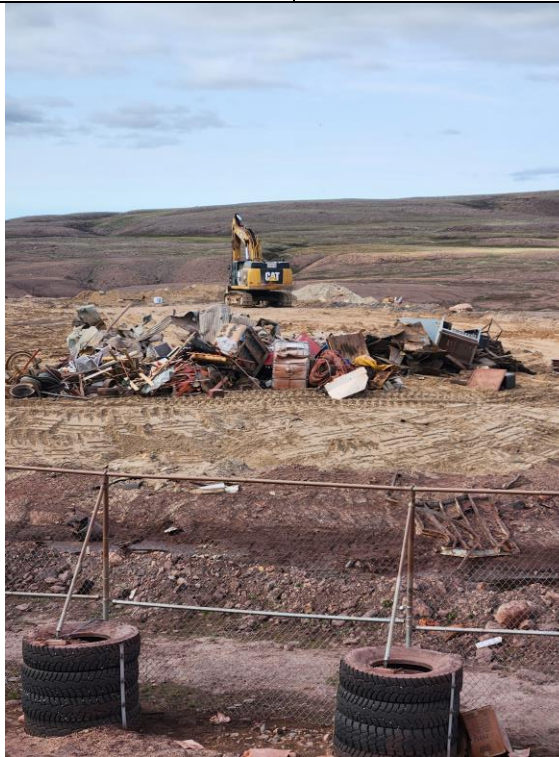
Photo of miscellaneous contents within the landfill.

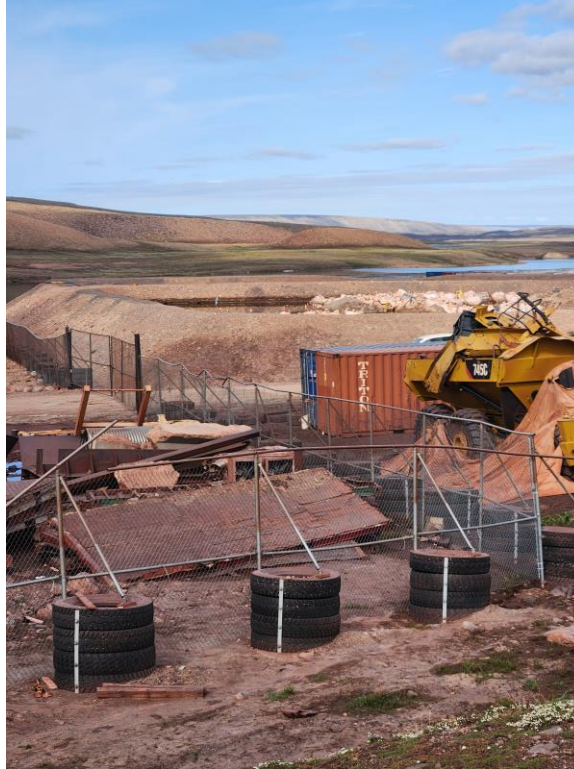
Some bulk material outside of the landfill will be sent out via sealift to be sent south for disposal.

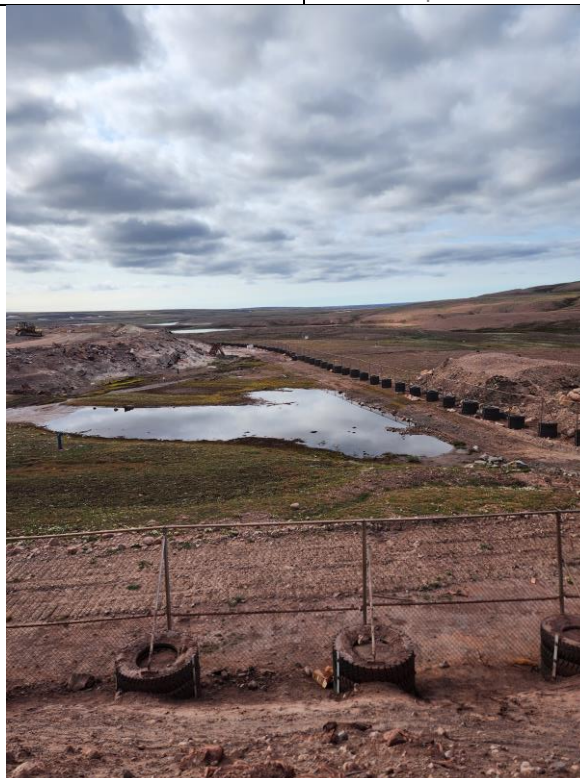
View of the North corner of the landfill.

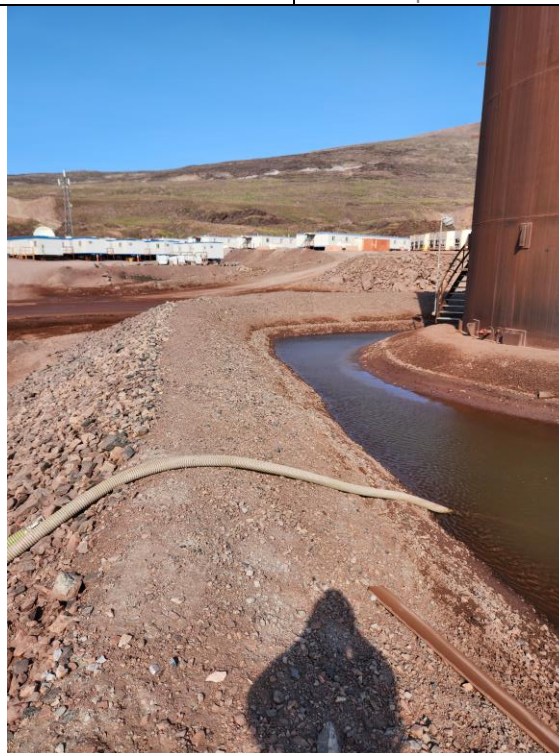
Another view of the Mary River tank farm.

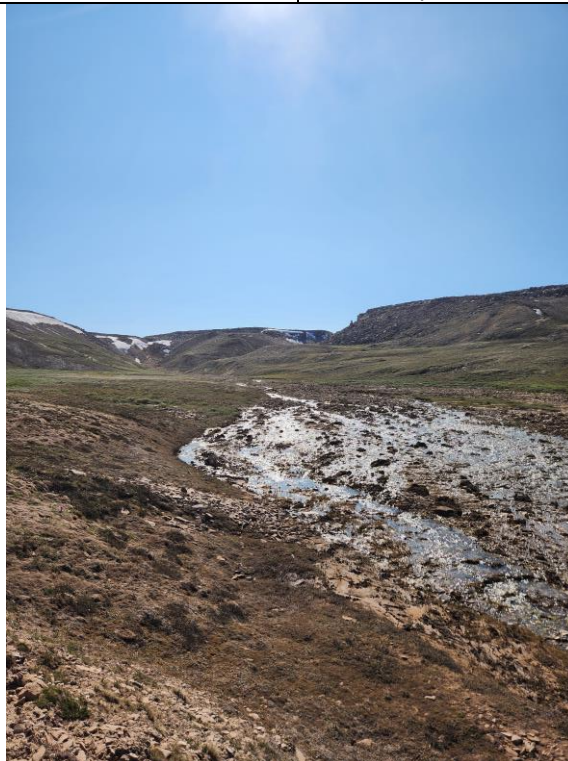
Photo showing the direction that the water had come through during the severe rain event.

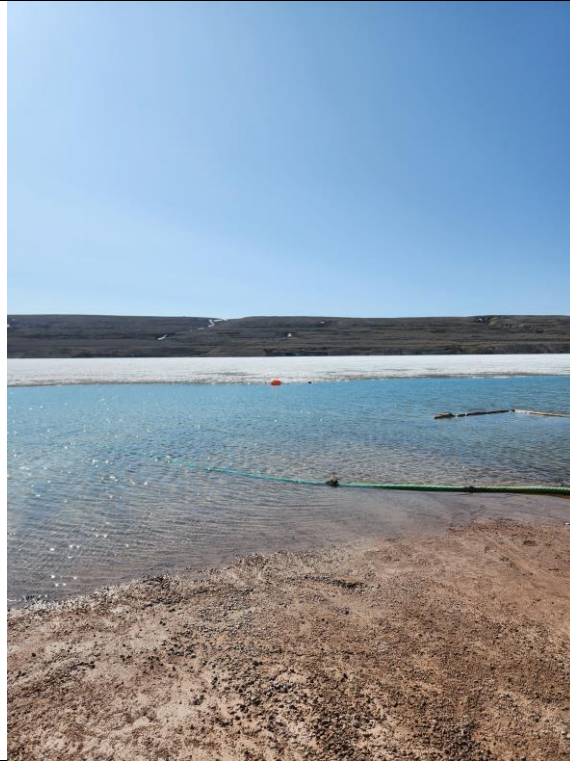
View of the Raw Water Intake location for the Milne Inlet site. Water is withdrawn from this lake and trucked to Milne Inlet.

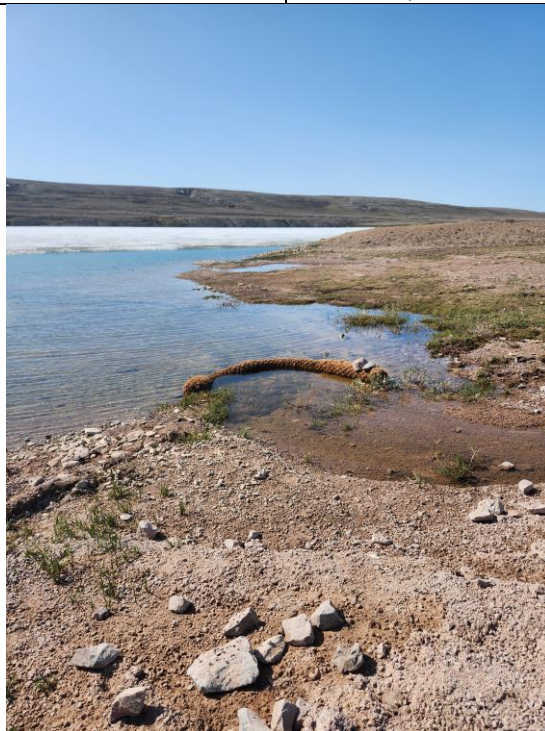
View of the Raw Water Intake location for the Milne Inlet site. Water is withdrawn from this lake and trucked to Milne Inlet.

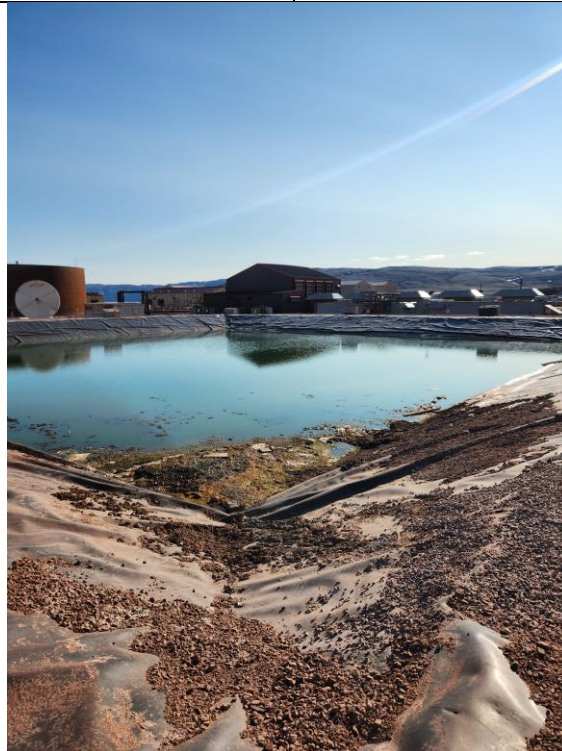
View of the polishing pond at the Milne Port Site. Sewage/grey water is pumped into this lined berm prior to treatment.

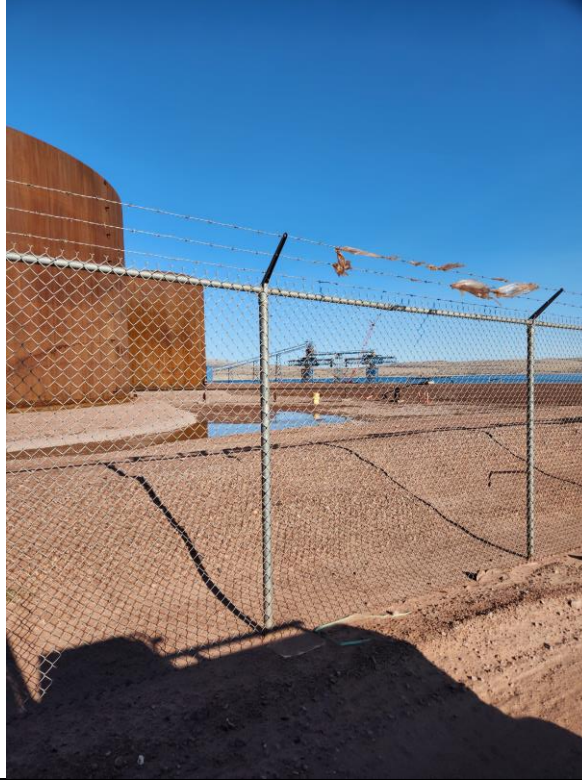
An inspection of the tank farm at the Milne Port Site was completed and no issues were observed at the time of the inspection.

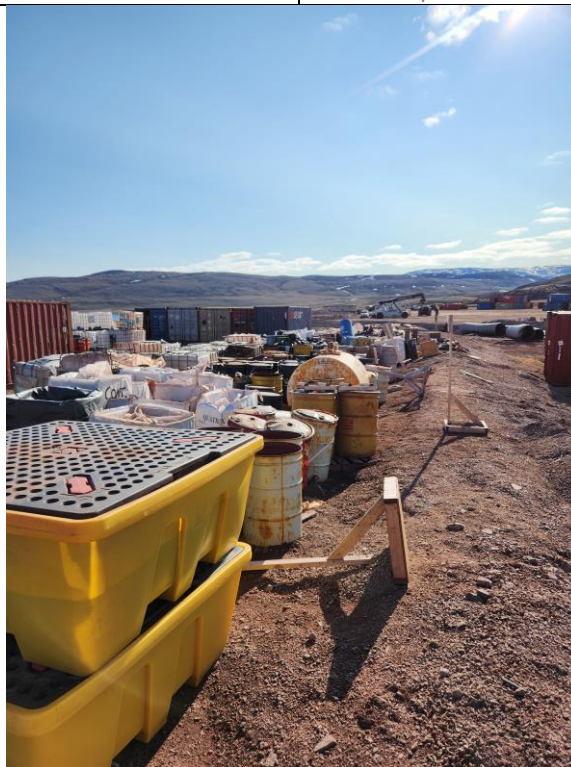
View of the Hazardous Waste Storage Facility at the Milne Port Site. Most of this hazardous waste was to be sent down south during the sealift season.

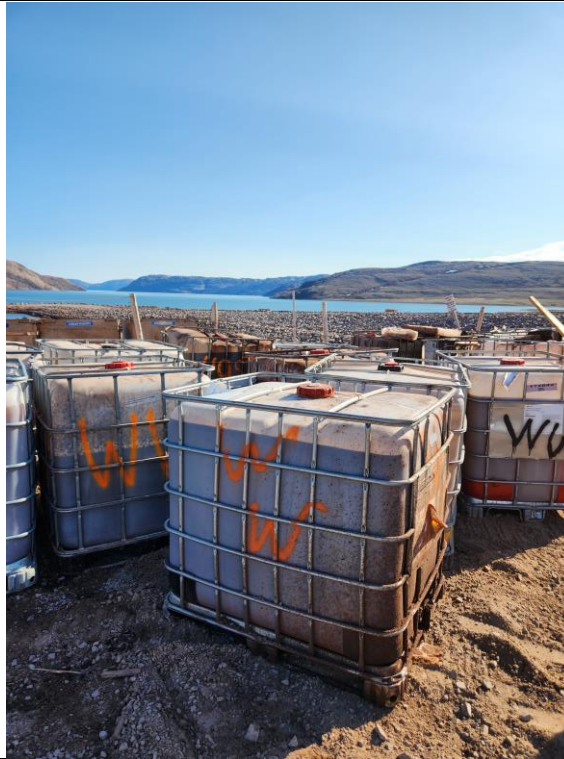
View of the Hazardous Waste Storage Facility at the Milne Port Site. Most of this hazardous waste was to be sent down south during the sealift season.

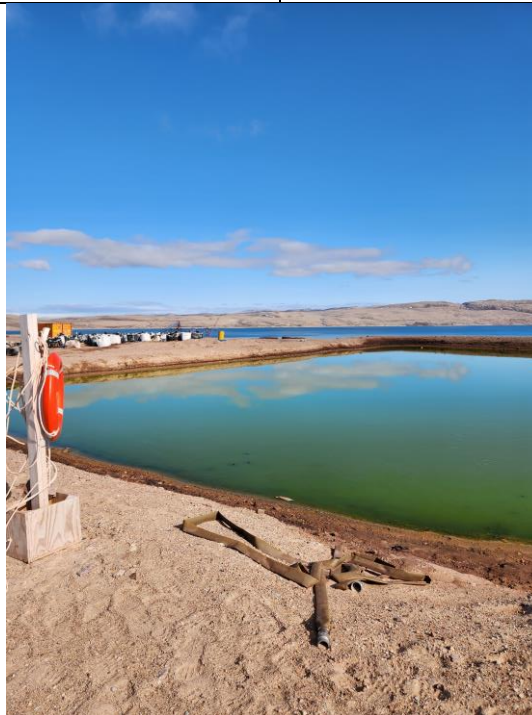
View of the Hazardous Waste Settlement Pond. Contaminated snow and water are sent here prior to being treated and discharged.

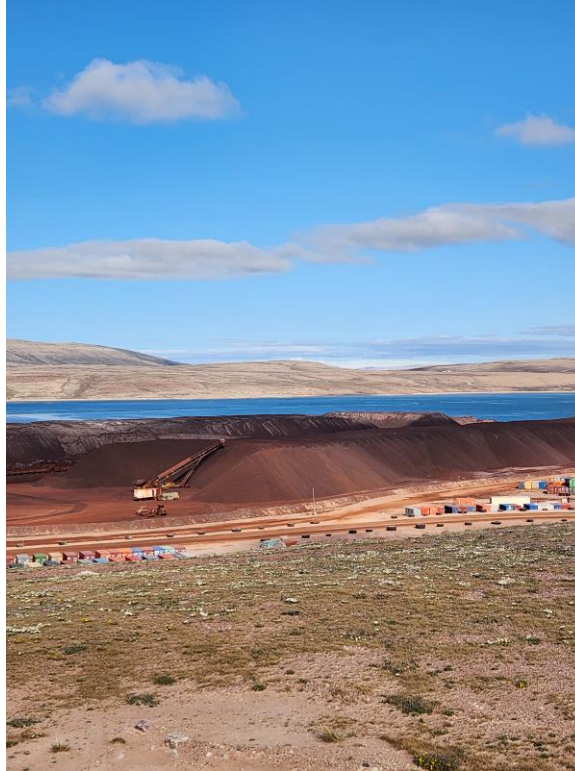
Photo of the ore stockpile at the Milne Inlet site.

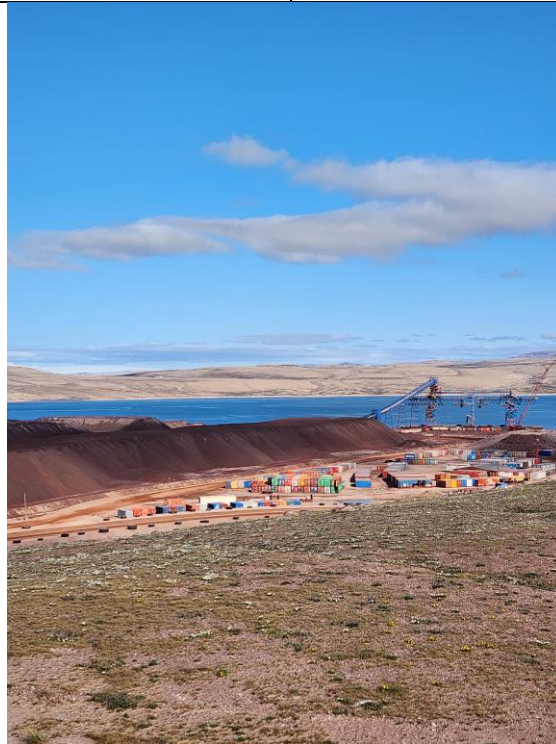
Photo of the ore stockpile at the Milne Inlet site. The Shiploader is also included in the photo.

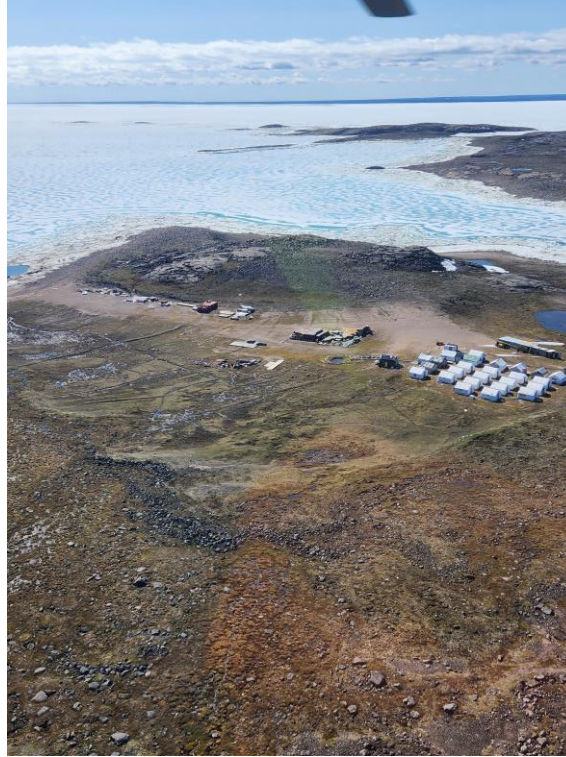
Aerial photo of the equipment and structures at the Steensby Inlet site.

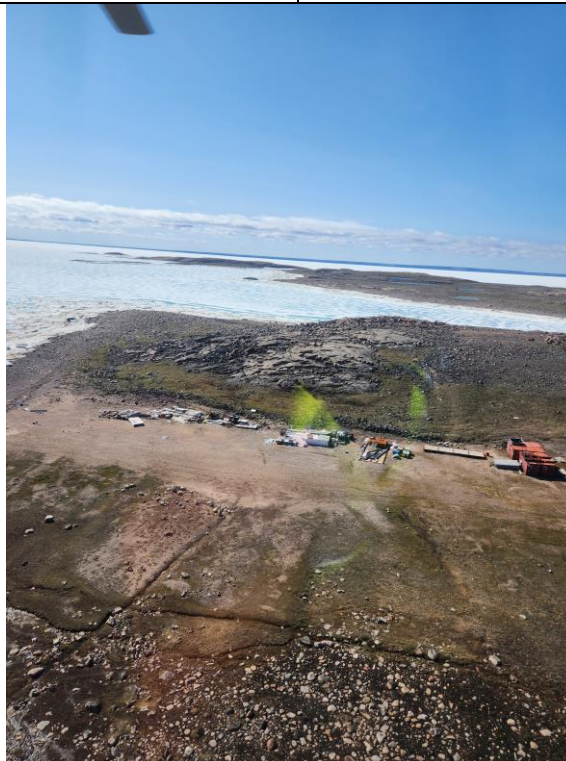
Aerial photo of the equipment and structures at the Steensby Inlet site.

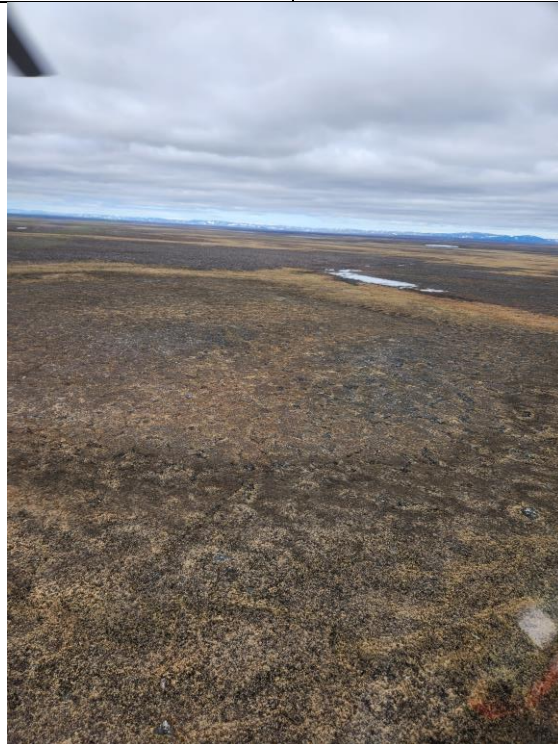
Aerial photo of the helicopter crash that has since been remediated.

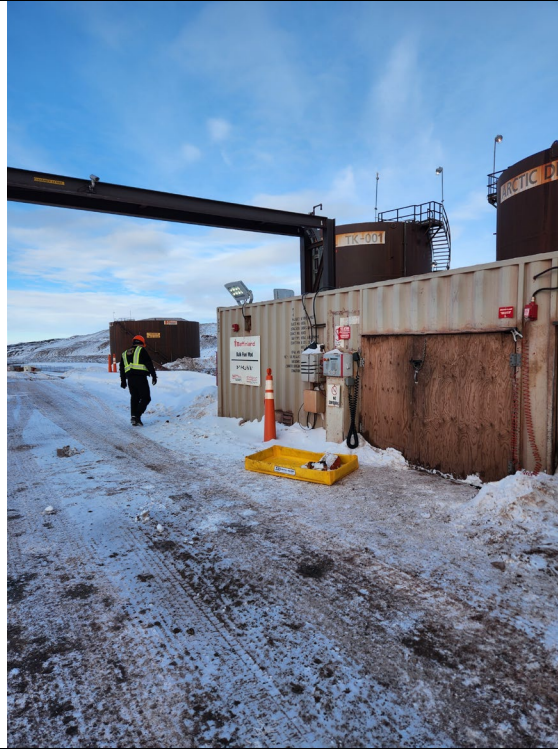
Photo No. 1
Photo

Description: Photo of fuel refuelling station for light duty vehicles.
--

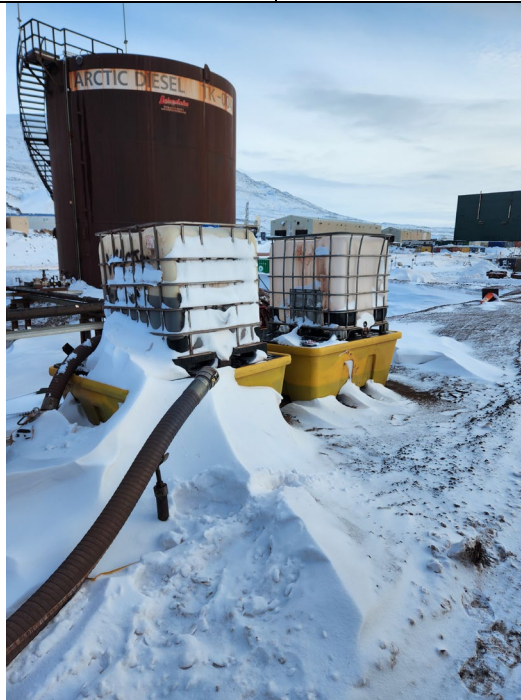
Photo No. 2
Photo

Description: Secondary containment devices at the refuelling station.

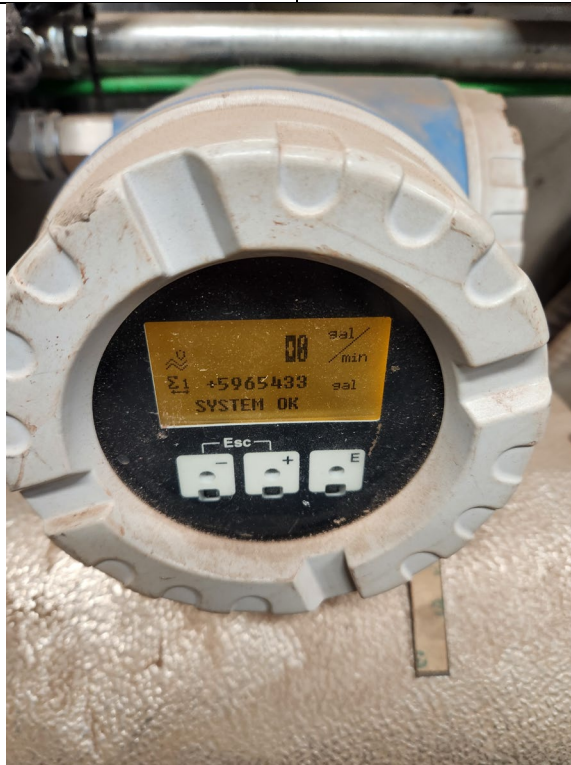
Digital water use monitoring at the water intake station.

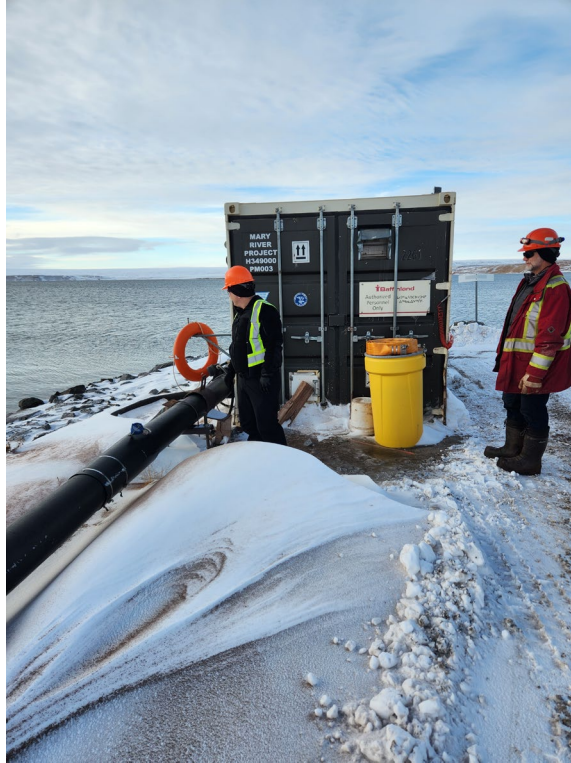
Photo of water intake station. Water is pumped from Camp Lake to provide water for the Mary River Mine Site.

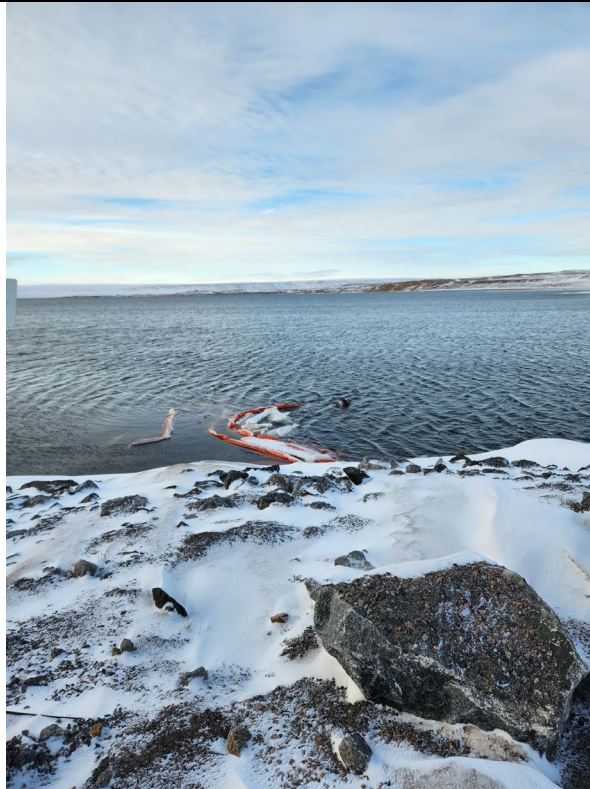
Camp Lake water intake.
