## APPENDIX E.8.3

### 2025 Initial and Follow-up Spill reports

**Re: Follow-Up to Spill #2025-091**  
**Mary River Project - Water Licence No. 2AM-MRY1325**

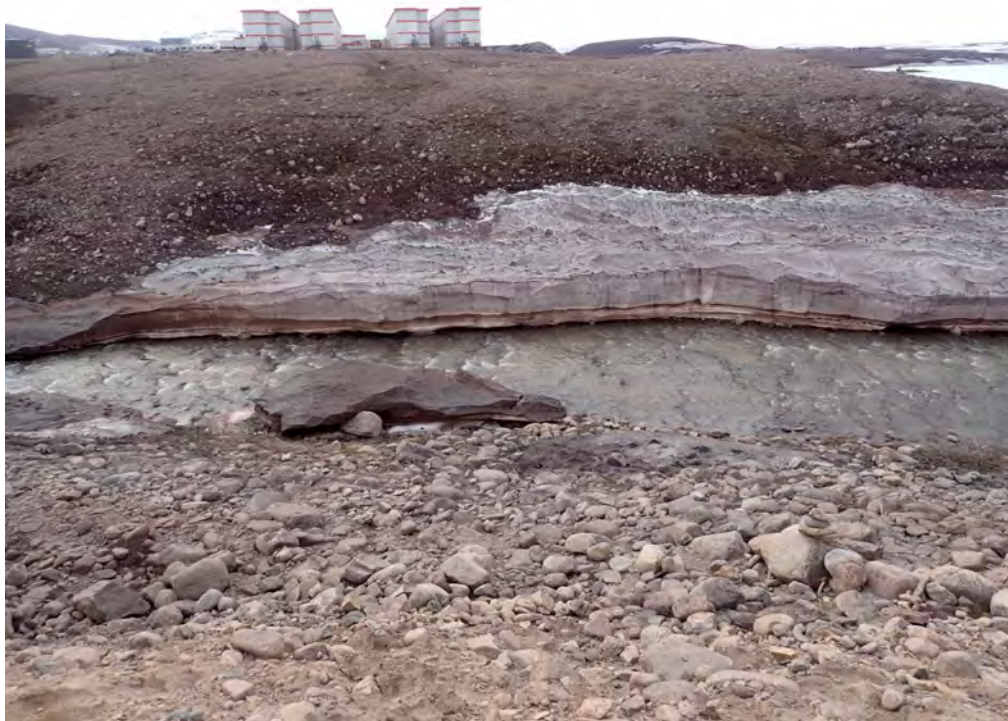
**Photo 2: SDLT-OUT Sample Location - June 1, 2025**

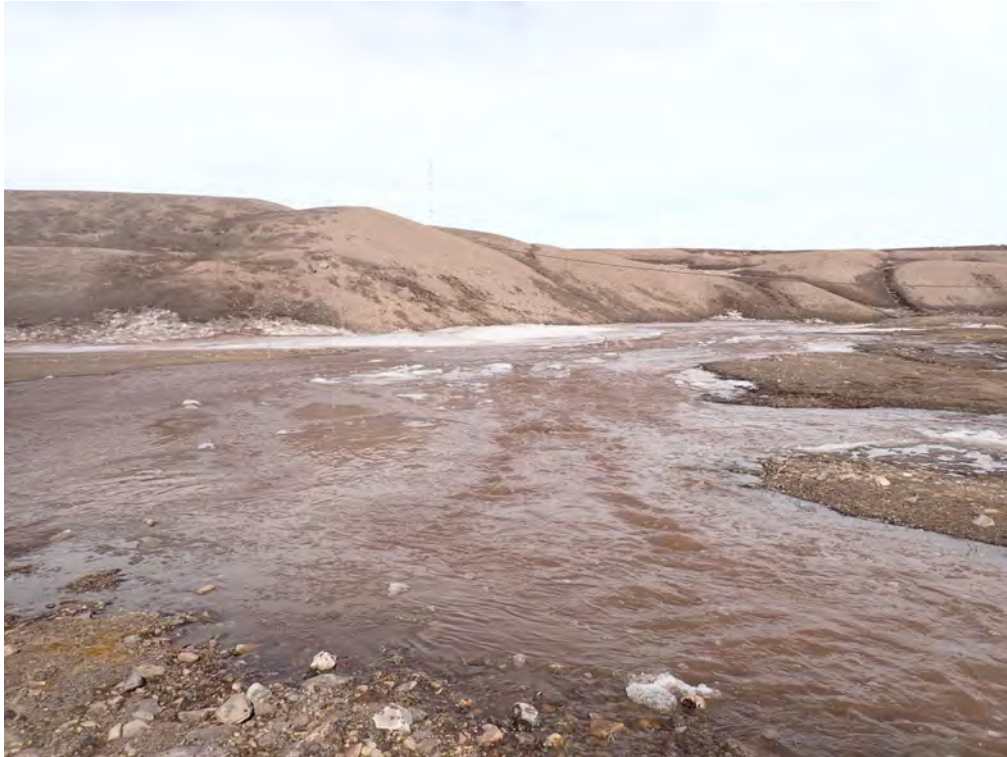
**Photo 12: CLT-OUT Sample Location May 23, 2025**

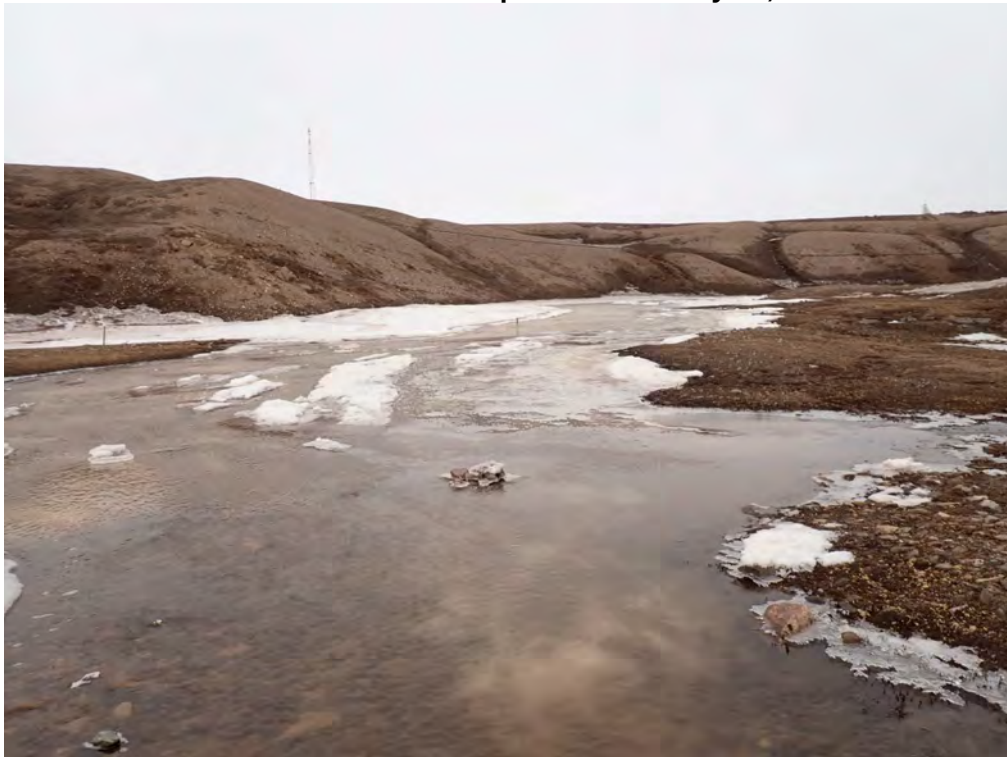
**Photo 13: CLT-OUT Sample Location May 24, 2025**

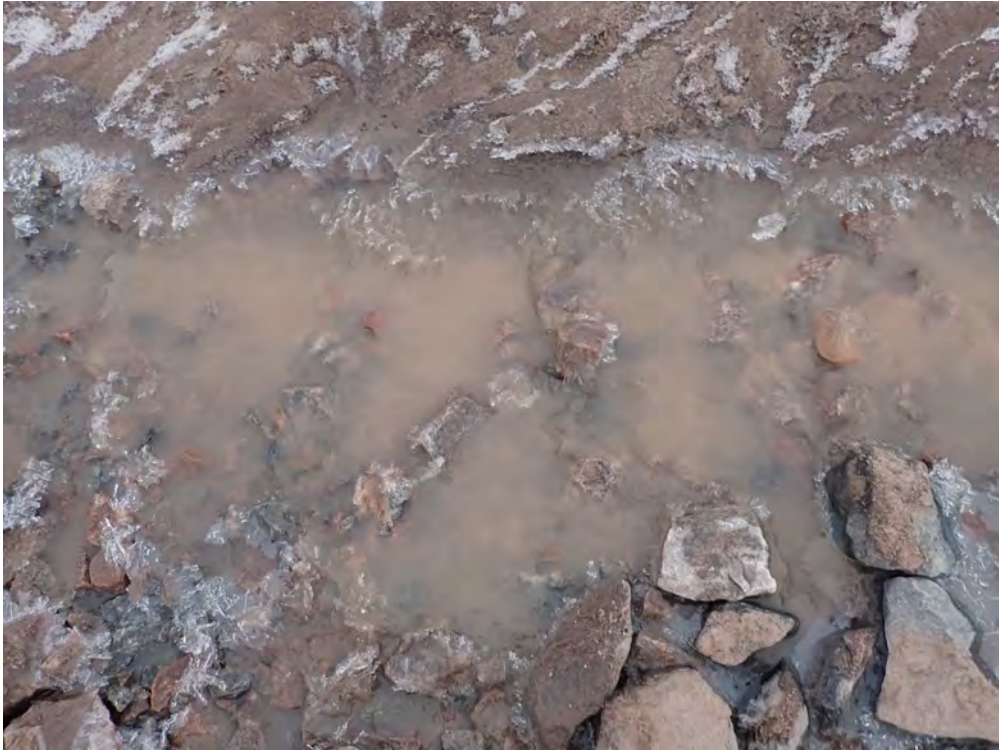
**Photo 16: CLSP-OUT Sample Location May 24, 2025**

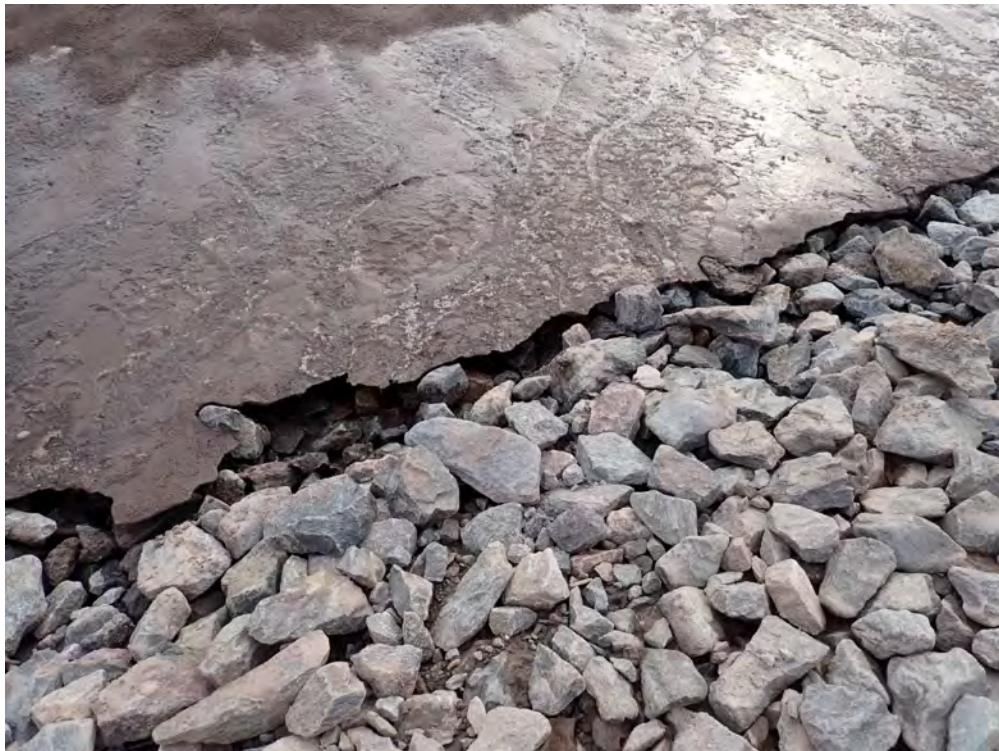
**Photo 17: CLSP-OUT Sample Location with no flow – June 1, 2025**

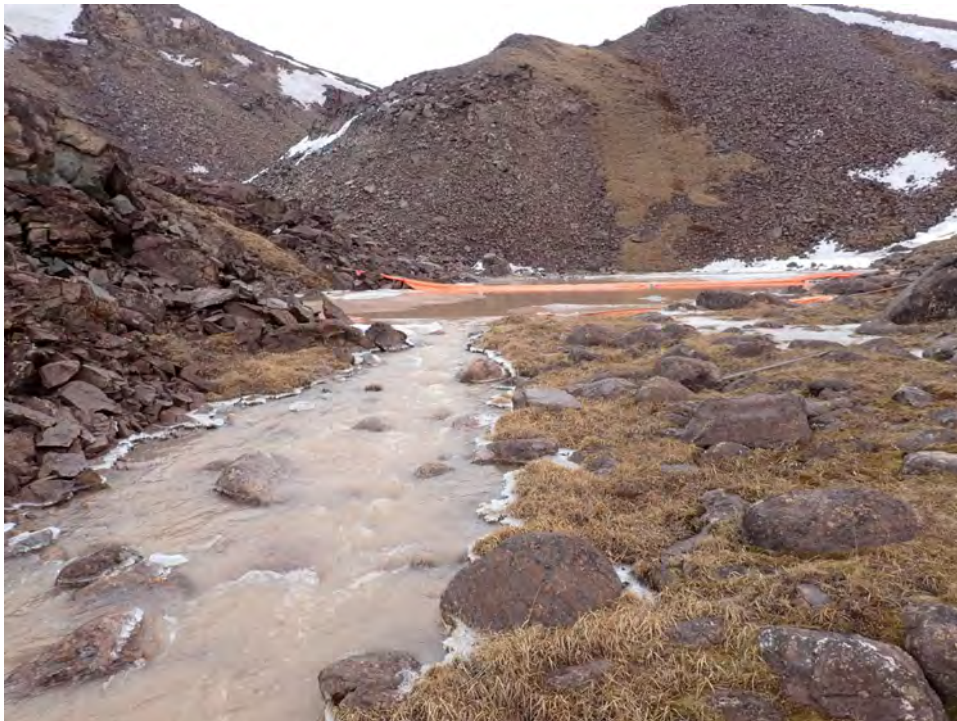
**Photo 2:** Flowing Water at Proposed MS-11 Discharge Point - May 24, 2025

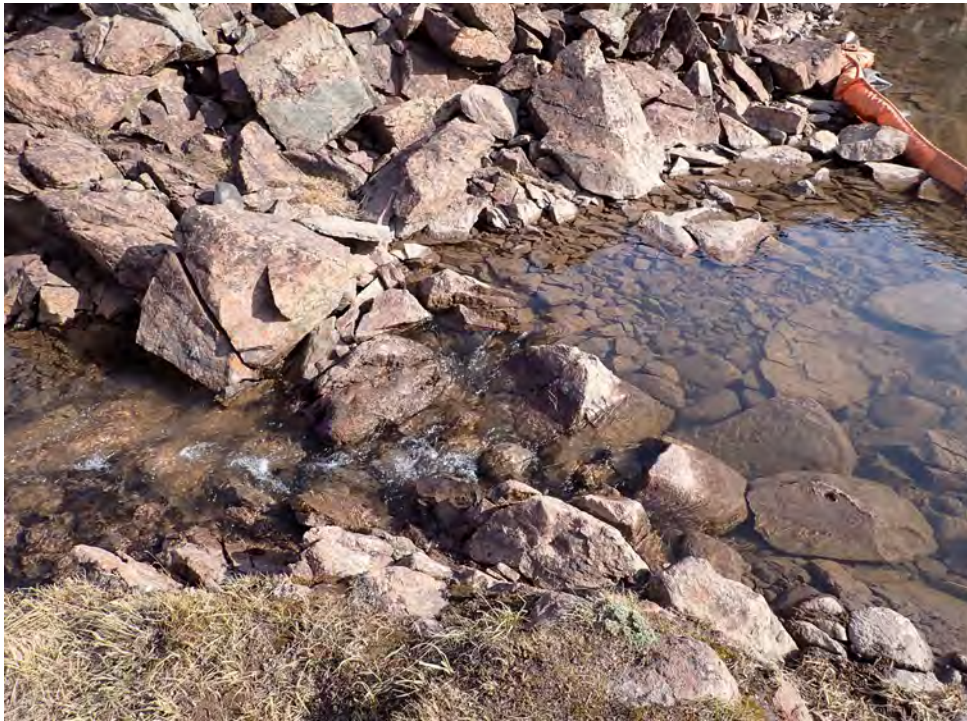
**Photo 3:** Flowing Water at Proposed MS-11 Discharge Point - June 17, 2025

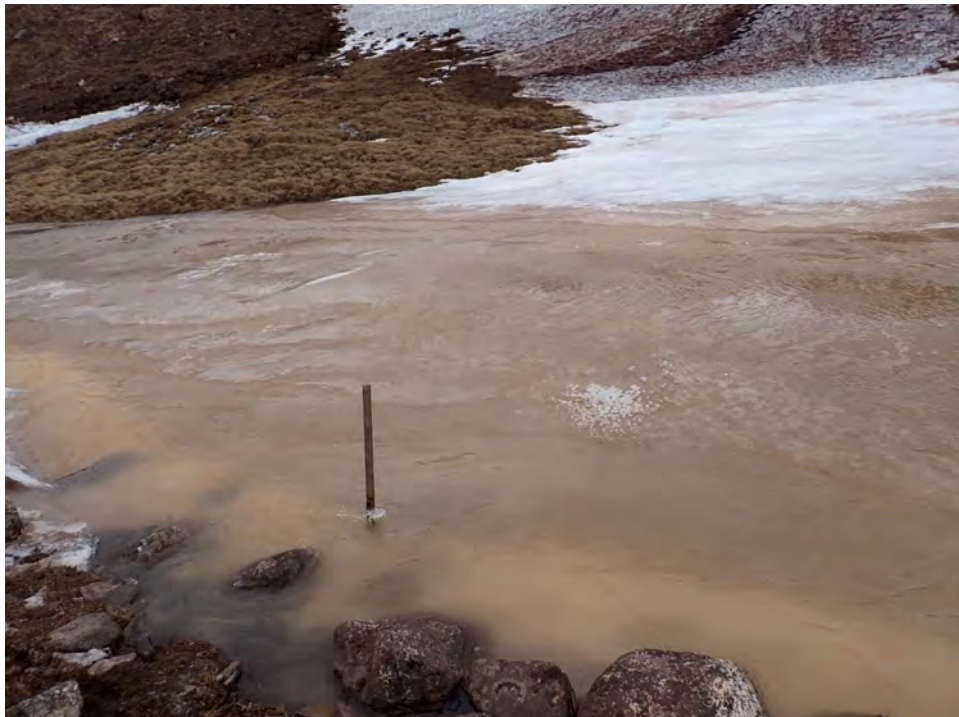
**Photo 4:** Flowing Water at Downstream Monitoring Location D1-05 - May 24, 2025

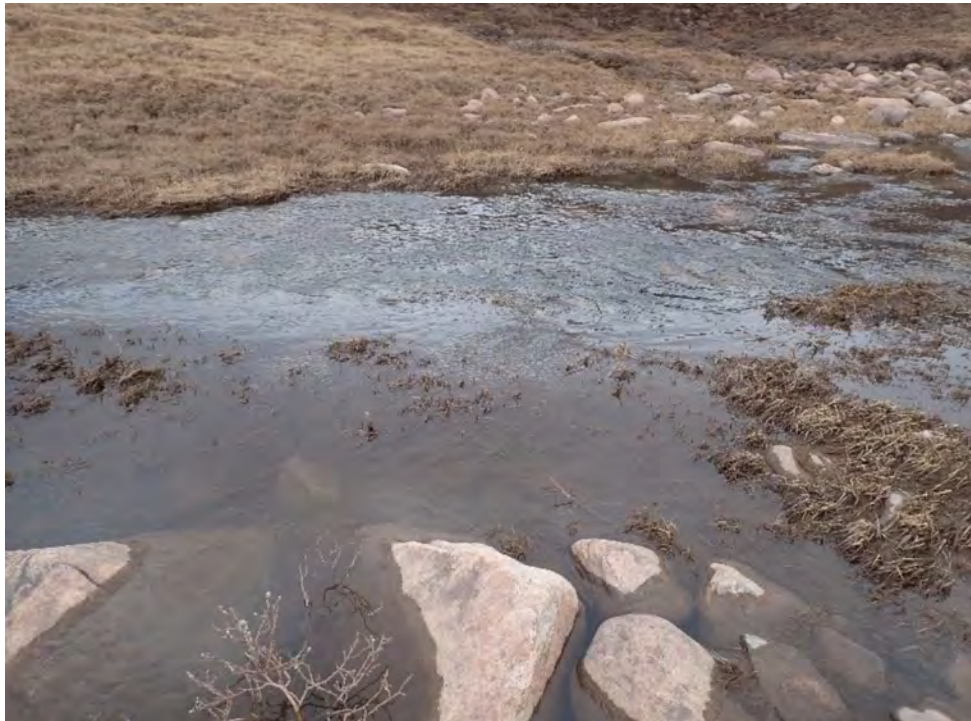
**Photo 5:** Flowing Water at Downstream Monitoring Location D1-05 - June 8, 2025

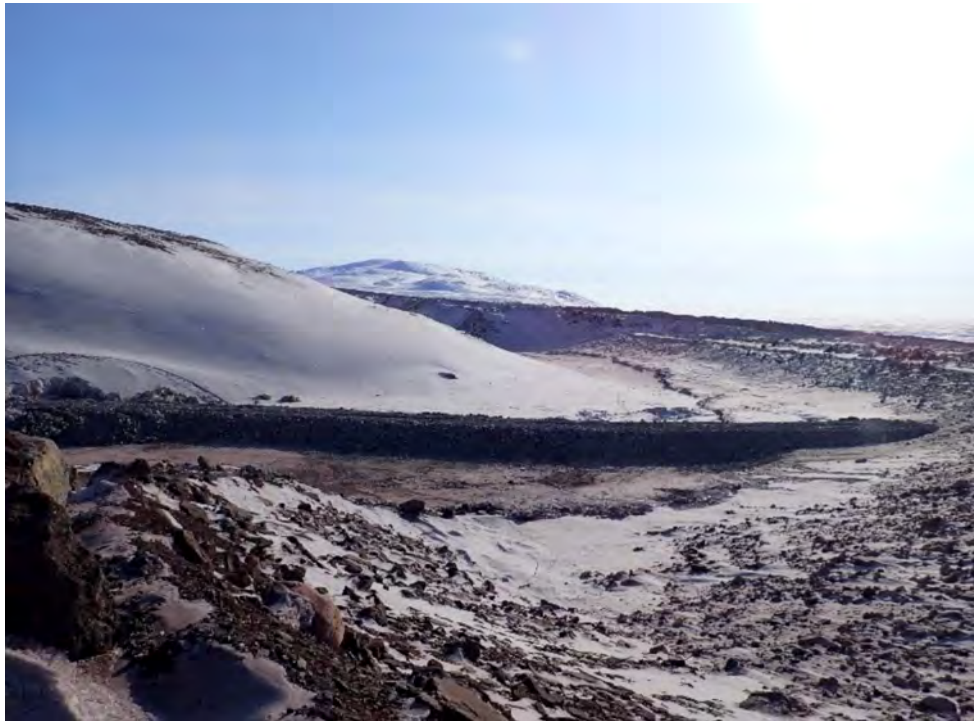
**Photo 7:** Filter Berm within KM 105 Valley Water Management Infrastructure - March 31, 2025

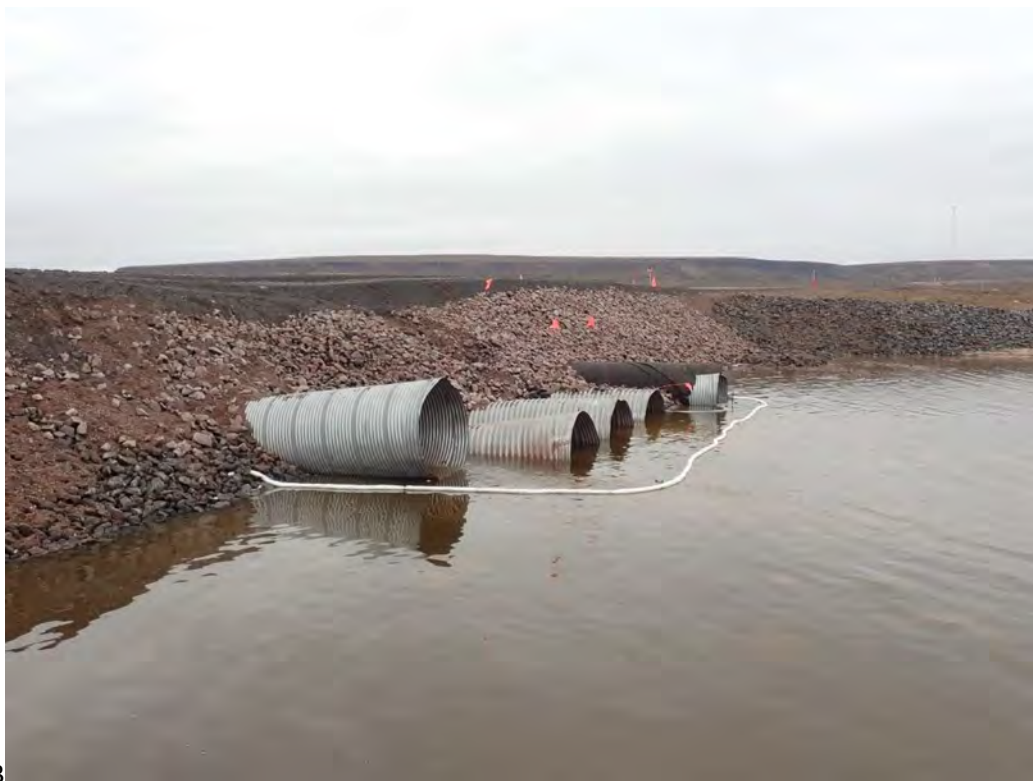
**Photo 1:** Spill Pads Placed on Contaminated Soil and Surface of the Water Upstream of CV-216 – July 16, 2025
