RE: Submission of 2019 Geotechnical Inspection Report No. 1 (July 2019)

Project #: TC190307

Annual Geotechnical Inspections – 2019 Report 1. Mary River Iron Mine Complex – Nunavut

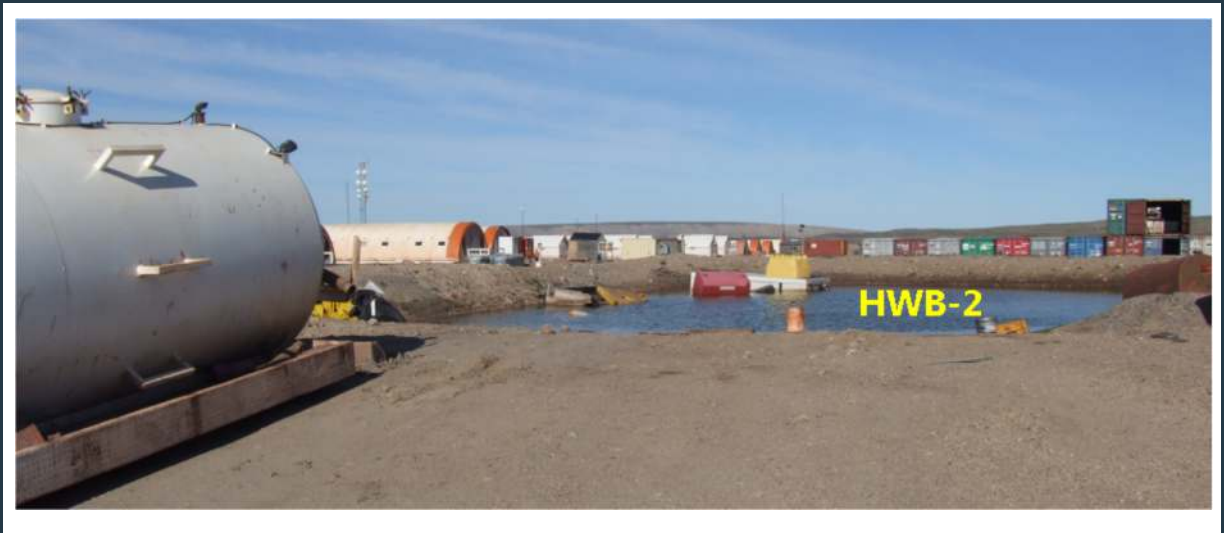
As shown in Figure 12, the perimeter berm appears to be stable. The presence of water visible within the pond demonstrates that the liner is intact. No visible seepage from the pond was noted around the berm, and the pond operates as intended.

Figure 12: View of HWB-2

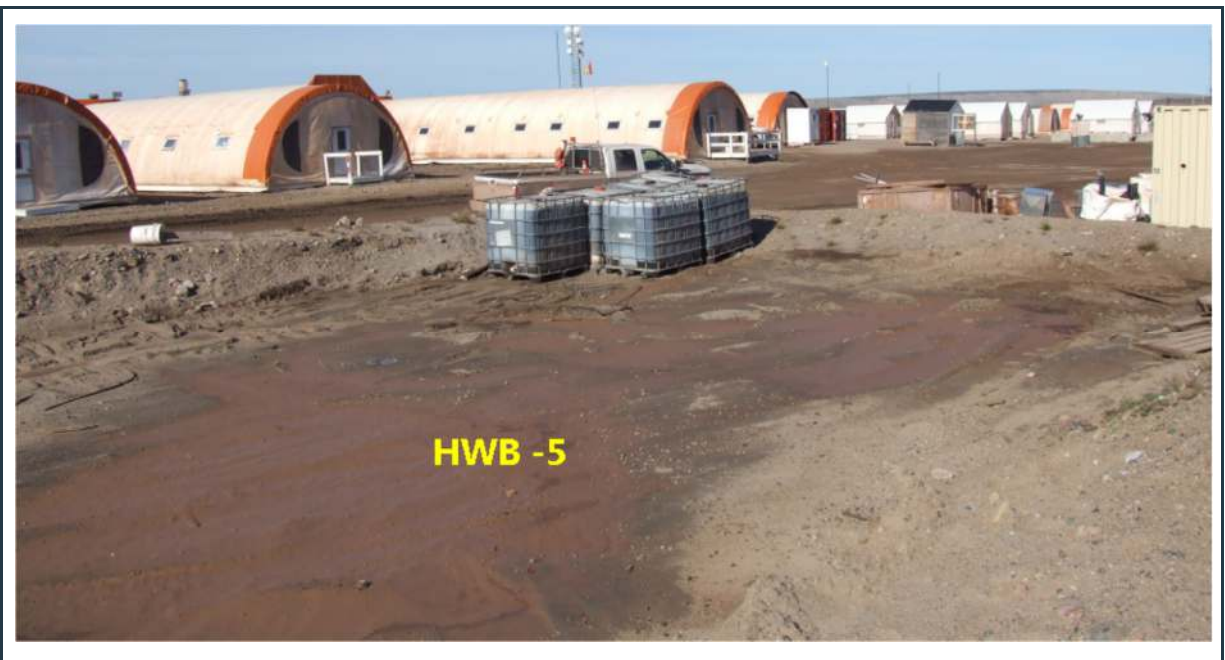
As shown in Figure 15, there are a few totes of lubricants currently stored in this cell. The berms around the cell appear to be stable and there is no visible liner damage. As recommended above, foot and truck traffic on the slopes and the crest of the berm should be prohibited with controlled / ramped access points (preferably one) provided for the skid-steers to dispose designated materials in the cell.

Figure 15: View of HWB-5

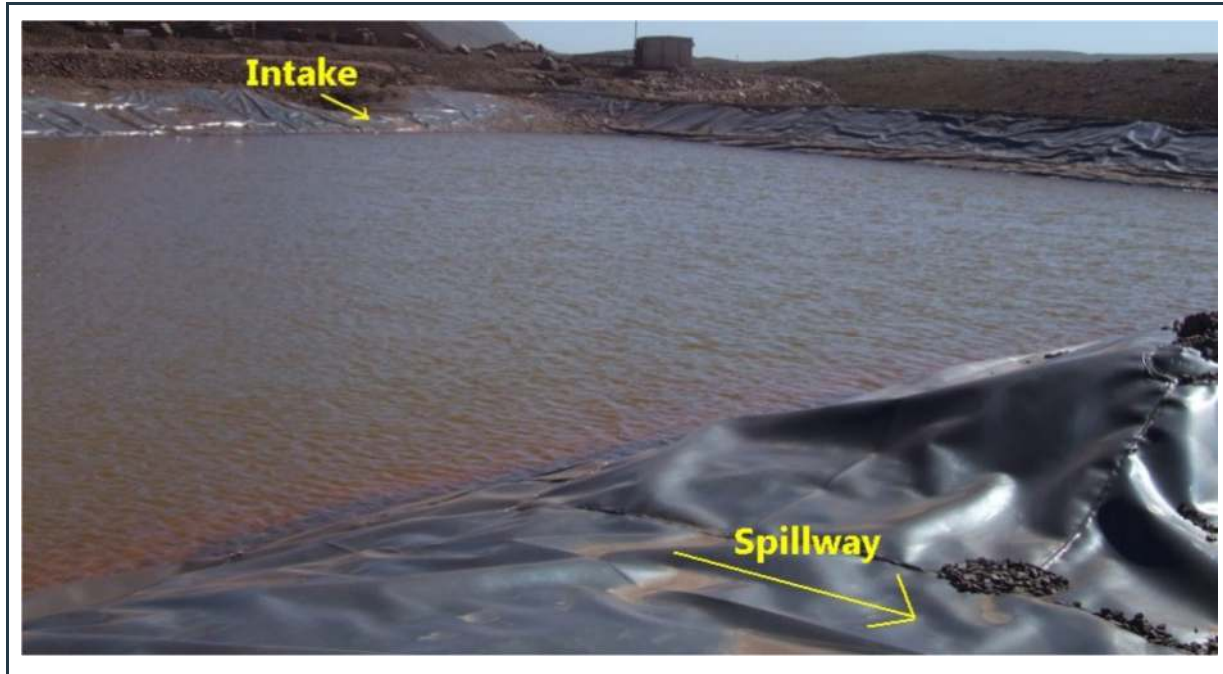
Figure 20: MS-06 surface water collection pond

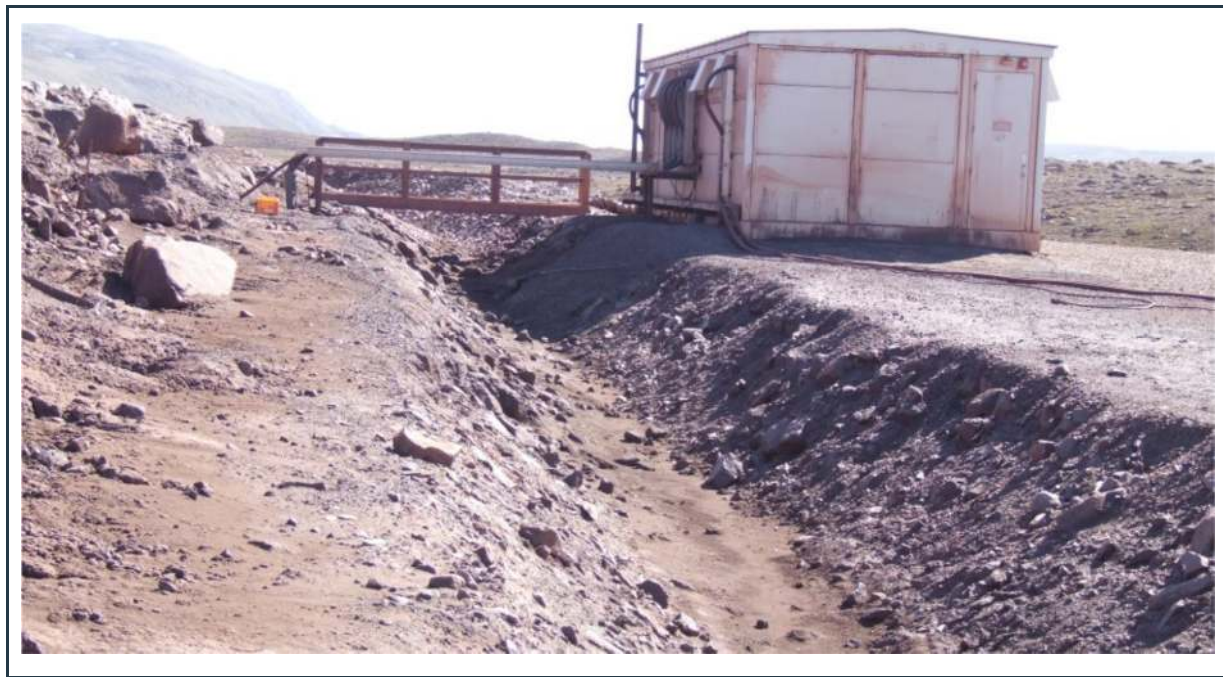
The side slopes of the water collection ditches were observed to be stable (Figures 21, 22 and 23). As with any other run-off collection ditches, the silt sized soil particles are accumulated at the base of the ditches (siltation), wherever the effluent flow velocity decreases. This is evident in Figures 21, 22 and 23. The siltation tends to reduce the design wet section of the ditches (flow capacity). The observed silt accumulation does not warrant maintenance measures at this time. However, this should be regularly monitored by mine personnel and any significant reductions in the flow capacity of the ditch should trigger maintenance measures by means of silt removal.

Figure 21: Surface water collection ditch around the crusher plant

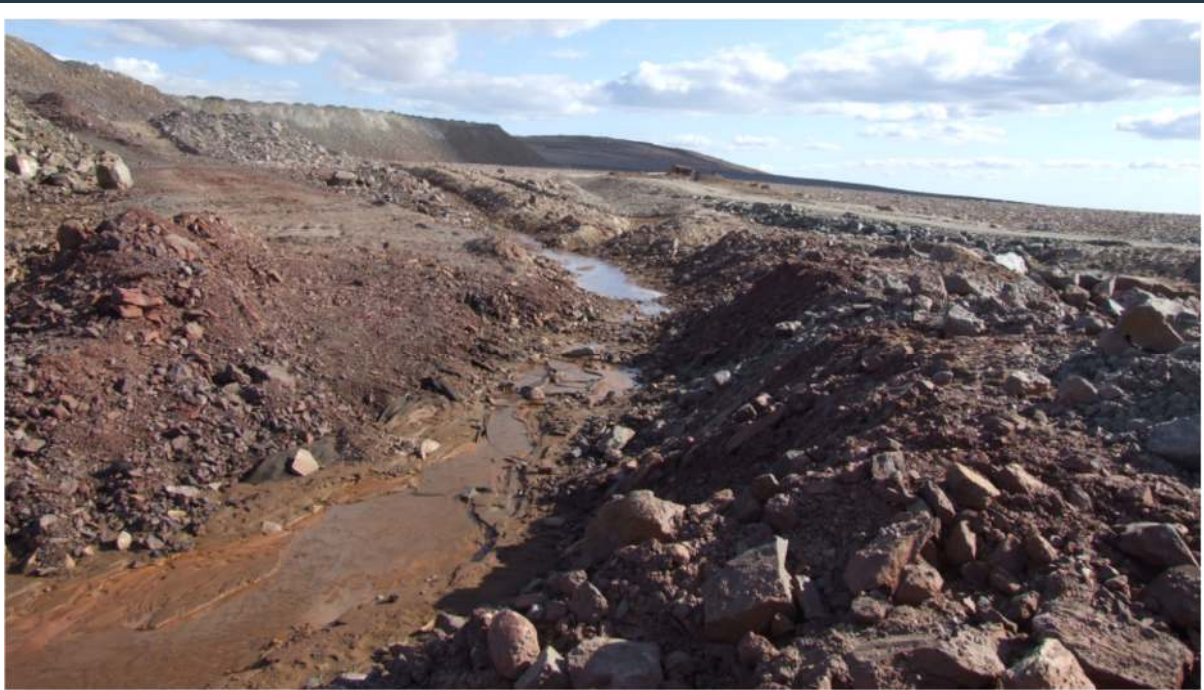
Figure 26: Side-ditch under construction around the waste rock dump

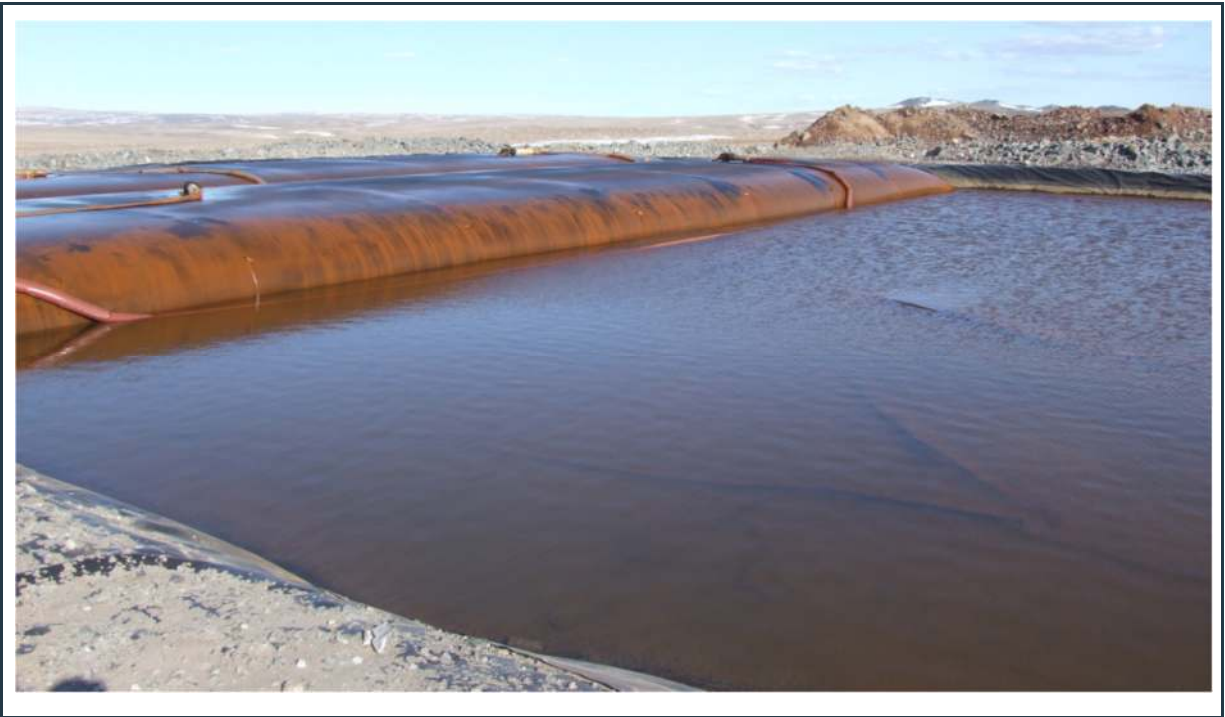
Figure 28: Water treatment pond adjacent to the waste rock dump and MS-08

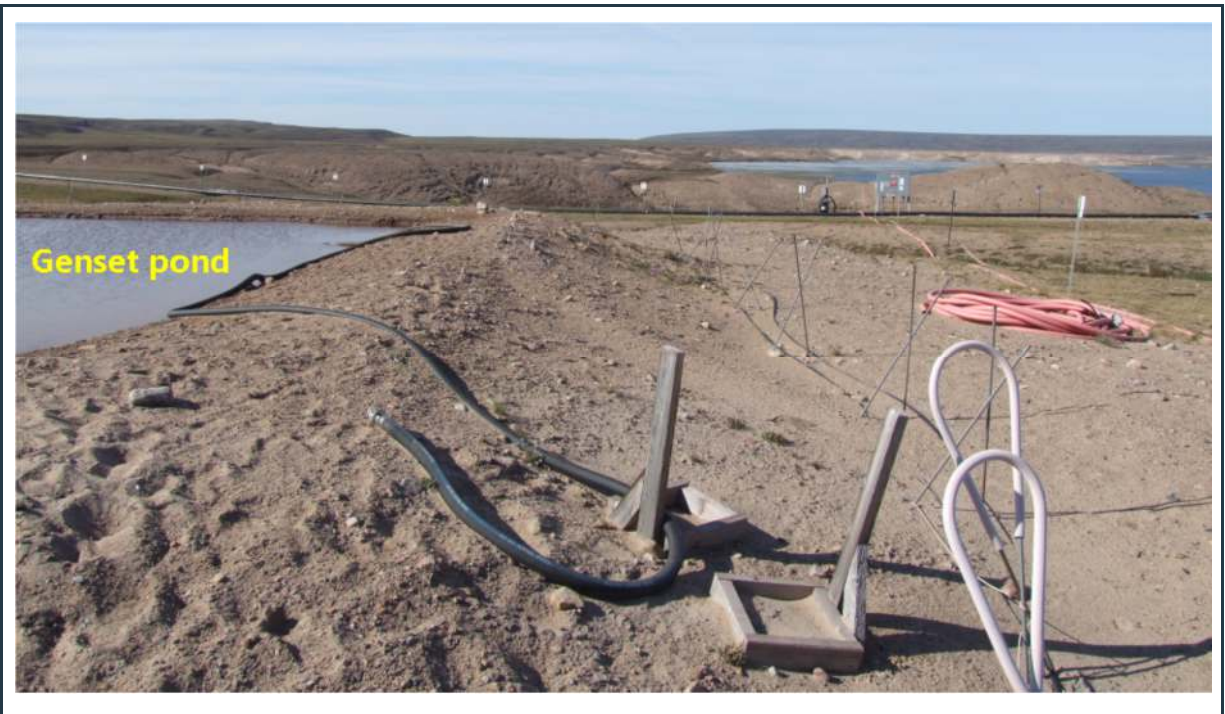
Figure 29: View of the berm at the Genset pond

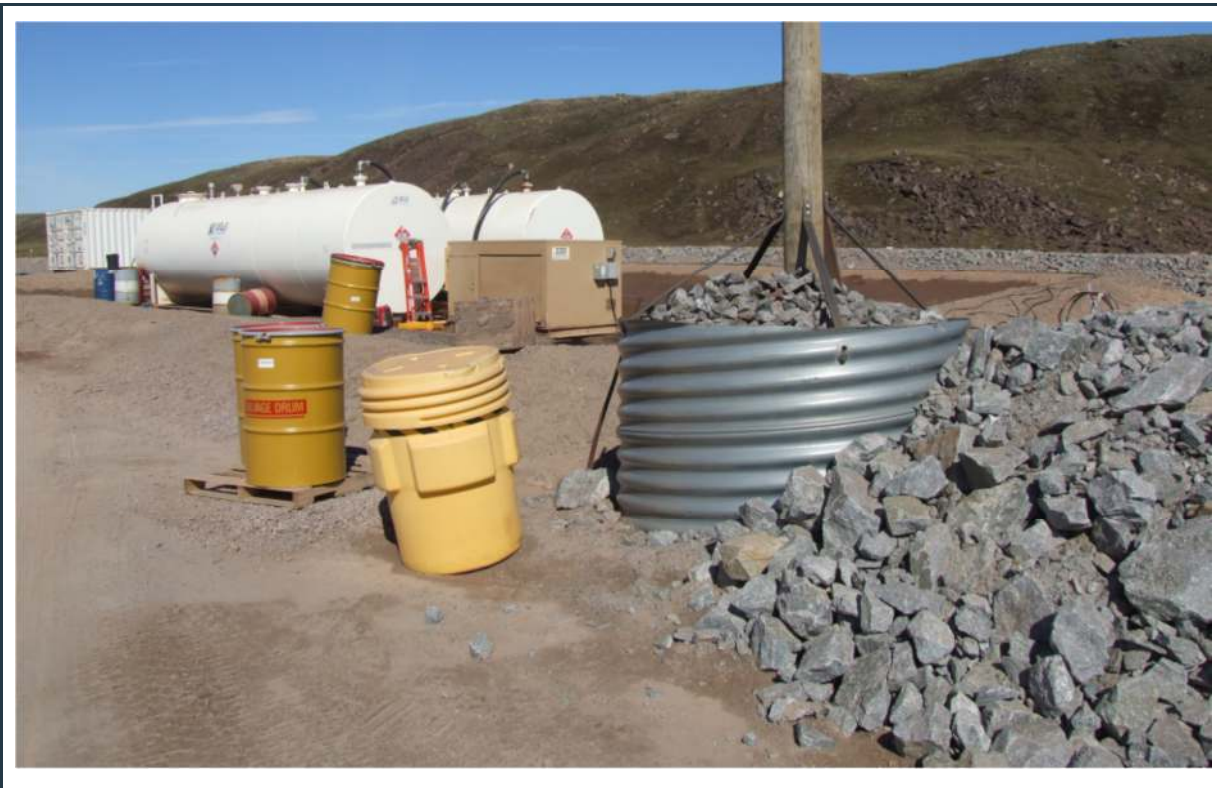
Figure 32: View of the jetfuel farm's double berm system (note the additional crushed rock berm)

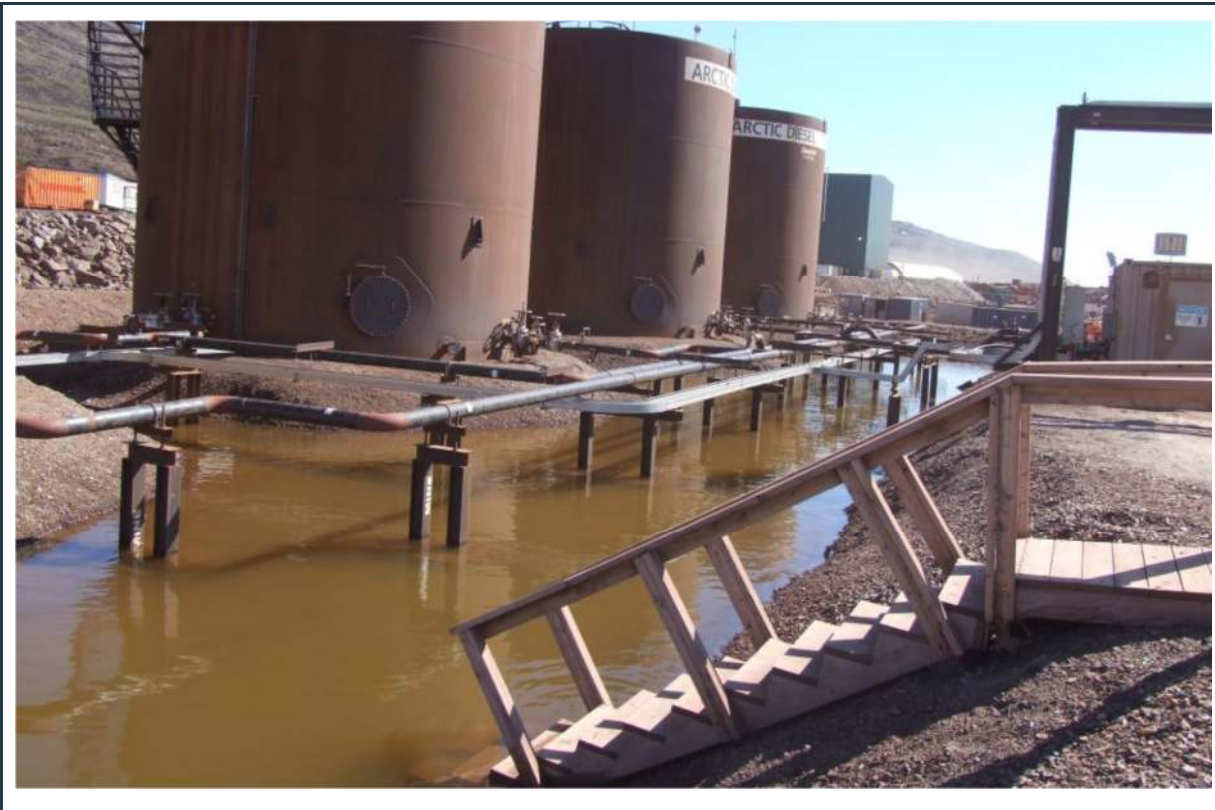
Figure 34: View of the MS-03 diesel fuel farm

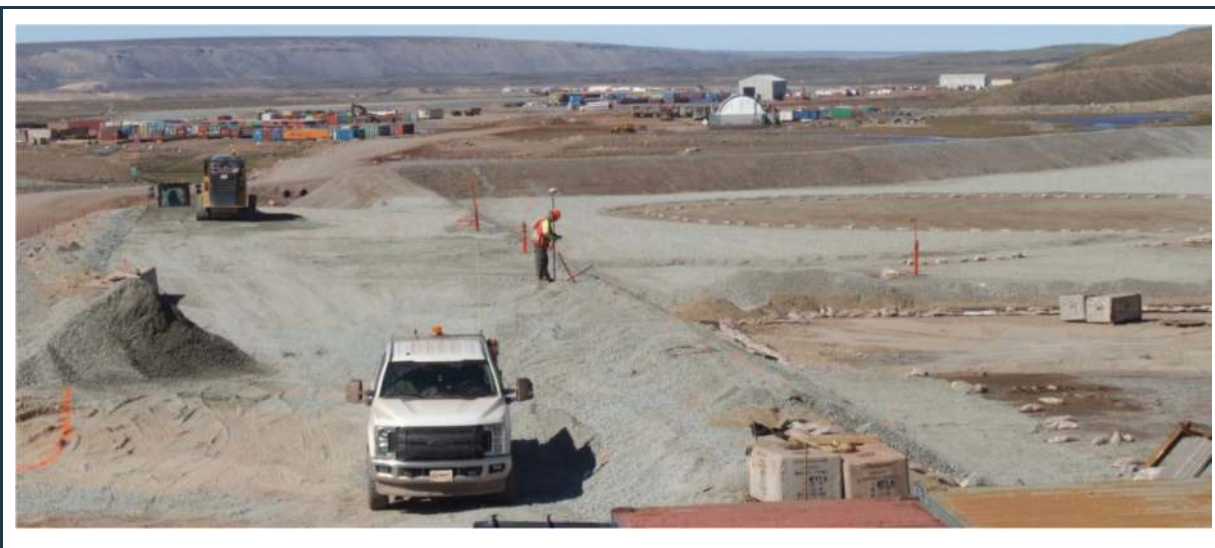
Figure 35: View of the new fuel tank farm (under construction)

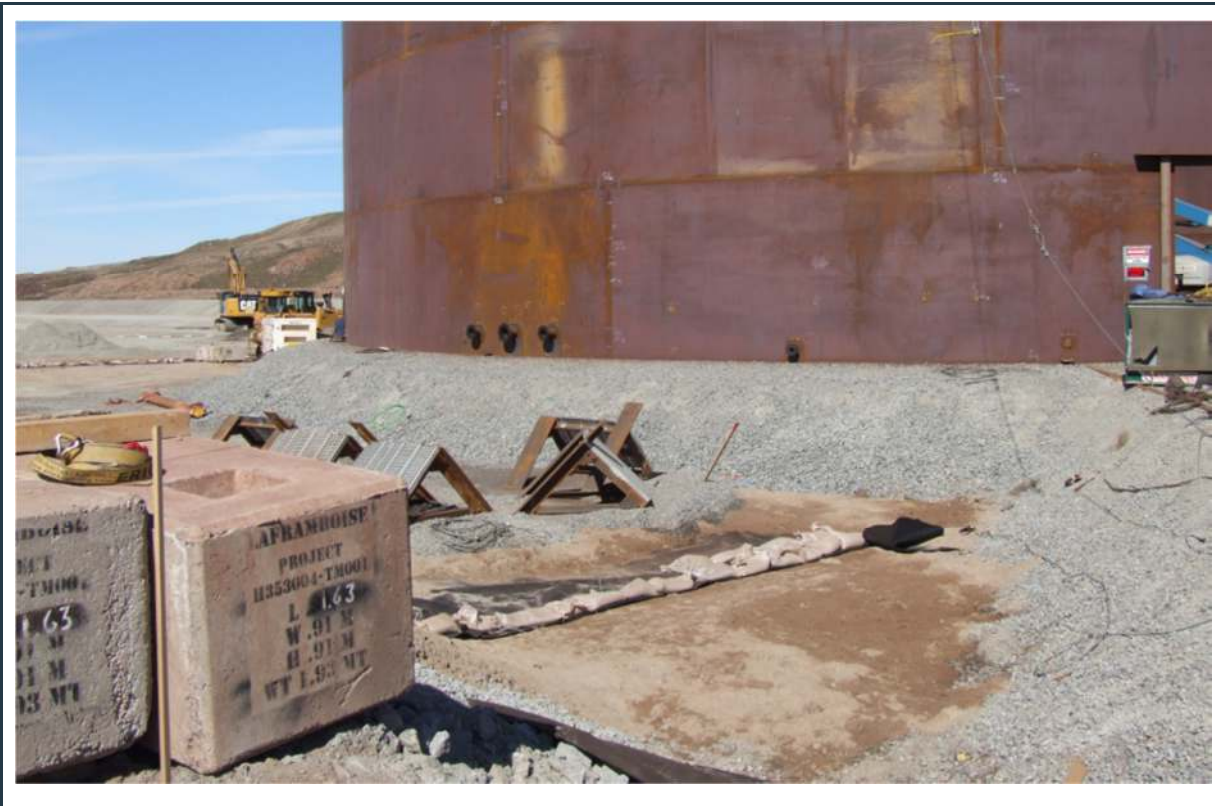
Figure 36: View of the new fuel tank farm at the Mary River site (under construction)

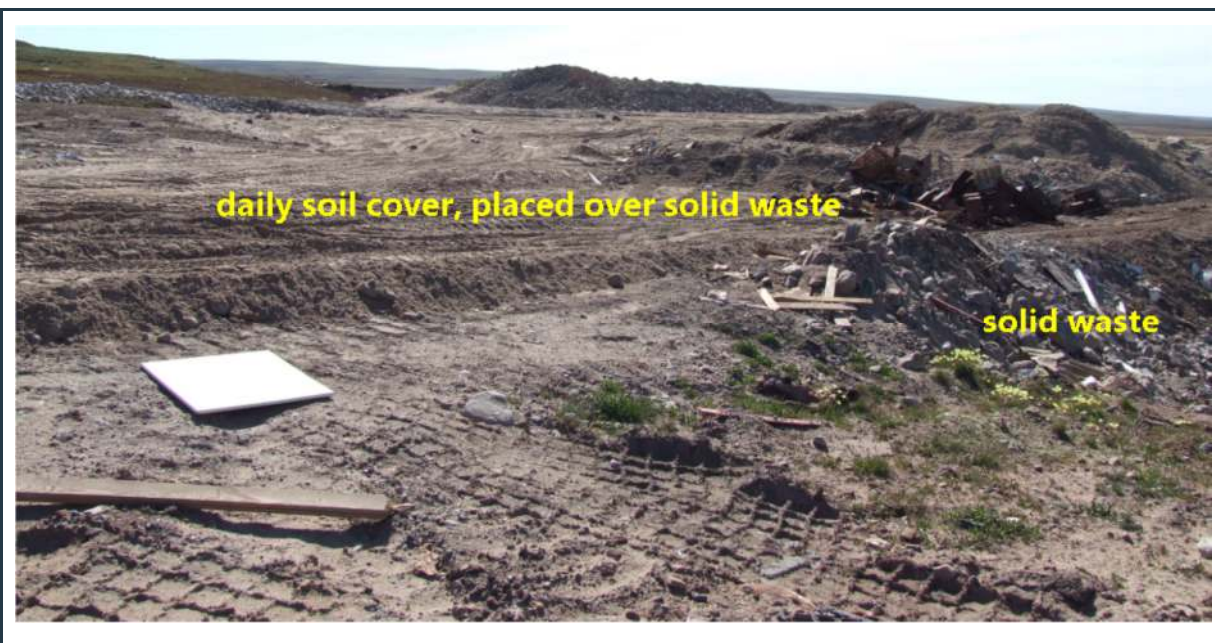
Figure 37: Solid waste landfill facility

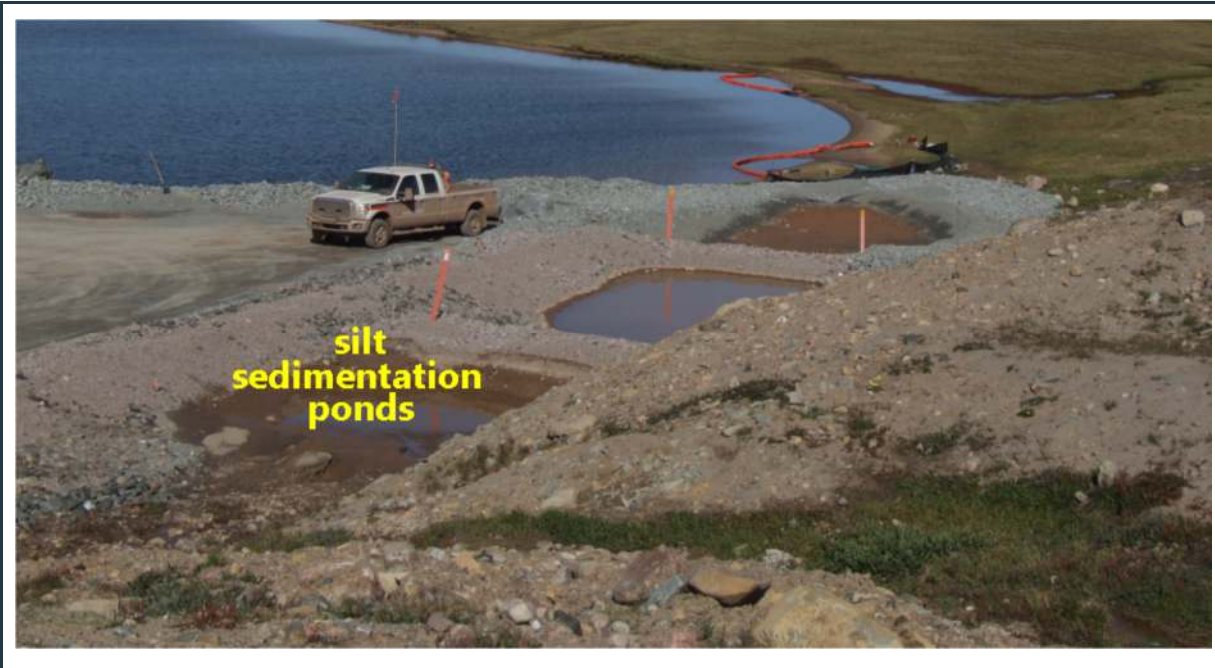
Figure 38: CLSP silt sedimentation check dams forming small ponds

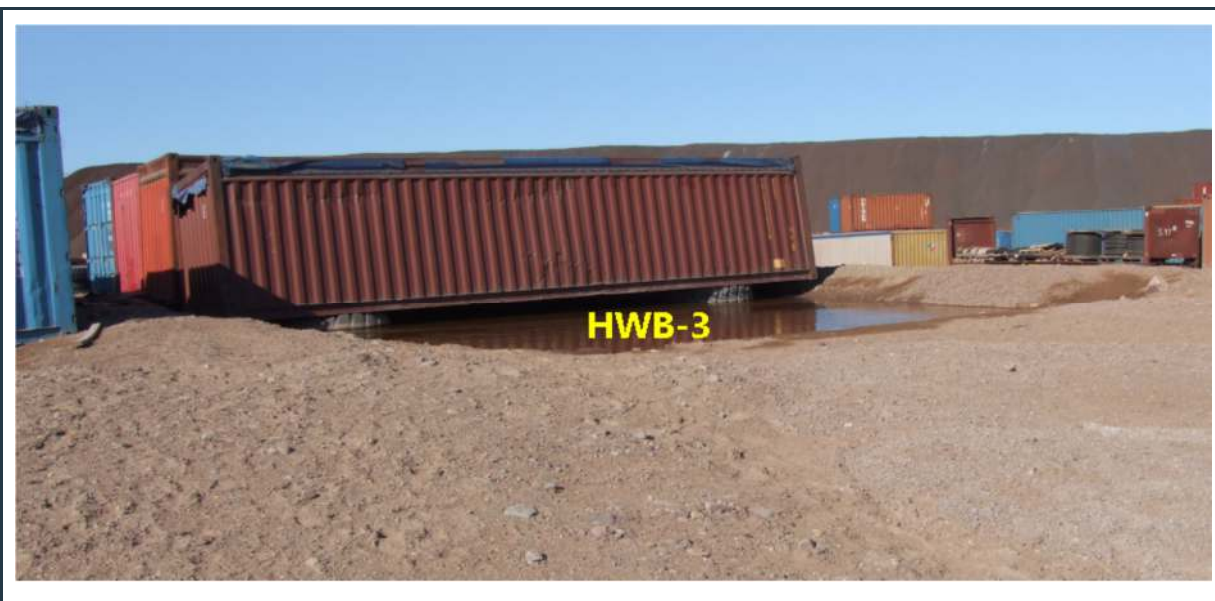
Figure 45: View of the HWB-3 cell, containing shipping containers

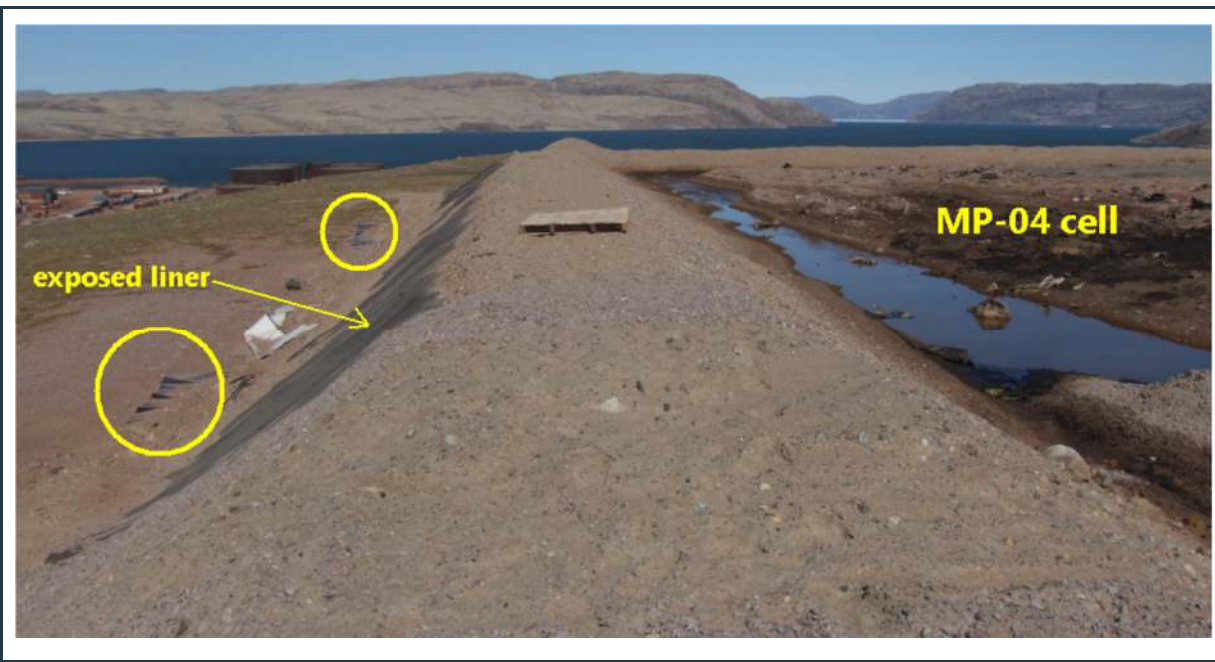
Figure 53: Stable berm at the MP-04 landfarm with exposed liner on the downstream face of the berm

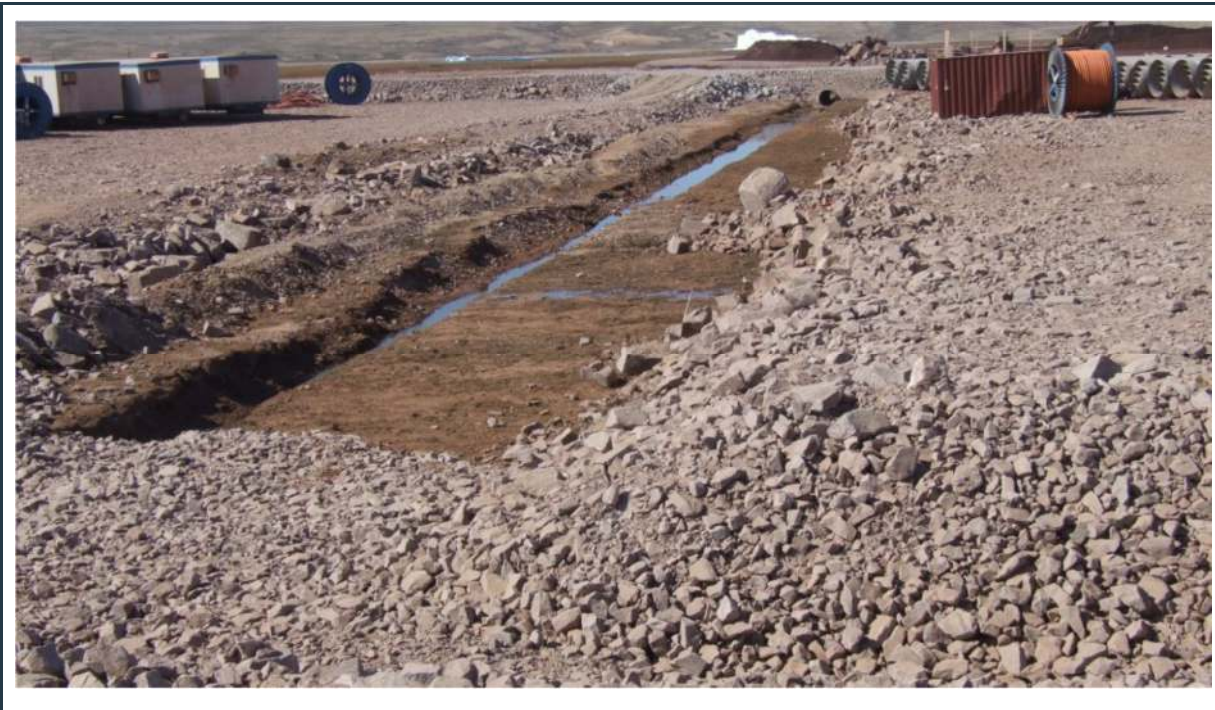
There are several water collection drainage ditches (listed above), most of them still under construction or improvement, as shown in Figures 62 to 67. These open ditches are excavated somewhat into the native soils and then their sides and inverts receive erosion protection layers composed of fine crushed rock. It was noted during the inspection that geotextile have been used wherever the native subgrade composed of fine-grained material to prevent migration of fines into the rockfill. The condition of these ditches should be monitored, particularly prior to the spring freshet, and any potential slope deterioration should be rectified prior to the anticipated increased flow during the thaw period of the year.

Figure 66: W13-W14 surface water collection ditch (under construction)

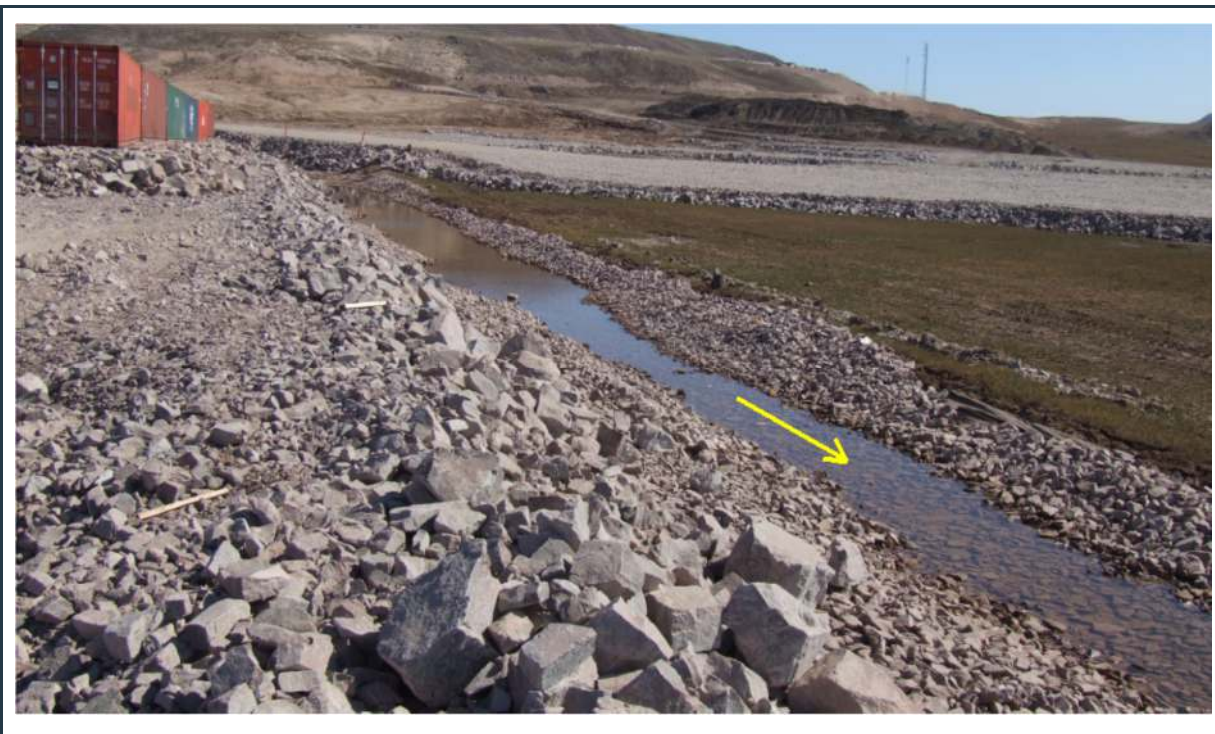
Figure 67: 380 M surface water collection ditch (under construction)

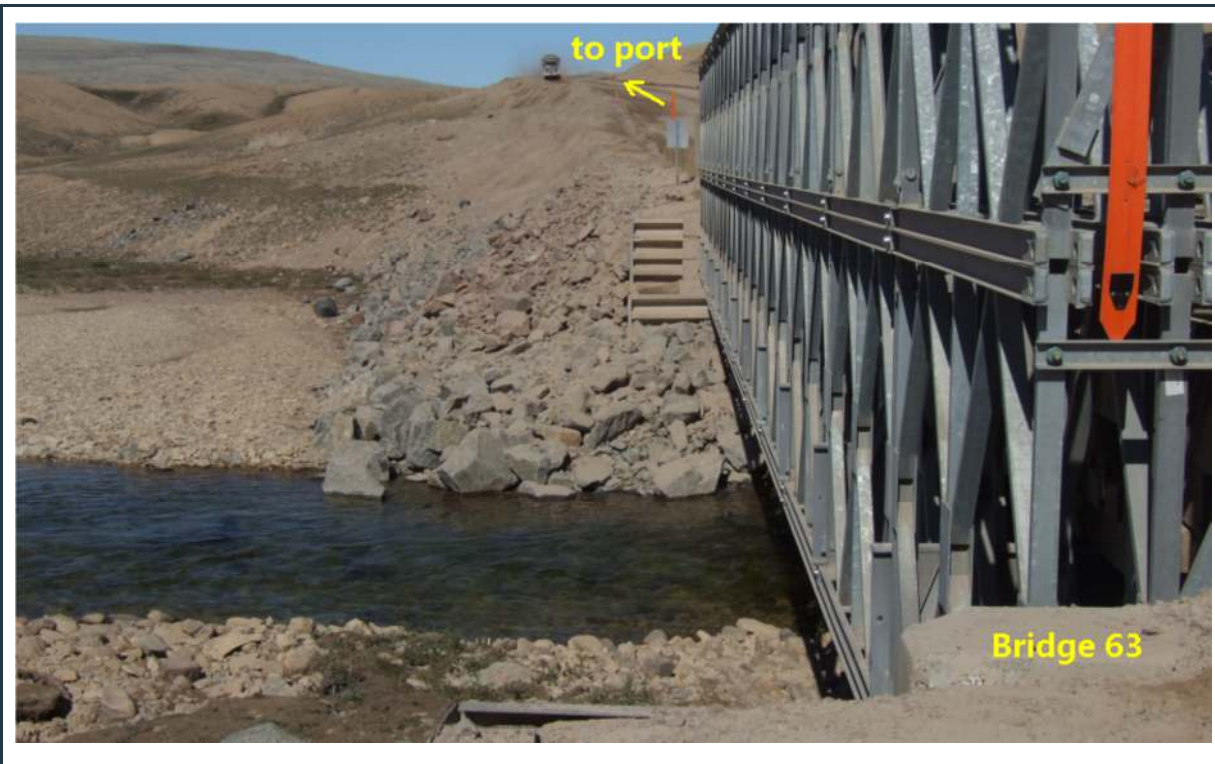
As shown in Figures 76 to 78, the abutments of this bridge are stable and no scour in the river-bed was noted during the site visit. The abutments show no differential settlement or any structural discrepancy like cracking on the foundation concrete. The wing-wall at the north-west abutment appears to be short and minor erosion of the road fill was noticed (Figure 78). At that location a metal section should be added to the wing-wall or alternatively some rock-fill be placed there to prevent soil erosion from the road into the river.

Figure 76: View of bridge 63, looking north

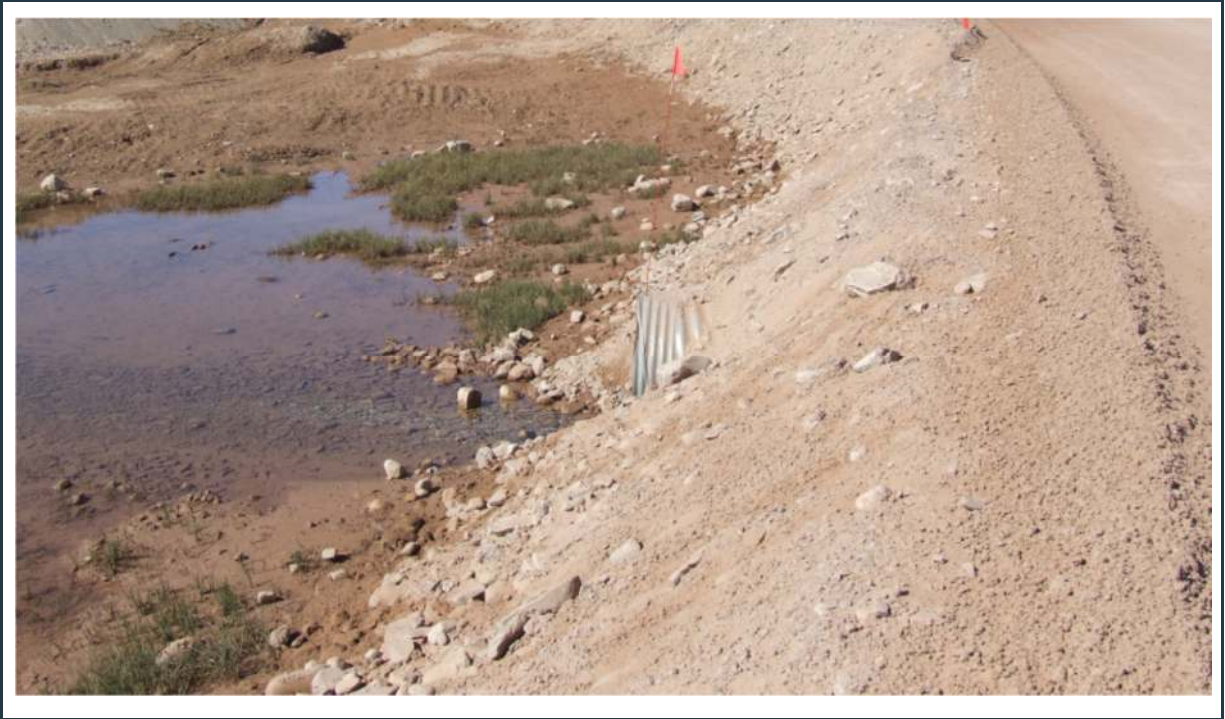
Figure 82: View of culvert 076 (outlet)

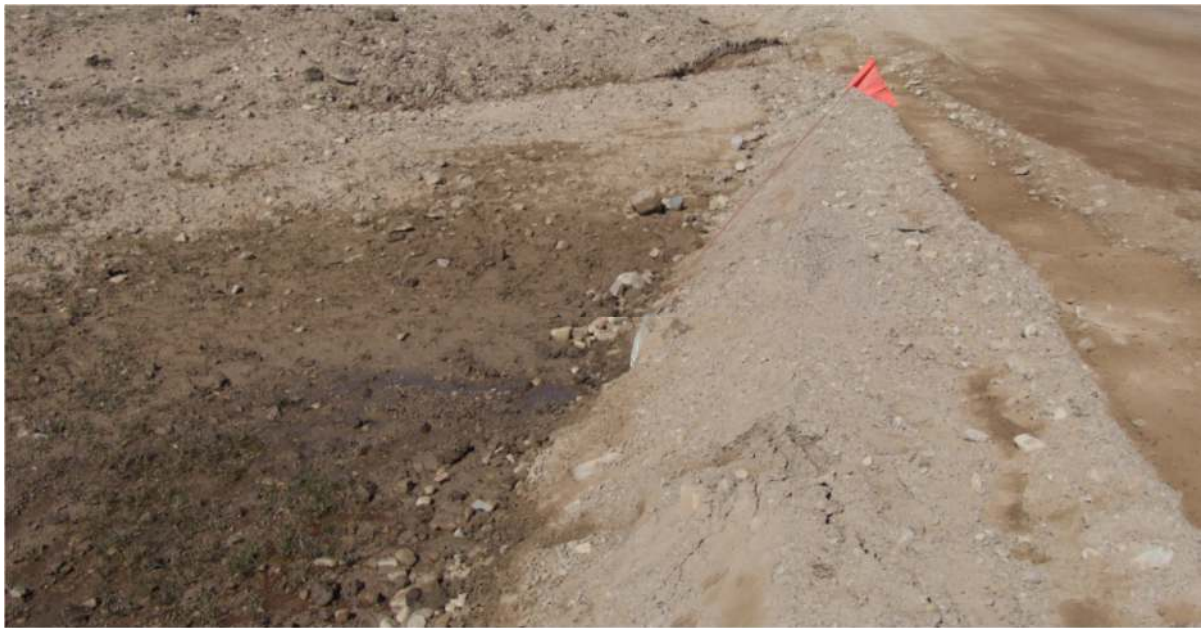
Figure 92: View of culvert 107 (outlet)

CV-107 (Figures 92 and 93): Both ends of this culvert are short, particularly at the inlet side. Consideration shall be given to replace this culvert with a longer and somewhat larger pipe. It is visible in Figure 93 that the inlet's invert is currently located above the water level, resulting in ponding water at the front of the inlet. A larger and longer pipe would facilitate uninterrupted flow of water from upstream to the other side of the road.
