## **RE: Submission of 2021 Geotechnical Inspection Report No. 1 (June 2021)**

August 23, 2021,  
Project #: TC190307.2021

### Annual Geotechnical Inspections – 2021 Report 1. Mary River Project – Nunavut

### Annual Geotechnical Inspections – 2021 Report 1. APPENDIX "A" - Mary River Mine Complex - Photographs

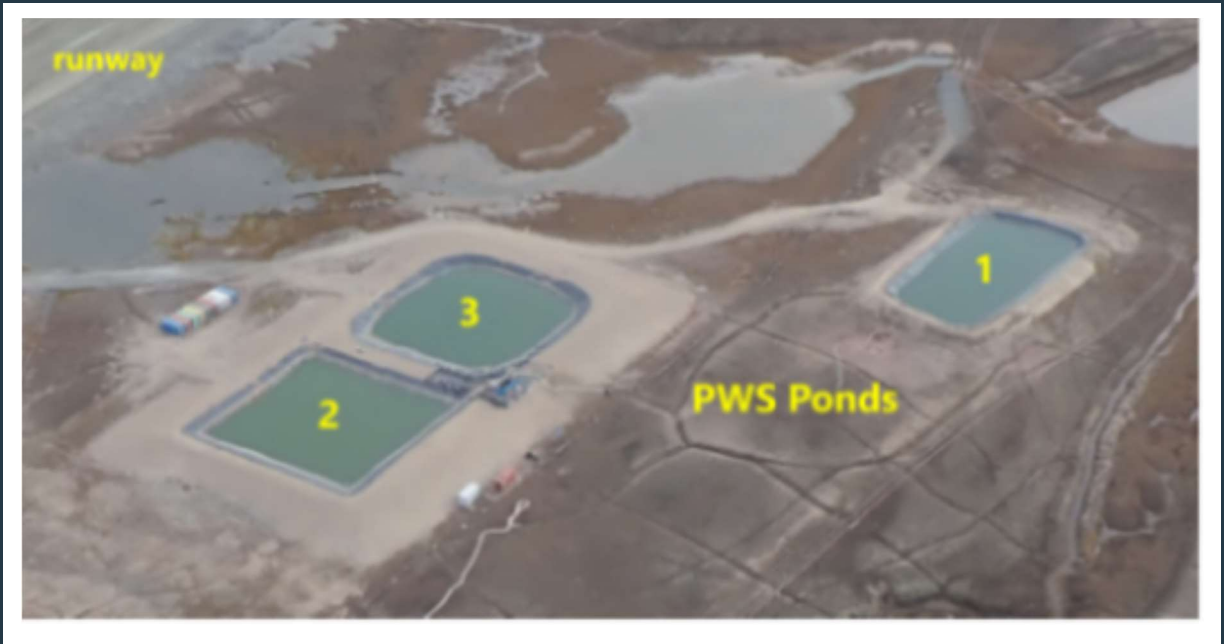
There are three (3) polishing/waste stabilization ponds, located adjacent to the runway, as shown in Figure 3. Pond #1 is a single structure, while Ponds #2 and #3 were constructed as twin-cells, as shown in Figure 9, which is a historic aerial image showing the robust berms around the ponds. According to previous inspection reports, these ponds were associated with the exploration phase of the mine, and currently serve as emergency holding ponds in case problems would arise, which would prevent the discharge of treated effluent directly to the receiving environment. The stable berms around the ponds generally comprise granular materials (rock fill, sand, and gravel), supporting High Density Polyethylene (HDPE) geomembrane liners. The liners are secured in anchor trenches on the crest of the berms, and no damage is visible on the membranes on the upstream face of the slopes (see Figures 10 to 12).

Figure 9: Aerial view of the stable berms around the three PWS ponds. (Historic image to present the layout of the three ponds and to show the robust berms around the facilities).

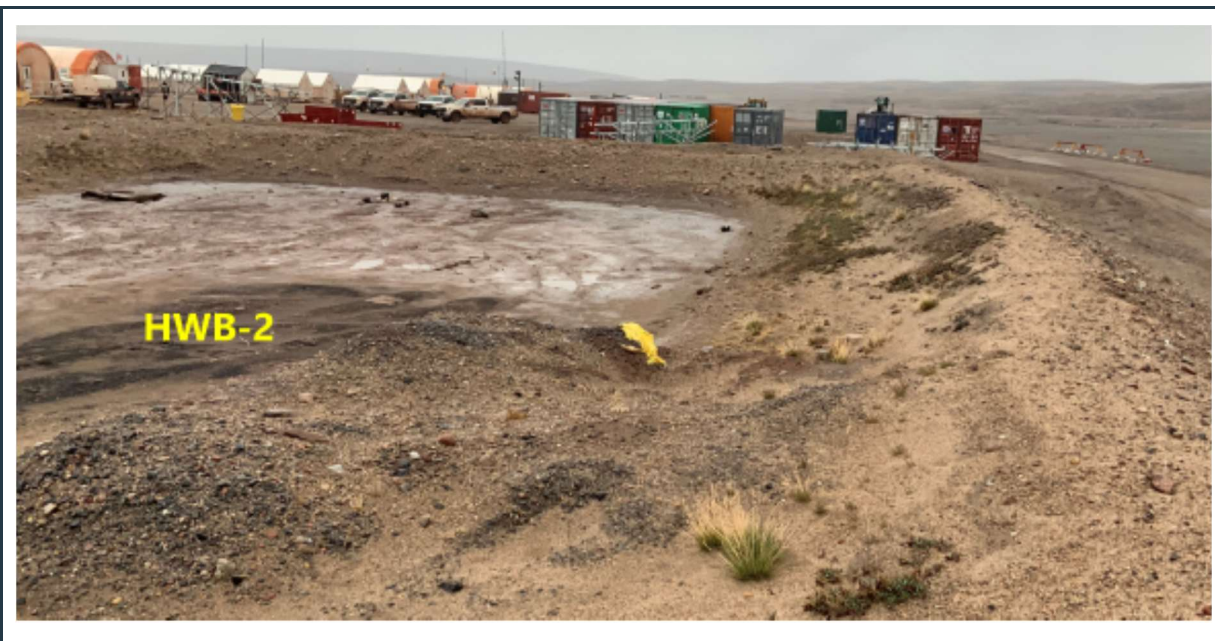
### b) HWB-2

As shown in Figure 14, this cell is currently empty. It is also shown in the relevant image that the perimeter berms around the cell appear to be stable. No visible seepage from the cell was noted around the berm, and the cell operates as intended, although no material is currently stored in this cell.

Figure 14: View of stable berms around HWB-2. The cell is currently empty.

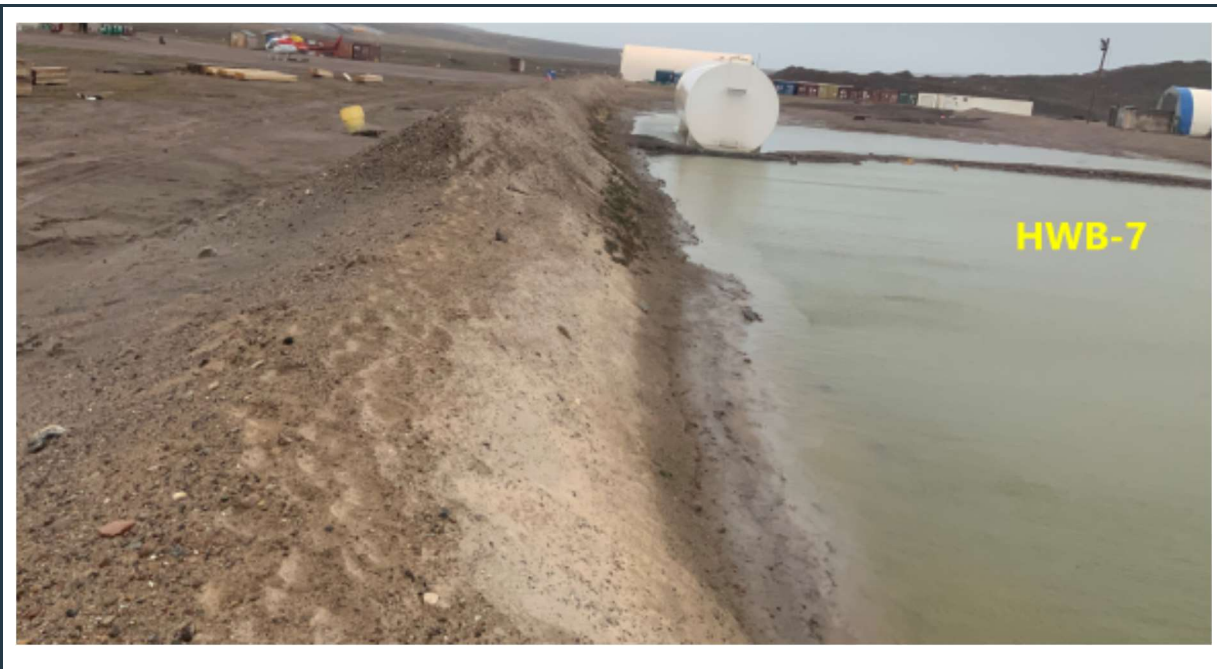
f) HWB-7

Only one (1) large fuel tank is stored in this large cell, as shown in Figure 19 (white tank). The robust perimeter berms around the cell appear to be stable and the visible water (rain and melted snow) within the cell is indicative of adequate liner performance within the cell.

Figure 19: View of the large, flooded HWB-7 cell, with only one fuel tank stored.

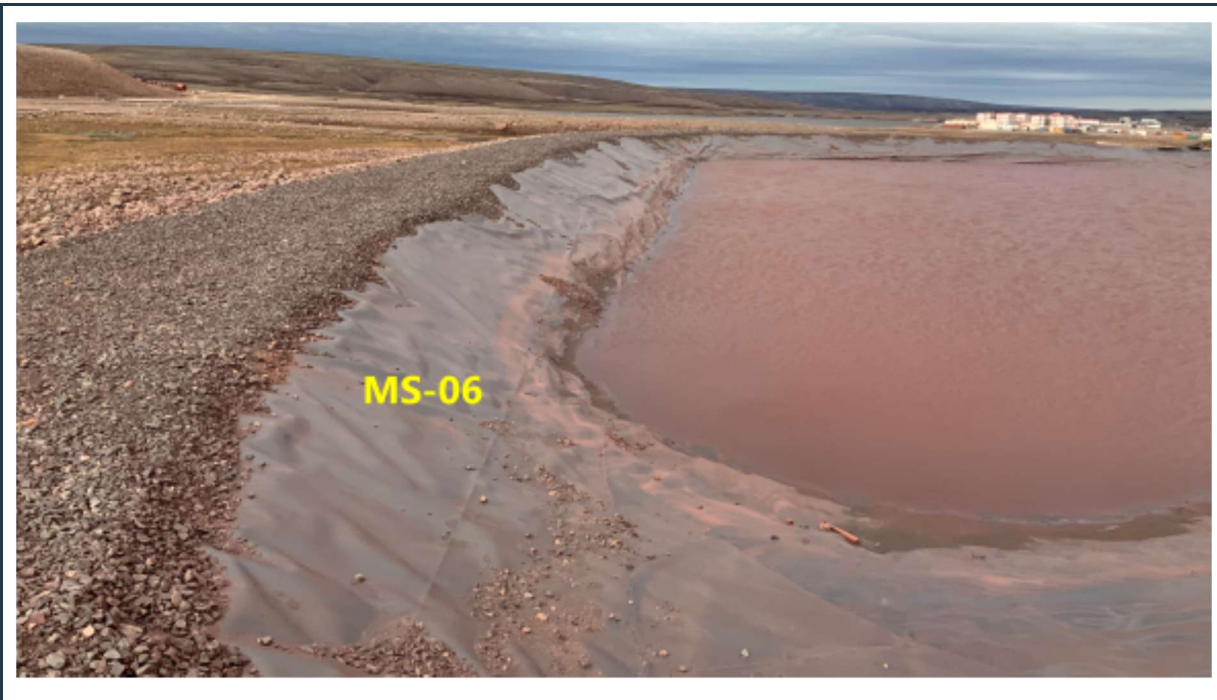
Figure 20: MS-06 surface-water collection and settling pond with robust, stable berms and intact liner.

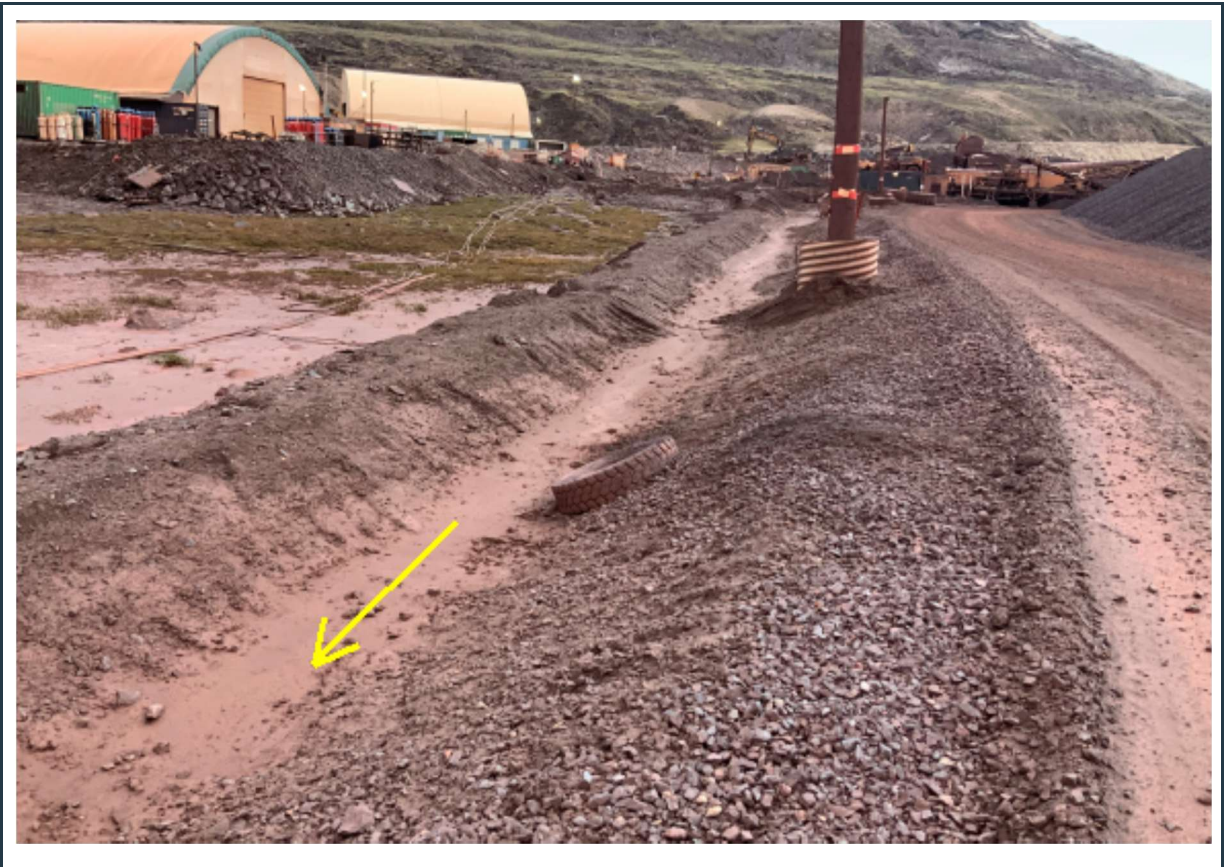
Figure 21: Well-maintained drainage ditch next to the crusher plant, leading to the MS-06 pond.

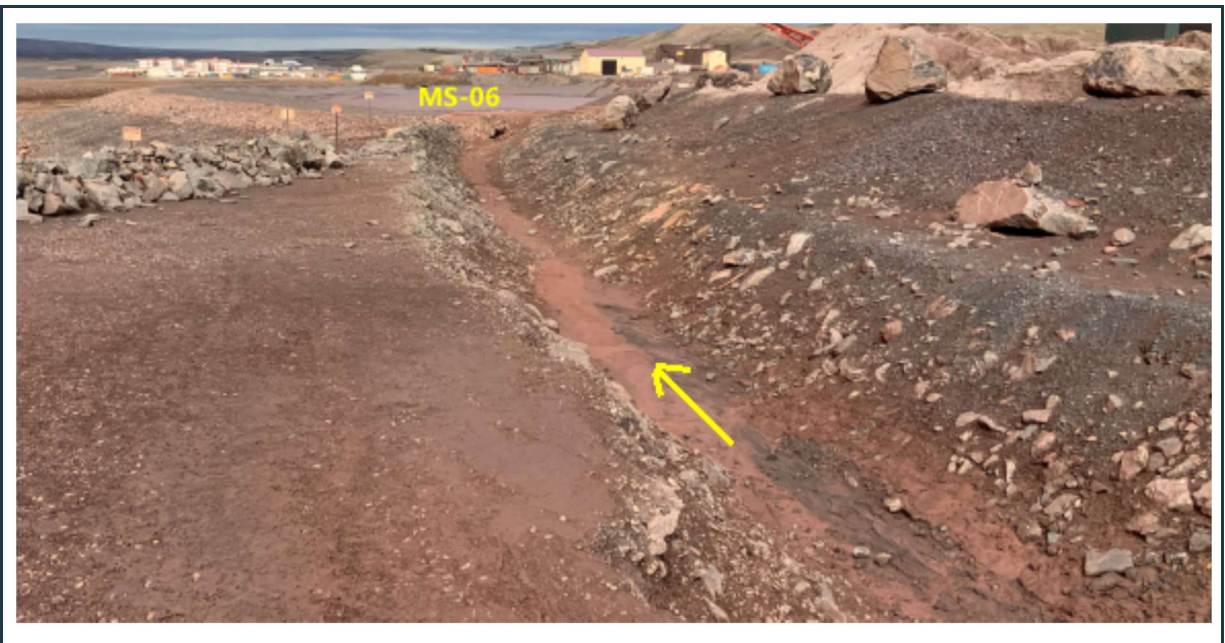
Figure 22: Drainage ditch next (south-west) to the crusher plant, leading to the MS-06 pond.

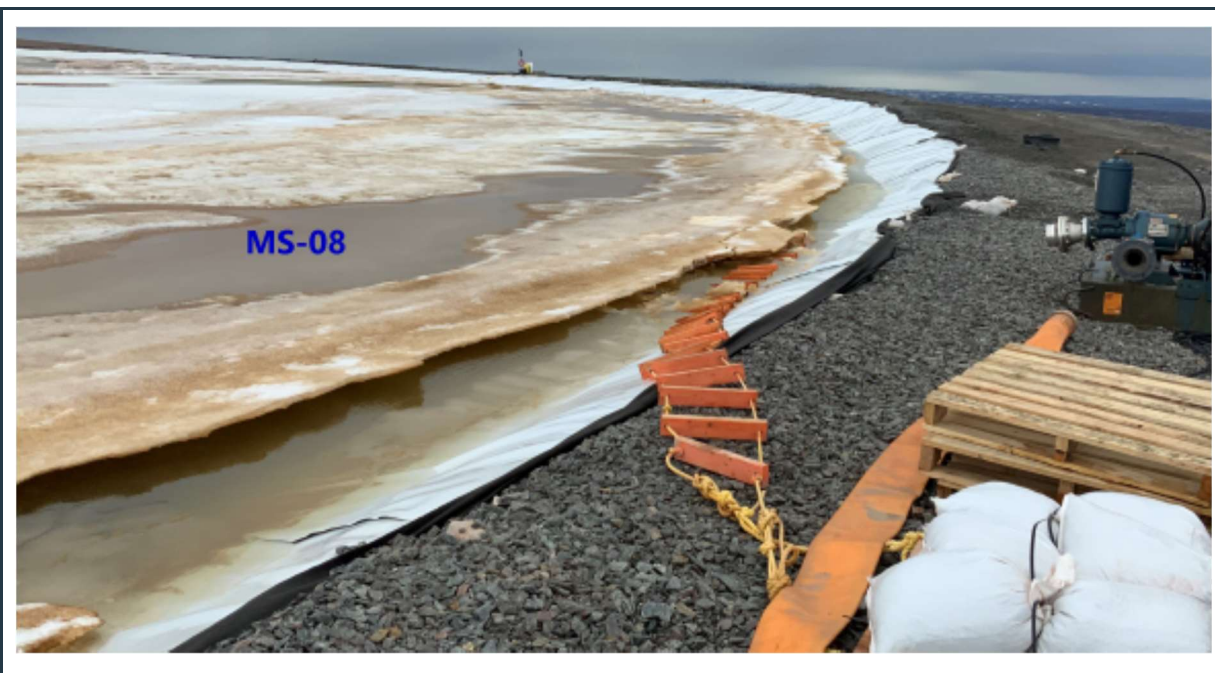
At the time of the June 2021 inspection, ice and snow still covered the entire pond, shown in Figure 24. As pointed out earlier, contact water from the WRF is collected in perimeter ditches and the collected water flows to the settling pond from the east and west. As shown in Figures 25 and 26, the drainage ditches are well maintained, having stable slopes. A few boulders have rolled into the west ditch from the adjacent waste rock pile and these boulders should be removed from the ditch.

Figure 24: View of stable berm and intact liner at the MS-08 pond. Ice is still present at the end of June.

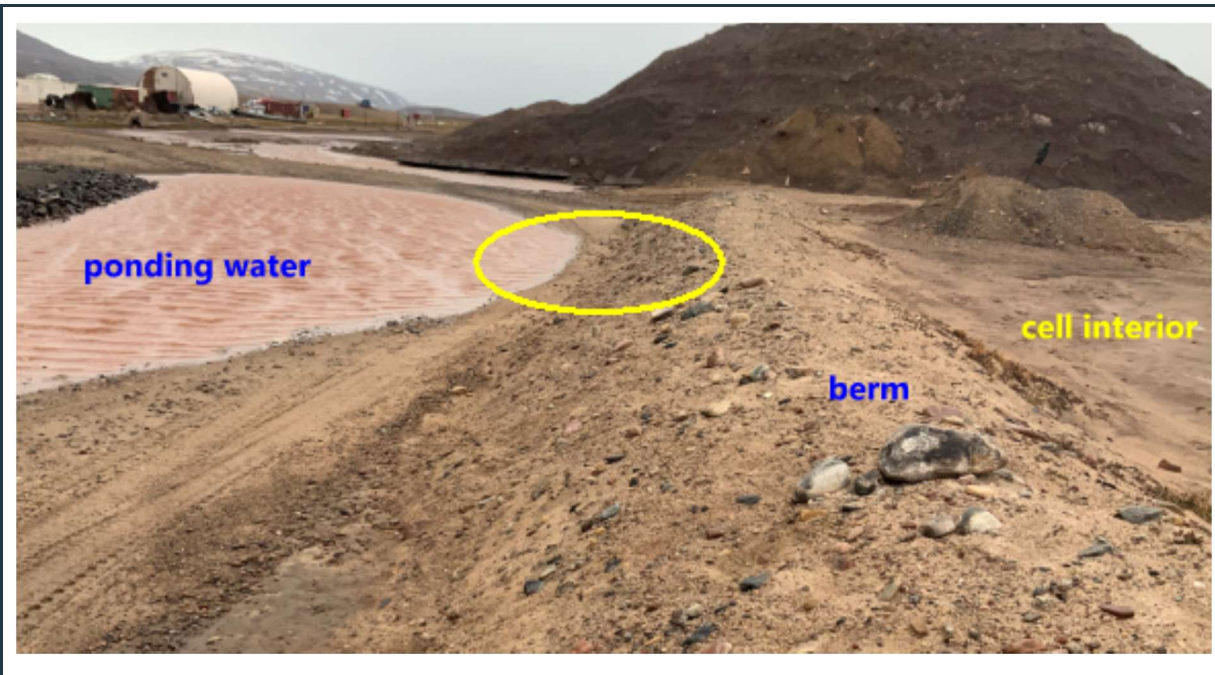
Figure 29: View of ponding water adjacent to the north-east berm of the “fuel bladder” cell. Trucks bypassing the ponding water on the road are “cutting” into the toe of the berm (yellow circle).

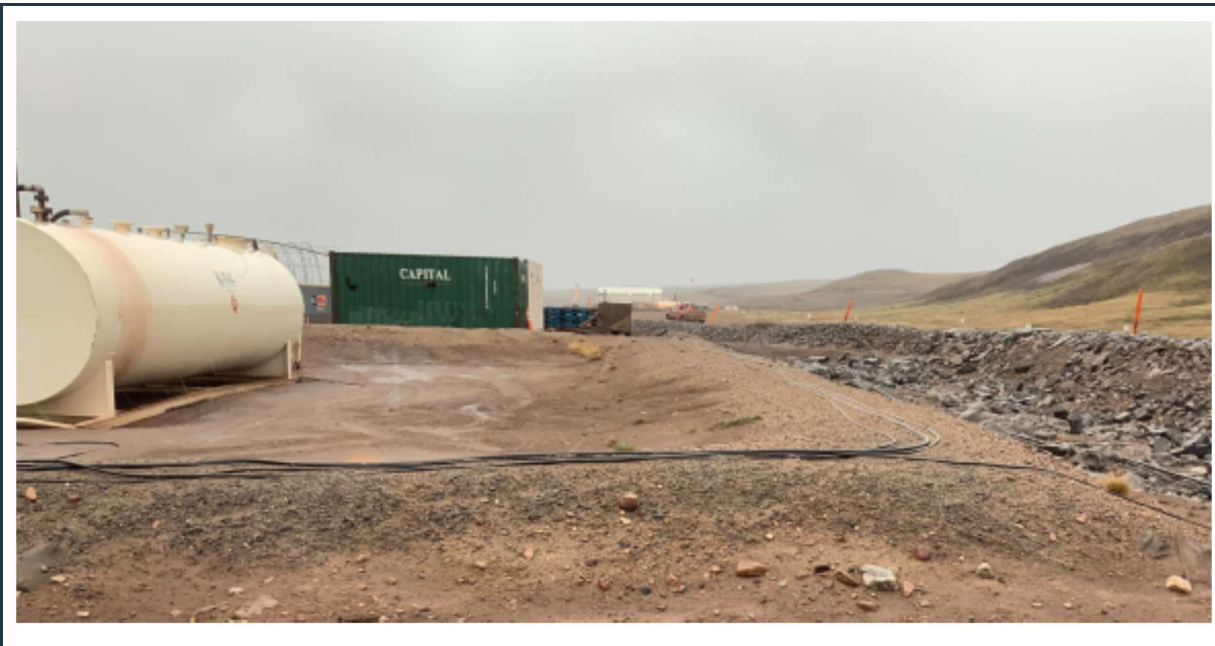
Figure 30: View of the well-maintained sand and gravel berm at the lined jet-fuel storage facility, with the additional rock fill protective berm, constructed between the cell and the tote road.

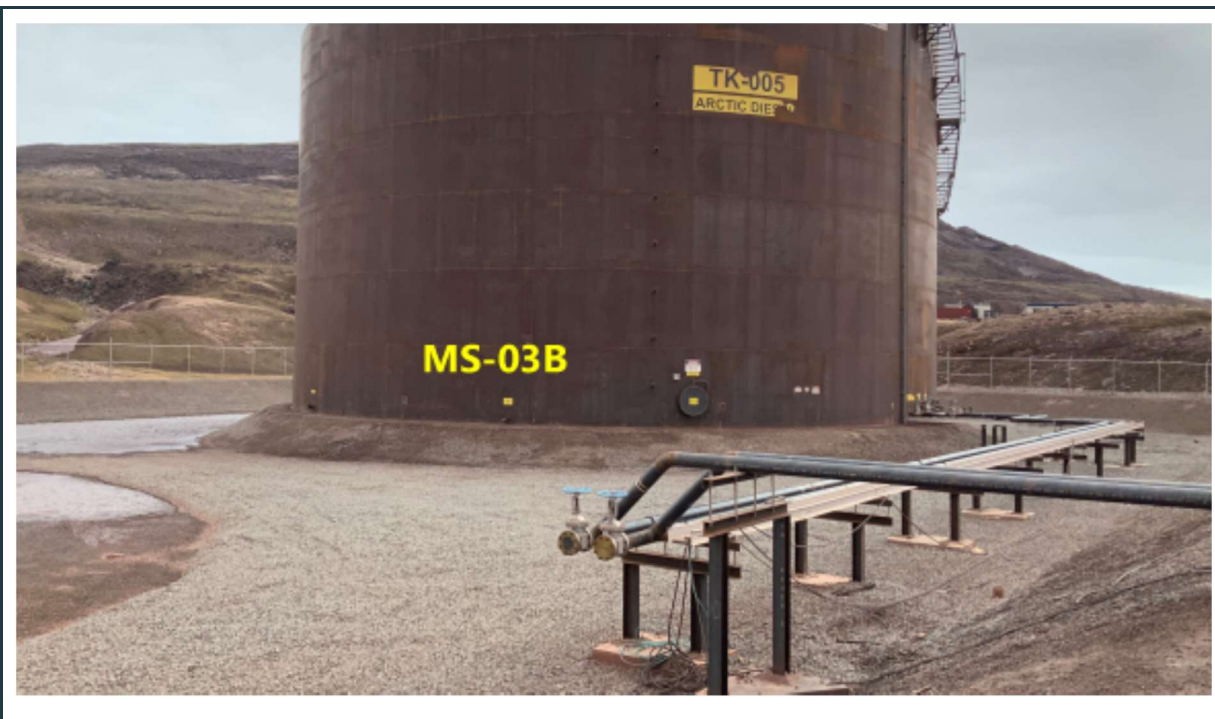
Figure 32: View of the well-maintained new fuel tank farm, with some ponding water.

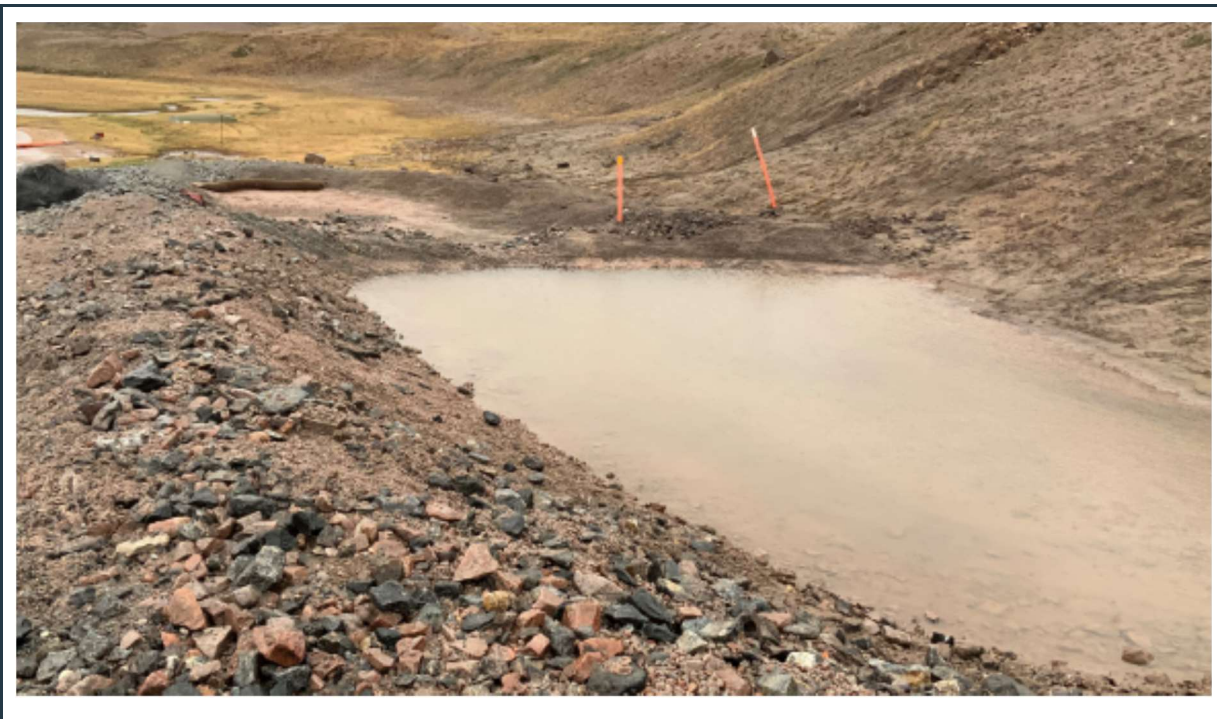
Figure 34: Camp Lake check dams and berms, constructed around the silt sedimentation cells.

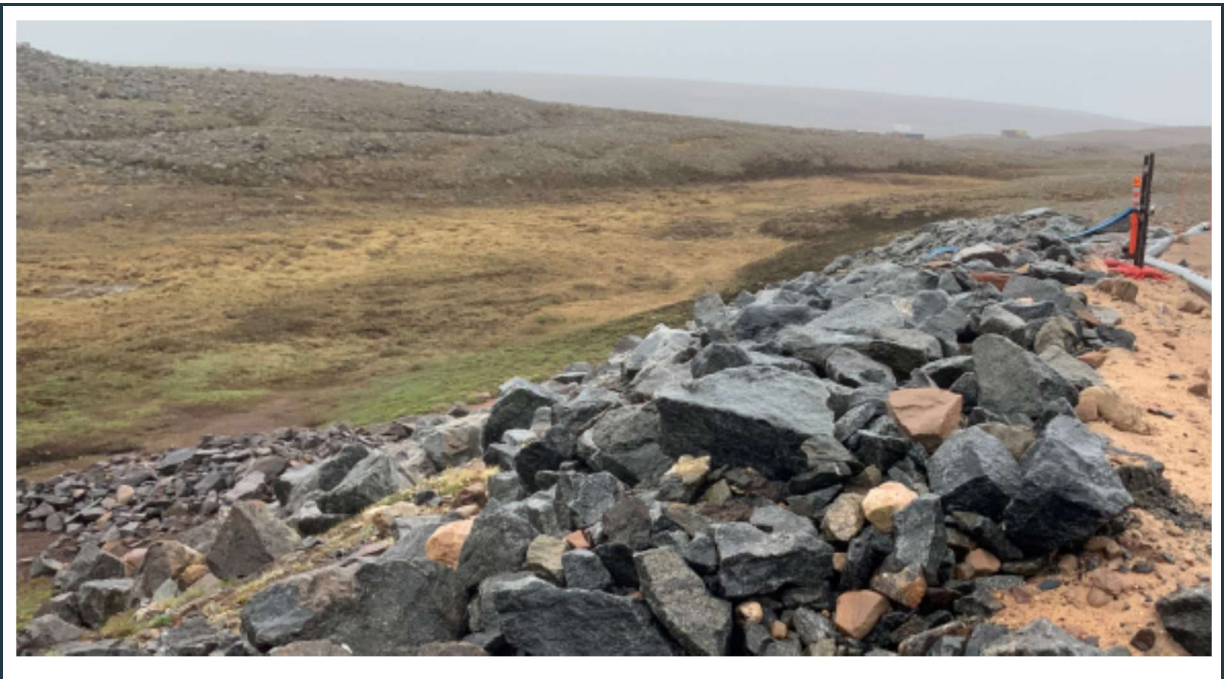
Figure 35: Stable rock fill riprap slope protection at the water discharge area.

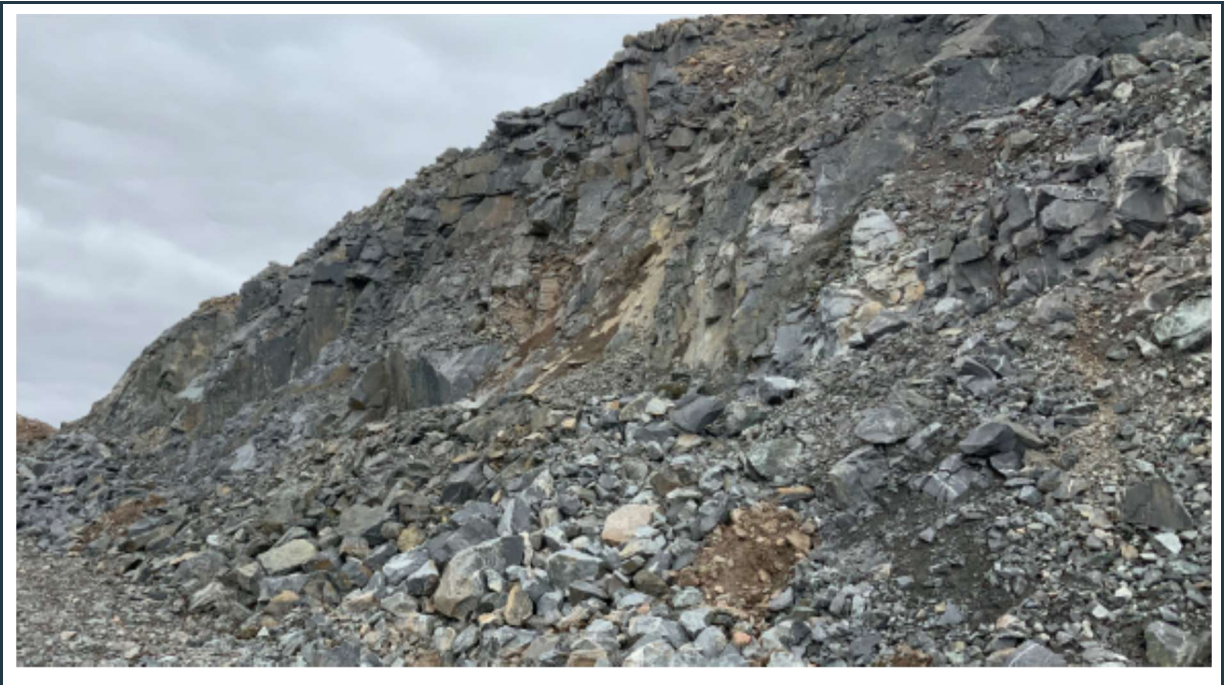
Figure 39: View of the early stage of rock excavation in the new D1Q1 rock quarry.

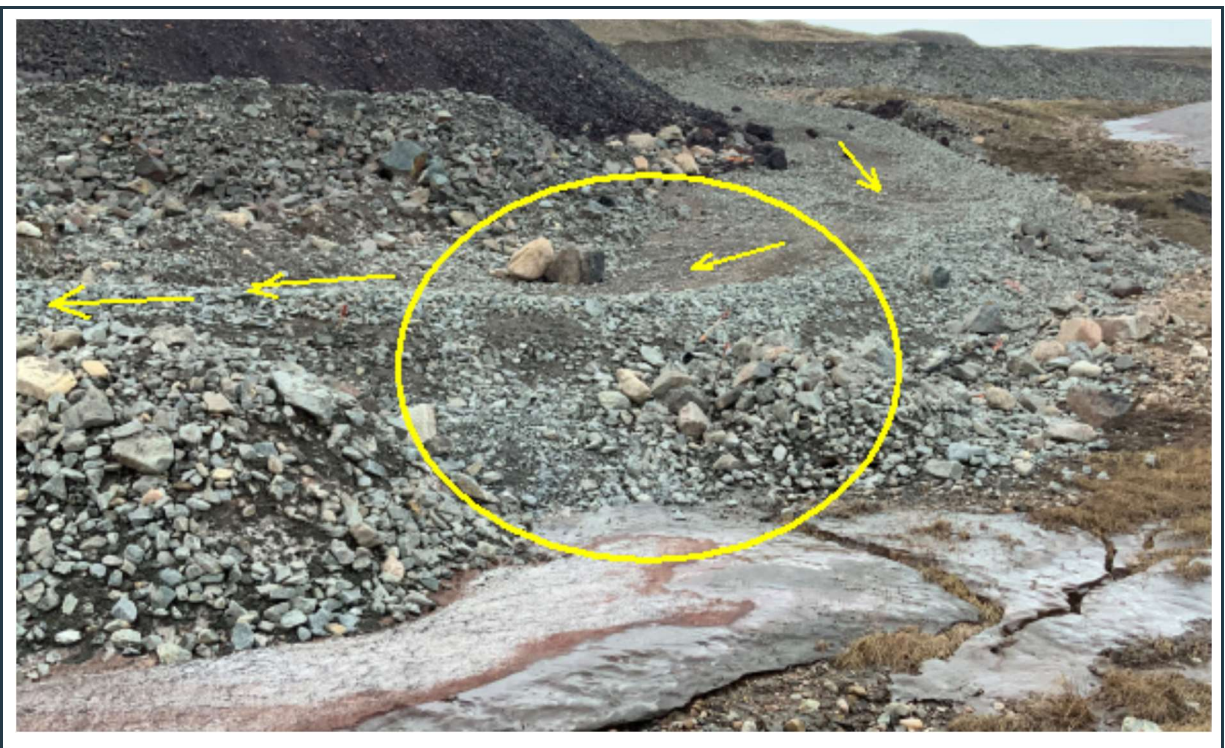
Figure 40: View of the surface water diversion berm at the new KM-106 ore stockpile area.

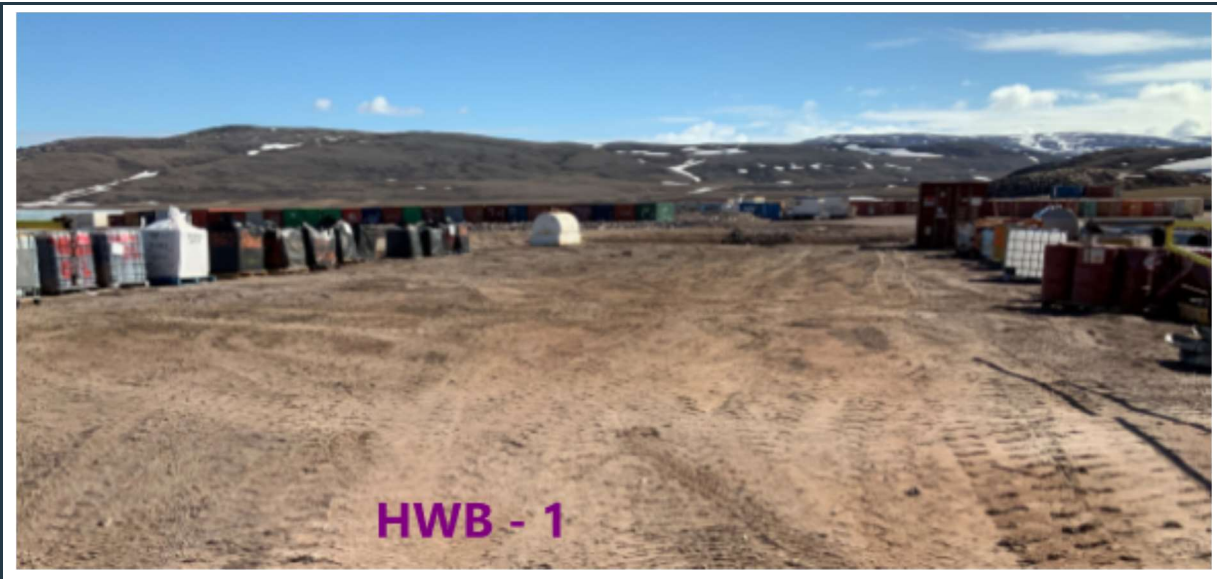
Figure 41: View of the practically empty HWB-1 cell with upgraded (regraded) cell floor.

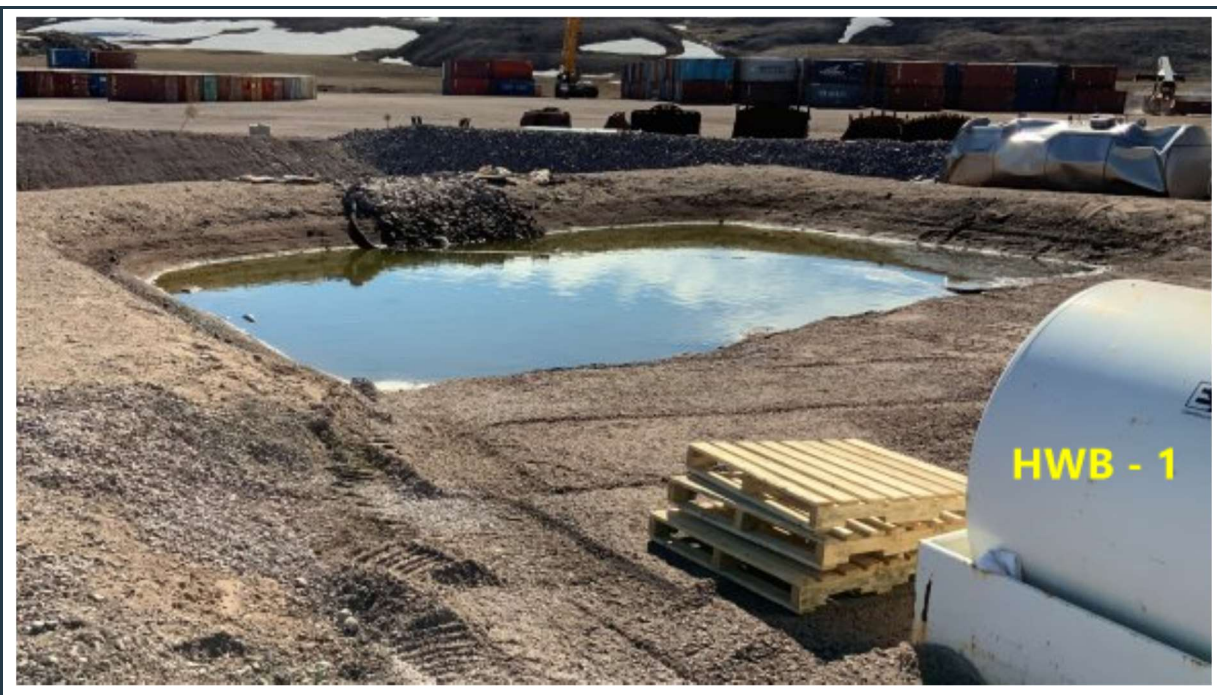
Figure 42: View of the back of the HWB-1 cell, with ponding water and upgraded (regraded) cell floor.

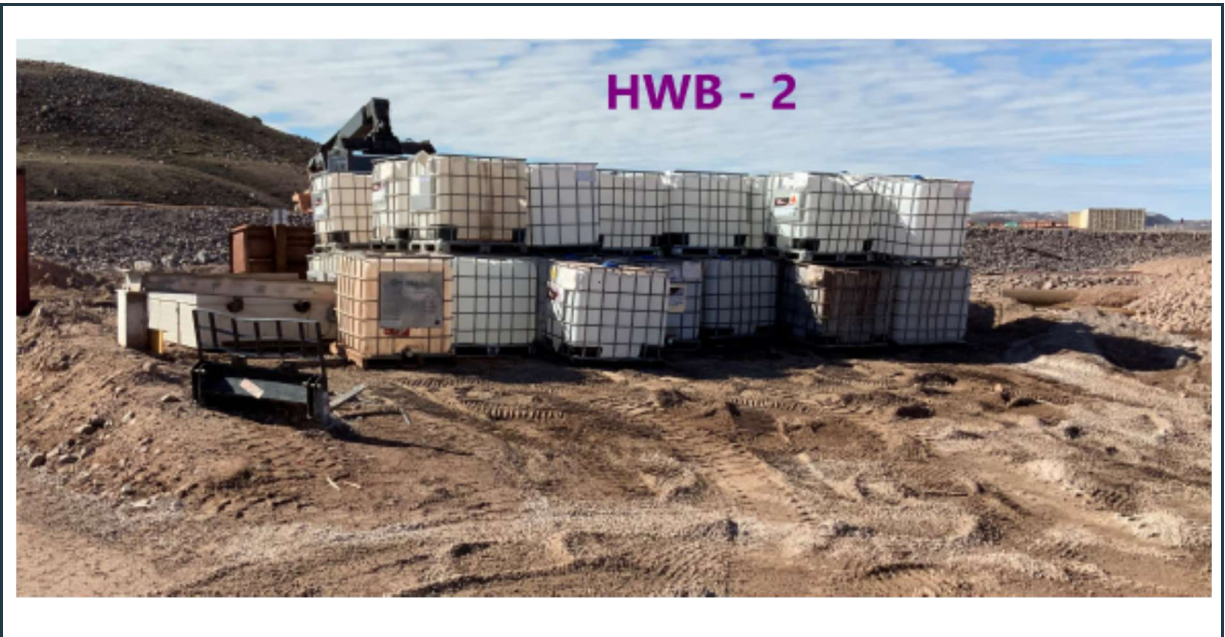
Figure 43: View of the former HWB-2 cell, with only empty containers stored on the top of clean sand and gravel fill pad. No hazardous waste is stored in this cell.

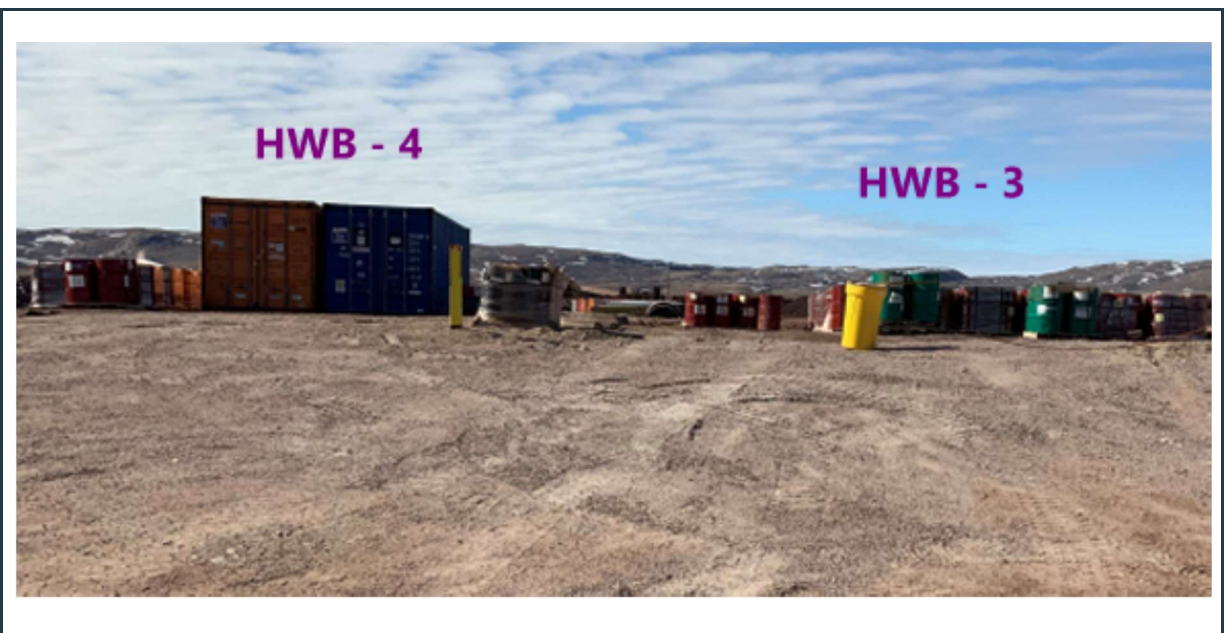
Figure 44: View of the HWB-3 and HWB-4 cells, containing fuel barrels and two shipping containers.

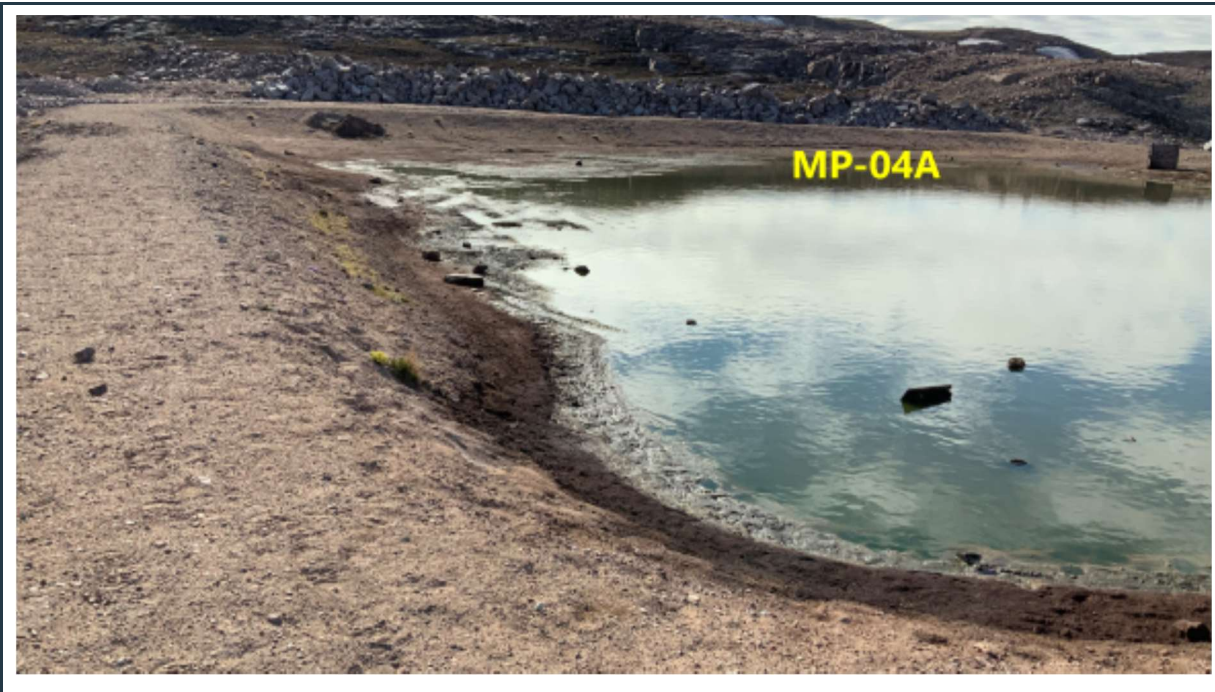
Figure 49: View of the MP-04A cell with stable berms and ponding melted snow.

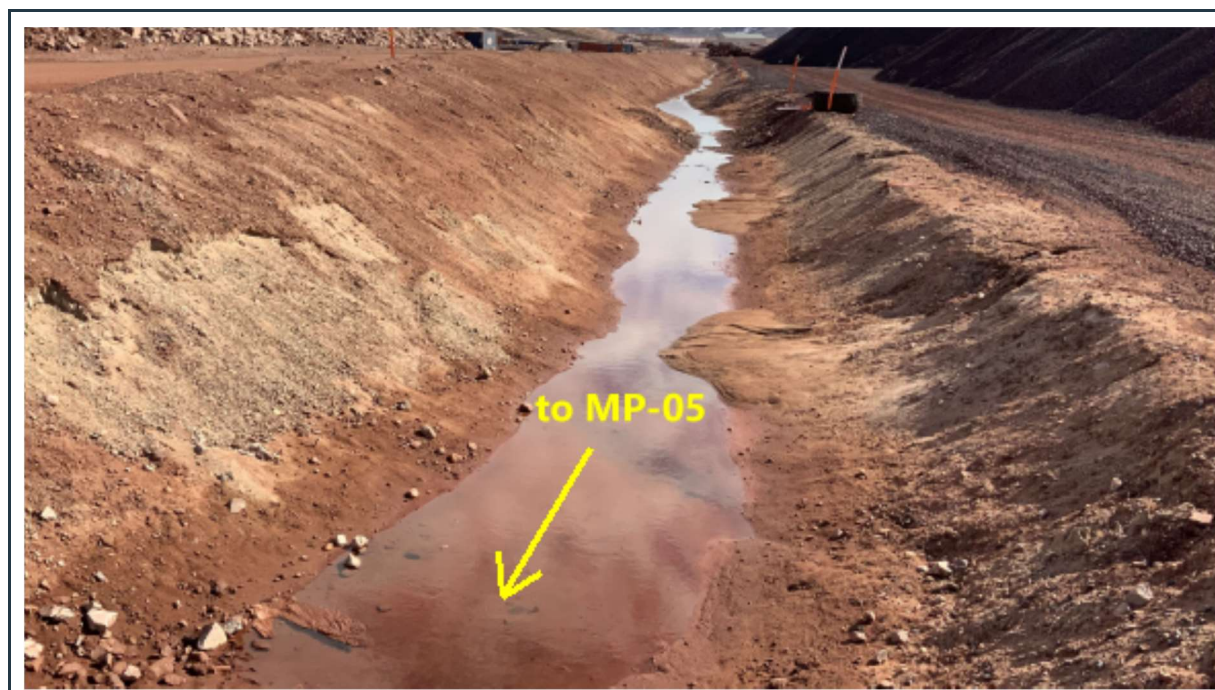
Figure 54: Surface water collection ditch adjacent (east) to the ore storage, draining to the MP-05 pond.

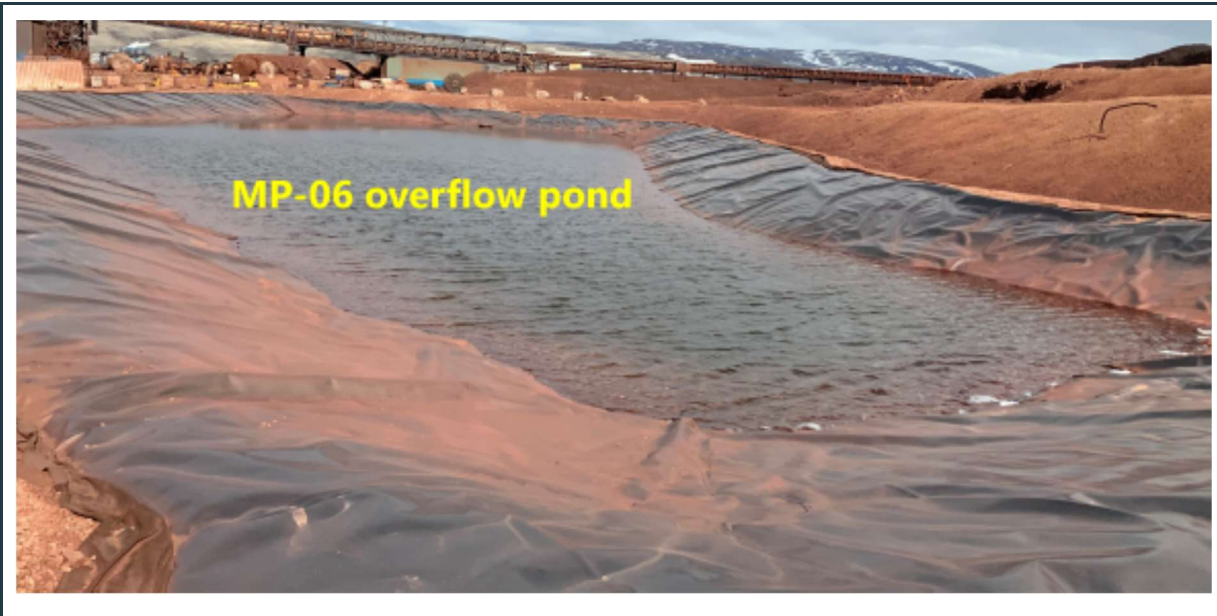
Figure 57: View of the lined MP-06 overflow pond, with stable berms.

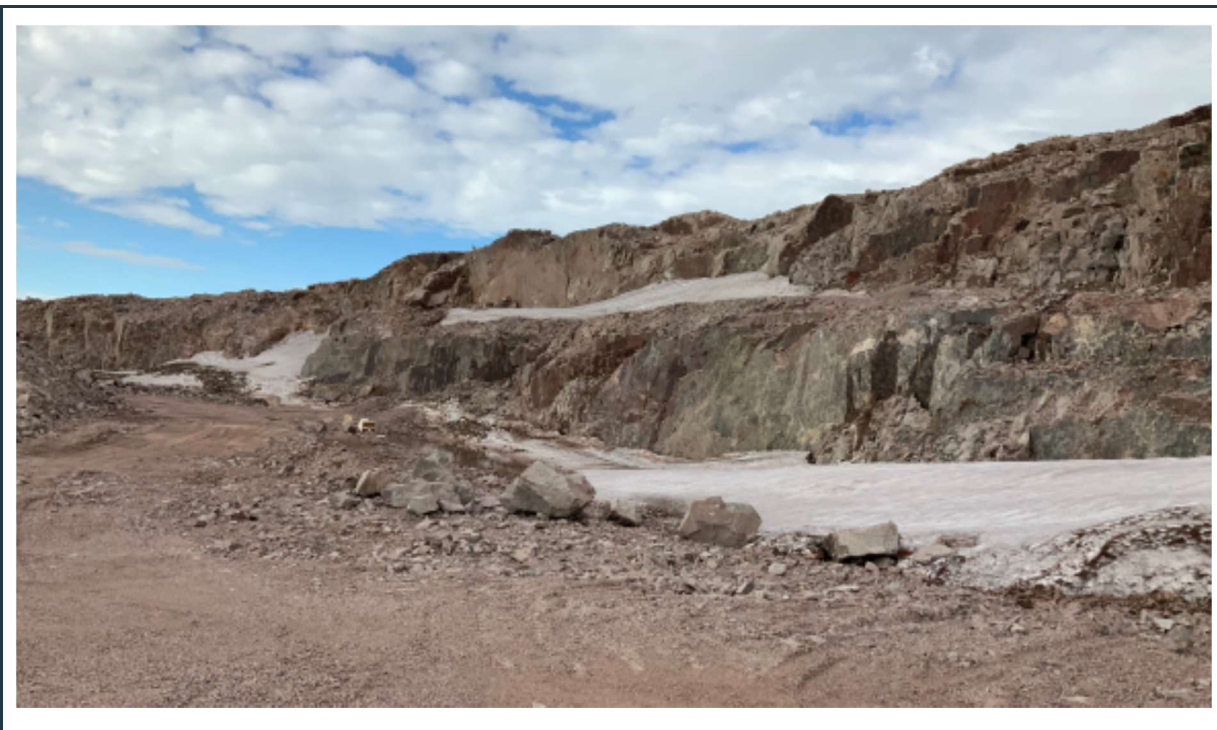
Figure 58: View of stable highwalls with minor weathering and bench erosion in the Q01 rock quarry.  
Note the accumulated snow on the top of the benches.

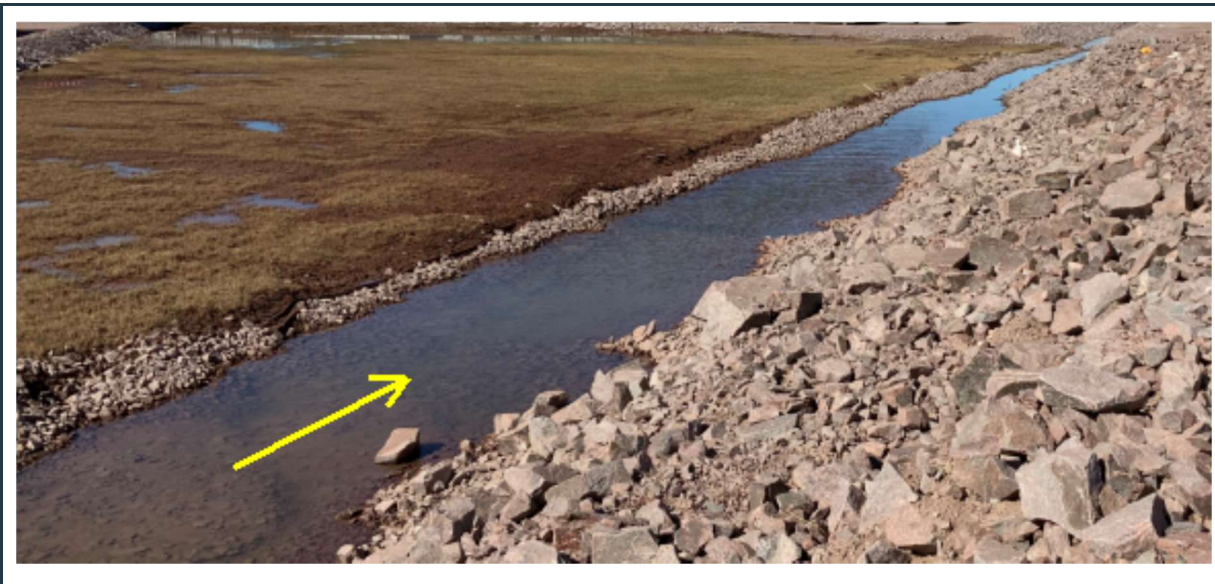
Figure 66: View of the south section of the 380 M surface water collection ditch.

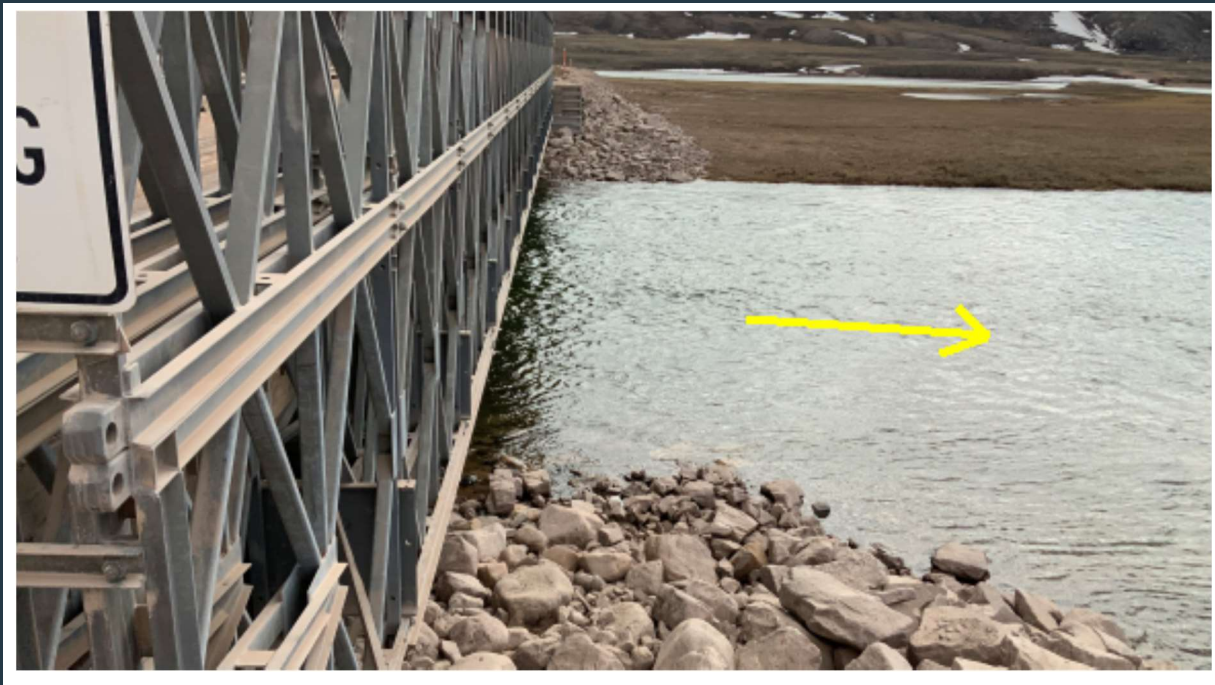
Figure 71: View of the north side of "bridge 17". Note the rip-rap scour protection at the abutments.

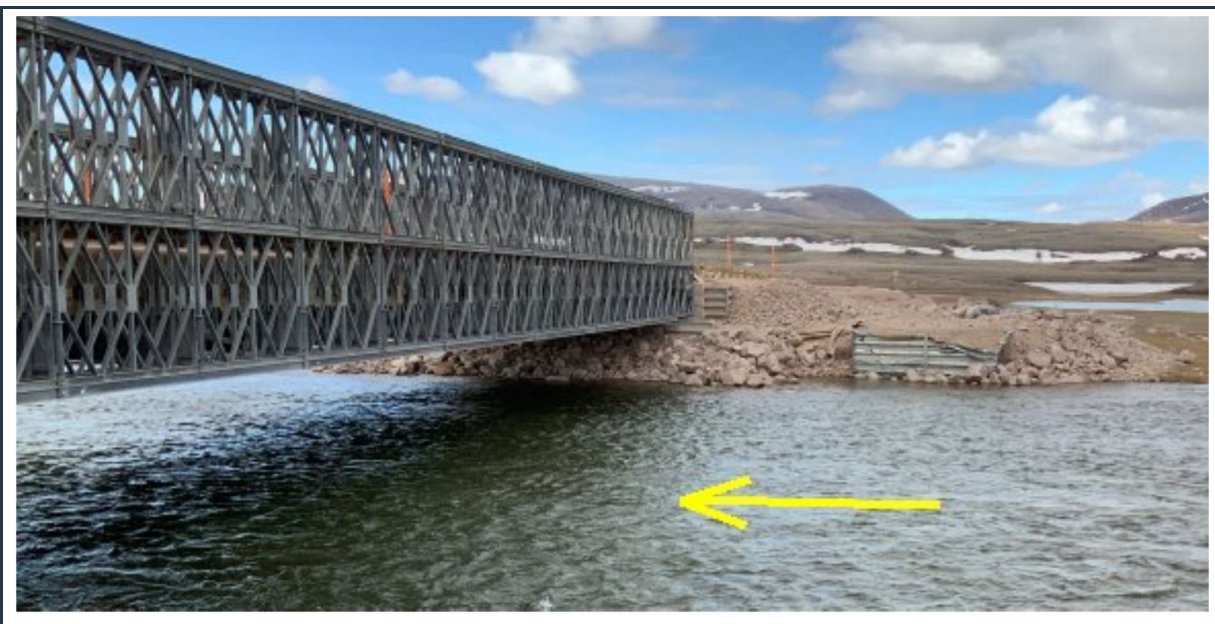
As shown in Figures 71 and 72, the abutments of this bridge are stable and no scour in the riverbed around the abutments was noted during the recent site visit in June. The abutments show no visible differential settlement or any structural discrepancy like deterioration of the steel bolt-a-bin abutments or sloughing of the riprap rock fill. There are two (2) historic abutments located immediately adjacent to the "new" ones, one (1) of which is visible in Figure 72. The metal bin structures of both "old" abutments have suffered some damages in the past, particularly the south abutment. As pointed out in earlier reports, the two (2) old (somewhat damaged) abutments should be kept in place since they provide additional support to the adjacent "new" abutments.

Figure 72: View of the south side of "bridge 17", with stable abutment and riprap scour protection.

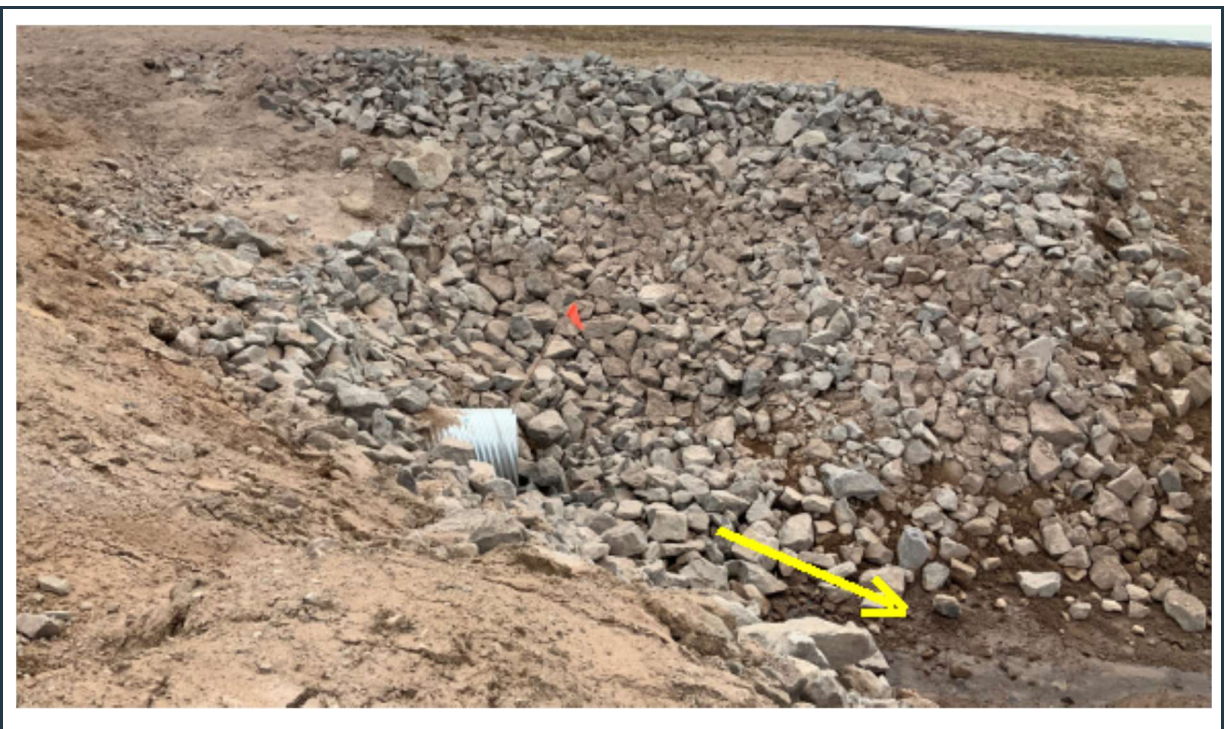
CV-038 (Figures 83 and 84): The inlet of this culvert is too short, and the riprap is missing from around the pipe. This problem may result in slope erosion of the road embankment around the pipe and early siltation and potential clogging of the pipe. The suggested repairs are in alignment with the current approved Civil Design Criteria for the Project.

Figure 84: View of culvert BG-038 outlet.
