## **RE: Submission of 2021 Geotechnical Inspection Report No. 1 (June 2021)**

August 23, 2021,  
Project #: TC190307.2021

### Annual Geotechnical Inspections – 2021 Report 1. Mary River Project – Nunavut

### Annual Geotechnical Inspections – 2021 Report 1. APPENDIX "A" - Mary River Mine Complex - Photographs

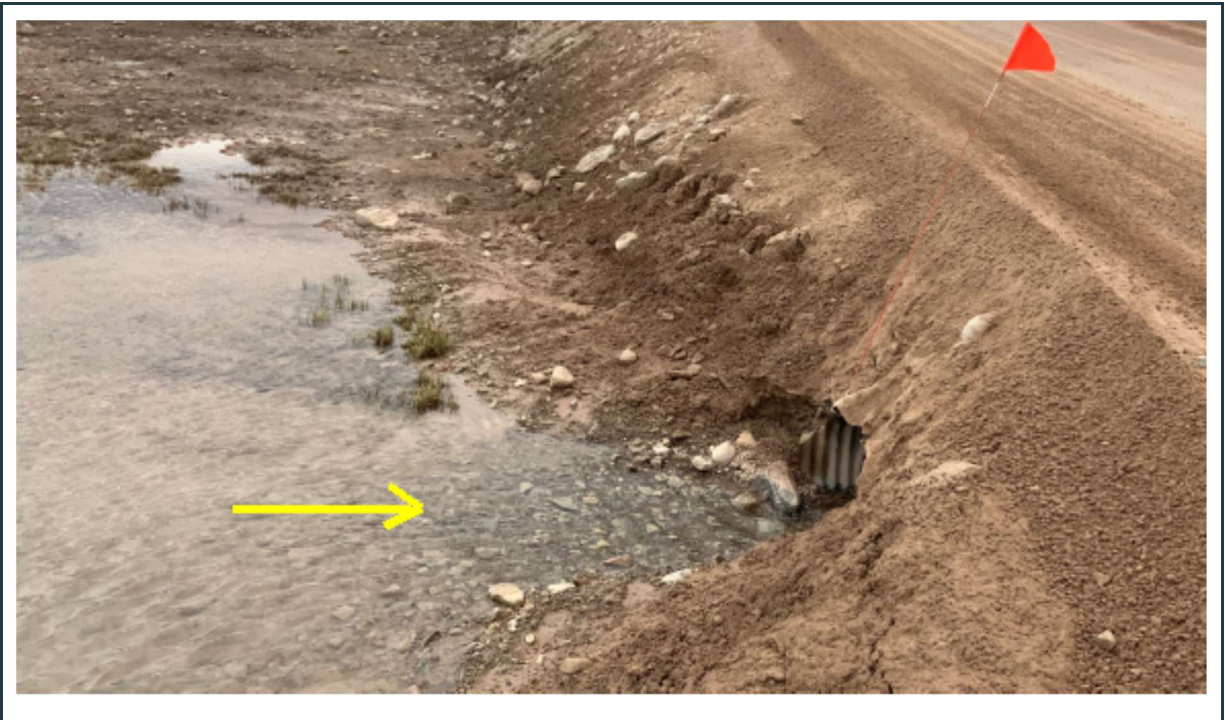
CV-076 (Figures 85 and 86): The inlet of this culvert is too short. As shown in Figure 85 this problem resulted in too steep slope of the road embankment and its erosion around the pipe. The suggested repairs are in alignment with the current approved Civil Design Criteria for the Project.

Figure 85: View of culvert 076 inlet.

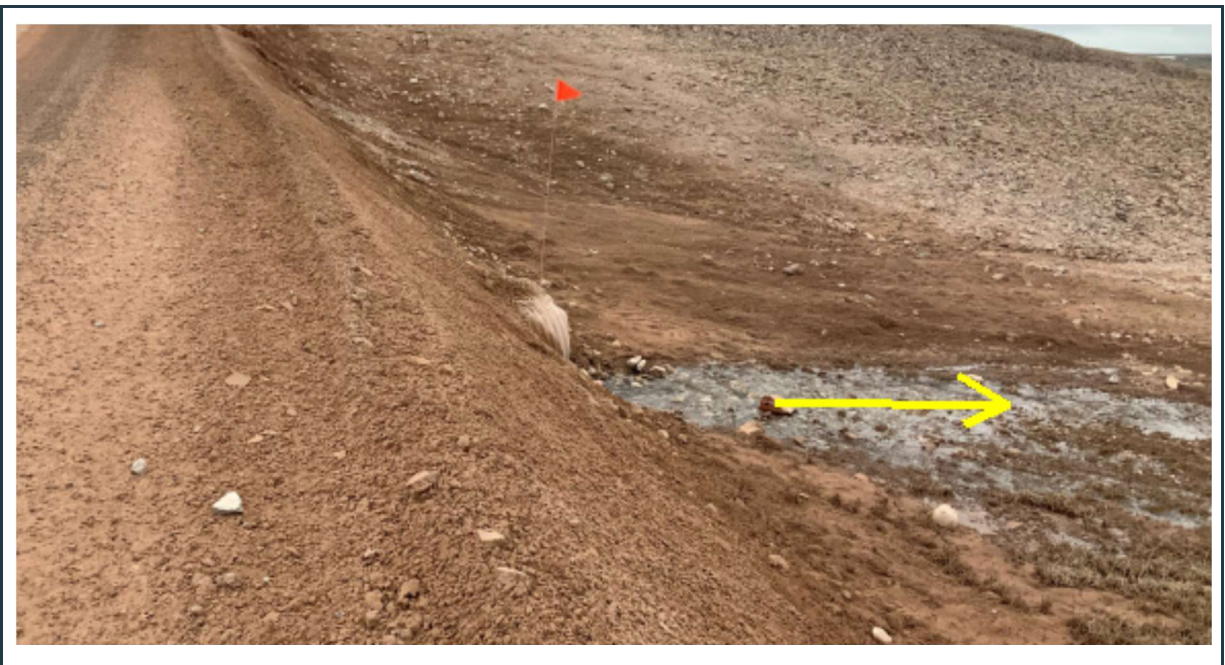
Figure 86: View of culvert 076 outlet.

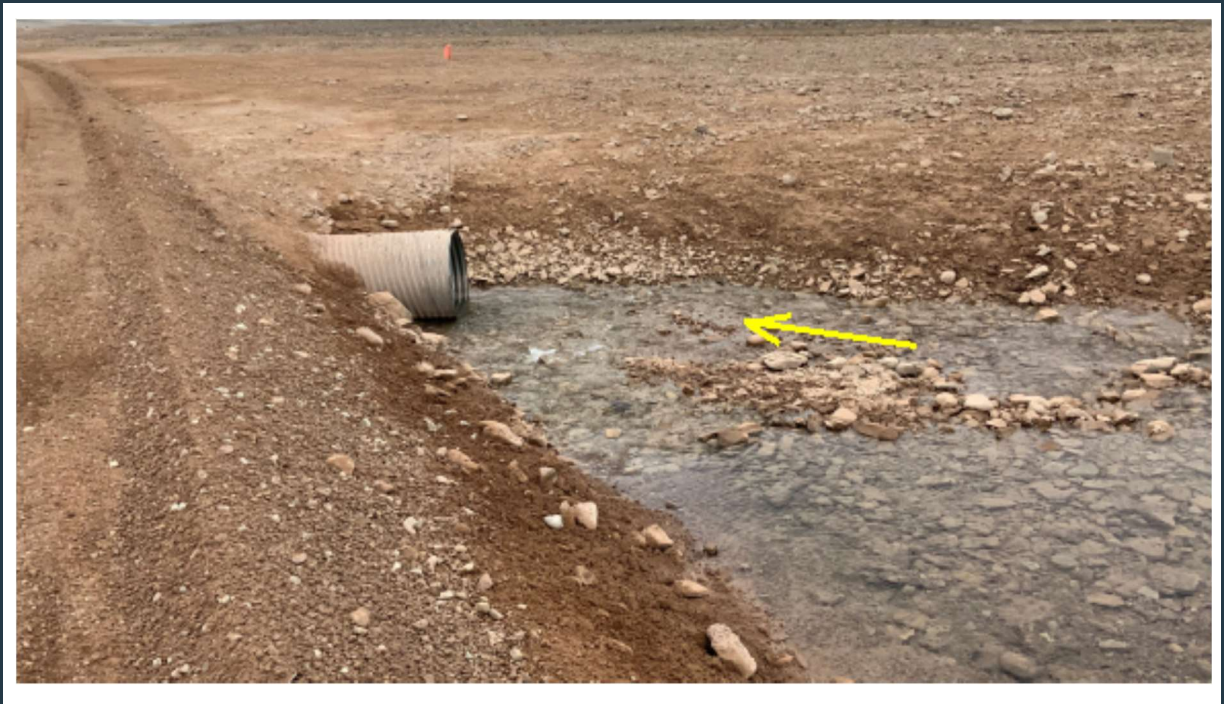
CV-083 (Figures 89 and 90): The outlet of this culvert appears to be somewhat short. As a result, erosion of the road embankment is visible around the culvert. The pipe should be extended by about 1.5 m and

Figure 89: View of culvert 083 inlet (looking north).

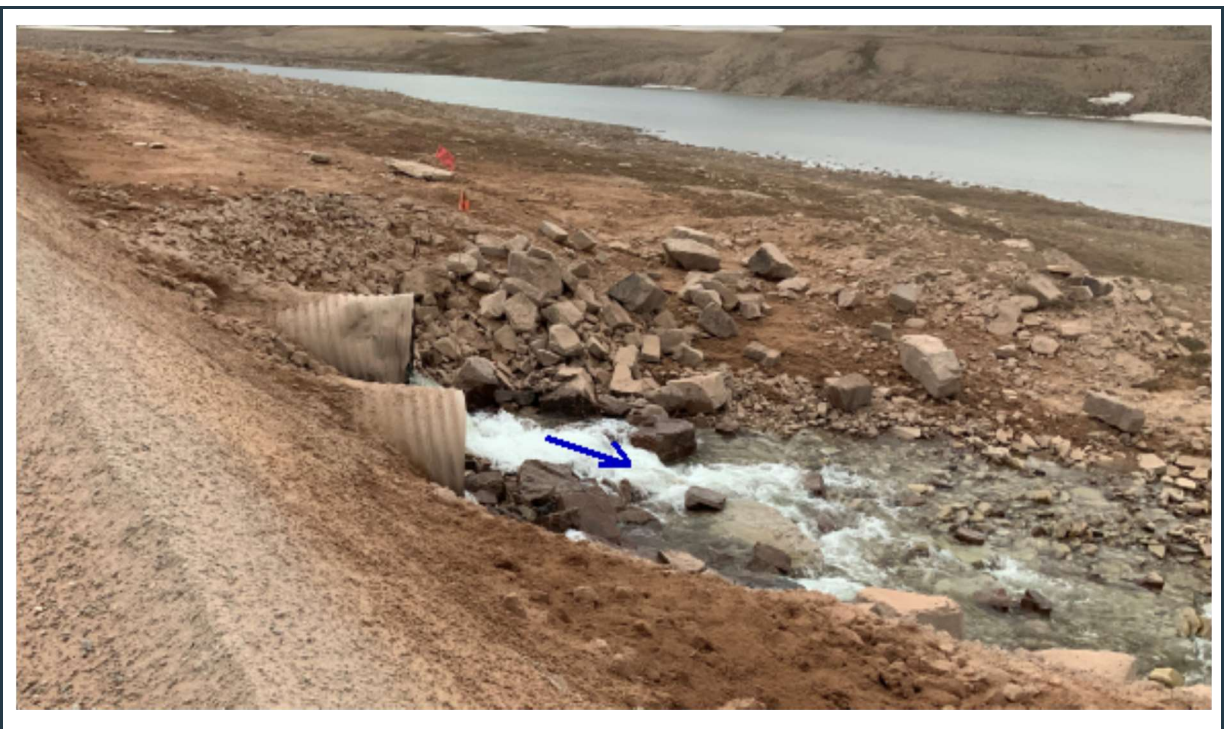
Figure 92: View of culvert(s) 094 outlet.

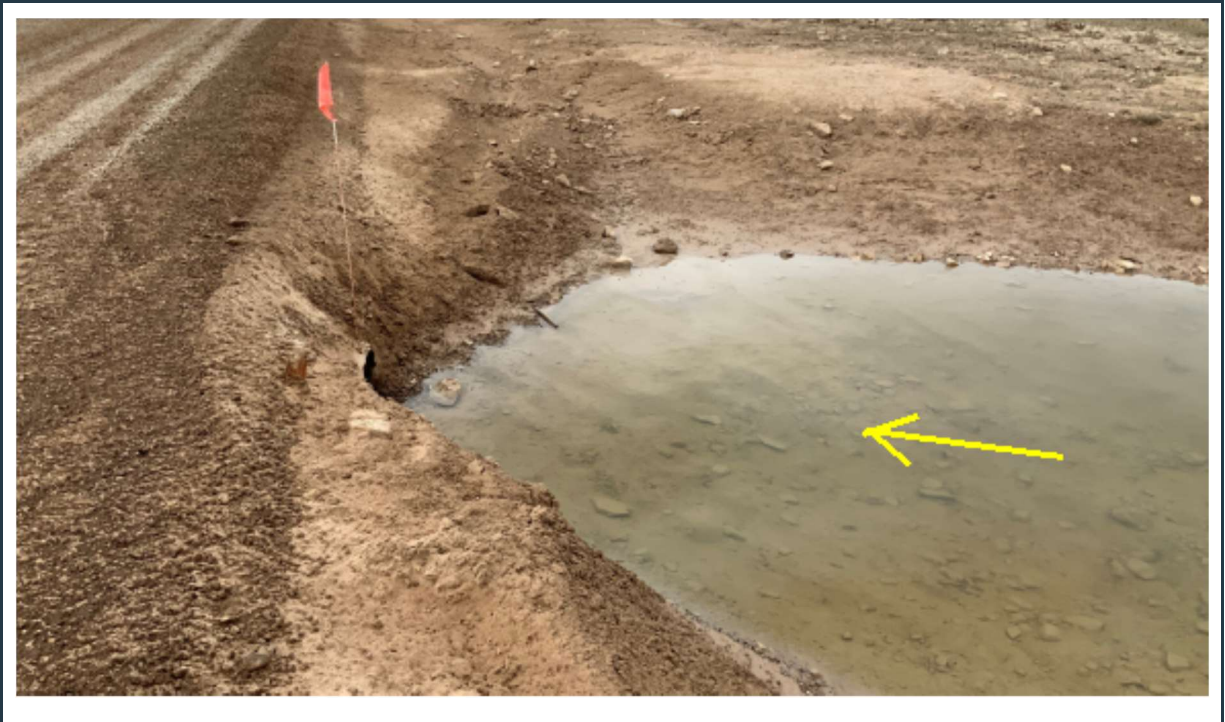
CV-107 (Figures 95 and 96): This is a short, small diameter culvert that was installed at somewhat higher elevation instead of the lowest point of the native ground in the area. Consideration shall be given to replace this culvert with a longer and somewhat larger pipe a few meters south of the current location, shown by the yellow question mark in Figure 96. It is visible around that question mark in the image that most of the water is seeping through the road embankment at that location, instead of flowing through the culvert. Such internal seepage within the embankment may result in erosion and instability of the road, hence the installation of a new culvert at this location is suggested.

Figure 95: View of culvert 107 inlet.

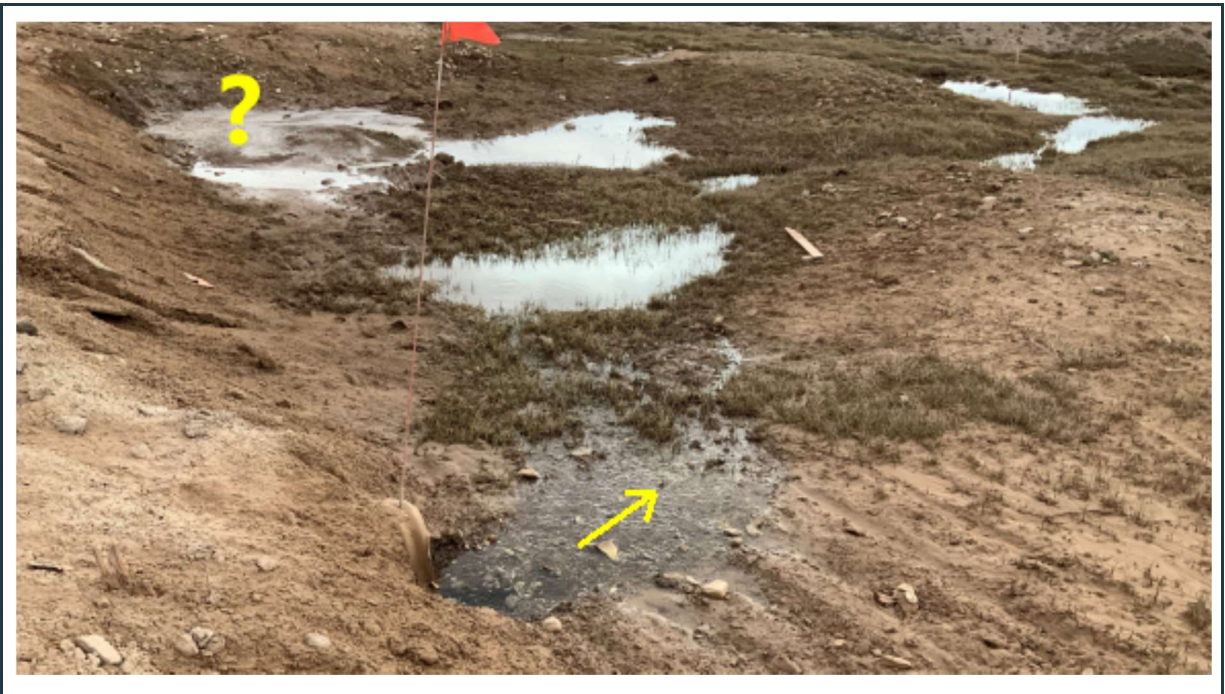
Figure 96: View of culvert 107 outlet. See comment about the question mark in the report.

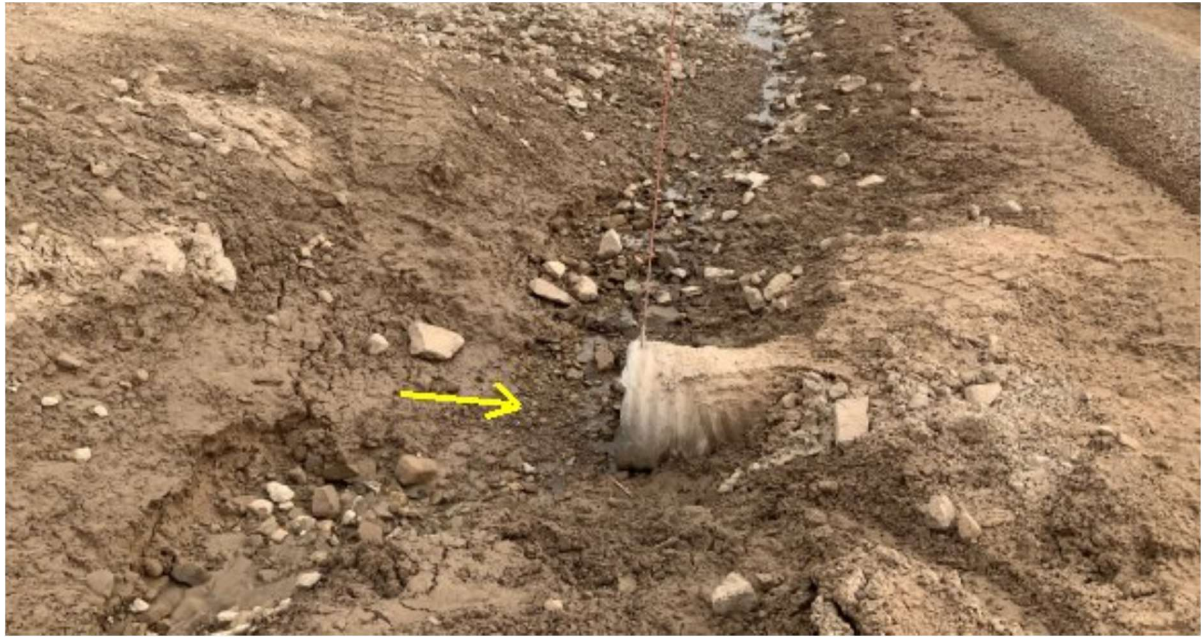
CV-110A (Figures 97 and 98): Minor damage was visible on the outlet of this culvert last year; however, the long end of the pipe has recently been cut off, as shown in Figure 98. The image also shows some erosion on the road embankment's slope adjacent to this culvert, which shall be repaired by placing and compacting soil fill into the embankment first, followed by the placement of crushed rock riprap as specified earlier for other culverts as per Civil Design Criteria.

Figure 97: View of culvert 110A inlet.

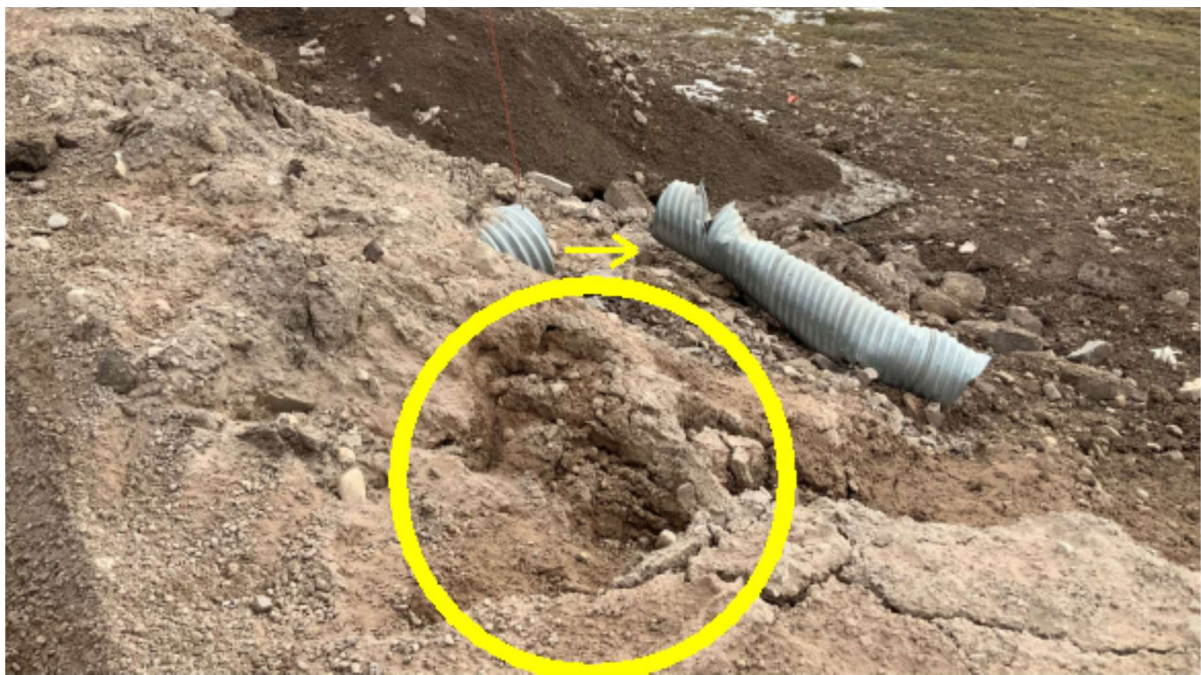
Figure 98: View of culvert 110A outlet. Note that a section of the pipe was cut off, and the erosion of the road embankment adjacent to the culvert (yellow circle).

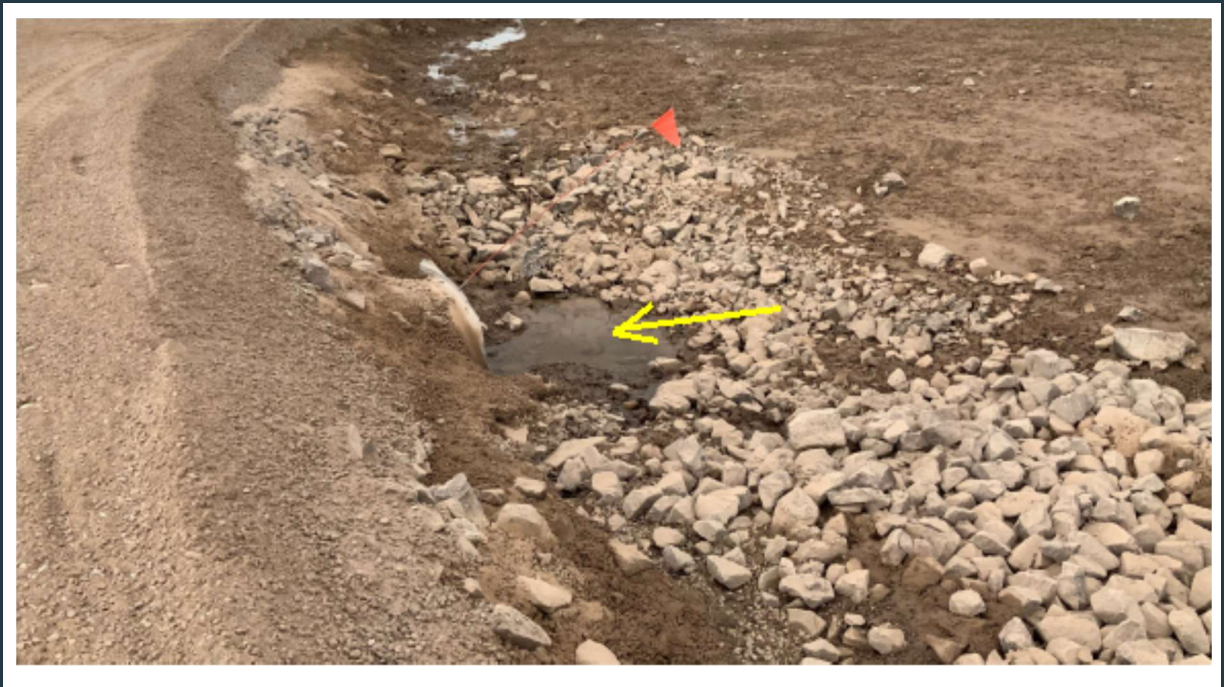
CV-202 (Figures 105 and 106): There are two (2) problems with this culvert, which were previously reported in 2020. At the inlet end, the eroding embankment material has resulted in some siltation and clogging of the pipe. The second issue is visible at the outlet end of the pipe where its invert is located below the original ground level, which has resulted in continuous ponding water around the pipe end. It is suggested that the native ground at the front of the pipe be regraded, and uninterrupted flow be provided.

Figure 105: Culvert 202 inlet.

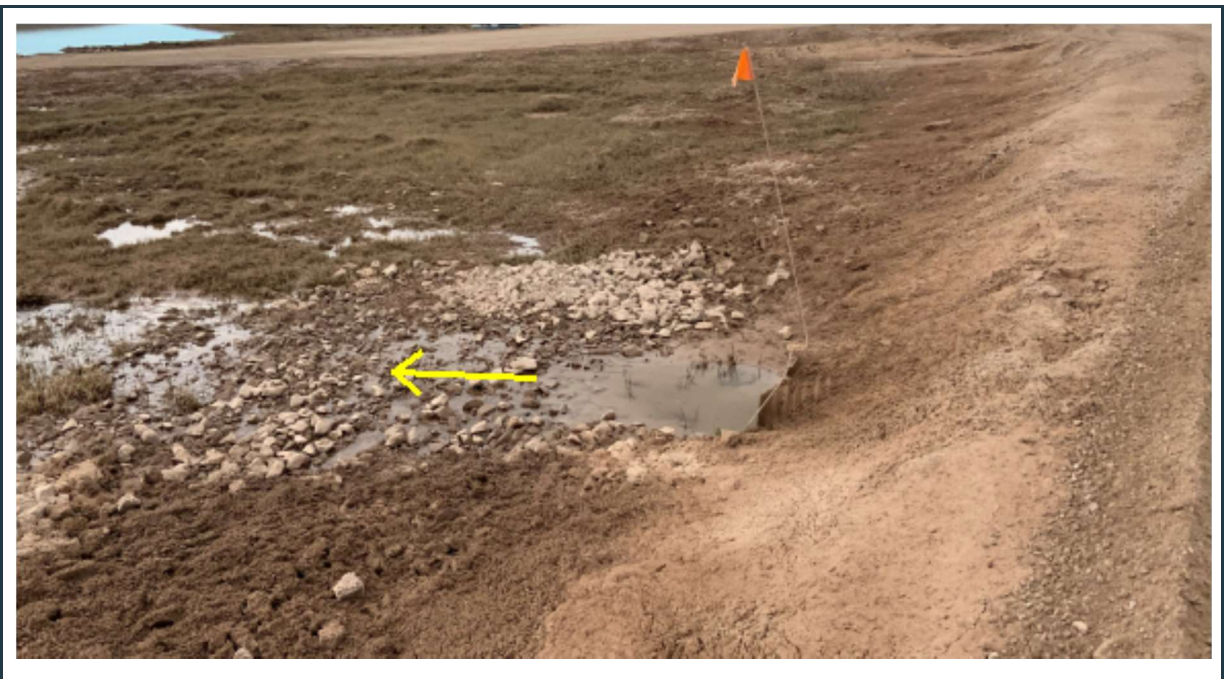
Figure 106: View of culvert 202 outlet.
