RE: Submission of 2021 Geotechnical Inspection Report No. 2 (September 2021)

Mary River Project – Nunavut

November 16, 2021
TC190307.2021

Wood Environment & Infrastructure Solutions (Wood), has completed the second geotechnical field inspection of 2021 at the Mary River Project, which is a condition of the Type “A” Water Licence No: 2AM-MRY1325 – Amendment No.1 (“Water Licence”).

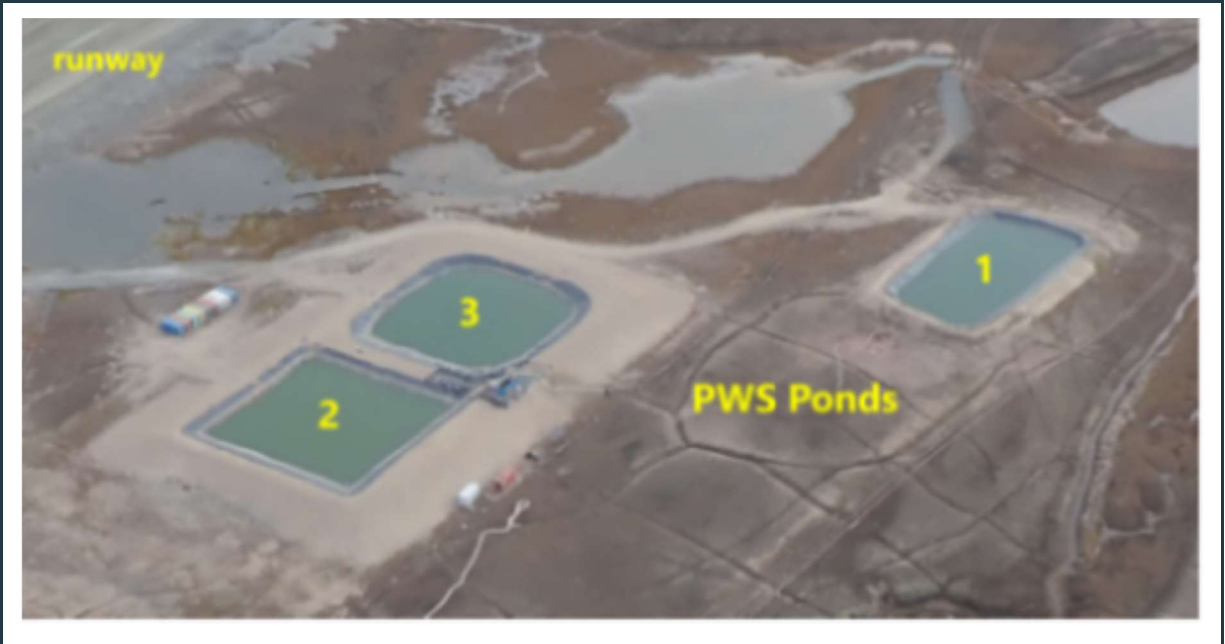
There are three (3) polishing/waste stabilization ponds, located adjacent to the airstrip, as shown in Figure 3. Pond #1 is a single structure, while Ponds #2 and #3 were constructed as twin-cells, as shown in Figure 9. This photograph is a historic aerial image showing the robust and stable berms around the ponds. As pointed out in previous inspection reports, these ponds were associated with the exploration phase of the mine, and currently serve as emergency holding ponds in case problems should arise, which would prevent the discharge of treated effluent directly to the receiving environment. The stable berms around the ponds generally comprise granular materials (rock fill, sand, and gravel), supporting High Density Polyethylene (HDPE) geomembrane liners. The liners are secured in anchor trenches on the crest of the berms, and no damage is visible on the membranes in the cells or on the upstream face of the slopes (see Figures 10 to 12). All previous (minor) damages on the liners have been properly repaired, as visible in Figure 10.

Figure 9: Aerial view of the stable berms around the three PWS ponds. (Historic image to present the layout of the three ponds and to show the robust berms around the facilities).

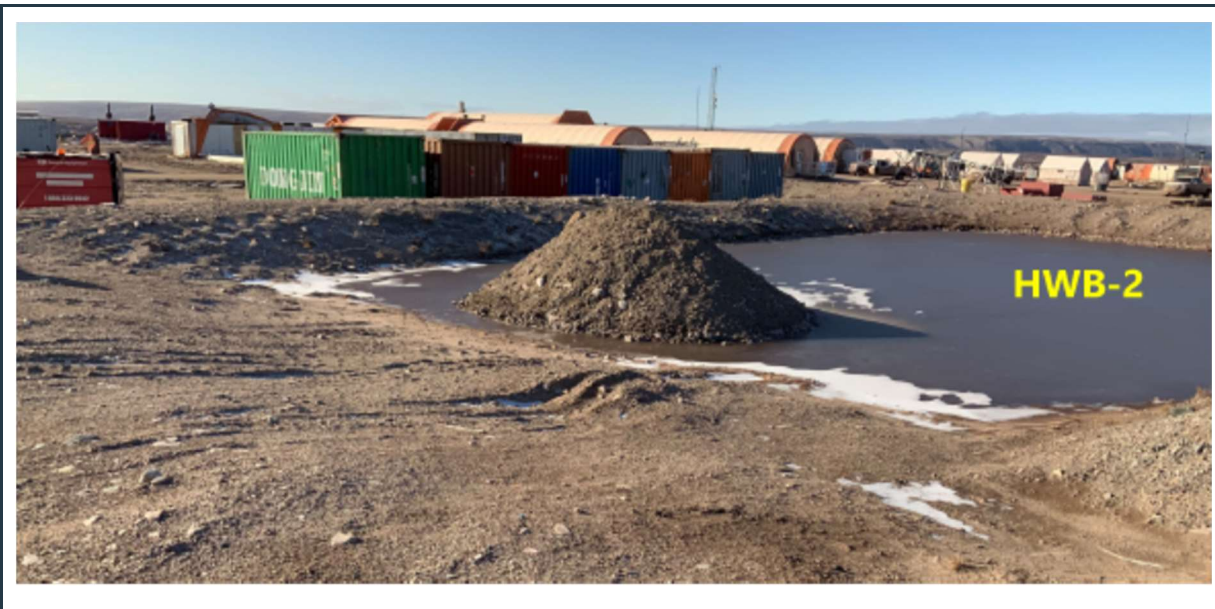
b) HWB-2

As shown in Figure 14, this cell is currently holding some water and some soil have been placed into the cell recently. The perimeter berms around the cell appear to be stable and the presence of ponding water indicates good liner performance.

Figure 14: View of stable berms around HWB-2, and a pile of disposed soil that was dumped into the cell recently. The presence of water in the cell indicates good liner performance.

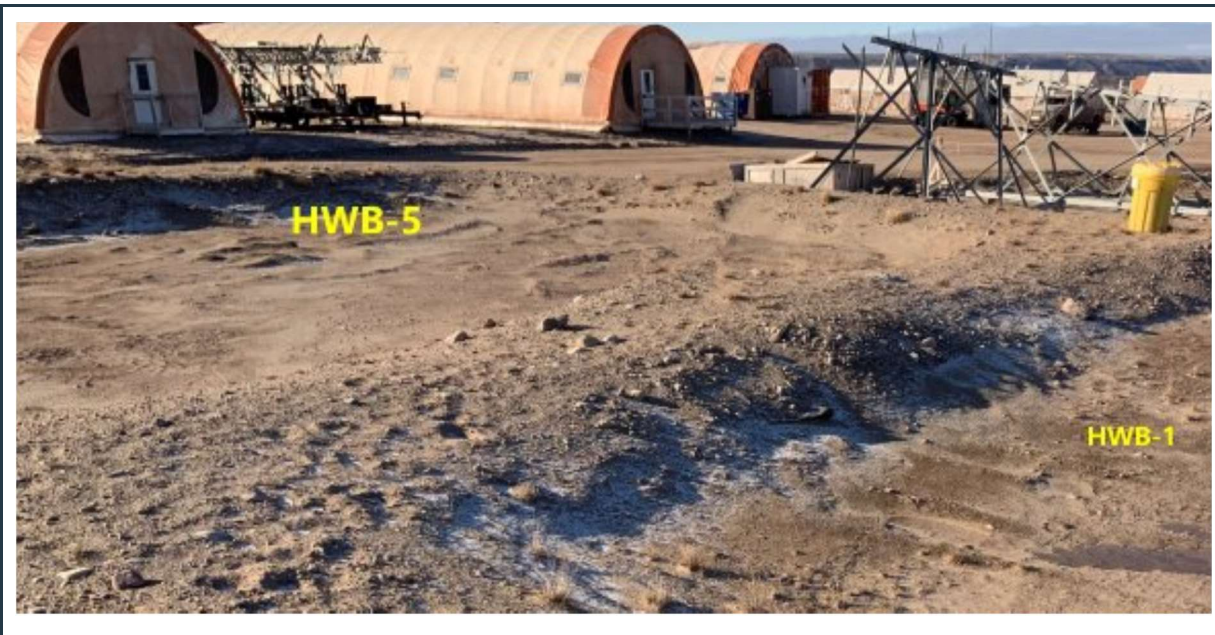
d) HWB-5

As shown in Figure 17, this cell is currently empty. The shallow berms around this cell appear to be stable and there is no visible liner damage in the cell.

Figure 17: View of the berms around the currently empty HWB-5 cell, adjacent to the HWB-1 cell.

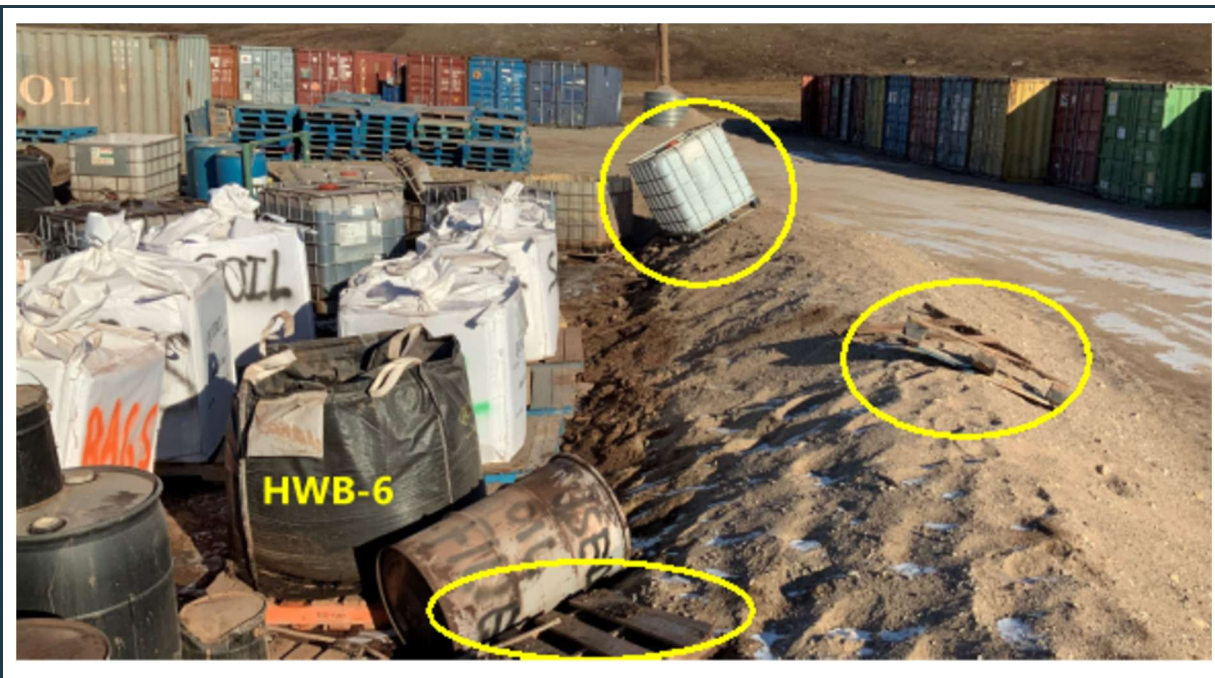
e) HWB-6

The berms around this cell and the internal "floor" have been regraded and stabilized recently using clean granular fill. The cell was almost empty at the time of the June 2021 inspection; however, it was completely full during the September inspection. As shown in Figure 18, some containers and wooden debris have been placed on the slopes and crest of the perimeter berm instead of inside the cell. Those items should be removed from the berm and stored inside the cell. This process should be followed by regrading the damaged slopes and crest by hand to prevent damage to the liner.

Figure 18: View of the now full HWB-6 cell. Note a container and some wooden debris placed on the berm instead of inside the cell. Those items should be placed inside the cell and the berm shall be regraded.

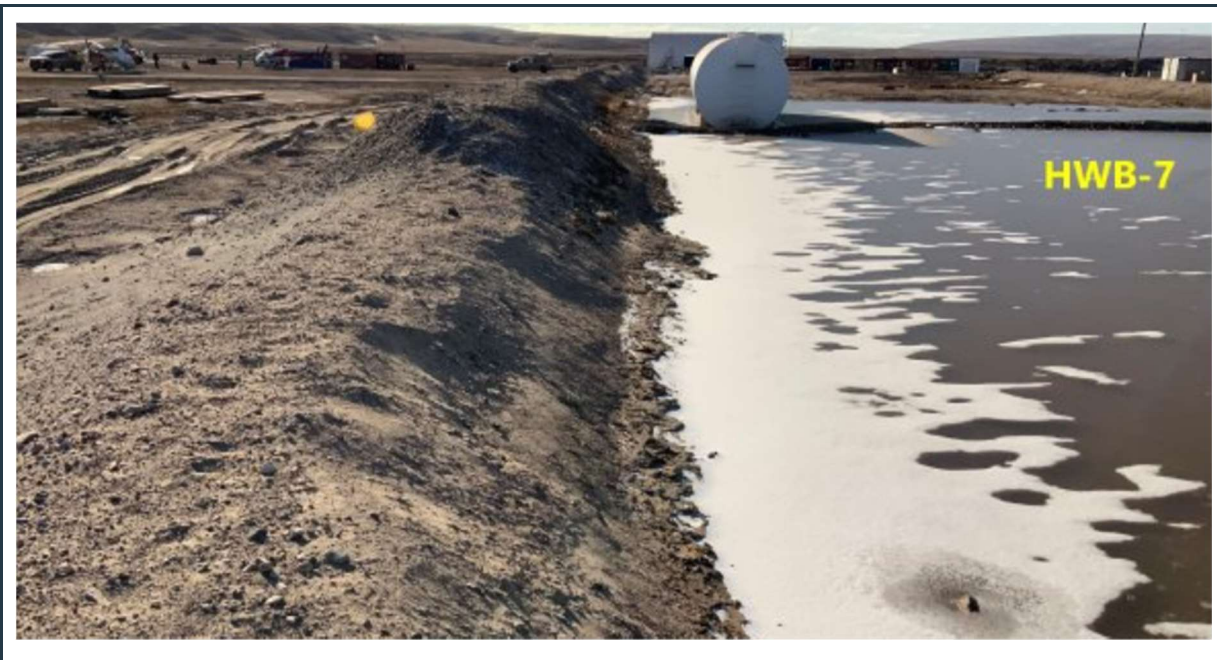
f) HWB-7

Only one (1) large fuel tank is stored in this cell, as shown in Figure 19 (white tank). The perimeter berms around the cell appear to be stable and the visible water within the cell is indicative of adequate liner performance. As shown in Figure 19, ice was already formed on the water's surface in September.

Figure 19: View of the large, flooded (now ice covered) HWB-7 cell, with only one old fuel tank stored.

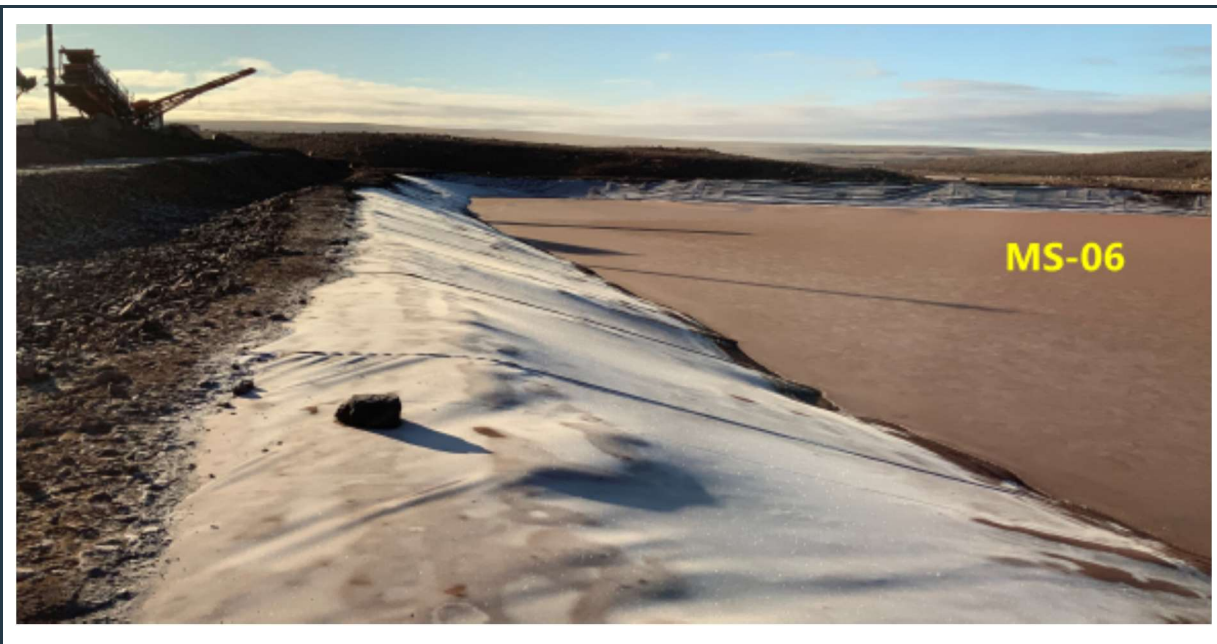
There are two (2) intake locations to the pond at the northeast and southeast corners, and there is an emergency spillway located opposite to the intakes. The liner within the pond and on the upstream slopes of the berm appears to be intact (see Figure 20), and no wet downstream slopes or toe seepage from the pond were visible at the time of the inspection. However, seepage water within the relatively permeable, cobbly overburden adjacent to the toe of the south berm of the pond was noted within a temporary containment sump which was constructed to contain the seepage water and divert it to the settling pond, as shown in Figure 22. The visible water in the sump appears to be surface water, percolating down into the ground and flowing from higher elevations within the valley adjacent to the crusher pad toward the MS-06 pond. The excavated temporary containment sump could endanger the stability of the existing berm, and therefore must be backfilled with native soil prior to the next freshet (yellow circle in Figure 22). To maintain the structural integrity of the pond berm, no soil should be removed from the toe of the berm. Temporary containment sumps could be excavated at least 10 m away from the toe of the berm.

Figure 20: MS-06 settling pond with robust, stable berms and intact liner.

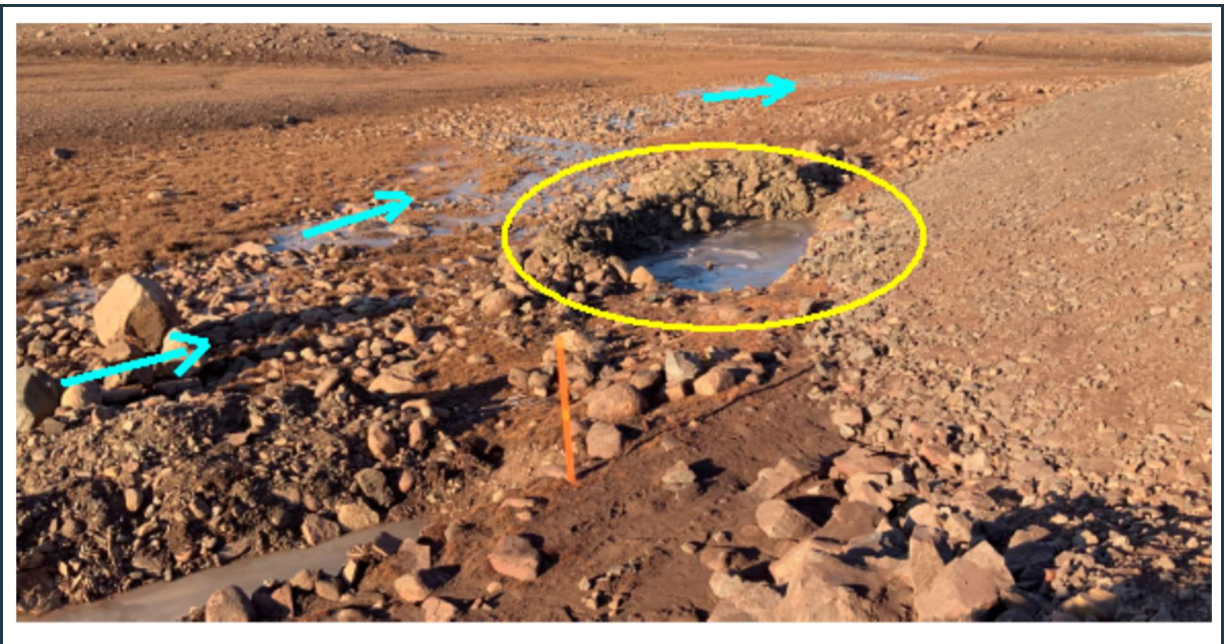
Figure 22: Seepage water within the relatively permeable, cobbly overburden adjacent to the area of the crusher pad and MS-06 pond. It appears to be surface water, percolating down into the ground and flowing from higher elevations within the valley adjacent to the crusher pad. The excavated hole (temporary sump) at the toe of the MS-06 berm must be filled (yellow circle).

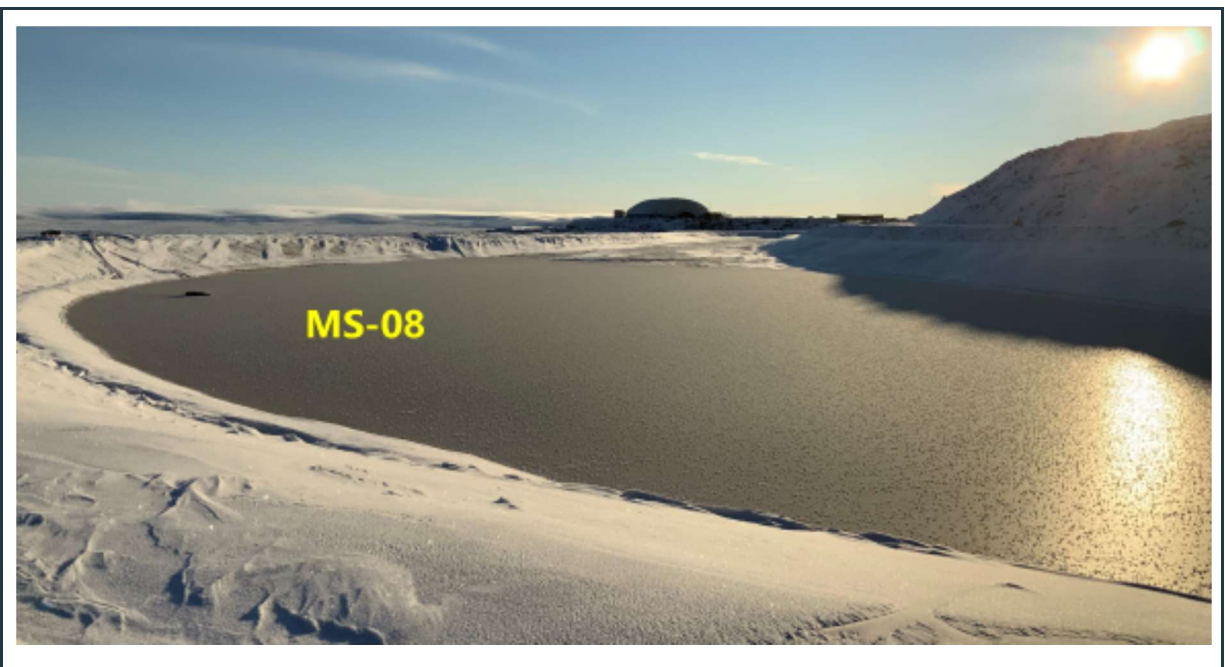
Figure 24: View of stable berm and intact liner at the MS-08 pond. Ice and snow were already present in the area in September.

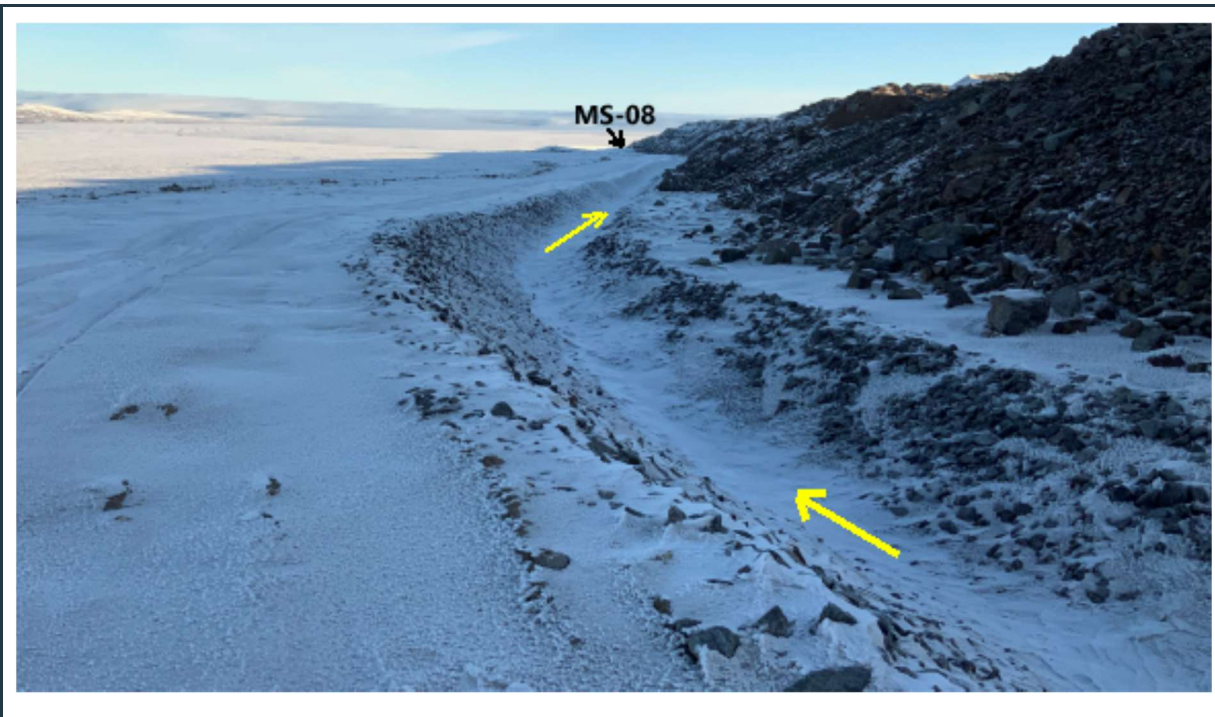
Figure 25: Drainage ditch around the west side of the waste rock facility.

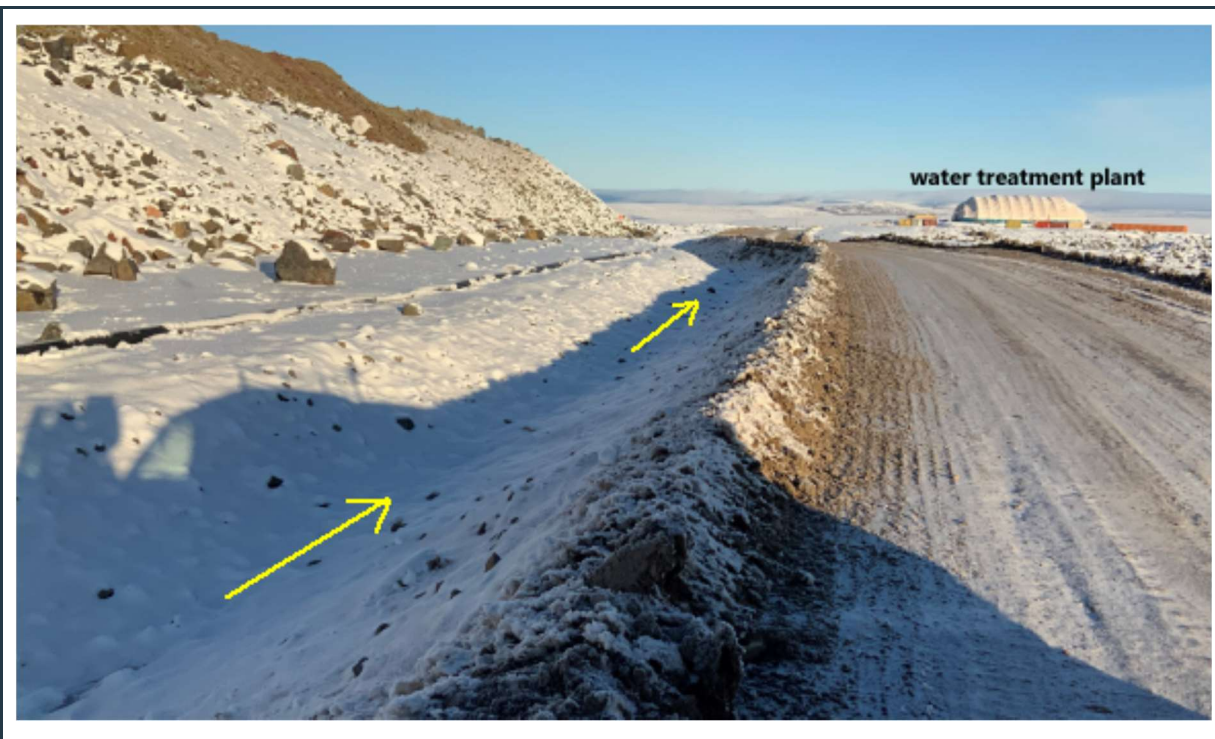
Figure 26: Snow visible in the drainage ditch around the east side of the waste rock facility, leading to the MS-08 pond. Note the water treatment plant at the site.

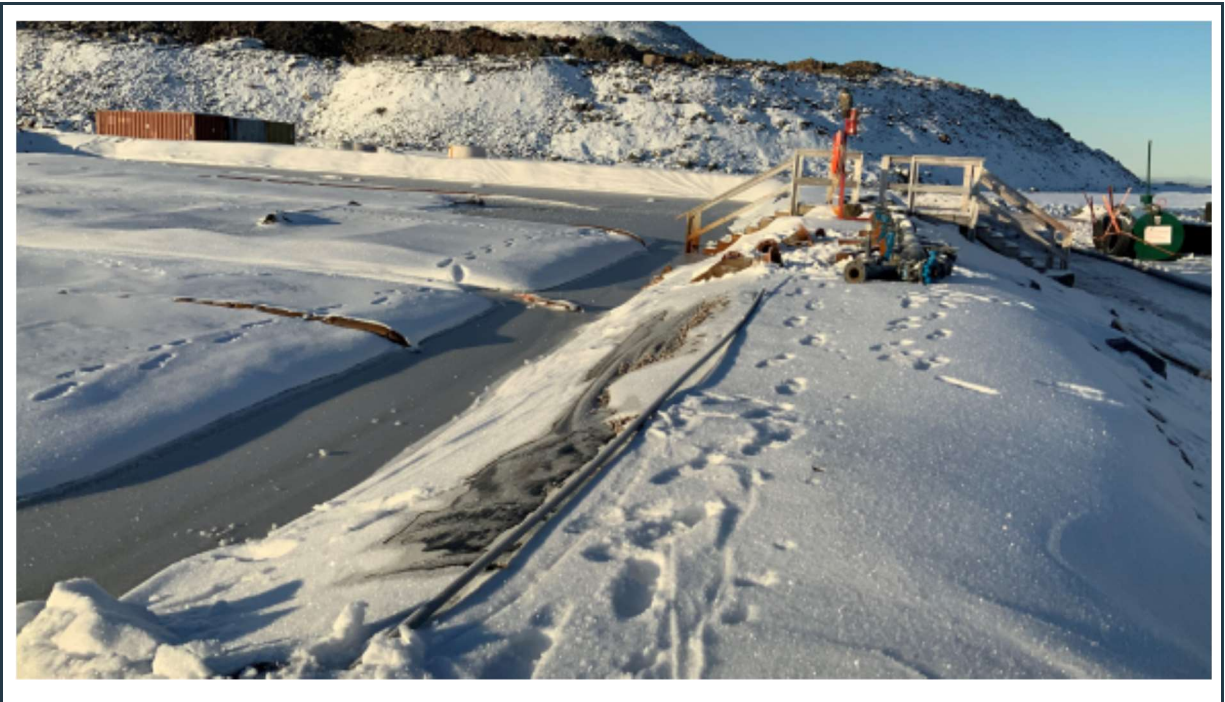
Figure 27: Stable berm and intact liner at the water treatment pond, adjacent to the waste rock facility.

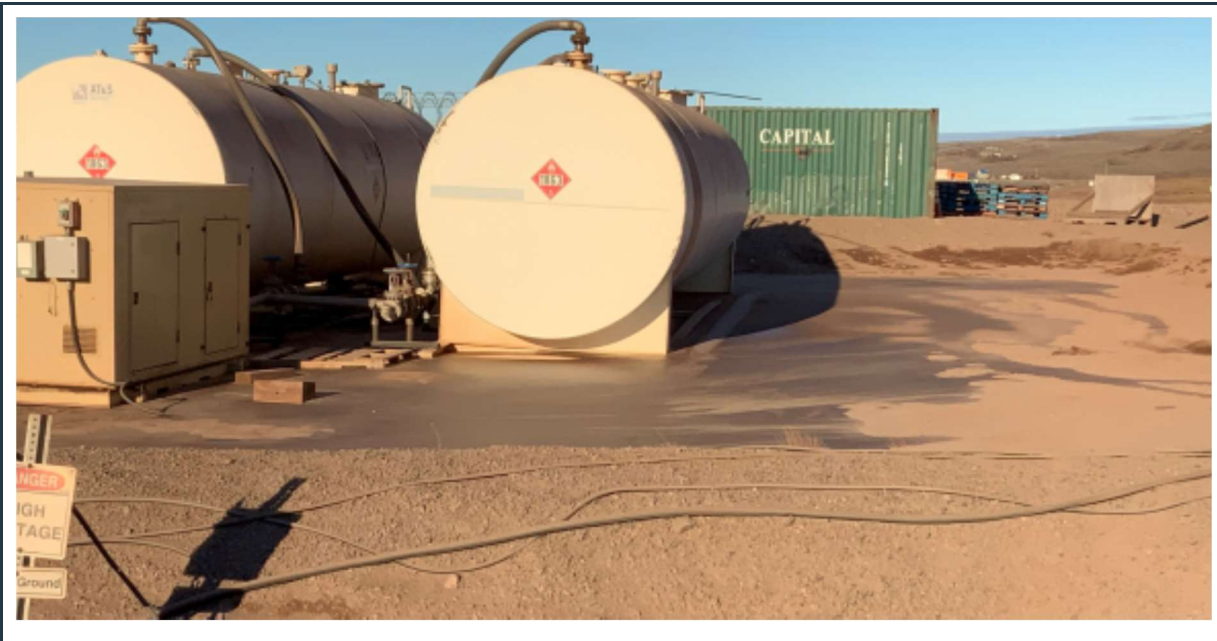
berms, and the liner within the cell appears to be in good condition, indicated by the ponding water within the cell, as shown in Figure 30.

Figure 30: View of the well-maintained sand and gravel berm at the lined jet-fuel storage facility. The ponding water within the cell indicates good liner performance.

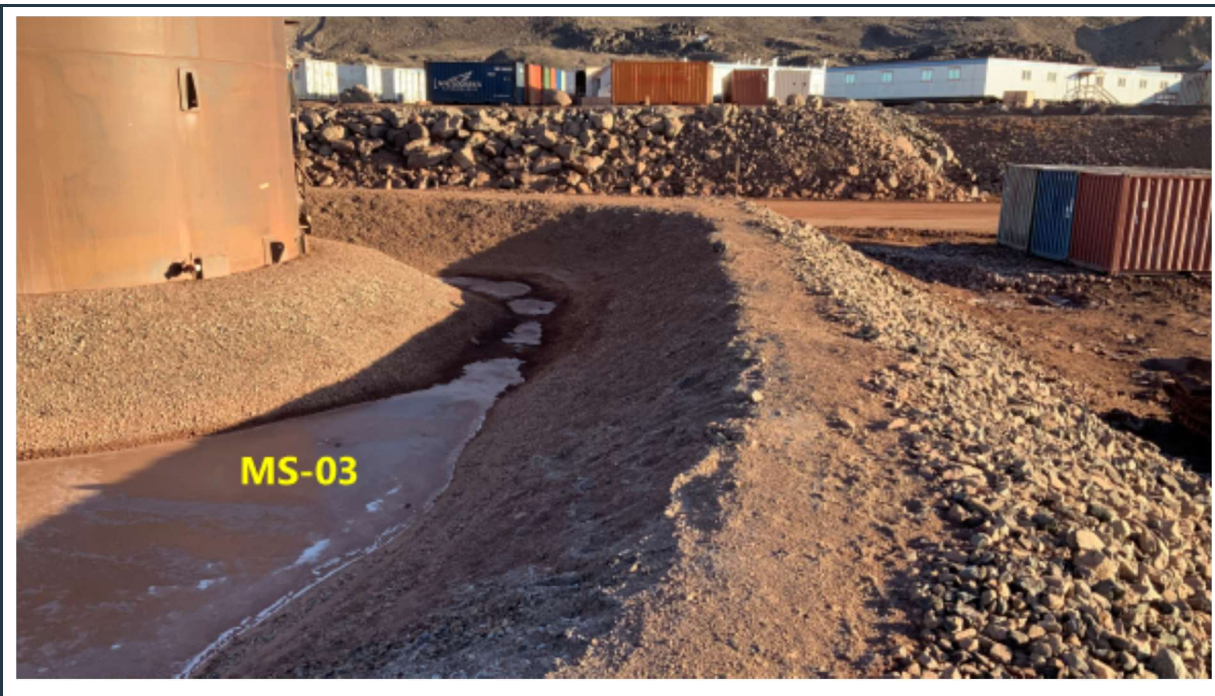
Figure 31: Well-maintained, stable berm around the MS-03 diesel fuel farm, with some ponding water.

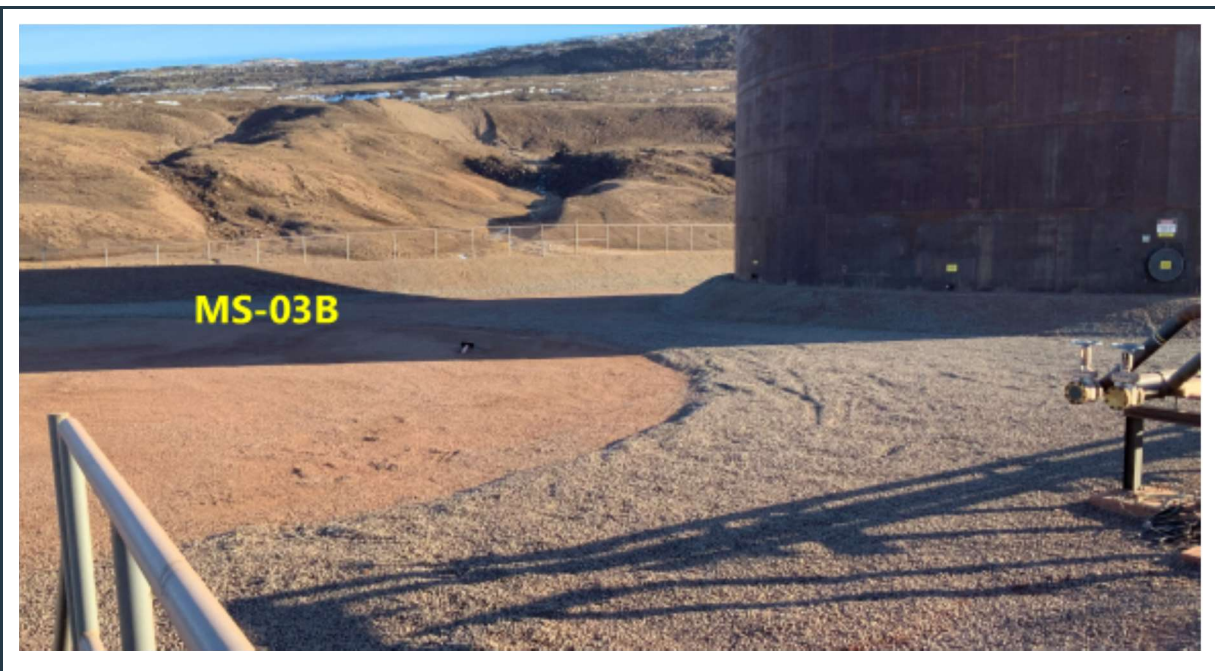
Figure 32: View of the well-maintained new fuel tank farm. The location of additional tank is already prepared within the facility.

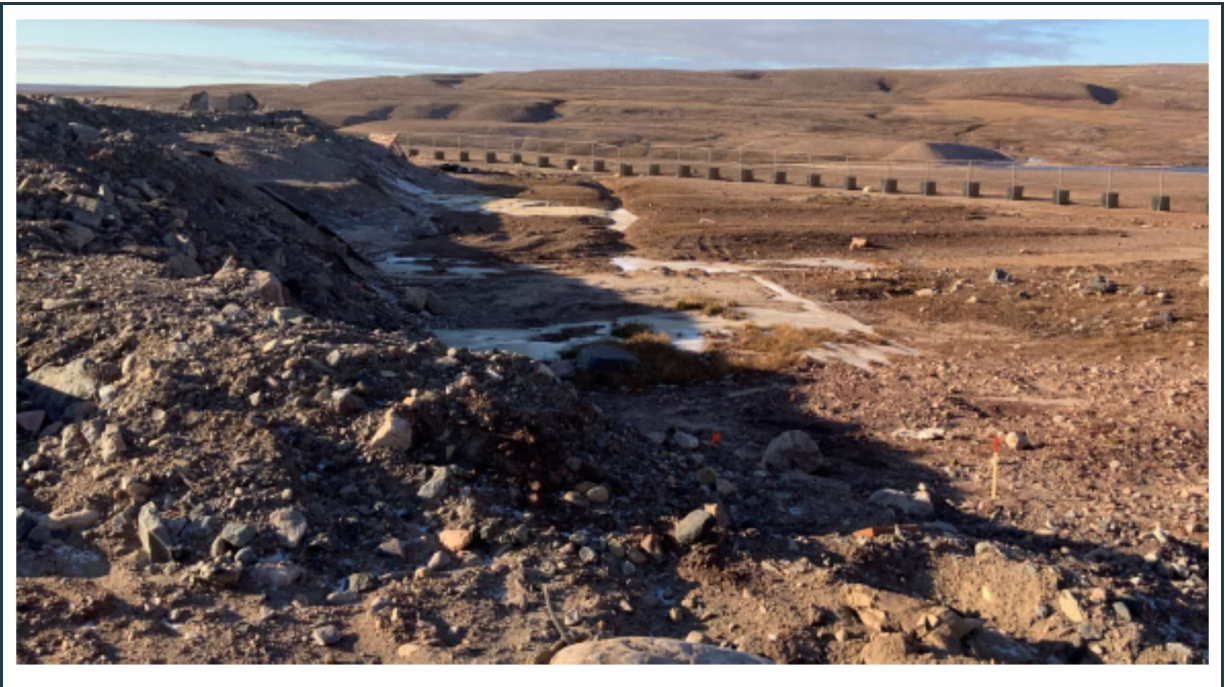
Figure 33: Solid waste landfill facility with some ponding water adjacent to the soil-covered waste.

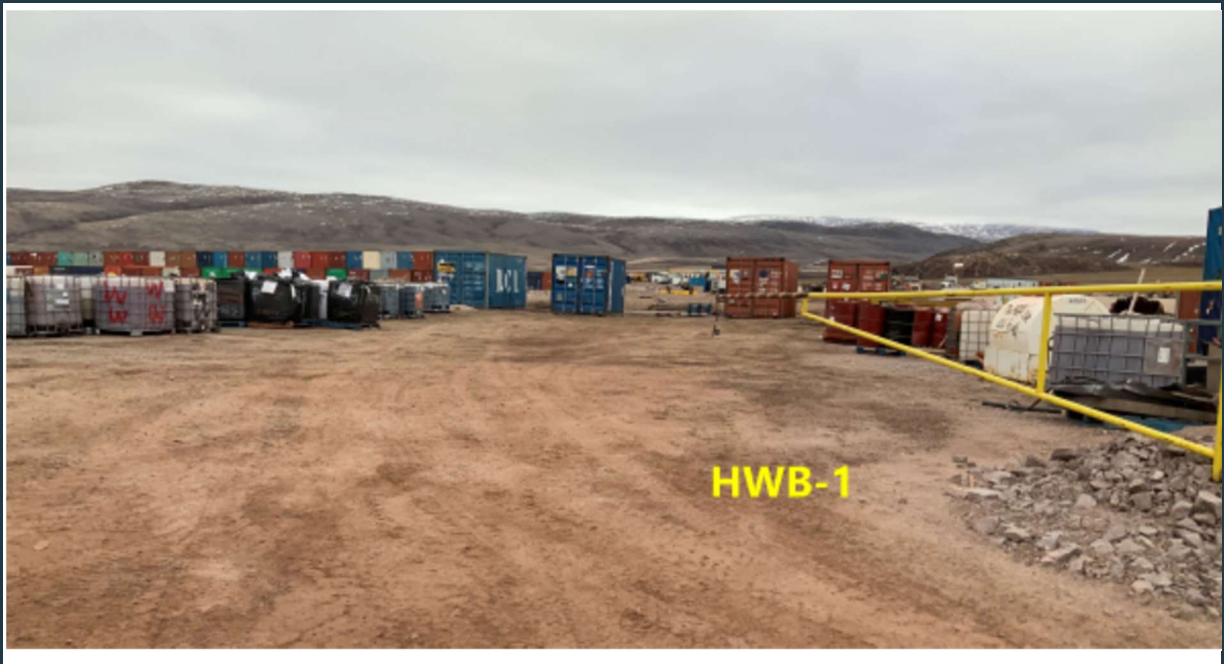
a) HWB-1

Figure 41: View of the practically empty HWB-1 cell with upgraded (regraded) cell floor.

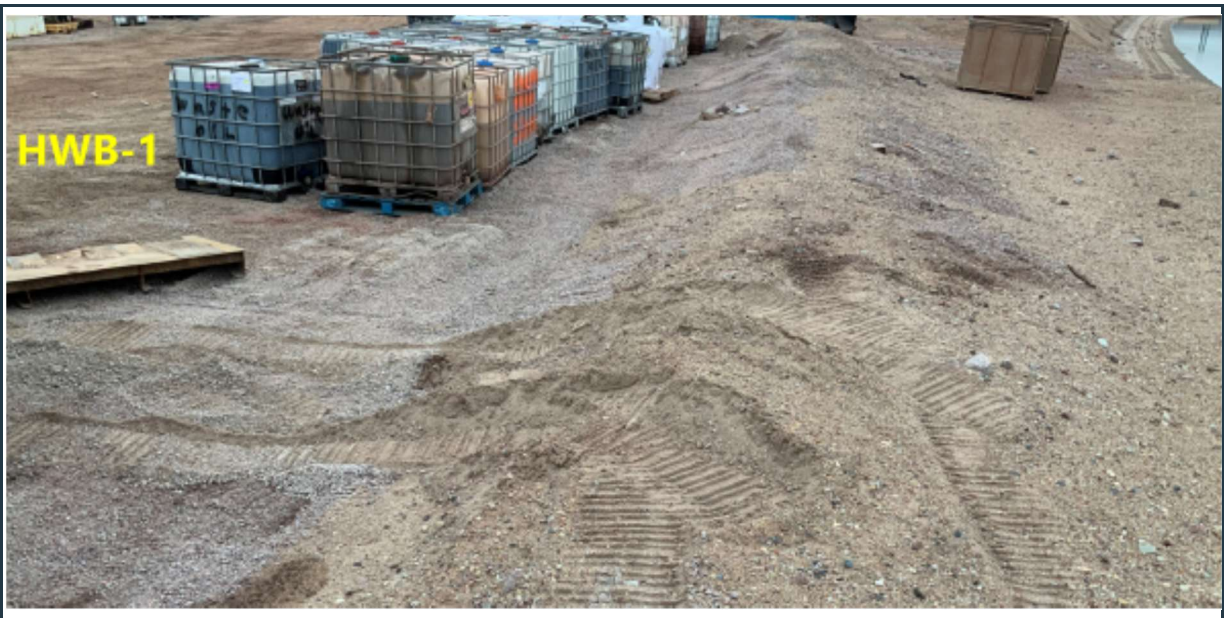
Figure 42: View of one of the berms with tire-tracks. Driving trucks on the berms should be avoided.

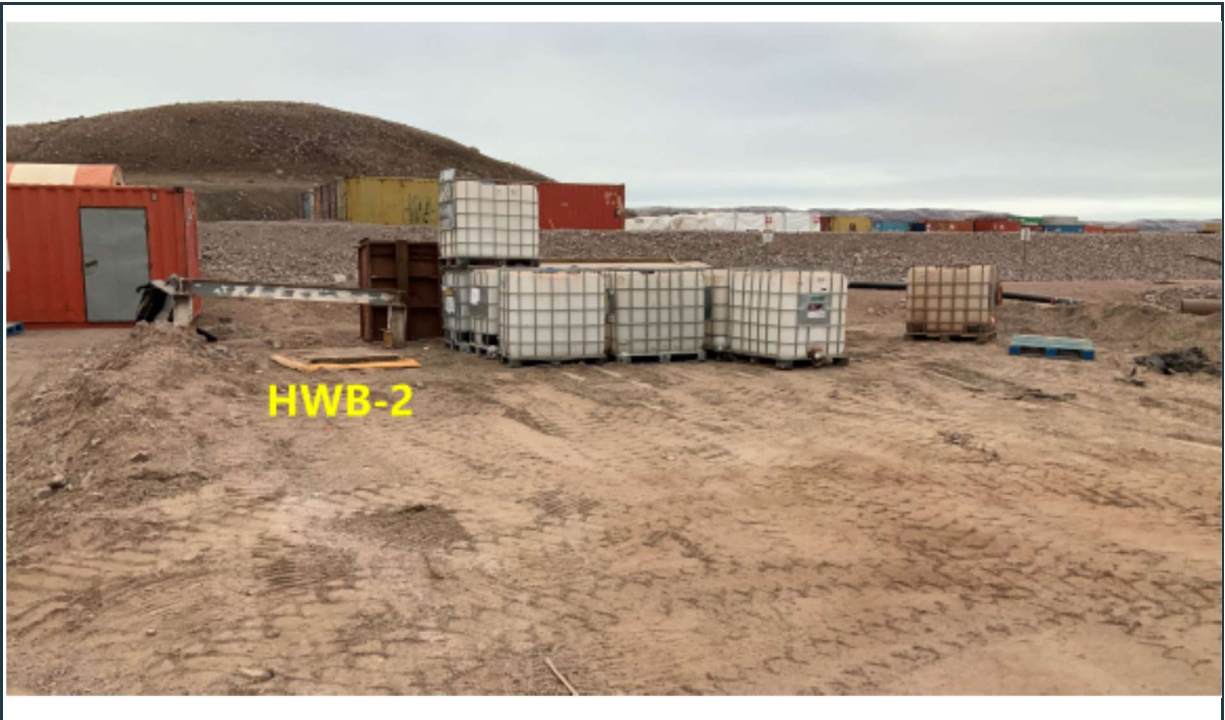
b) HWB-2

Figure 43: View of the former HWB-2 cell, with only a few empty containers stored on the top of clean sand and gravel fill pad. No hazardous waste is stored in this cell.

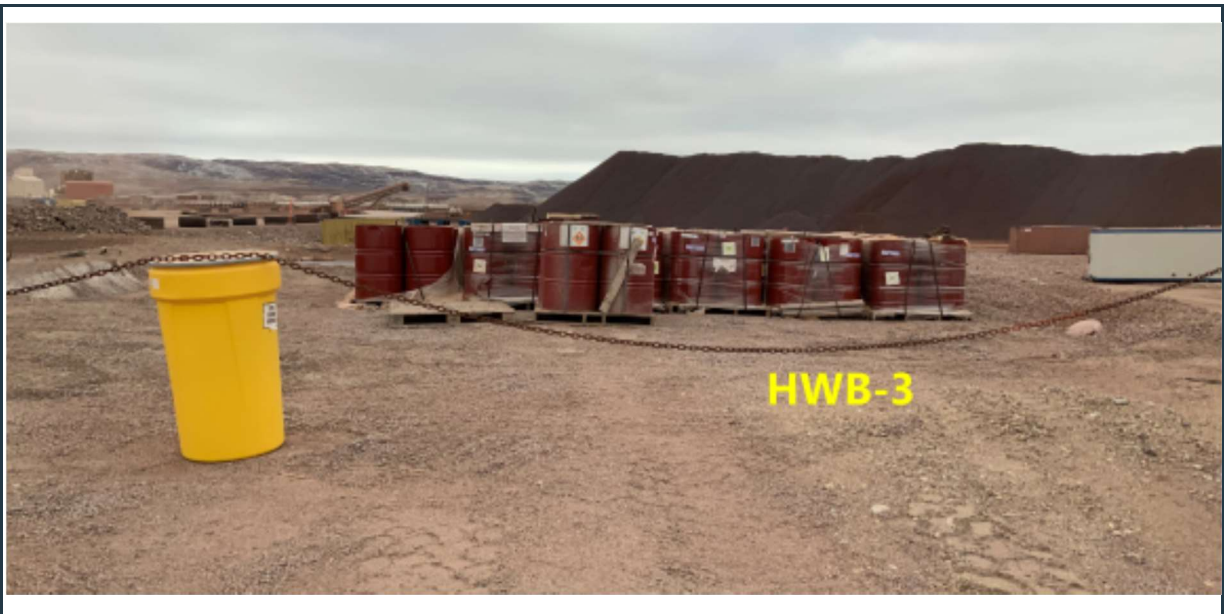
Figure 44: View of the HWB-3 cell with stable berms, containing fuel barrels.

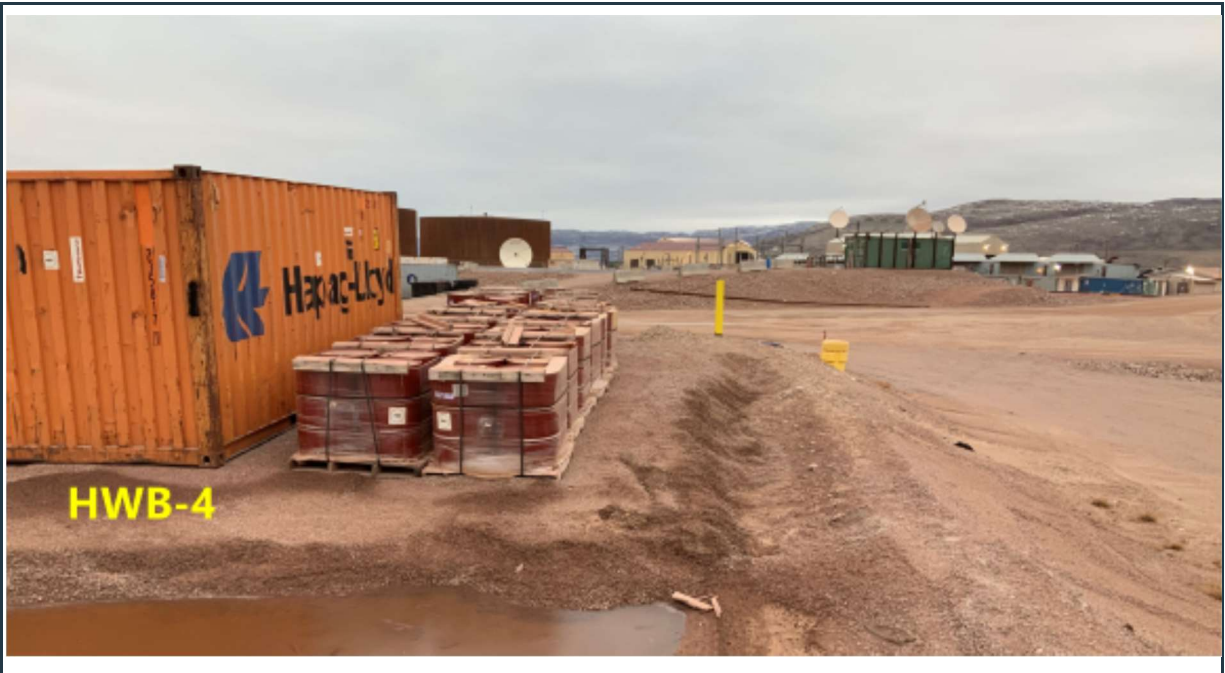
Figure 45: Stable berms around and ponding water within the HWB-4 cell, storing jetfuel and containers.

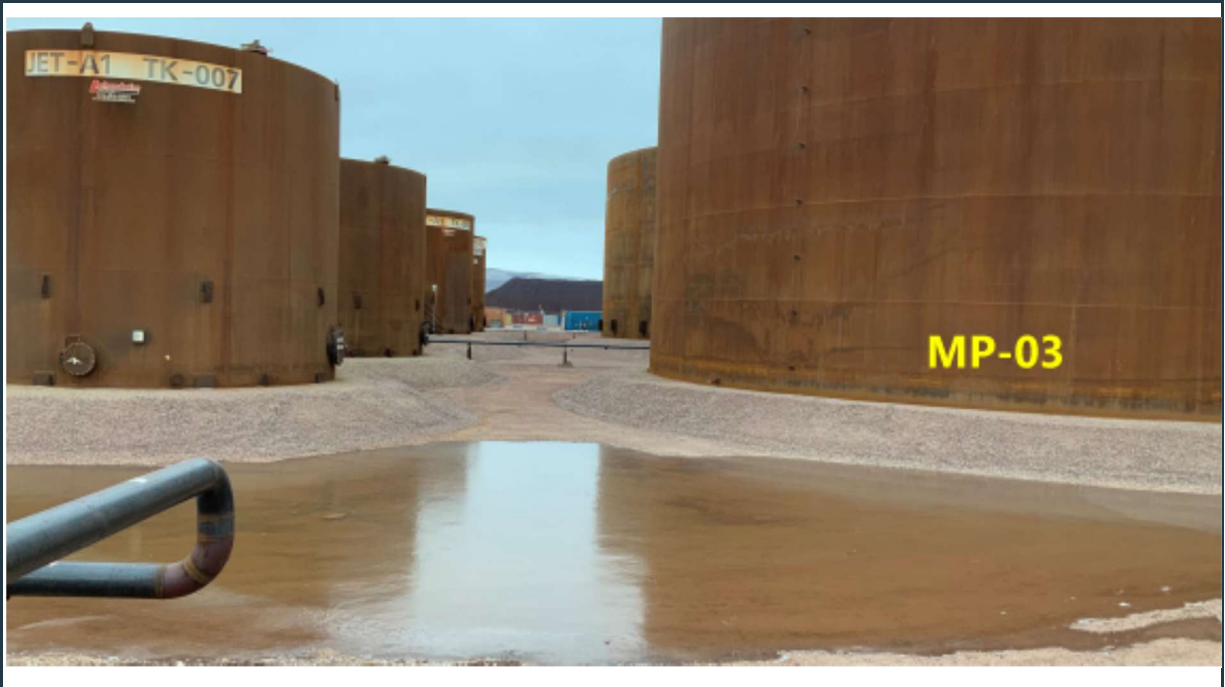
Figure 47: View of the well maintained MP-03 fuel tank farm. The ponding water indicates good liner performance.

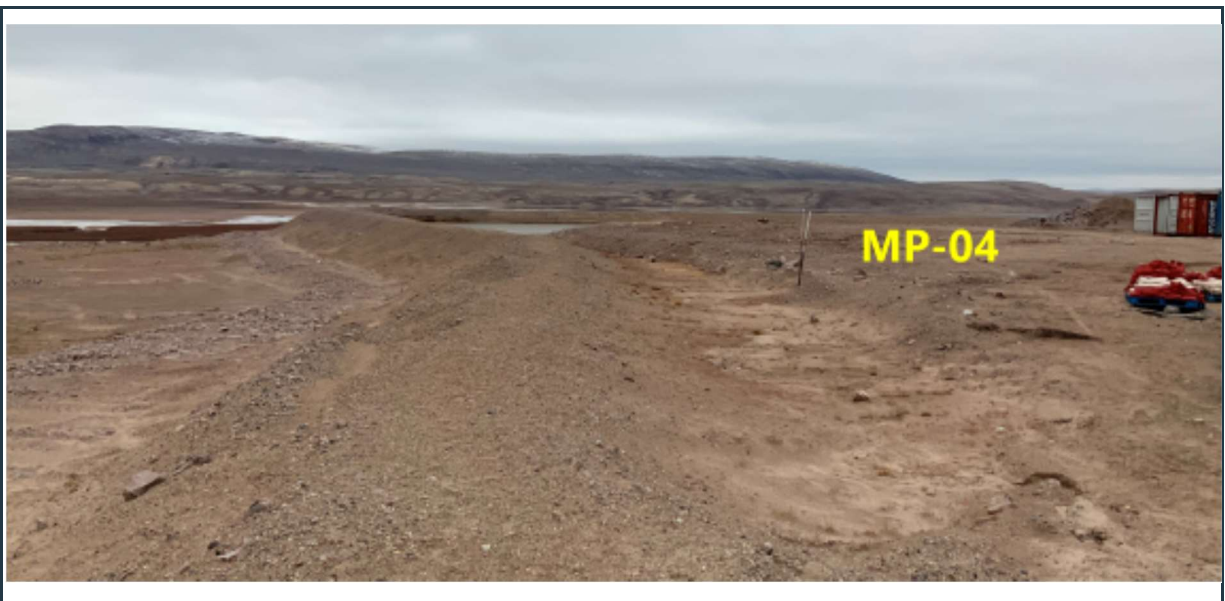
Figure 48: View of stable berm around the MP-04 landfarm, with soil covered waste and a few empty shipping containers within the cell.

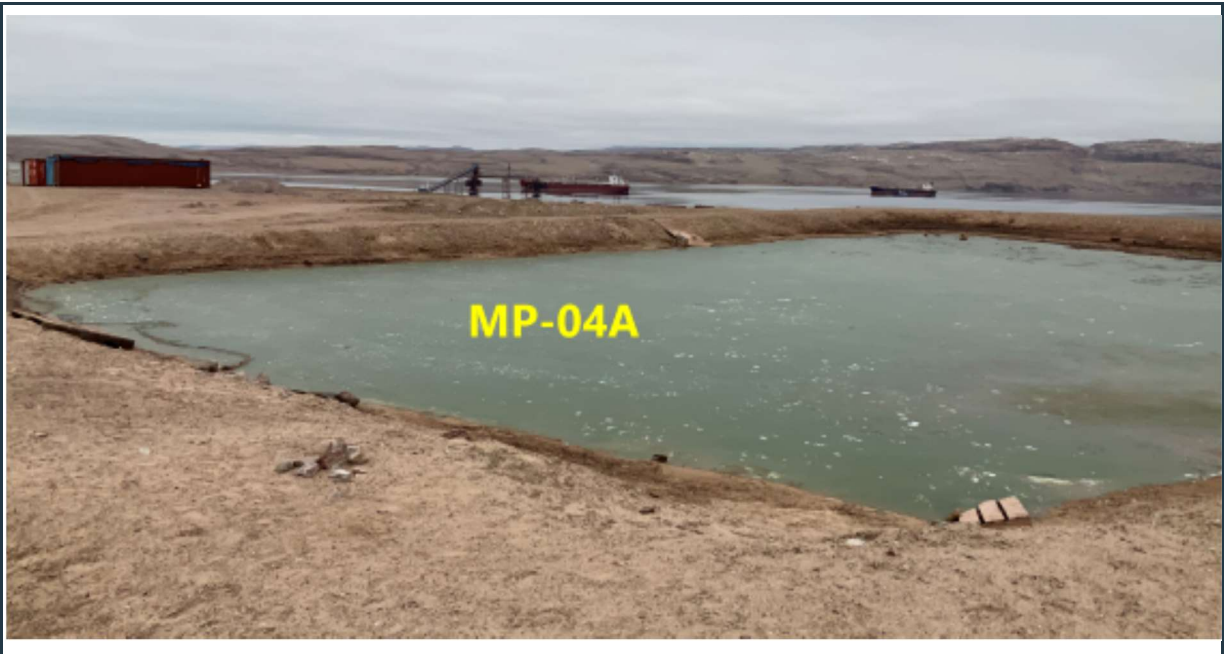
Figure 49: View of the MP-04A cell with stable berms. The ponding water indicates good liner performance.

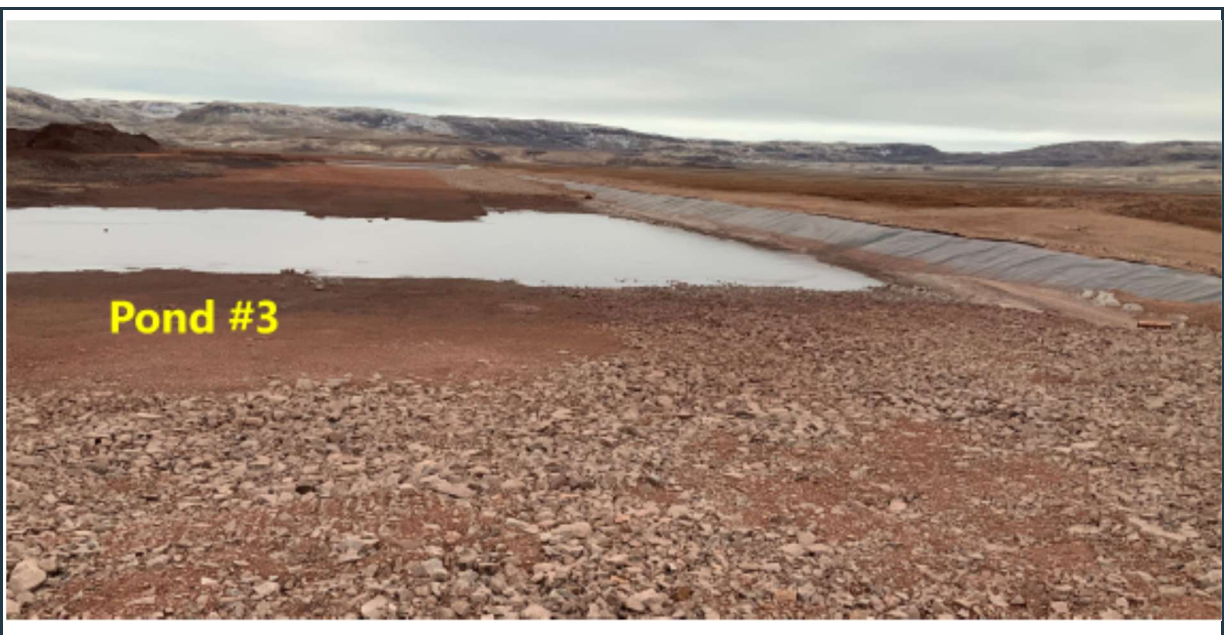
a) Settling Pond #3

Figure 50: View of settling pond #3, with lined, stable berms along three sides of the pond.

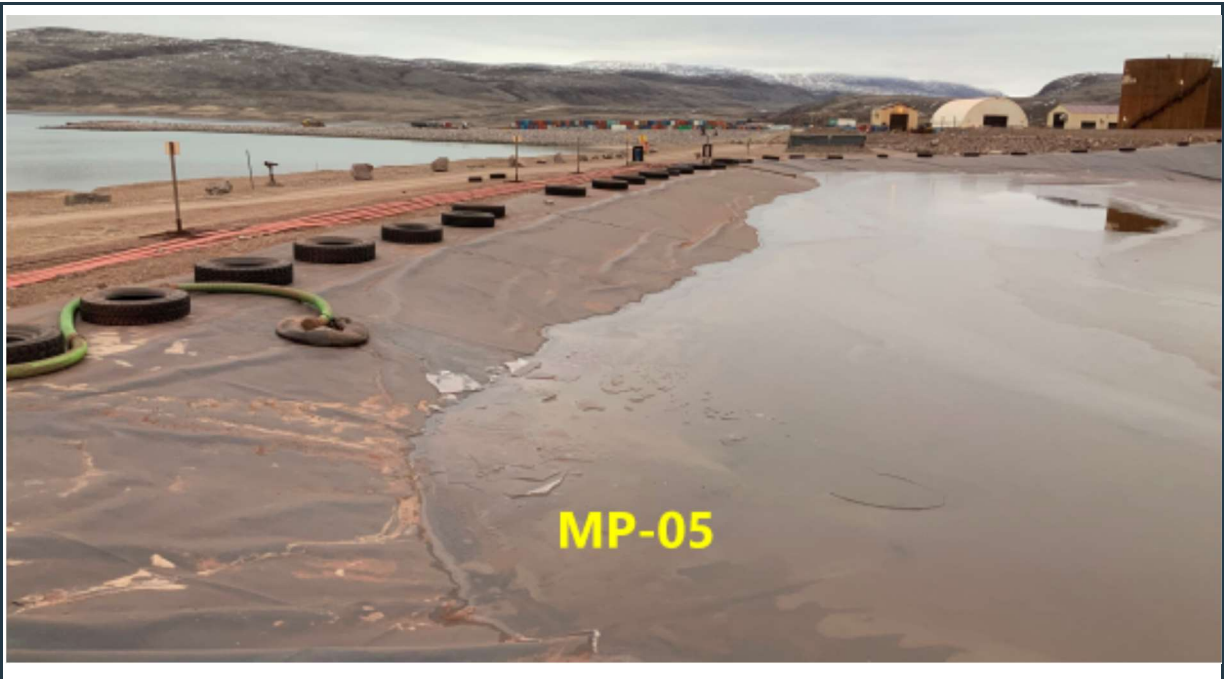
b) MP-05 Settling Pond

Figure 51: View of the stable berms and intact liner at the MP-05 settling pond.

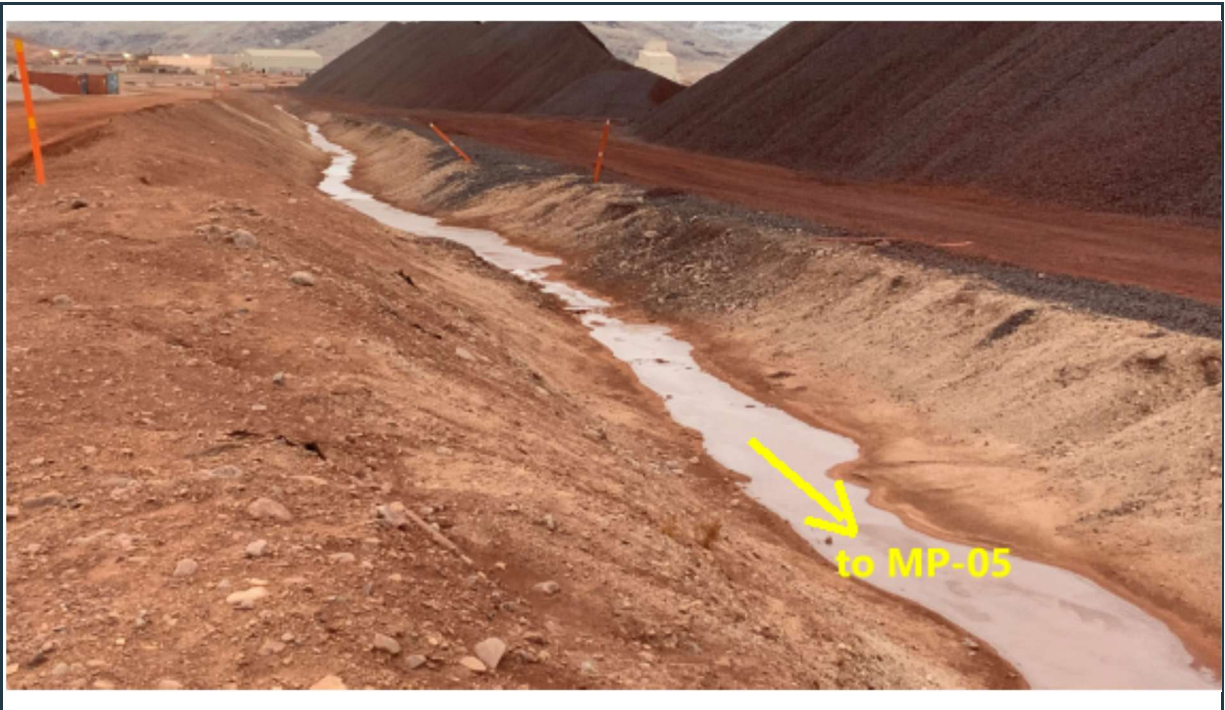
Figure 53: Surface water collection ditch adjacent (east) to the ore storage, draining to the MP-05 pond.
