RE: Submission of 2021 Geotechnical Inspection Report No. 2 (September 2021)

Mary River Project – Nunavut

November 16, 2021
TC190307.2021

Wood Environment & Infrastructure Solutions (Wood), has completed the second geotechnical field inspection of 2021 at the Mary River Project, which is a condition of the Type “A” Water Licence No: 2AM-MRY1325 – Amendment No.1 (“Water Licence”).

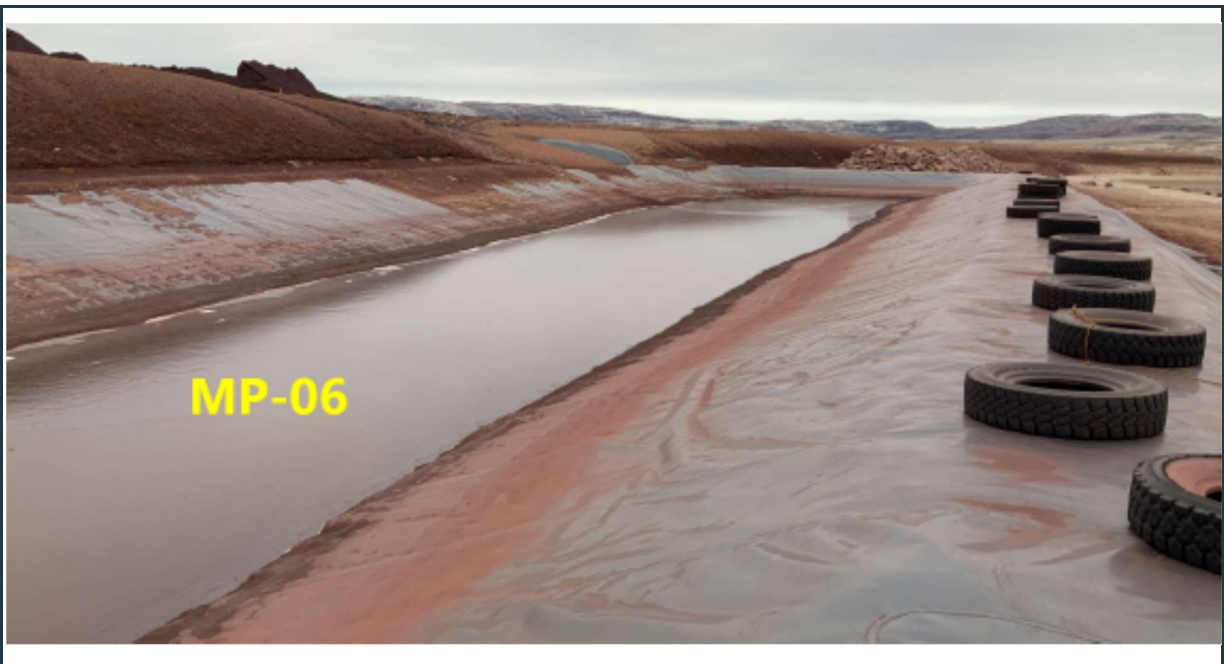
Figure 54: View of the lined MP-06 pond with robust, stable berms.

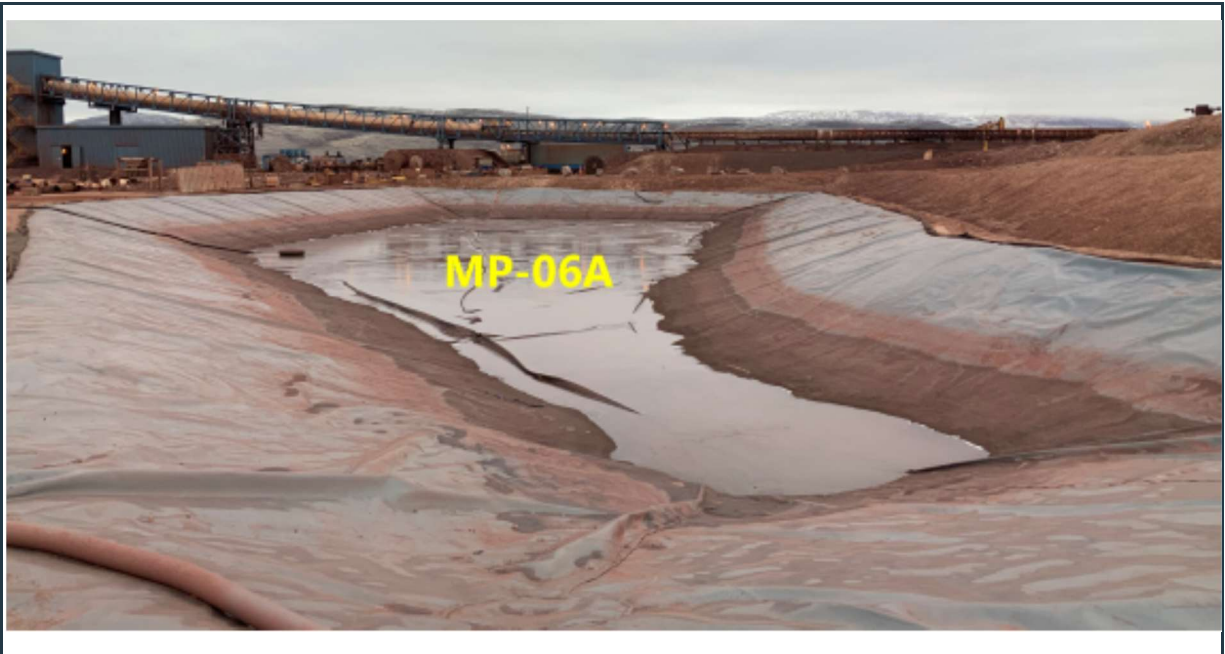
Figure 55: View of the lined MP-06A overflow pond, with stable berms.

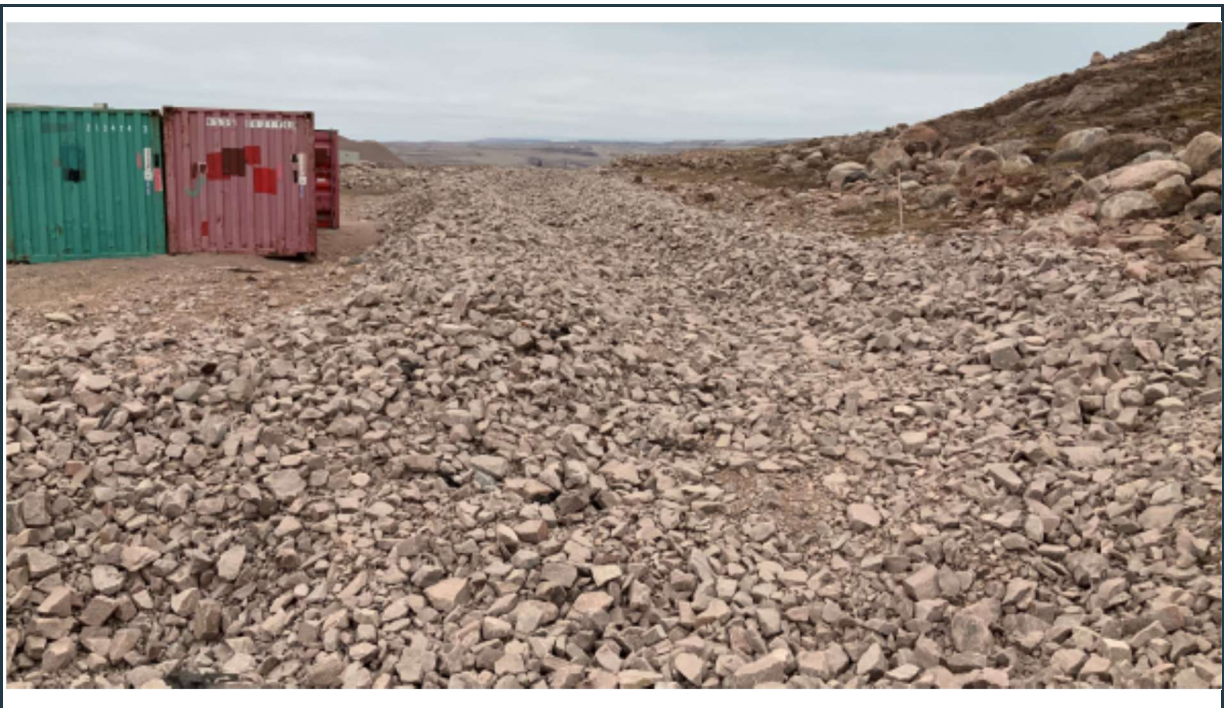
Figure 60: View of the rock fill lined P-SWD-6 surface water collection ditch.

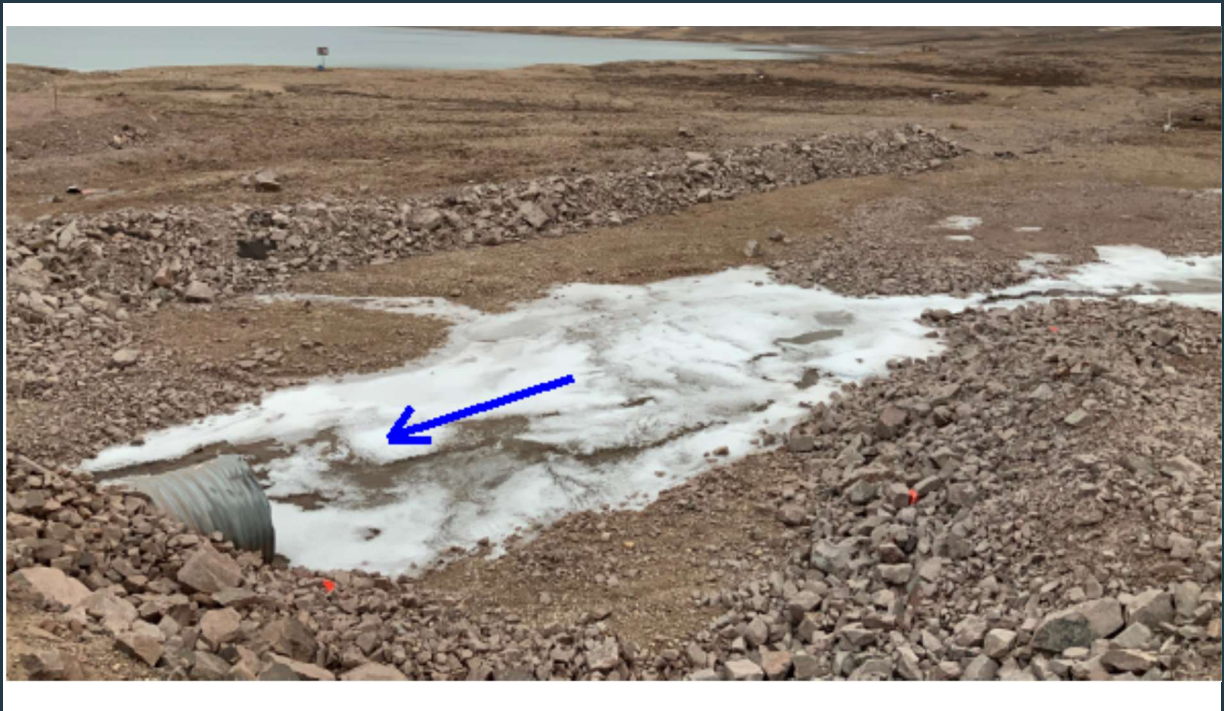
Figure 61: View of the P-SWD-7 surface water collection ditch and culverts (inlet).

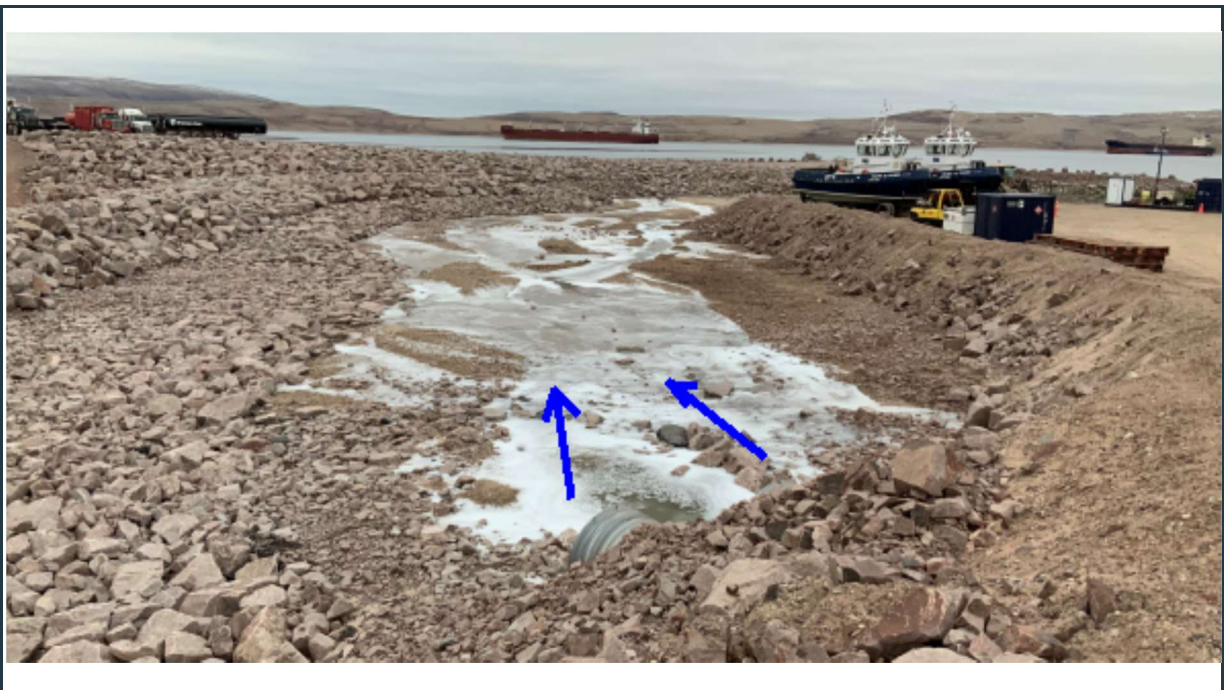
Figure 62: View of the well-maintained P-SWD-7 surface water collection ditch and culverts (outlet).

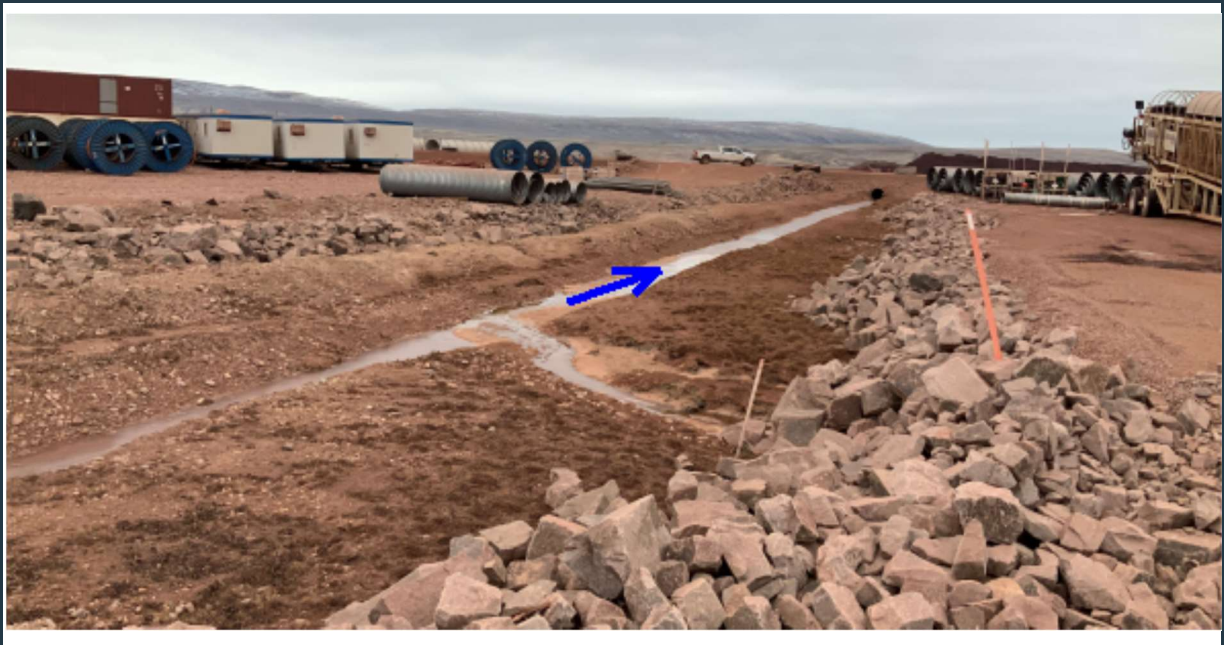
Figure 63: View of the W3/W14 uncompleted surface water collection ditch with some erosion.

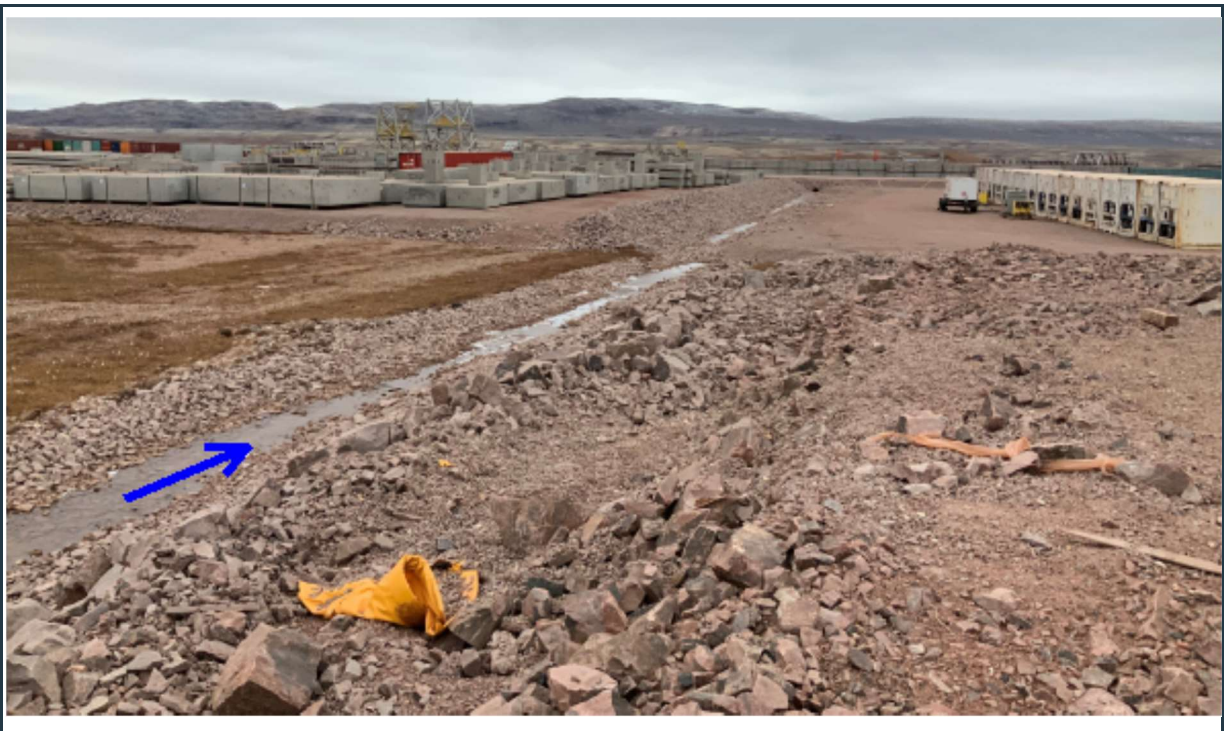
Figure 64: View of the south section of the 380 M surface water collection ditch.

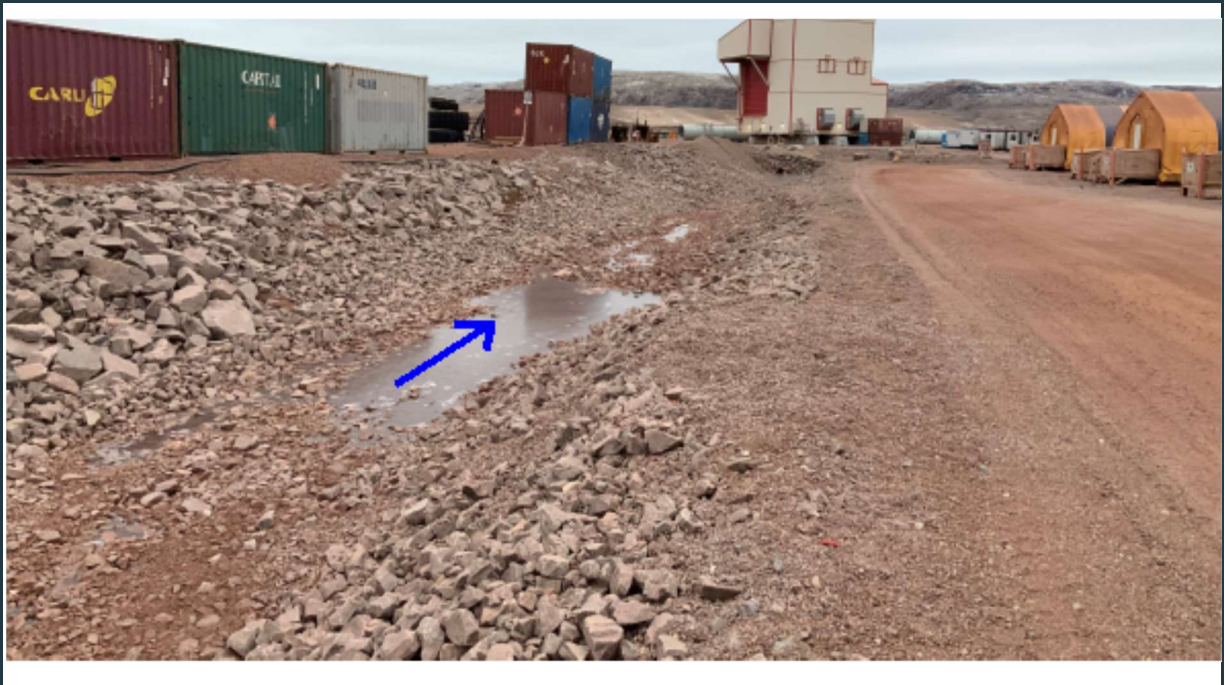
Figure 65: View of the east section of the 380 M surface water collection ditch in good condition.

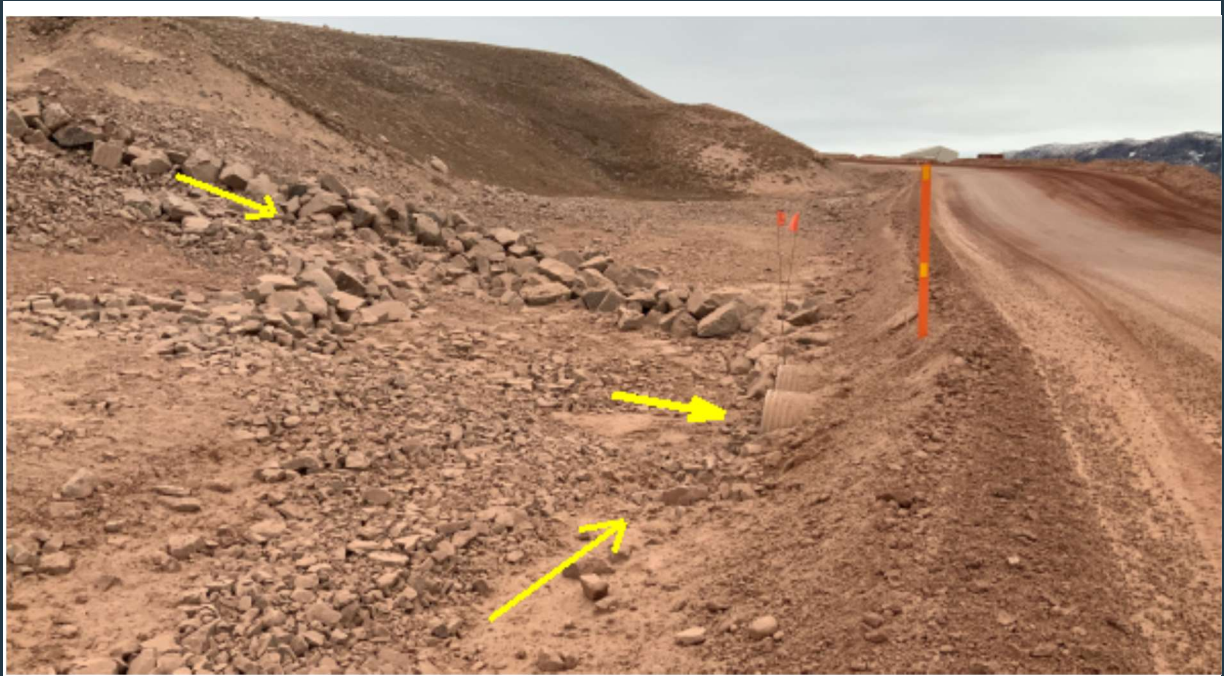
Figure 67: View of twin culverts, draining surface water from the quarry area under the tote road (inlet).

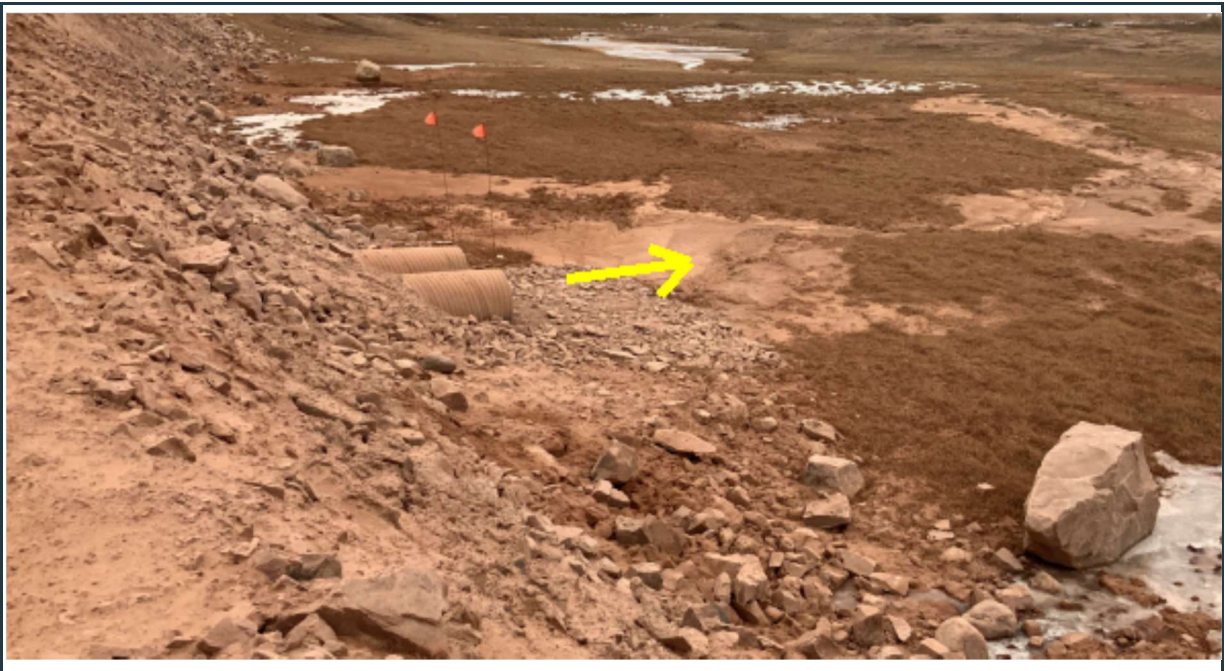
Figure 68: View of twin culverts, draining surface water from the quarry area (outlet).

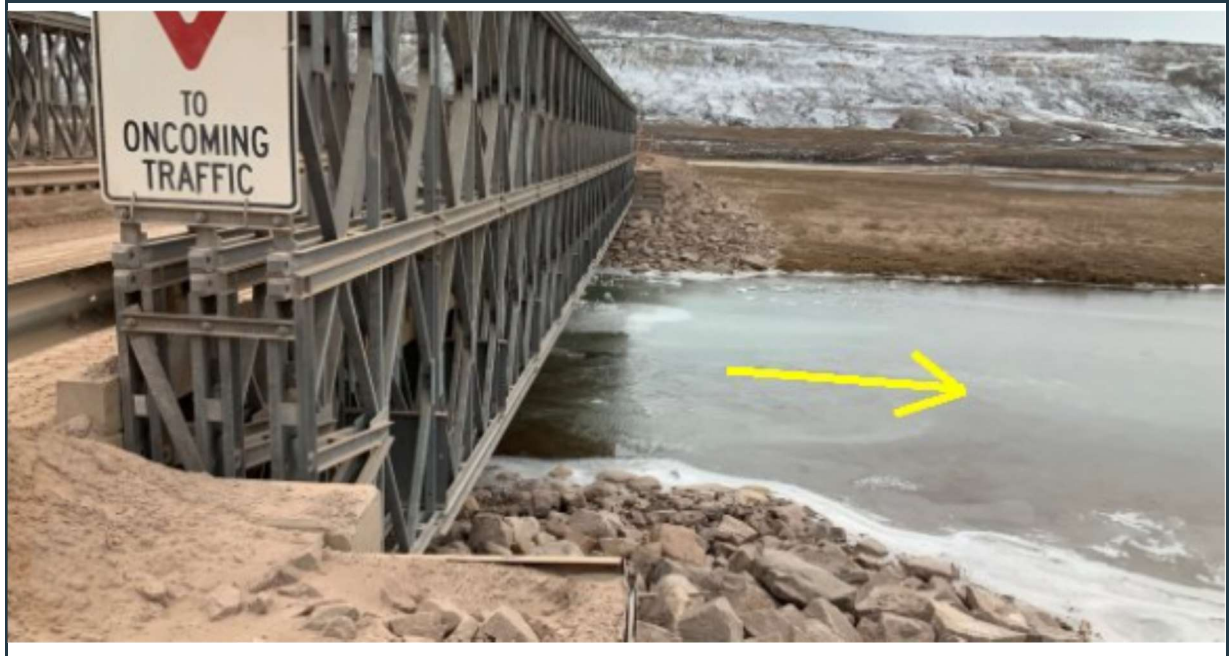
Figure 69: View of the north side of "bridge 17", with stable rip-rap scour protection at the abutments.

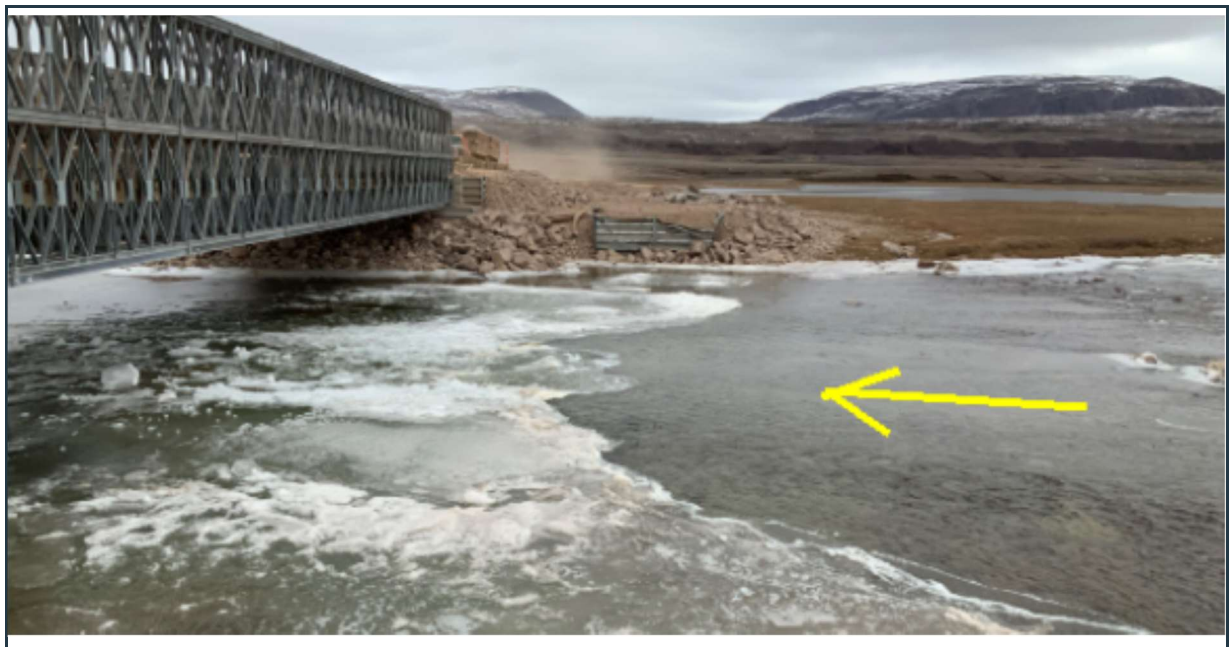
Figure 70: View of the south side of "bridge 17", with stable abutments.

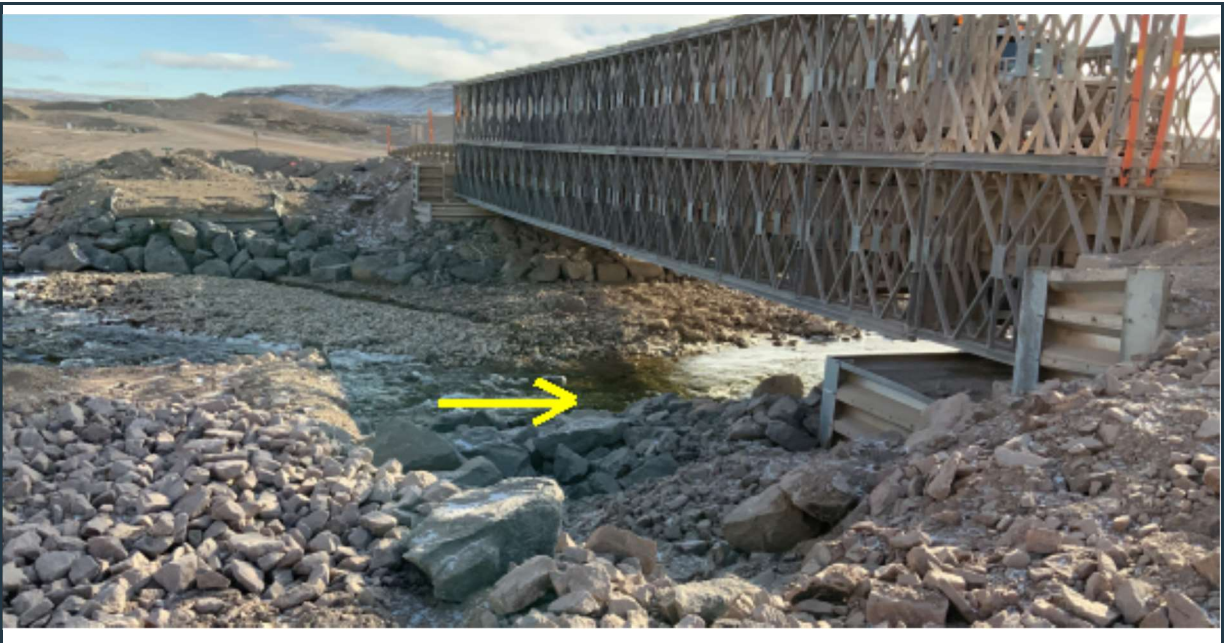
As shown in Figure 71 and Figure 72, the abutments of this bridge are stable and no scour around the abutments was noted during the site visit. The abutments show no visible differential settlement or any structural discrepancy like damages to the bolt-a-bin foundation cribs. Similar to bridge 17, there are the "remnants" of two (2) historic abutments (visible in Figure 72), located immediately adjacent to the "new" ones and damage to the metal bins of both old abutments are visible. In order to maintain the stability of the currently used bridge abutments and approach embankments, the two (2) old abutments should be kept in place since they provide support to the adjacent new structures.

Figure 72: View of the east side of bridge 63, and the "old" abutments with low flow, looking south.

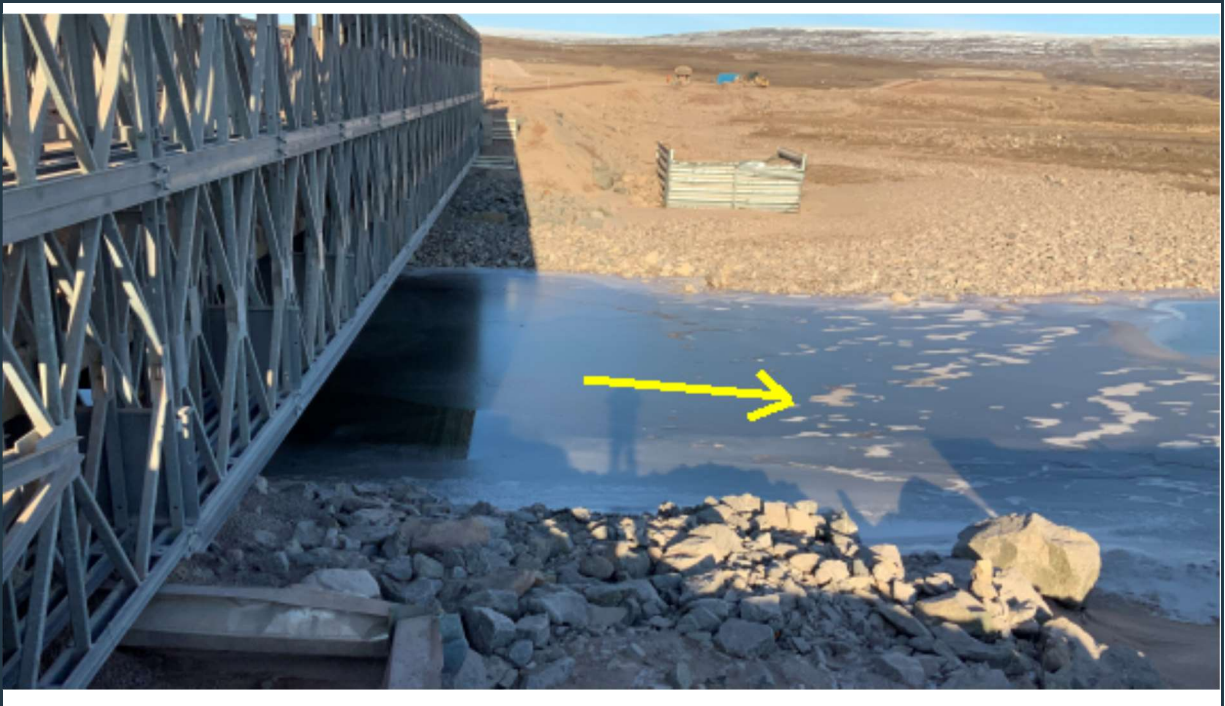
As shown in Figure 75 and Figure 76, the abutments of this bridge appear to be stable and no scour in the riverbed and around the approach embankments was noted during the site visit. The abutments show no differential settlement or any structural discrepancy like deterioration of the foundation bins. There are two (2) culverts installed under the Tote Road just south of the bridge, to convey some of the water in the river channel to the west side of the Tote Road (bypassing the bridge). The outlet end of the culvert and the following water channel is shown in the cover image of Appendix "C", left of the bridge.

Figure 75: View of the west side of bridge 97, with ice already developing in the river.

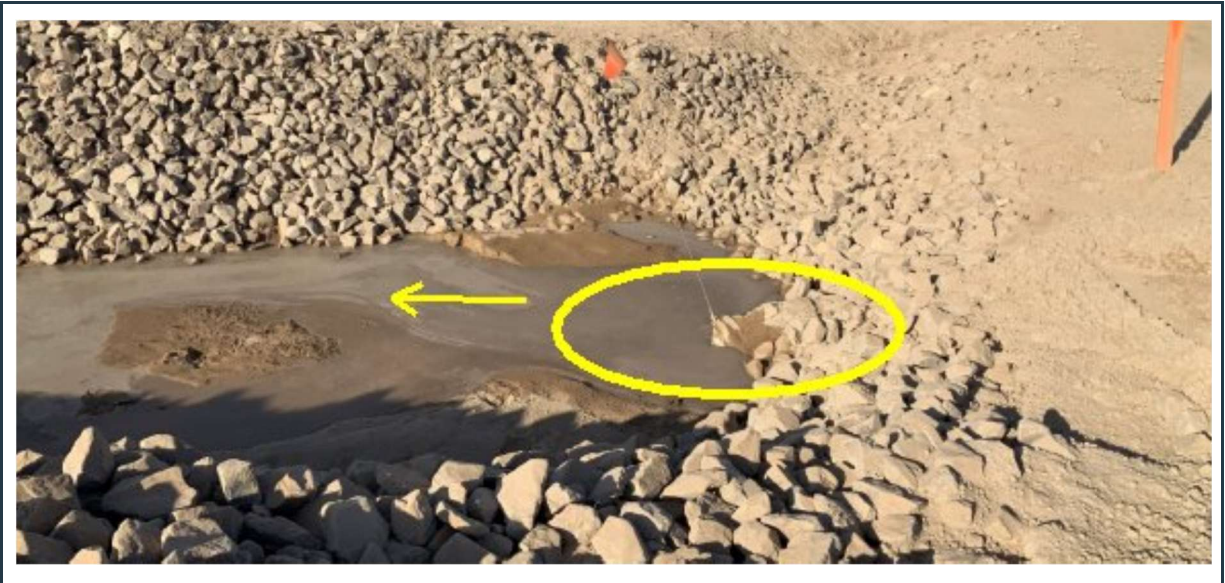
Lake access road check dams at KM33 - (figures 77 to 79): As shown in Figure 77, there is a small diameter culvert at KM33 of the tote road, which currently appears to be almost fully clogged with silt. There are three (3) check-berms located downstream of the culvert's outlet (Figure 78) which were installed in 2020 adjacent to the lake access road. These berms work well and have collected a significant amount of silt since their construction. Two (2) additional check-berms were also installed upstream of the culvert's inlet in 2020, as shown in Figure 79, to prevent silt from entering the culvert. One of these berms has started to wash away (see the yellow circle in the associated figure) and should be reinstated. In addition, silt should be removed from the clogged culvert, and periodically from the upstream ditch, to restore and maintain proper drainage.

Figure 77: View of the outlet of a culvert at KM33 near the lake access check-dams. Note that the ditch and culvert are full with silt, they should be cleaned.

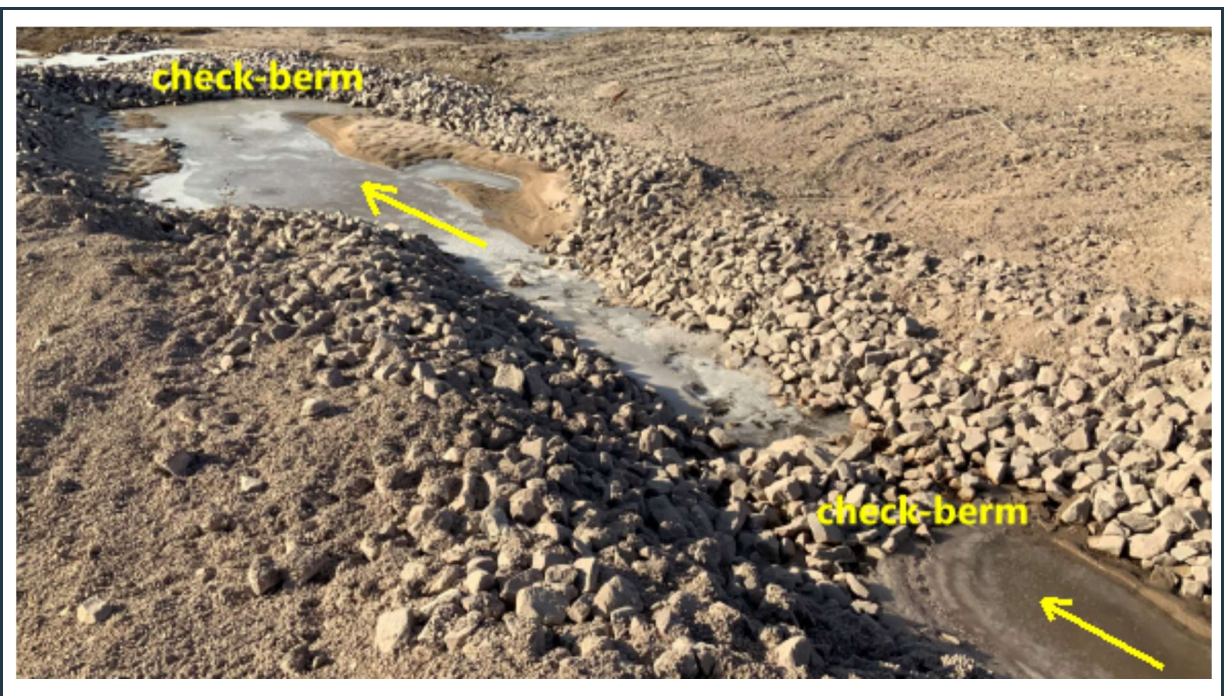
Figure 78: View of the check-dams downstream of the culvert at KM33, shown above.

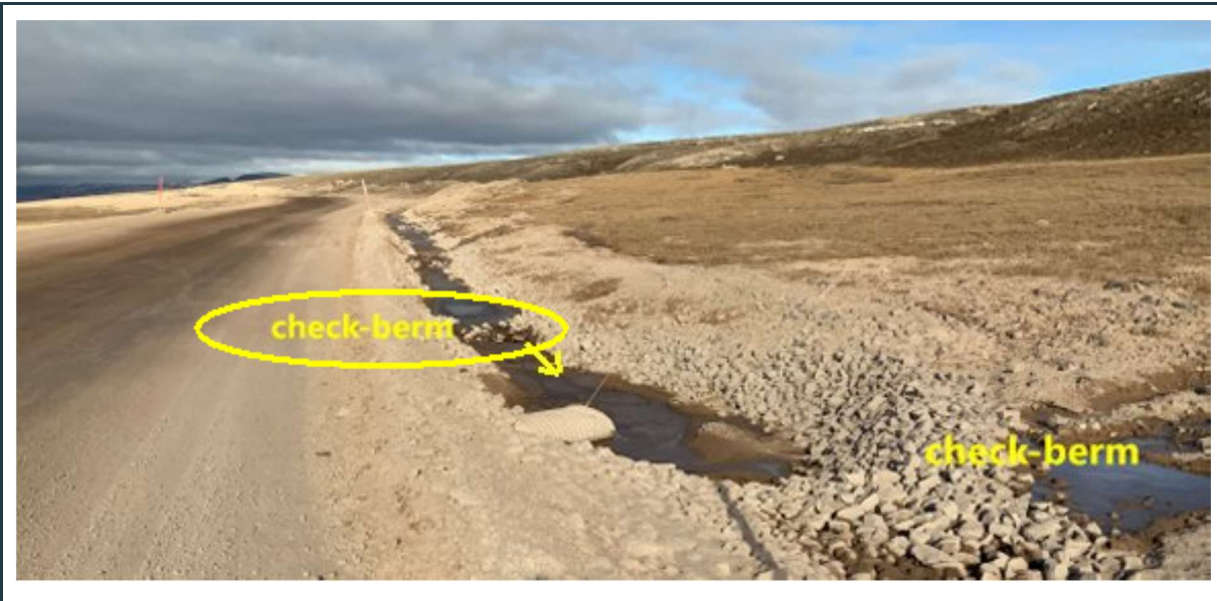
Figure 79: View of check-berms upstream of the culvert's inlet.

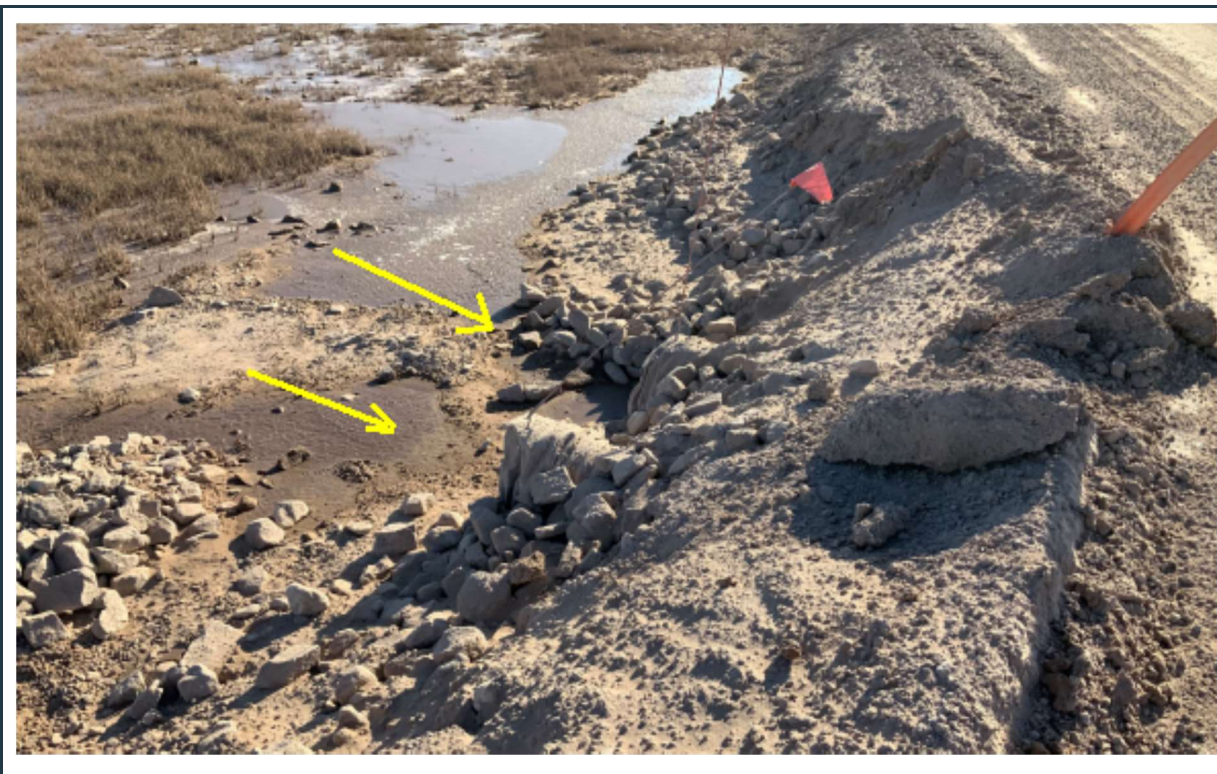
Culvert CV-098 (KM38+300) - (Figure 80 and Figure 81): A set of culverts was installed in 2020 near KM38.3 for roadway drainage to the tundra. The two (2) (twin) culverts at this location appear to be in good condition. It is suggested; however, that more rock fill be placed upstream of the culverts' inlet, in accordance with the approved Civil Design Criteria to minimize siltation within the culverts.

Figure 80: View of the inlet of the two culverts.

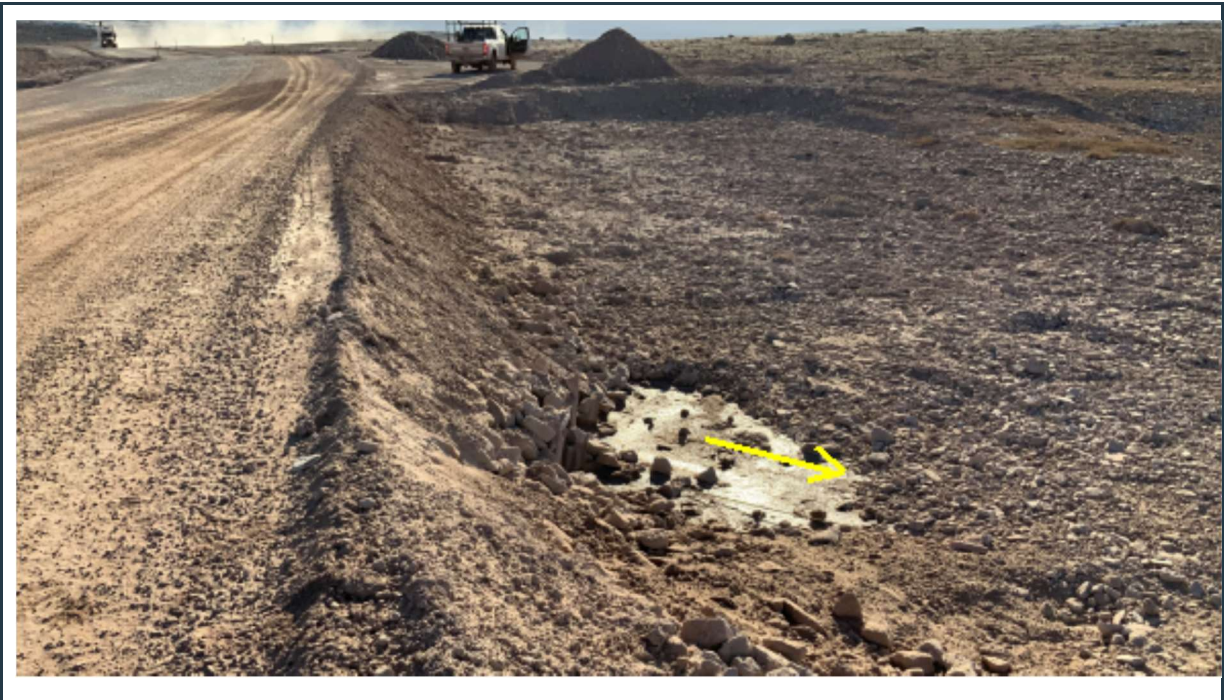
Figure 81: View of the outlet of the two culverts.

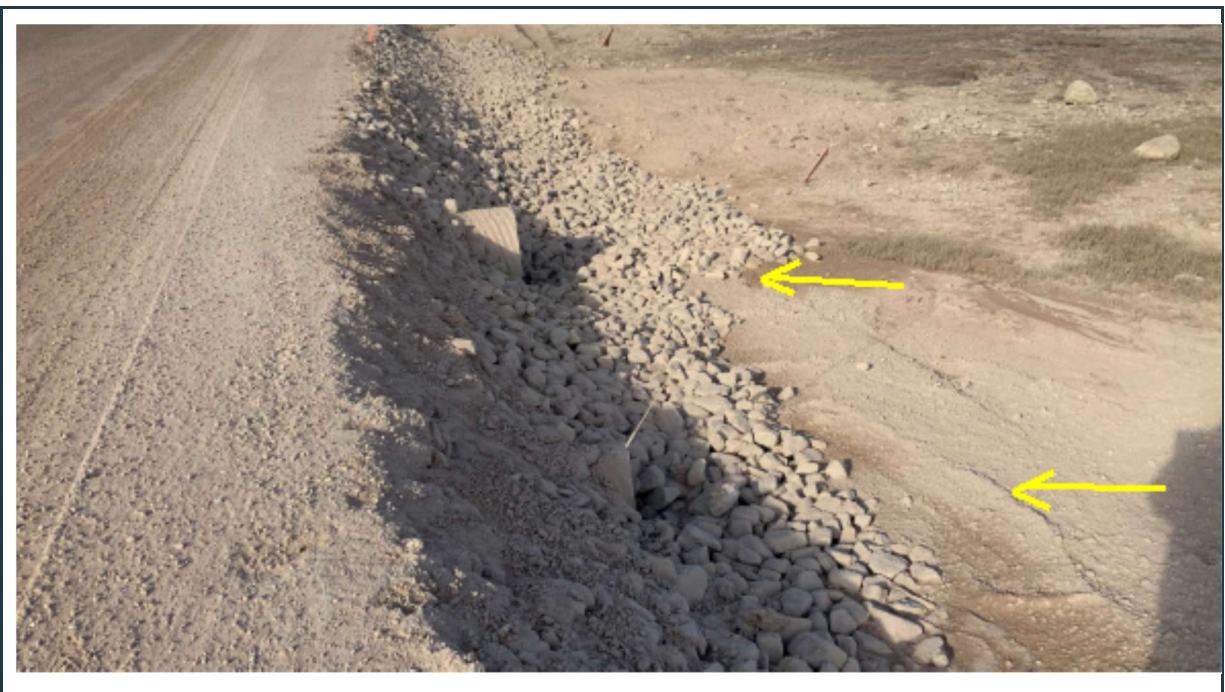
Figure 82: View of the inlet of the two culverts.

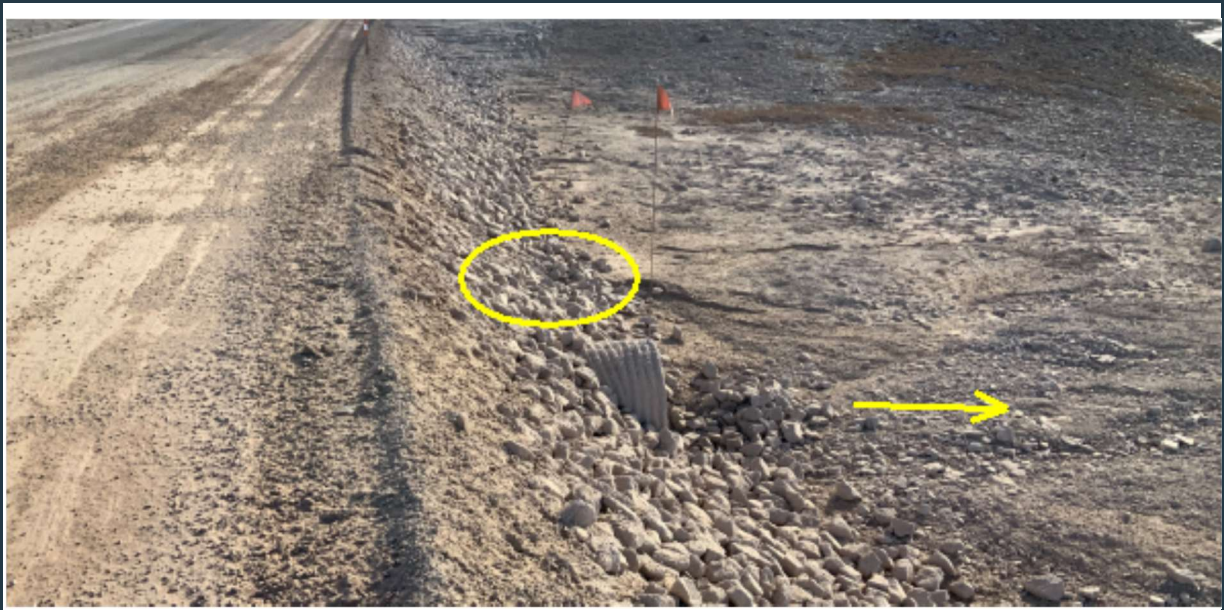
Culvert CV-093 (KM42+100) - (Figure 82 and Figure 83): These two (2) (twin) culverts were extended on both the upstream and downstream sides in 2021 as per the approved Hatch Tote Road Plan. Both culverts at this location appear to be in good condition. The end of one of the culverts is partially blocked by rock fill that should be removed from the front of the culvert pipe and spread around the outlet (yellow circle in Figure 83).

Figure 83: View of the outlet of the culverts. The end of one of the culverts is partially blocked by rock fill that should be removed from the front of the pipe and spread around the outlet (yellow circle).

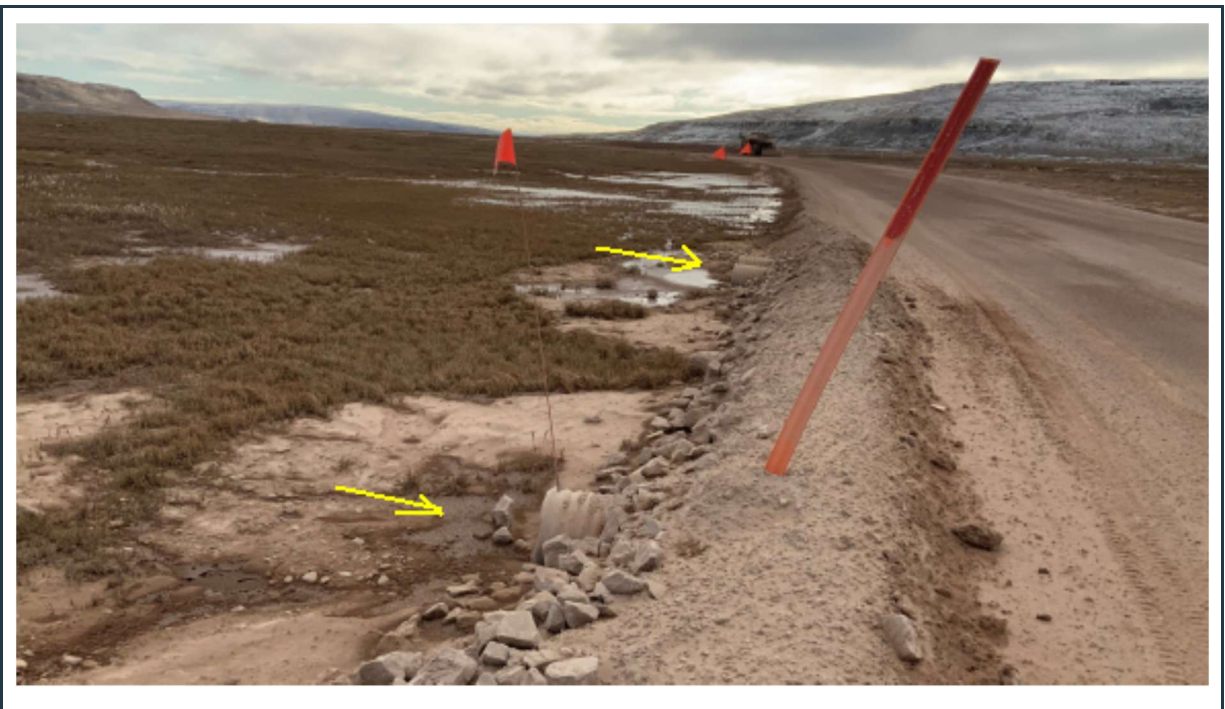
Culvert CV-064 (KM42+100) - (Figure 84 and Figure 85): There are three (3) culverts at this location; one (1) set of twin culverts and one (1) single culvert as shown in the relevant images. All three (3) culverts appear to be in good condition.

Figure 84: View of the inlet of the three culverts.

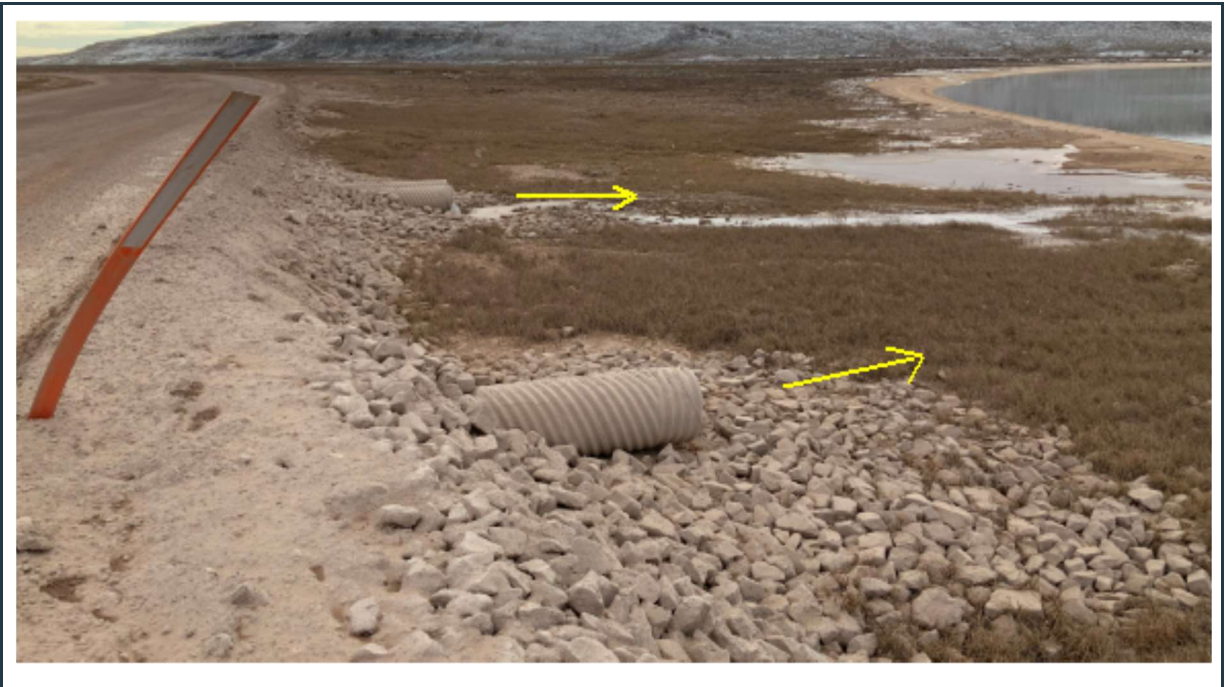
Figure 85: View of the outlet of the three culverts.

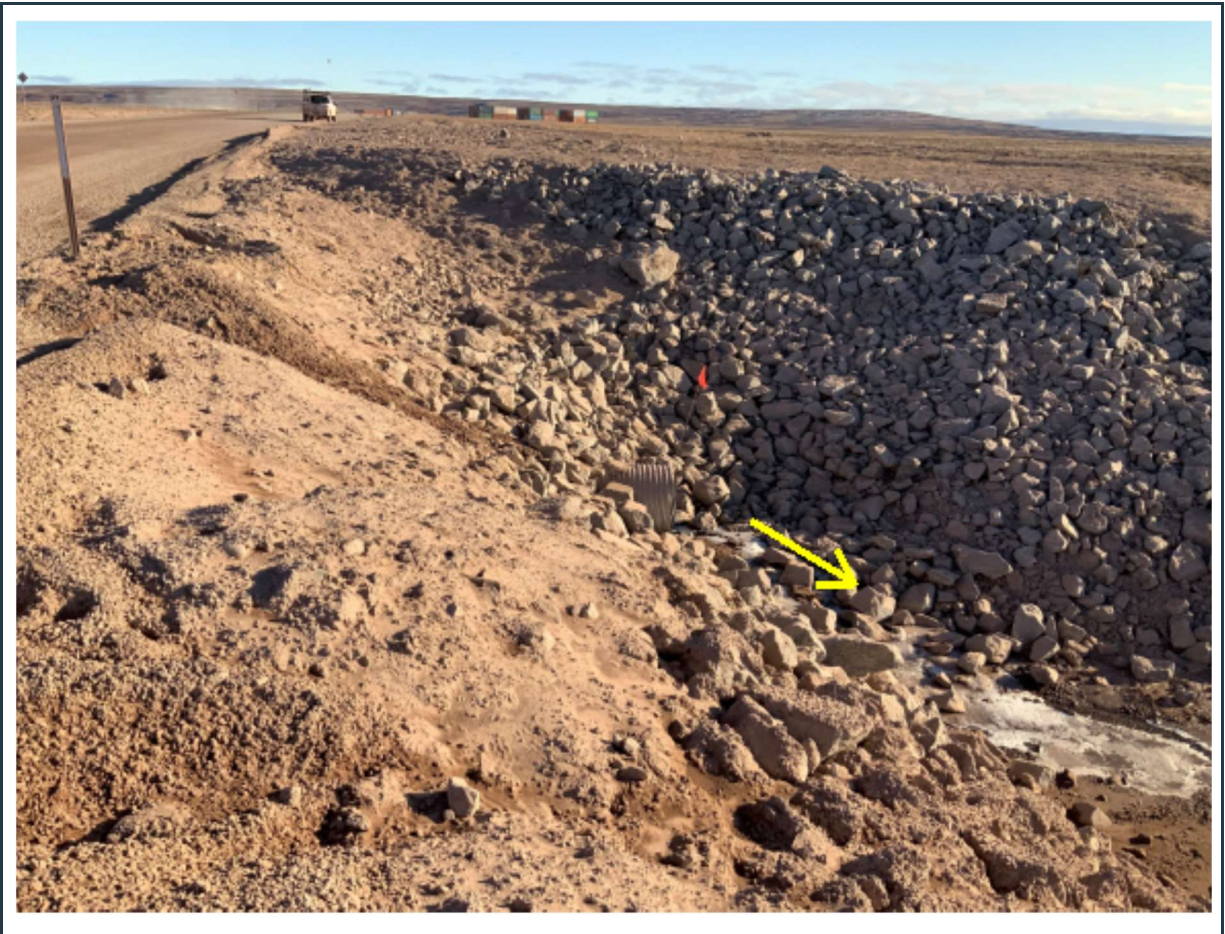
Figure 89: View of the outlet of culvert BG-03A.
