RE: Submission of 2022 Geotechnical Inspection Report No. 1 (June 2022)

Annual Geotechnical Inspections – 2022 Report 1.

Mary River Project – Nunavut

August 21, 2022,
OMGM2212

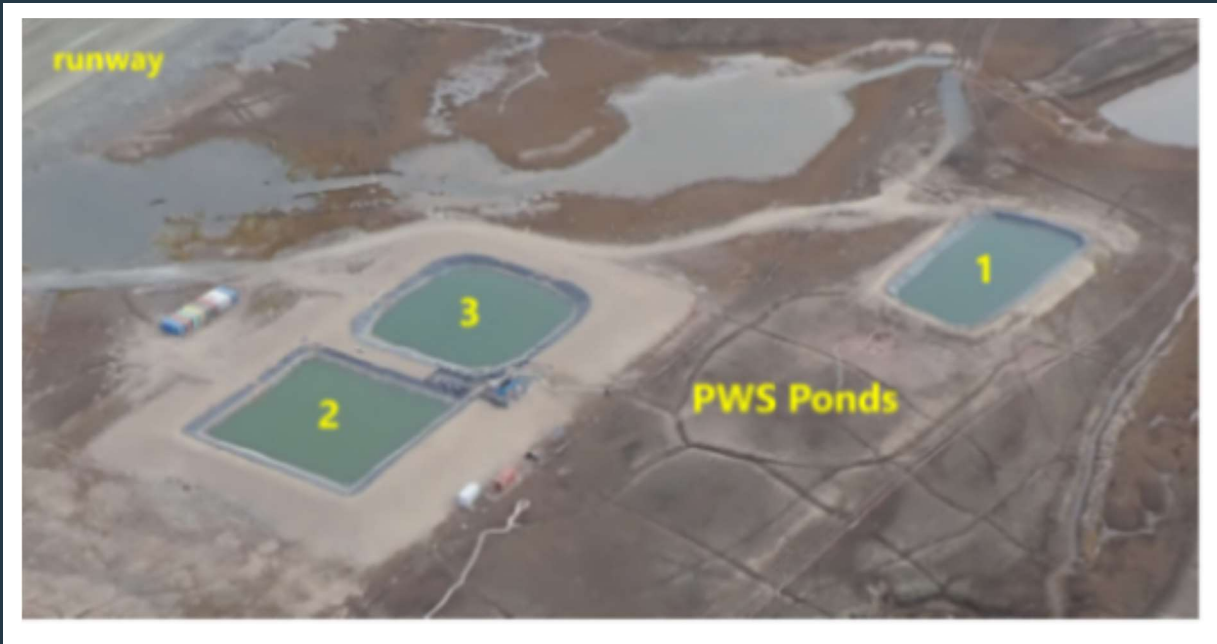
There are three (3) polishing/waste stabilization ponds, located adjacent to the airstrip, as shown in Figure 3. Pond #1 is a single structure, while Ponds #2 and #3 were constructed as twin-cells, as shown in Figure 8. This photograph is a historic aerial image showing the robust, stable berms around the three (3) ponds. These ponds were associated with the exploration phase of the mine, and currently serve as emergency holding ponds in case problems should arise, which would prevent the discharge of treated effluent directly to the receiving environment. The robust, stable berms around these ponds generally comprise granular materials (rock fill, sand, and gravel), supporting High Density Polyethylene (HDPE) geomembrane liners. The liners are secured in anchor trenches on the crest of the berms, and no damage is visible on the membranes on the upstream face of the slopes (see figures 9 to 11).

As shown in the relevant images, the berms around the three (3) ponds are stable, having shallow downstream slopes. Based on visual inspection of the berms' materials, these structures were built using non-frost-susceptible compacted granular materials. It appears that the subgrade around the berms comprise thaw-stable, predominantly granular soils with trace to some fines (silts and clays). Hence, the berms are assumed to have stable foundations, which is further supported by the fact that there are no indications of ground displacement (settlement) or sloughing at and around the berms. In summary, the robust berms are structurally stable with no sign of seepage from any of the three (3) ponds.

Figure 8: Aerial view of the robust, stable berms around the three PWS ponds. (Historic image to present the layout of the three ponds).

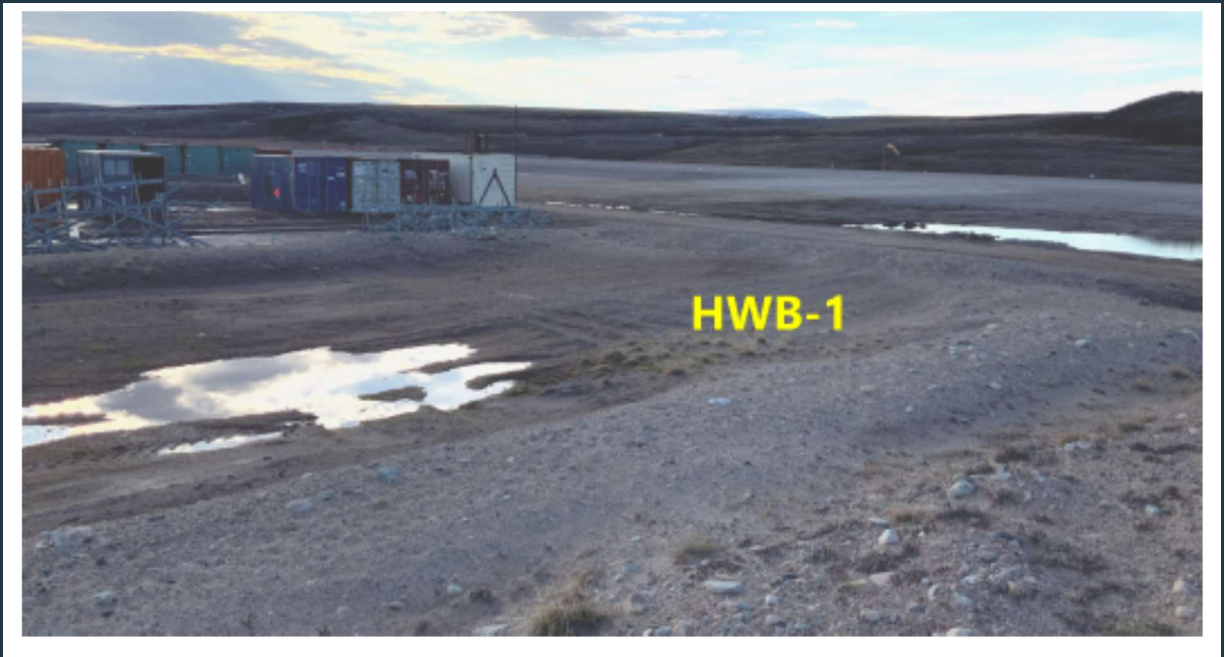
a) HWB-1

This cell is currently empty, as shown in Figure 12. As reported previously, concerns had been raised in the past to suspected potential liner damage within this cell, and consequently no material has been stored in this cell since this concern was identified. Baffinland has previously committed to removing the old liner from this cell and replacing it with a new one should use of the HWB be required in the future, prior to storing material in the cell.

Figure 12: View of HWB-1 – This cell is out of operation for years, and no materials are stored in the cell.

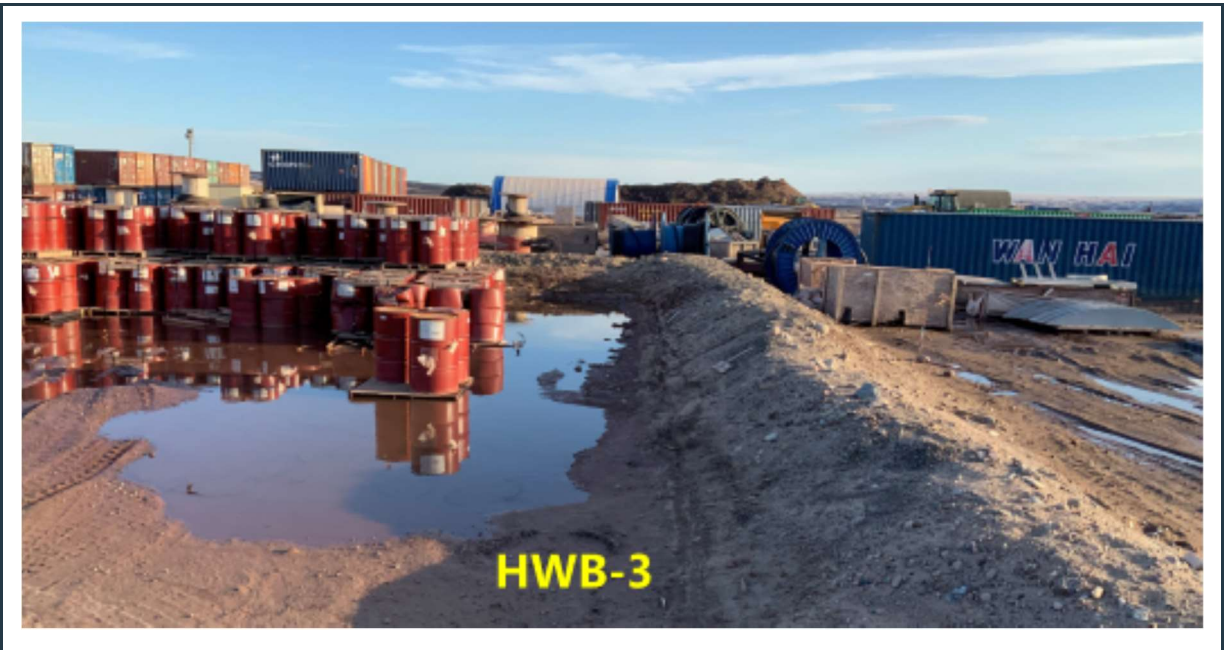
These cells were constructed as "twin-cells" and were called "Fuel Containment" cells in historic inspection reports. As shown in Figures 14 and 15, there are fuel barrels stored on wooden pallets in both cells (jet-fuel and diesel). The berms and liner around and within the cells appear to be in good condition and no seepage from either of the cells was noted. Wooden pallet fragments, shown in Figure 15, should be removed from the cells during regular maintenance work to prevent potential damage to the liner.

Figure 14: View of stable berms and stored fuel barrels in HWB-3.

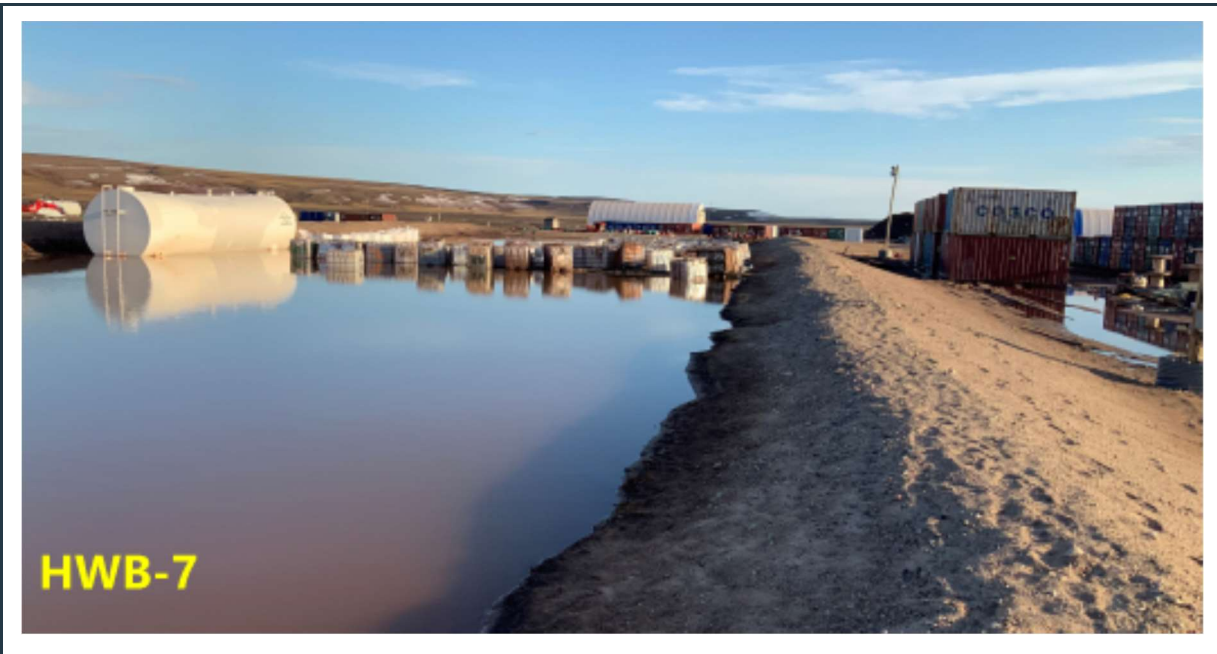
f) HWB-7

One (1) large fuel tank and a few plastic containers are stored in this large cell, as shown in Figure 18. The robust perimeter berms around the cell appear to be stable and the visible water (rain and melted snow) within the cell is indicative of adequate liner performance. As shown in Figure 19; however, the crest of the east berm appears to be lower than the other sections of the perimeter berm providing only minimal freeboard along this section of the berm. Consideration shall be given to raise this (north-east) section of the berm, or alternatively remove and treat the water from the cell.

Figure 18: View of the large, flooded HWB-7 cell, with one large fuel tank and some containers stored.

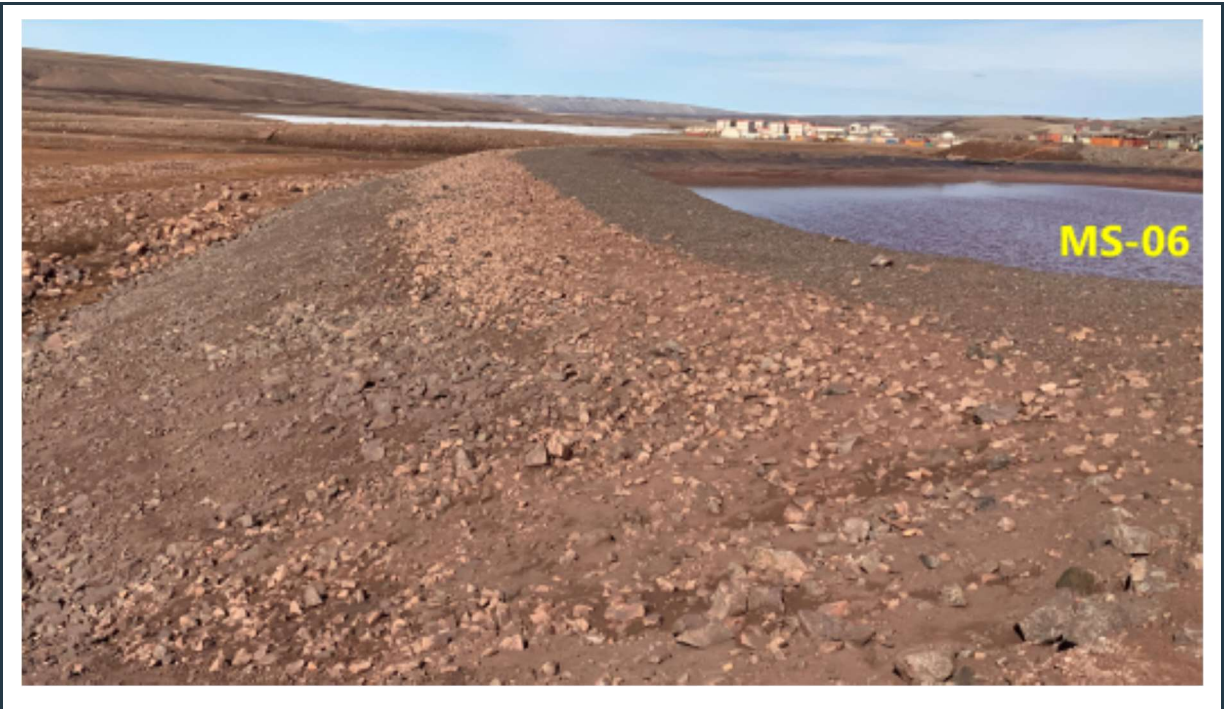
Figure 20: View of the MS-06 settling pond with robust, stable berms and intact liner.

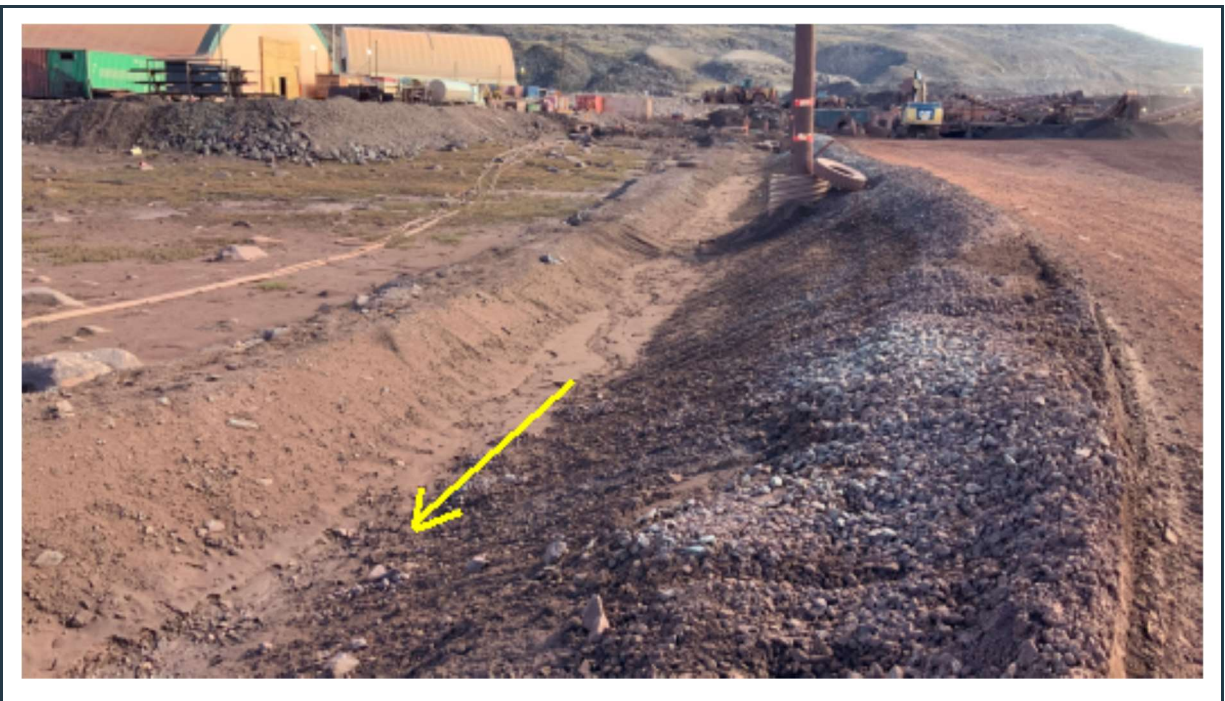
The MS-06 settling pond generally collects surface water from the area of the crusher pad. The rainwater and melted snow are collected in side-ditches around the crusher pad and conveyed to the MS-06 settling pond. There are two (2) intake locations to the pond at the northeast and southeast corners, and there is an emergency spillway located opposite the intakes. The spillway was extended in 2018/2019 and the berm's crest raised. Details of that work were summarized in a Construction Summary Report, dated December 2019. The liner within the pond and on the upstream slopes of the berm appeared to be intact (see Figure 20), and no wet downstream slopes or toe seepage from the pond were visible at the time of the inspection. The side slopes of the well-maintained surface-water collection ditches leading to the pond were observed to be stable (see Figure 21) and the ditches are unobstructed.

Figure 21: Well-maintained drainage ditch next to the crusher plant, leading to the MS-06 pond.

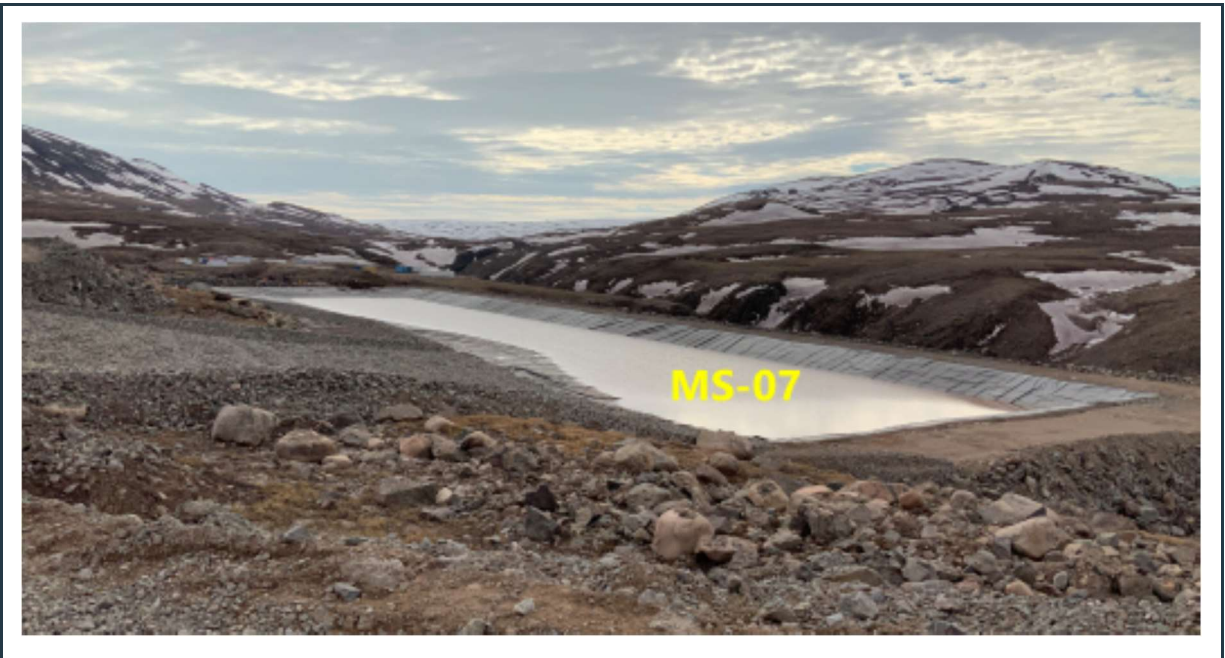
Figure 22: View of the MS-07 surface-water collection pond with robust, stable berms and intact liner.

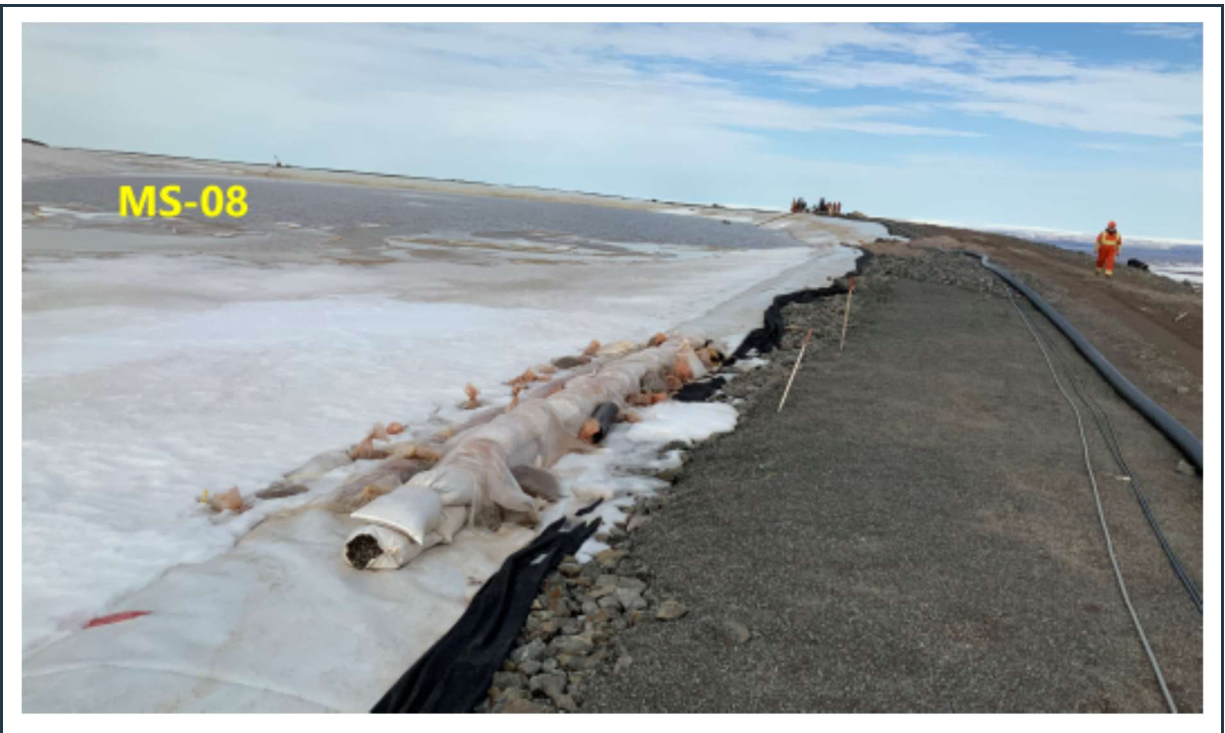
Figure 23: View of stable berm and intact liner at the MS-08 pond. Ice is still present at the end of June.

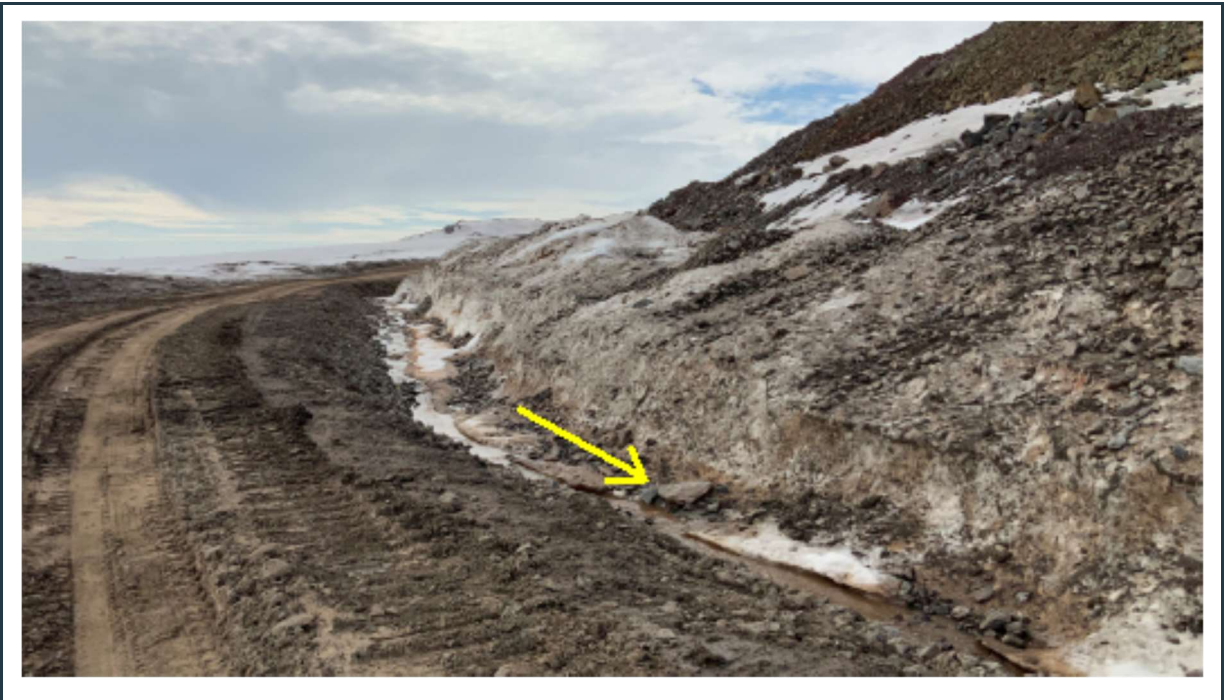
Figure 24: Snow-filled stable drainage ditch around the east side of the waste rock facility.

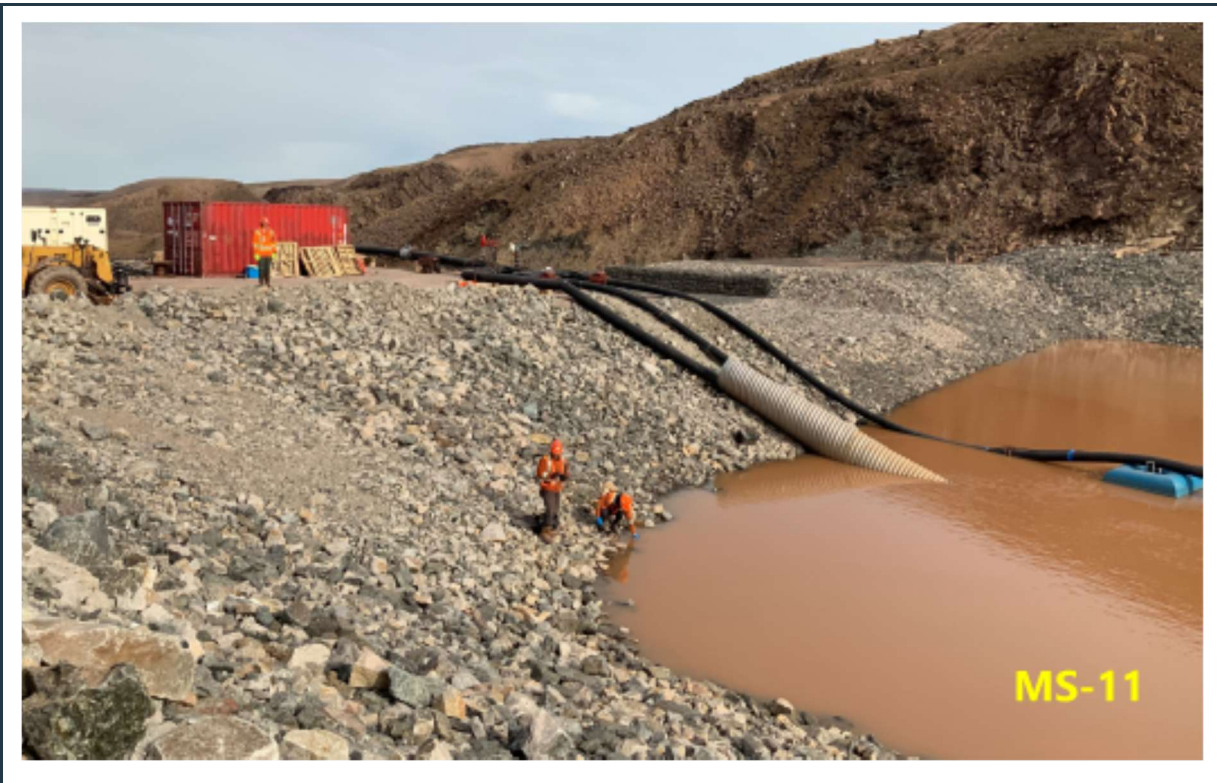
Figure 26: View of the recently completed robust, stable rock-fill dam at the MS-11 pond at KM105.

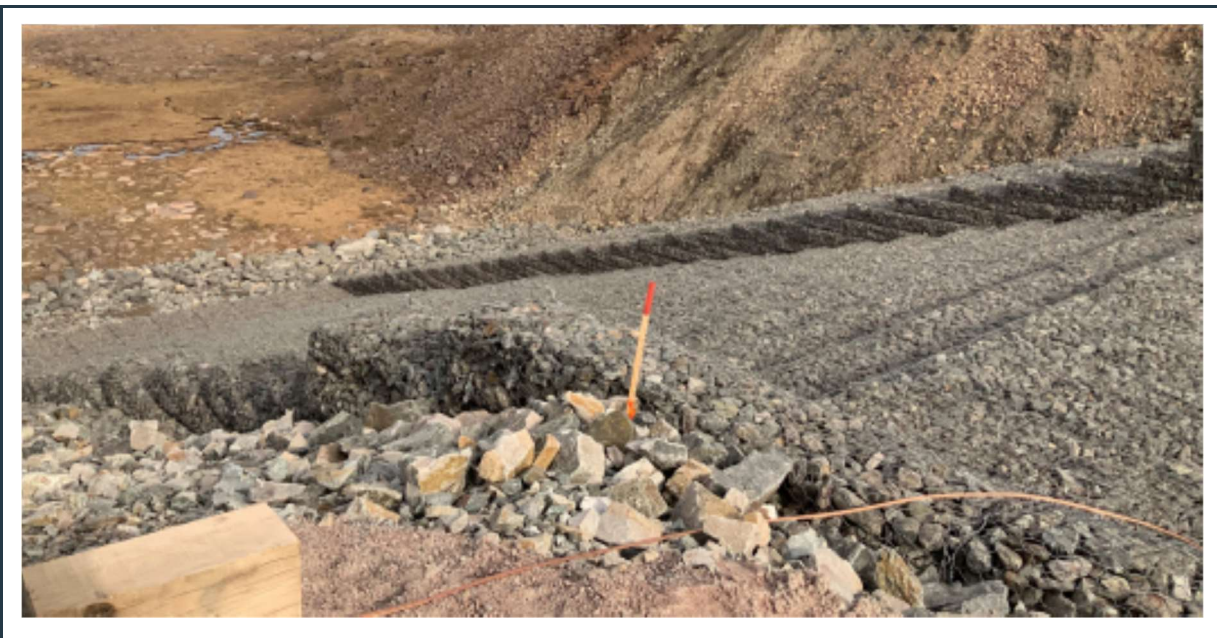
Figure 27: View of the recently completed stable emergency spillway (crushed rock filled gabion baskets and blankets) at KM105.

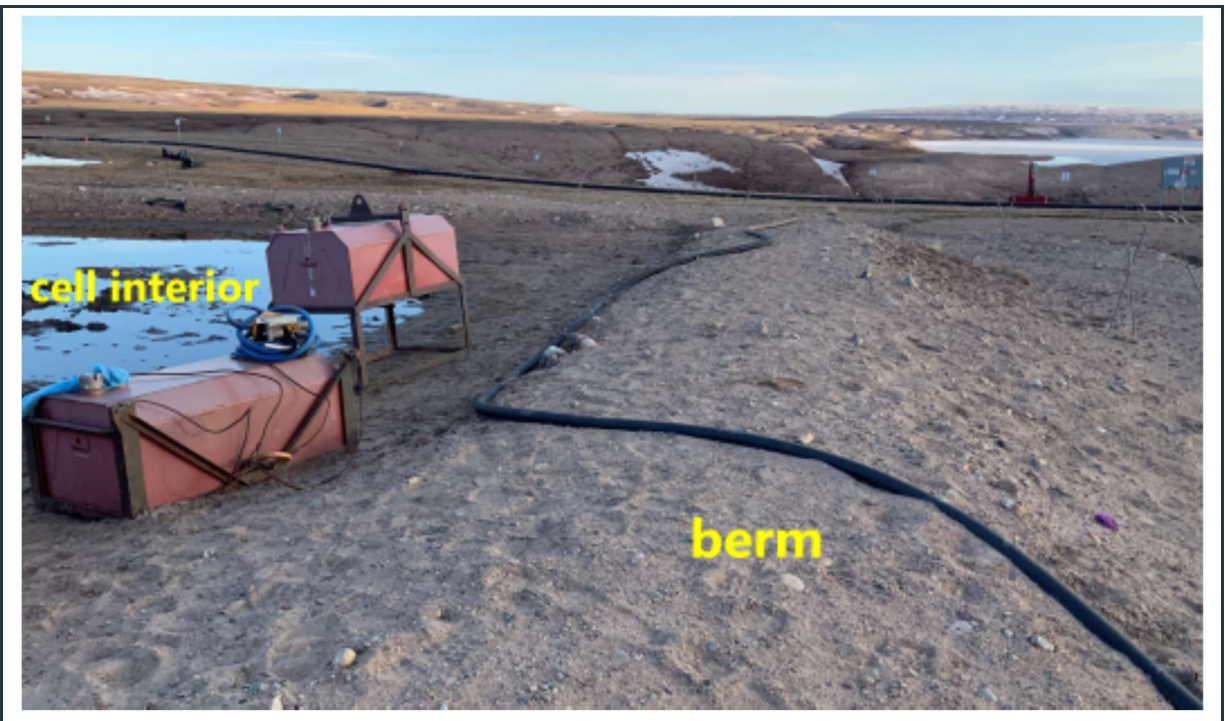
Figure 29: View of the stable berm around the "generator fuel bladder" cell.

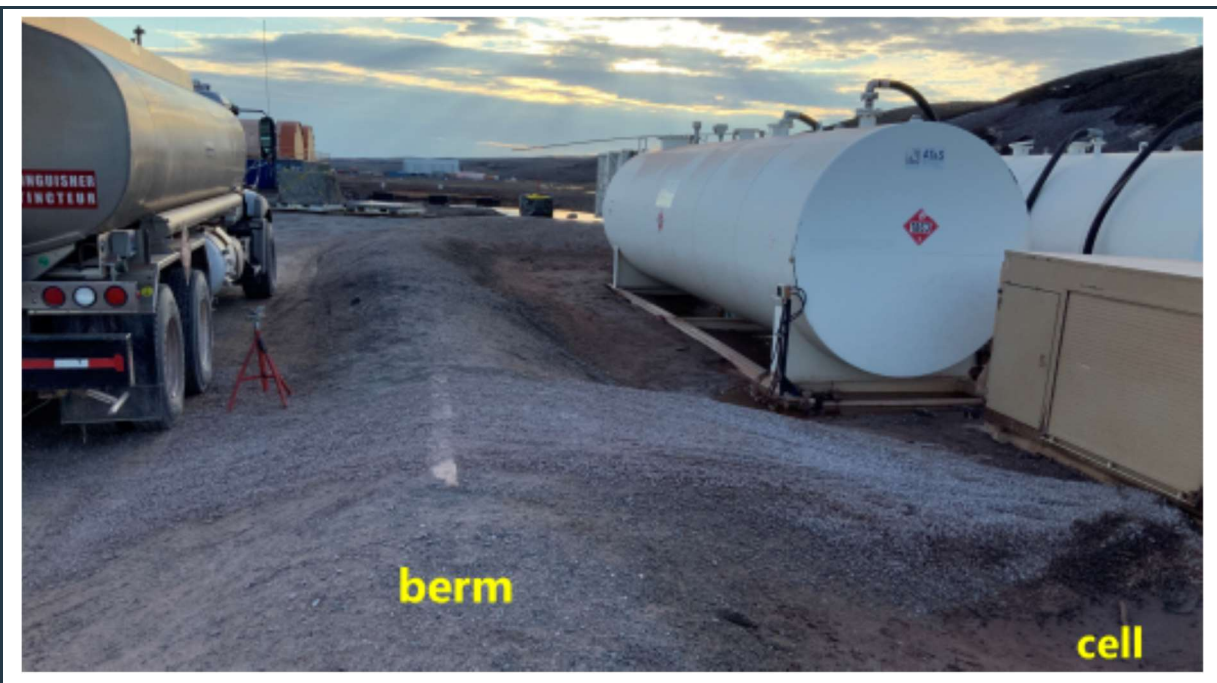
Figure 31: View of the well-maintained sand and gravel berm at the lined jet-fuel storage facility.

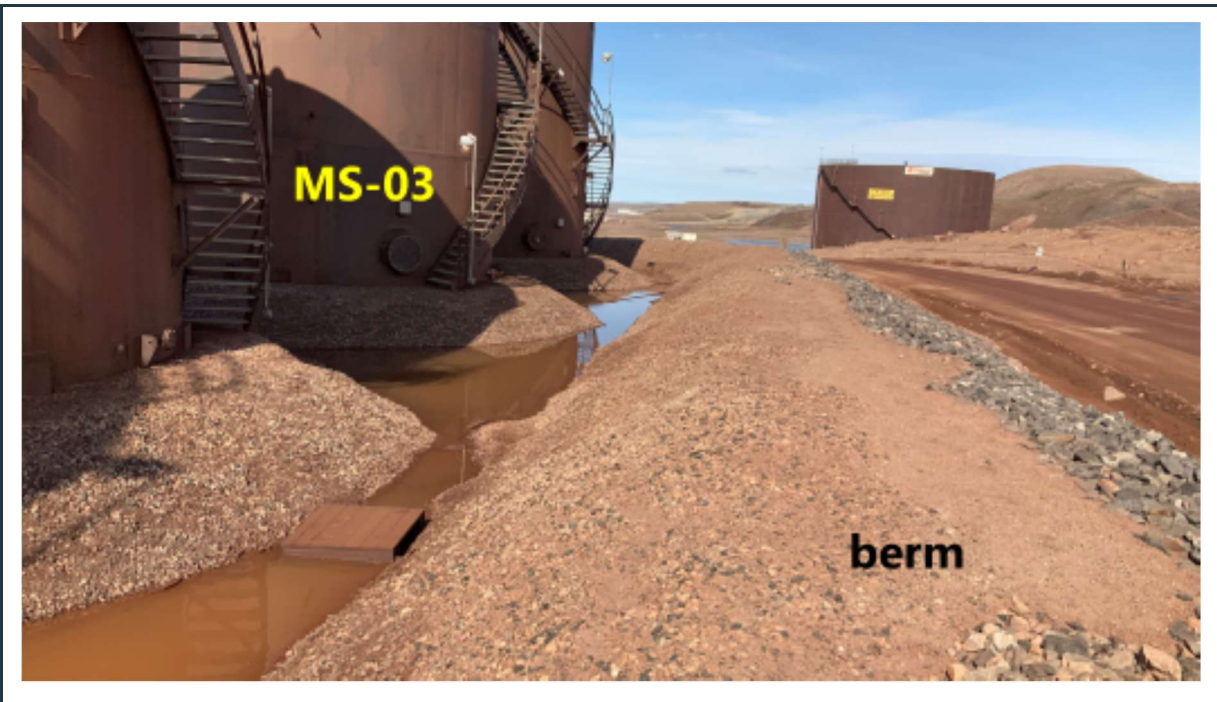
Figure 32: Well-maintained, stable berm around the MS-03 diesel fuel farm, with some ponding water.

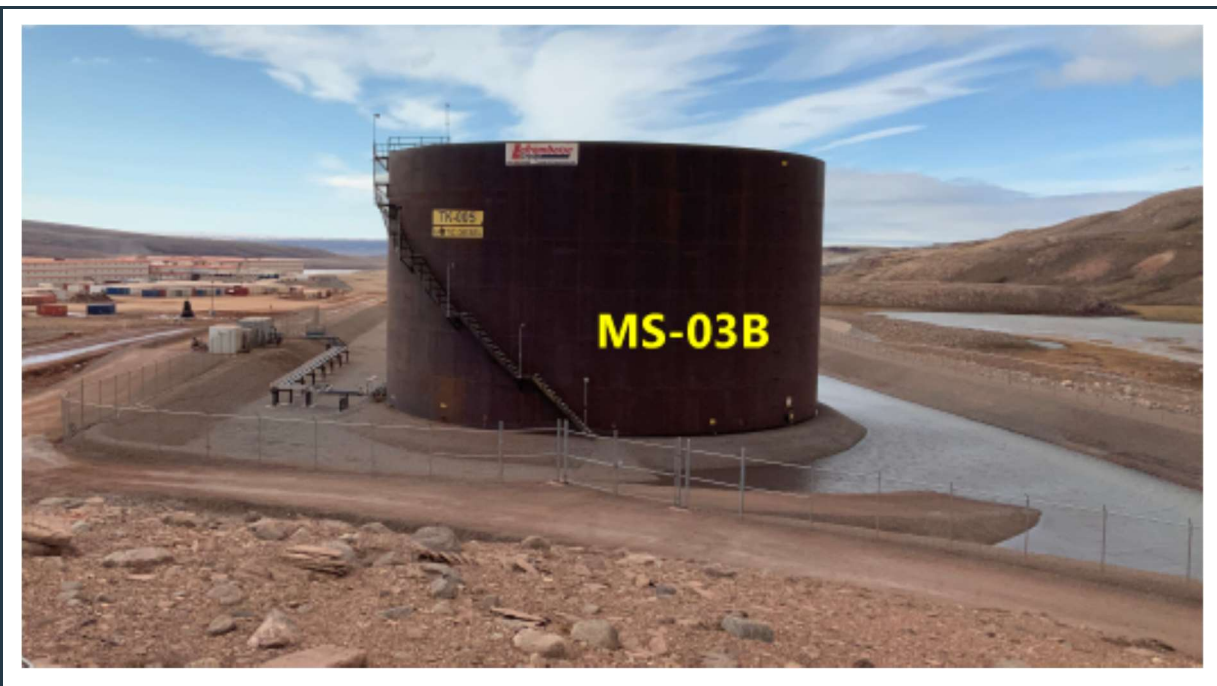
Figure 33: View of the well-maintained stable berms around the new lined fuel tank farm.

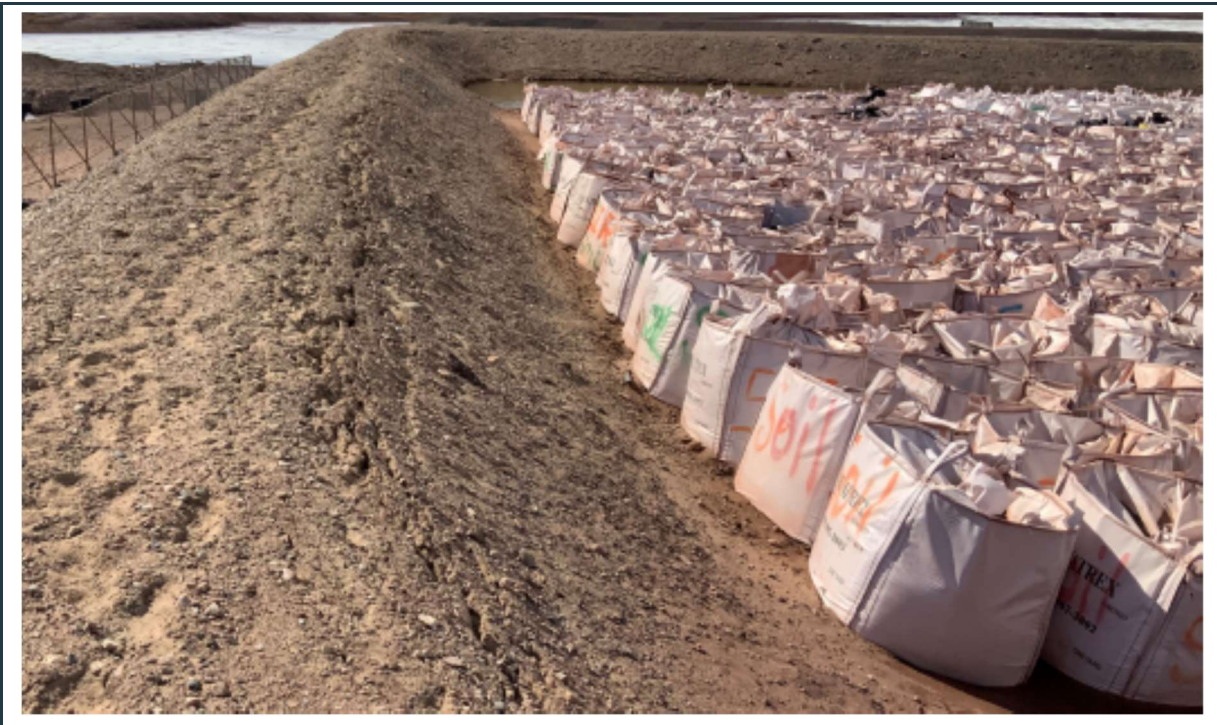
Figure 35 shows a new stable berm constructed around a new non-hazardous waste disposal cell at the facility.

Figure 35: View of stable berms around a new non-hazardous solid waste disposal cell at the landfill facility.

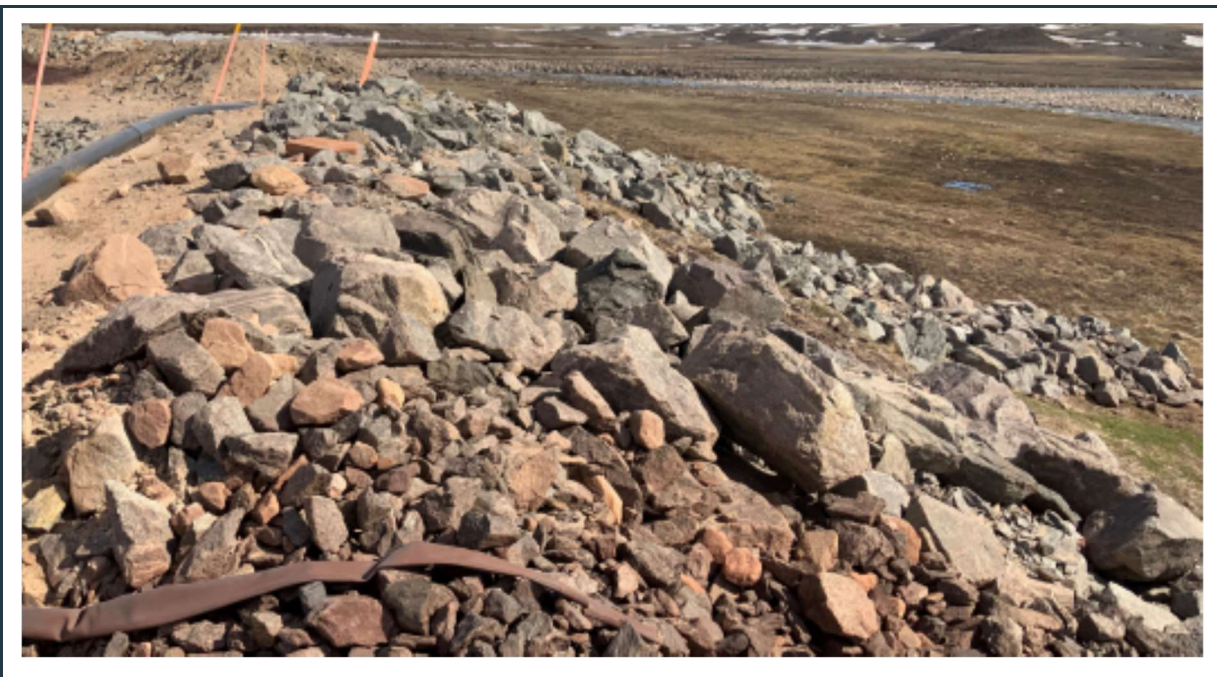
Figure 37: Stable rock fill riprap slope protection at the water discharge area.

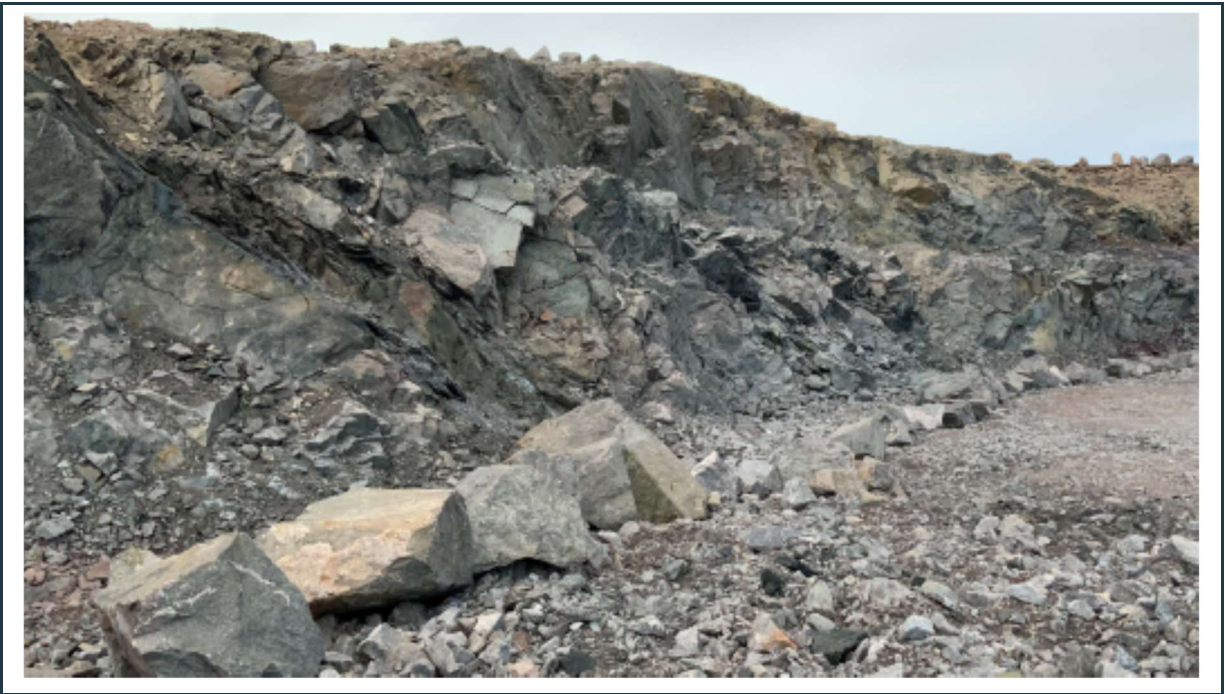
Figure 39: Generally stable rock face at the upper level at the currently unused quarry.

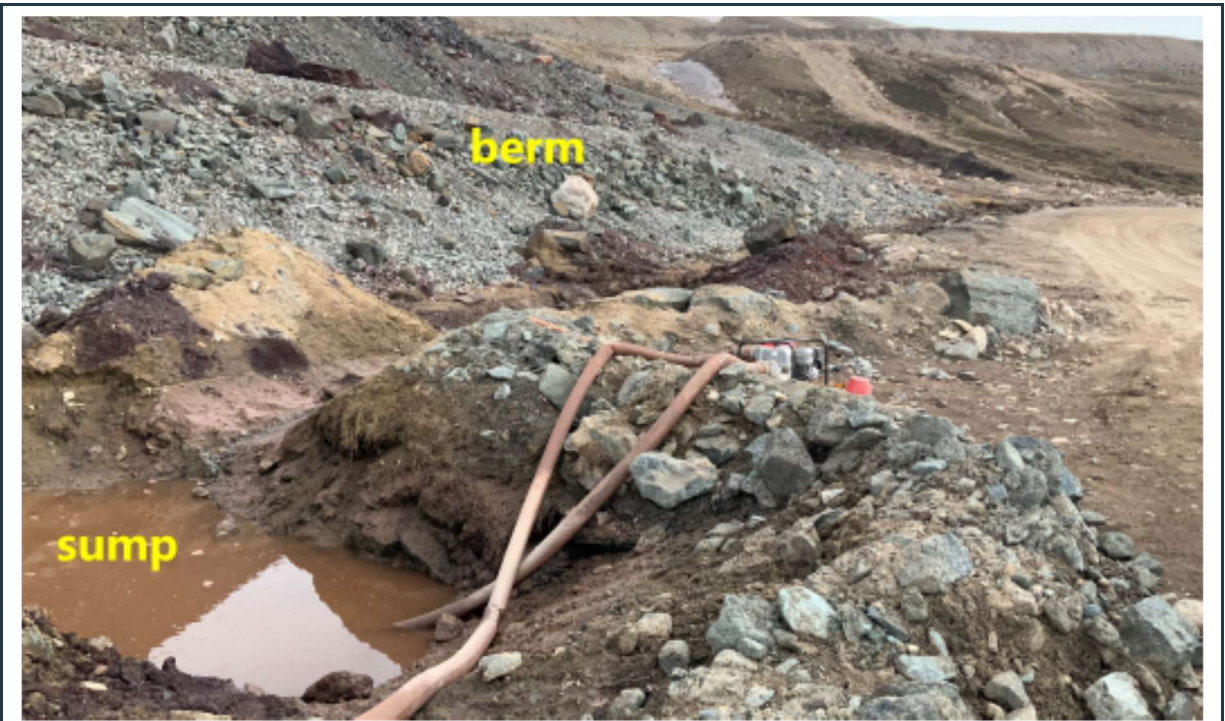
Figure 41: View of a temporary sump pit adjacent to the surface water diversion berm at the KM-106 ore stockpile area. The water from the sump is pumped to the nearby MS-07 pond.

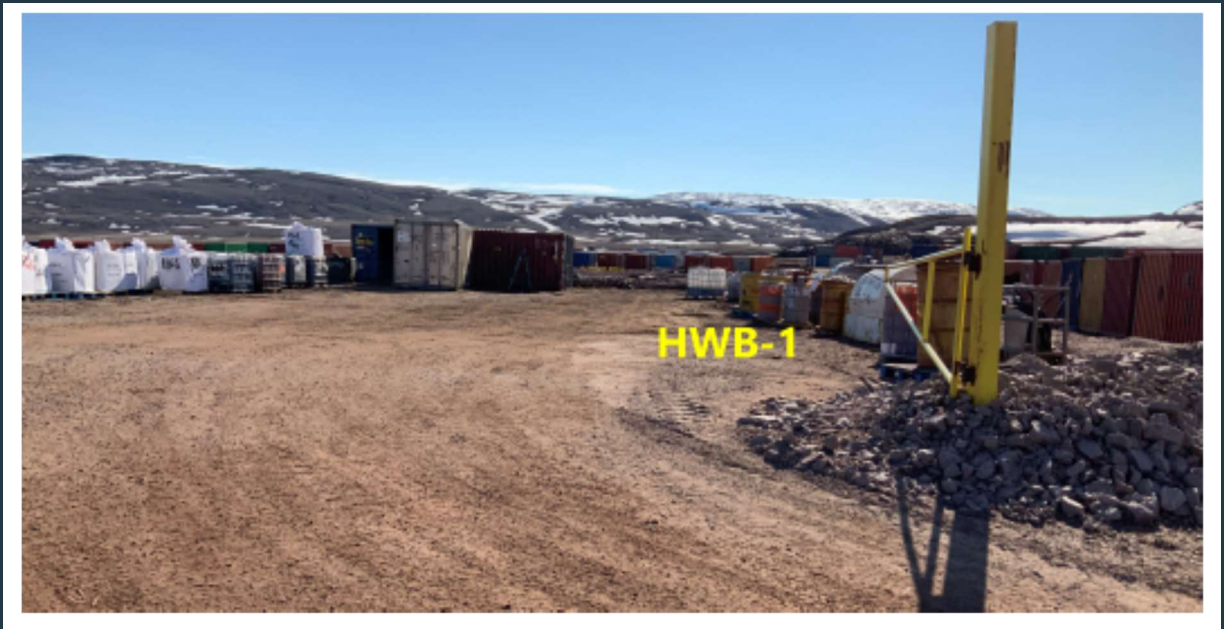
Figure 42: View of the well-maintained HWB-1 cell with stable berms and well protected liner.

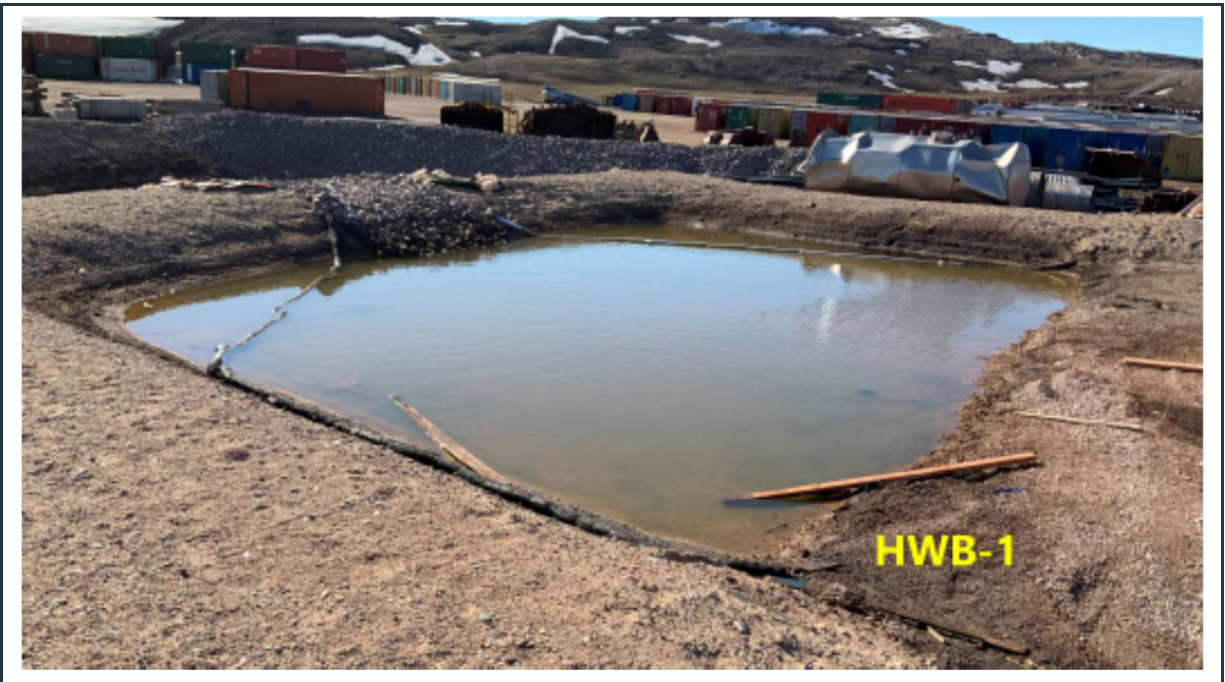
Figure 43: View of the back of the HWB-1 cell, with ponding water and stable spillway.

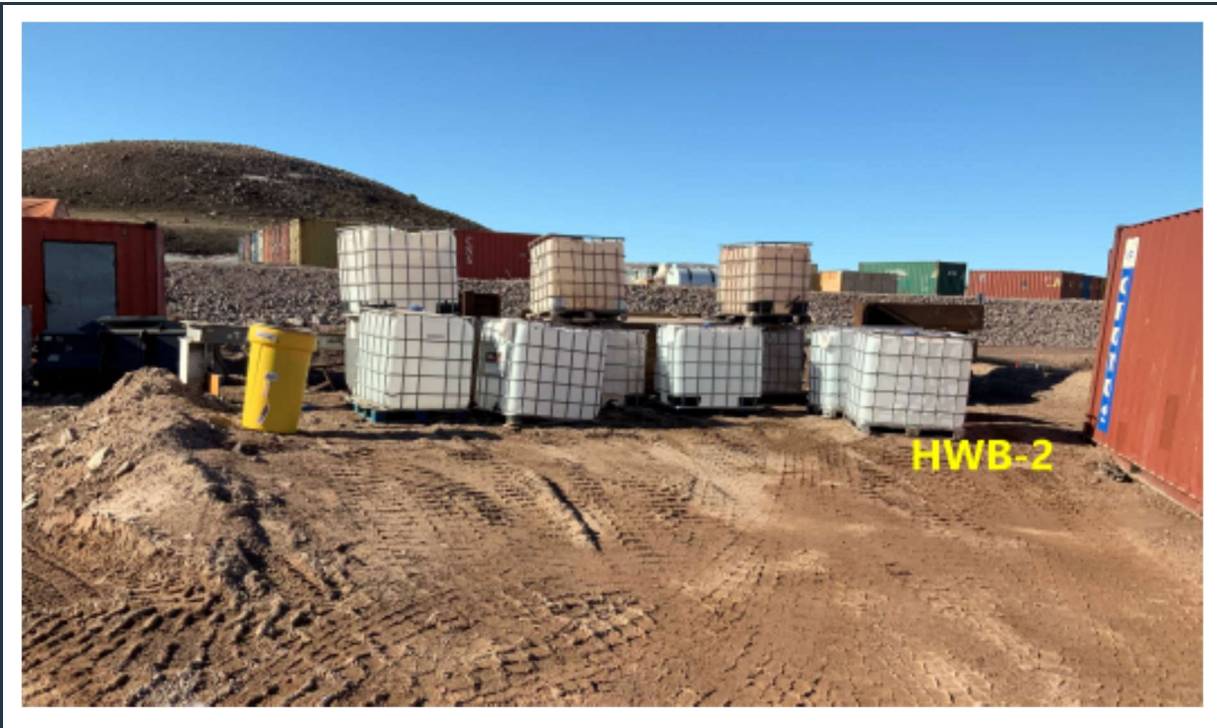
b) HWB-2

Figure 44: View of the former HWB-2 cell, with only empty containers stored on the top of clean sand and gravel fill pad. No hazardous waste is stored in this cell.

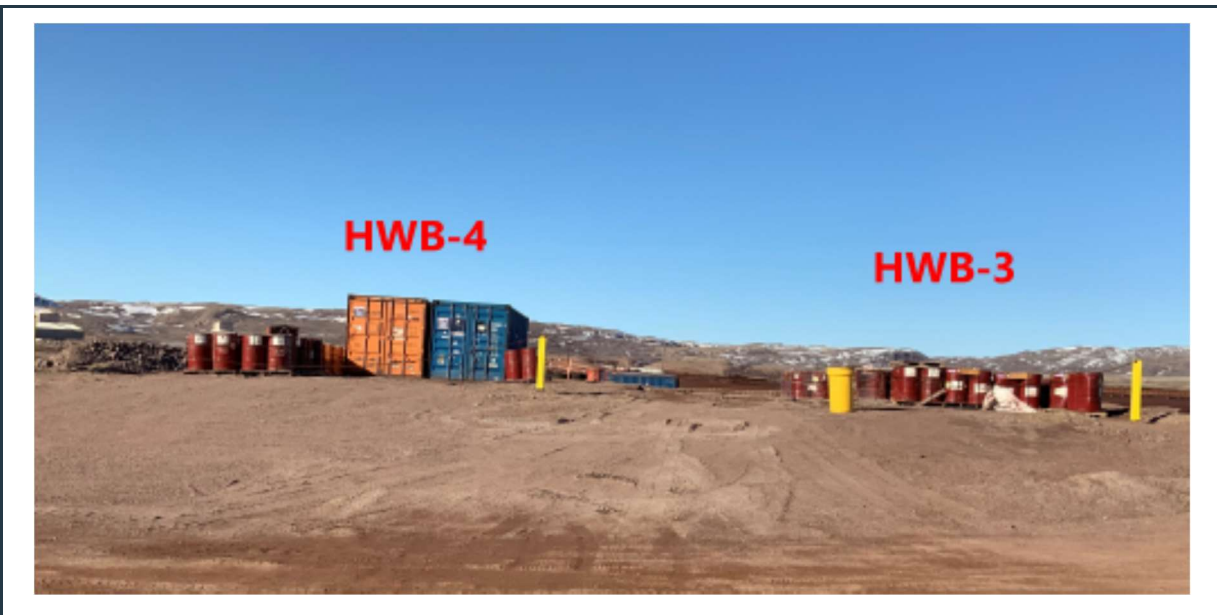
Figure 45: View of the HWB-3 and HWB-4 cells, containing fuel barrels and two shipping containers.

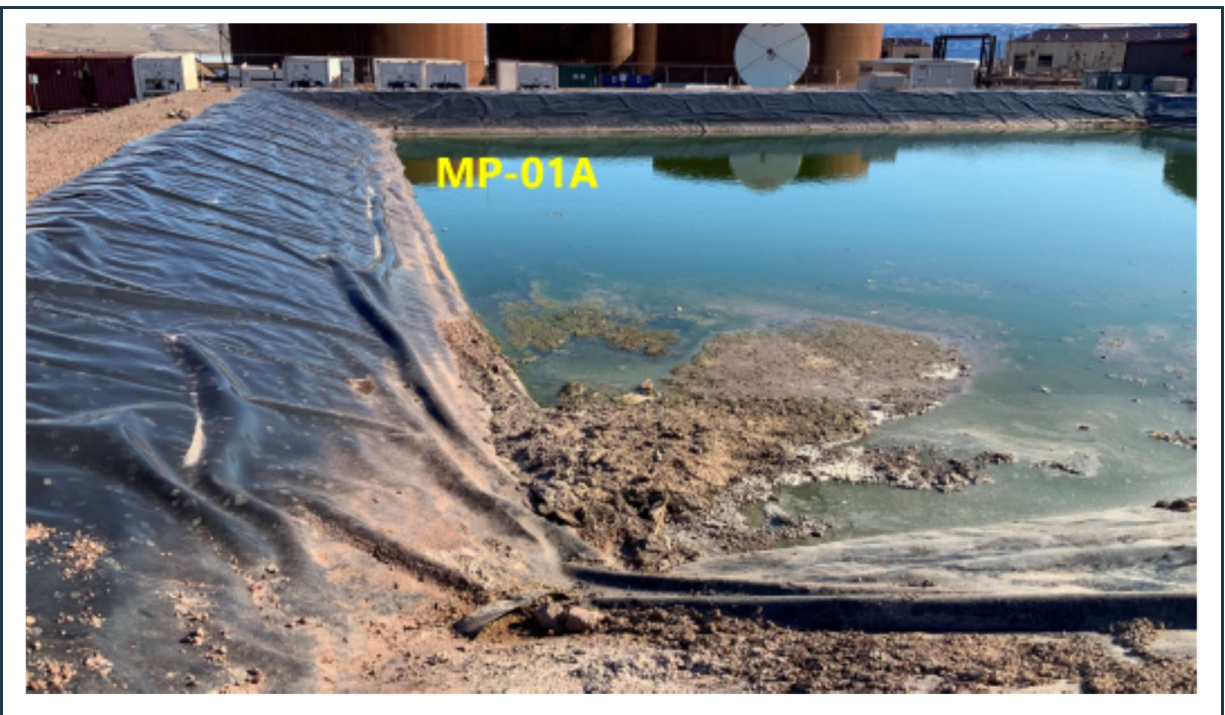
2.2 MP-01A Pond

Figure 47: Berms and liner in good condition with stable slopes around the MP-01A pond.

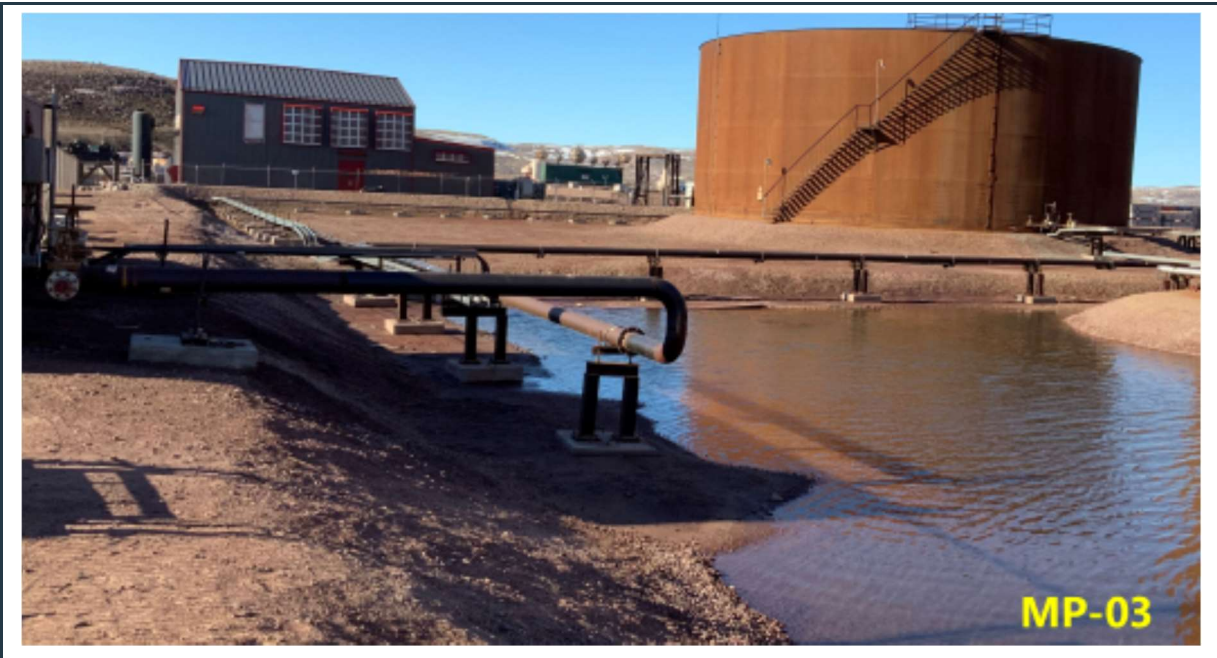
Figure 48: View of the well maintained MP-03 fuel tank farm (ponding clean melted snow in the cell).
