RE: Submission of 2022 Geotechnical Inspection Report No. 1 (June 2022)

Annual Geotechnical Inspections – 2022 Report 1.

Mary River Project – Nunavut

August 21, 2022,
OMGM2212

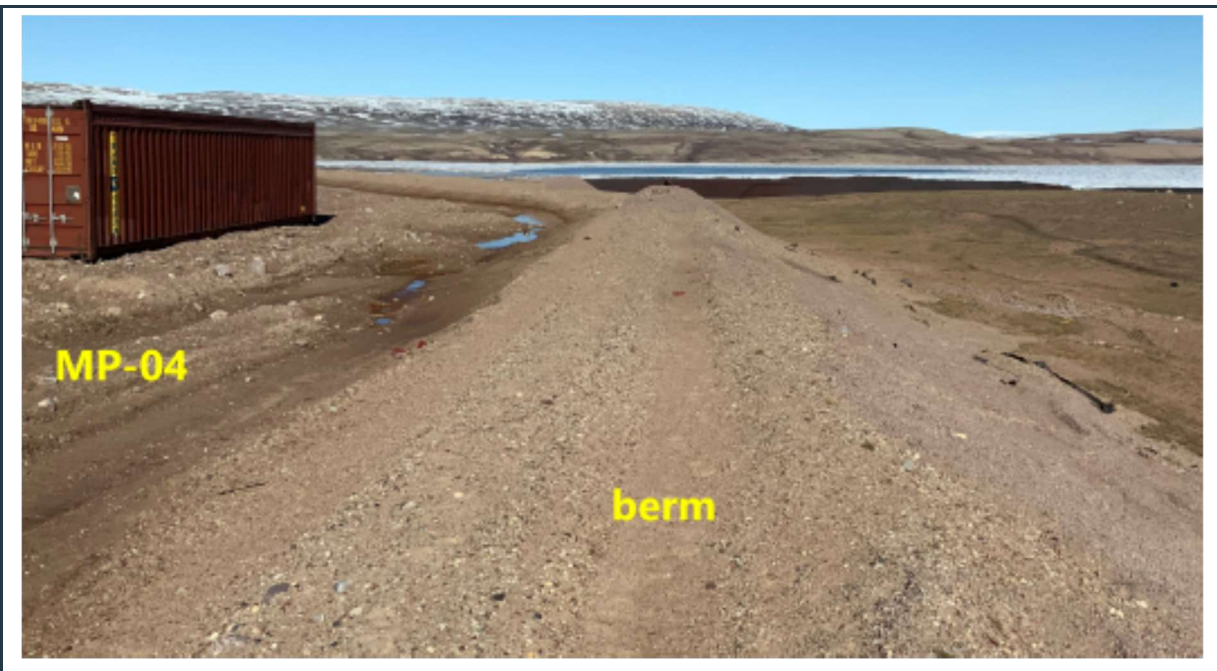
Figure 49: View of stable, robust berms around the MP-04 landfarm, with empty shipping containers stored within the cell.

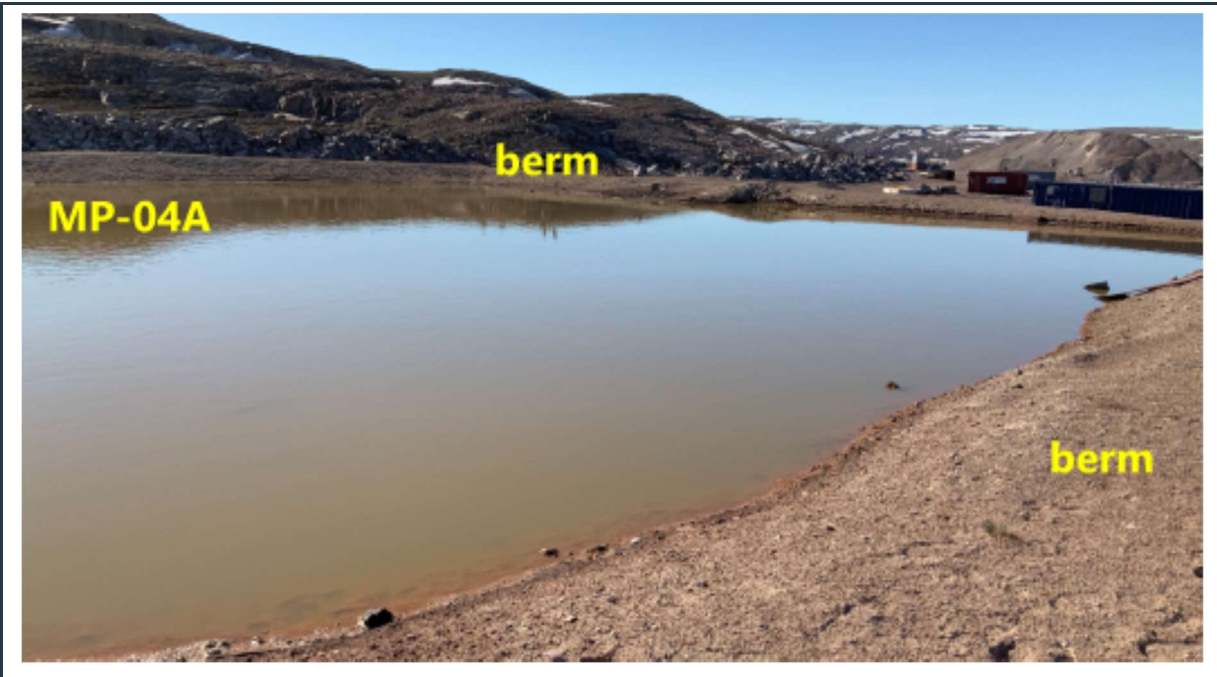
Figure 50: View of the MP-04A cell with stable berms and ponding melted snow.

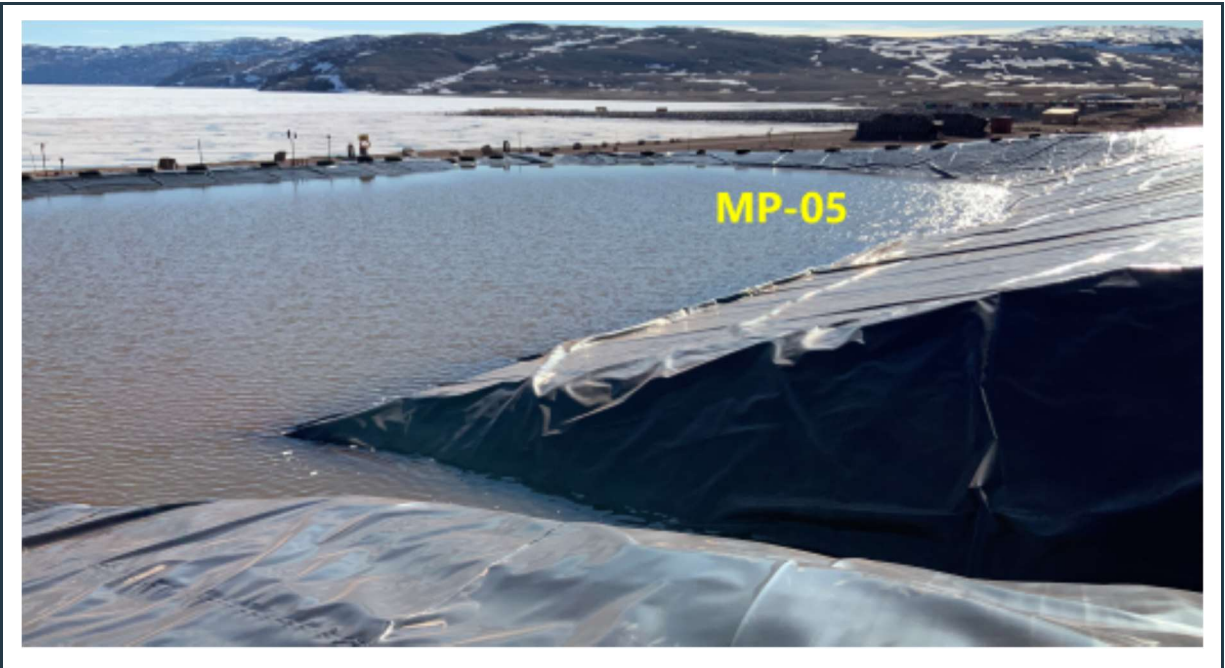
The MP-05 settling pond is located adjacent to the north-east corner of the ore stockpile, while MP-06 was constructed at the north-west corner. Both settling ponds are in excellent condition with stable, well-maintained berms and intact geomembrane liners, as shown in Figures 52 to 56.

No instability, erosion or settlement was noted at the berms of the MP-05 pond and no toe seepage from the pond is visible anywhere around the pond's perimeter berm. Minor liner damage was noted on the west slope of the southern intake channel to the pond during the June 2022 inspection, as shown in Figure 53. It appears that these damages are returning problems on the slopes of the inlet channel, most likely caused by snow clearing equipment during winters. Used tires, weighing down the liner along the crest of the berms, do not cause such damages. As suggested in earlier reports, consideration should be given to place protective berms adjacent to the slope's crest near the inlet channel to prevent potential damages caused by snow clearing equipment.

Figure 52: View of the stable berms and intact liner at the MP-05 settling pond (east of shiploader).

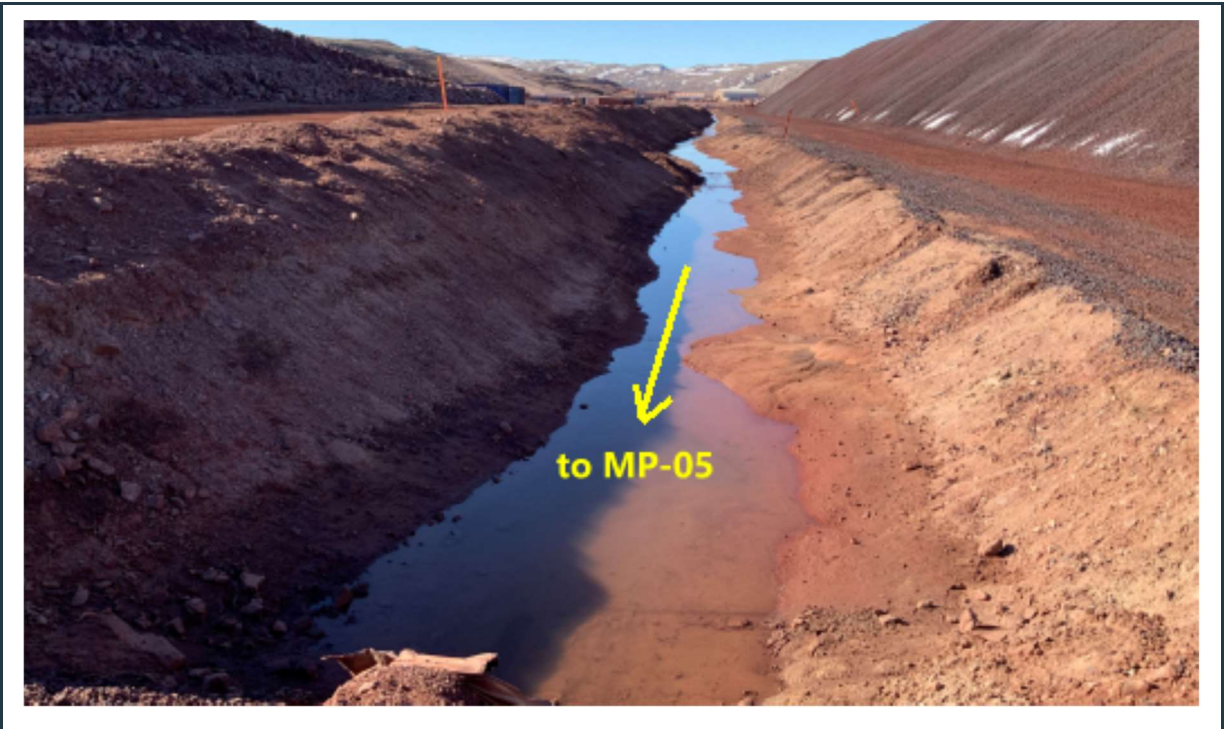
Surface water from around the ore stockpile is collected in well-maintained drainage ditches. The slopes of the drainage ditch leading to the MP-05 pond appeared to be in good condition, as shown in Figure 54.

Figure 54: Surface water collection ditch adjacent (east) to the ore storage, draining to the MP-05 pond.

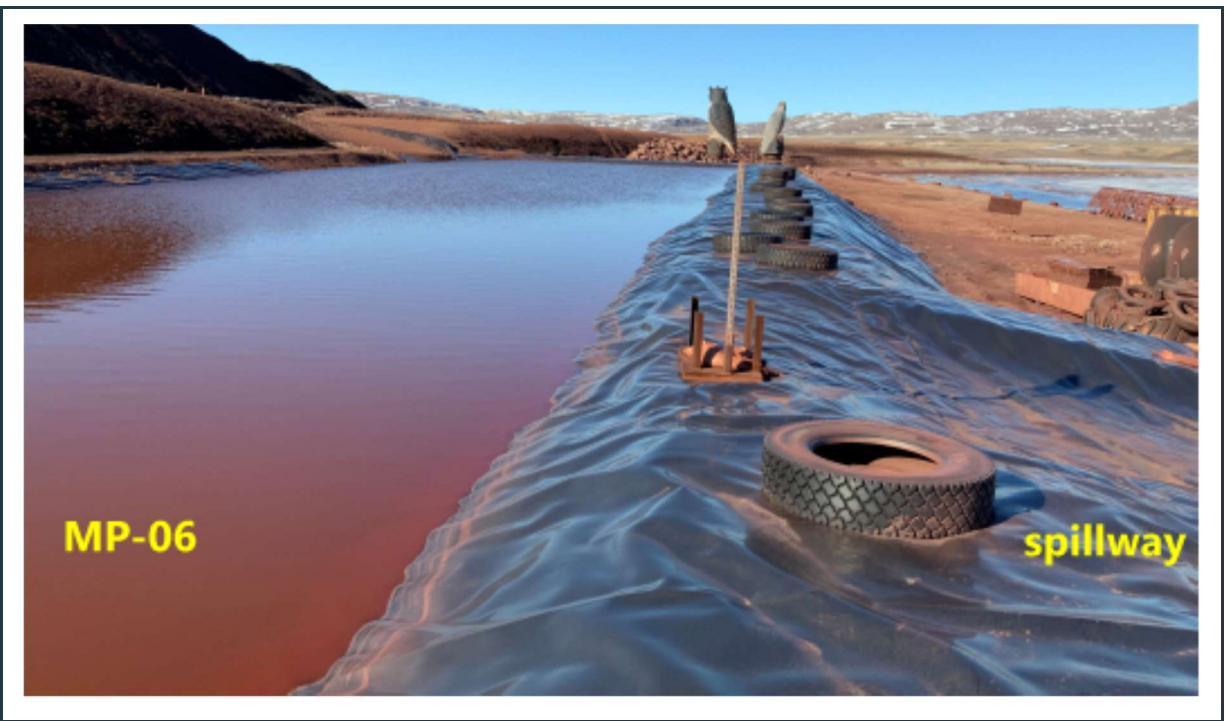
MP-06 is a large settling pond adjacent to the north-west corner of the ore stockpile area, which is divided into two (2) cells by a liner-covered internal berm. The main (south) part of the pond is identified as MP-06 and is shown in Figure 55 and the northern cell is called the "overflow pond" MP-06A, as shown in Figure 56. The liners in the ponds appear to be intact. Both settling ponds have emergency spillways and the water level in both ponds was below the spillway inverts at the time of the June 2022 inspection. The robust berms around the ponds are in good condition, and no seepage was noted from the cells indicating good liner performance.

Figure 55: View of the lined MP-06 pond with robust, stable berms and spillway.

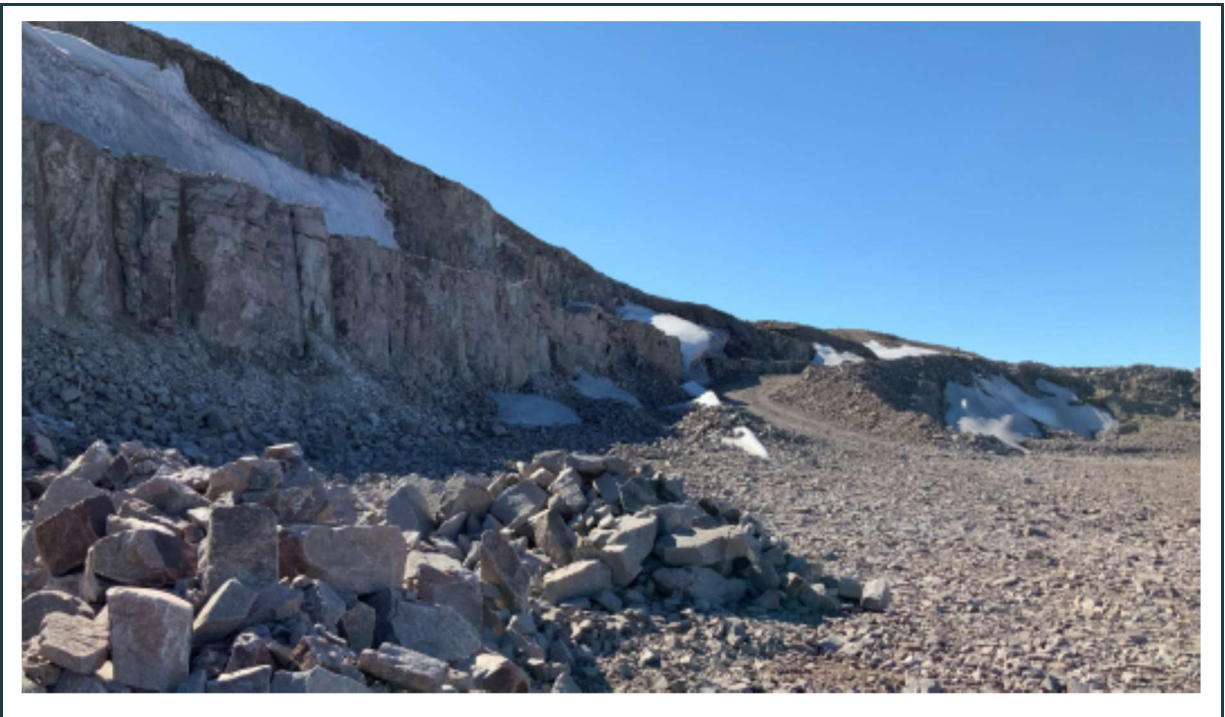
No activity was noted in the Q01 rock quarry at the time of the inspection. The rock slopes in the quarry appeared to be in stable condition and were covered with snow in some areas, as shown in Figure 57.

Figure 57: View of stable rock face with minor weathering and erosion in the Q01 rock quarry. The quarry is currently not in operation.

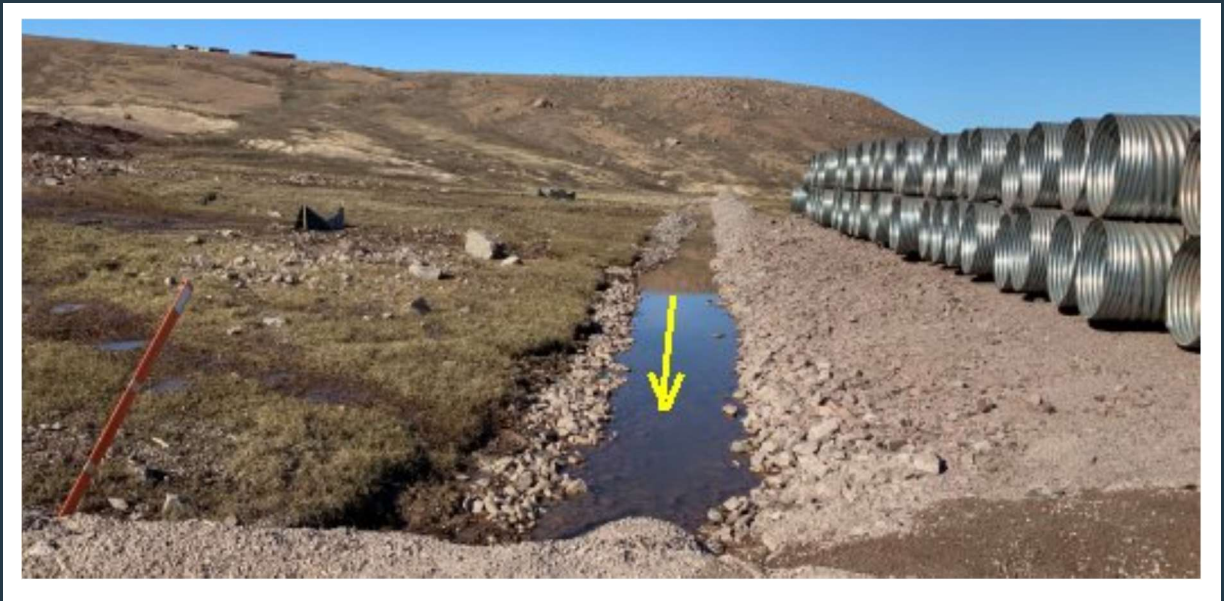
As noted during previous inspections and still visible this year, sloughing of the sides of the P-SWD-3 ditch, adjacent to the LP2 laydown area, has occurred at several locations along the ditch, as shown in Figure 58 and Figure 59. It is evident that the sloughing of the ditch's slopes is a direct result of uncontrolled sheet-flow of surface water (melting snow from the adjacent snow stockpile), continuously flowing into the ditch during freshet that is not able to convey the collected water to the designed discharge location to the north. The main cause of this problem is that the invert level of the ditch at its designed discharge-end is higher than the invert along the rest of the ditch. As previously recommended, the existing condition of the P-SWD-3 drainage ditch and adjacent topography should be re-evaluated, and the ditch should be redesigned and reconstructed to drain the large amount of surface water to the correct direction to the north. It is also suggested that the snow stockpile be relocated to the north (from the area of the red circle in Figure 6, to the area marked by the green circle) or to another suitable location away from the immediate vicinity of the P-SWD-3 ditch.

Figure 58: View of the "P-SWD-3 surface water collection ditch with ponding water and unstable slopes.

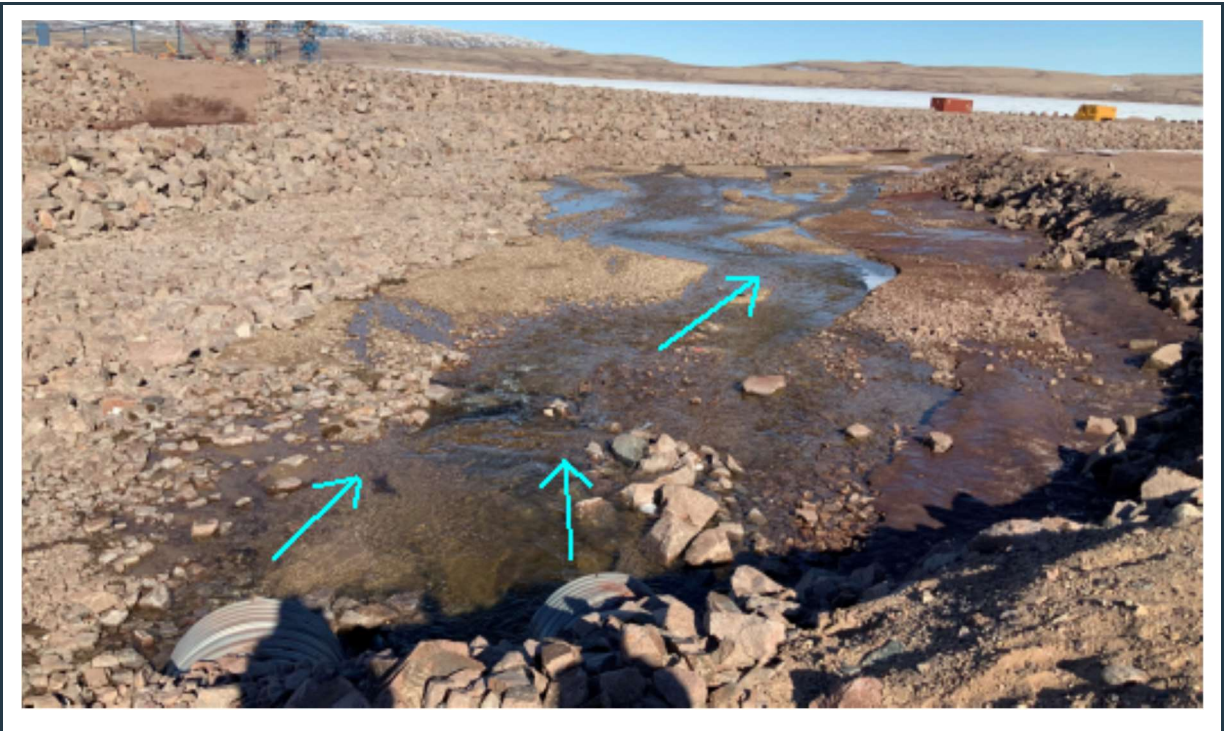
The P-SWD-7 drainage ditch and twin culverts are in good condition, as shown in Figure 63 and Figure 64.

Figure 64: View of the P-SWD-7 surface water collection ditch and culverts (outlet).

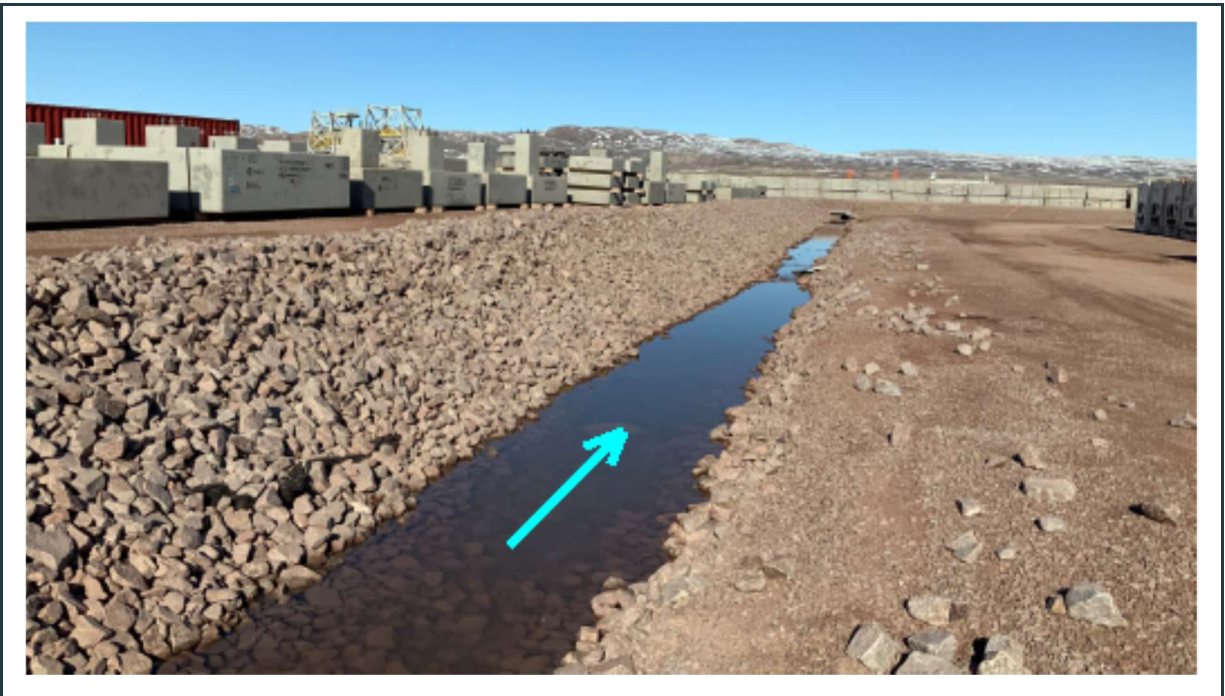
Both the east and south sections of the 380M drainage ditch are in good condition, as shown in Figure 66 and Figure 67.

Figure 66: View of the south section of the 380 M surface water collection ditch in good condition.

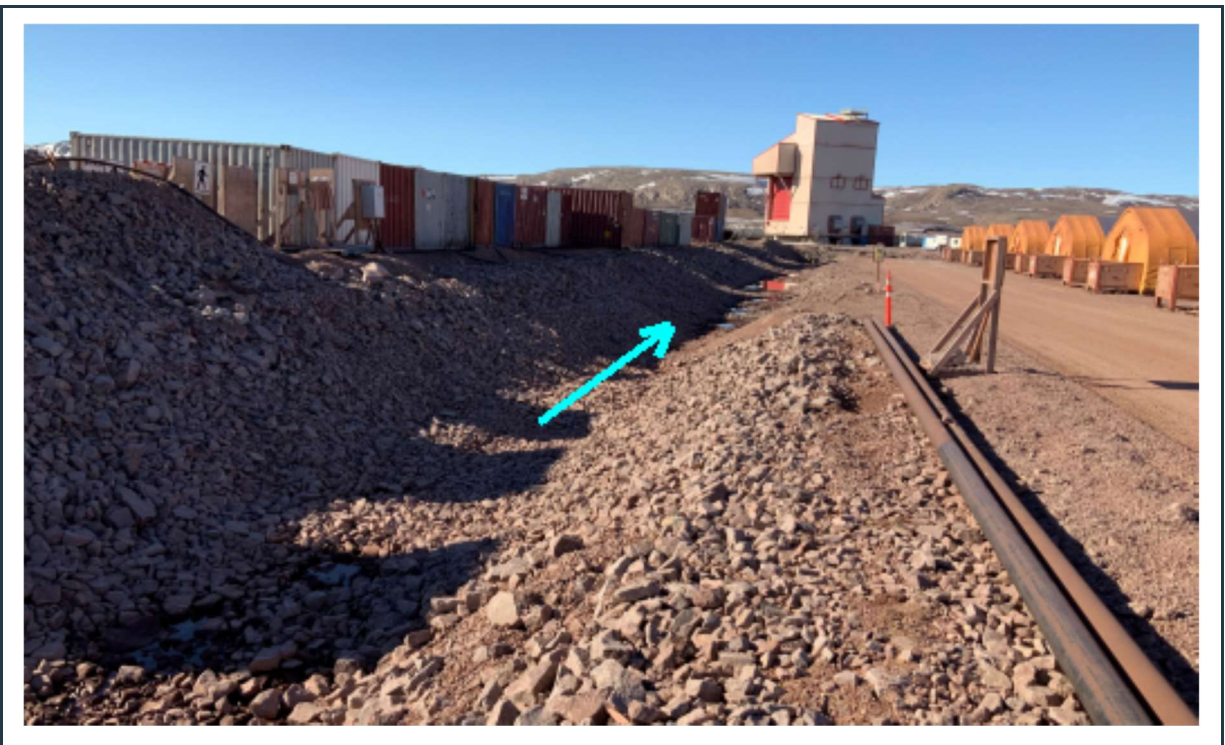
Figure 67: View of the east section of the 380 M surface water collection ditch in good condition.

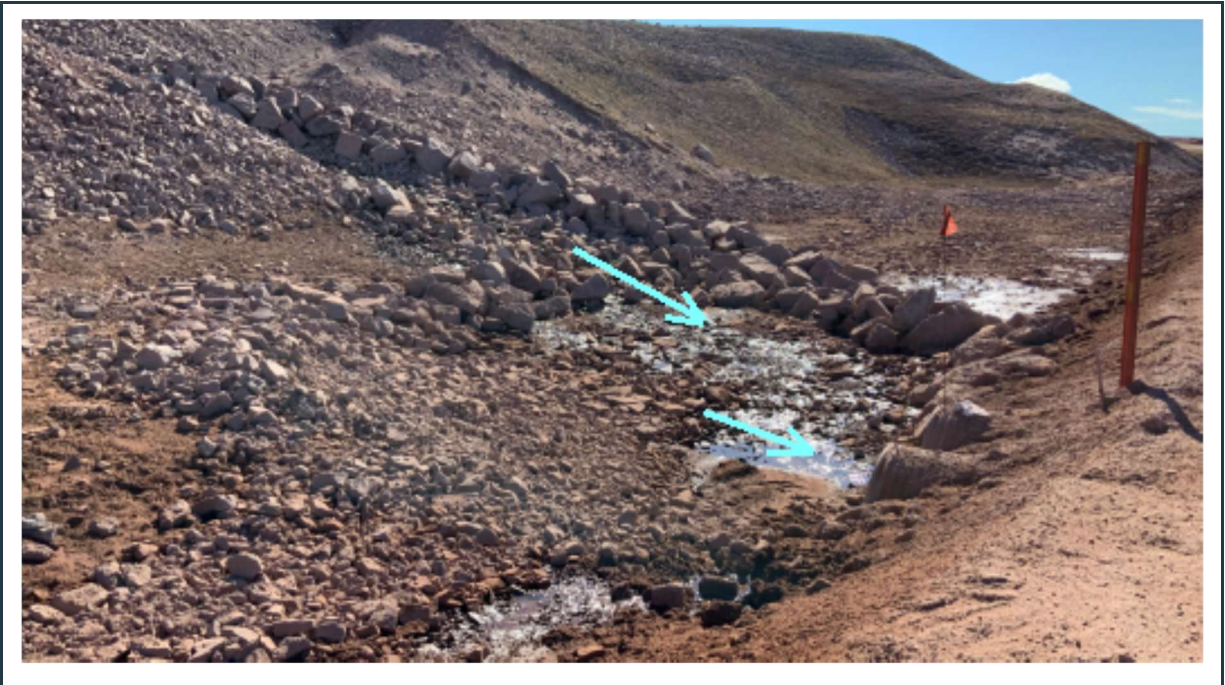
As noted above, surface water from the drainage ditch P-SWD-6 is conveyed down the slope through corrugated galvanized steel culverts, installed under an internal haul road adjacent to the rock quarry and then under the Tote Road (Figure 70 and Figure 71). The water in the ditches is conveyed through

Figure 70: View of twin culverts' inlet, draining surface water from the P-SWD-6 - "Q01 South" surface water collection ditch.

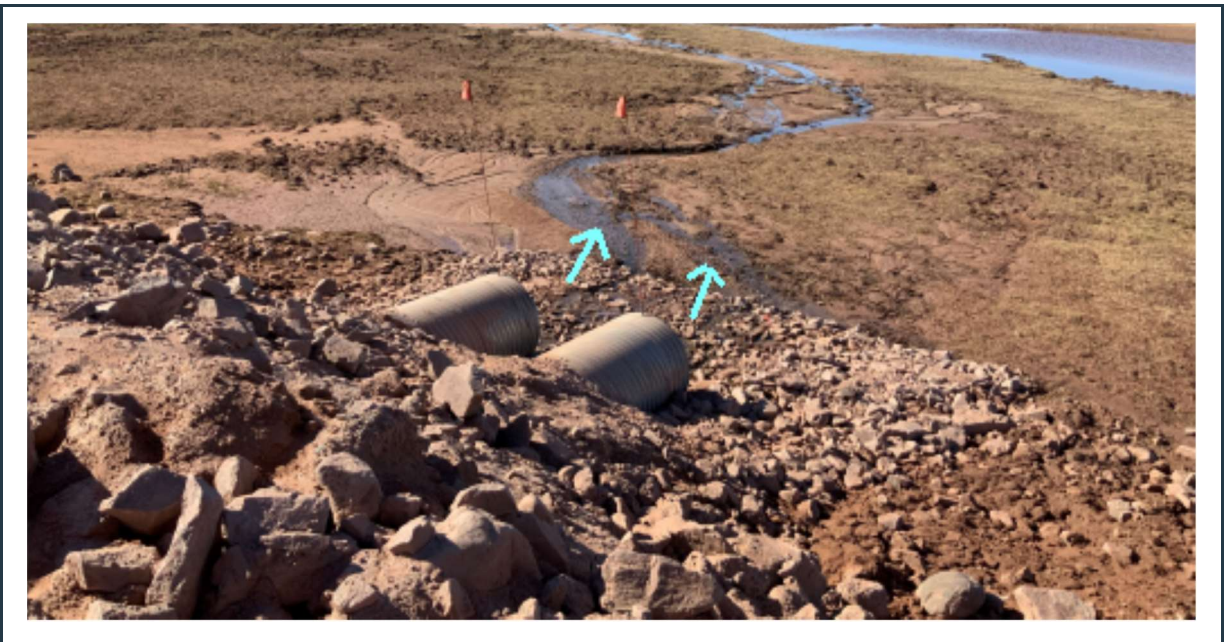
Figure 71: View of twin culverts installed under the tote road, draining surface water from the quarry area (outlet).
