PROJECT	AGNICO EAGLE MINES LIMITED MEADOWBANK GOLD PROJECT NUNAVUT				
TITLE	PG 28AUG14 EAST DIKE - SECTION 60+490 PIEZOMETRIC DATA (Aug 1/17 to Aug 1/18)

APPENDIX C2

P4– CENTRAL DIKE UPDATE

CENTRAL DIKE UPDATE 2018

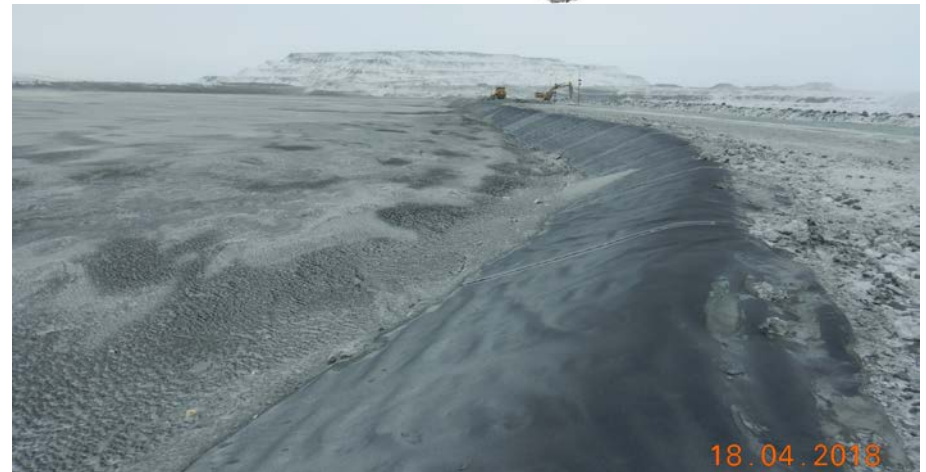
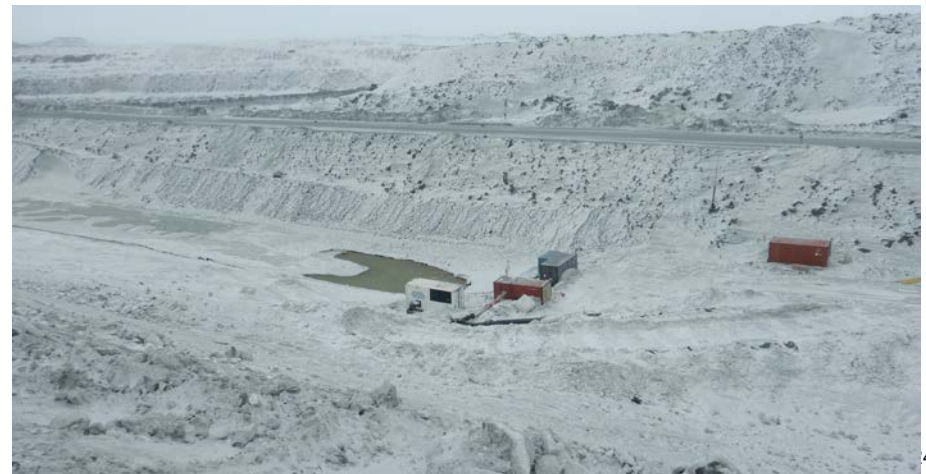
APRIL 2018

Construction started at the end of April, deposition points were removed

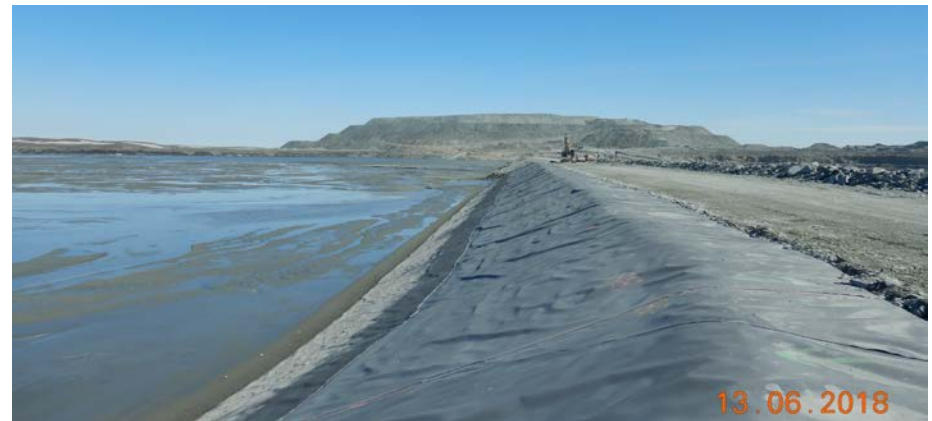
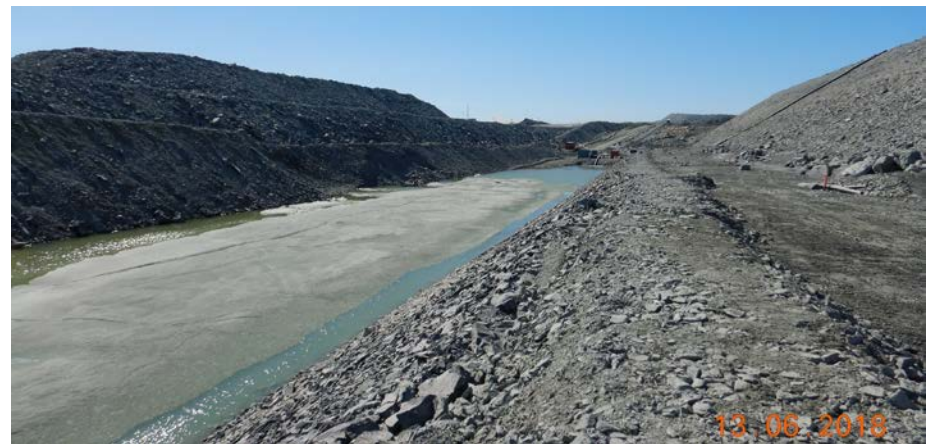
JUNE 2018

Deposition points were reinstalled

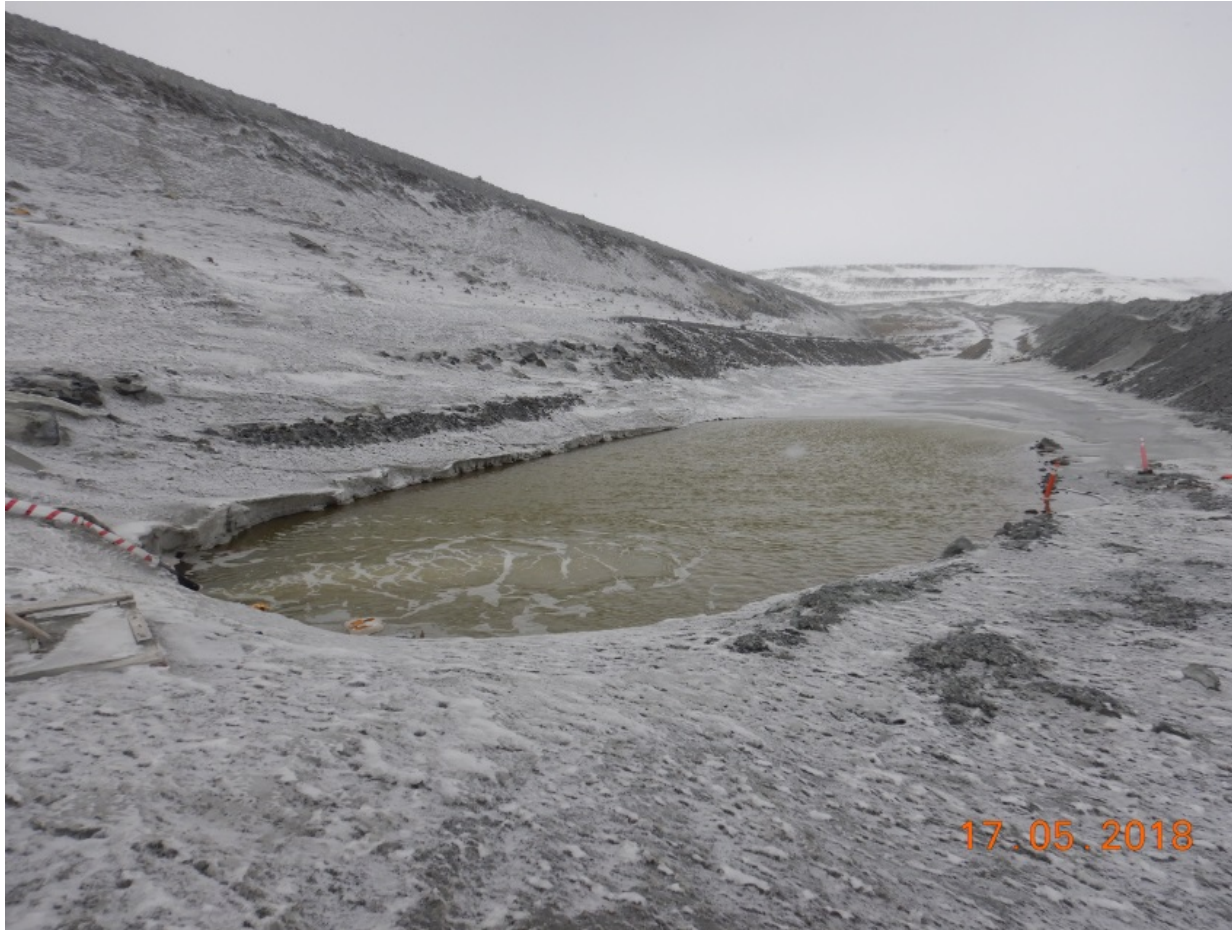
May 17th, 2018

Monthly Photo of D/S Pond Coloration

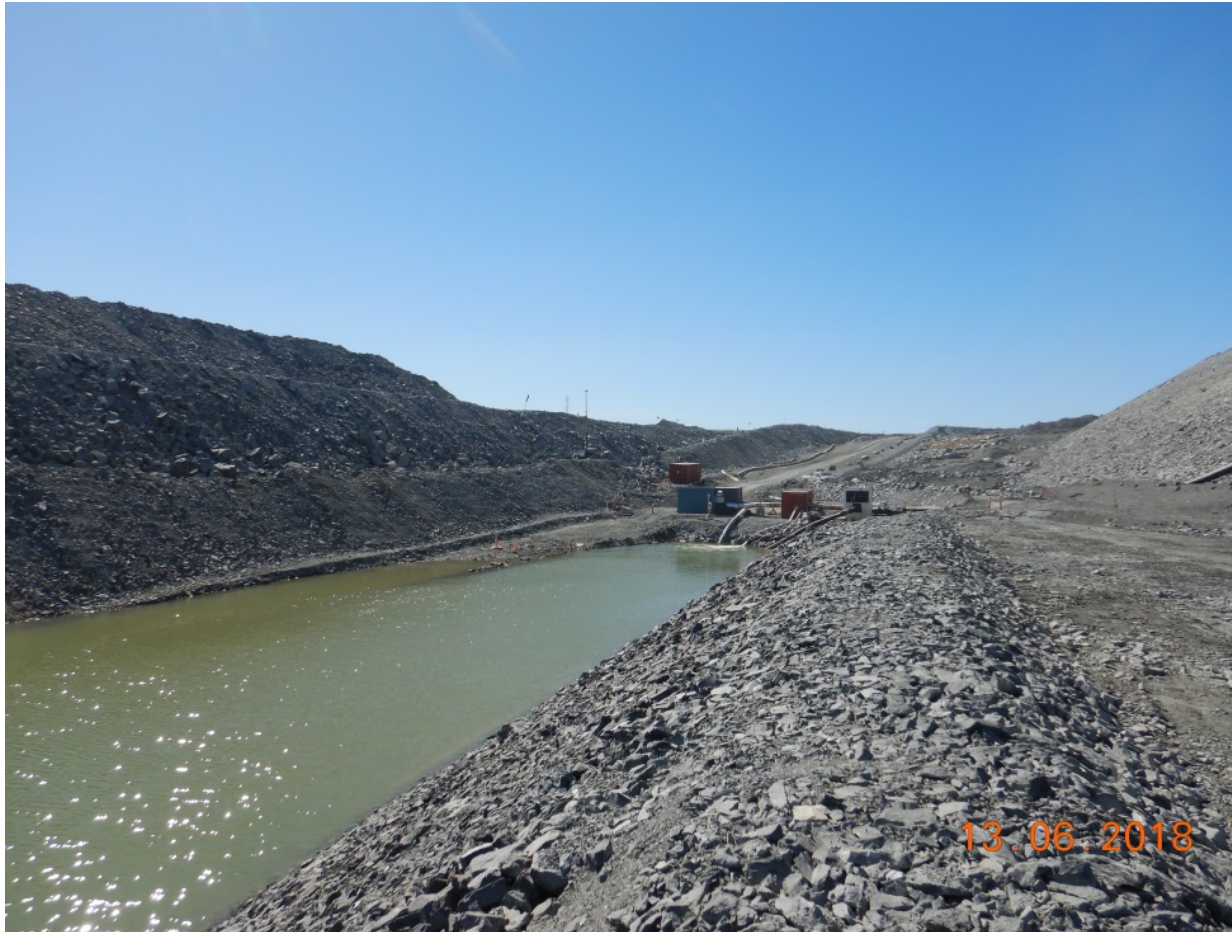
June 13th, 2018

Monthly Photo of D/S Pond Coloration

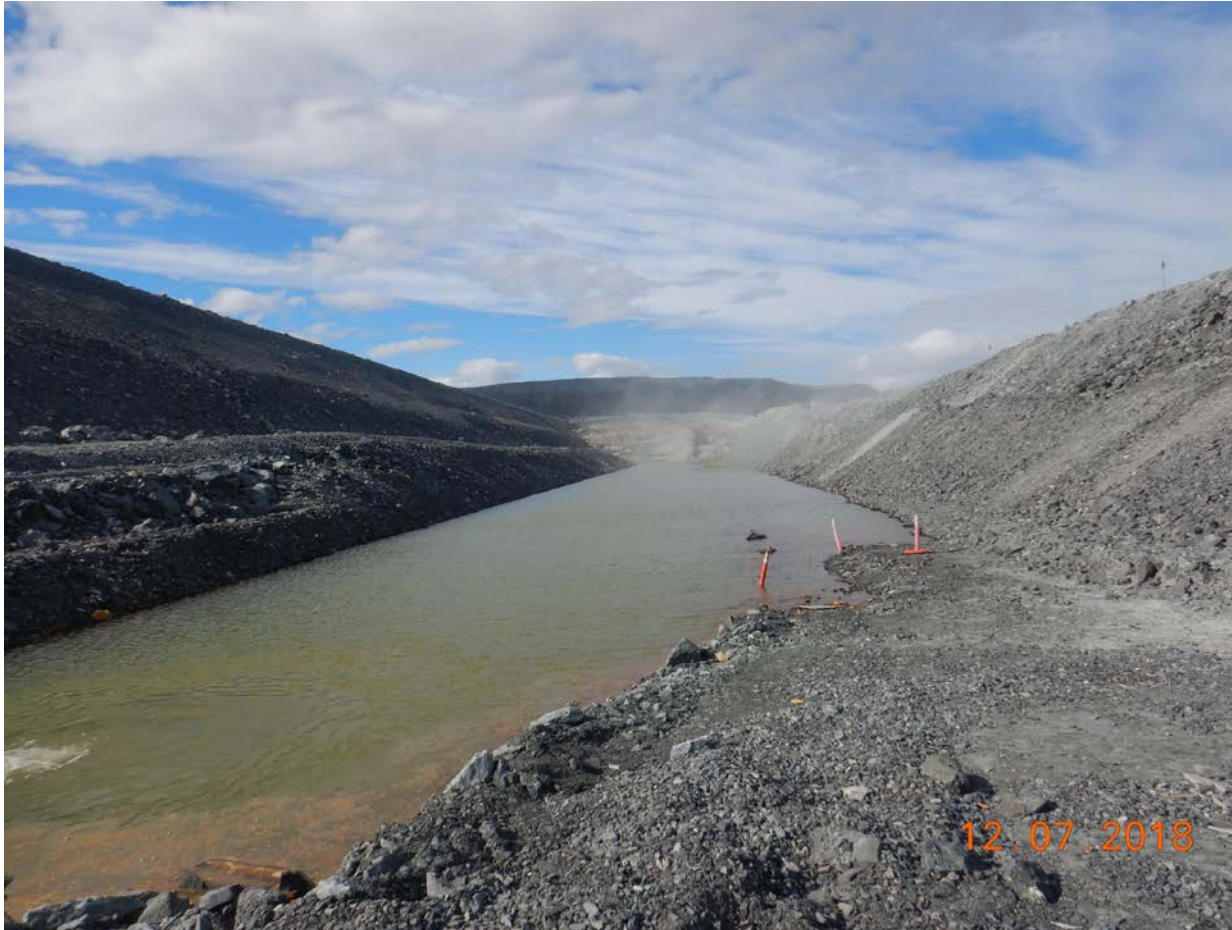
July 12th, 2018

Monthly Photo of D/S Pond Coloration

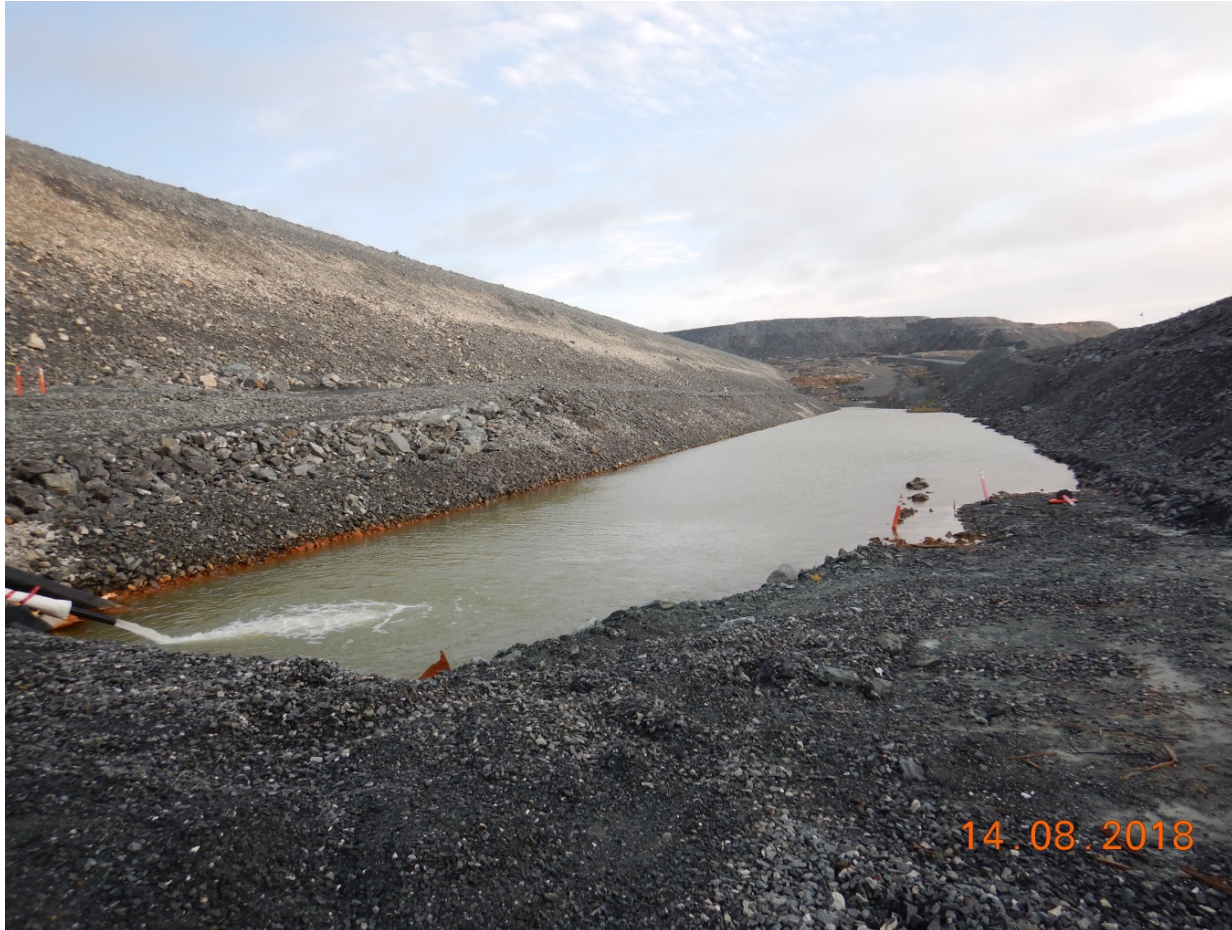
August 14th, 2018

Monthly Photo of D/S Pond Coloration

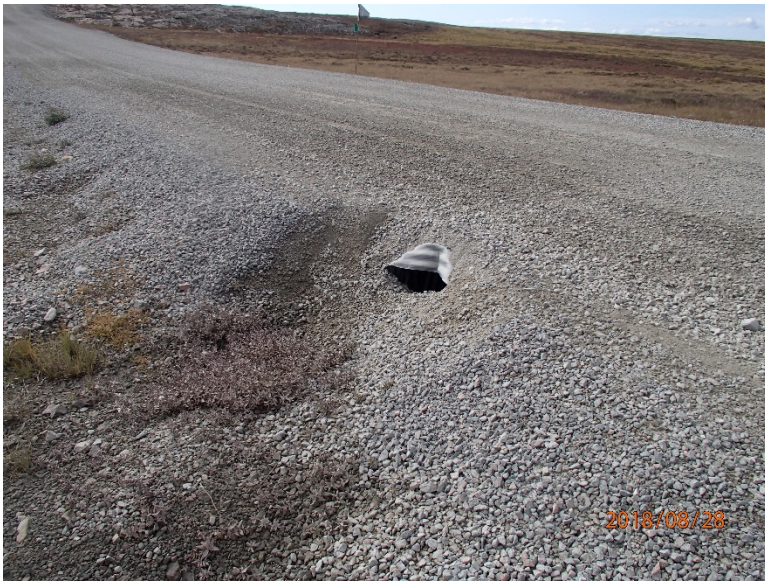
Photograph D1-1: unnamed km 5+700

Description: View of the culvert inlet. Good condition, inlet is short in length as the road rolling surface is at the edge of the inlet.

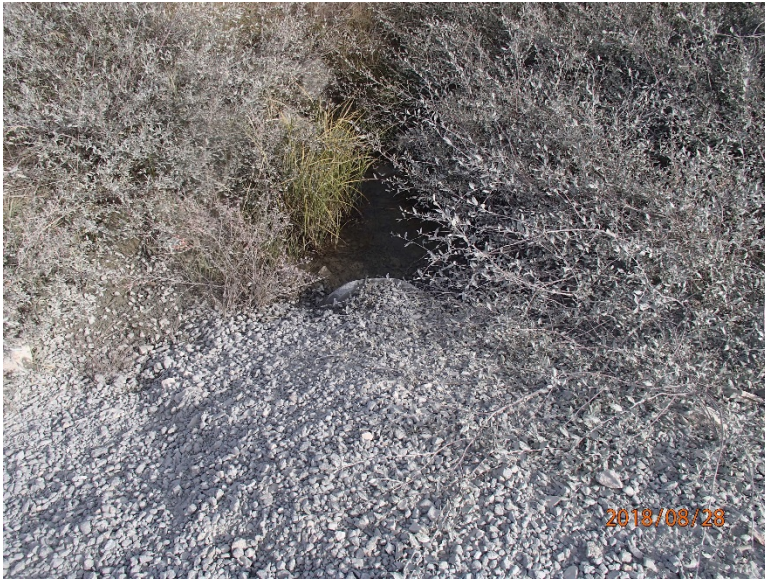
Photograph D1-13: PC-11 km 39+552

Description: View of the culvert outlet. In good condition, almost submerged.

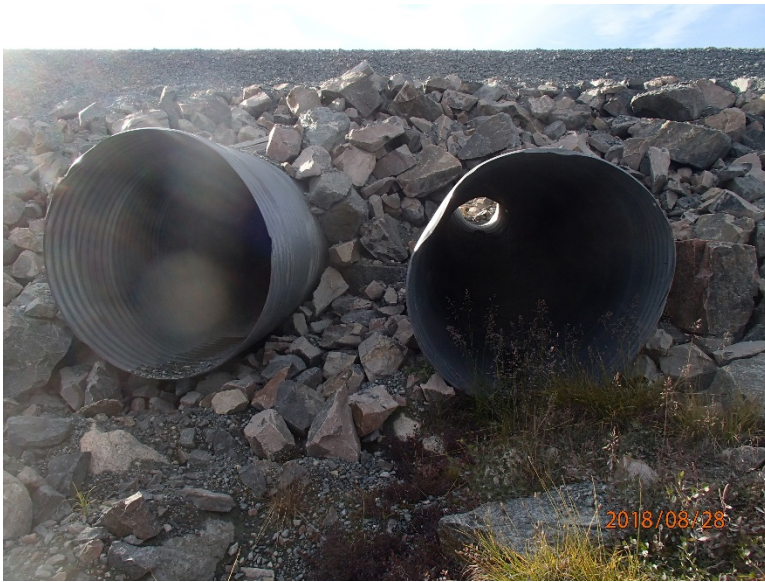
Photograph D1-25: R-24 km 98+100

Description: View of the culverts outlet. Both outlets are installed too high. The outlet of the southern culvert (left) shows signs of erosion. Both culverts show deformation in the upper part.

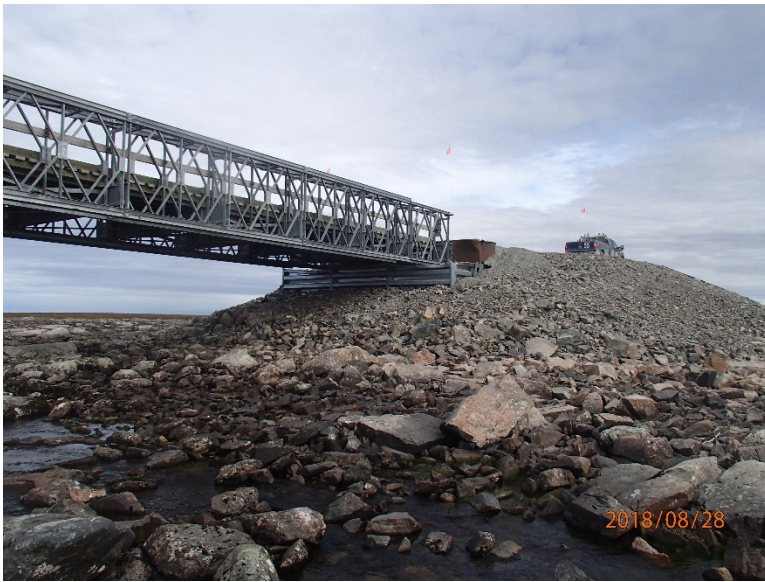
Photograph D2-1 Bridges 1 – R02 km 8+750

Description: Looking at the north abutment.

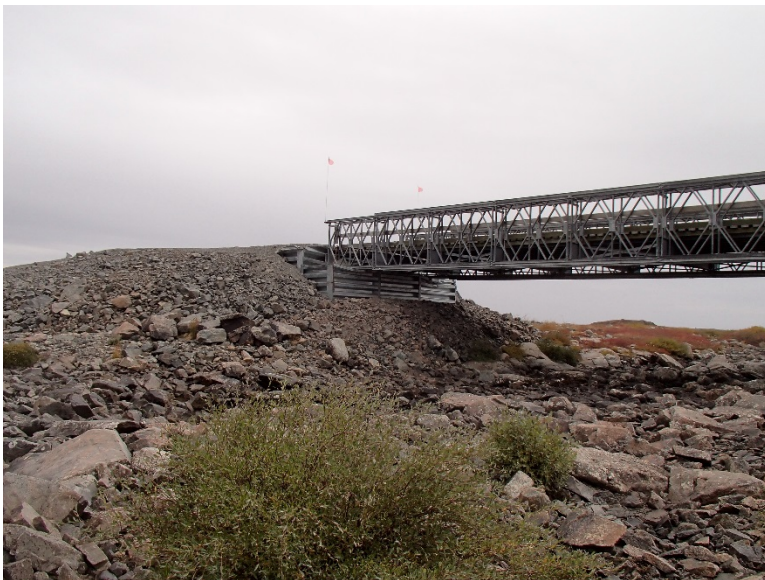
Photograph D2-2 Bridges 1 – R02 km 8+750

Description: Looking at the south abutment.

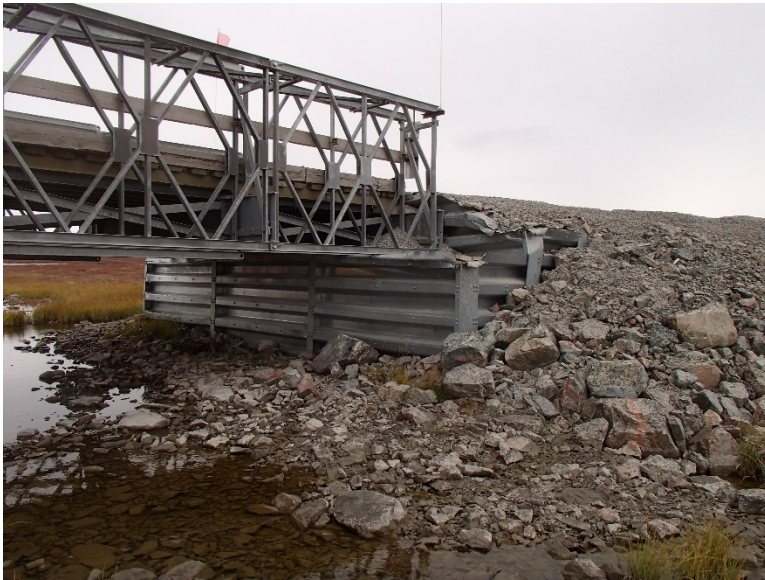
Photograph D2-3 Bridges 2 – R05 km 17+600

Description: Looking at the north abutment.

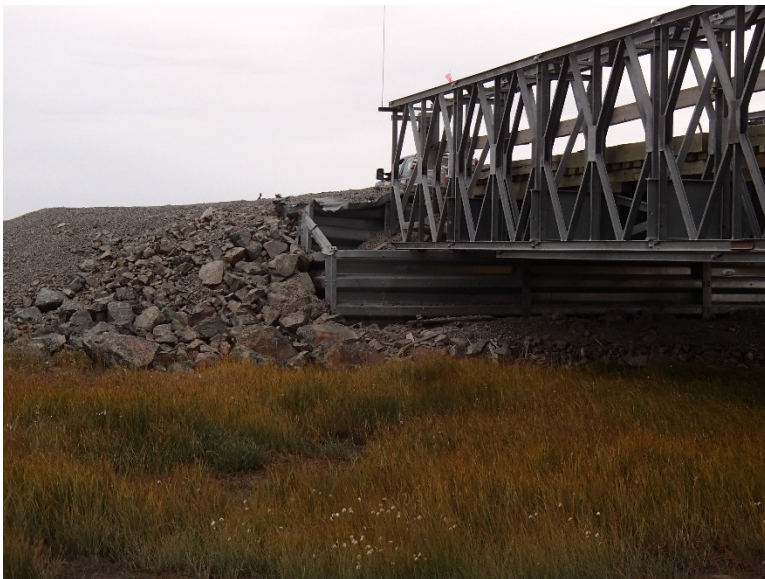
Photograph D2-4 Bridges 2 – R05 km 17+600

Description: Looking at the south abutment. Minor damage to the bin wall.

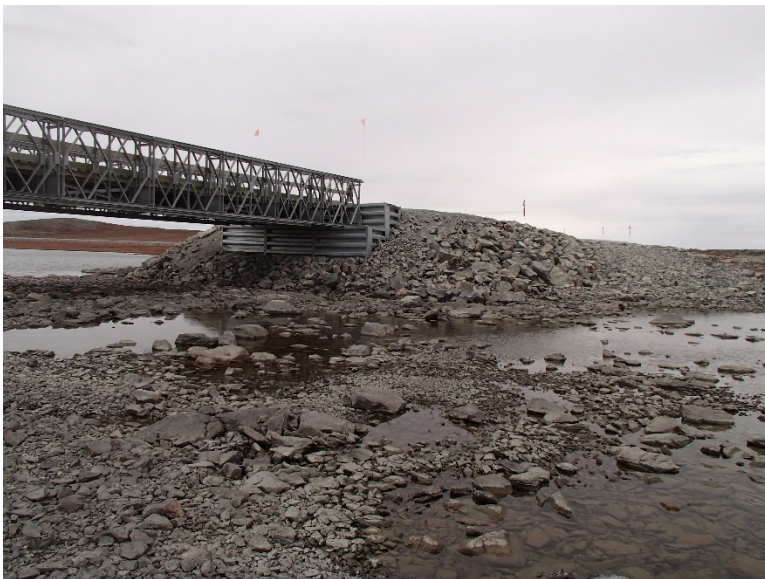
Photograph D2-6 Bridges 3 – R06 km 23+100

Description: Looking at the south abutment.

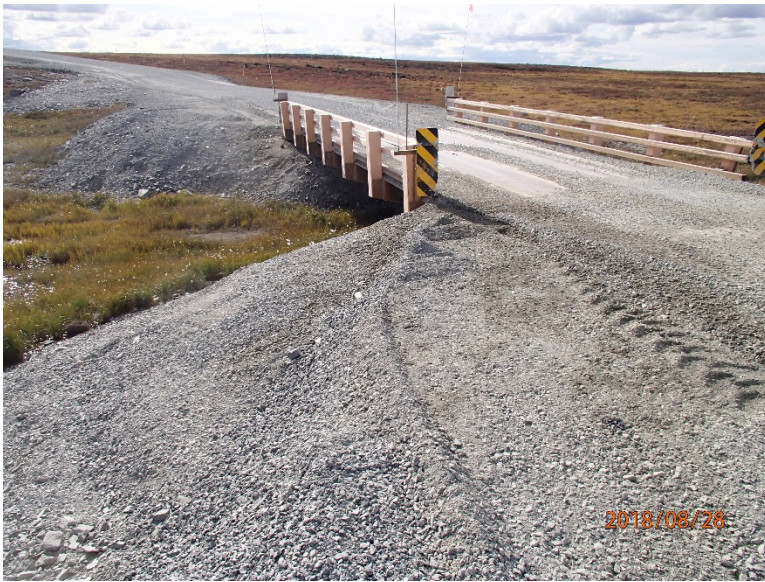
Photograph D2-7 Bridges 5 – R13 km 62+060

Description: Looking at the bridge from the south abutment.

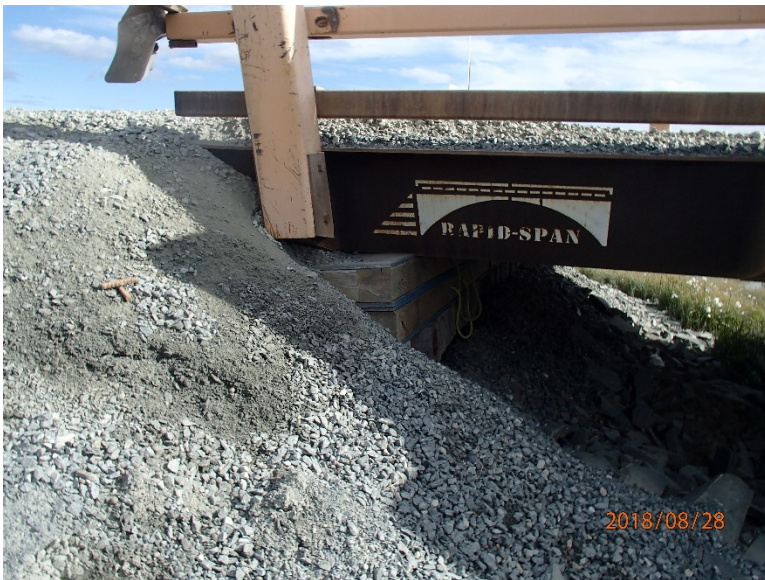
Photograph D2-8 Bridges 5 – R13 km 62+060

Description: Looking at the bridge (north abutment).

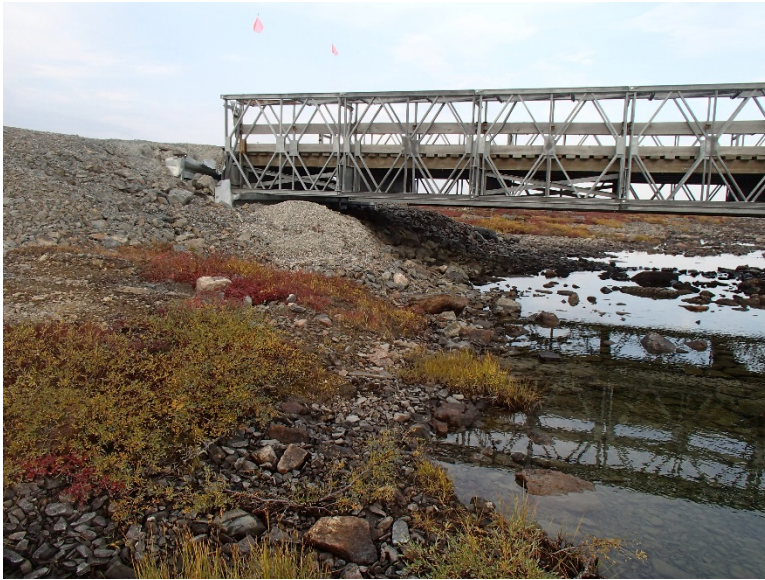
Photograph D2-9 Bridges 6 – R15 km 69+200

Description: Looking at the south abutment. Damage to the bin wall likely caused during snow removal activities. Bridge is tipping toward the west side on the abutment.

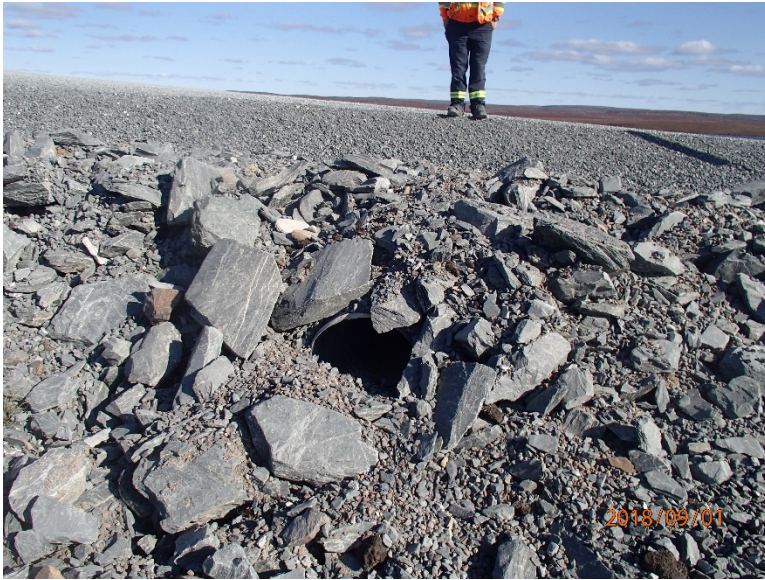
Photograph E1-1: Culvert #66 km 16+324

Description: View of culvert inlet, half buried.

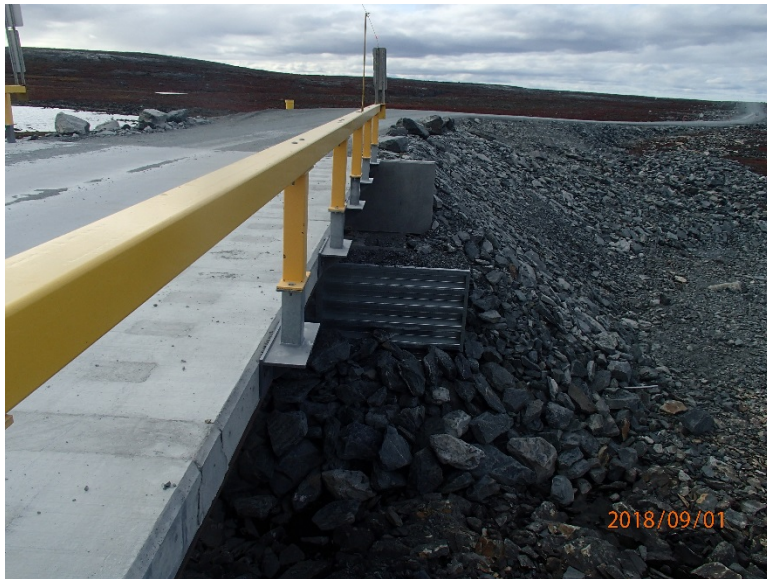
Photograph E2-1 Bridges 1 – km 3+400

Description: Looking at the north abutment from downstream.

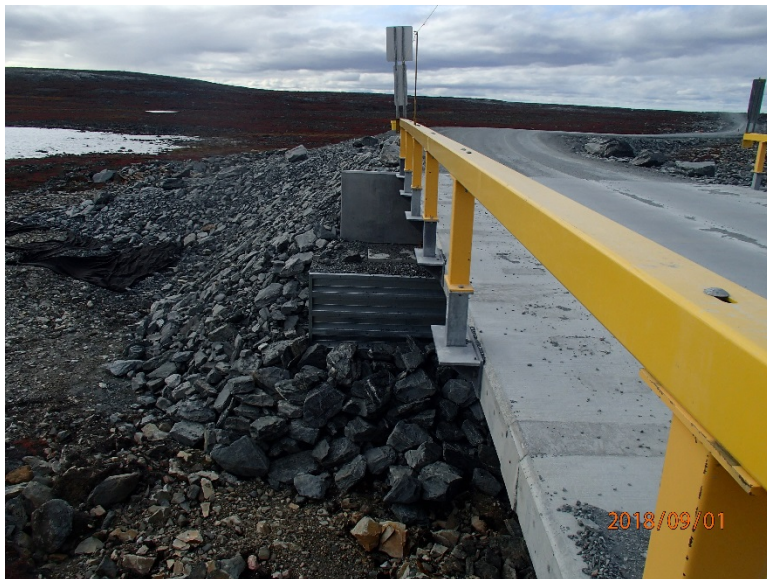
Photograph E2-2 Bridges 1 – km 3+400

Description: Looking at the north abutment from upstream.

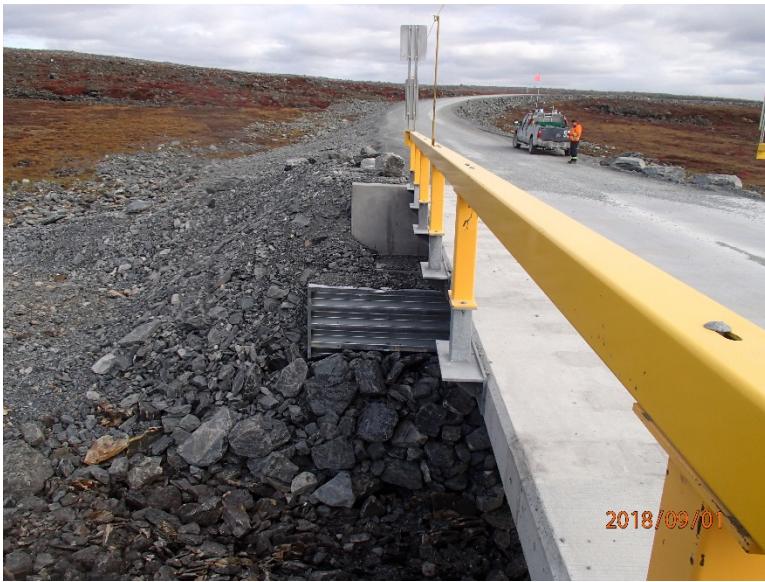
Photograph E2-3 Bridges 1 – km 3+400

Description: Looking at the south abutment from downstream.

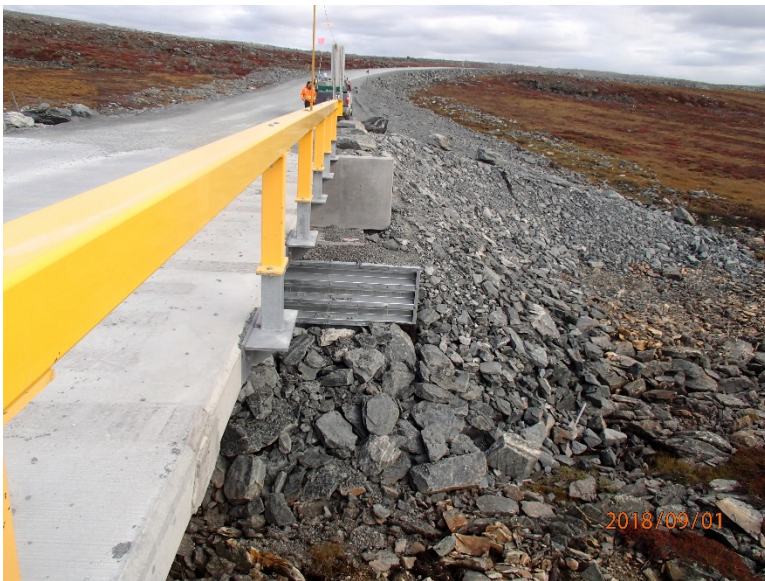
Photograph E2-4 Bridges 1 – km 3+400

Description: Looking at the south abutment from upstream.

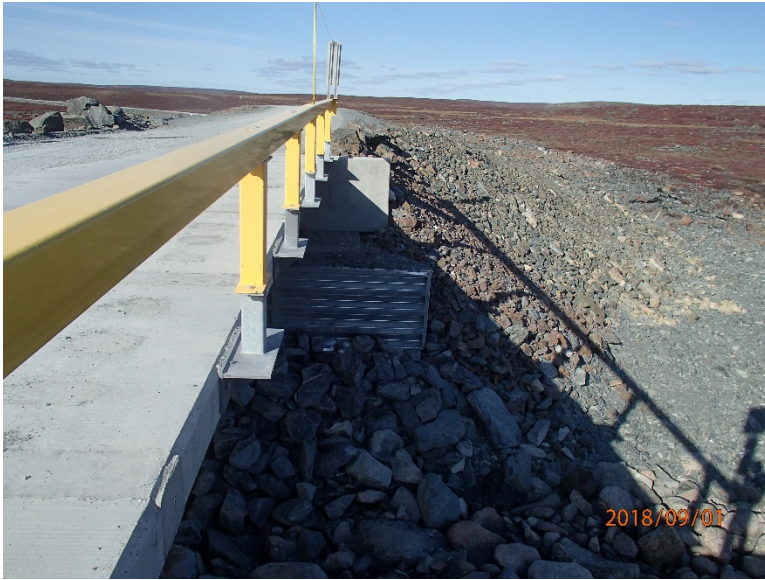
Photograph E2-5 Bridges 2 – km 10+700

Description: Looking at the north abutment from upstream.

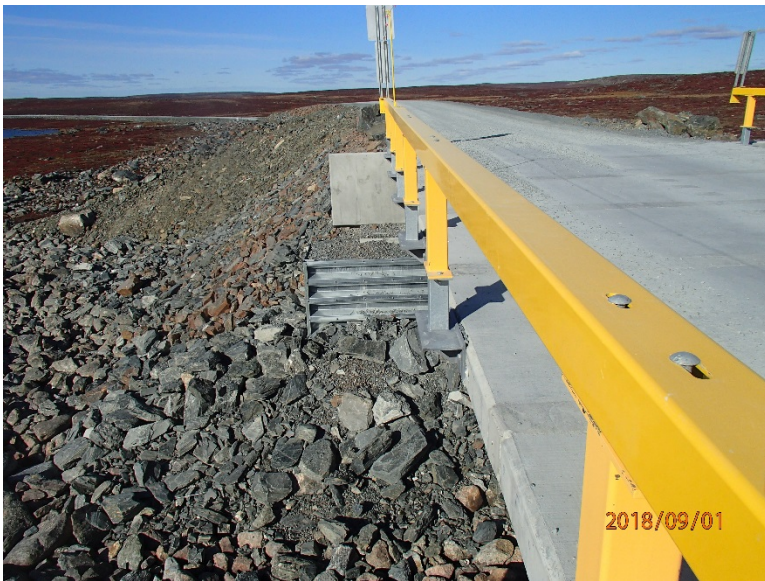
Photograph E2-6 Bridges 2 – km 10+700

Description: Looking at the north abutment from downstream.

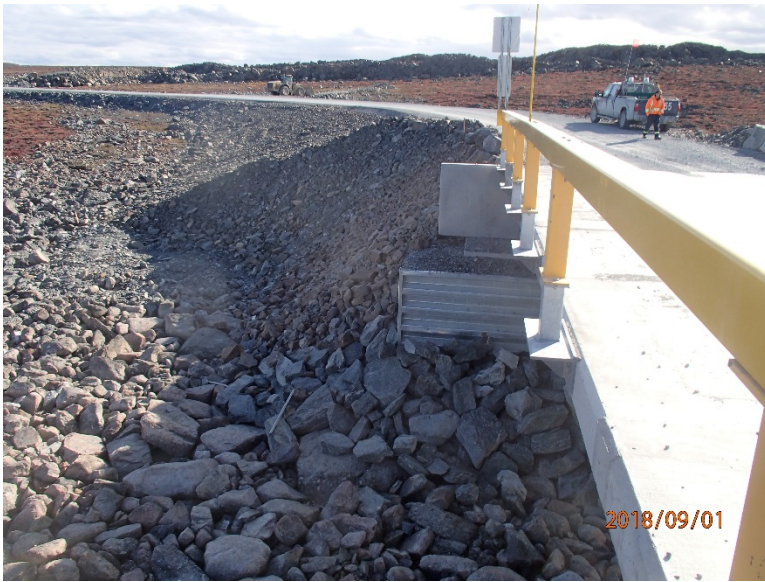
Photograph E2-7 Bridges 2 – km 10+700

Description: Looking at the south abutment from upstream.

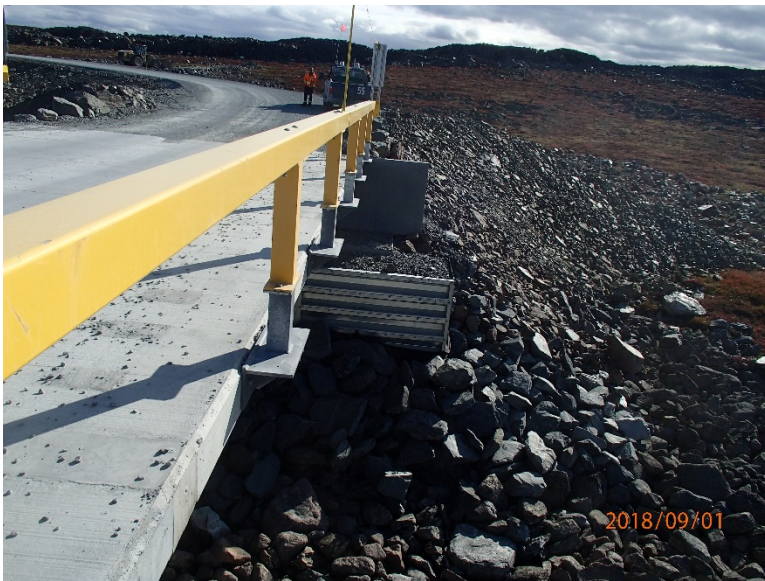
Photograph E2-8 Bridges 2 – km 10+700

Description: Looking at the south abutment from downstream.

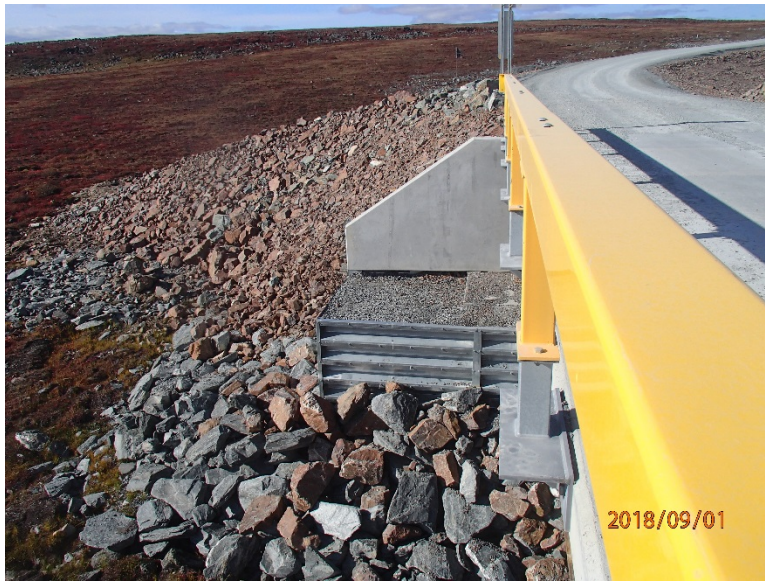
Photograph E2-9 Bridges 3 – km 16+000

Description: Looking at the north abutment from upstream.

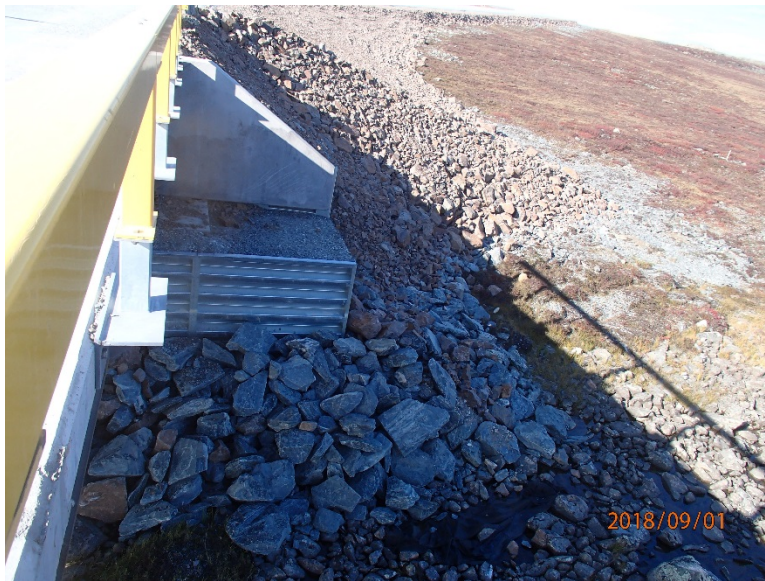
Photograph E2-10 Bridges 3 – km 16+000

Description: Looking at the north abutment from downstream.

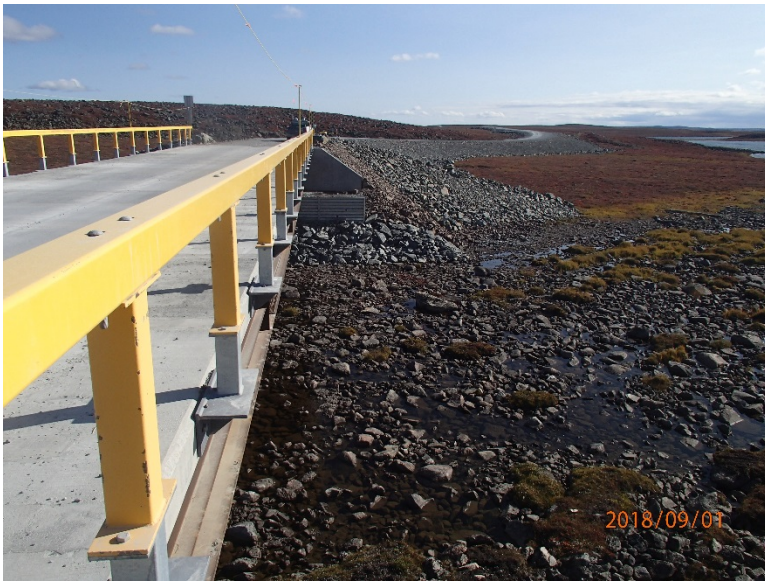
Photograph E2-11 Bridges 3 – km 16+000

Description: Looking at the south abutment from upstream.

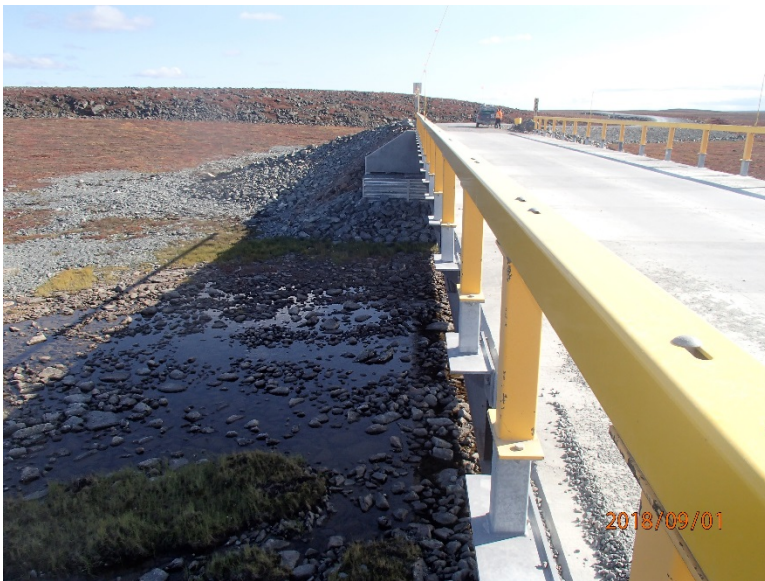
Photograph E2-12 Bridges 3 – km 16+000

Description: Looking at the south abutment from downstream.

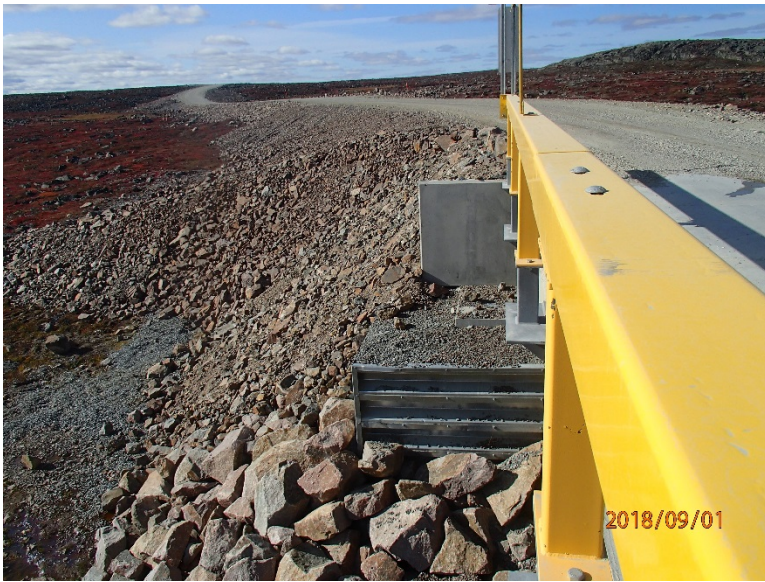
Photograph E2-13 Bridges 4 – km 20+000

Description: Looking at the north abutment from upstream.

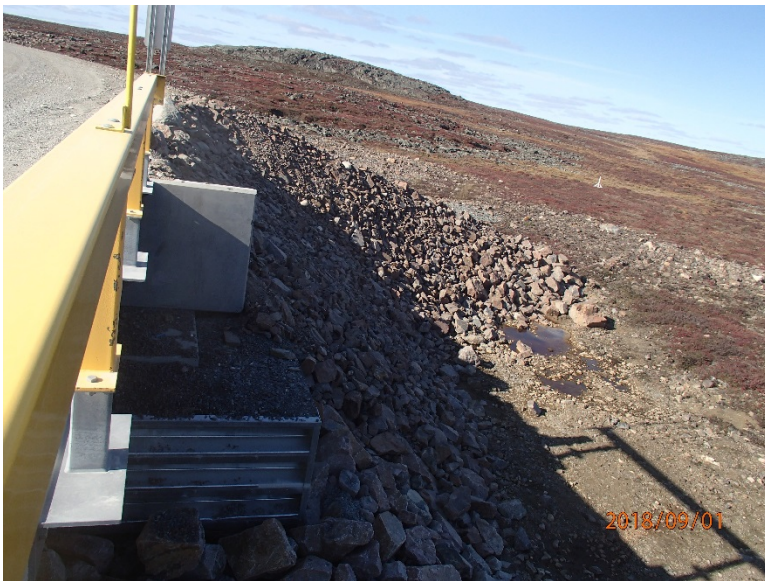
Photograph E2-14 Bridges 4 – km 20+000

Description: Looking at the north abutment from downstream.

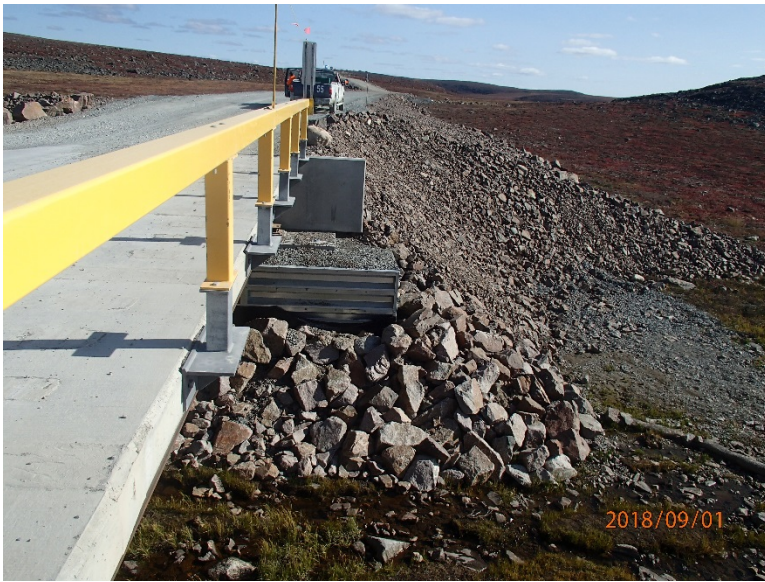
Photograph E2-15 Bridges 4 – km 20+000

Description: Looking at the south abutment from upstream.

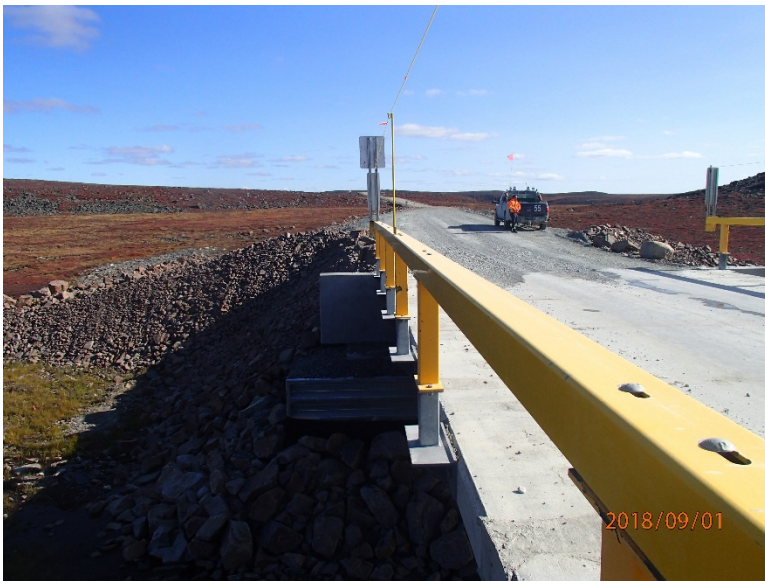
Photograph E2-16 Bridges 4 – km 20+000

Description: Looking at the south abutment from downstream.

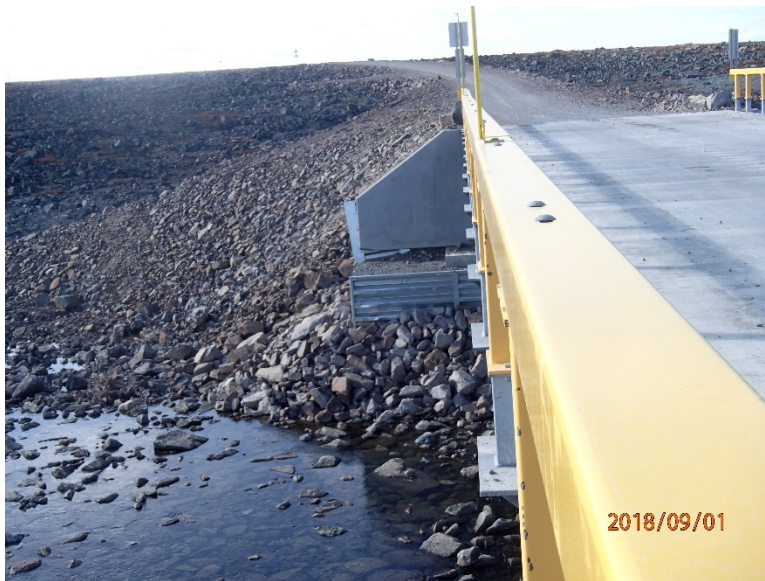
Photograph E2-17 Bridges 5 – km 23+900

Description: Looking at the north abutment from upstream.

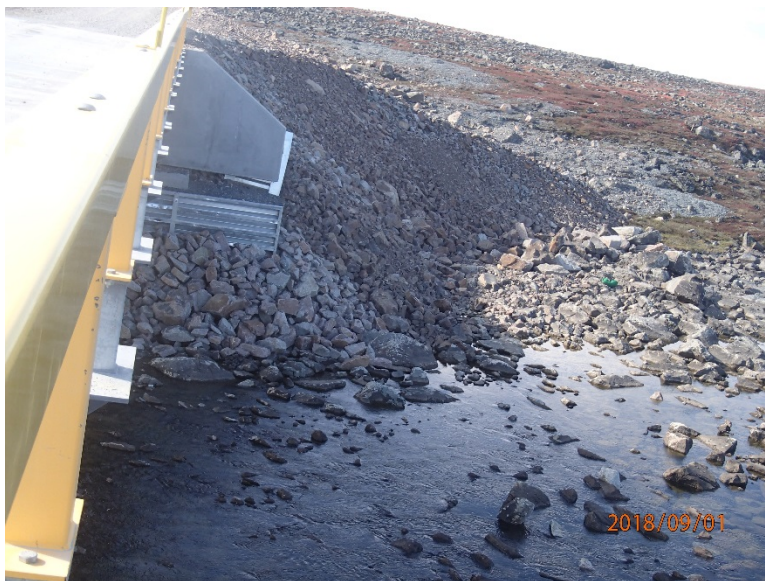
Photograph E2-18 Bridges 5 – km 23+900

Description: Looking at the north abutment from downstream.

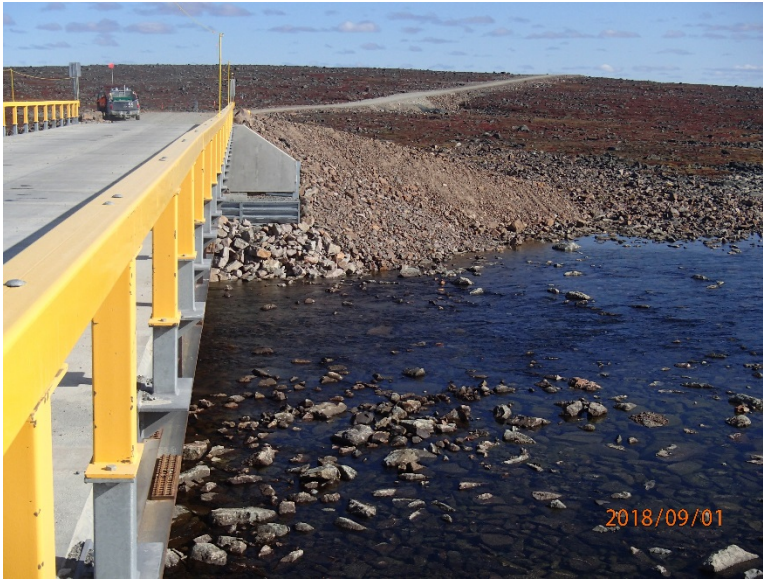
Photograph E2-19 Bridges 5 – km 23+900

Description: Looking at the south abutment from upstream.

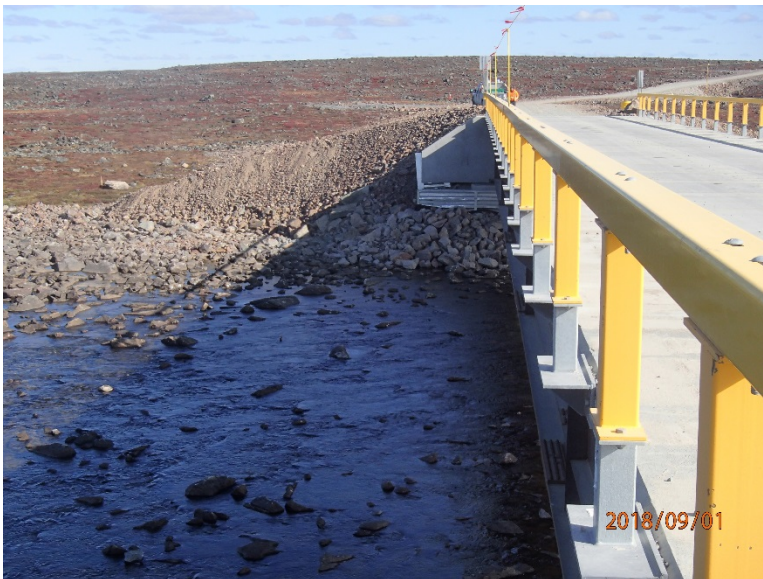
Photograph E2-20 Bridges 5 – km 23+900

Description: Looking at the south abutment from downstream.

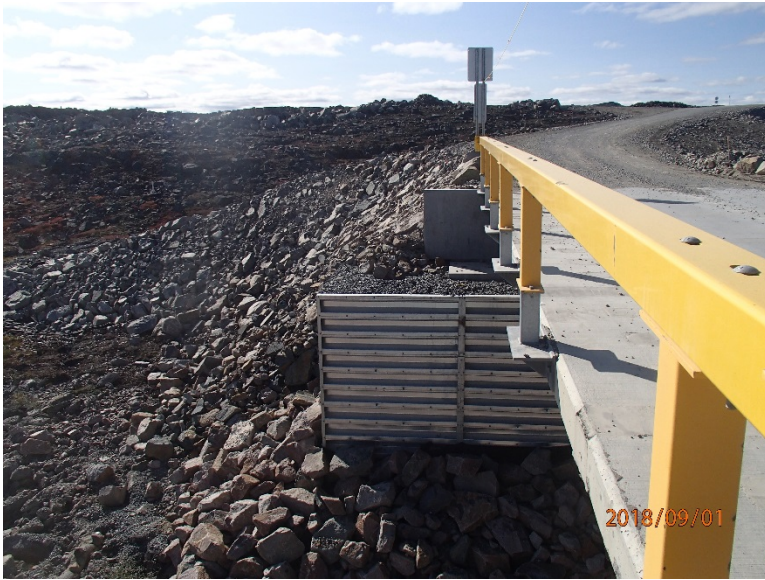
Photograph E2-21 Bridges 6 – km 26+100

Description: Looking at the north abutment from upstream.

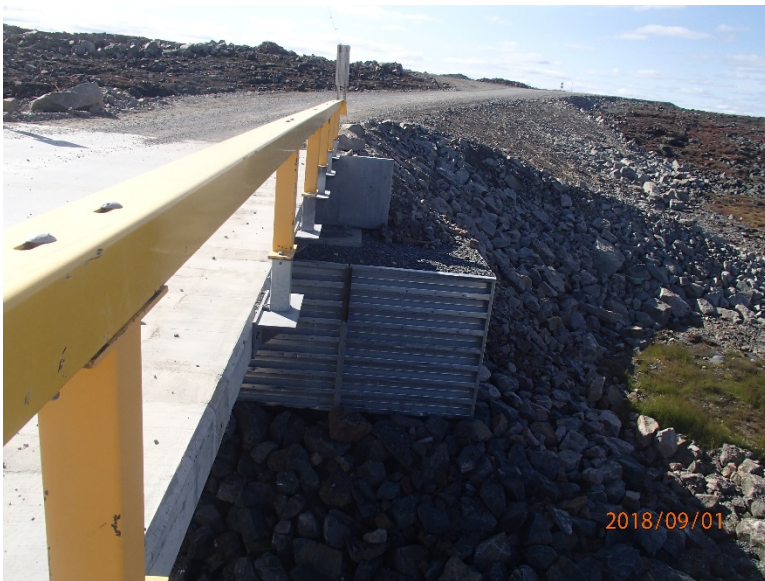
Photograph E2-22 Bridges 6 – km 26+100

Description: Looking at the north abutment from downstream.

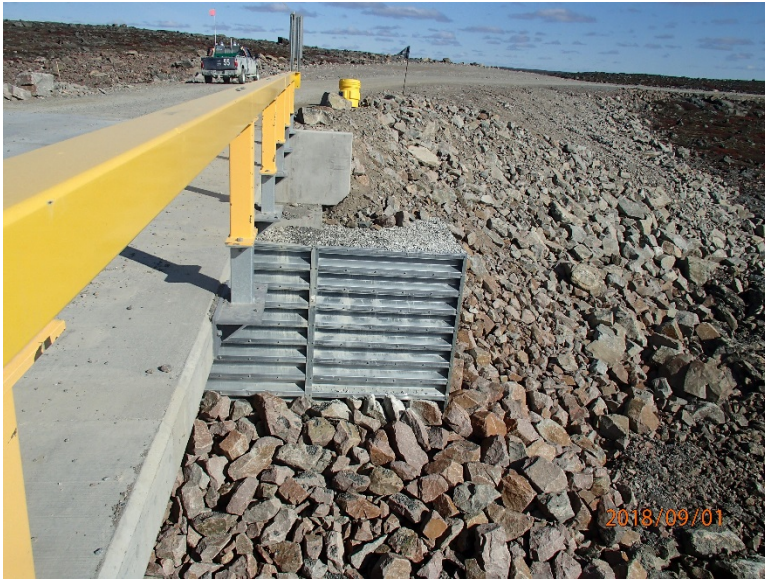
Photograph E2-23 Bridges 6 – km 26+100

Description: Looking at the south abutment from upstream.
