# CONSTRUCTION SUMMARY REPORT

## Whale Tail Dewatering Phase 2

Agnico Eagle Mines Ltd

6127-648-132-REP-002\_R2

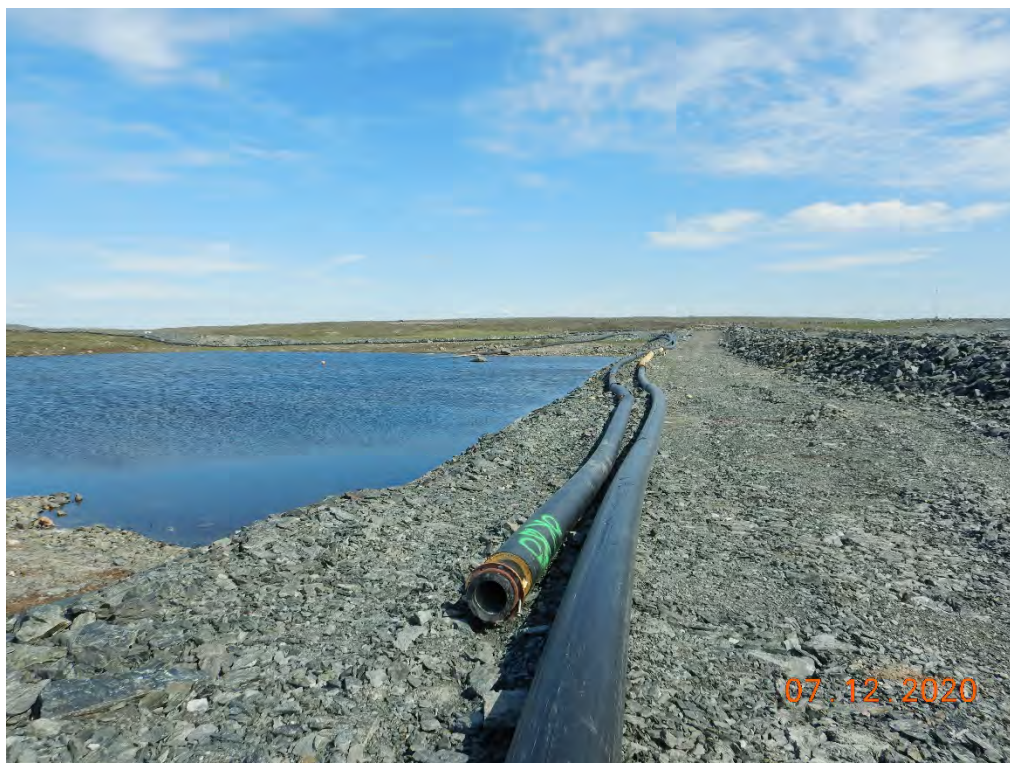
*Photo 2. Line PC17-0200 and PC11-0214 from left to right, NE Dike*

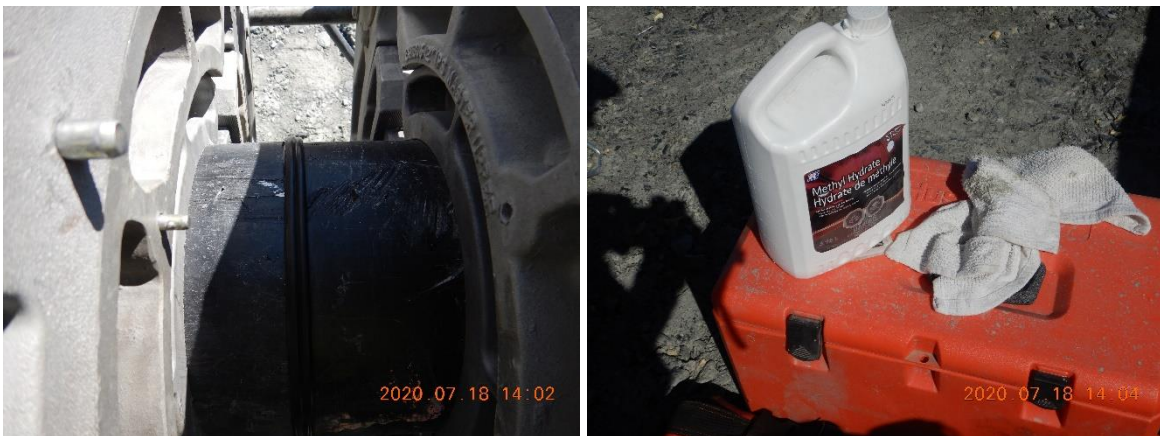
*Photo 2. Fusion spot check*

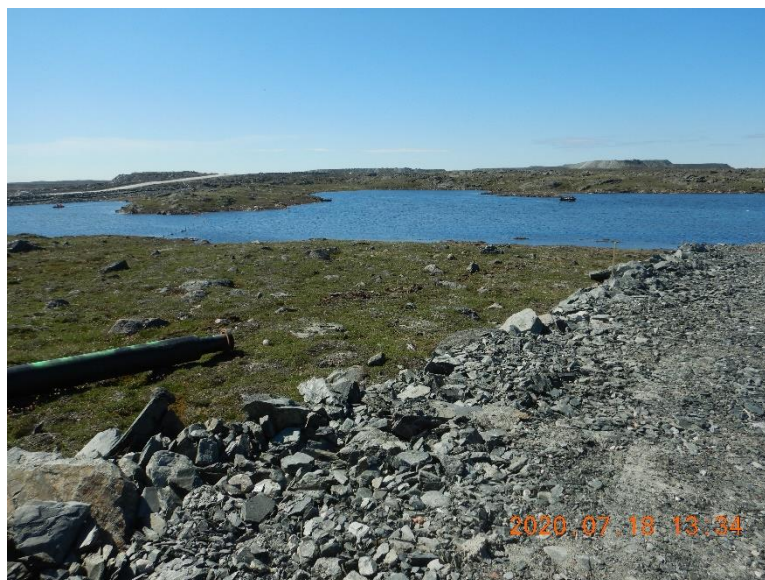
| Elements | Location | Scope and comments |
|---|---|---|
| Piping | Line #0200 | Pipe section to be installed by Lake A47A (see photo #3) |

*Photo 3. Line #0200 by A47-A lake*

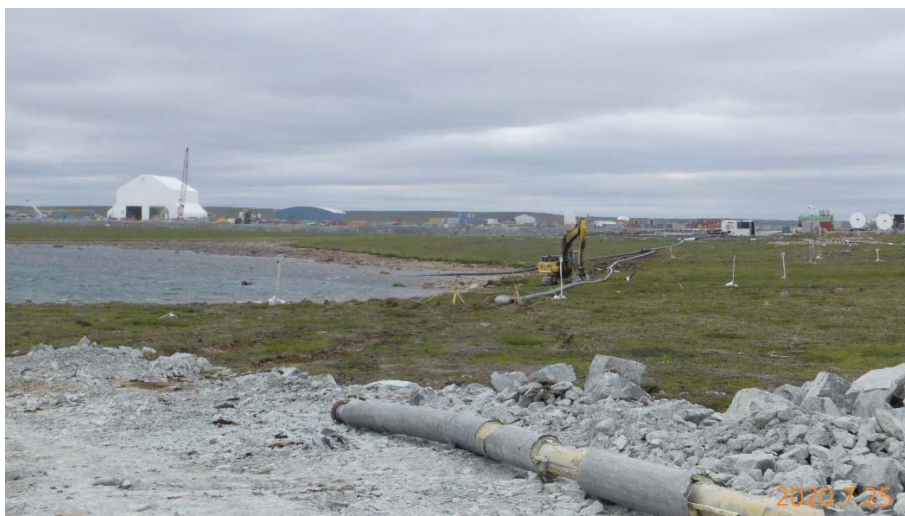
*Photo 2. Finalization of the discharge of the Line #0217*

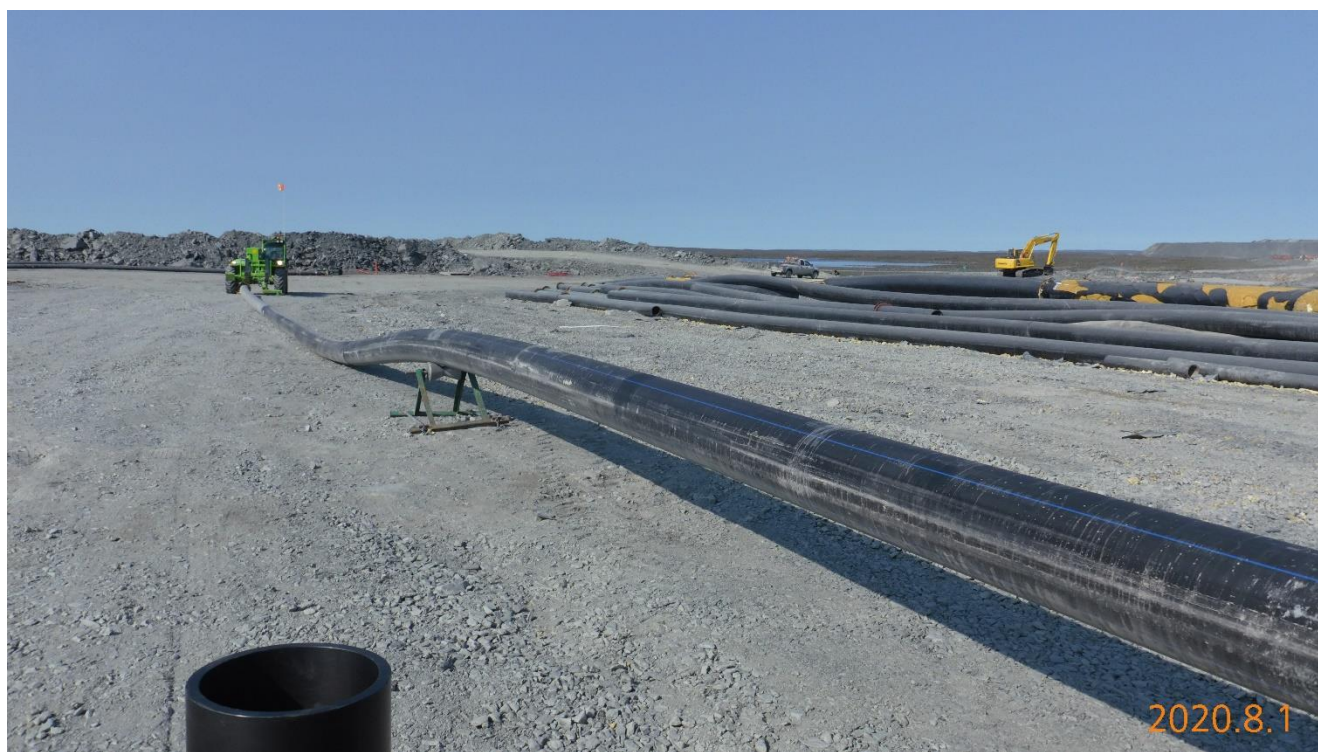
*Photo 2. Pipe alignment for*

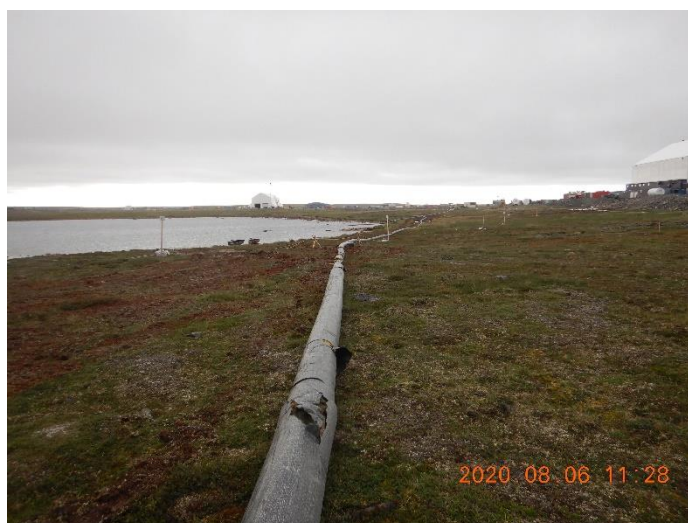
*Photo 4. Line #0219 towards A53 lake*

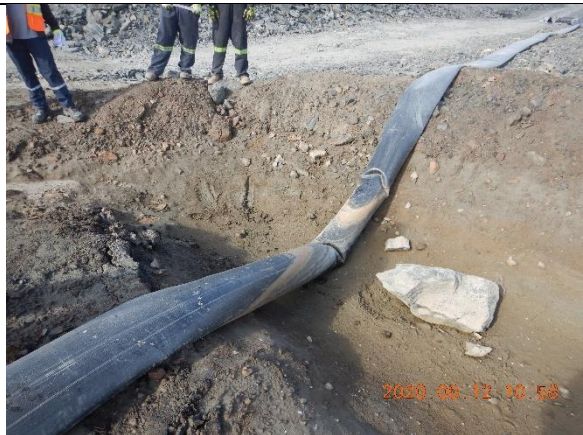
1.2 Bend

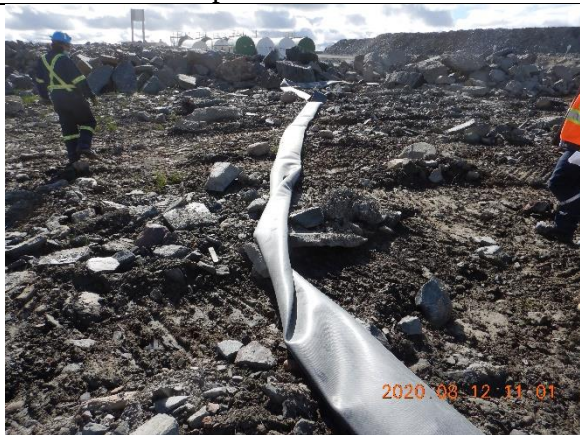
1.3 Pipe complete twist

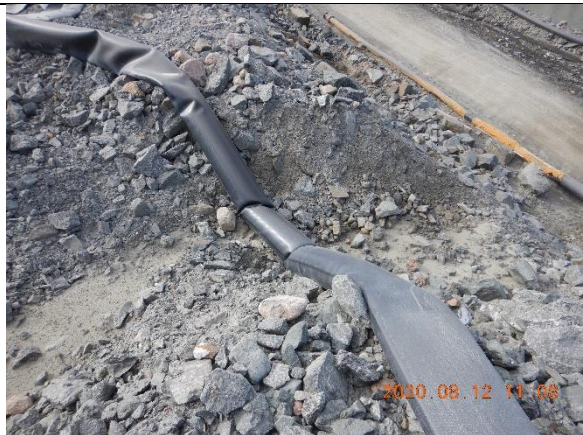
1.4 bend

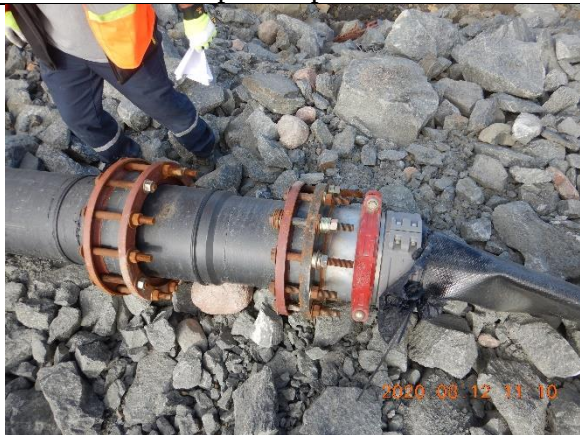
1.5 Reducer 14"x12" at mineflex connection

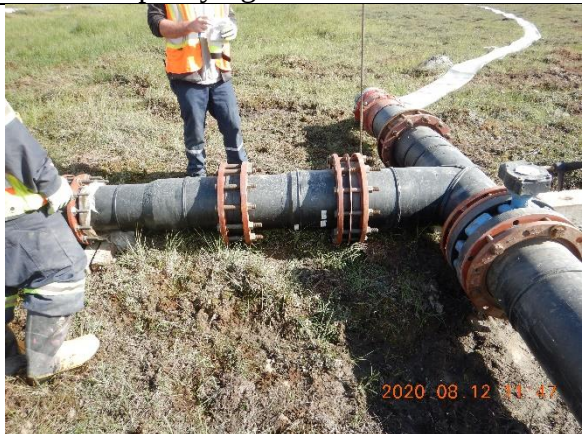
| Activities | Approximate location | Visual observation during field visit |
|---|---|---|
| Pipe walkdown | A53 to attenuation pond | <ul style="list-style-type: none"> <li>• Bad pipe alignment at fusion connection (line 210)</li> <li>• Pipe running on electrical cable (line 210)</li> <li>• Improper/insufficient bolting at valve connections (line 210 &amp; 211 tie-in)</li> </ul> |

2.4 Insufficient bolting at valve connections

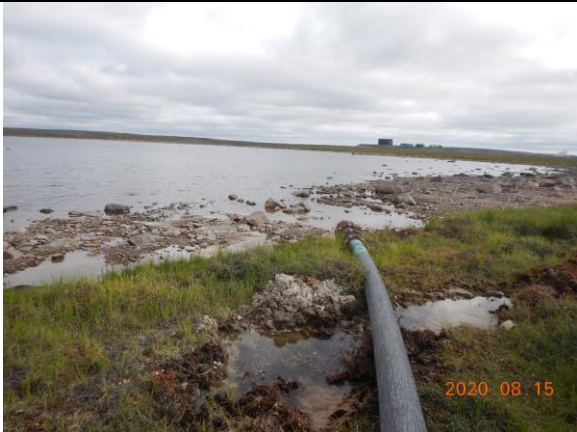
| Pipe walkdown | A50,A51 & AP21 to IVR att. pond | <ul style="list-style-type: none"><li>• Piping in bad condition (old pipe)</li><li>• No gasket on flanged connections</li><li>• 2 washers per bolt, all bolts are present and tight</li><li>• A53 discharge is directly on the shore</li><li>• Pump and suction at A50 still missing, to be installed shortly</li><li>• New access road to att. Pond is being built.</li><li>• A52 is already dewatered, the pipe hasn't been installed</li></ul> |

3.2 Flange properly bolted, without gasket  
Pipe showing damage

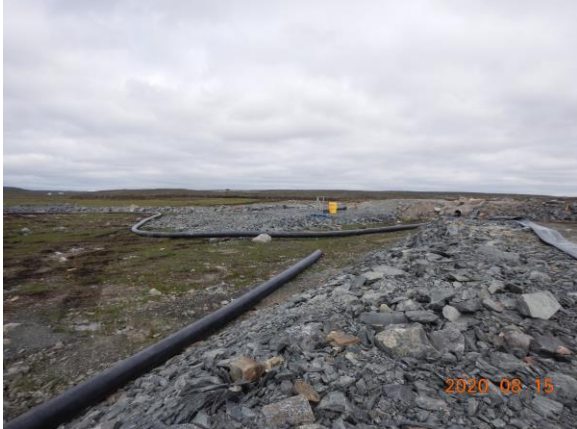
3.4 Acces road to AP-21, pad to be extended

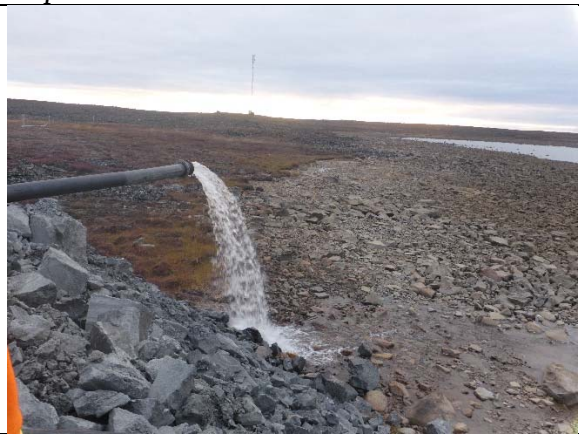
| Activities | Approximate location | Visual observation during field visit |
|---|---|---|
| Dewatering pipe inspection | Lake A-50 and A-51 | <ul style="list-style-type: none"> <li>• The dewatering of the lake A-50 and A-51 is ongoing.</li> <li>• Gaskets missing on multiple flanges.</li> <li>• The pipe used for the dewatering of lake A-50 is cracked and leaking.</li> <li>• The pipe used for the dewatering of lake A-51 is cracked and leaking.</li> <li>• Both pumps are activated and pumping the two lakes in lake A-53.</li> <li>• One flange is leaking on the pipe used for the dewatering of lake A-50</li> </ul> |

1.2 Pipe cracked between lake A-51 and lake A-53

The cracked pipes were replaced and the pumping is now continuing free of leaks
