**APPENDIX C**

# Construction Photographs

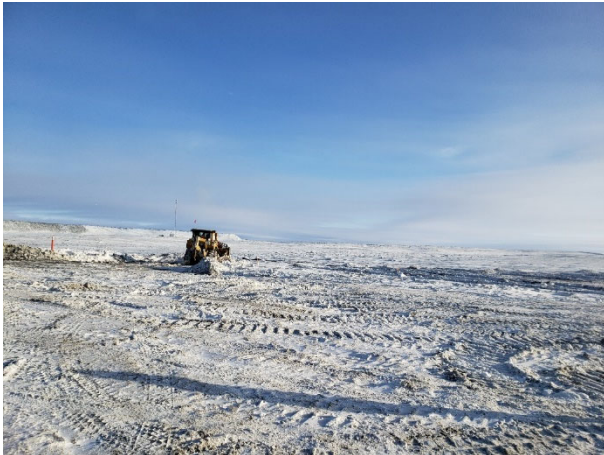
**2001: (2021-02-20), looking NE from Sta. 0+100. CAT dozer removing snow within footprint of upstream shell at Dyke D1.**

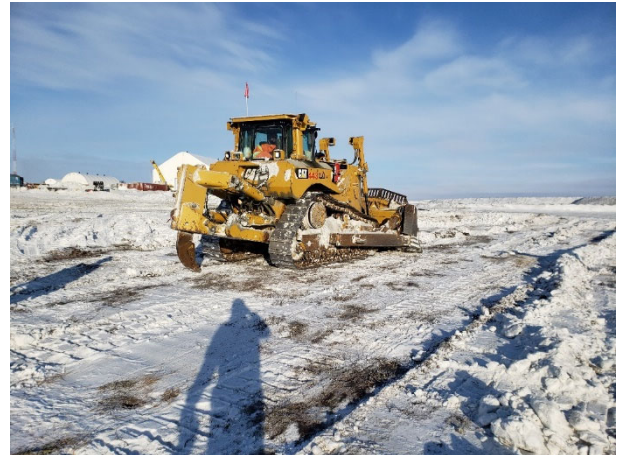
**2002: (2021-02-20), looking N from Sta. 0+160. CAT dozer continuing to remove snow and organics within footprint of downstream shell at Dyke D1.**

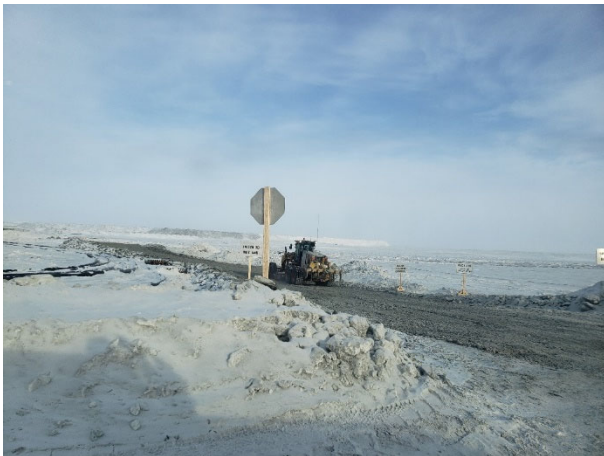
**2003: (2021-02-21), looking NE from west dyke access. CAT grader improving road access along west abutment of IVR Dyke.**

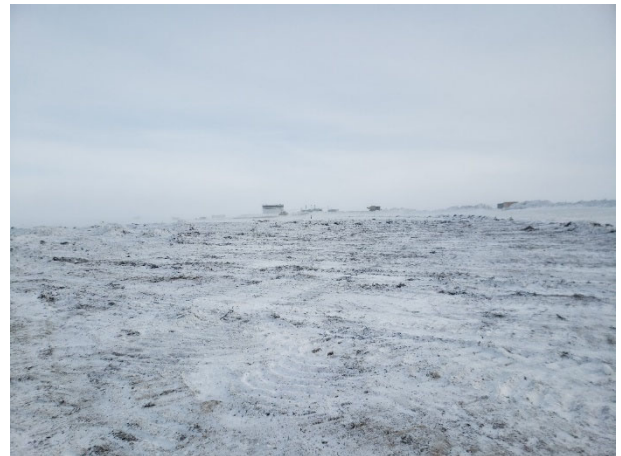
**2004: (2021-02-21), looking E from Sta. 0+160. Additional snow and ice removed within footprint of downstream shell for road access.**

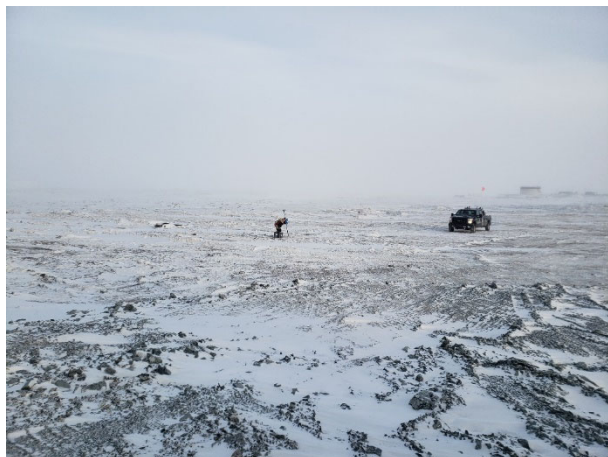
2007: (2021-02-22), looking E from Sta. 0+060. Surveyor laying out drill pattern in preparation for drilling activities scheduled for tomorrow.

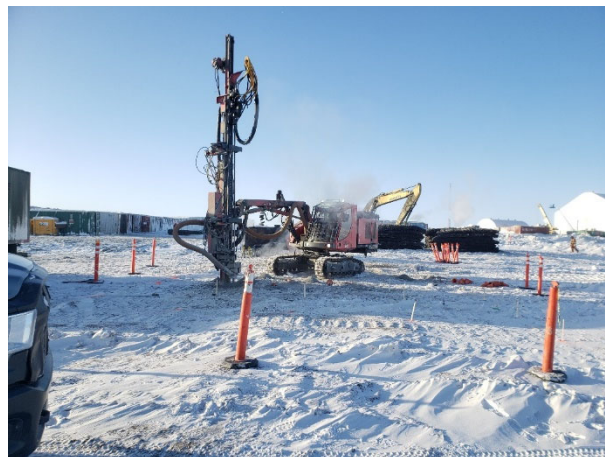
2008: (2021-02-23), looking W from Sta. 0+120. KCG drilling holes through overburden in advance of blasting for key trench at the IVR Dyke.

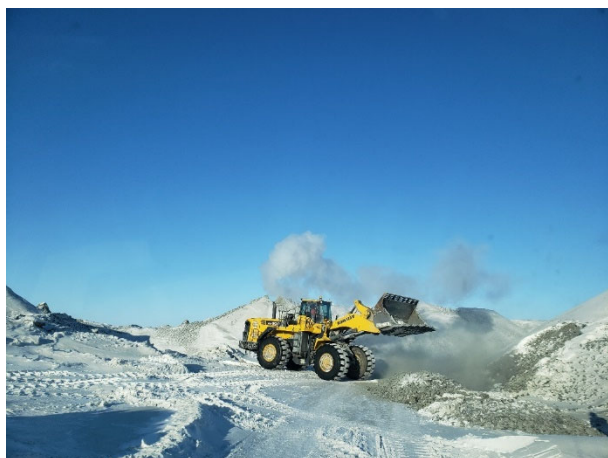
2010: (2021-02-24), looking E from Zone 3 stockpile at WSRF. KCG loader creating test pad for Zone 3 material.

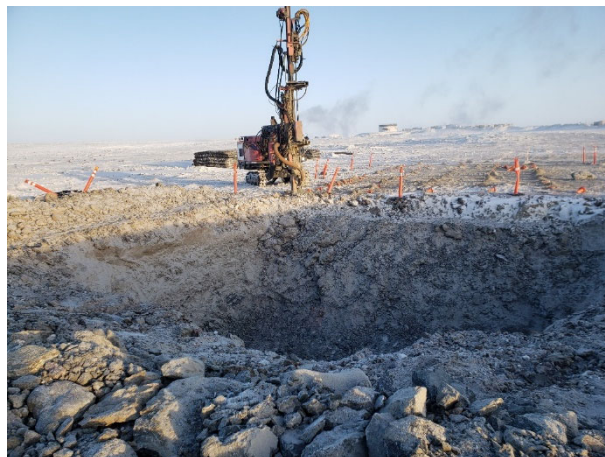
2013: (2021-02-25), looking E from Sta. 0+115. Key trench excavation from first blast between Sta. 0+117 and Sta. 0+129.

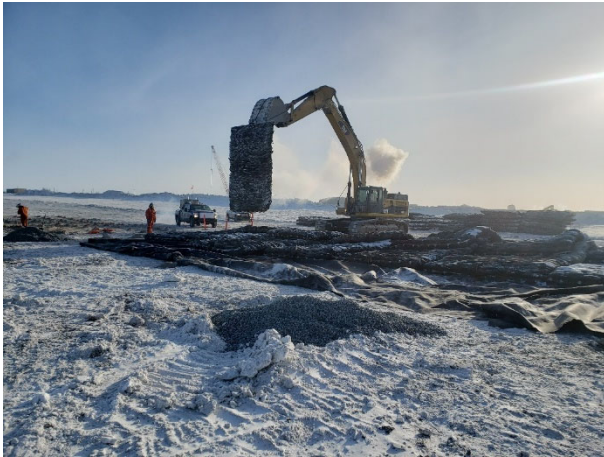
2015: (2021-02-26), looking SE from Sta. 0+130. CAT excavator placing blast mats over geotextile in preparation for second blast schedule for tomorrow.

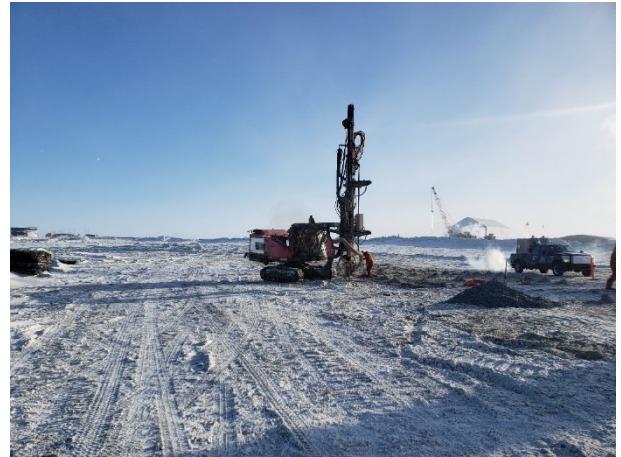
2016: (2021-02-26), looking E from Sta. 0+140. KCG drilling holes for third key trench blast.

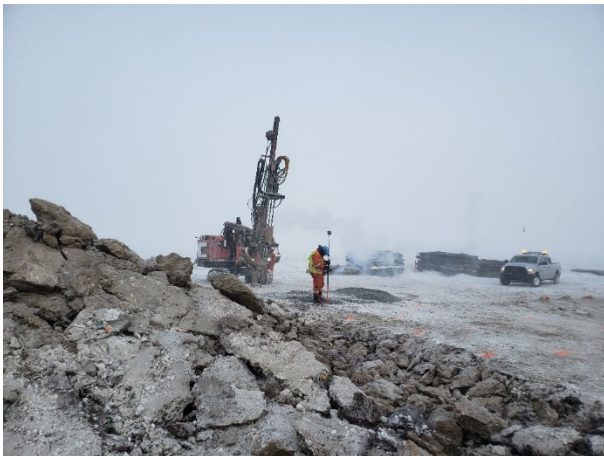
2017: (2021-02-27), looking NE from Sta. 0+150. KCG drilling remaining for third key trench blast.

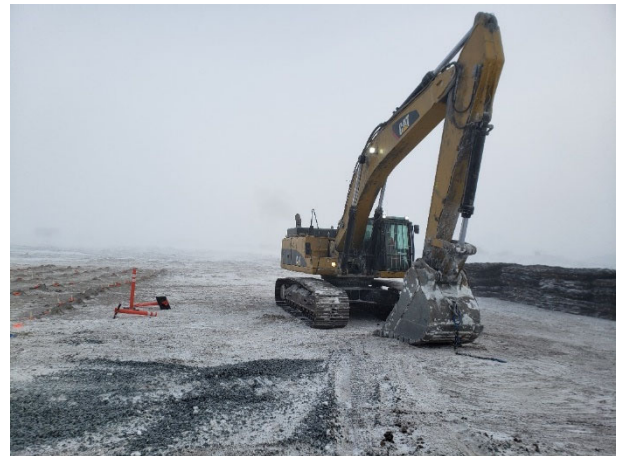
2018: (2021-02-27), looking E from Sta. 0+140. CAT excavator working to remove blast mats over second key trench blast between Sta. 0+129 and Sta. 0+149.

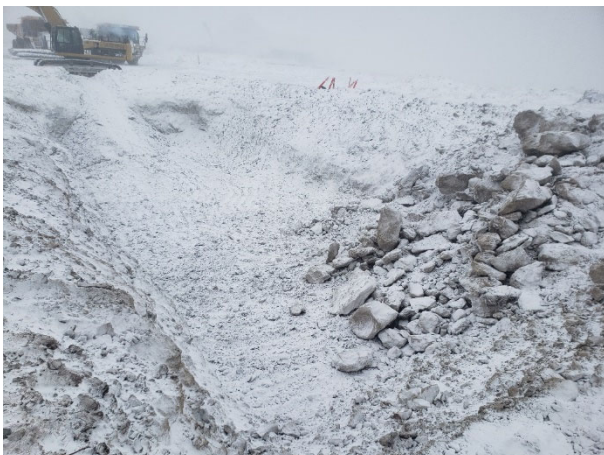
2019: (2021-02-28), looking W from Sta. 0+150. Status of excavation from second cut for key trench excavation.

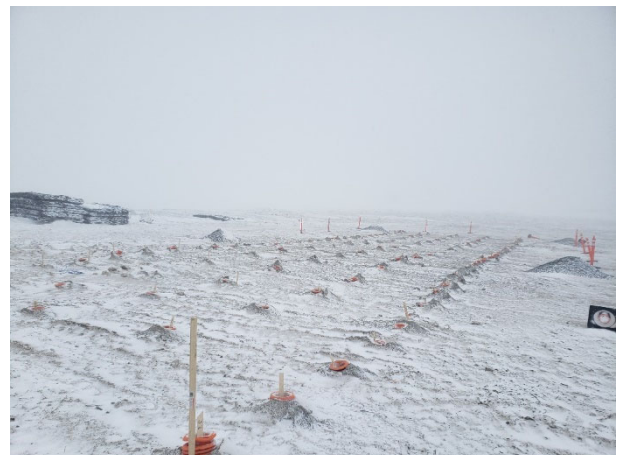
2020: (2021-02-28), looking E from Sta. 0+150. Holes drilled in advance of third blast for key trench construction.

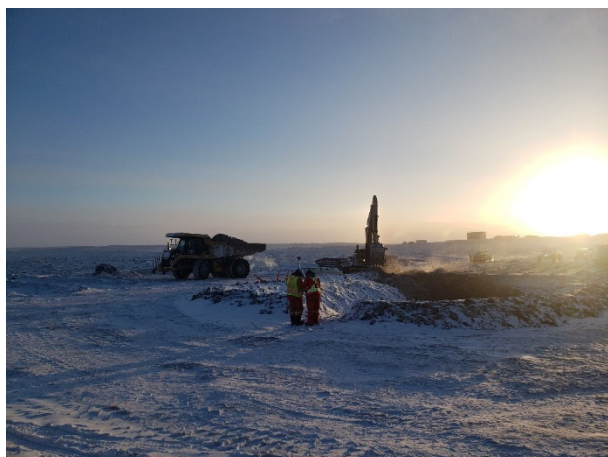
**2021: (2021-03-01), looking NE from Sta. 0+120. KCG excavating blasted overburden material from second blast for key trench.**

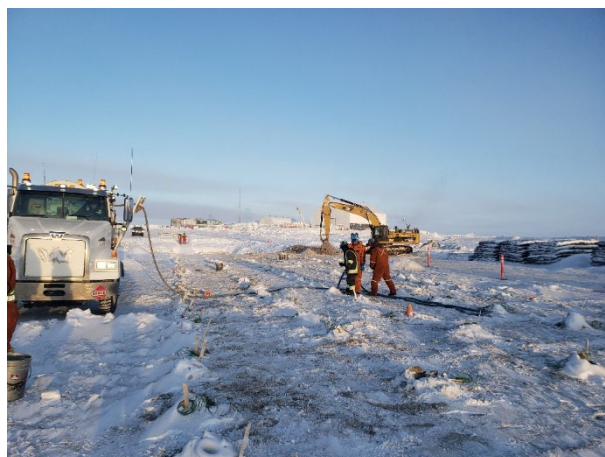
**2022: (2021-03-01), looking W from Sta. 0+170. Dyno loading drill pattern for third key trench blast.**

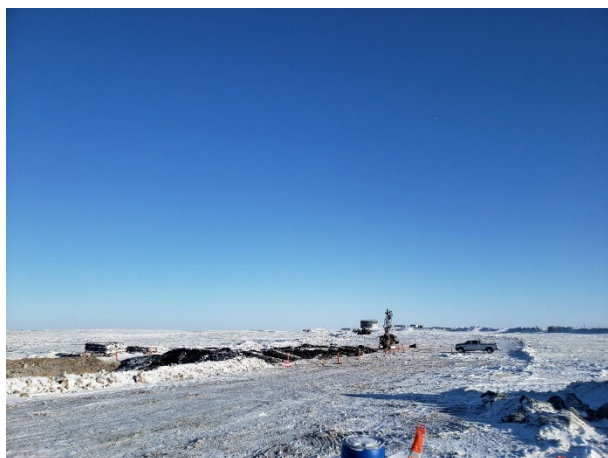
**2023: (2021-03-01), looking E from Sta. 0+125. Blast mats installed over drill pattern in preparation for third key trench blast.**

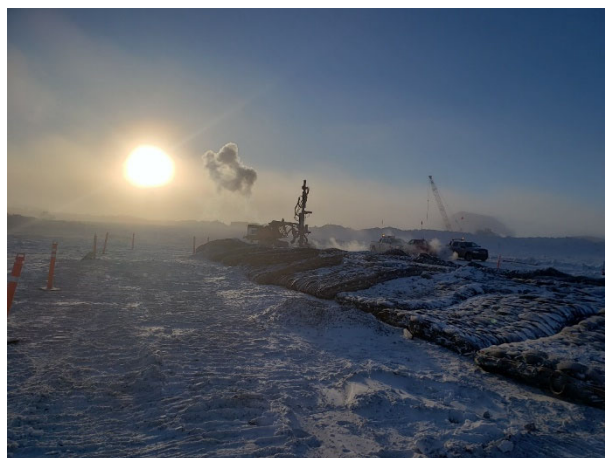
**2024: (2021-03-02), looking E from Sta. 0+160. KCG continuing to drill holes for fourth key trench blast.**

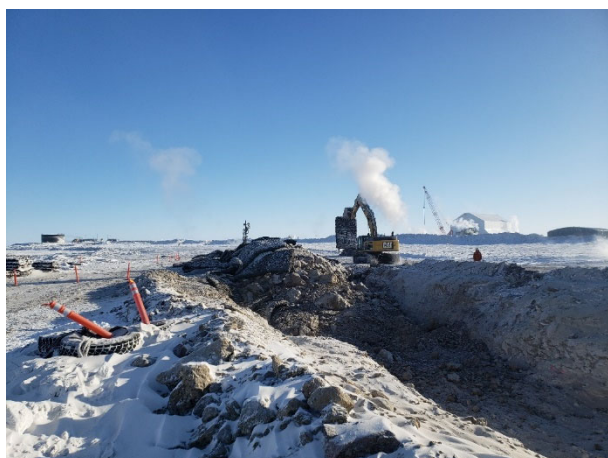
**2025: (2021-03-02), looking E from Sta. 0+0+145. CAT excavator removing blast mats at the IVR Dyke.**

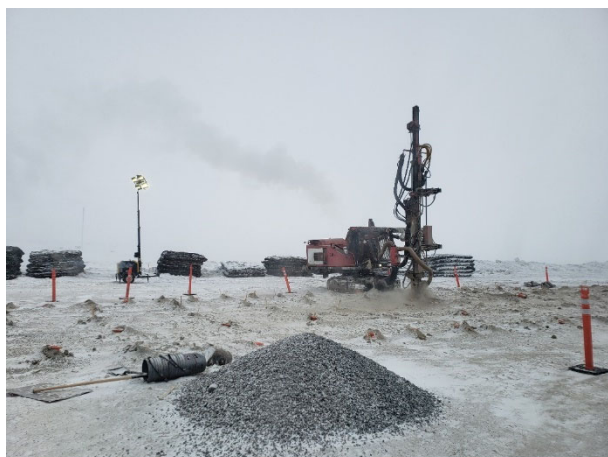
2027: (2021-03-03), looking N from Sta. 0+230. KCG continuing to drill holes for fifth key trench cut.

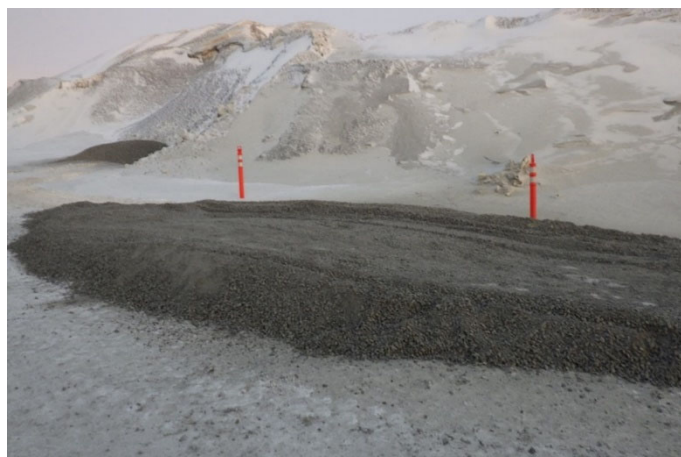
2028: (2021-03-03), looking N at Zone 2A stockpile. Test pad for fine filter Zone 2A material.

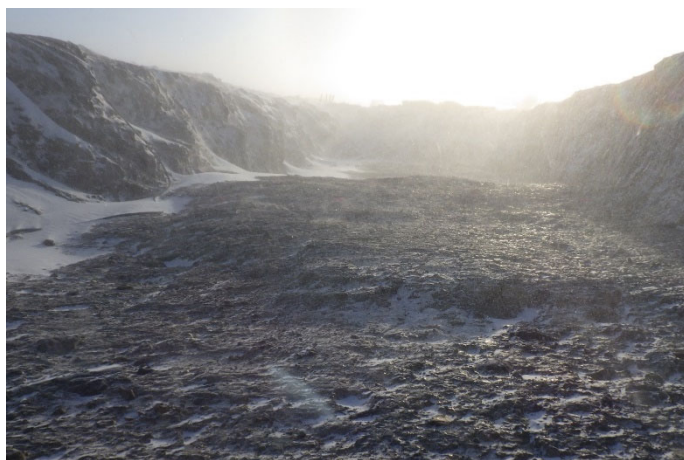
2029: (2021-03-04), looking W from Sta. 0+0+160. Key trench excavation prepared between Sta. 0+130 and Sta. 0+160.

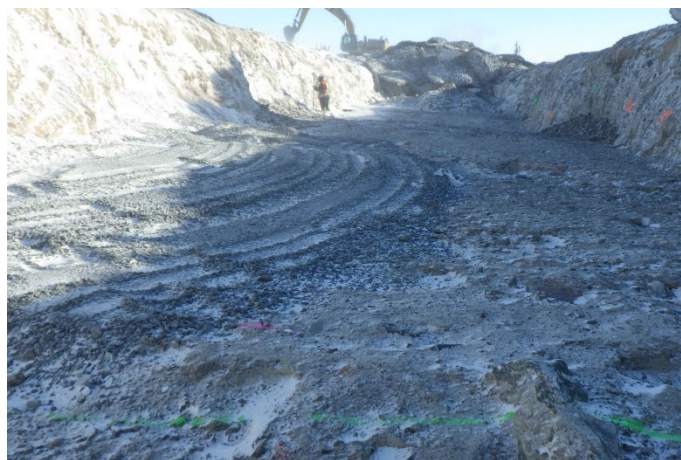
2030: (2021-03-04), looking E from Sta. 0+140. KCG starting to place first 250 mm lift of Zone 2B FFAB material along floor of key trench.

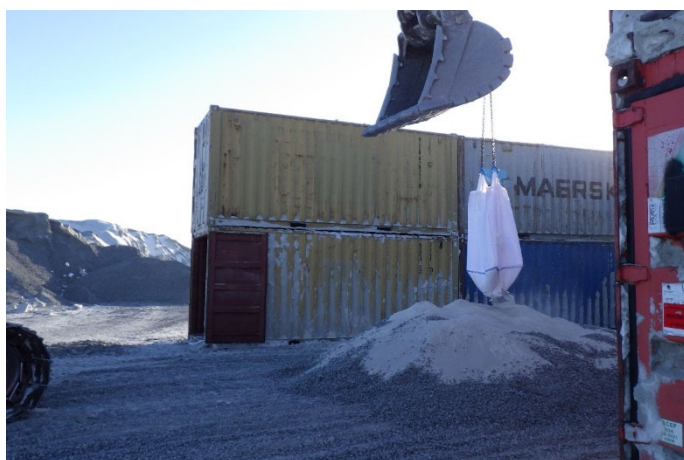
2031: (2021-03-04), looking N at mixing station. KCG producing Zone 2 B FFAB material at the mixing pad.

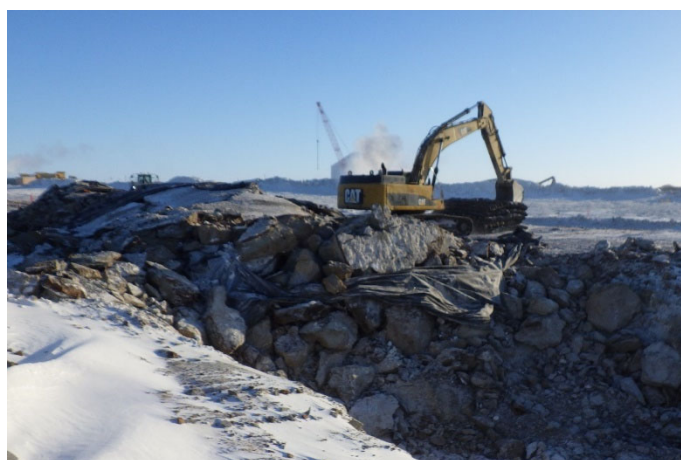
2032: (2021-03-04), looking SE from Sta. 0+0+185. CAT excavator removing blast mats at the IVR Dyke.

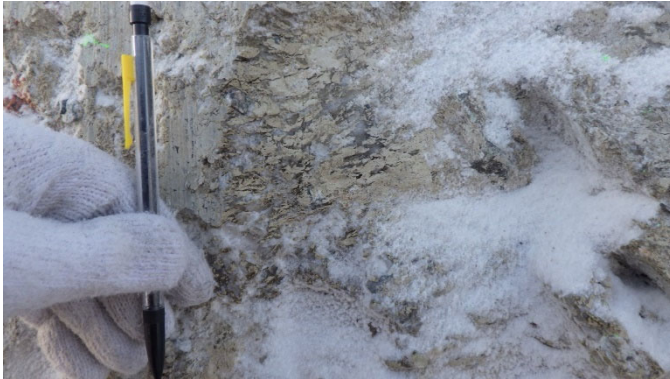
**2033: (2021-03-04), looking N from Sta. 0+140. Upstream side wall of key trench excavation: small ice lenses (1-4 mm) observed.**

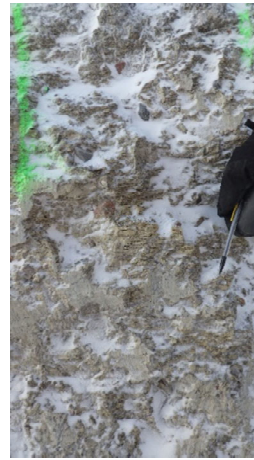
**2034: (2021-03-04), looking S from Sta. 0+145. Downstream side wall of key trench excavation: small ice lenses (1-2 mm) observed.**

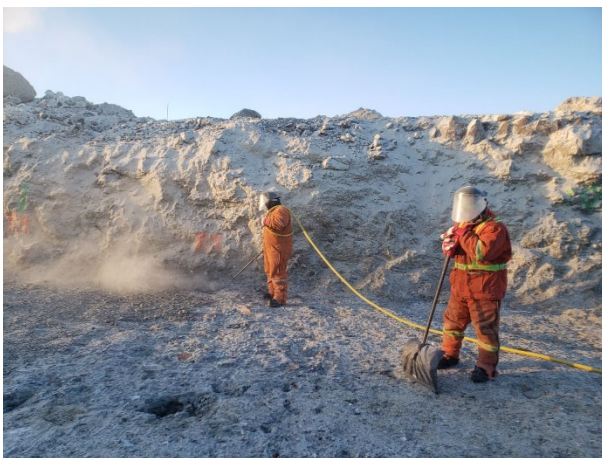
**2037: (2021-03-05), looking S from Sta. 0+190. KCG labourers preparing foundation of key trench.**

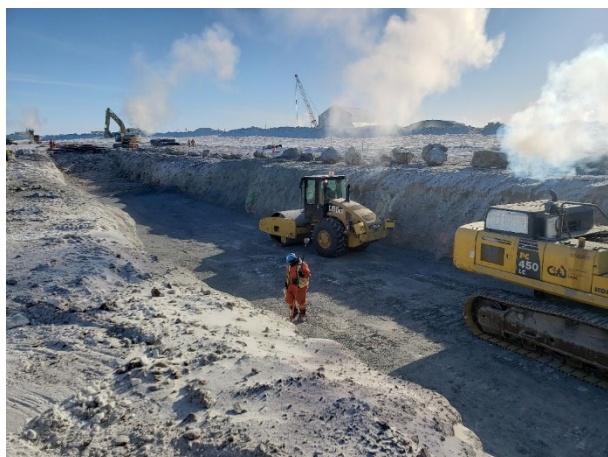
**2039: (2021-03-05), looking SE from Sta. 0+150. KCG compacting first placed lift of FFAB material.**

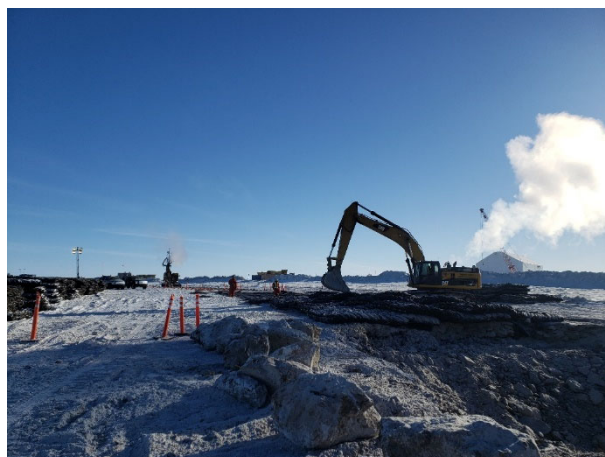
**2040: (2021-03-05), looking E from Sta. 0+220. CAT excavator placing blast mats for fifth key trench blast.**

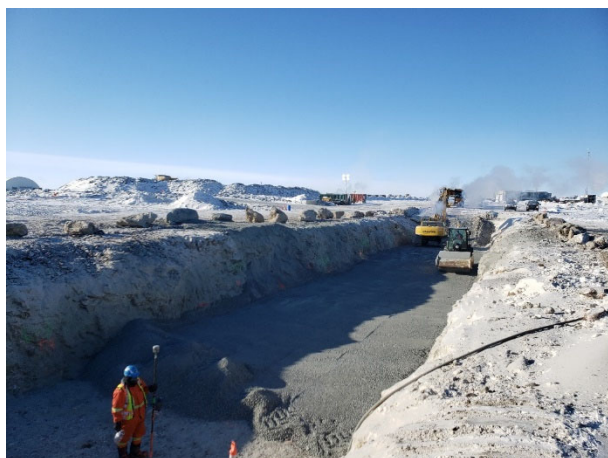
**2041: (2021-03-05), looking W from Sta. 0+190. KCG compacting second placed lift of FFAB material.**

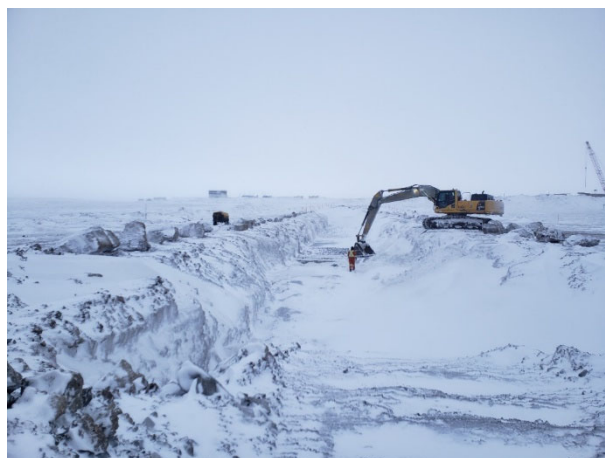
**2042: (2021-03-07), looking E from Sta. 0+130. CAT excavator removing snow from yesterday's blizzard.**

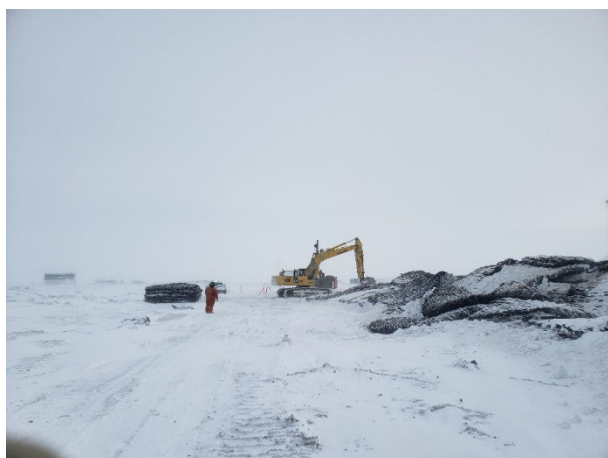
**2043: (2021-03-07), looking E from Sta. 0+275. CAT excavator removing snow along tie in between sequence 6 and 7 in advance of drilling.**

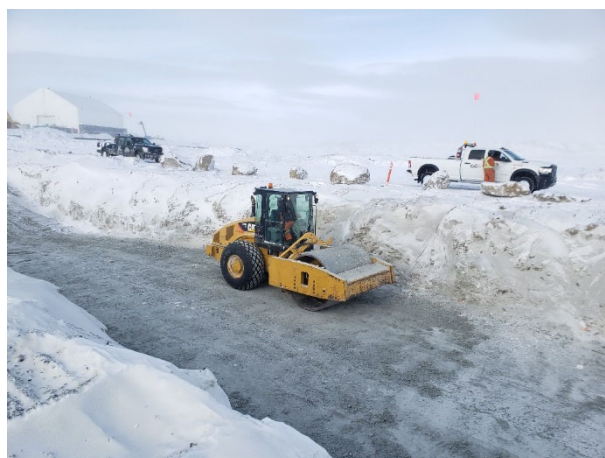
**2044: (2021-03-07), looking NW from Sta. 0+140. Smooth drum roller compacting placed lift of Zone 2B FFAB material.**

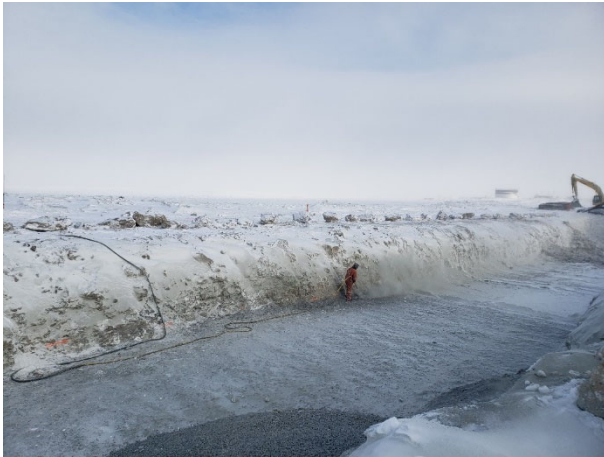
2045: (2021-03-07), looking NE from Sta. 0+130. KCG labourer removing snow along trench excavation side walls in advance of Zone 2B FFAB placement.

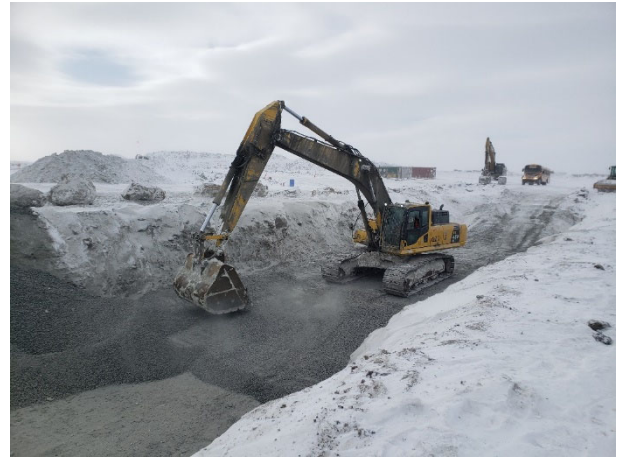
2046: (2021-03-07), looking W from Sta. 0+145. CAT excavator placing 250 mm lift of Zone 2B FFAB material.

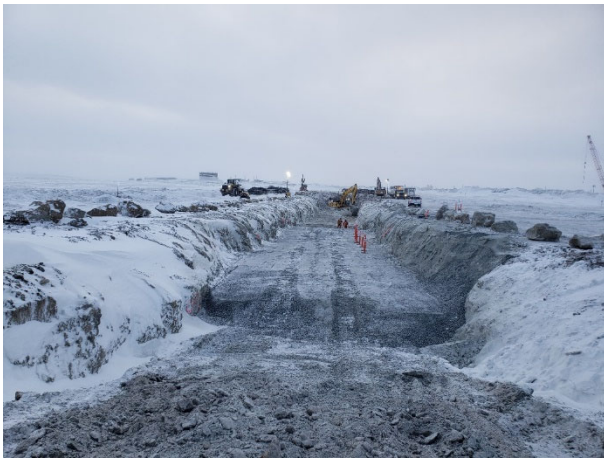
2047: (2021-03-08), looking E from Sta. 0+130. Zone 2B FFAB material placed to approx. elev. 160.0 m (2.5 m below existing ground). Area approved for placement of fine filter.

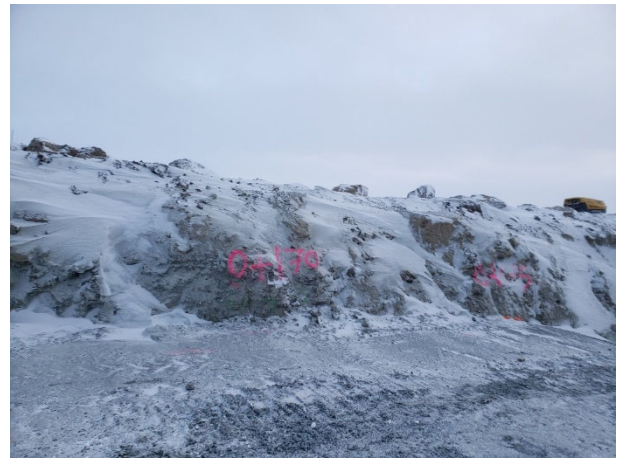
2048: (2021-03-08), looking NE from Sta. 0+170. Additional snow to be removed along upstream excavation wall in advance of Zone 2A (fine filter) material placement.

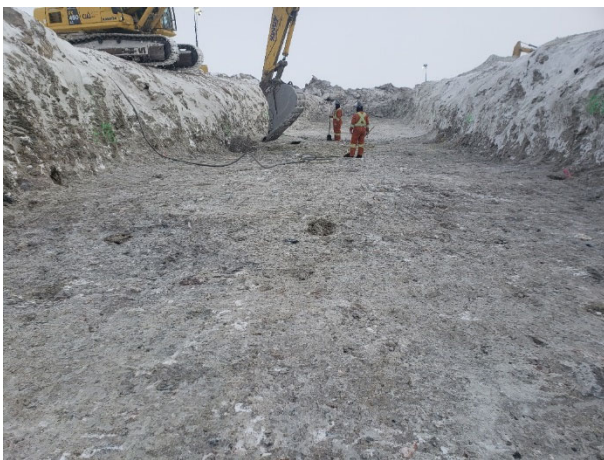
2049: (2021-03-08), looking E from Sta. 0+185. KCG continuing to prepare floor of key trench in advance of Zone 2B FFAB material placement.

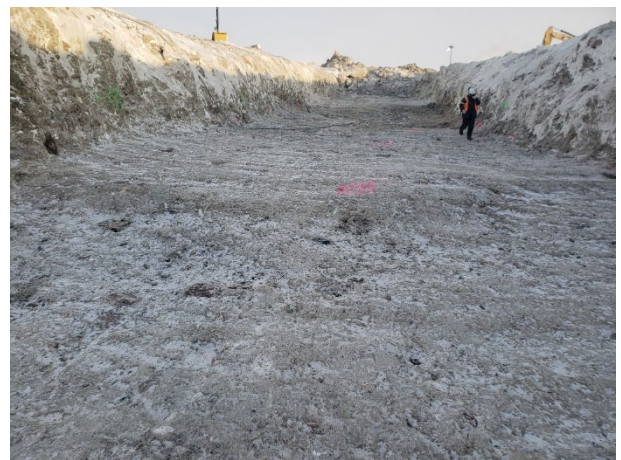
2050: (2021-03-08), looking E from Sta. 0+180. Key trench foundation approved between Sta. 0+180 and Sta. 0+205.

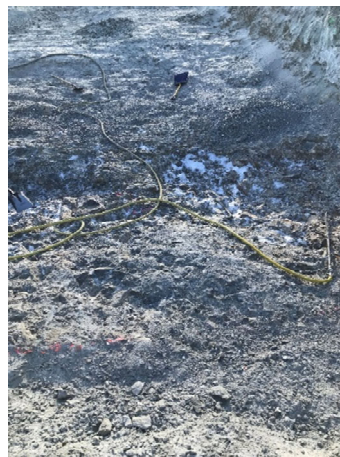
**2052: (2021-03-10), looking E from Sta. 0+207. Ice after excavating down 0.3 m.**

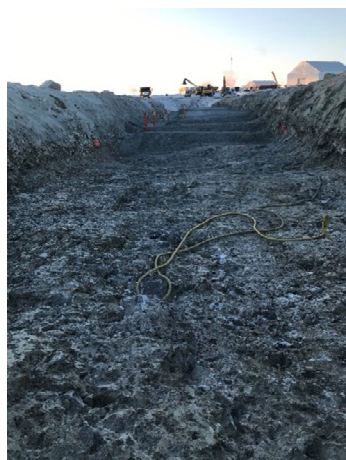
**2053: (2021-03-10), looking E from Sta. 0+205. Key trench foundation approved, Sta. 0+205 to 0+227.**

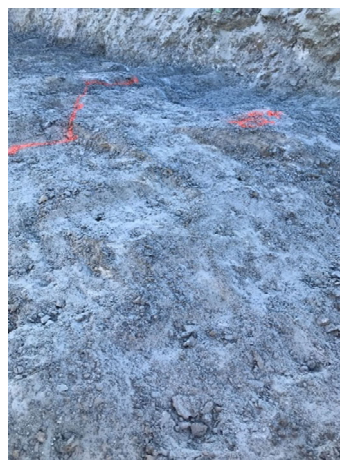
**2054: (2021-03-10), looking E from Sta. 0+225. High spot of subgrade foundation (50 mm too high).**

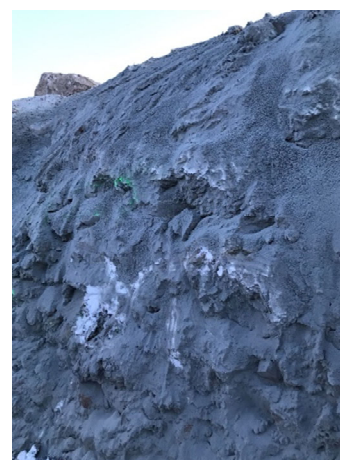
**2056: (2021-03-11), looking E from Sta. 0+200. Wind deposited snow on trench walls to be cleaned prior to fill.**

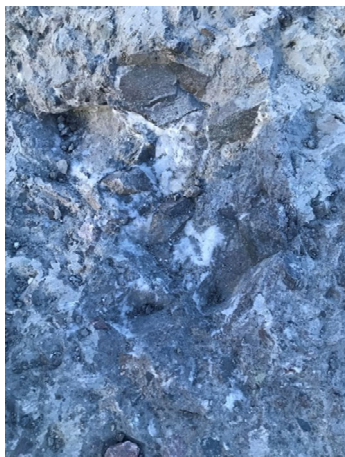
**2057: (2021-03-11), looking E from Sta. 0+230. Small pocket of ice (<0.5 square meters) observed in trench floor, typical of this section.**

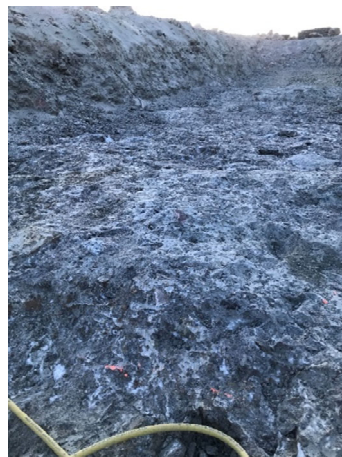
**2058: (2021-03-11), looking E from Sta. 0+227. Final foundation approved for placement of Zone 2B material.**

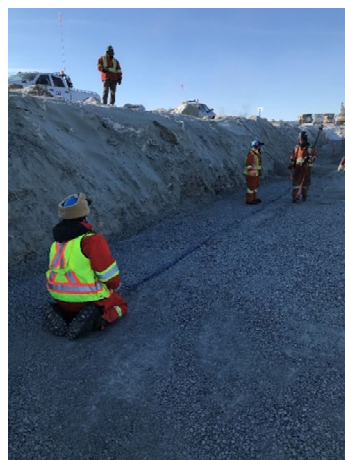
**2059: (2021-03-11), looking W from Sta. 0+220. Installation of horizontal thermistor.**

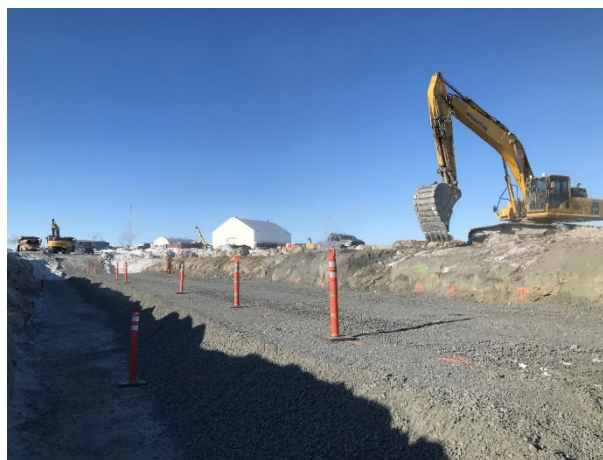
**2060: (2021-03-11), looking W from Sta. 0+200. Excavator cleaning loose material, snow and dust from back-break area of trench wall.**

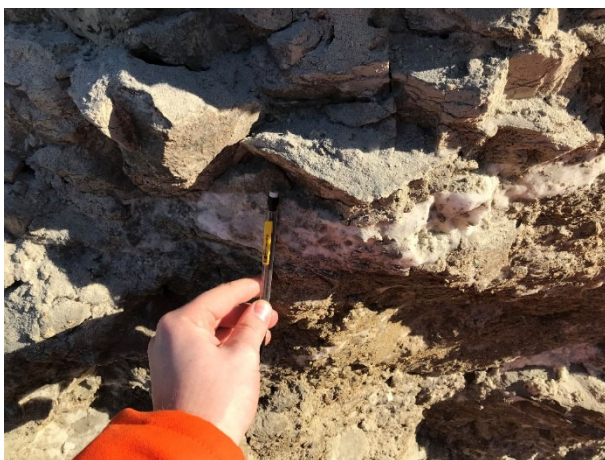
**2061: (2021-03-12), looking N from Sta. 0+0+226. Ice seam in upstream trench.**

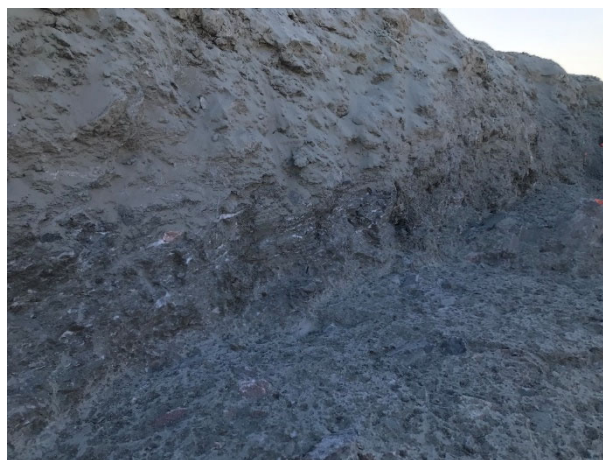
**2062: (2021-03-12), looking W from Sta. 0+0+260. Ice lenses in downstream trench wall from Sta. 0+260 to 0+250.**

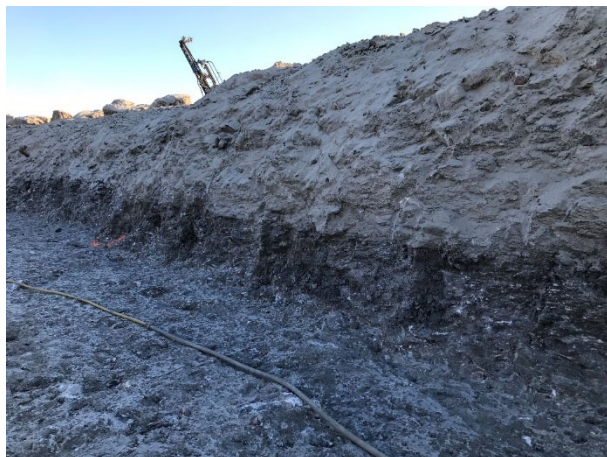
2063: (2021-03-12), looking E from Sta. 0+260. Ice lenses in downstream trench wall from Sta. 0+260 to Sta. 0+270.

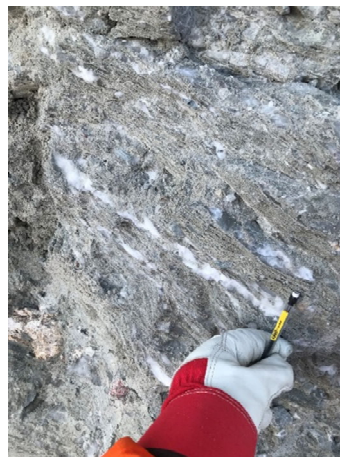
2064: (2021-03-12), looking S from Sta. 0+0+260. Close up view of ice lens in downstream trench wall.

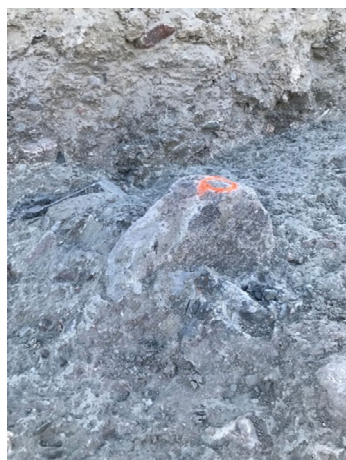
2065: (2021-03-12), looking SW from Sta. 0+254. Boulder sticking out of trench floor.

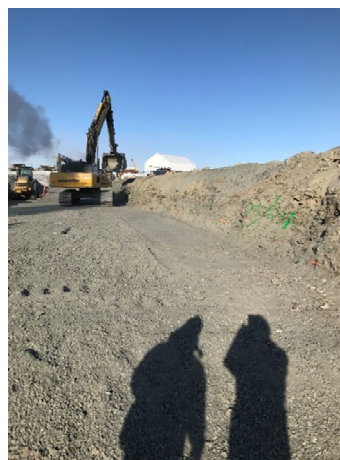
2066: (2021-03-12), looking W from Sta. 0+241. Approved fill placement from Sta. 0+180 to Sta. 0+241.

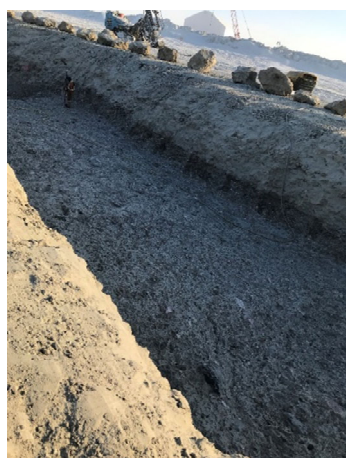
2067: (2021-03-12), looking SE from Sta. 0+250. Approved key trench subgrade foundation from Sta. 0+248 to Sta. 0+280.

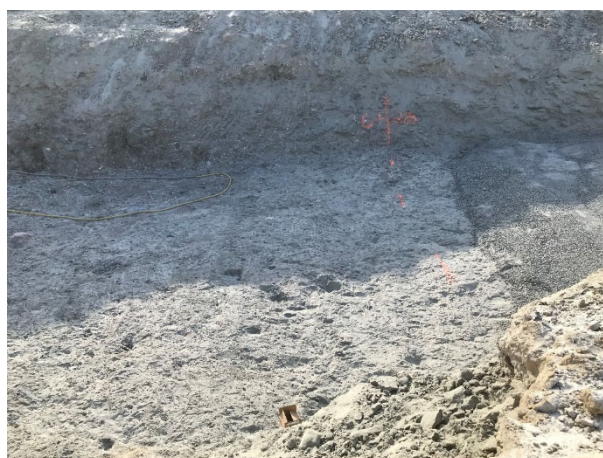
2068: (2021-03-13), looking W from Sta. 0+280. Key trench subgrade foundation approved from Sta. 0+280 to Sta. 0+300.

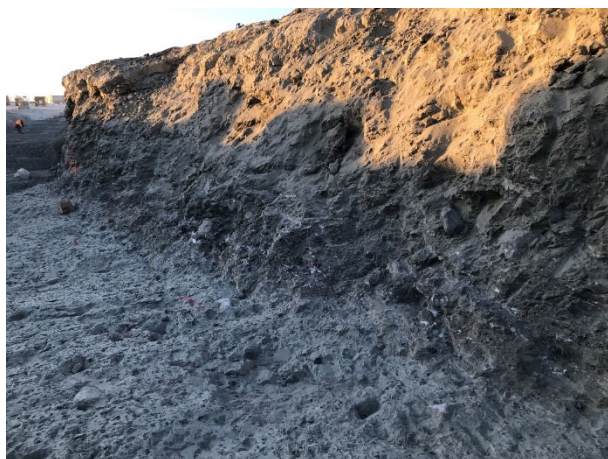
**2069:** (2021-03-13), looking W from Sta. 0+300. Ice lenses in trench wall from Sta. 0+280 to Sta. 0+300.

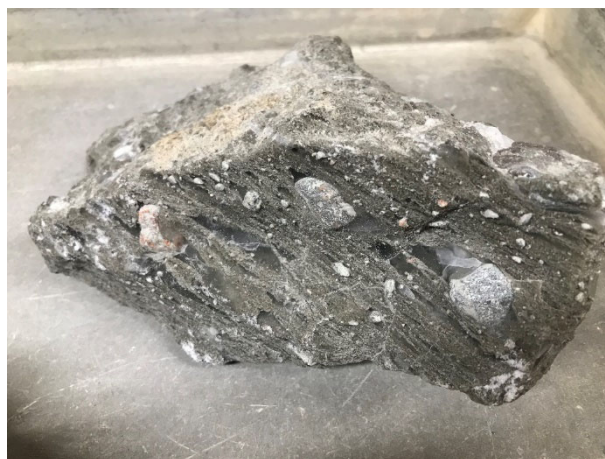
**2070:** (2021-03-13), Close-up of key trench floor sample taken from Sta. 0+300.

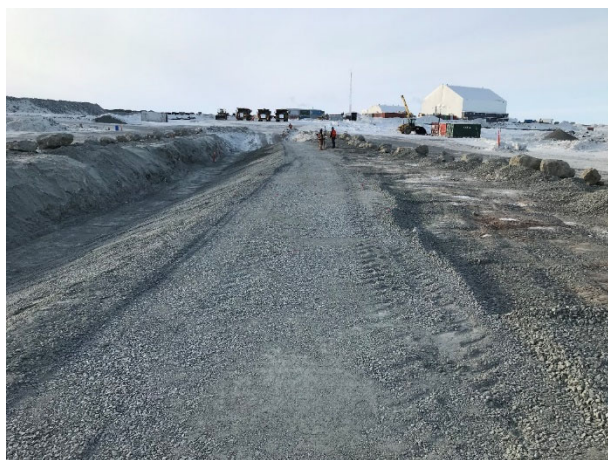
**2071:** (2021-03-14), looking W from Sta. 0+270. Zone 2A material placed to original ground level.

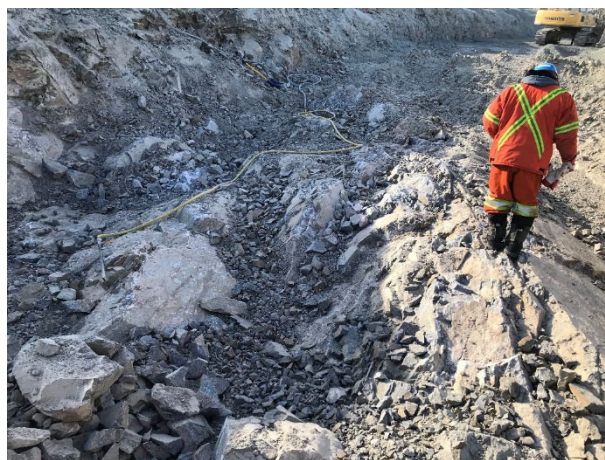
**2072:** (2021-03-14), looking E from Sta. 0+0+320. Bedrock in key trench foundation.

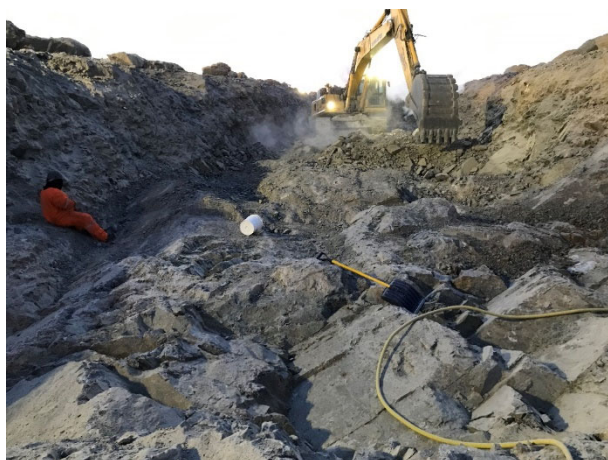
**2073:** (2021-03-15), looking W from Sta. 0+340. Bedrock in key trench.

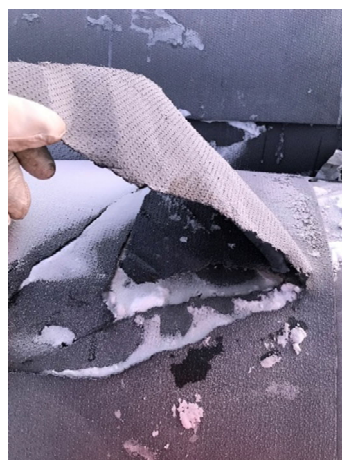
**2074:** (2021-03-15), Damage to liner roll during transport.

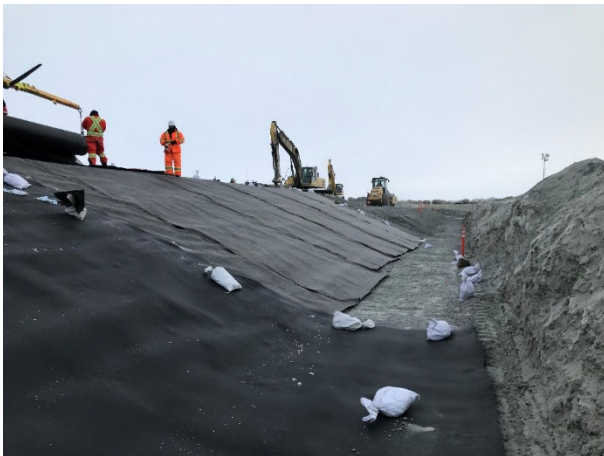
2077: (2021-03-15), looking E from Sta. 0+170. Liner installation.

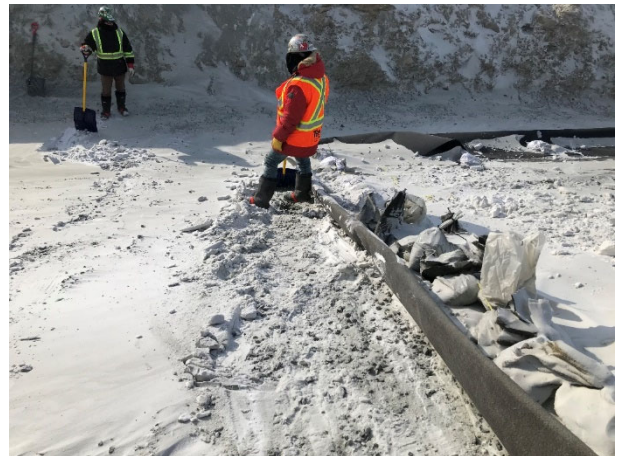
2078: (2021-03-16), looking E from Sta. 0+210. Snow on geotextile/LLDPE liner bedding surface

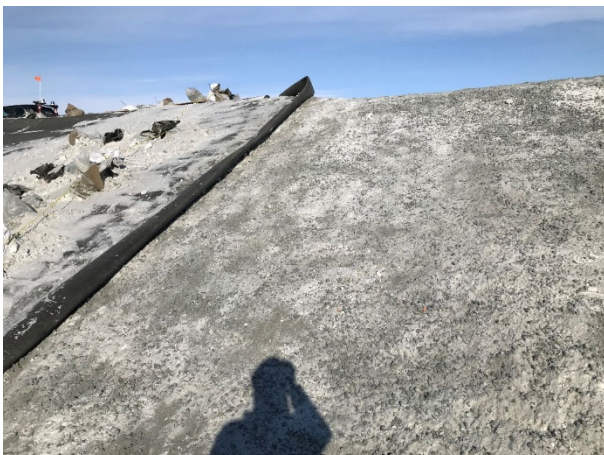
2079: (2021-03-16), looking N from Sta. 0+210. Bedding surface for geotextile/LLDPE liner after cleaning snow

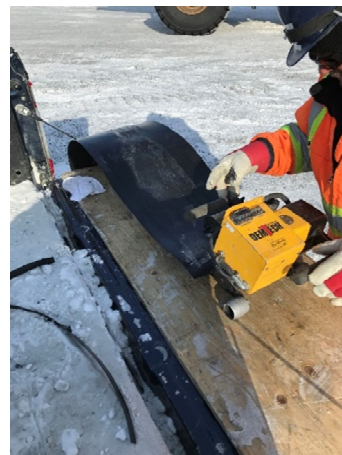
2080: (2021-03-16), Calibration weld of LLDPE liner.

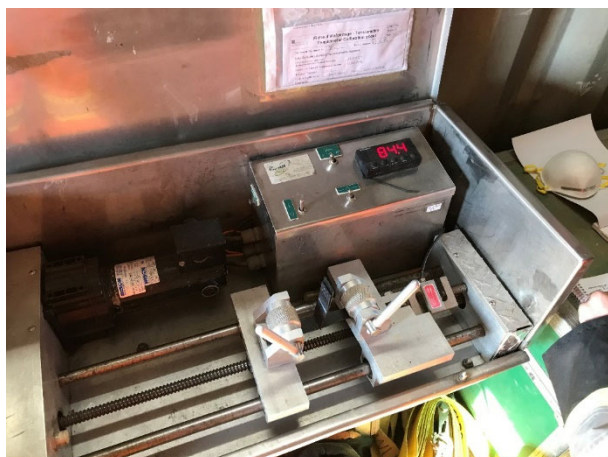
2081: (2021-03-16), Tensiometer peel test on calibration sample.

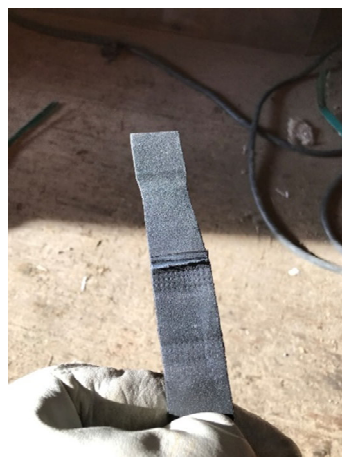
2082: (2021-03-16), Calibration peel test fracture result.

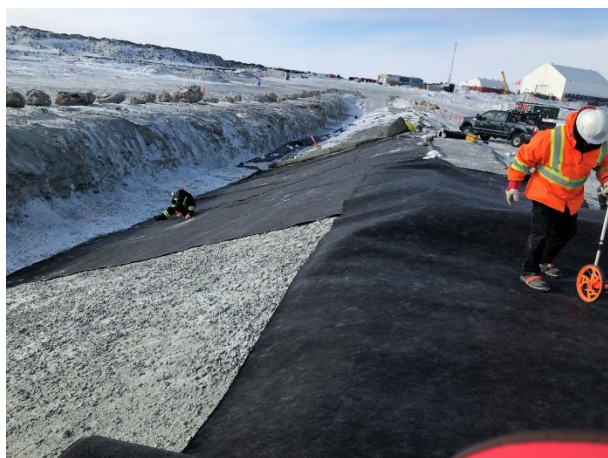
2083: (2021-03-16), looking W from Sta. 0+250. Geotextile installation on lower key trench slope

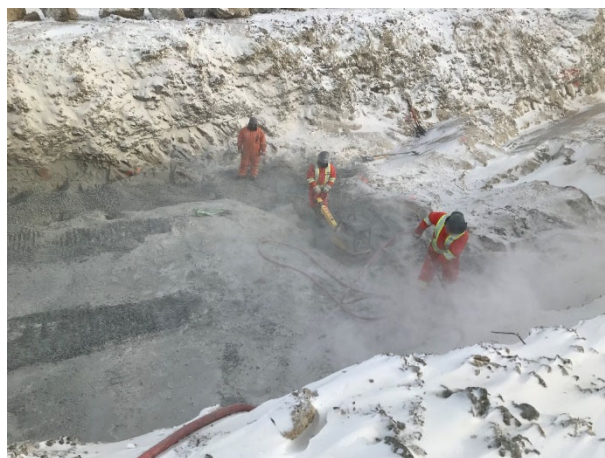
2084: (2021-03-16), looking E from Sta. 0+0+315. Cleaning, placement & compaction of Zone 2B (FFAB) material over bedrock section of key trench

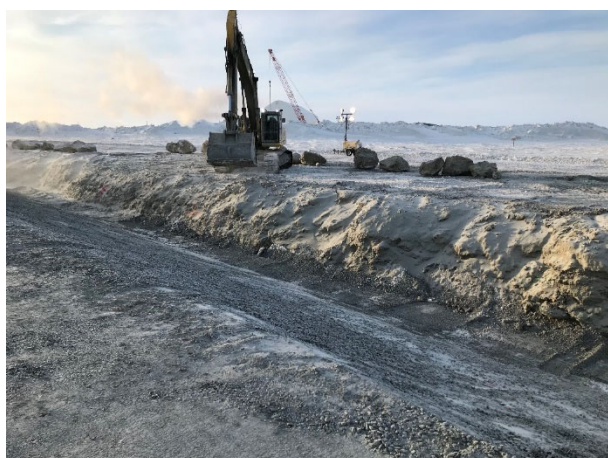
2085: (2021-03-16), looking SE from Sta. 0+240. Excavator cleaning of bedding surface for LLDPE liner at bottom of slope.

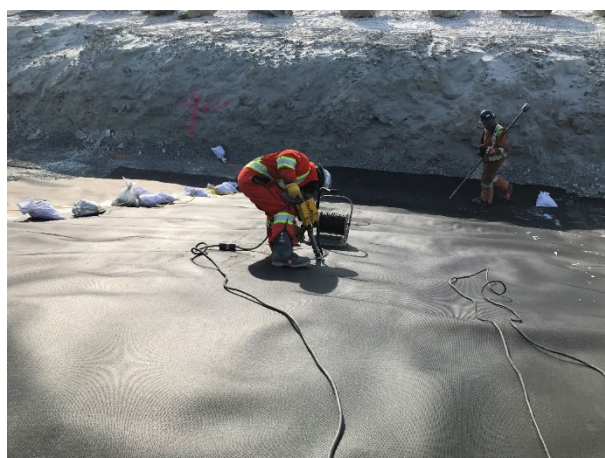
2086: (2021-03-17), looking S from Sta. 0+265. Extrusion weld of R3 on Panel 14.

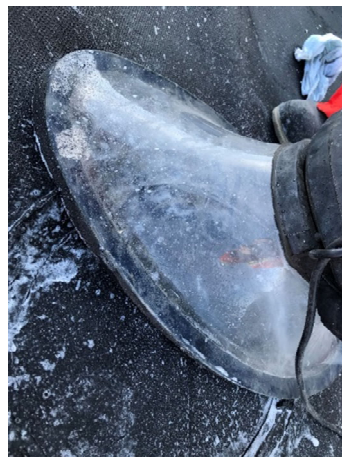
2088: (2021-03-17), looking S from Sta. 0+265. Vacuum box test on patch R3, Panel 14.

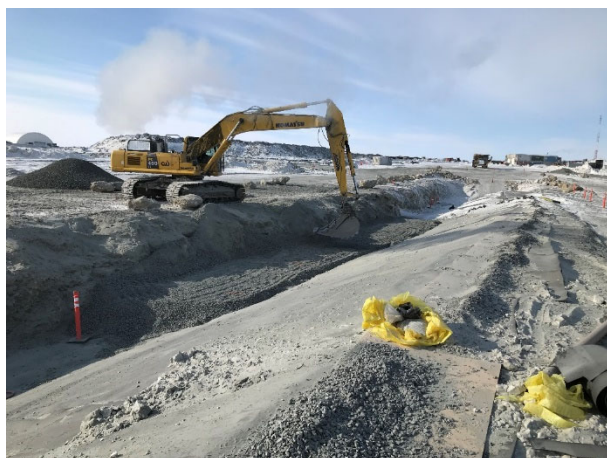
2089: (2021-03-17), looking W from Sta. 0+200. Placement of Zone 2B (FFAB) over LLDPE liner.

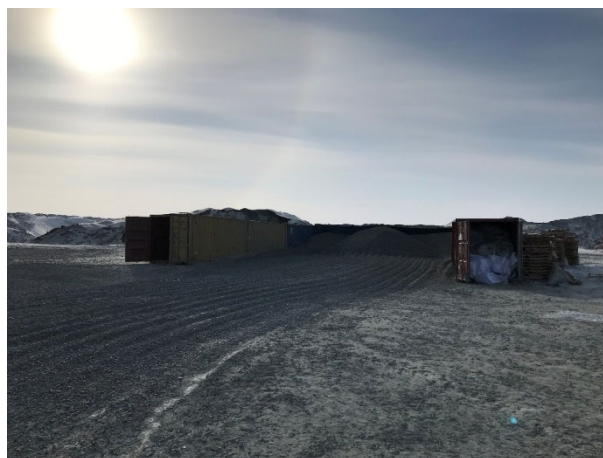
2090: (2021-03-17), looking E at Mixing Station. Stockpile of Zone 2B FFAB material.

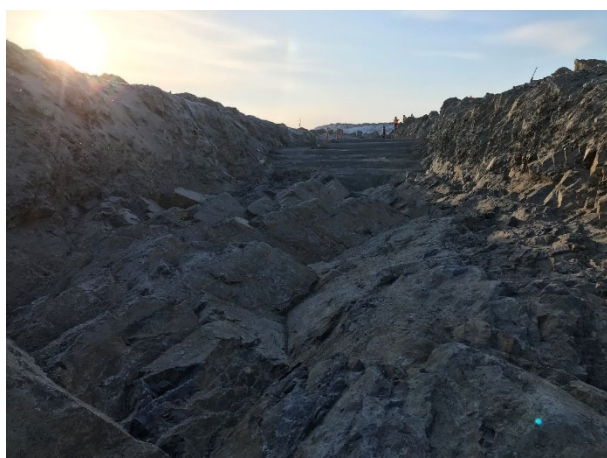
2091: (2021-03-17), looking W from Sta. 0+377. Bedrock in key trench foundation approved for placement of Zone 2B material.

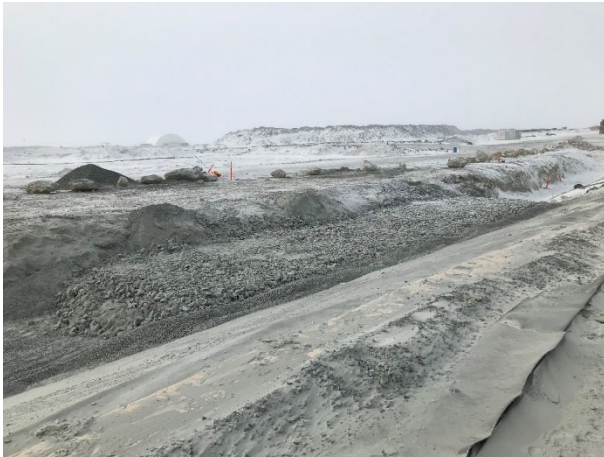
**2093: (2021-03-18), looking SW from Sta. 0+320.  
Placement of Zone 4 on top of Zone 2B overlying liner.**

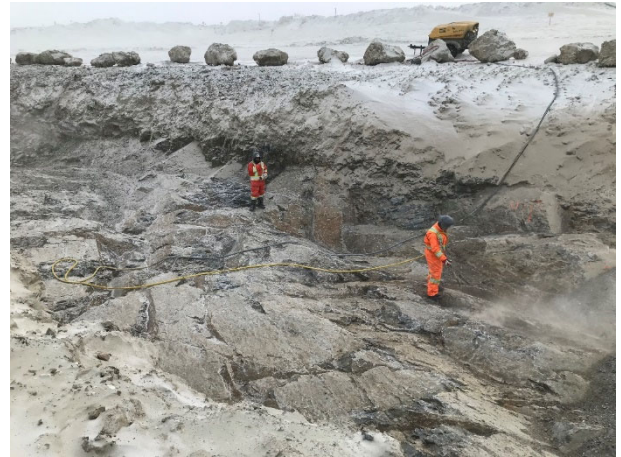
**2094: (2021-03-18), looking SE from Sta. 0+372.  
Cleaning of bedrock surface in key trench.**

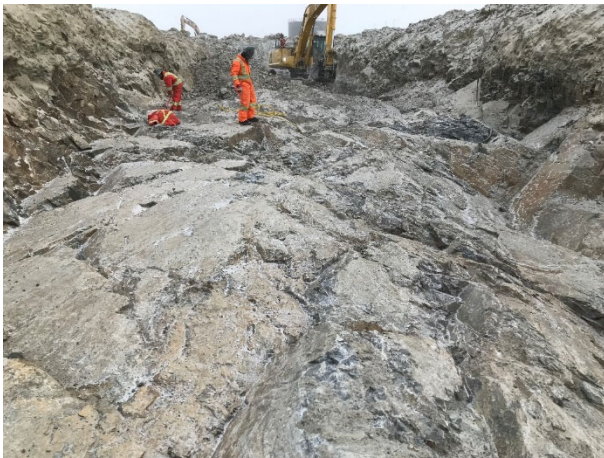
**2095: (2021-03-18), looking E from Sta. 0+377.  
Approved key trench foundation, Sta. 0+377 to 0+388.**

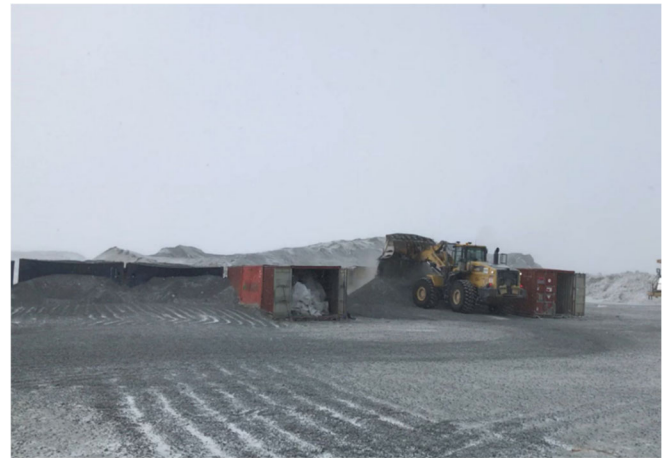
**2096: (2021-03-18), looking E at Mixing Station.  
Additional bentonite mixing station set up to mix 4% and 6% bentonite FFAB separately.**
