**APPENDIX C**

# Construction Photographs

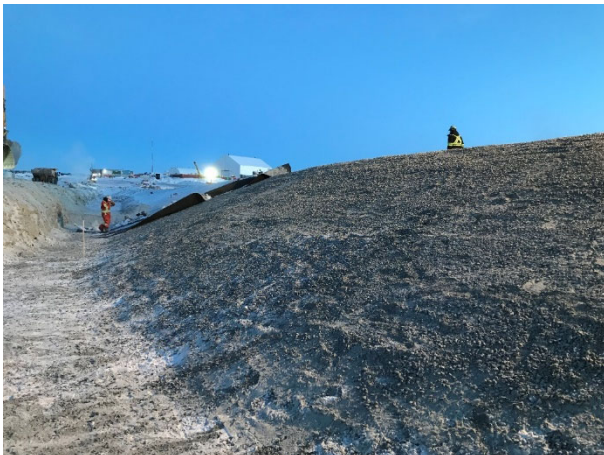
**2097: (2021-03-19), looking W from Sta. 0+315.  
Approved bedding surface for  
geotextile/geomembrane.**

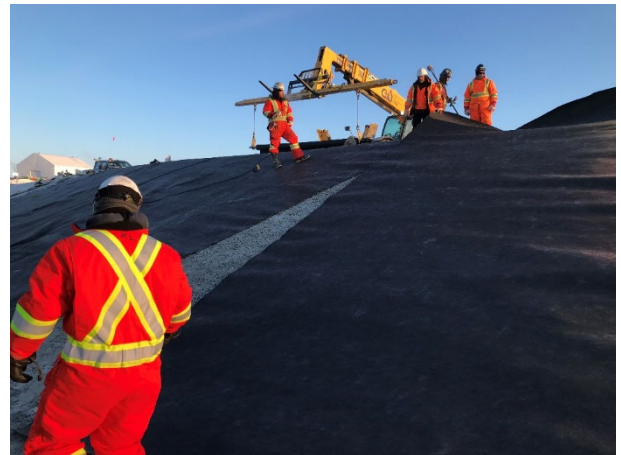
**2098: (2021-03-19), looking NW from Sta. 0+310.  
Installation of geotextile under LLDPE liner.**

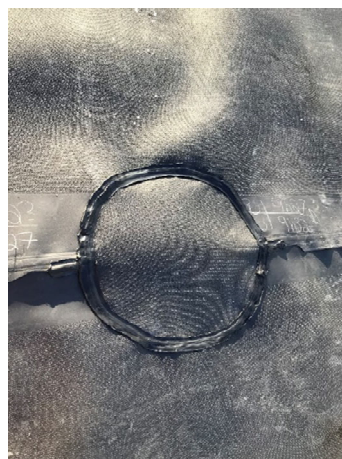
2100: (2021-03-19), looking S from Sta. 0+310. Extrusion welded patch R4 on seam P16/17

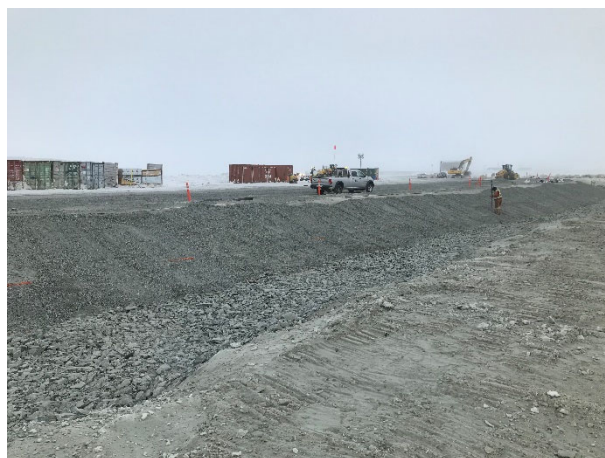
2102: (2021-03-20), looking NE from Sta. 0+165. Zone 2A and Zone 4 on top of LLDPE liner, Sta. 0+165 to Sta. 0+300.

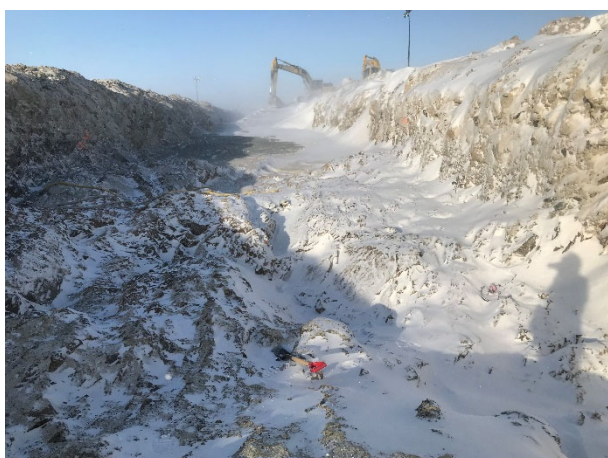
2103: (2021-03-21), looking W from Sta. 0+423. Key trench bedrock foundation from Sta. 0+423 to Sta. 0+445.

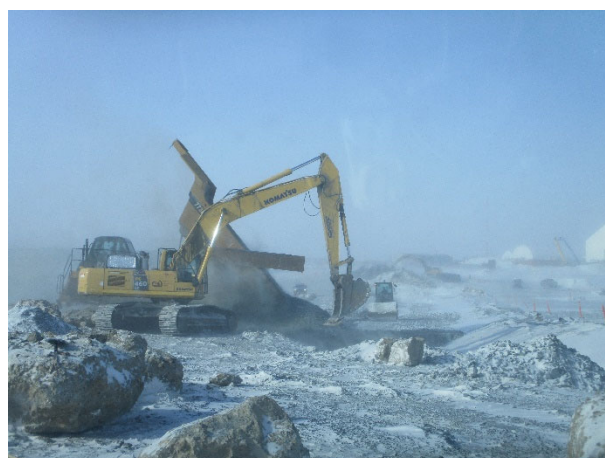
2104: (2021-03-21), looking W from Sta. 0+300. Placement of Zone 2B in key trench.

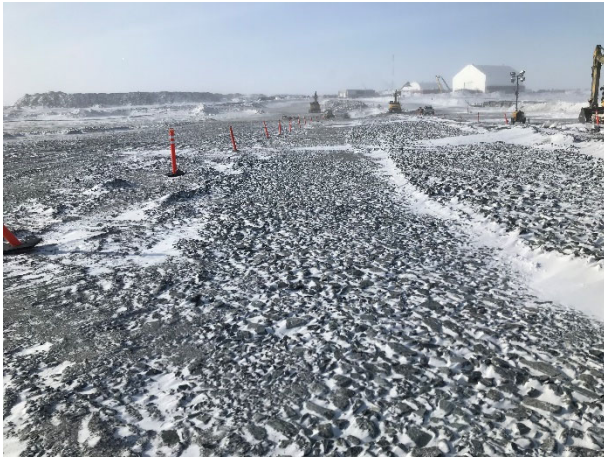
**2105: (2021-03-22), looking W from Sta. 0+0+165. Approved downstream dam footprint foundation between Sta. 0+165 and Sta. 0+318.**

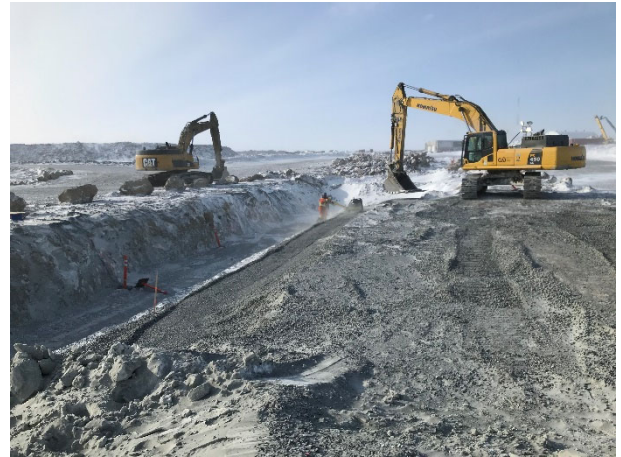
**2106: (2021-03-22), looking W from Sta. 0+130. Rebuilding over excavated section between Sta. 0+130 to 0+160.**

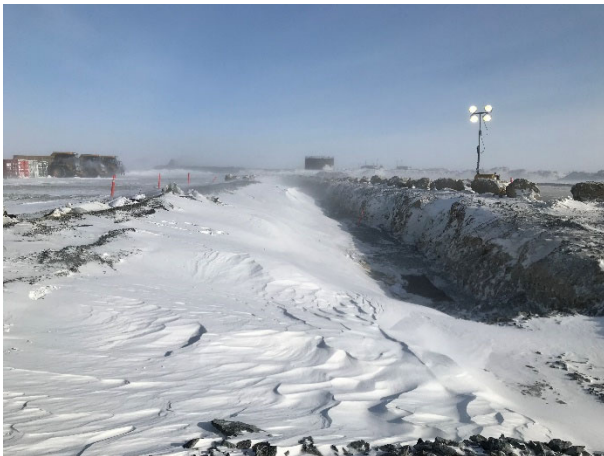
**2107: (2021-03-22), looking W from Sta. 0+450. Key trench filled in with snow.**

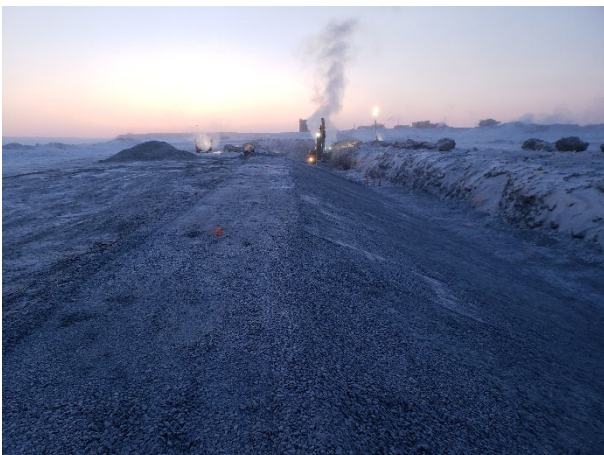
**2111: (2021-03-24), looking E from Sta. 0+315. Fill placement of Zone 2B material under liner.**

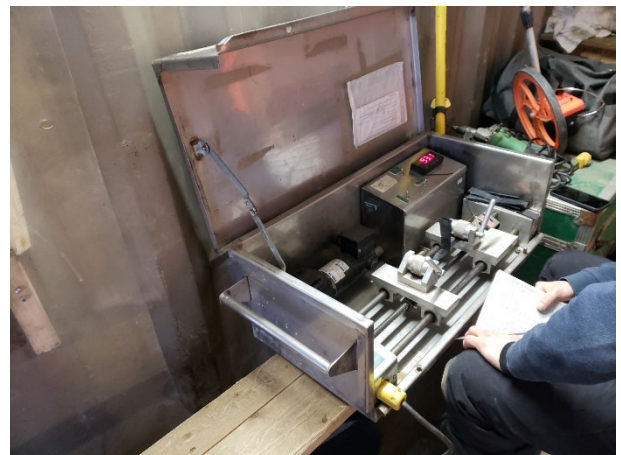
**2112: (2021-03-24) Liner QC conducting first calibration test at 7 AM, loads at failure in peel and shear were greater than minimum values presented in Technical Specifications.**

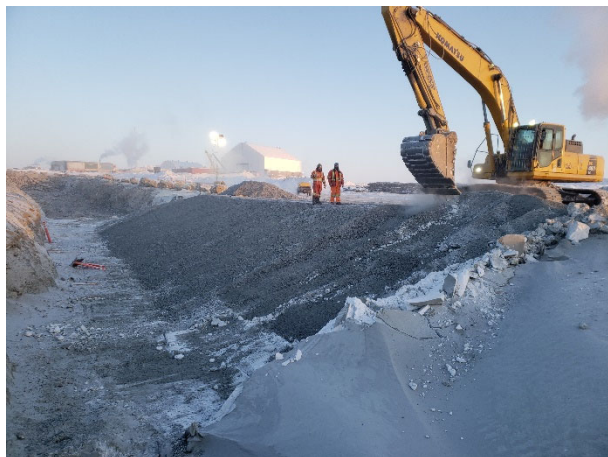
**2113: (2021-03-24), looking NW from Sta. 0+175. Excavator shaping Zone 2A to design lines at approx. Sta. 0+175.**

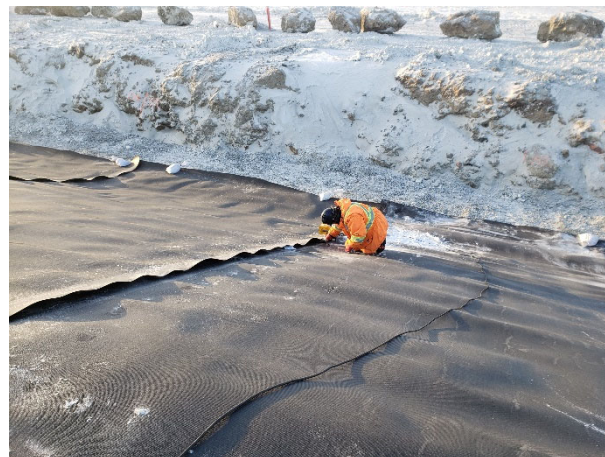
**2114: (2021-03-24), looking S from Sta. 0+320. FC liner welding LLDPE liner Sta. 0+321 between panel seams P23/P24.**

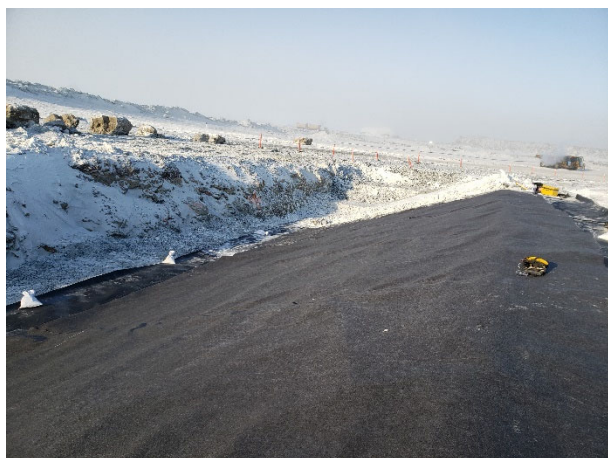
**2115: (2021-03-24), looking W from Sta. 0+335. Geotextile installed over LLDPE liner between approx. Sta. 0+335 and Sta. 0+315.**

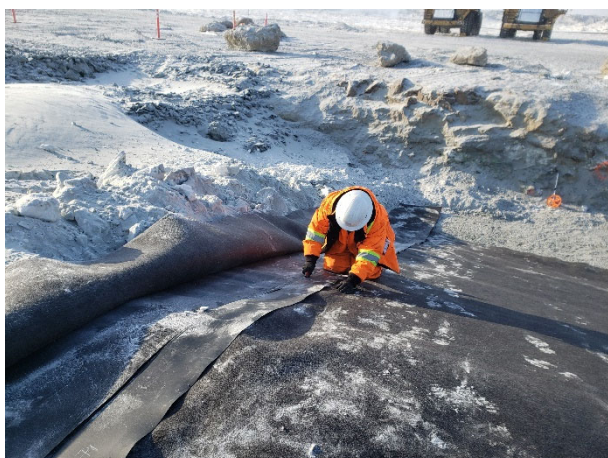
**2117: (2021-03-24), looking S from Sta. 0+170. FC liner removing 'smooth' portion of panel P01 at approx. Sta. 0+170 due to damage along seam caused by excavator during snow removal.**

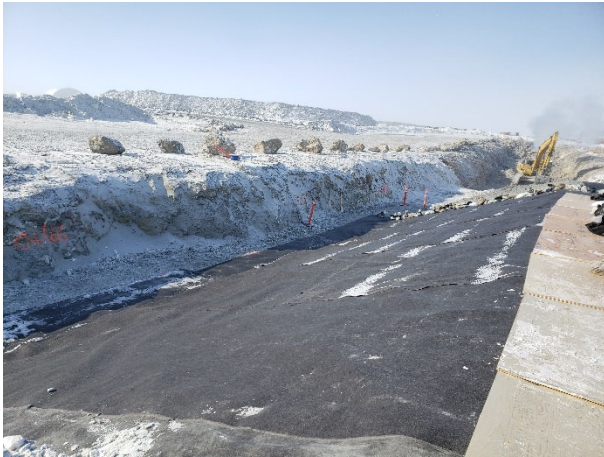
**2119: (2021-03-24), looking W from Sta. 0+165. Geotextile installed over LLDPE liner between approx. Sta.0+165 and Sta. 0+135.**

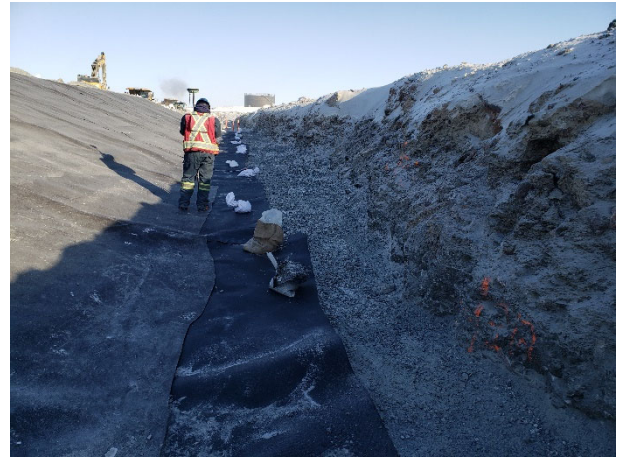
**2120: (2021-03-24), looking E from Sta. 0+315. Snow removed along lower portion of downstream trench excavation sidewall and base of Zone 2B in preparation for Zone 2B placement over installed LLDPE.**

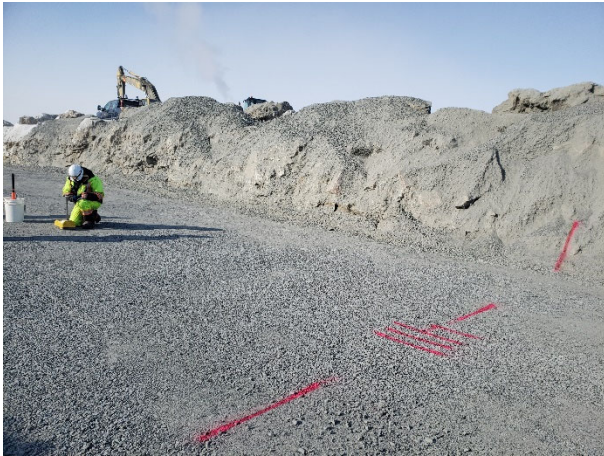
**2121: (2021-03-24), looking W from Sta. 0+405. QC conducting compaction testing on placed Zone 2B material.**

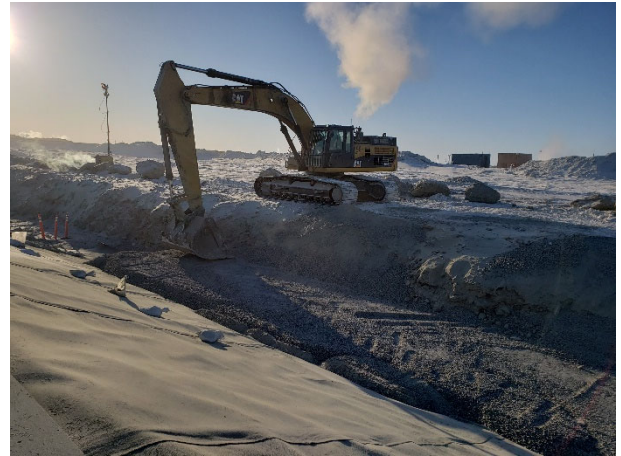
**2122: (2021-03-25), looking SE from Sta. 0+330. Approved placement of Zone 2B material over LLDPE liner.**

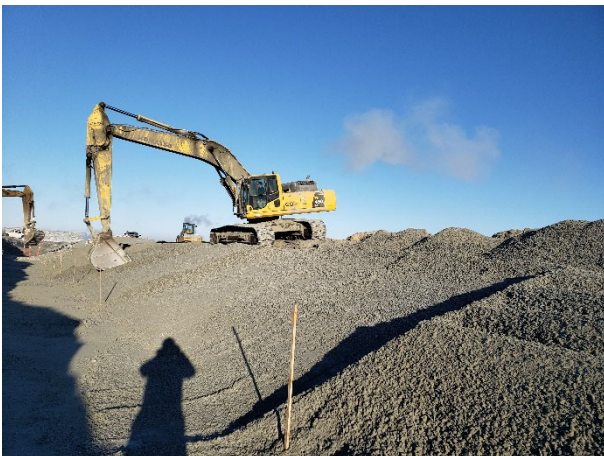
**2123: (2021-03-25), looking W from Sta. 0+395. Excavator shaping Zone 2A to design lines.**

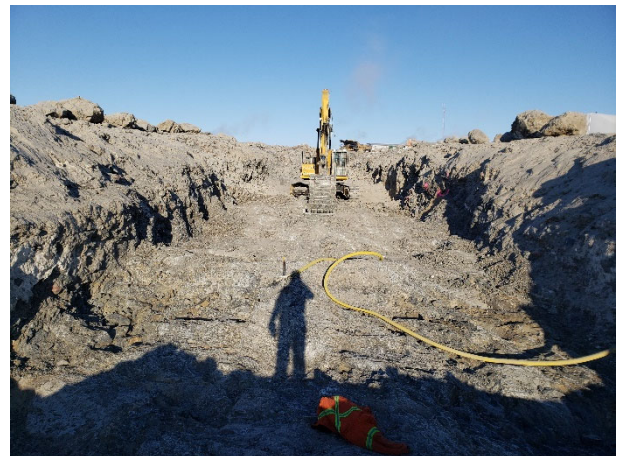
**2124: (2021-03-25), looking W from Sta. 0+110. Excavator continuing to prepare key trench foundation.**

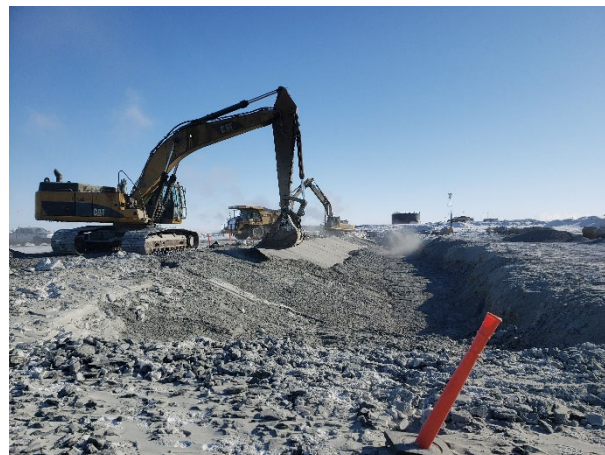
2126: (2021-03-25), looking E from Sta. 0+320. Excavator placing Zone 2A over installed LLDPE.

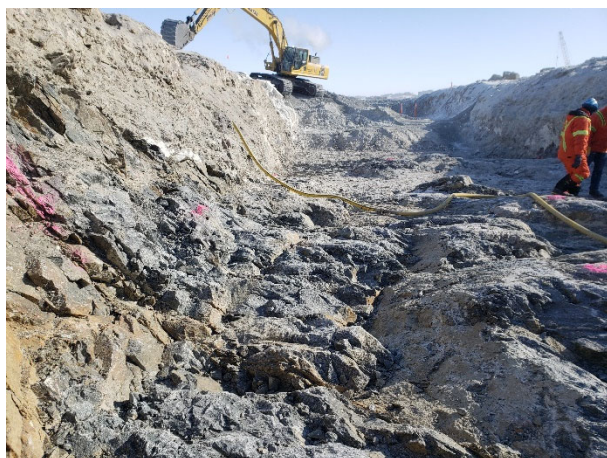
2127: (2021-03-25), looking E from Sta. 0+115. Prepared section of key trench.

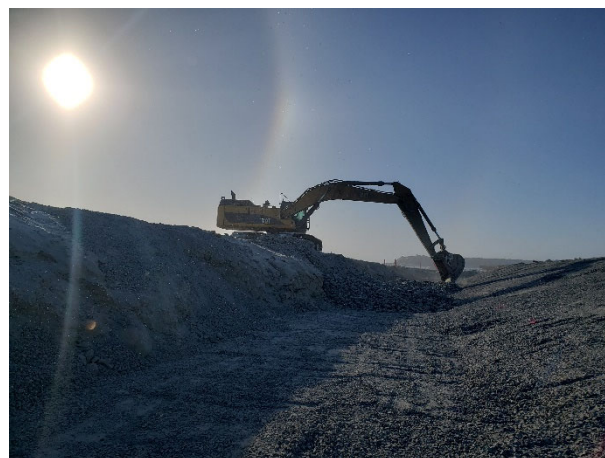
2128: (2021-03-25), looking W from Sta. 0+320. Excavator placing Zone 3 over Zone 2A/2B.

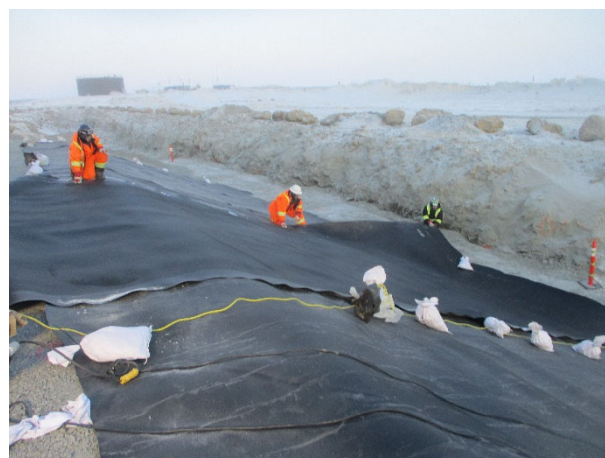
2130: (2021-03-25), looking SW from Sta. 0+150. FC liner installing LLDPE between Sta. 0+150 and Sta. 0+170.

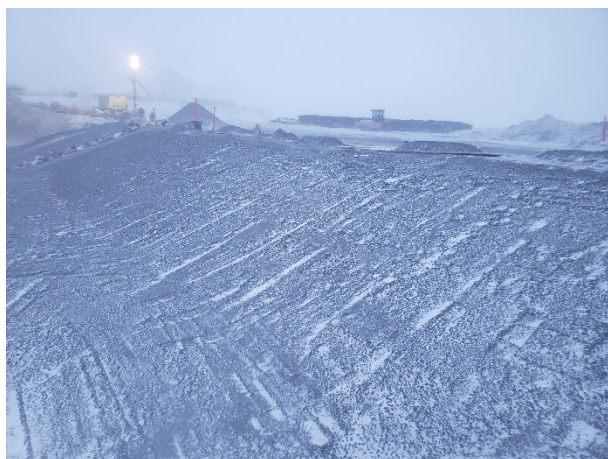
**2131: (2021-03-26), looking W from Sta. 0+180.**  
Approved placement of Zone 2A material over LLDPE liner.

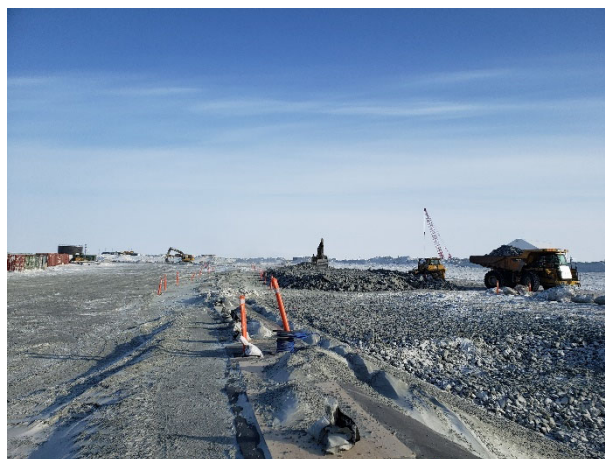
**2132: (2021-03-26), looking E from Sta. 0+200.**  
Excavator placing Zone 1 rockfill within footprint of downstream shell.

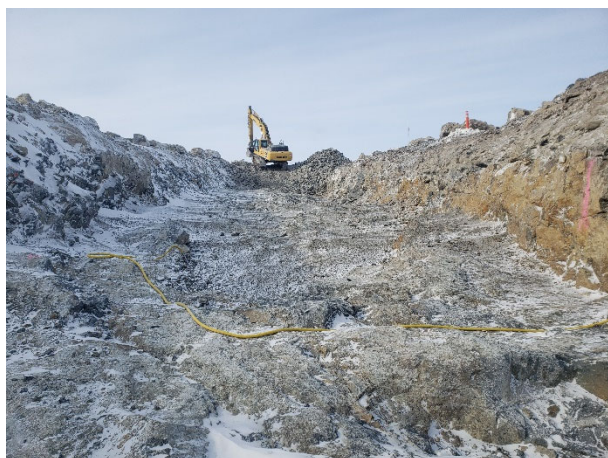
**2133: (2021-03-26), looking W from Sta. 0+060.**  
Excavator continuing to prepare key trench foundation.

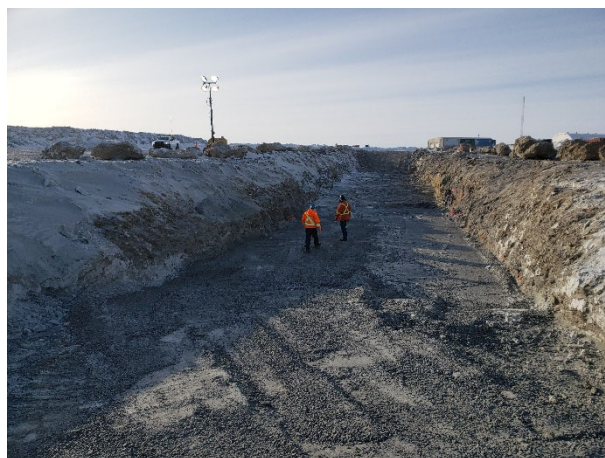
**2134: (2021-03-26), looking W from Sta. 0+130.** Snow removed over previously placed Zone 2B in preparation for additional placement during nightshift.

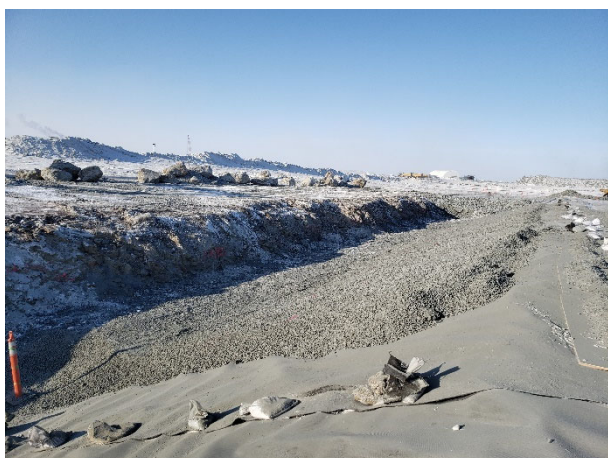
**2135: (2021-03-27), looking W from Sta. 0+400.**  
Approved placement of Zone 2A material over LLDPE liner.

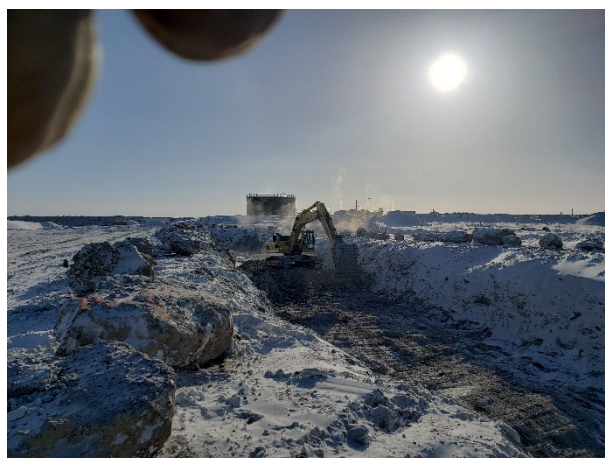
**2136: (2021-03-27), looking E from Sta. 0+450.**  
Excavator preparing key trench foundation.

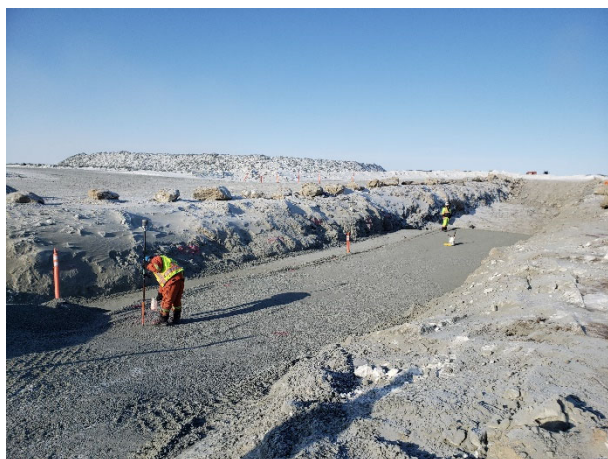
**2137: (2021-03-27), looking SW from Sta. 0+110. QC representative conducting PNG testing on placed Zone 2A material.**

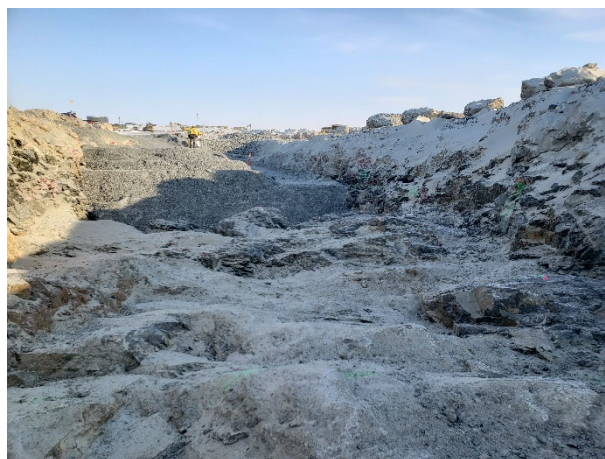
**2138: (2021-03-27), looking E from Sta. 0+085. Approved section of key trench foundation.**

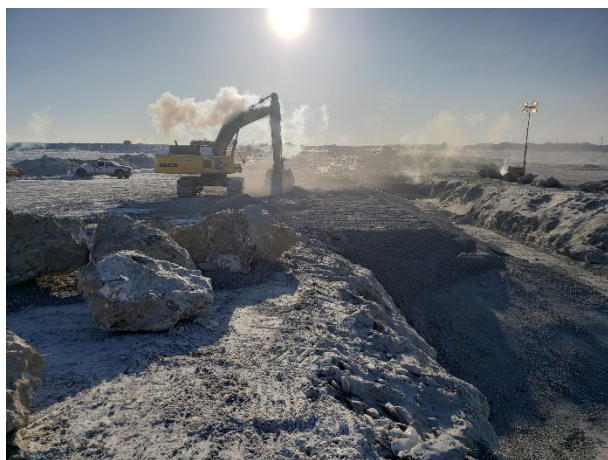
**2139: (2021-03-28), looking E from Sta. 0+130. Excavator placing lift of Zone 2A material.**

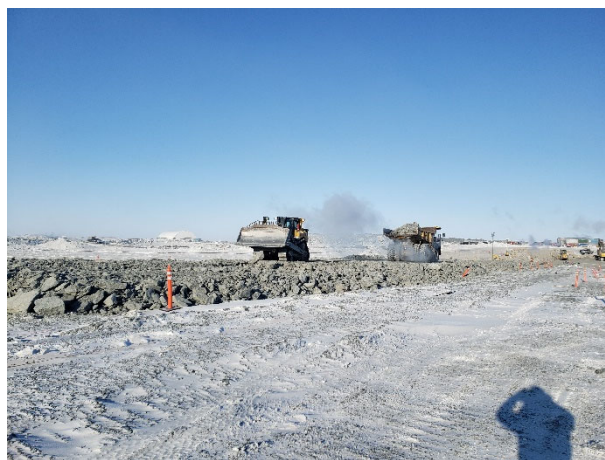
**2140: (2021-03-28), looking SW from Sta. 0+260. KCG placing Zone 1 for construction of downstream shell.**

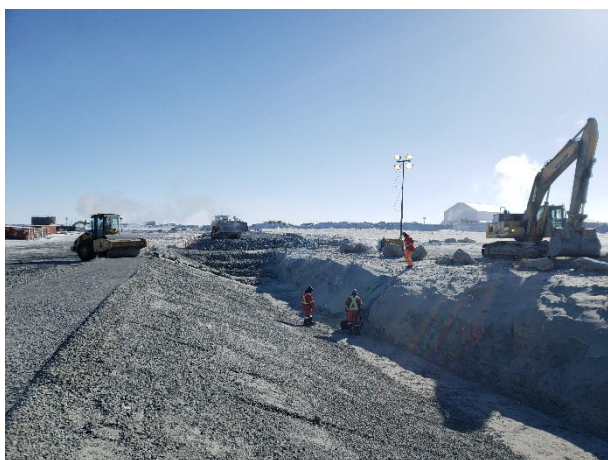
**2141: (2021-03-28), looking E from Sta. 0+135. KCG labourers removing snow along toe of Zone 2A in advance of LLDPE installation.**

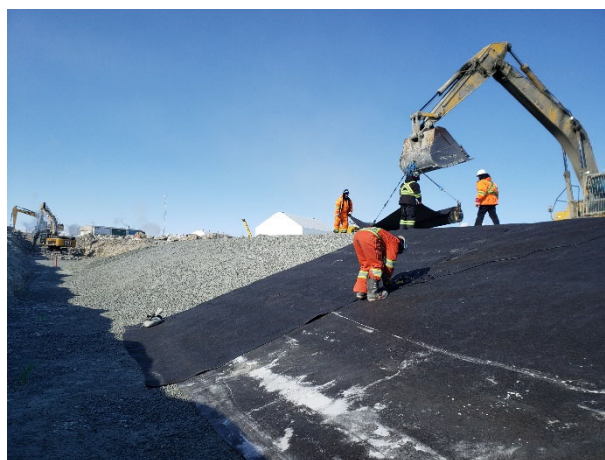
**2142: (2021-03-28), looking NW from Sta. 0+140. FC liner installing geotextile.**

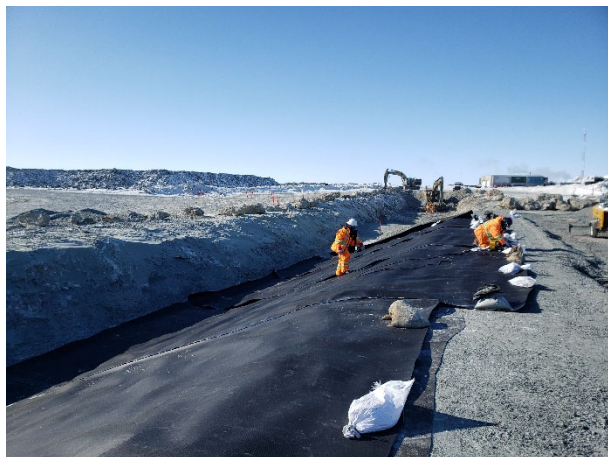
**2143: (2021-03-28), looking W from Sta. 0+135. FC liner installing LLDPE liner.**

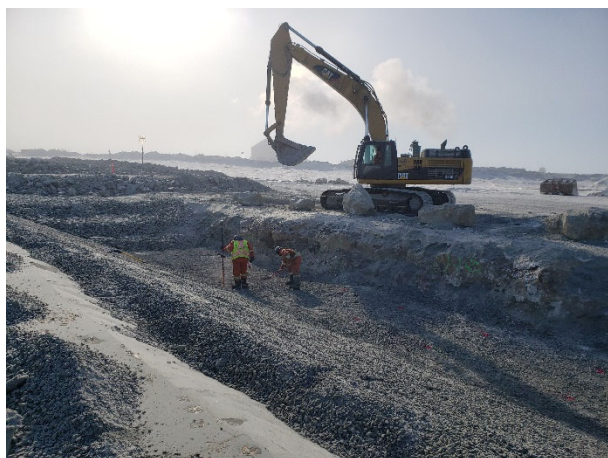
**2145: (2021-03-29), looking SE from Sta. 0+140. Excavator removing snow along crest and downstream side walls of trench excavation.**

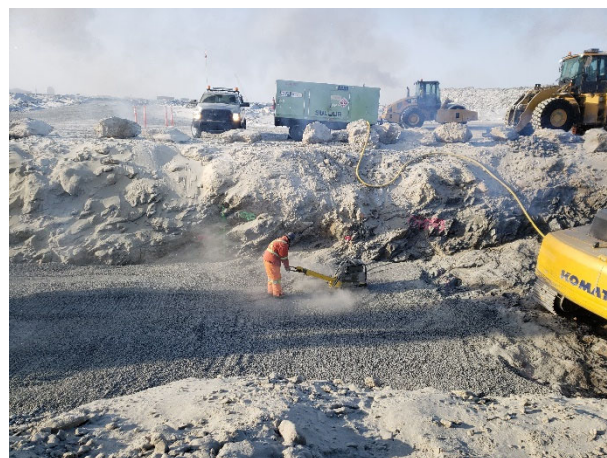
**2146: (2021-03-29), looking S from Sta. 0+085. KCG labourer using plate tamper to compact first lift of Zone 2B over bedrock.**

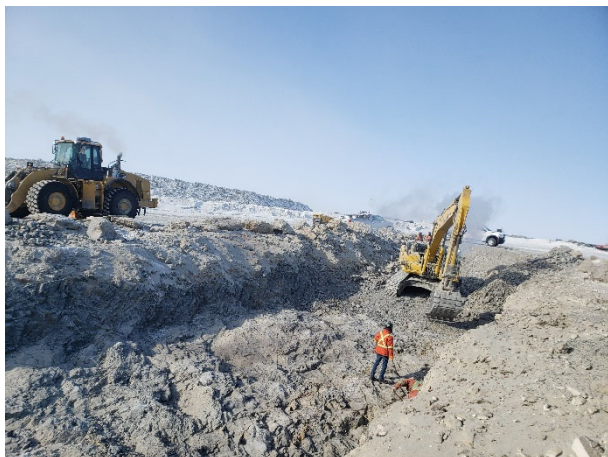
**2147: (2021-03-29), looking SW from Sta. 0+065. Excavator preparing key trench foundation.**

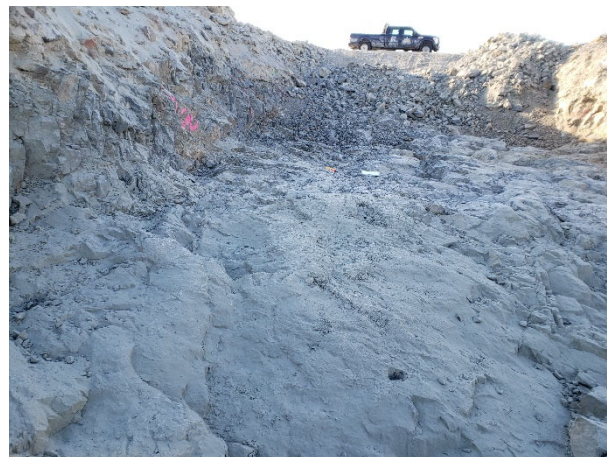
**2148: (2021-03-29), looking E from Sta. 0+080. Prepared section of key trench foundation.**

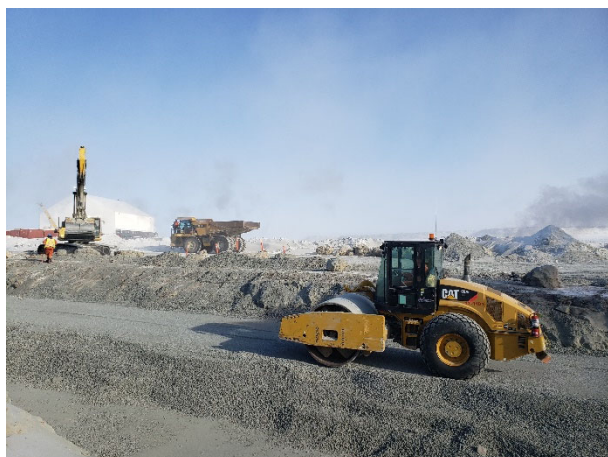
2149: (2021-03-29), looking N from Sta. 0+100. KCG utilizing smooth drum roller to compact placed Zone 2A material.

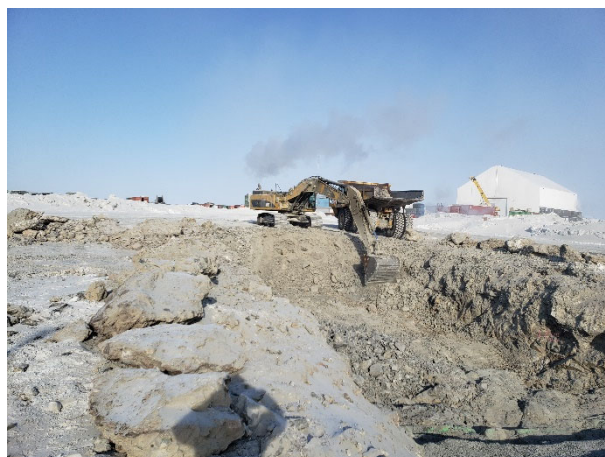
2150: (2021-03-30), looking NW from Sta. 0+060. Excavator removing blasted material to prepare key trench foundation.

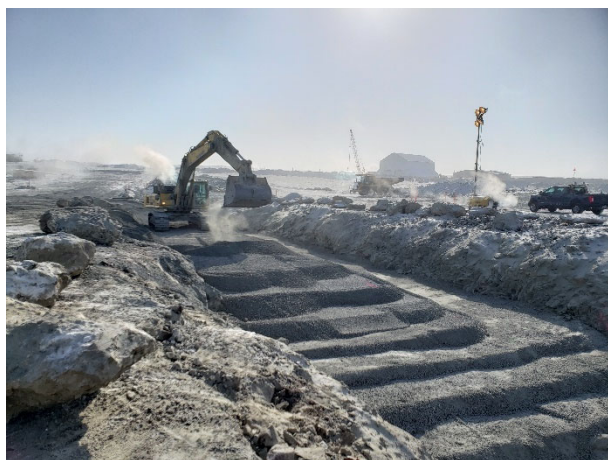
2151: (2021-03-30), looking SE from Sta. 0+090. Excavator placing Zone 2A material.

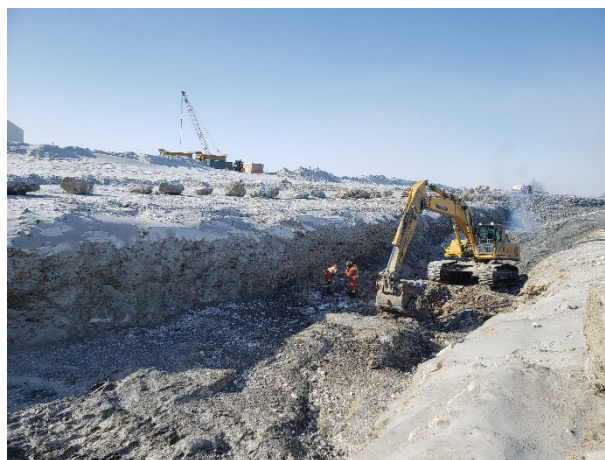
2152: (2021-03-30), looking SW from Sta. 0+435. KCG labourers removing ice and snow within footprint of key trench.

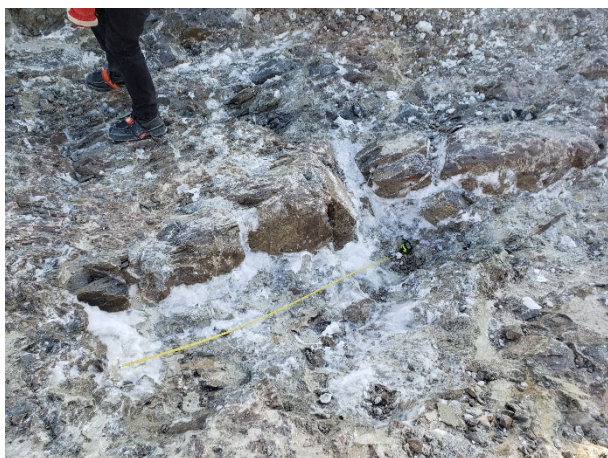
2153: (2021-03-30), looking S from Sta. 0+438. Ice pocket observed in bedrock along base of key trench.

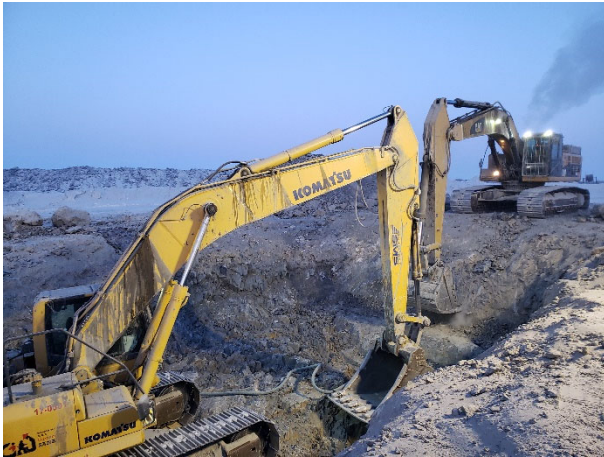
**2155: (2021-03-31), looking SW from Sta. 0+055. KCG continuing to clean key trench between Sta. 0+055 and Sta. 0+045.**

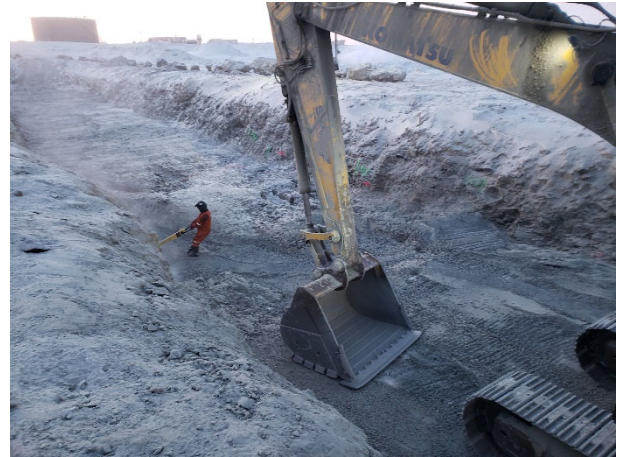
**2156: (2021-03-31), looking SE from Sta. 0+430. KCG utilizing plate tamper to compact low spots in key trench.**

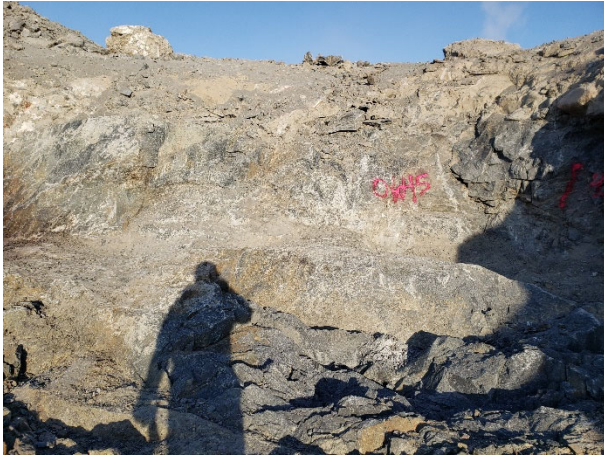
**2157: (2021-03-31), looking W from Sta. 0+050. Approved section of key trench foundation.**

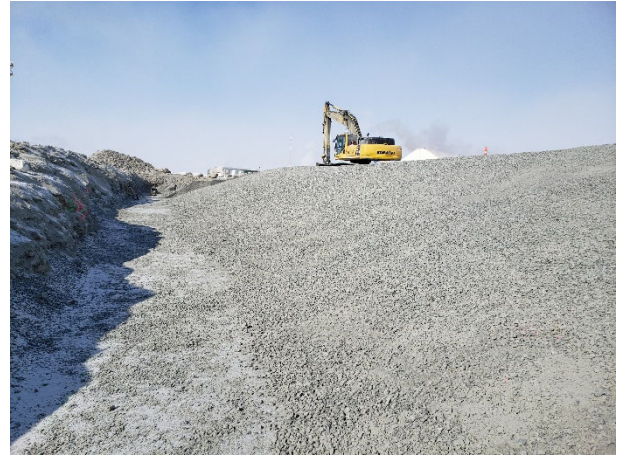
**2158: (2021-03-31), looking W from Sta. 0+100. Approved section of Zone 2A/2B under liner.**

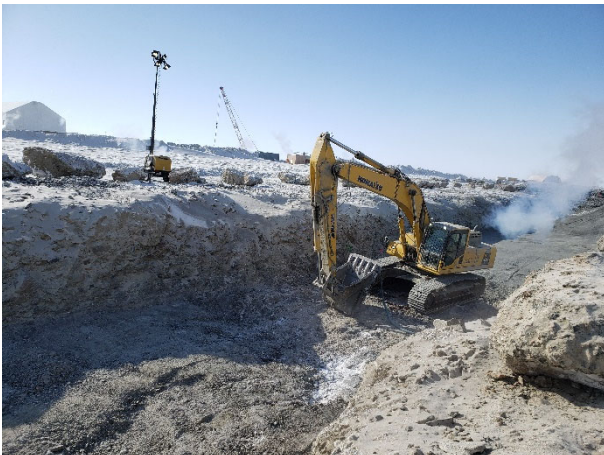
**2159: (2021-03-31), looking SW from Sta. 0+450. Excavator utilizing blow pipe to clean key trench foundation.**

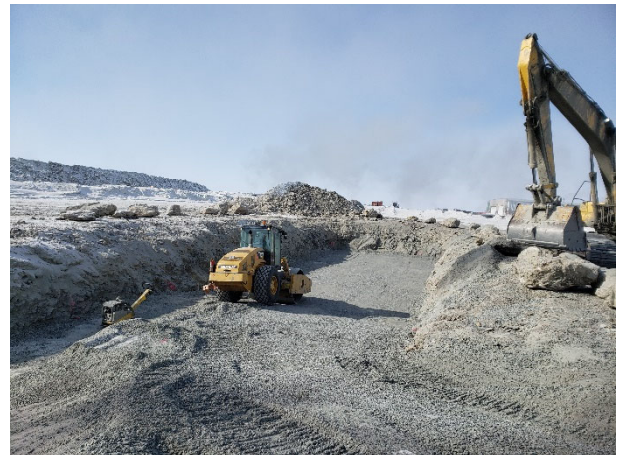
**2160: (2021-03-31), looking W from Sta. 0+65. KCG compacting placed lift of Zone 2B material.**

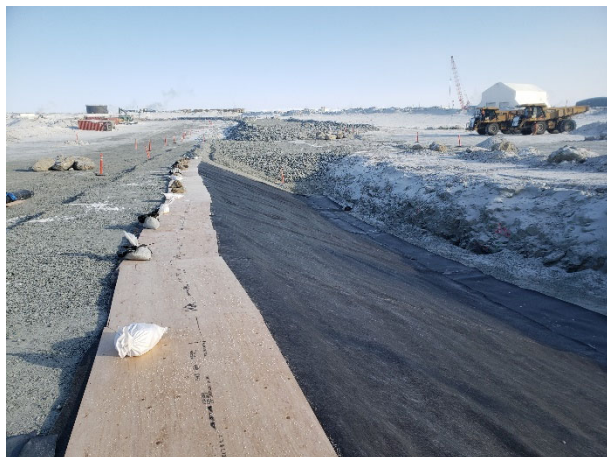
2161: (2021-03-31), looking E from Sta. 0+089. LLDPE liner installed between approx. Sta. 0+120 and Sta. 0+089.

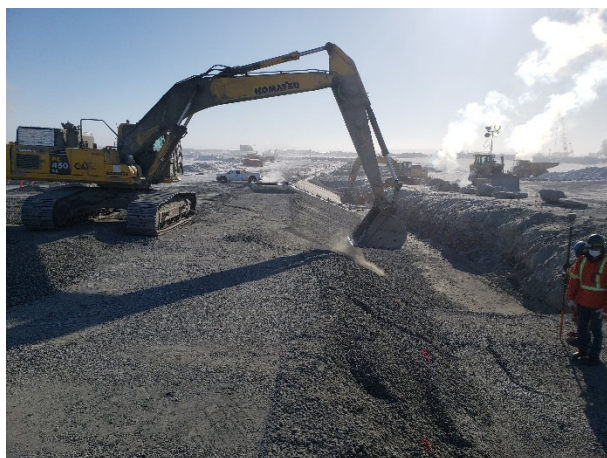
2163: (2021-04-01), looking E from Sta. 0+050. Excavator sloping Zone 2B under liner slope to design lines.

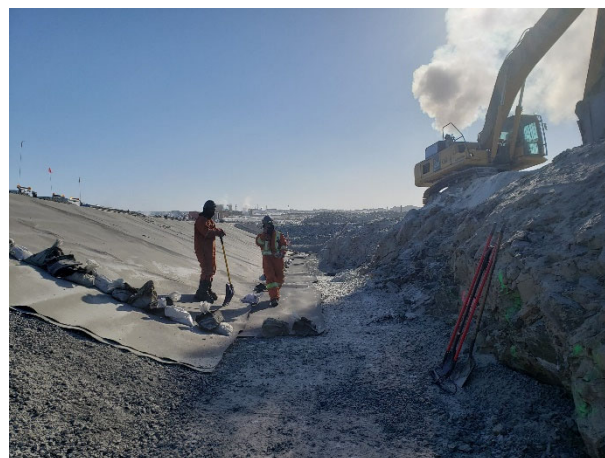
2164: (2021-04-01), looking E from Sta. 0+080. KCG removing snow along downstream key trench excavation wall.

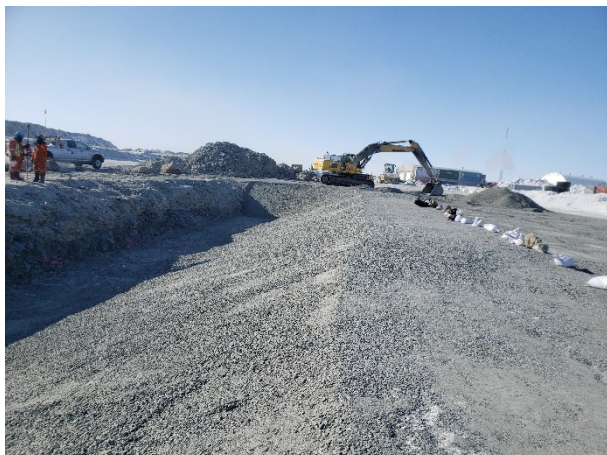
2165: (2021-04-01), looking W from Sta. 0+070. Approved placement of Zone 2A/2B under liner.

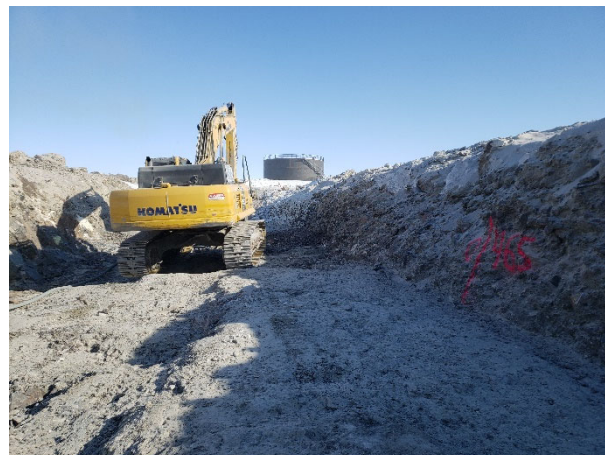
2166: (2021-04-01), looking E from Sta. 0+450. Approved section of key trench.

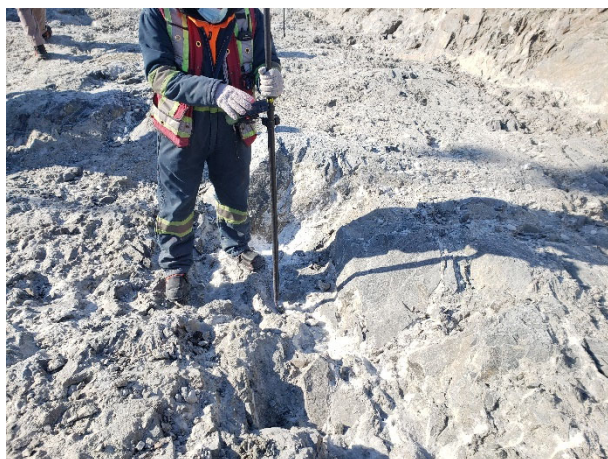
**2167: (2021-04-01), looking W from Sta. 0+455. Ice pocket 4.2 meters below ground surface.**

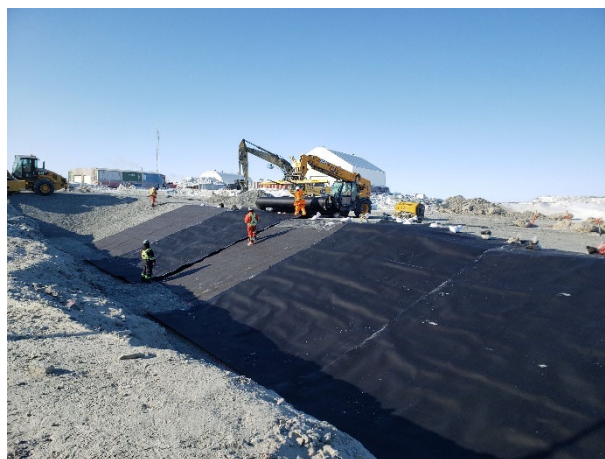
**2168: (2021-04-01), looking NW from Sta. 0+070. FC Liner installing LLDPE liner panels.**

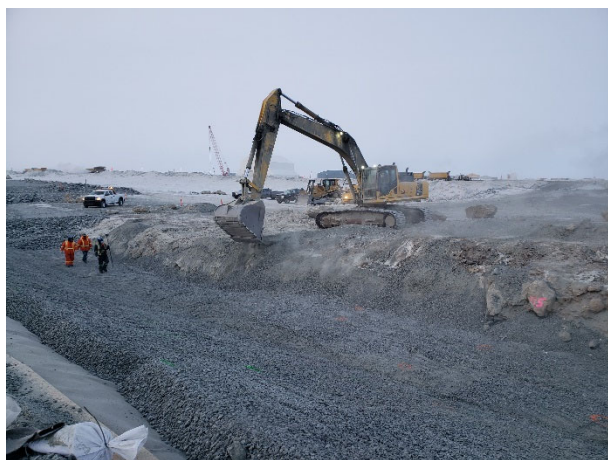
**2169: (2021-04-02), looking SE from Sta. 0+070. Komatsu excavator removing snow along downstream crest of key trench.**

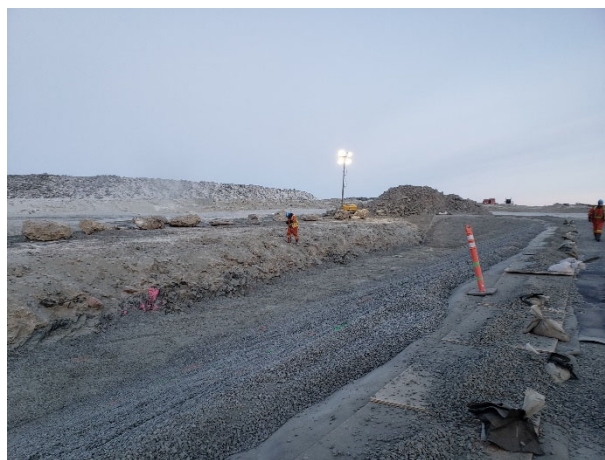
**2170: (2021-04-02), looking SW from Sta. 0+065. Approved placement of Zone 2A/2B material.**

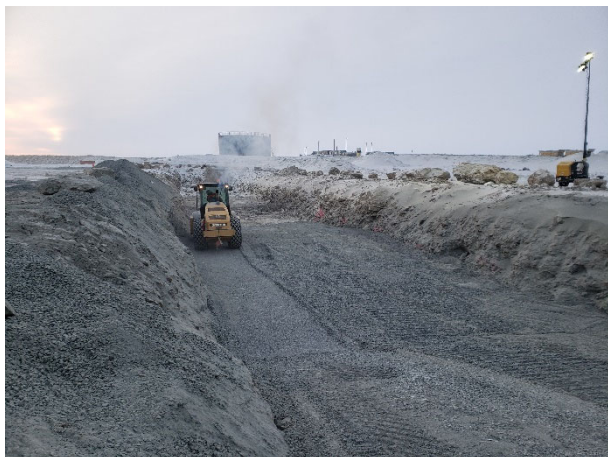
**2171: (2021-04-02), looking E from Sta. 0+460. KCG compacting placed Zone 2B material.**

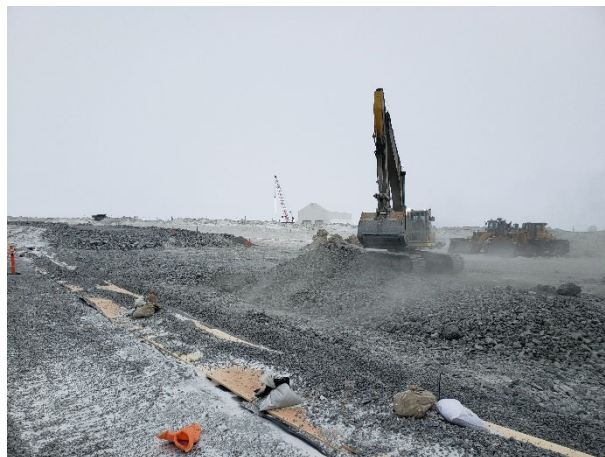
**2172: (2021-04-02), looking SE from Sta. 0+090. KCG placing Zone 3 for key trench backfill.**

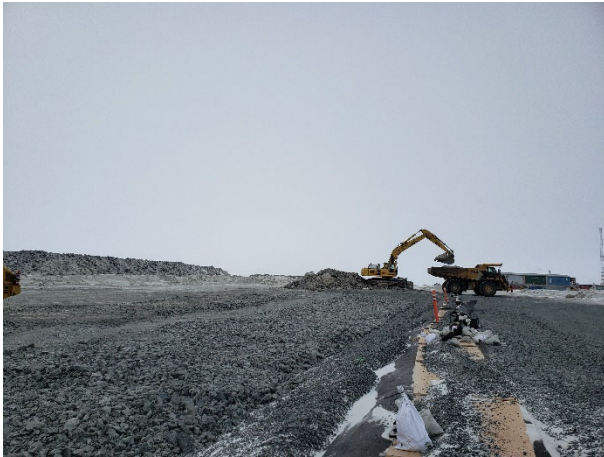
**2173: (2021-04-02), looking W from Sta. 0+040. Komatsu excavator loading rock truck with stockpiled overburden material.**

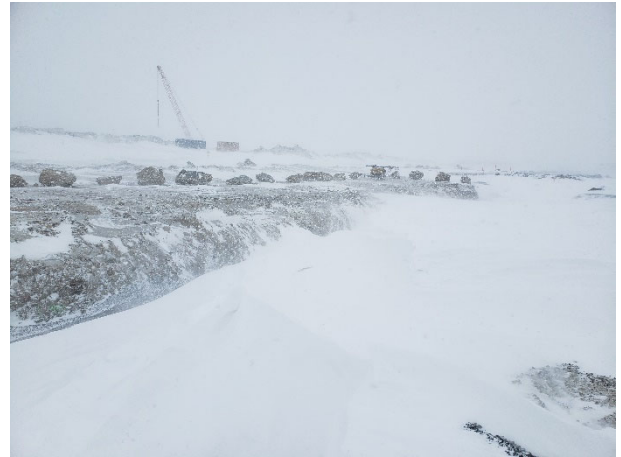
**2174: (2021-04-03), looking SW from Sta. 0+440. Key trench filled with snow following winter storm.**

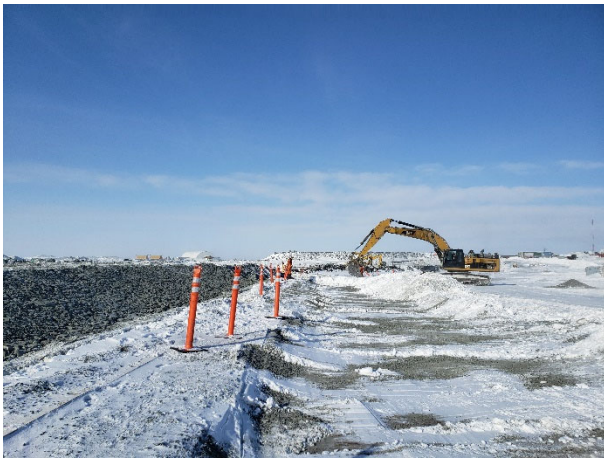
**2175: (2021-04-04), looking W from Sta. 0+320. Komatsu excavator removing snow upstream of hinge point.**

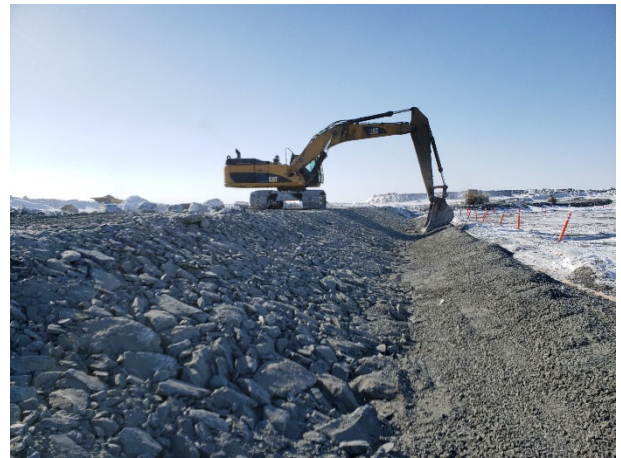
**2176: (2021-04-04), looking W from Sta. 0+360. Zone 1 rockfill sloped to design lines at approx. Sta. 0+360, view looking W.**

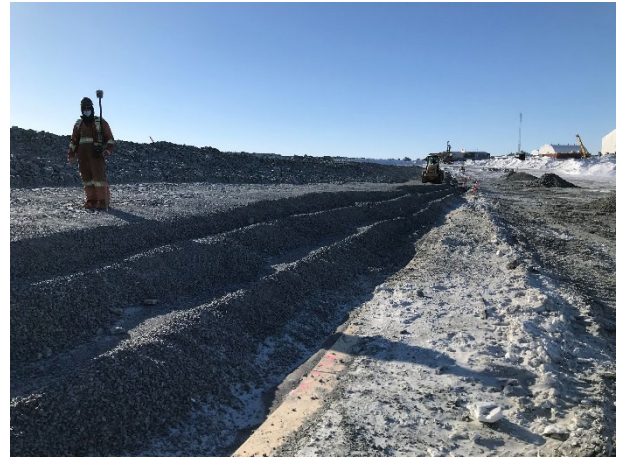
**2185: (2021-04-07), looking E from Sta. 0+465. Key trench foundation approved from Sta. 0+465 to Sta. 0+482.**

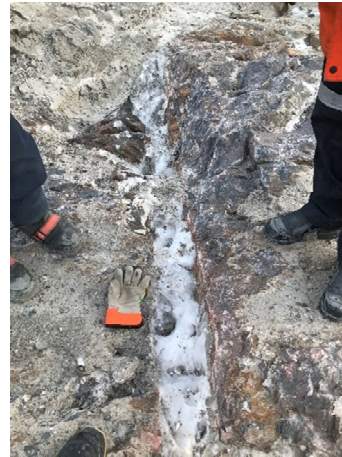
**2191: (2021-04-10), looking E from Sta. 0+482.**  
Approved key trench bedrock foundation surface, Sta. 0+482 to Sta. 0+515.

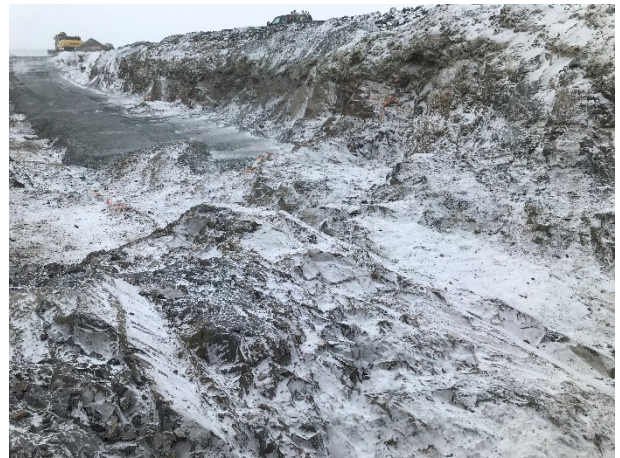
**2193: (2021-04-10), looking W from Sta. 0+515.**  
Approved key trench bedrock foundation, Sta. 0+482 to Sta. 0+515.

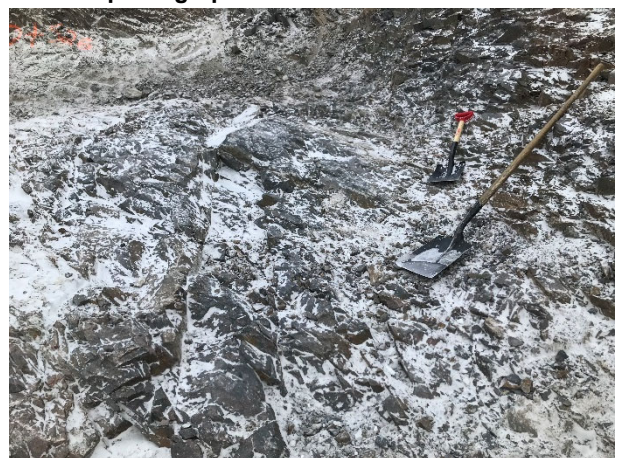
**2195: (2021-04-10), looking E from Sta. 0+515.**  
Termination of dam alignment (Eastern abutment) in key trench.

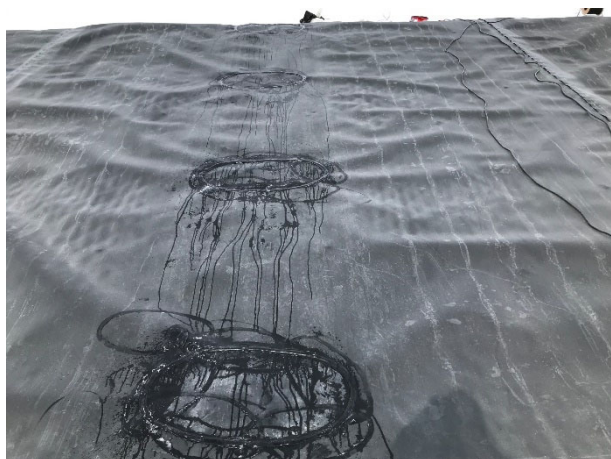
**2203: (2021-04-13), looking N from Sta. 0+420. Forklift holes on panel P59.**

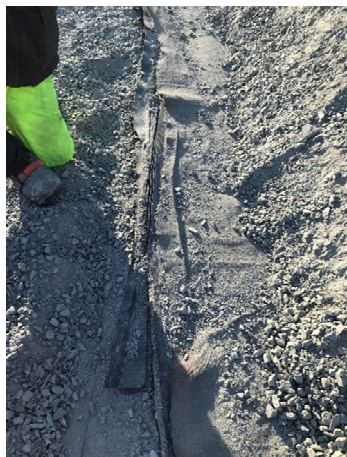
**2211: (2021-04-17), Liner trimmings showing damaged hinge weld.**

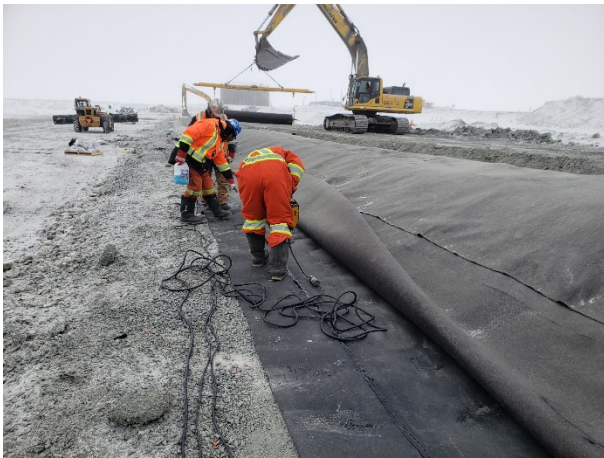
**2225: (2021-04-21), looking E from Sta. 0+500. Komatsu excavator placing Zone 2A along east abutment in advance of liner placement.**

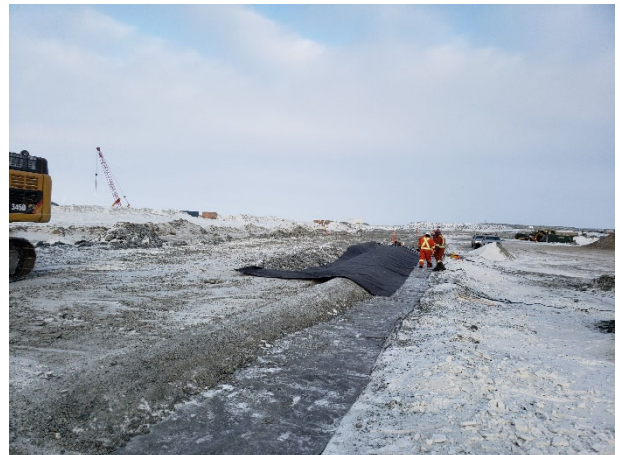
**2228: (2021-04-21), looking SW from Sta. 0+380. Komatsu excavator placing Zone 3 along dyke crest over installed LLDPE liner.**
