**APPENDIX C**

# Construction Photographs

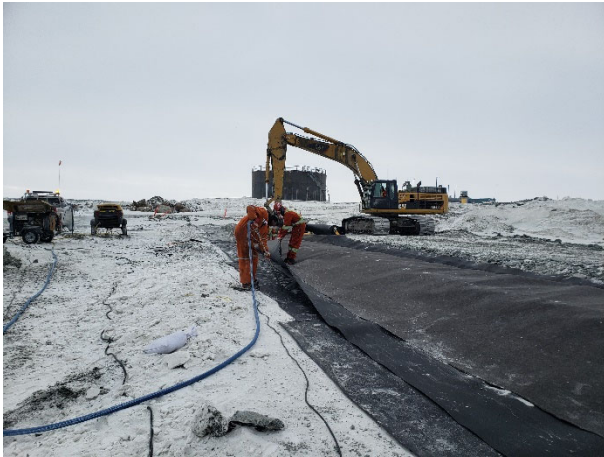
**2229: (2021-04-22), looking W from Sta. 0+490. FC liner installing geotextile over Zone 2A material.**

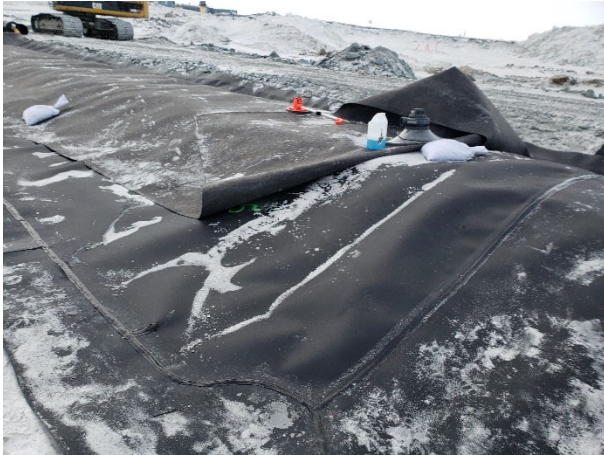
**2231: (2021-04-22), looking W from Sta. 0+050. Komatsu excavator placing Zone 2A along west abutment for upper liner slope.**

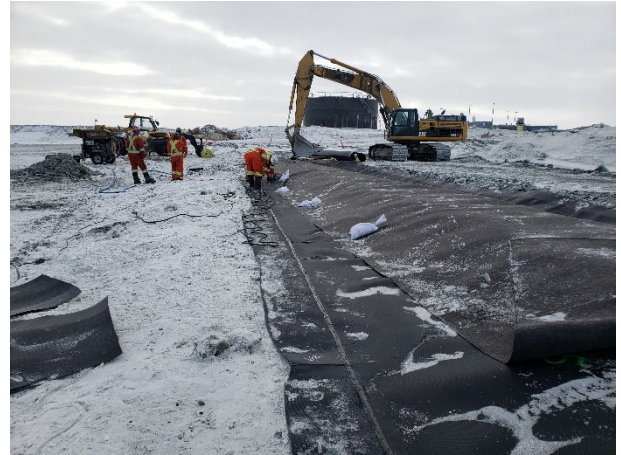
**2232: (2021-04-22), looking SE from Sta. 0+483. Extrusion weld between panels P124/P125.**

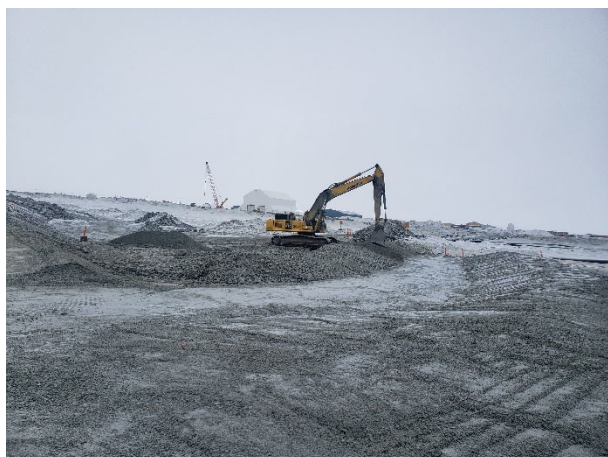
**2235: (2021-04-22), looking S from Sta. 0+080. Komatsu excavator removing snow and ice from foundation of key trench.**

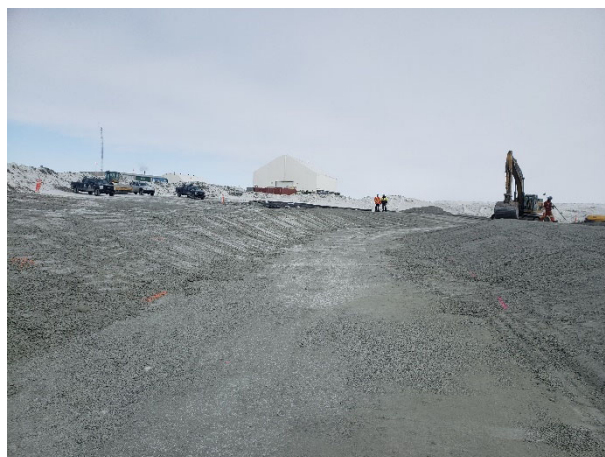
**2236: (2021-04-23), looking S from Sta. 0+080. Komatsu excavator placing Zone 2A over spillway slopes.**

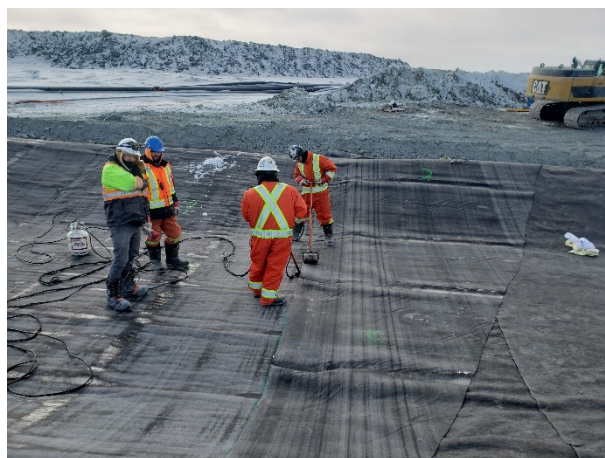
**2238: (2021-04-23), looking SW from Sta. 0+080. GBM installed along spillway channel.**

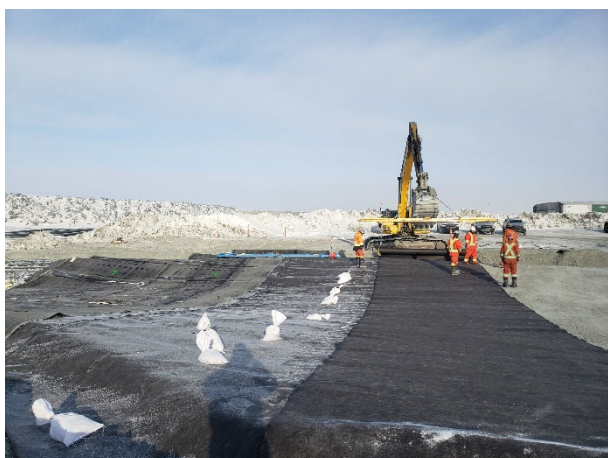
**2239: (2021-04-23), looking W from Sta. 0+080. FC Liner heat welding GBM panels P1/P2.**

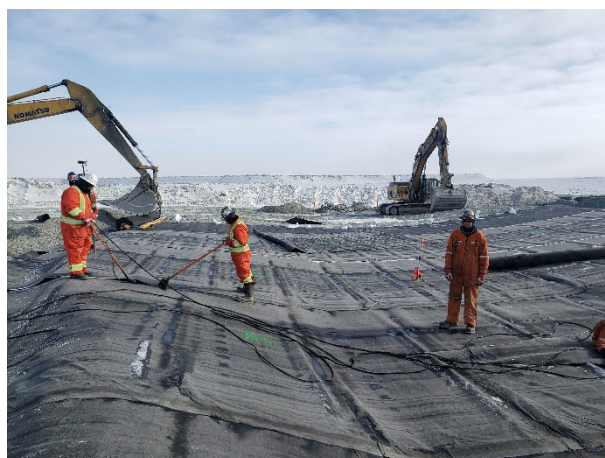
**2240: (2021-04-24), looking W from Sta. 0+080. FC liner installing geotextile through spillway channel.**

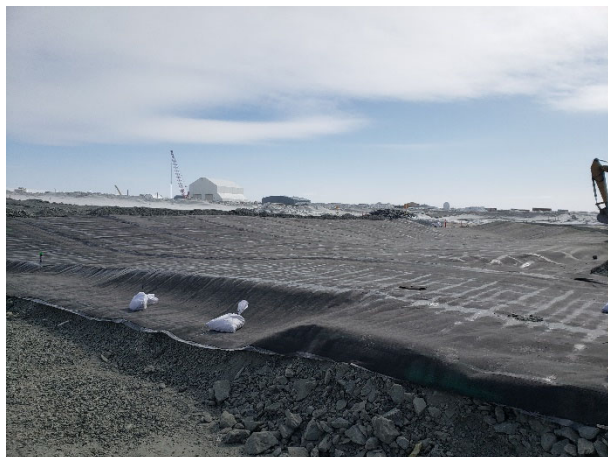
**2241: (2021-04-24), looking N from Sta. 0+080. FC Liner heat welding GBM panels P10/P11.**

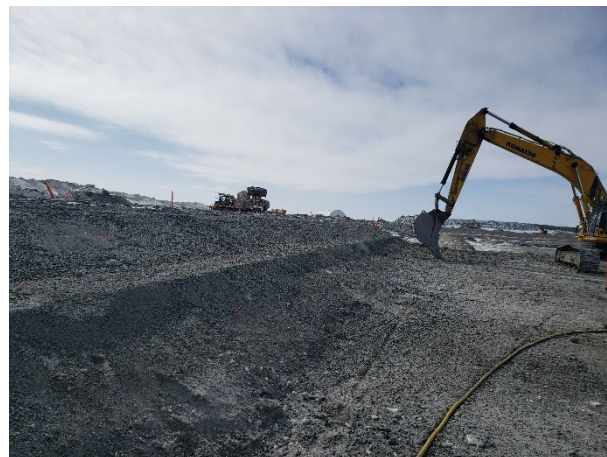
**2242: (2021-04-24), looking S from Sta. 0+080. Approved placement of GBM through spillway channel.**

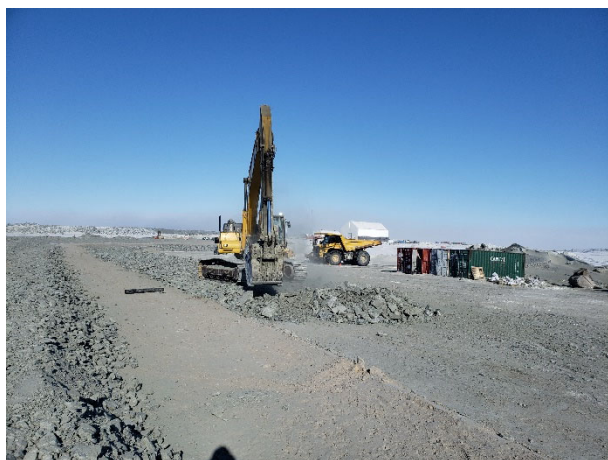
**2243: (2021-04-24), looking W from Sta. 0+375. Komatsu excavator removing snow over footprint of upstream shell in advance of Zone 4 placement.**

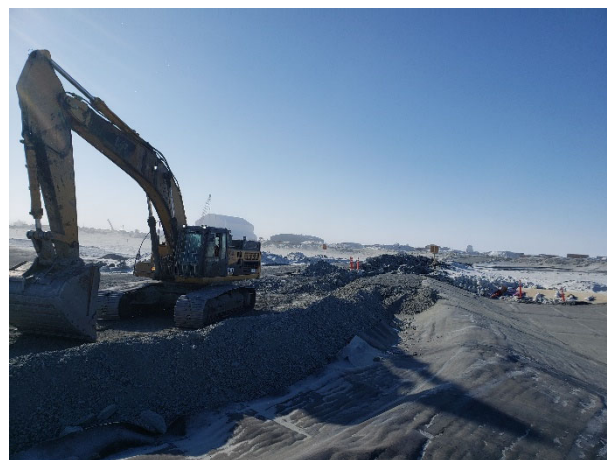
**2244: (2021-04-25), looking W from Sta. 0+325. Komatsu excavator placing Zone 1 rockfill.**

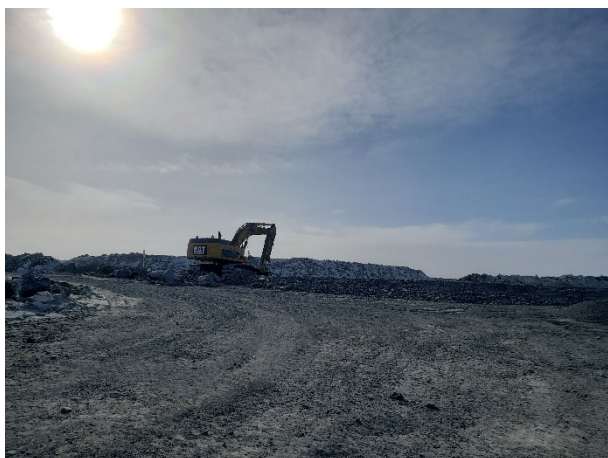
**2245: (2021-04-25), looking S from Sta. 0+080. CAT excavator placing Zone 2A (FF) over installed geotextile/GBM.**

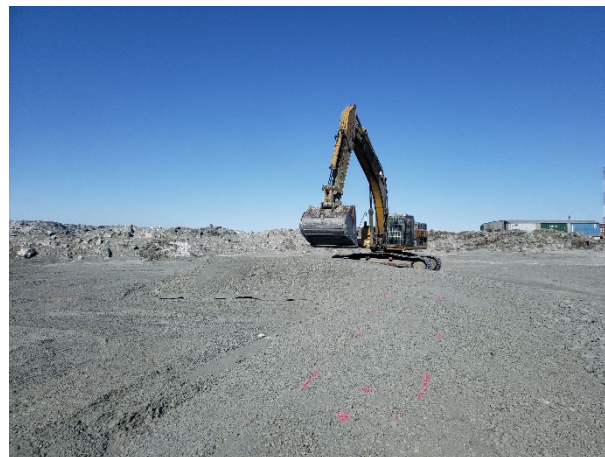
**2248: (2021-04-26), looking W from Sta. 0+120. Komatsu excavator shaping Zone 1 to design lines.**

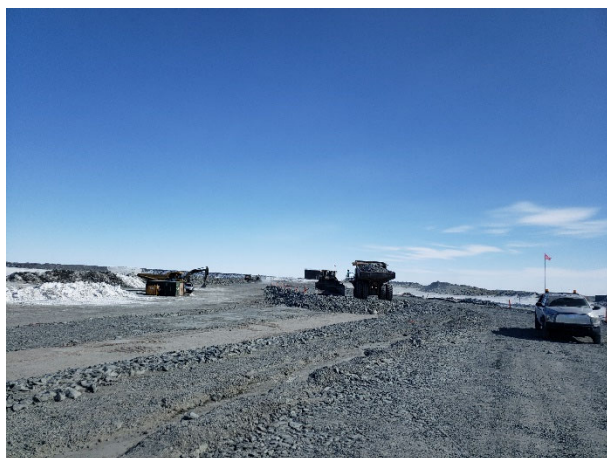
**2249: (2021-04-26), looking W from Sta. 0+45. CAT excavator bucket packing placed lift of Zone 2A material.**

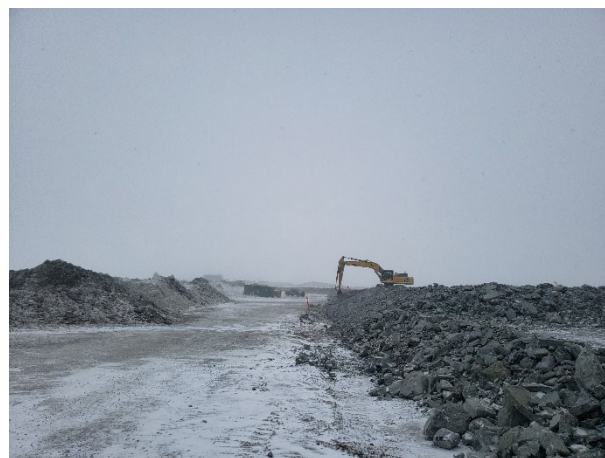
**2250: (2021-04-26), looking W from Sta. 0+270. Dozer spreading Zone 1 material.**

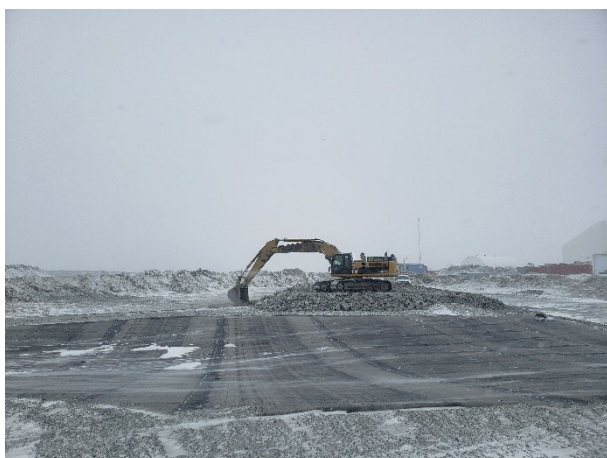
**2251: (2021-04-27), looking E from Sta. 0+200. Komatsu excavator sloping upstream Zone 1 to design lines.**

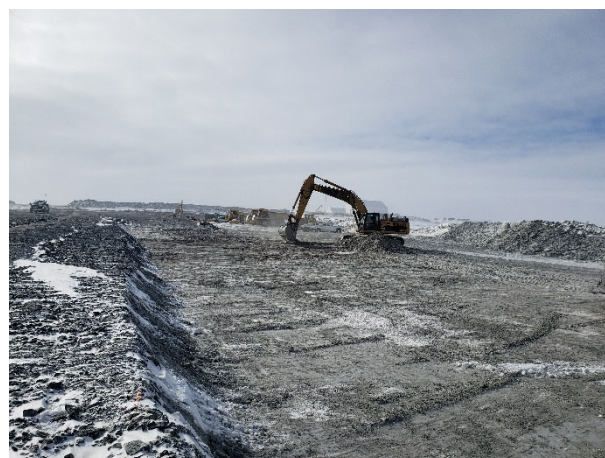
**2252: (2021-04-27), looking W from Sta. 0+050. CAT excavator placing Zone 1 along west abutment.**

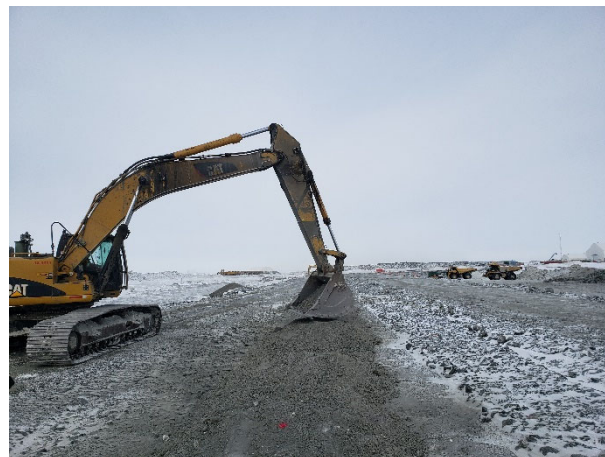
**2254: (2021-04-28), looking W from Sta. 0+225. Komatsu excavator shaping upstream Zone 1 slope to design lines.**

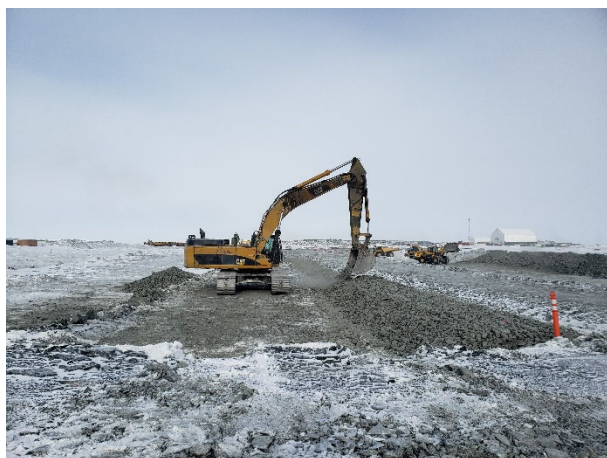
**2255: (2021-04-29), looking W from Sta. 0+515. CAT excavator placing Zone 2A over installed LLDPE liner along dyke crest.**

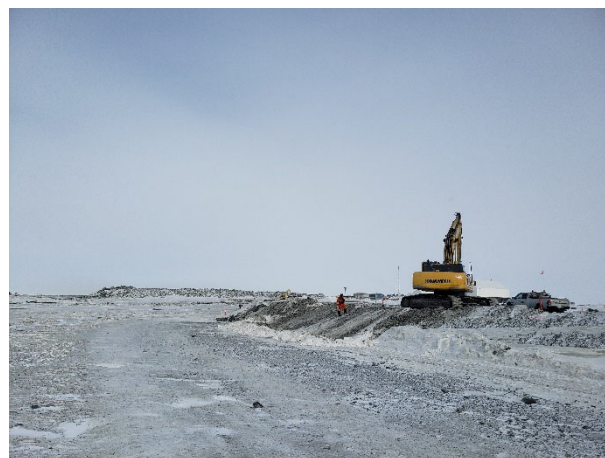
**2256: (2021-04-29), looking W from Sta. 0+515. CAT excavator placing Zone 3 over previously placed Zone 2A.**

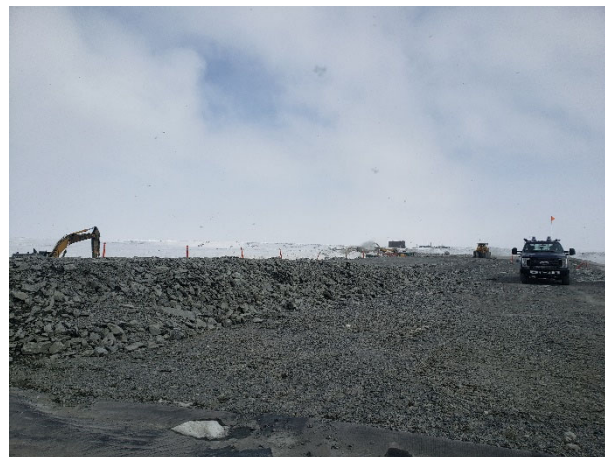
**2258: (2021-04-29), looking W from Sta. 0+200. Dozer spreading lift of Zone 1 (rockfill).**

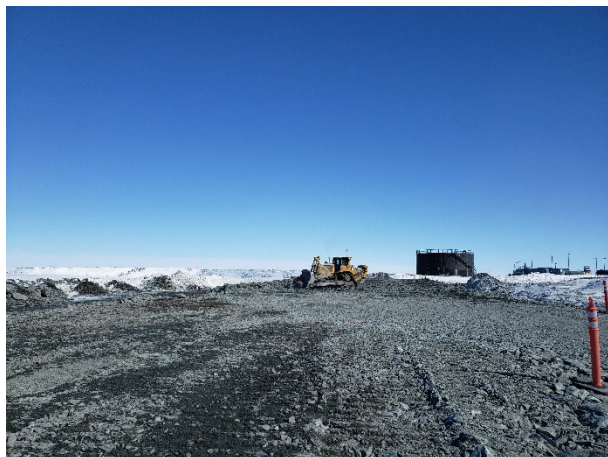
**2259: (2021-04-29), looking E from Sta. 0+090. Zone 2A and Zone 3 placed over existing LLDPE liner.**

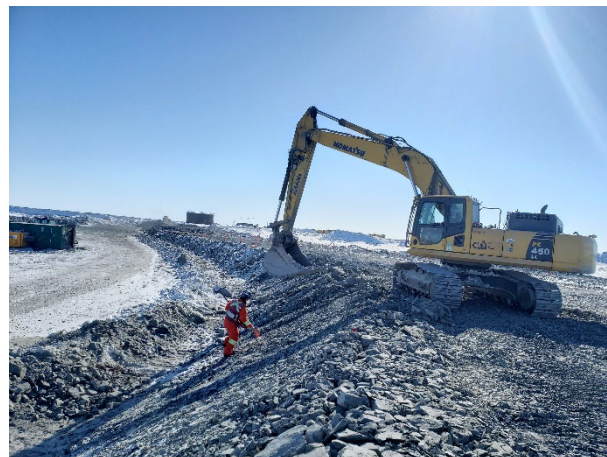
**2260: (2021-04-30), looking E from Sta. 0+490. Komatsu dozer placing Zone 1 (rockfill) material for thermal berm along east abutment.**

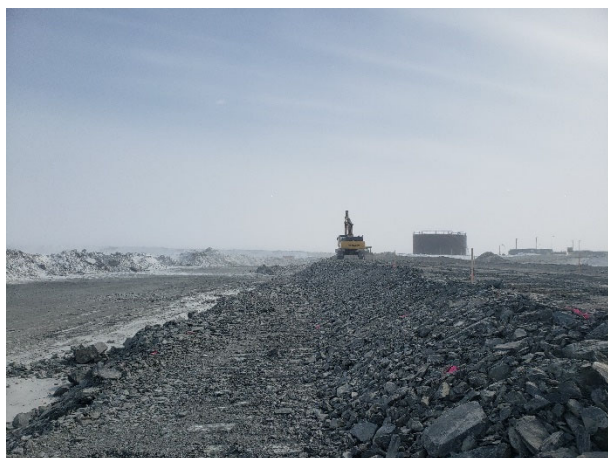
**2261: (2021-04-30), looking E from Sta. 0+300. Komatsu excavator shaping upstream Zone 1 (rockfill) to design lines.**

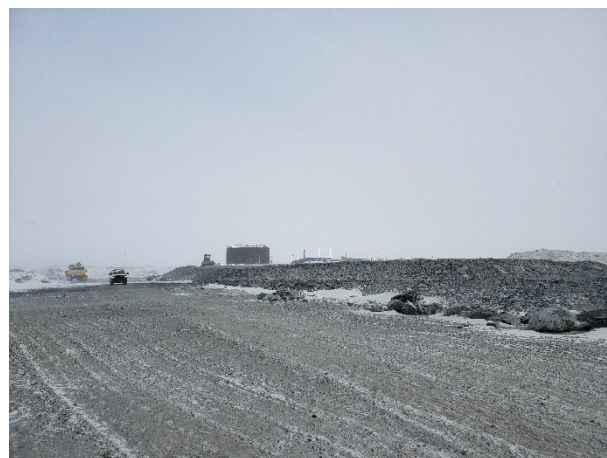
**2262: (2021-05-01), looking E from Sta. 0+450. Komatsu excavator shaping upstream Zone 1 slope to design lines.**

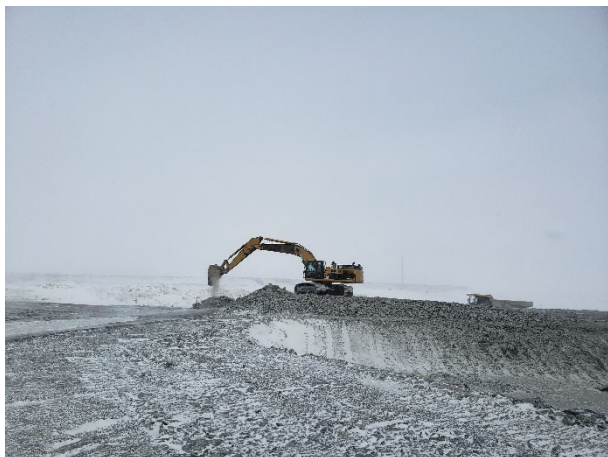
**2263: (2021-05-01), looking SE from Sta. 0+410. Upstream Zone 1 slope shaped to design lines.**

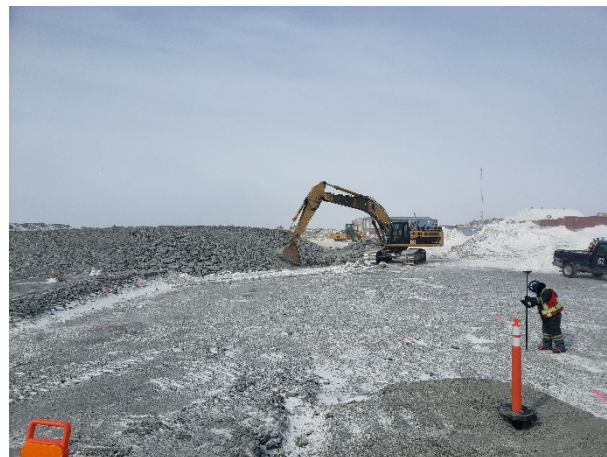
**2264: (2021-05-01), looking N from Sta. 0+085. CAT excavator placing Zone 1 (rockfill) for thermal berm.**

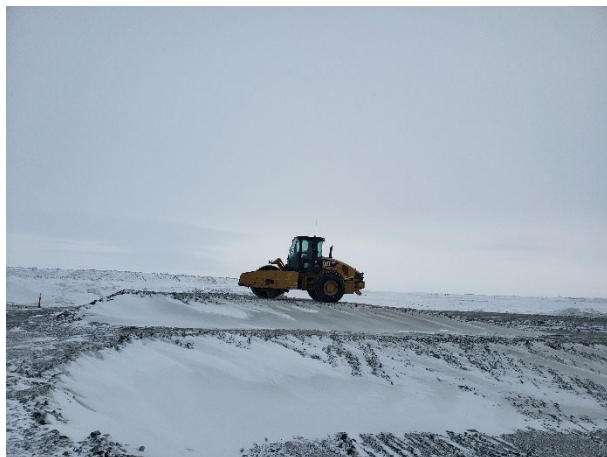
**2266:** (2021-05-02), looking SE from Sta. 0+090. KCG utilizing smooth drum roller to compact placed Zone 1.

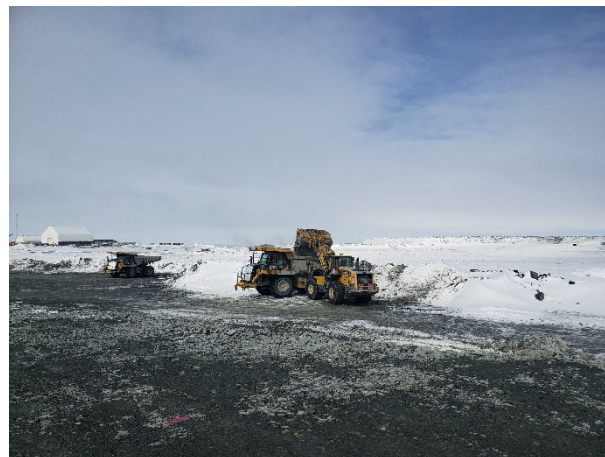
**2267:** (2021-05-02), looking N from Sta. 0+500. Komatsu loader loading rock truck with overburden/rock upstream of dyke.

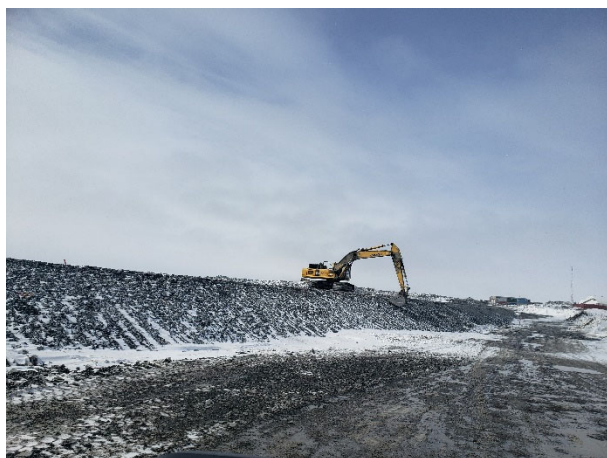
**2268:** (2021-05-02), looking W from Sta. 0+200. Komatsu excavator finalizing upstream slope at approx. Sta. 0+200, view looking W.

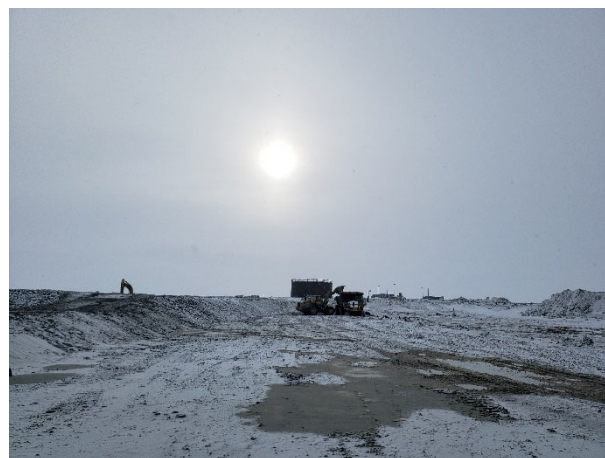
**2269:** (2021-05-03), looking E from Sta. 0+500. Loader loading rock truck with overburden/waste rock material downstream of IVR dyke.

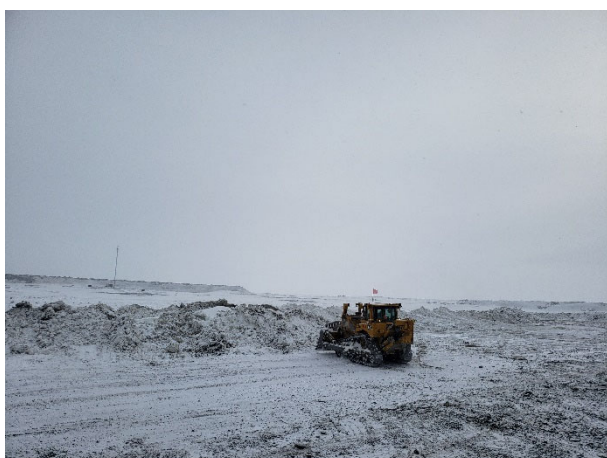
**2270:** (2021-05-03), looking NE from Sta. 0+490. Komatsu dozer flattening snow stockpiles upstream of the IVR Dyke.

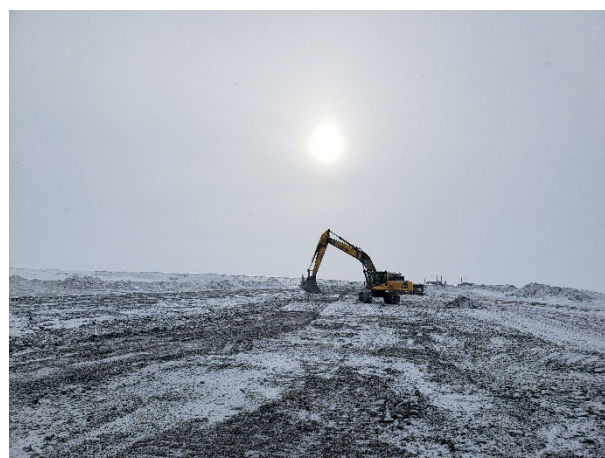
**2271:** (2021-05-03), looking E from Sta. 0+300. Komatsu excavator leveling dyke crest.

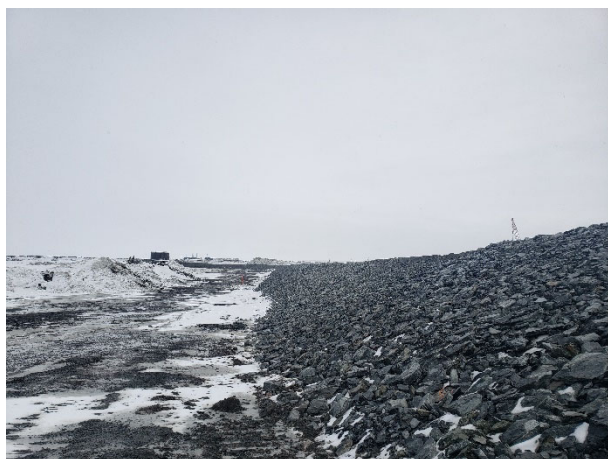
**2272: (2021-05-03), looking E from Sta. 0+125.  
Upstream Zone 1 sloped to design lines.**

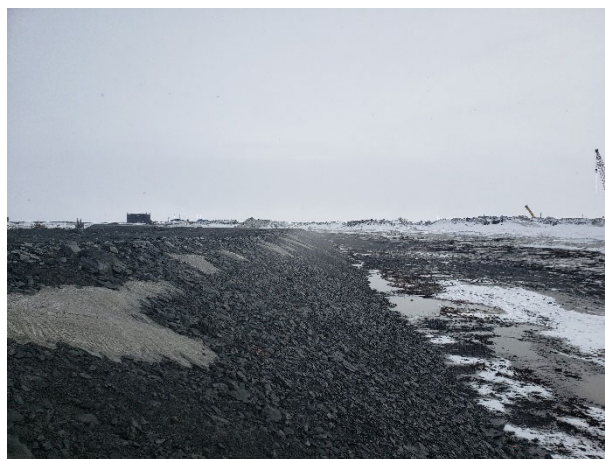
**2273: (2021-05-03), looking E from Sta. 0+200.  
Downstream Zone 1 sloped to design lines.**
