Construction Summary Report IVR Diversion Channel

Agnico Eagle Mines Ltd

6127-695-132-REP-012_R2

February 16, 2021

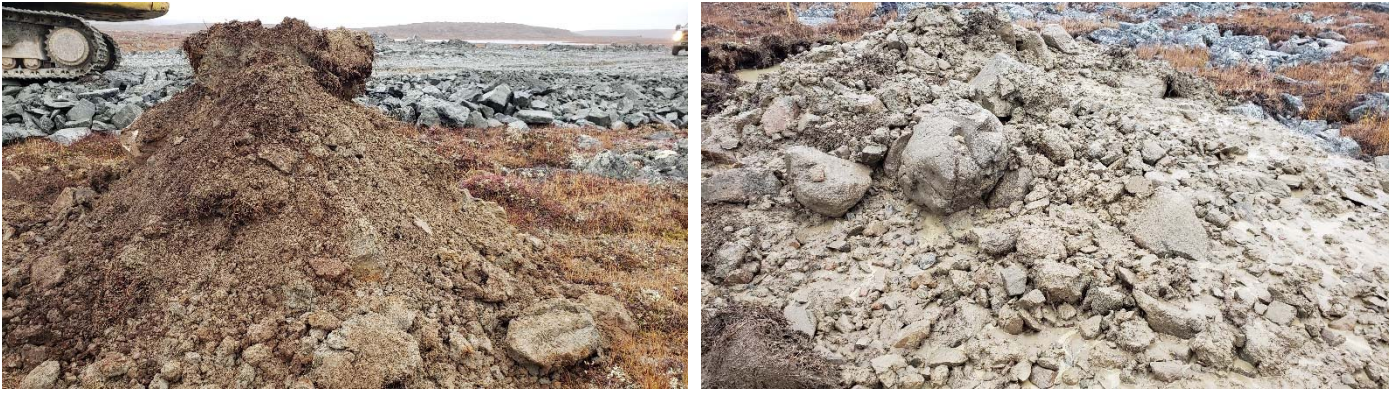
Photo 2: examples of variety of material found in the excavation of the channel.

Left: St.0+115, silty brown material, almost dry overlying a damp grey till at the bottom

Right: soaked sand, gravel and blocks, depleted in fines from St.0+223. Visually a boulder field at surface.

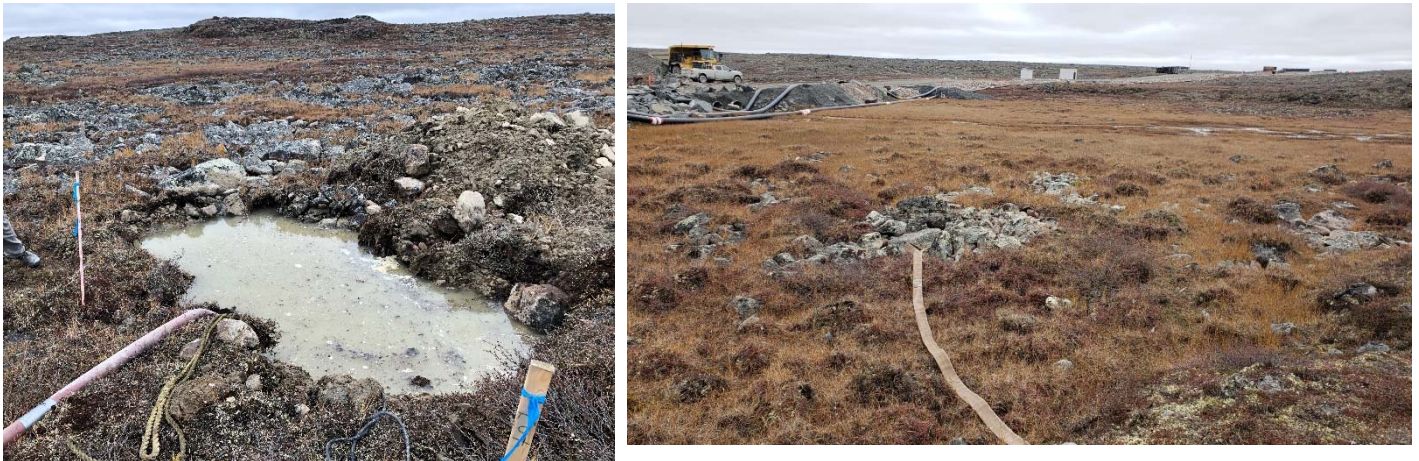
Photo 3: water management in the foundation. To drain the water contained in the boulder field to allow for a proper excavation, a sump was dug into the channel footprint and water redirected downstream of the Construction site. Pumping was effective to drain most of the boulder field after one night of continuous dewatering.

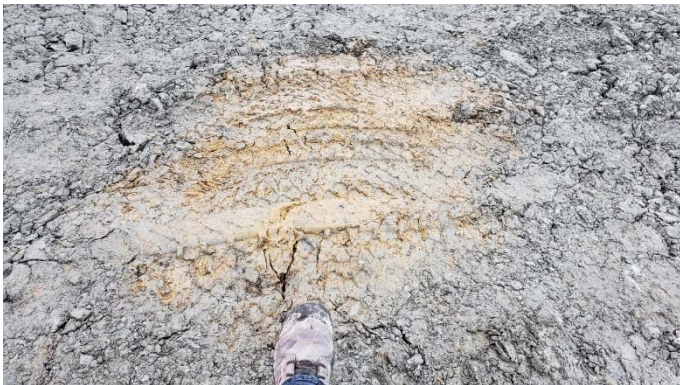
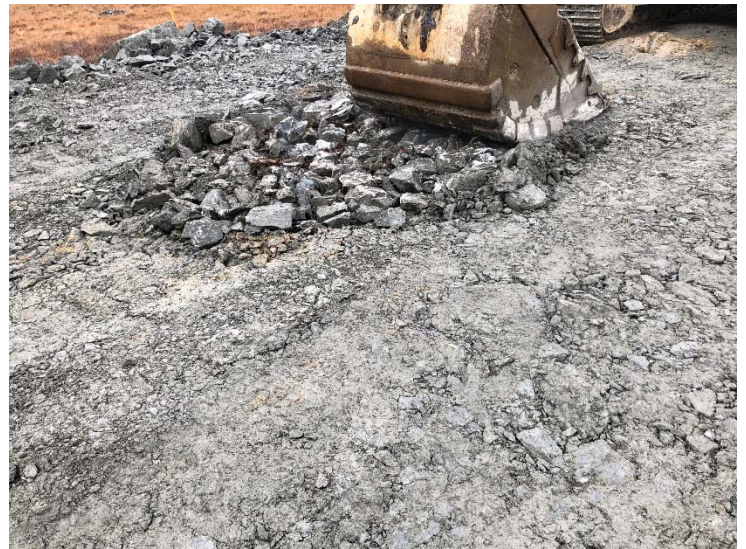
Photo 3: 1 of the 3 soft spots in the platform at St.0+225, overburden protruding through the rockfill. Soft materials were excavated and replaced with muck and compacted with the bucket of the excavator.

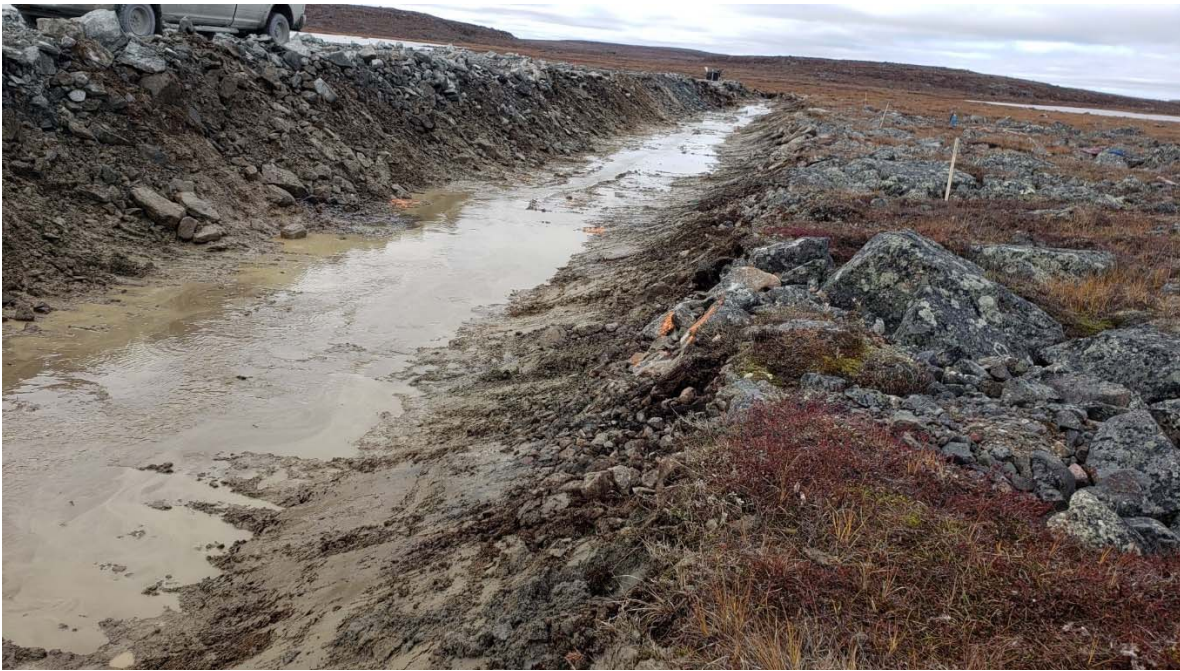
Photo 2: first pass of the excavation of the channel completed from 0+143 to +0281. Water from boulder fields along the channel and foundation still draining.

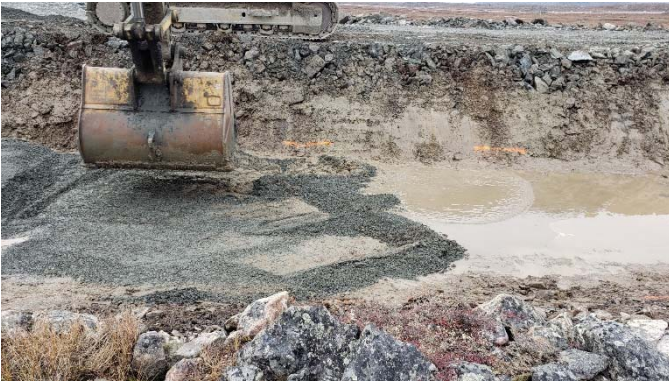
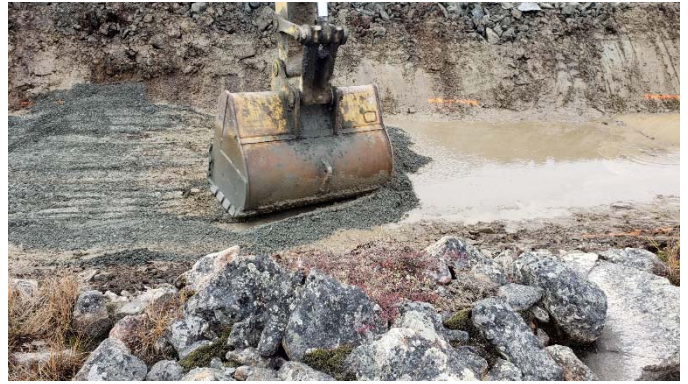
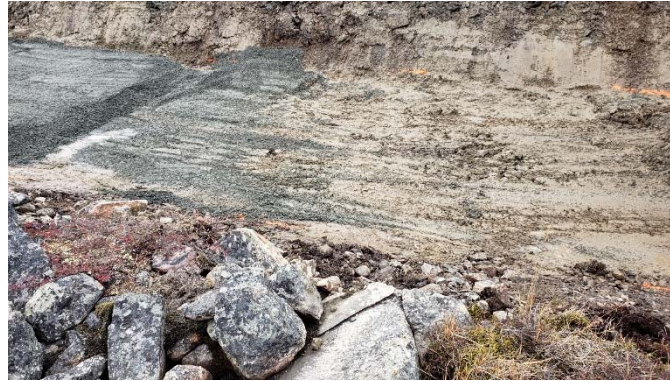
Photo 2: for the section where water keeps coming at the bottom of the excavation, mud and water is mixed with FF then material is pushed away by the side of the excavator bucket.

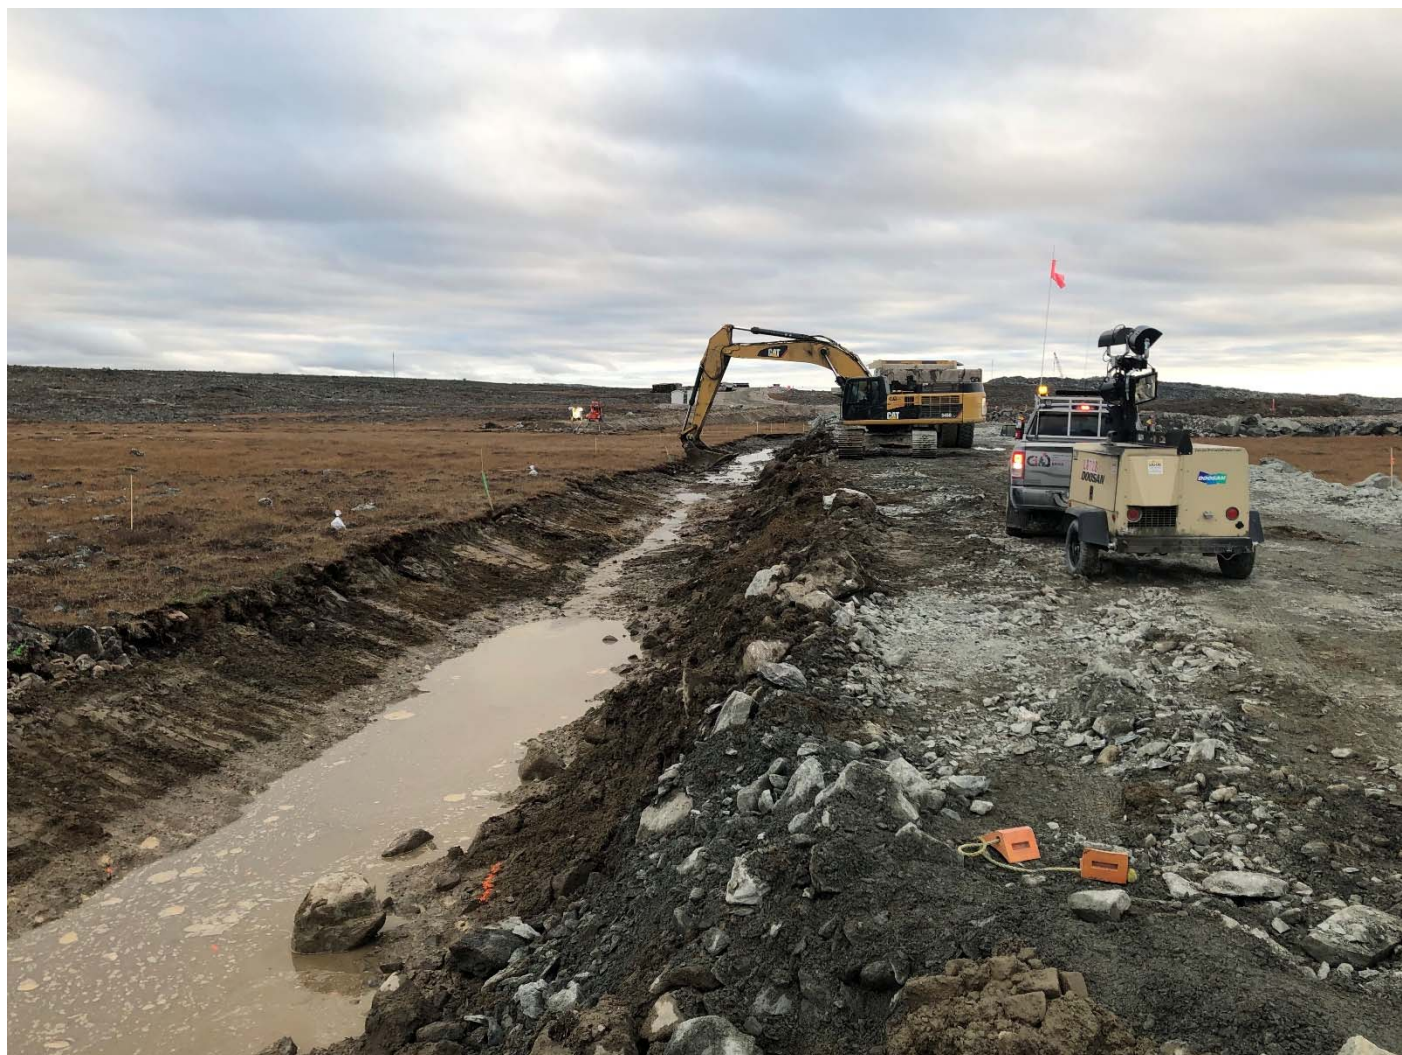
Photo 4: first pass of excavation for the South sector. St.0+139 looking towards 0+035. Lots of water draining from the tundra is managed through series of sumps.

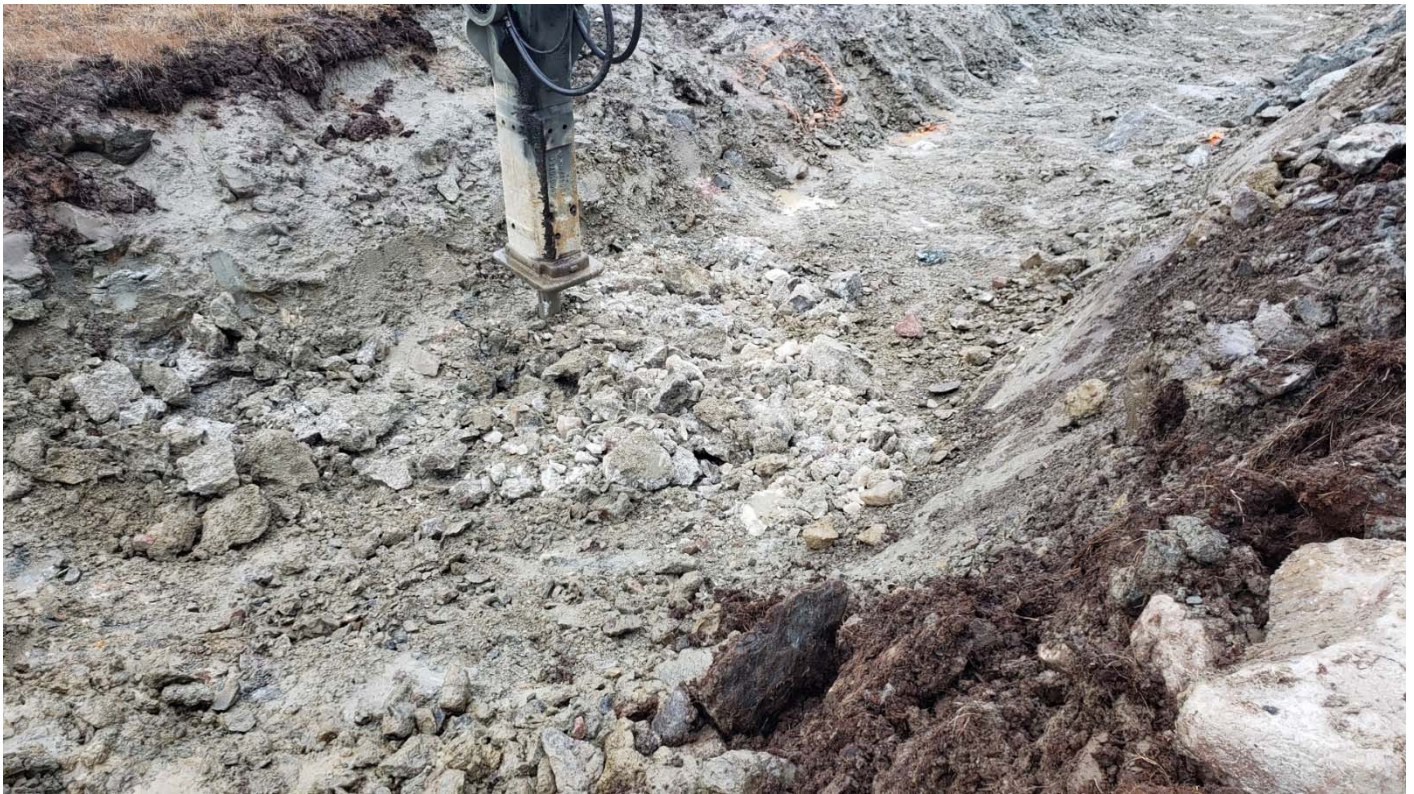
Photo 3: 2nd pass of the removal of the ice rich till with hydraulic hammer, Sta. 0+260 looking South-East.

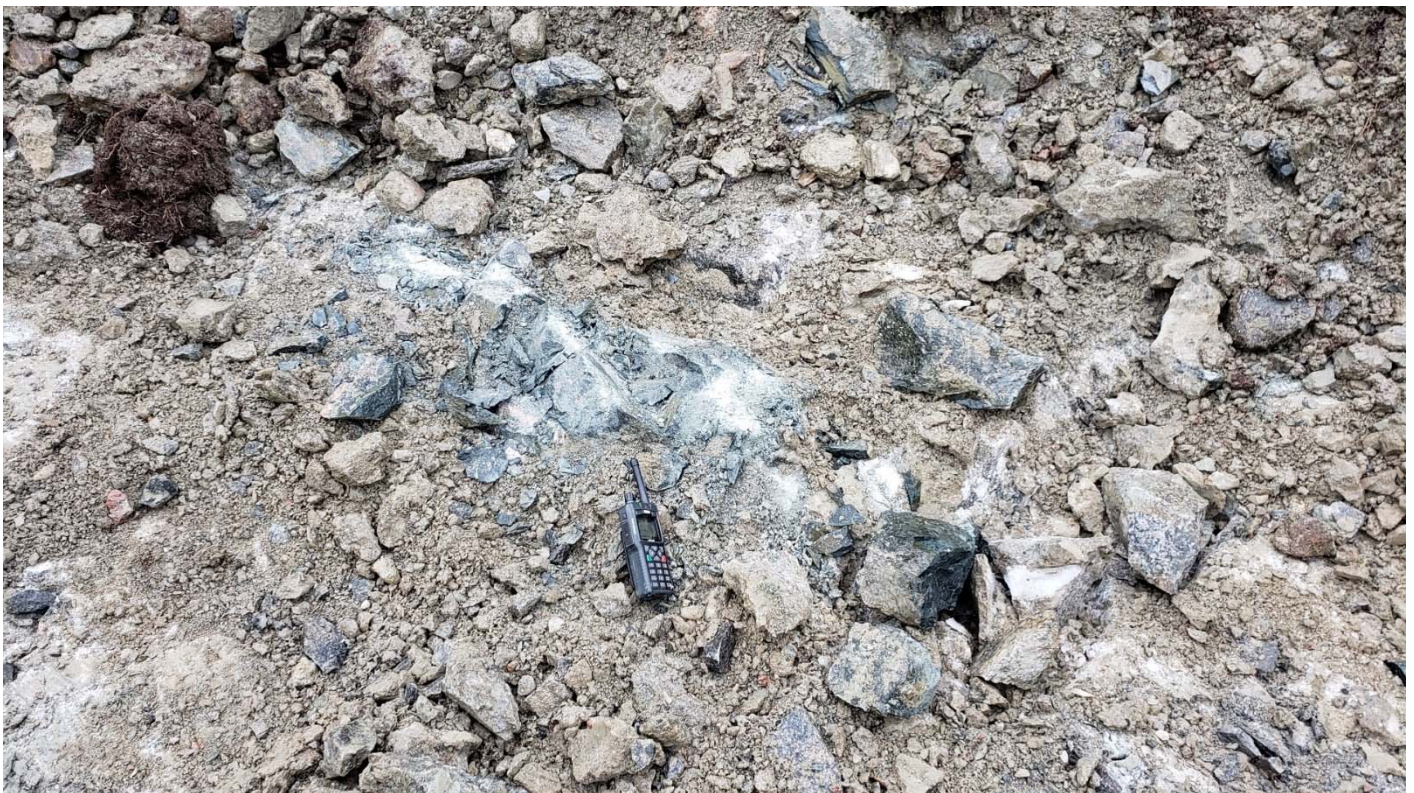
Photo 4: bedrock found at St.0+255. Estimate that about 10% of the surface was on bedrock.

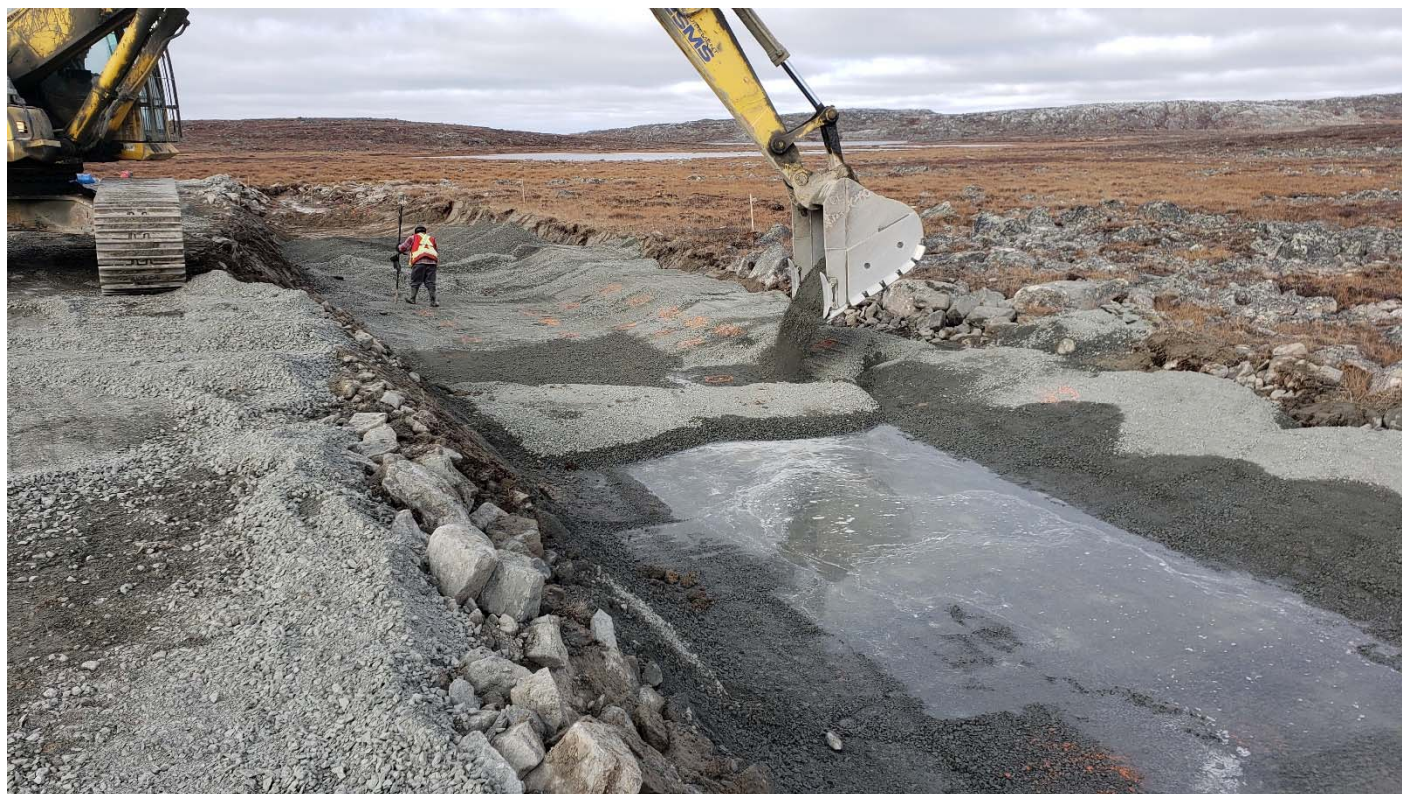
Photo 2: Fine filter placement on top of the esker, from St.0+200 looking North.

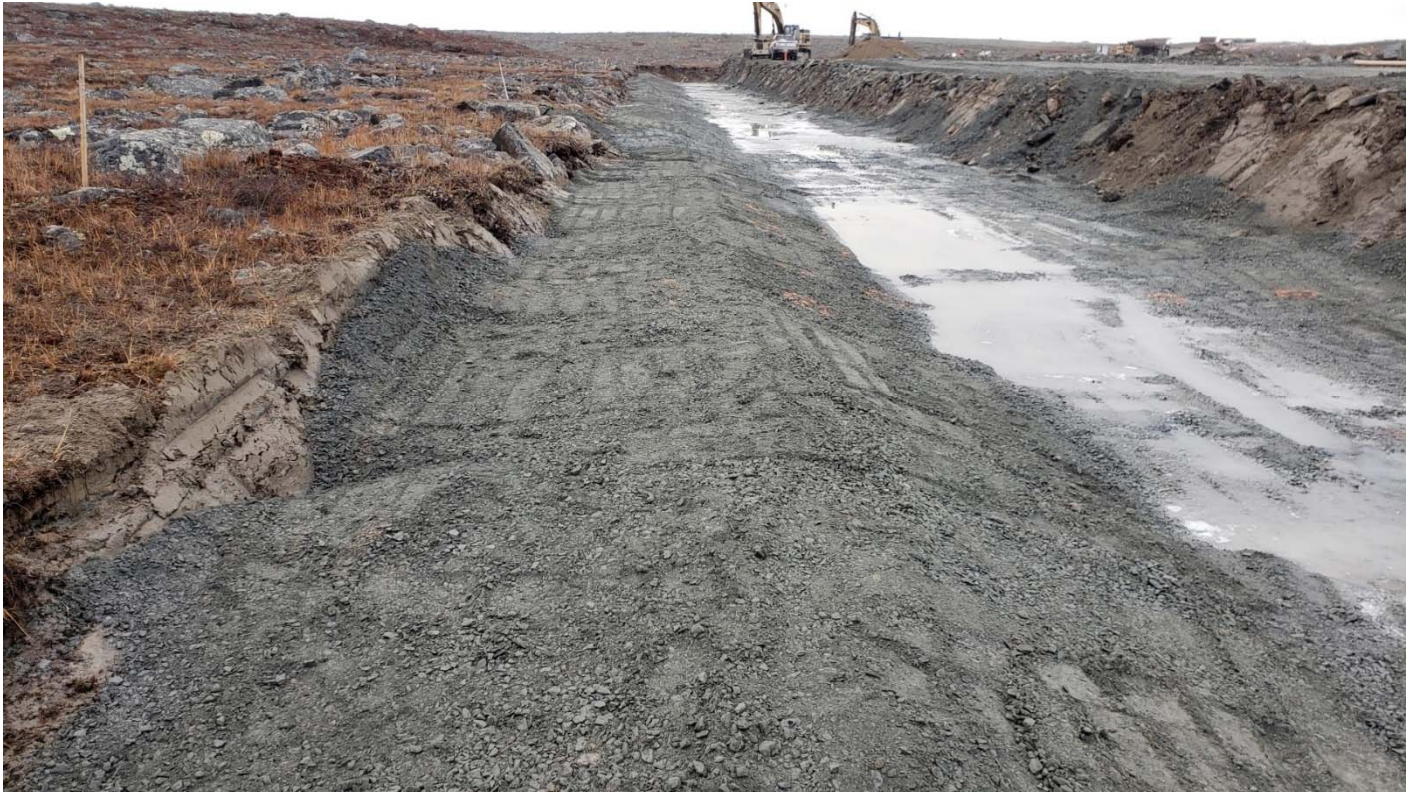
Photo 4: fine filter placement completed on the upstream tablet, St.0+240 looking South. Tablet was built on the entire length between 0+281 to 0+139.

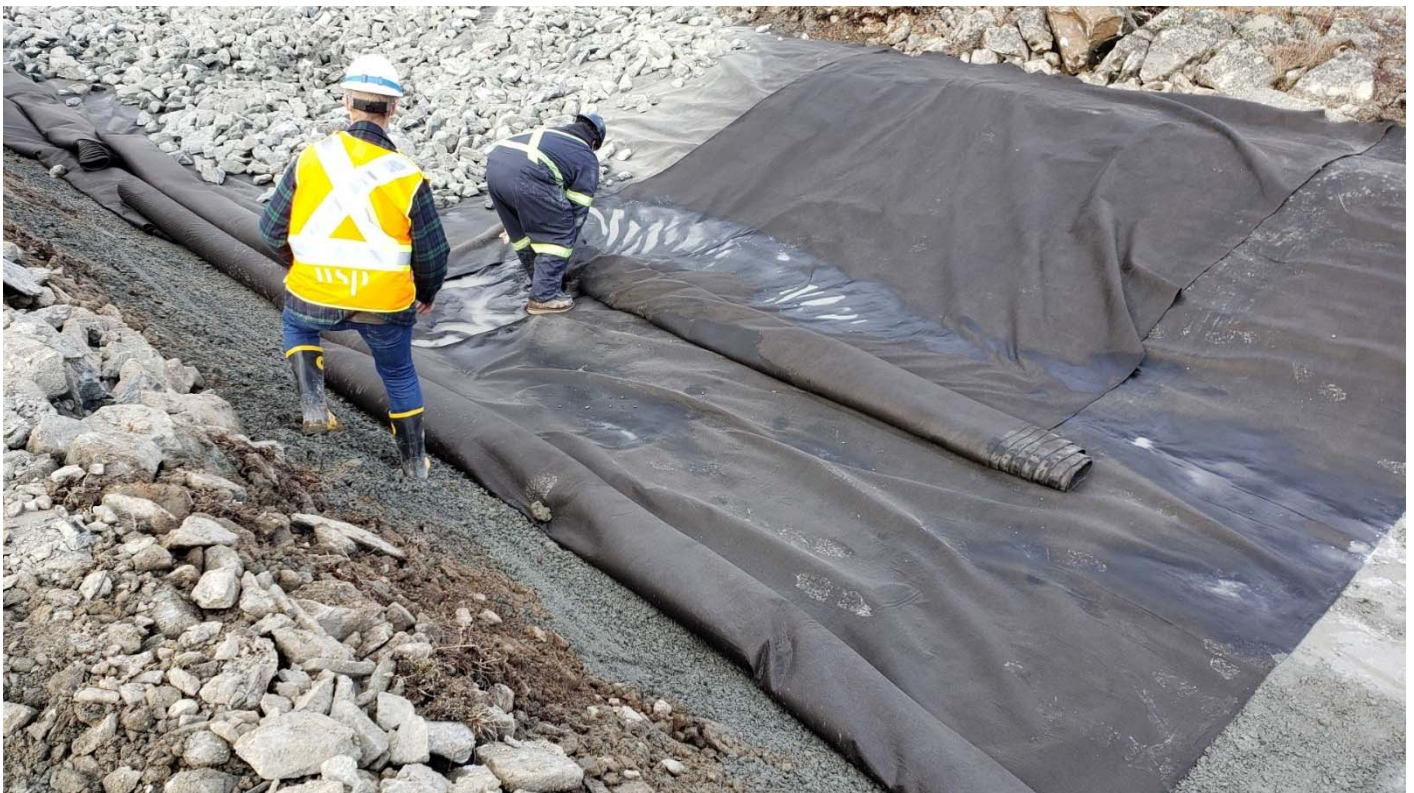
Photo 5: geotextile placement of 2 layers of Novatex V. Bottom layer overlap of 600mm respected, top layer overlapping the first layer by half a roll.

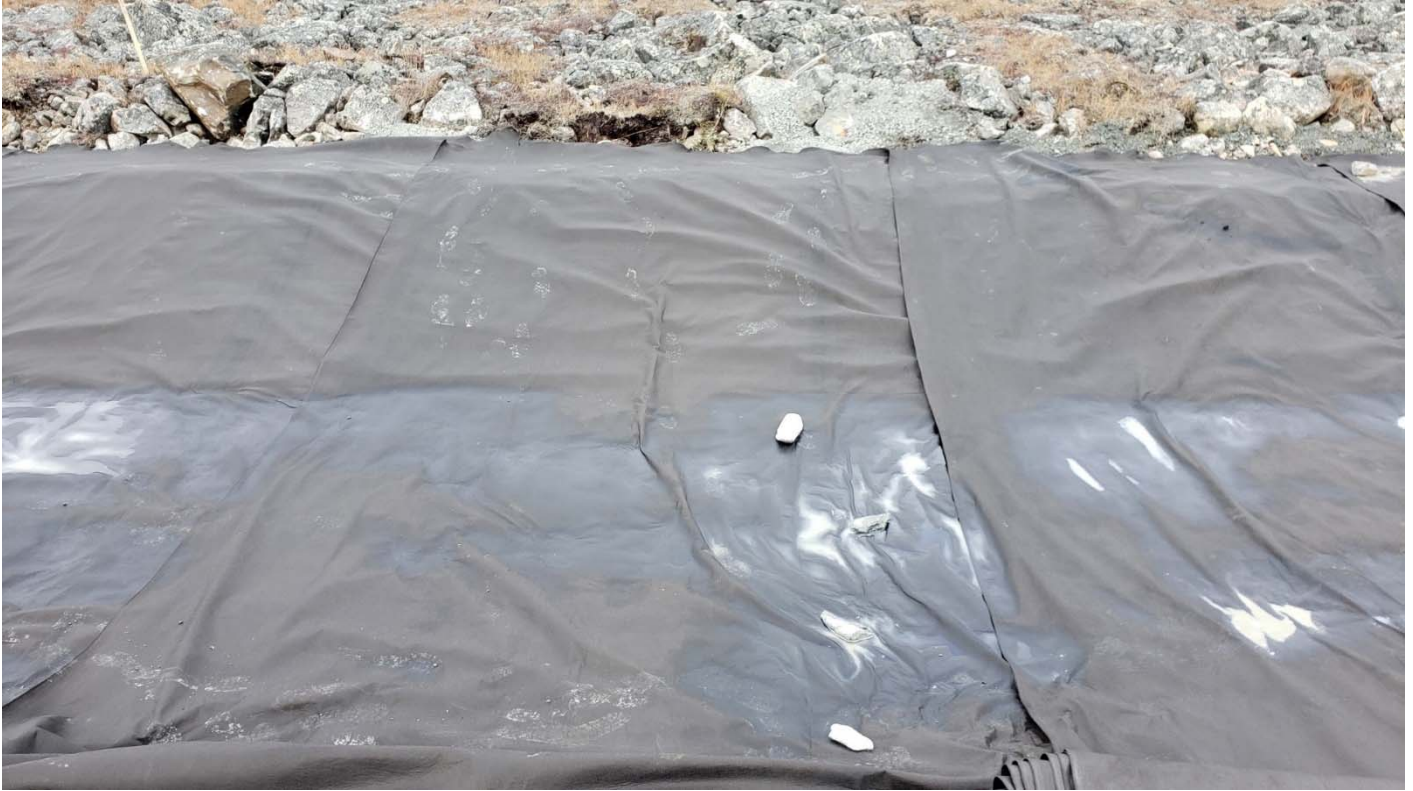
Photo 6: geotextile placement, example of a completed section St.0+150. Flow of the channel towards left of photo.

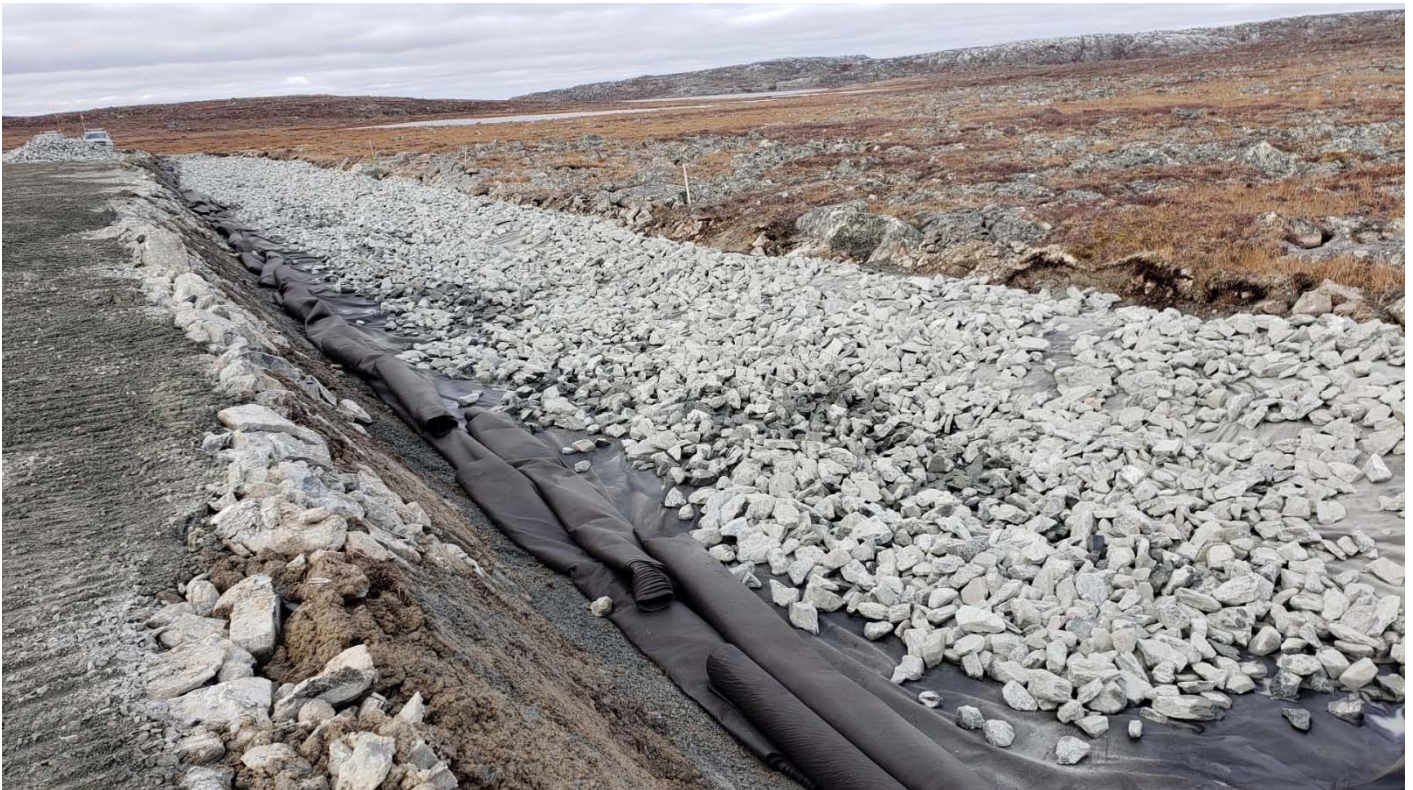
Photo 6: rip rap placement over the geotextile to hold it in place. Final riprap thickness to be adjusted and profiled, St.0+150 looking North.

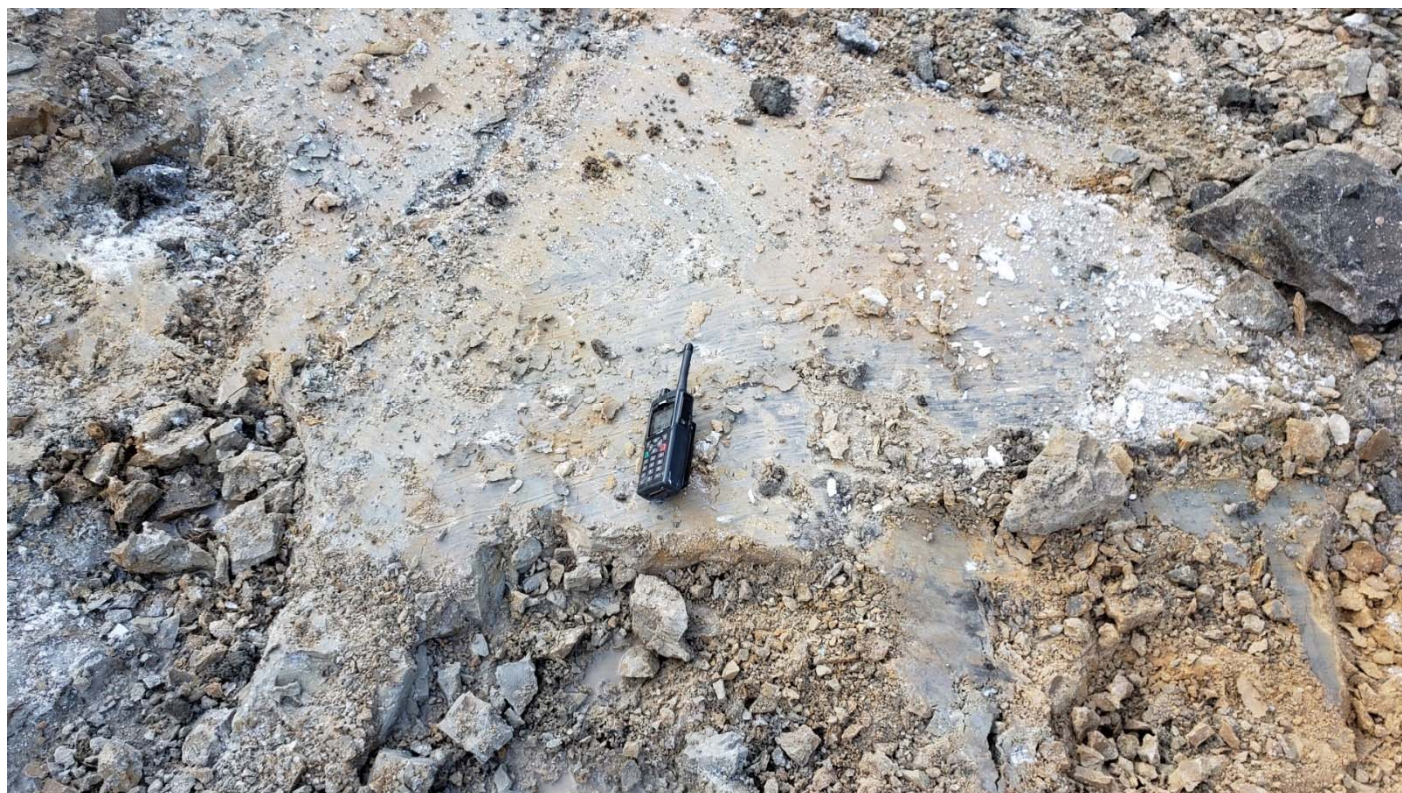
Photo 1: Frozen silty sand at the bottom of the excavation after material removal. Visually the material is ice-poor so it was accepted as is and covered with 2 layers of esker. Sample Ex-15 was taken for water content.

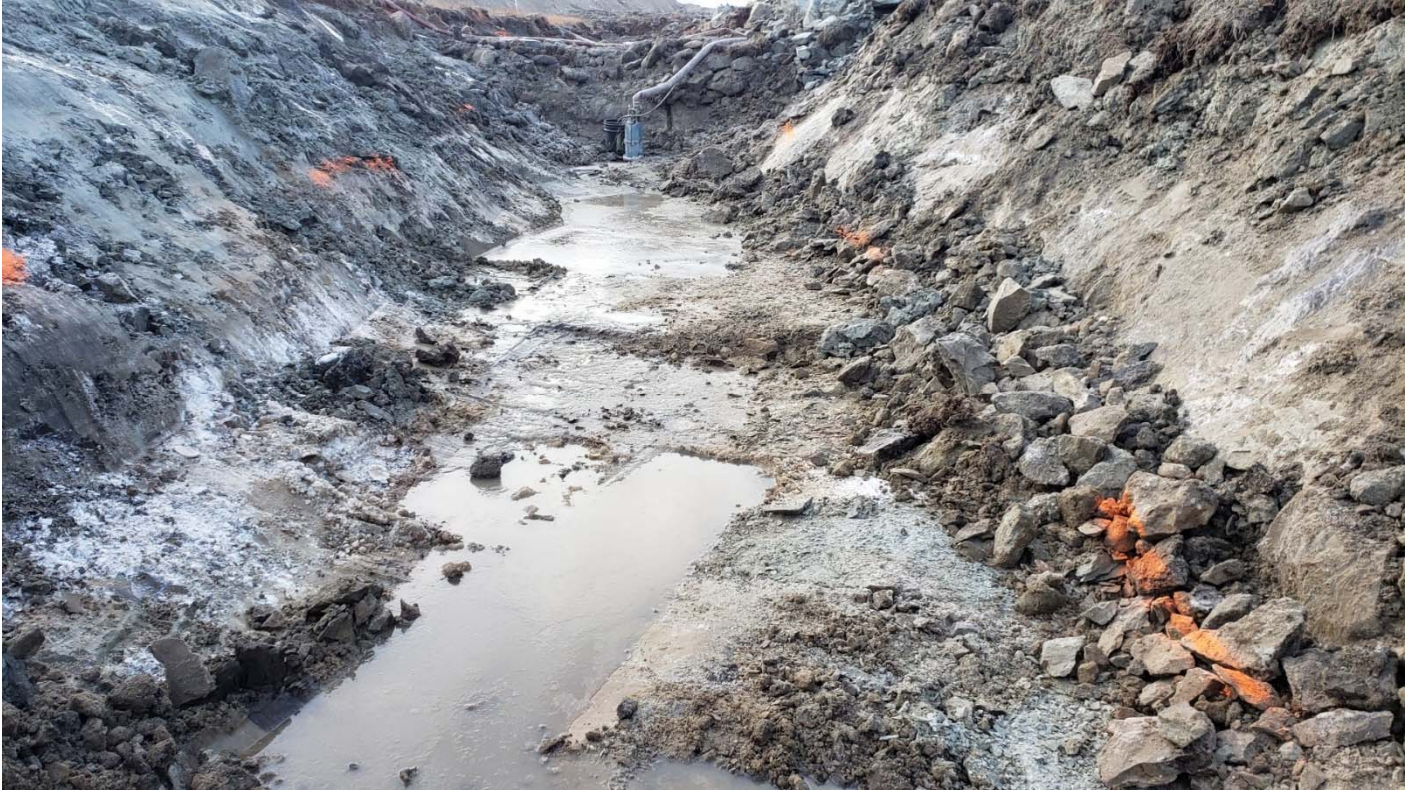
Photo 2: view of the bottom of the approved excavation at St.0+090 looking South.

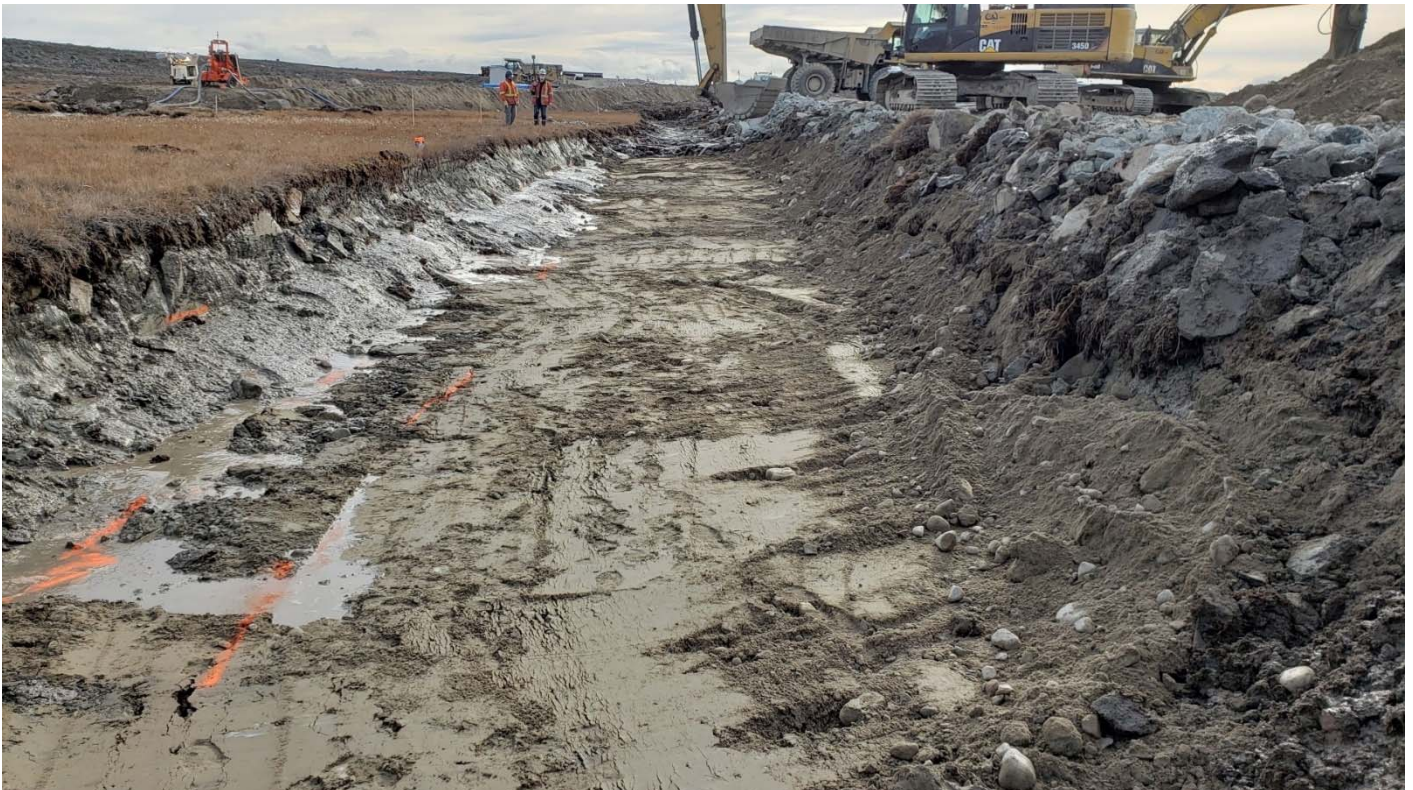
Photo 3: view of the same area after till placement, final grading ongoing.

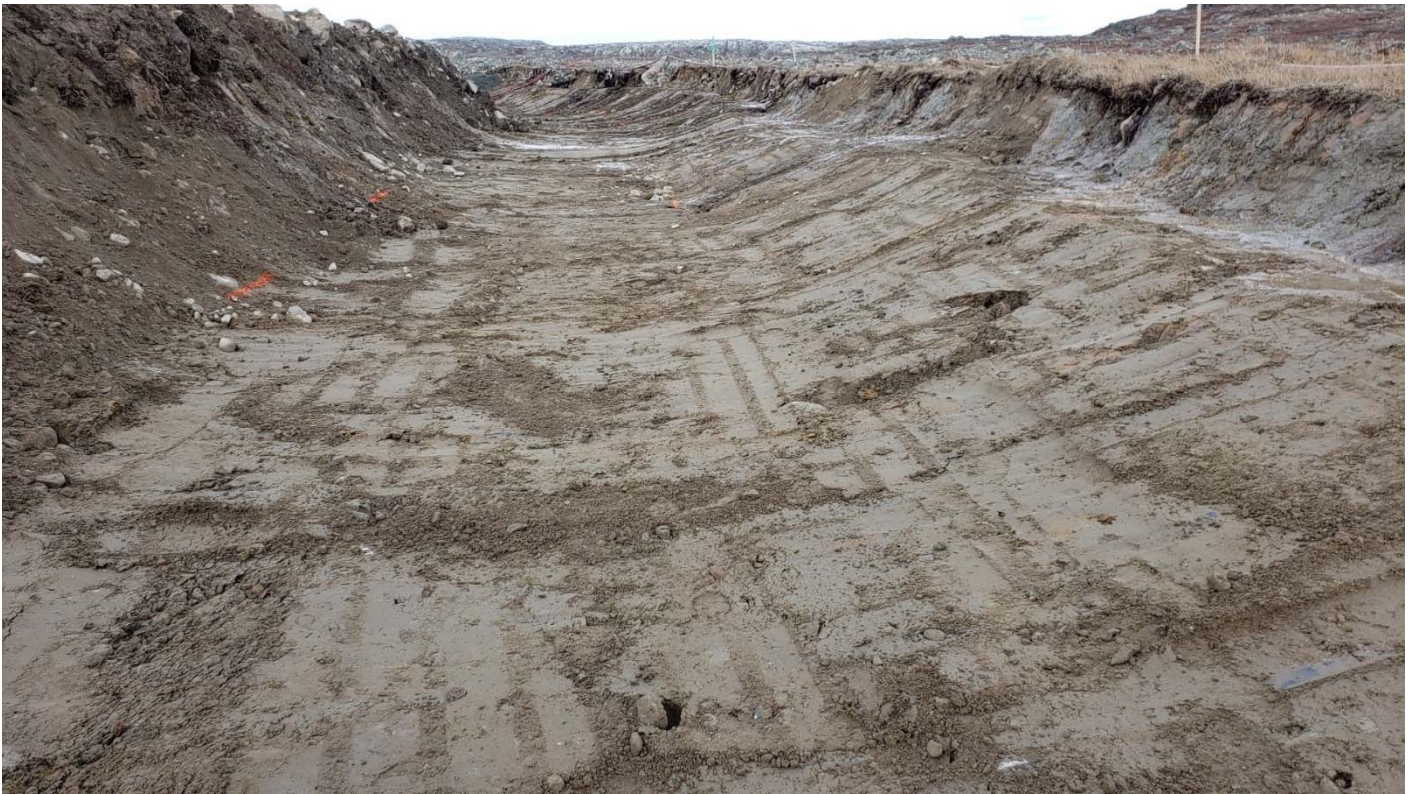
Photo 4: view of the esker placement completed & the upstream tablet built, St.0+090 looking North to 0+125.

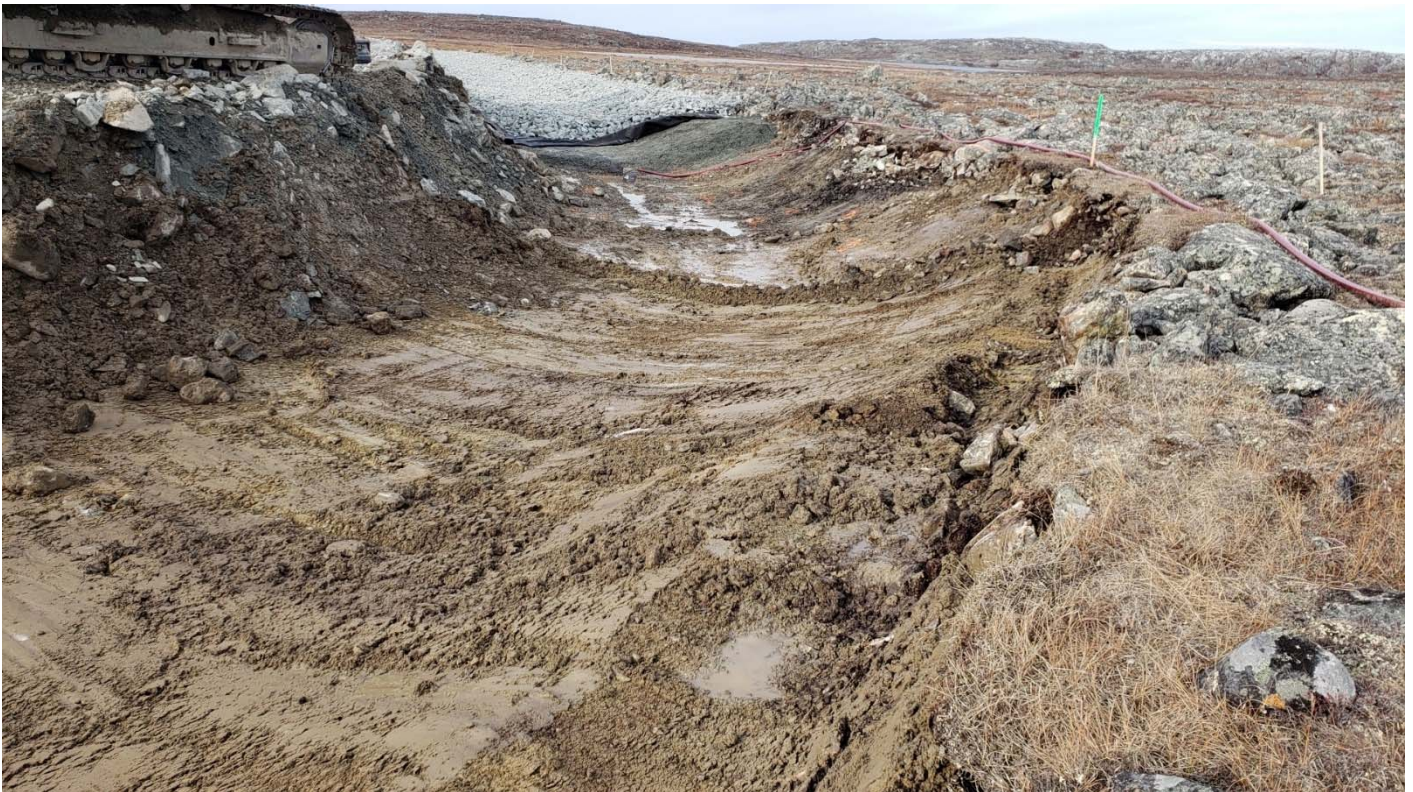
Photo 5: view of the thawed sand and gravel foundation from St.0+125 looking North to 0+150.

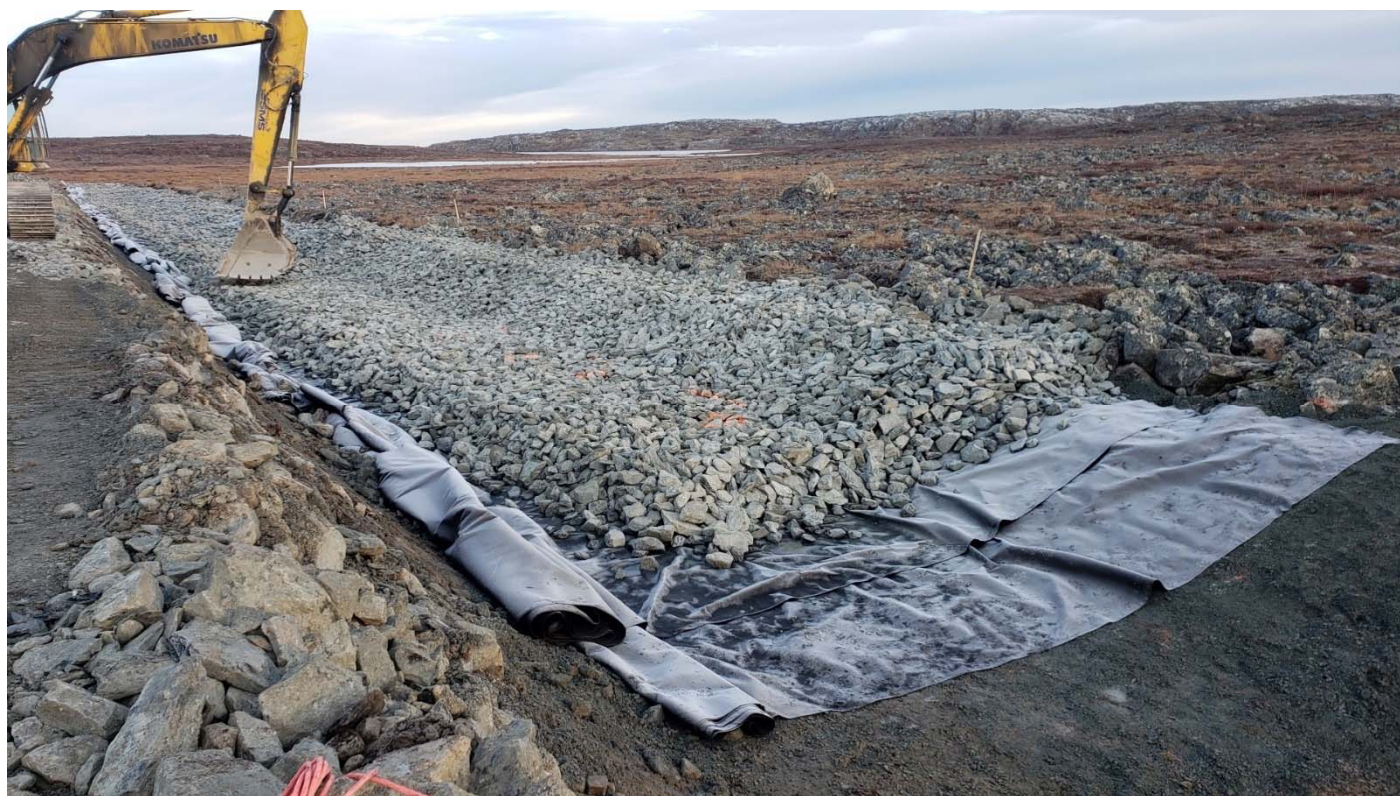
Photo 6: rip rap placement over the geotextile, final thickness adjusted and profiled, St.0+150 looking North.

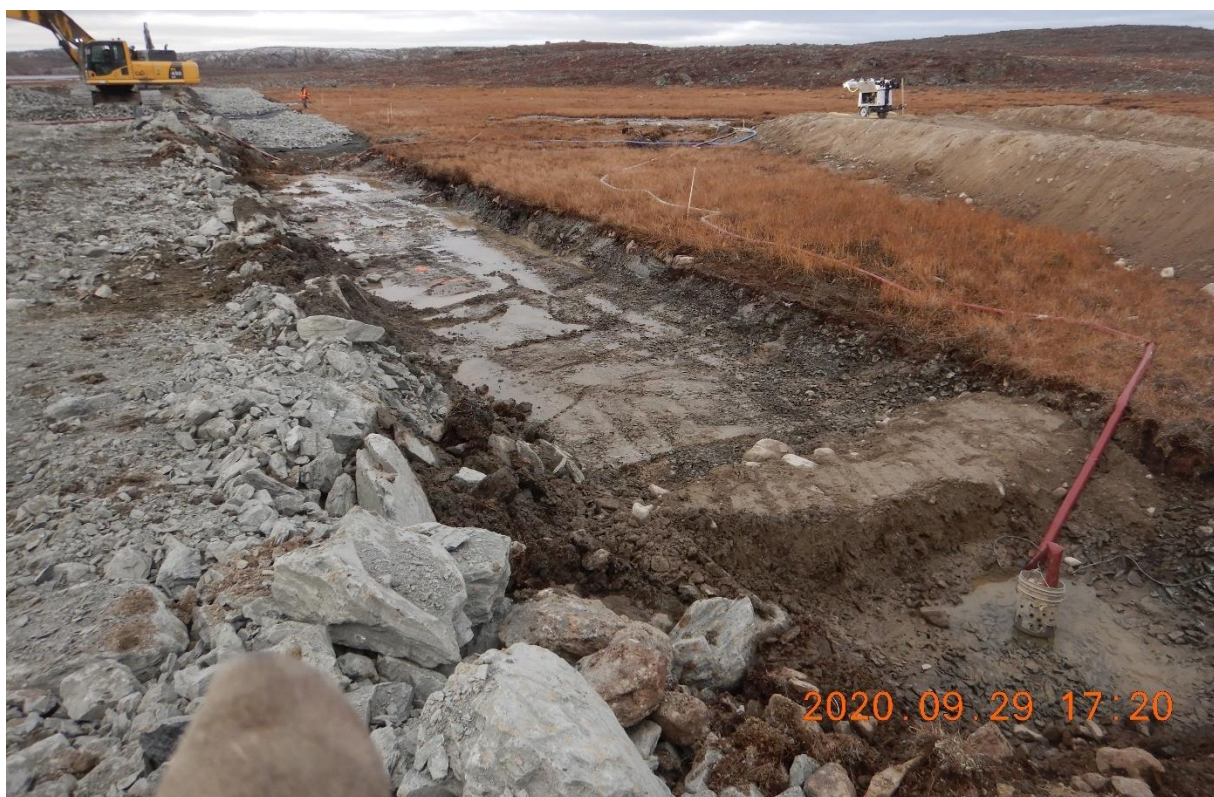
Photo 1: view of the bottom of the excavation, not final, at St.-0+015 looking North. Sump located at the upstream end of the channel at -0+015. Water in the excavation is coming from tundra runoff. Final excavation clean up to do prior to placing fine filter material.

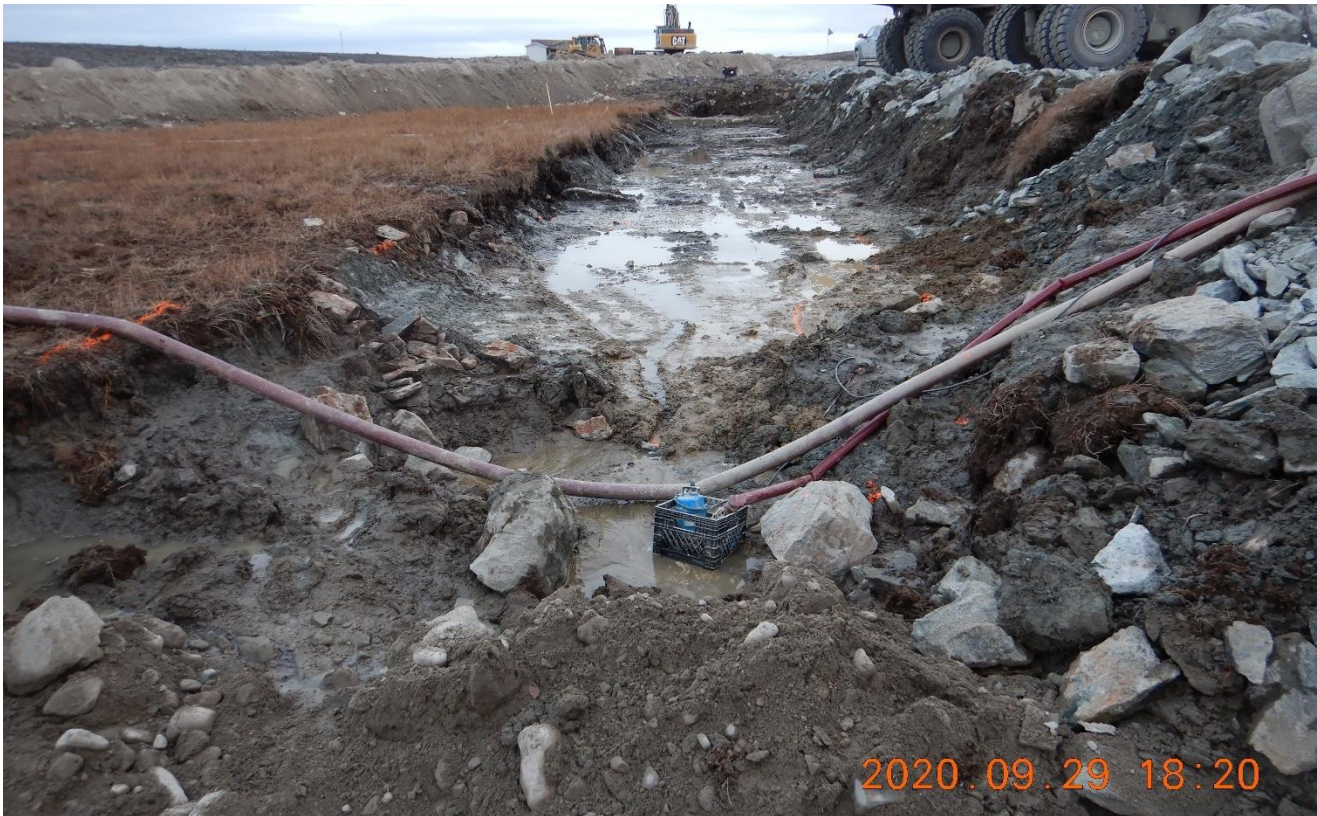
Photo 2: view of the same area. Looking South from Sta 0+029 where second active sump is located.

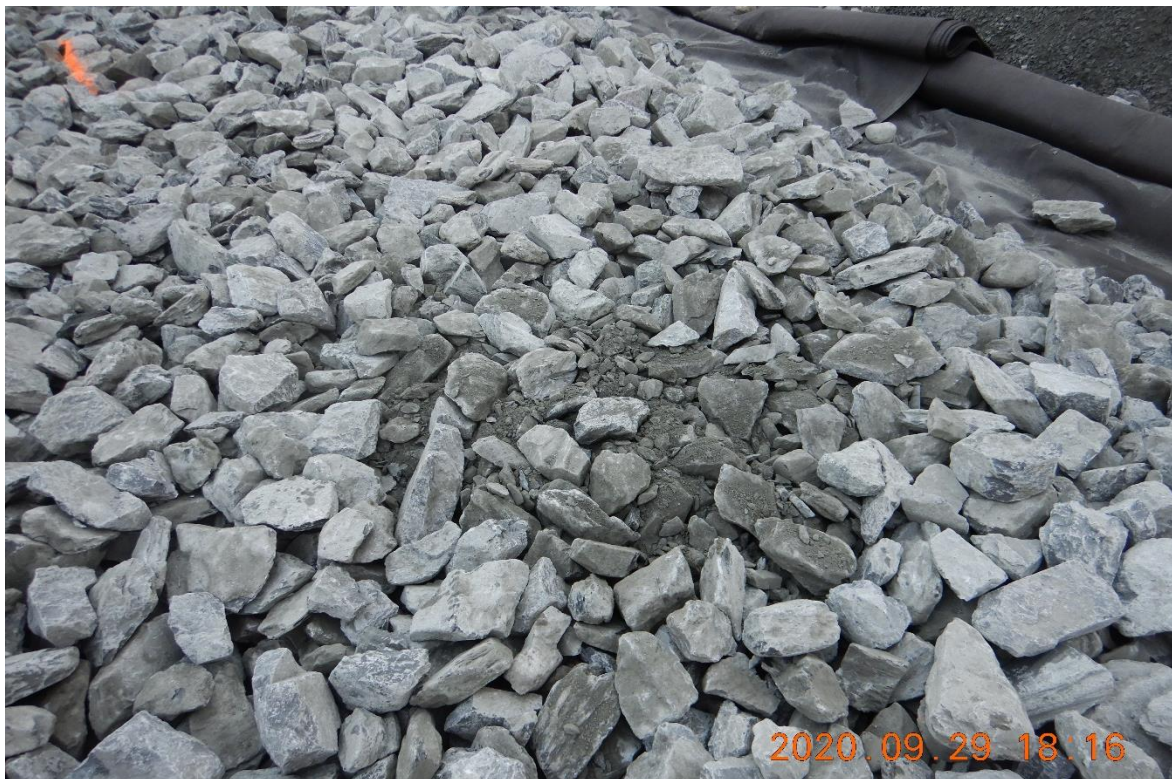
Photo 3: Localized excess of finer material in rip rap at 0+140 & 0+045 to be removed.
