Construction Summary Report IVR Diversion Channel

Agnico Eagle Mines Ltd

6127-695-132-REP-012_R2

February 16, 2021

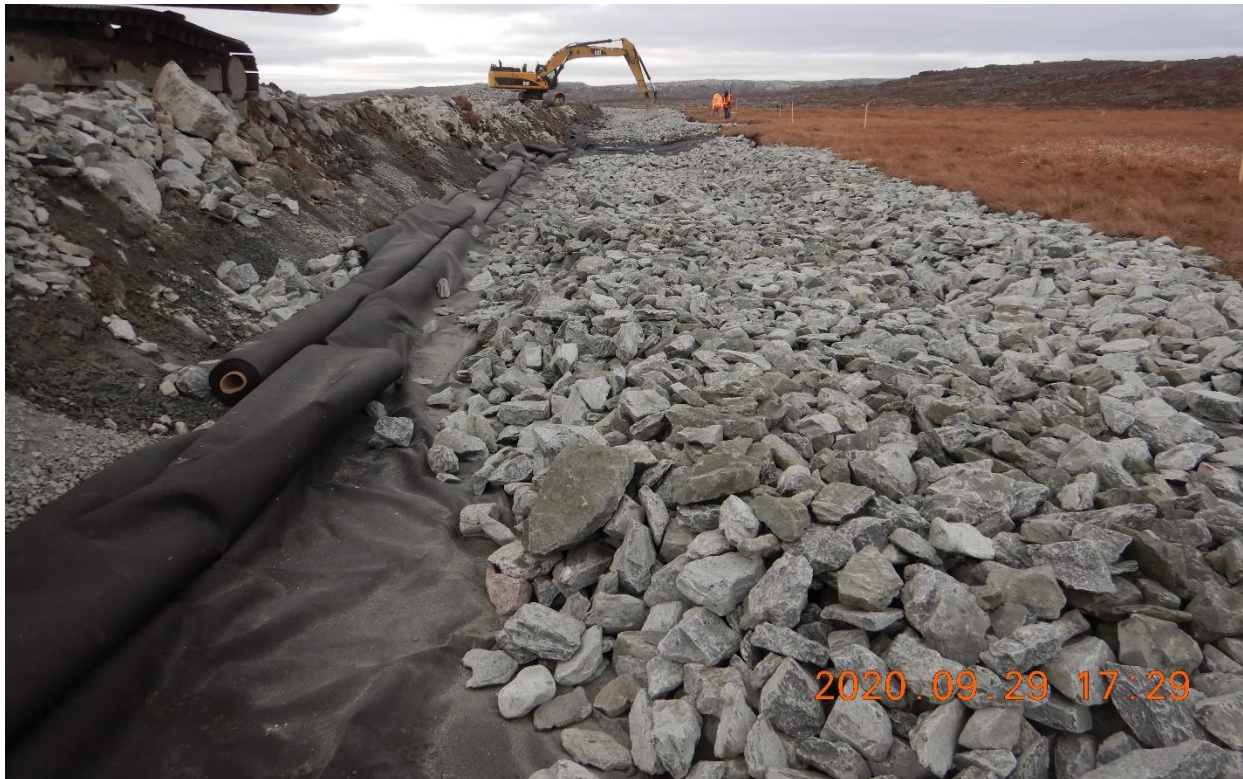
Photo 4: rip rap placement over the geotextile, St.0+035 looking North.

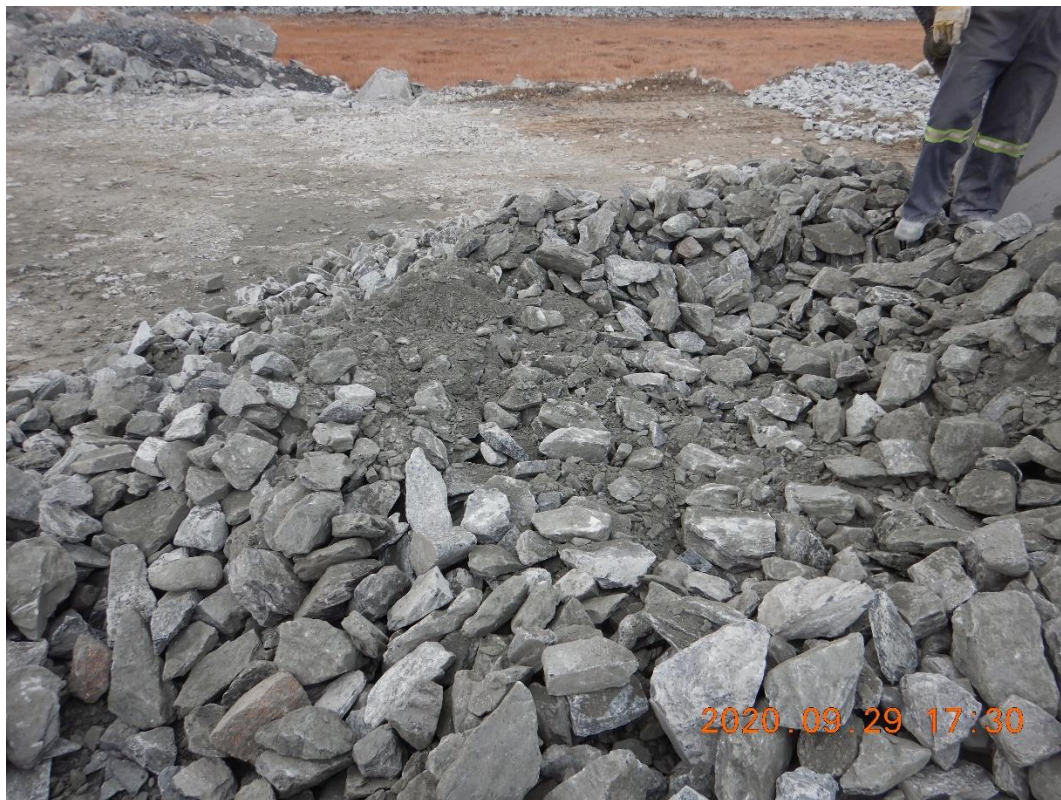
Photo 5: rip rap load containing a localized amount of finer material. This amount is rejected and tossed away. Such finer material shall not be placed in the channel. If it is so, it will need to be cleaned manually, to minimize risks of damaging the geotextile liner.

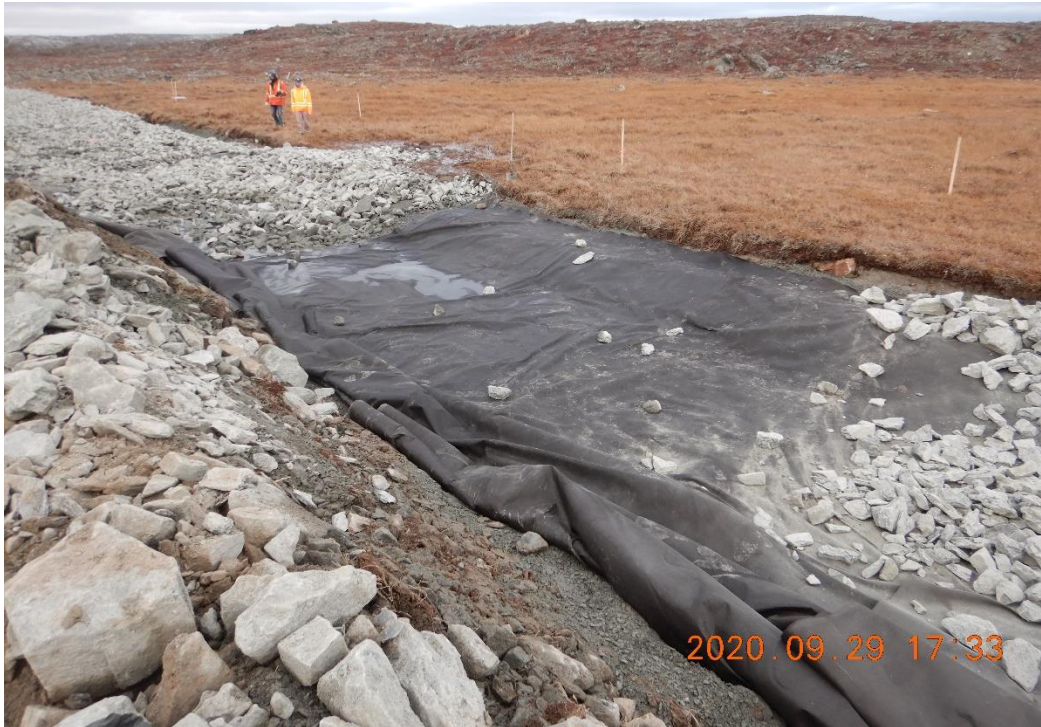
Photo 6: Rip rap placement on geotextile. Sta 0+070 looking north west. Water ingress (tundra runoff) at around 0+100 is visible on the photo. Water is properly flowing within the rip rap material, over the geotextile.

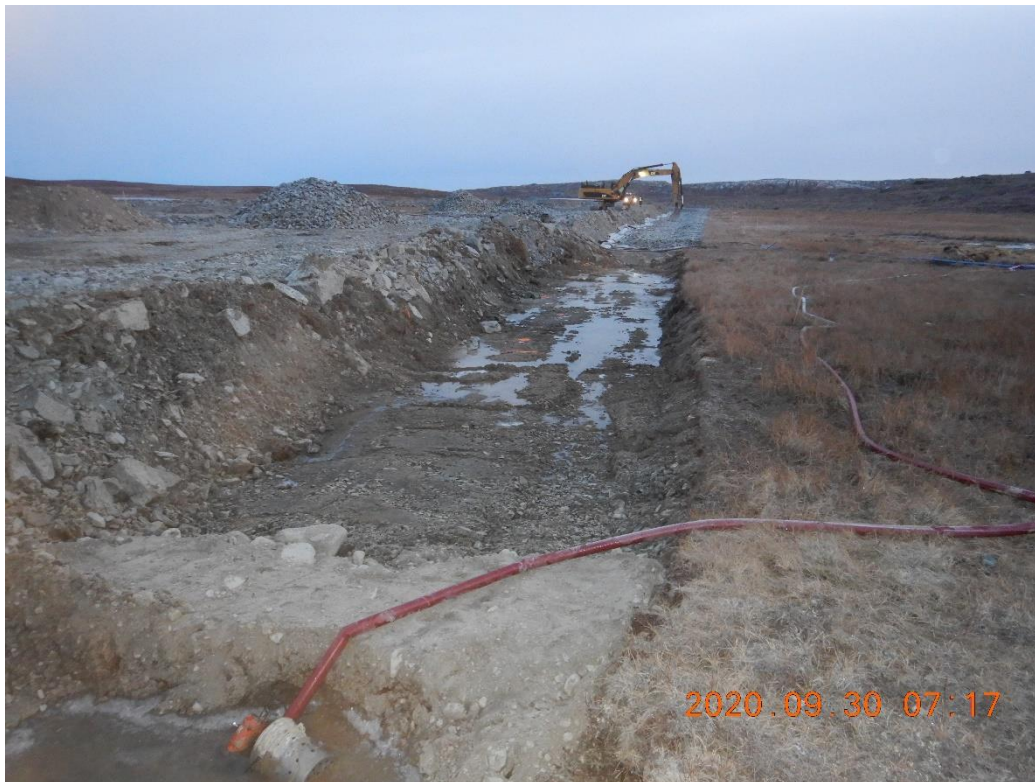
Photo 1. Bottom of the exvaction from -0+015 to 0+029 before final clean up. Looking north. Water in the excavation is coming from tundra runoff and has been removed, along with superficial thawed material, prior to approval.

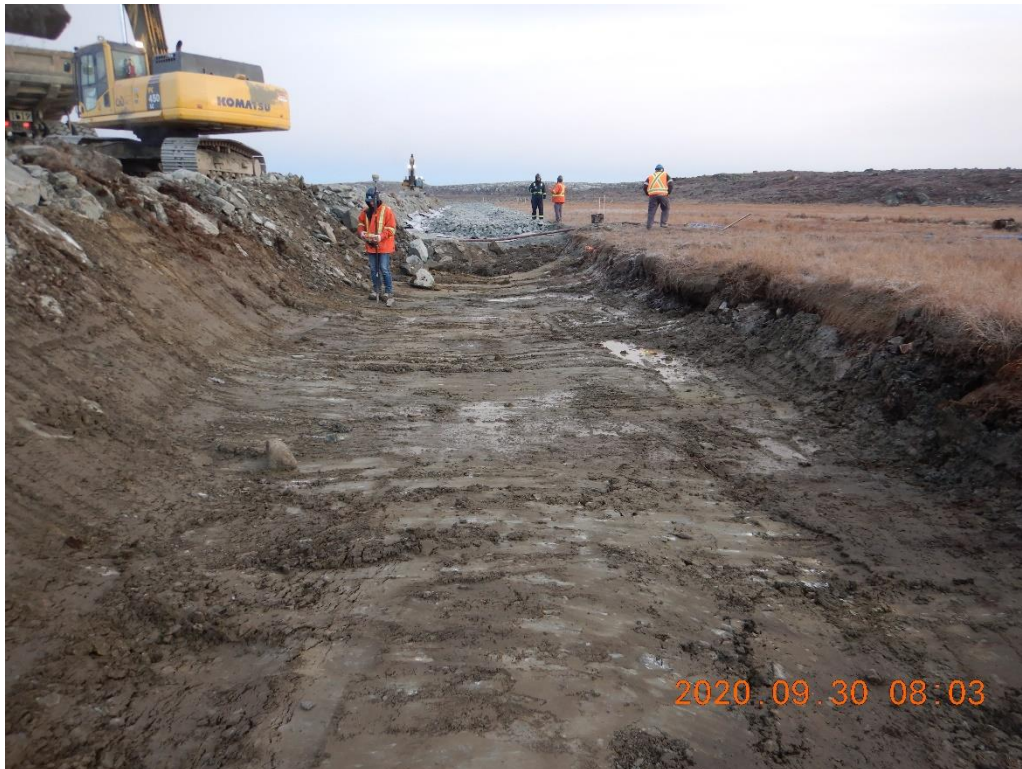
Photo 2. Bottom of the excavation from -0+015 to 0+029 after final clean up, looking north. Superficial thawed soil and water removed prior to backfilling FF.

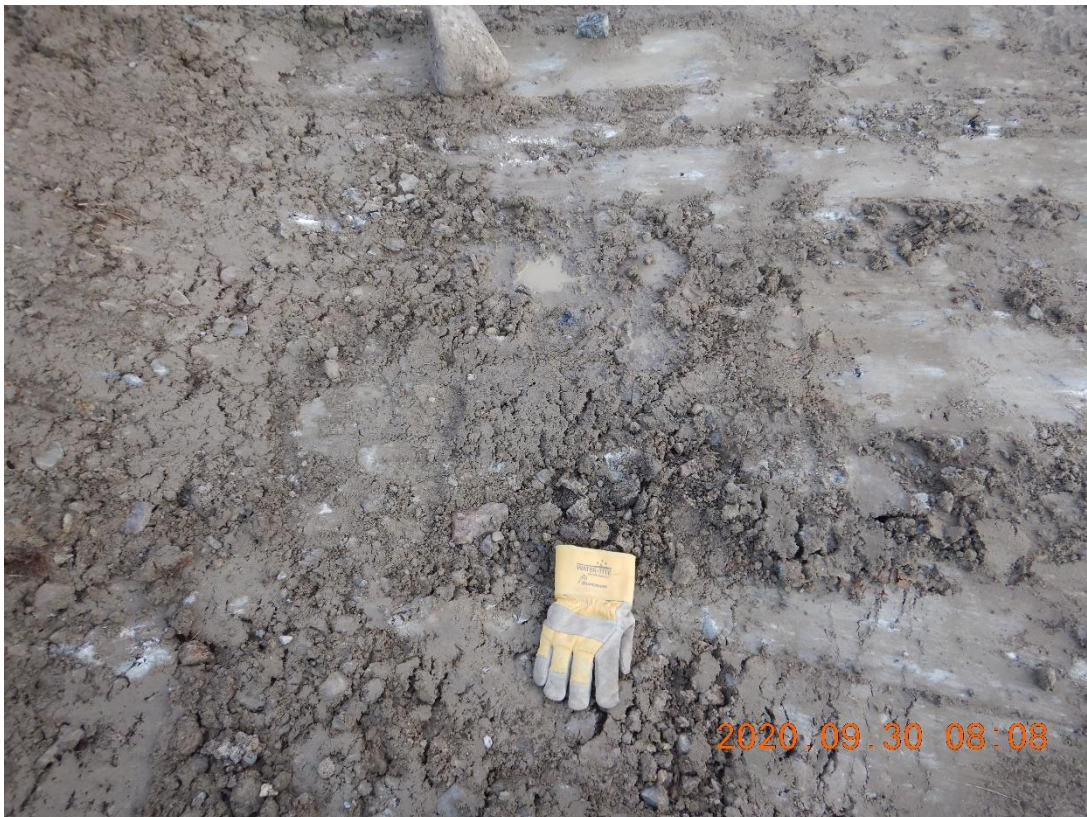
Photo 3. Close up view on foundation material in 0+000 to 0+029 area. Ice poor material, mix of sand, gravel and finer material. Superficial thawed soil and water removed prior to backfilling FF. Sample EX-15 taken in that area.

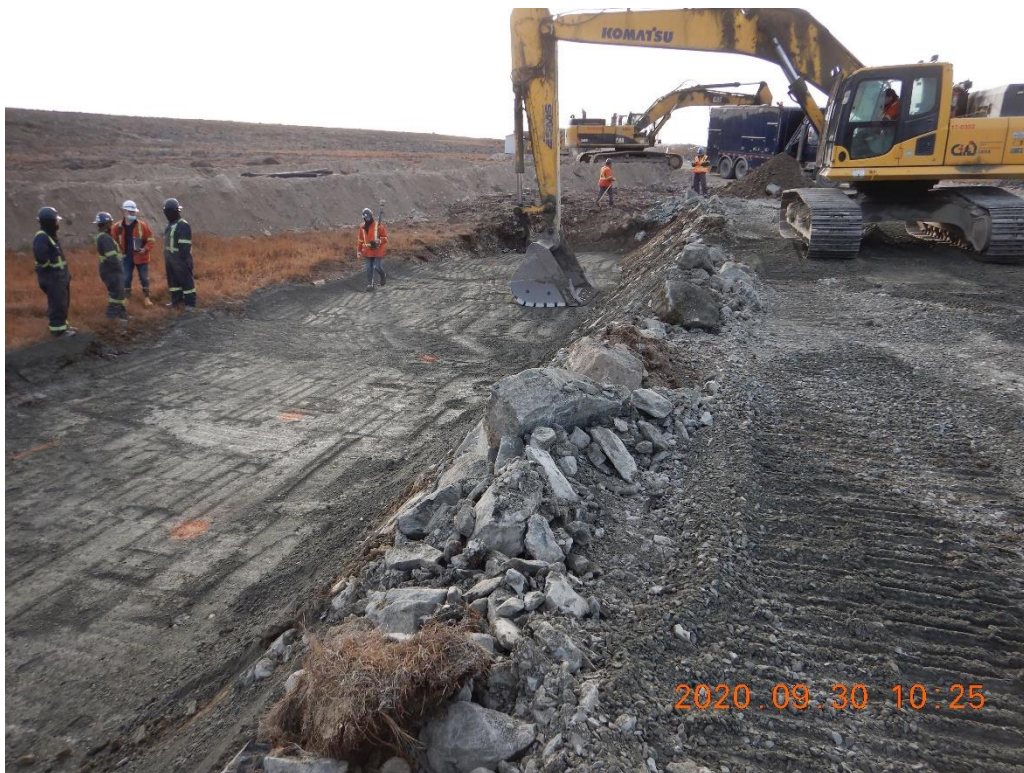
Photo 4. Completion of Fine filter material placement. Compaction with excavator bucket.

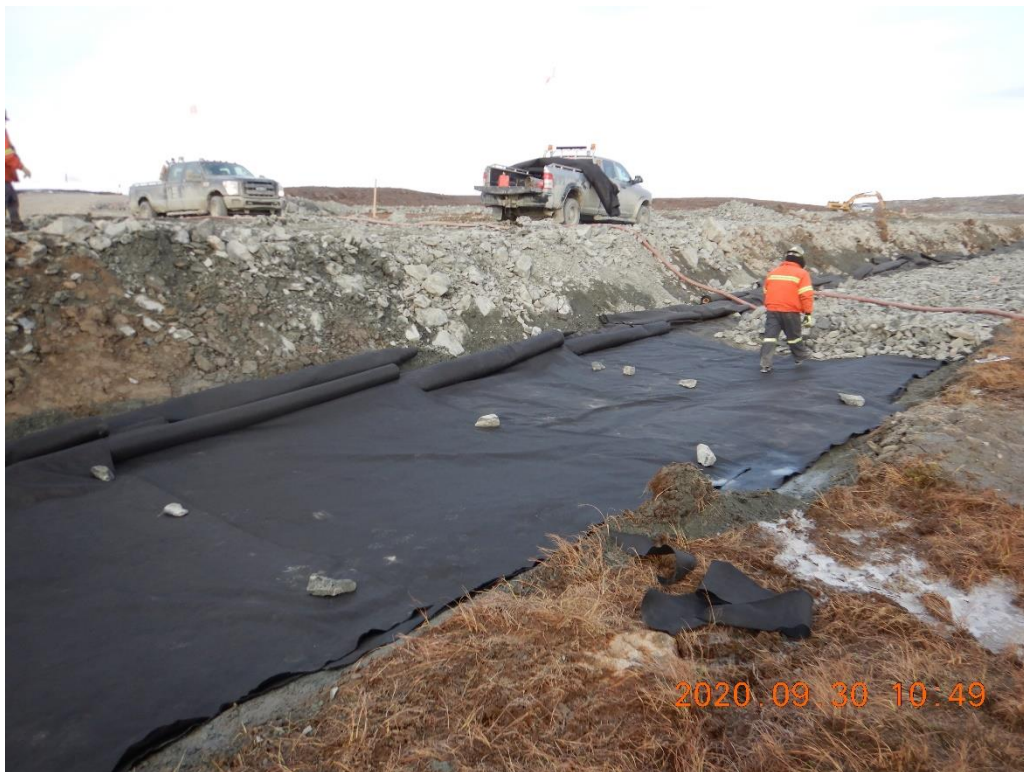
Photo 5. Geotextile installation on top of FF layer. Two layers of Tencate Mirafi 1100N with proper overlaps. Looking north from 0+020.

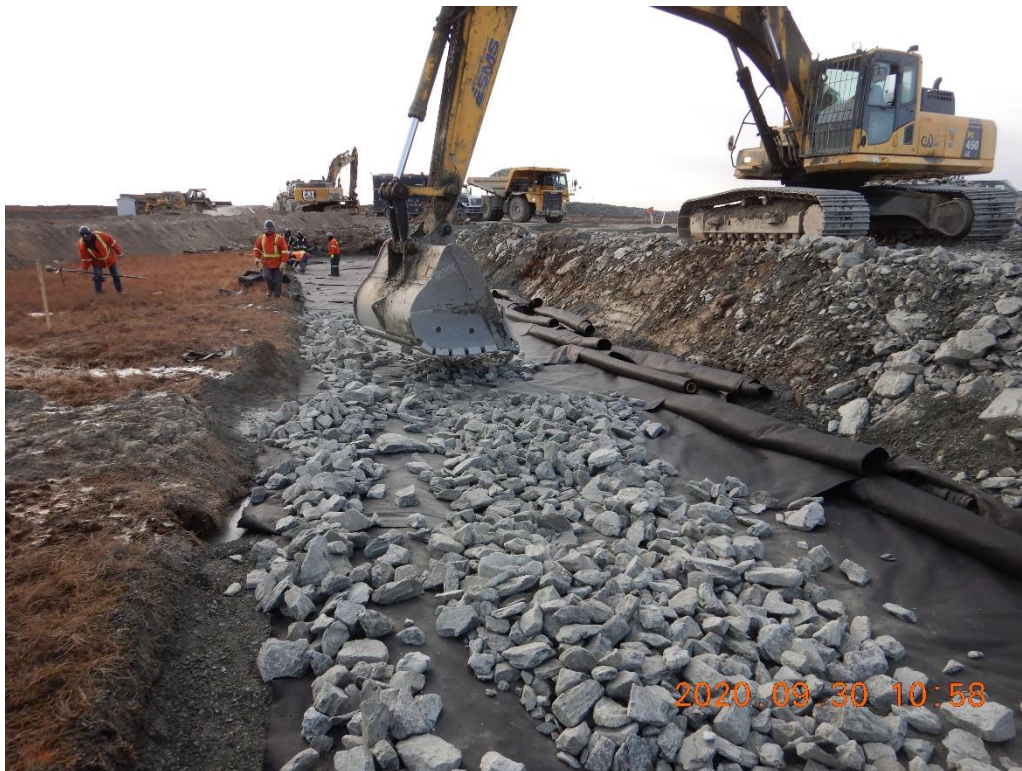
Photo 6. Rip rap placement, STA -0+015 to 0+032. Looking south

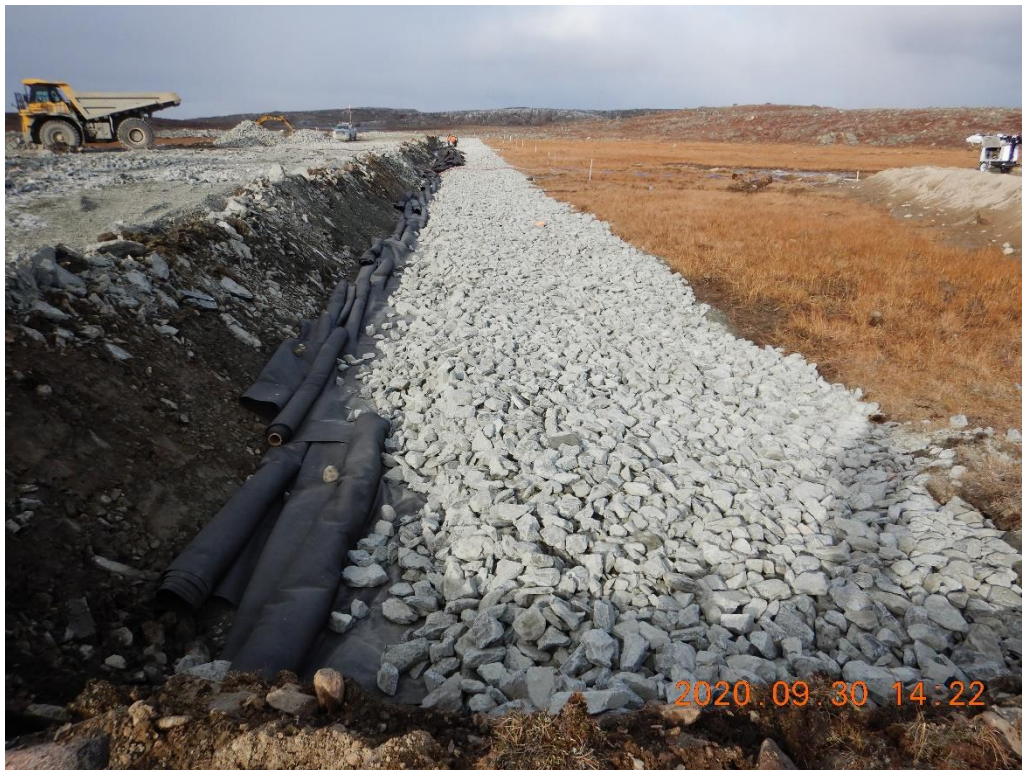
Photo 7. Rip rap placed to final grade on the invert and east slope, looking north from -0+015.

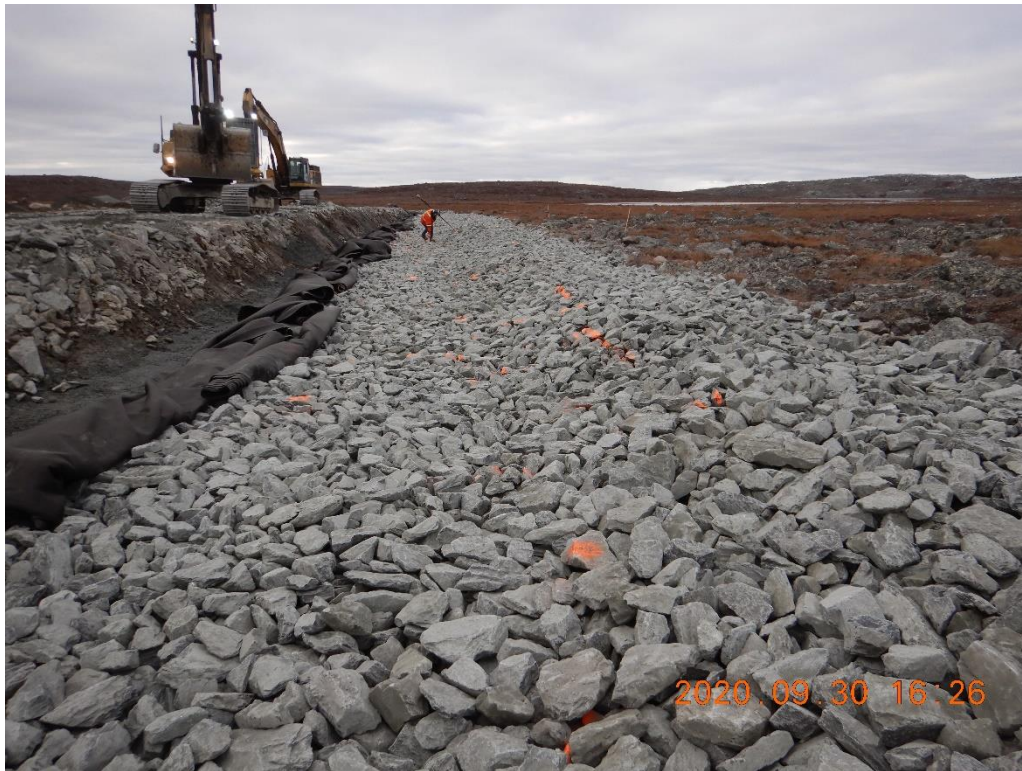
Photo 8. Final sloping, profiling and grading of the rip rap layer, invert and east slope. Photo taken around 0+160 looking north.

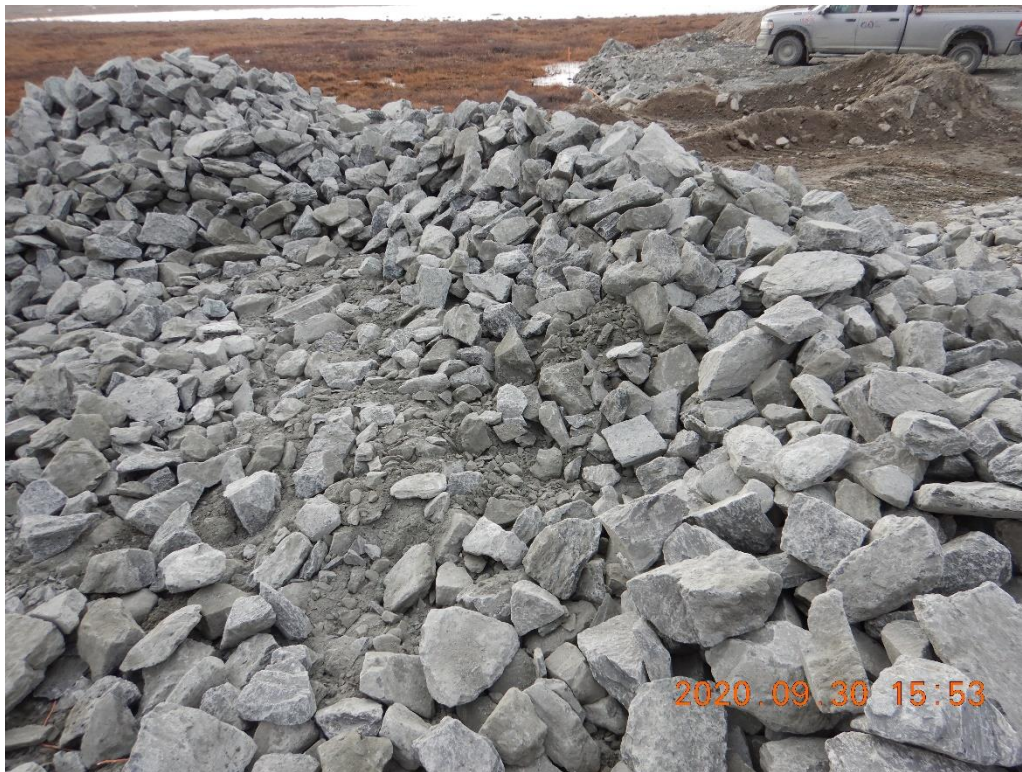
Photo 9. Non-compliant rip rap load, containing fines and gravel <100mm. Material on the photo has not been placed on the channel.

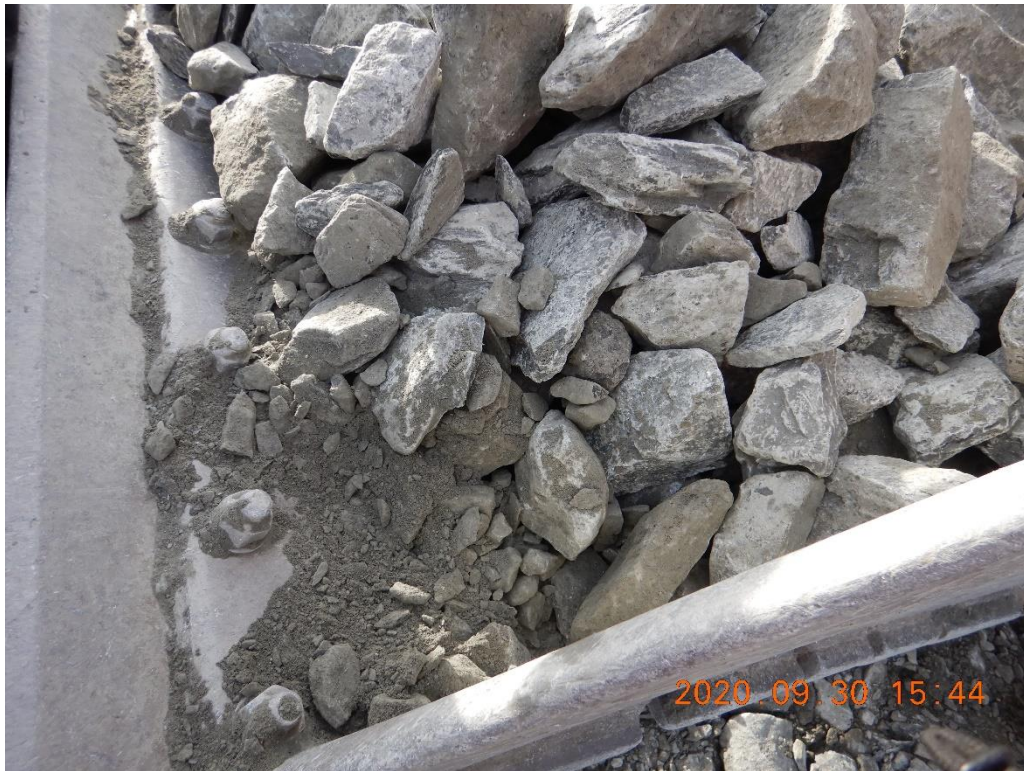
Photo 10. Non-compliant rip rap material containing fines and gravel <100mm. Excavator were told not to place any material of that kind. Manual cleaning will be required at some location along the channel where finer material was observed within the rip rap. Refer to comment section above.

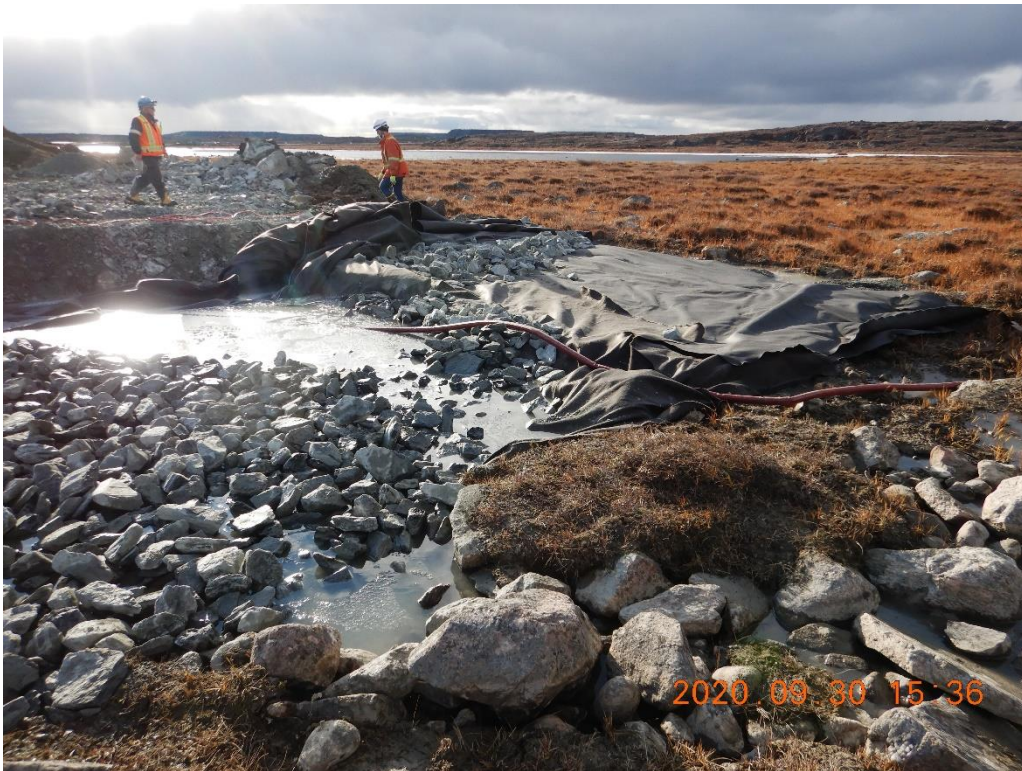
Photo 12. Two layers of geotextile placed on top of fine filter material (Photo 11). Rip rap placement ongoing on top of geotextile. Thin layer of rip rap will be placed to hold geotextile in place.

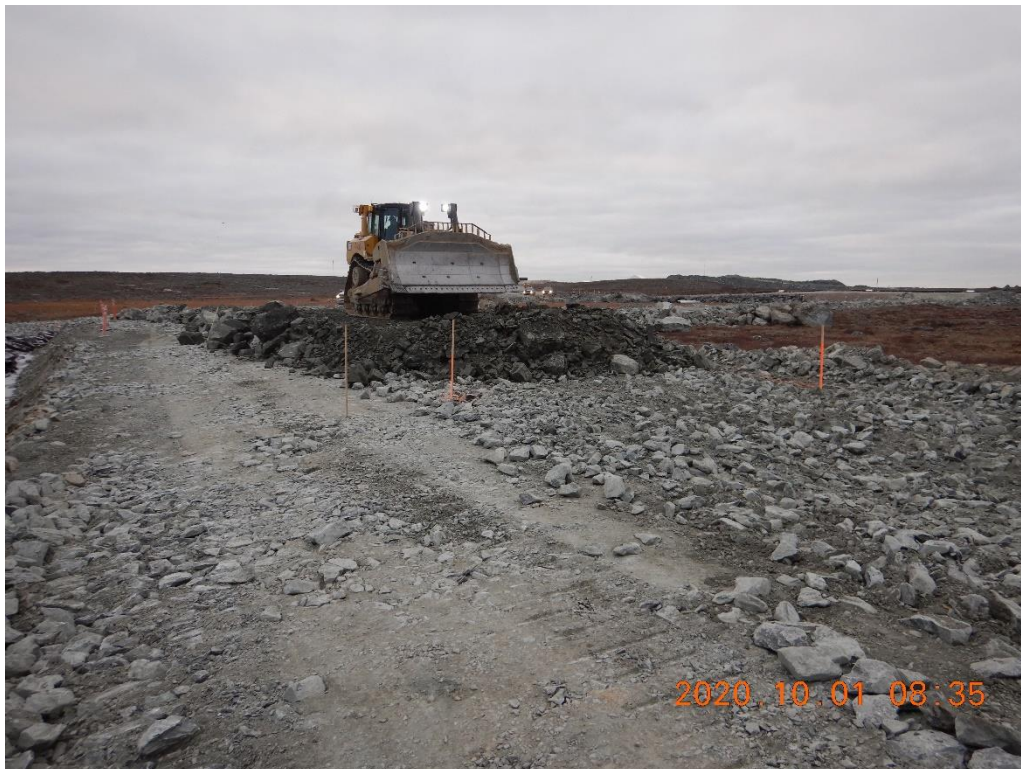
Photo 1. Rockfill placement for final lift of the access road along the west side of the channel looking south from around 0+200

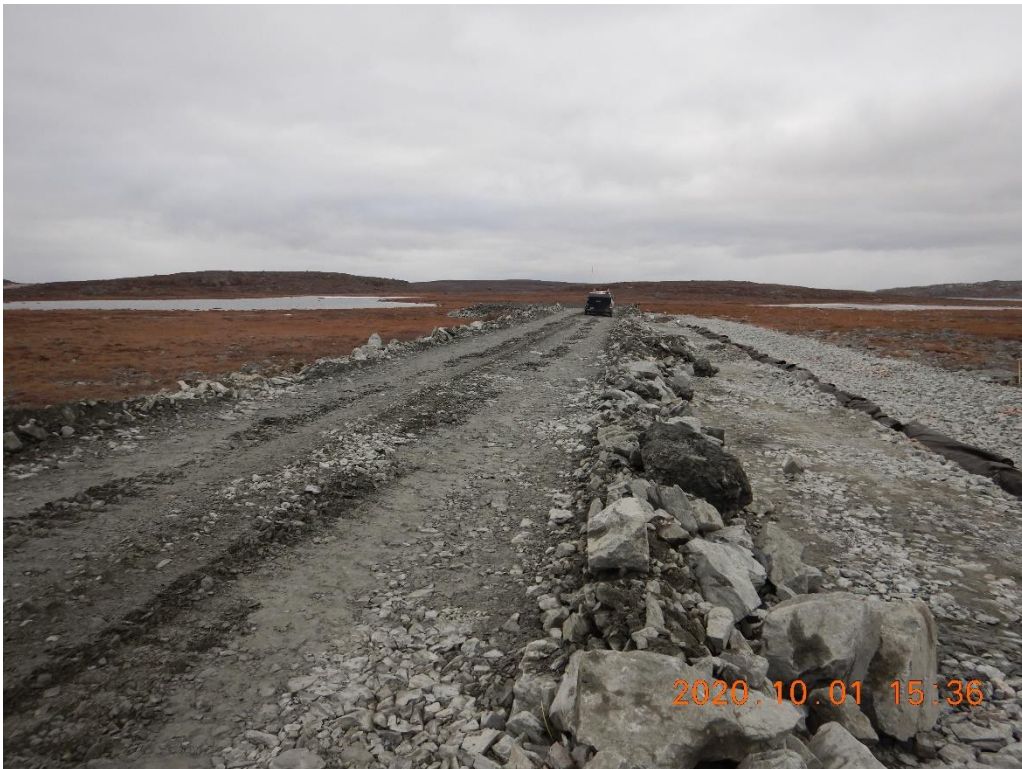
Photo 2. Final access road rockfill lift. Surface compaction with dozer and truck traffic. Adequate rolling surface. Looking North, STA 0+200

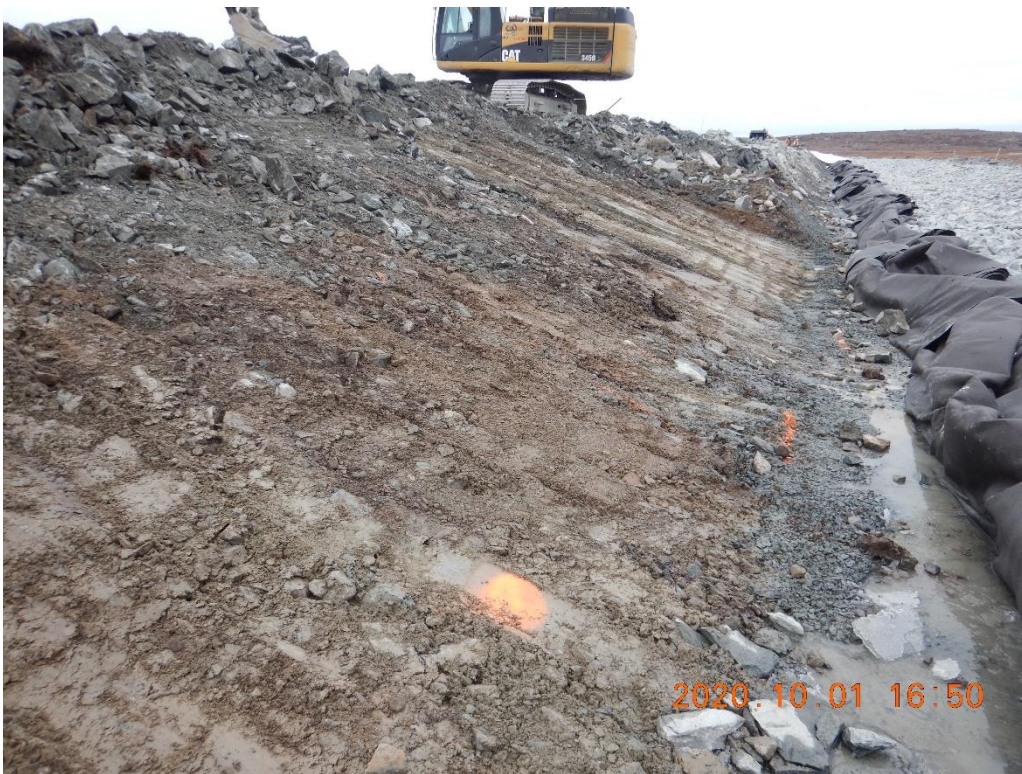
Photo 3. Excavation of the side of the road to prepare west slope of the channel, looking north STA 0+160. Some water ponding on top of the invert fine filter layer. Rolls of remaining geotextile moved on the rip rap to leave as much room as possible for the excavator to work the slope.

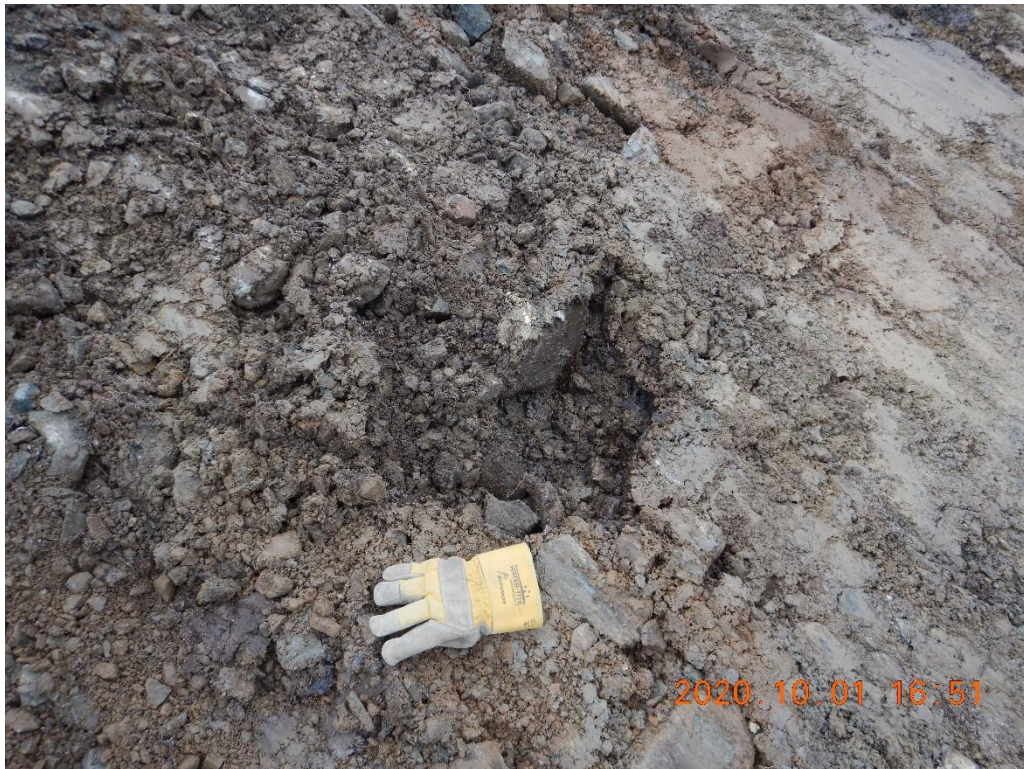
Photo 4. Ongoing slope excavation. Natural ground material. Till with gravel, sand, boulders and some organic matter in the upper portion. Material is dryer towards the top and more humid at the toe

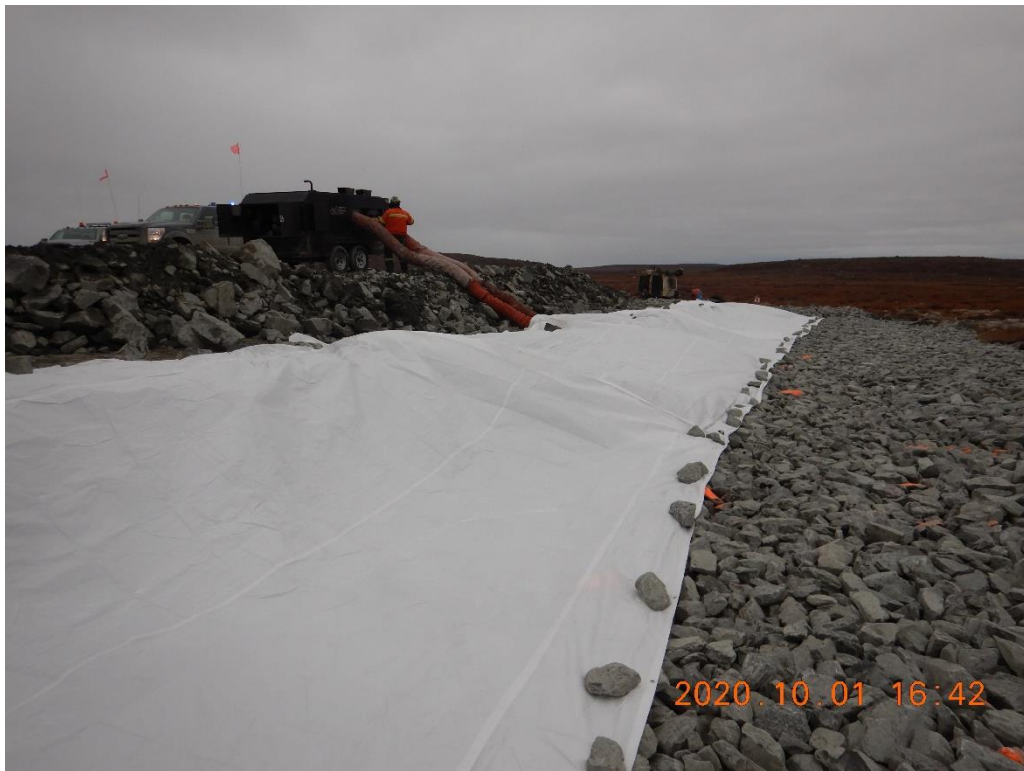
Photo 5. Tarps and frost-fighter installed at the downstream end of the channel to keep water and geotextile rolls above the freezing point.

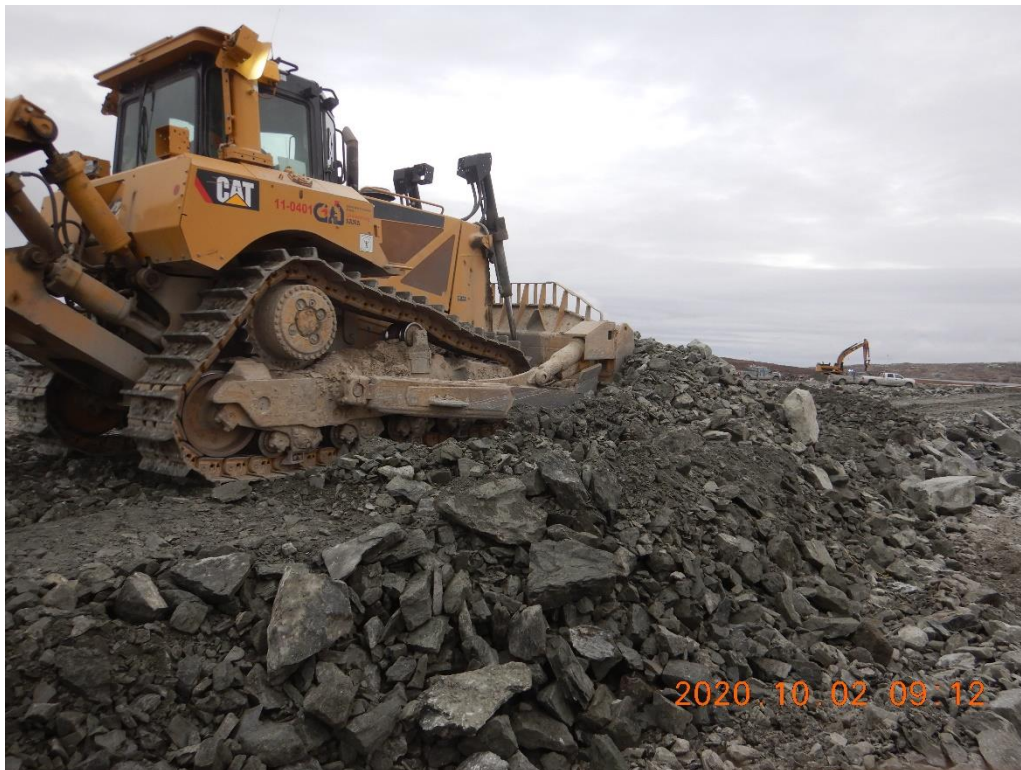
Photo 1. Rockfill placement for final lift of the access road along the west side of the channel looking south from around 0+050

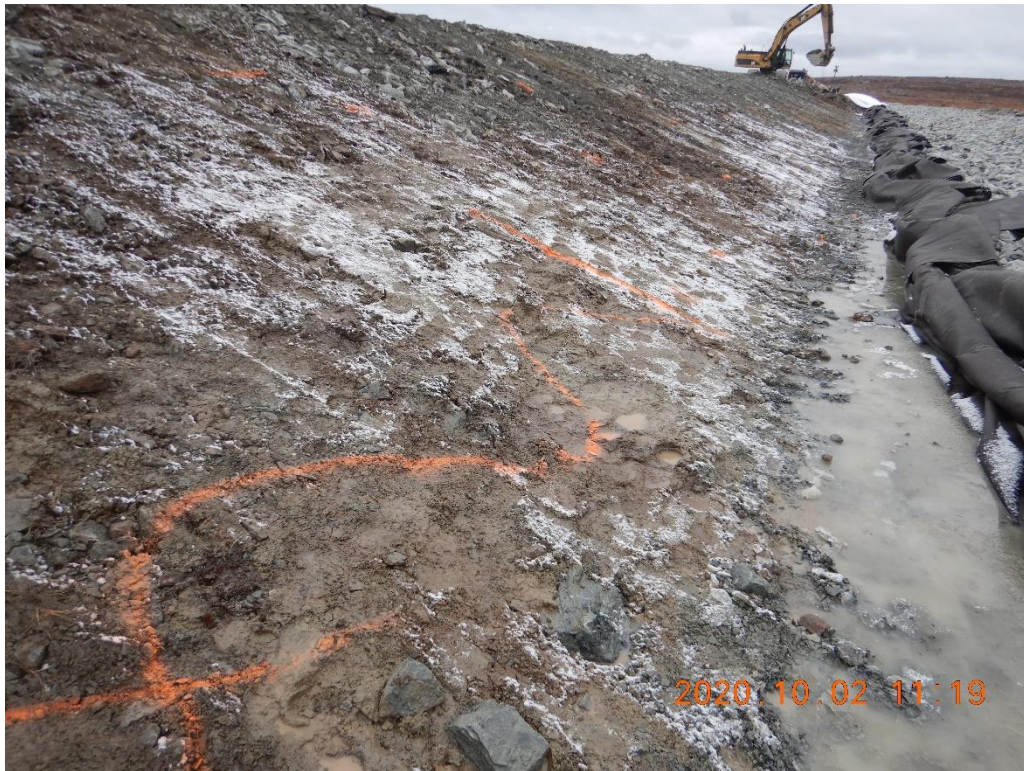
Photo 2. West slope at around 0+160. Zones with soft oversaturated material maked with spay paint, to be removed prior to FF placement

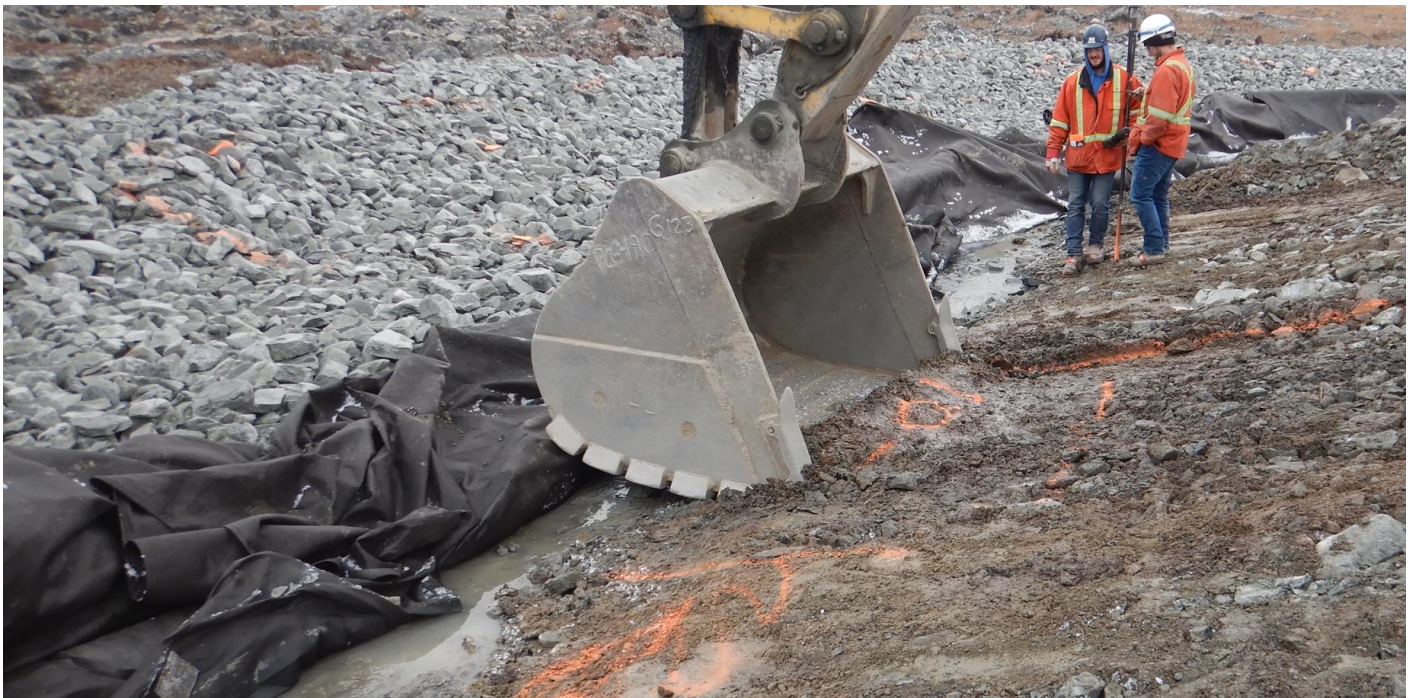
Photo 3. Soft oversaturated material starting to be removed by the excavator

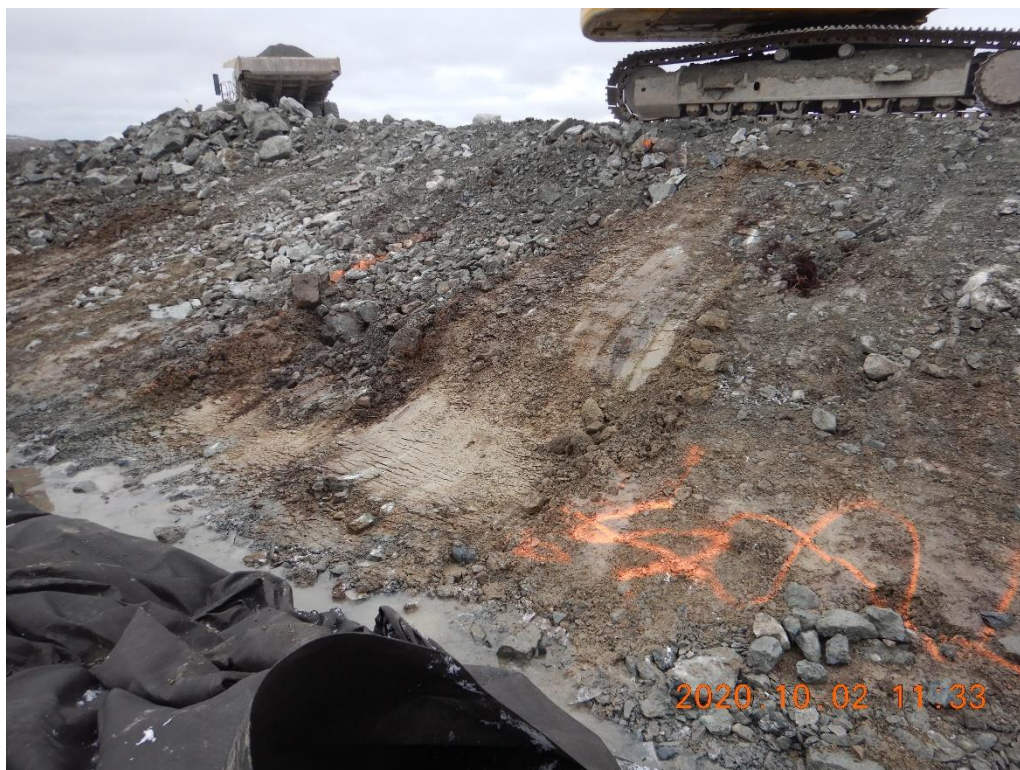
Photo 4. Ongoing process of removal of soft oversaturated material at the toe of the slope. About 0.1 to 0.3m removed in the center of the photo. Exposed material is much dryer and competent. Marked material on the right hand side remains to be excavated.

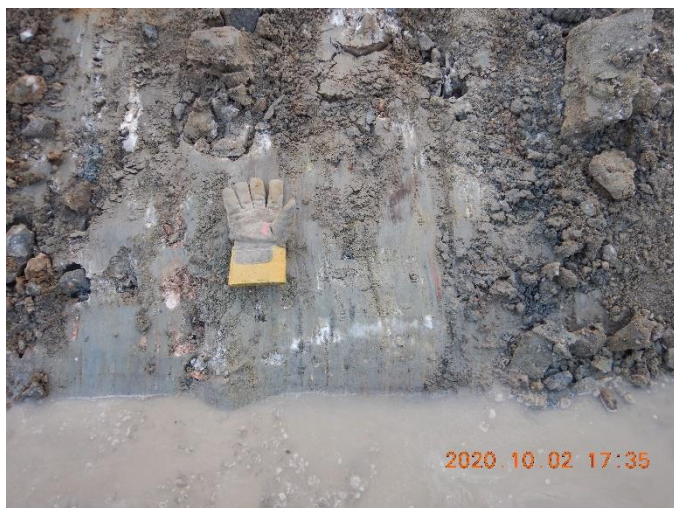
A

Photo 5. Ice lenses (A), ice pockets and ice rich material (B) observed between 0+230 and 0+240. All this material has been removed.

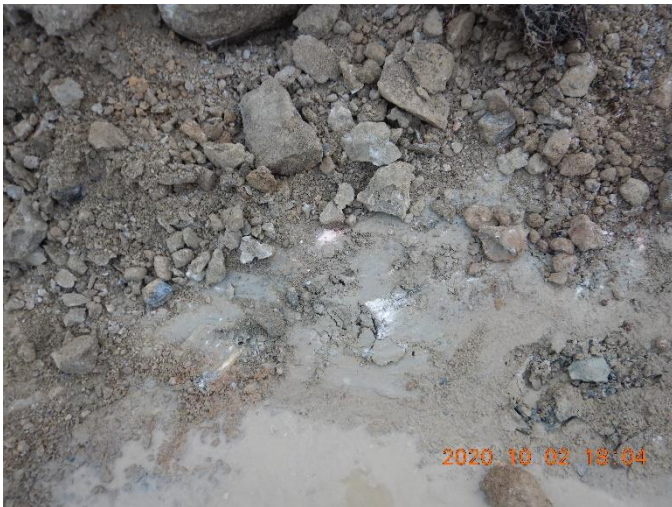
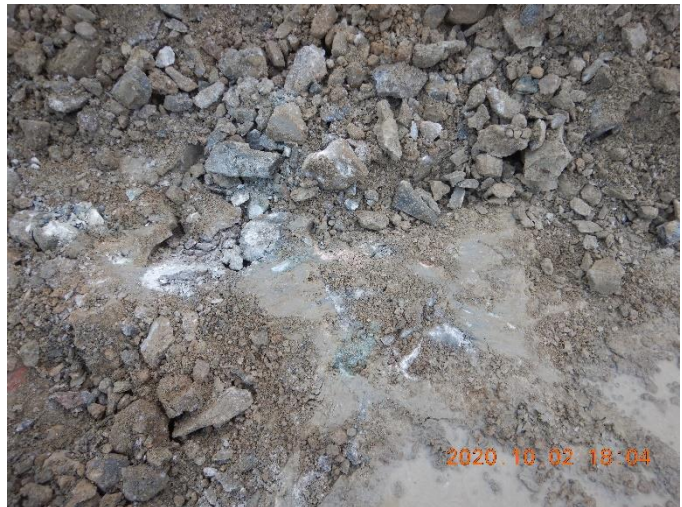
Photo 6. Looking at foundation material once ice-rich material removed (0+230 to 0+240). There was no more ice in the material at the excavated level. White spots on the photos are broken rocks, not ice.

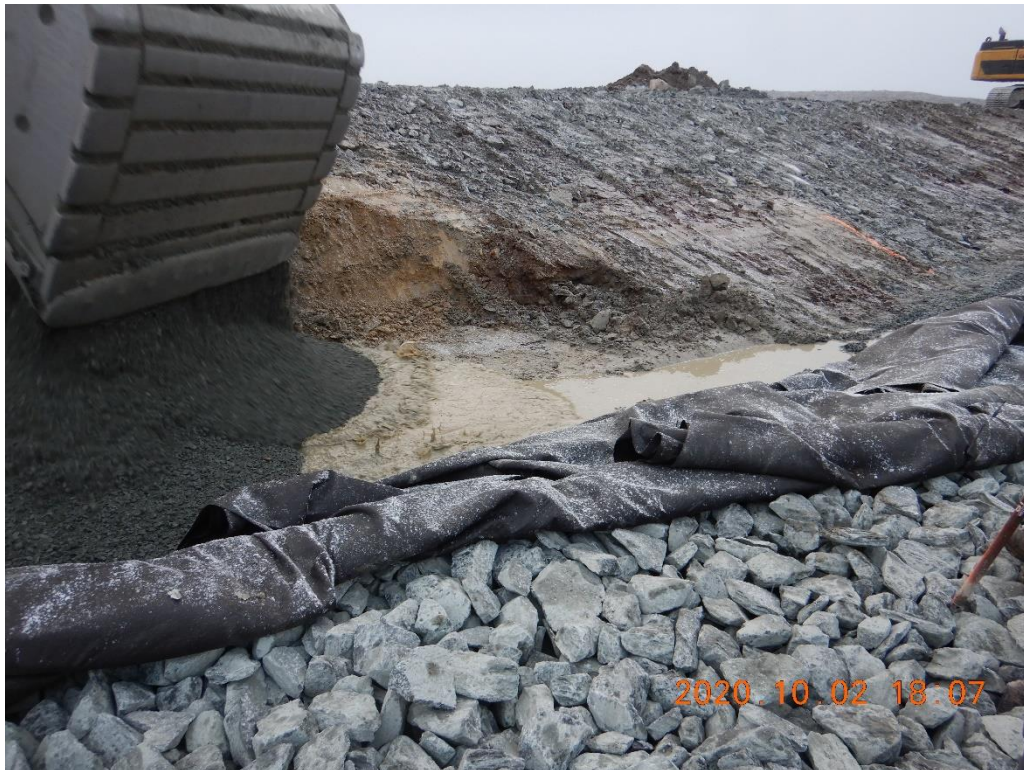
Photo 7. Fine filter placed in a way to push water further down the channel. Preliminary FF filling of the overexcavation where ice was found, STA 0+235

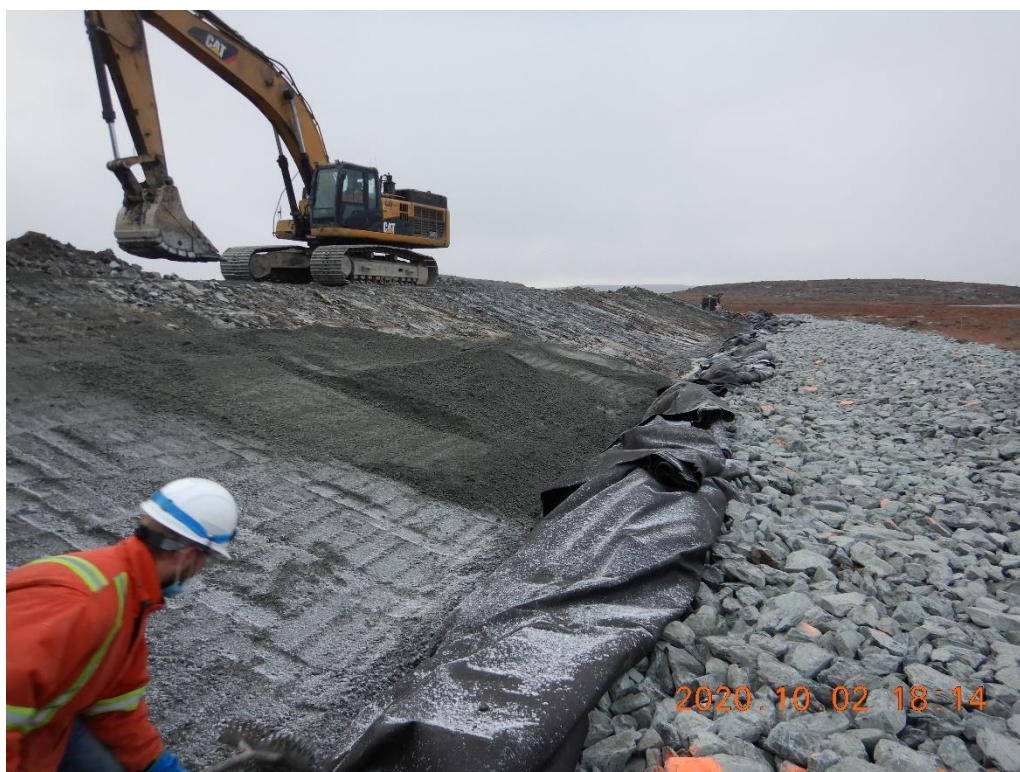
Photo 8. Fine filter placement, Looking north from around 0+225

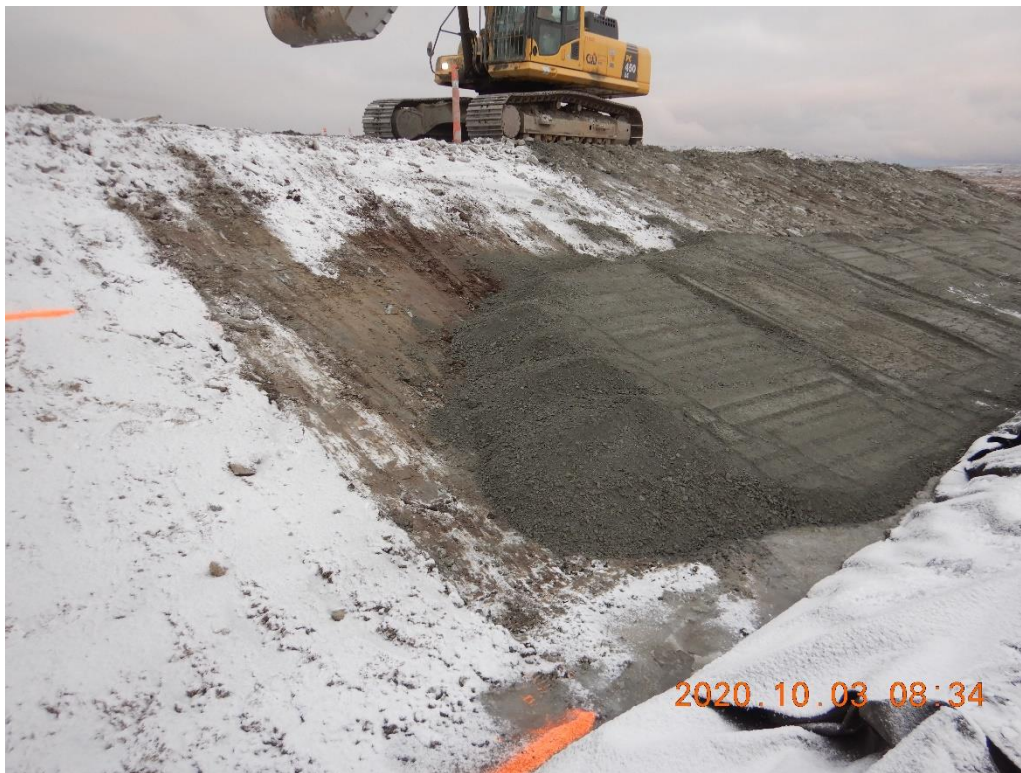
Photo 1. Fine filter placement at the downstream end of the channel. STA 0+250 looking north. Excess of snow was removed.
