Construction Summary Report IVR Diversion Channel

Agnico Eagle Mines Ltd

6127-695-132-REP-012_R2

February 16, 2021

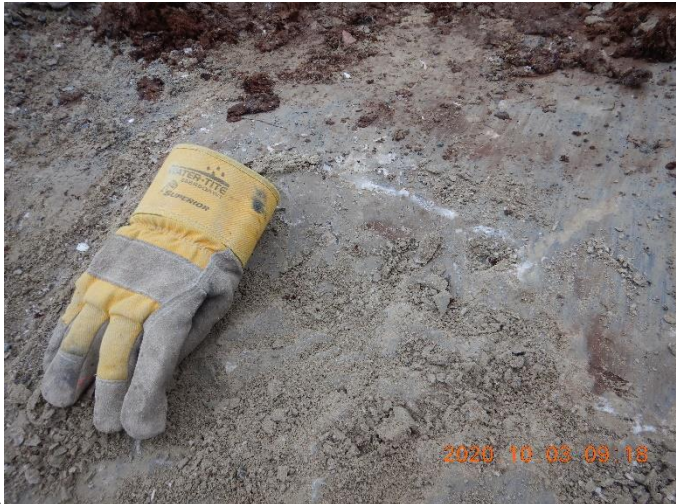
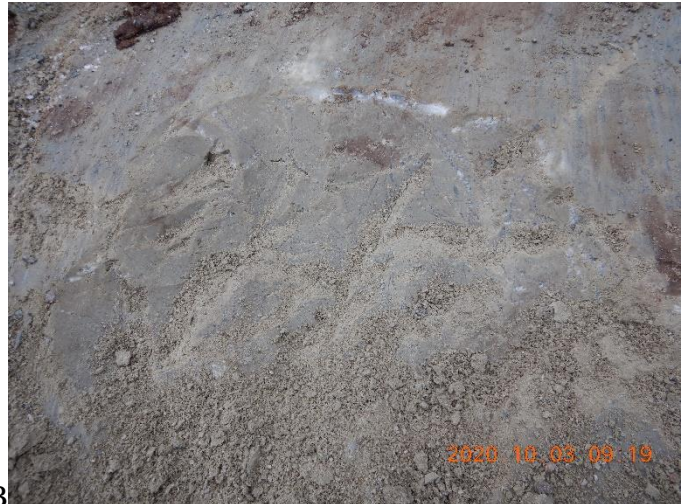
Photo 2. Foundation spot check STA 0+260, about 0.3m below grade. Visible presence of ice. Some ice lenses at mm scale and an isolated 1cm thick one.

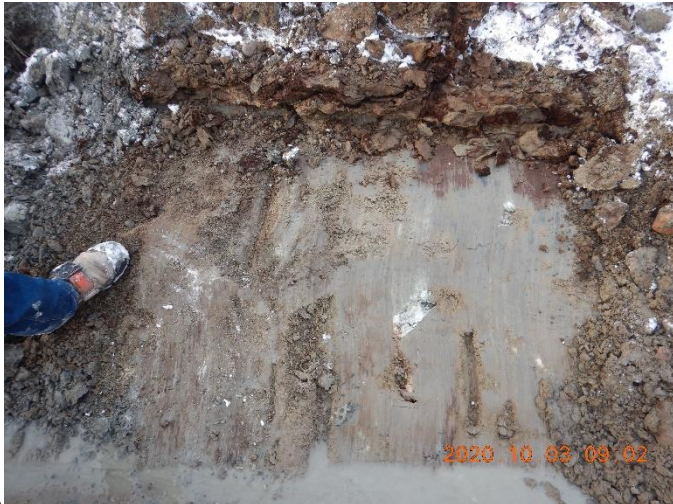
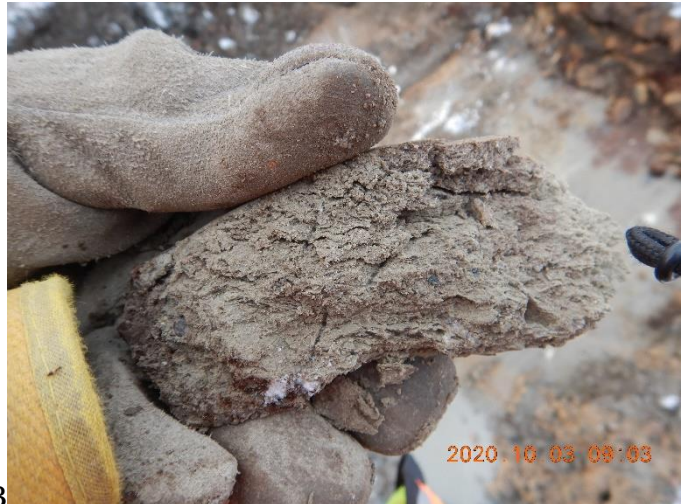
Photo 3. Foundation spot check STA 0+250, about 0.3m below grade. some ice visible at mm scale. Sample taken to confirm ice content.

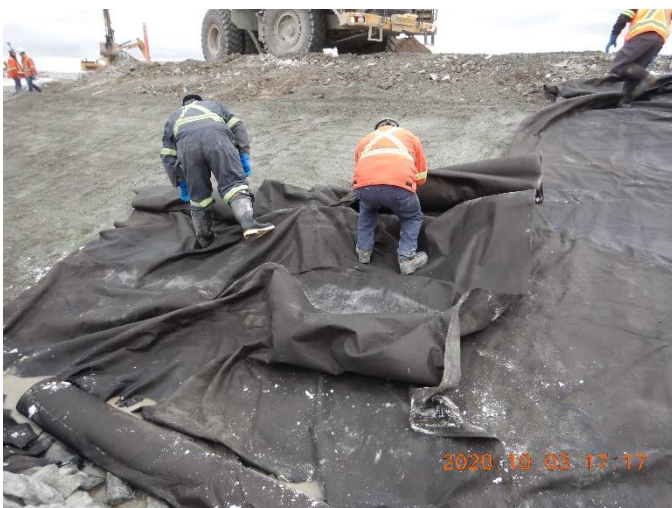
Photo 4. Geotextile placement at 0+150. Roll on the photo was partially damp and frozen

- Frost fighter and tarp setup used when needed to unfreeze the geotextile rolls.
- The small amount of water ponding at the toe of the exaction was properly pushed away while placing the fine filter material on the slope.

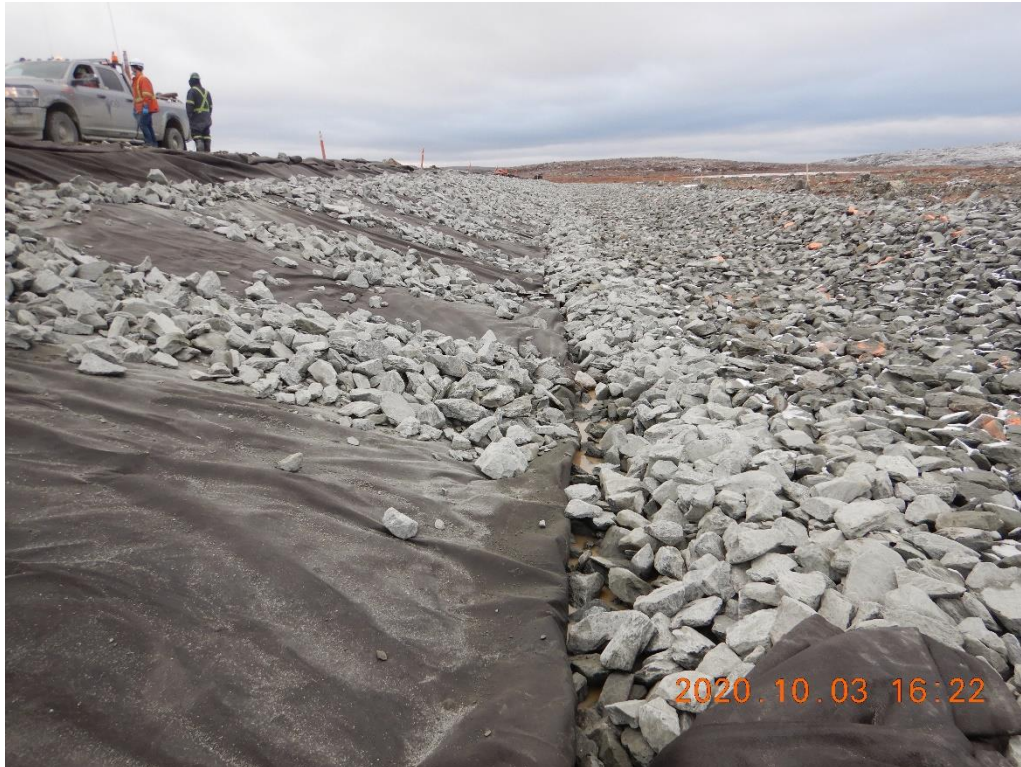
Photo 5. Rip rap placed to hold the geotextile on the west slope before completion of rip rap final layer. Visible on the photo is a fold in the geotextile at the toe of the slope, where the water within the geotextile remain frozen, because the rolls were on the invert side during sloping. Fine filter material underneath is at grade. As rip rap is placed in this zone, the geotextile levels to the top of the fine filter layer.

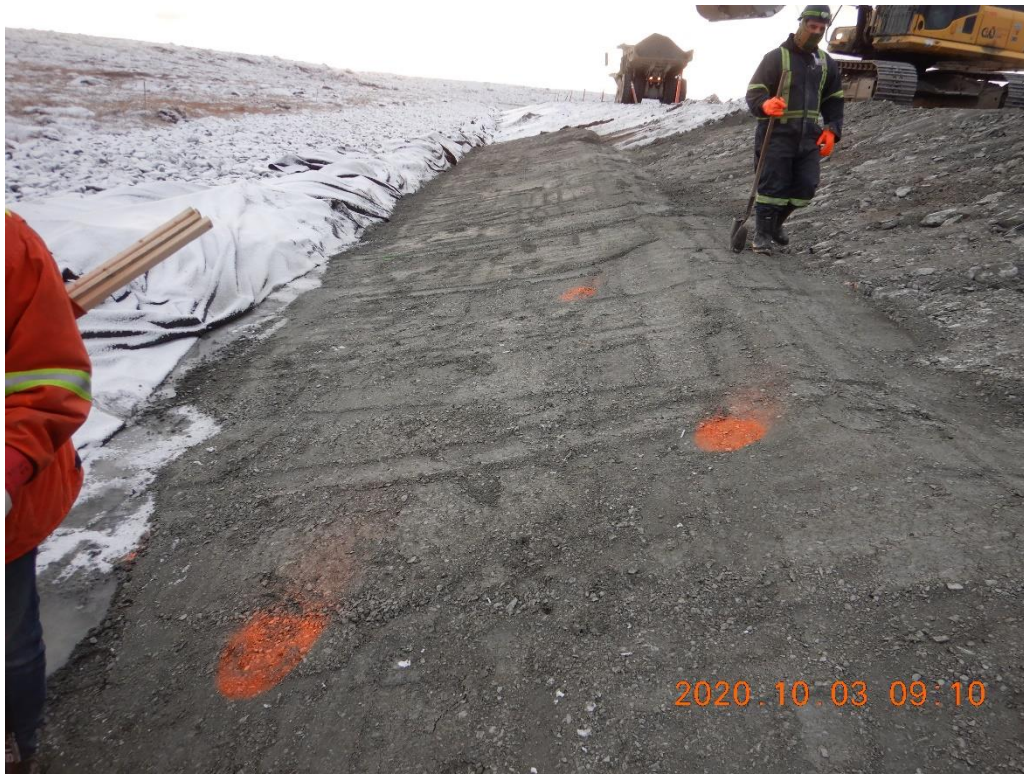
Photo 7. Fine filter layer at grade. From about 0+200, looking south

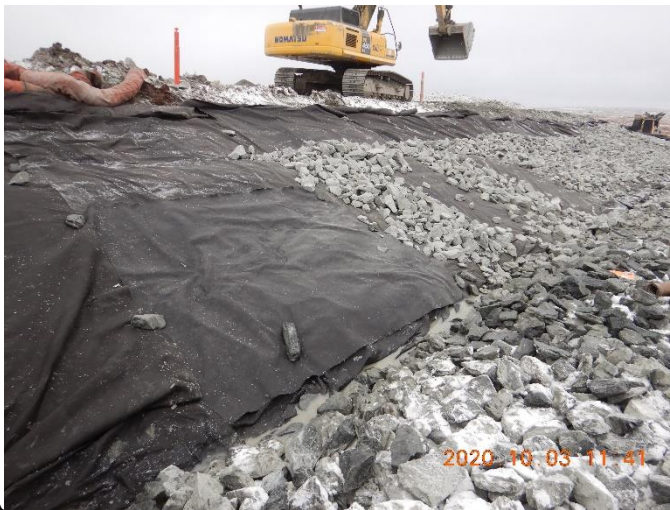
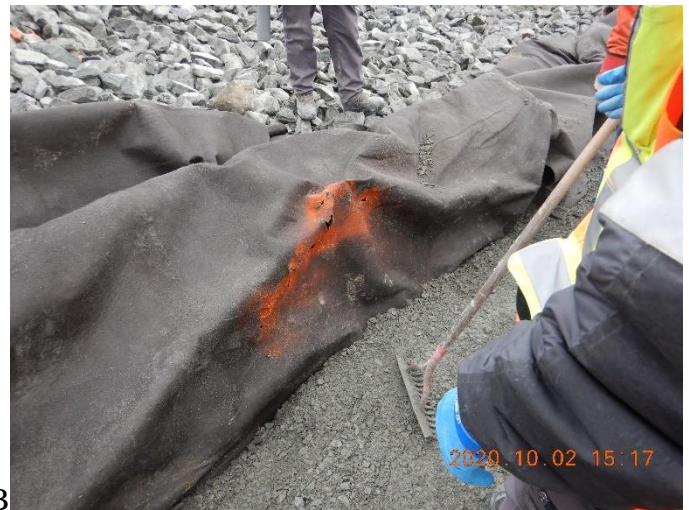
Photo 8. A) patch installed on the slope to cover the damaged geotextile. B) Close up on the damaged geotextile found the day before.

- 0+250: No significant ice lense. Fine material with some ice content (ice poor). Sample taken at that location to confirm ice content.
- Adequate corrective measures were taken for the geotextile that has been damaged during FF placement. Tear holes were located at the toe of the west slope. When unrolling the rolls, full width geotextile patches were added in a way that the the patch covered a zone of 1-2m around the damaged area when possible. When the damaged area was too close to the toe, the covering offset was less on the side of the channel invert because of the rip rap already in place. On that side, the patch covered an area of about 0.3m beyond the damaged zone.

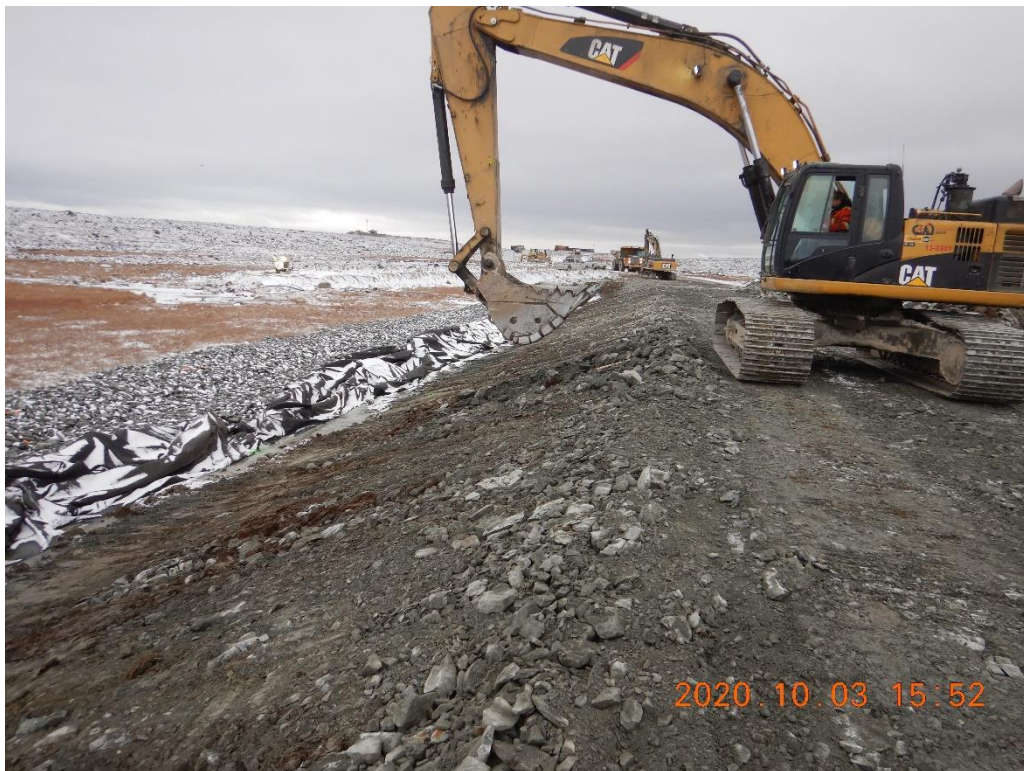
Photo 10. Remaining material from initial road lift being removed for the slope profiling. 0+070 looking south.

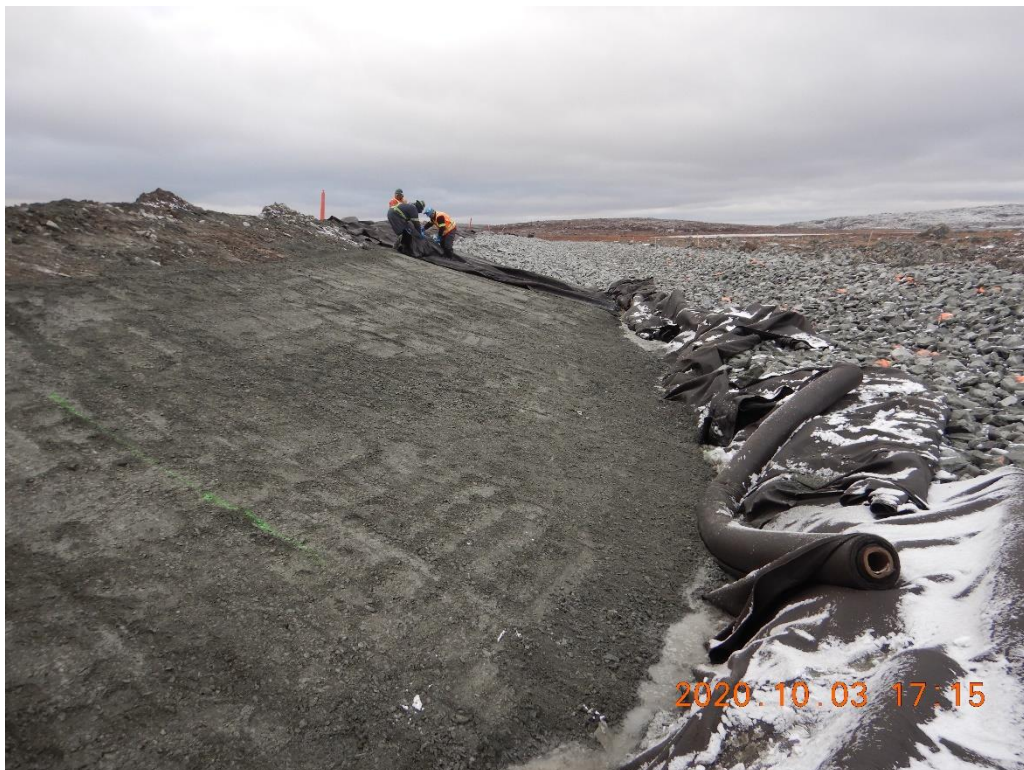
Photo 11. Geotextile being unrolled on the fine filter layer, 0+130 looking south

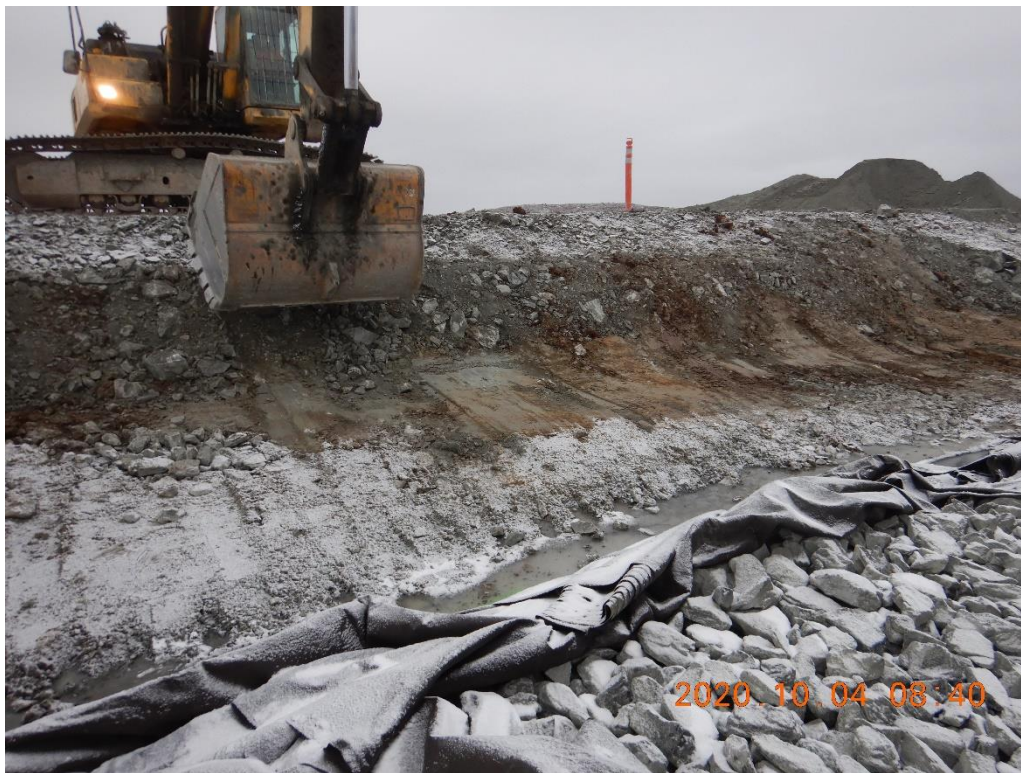
Photo 1. West slope excavation on going. Organic matter and boulders being removed to expose adequate foundation. Looking west between 0+050 to 0+090.

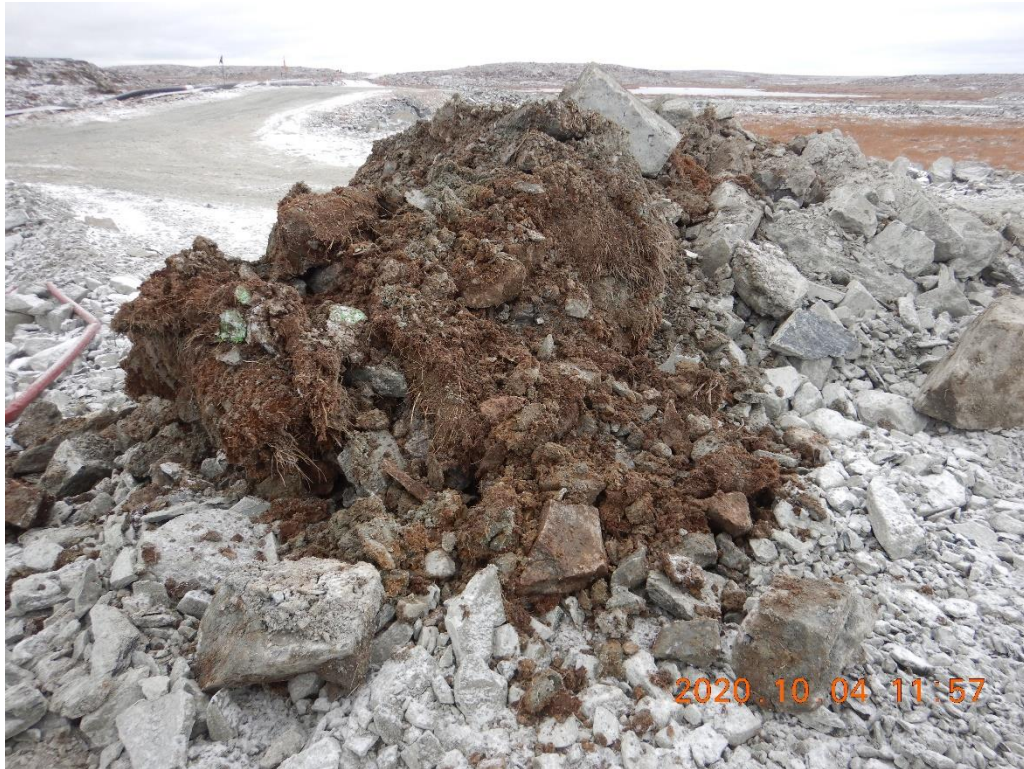
Photo 2. Organic matter removed from the foundation (west slope between 0+000 to 0+090)

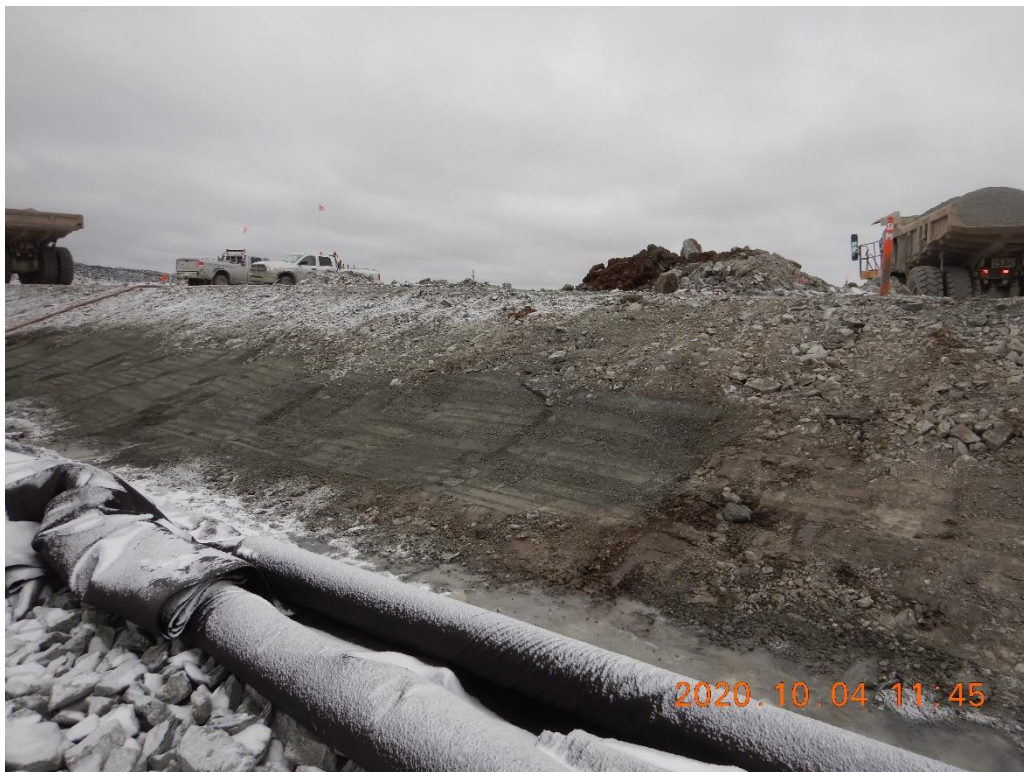
Photo 3. Foundation after corrections (boulder, soft pockets and organic matter removal), Sta 0+050 looking south

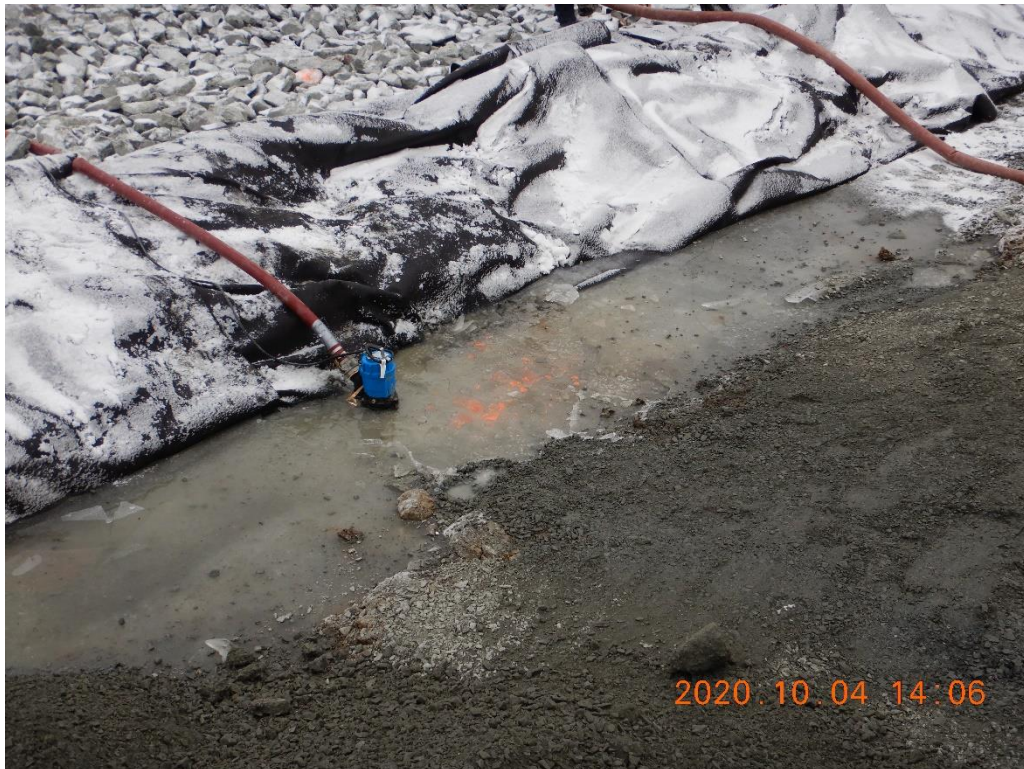
Photo 4. Water being pumped at slope toe prior to FF placement, STA 0+015 to 0+025

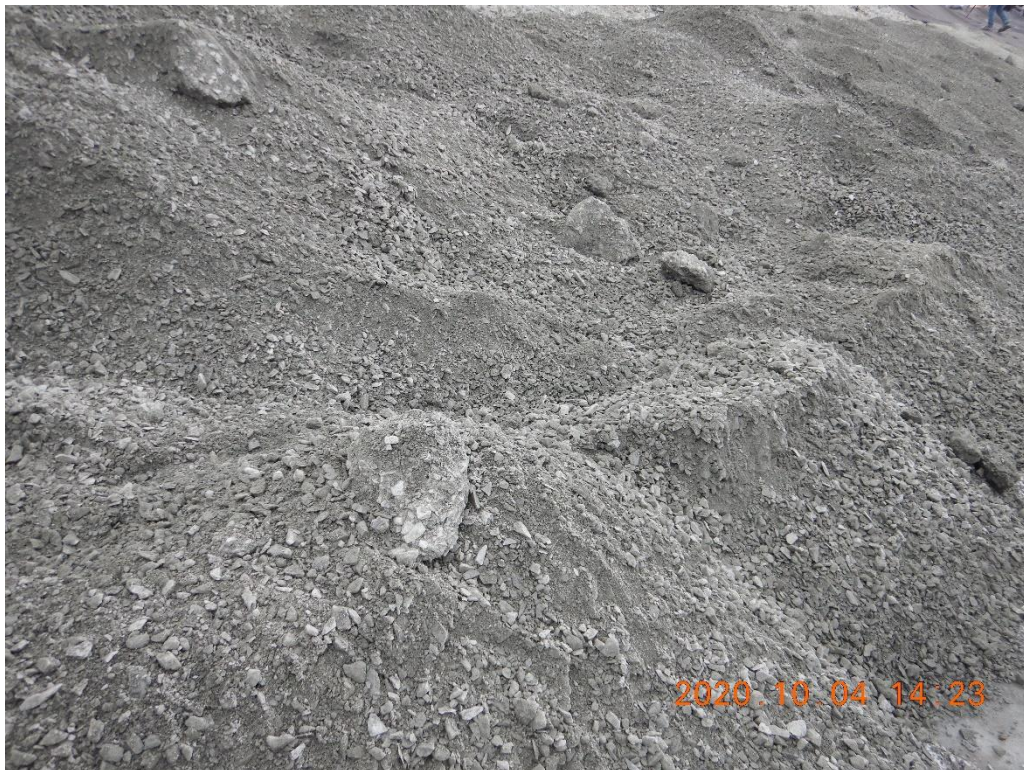
Photo 5. Fine filter with some chunks that were crushed during compaction.

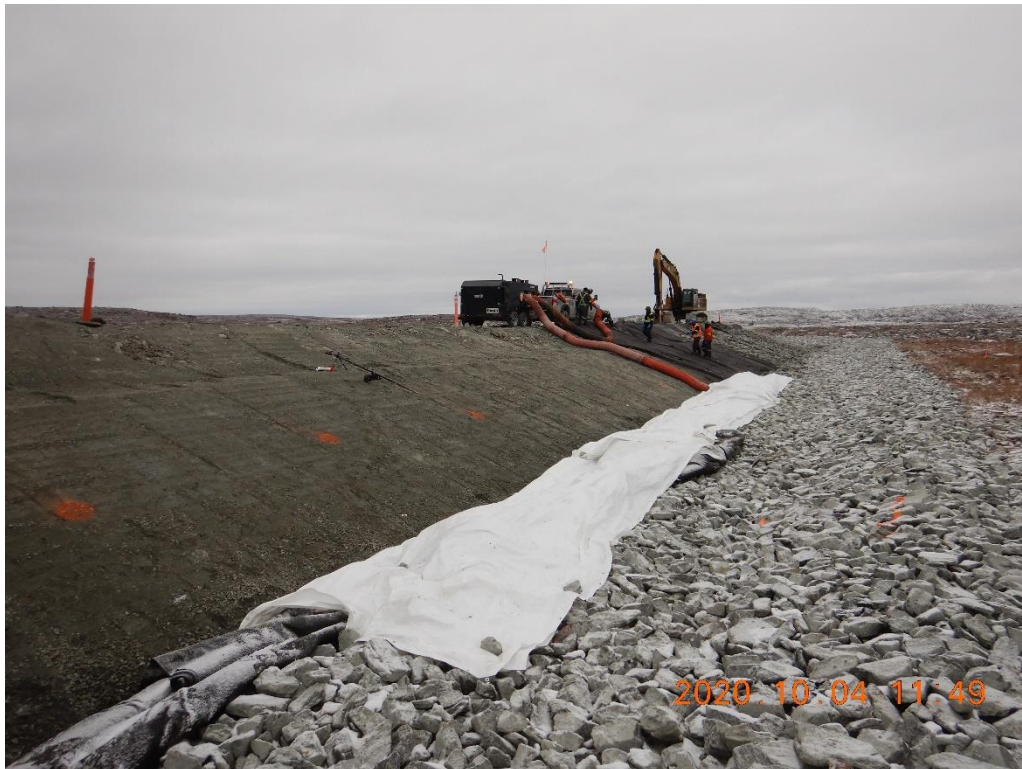
Photo 6. Frost fighter and tarp setup used when needed to unfreeze the geotextile rolls.

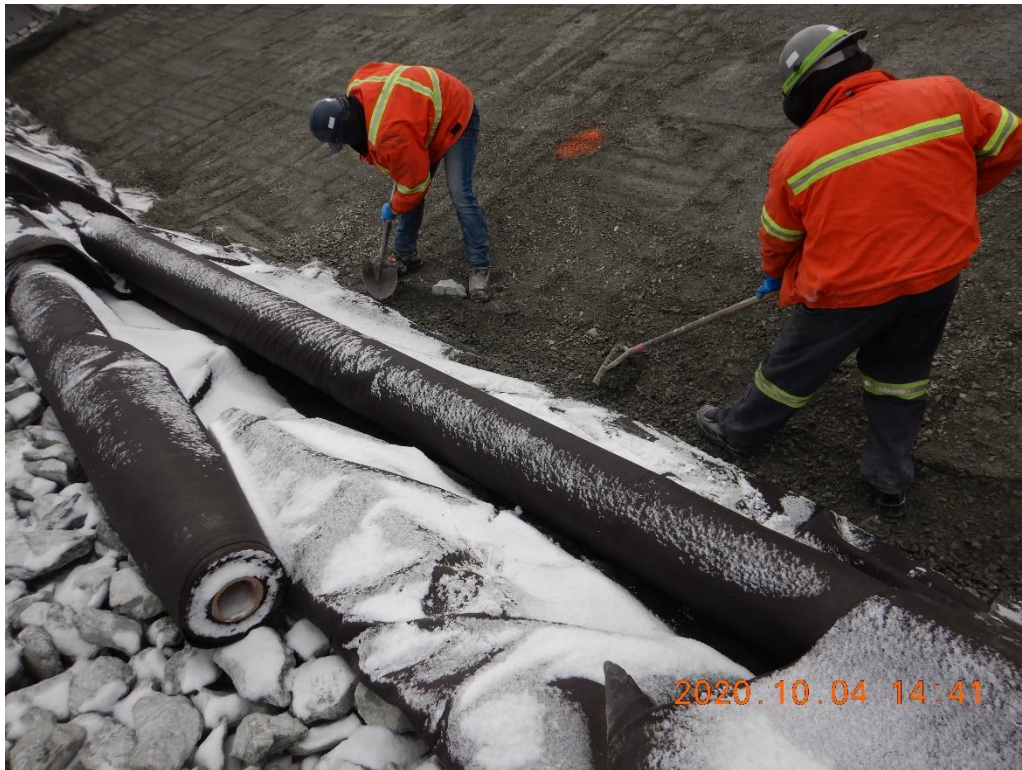
Photo 7. Ongoing finishing of the FF at the toe of the slope to ensure adequate continuity with invert FF layer and to allow easier geotextile unrolling

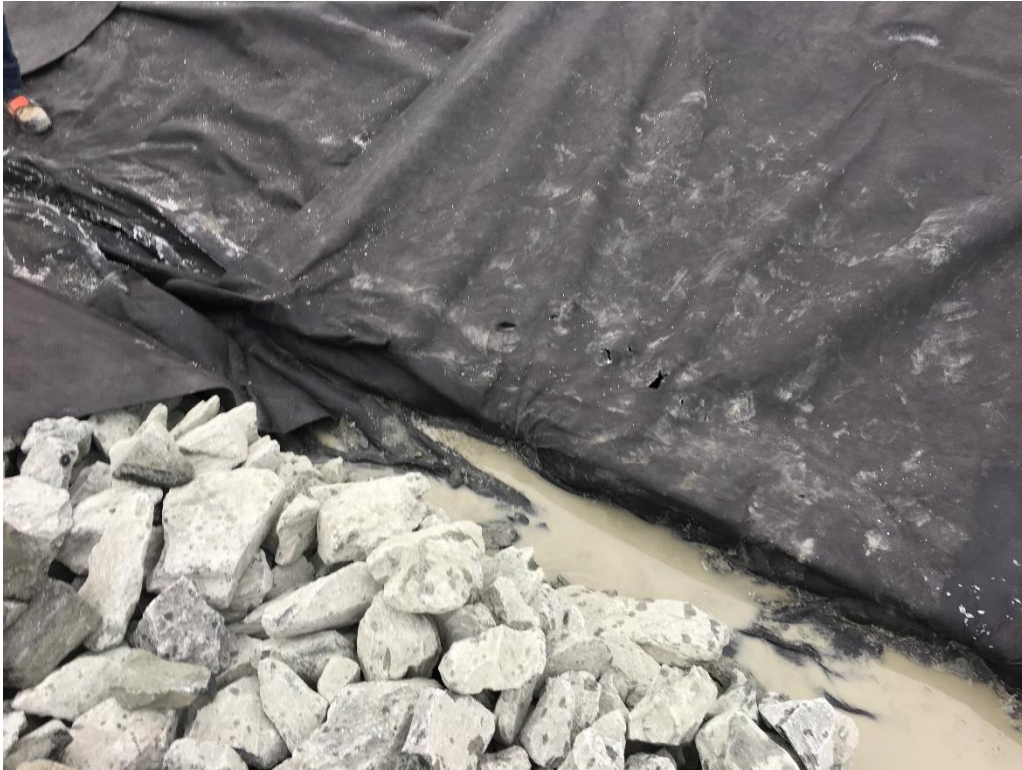
Photo 8. Damaged geotextile. Rip rap material has been manually removed at the toe to allow proper overlap of the patch to be installed

- Adequate corrective measures were taken for the geotextile that has been damaged during FF placement. Tear holes were located at the toe of the west slope. When unrolling the rolls, full width geotextile patches were added in a way that the the patch covered a zone of 1-2m around the damaged area when possible. When the damaged area was too close to the toe, the covering offset was less on the side of the channel invert because of the rip rap already in place. On that side, the patch covered an area of about 0.3m beyond the damaged zone. Rip rap material was moved manually to allow such an overlap. Also, the damaged geotextile was folded over 1-2m as an addittional protection to ensure that the tear holes were properly patched.

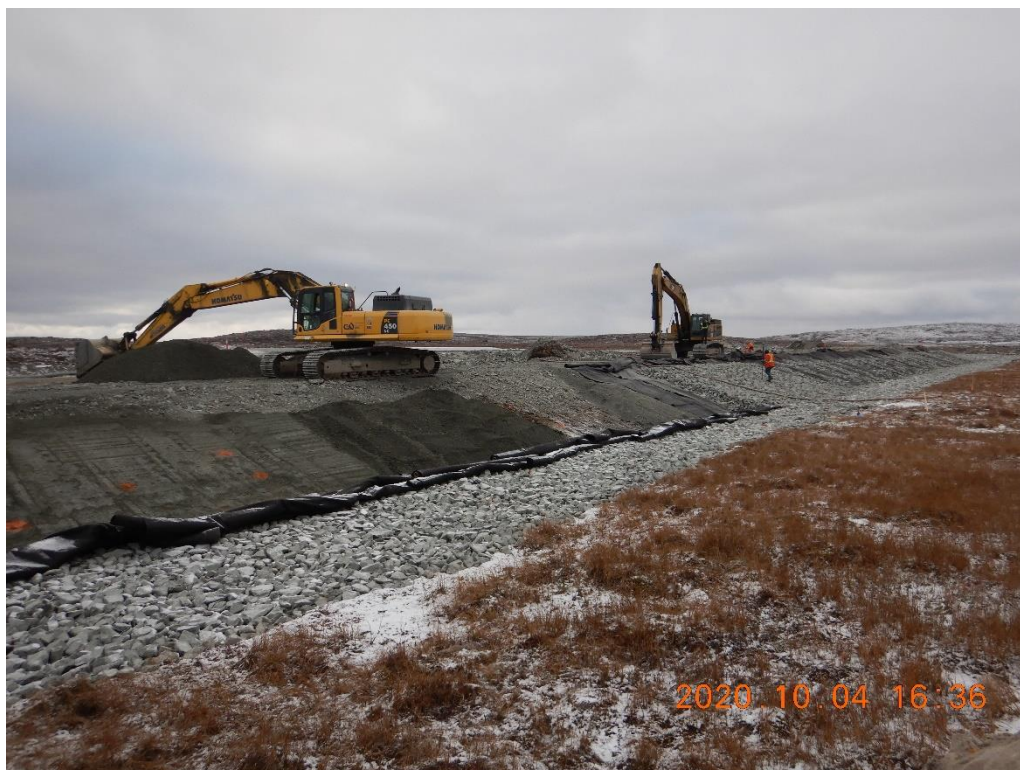
Photo 10. Upstream end of the channel. FF and Rip Rap placement. Sta -0+015 looking north

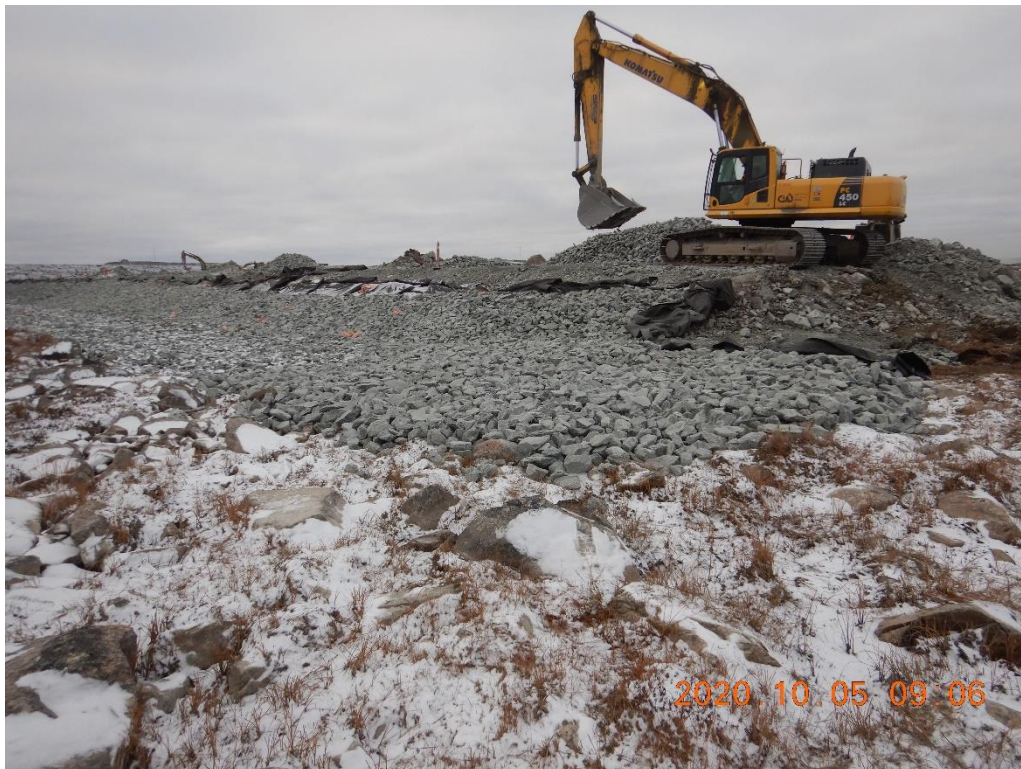
Photo 1. Preparing surface to lay geotextile on. Exceeding mterial removed to remain at natural ground elevation. There is a natural slope from west to east. Photo is looking at west side of the channel downstream end

- Downstream end of the channel has been finished on the west side the same way it was done on the invert & east side: Exceeding material above natural ground was removed. A sheet of geotextile (Mirafi 1100N) was placed on top of the natural ground elevation (natural ground with some FF material), with sufficient overlap. A final rip rap layer was placed on top of the geotextile. The sketch below summarizes the job done.

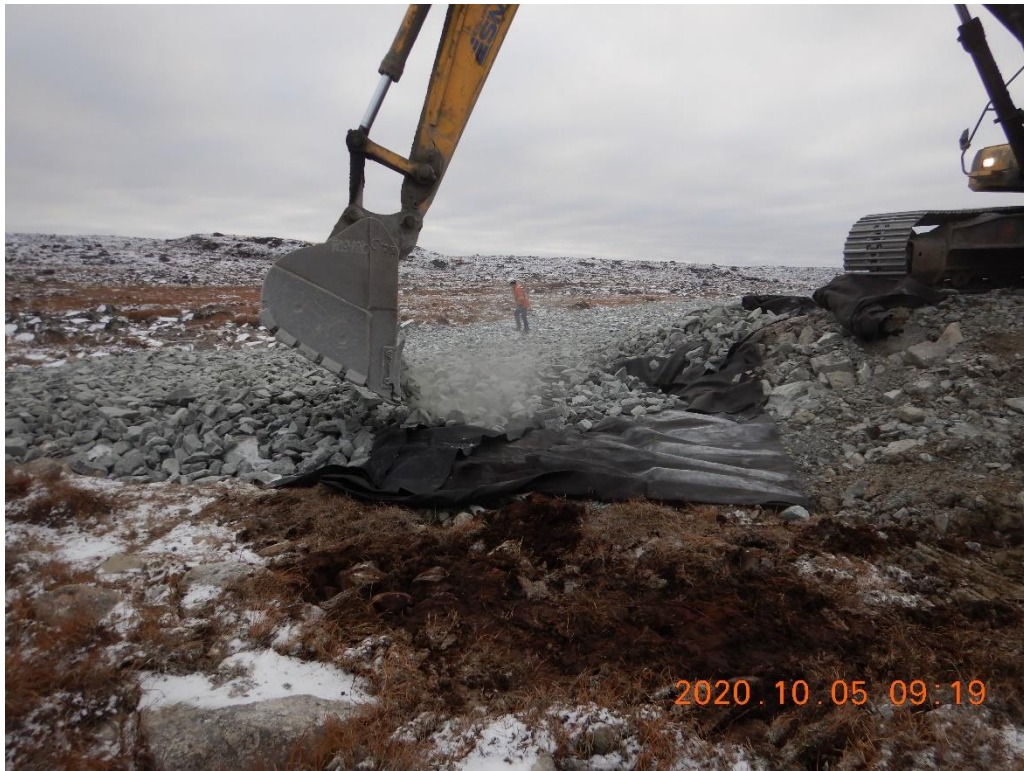
Photo 2. Rip rap placement at downstream end of the channel. Geotextile laying at natural ground elevation. Looking South-East.

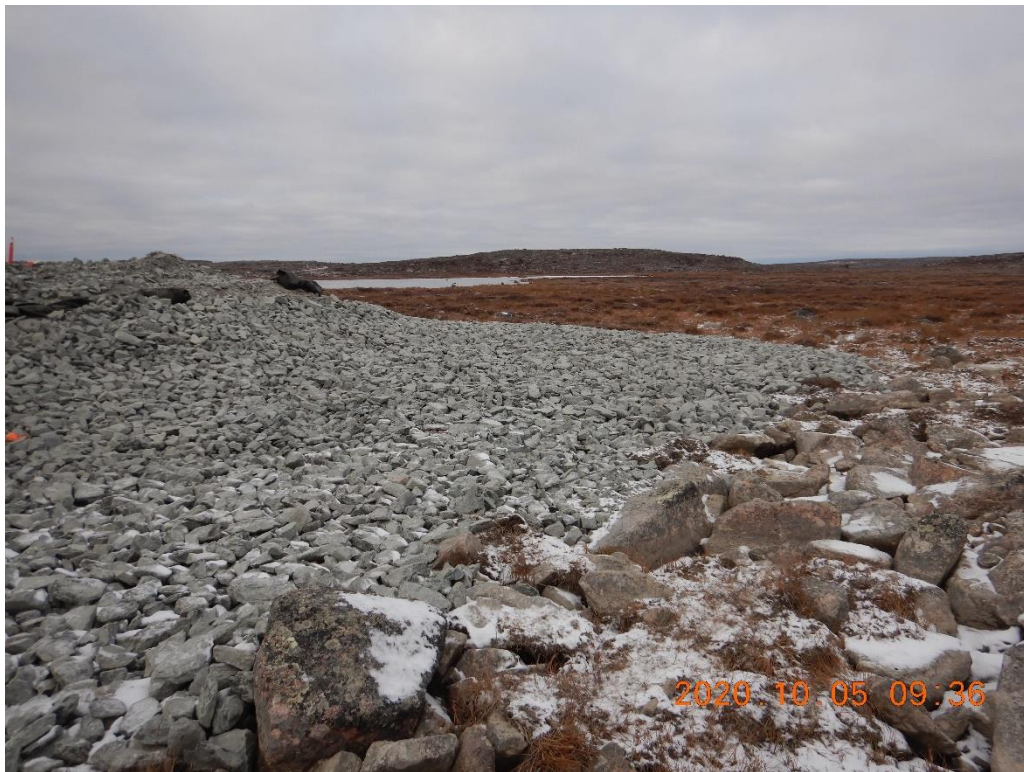
Photo 3. Finished downstream end of the channel, looking North-West

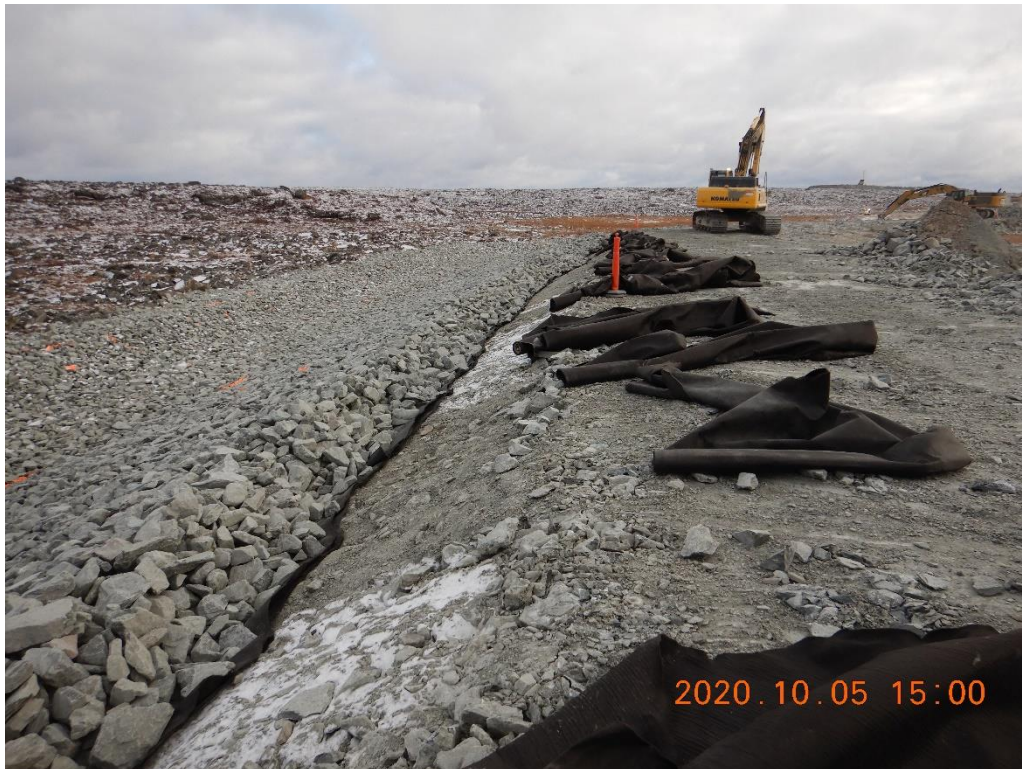
Photo 4. Exceeding geotextile removal, 0+200 looking South.

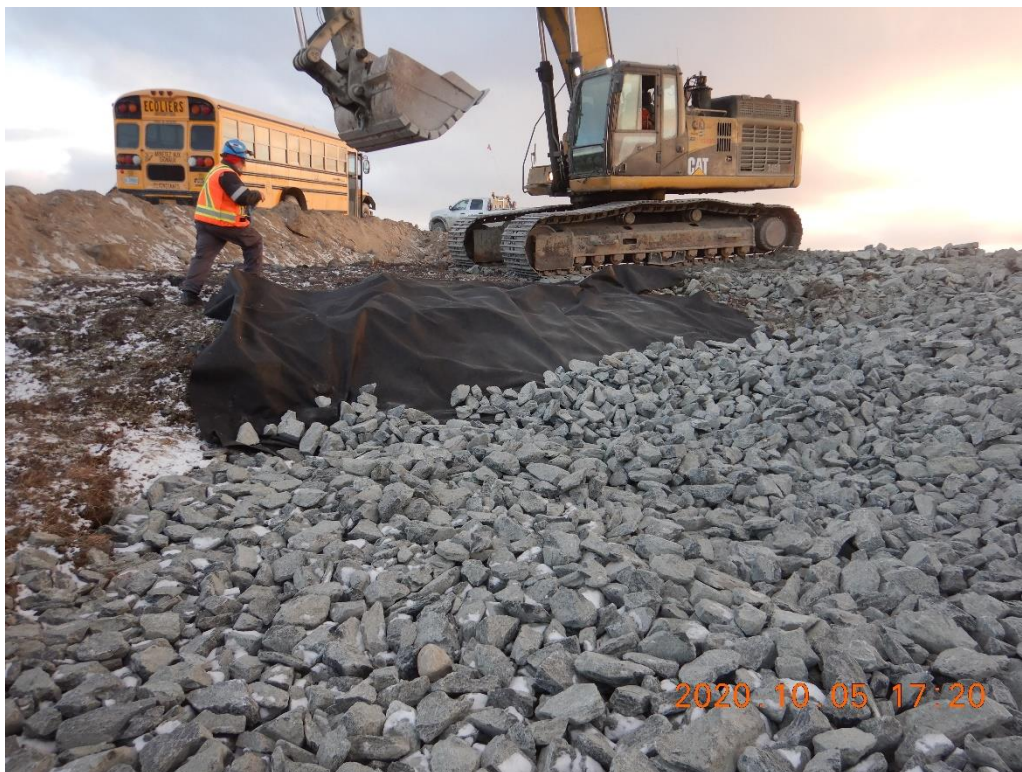
Photo 5. Geotextile placed over the natural slope at the upstream end of the channel.

- Upstream end of the channel has been improved to limit risks of erosion. The natural ground has been gently profiled with the back of the bucket (no material was removed) and a geotextile placed on top. It was not possible to have any kind of overlap with the channel geotextile because of the rip rap already in place. For finishing, enough rip rap has been placed to hold the geotextile in place and minimize potential superficial erosion in the area.
- Before final approval of the rip rap placement, finer material needs to be removed at specific locations.

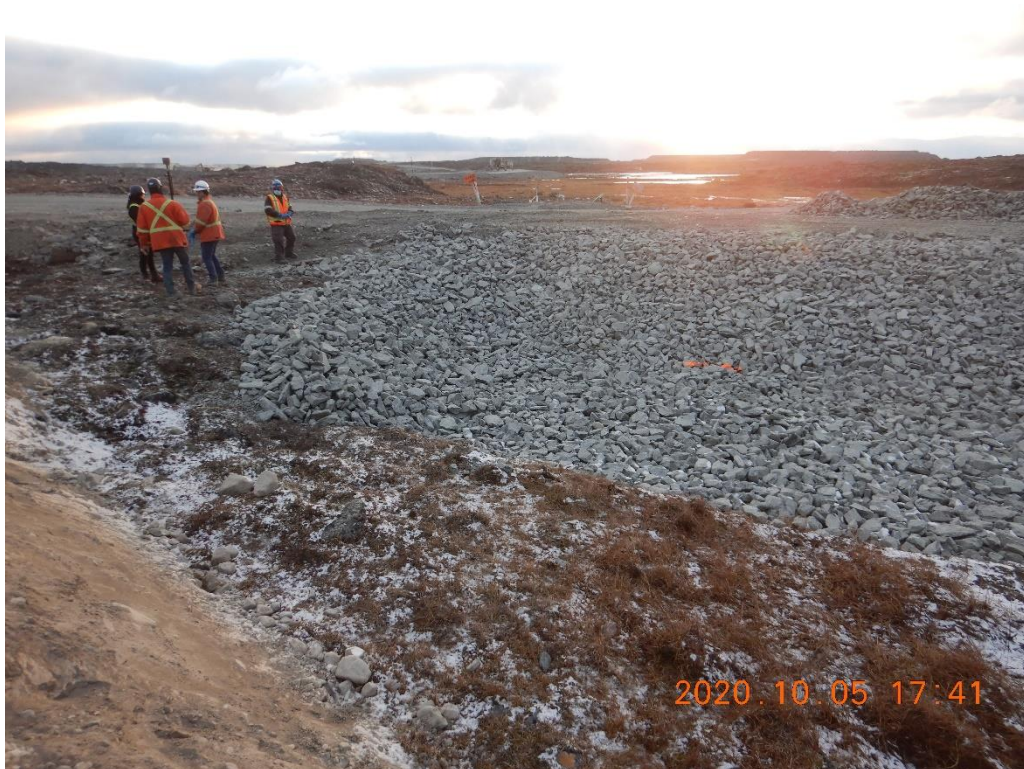
Photo 6. Finished upstream end of the channel with rip rap layer

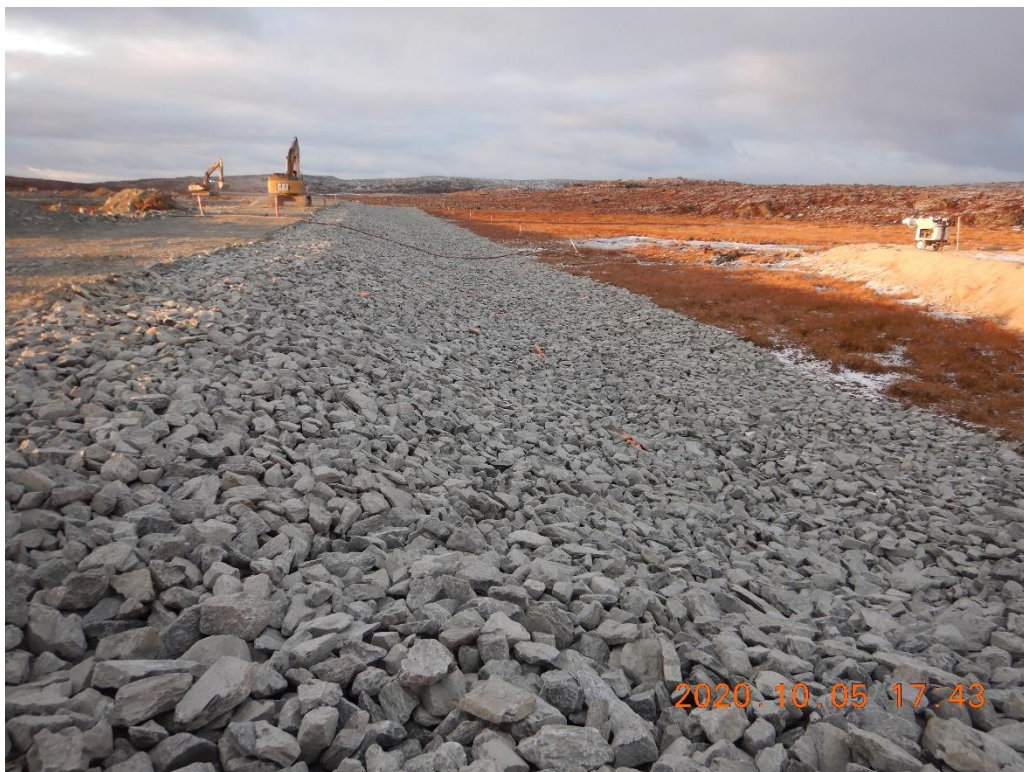
Photo 7. Finished rip rap placement, STA -0+010 looking North

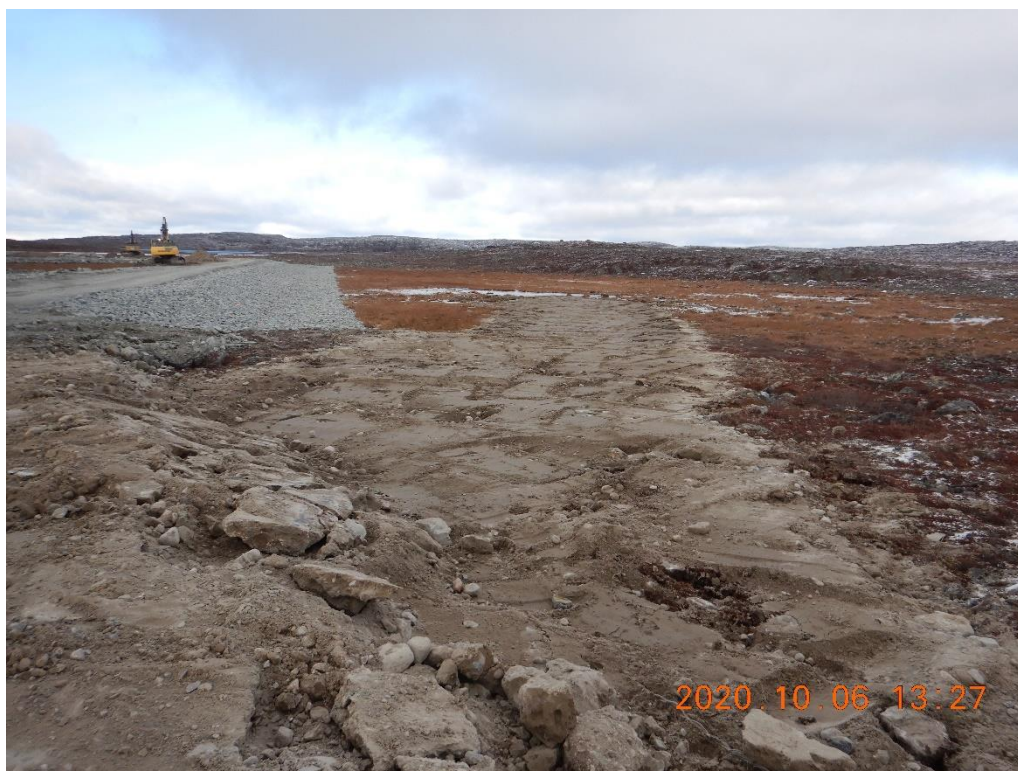
Figure 1. Temporary esker dewatering road removed

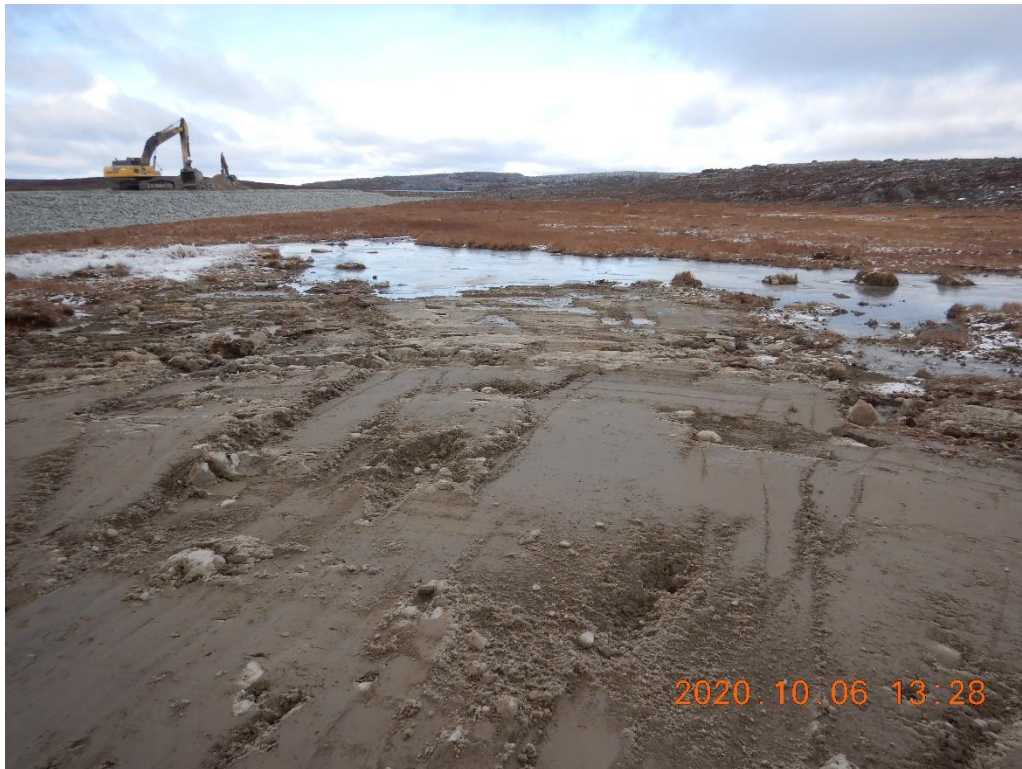
Figure 2. Main dewatering sump used during construction has been backfilled with esker material

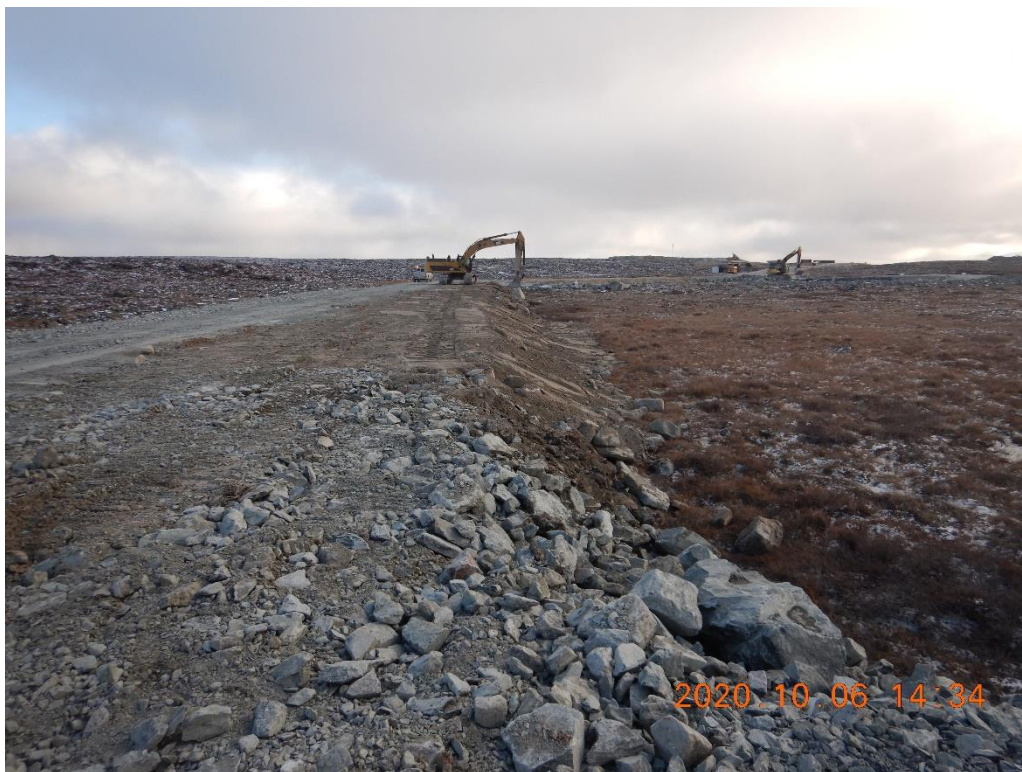
Figure 3. Sloping west side of the access road, reusing leftover material including esker. Sta 0+250 looking South

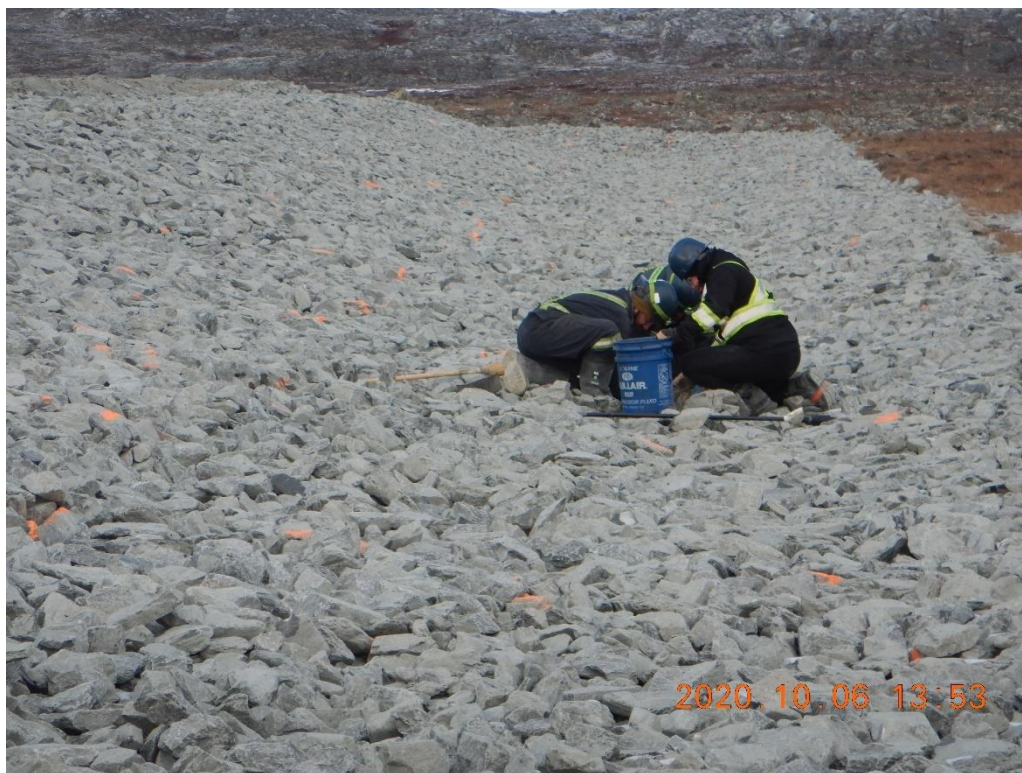
Figure 5. Rip rap fine particle cleaning by hand. A few bucket full of fines were successfully removed. STA 0+050 looking North.
