Construction Summary Report IVR Diversion Channel

Agnico Eagle Mines Ltd

6127-695-132-REP-012_R2

February 16, 2021

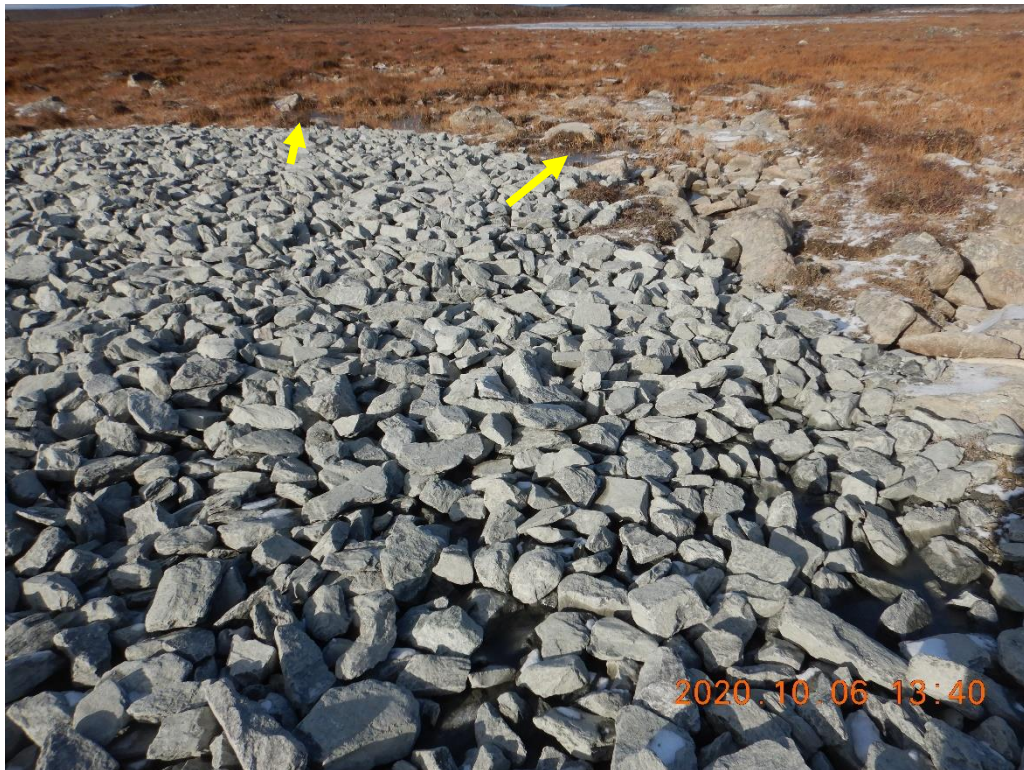
Figure 7. Downstream end of the channel. Water flowing through the rip rap layer and seeping out in the tundra at different locations (yellow arrows). Looking North.

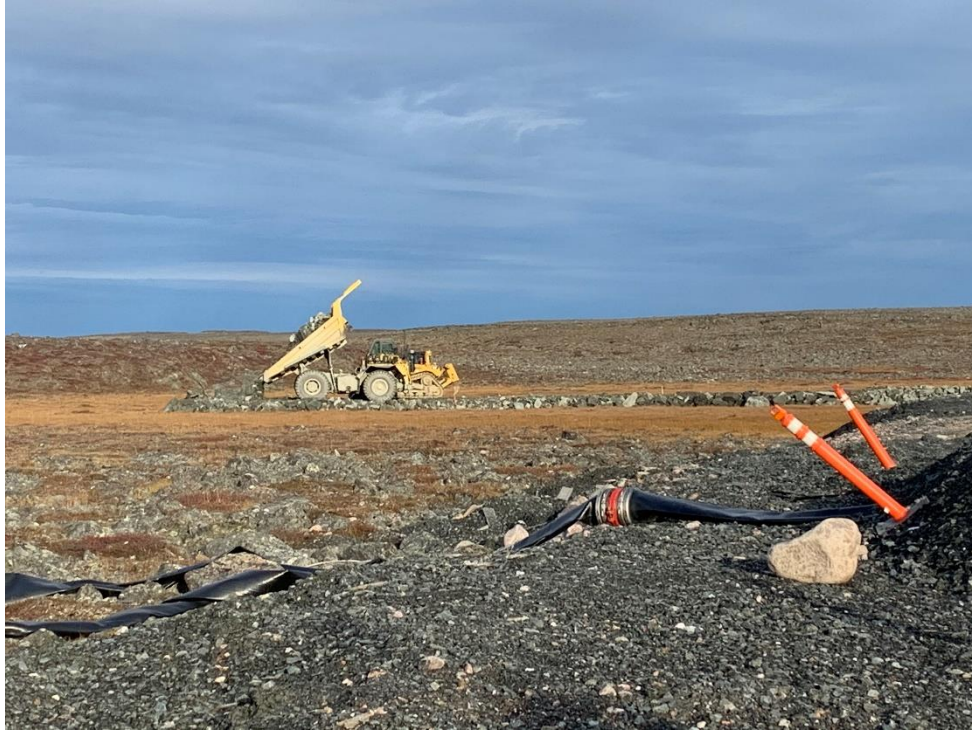
Figure 1: The thickness of the rockfill road is uniform and conforms to the requirements

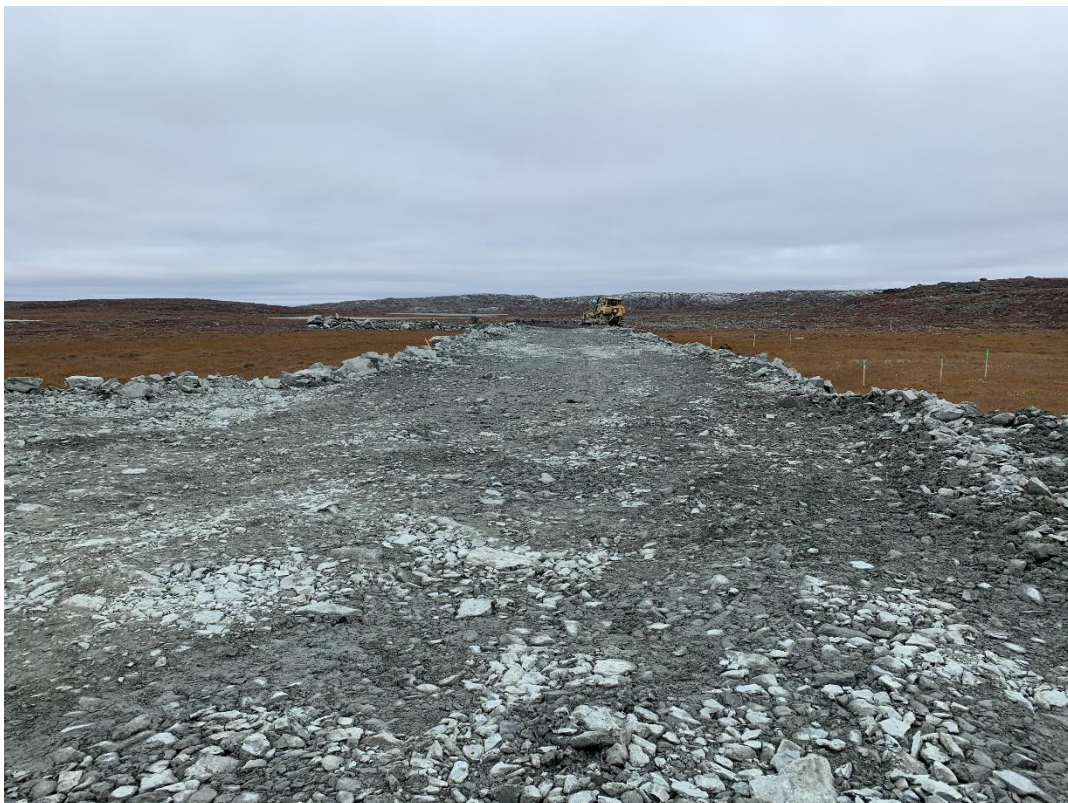
Figure 4: The first part of the access road is well compacted and stable (0+024 to 0+111)

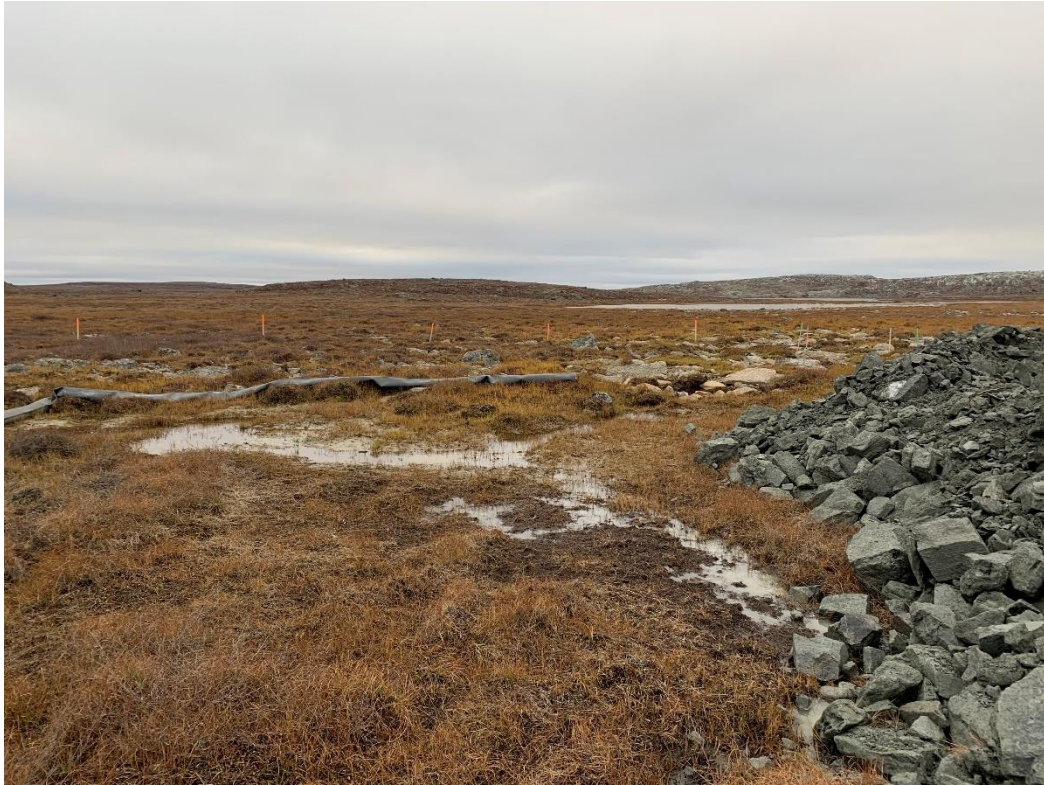
Figure 7: The pipe at the end of the access road (water accumulation can also be seen)

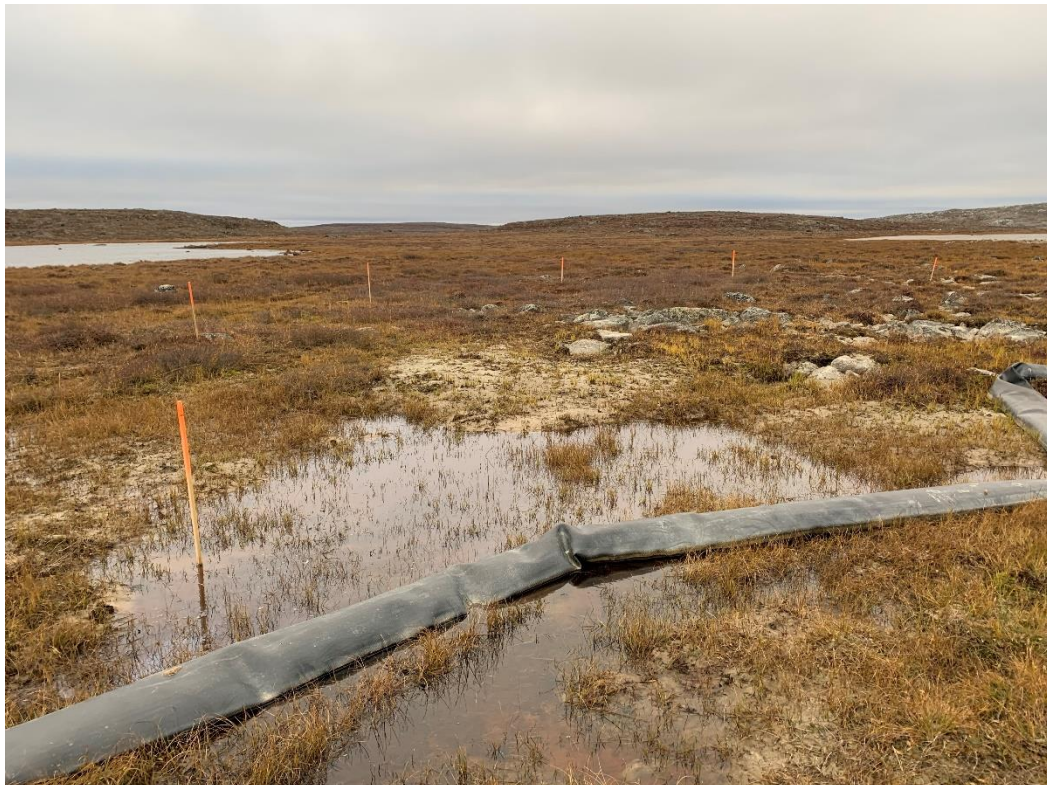
Figure 8: Water accumulation at the end of the access road

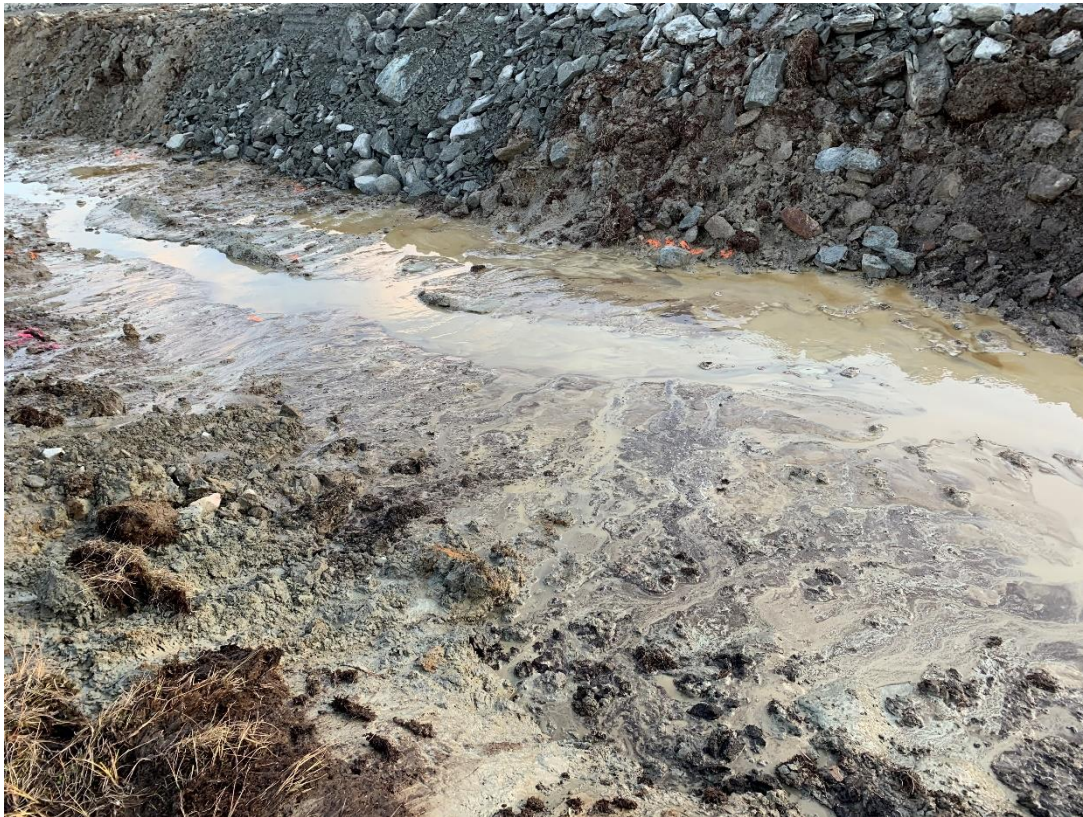
Figure 3: Ice-rich material at the bottom of the excavation

Corrective action to be taken:			
<ul style="list-style-type: none">Remove the ice-rich material between 0+235 and 0+260 and replace it by esker.			
<ul style="list-style-type: none">			
Follow up visit required: Yes <input checked="" type="checkbox"/> No <input type="checkbox"/>

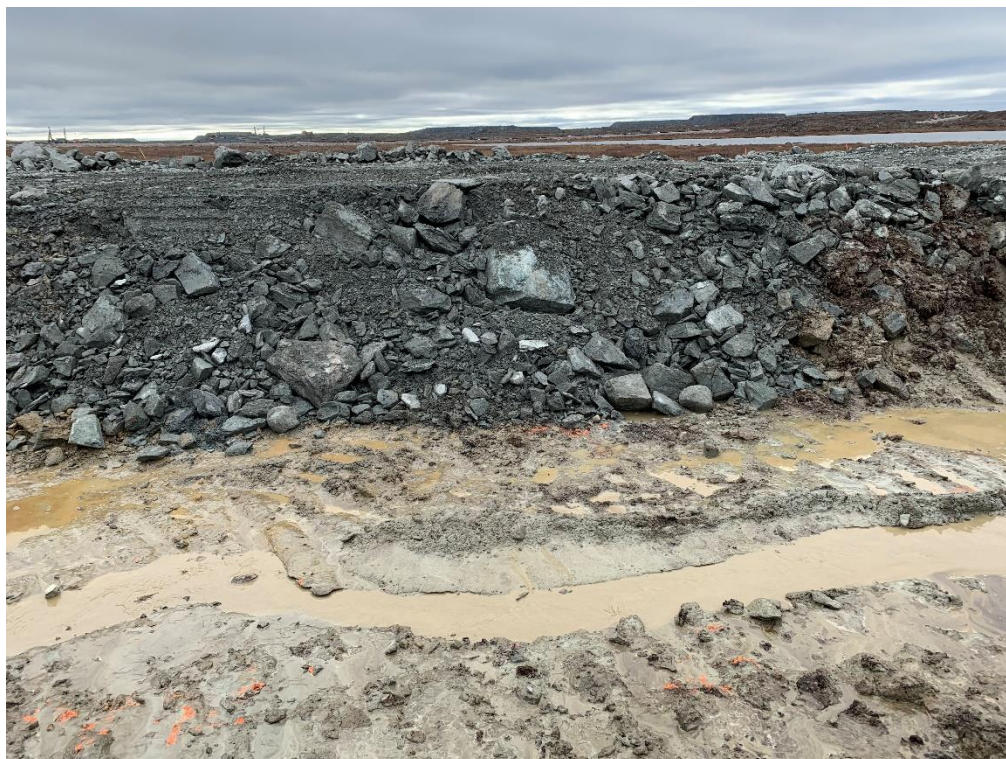
Figure 4: A ice lump has been removed and replaced by rockfill

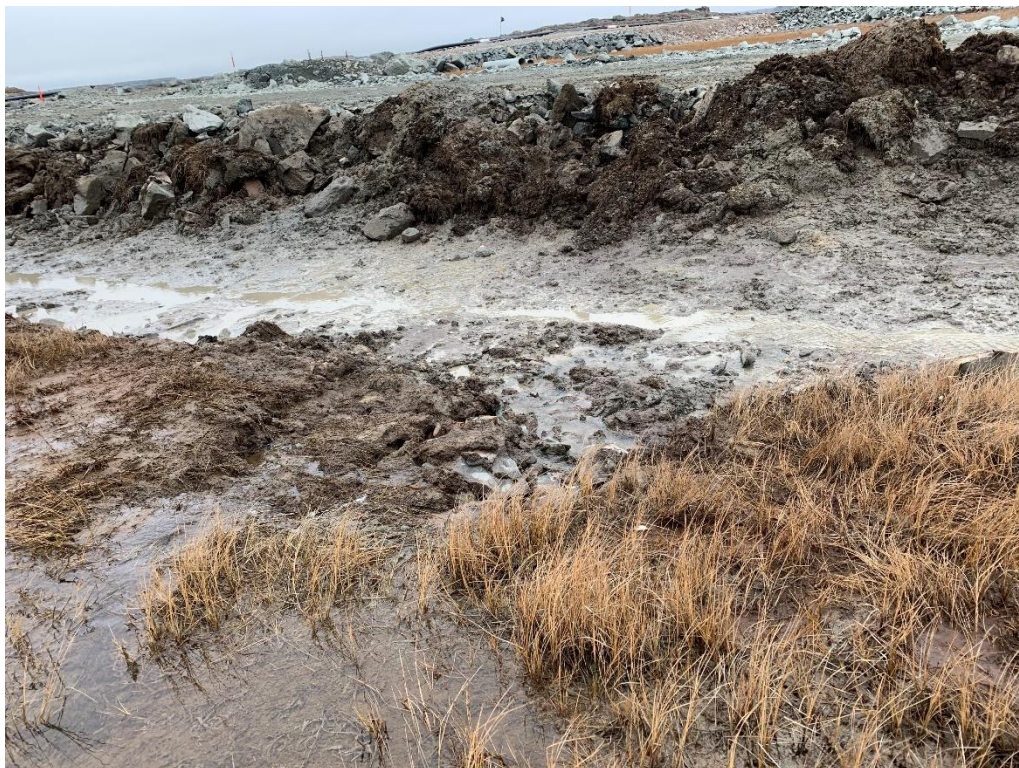
Figure 4: Water flowing in the channel at 0+067

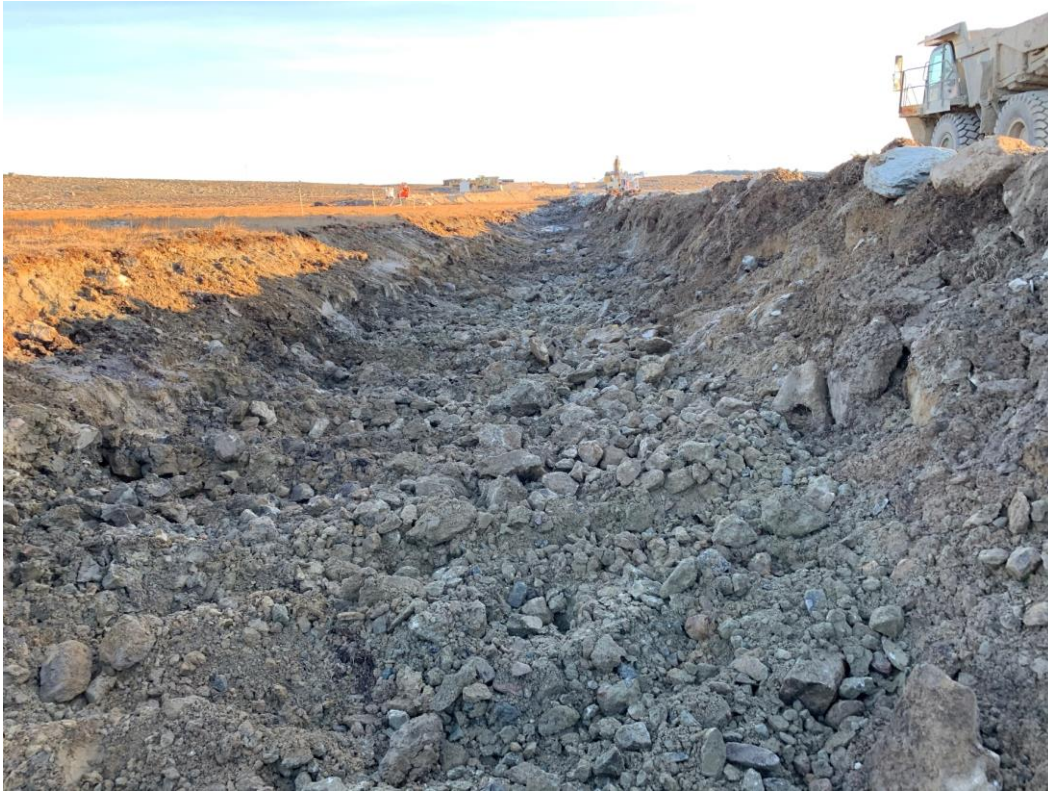
Figure 5: A layer of hammered ice-rich material between 0+090 and 0+125

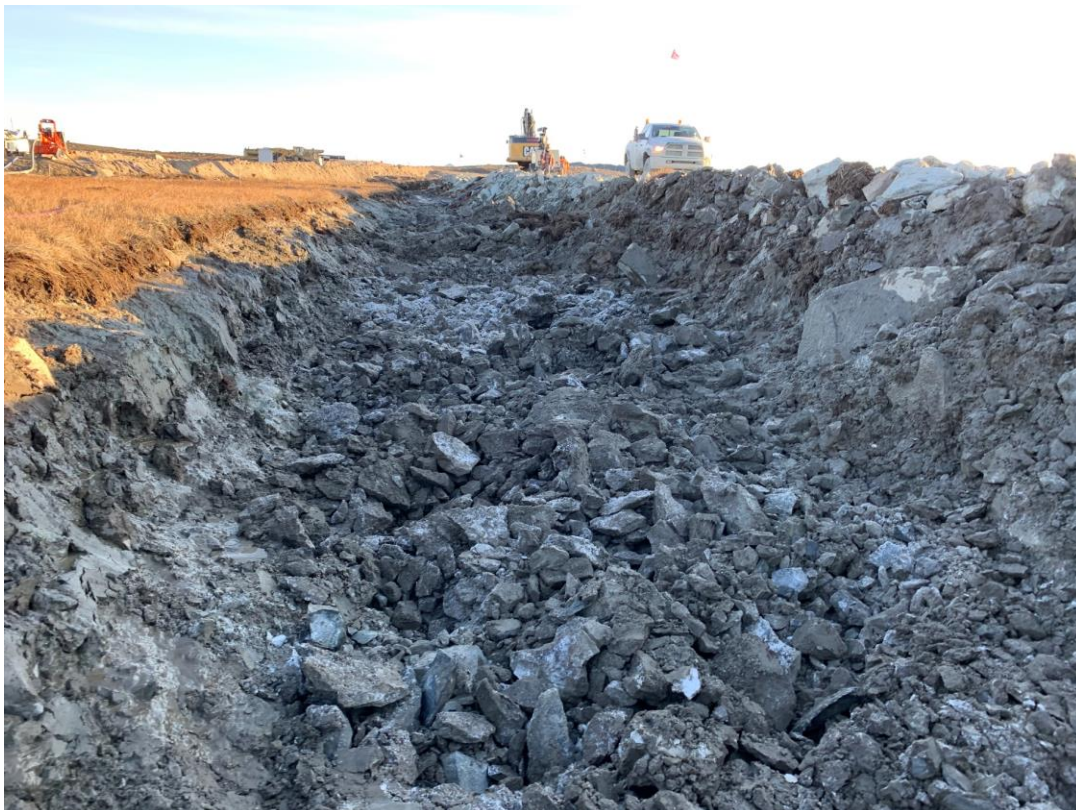
Figure 6: A layer of hammered ice-rich material between 0+029 and 0+070

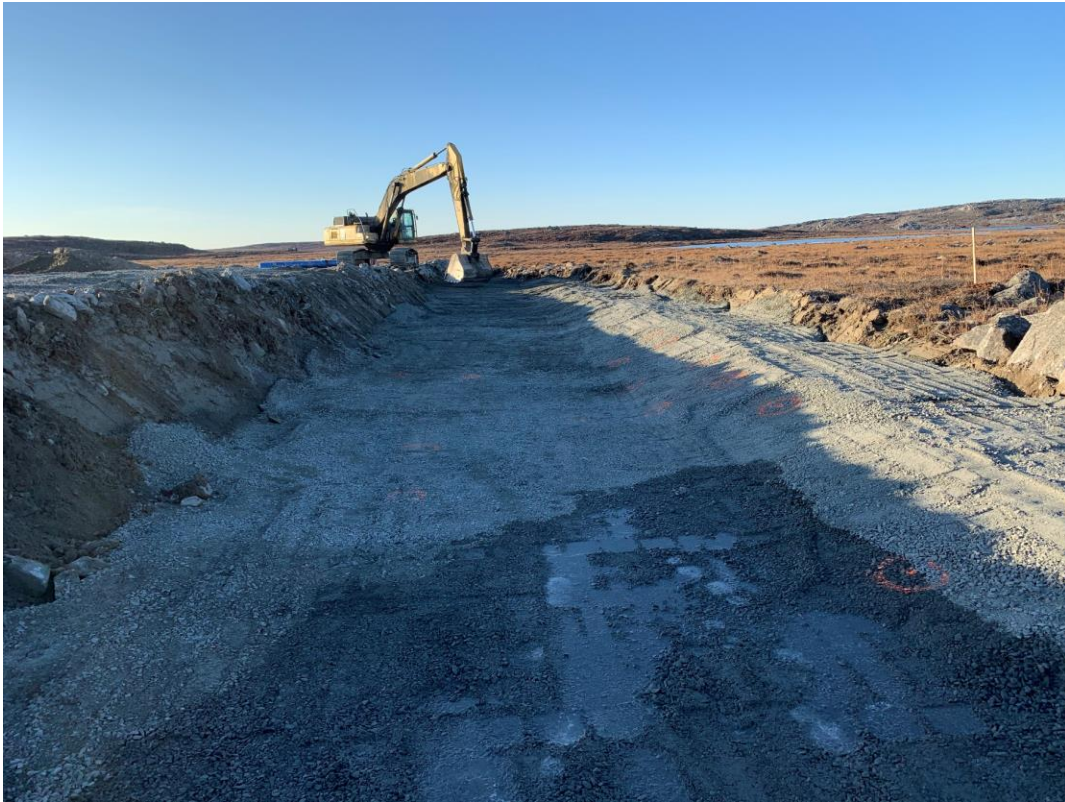
Figure 7: Fine filter fill between 0+234 and 0+281 (ongoing)

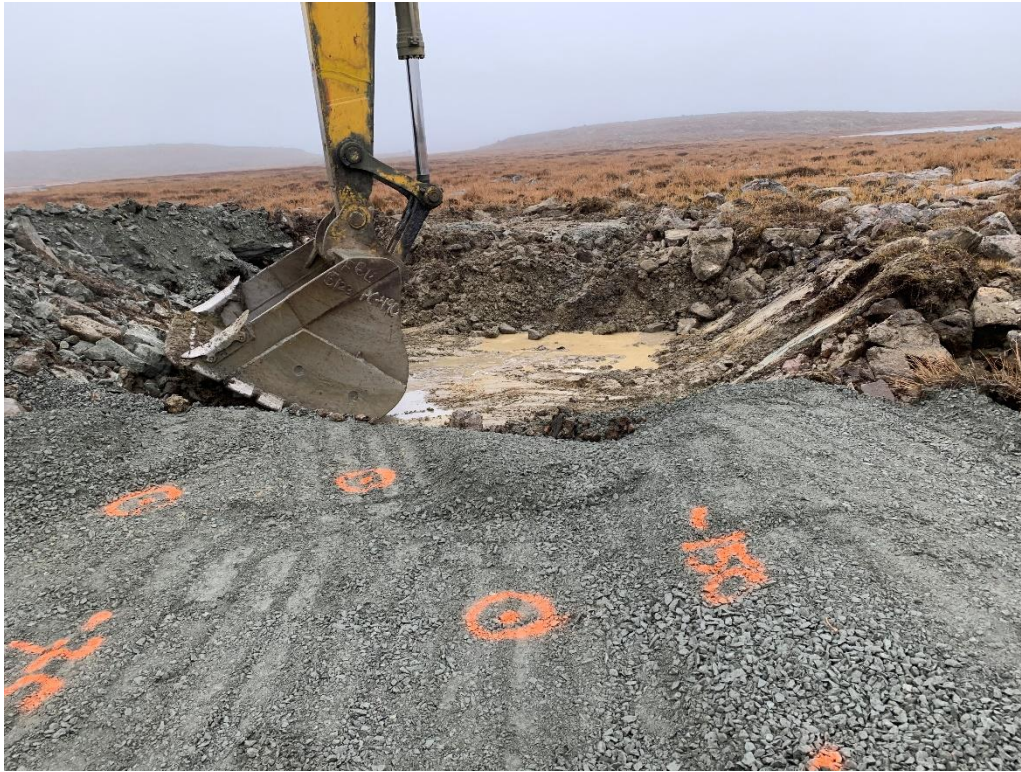
Figure 1: Energy dissipator

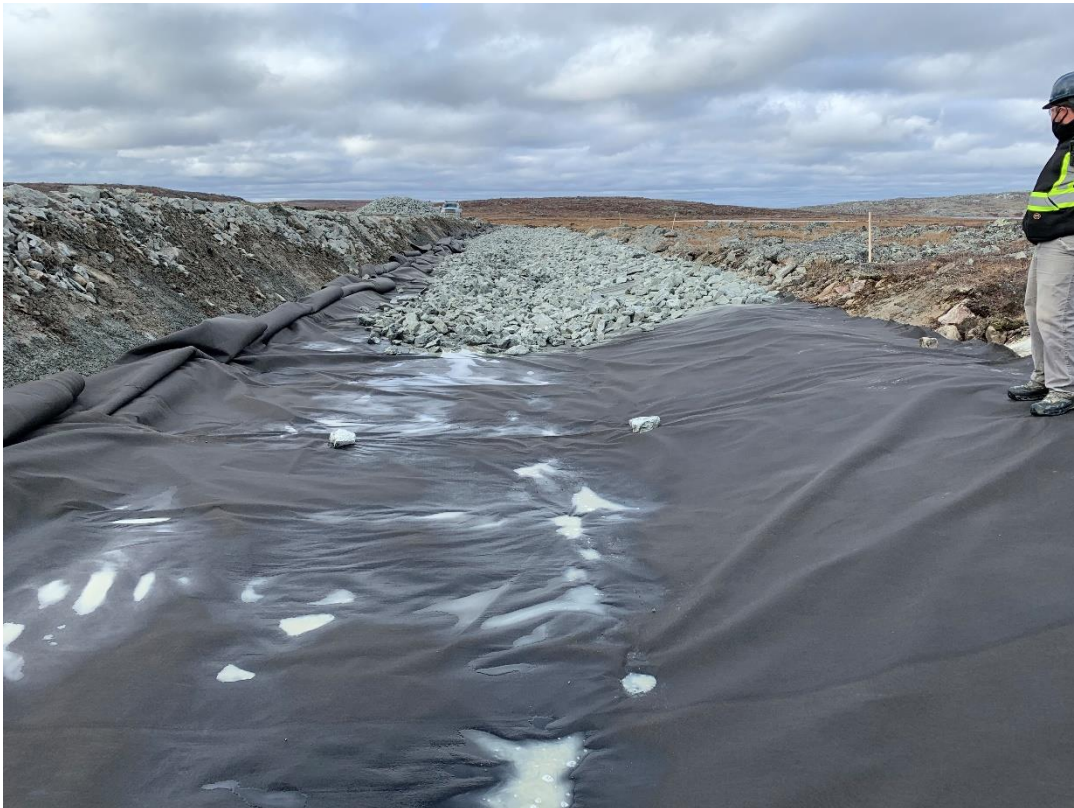
Figure 2: Geotextile placement between 0+284.5 and 0+152

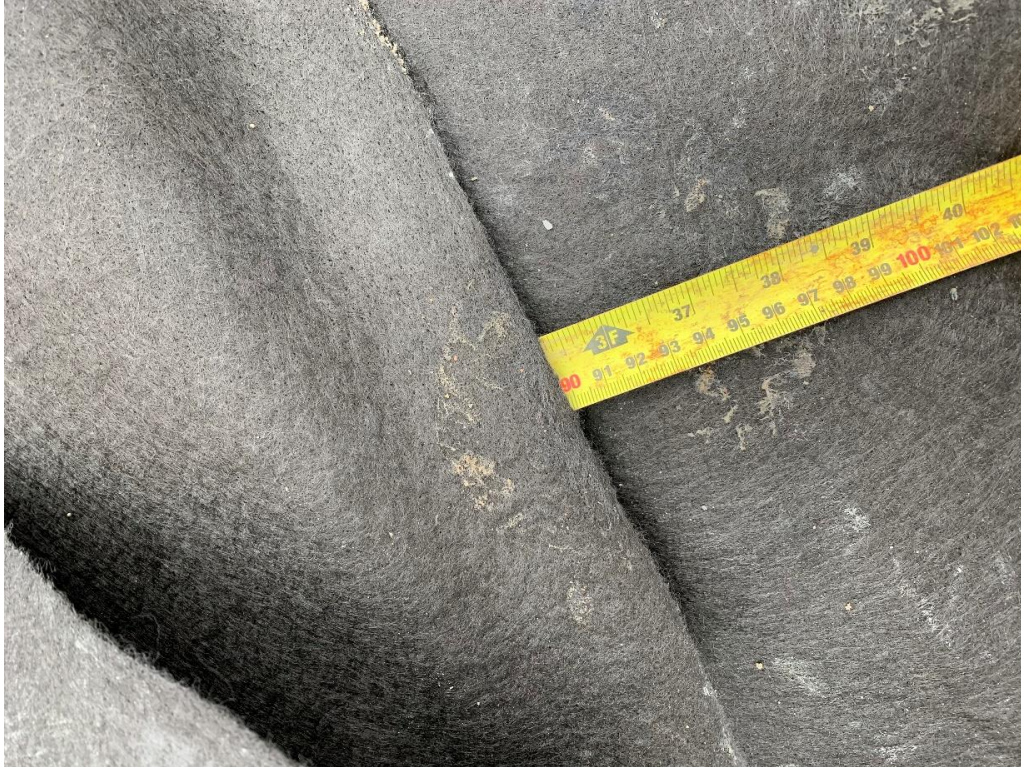
Figure 3: The geotextile overlaps were all above 600mm

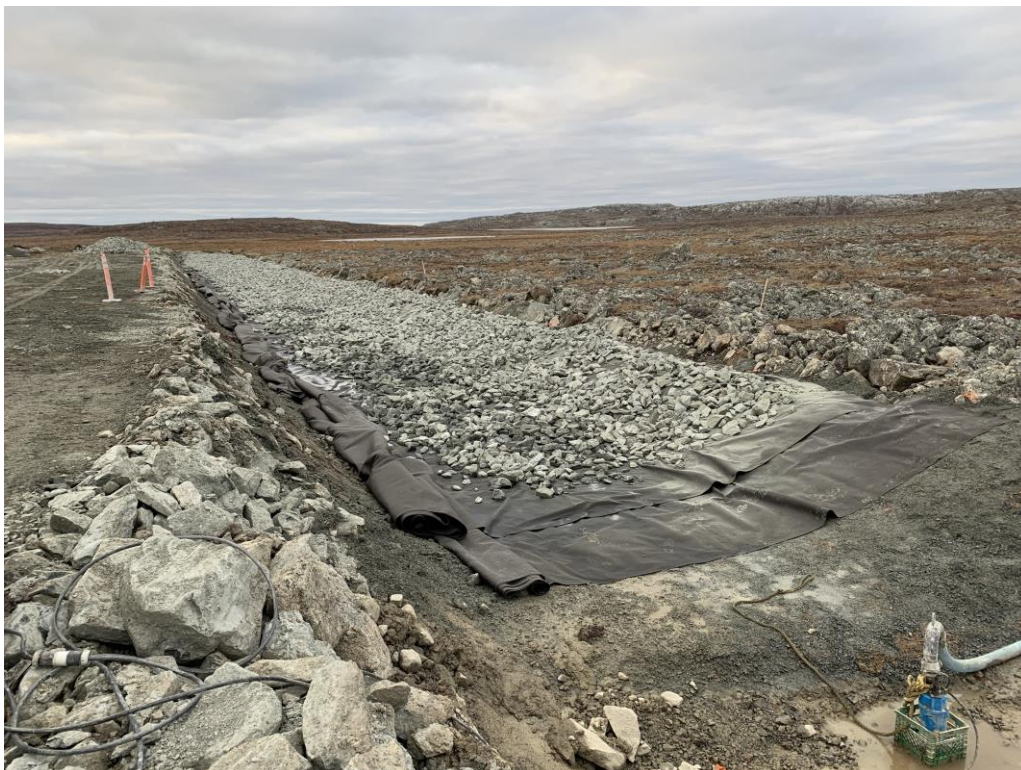
Figure 4: Preliminary riprap placement over the geotextile to hold it in place

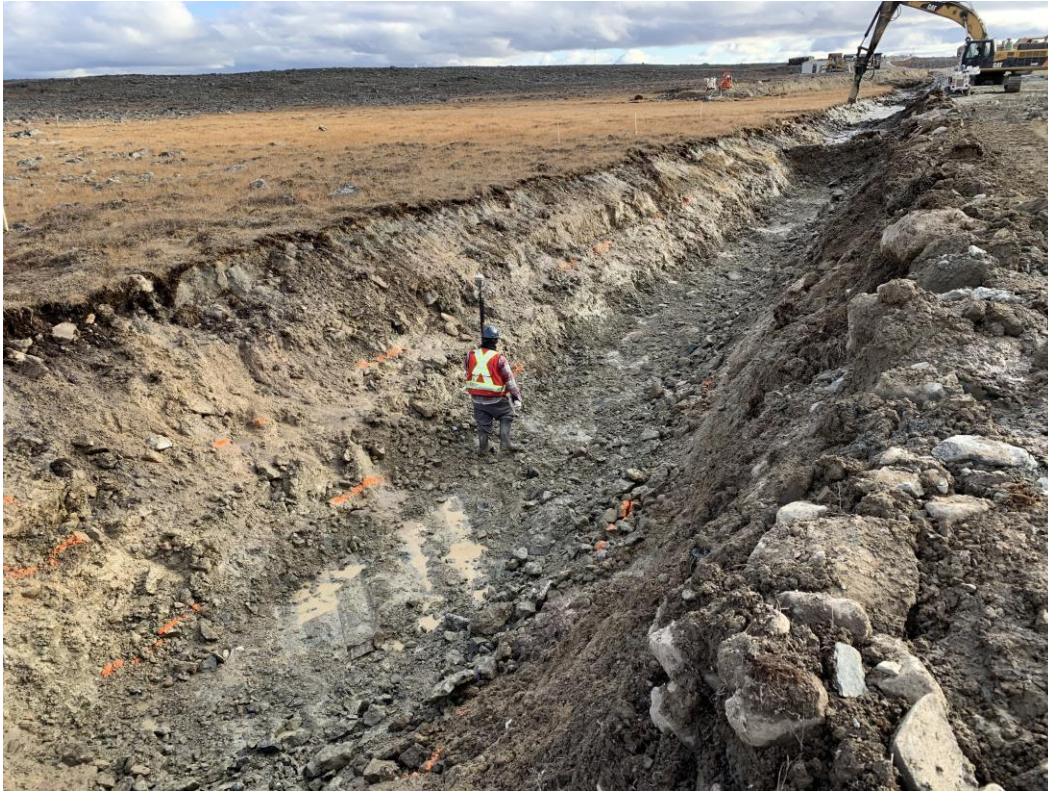
Figure 5: Ice removed (average thickness removed= 1.1m) between 0+090 and 0+125

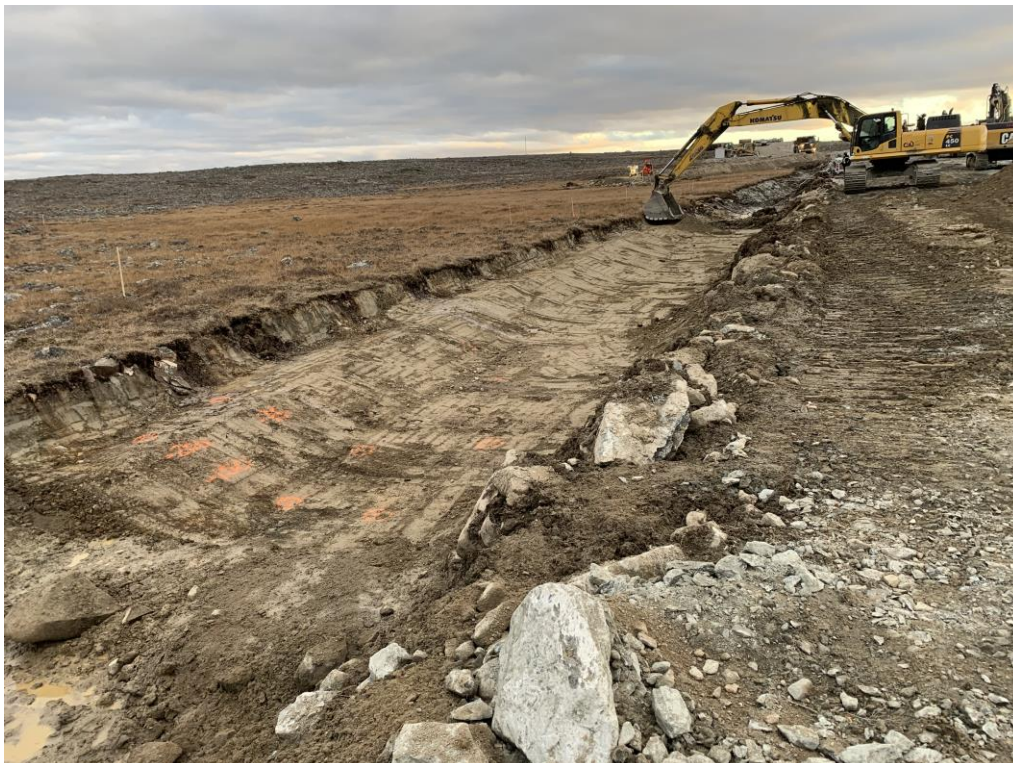
Figure 6: Esker placement between 0+090 and 0+125

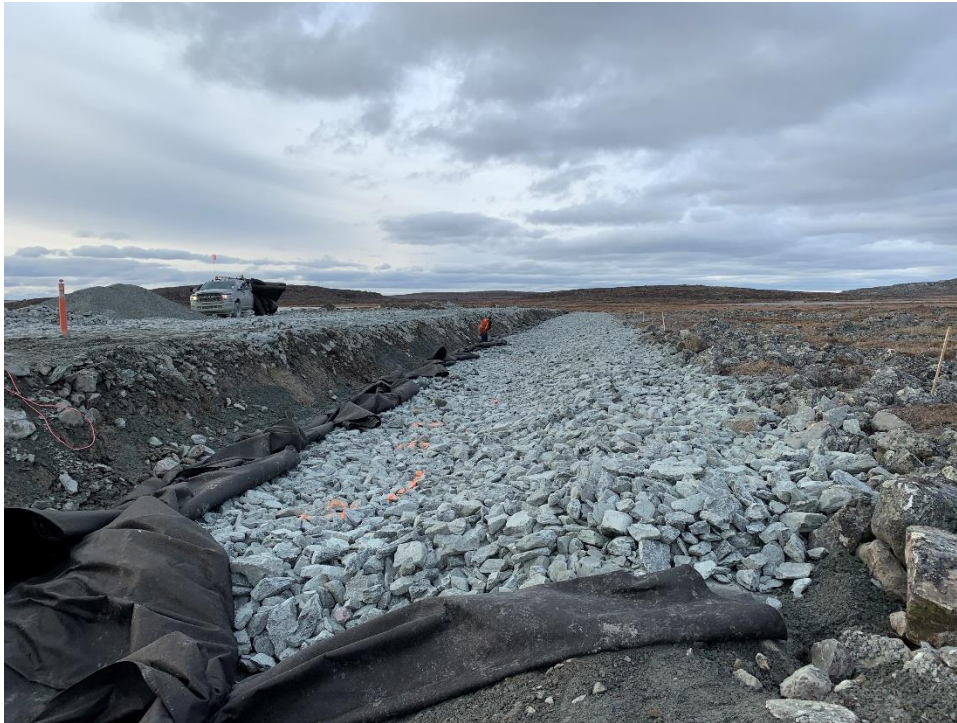
Figure 1: Riprap placement to grade between 0+155 and 0+284.5

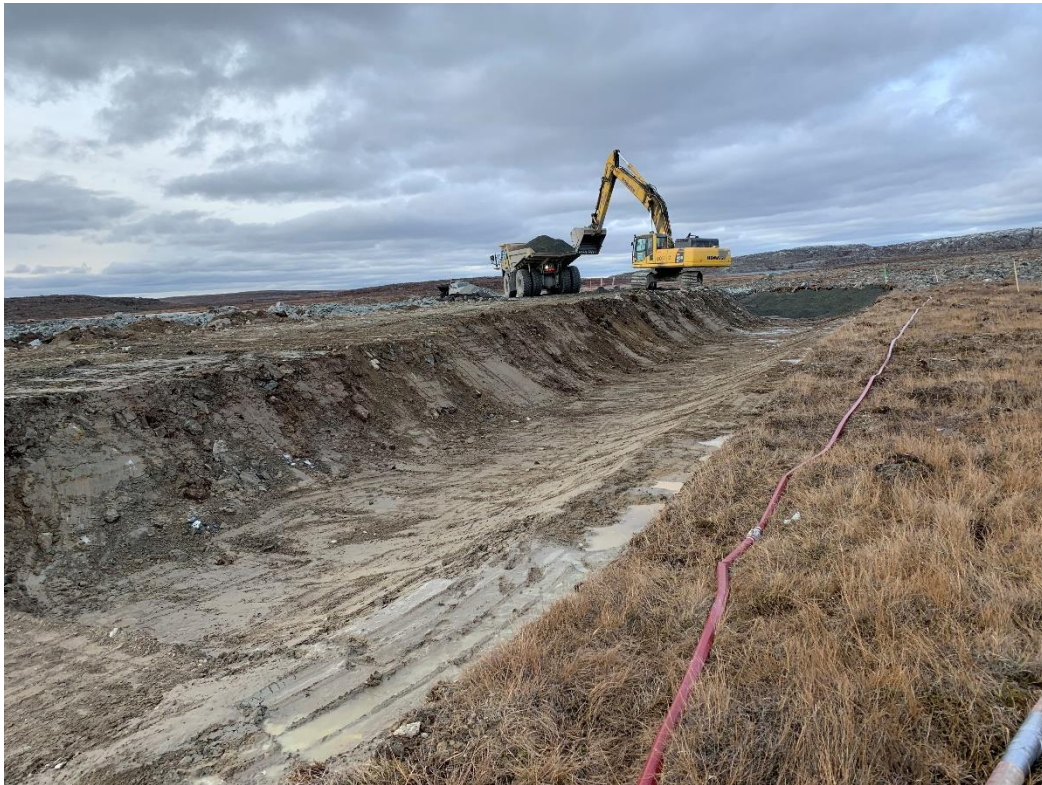
Figure 3: Foundation approval between 0+090 and 0+149

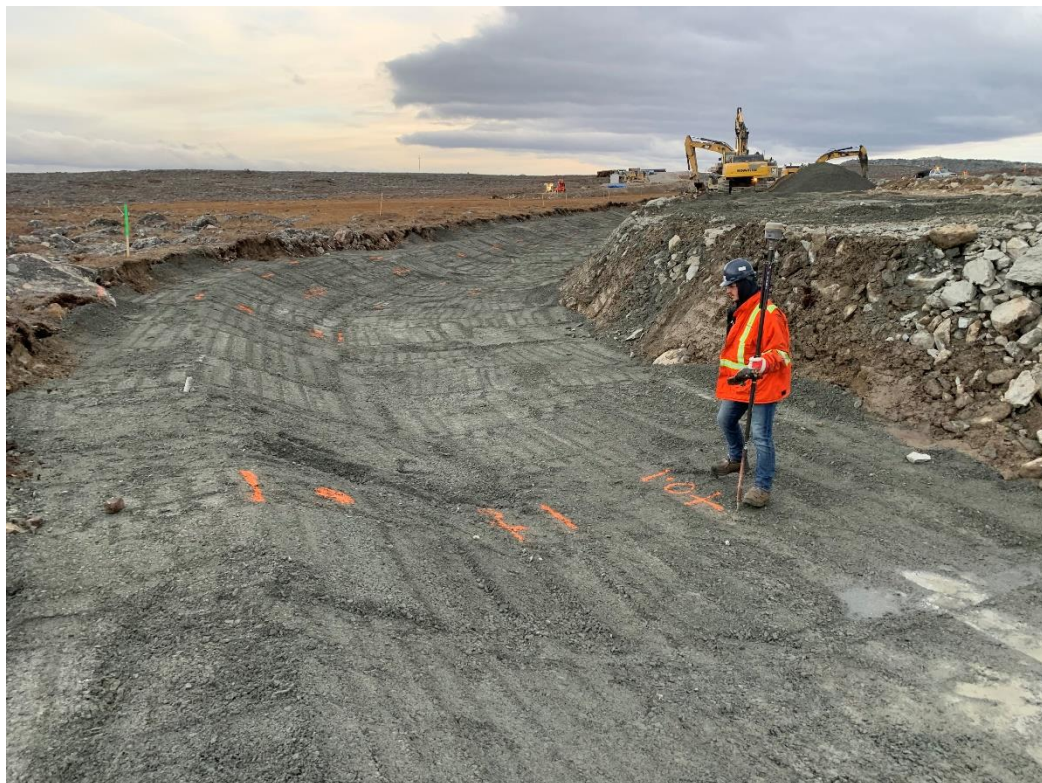
Figure 4: Fine filter fill between 0+090 and 0+149

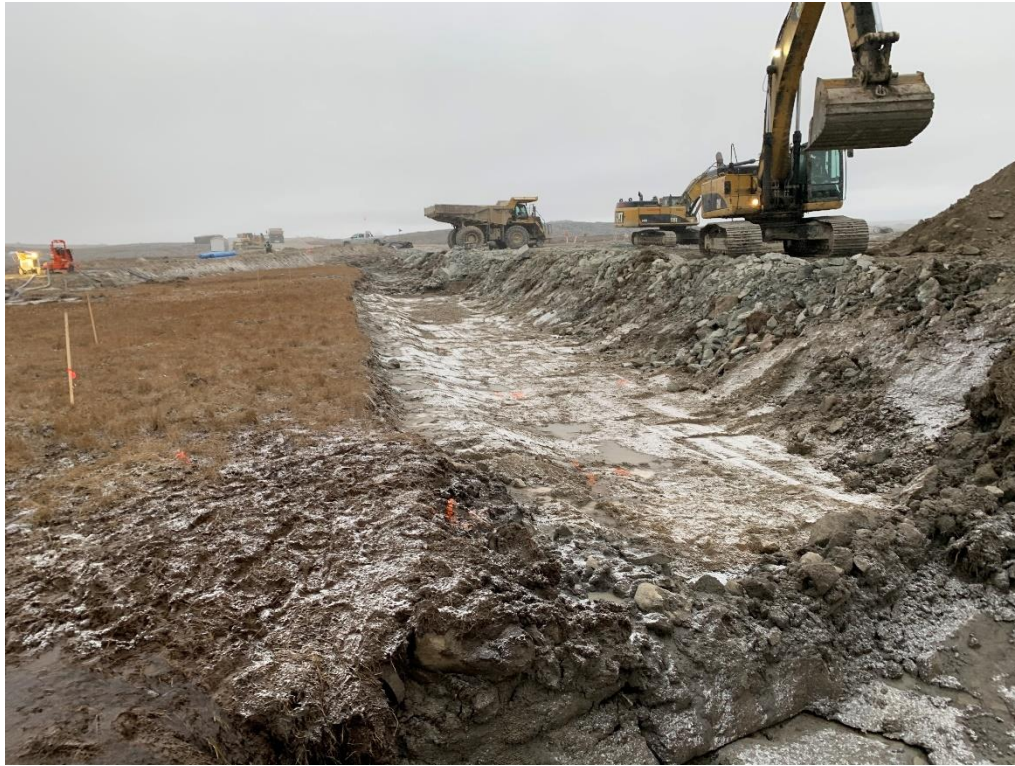
Figure 1: Foundation approval between 0+029 and 0+070

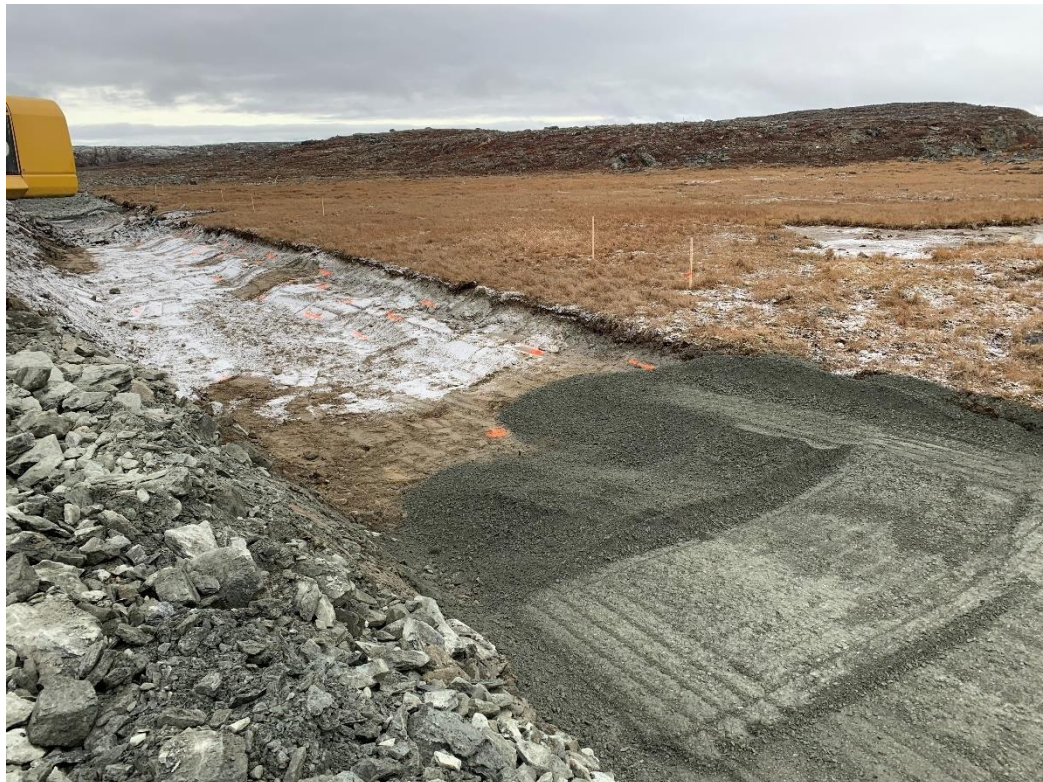
Figure 2: Fill placement in progress between 0+029 and 0+070

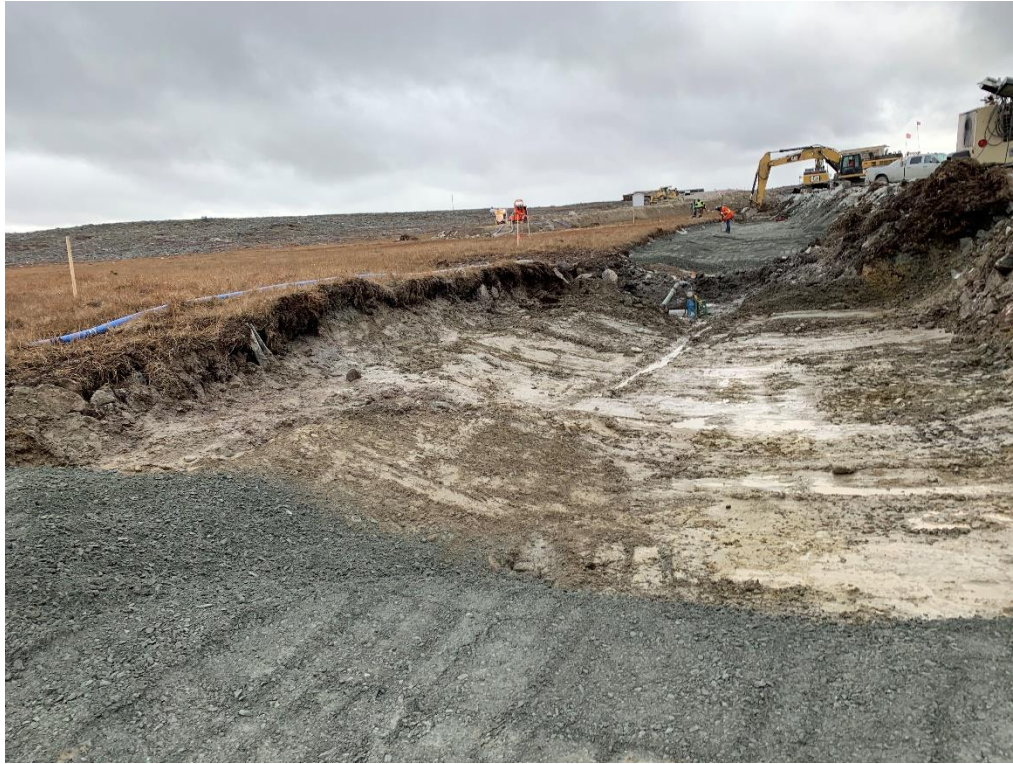
Figure 3: Foundation approval between 0+070 and 0+090

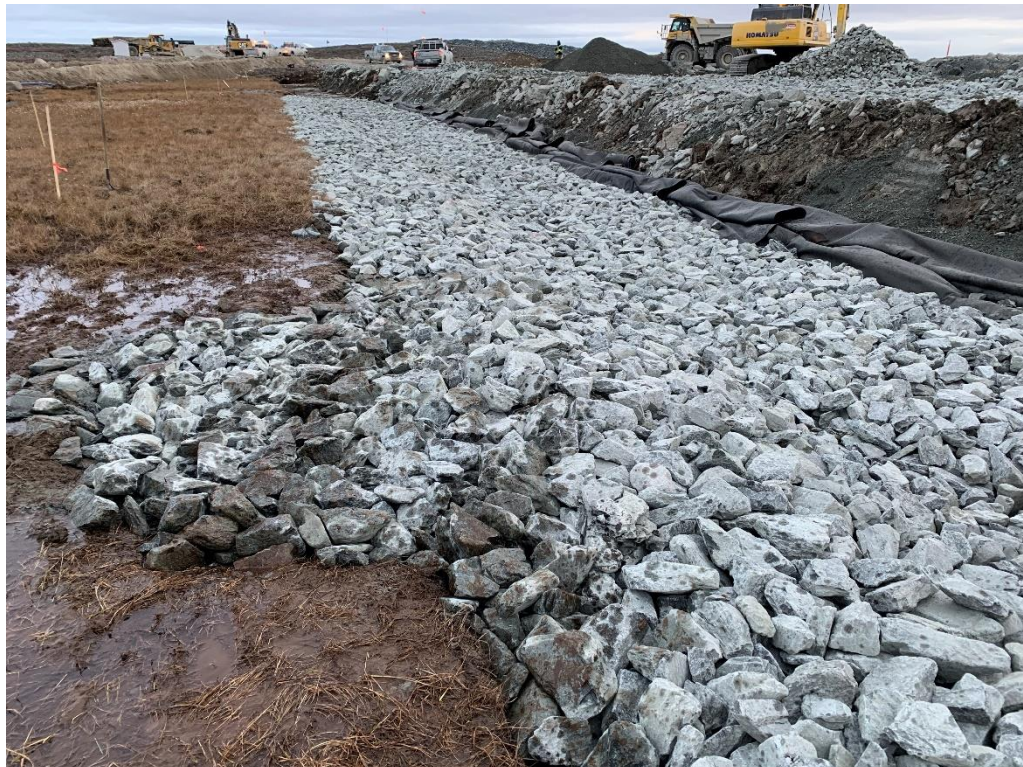
Figure 4: Channel extending further in the tundra at station 0+073

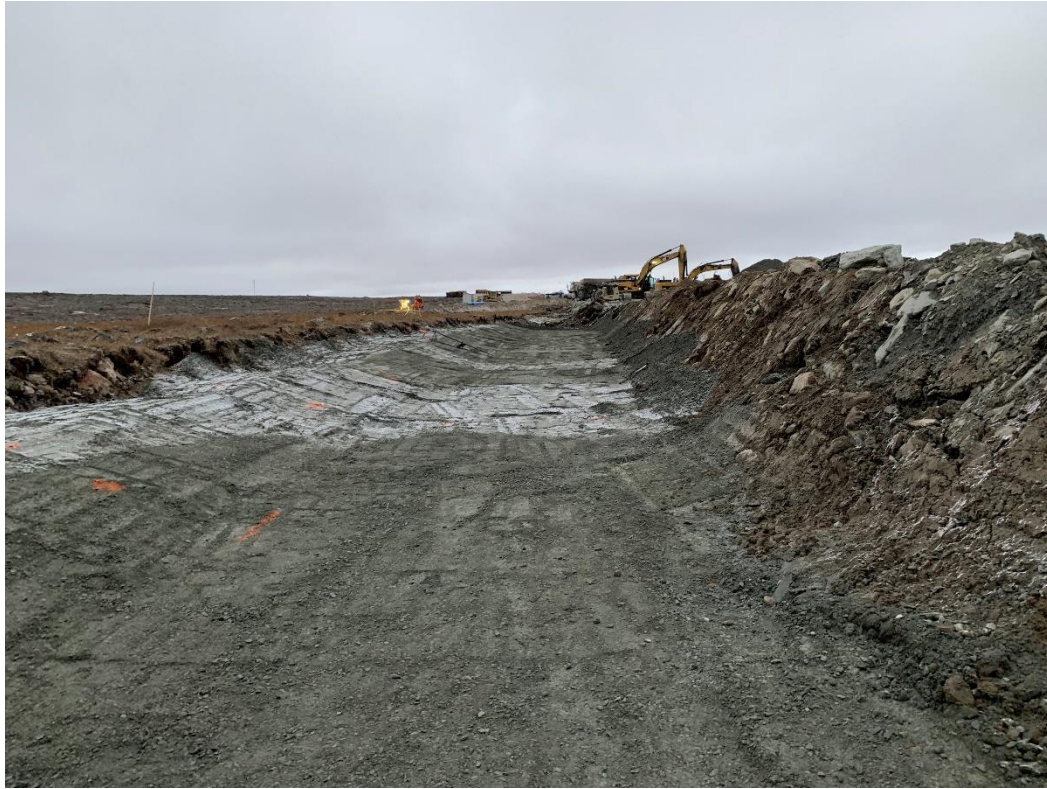
Figure 5: Fine filter approval between 0+090 and 0+149

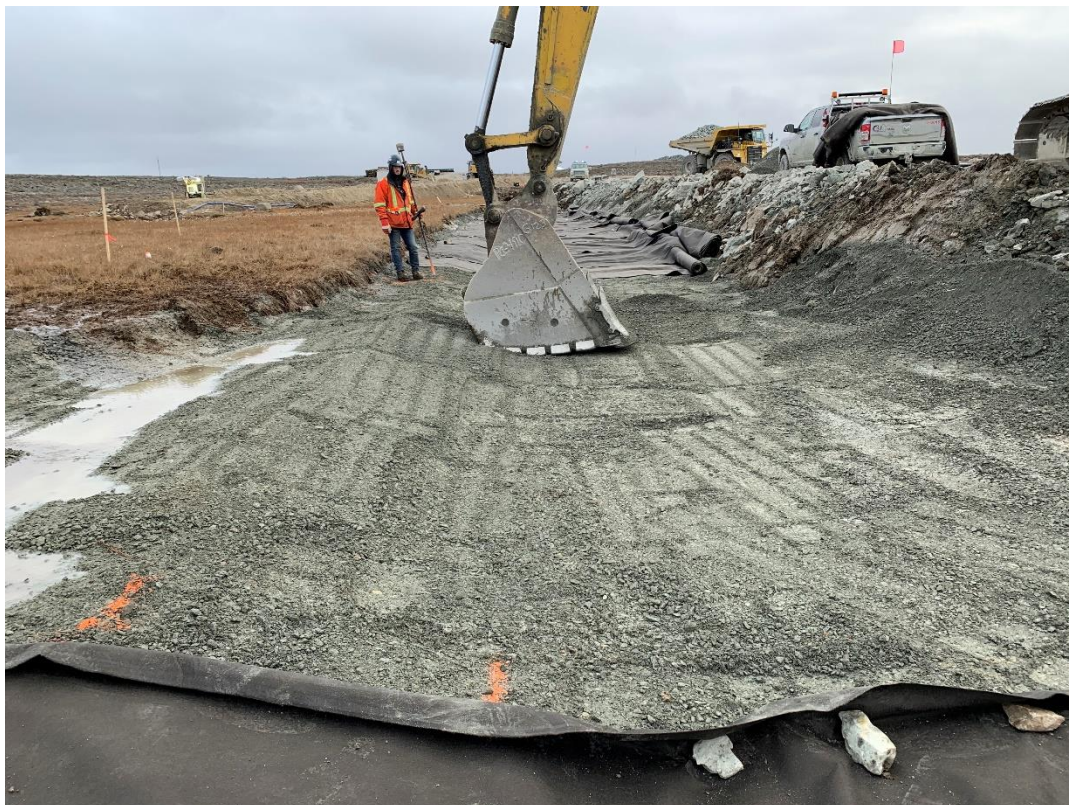
Figure 6: Fine filter approval between 0+070 and 0+090

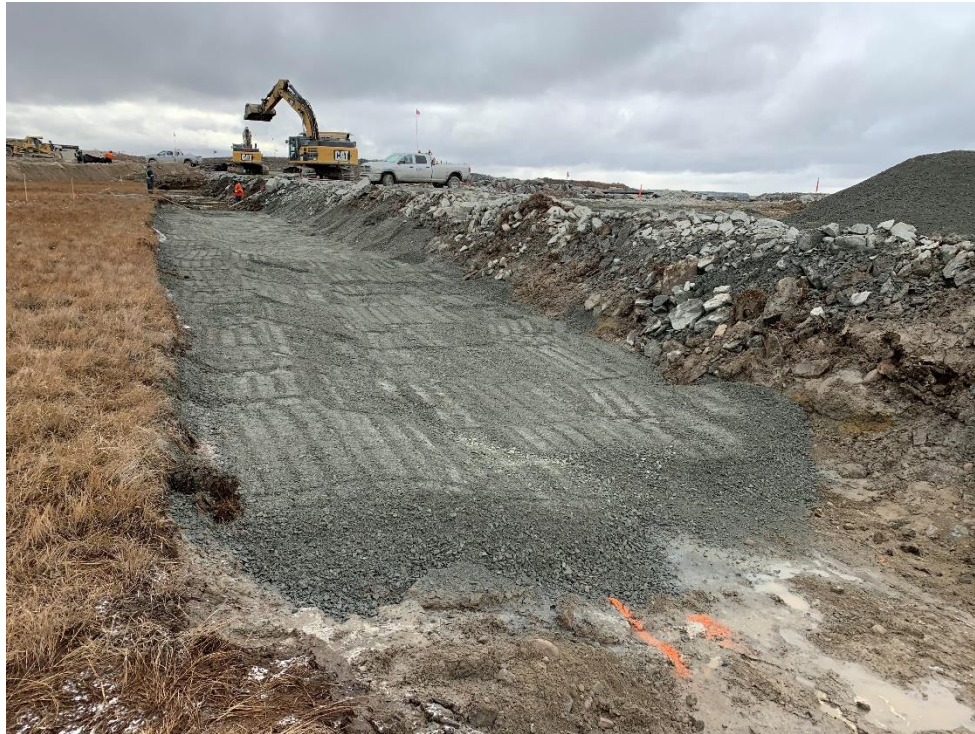
Figure 7: Fine filter approval between 0+029 and 0+070

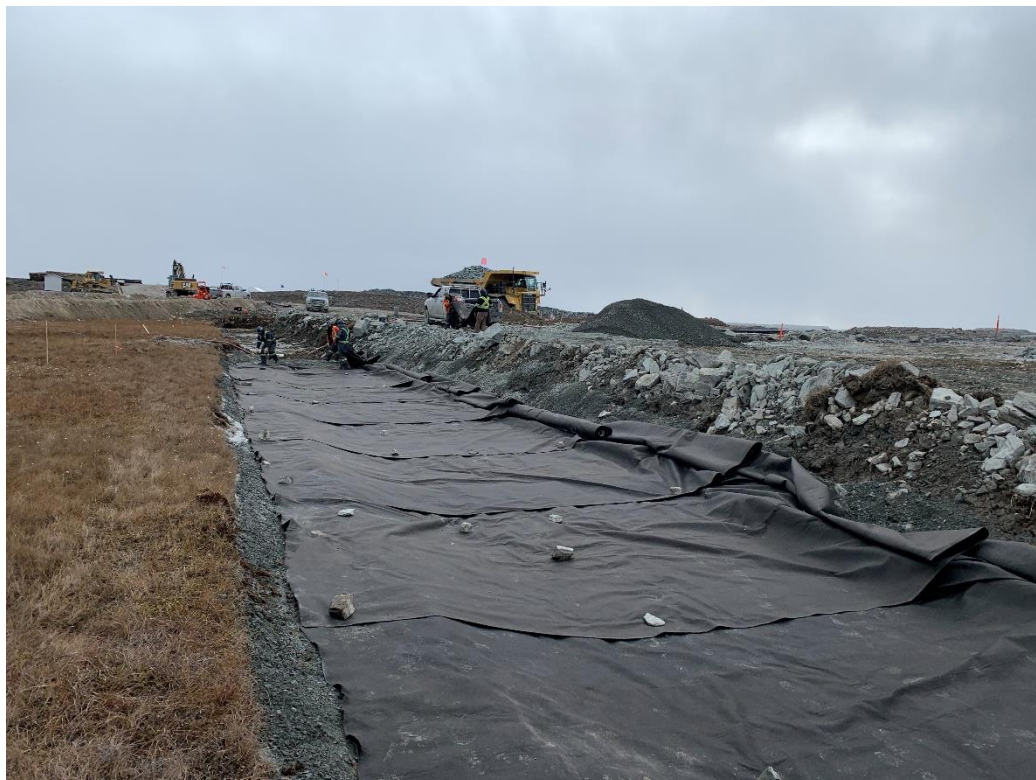
Figure 8: Geotextile between 0+029 and 0+070
