Construction Summary Report IVR Diversion Channel

Agnico Eagle Mines Ltd

6127-695-132-REP-012_R2

February 16, 2021

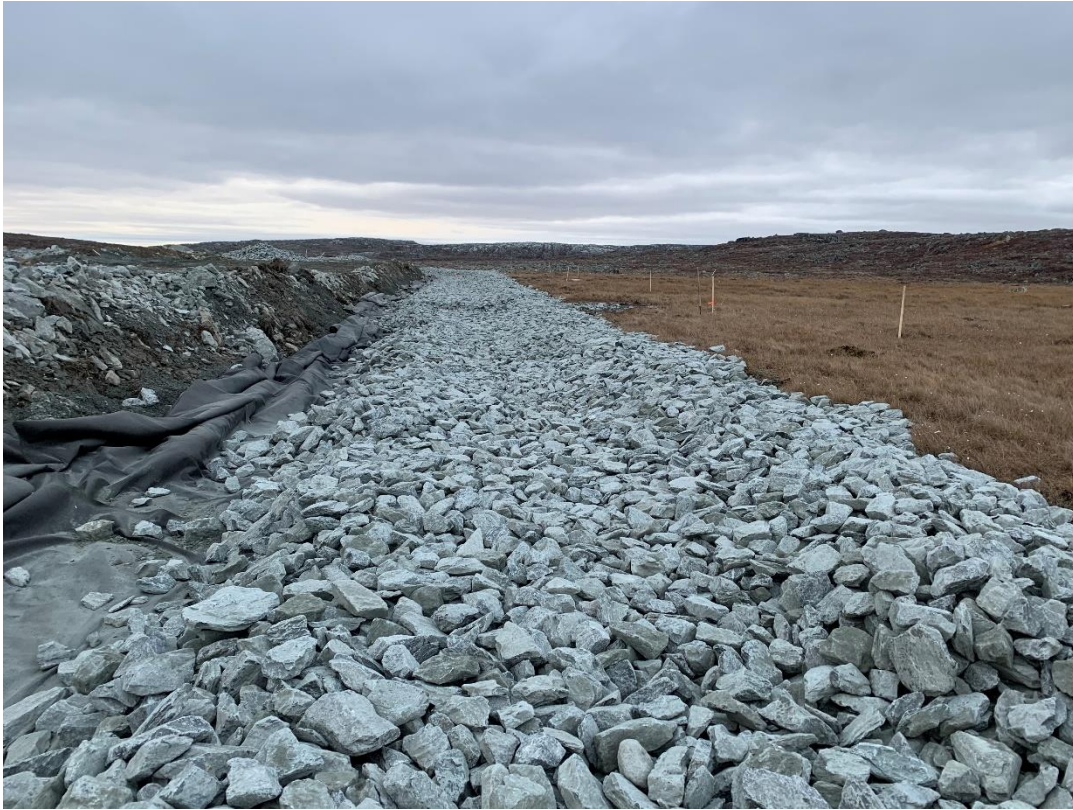
Figure 9: Geotextile and preliminary riprap between 0+034

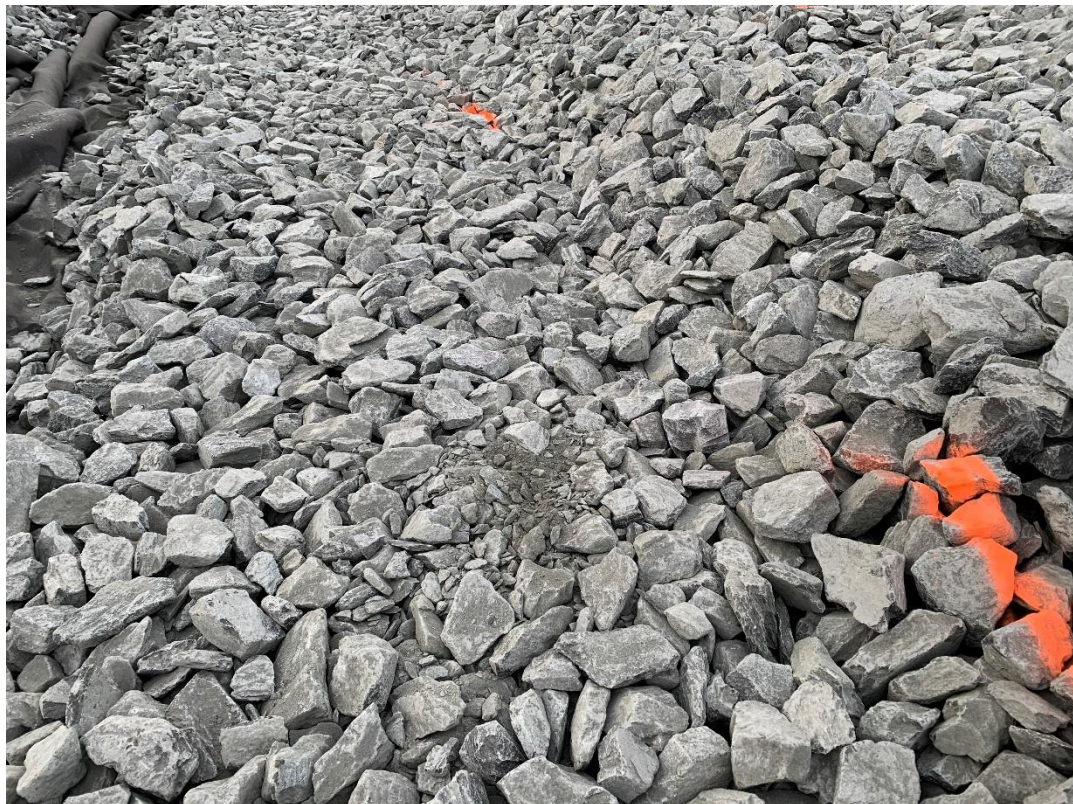
<ul style="list-style-type: none">Riprap with too much fines observed at 3 locations in the channel (the amount corresponds to 3 excavator buckets through the 250m length completed so far). (Figure 10) This situation is observable on a surface representing less than 1% of the portion completed so far. The overall quality of the riprap is thus acceptable overall and the amount of fines present in the riprap should have a negligible effect on quality of the water coming out of the channel. Nonetheless, a final inspection of the riprap will be done once it will be finalized and all the sections with too much fine material will be sorted by hand.						
<ul style="list-style-type: none">						
<ul style="list-style-type: none">						
Corrective action to be taken:						
<ul style="list-style-type: none">n/a						
<ul style="list-style-type: none">						
Follow up visit required: Yes <input checked="" type="checkbox"/> No <input type="checkbox"/>

Figure 10: Riprap with too much fine material

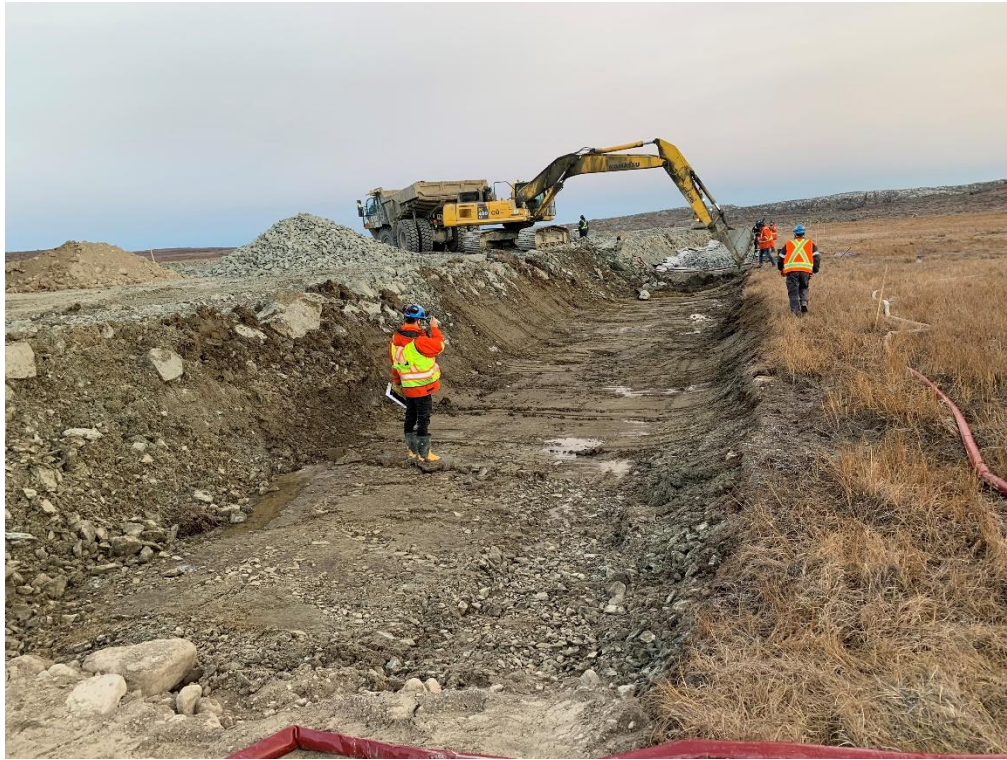
Figure 1: Foundation approval between 0-010 and 0+029

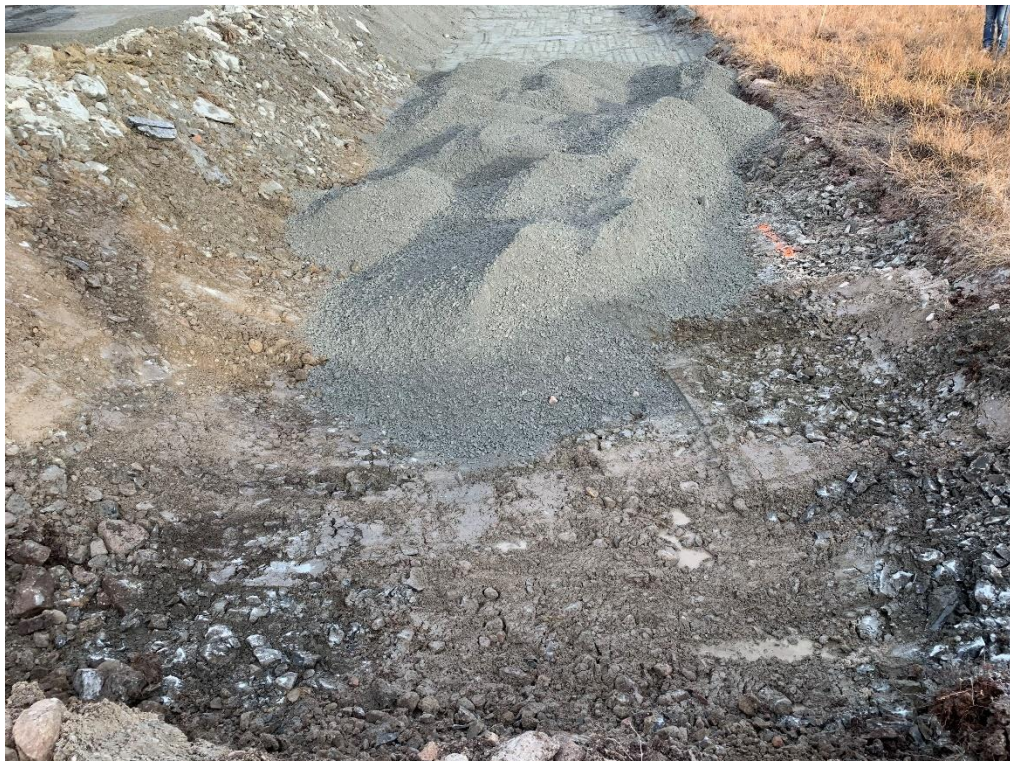
Figure 2: Foundation approval between 0-010 and 0-015

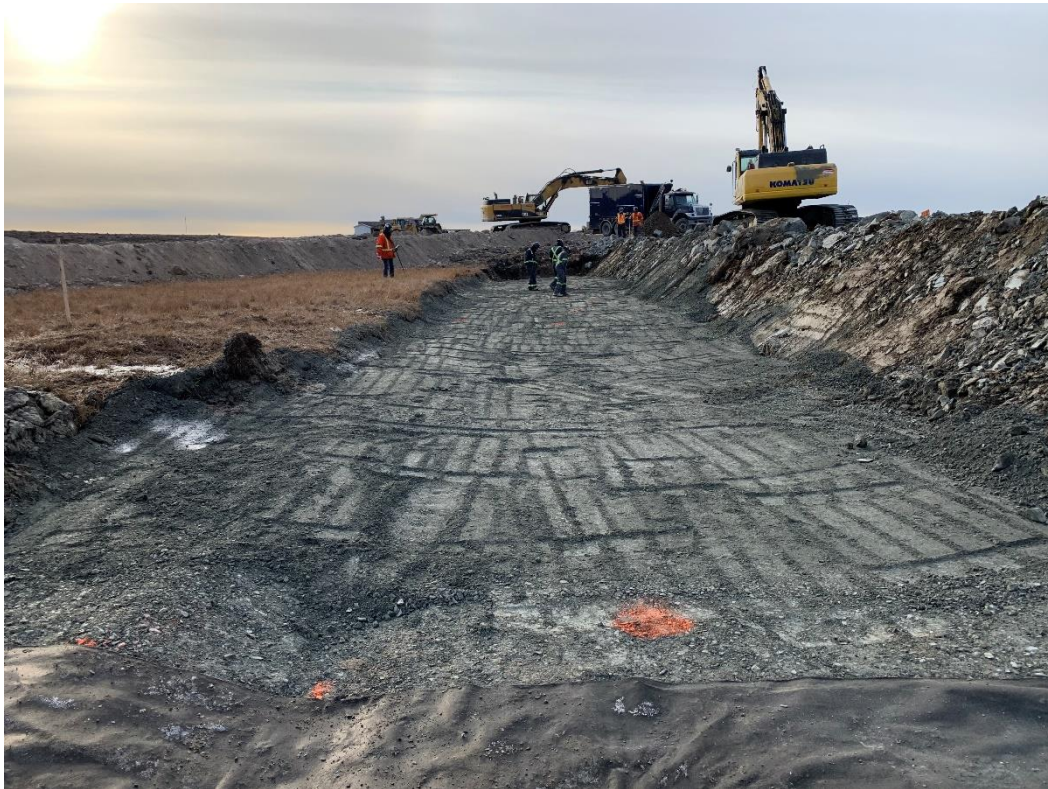
Figure 3: Fine filter fill approval between 0-015 and 0+029

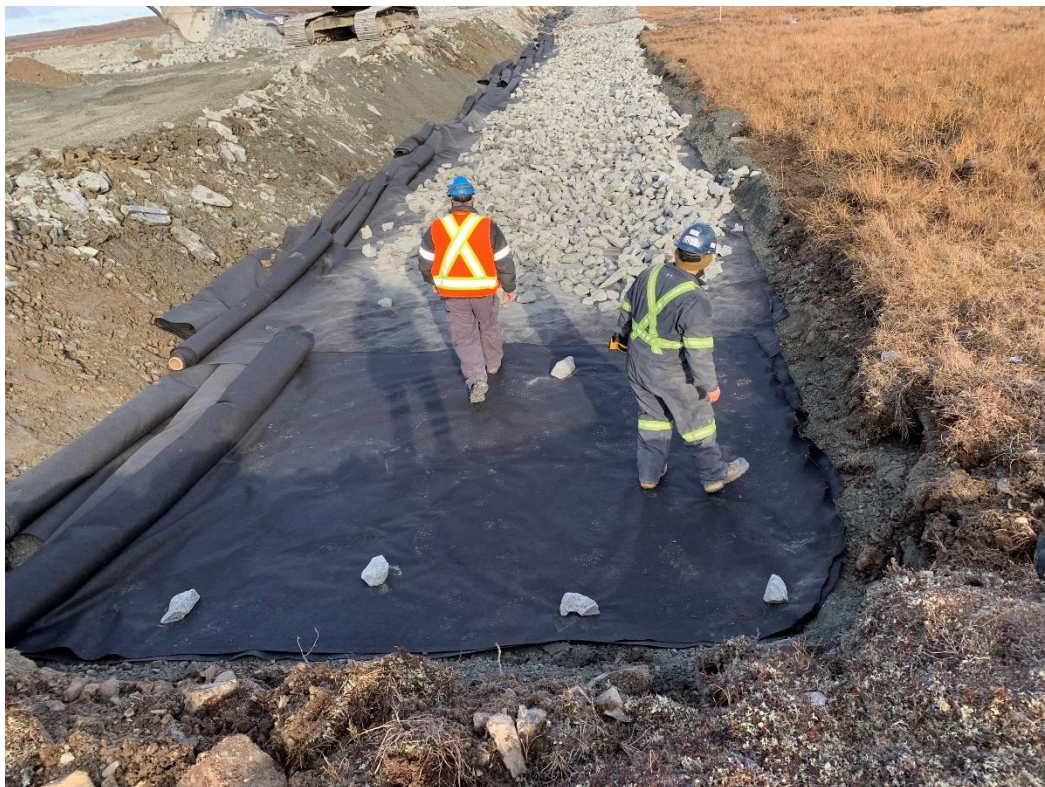
Figure 4: Geotextile placement between 0-015 and 0+032

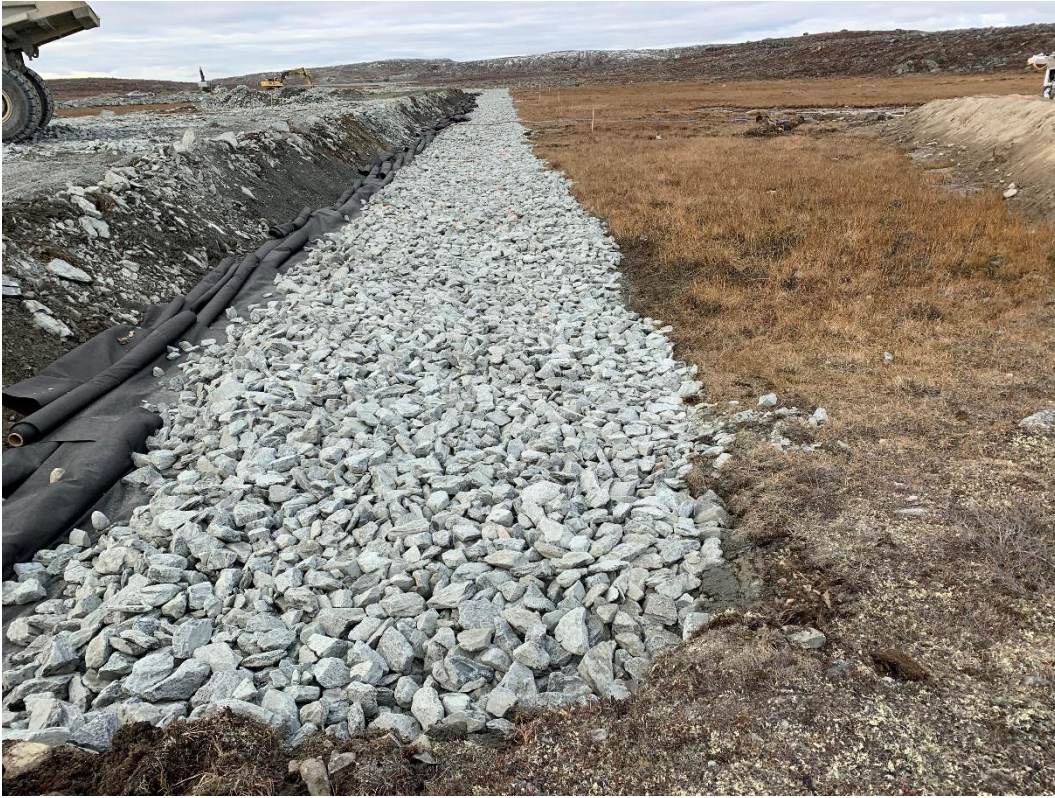
Figure 5: Riprap approval between 0-015 and 0+140

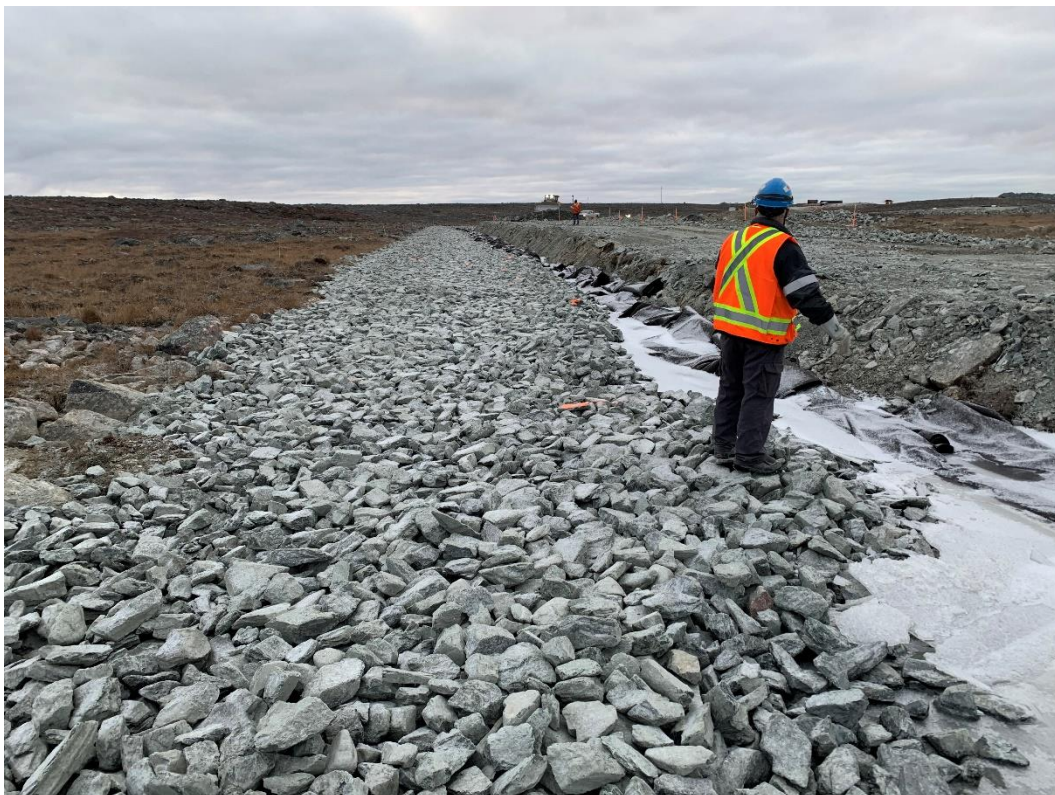
Figure 6: Riprap approval between 0+140 and 0+284.5

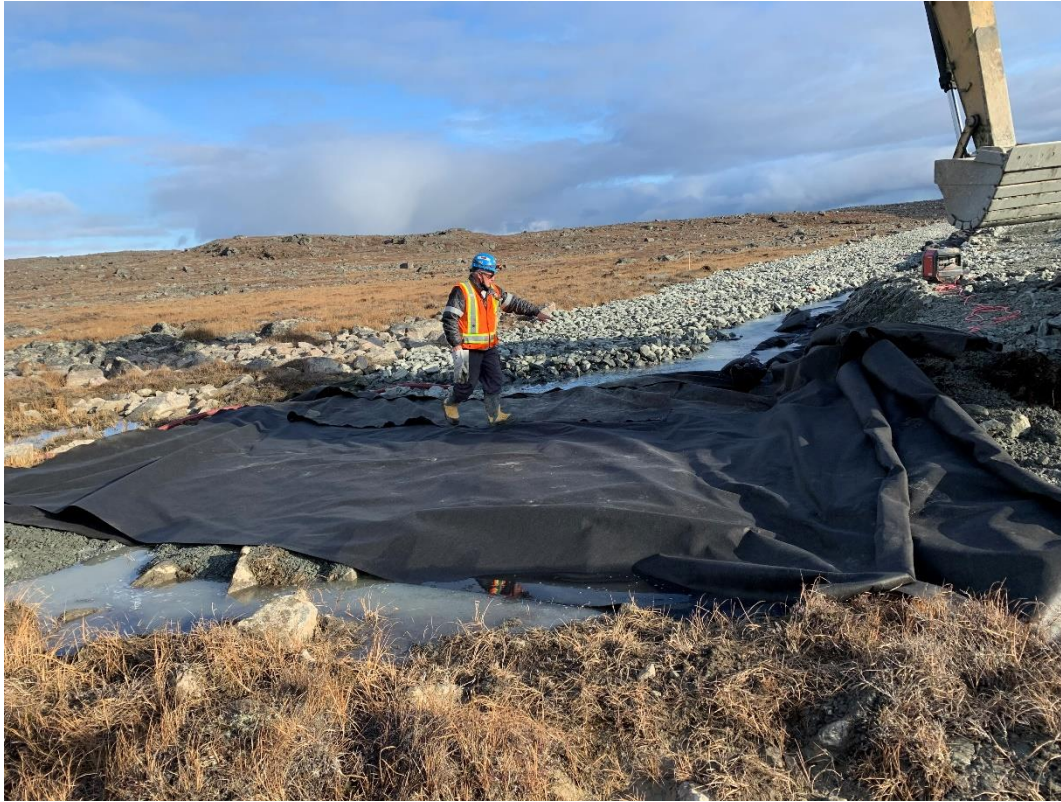
Figure 7: Geotextile placement at the downstream end between 0+284.5 and 0+290

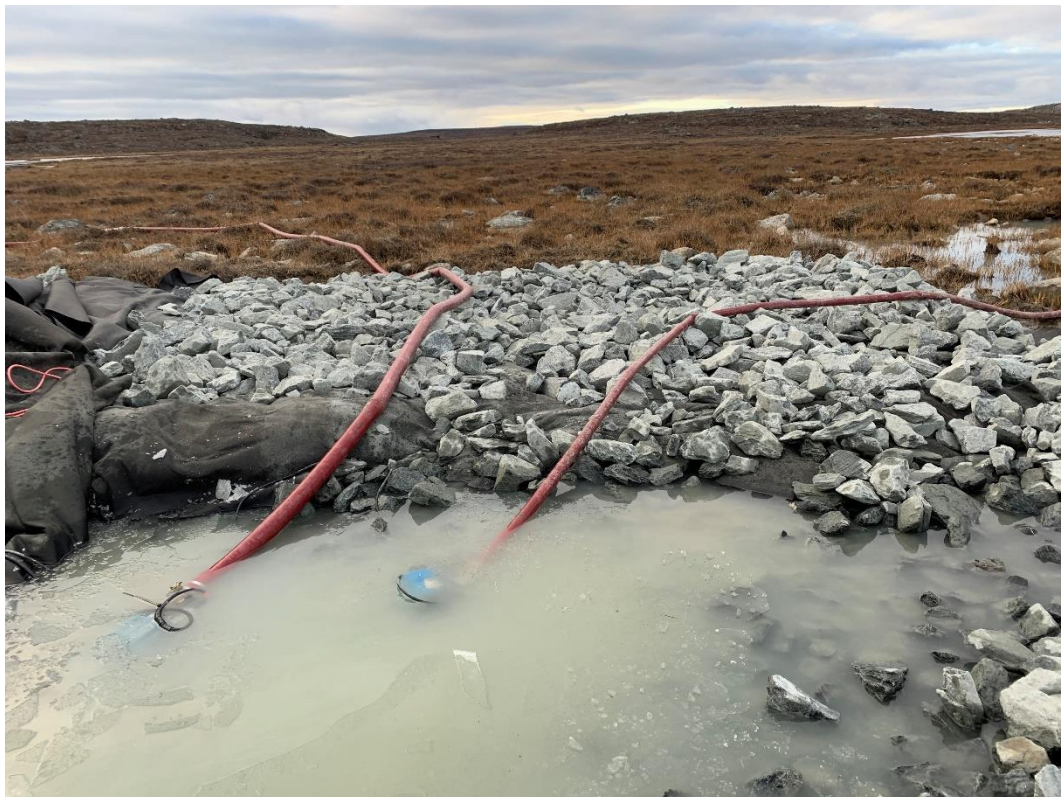
<ul style="list-style-type: none">Pumps haven been added at the bottom of the channel to pump the water out of it. (Figure 8) The 3-inch pump is pumping the water to lake A-53 while the 2-inch pump was only temporary to manage the water until the 3-inch pump was installed. The geotextiles are soaked, so they are hard to move away from the slope and removing the water accumulated at the bottom should help improving the situation.						
<ul style="list-style-type: none">Riprap material coming on site was not acceptable at the end of the afternoon. Too much fines were present in it. (Figure 9). The loading method at the stockpile is acceptable, but the stockpile of riprap is next to a stockpile of 0-3/4" material, so there might be contamination of this material in the riprap. The excavator operators on site have a good method to scoop the riprap. They are not scraping the access road material and they leave a good floor of riprap. The excavator operators were asked to filter the riprap by dropping buckets of riprap on the ground to let the fines go at the bottom. The material placed from the non-conforming loads was appropriately sorted by the excavator operators, except for a few buckets that had too much fines in it. The sections with too much fine material will be corrected by hand to avoid ripping the geotextile.

Figure 8: Pumps added at the end of the channel (0+284.5)

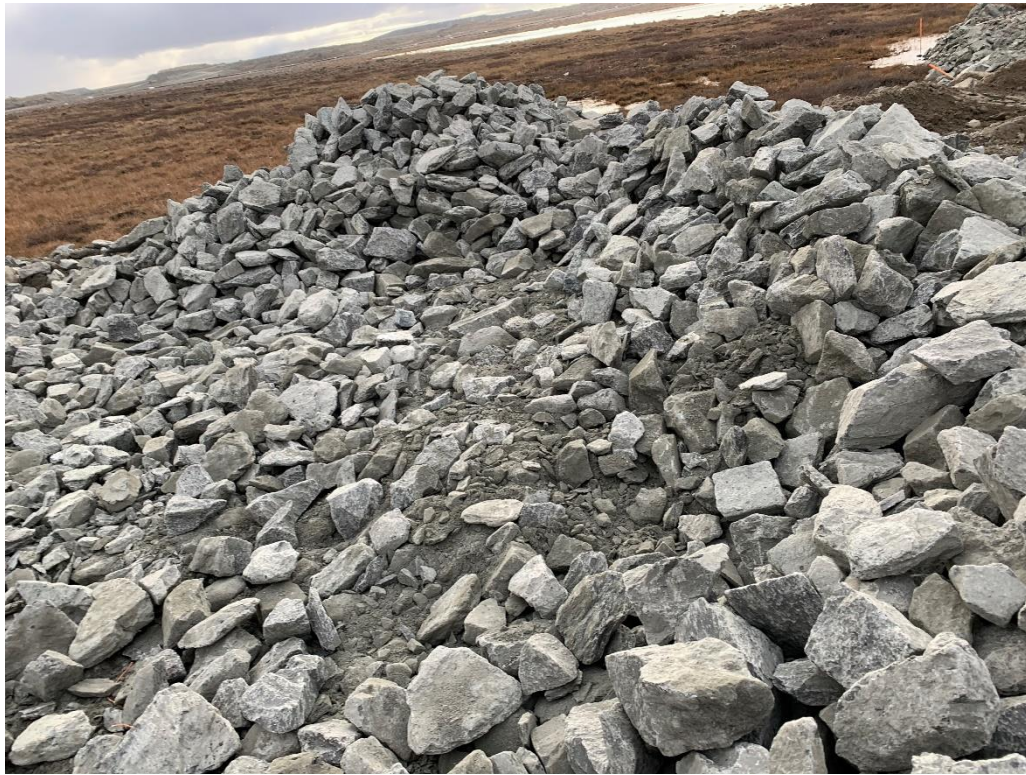
Figure 9: Non-conforming load of riprap

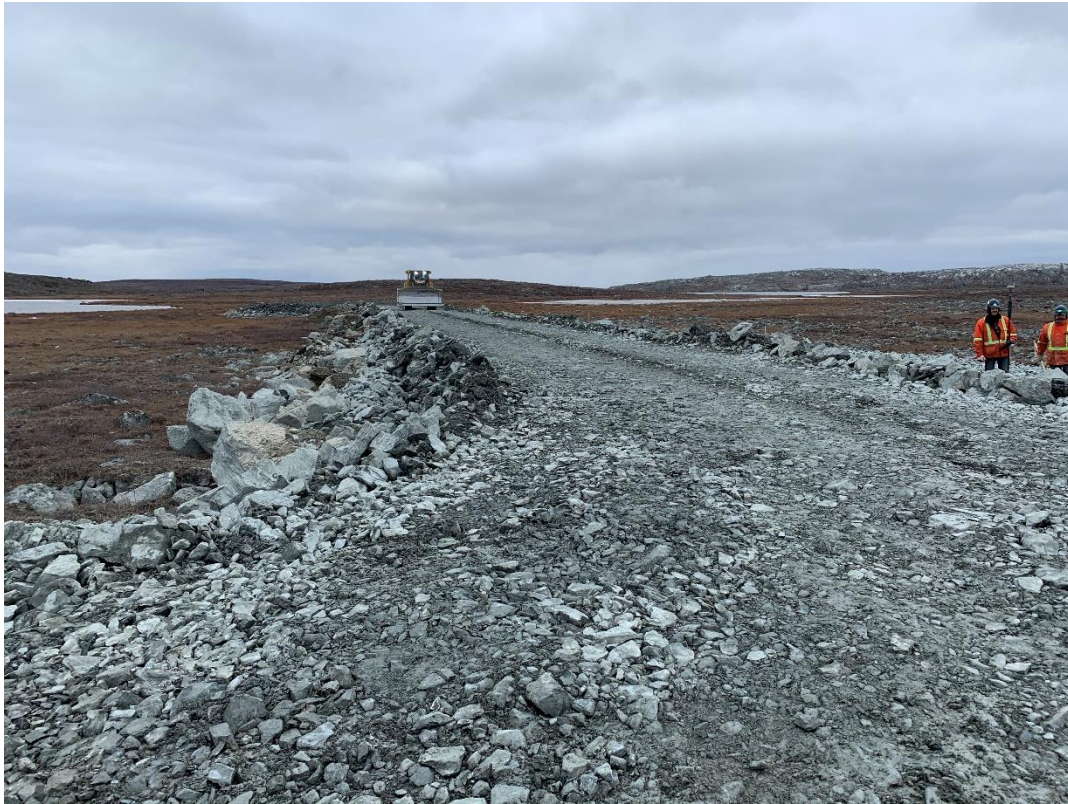
Figure 1: Final access road lift between 0+162 and 0+284.5

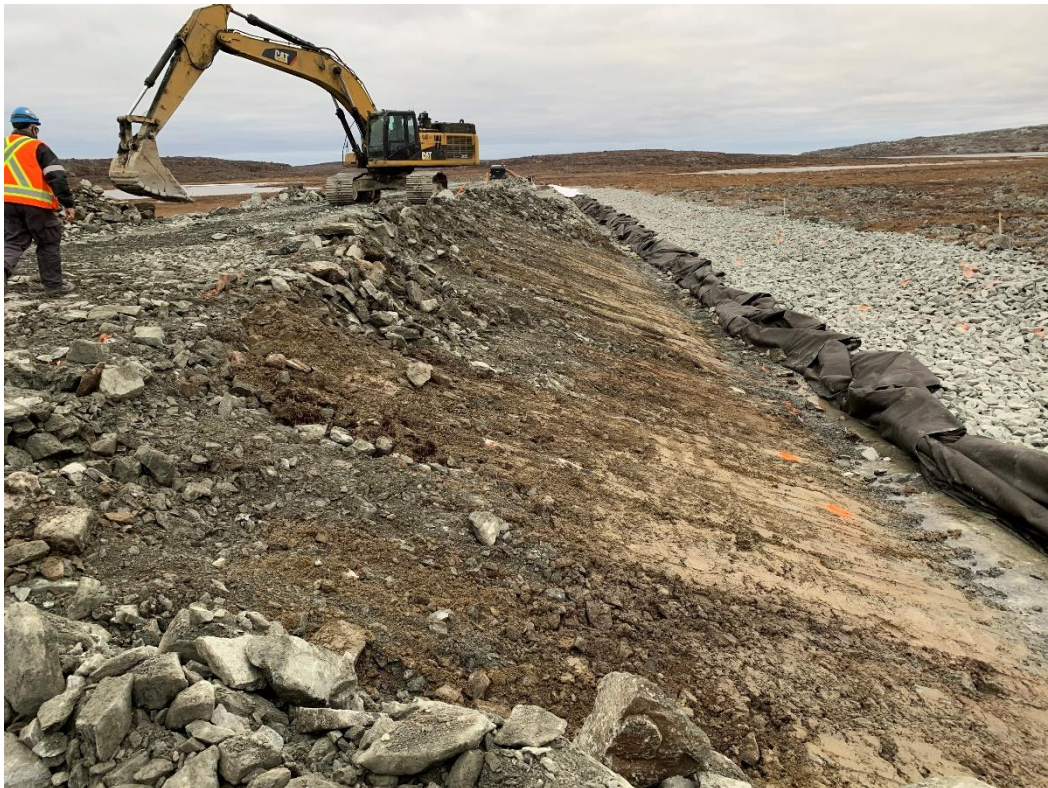
Figure 2: Slope completed between 0+162 and 0+188

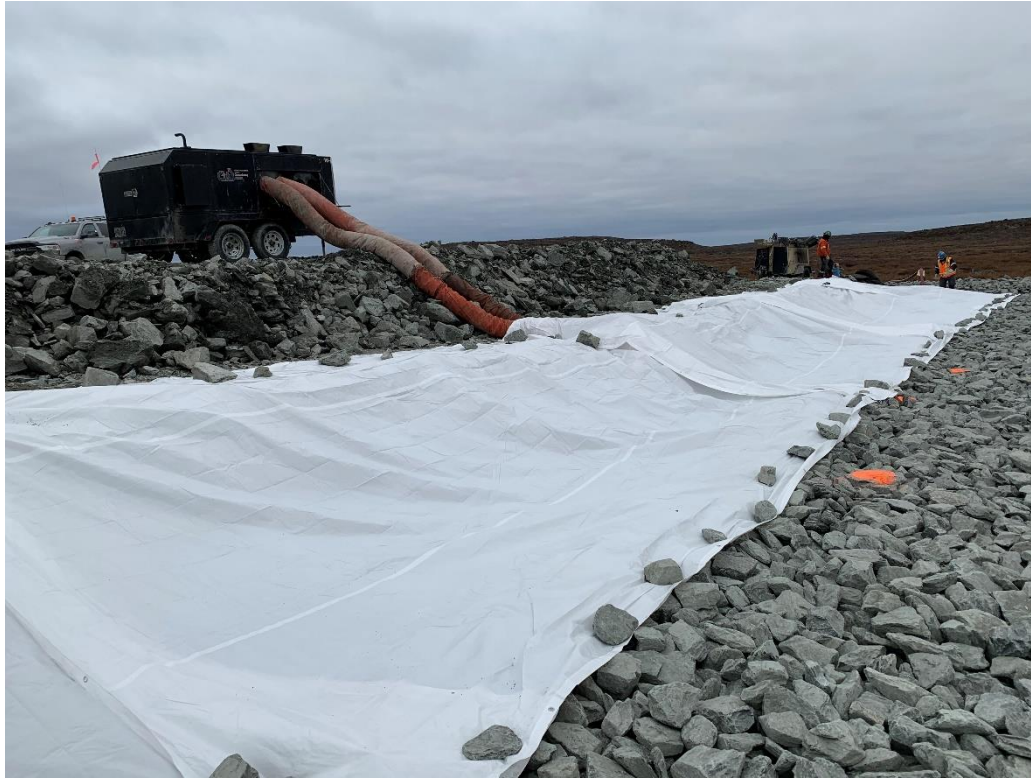
Figure 3: Heating provided between 0+235 and 0+284.5 to avoid freezing of wet geotextile

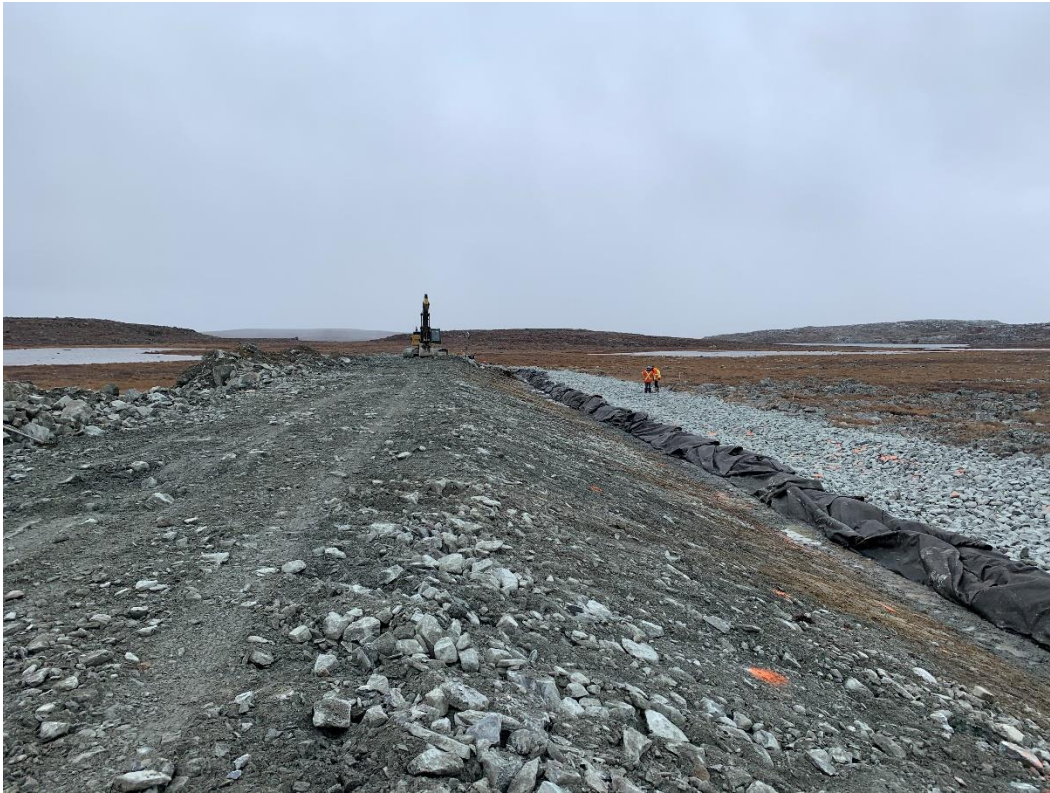
Figure 1: Access road slope completed between 0+188 and 0+284.5

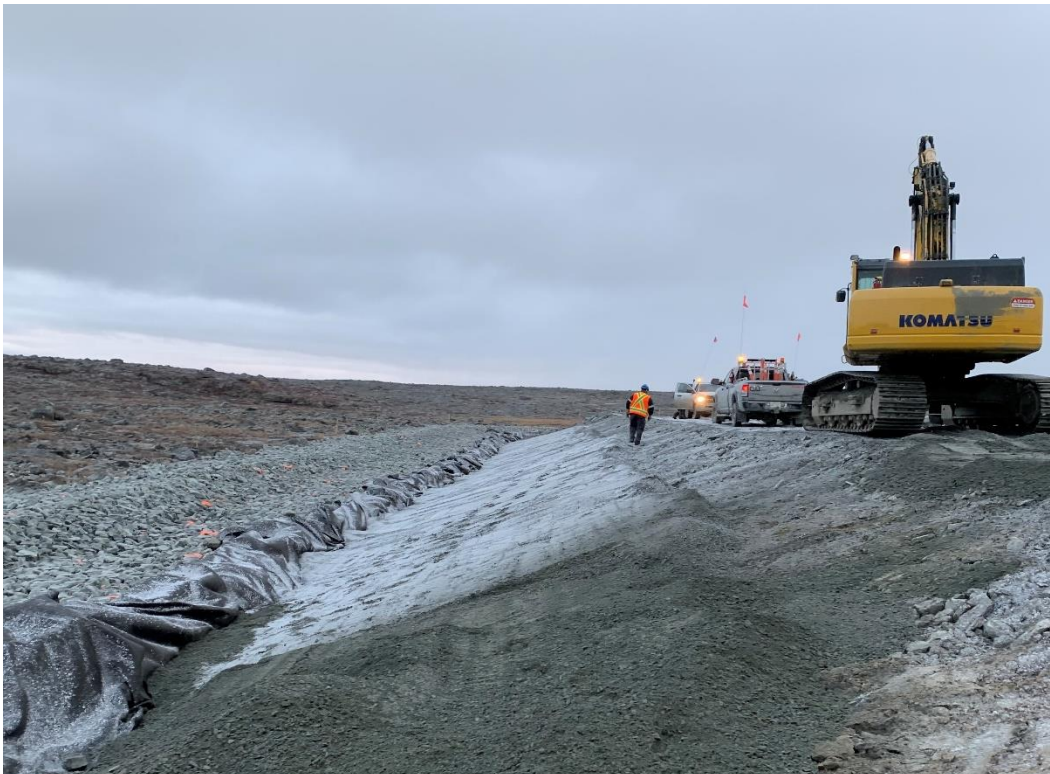
Figure 2: Fine filter placed between 0+162 and 0+230

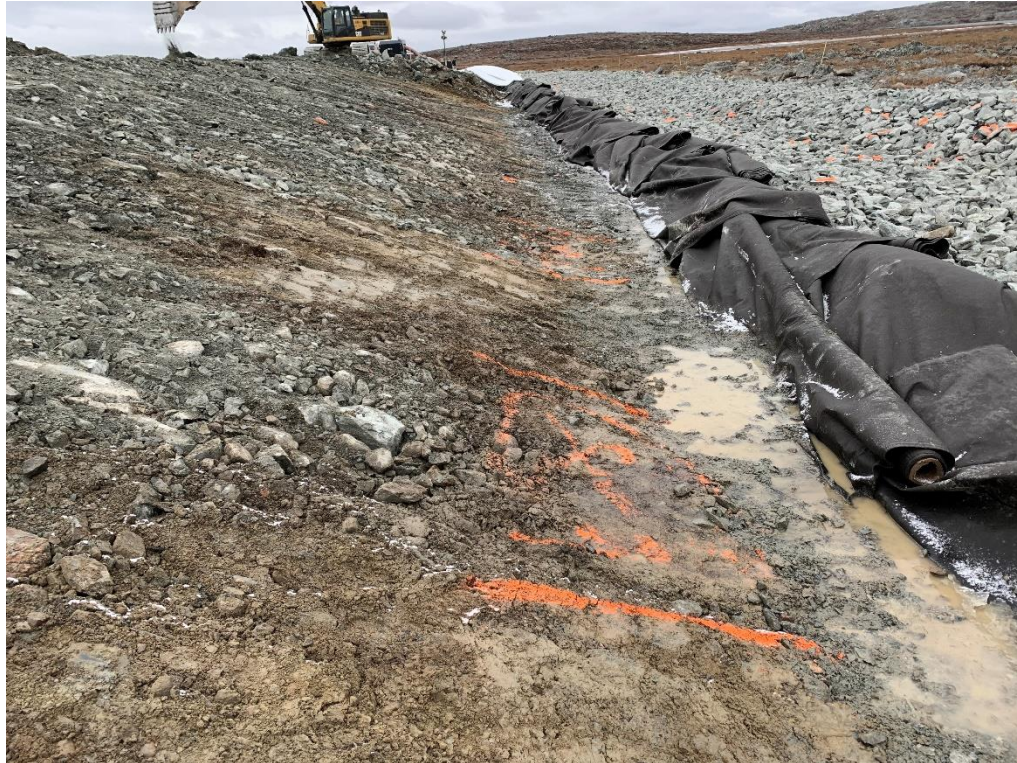
Figure 3: Soft spot identified

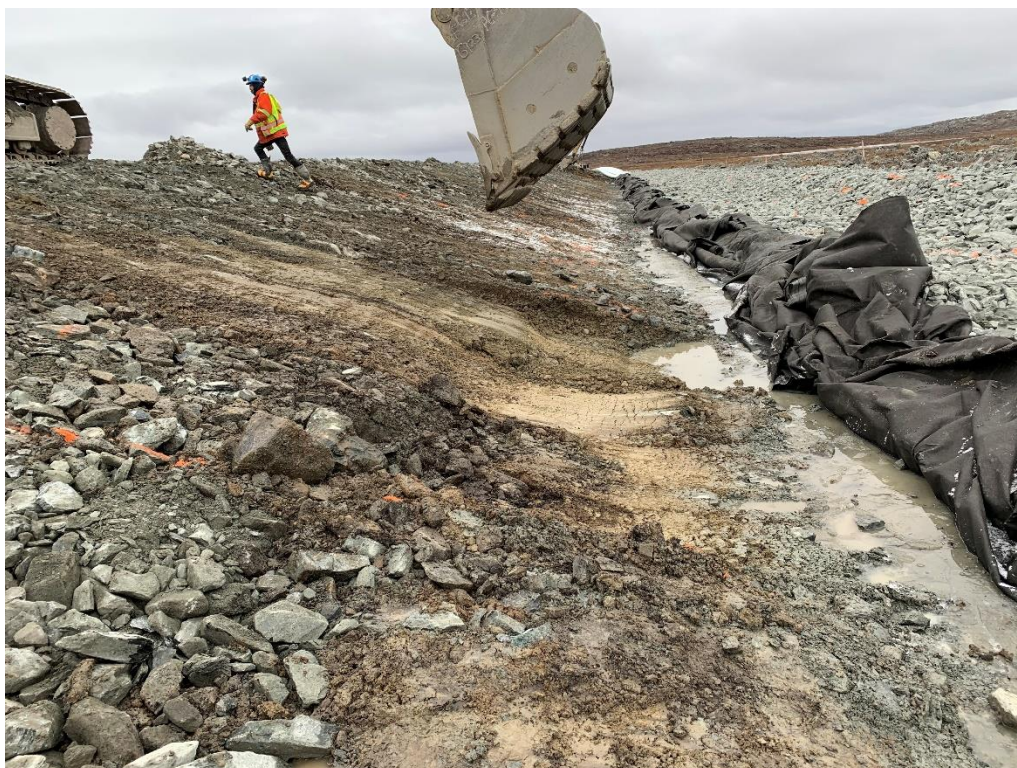
Figure 4: Soft spot excavated

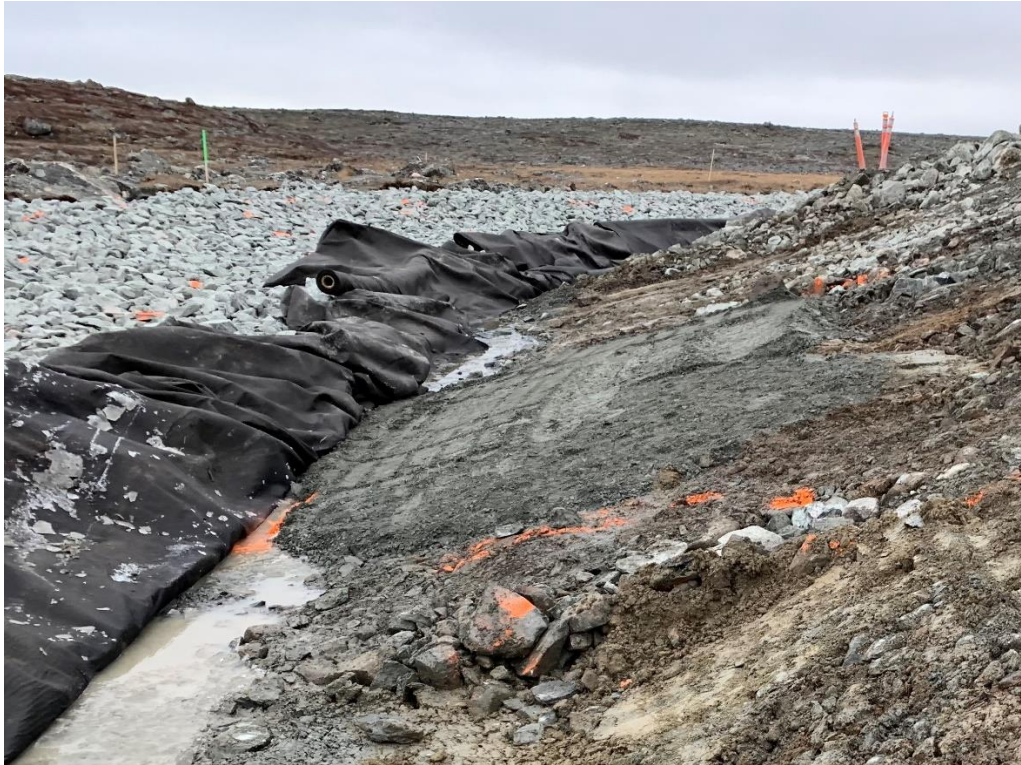
Figure 5: Excavated soft spot filled with well compacted fine filter

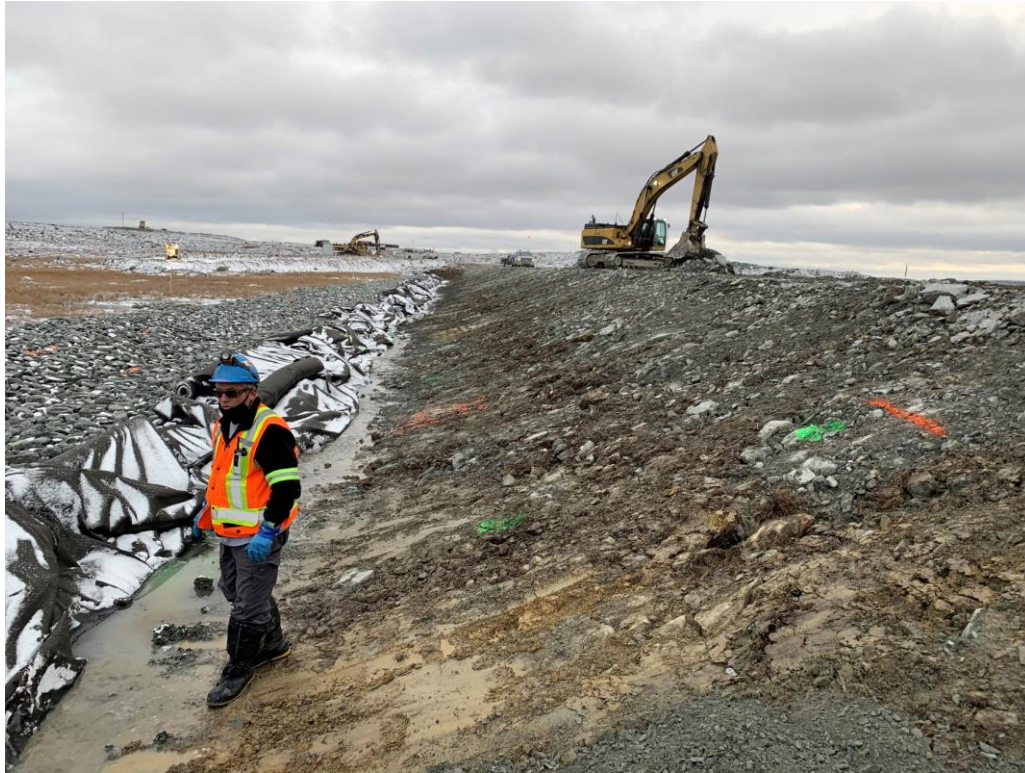
Figure 1: Slope preparation between 0-015 and 0+140

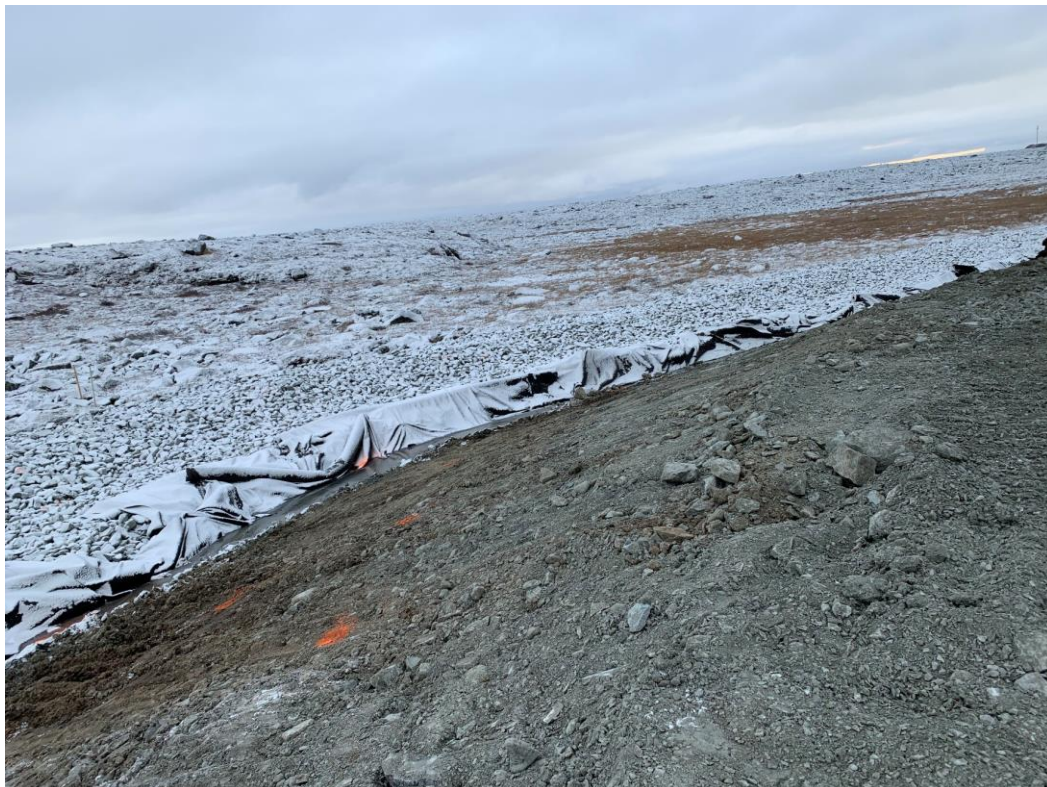
Figure 2: Slope preparation between 0+140 and 0+160

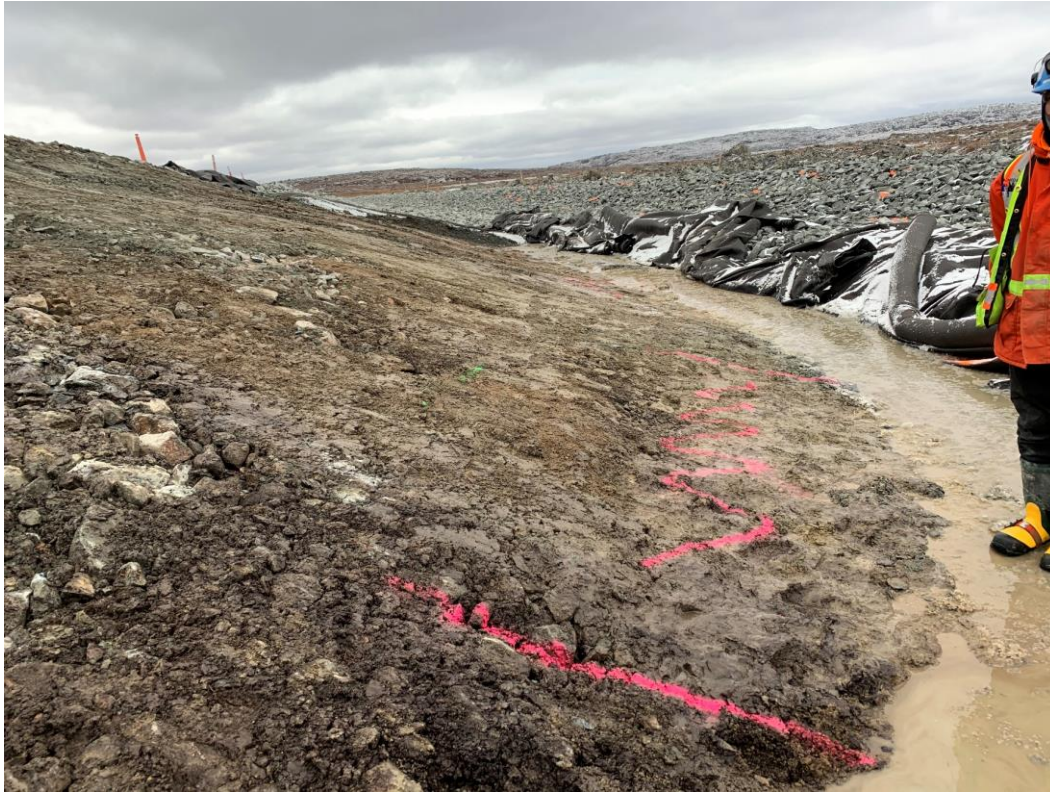
Figure 3: Foundation approval between 0+140 and 0+155

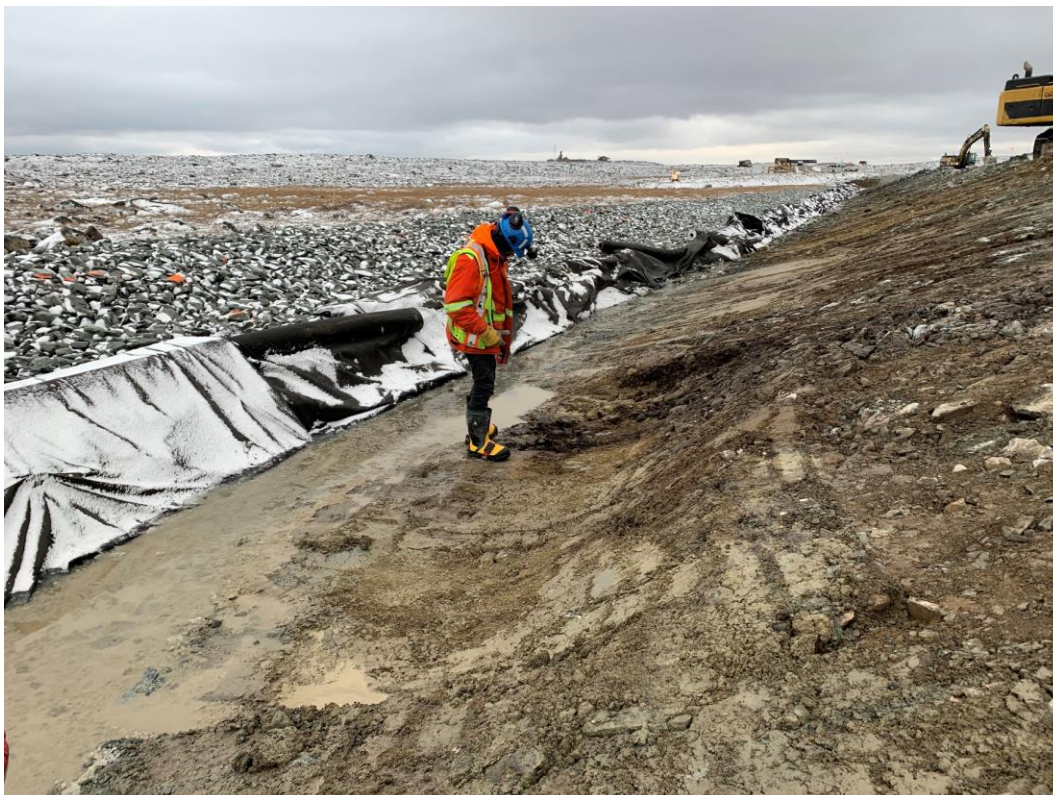
Figure 4: Foundation approval between 0+090 and 0+140

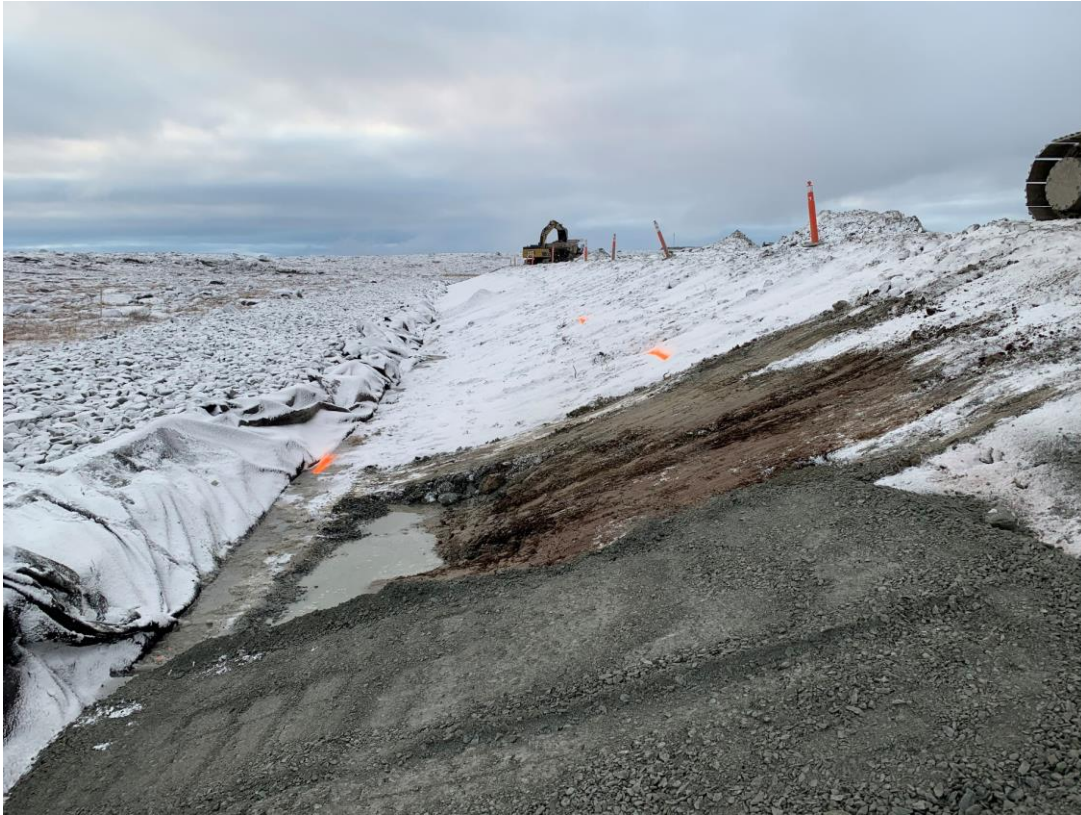
Figure 5: Foundation approval between 0+220 and 0+260

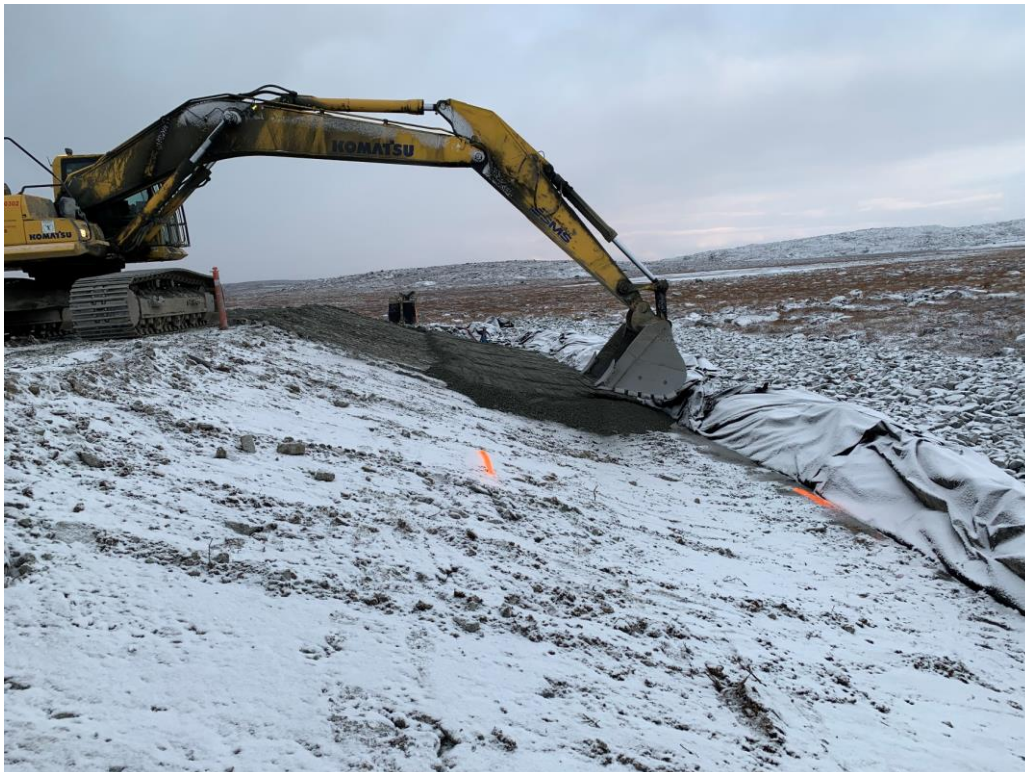
Figure 6: Foundation approval between 0+260 and 0+284.5

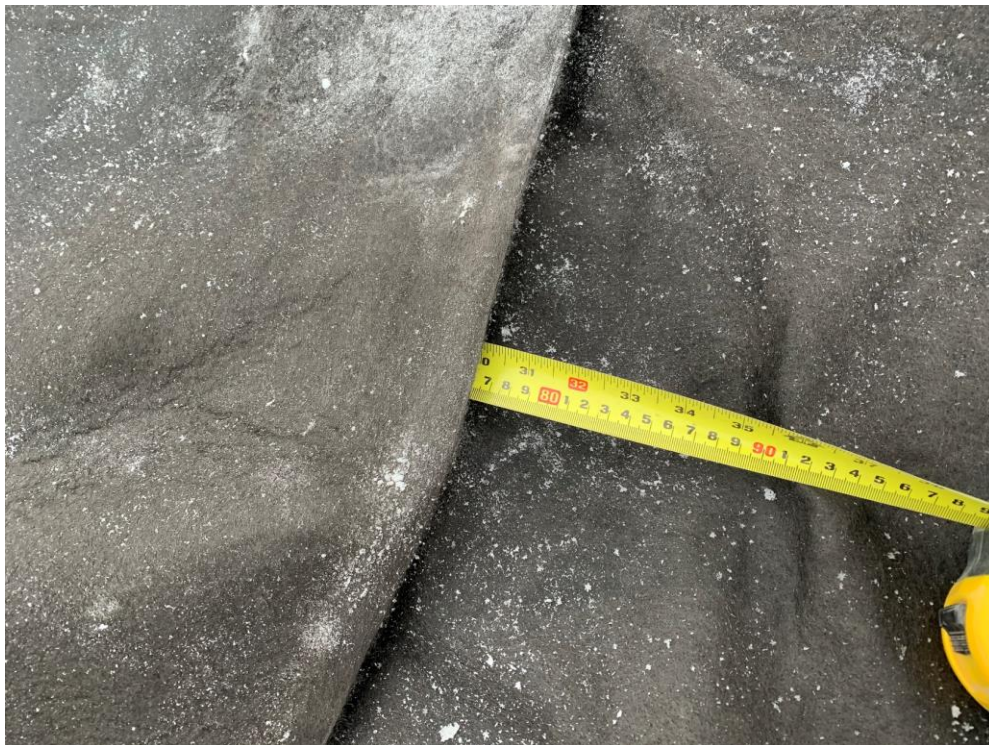
Figure 12: All the overlaps measured are conforming to minimum requirement of 600

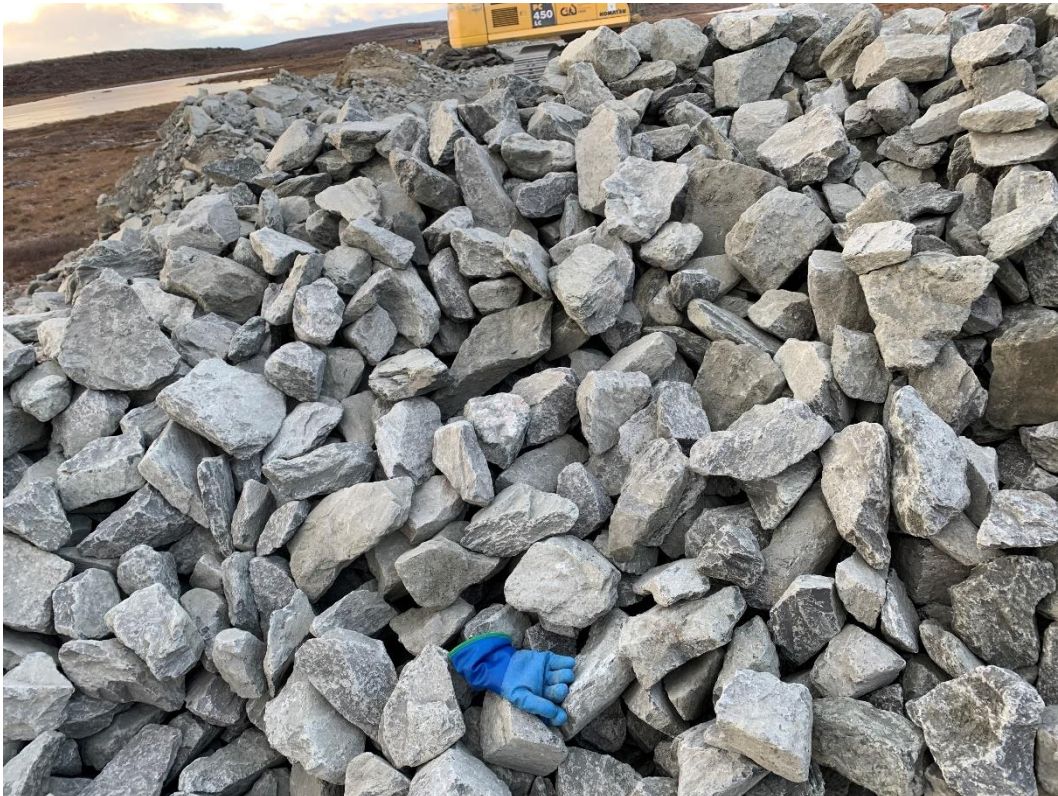
Figure 6: Riprap from the first half dumping process
