Construction Summary Report IVR Diversion Channel

Agnico Eagle Mines Ltd

6127-695-132-REP-012_R2

February 16, 2021

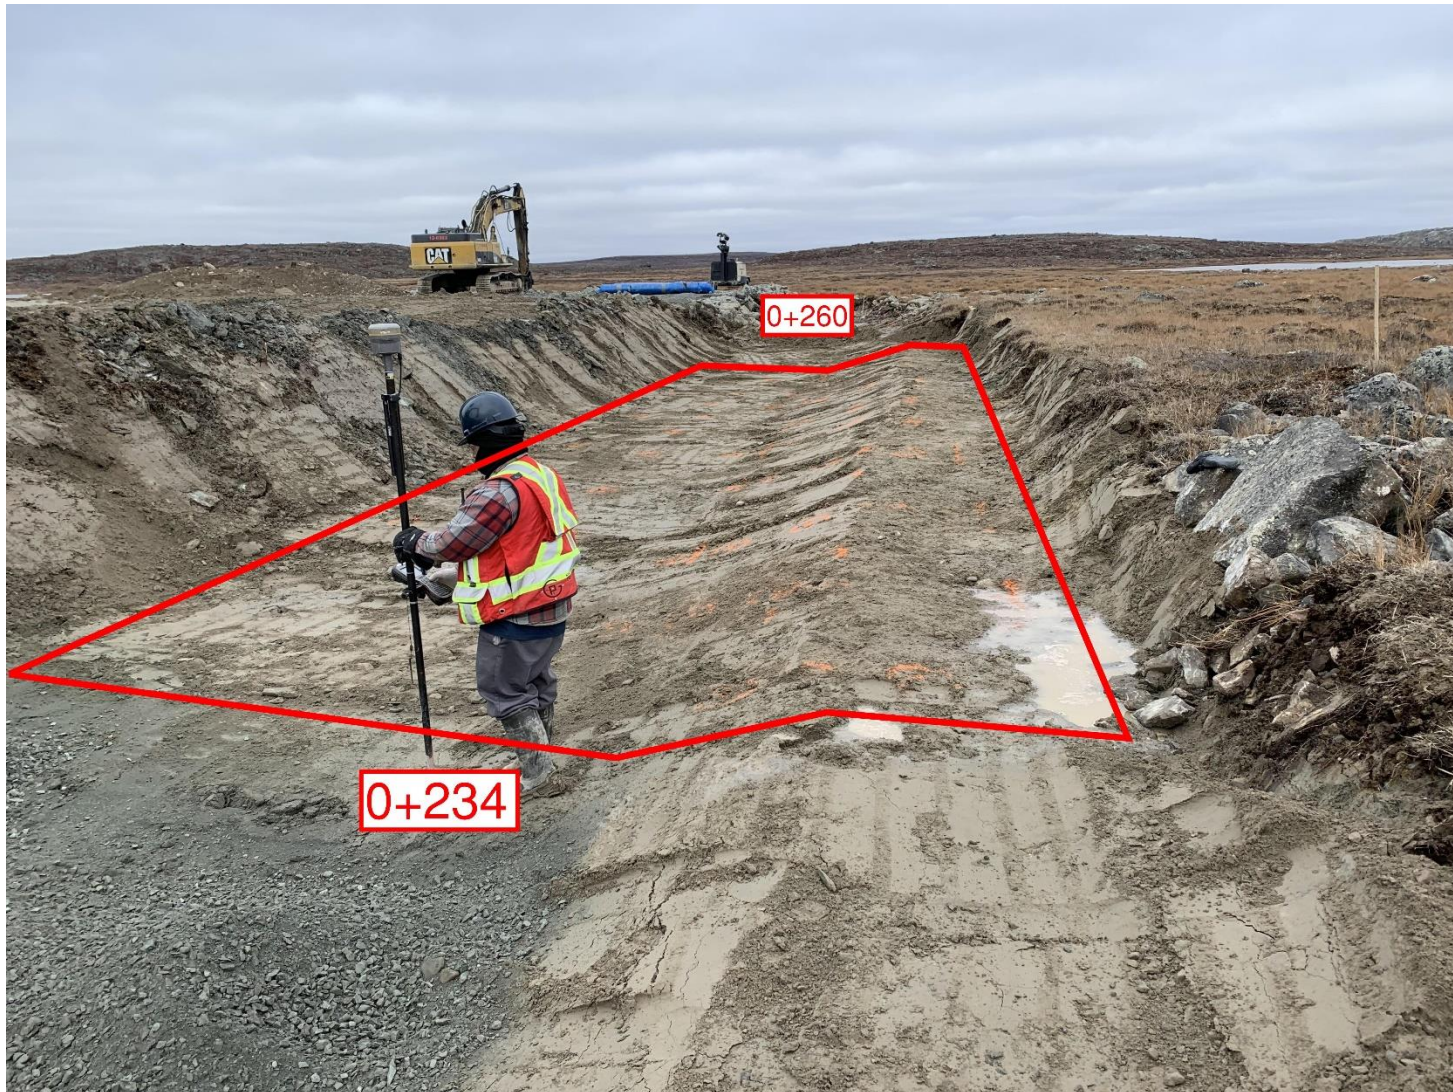
<u>APPROVED BY:</u>			
		QA AEM		QC AEM	
		Y	N	Y	N
ITEM					
2	Ice-rich material removed over an average depth of 1.2m and replaced by esker. Refer to 20200925-FDN-03 for details.	✓		✓

Figure 1: Foundation approval between 0+234 and 0+260

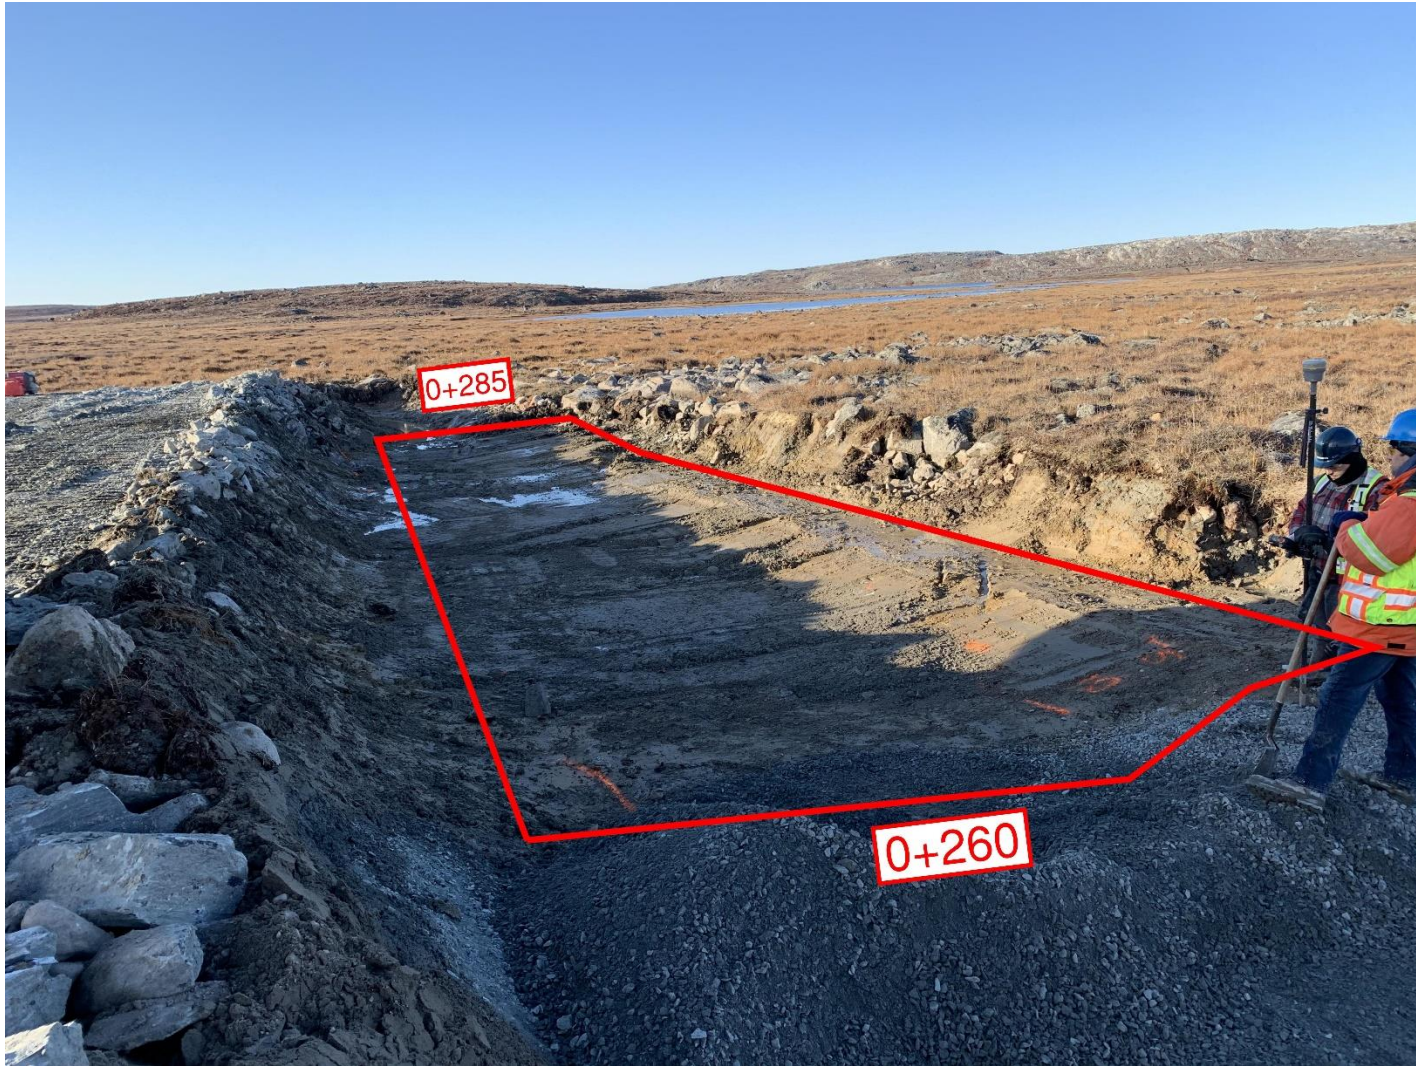
<u>APPROVED BY:</u>			
		QA AEM		QC AEM	
		Y	N	Y	N
ITEM					
2	Presence of water at the bottom of excavation. Fill placement from upstream to downstream to push the water out before placing the material. Remove and replace the fill by appropriate material when it becomes oversaturated with water/mud.	✓		✓

Figure 1: Foundation approval between 0+260 and 0+285

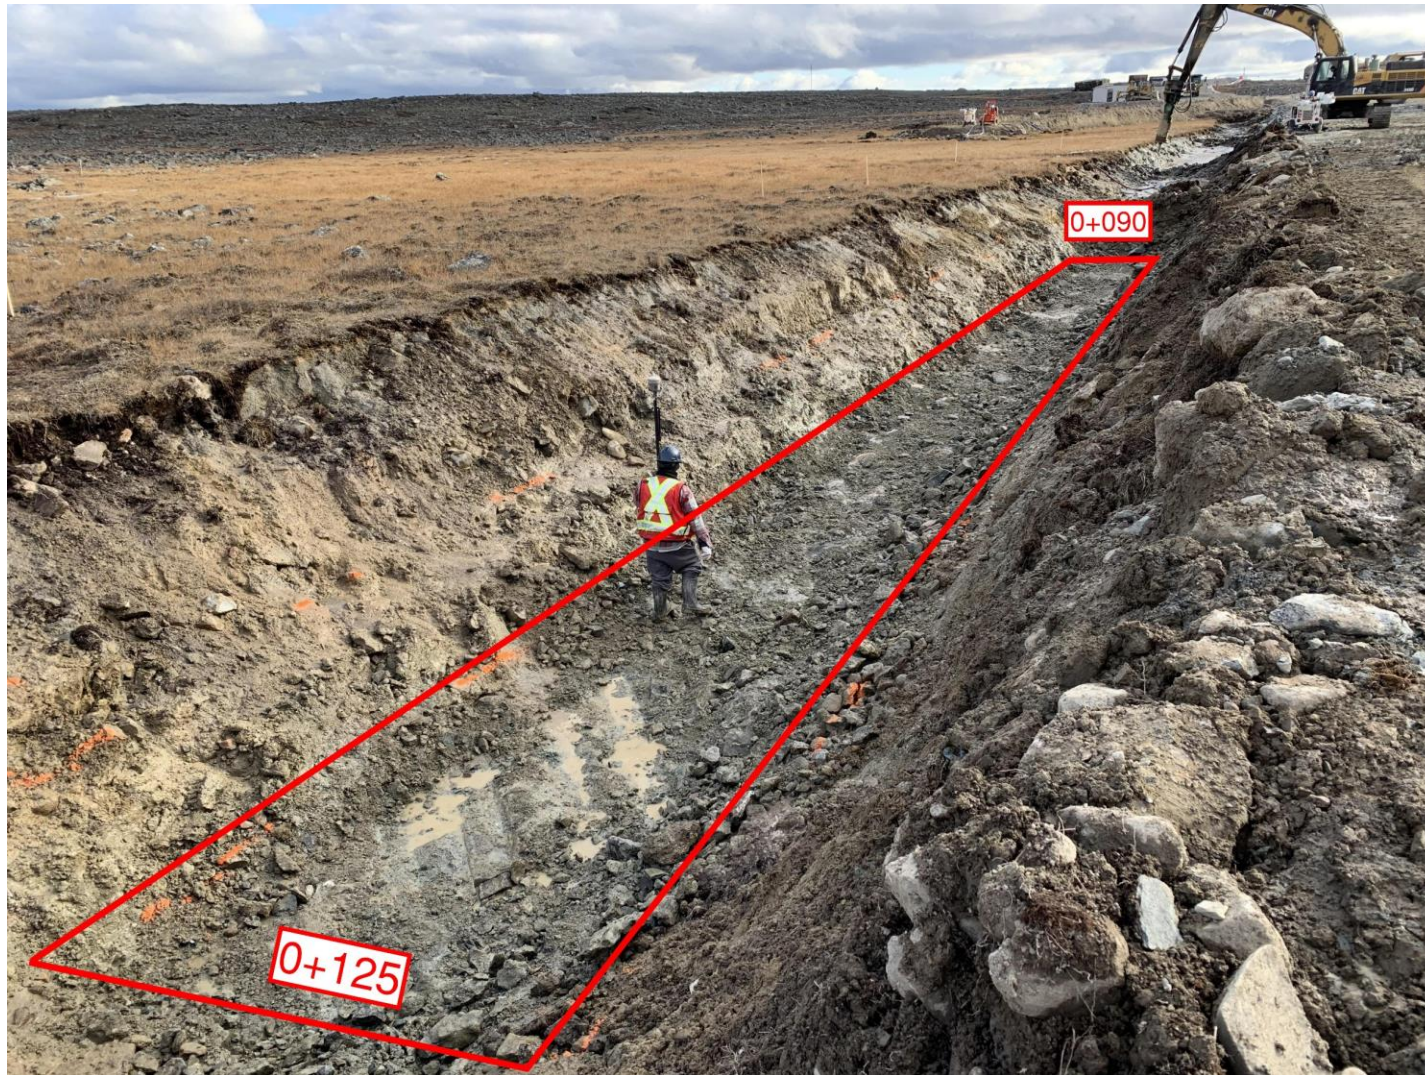
<u>APPROVED BY:</u>			
		QA AEM		QC AEM	
		Y	N	Y	N
ITEM					
2	The bottom of the excavation is composed of ice-rich till. The ice-rich till has been excavated to an average depth of 1.1m below the normal elevation of the bottom of the channel. The excavation could not have been done deeper due to safety reasons. The ice-rich material removed will be replaced by esker.	✓		✓

Figure 1: Ice removal approval between 0+090 and 0+125

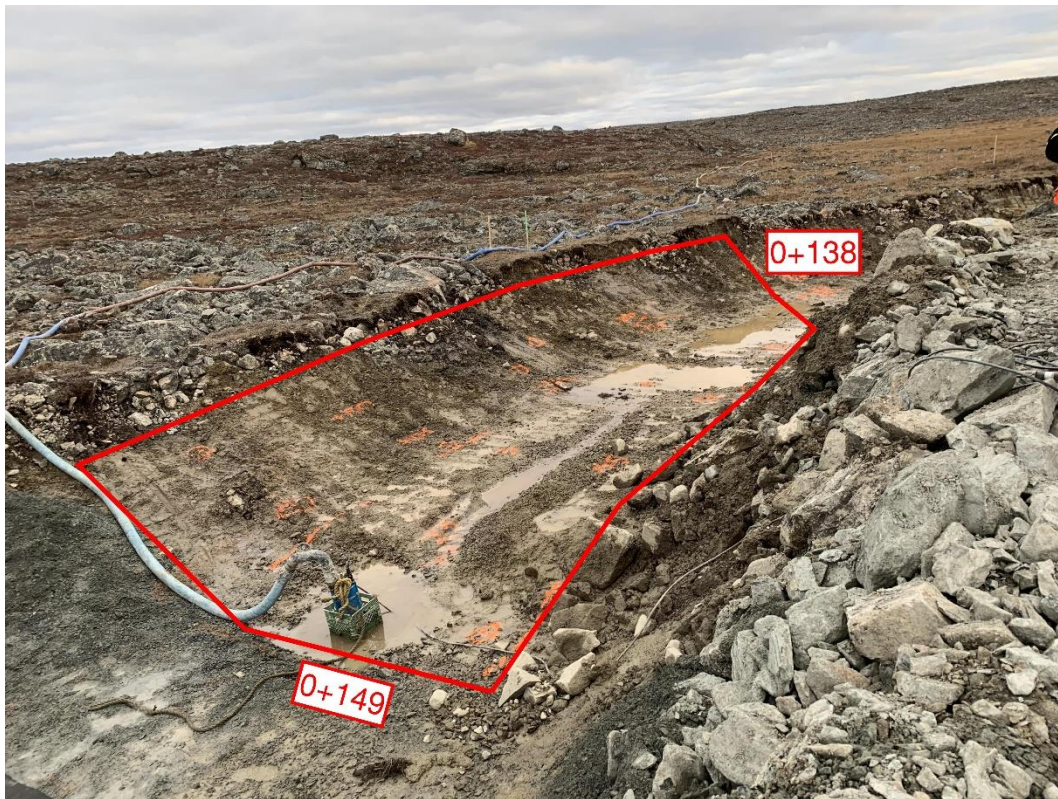
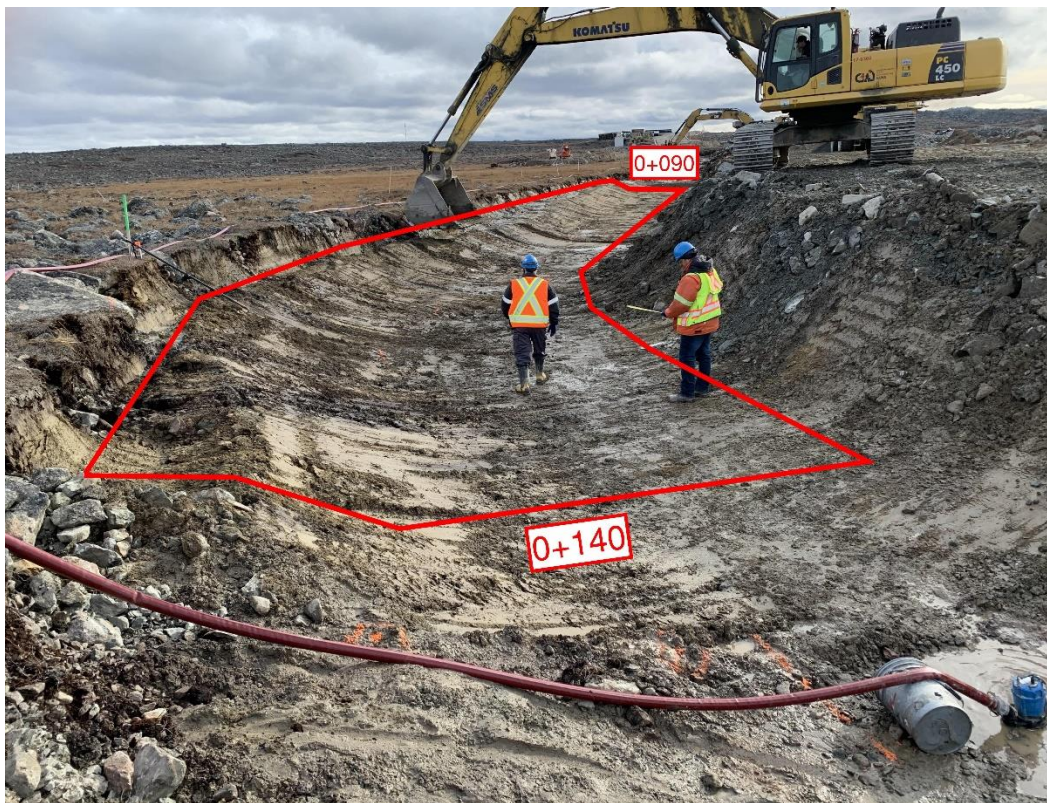
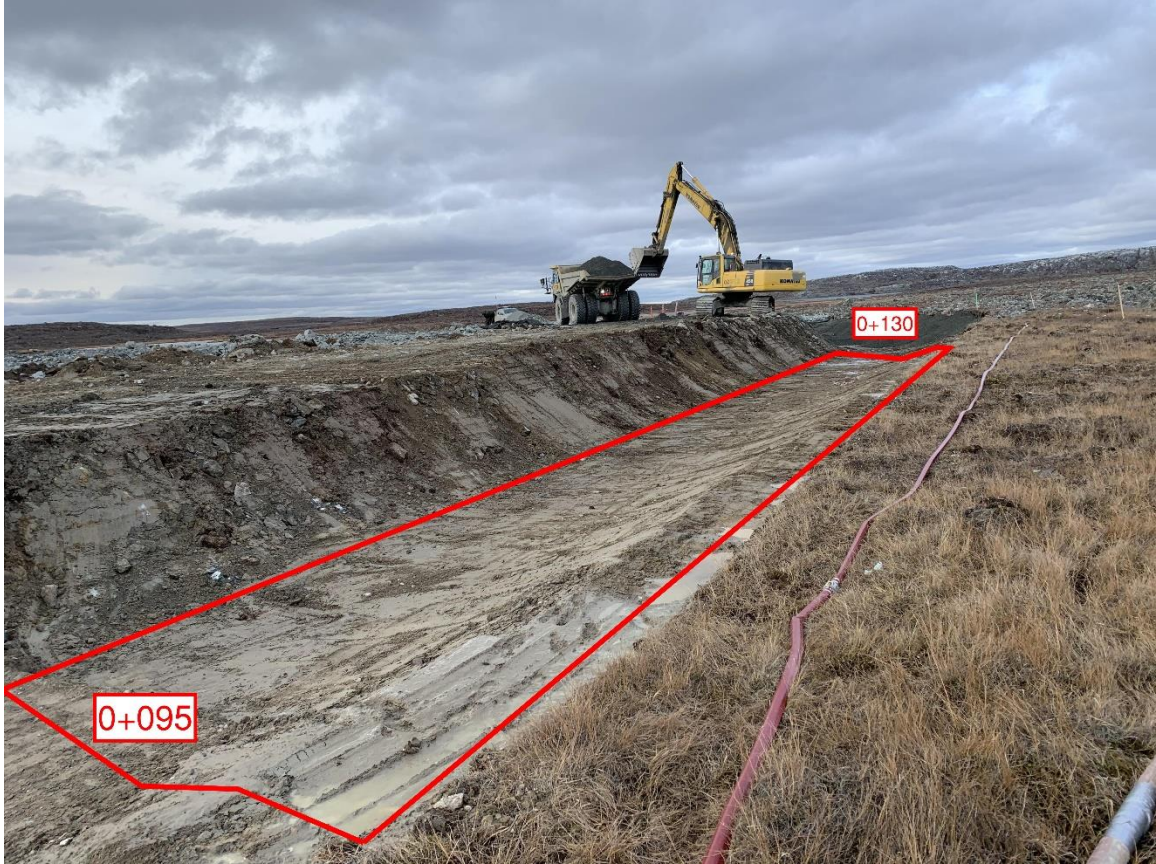
<u>APPROVED BY:</u>			
		QA AEM		QC AEM	
		Y	N	Y	N
ITEM					
2	Ice-rich material removed over an average depth of 1.1m and replaced by esker between 0+090 and 0+125. Refer to 20200927-FDN-06 for details.	✓		✓

Figure 1: Foundation approval between 0+138 and 0+149

Figure 2: Foundation approval between 0+090 and 0+140

Figure 3: Foundation approval, different point of view

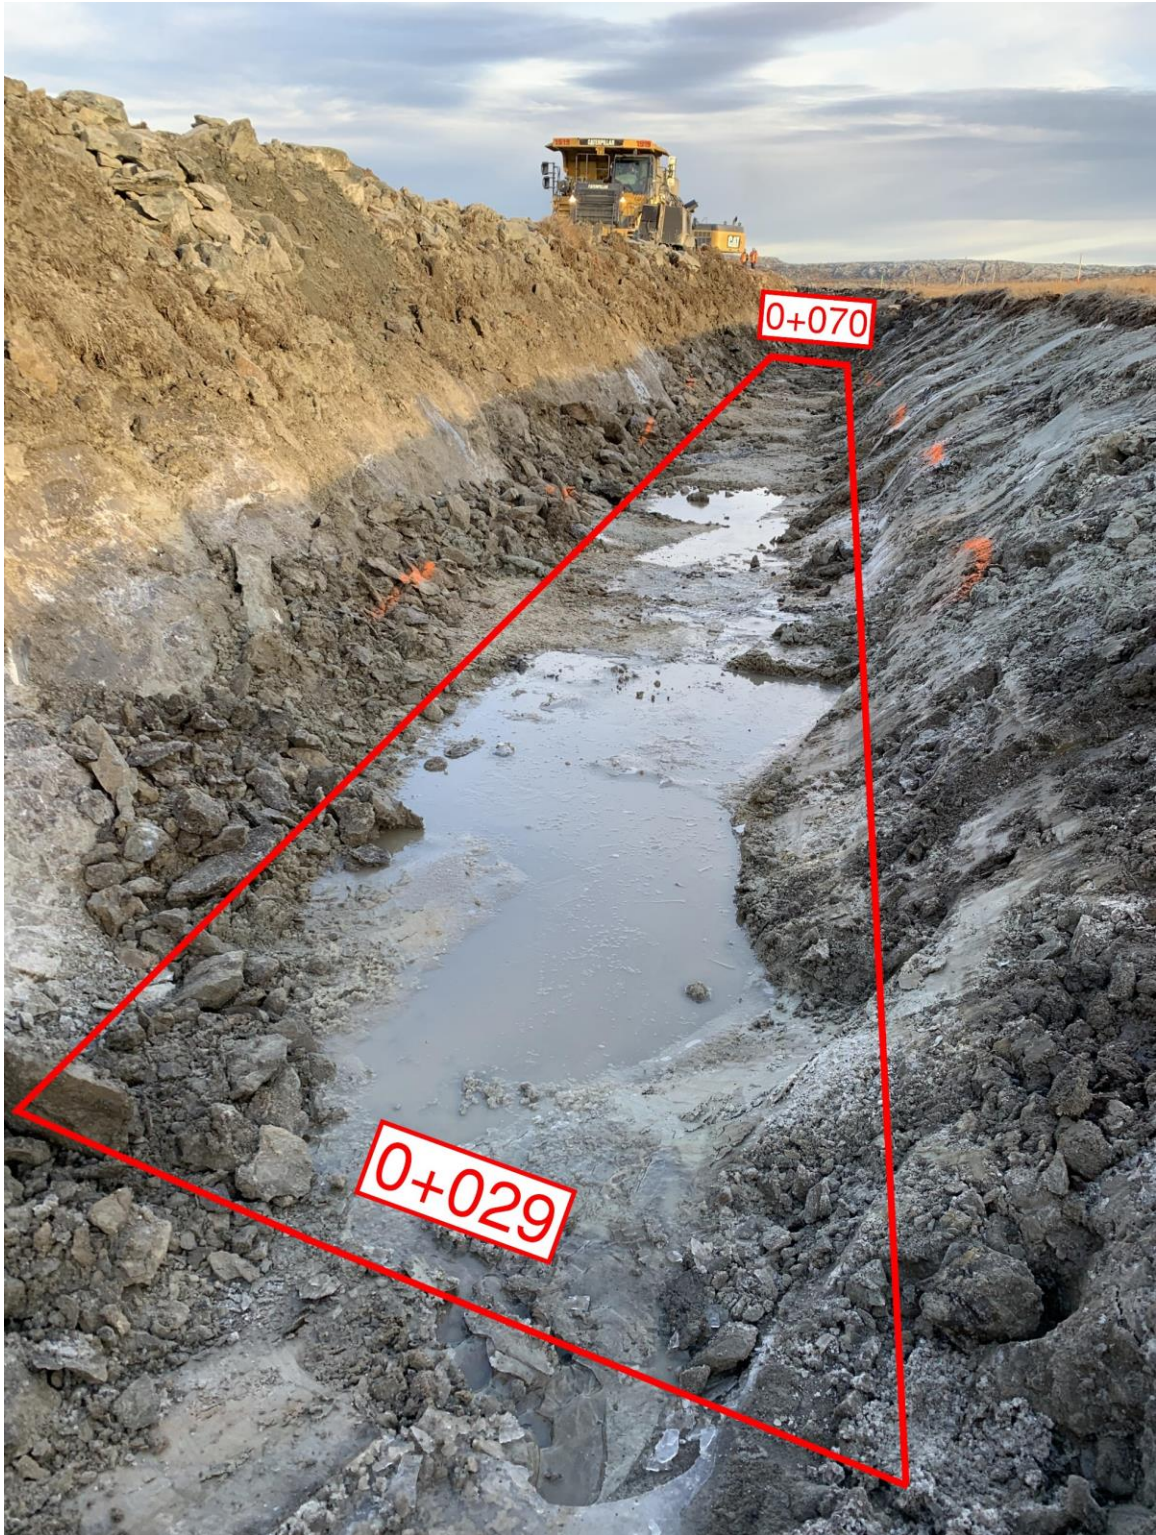
<u>APPROVED BY:</u>			
		QA AEM		QC AEM	
ITEM		Y	N	Y	N
2	The bottom of the excavation is composed of ice-rich till. The ice-rich till has been excavated to an average depth of 1.2m below the normal elevation of the bottom of the channel. The excavation could not have been done deeper due to safety reasons. The ice-rich material removed will be replaced by esker.	✓		✓

Figure 1: Ice removal approval between 0+029 and 0+070

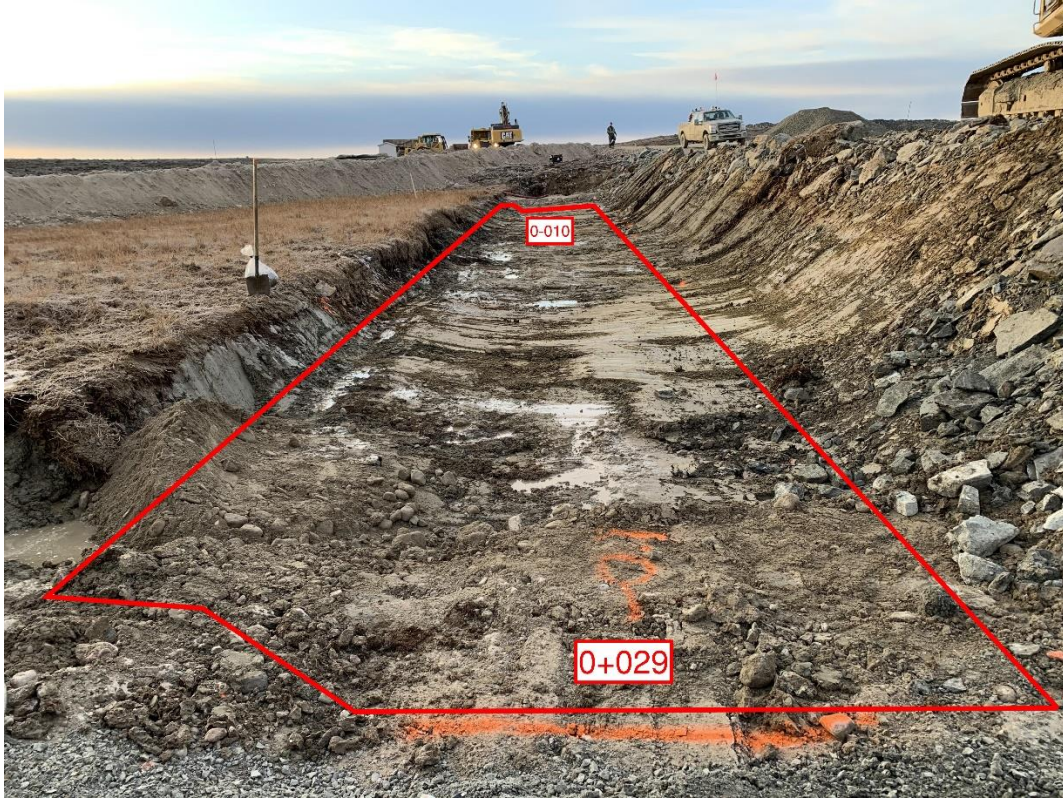
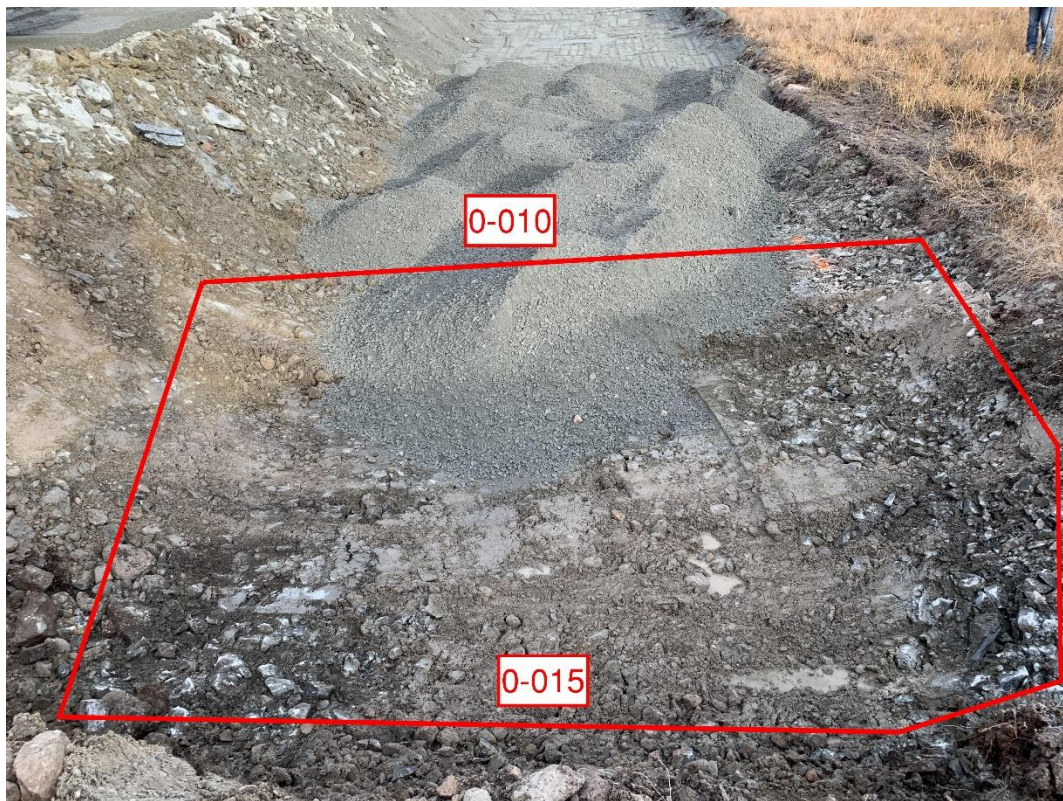
<u>APPROVED BY:</u>			
		QA AEM		QC AEM	
		Y	N	Y	N
ITEM					
2	Presence of water at the bottom of excavation. Fill placement from upstream to downstream to push the water out before placing the material. Remove and replace the fill by appropriate material when it becomes oversaturated with water/mud.	✓		✓

Figure 1: Foundation approval between 0-010 and 0+029

Figure 2: Approval between 0-015 and 0-010

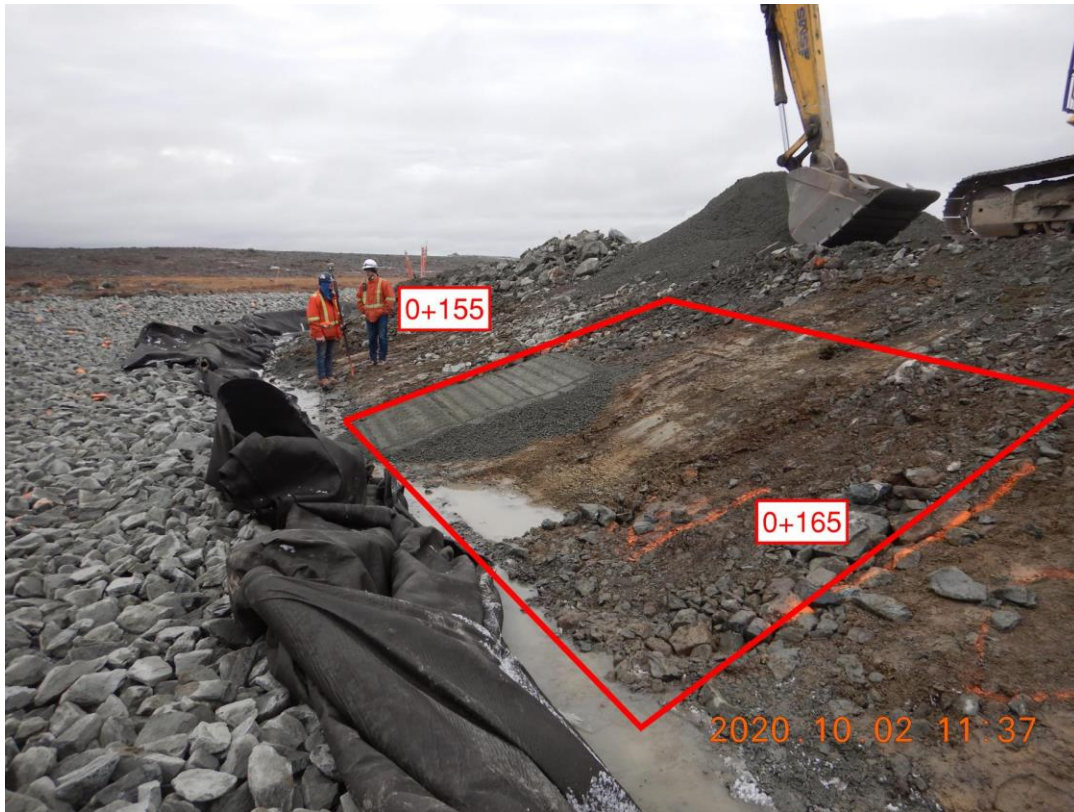
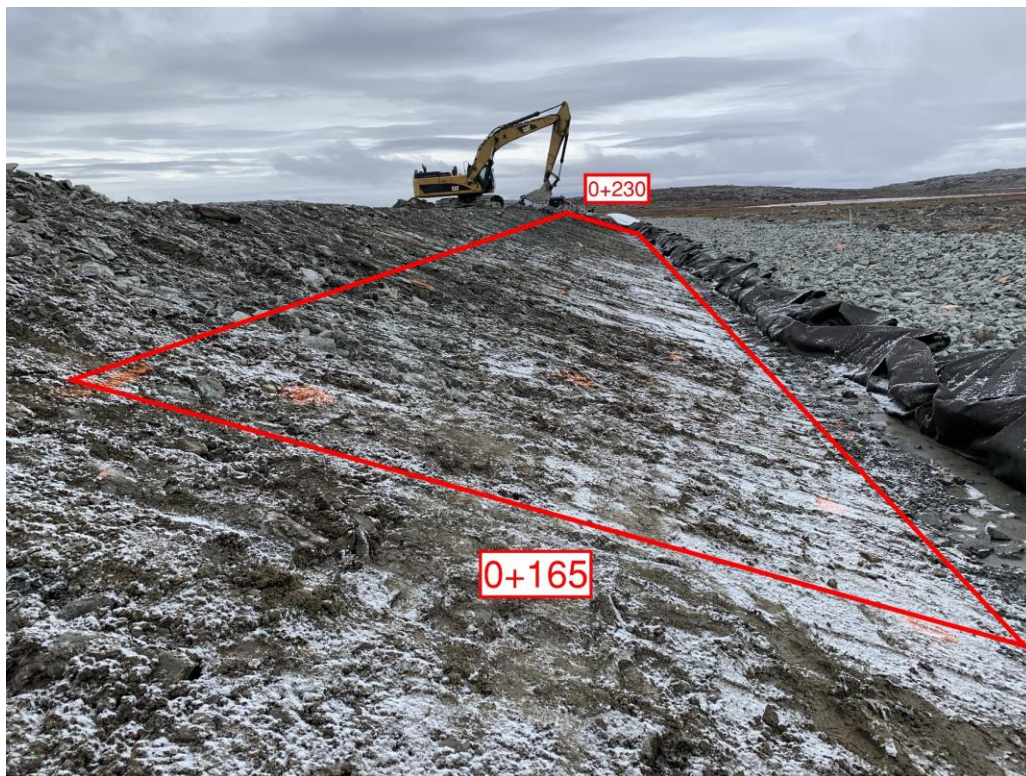
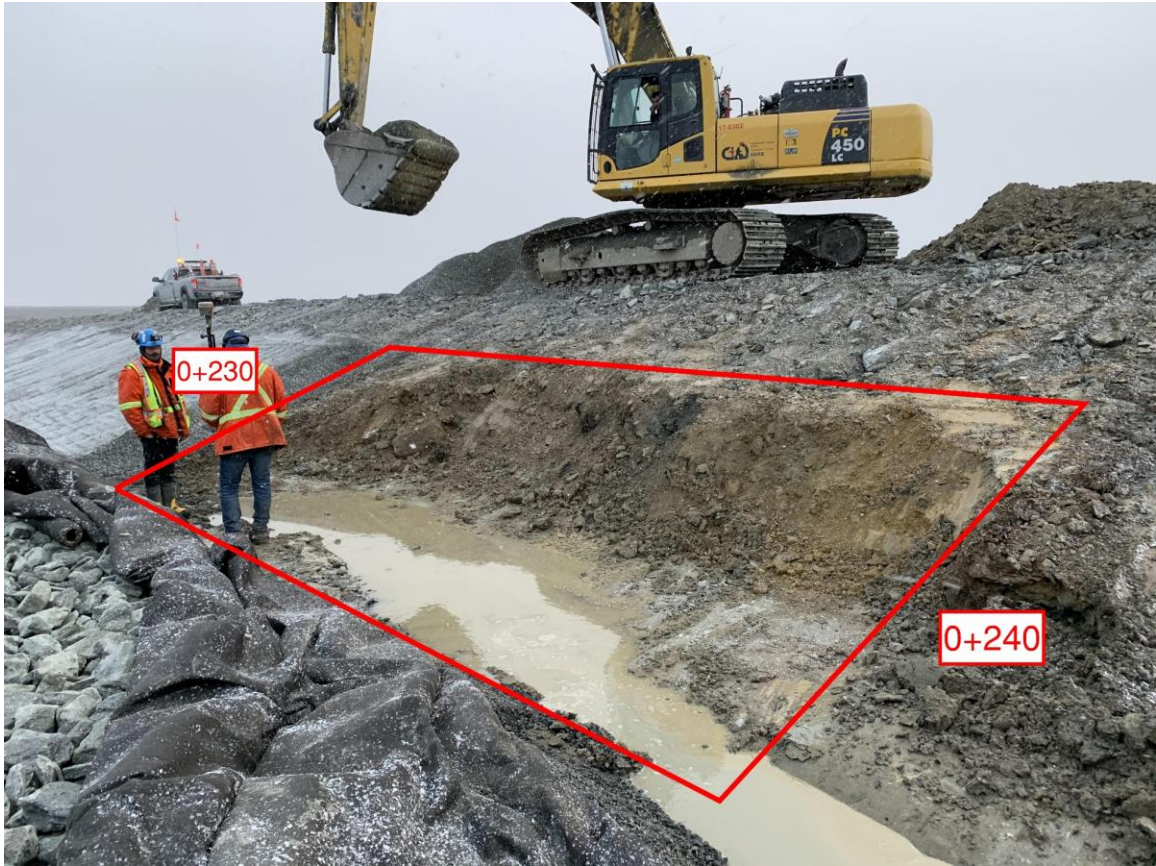
<u>APPROVED BY:</u>			
		QA AEM		QC AEM	
ITEM		Y	N	Y	N
2	Presence of water at the bottom of the slope. The remaining part of the slope is free from ice, snow and water.	✓		✓	
3	Slope is well cleaned, rocks over the top of the slope were removed by hand. Non-conforming material like organic material or soaked material has been excavated and replaced by well-compacted fine filter. The locations at which material was removed and replaced by fine filter are from 0+155 to 0+166, 0+195 to 0+205 and 0+230 to 0+240.	✓		✓

Figure 1: Approval between 0+155 and 0+165

Figure 2: Approval between 0+165 and 0+230

Figure 3: Approval between 0+230 and 0+240

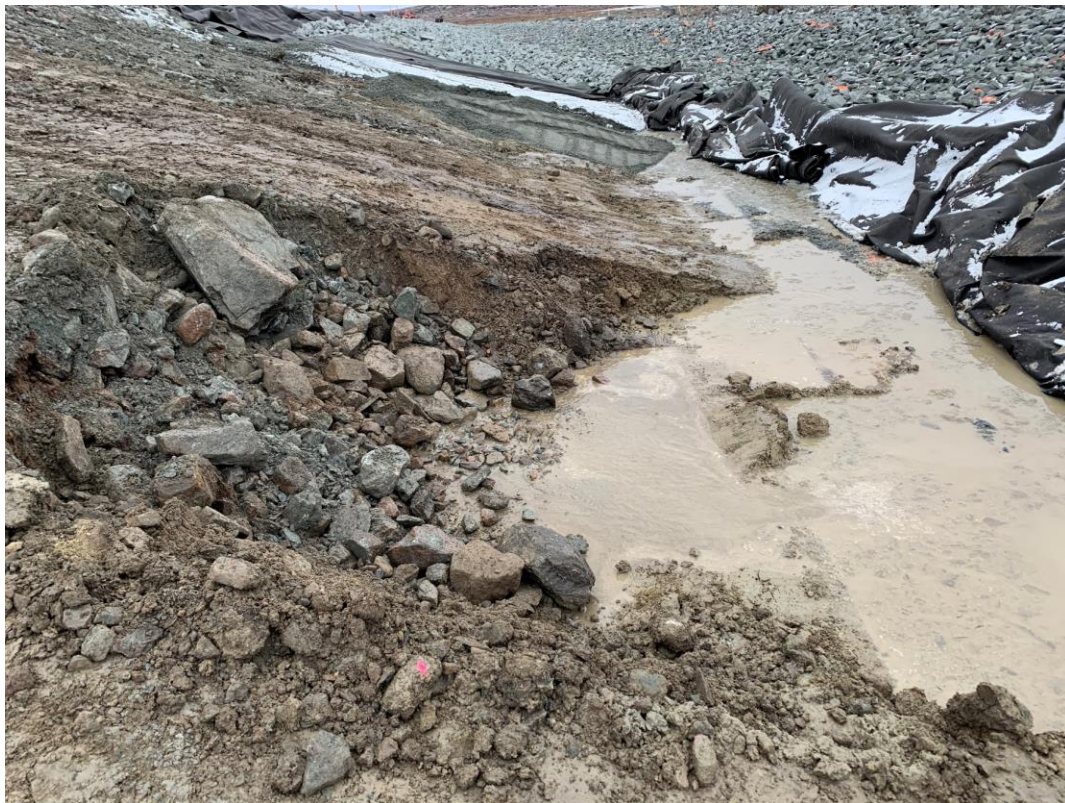
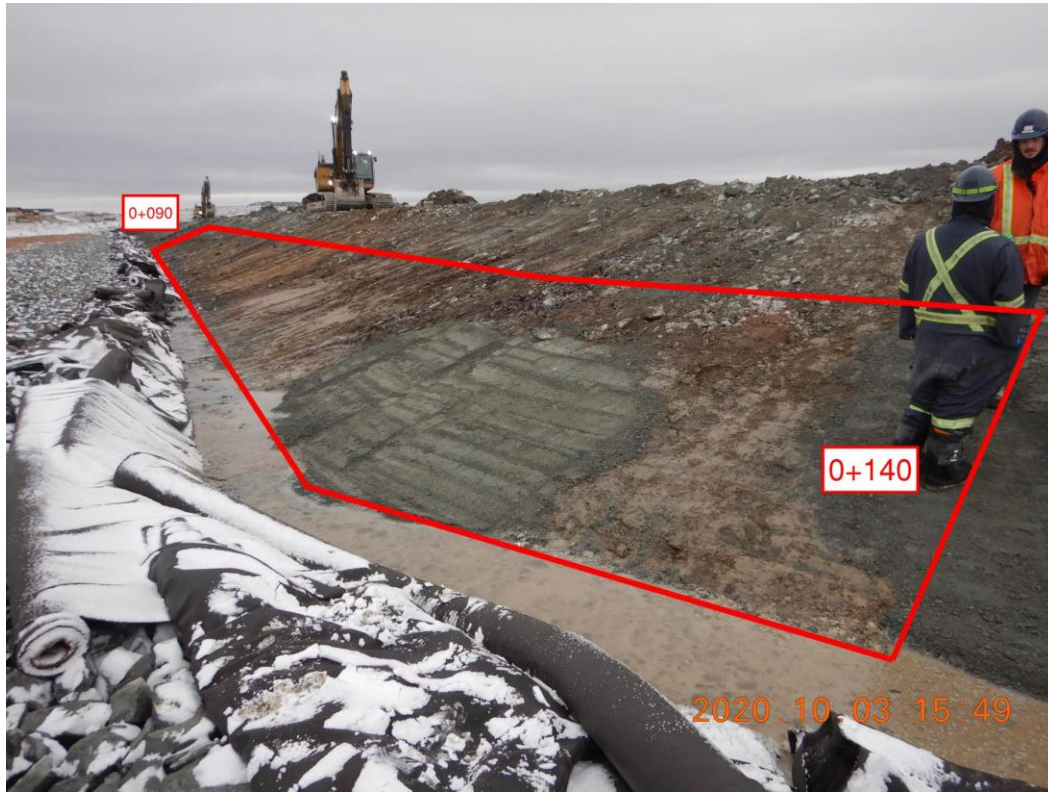
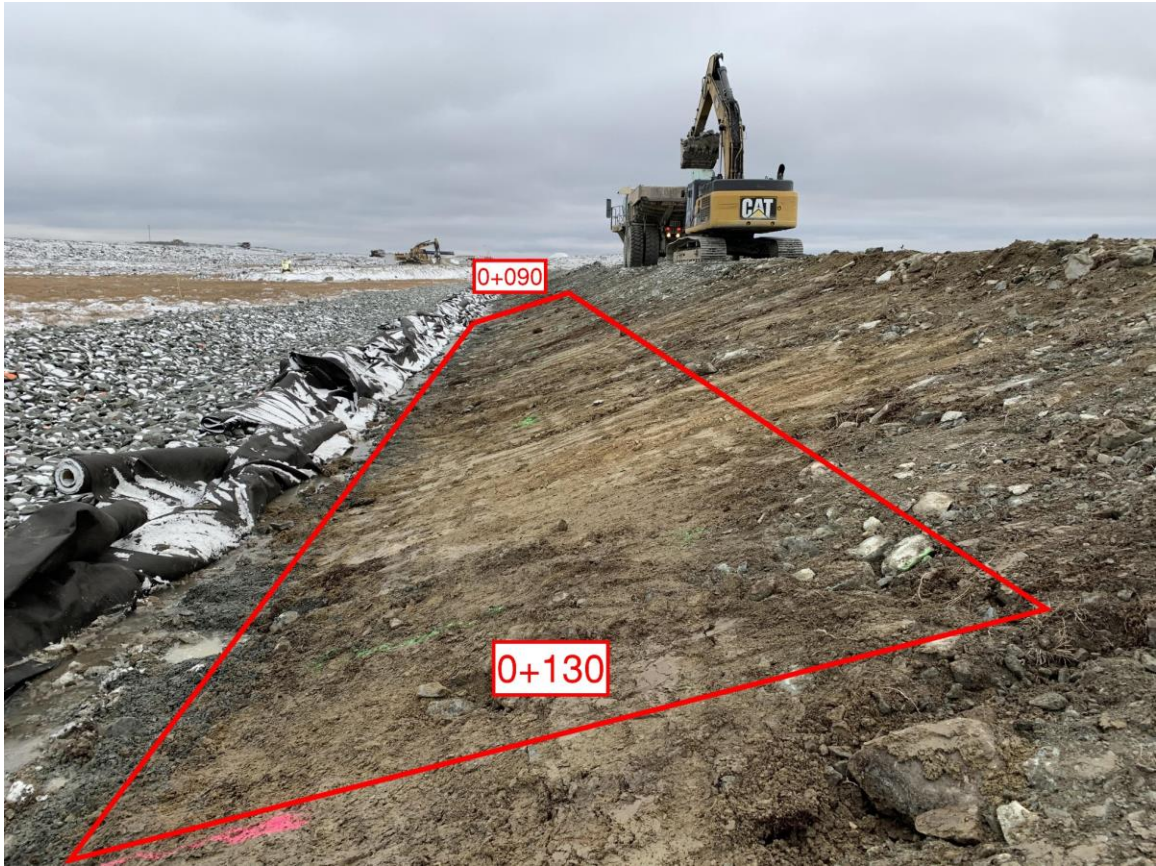
APPROVED BY:			
		QA AEM		QC AEM	
ITEM		Y	N	Y	N
2	Presence of water at the bottom of the slope. Water entry from under the road at 0+145. Material has been excavated and replaced by well compacted fined filter. Water was still coming out, but the flow was considerably reduced.	✓		✓	
3	Slope is well cleaned, rocks over the top of the slope were removed by hand. Nonconforming material like oversaturated mud and organic material was identified (Figure 1), removed (Figure 2) and replaced by well compacted fine filter (Figure 3). Material was removed and replaced by fine filter from 0+130 to 0+140 and from 0+145 to 0+150.	✓		✓

Figure 1: Approval between 0+140 and 0+155

Figure 2: Material excavated near 0+140

Figure 4: Approval between 0+090 and 0+140

Figure 5: Alternate view of approval between 0+090 and 0+130

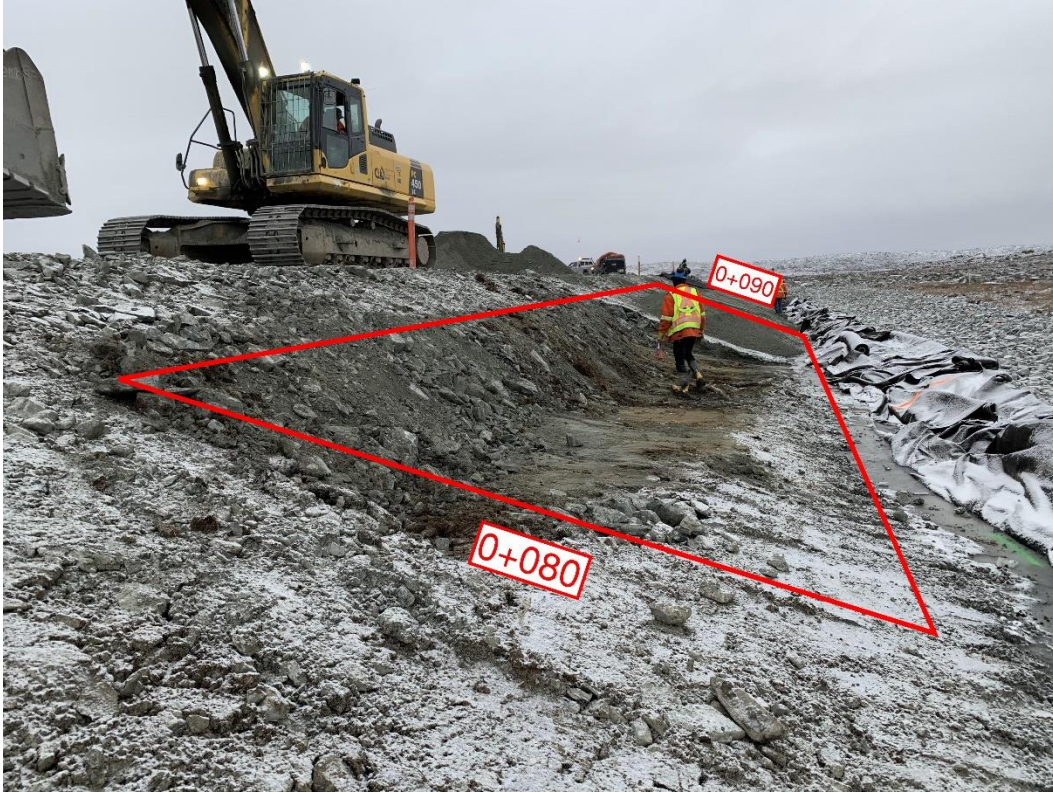
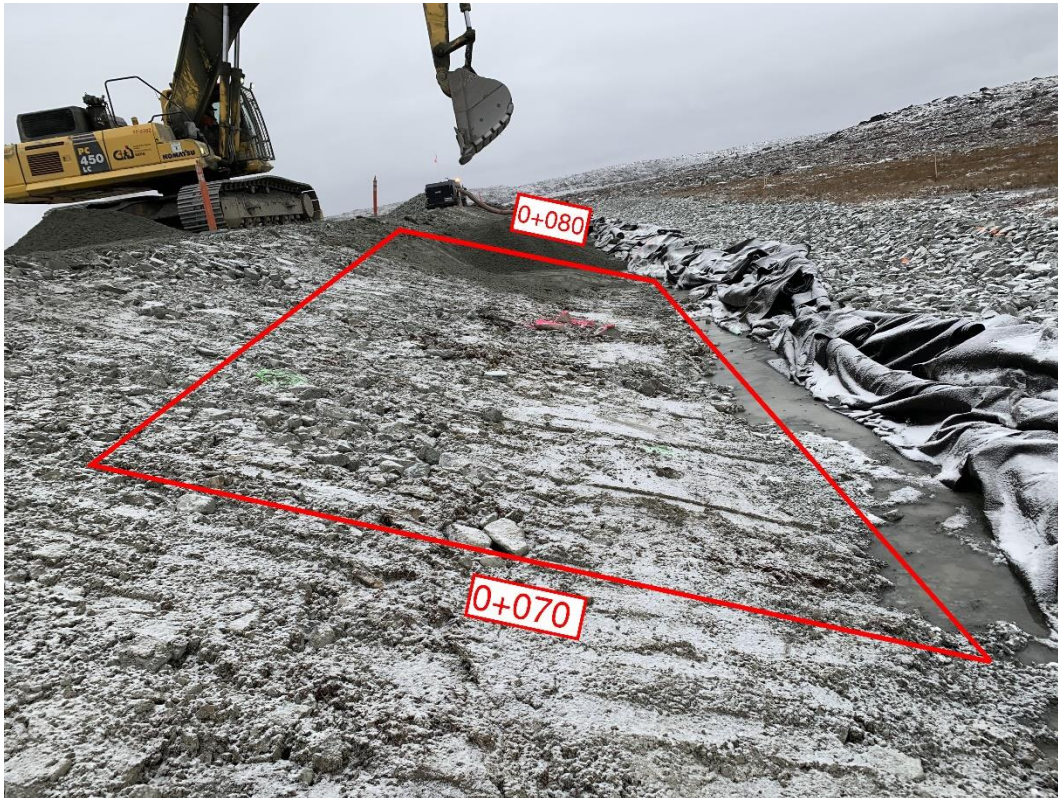
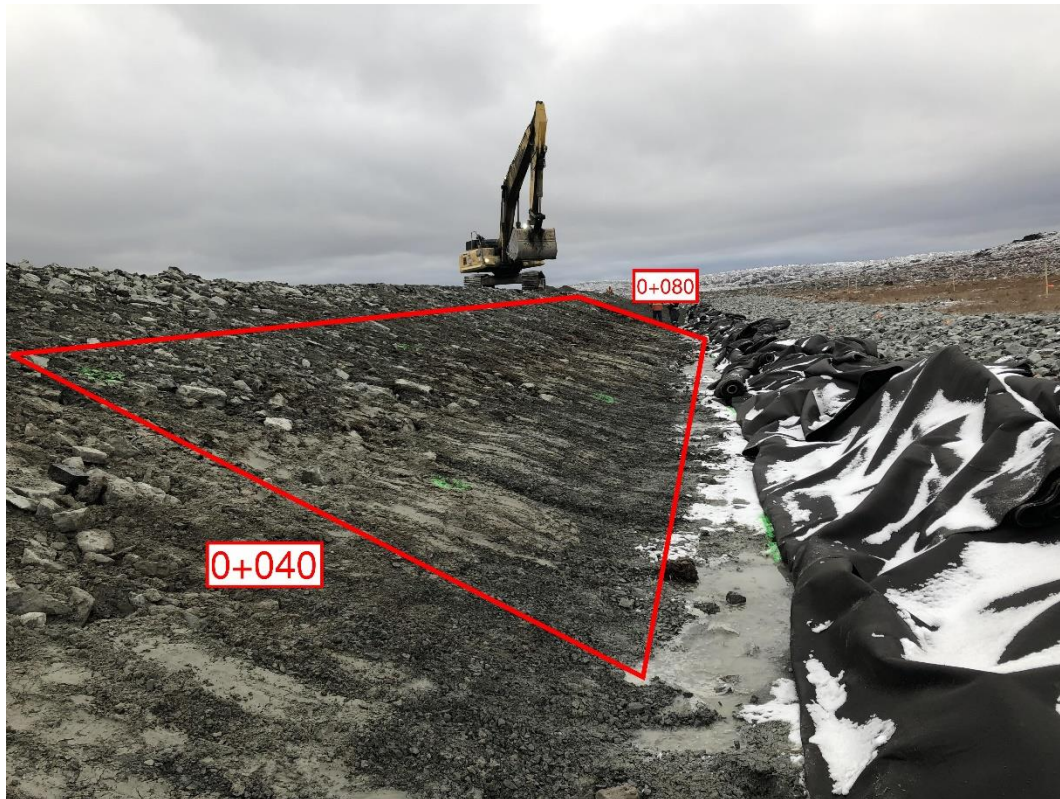
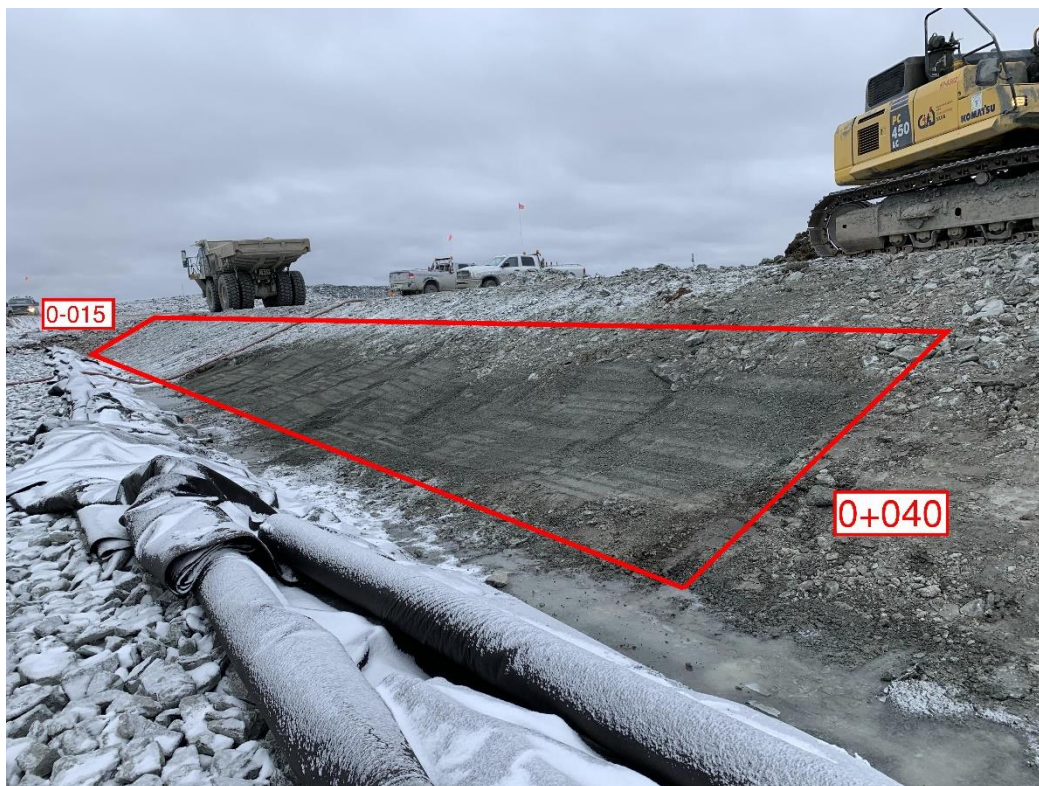
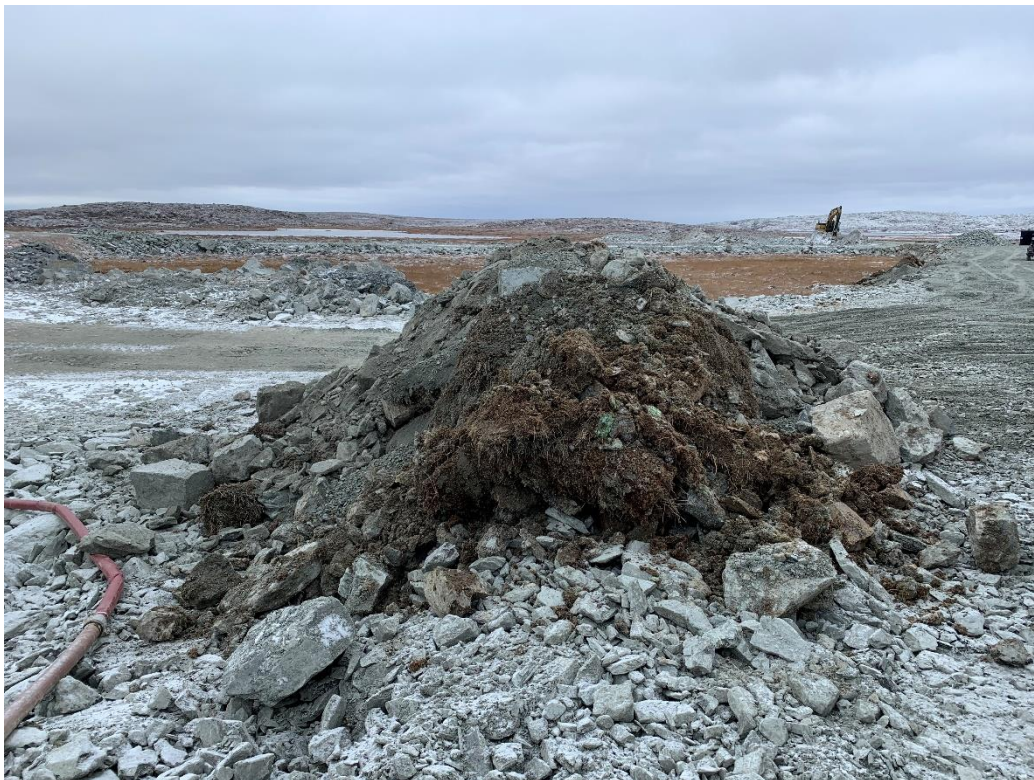
<u>APPROVED BY:</u>			
		QA AEM		QC AEM	
ITEM		Y	N	Y	N
2	Presence of water at the bottom of the slope. A pump was placed near 0+010 to remove excess water before fine filter placement. (Figure 5)	✓		✓	
3	Slope is well cleaned, rocks over the top of the slope were removed by hand. Nonconforming material like oversaturated mud and organic material was identified, removed and replaced by well compacted fine filter from 0+010 to 0+040 and from 0+080 to 0+090.	✓		✓

Figure 1: Approval between 0+080 and 0+090

Figure 2: Approval between 0+070 and 0+080

Figure 3: Approval between 0+040 and 0+080

Figure 4: Approval between 0-015 and 0+040

Figure 5: Approval between 0-015 and 0+010

Figure 6: Material removed between 0+010 and 0+030
