Construction Summary Report IVR Diversion Channel

Agnico Eagle Mines Ltd

6127-695-132-REP-012_R2

February 16, 2021

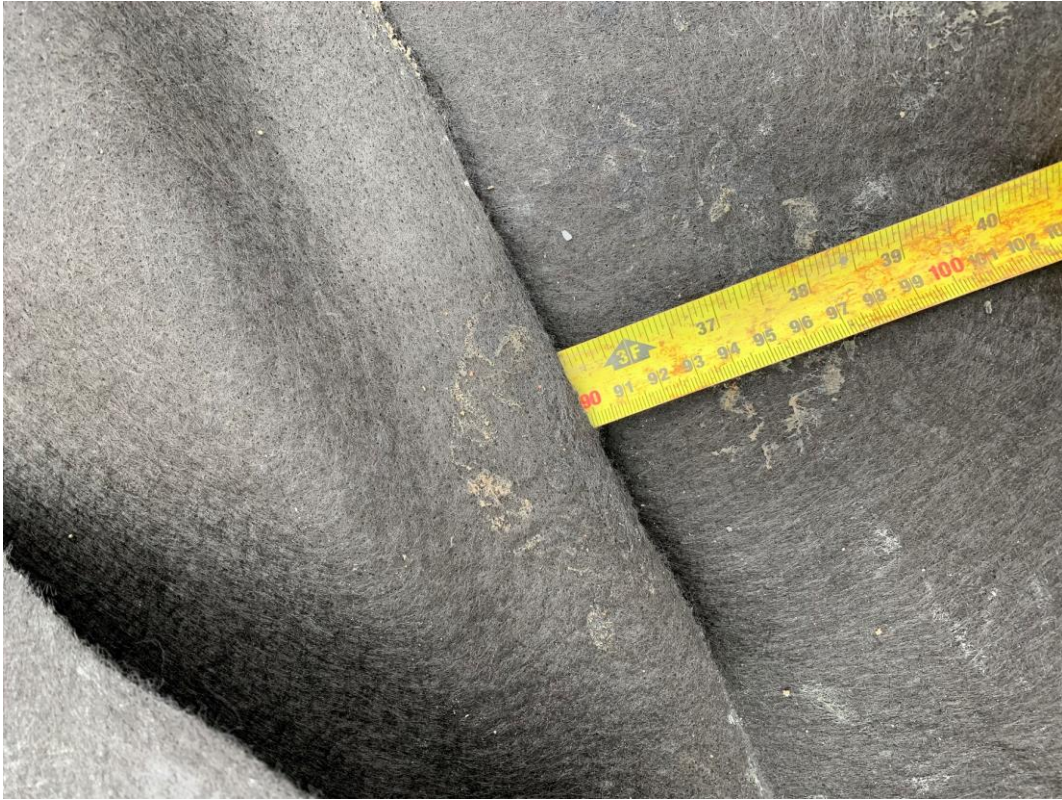
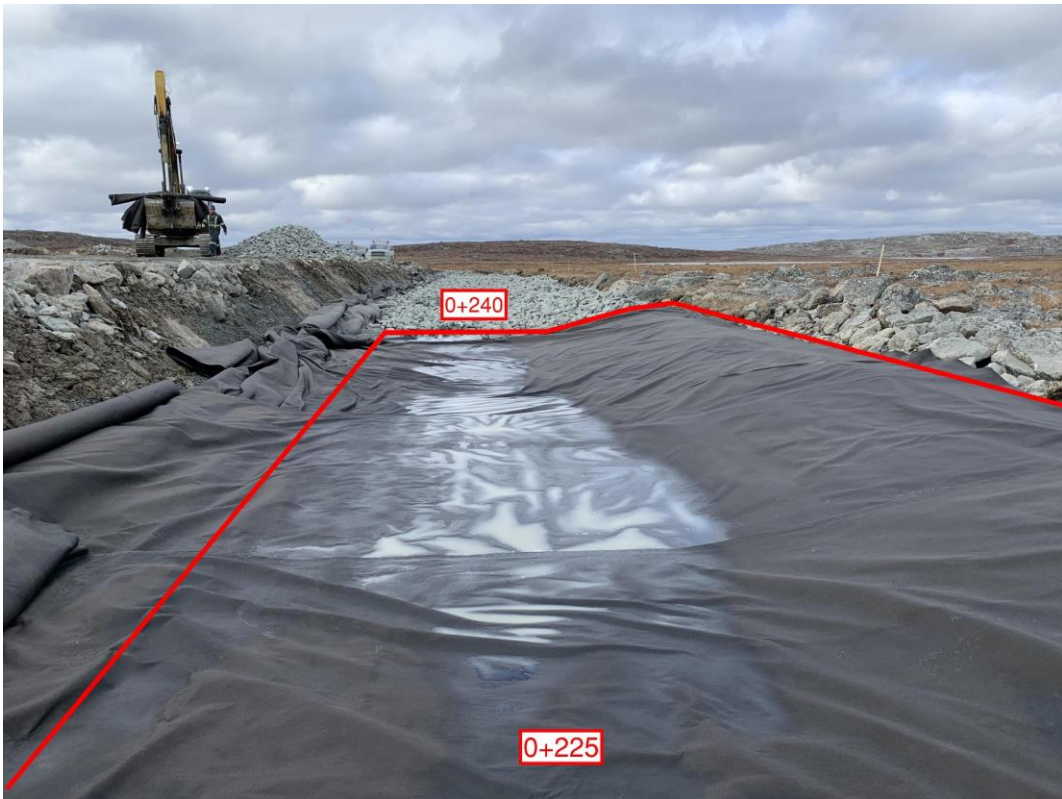
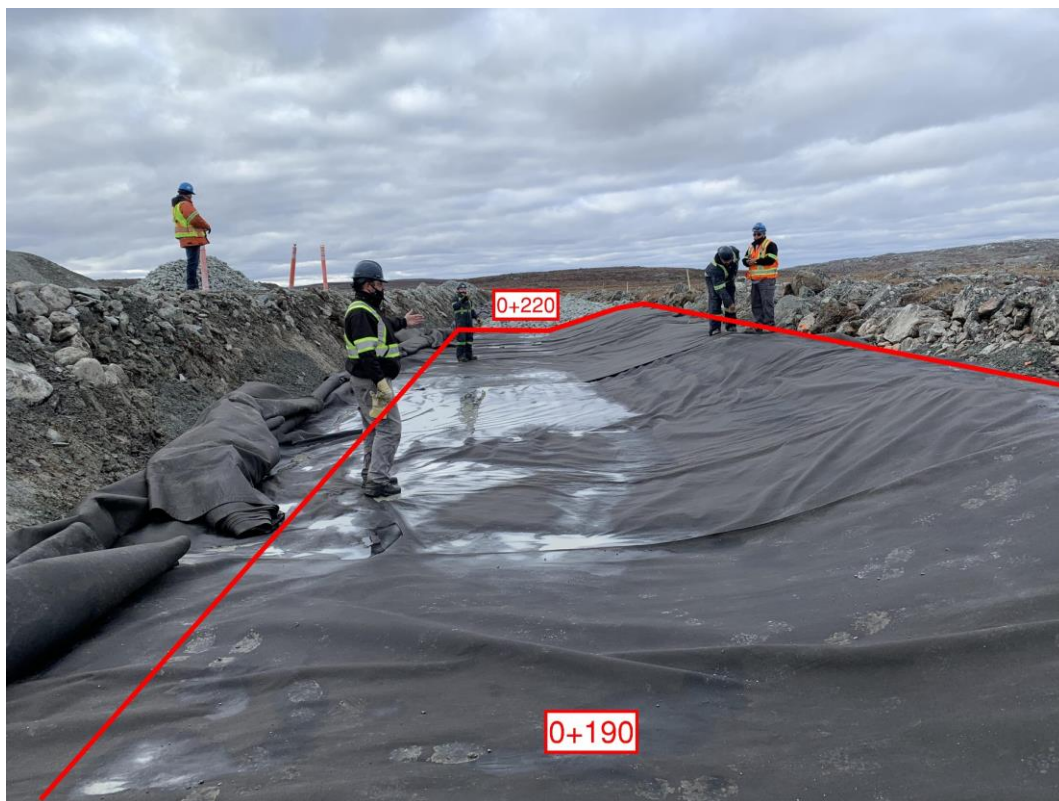
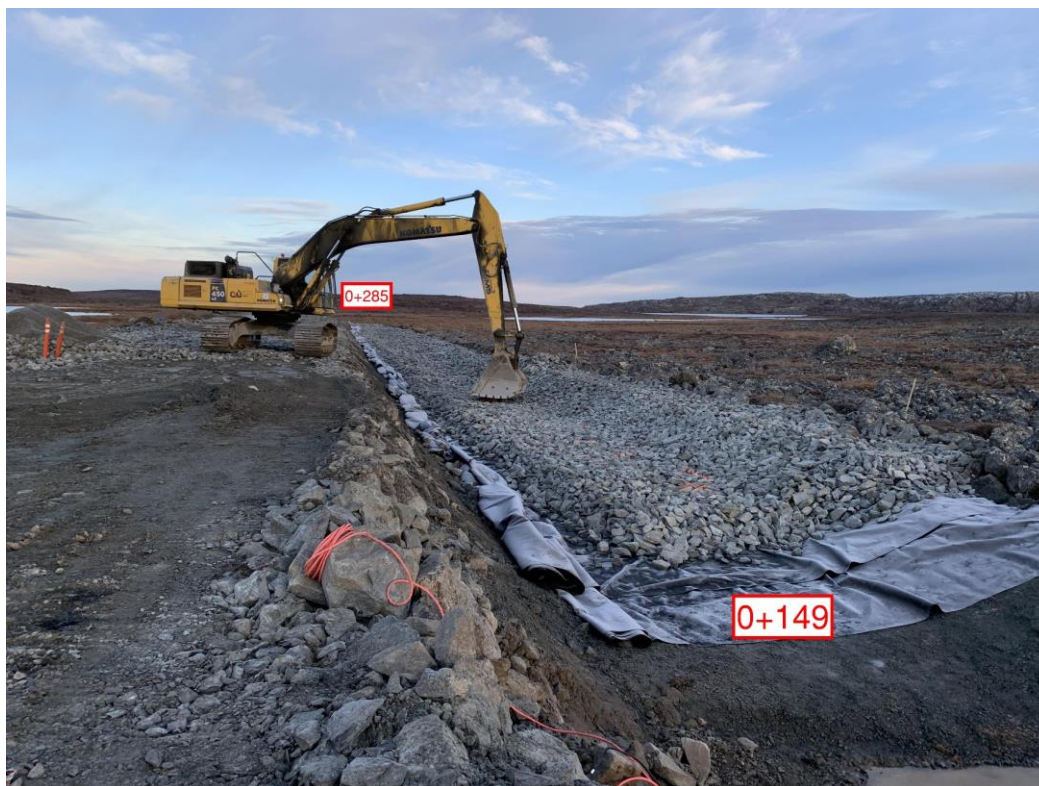
Figure 1: Overlaps are conforming to technical requirements

Figure 2: Geotextile between 0+225 and 0+240

Figure 3: Geotextile between 0+190 and 0+220

Figure 4: Global view of the geotextile between 0+149 and 0+285

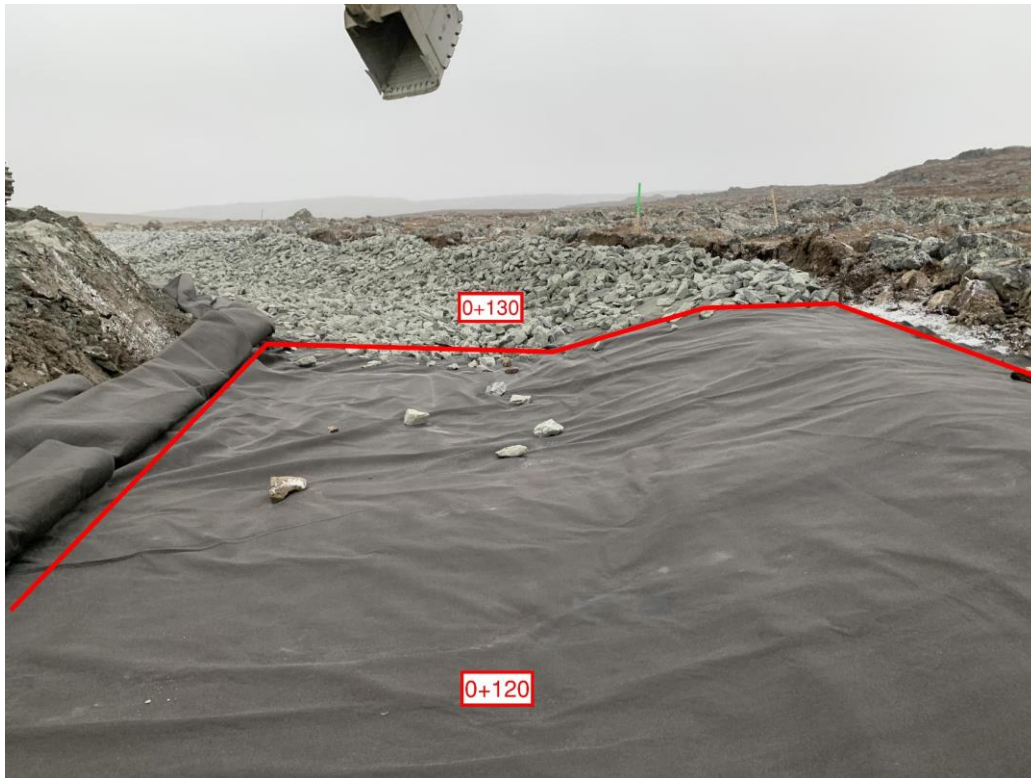
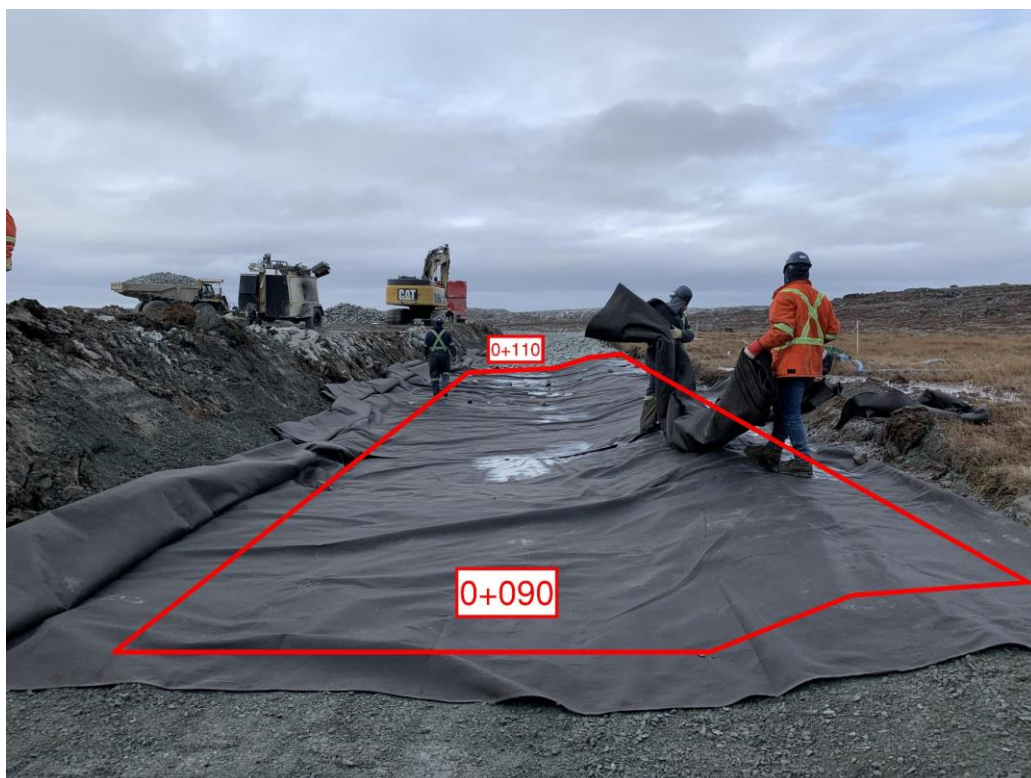
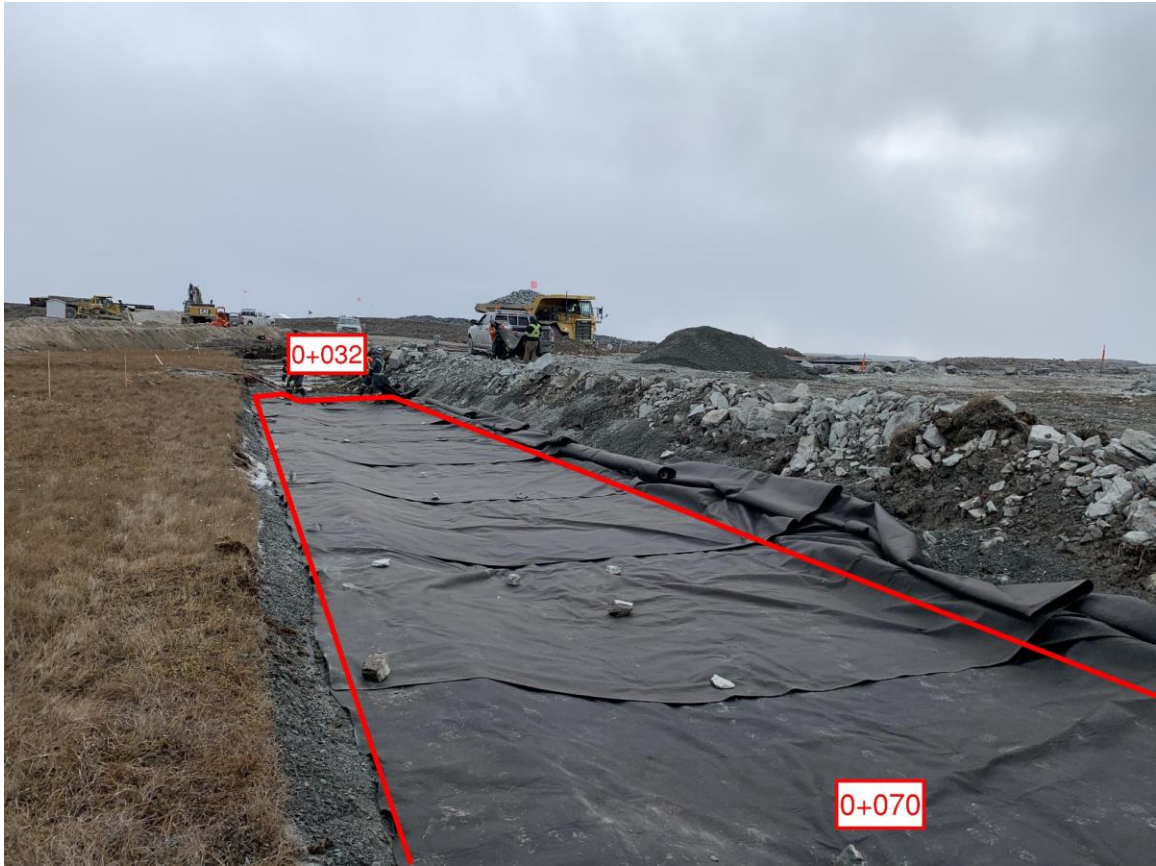
Figure 1: Geotextile between 0+120 and 0+130

Figure 2: Geotextile between 0+090 and 0+110

Figure 3: Geotextile between 0+032 and 0+070

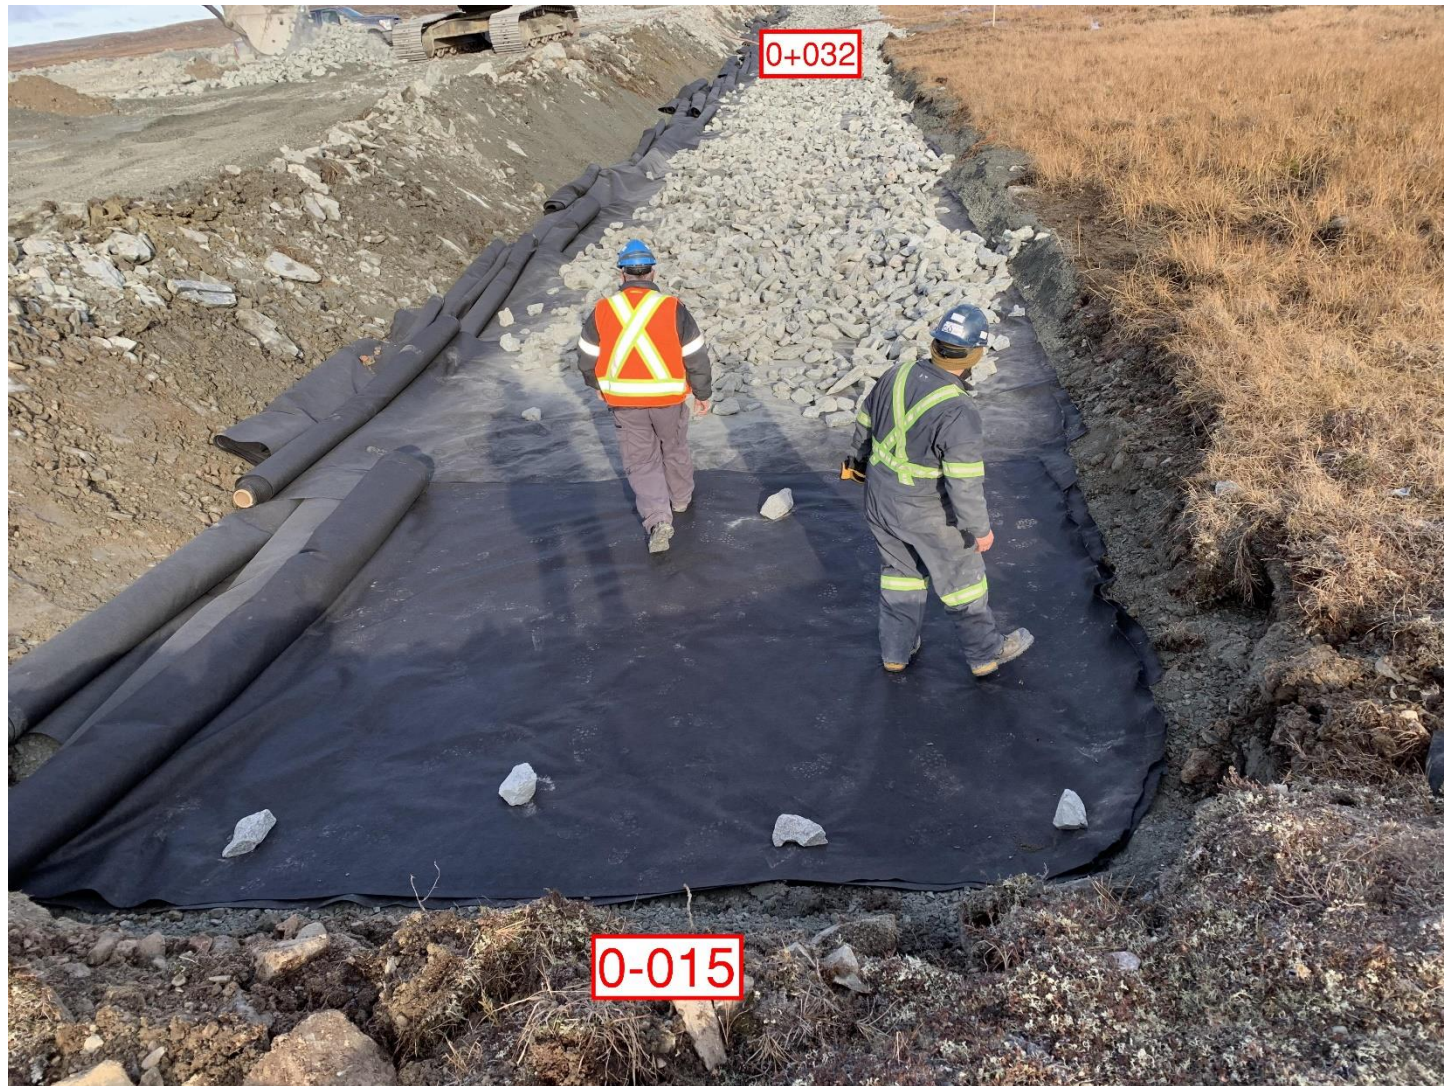
Figure 1: Final geotextile between 0-015 and 0+032

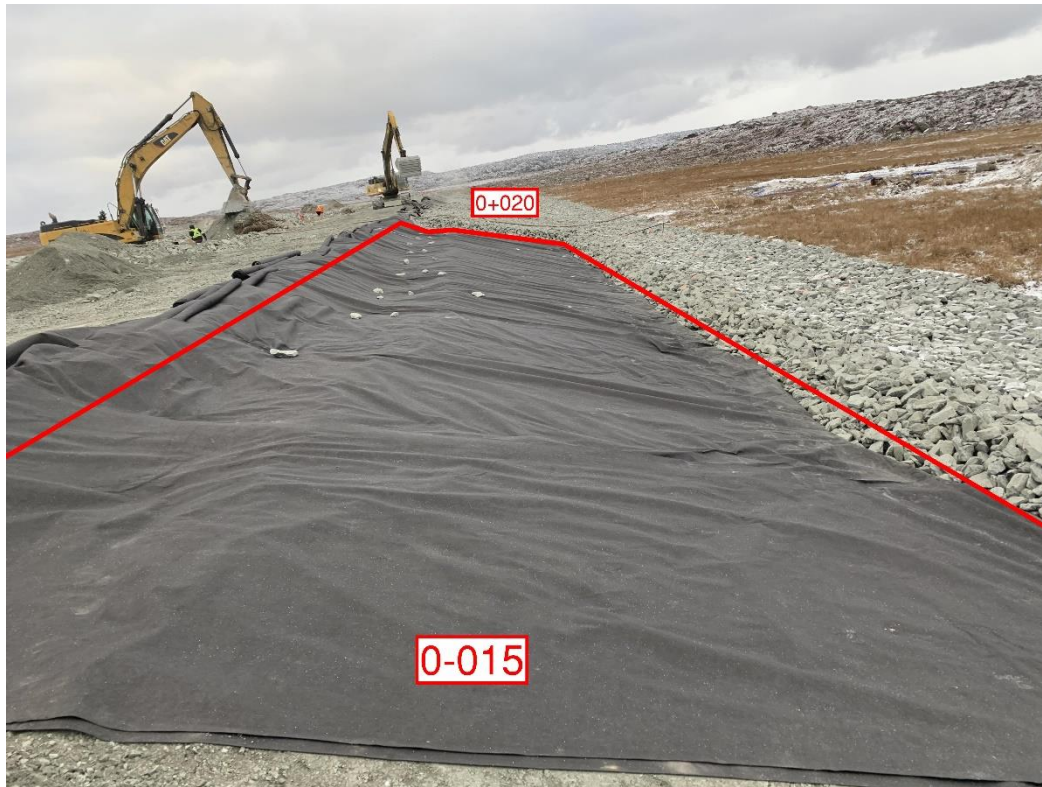
<u>APPROVED BY:</u>			
		QA AEM		QC AEM	
ITEM		Y	N	Y	N
2	Presence of water at the bottom. Some geotextile rolls were frozen and needed to be thawed before unrolling.	✓		✓	
9	Holes observed at some locations. All the holes identified are appropriately patched.	✓		✓	
N/A	2 layers of novatex V for most of the section between 0+032 and 0+140. 2 layers of Mirafi 1100N from 0-015 to 0+032 and 3-4 pieces used near 0+060.	✓		✓

Figure 1: Geotextile between 0-015 and 0+020

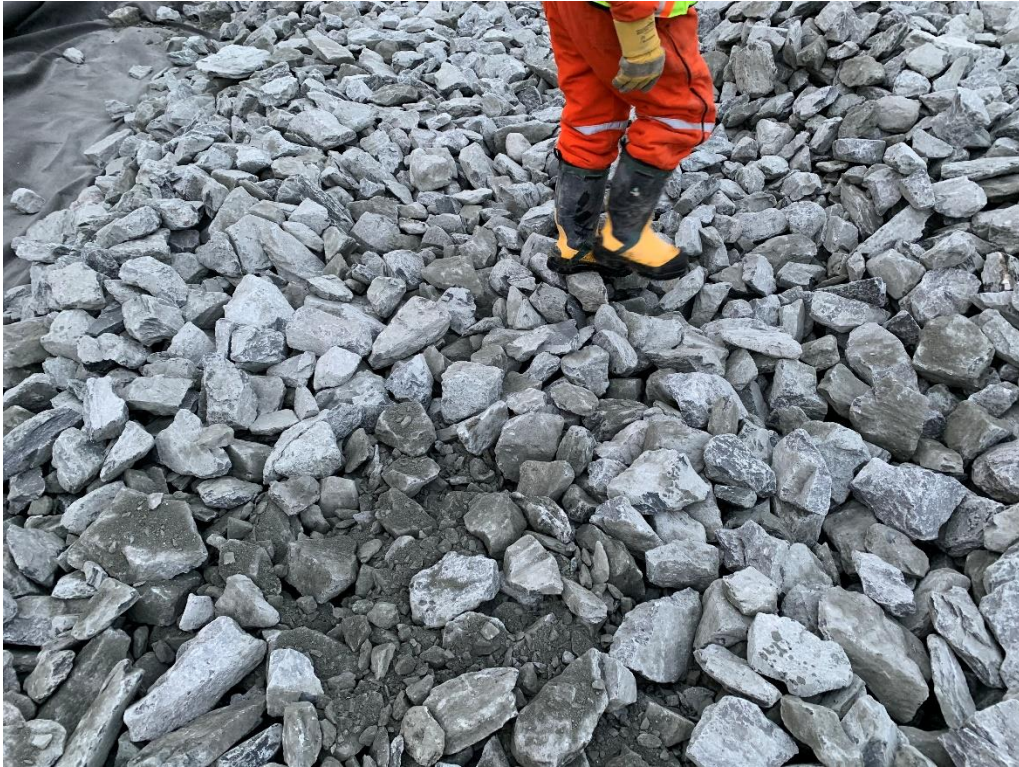
Figure 1: Nonconforming material to be removed before final approval

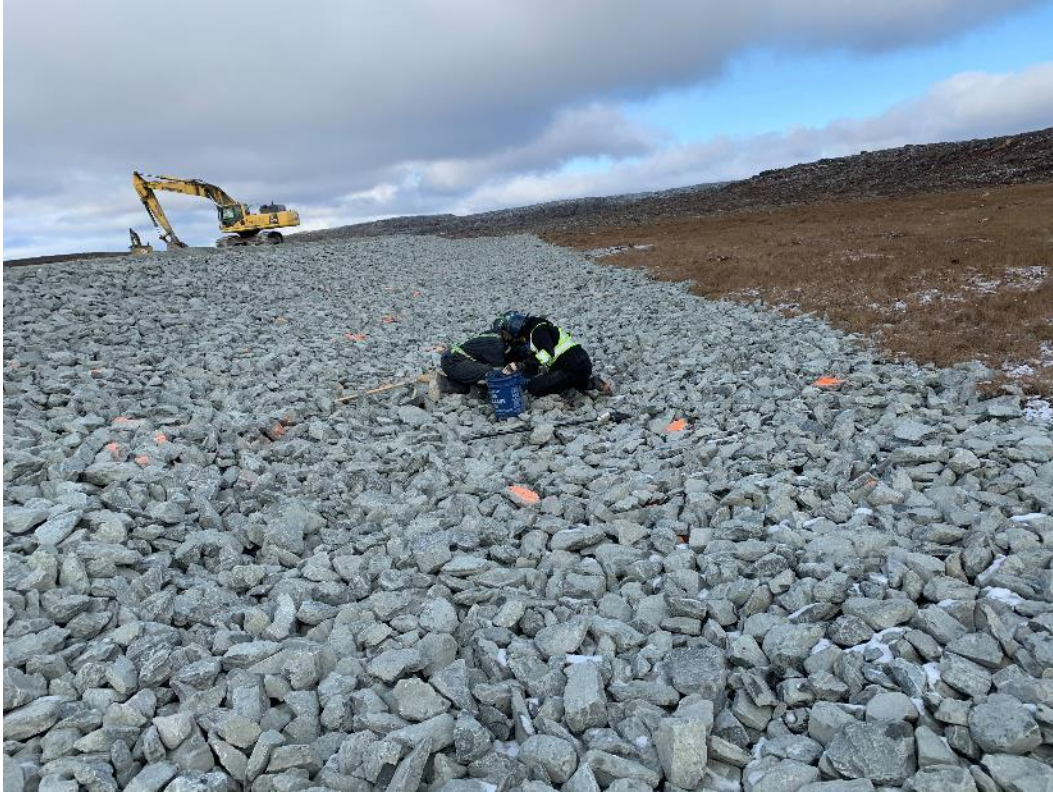
Figure 1: Fine material removal by hand

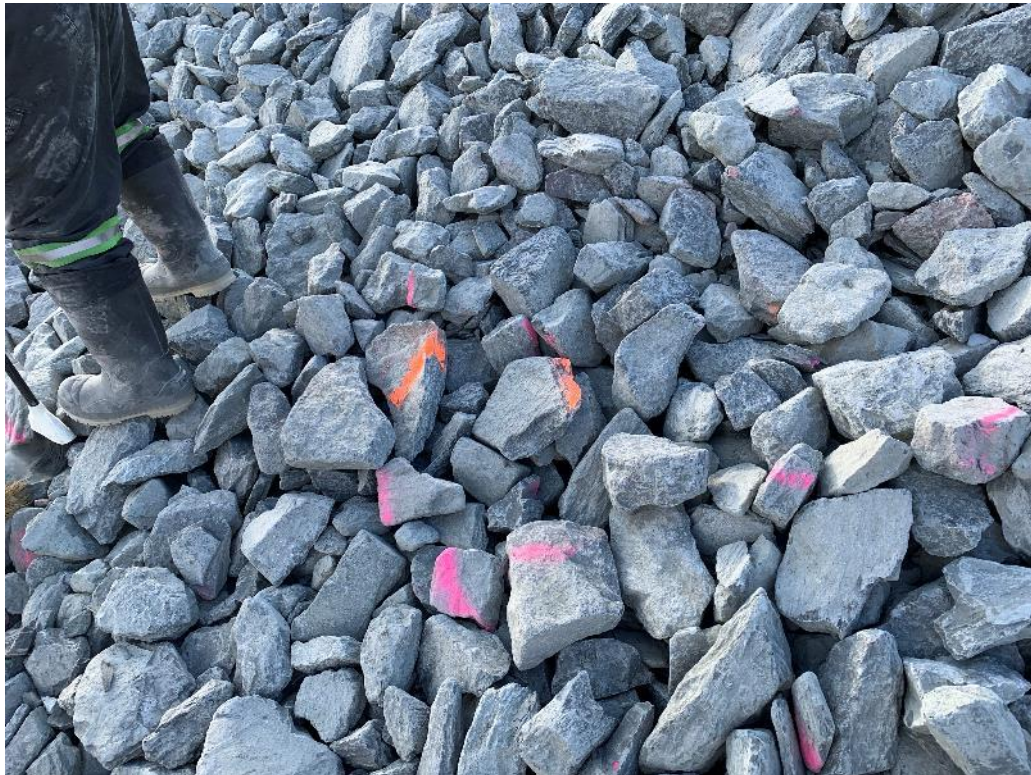
Figure 2: Riprap after fine material removal

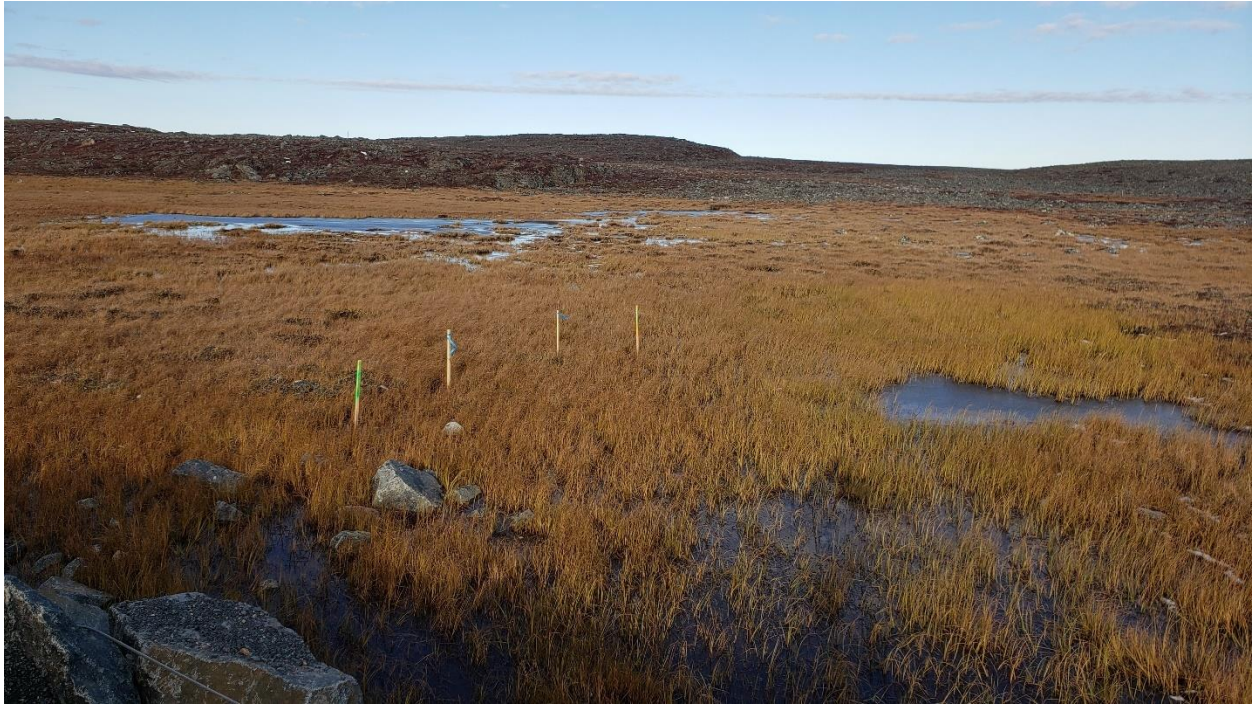
Photo 1: channel site before construction, St.0+000 looking North.

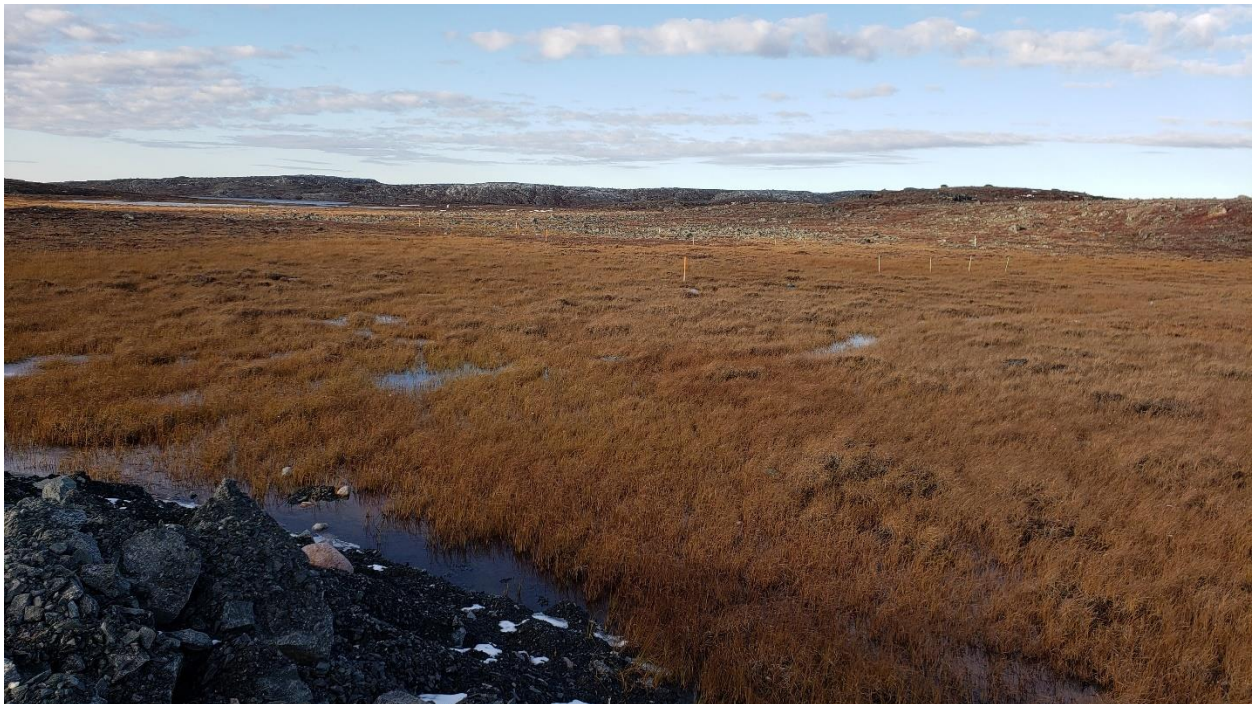
Photo 2: channel site before construction, St.0+025 looking North-West.

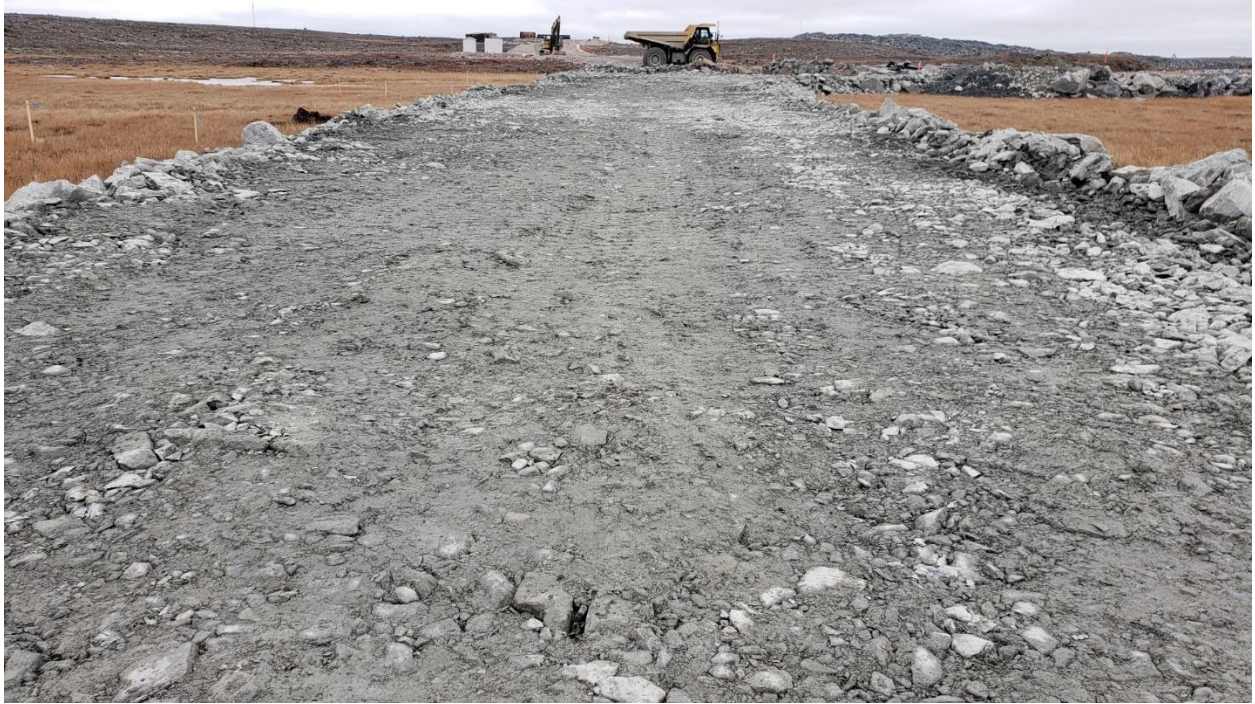
Photo 3: first lift of the downstream berm construction with ultramafic rockfill, St. 0+140 looking South.

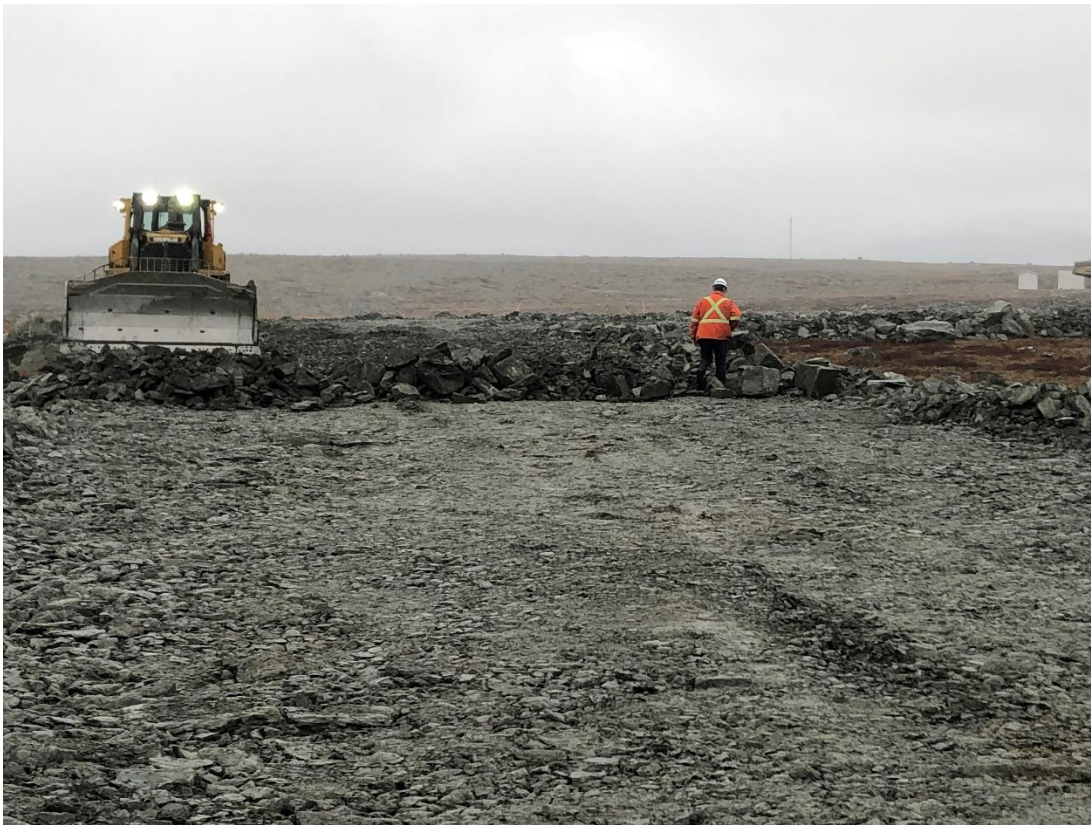
Photo 4: construction of the second lift of the downstream berm construction with ultramafic rockfill, St. 0+180 looking South.

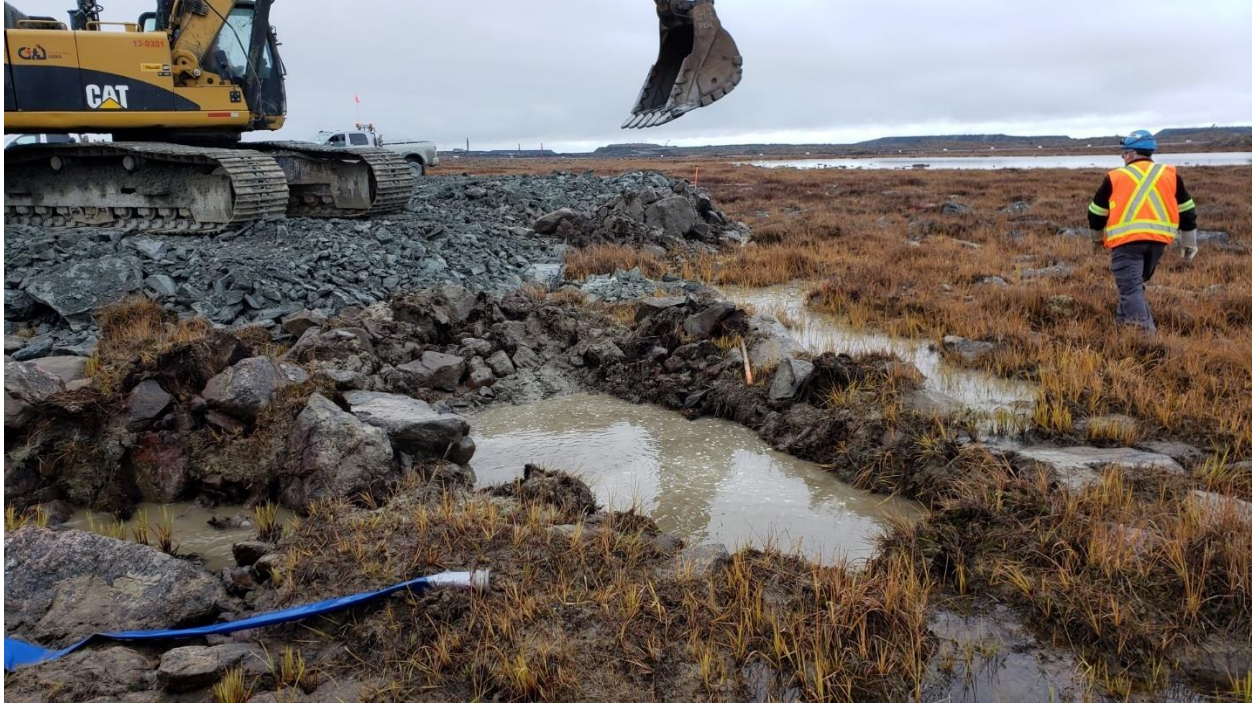
Photo 5: excavation of the temporary sump to manage water 5m North of the outlet, St.0+285 looking South.

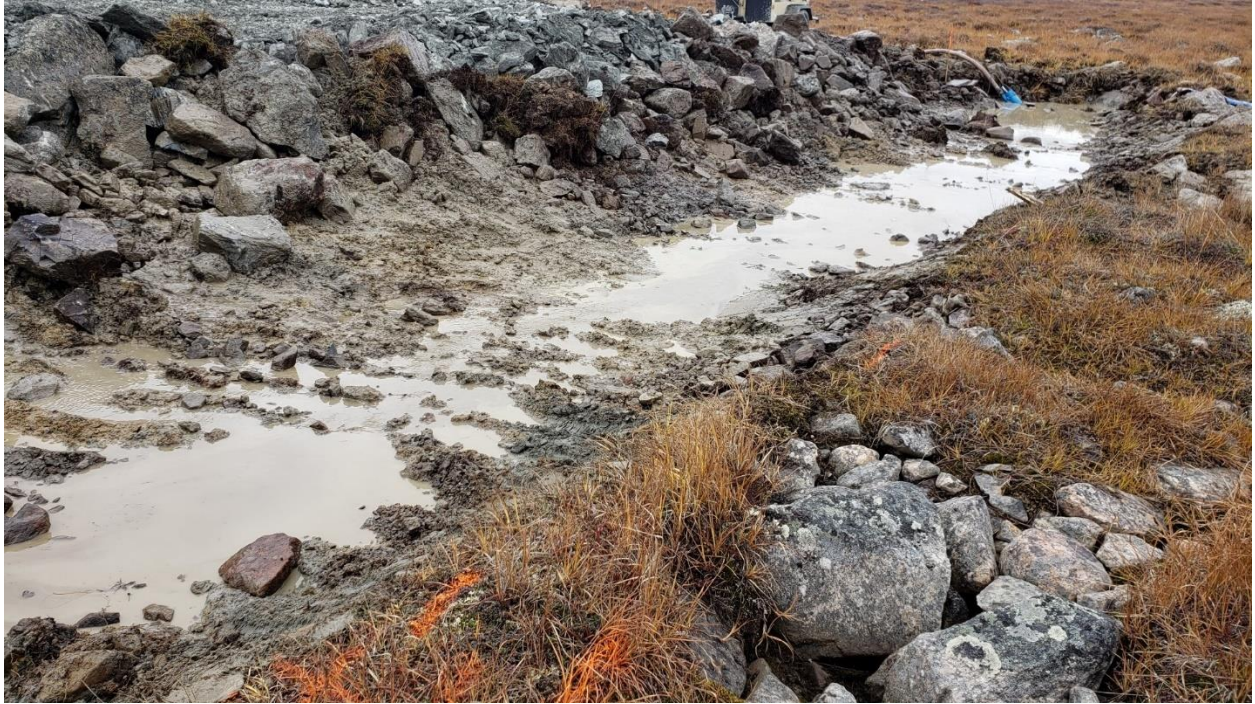
Photo 6: First step of the excavation where 500mm of material is dug to promote drainage of the overburden, St.0+270 looking North-east.

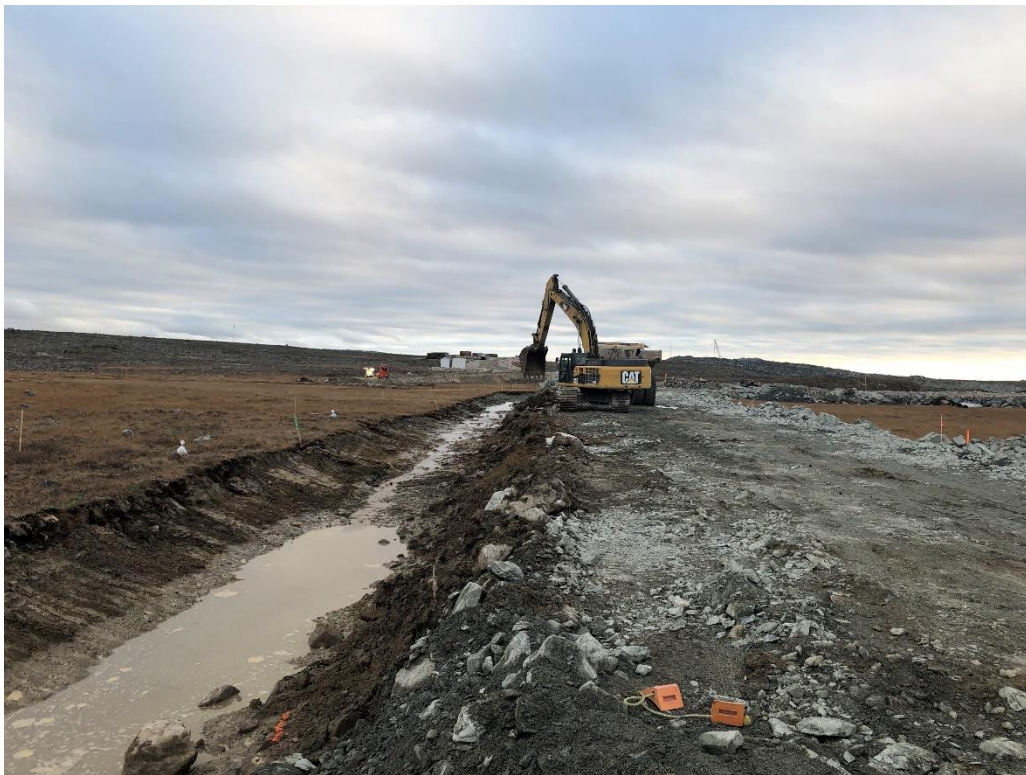
Photo 7: excavation St.0+150 looking South. First step of preliminary excavation near the shovel and final depth reached at bottom left, St.0+150 looking South-East.

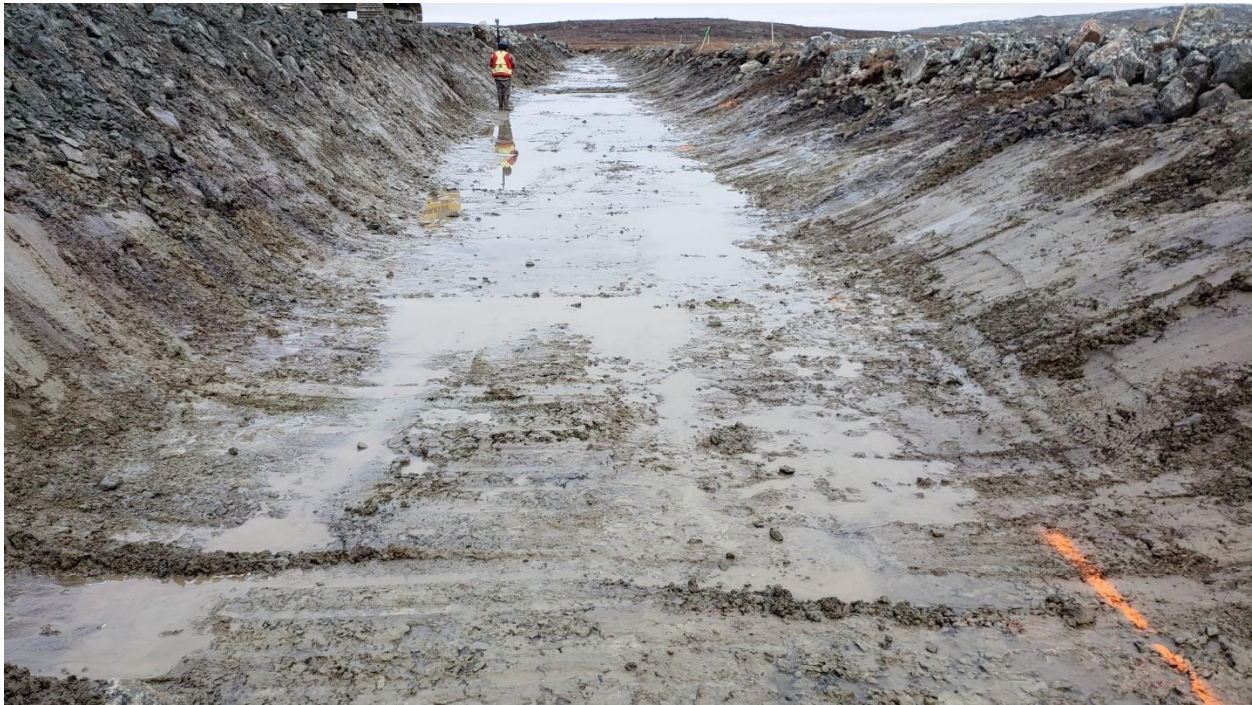
Photo 8: Final excavation at bottom of channel before the upstream tablet was completed, St.0+140 looking North-West.

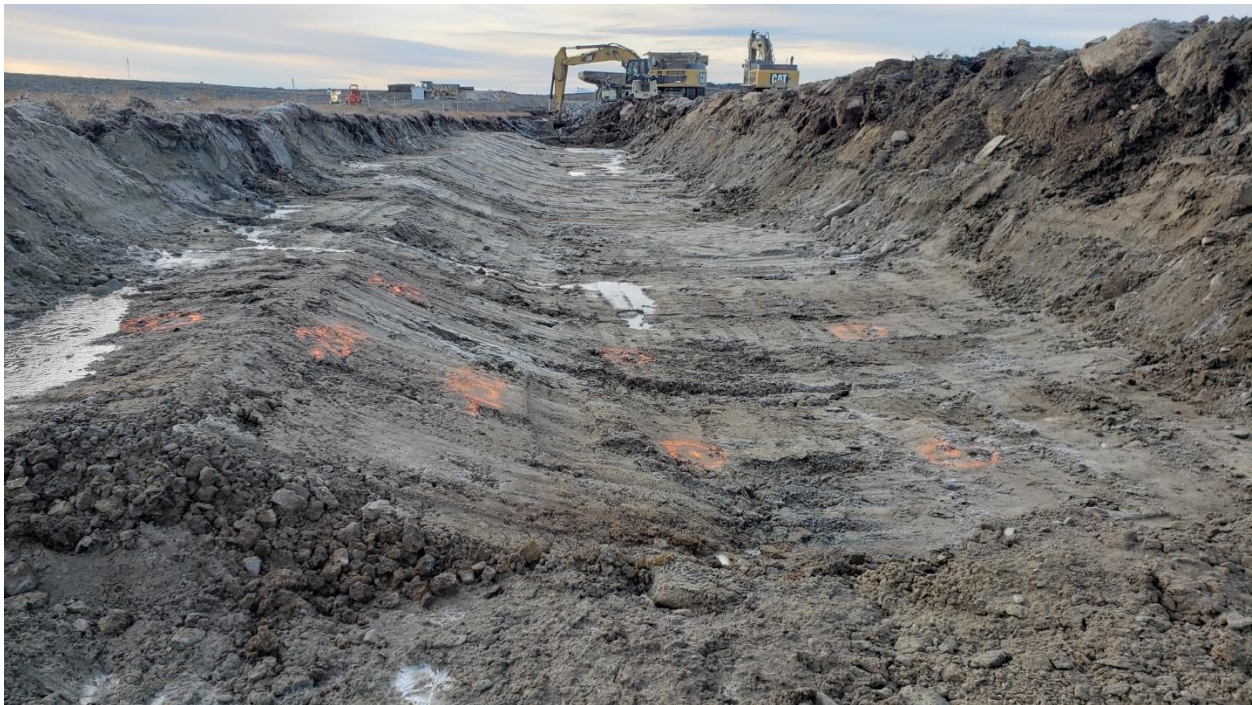
Photo 9: final excavation reached at bottom of the channel with tablet completed on the upstream slope. The downstream slope was not built to preserve excavator reach to place aggregates.

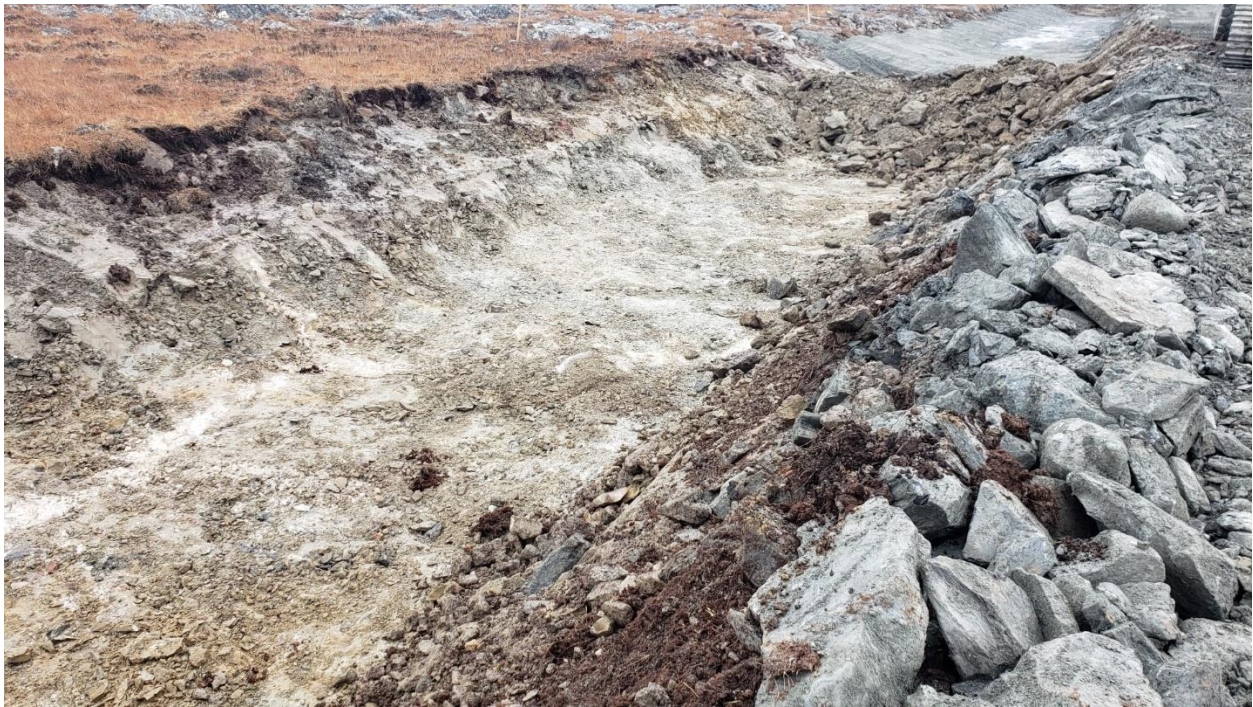
Photo 10: ice-rich till at the bottom of the planned excavation, St.0+250 looking North.

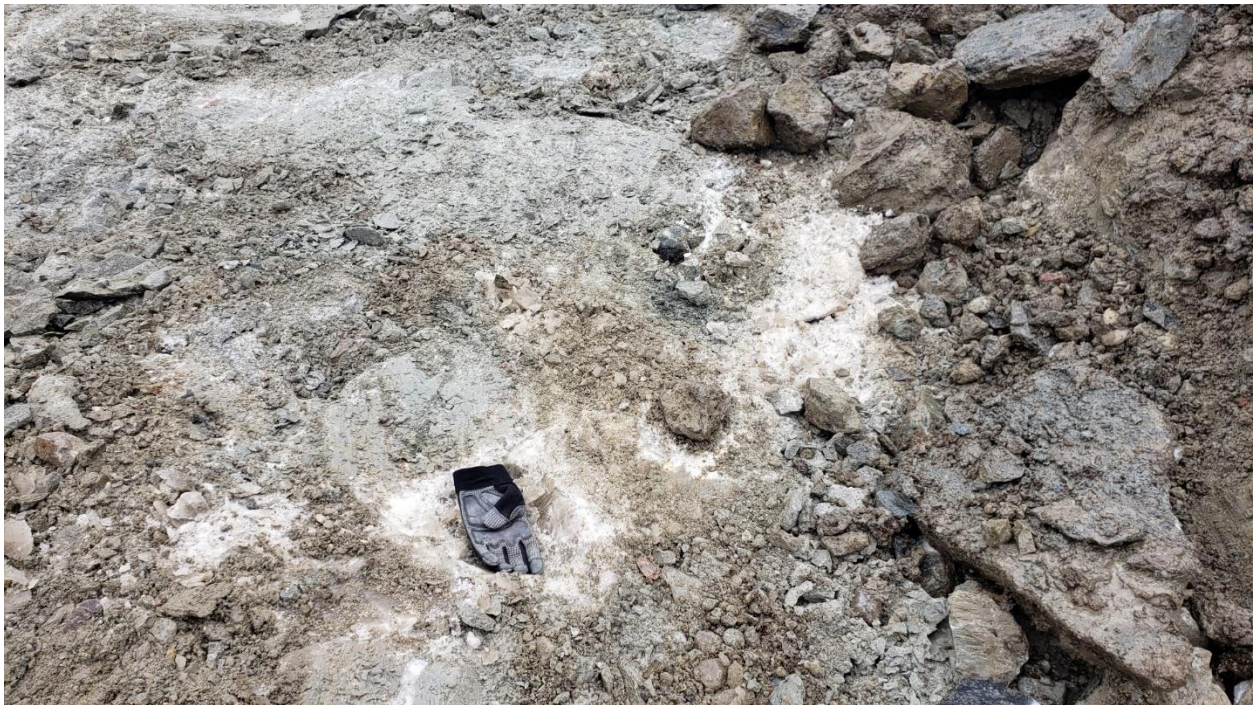
Photo 11: ice lens within an ice-rich till area, St.0+247. Ice was removed from the bottom of the excavation and under the downstream slope toe, right on the photo.

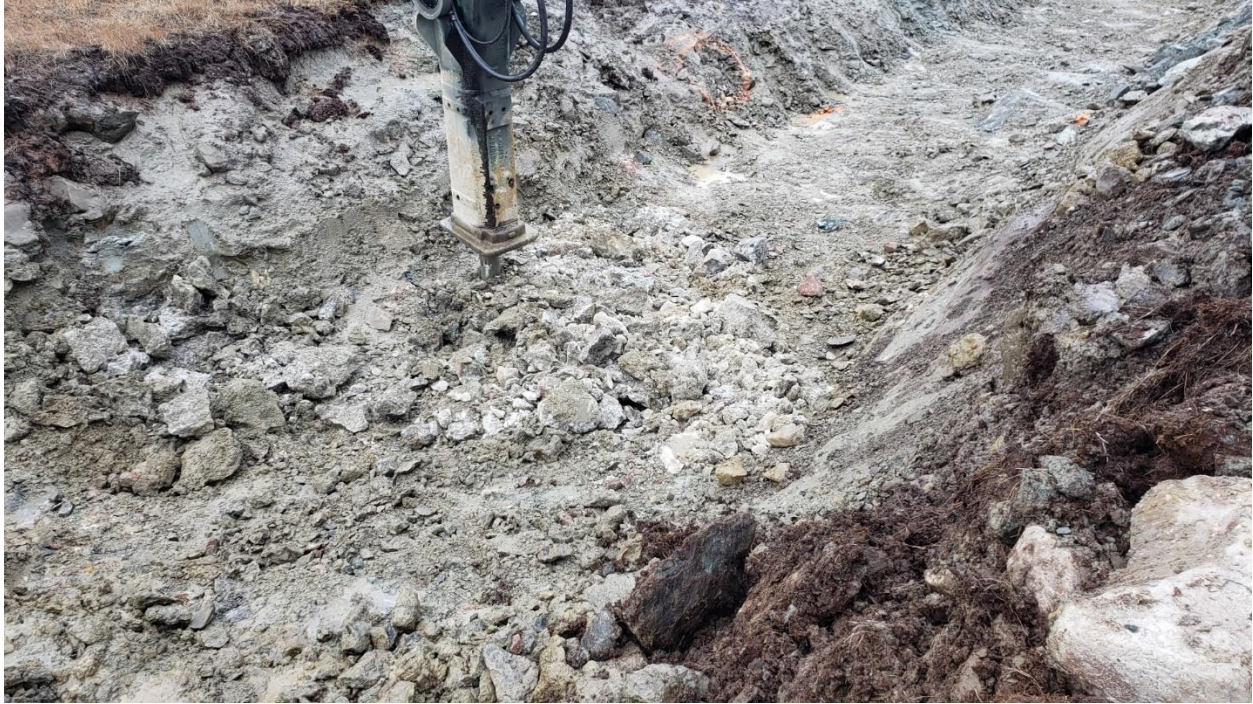
Photo 12: ice-rich till removal with a mechanical hammer, first 600mm material removal, St.0+125 looking South-East.

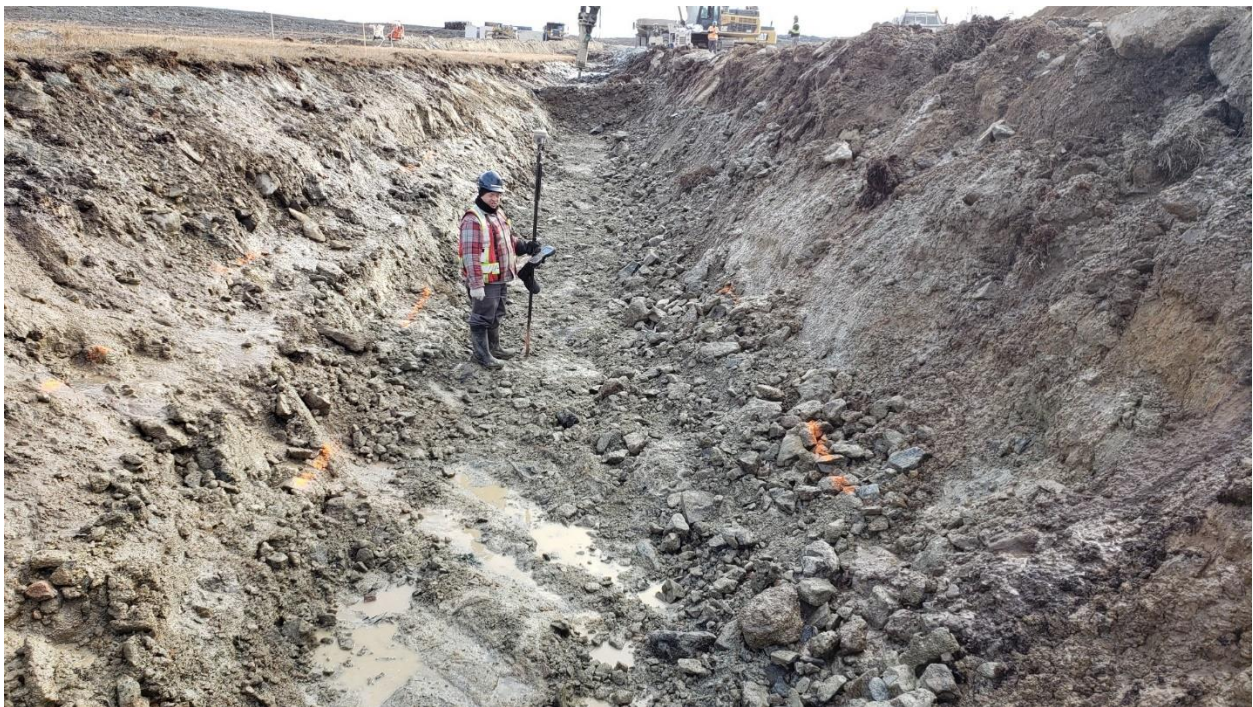
Photo 13: ice-rich till removal completed with the mechanical hammer, first 1200mm material removed, before backfilling it with esker, St.0+125 looking South-East.
