Construction Summary Report IVR Diversion Channel

Agnico Eagle Mines Ltd

6127-695-132-REP-012_R2

February 16, 2021

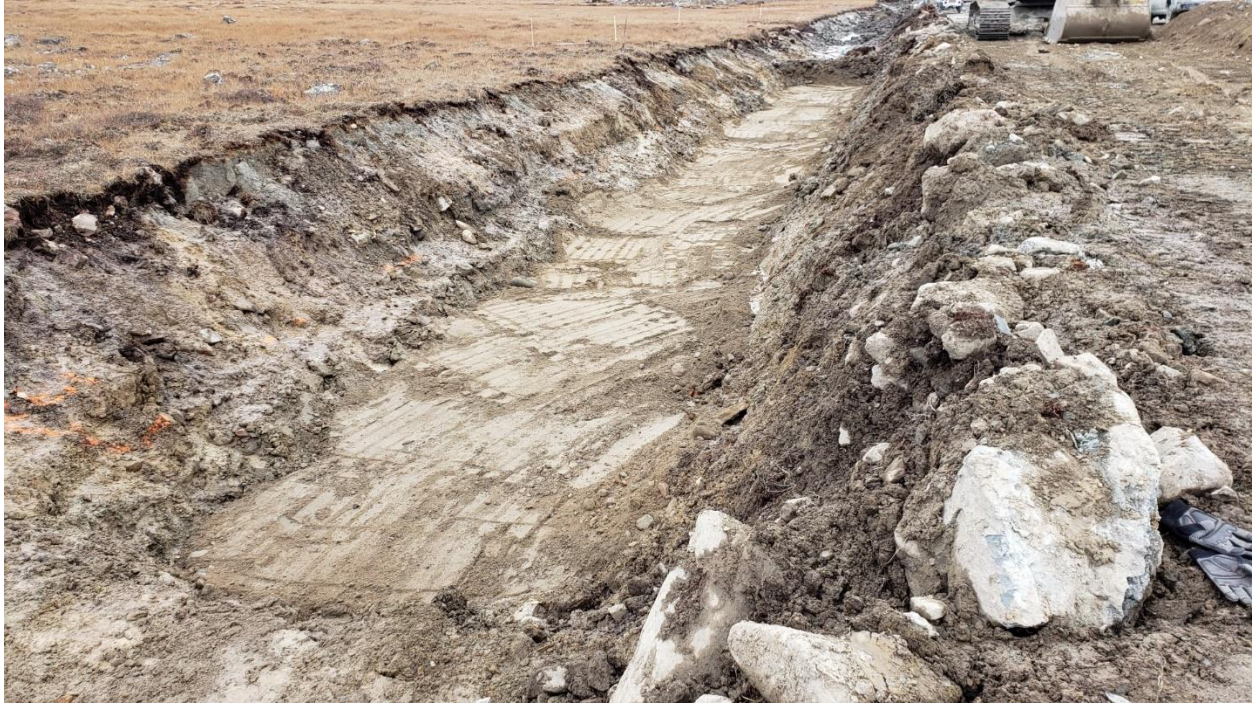
Photo 14: backfilling of the ice-rich till zone with compacted esker material, first 600mm completed. St.0+125 looking South East.

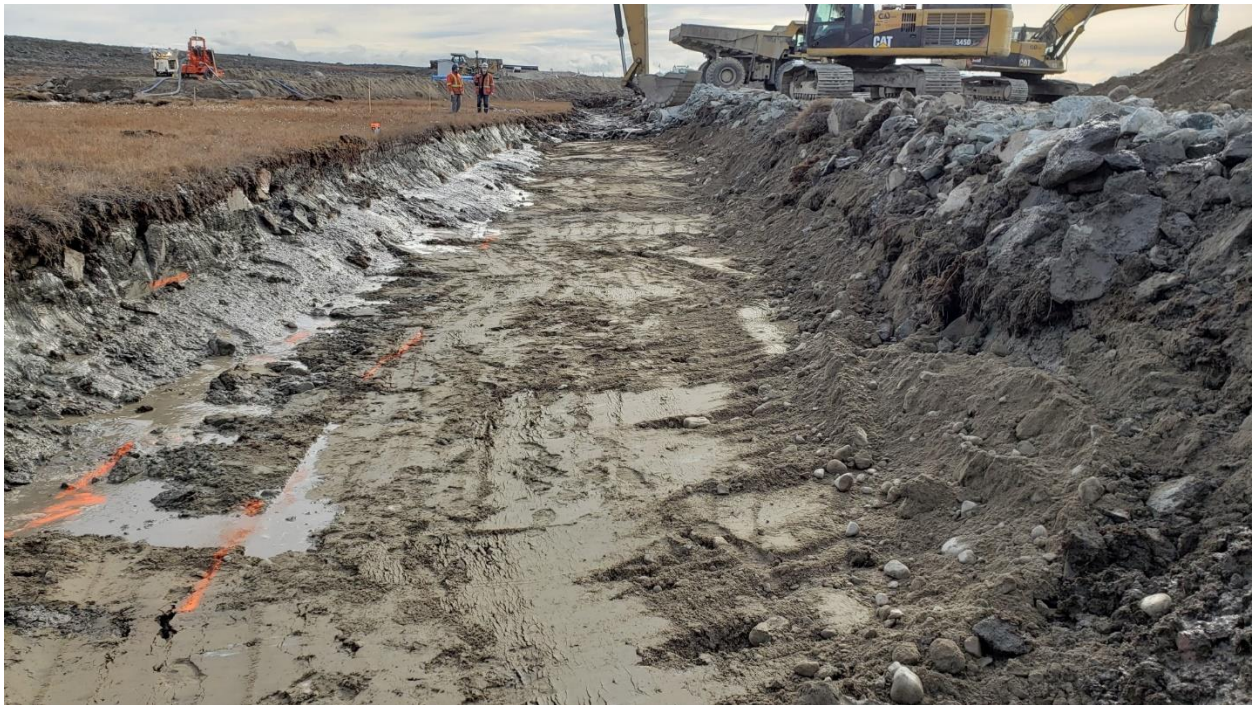
Photo 15: backfilling of the ice-rich till area 0+125-0+090 with compacted esker material completed to match planned channel bottom elevation, looking South-East.

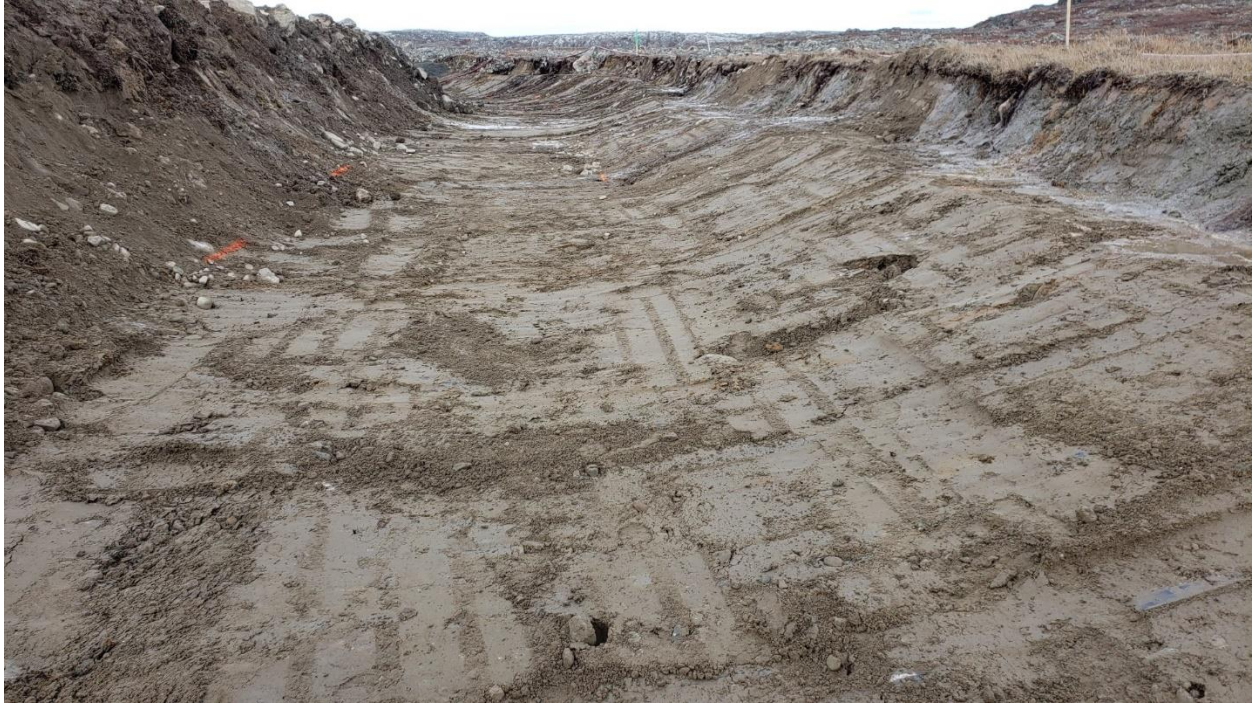
Photo 16: Approved foundation ready for the fine filter placement, St.0+090 looking North.

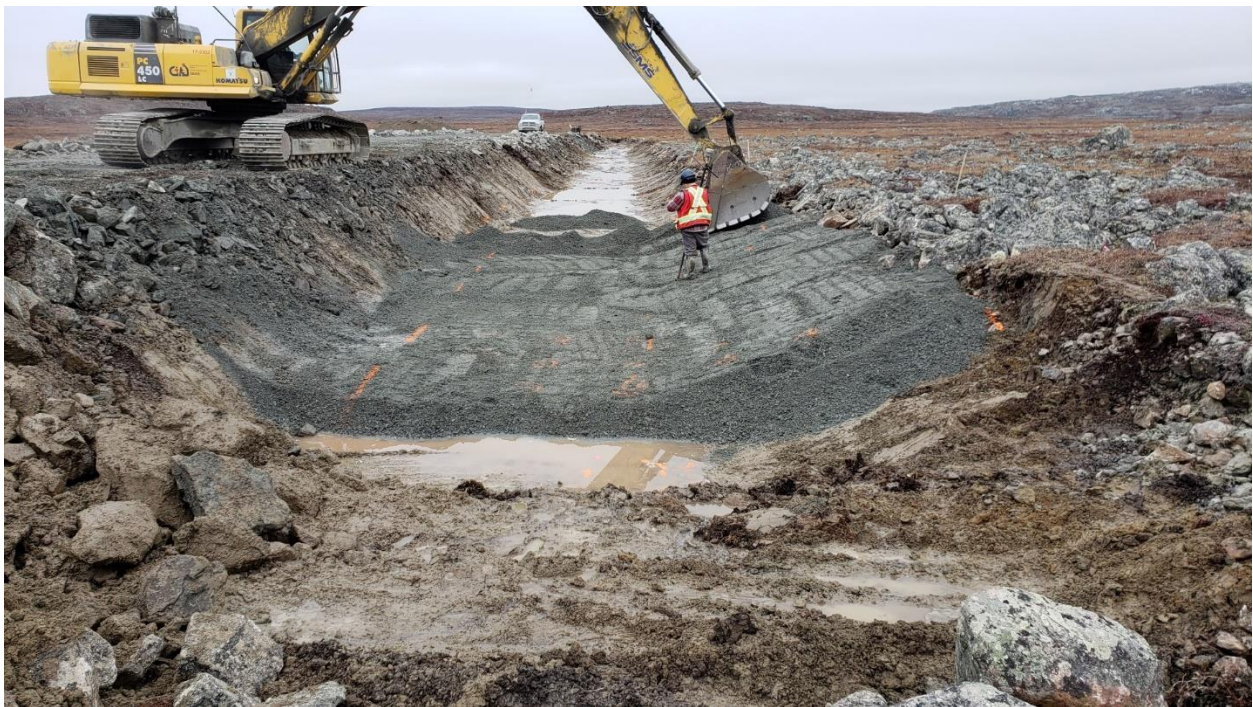
Photo 17: fine filter placement, St.0+145 looking North-West.

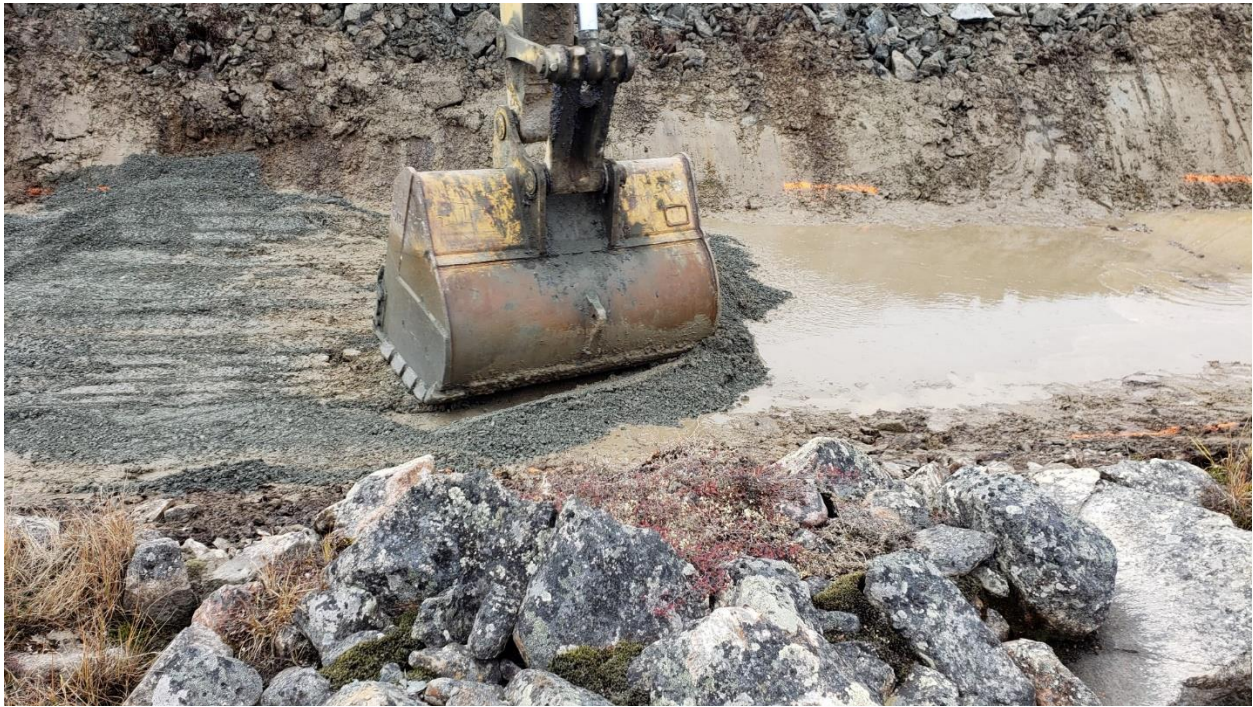
Photo 18: fine filter placement, pushing the water and mud out of the approved foundation before placement, St.0+240.

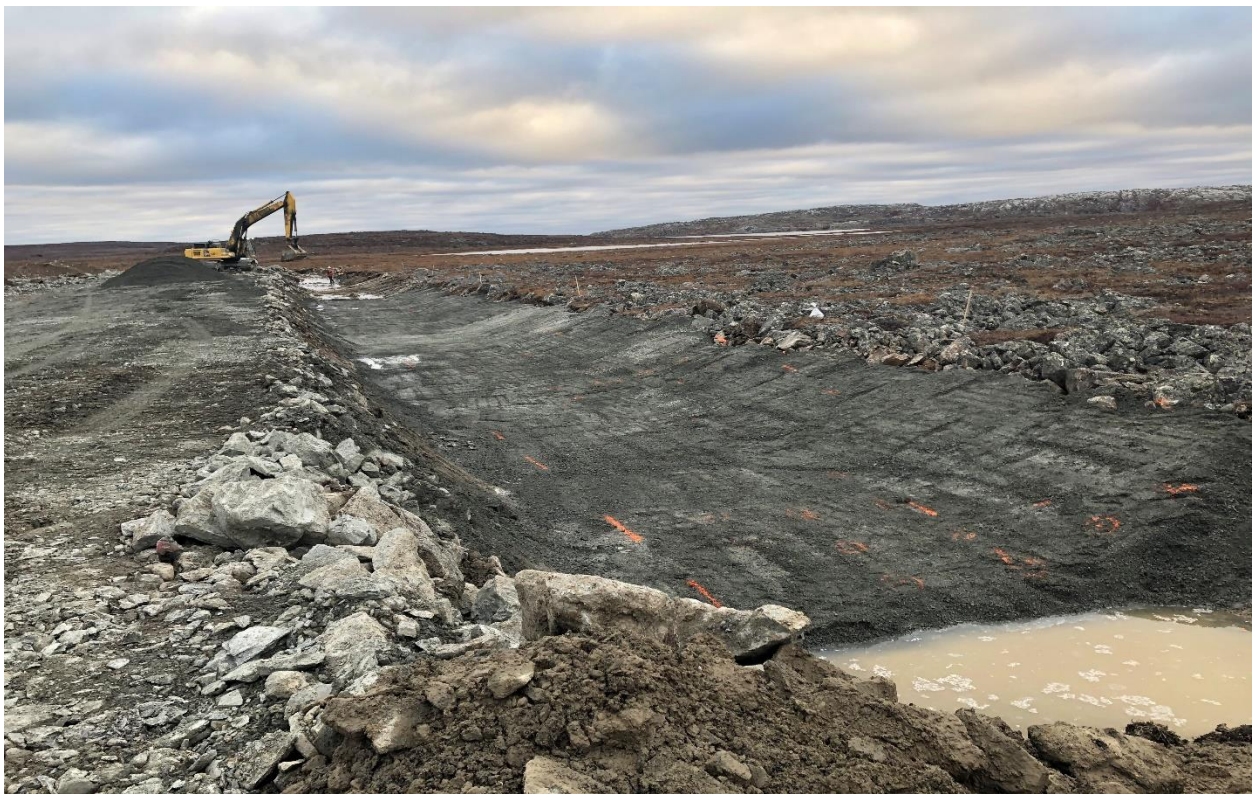
Figure 19: fine filter placement final approval before geotextile installation, St.0+140 looking North-West.

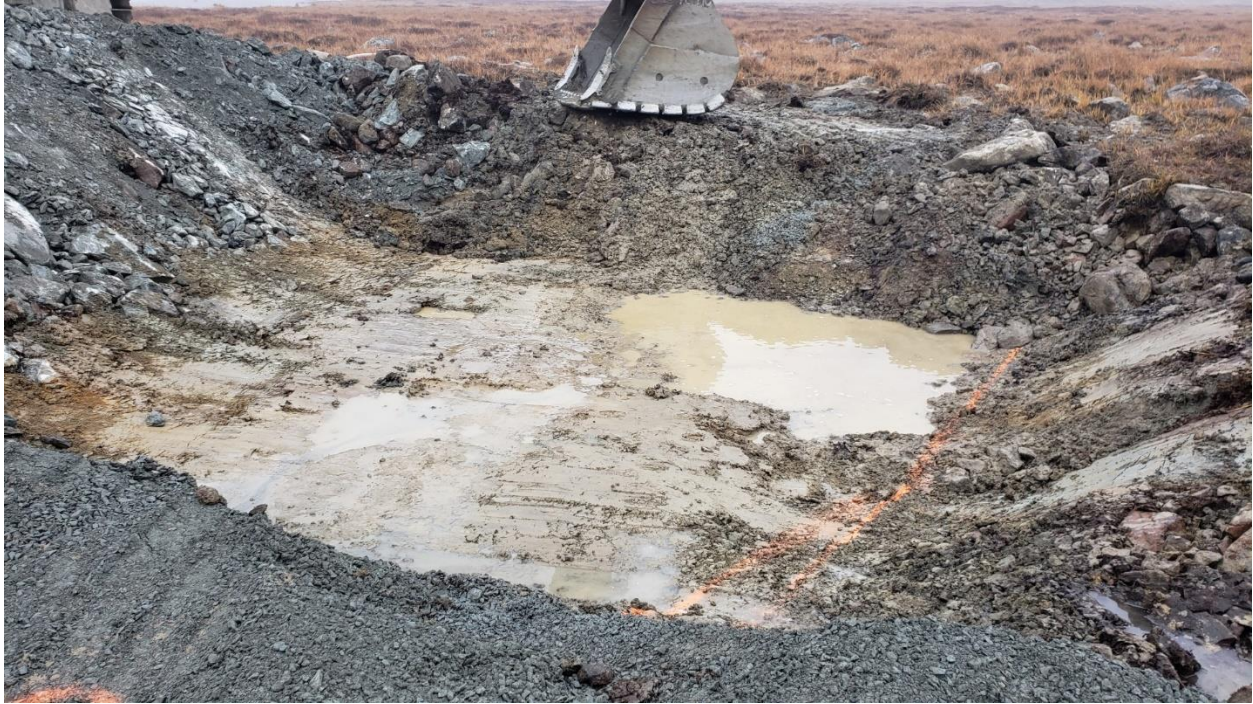
Photo 20: approved foundation of the energy dissipator following overburden excavation, looking at channel outlet.

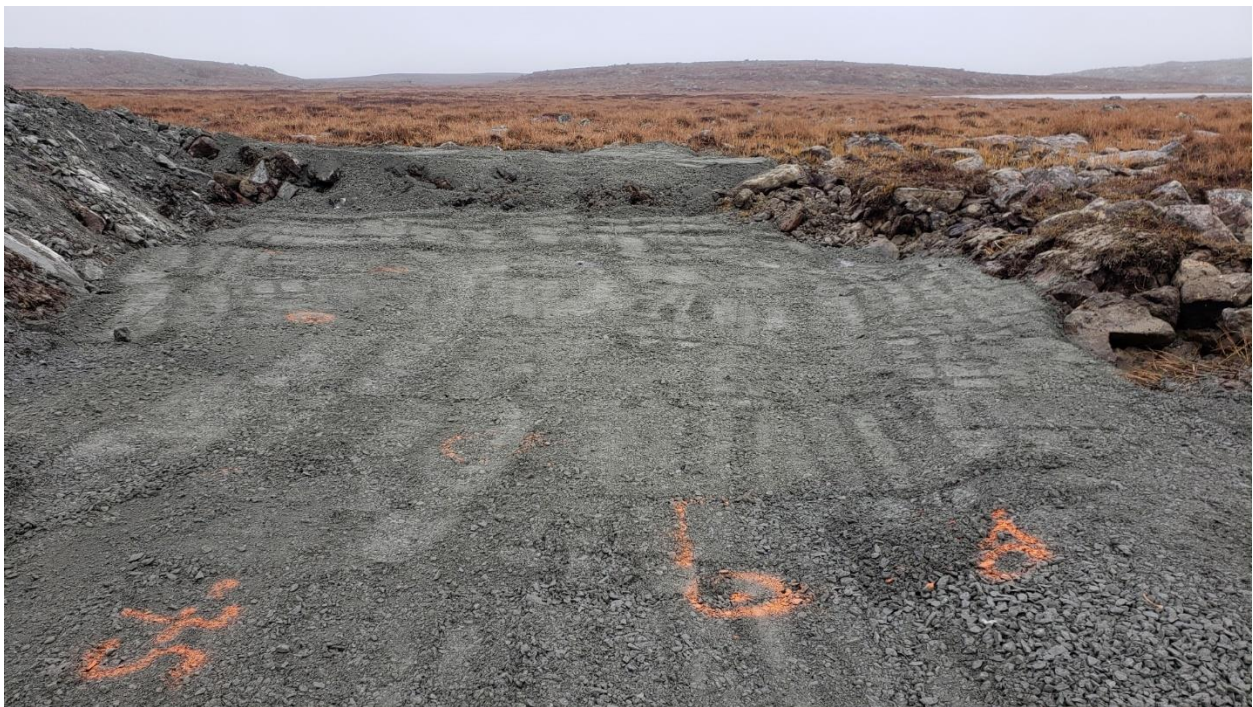
Photo 21: energy dissipator at the channel outlet covered with fine filter, St.0+275 looking North-West.

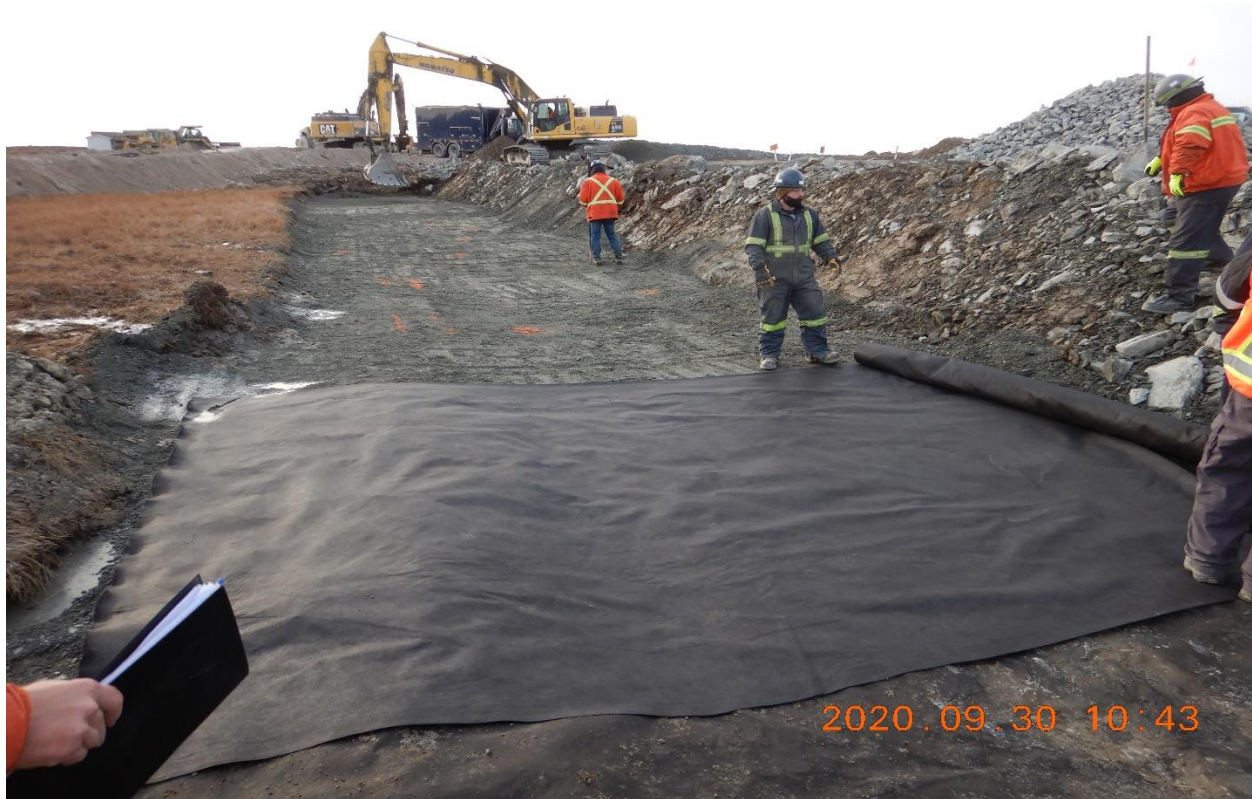
Photo 22: geotextile installation, St.0+050 looking South-East.

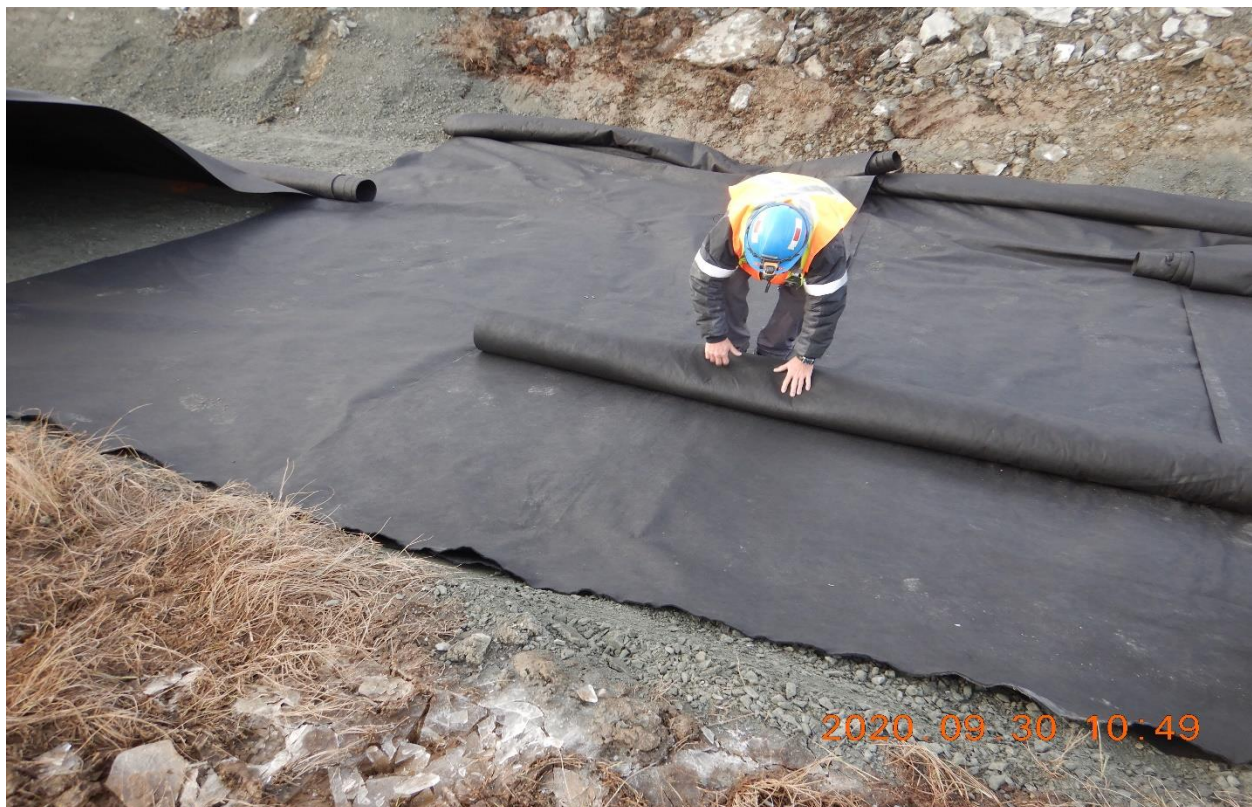
Photo 23: geotextile installation showing overlap of the different layers installed, St. 0+050.

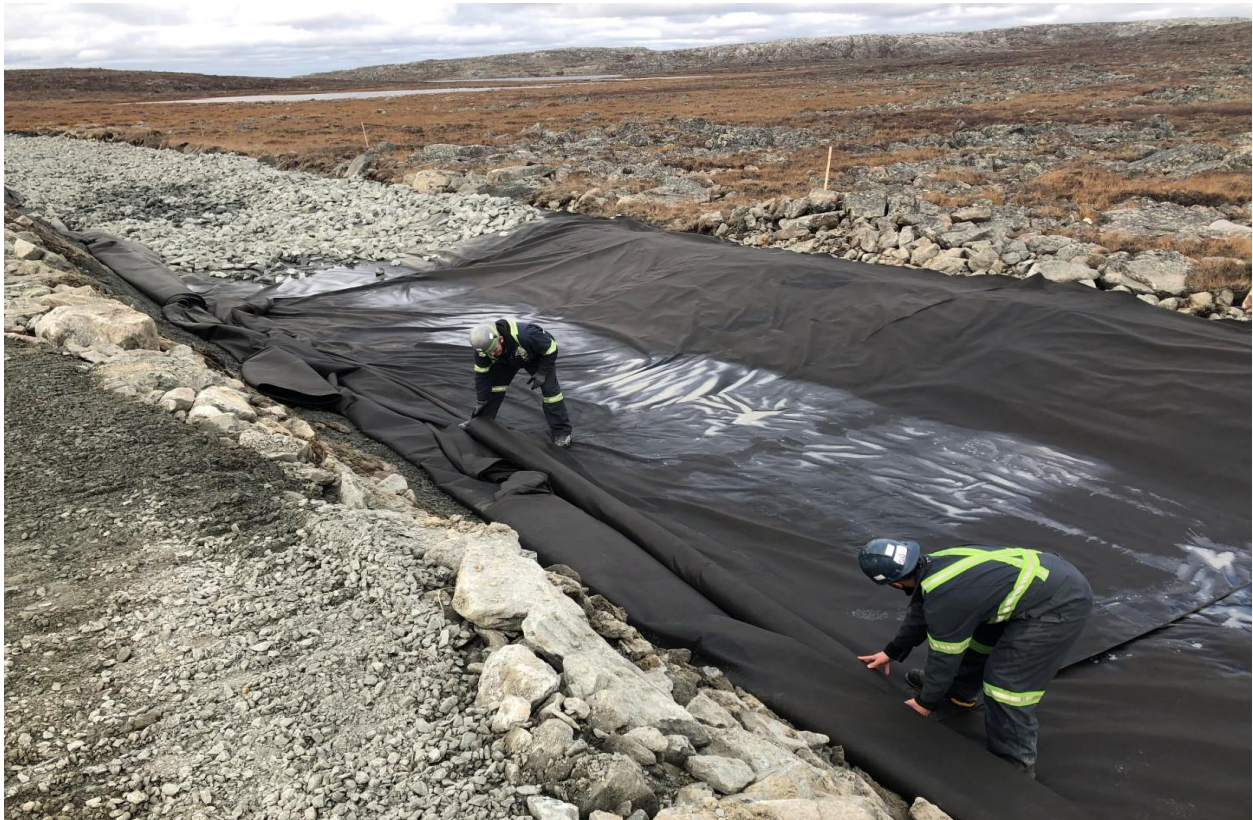
Photo 24: geotextile installation followed by rip-rap placement, St.0+200.

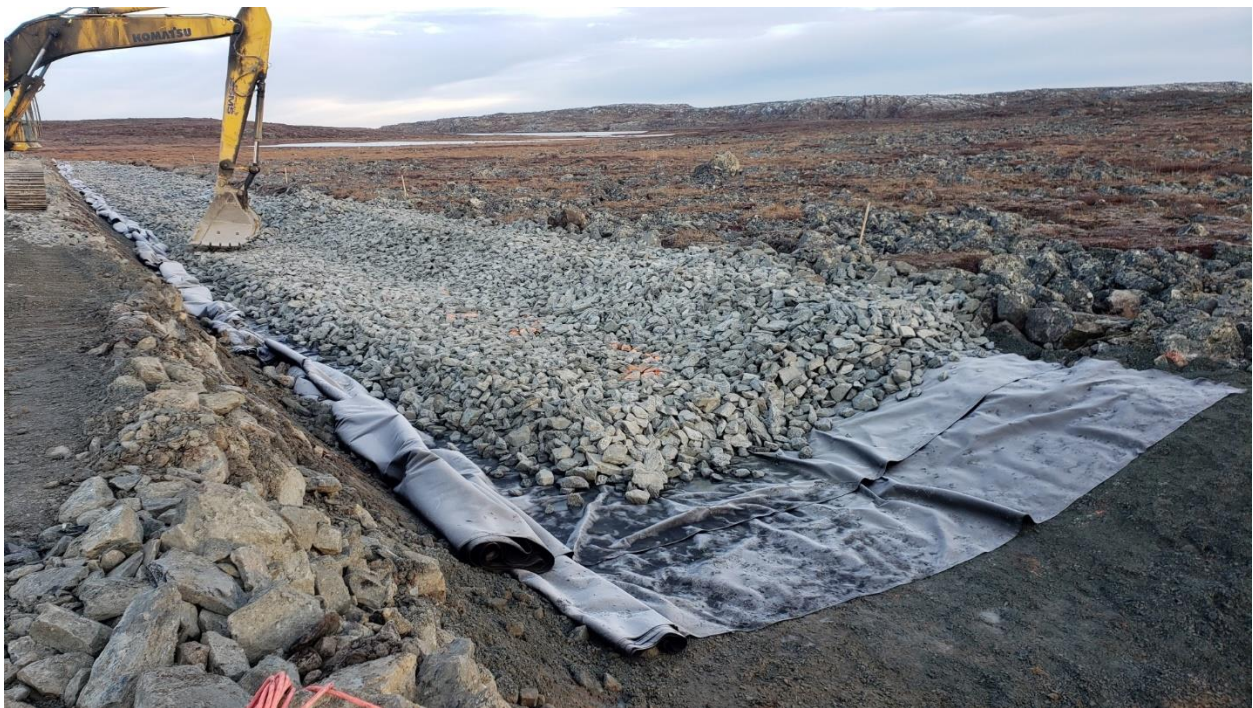
Photo 25: rip rap placement over the geotextile matching the natural topography on the upstream side, St.0+140 looking North.

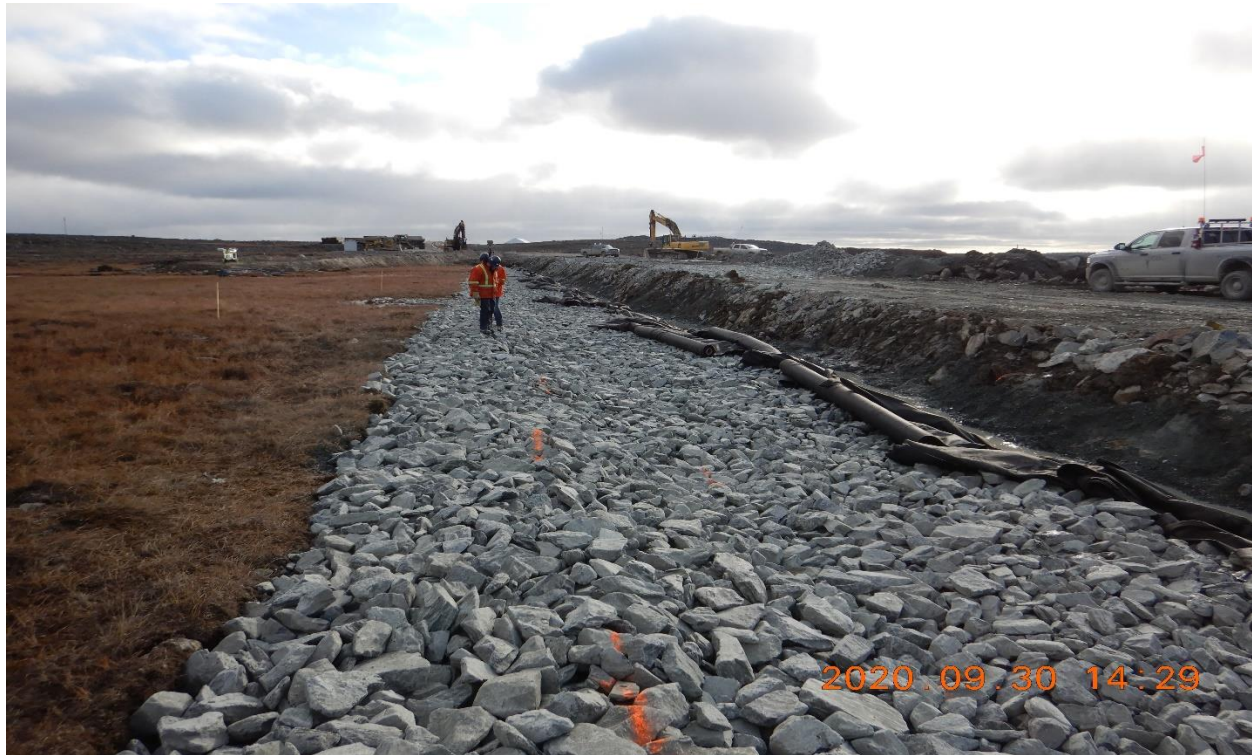
Photo 26: rip rap placement completed on the upstream side for section 0+015 to 0+090, looking South-East. Downstream berm not sloped to final grade.

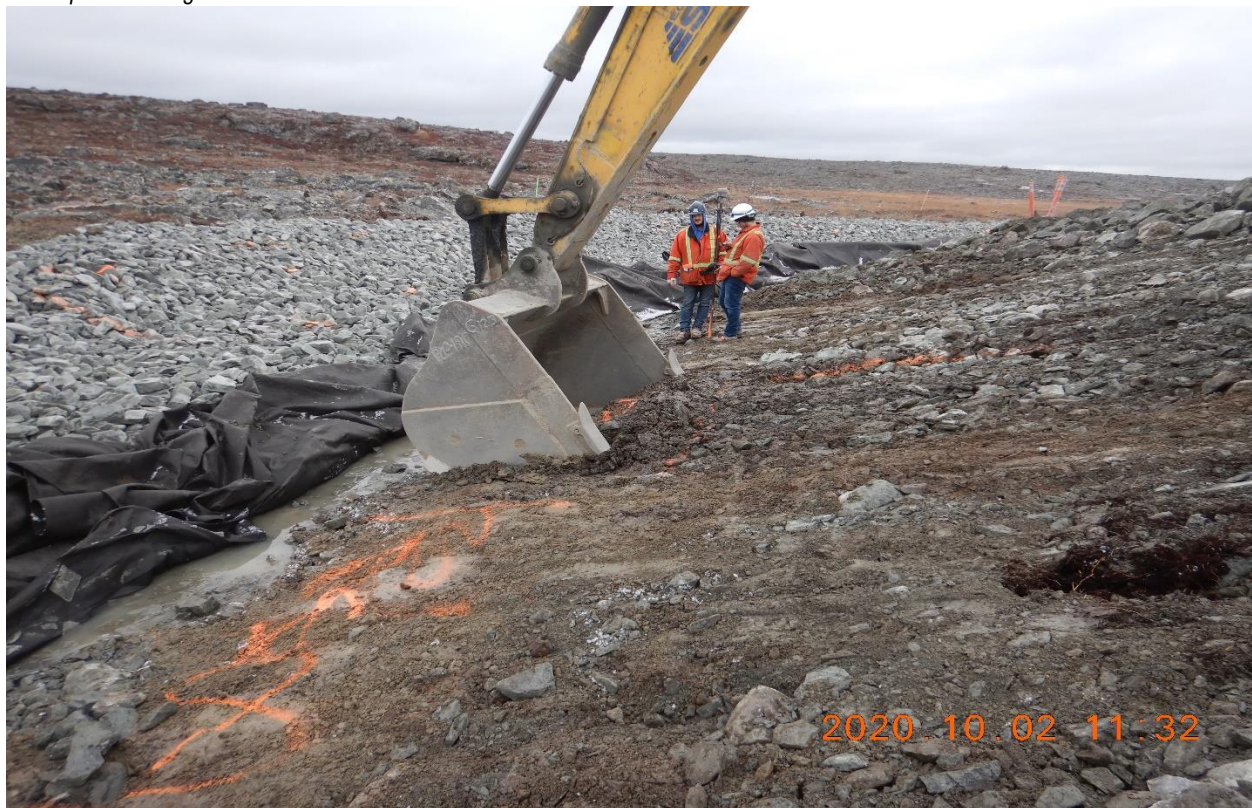
Photo 27: sloping of the downstream berm from foundation to top of platform, St.0+140 looking North-East.

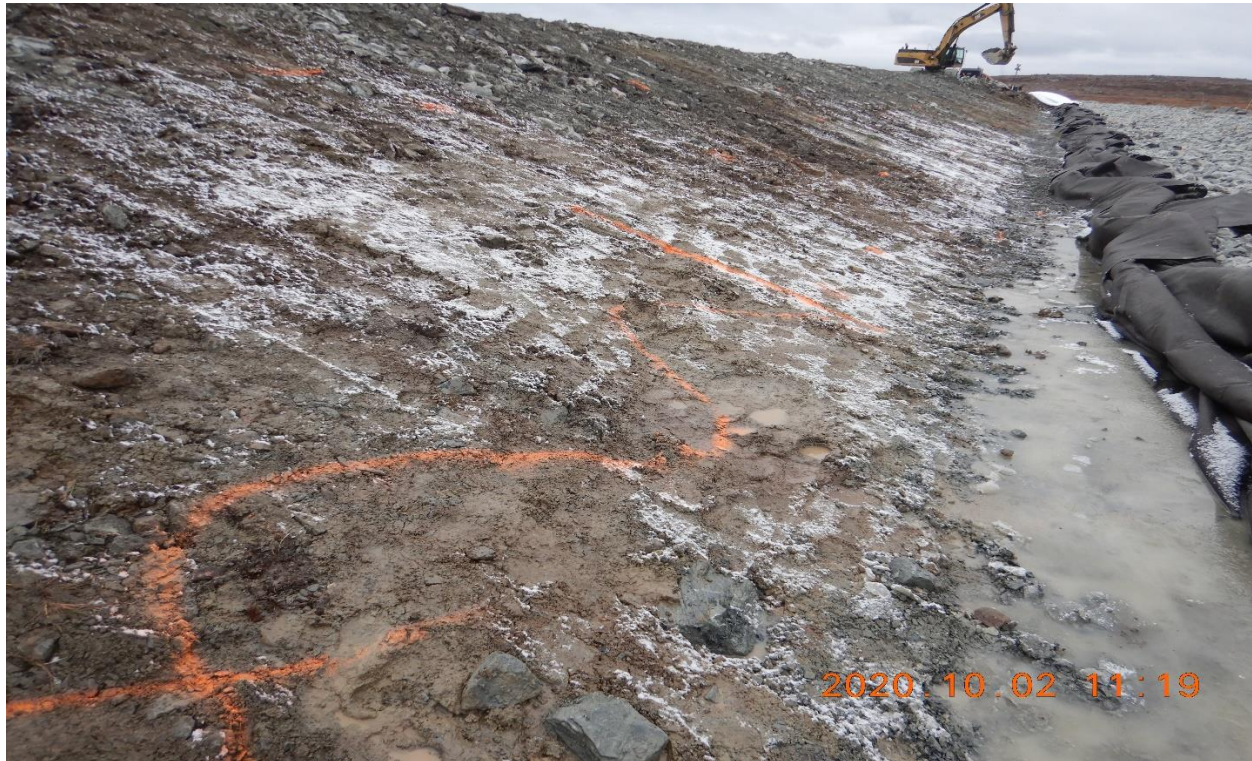
Photo 28: approved surface of the downstream berm sloped ready for fine filter placement, St.0+200 looking North-West.

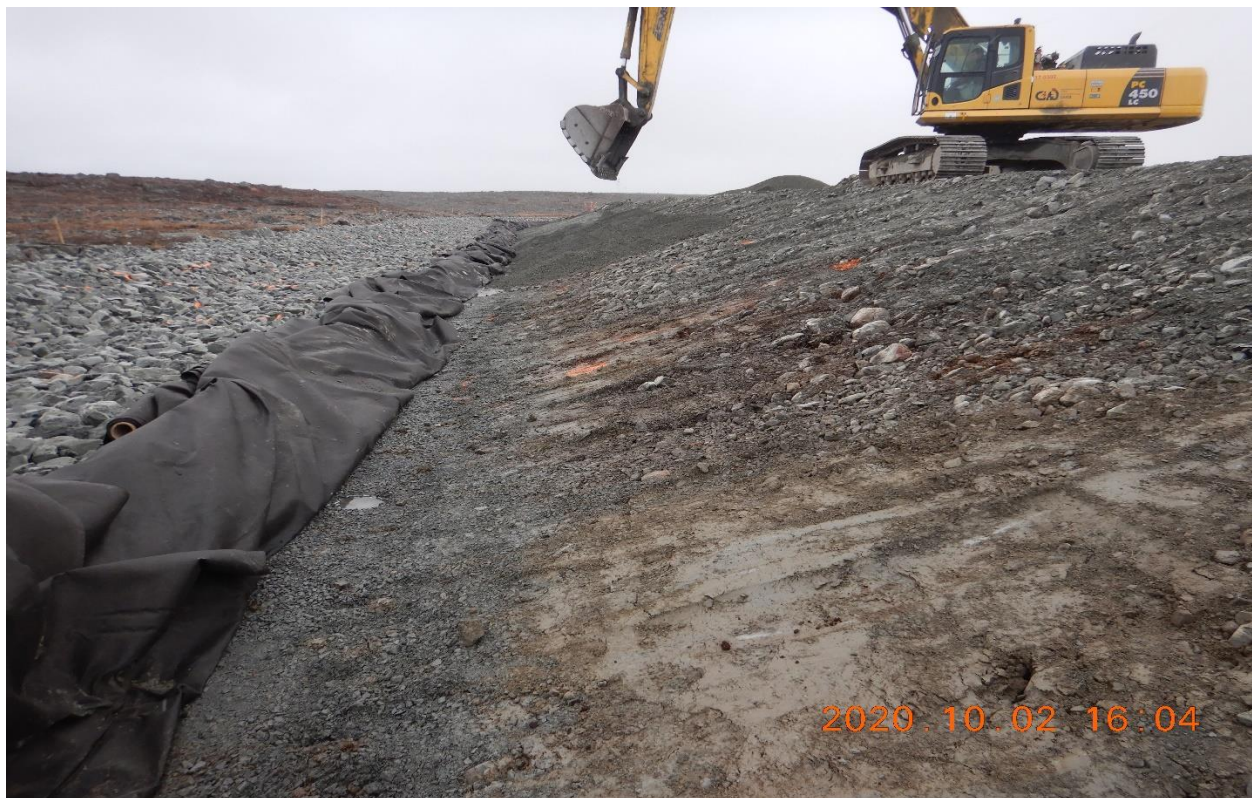
Photo 29: fine filter placement in downstream slope, St. 0+170 looking South-East.

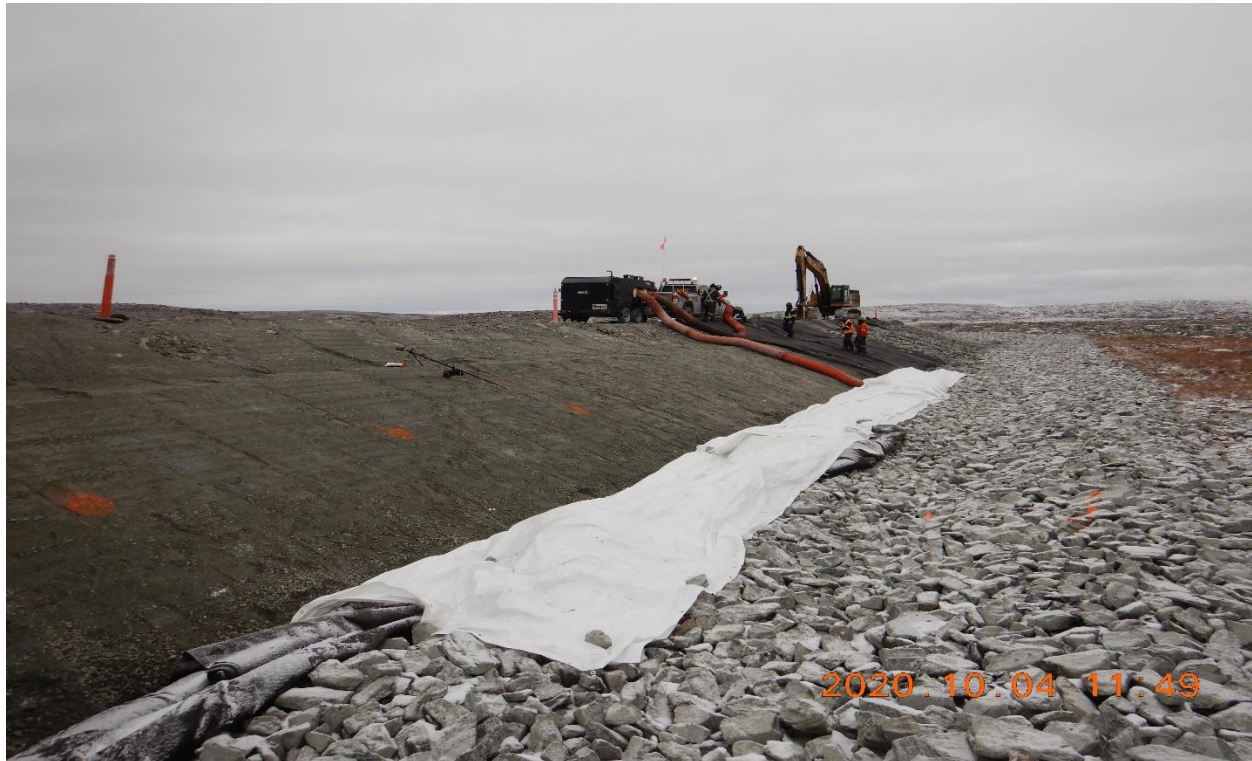
Photo 30: final fine filter placement in the downstream slope before geotextile placement, St. 0+070 looking North-West.

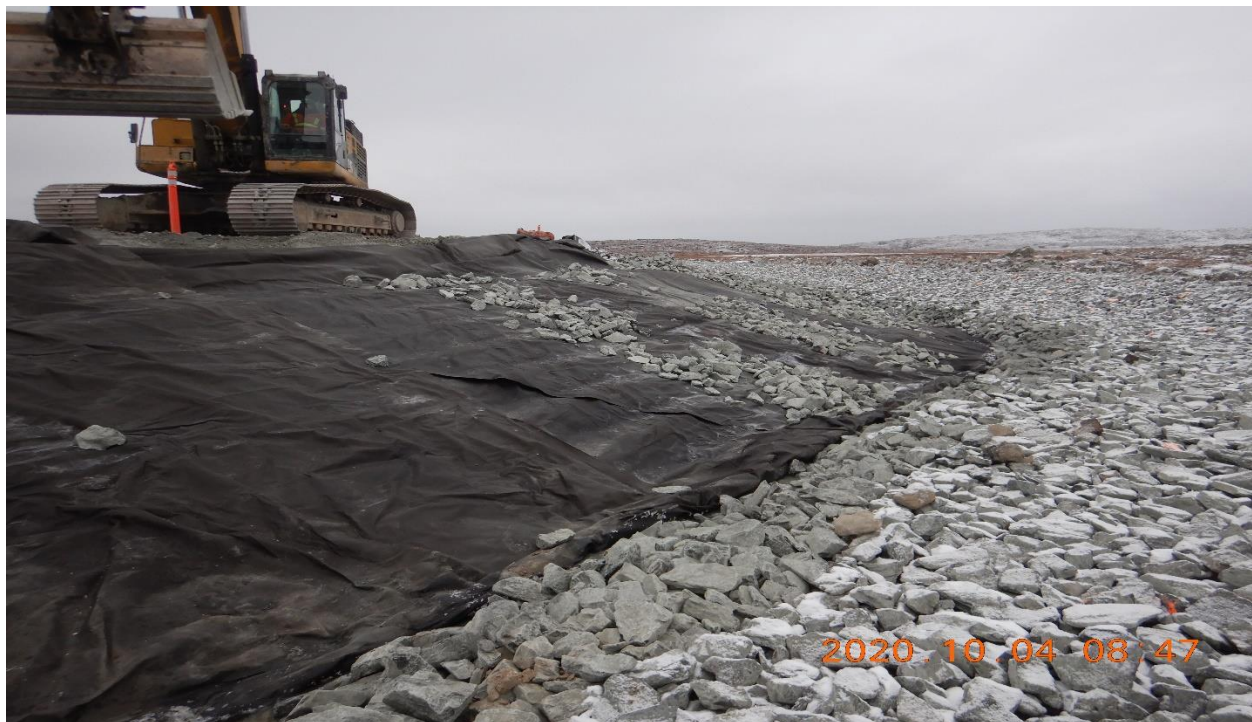
Figure 31: ballasting the approved installed geotextile with rip rap to prevent wind action, St. 0+125 looking North.

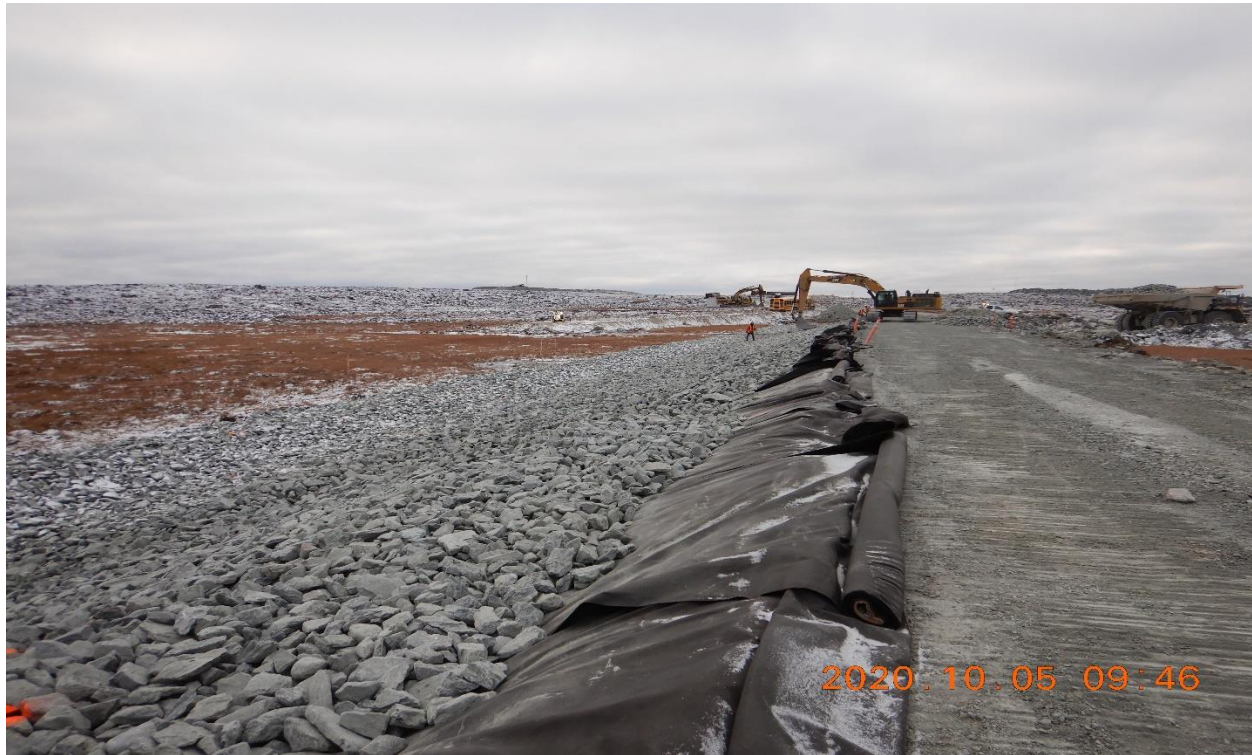
Figure 32: rip rap placement on top of geotextile in the downstream slope, St.0+100 looking South.

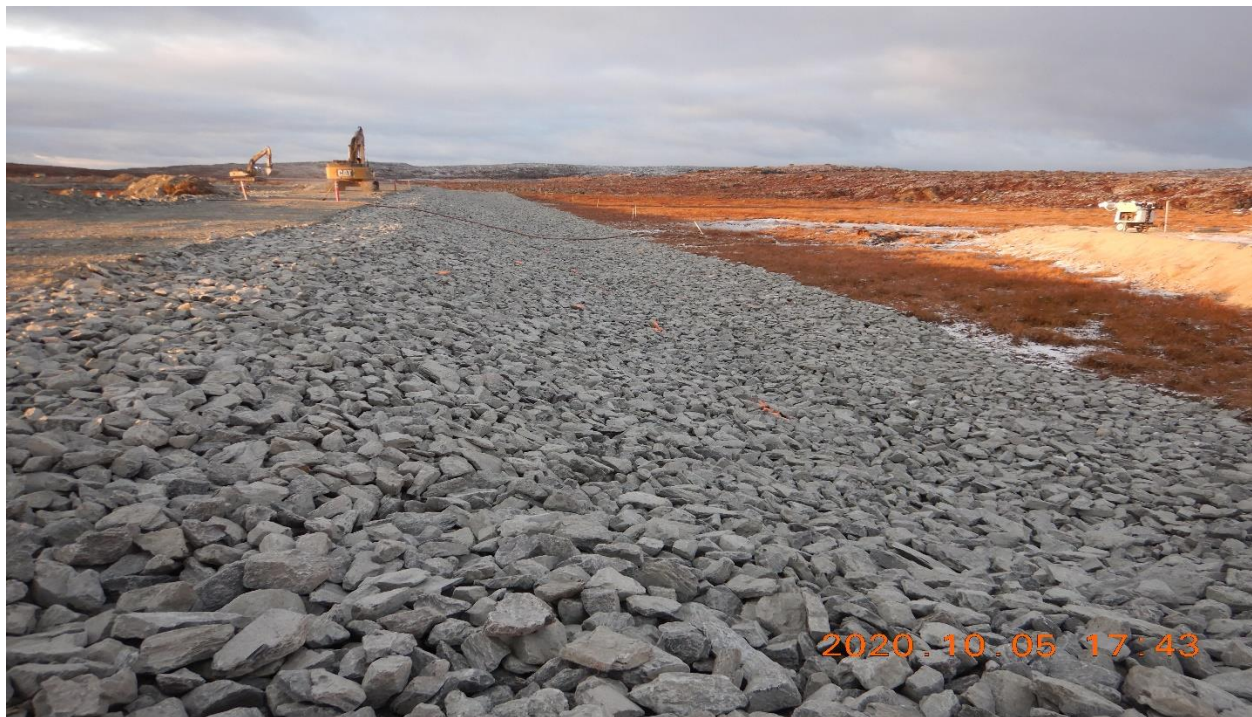
Photo 33: view of the finalized channel, St. 0+000 looking North-West.

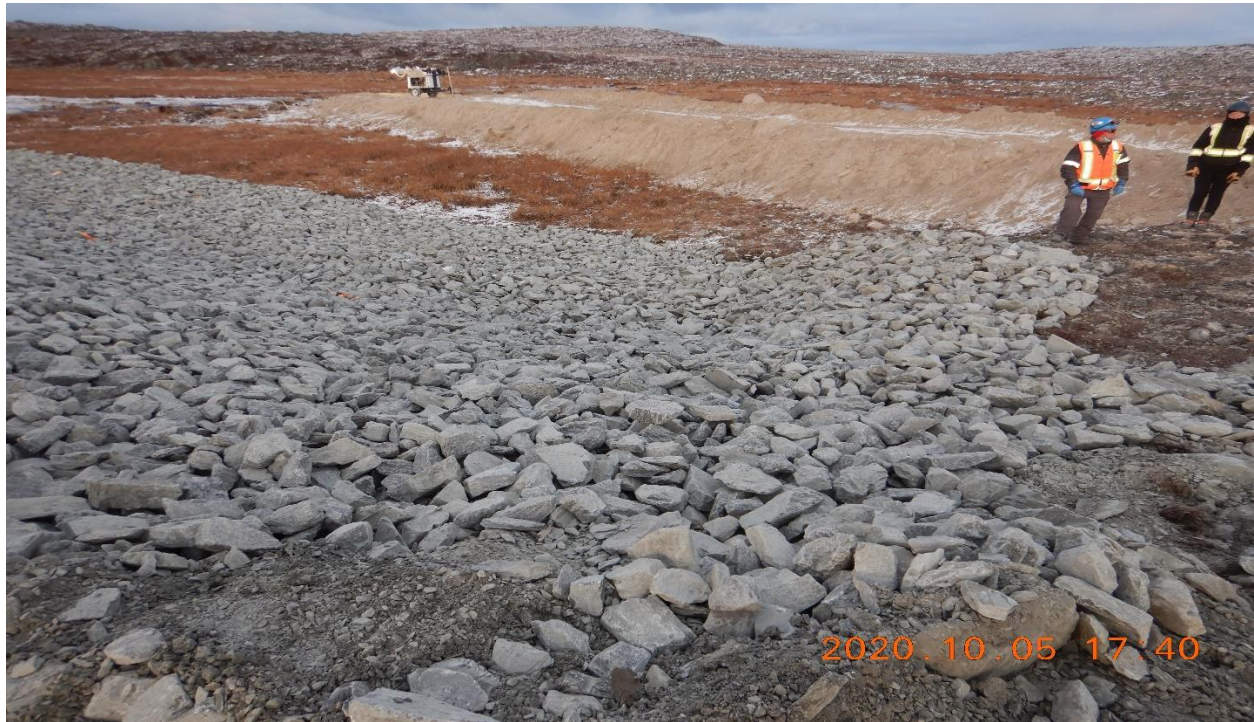
Photo 34: Channel inlet completed with rip rap placement.

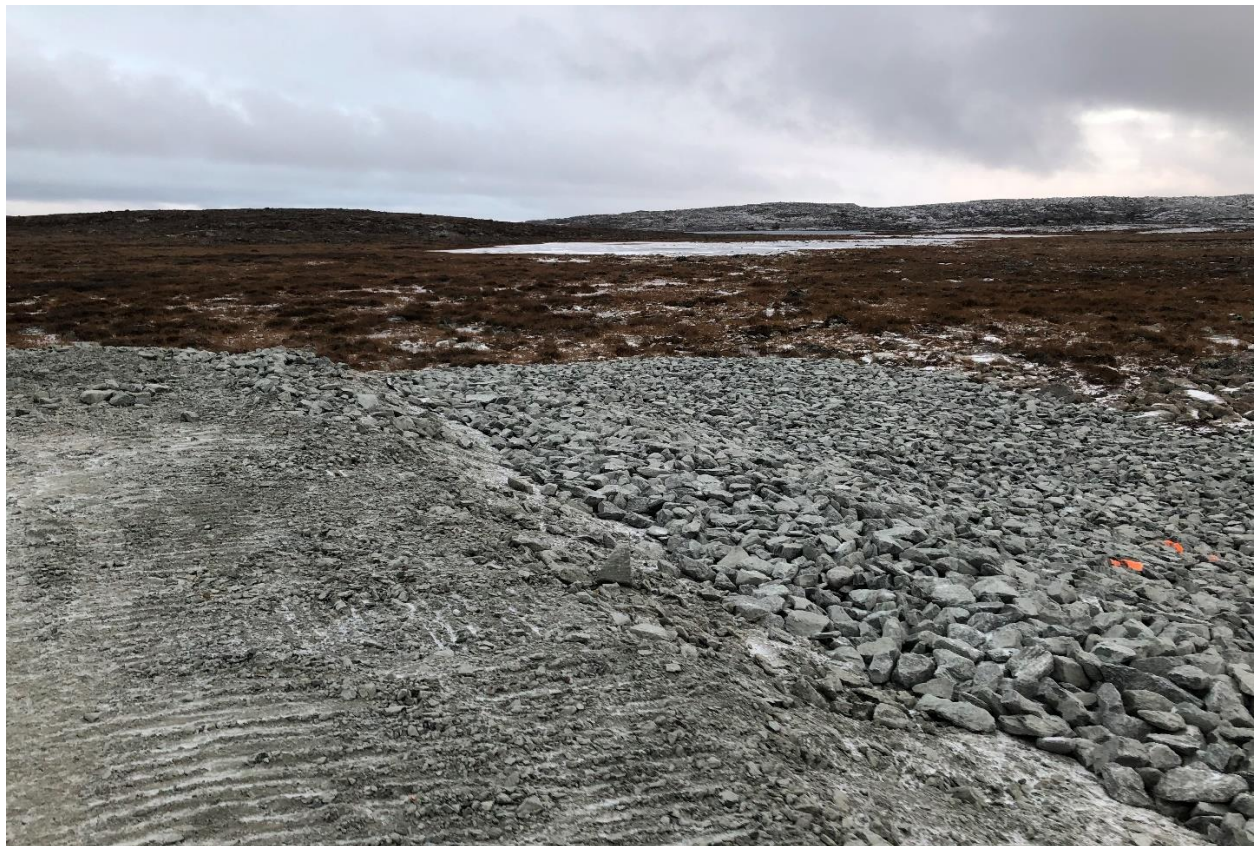
Photo 35: channel outlet completed with geotextile and rip rap.

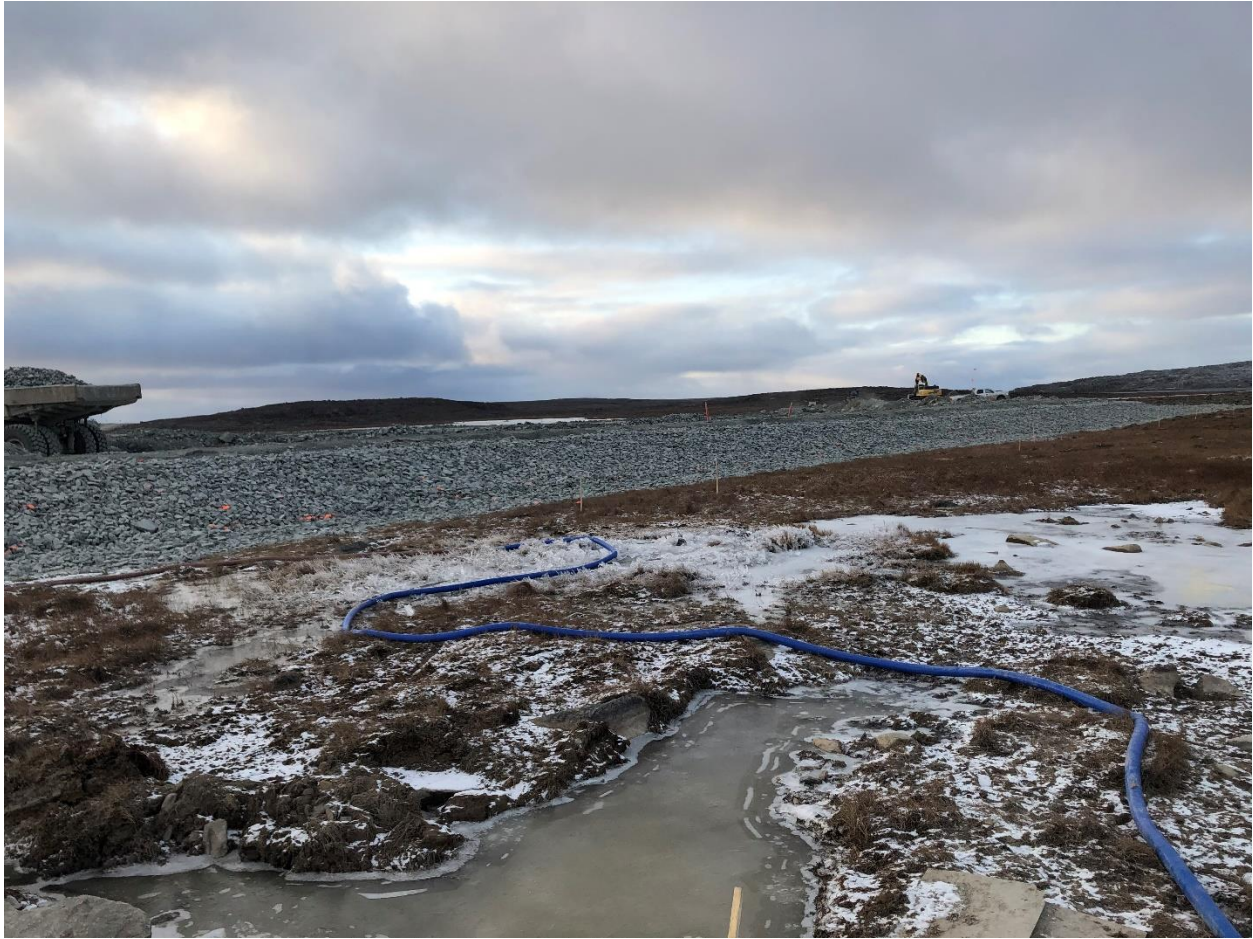
Photo 36: view of the completed channel section 0+000 to 0+140.
