# HOPE BAY MINING LIMITED

## 2009 Annual Geotechnical Inspection, Boston Advanced Exploration Project, Hope Bay, Nunavut

Project No. 1CH008.021

**November 2009**

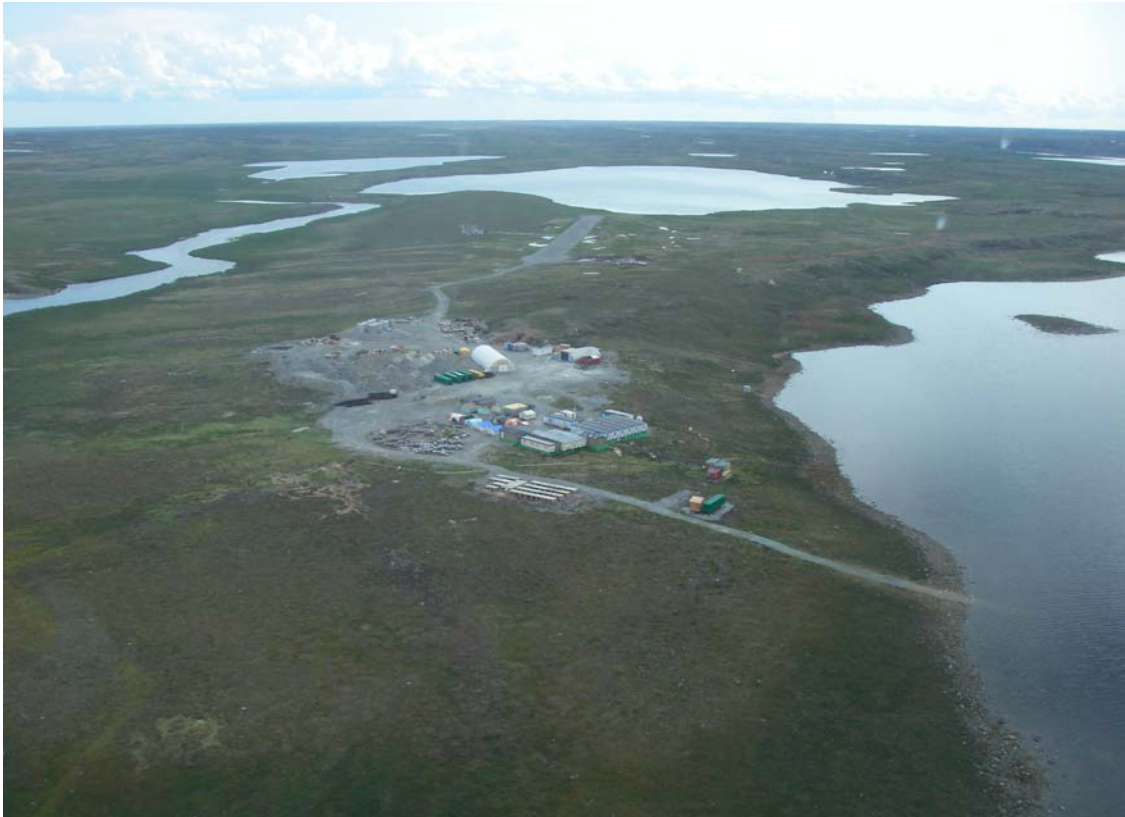
**Photo 1:** Oblique aerial view of Boston Camp looking south. Note Stickleback Lake in the background at the end of the airstrip.

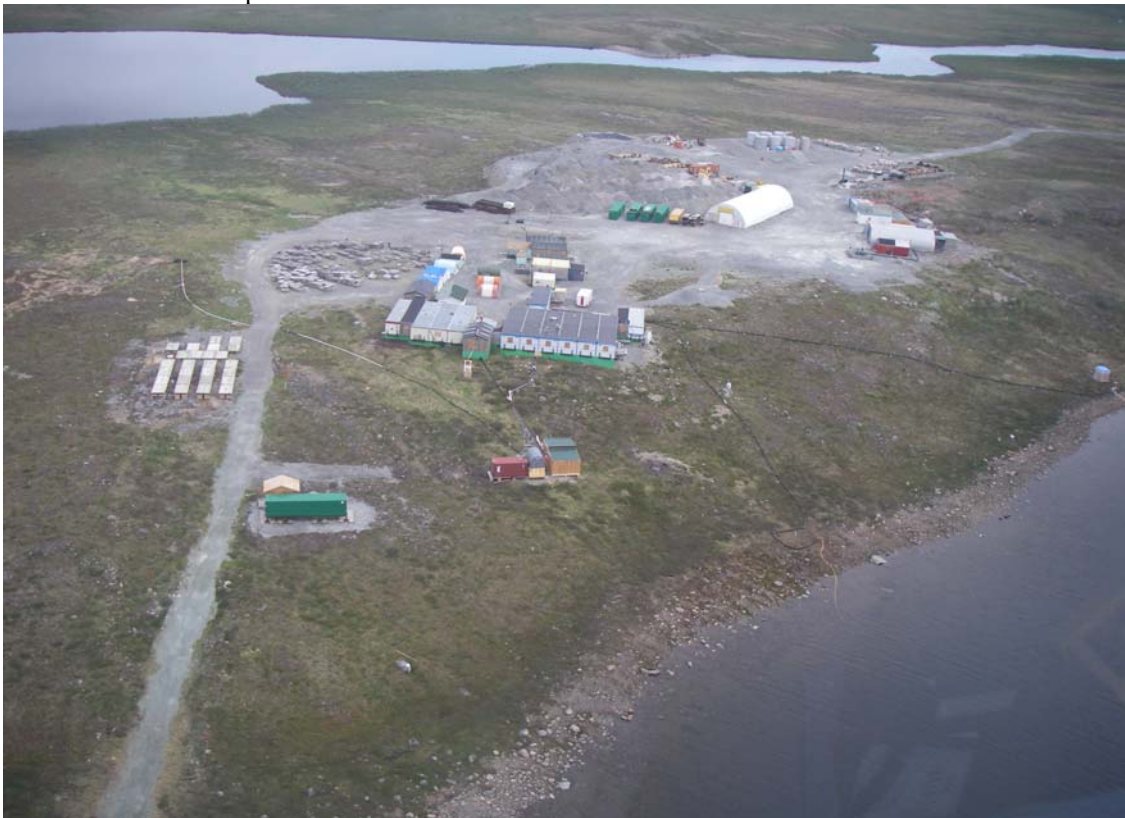
**Photo 2:** Oblique aerial view of Boston Camp looking south-east.

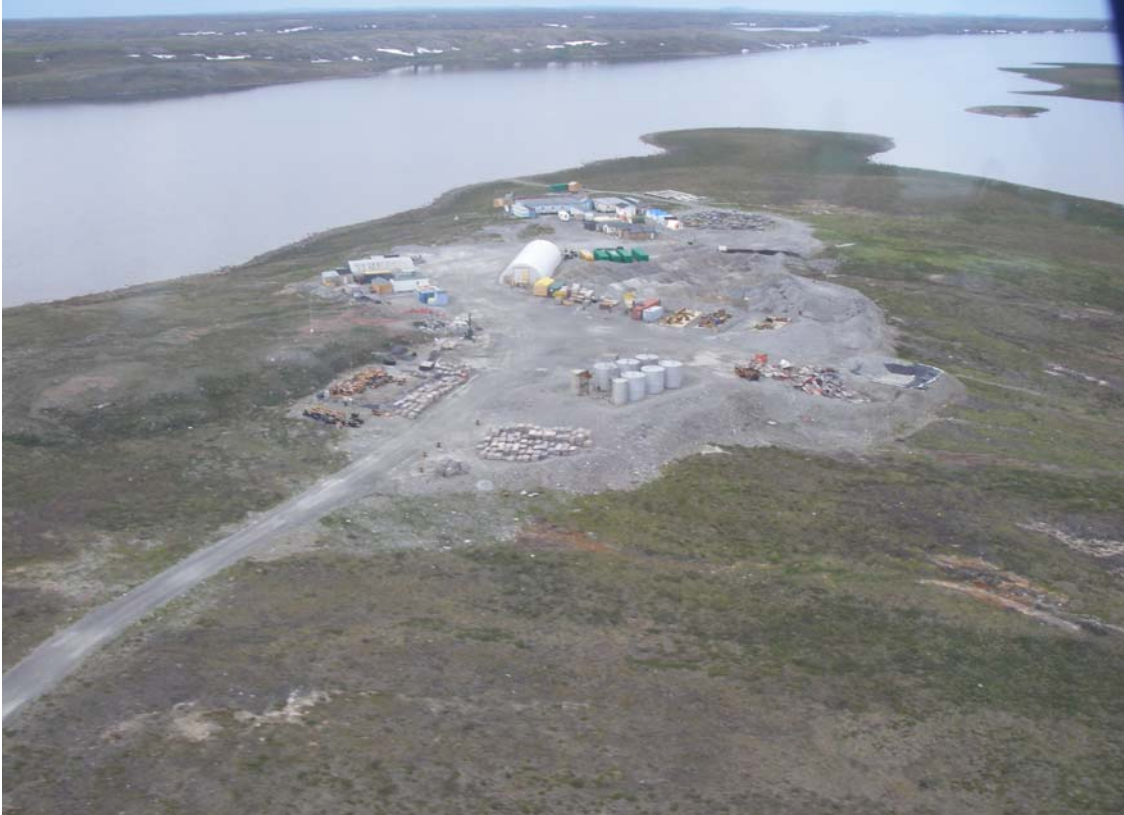
**Photo 3:** Oblique aerial view of Boston Camp looking north. The peninsula of Spyder Lake on which the camp is located is clearly visible from this picture.

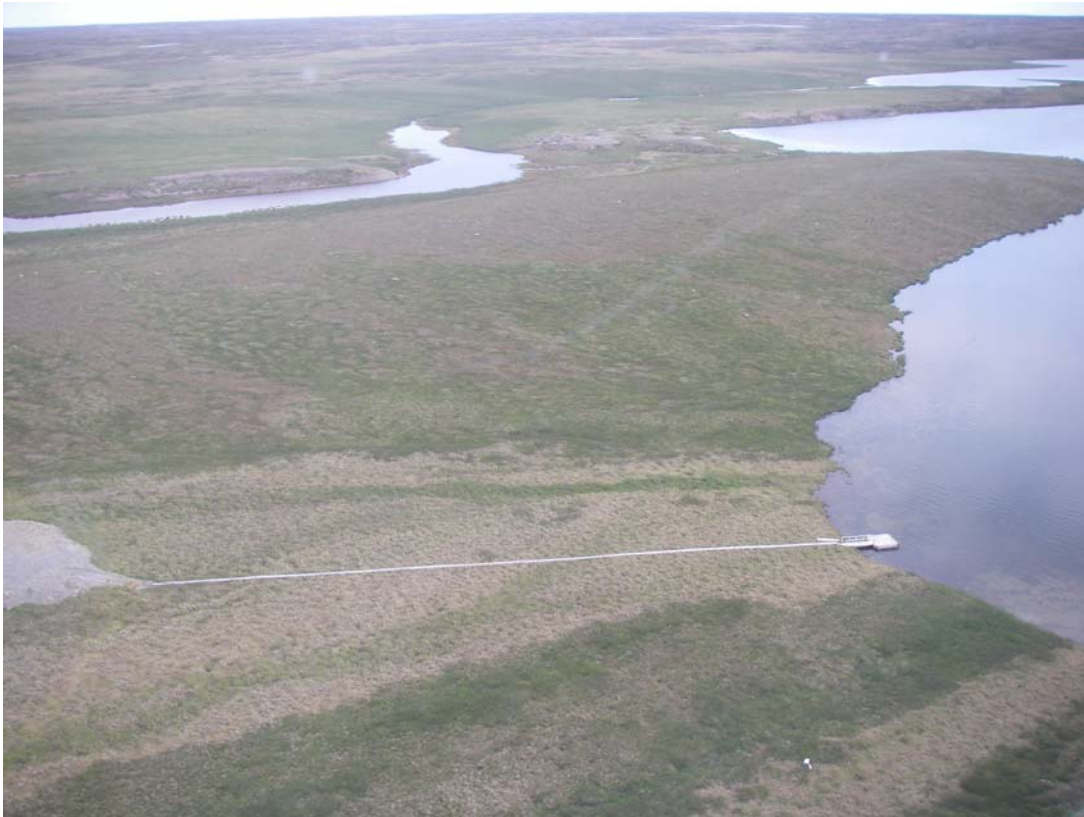
**Photo 7:** Oblique aerial view of the wooden walkway leading from the south end of the airstrip to the boat dock in Stickleback Lake.

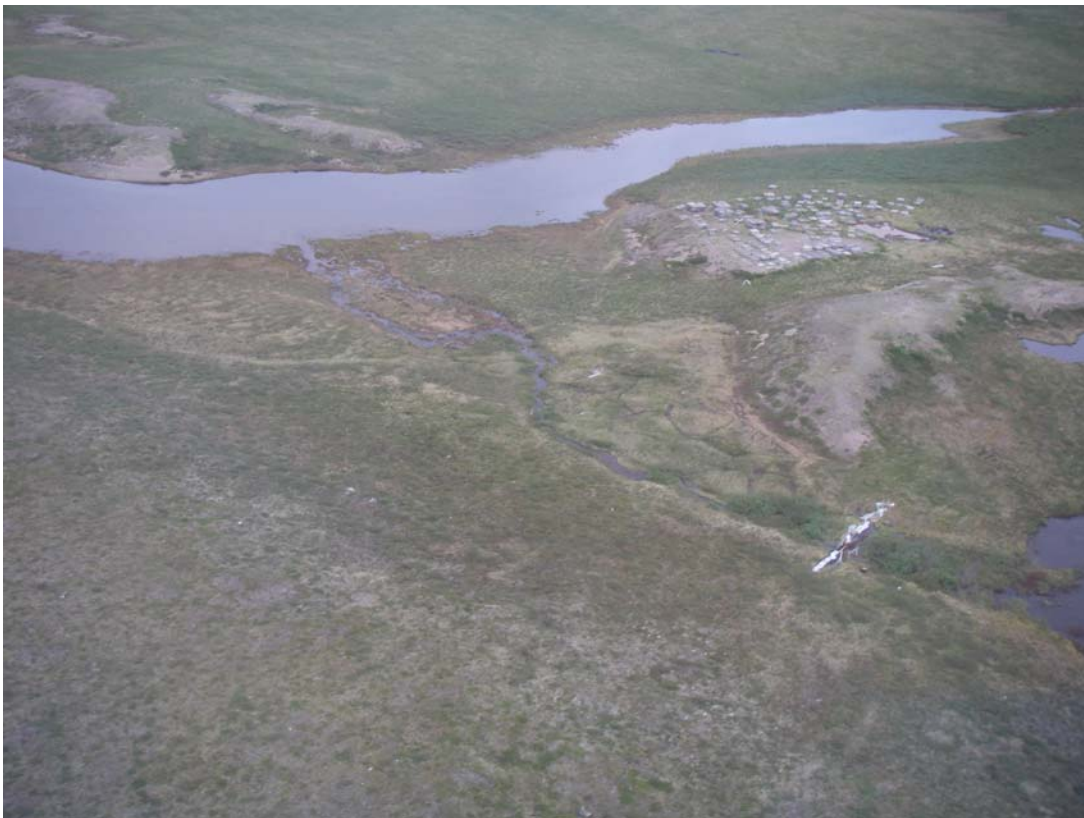
**Photo 8:** Oblique aerial view of the old v-notch weir at the outlet to Stickleback Lake.

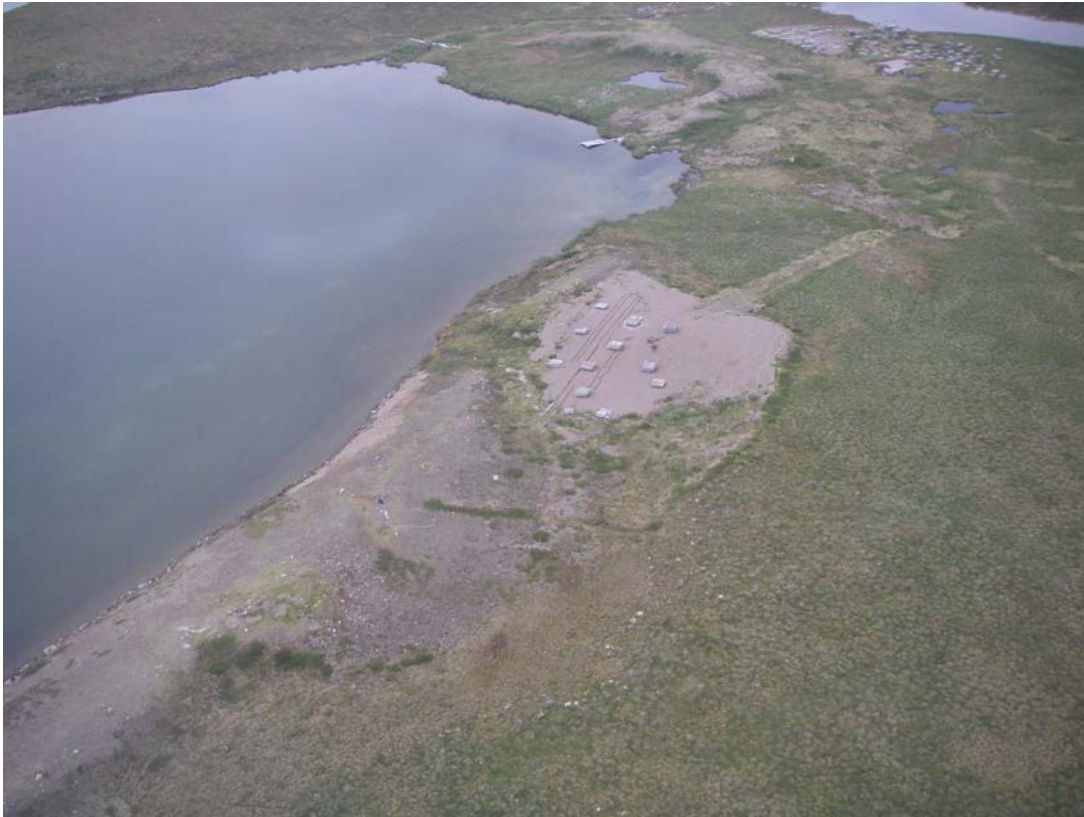
**Photo 9:** Oblique aerial view of the southern section of the core storage area on the eastern shore of Stickleback Lake.

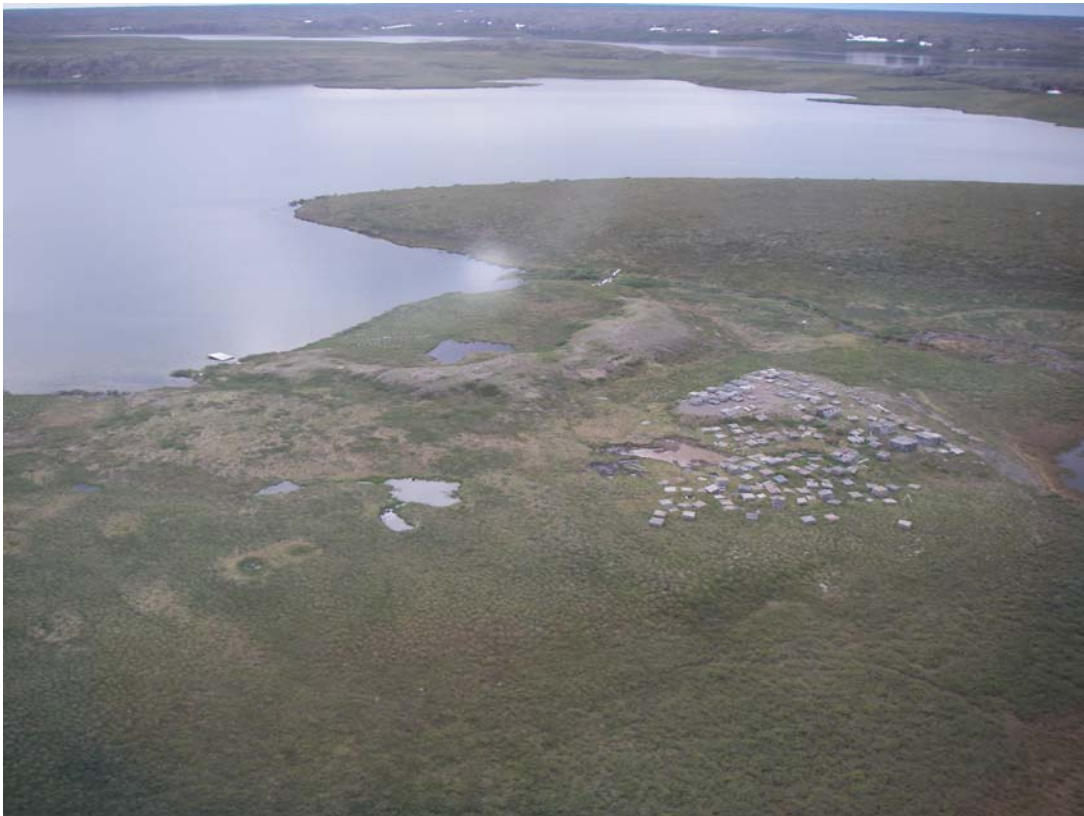
**Photo 10:** Oblique aerial view of the northern section of the core storage area located on the eastern shore of Stickleback Lake.

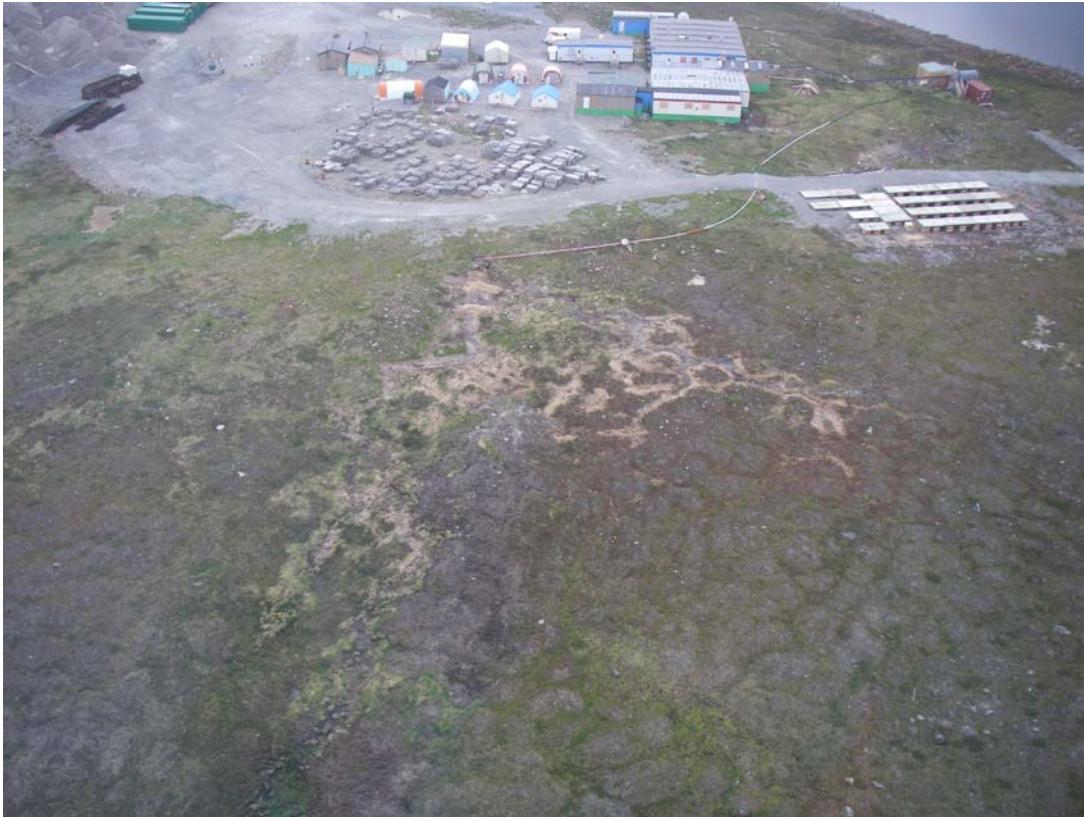
**Photo 11:** Oblique aerial view of the northern end of the Boston Camp pad where the sewage outfall is located.

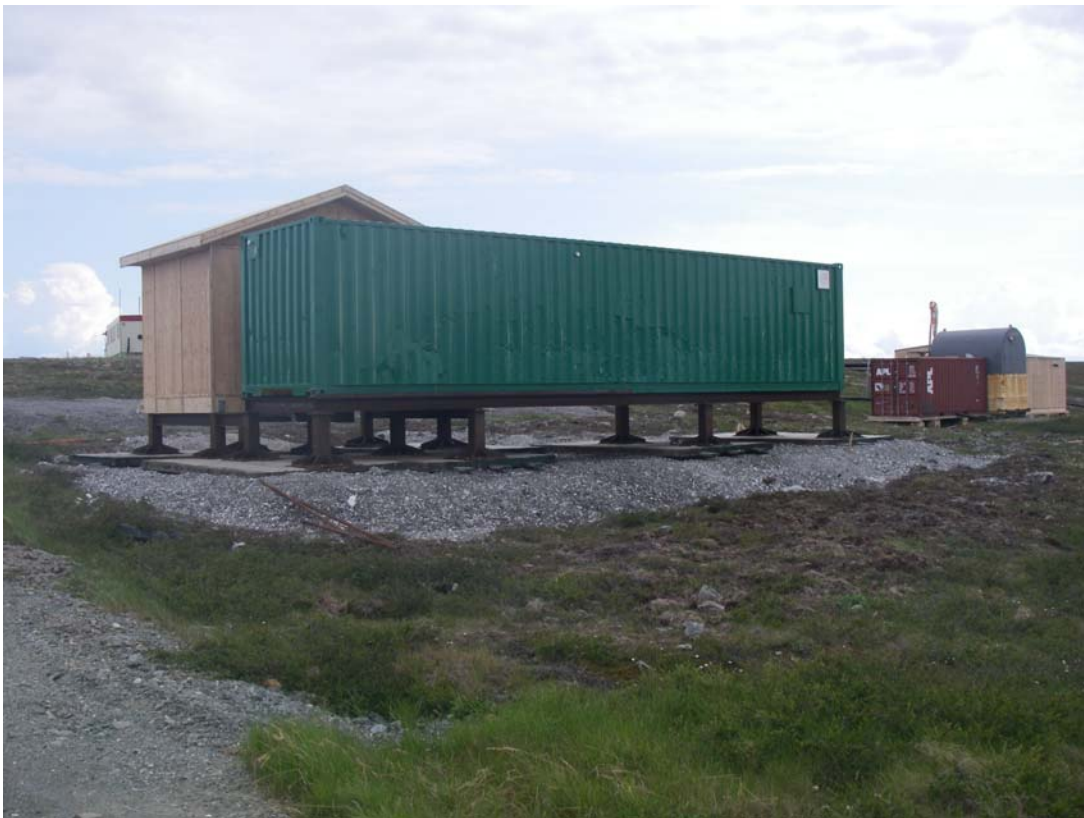
**Photo 12:** Thermal pad and raised foundation for components of the new Boston Sewage Treatment Plant.

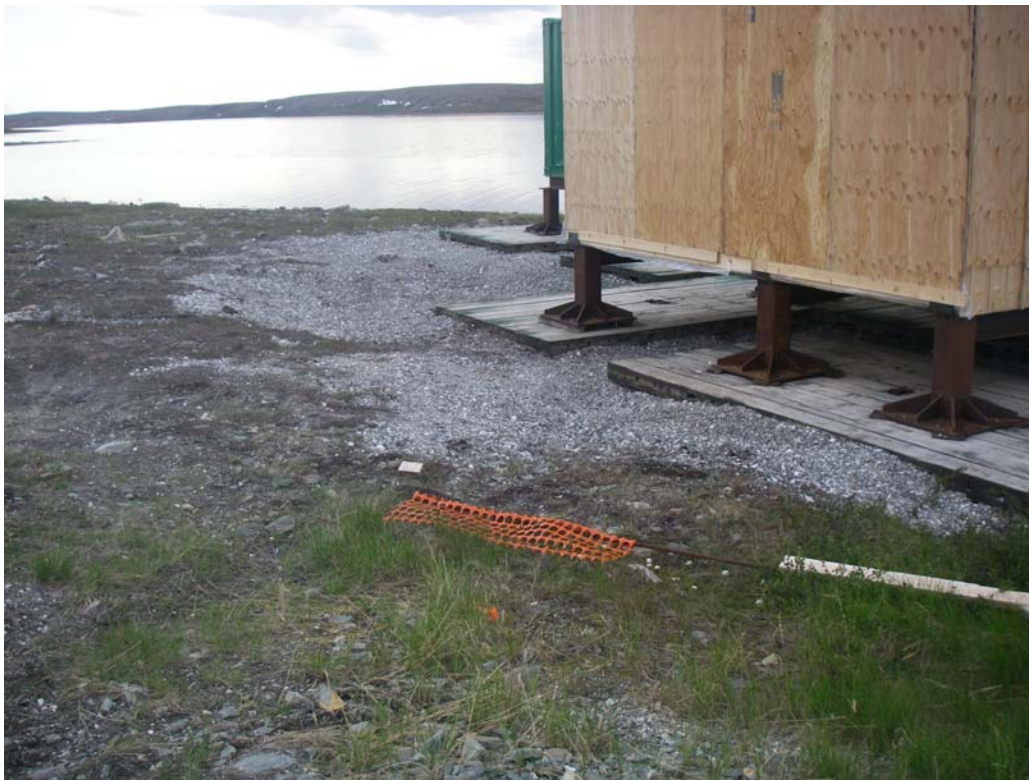
**Photo 13:** Close-up of raised foundation footings used on the new Boston Sewage Treatment Plant.

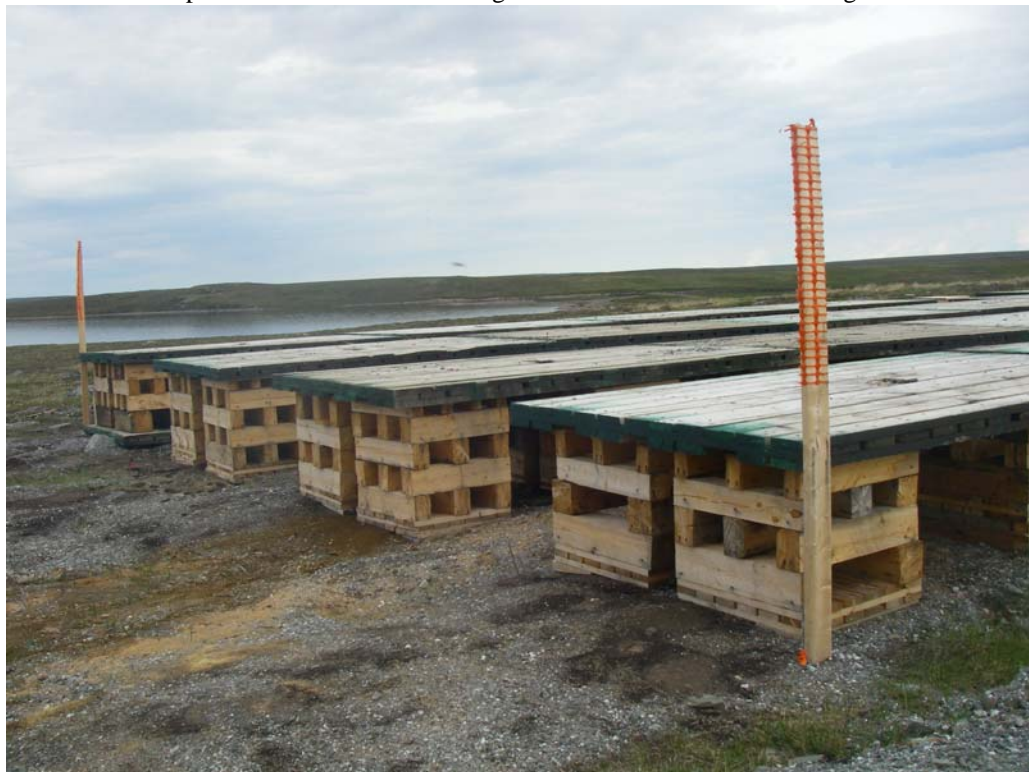
**Photo 14:** Lower end of the leveling foundation for the new Boston Sewage Treatment Plant.

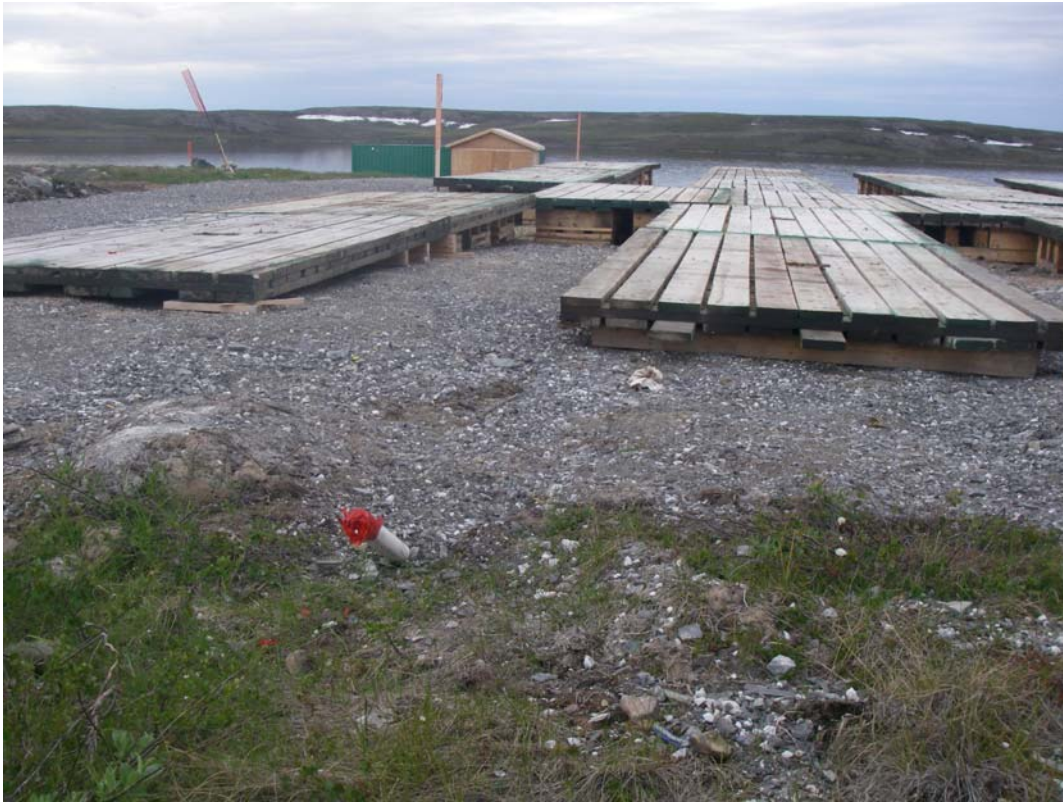
**Photo 15:** Upper end of the leveling foundation for the new Boston Sewage Treatment Plant.

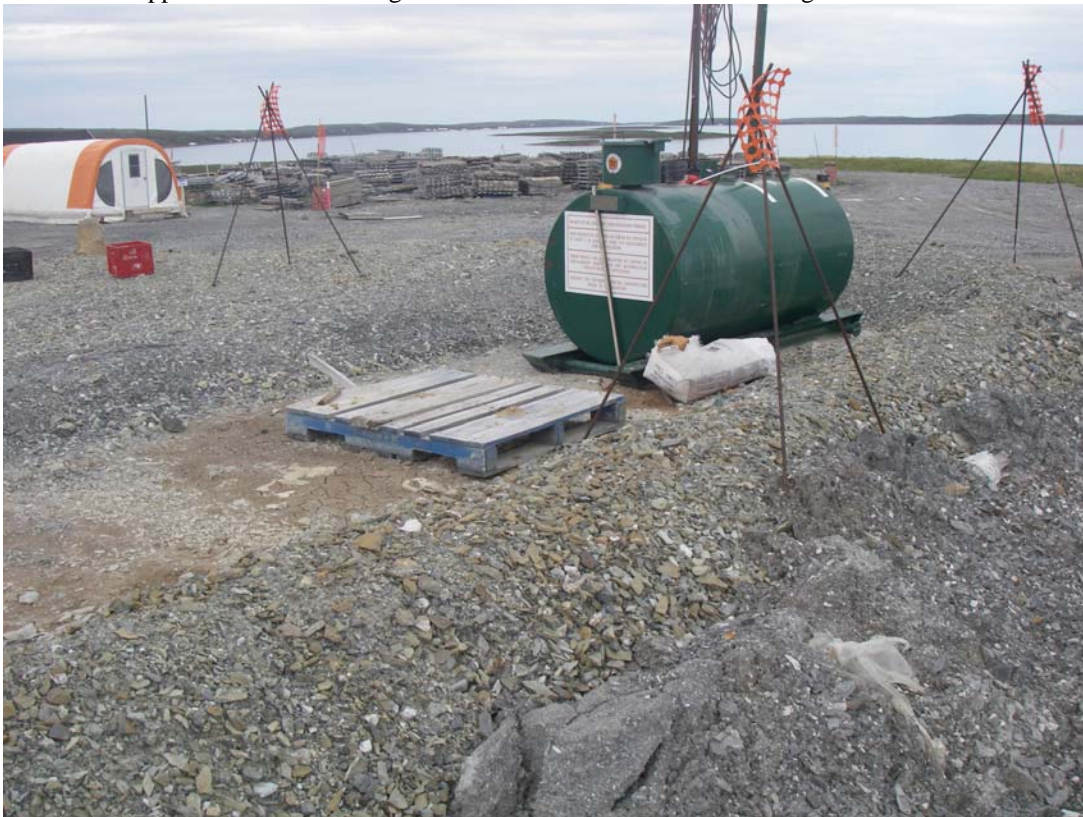
**Photo 16:** New fuel tank immediately north of the geology shacks.

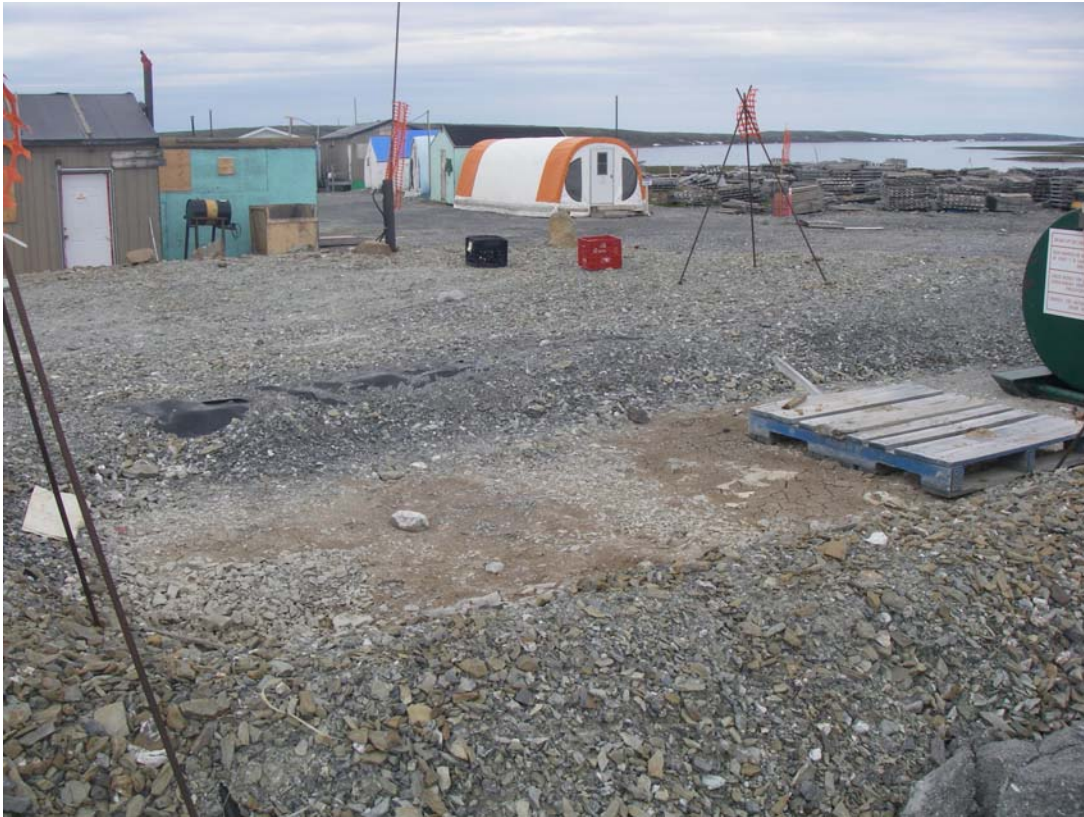
**Photo 17:** Another view of the new fuel tank and secondary containment facility immediately north of the geology shacks.

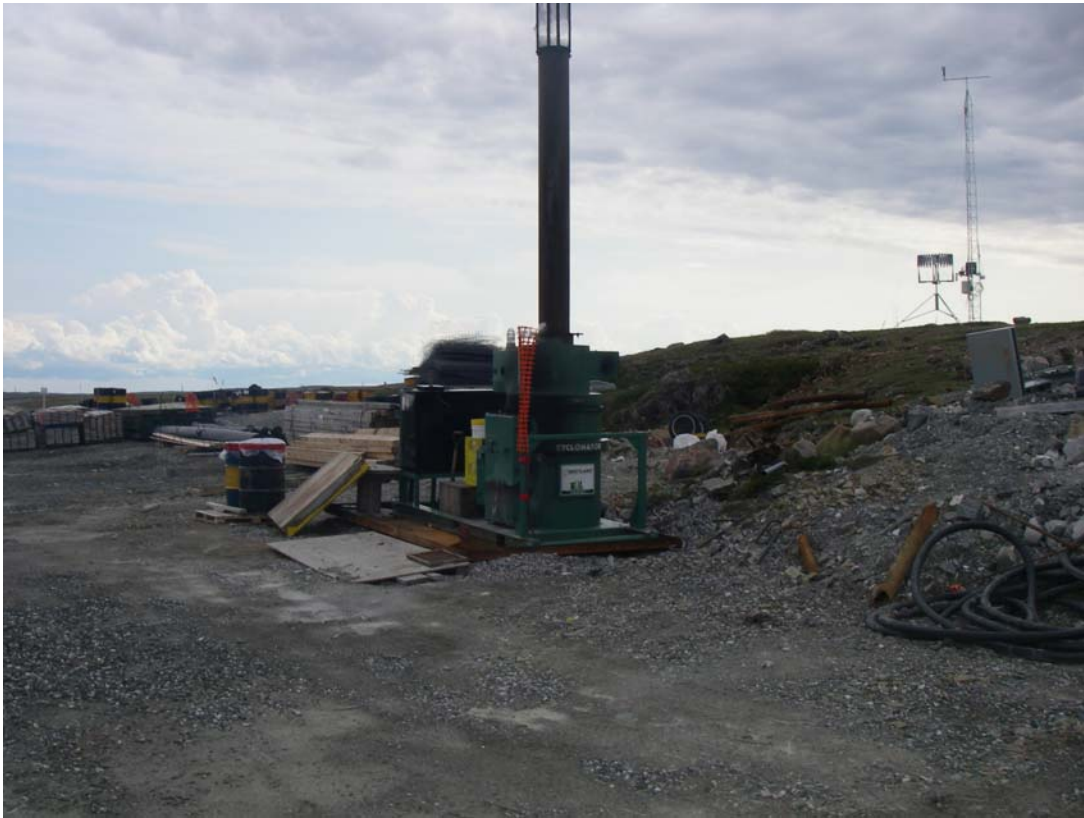
**Photo 19:** View of the Boston Camp incinerator.

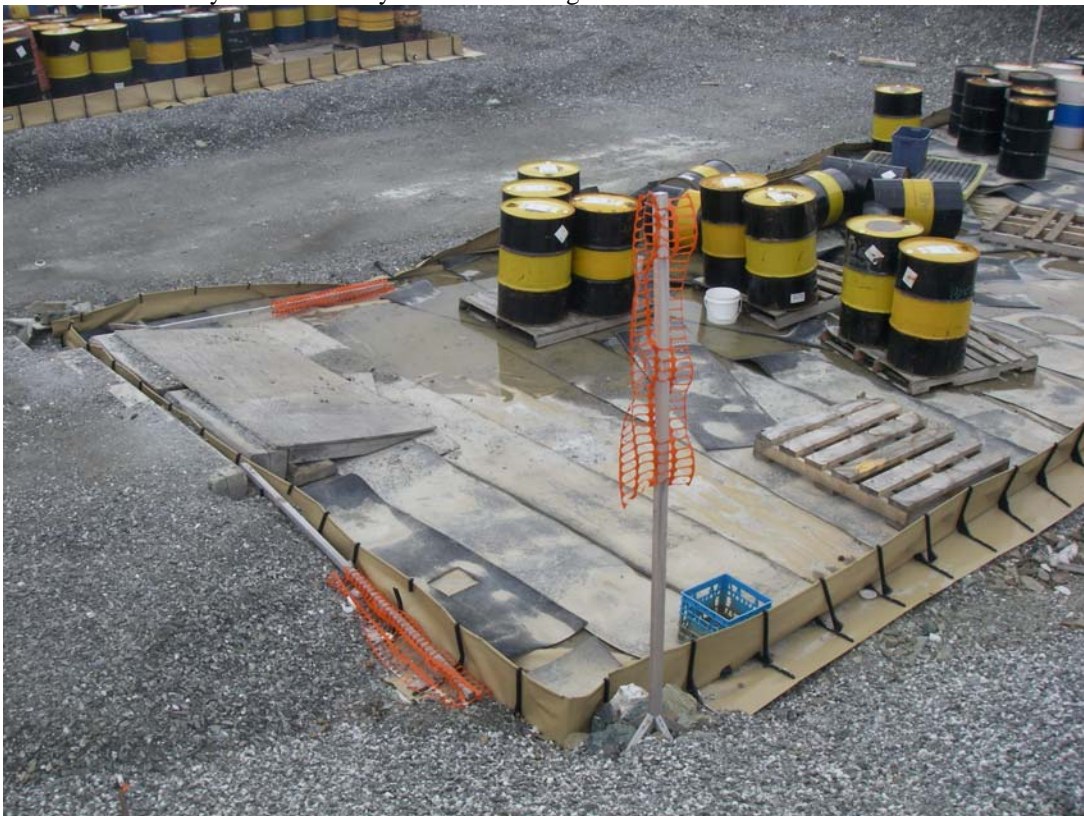
**Photo 22:** More jet fuel stored in a secondary containment facility. Note the access ramp constructed to facilitate loading and unloading of fuel.

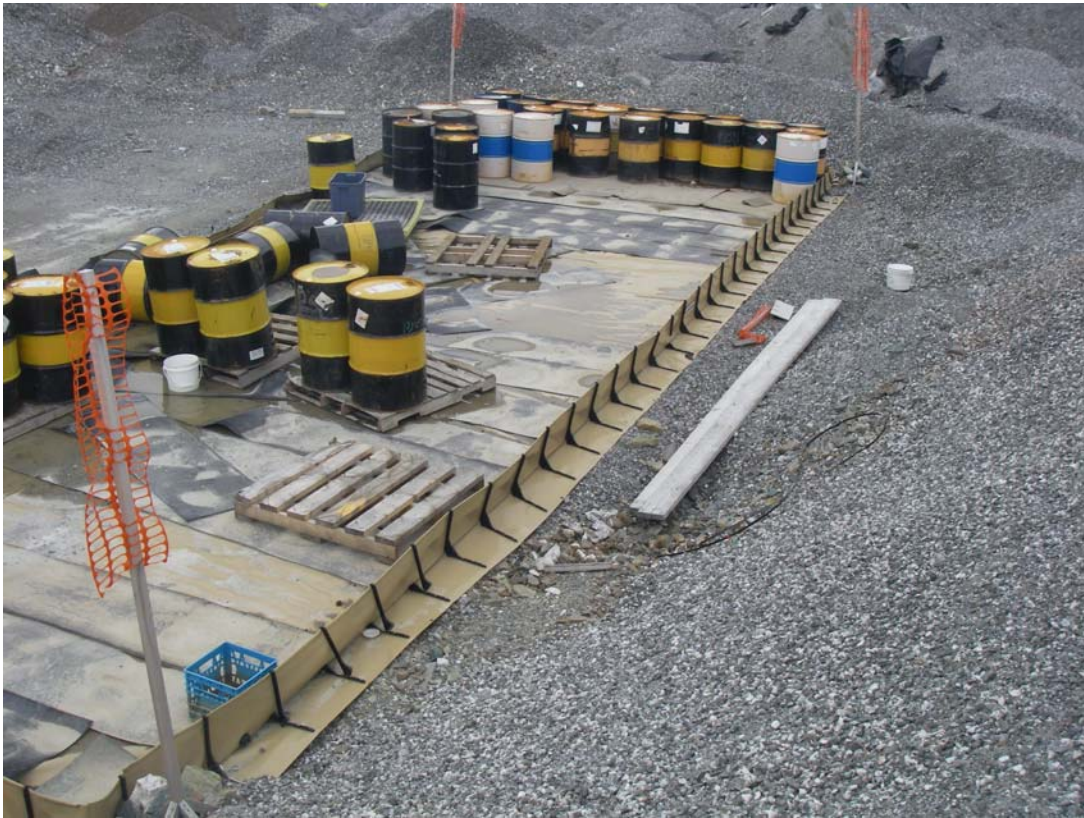
**Photo 23:** Another view of the secondary containment system used to store the jet fuel.

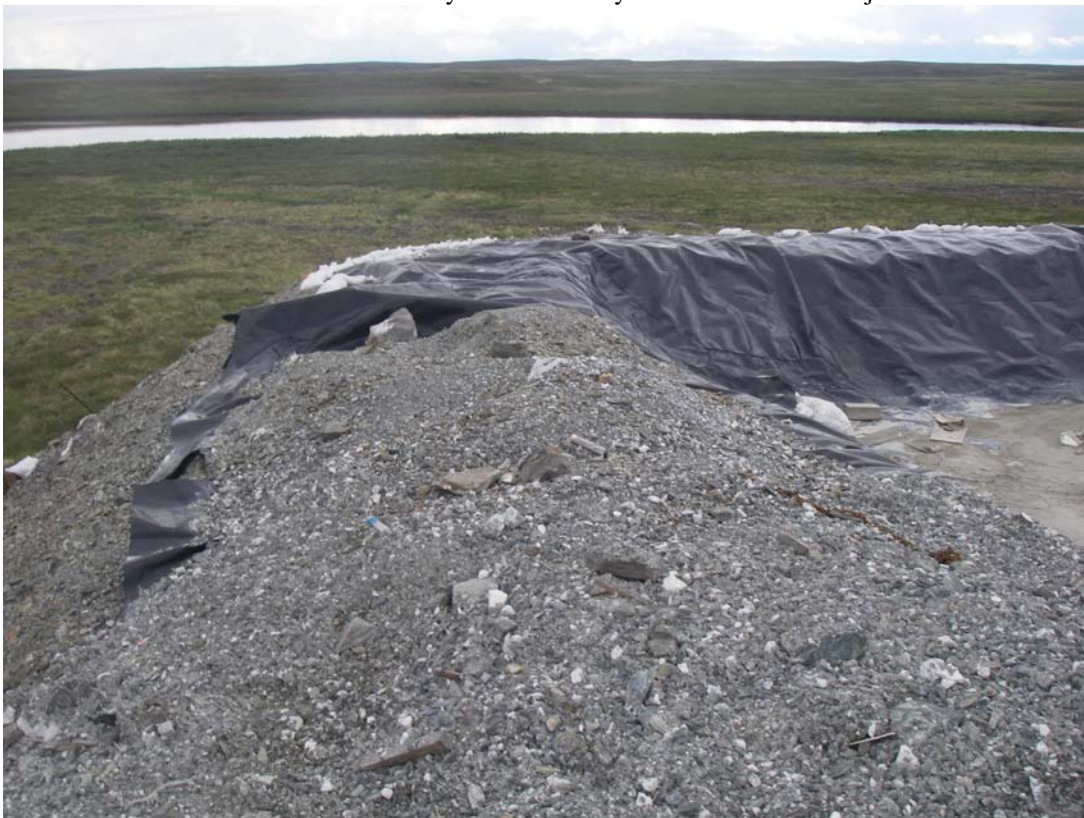
**Photo 24:** Looking east across the northern edge of the lined settling pond.

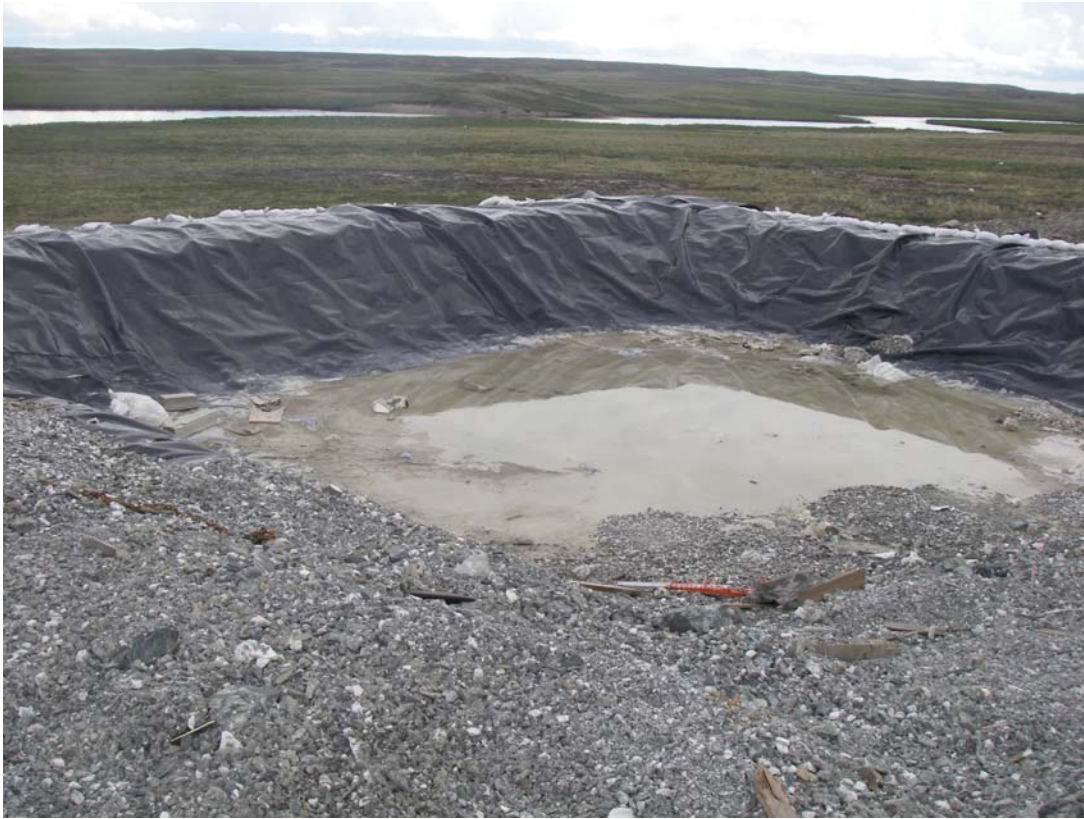
**Photo 25:** Another view across the central section of the lined settling pond

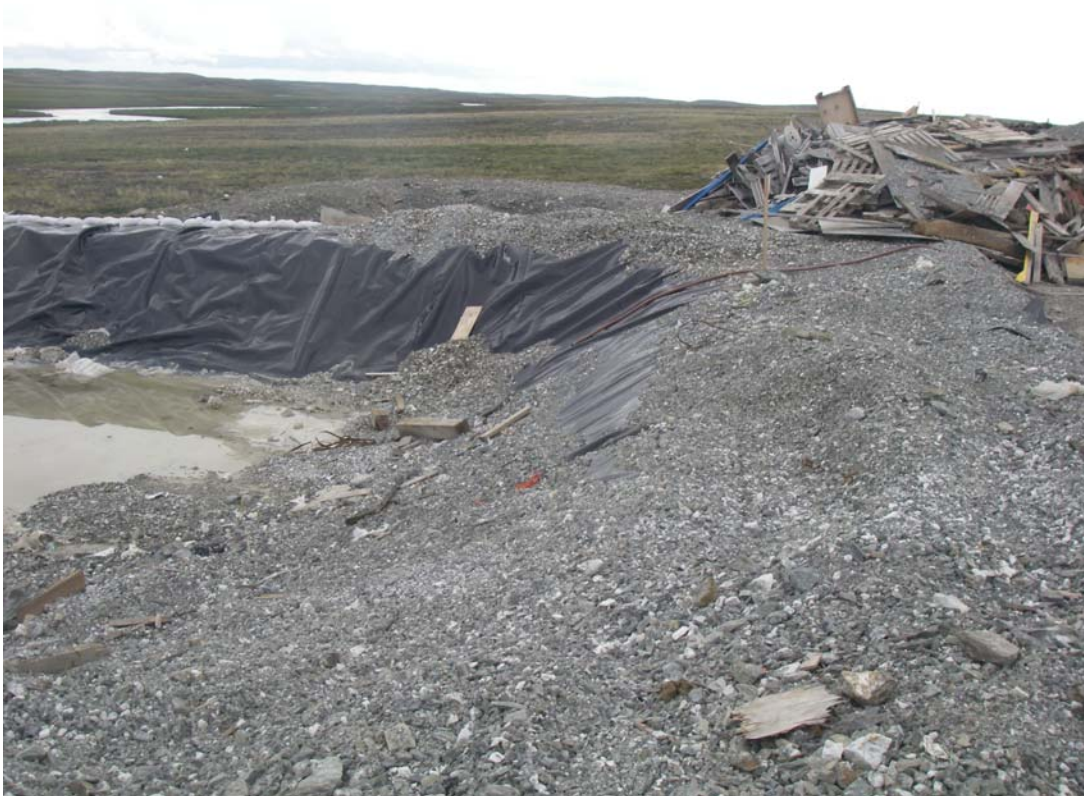
**Photo 26:** Looking out across the southern edge of the lined settling pond.

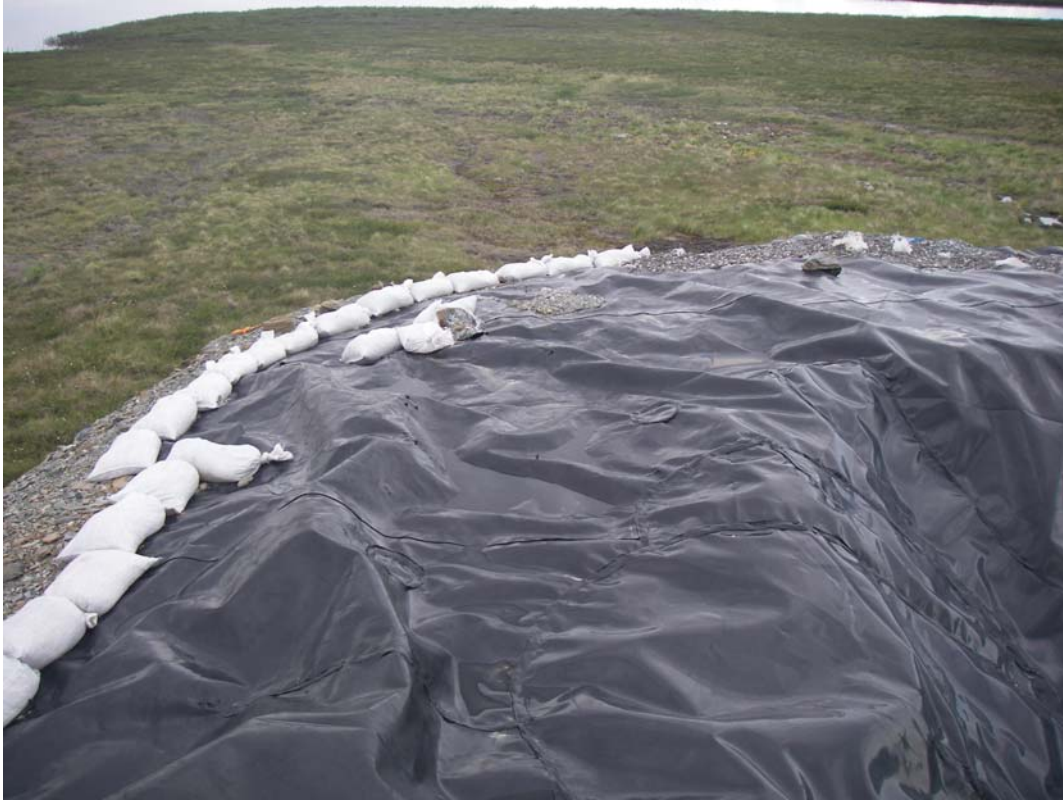
**Photo 27:** View of the sand bags used to anchor the liner for the setting pond.

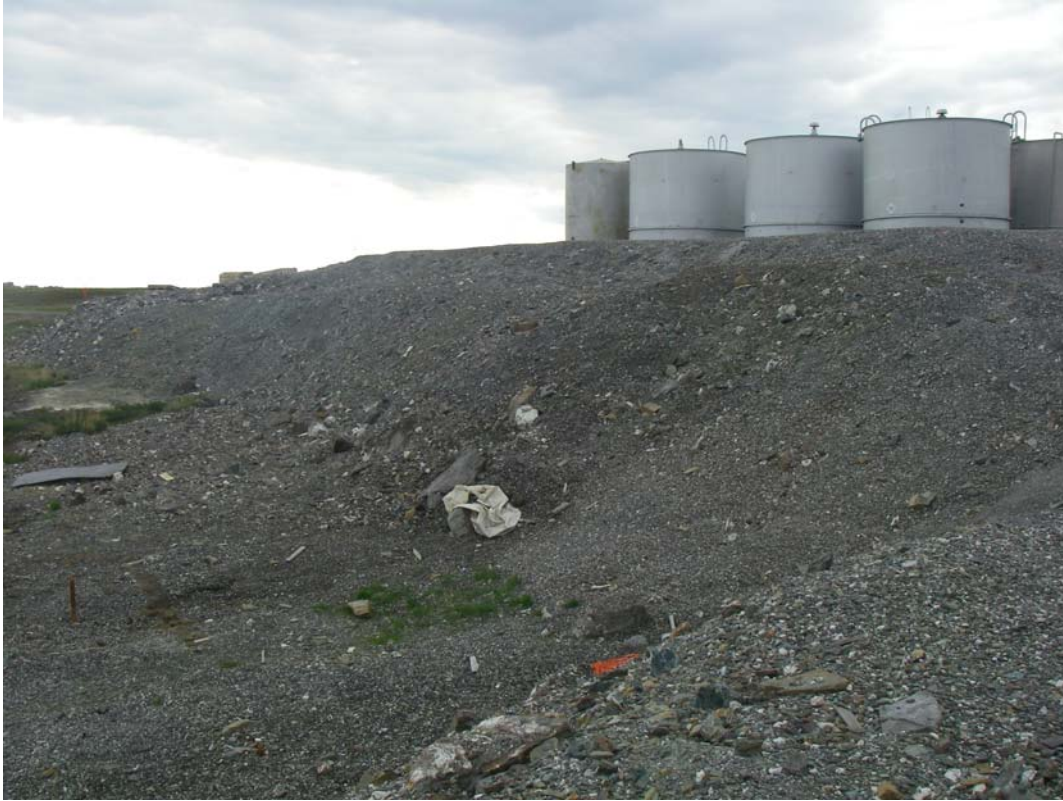
**Photo 29:** Looking south-west towards the outer edge of the thermal pad upon which the fuel tank farm has been constructed.

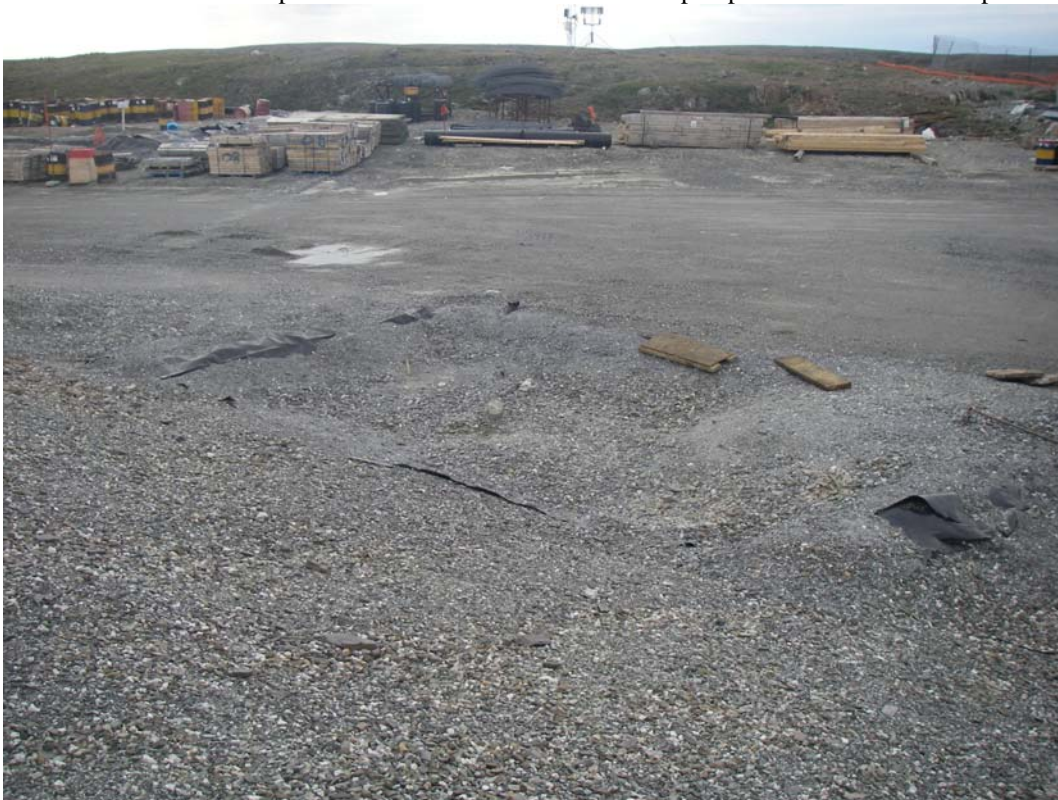
**Photo 32:** View of the secondary containment area where tidy tanks had been stored in the past. This area seems to no longer be in use.

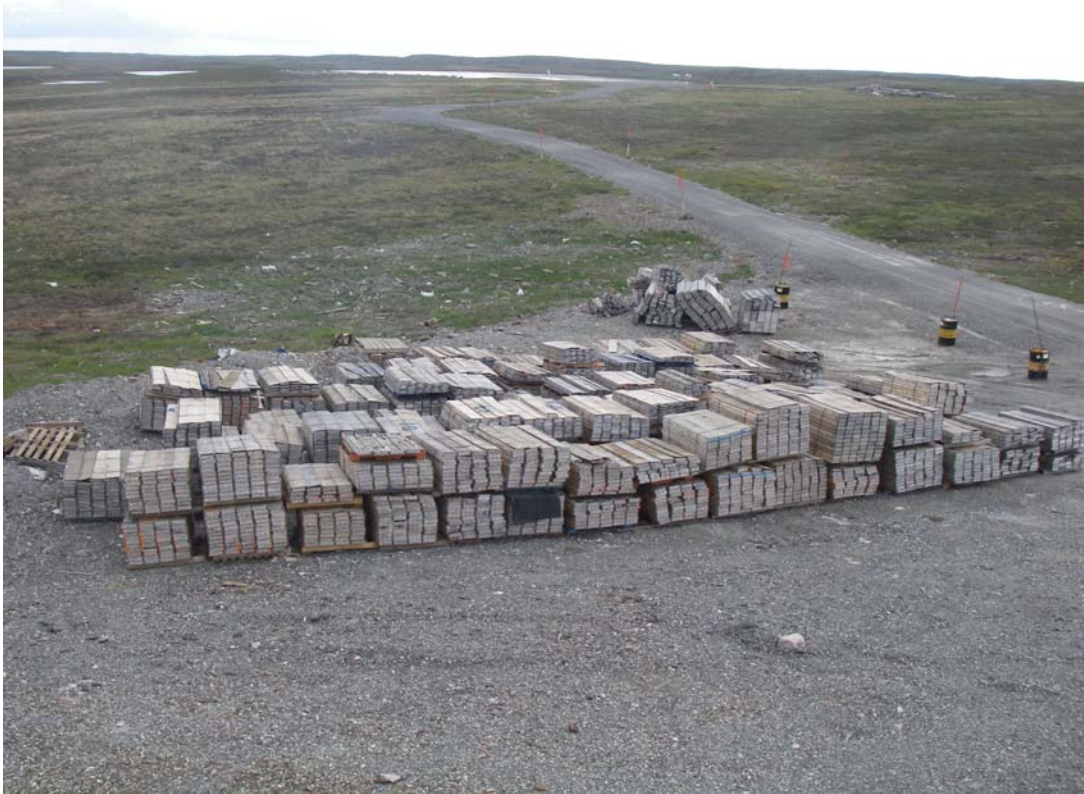
**Photo 33:** Looking south across a core storage area located immediately south of the fuel tank farm.

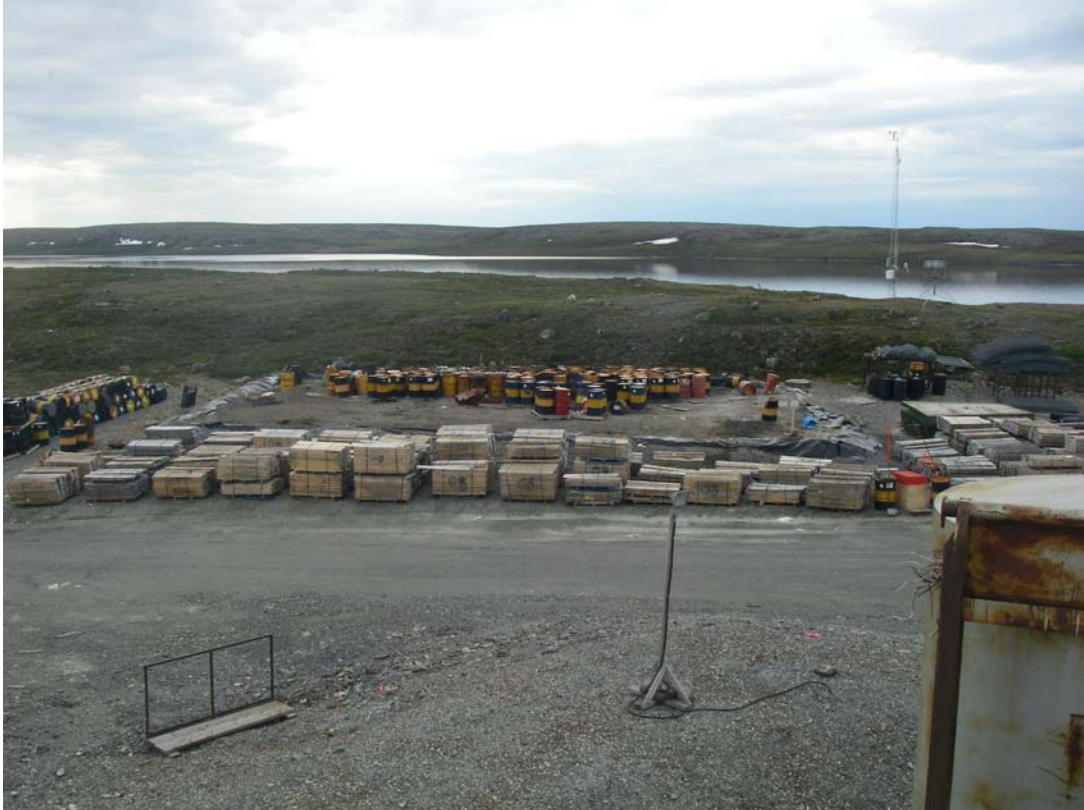
**Photo 34:** Looking west across a core storage area with the land farm in the background.
