# HOPE BAY MINING LIMITED

## 2009 Annual Geotechnical Inspection, Boston Advanced Exploration Project, Hope Bay, Nunavut

Project No. 1CH008.021

**November 2009**

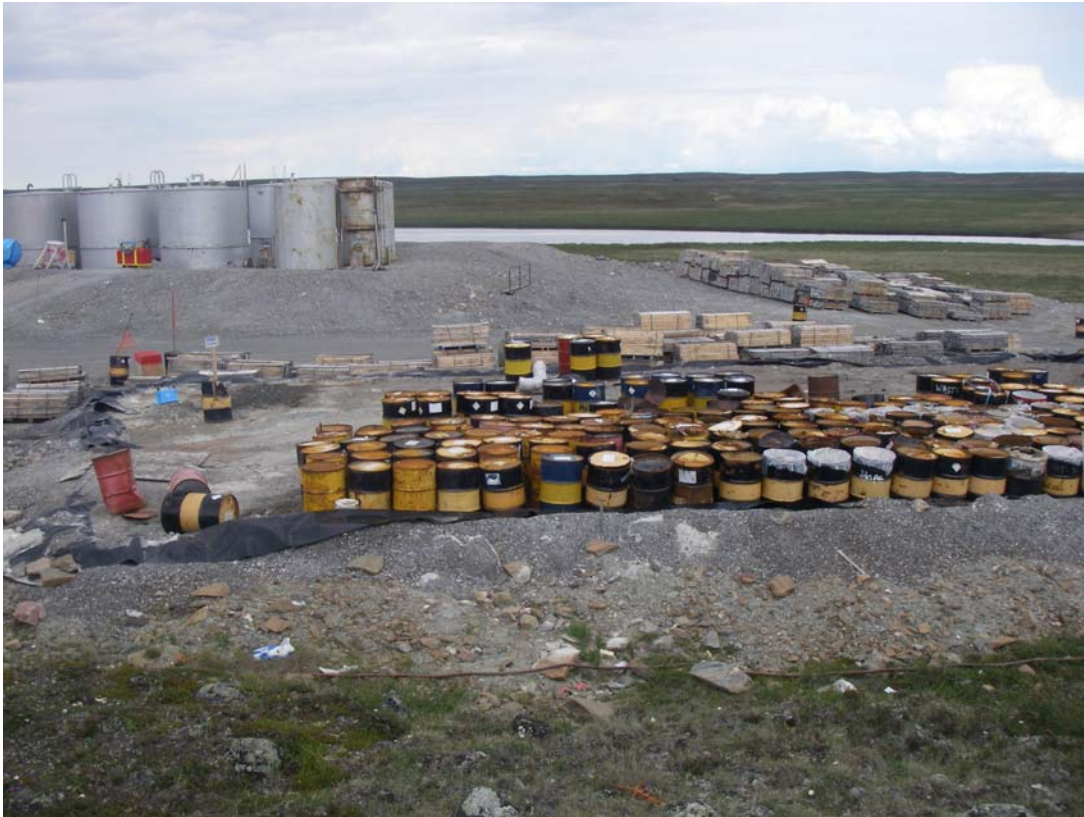
**Photo 35:** Looking east across the northern end of the land farm. Barrels filled with hydrocarbon contaminated soils are stored on the land farm.

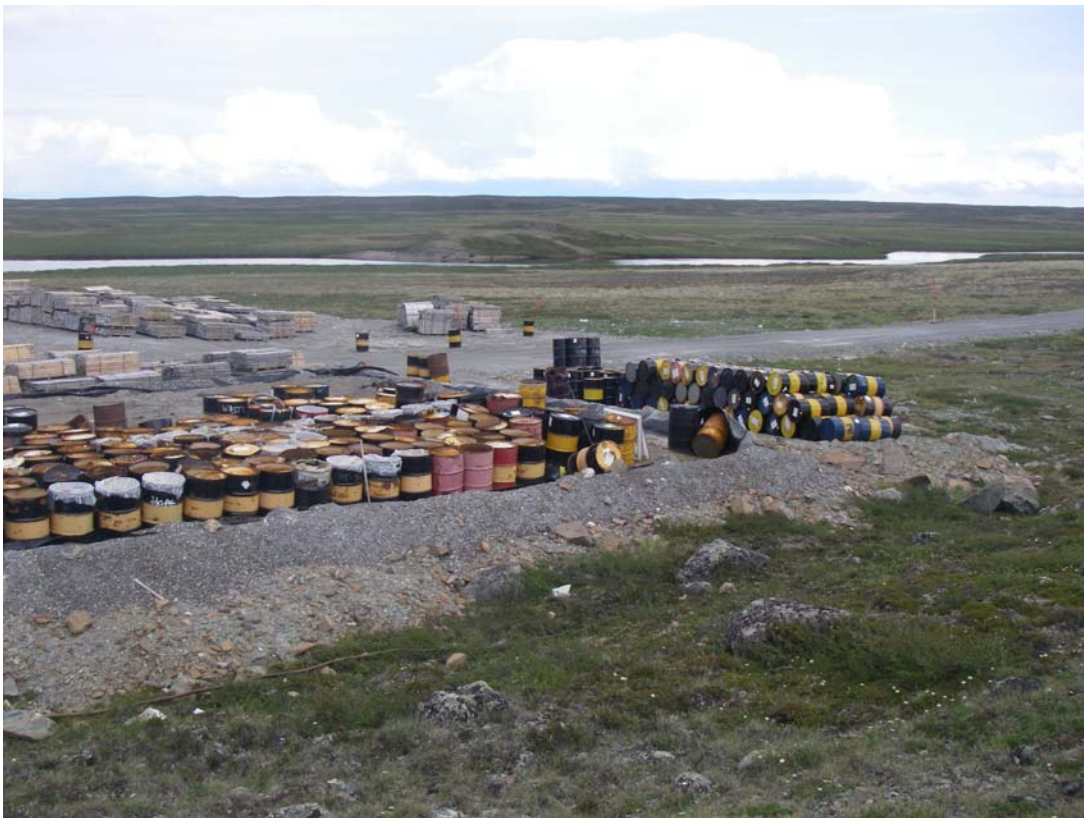
**Photo 36:** Looking east across the southern end of the land farm. There is a stockpile of empty barrels stored south of the land farm.

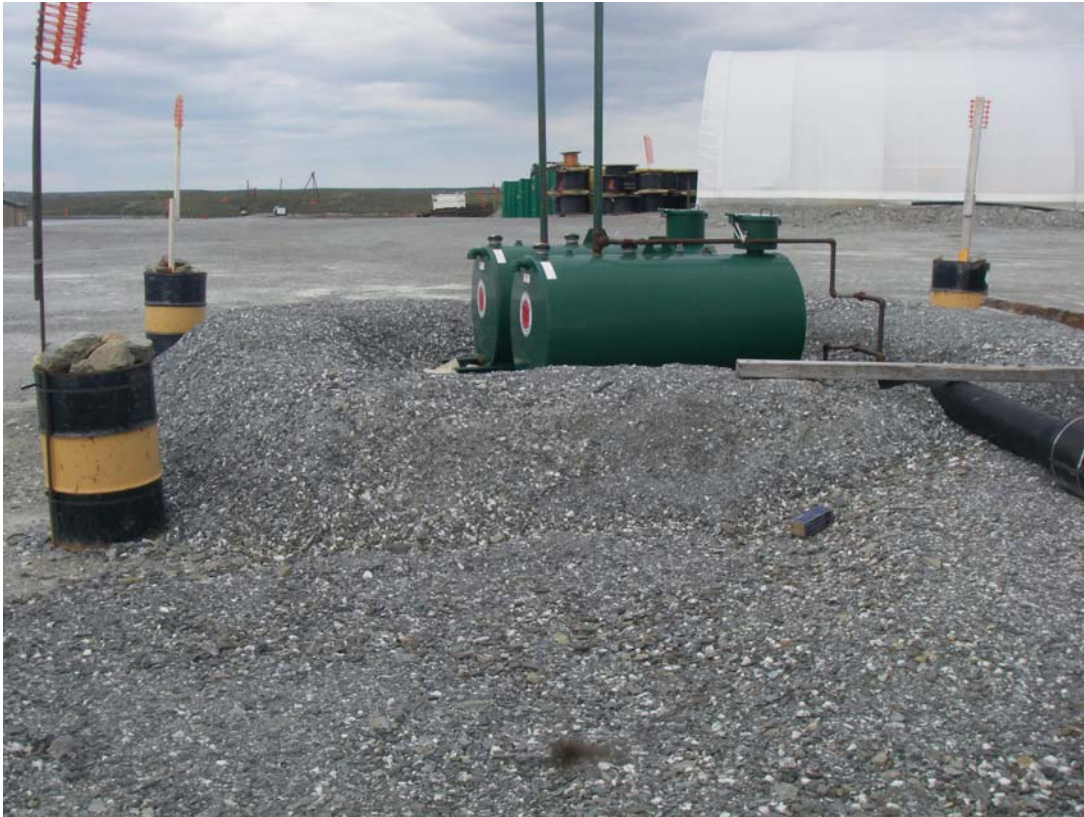
**Photo 39:** View of the secondary containment and fuel tanks (western section) supplying the diesel power generators.

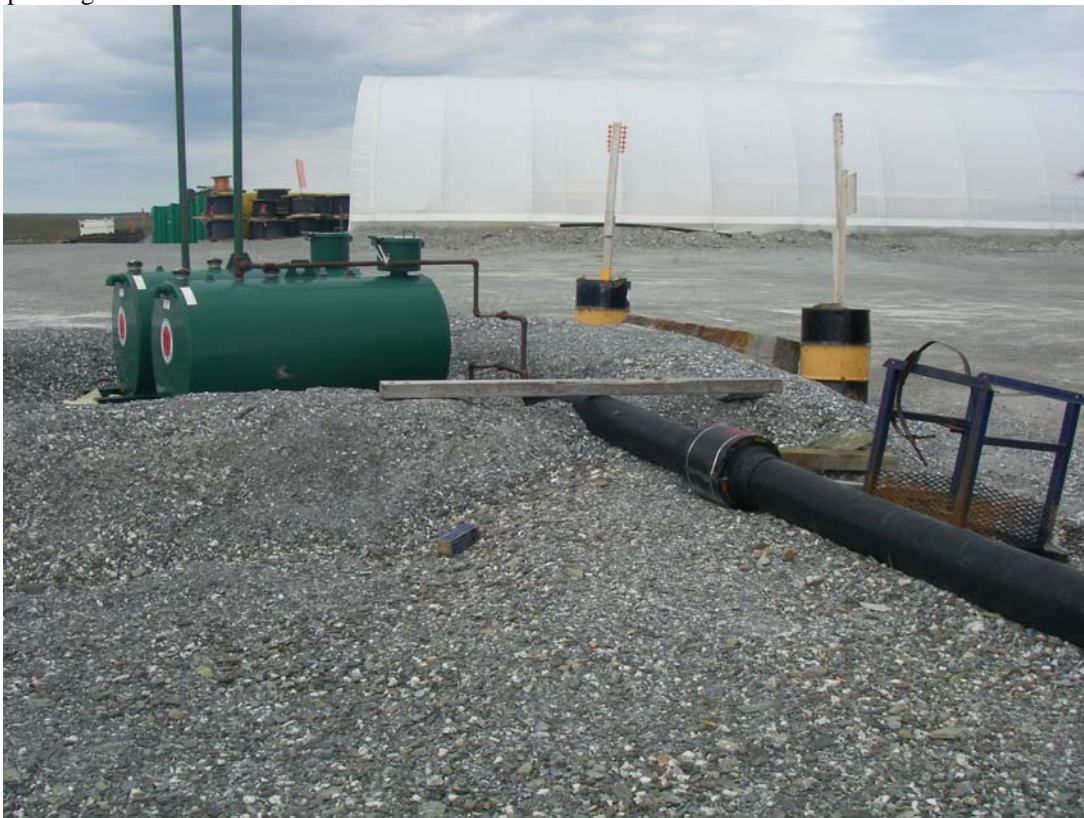
**Photo 40:** View of the secondary containment and fuel tanks (eastern section) supplying the diesel power generators.

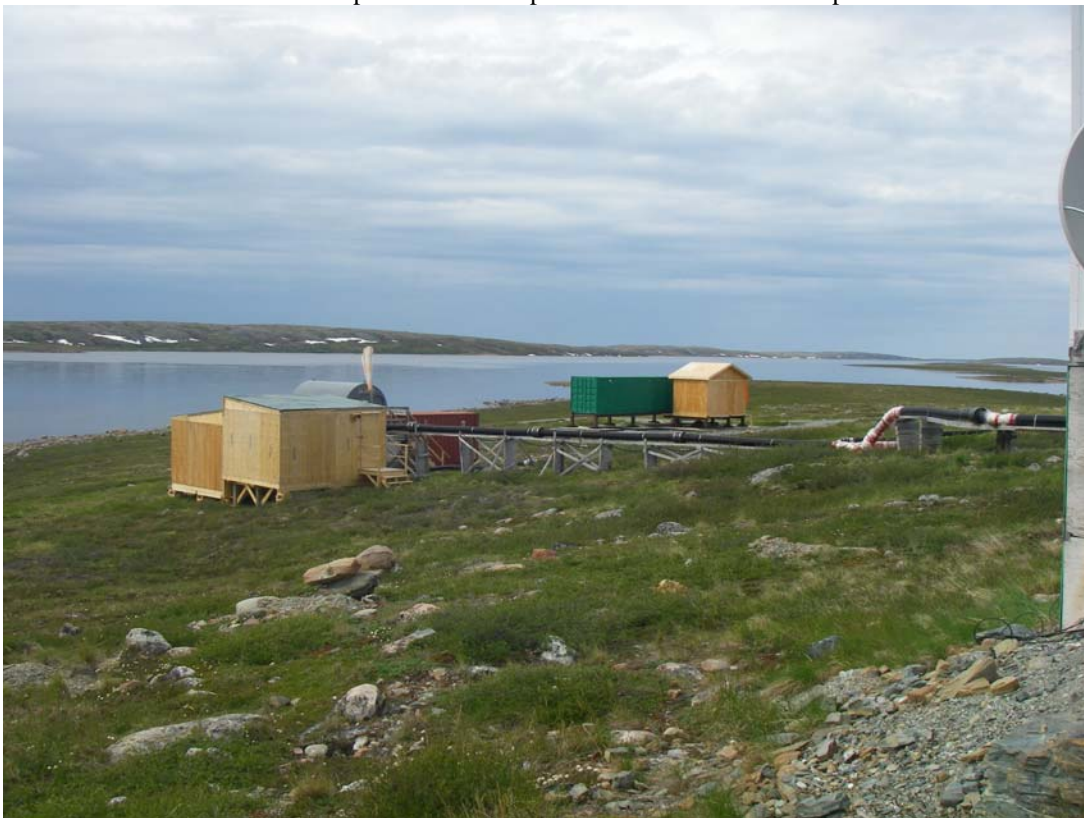
**Photo 42:** Looking north with the old (existing) sewage treatment plant (STP) in the foreground and the building that will contain the new STP in the background.

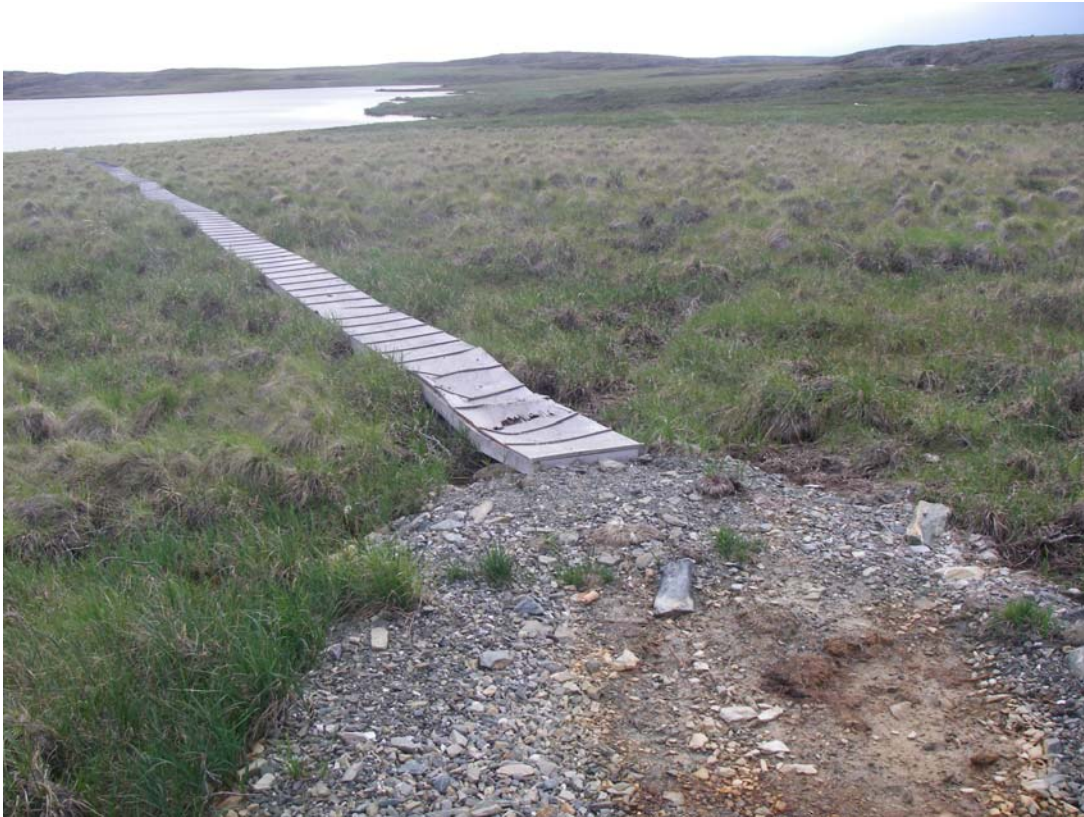
**Photo 49:** Looking south towards the wooden walkway leading from the south end of the airstrip towards the boat dock in Stickleback Lake.

Wooden Walkway to Boat Dock	<ul style="list-style-type: none"> <li>Consider raising the walkway above the tundra to prevent onset of permafrost degradation</li> <li>If boat dock is to be decommissioned consider removing the walkway altogether</li> </ul>	<ul style="list-style-type: none"> <li>Consider raising the walkway above the tundra to prevent vegetation dieback and possible onset of permafrost degradation</li> <li>If boat dock is to be decommissioned consider removing the walkway altogether</li> </ul>
Radio Tower and Shack	<ul style="list-style-type: none"> <li>Not reported in 2008</li> </ul>	<ul style="list-style-type: none"> <li>No action required</li> </ul>
Water Intake Pump Shack	<ul style="list-style-type: none"> <li>Not reported in 2008</li> </ul>	<ul style="list-style-type: none"> <li>Consider installing thermal pad or other appropriate foundation system</li> </ul>
Existing STP Foundation Pad	<ul style="list-style-type: none"> <li>Not reported in 2008</li> </ul>	<ul style="list-style-type: none"> <li>No action required</li> </ul>

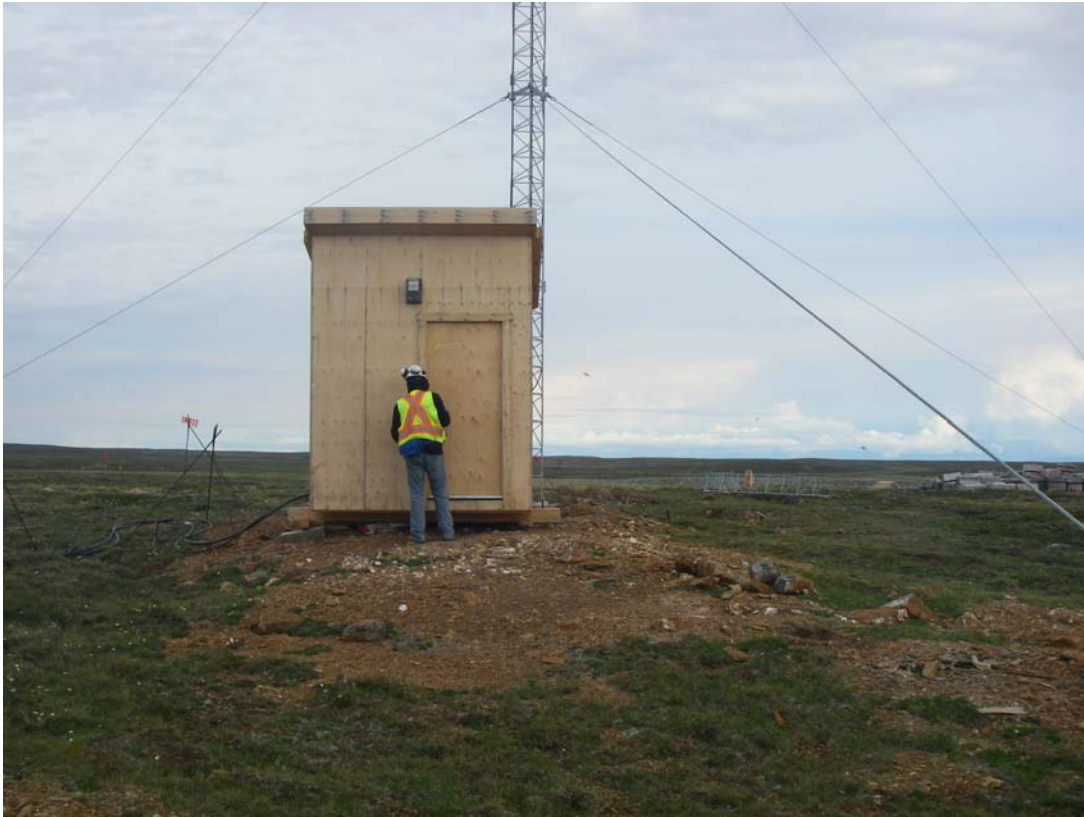
**Photo 51:** Enclosure for radio equipment installed on raised wooden foundation on rock outcrop.

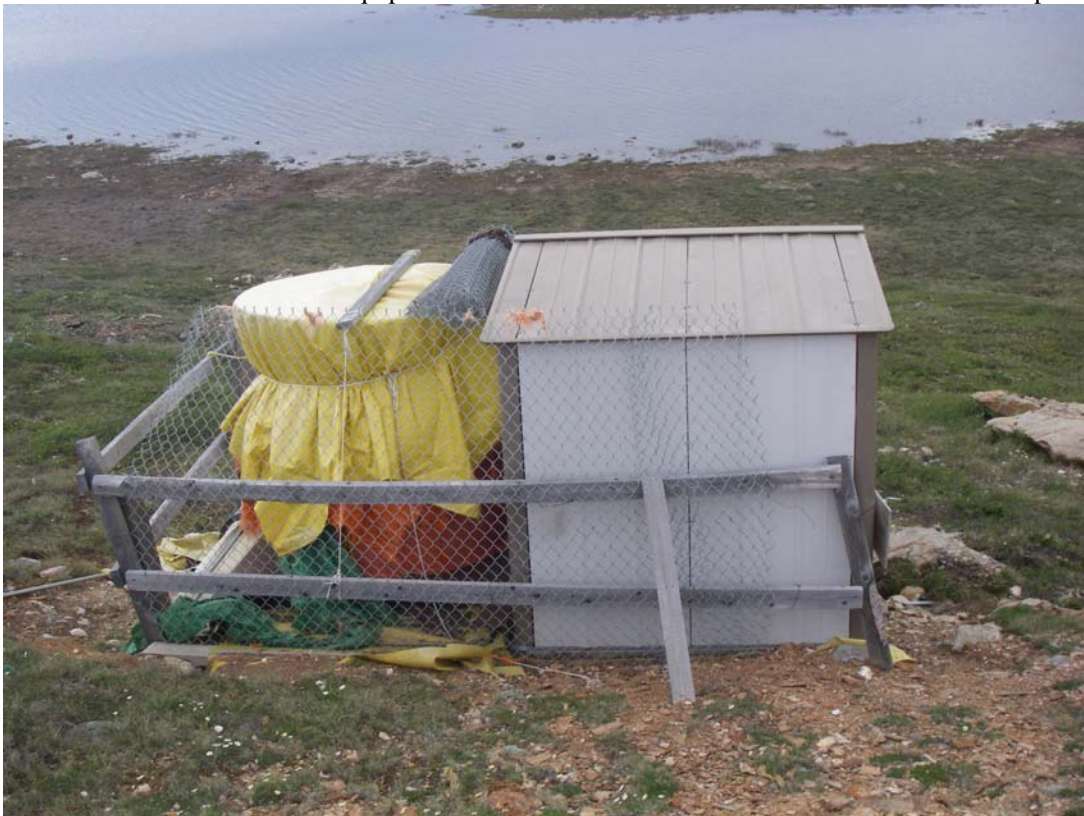
**Photo 52:** Looking west across the vent raise.

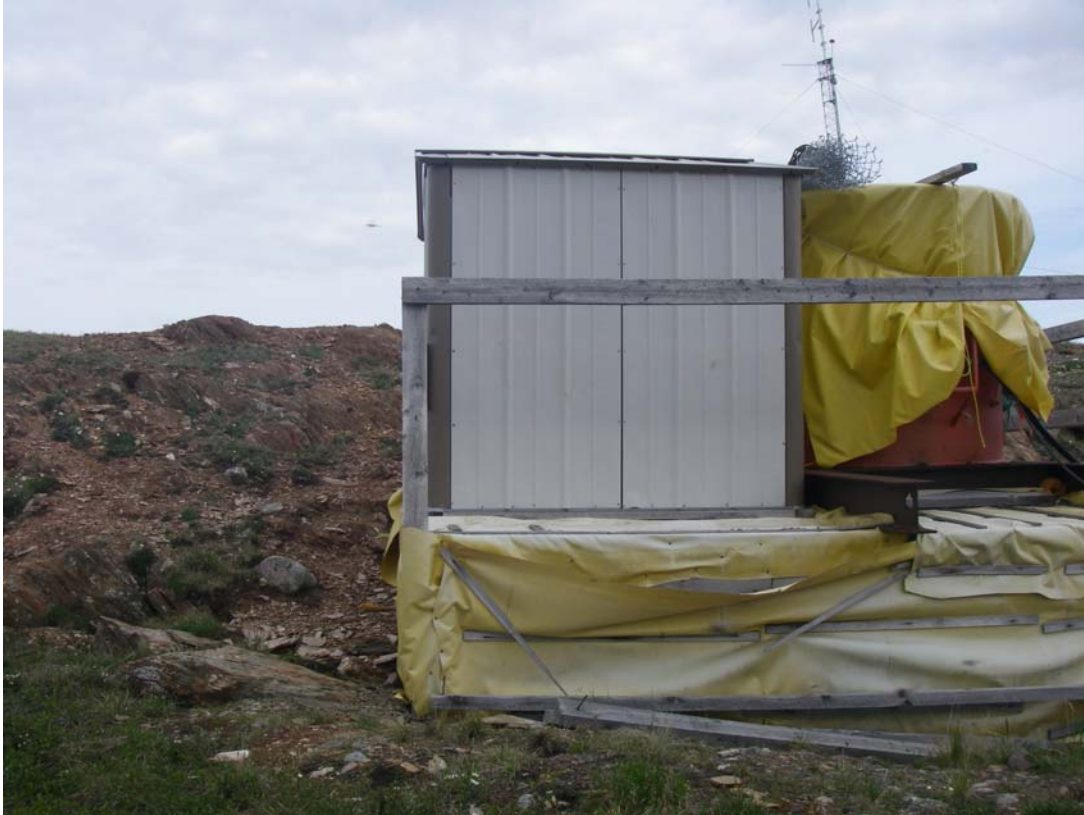
**Photo 53:** Looking east across the northern section of the vent raise.

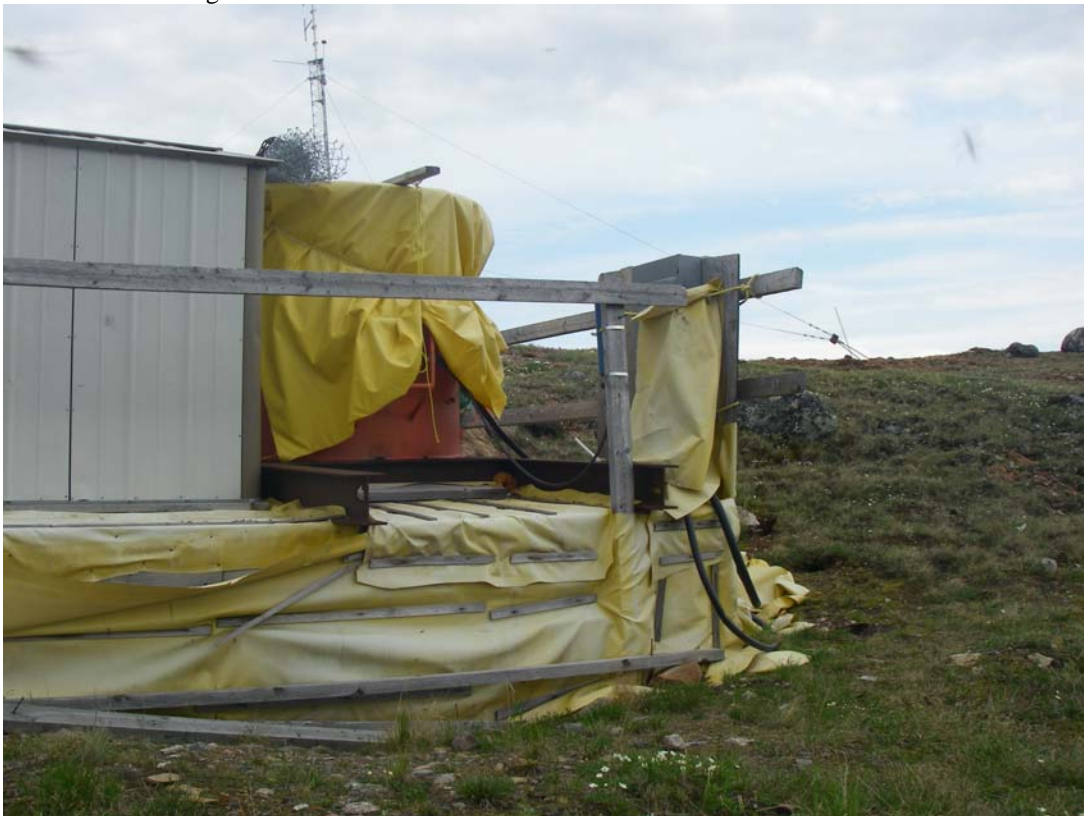
**Photo 54:** Looking east across the southern section of the vent raise.

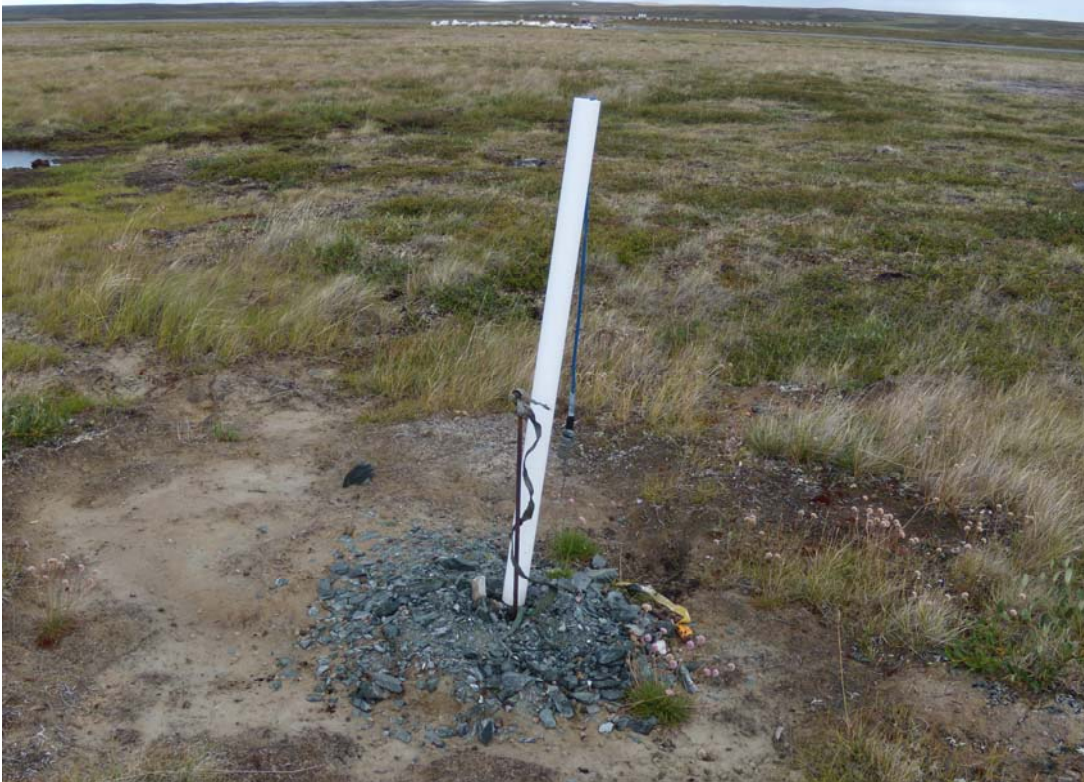
**Photo 58:** Drill hole 12259-05 (BH5) with thermistor string #1050.

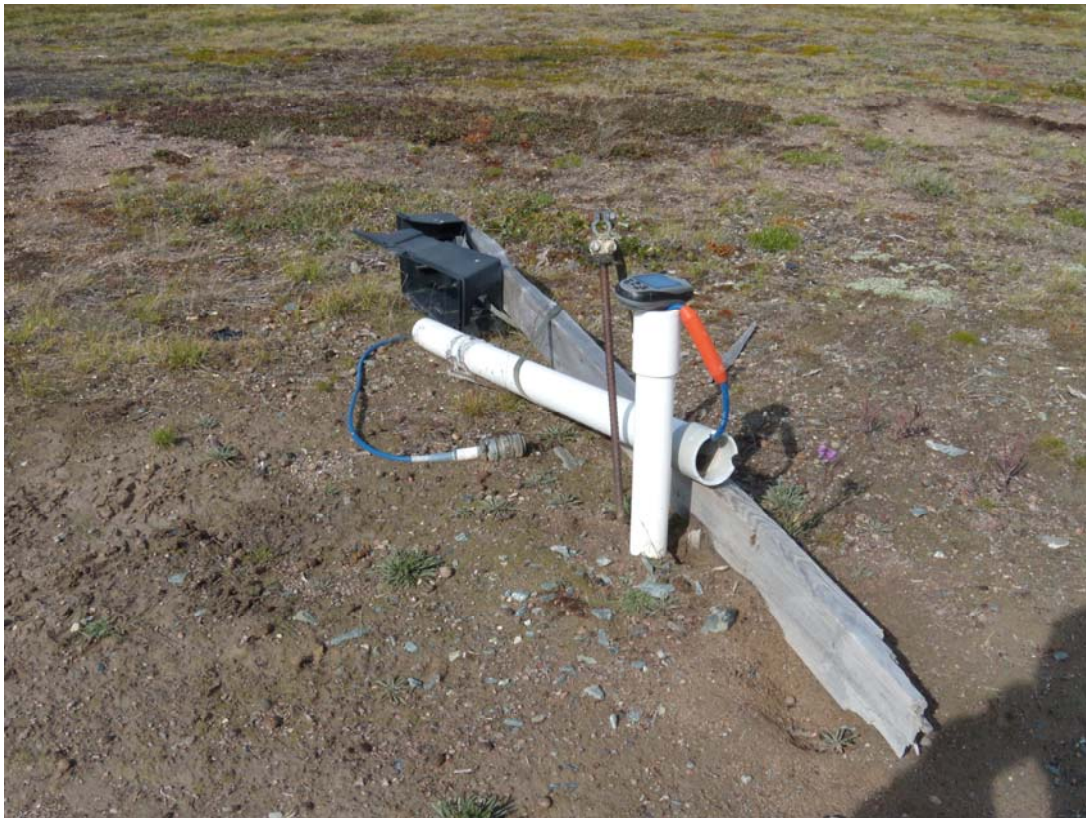
**Photo 59:** Drill hole 12259-06 (BH6) with thermistor string #1051.

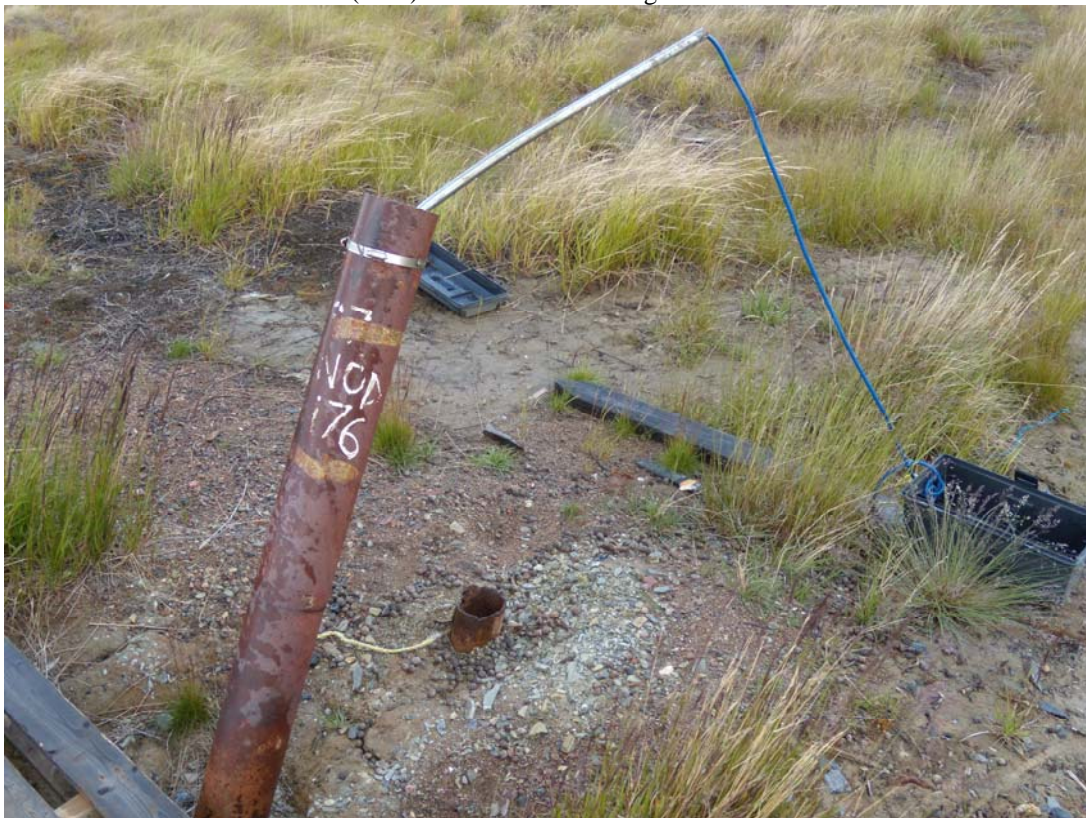
**Photo 60:** Drill hole 97NOD176 with thermistor string.

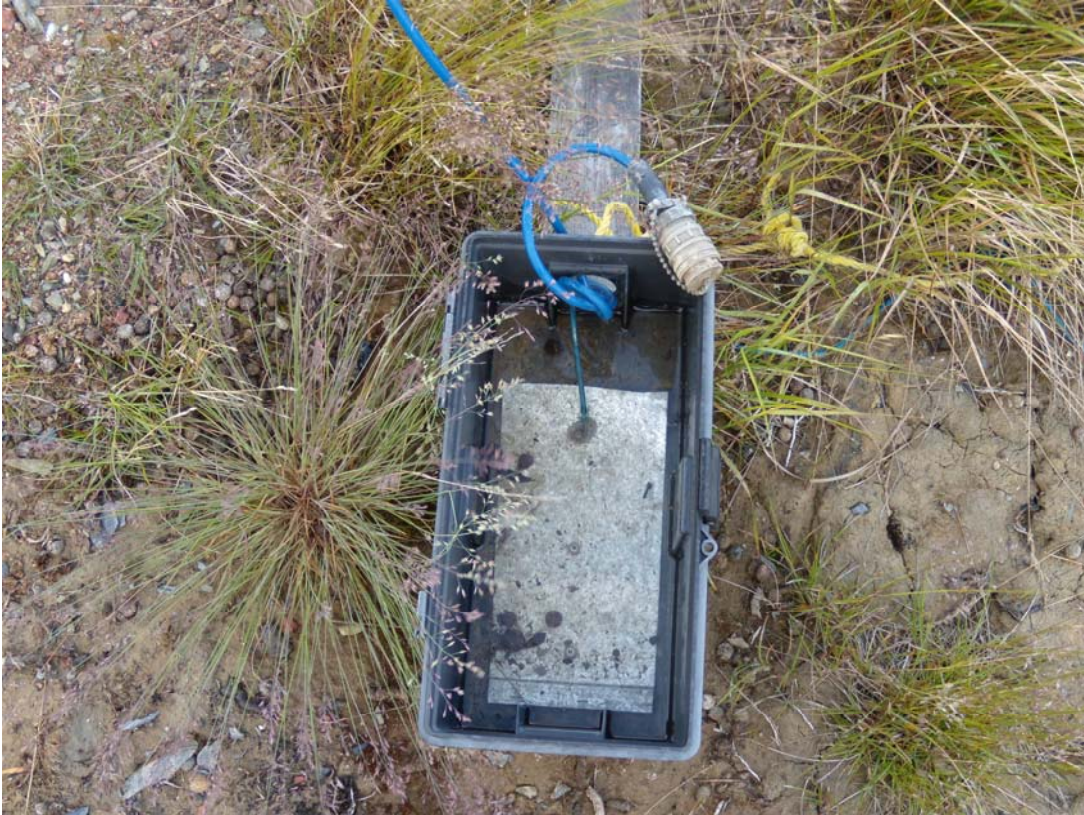
**Photo 61:** Close-up of the readout box and terminal connector for the thermistor string on drill hole 97NOD176.
