2010 Annual Geotechnical Inspection, Boston Advanced Exploration Project

Hope Bay, Nunavut

Project Reference Number
SRK 1CH008.032

February 2011

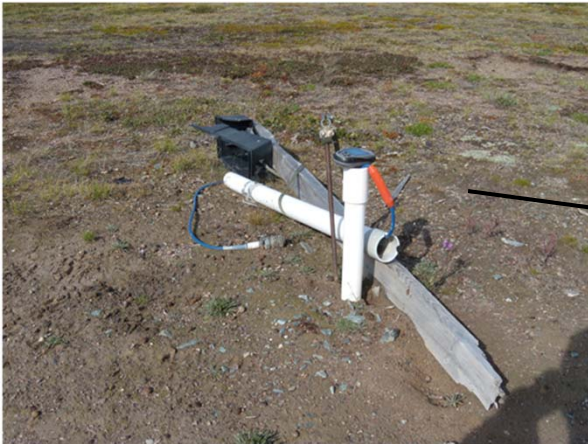
Drill hole 12259-06 (BH6) with thermistor string #1051.

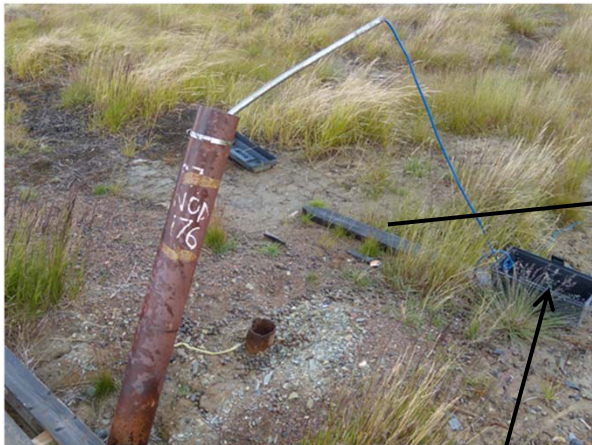
Drill hole 97NOD176 with thermistor string.

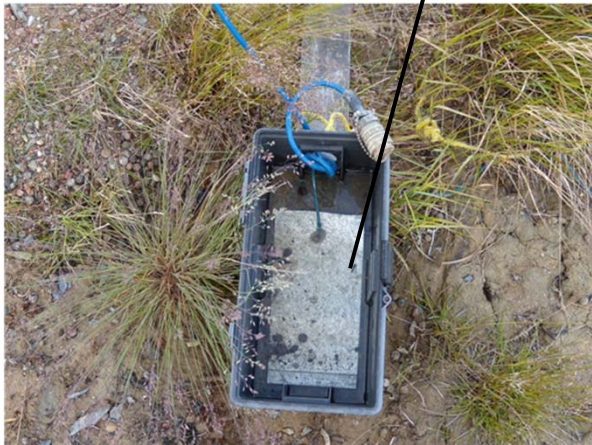
Close-up of the readout box and terminal connector for the thermistor string on drill hole 97NOD176.

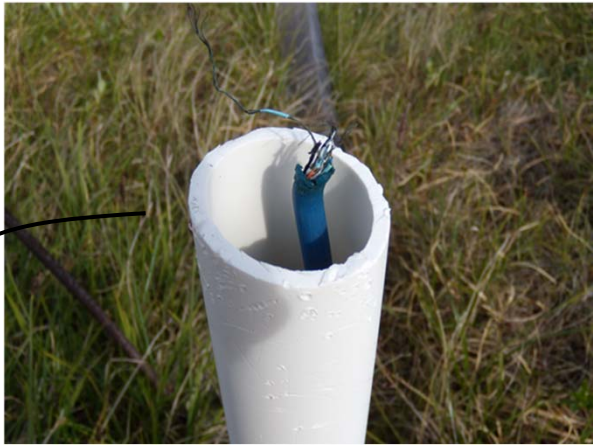
determine their status. One string was severed completely (drill hole 12259-03, see Figure 5), but the remaining three appear to be intact. A readout device compatible with the military connectors on the strings was not available to test the functionality of these strings. An appropriate readout device should be obtained from EBA Engineering (the original thermistor supplier) and the string functionality should be tested during the 2011 geotechnical inspection. If the three in-tact strings are functional, the fourth string should be spliced and tested as well.

Close-up of the severed cable on drill hole 12259-03 (BH3) with thermistor string #1049.

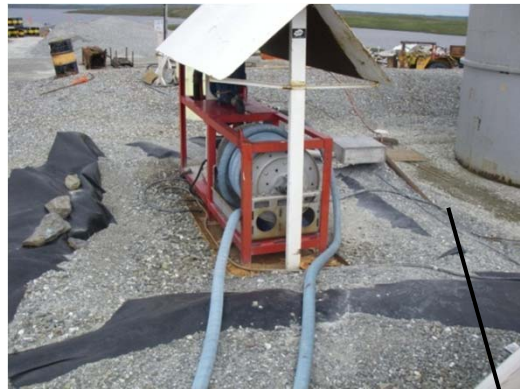
Fuel transfer pump on western containment berm.

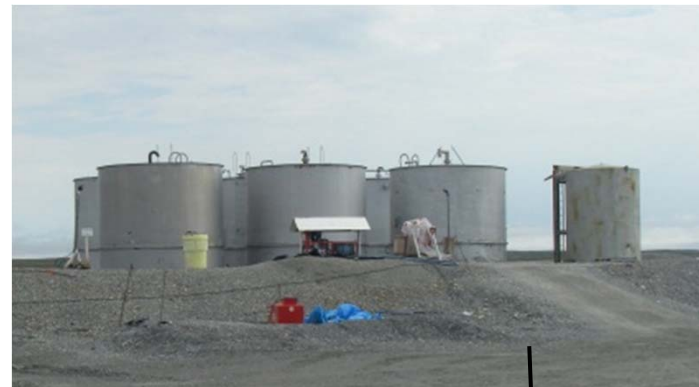
Looking east towards the tank farm.

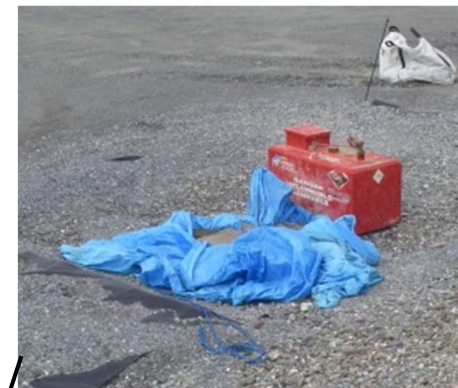
Tidy tank storage area west of containment area.

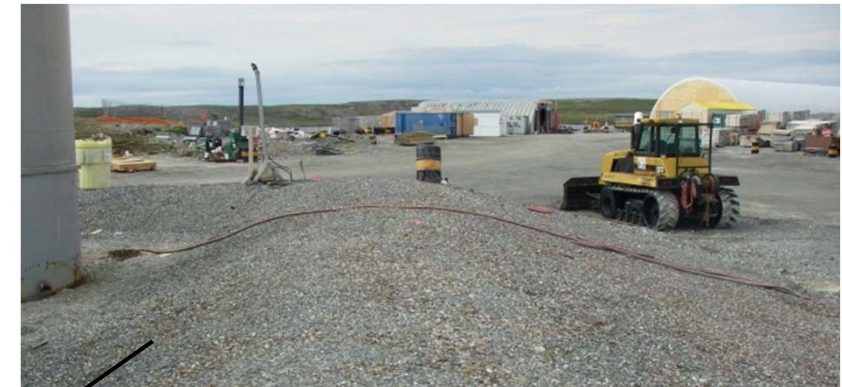
Western containment berm looking north.

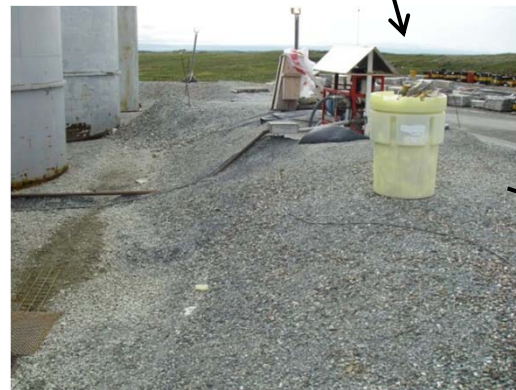
Western containment berm looking south.

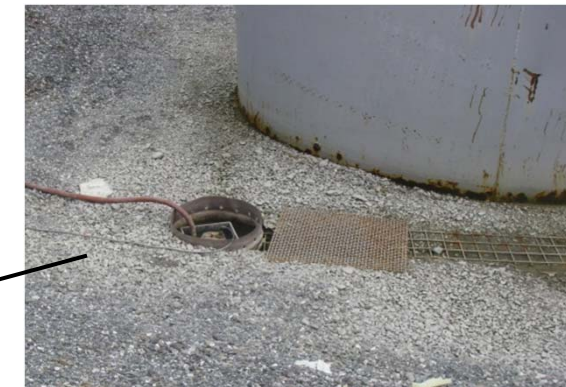
Sump with submersible pump in the northwest corner of the tank farm.

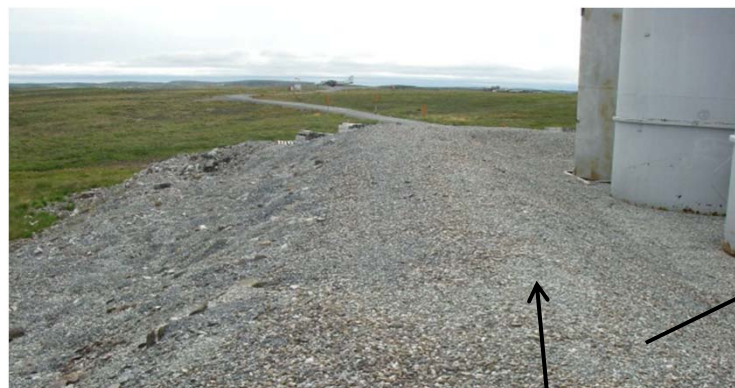
Crest of eastern containment berm looking south.

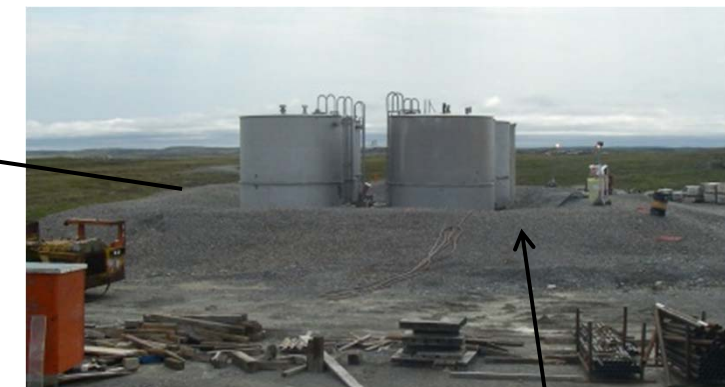
Looking south towards the tank farm.

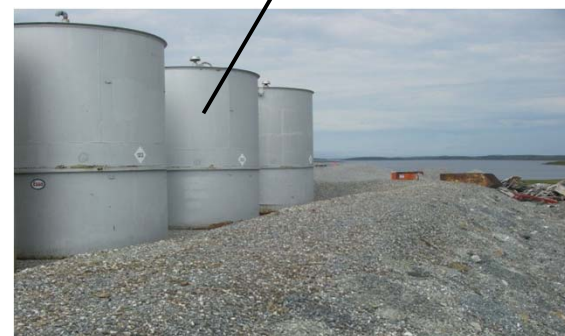
Eastern containment berm looking north.

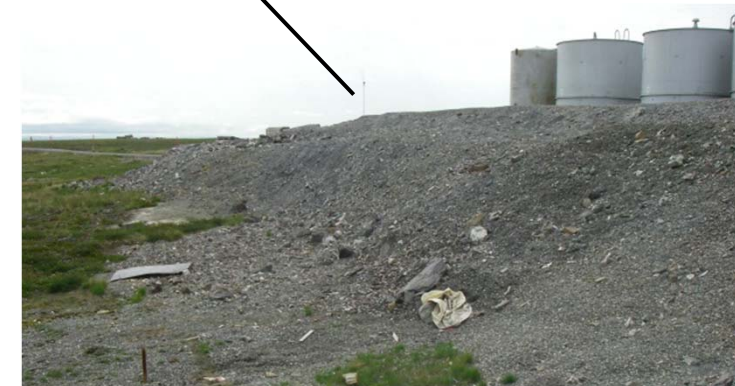
Eastern containment berm looking south.

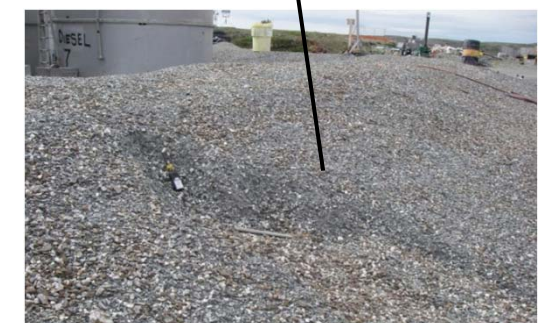
Erosion gulley on south outer containment berm.

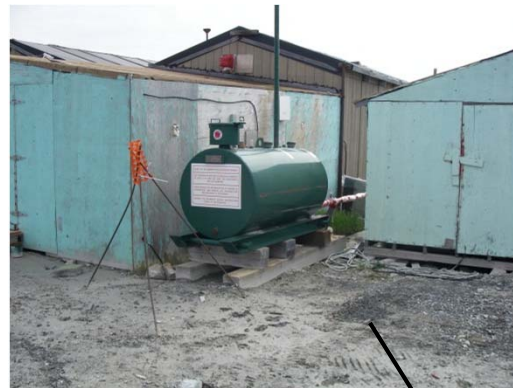
Secondary containment for fuel tank.

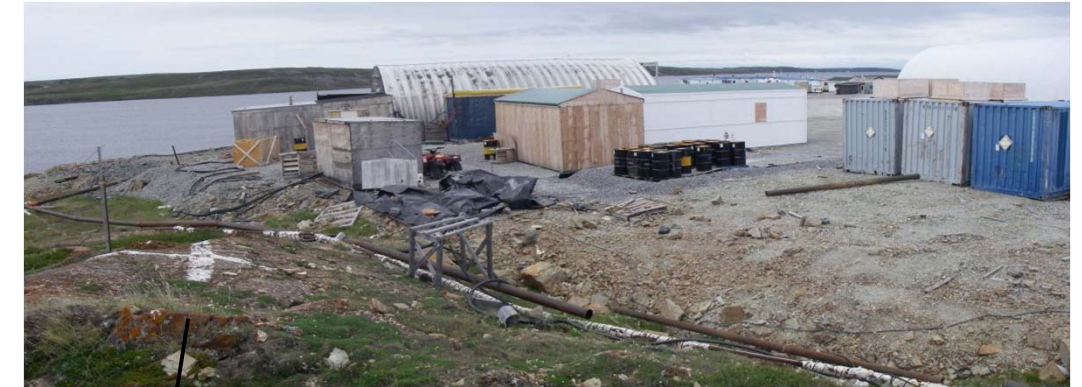
Fuel storage and pipelines behind workshop area.

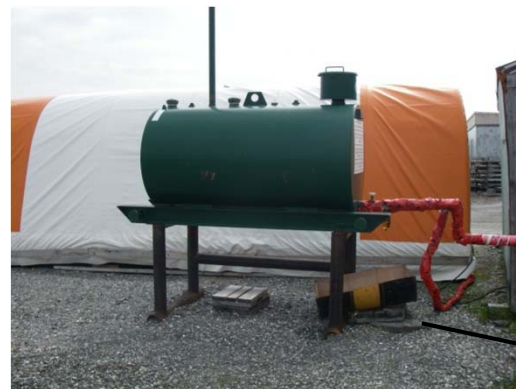
Fuel tank without secondary containment.

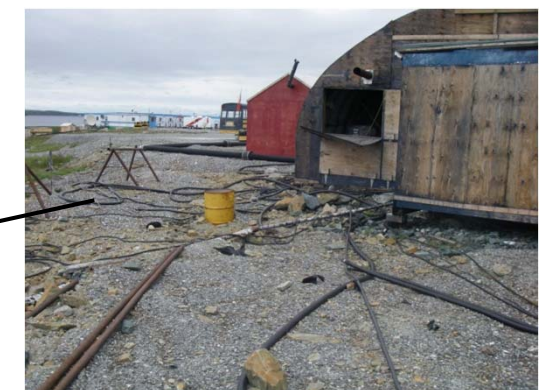
Looking north as seen from behind the workshop and powerhouse (red building).

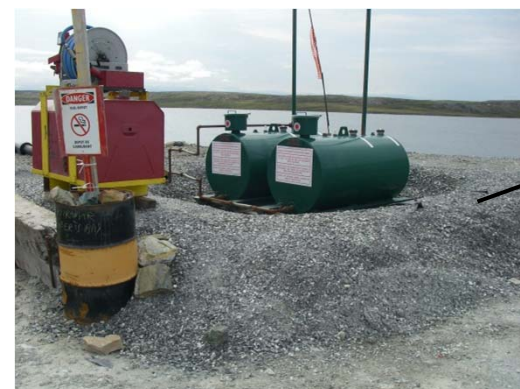
Secondary containment for fuel tanks supplying power house and workshop.

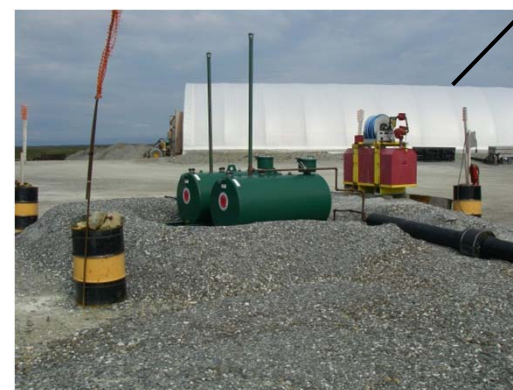
Secondary containment for fuel tanks supplying power house and workshop looking north.

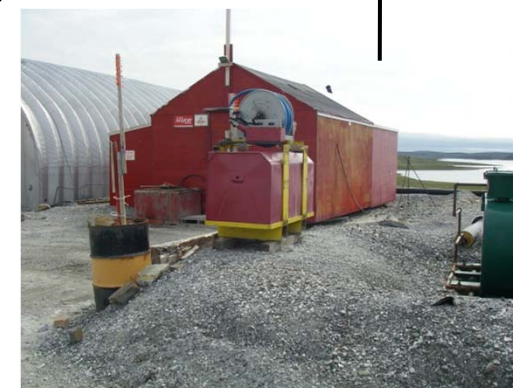
Front of powerhouse (red building).

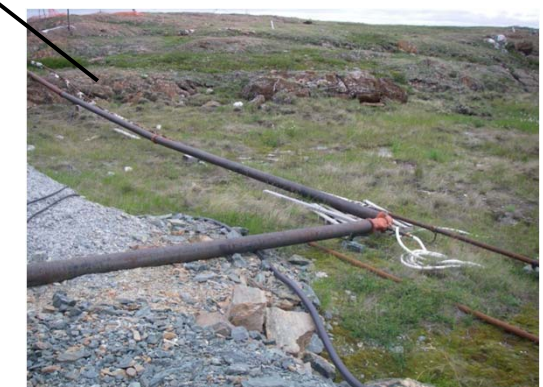
Fuel delivery pipeline to power house and workshop.

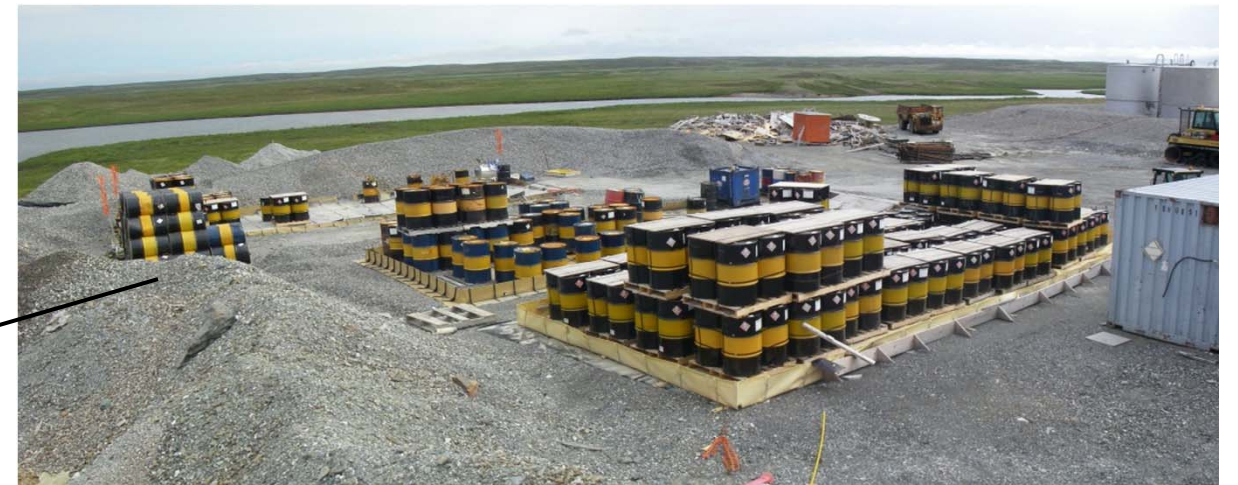
Looking southeast across the three jet fuel containment areas.

Containment berm supported by timber cribbing.

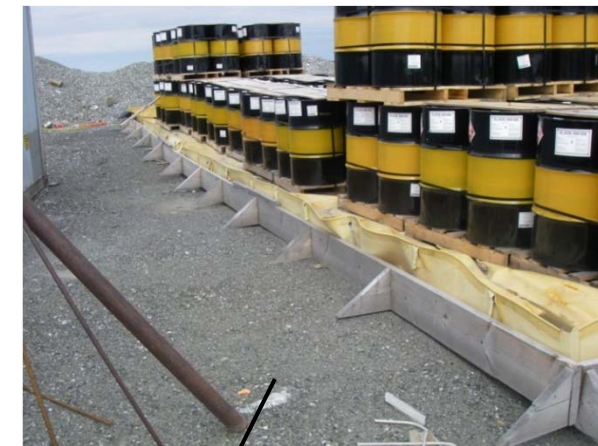
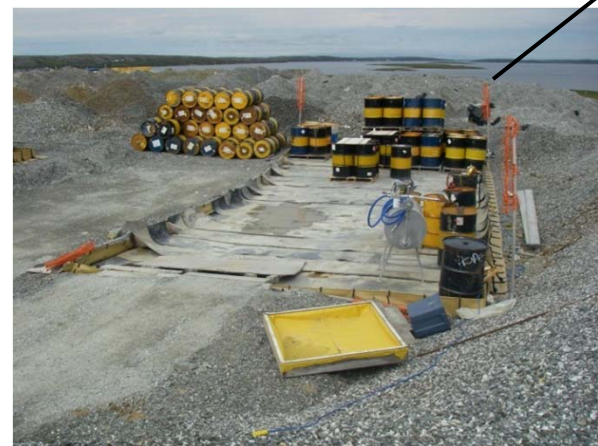
Looking north towards eastern most containment area.
Note access ramp leading into bermed area.

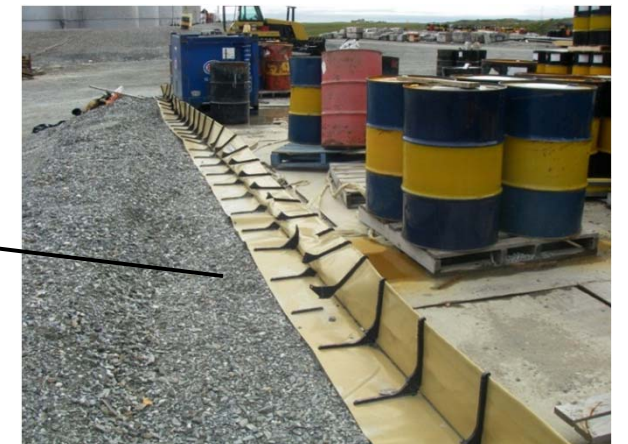
View towards the north of the southern containment berm of the settling pond.

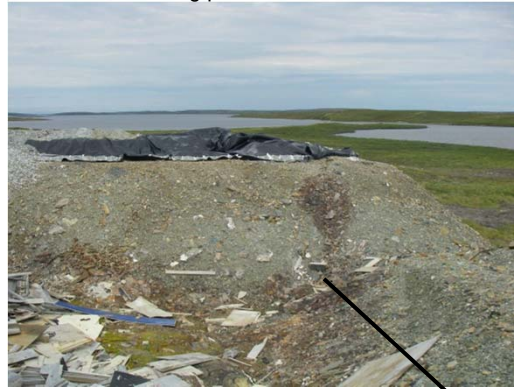
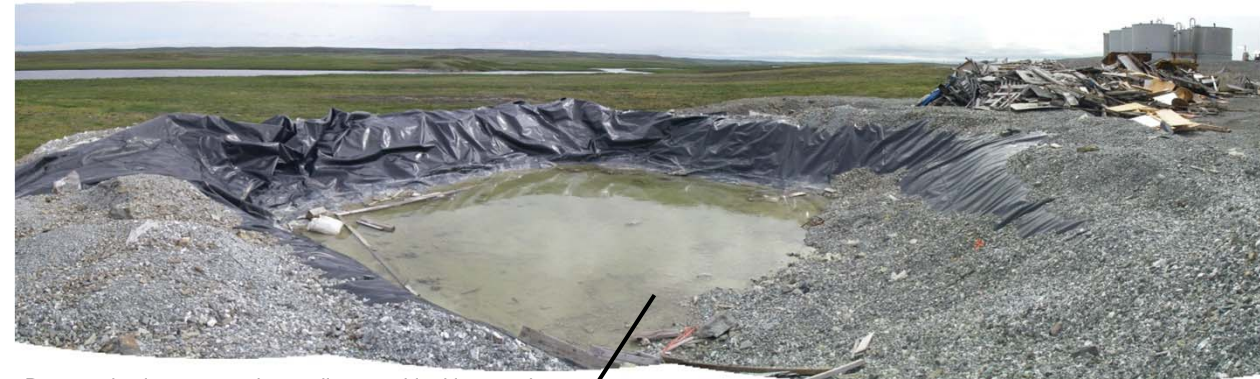
Panoramic view across the settling pond looking southeast.

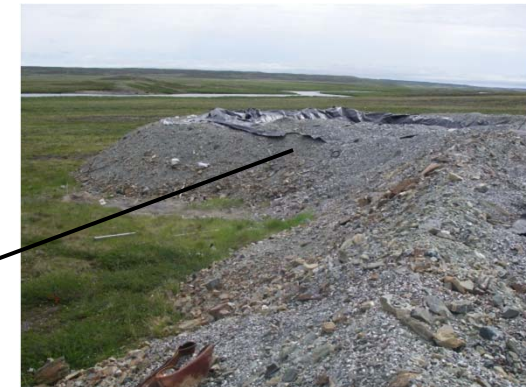
Looking northeast over the crest of the settling pond.

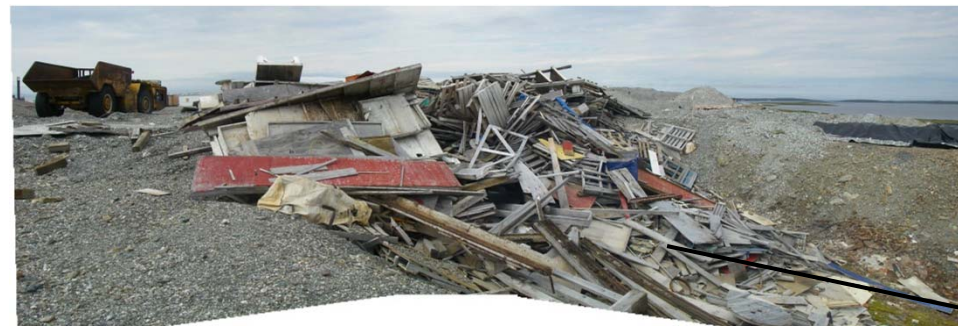
At one time, all wood waste was burned in a burn pit (a converted sedimentation pond) located immediately south of the active sedimentation pond (Figure 17); however, this practice has been discontinued and all non-combustible materials was removed from the pit. The burn pit itself is still used to contain unburned wood waste and ash, until such time as HBML backhauls these materials, or adopts an alternate strategy to dispose of these elements.

Panoramic view of burn pit looking southwest.

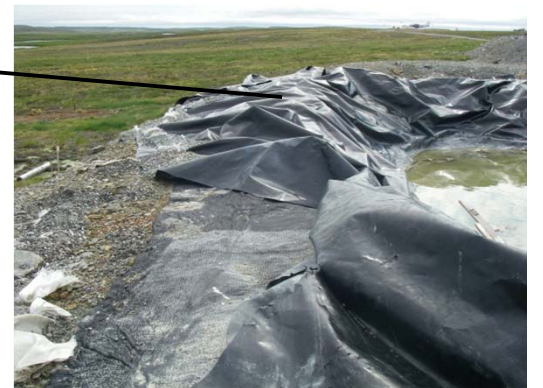
Crest of settling pond.

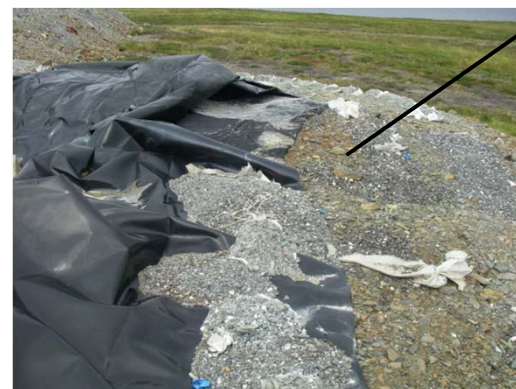
Crest of southeast corner of settling pond.

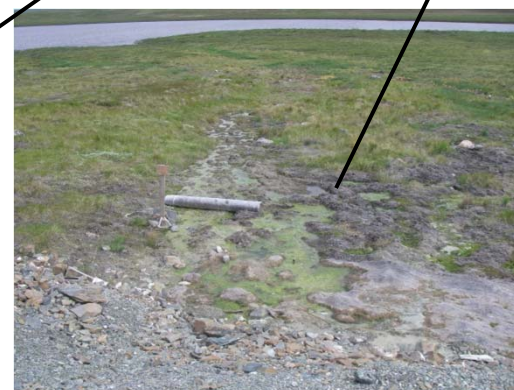
Signs of seepage from the settling pond.

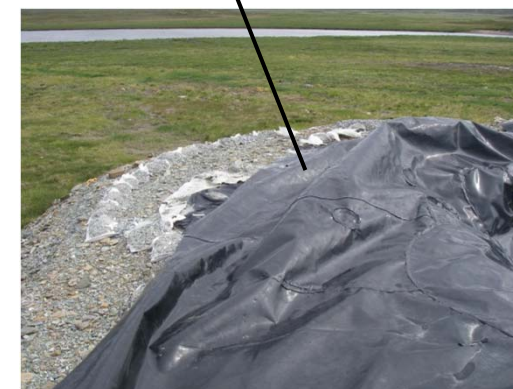
Crest of northeast corner of settling pond.

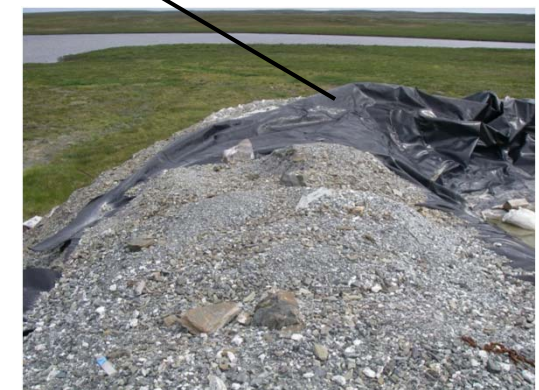
One lined settling pond (Figure 17) has been constructed along the eastern perimeter of the camp foundation pad (immediately north of the burn pit). As-built records for the construction of this pond are not available. It is understood that this pond was used to contain wash water during the screening and crushing of ore as part of the bulk sampling program.

Looking east across the northern edge of the lined settling pond

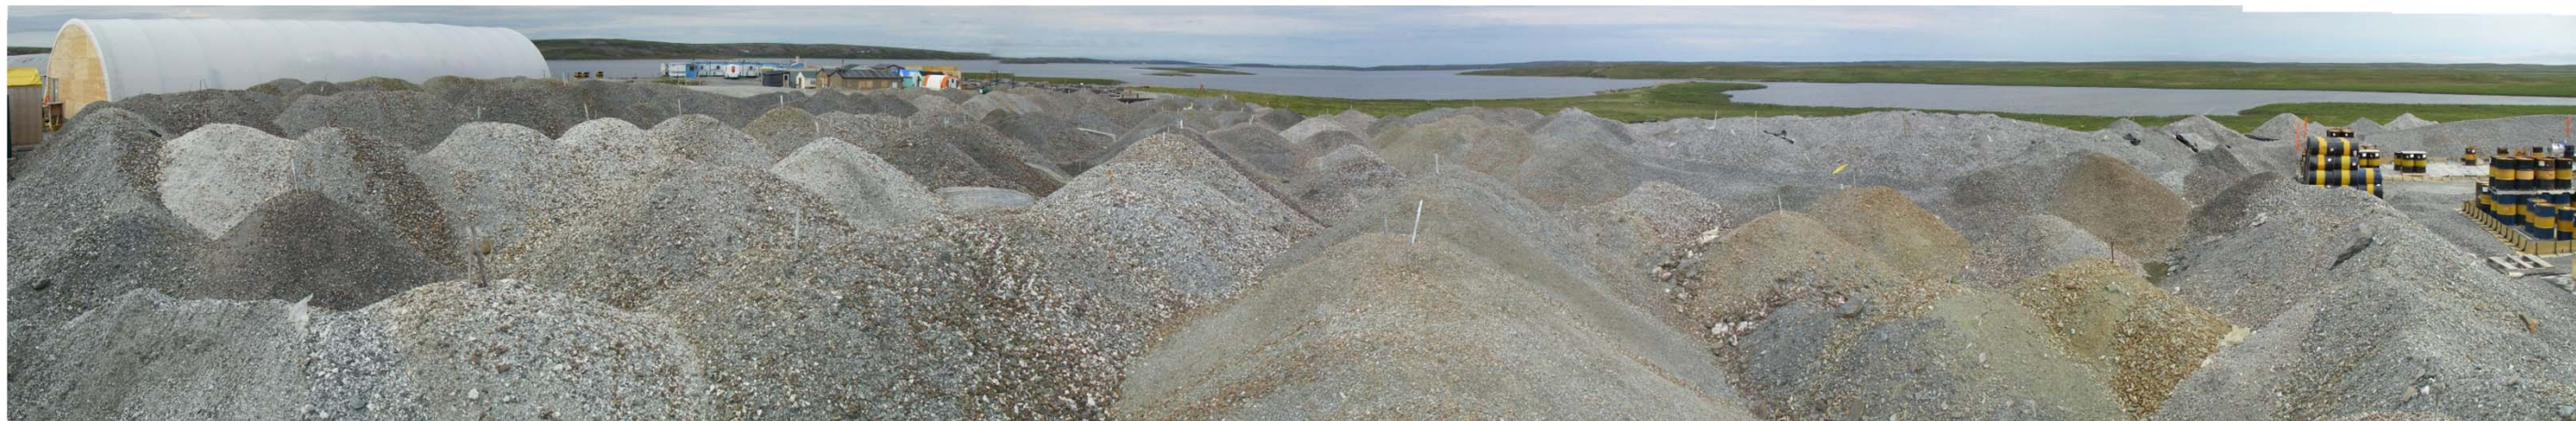
A large number of crushed ore stockpiles are located on the north-western portion of the camp complex foundation pad (Figure 18). This ore comes from the 27,000 ton bulk sampling program carried out between 1996 and 1997. These stockpiles are individual un-compacted end-dump piles. Surface water drainage from this part of the foundation pile is not specifically separated from the rest of the foundation fill pad, and is not contained, but allowed to flow directly onto the tundra.

Panoramic view of the ore stockpiles looking north.

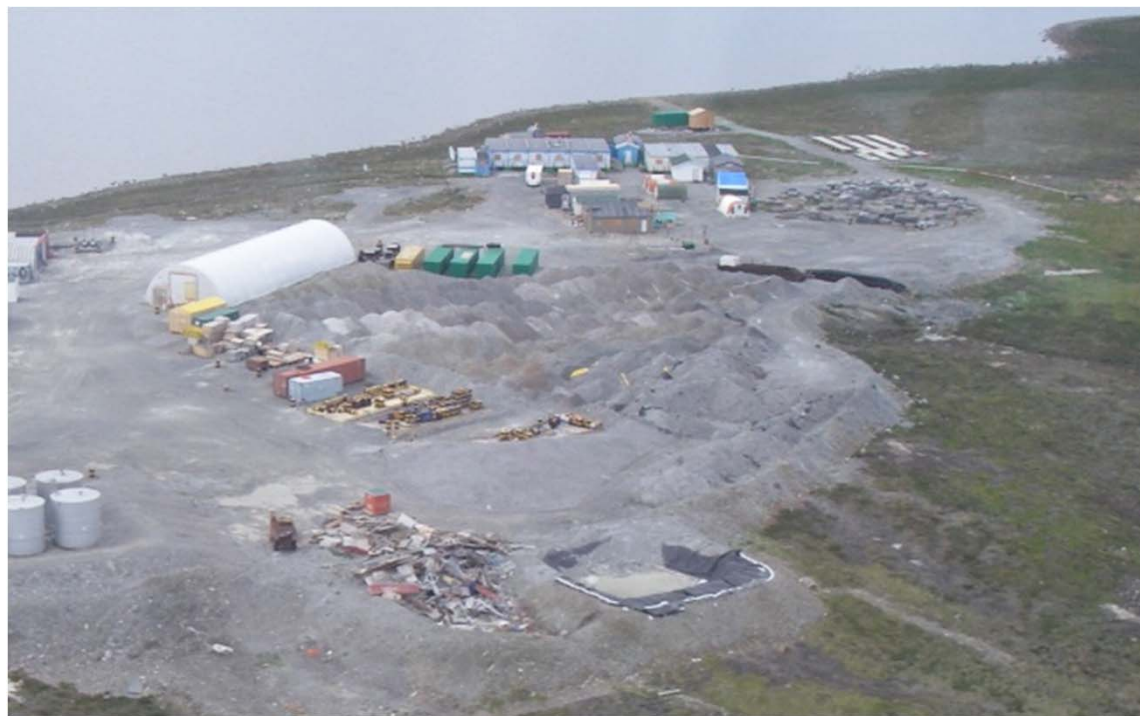
Oblique view looking northwest across the ore stockpiles.

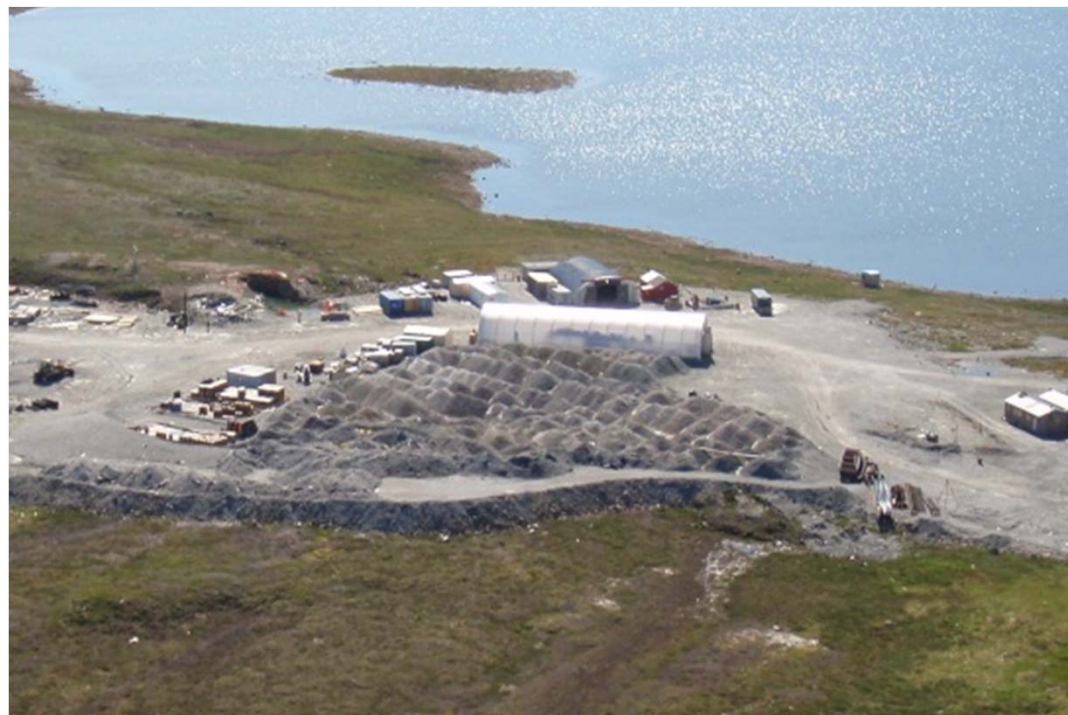
Oblique view looking southwest across the ore stockpiles.

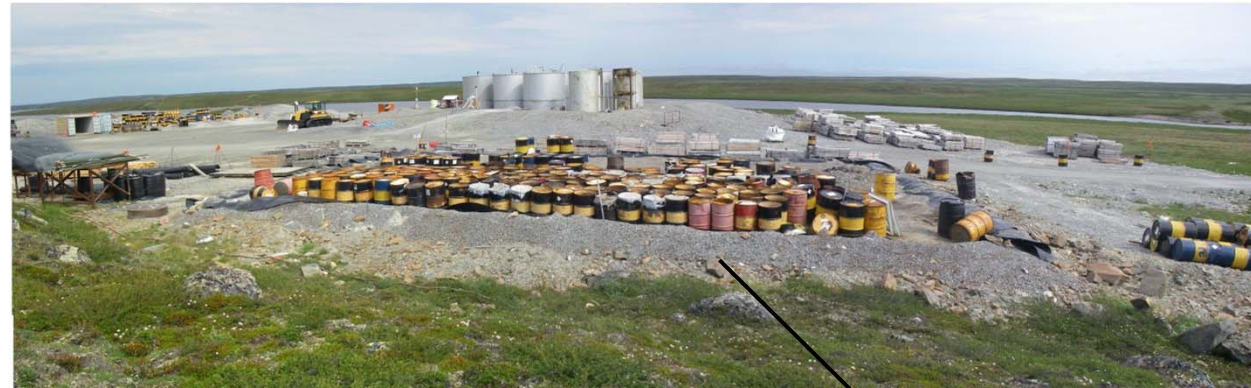
Looking southeast across the land farm.

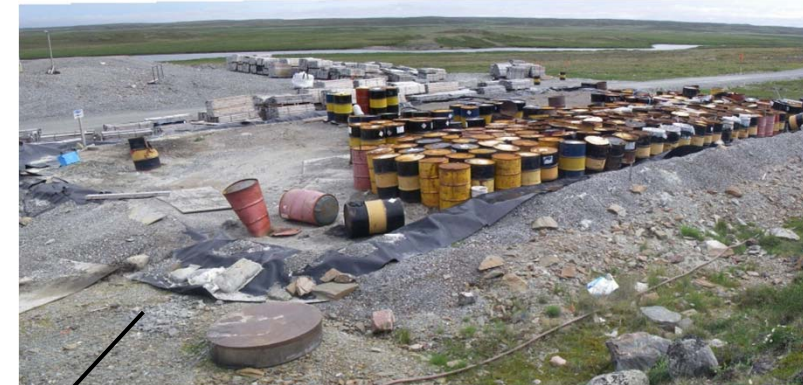
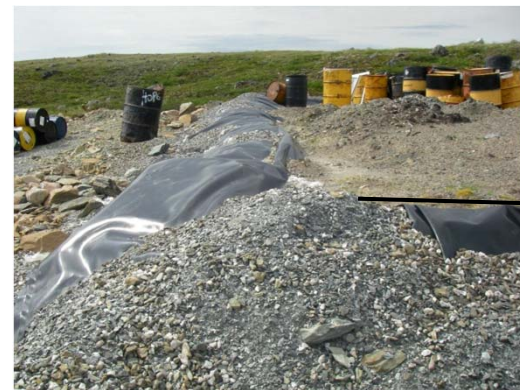
Exposed liner along the crest of the land farm south berm.

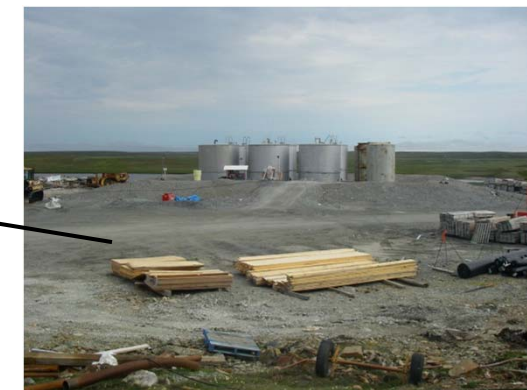
Wood, liner and other material scarps stored in the bone yard.

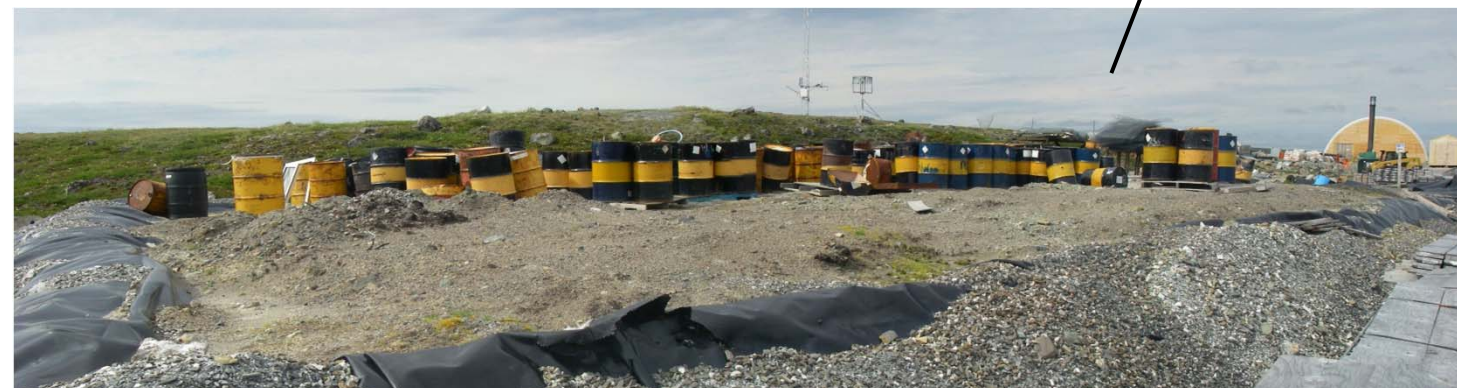
Looking west across the land farm.

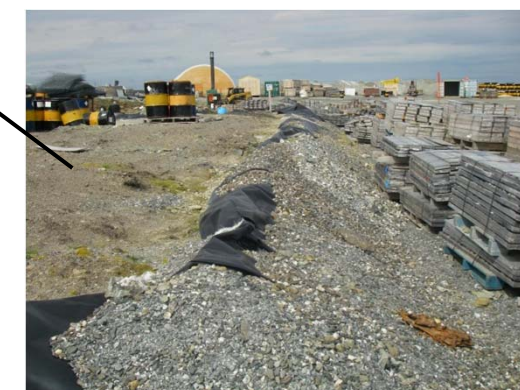
Exposed liner along the crest of the land farm east berm.

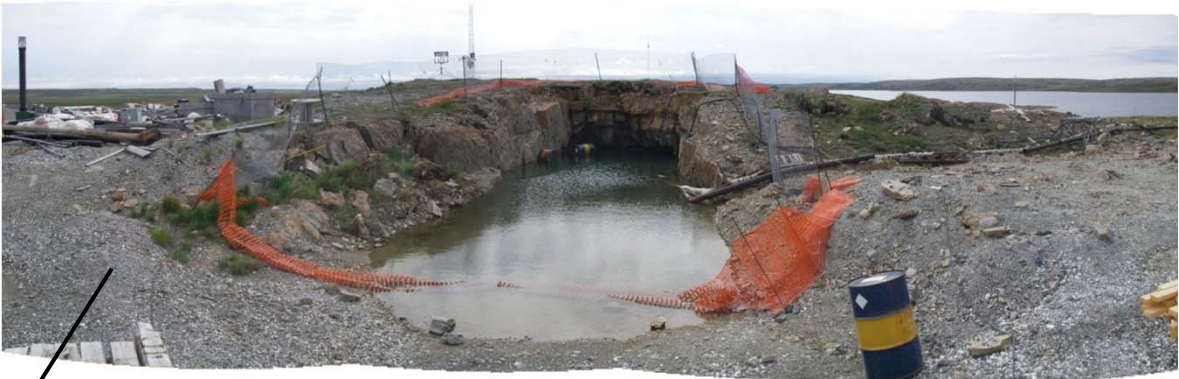
The portal, which is located about 25 m east of the maintenance shop as illustrated in Figure 20, was collared in altered volcanic rock, all within the permafrost. This was confirmed through installation of four underground thermistors (Golder 2000a, b). During extraction of the bulk sample, the portal was not heated but operated at an ambient temperature of about -10°C. The portal was operated under dry conditions with no groundwater inflow. After completion of the bulk sample collection, the portal was abandoned and sealed off with a locked gate.

Looking south across the portal.

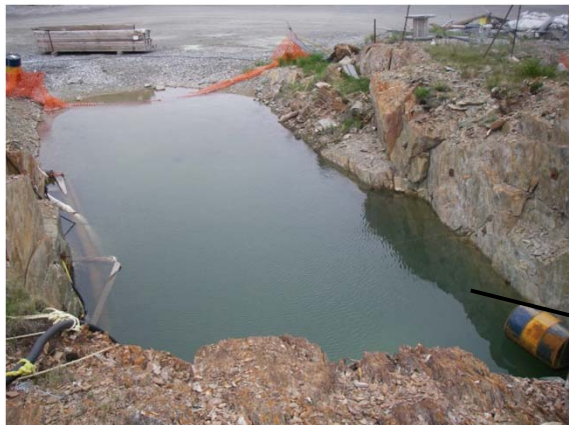
View across the portal from the top of the highwall.

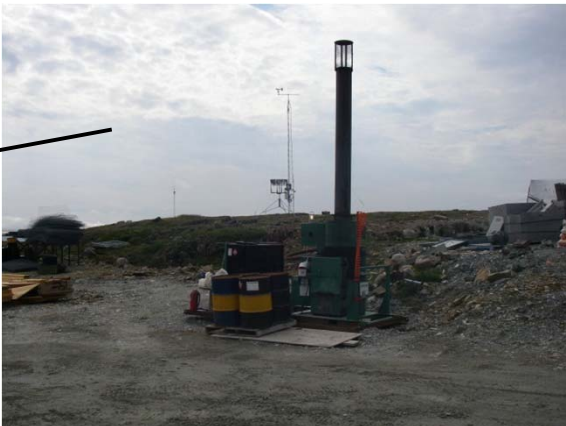
Front of the incinerator with cash of fuel drums.

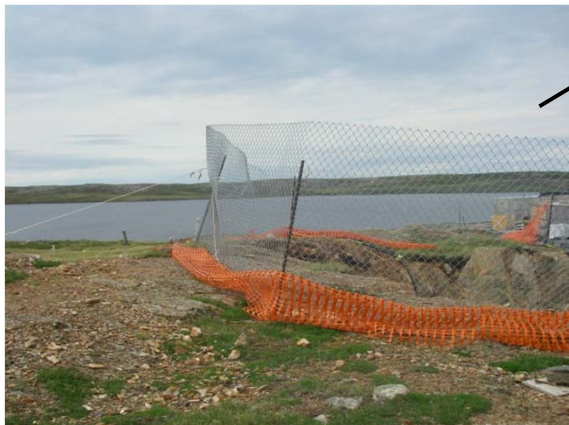
View of the protective fence along the highwall of the portal.

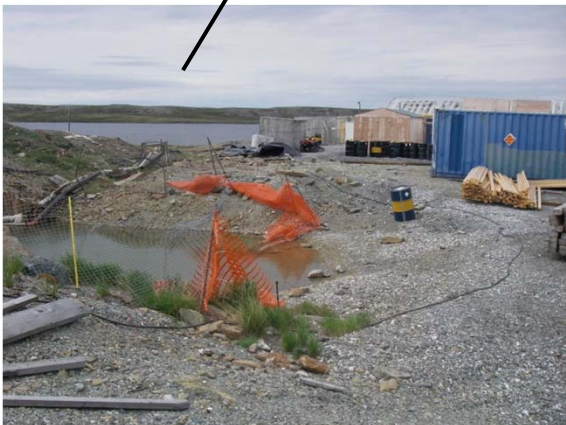
Entrance to the portal.

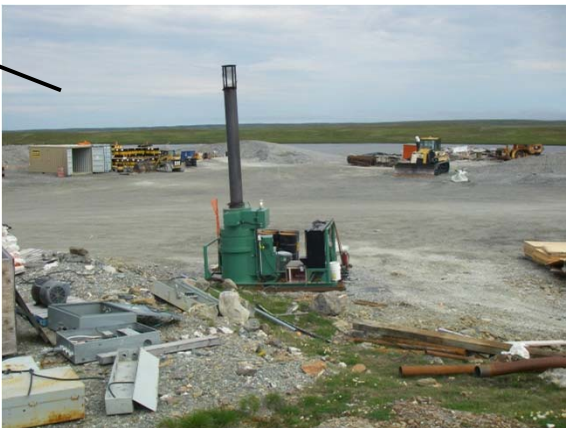
Another view of the incinerator form the back.

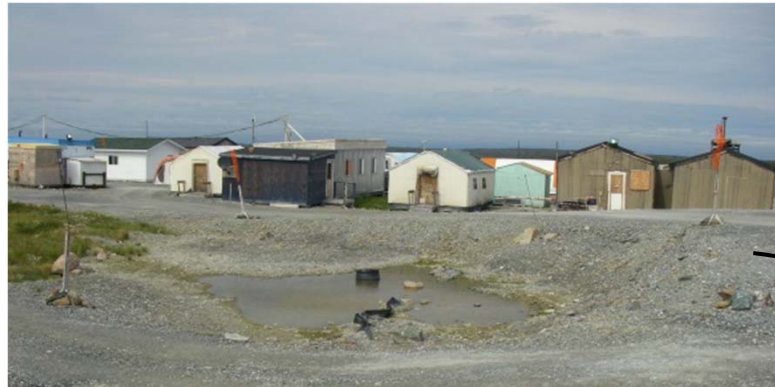
Looking north across the core logging sheds and other office units. The depression in the foreground is the historic hydrocarbon spill area.

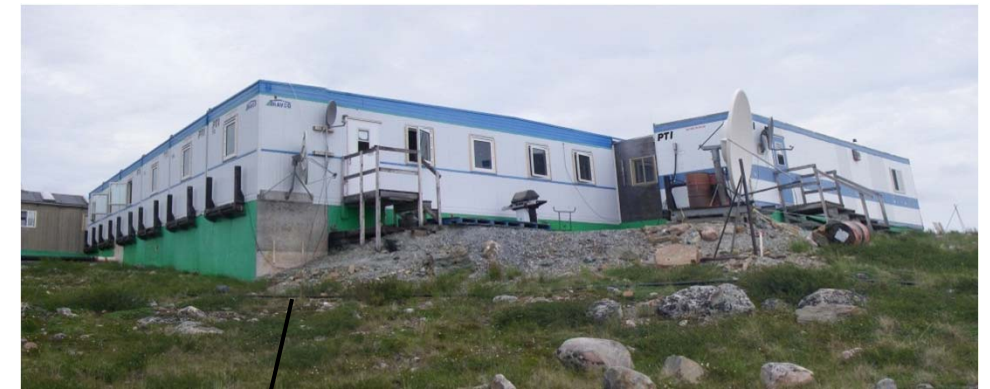
Looking north towards the southern camp complex consisting of skid mounted units.

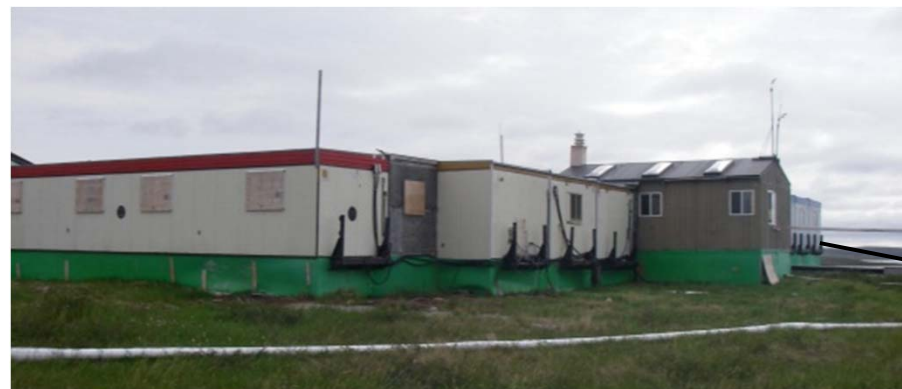
Looking south towards the older camp section and main office complex.

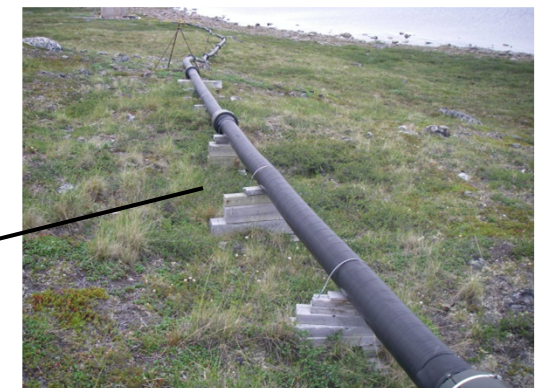
Potable water supply pipeline to camp.

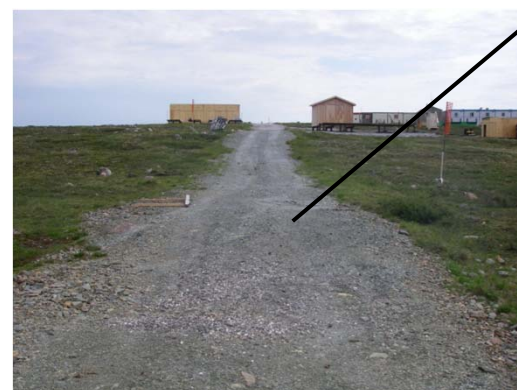
Looking east along the all-weather access road from the camp to Spyder Lake.

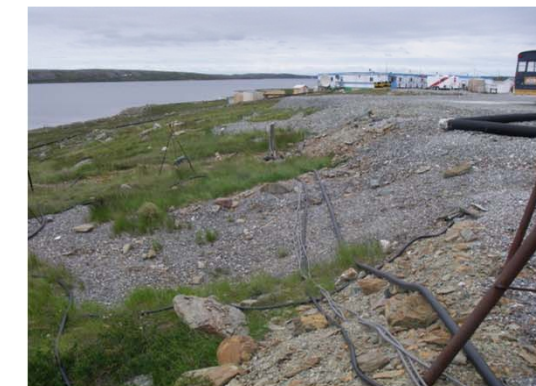
Looking northwest across the south end of the camp pad. Note power cables.

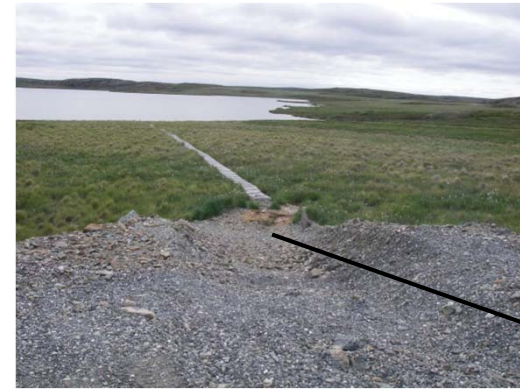
The wooden walkway leading from the southern end of the airstrip to a boat dock in Stickleback Lake (Figure 22) has been constructed as a floating walkway directly on the tundra. The walkway has settled into the tundra hummocks and although there is no lasting permafrost damage at this time, vegetation dieback may ultimately result in the start of an erosion gully, which in turn would lead to erosion permafrost degradation.

Looking south across wooden walkway to Stickleback Lake.

Wooden Walkway to Boat Dock	<ul style="list-style-type: none"> Consider raising the walkway above the tundra to prevent vegetation dieback and possible onset of permafrost degradation If boat dock is to be decommissioned consider removing the walkway altogether 	<ul style="list-style-type: none"> Consider raising the walkway above the tundra to prevent vegetation dieback and possible onset of permafrost degradation If boat dock is to be decommissioned consider removing the walkway altogether
Radio Tower and Shack	<ul style="list-style-type: none"> No action required 	<ul style="list-style-type: none"> No action required
Water Intake Pump	<ul style="list-style-type: none"> Consider installing thermal pad or 	<ul style="list-style-type: none"> Consider installing thermal pad or

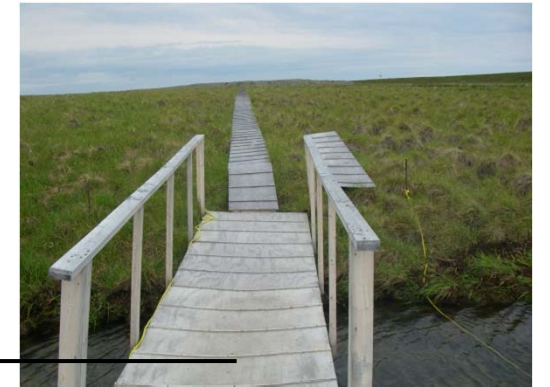
Looking north at bridge and walkway to boat dock on Stickleback Lake.

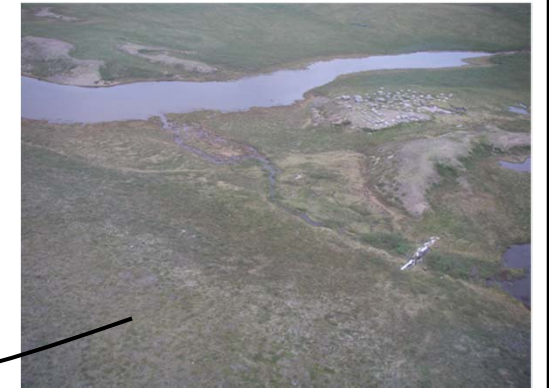
A V-notch weir was installed at the outlet from Stickleback Lake in the early 1990's as part of baseline data gathering studies (Figure 22). The installation was done with the least amount of invasive techniques, by wedging in the measurement weir using tote bags filled with drill cuttings. In accordance with the Water Licence, this weir should be removed. A detailed inspection of the conditions at this weir was not completed during the 2010 inspection.

Oblique aerial view of the old v-notch weir at the outlet to Stickleback Lake.

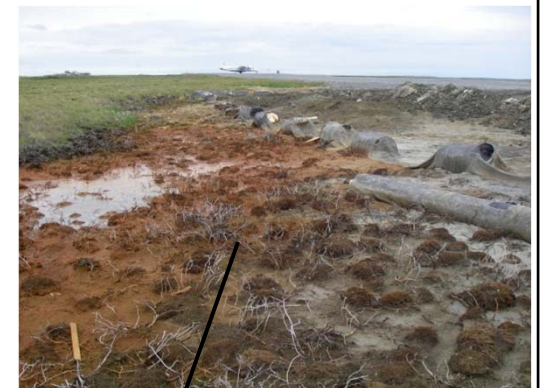
Close-up of vegetation dieback.

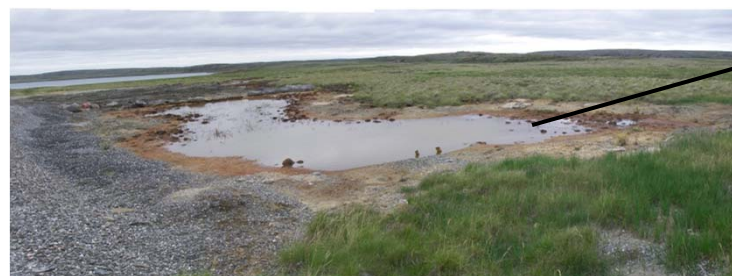
Close-up of permafrost vegetation and vegetation dieback.

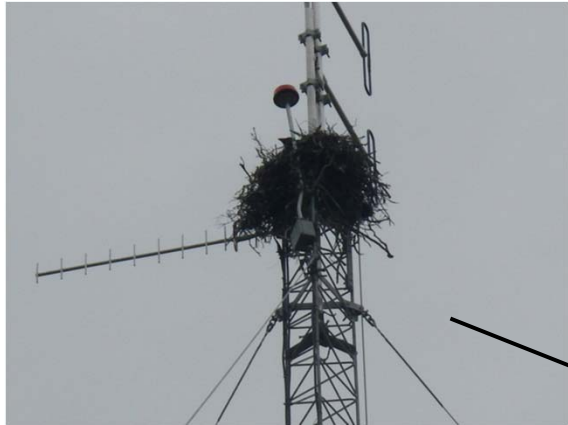
Bird nest at top of radio tower.

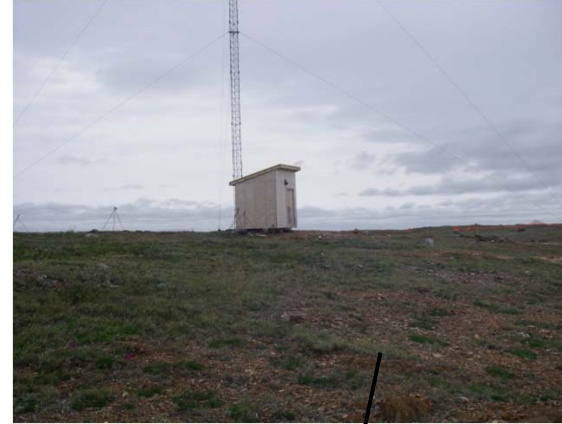
Looking northeast at enclosure for radio equipment installed on raised wooden foundation on rock outcrop.

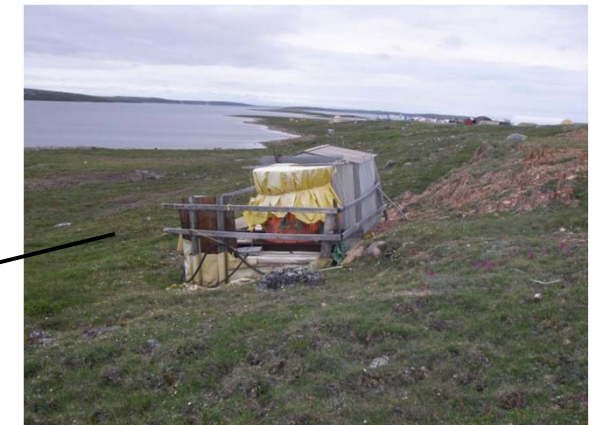
Looking north across the vent raise.

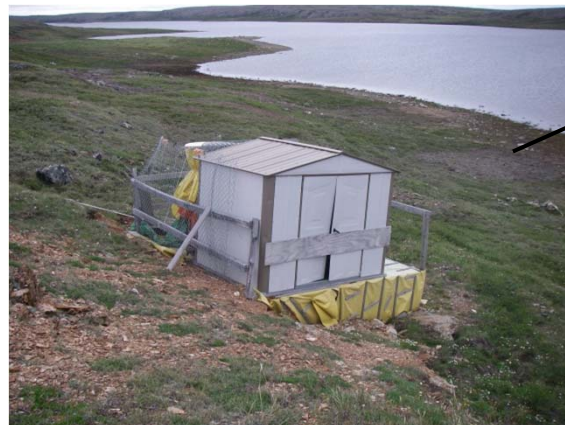
Looking south across the vent raise.

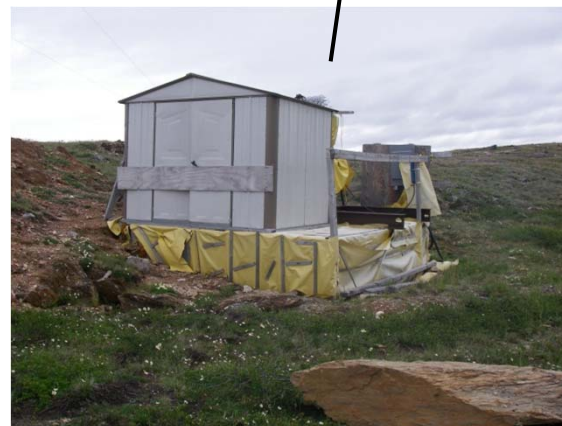
Looking southeast across the vent raise.

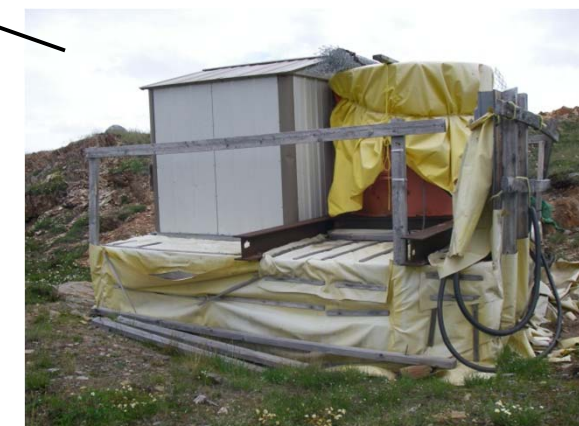
Looking northeast across the vent raise.

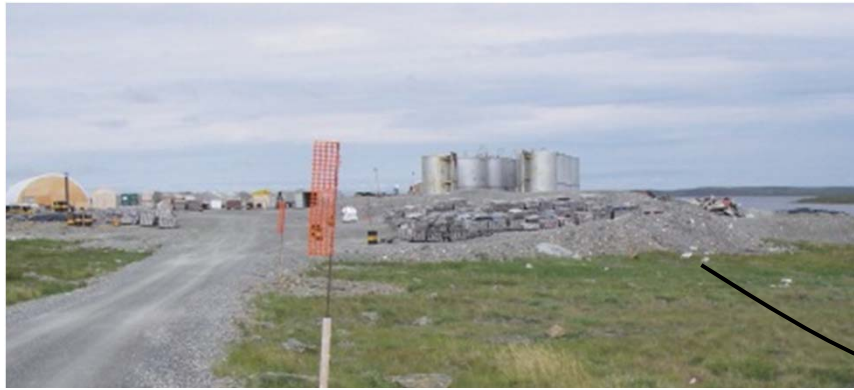
Looking north towards core box storage area on south end of camp pad.

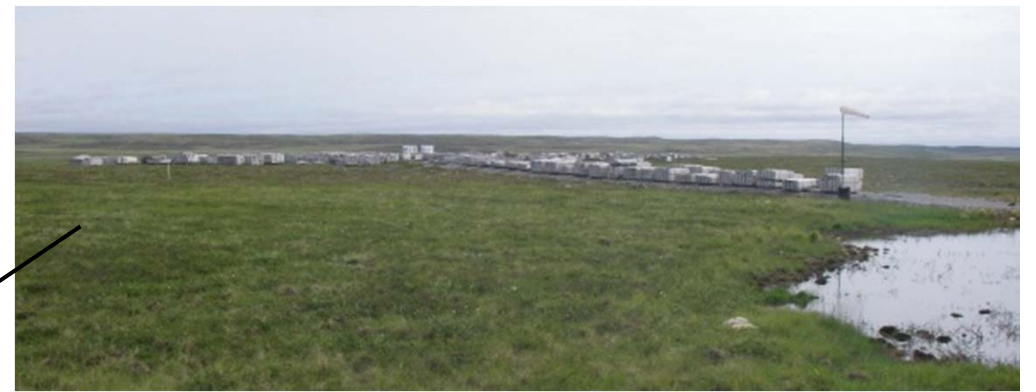
Looking south across the core storage area east of the airstrip.

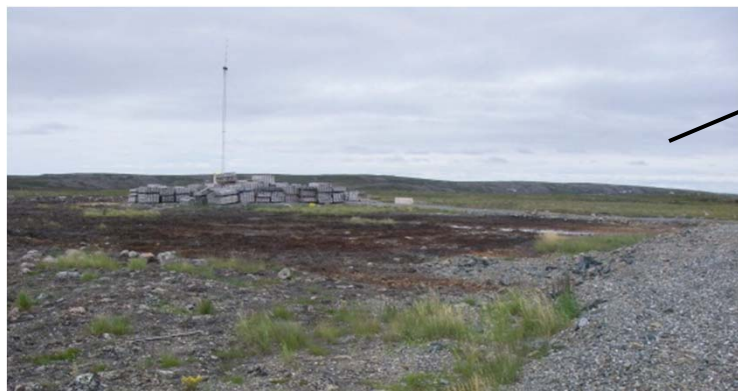
Looking north towards core storage area. Note extensive vegetation dieback zone in foreground.

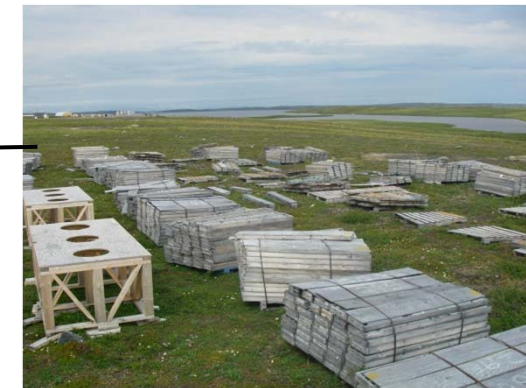
Close-up of the core storage area east of the airstrip.
