2010 Annual Geotechnical Inspection, Boston Advanced Exploration Project

Hope Bay, Nunavut

Project Reference Number
SRK 1CH008.032

February 2011

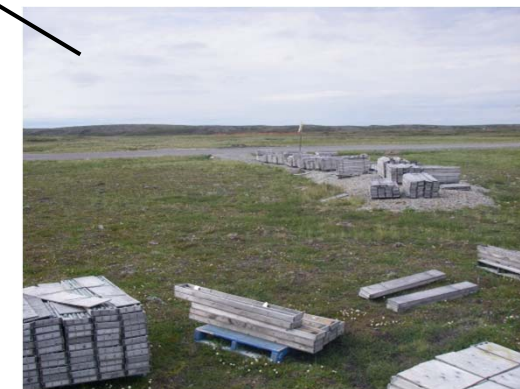
Looking west across the core storage area east of the airstrip.

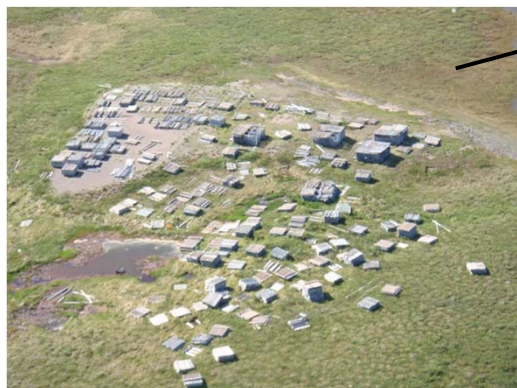
Oblique aerial view of the northern section of the core storage area located on the eastern shore of Stickieback Lake.

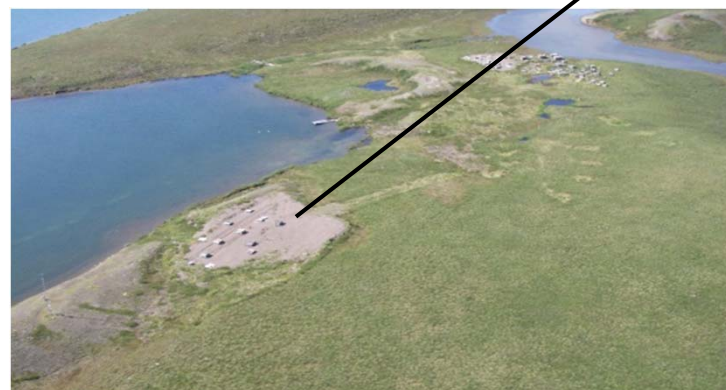
Oblique aerial view of the southern section of the core storage area on the eastern shore of Stickieback Lake.

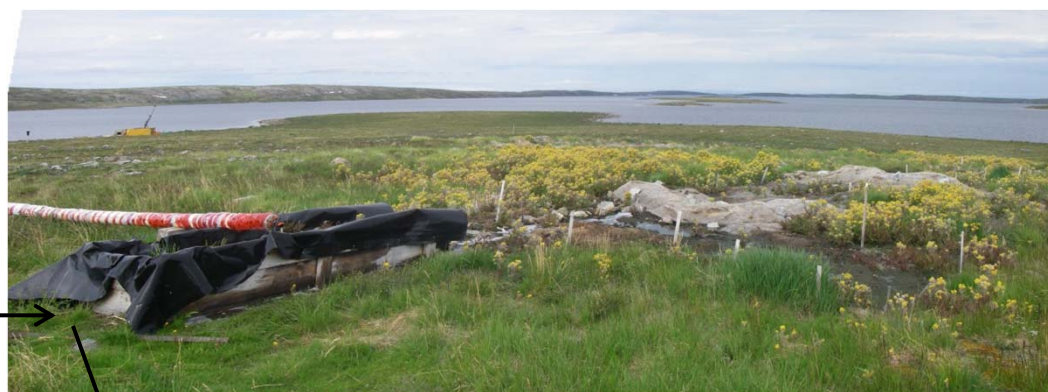
Looking north across the treated sewage treatment outflow diffuser and associated discharge area.

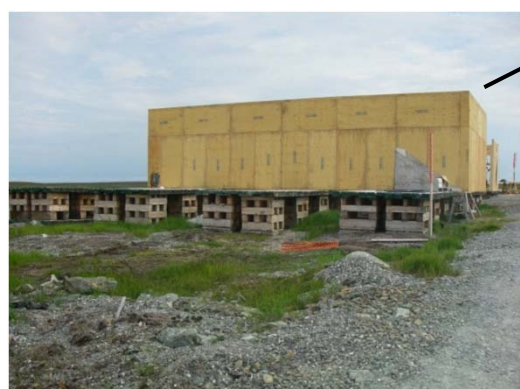
Lower end of the leveling foundation for the new Boston Sewage Treatment Plant.

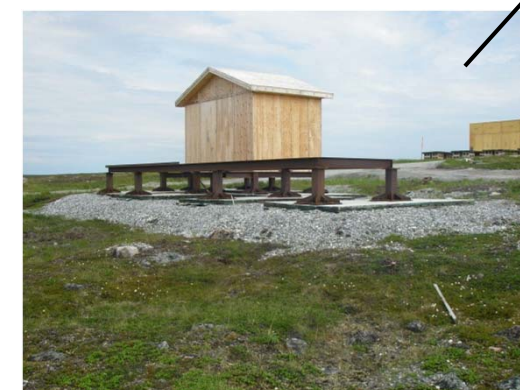
Thermal pad and raised foundation for components of the new Boston Sewage Treatment Plant.

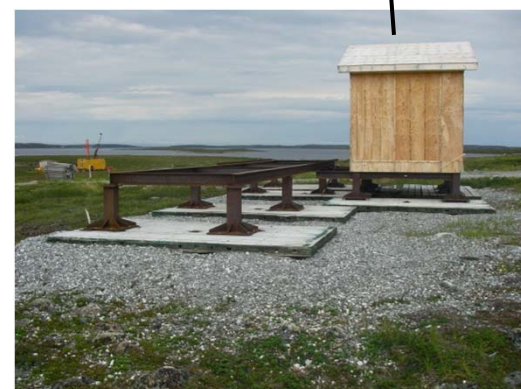
Close-up of raised foundation footings used on the new Boston Sewage Treatment Plant.

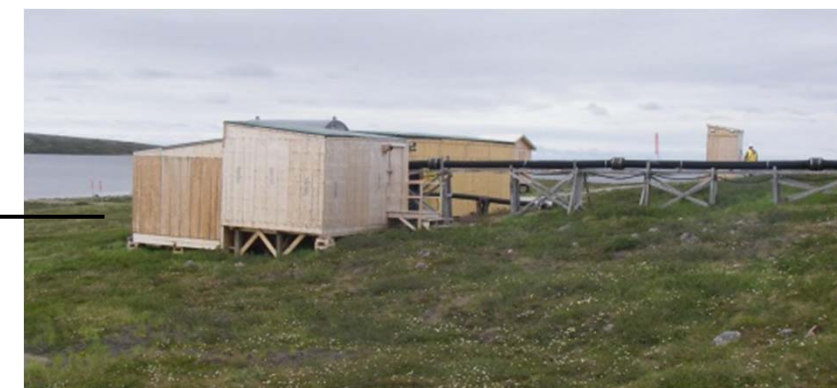
Looking north with the old (existing) sewage treatment plant (STP) in the foreground and the building that will contain the new STP in the background.

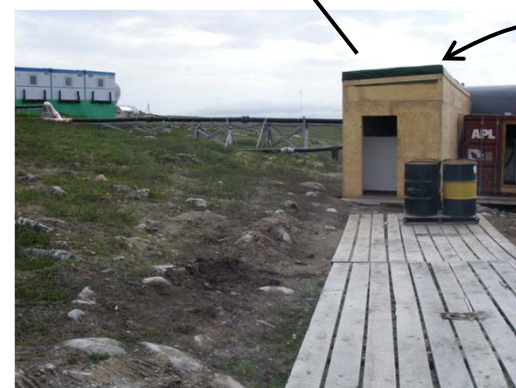
Looking south along the boardwalk leading up to the old STP extension.

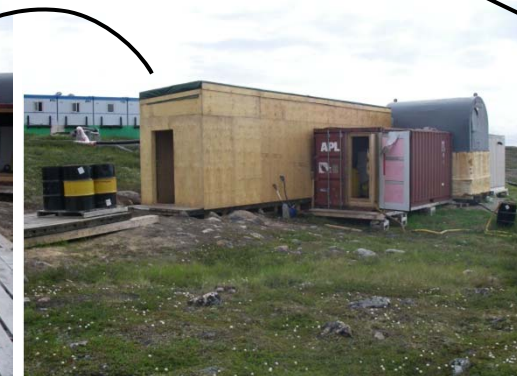
Looking southwest toward the new extension to the existing STP.

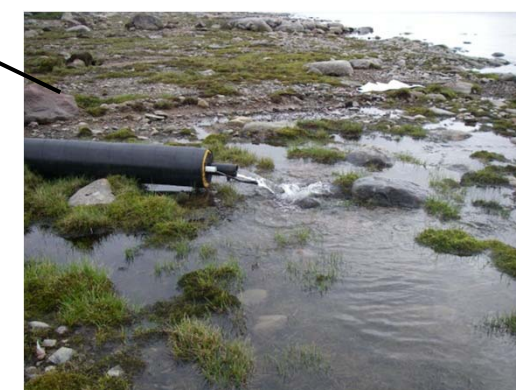
Excess potable water outflow.

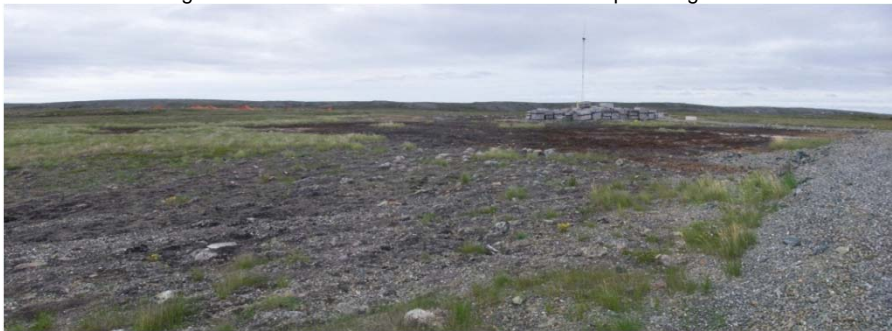
Vegetation dieback of the north end of the airstrip looking north.

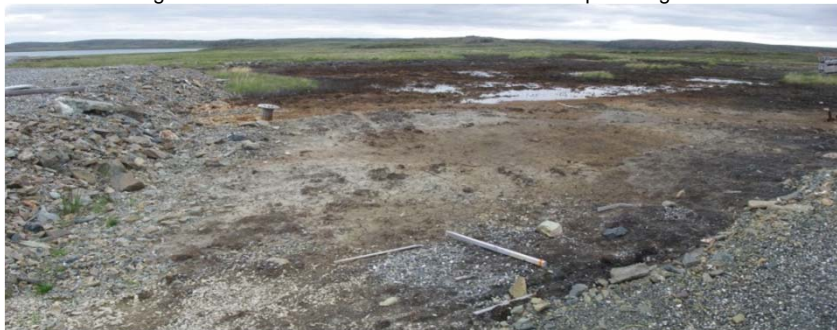
Vegetation dieback of the north end of the airstrip looking south.

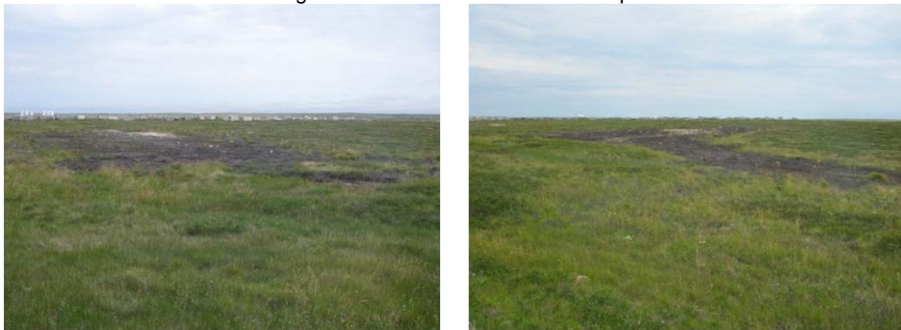
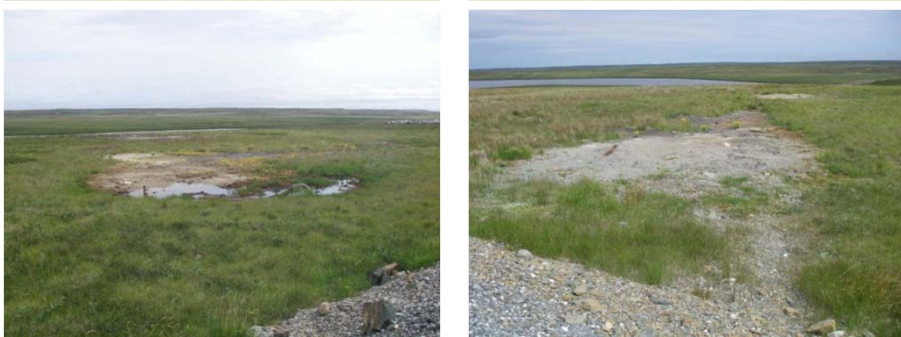
Vegetation dieback around the airstrip.

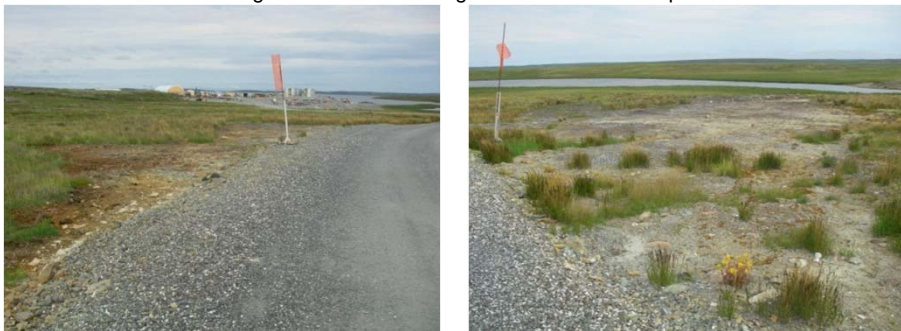
Vegetation dieback along side of road to airstrip.

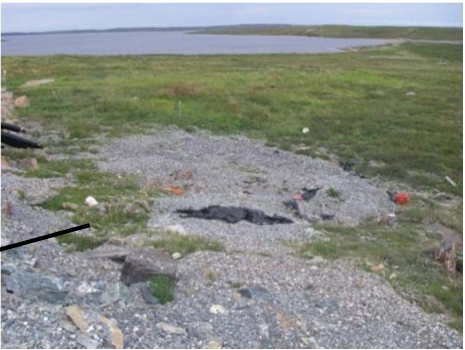
Gravel cover over an area of historic vegetation dieback.

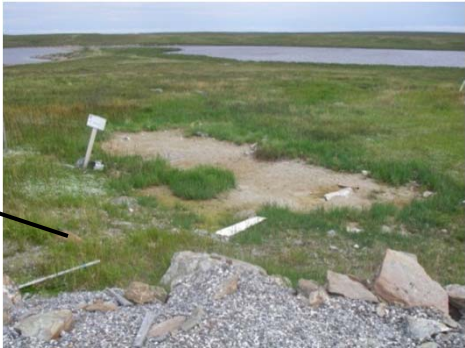
Coco matting over an area of historic vegetation dieback.

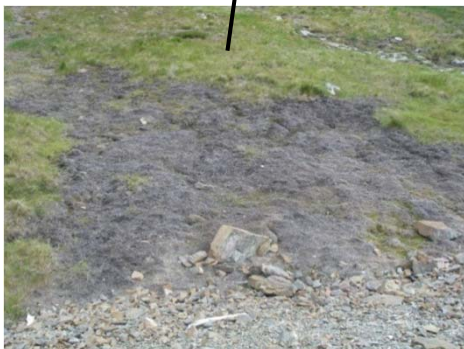
Vegetation dieback as seen from toe of camp pad.

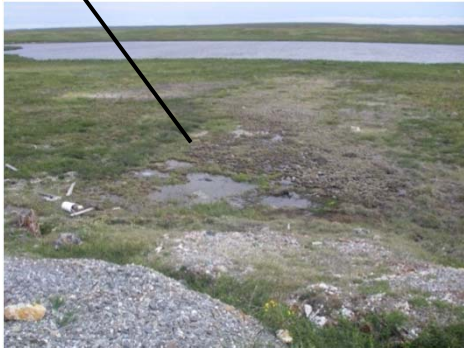
Ponding and vegetation dieback as seen at toe of camp pad.

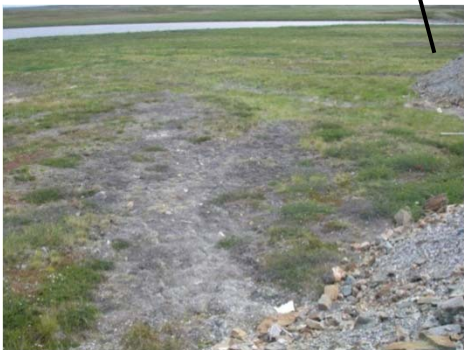
Vegetation dieback from toe of camp pad.

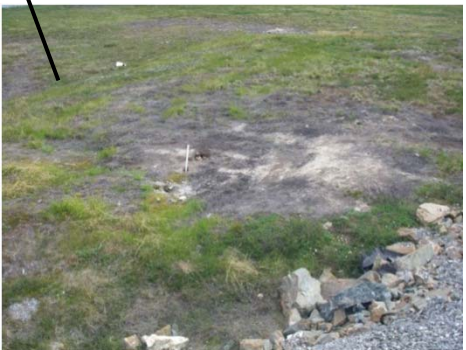
Vegetation dieback from toe of camp pad.

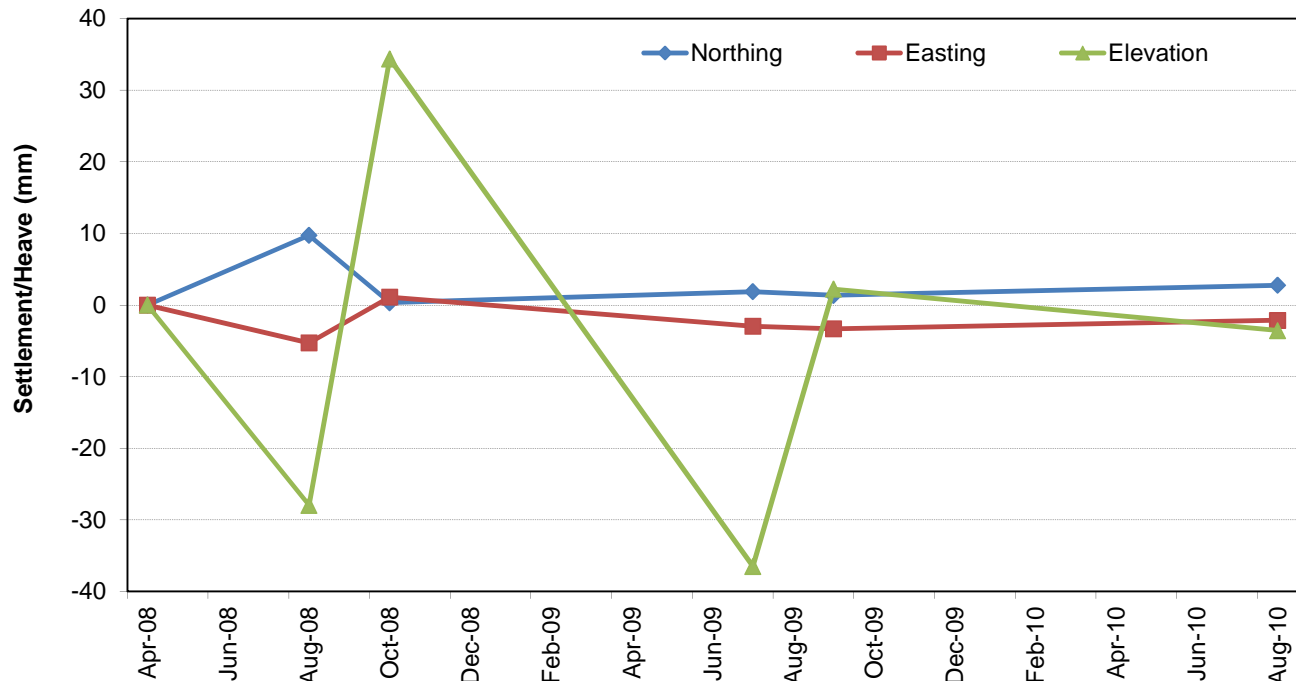
Tank #8

TANK AVERAGES BY DATE (mm)	22-Apr-08	0	0	0
	8-Aug-08	9.7	-5.3	-28.0
	18-Oct-08	0.3	1.1	34.4
	25-Jul-09	1.9	-3.0	-36.5
	19-Sep-09	1.3	-3.3	2.2
	2-Aug-10	2.8	-2.1	-3.6
OVERALL PERIOD AVERAGE (mm)		3.2	-2.5	-6.3
