2011 Annual Geotechnical Inspection, Boston Advanced Exploration Project, Hope Bay, Nunavut

Hope Bay Mining Ltd

SRK Consulting (Canada) Inc.
1CH008.046
March 2012

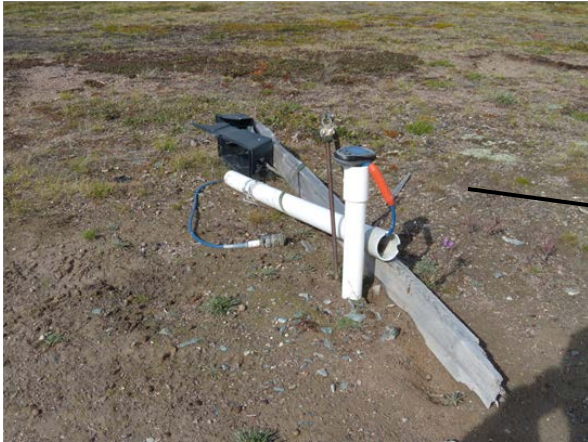
Drill hole 12259-06 (BH6) with thermistor string #1051.

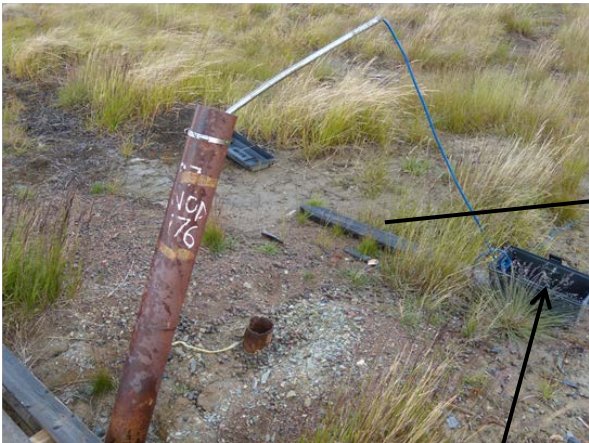
Drill hole 97NOD176 with thermistor string.

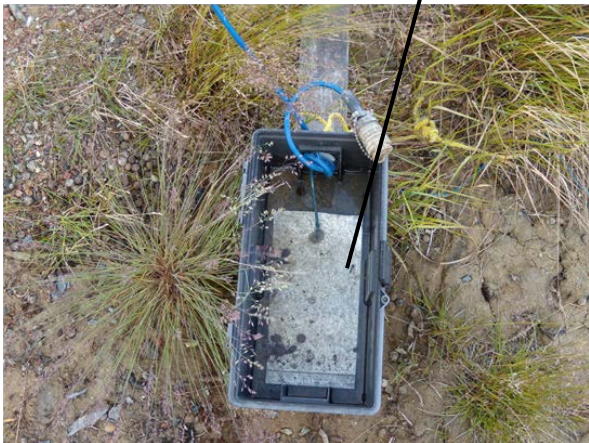
Close-up of the readout box and terminal connector for the thermistor string on drill hole 97NOD176.

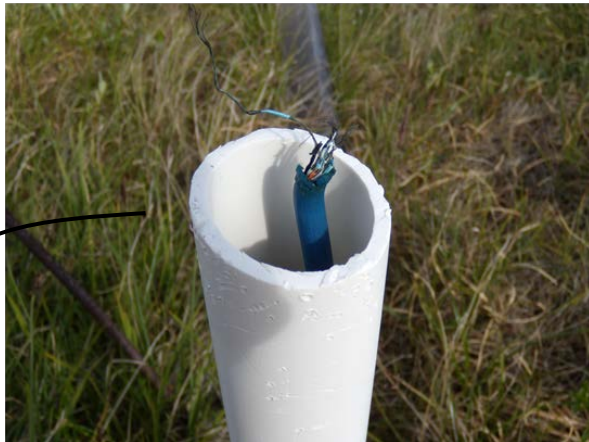
Close-up of the severed cable on drill hole 12259-03 (BH3) with thermistor string #1049.

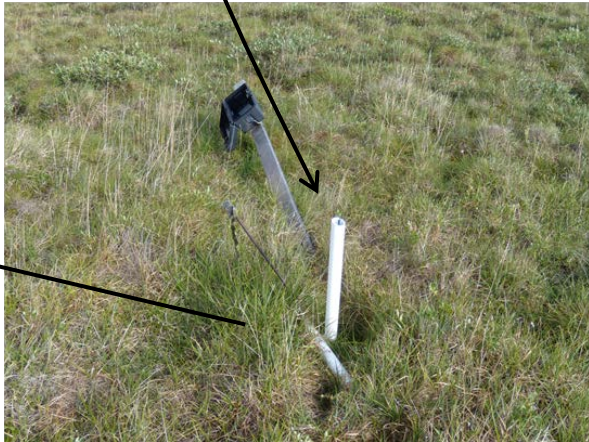
Drill hole 12259-03 (BH3) with thermistor string #1049. The cable has been severed.

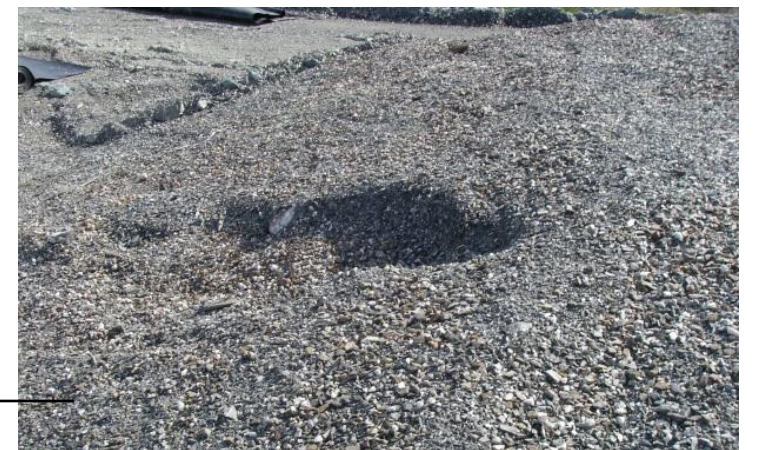
Settlement deformation of the north berm of the tank farm

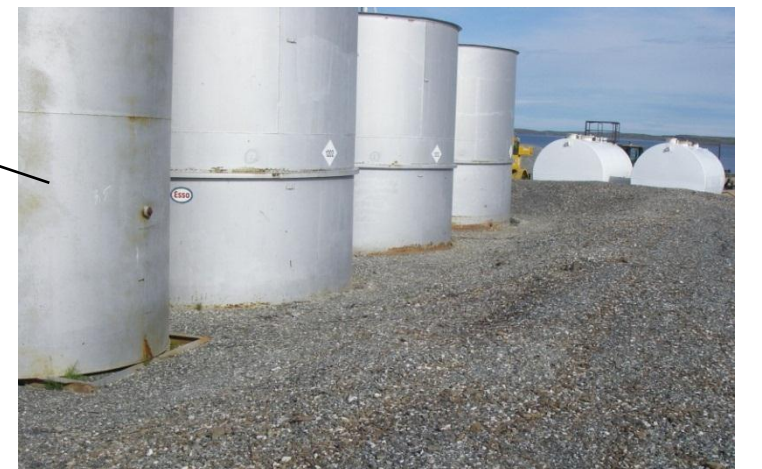
Looking along the east containment berm, facing northeast

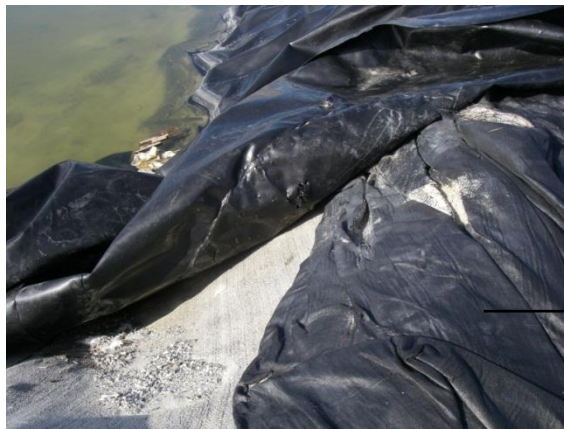
Closer look at tears and rips in the liner

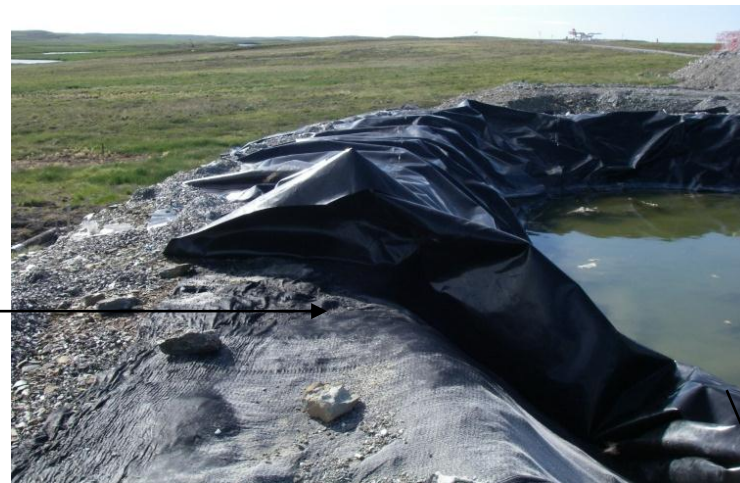
Folded portion of liner with tears and rips

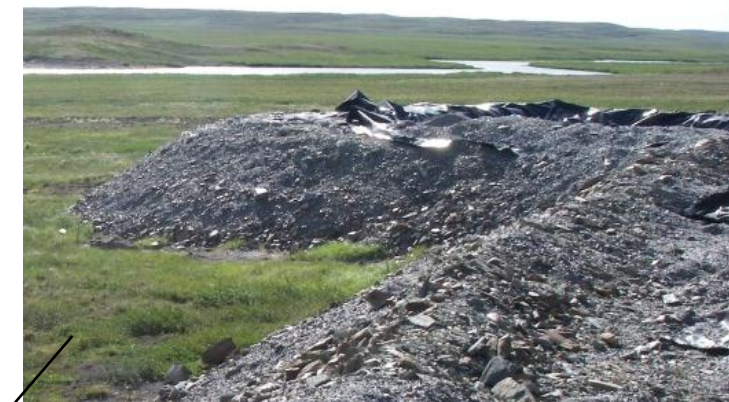
Edge of pad and Sediment Pond Berm. Photo looking south

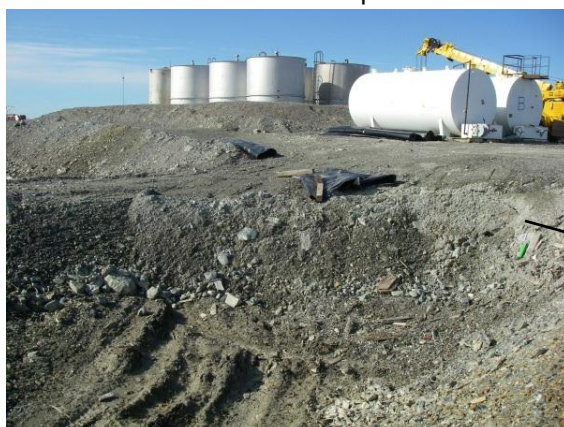
West side of Burn Pit

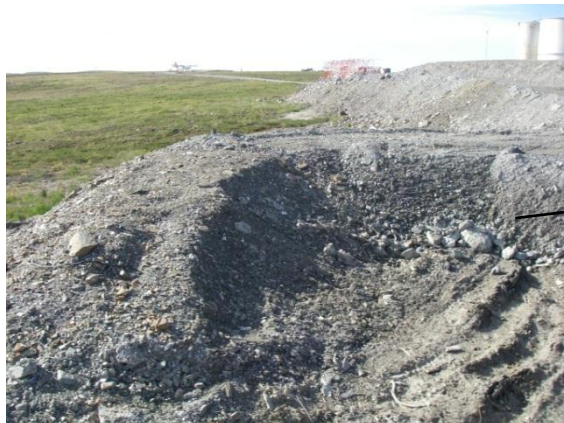
Southeast corner of Burn Pit

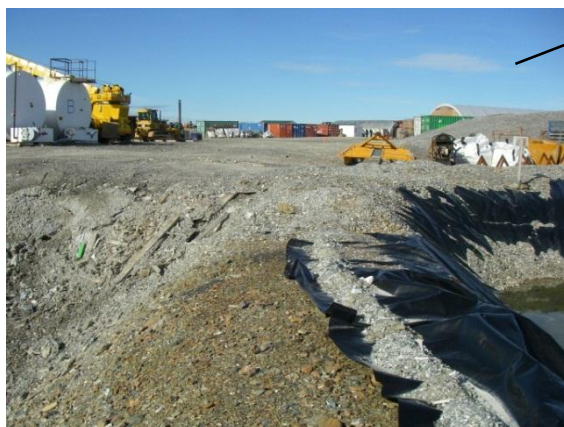
Berm between Burn Pit and Sediment Pond.
Photo looking west

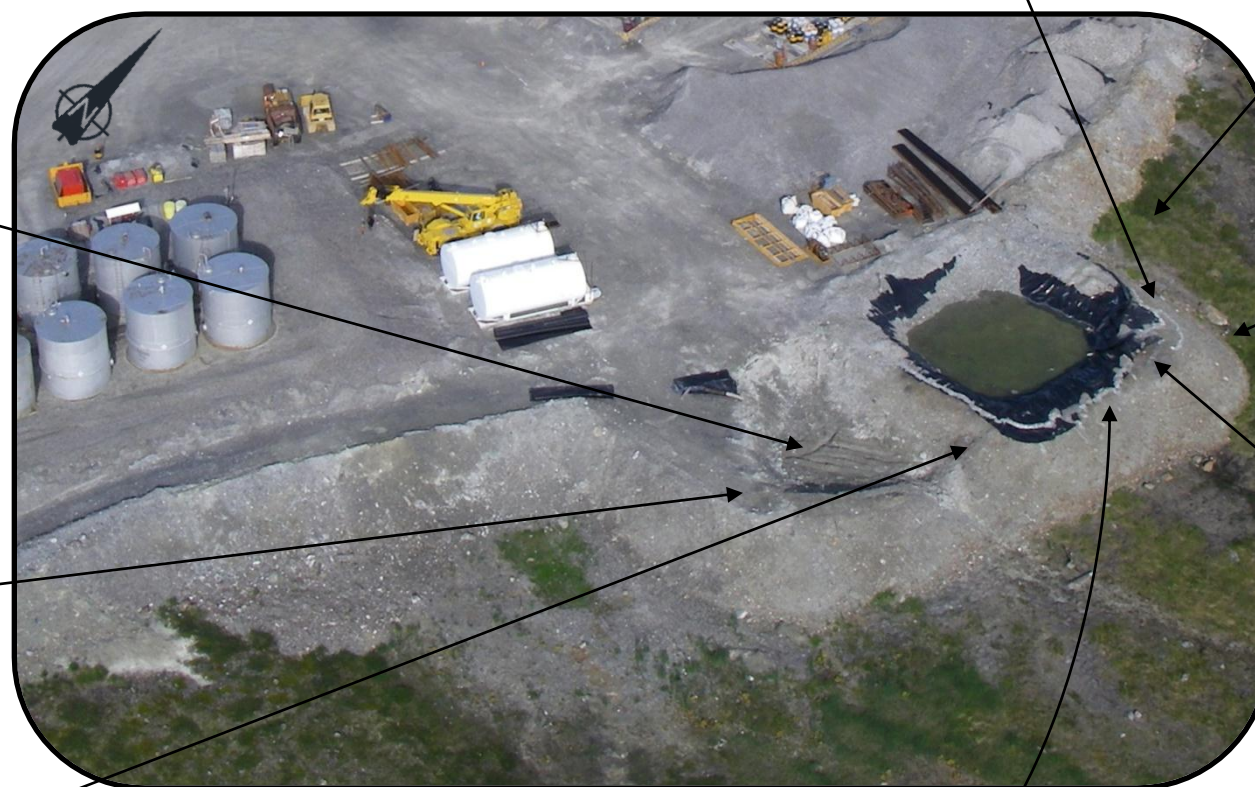
One lined settling pond (Figure 17) has been constructed along the eastern perimeter of the camp foundation pad (immediately north of the burn pit). As-built records for the construction of this pond are not available. It is understood that this pond was used to contain wash water during the screening and crushing of ore as part of the bulk sampling program.

Aerial view of Sediment Pond and Berm Pit

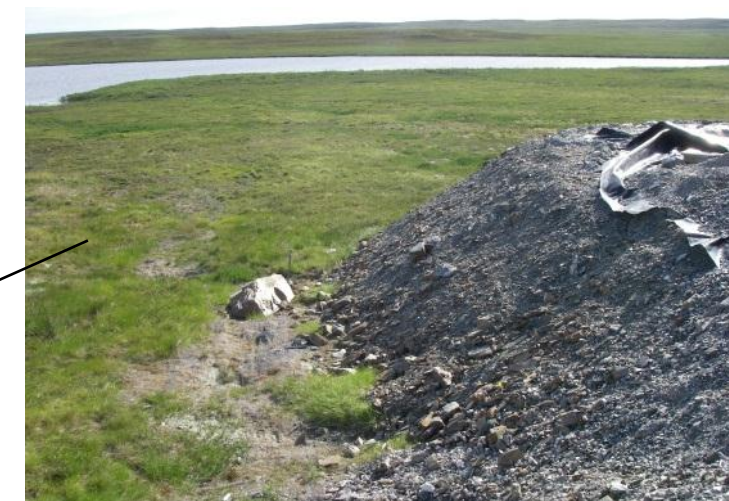
Edge of Sediment Pond berm, photo looking North

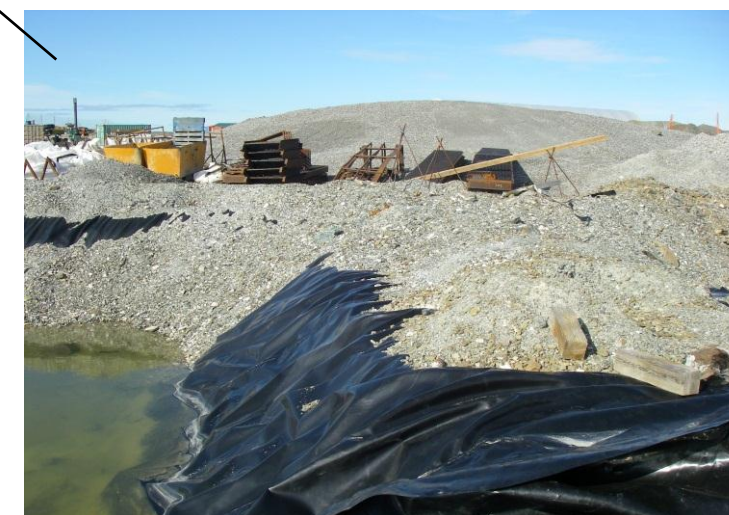
Northwest corner of Sediment Pond

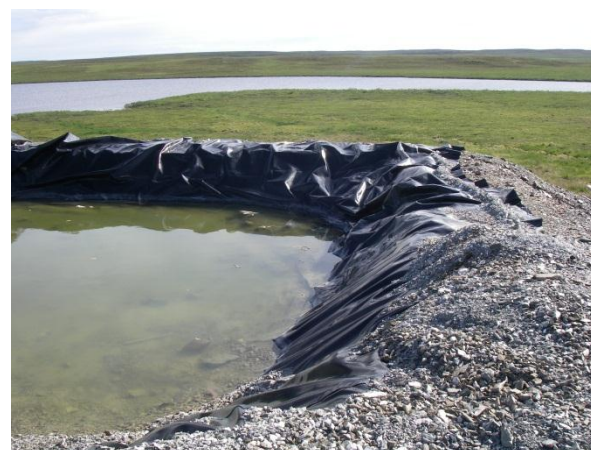
Northeast corner of sediment pond

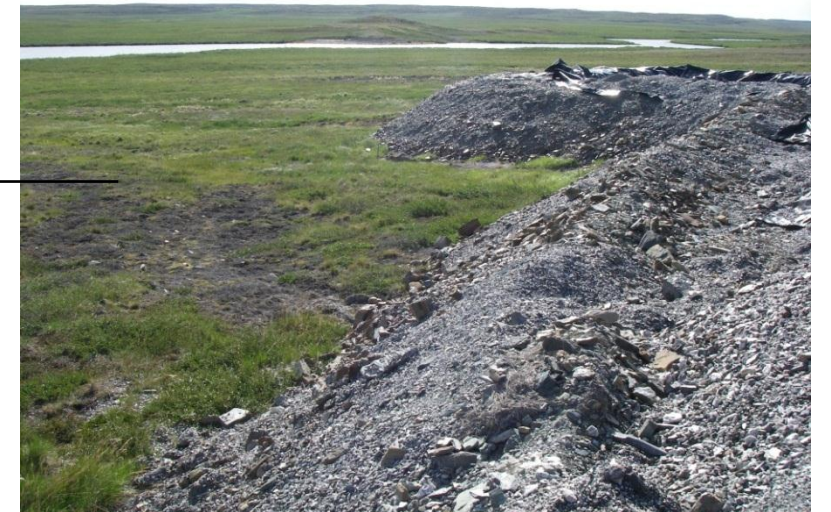
Closer look at edge of rockfill pad beside ore stockpile. Photo looking southeast

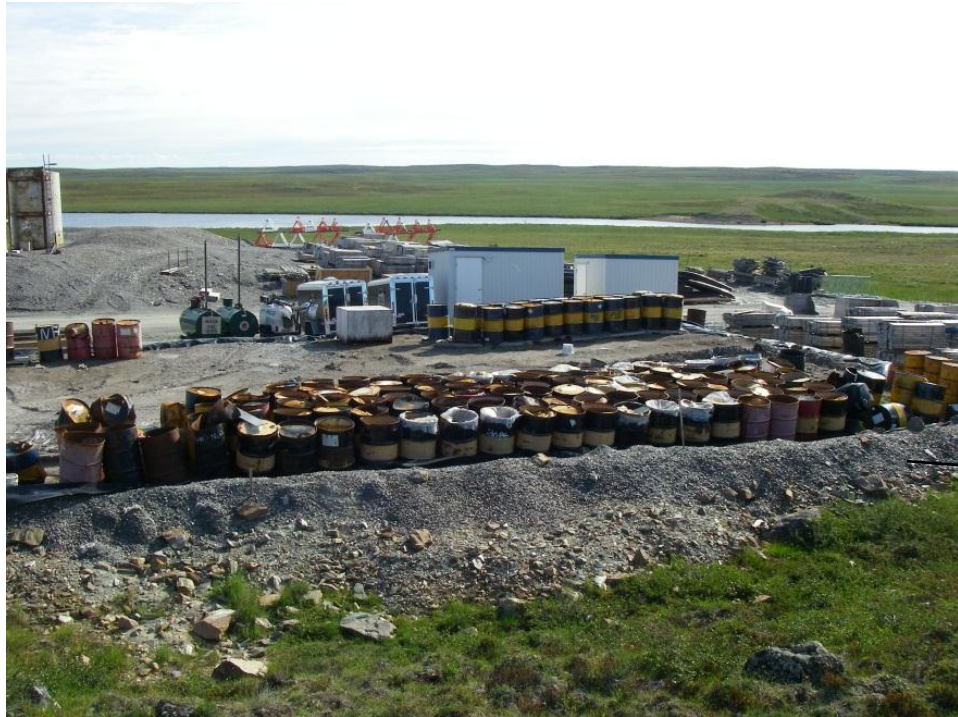
As a result of a historic fuel spill, HBML constructed a lined soil containment facility (Figure 19) within which all excavated contaminated soils have been stored (EBA 2004). SRK reviewed the as-built records for this facility (EBA 2004) and, supported by visual inspection, confirms that it consists of a bermed and lined area in which contaminated soil is placed. In addition to soils spread about 1 m thick over the entire surface of the facility, there are also a large number of old fuel drums filled with contaminated soils contained within the confines of the facility.

Looking east at Landfarm

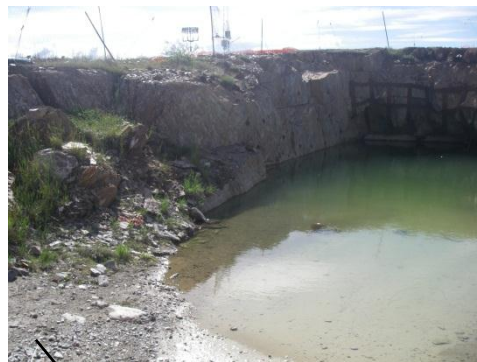
The portal, which is located about 25 m east of the maintenance shop as illustrated in Figure 20, was collared in altered volcanic rock, all within the permafrost. This was confirmed through installation of four underground thermistors (Golder 2000a, b). During extraction of the bulk sample, the portal was not heated but operated at an ambient temperature of about -10°C. The portal was operated under dry conditions with no groundwater inflow. After completion of the bulk sample collection, the portal was abandoned and sealed off with a locked gate.

View of east side of Portal

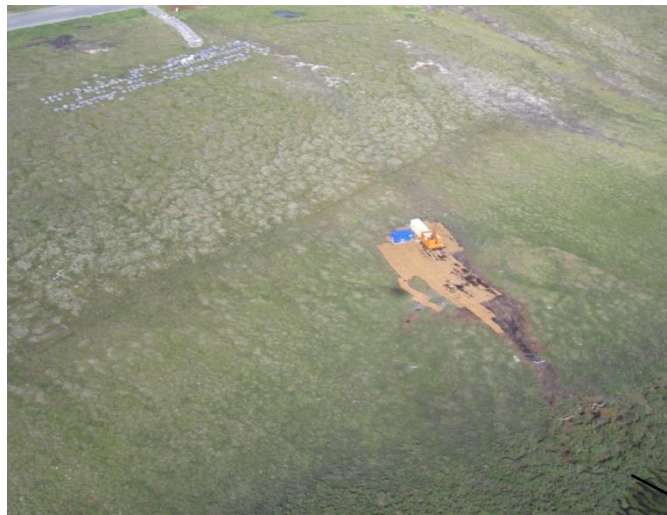
An incident at an exploration drill located due east of the airstrip in 2011 resulted in release of a significant amount of drilling fluid (brine) which subsequently resulted in a substantial salt-burn killing the tundra vegetation (Figure 22). In addition, immediately beneath the drill permafrost degradation occurred leaving an exposed hole with no drainage. Perpetual ponding will exacerbate permafrost degradation at this location.

Aerial photo of Brine spill on east side of Airstrip

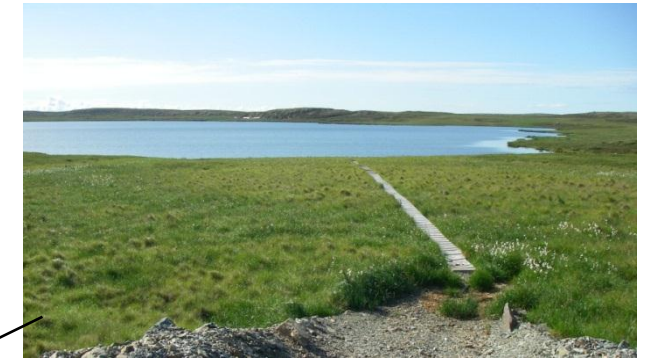
The wooden walkway leading from the southern end of the airstrip to a boat dock in Stickleback Lake (Figure 22) has been constructed as a floating walkway directly on the tundra. The walkway has

Boardwalk to boat dock on Stickleback Lake

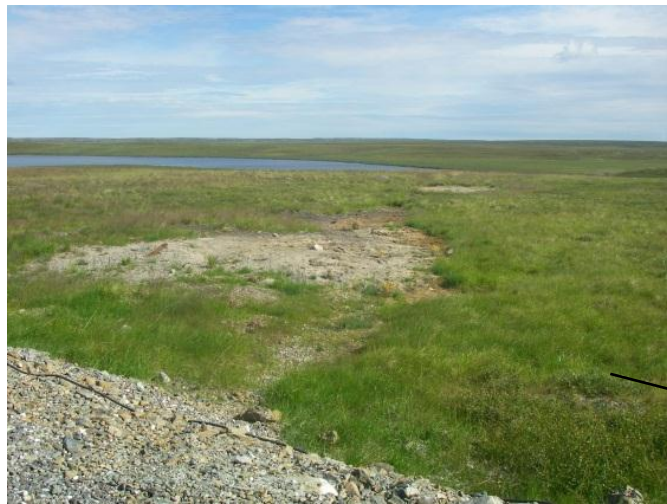
In addition to the localized areas of vegetation dieback described in Section 3.5.2 and 3.5.3, there are two large areas of vegetation dieback on the property, the origin of which is not clear. The first is an area south of the core storage road and east of the airstrip. In this area the vegetation has died but the underlying soils have not yet been exposed. The second area is between the drill road and the airstrip. Figure 22 provides examples of this damage. At this location the vegetation has died and the overburden soils have been exposed. The area is wet and difficult to traffic.

Vegetation die-back on north end of Airstrip

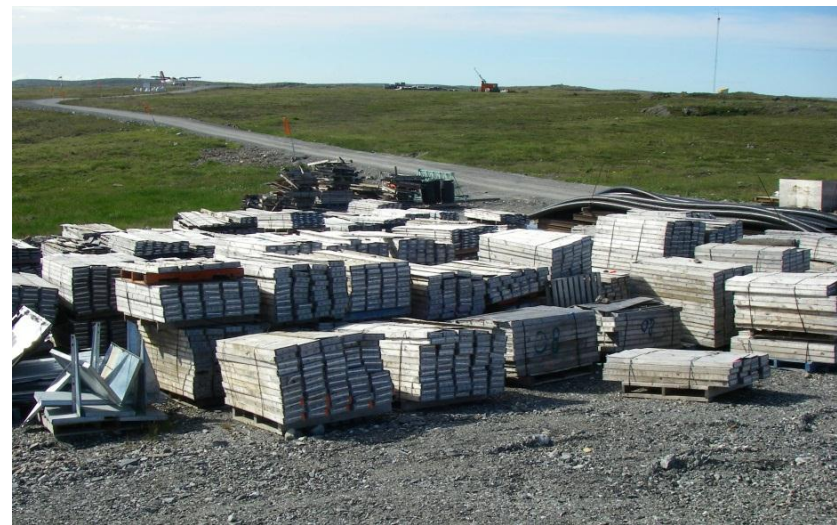
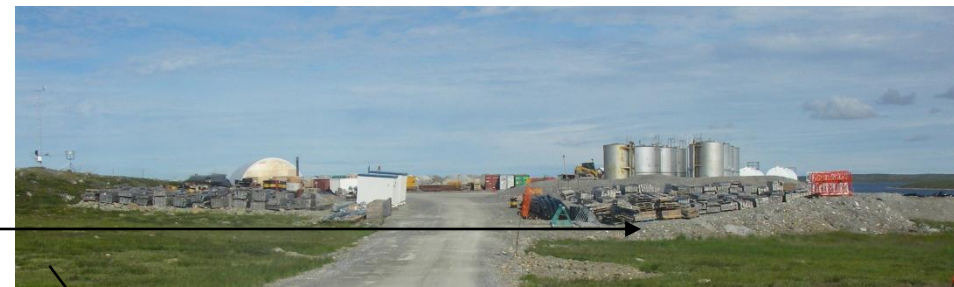
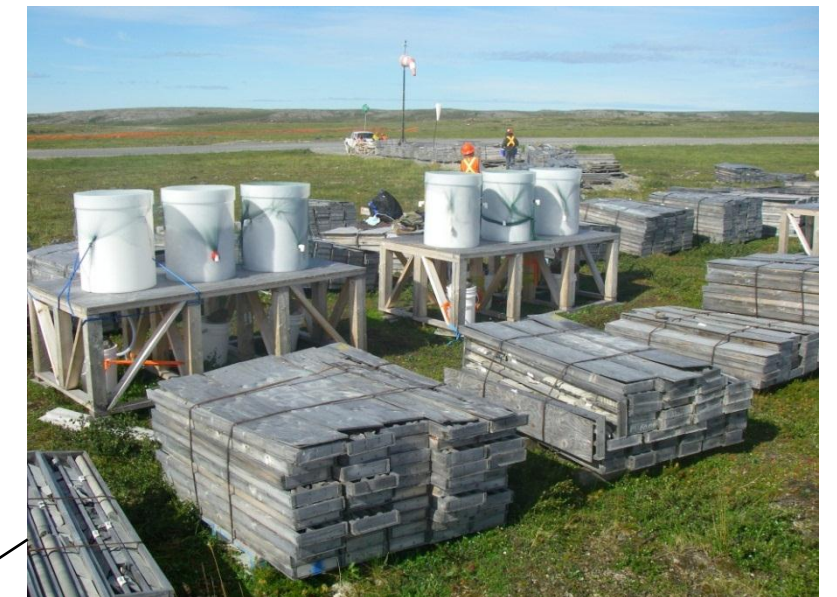
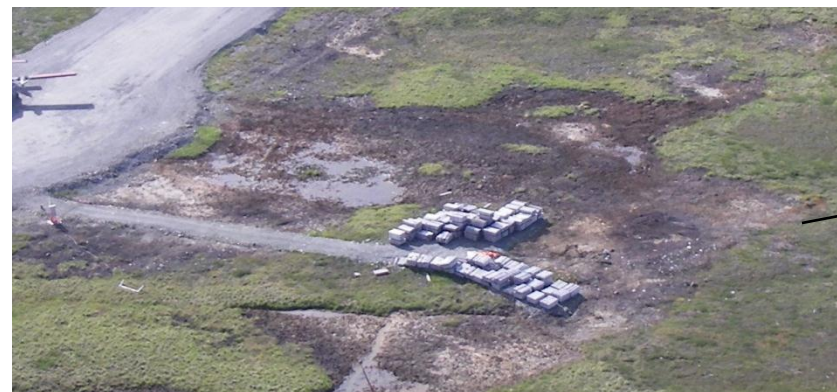
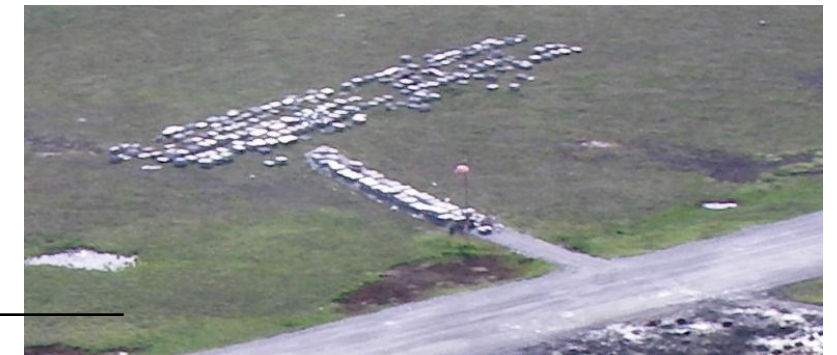
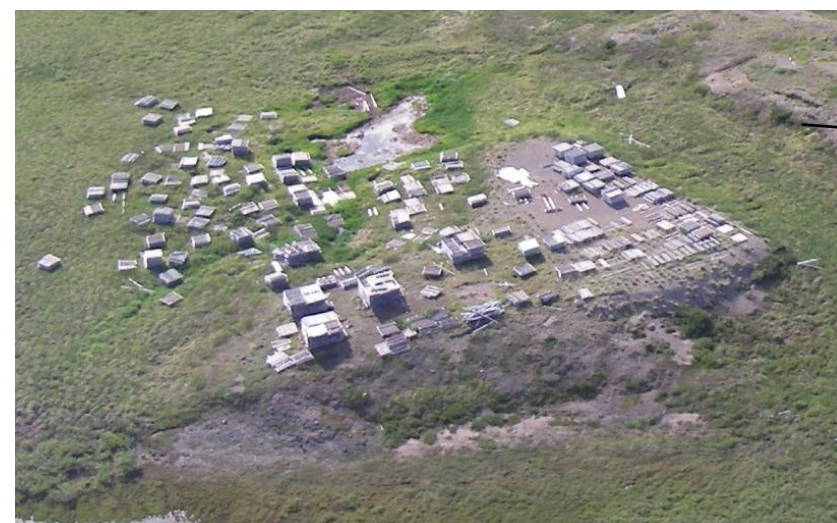
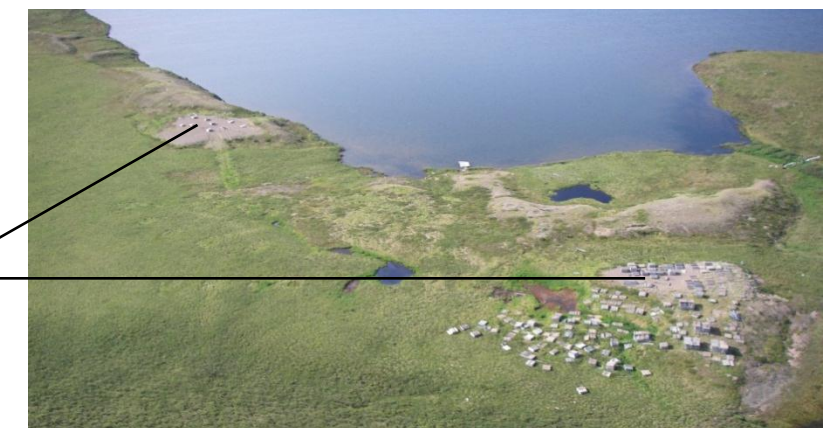
2011 Geotechnical Inspection		
		Radio Tower and Vent Raise		
Job No: 1CH008.046	HOPE BAY MINING LTD.	Date: March 2012	Approved: EMR	Figure: 23
Filename: Figure 23_RadioTower&VentRaise.pptx

There is a single vent raise located about 100 m south-west of the portal entrance (Figure 23). Mechanical and electrical support equipment is installed on a levelled wooden platform about 0.6 m off the tundra. The vent area and wooden platform base are sealed off with tarps and the mechanical and electrical equipment is locked in a steel shed. Overall the facility looks weathered; but there does not appear to be permafrost degradation. Site staff could not confirm when the facility was last accessed or inspected in detail.

A new radio repeater tower was installed south-east of the vent raise in 2009 (Figure 23). The tower was designed and installed by SLEC. The tower is supported by a concrete foundation embedded in bedrock and three wire anchors embedded in bedrock. The radio tower equipment is installed in an un-insulated wooden shack immediately adjacent to the tower. The shack is on a timber foundation of levelling blocks directly on an outcrop area.

Enclosure for radio equipment installed on raised wooden foundation rock outcrop

Looking southwest at foundation of radio tower and enclosure for radio equipment

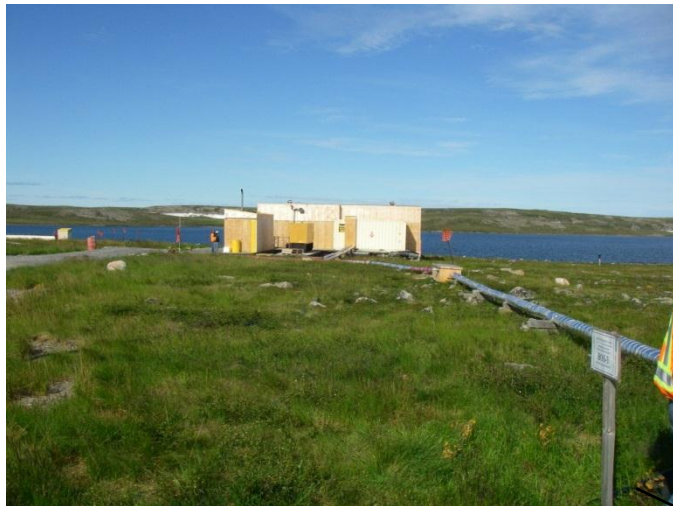
Pipe running from old sewage treatment to diffuser

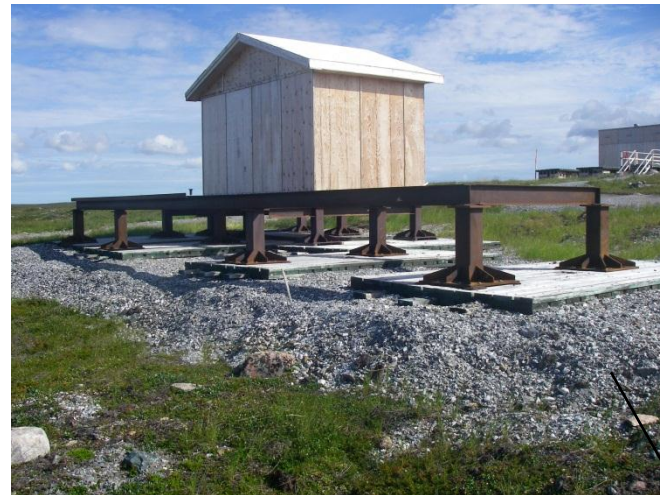
Close up look at thermal pad and raised foundations of new sewage treatment plant

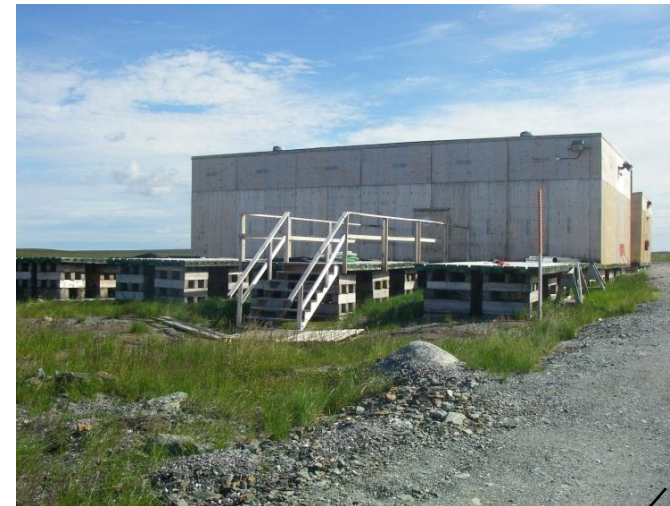
Closer look at foundations of old sewage treatment plant

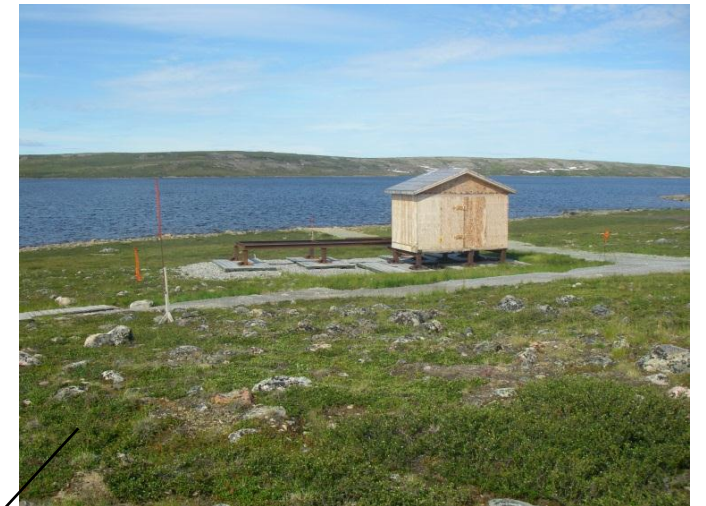
New Boston sewage treatment plant

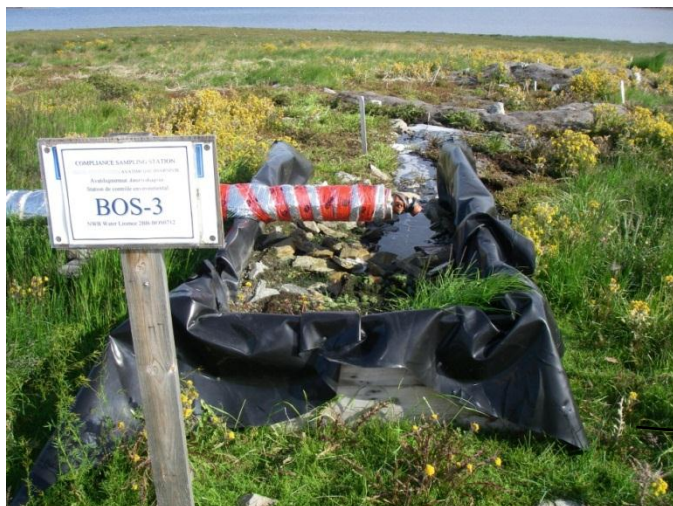
Diffuser for treated sewage effluent

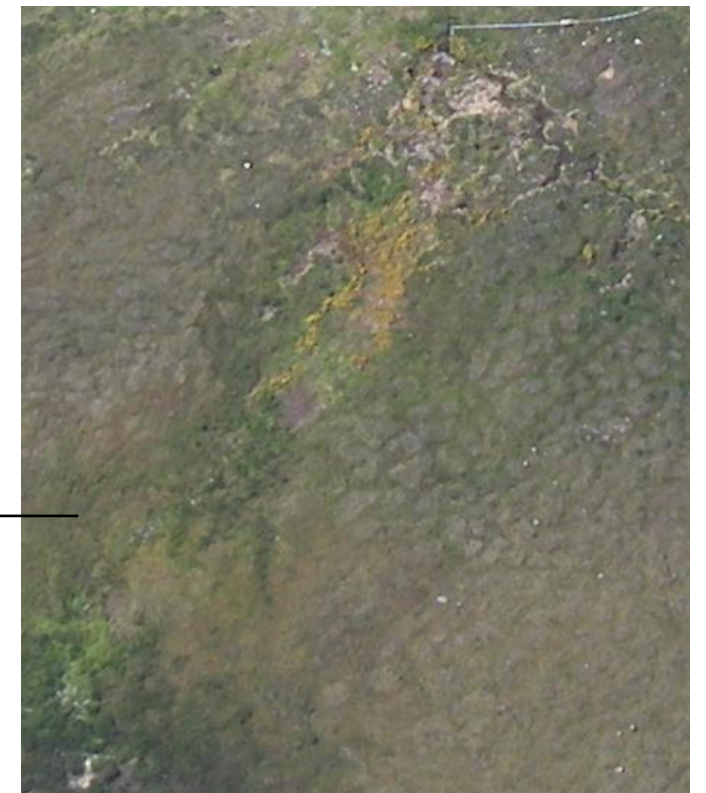
Aerial photo of tundra downstream of treated sewage discharge point

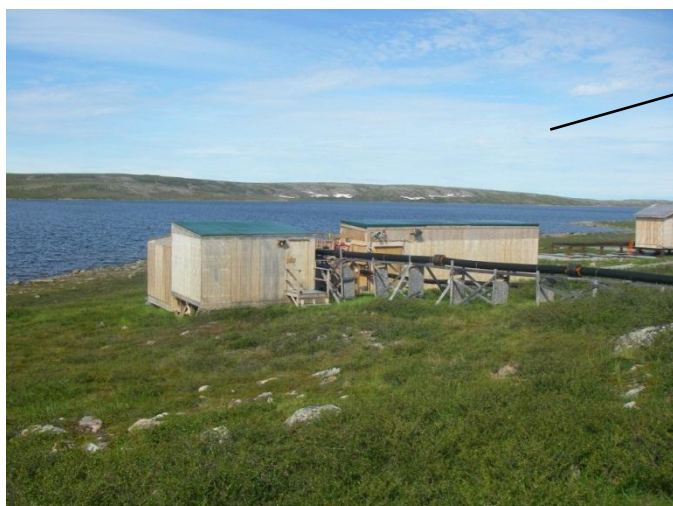
Looking northeast at old sewage treatment plant (foreground) and new sewage treatment plant (right)
