# 2012 Annual Geotechnical Inspection Boston Advanced Exploration Project Hope Bay, Nunavut

SRK Consulting (Canada) Inc.  
1CH008.066  
January 2013

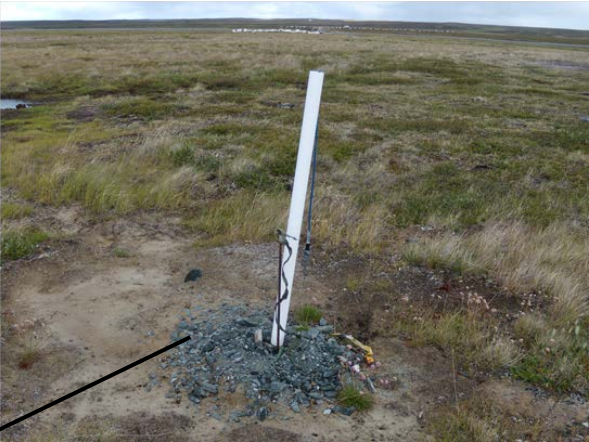
Drill hole 12259-05 (BH5) with thermistor string #1050.

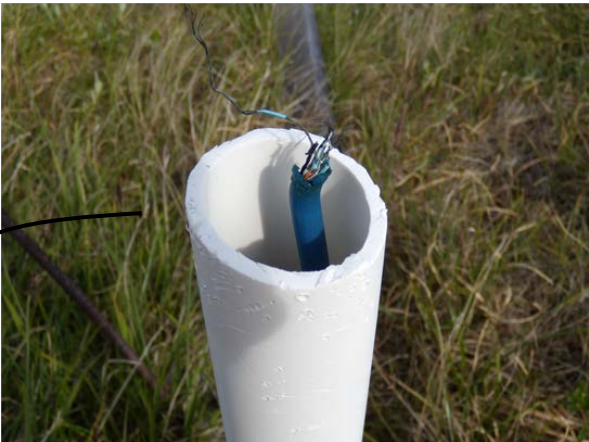
Close-up of the severed cable on drill hole 12259-03 (BH3) with thermistor string #1049.

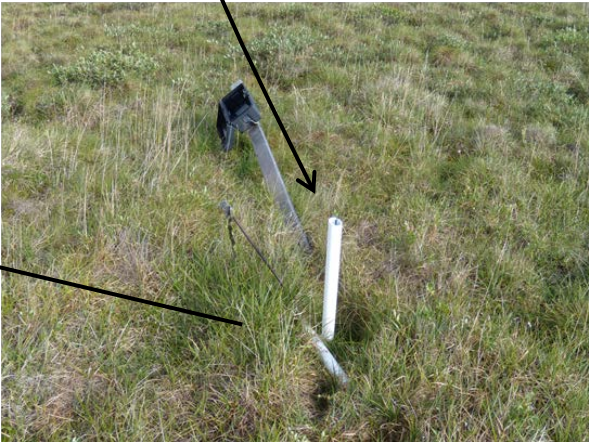
Drill hole 12259-03 (BH3) with thermistor string #1049. The cable has been severed.

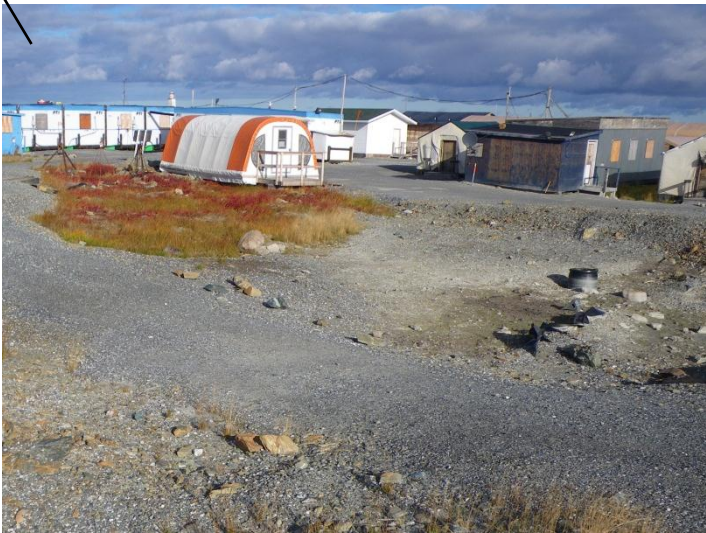
Old fuel spill area

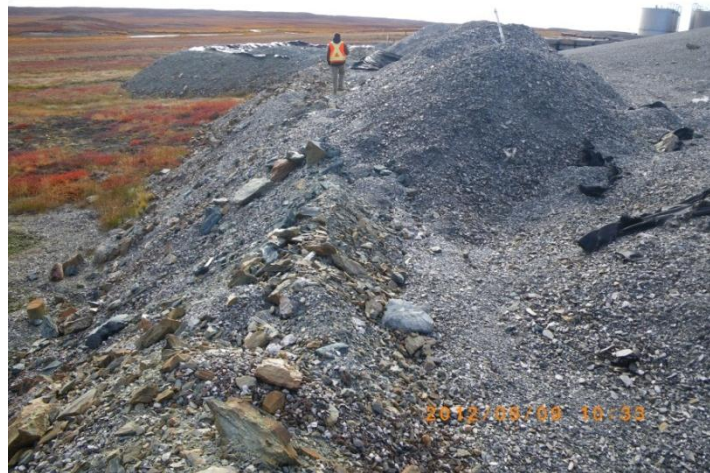
Looking south across the edge of the rock fill pad beside the ore stockpile. The sedimentation pond in the background

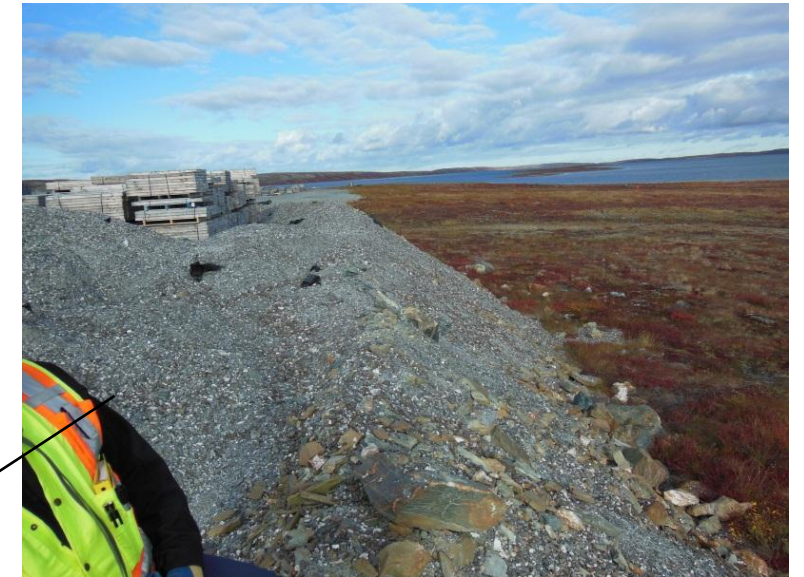
End of rock fill pad besides ore stockpile – looking north

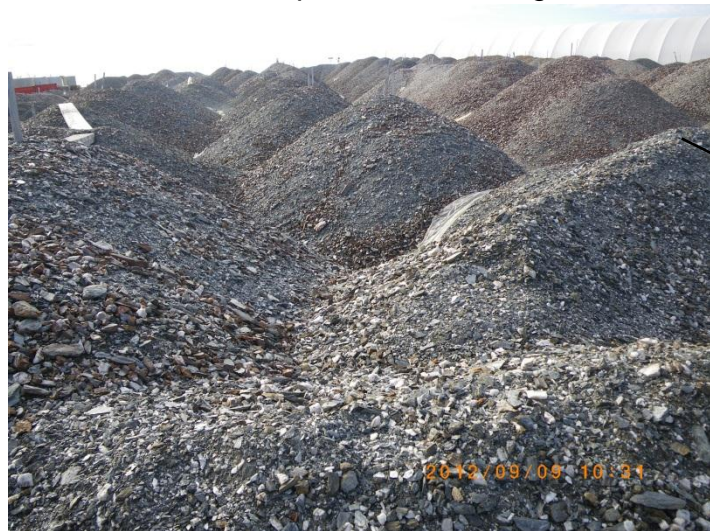
Top of ore stockpile – looking south towards crusher enclosure

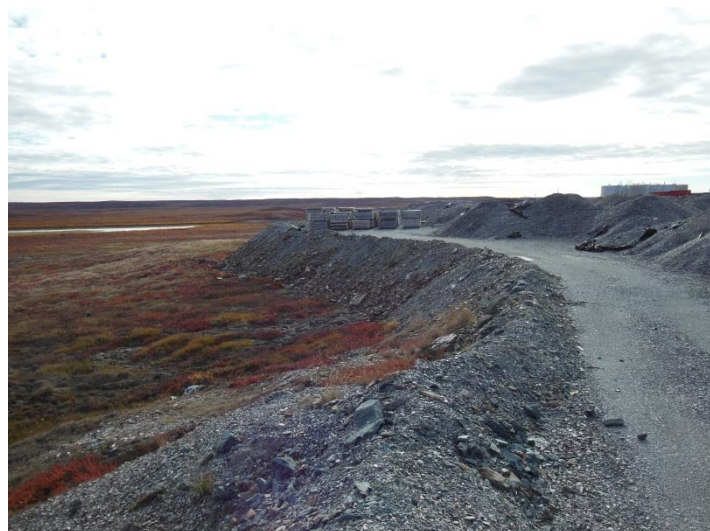
Edge of rock fill pad at the south end of the ore stockpile - looking south towards the core box storage

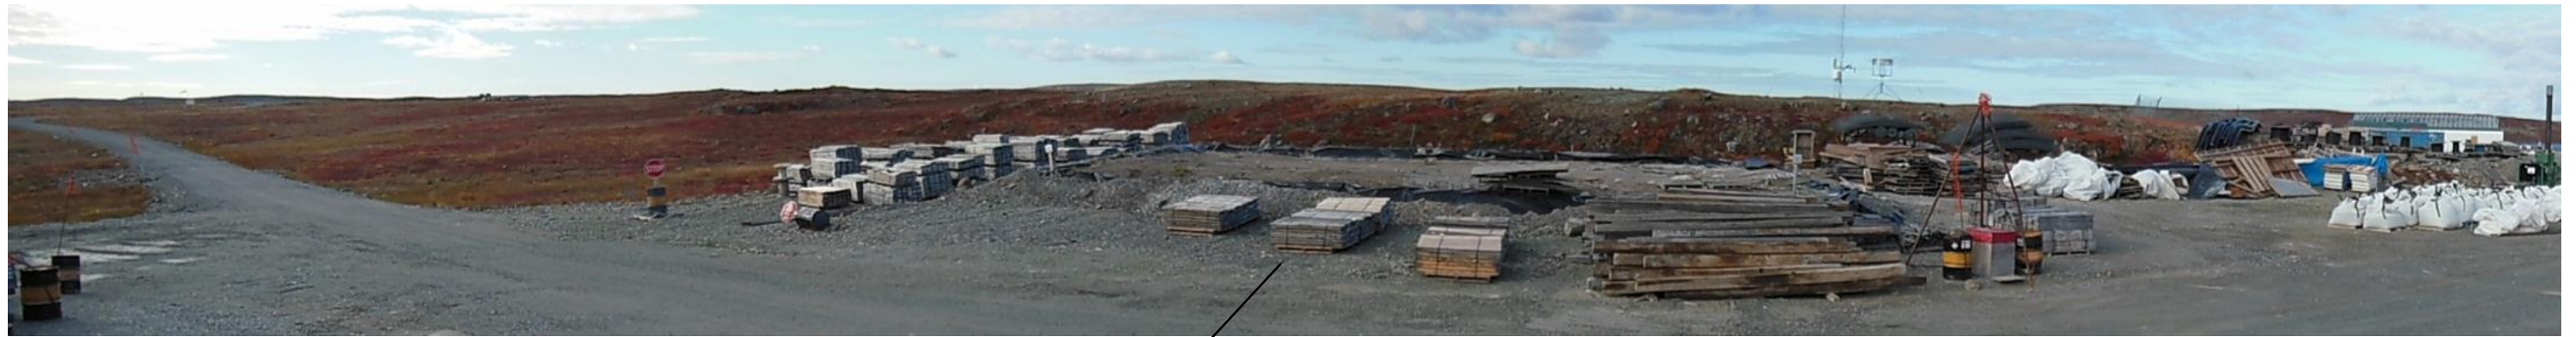
Panoramic view of core box storage, landfarm and bone yard – looking southwest from the fuel tank farm

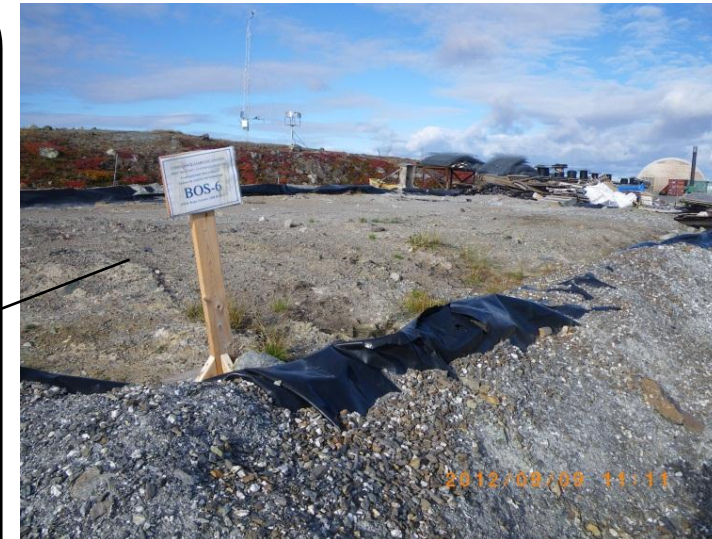
Top surface of landfarm soils – looking northwest towards the weather station

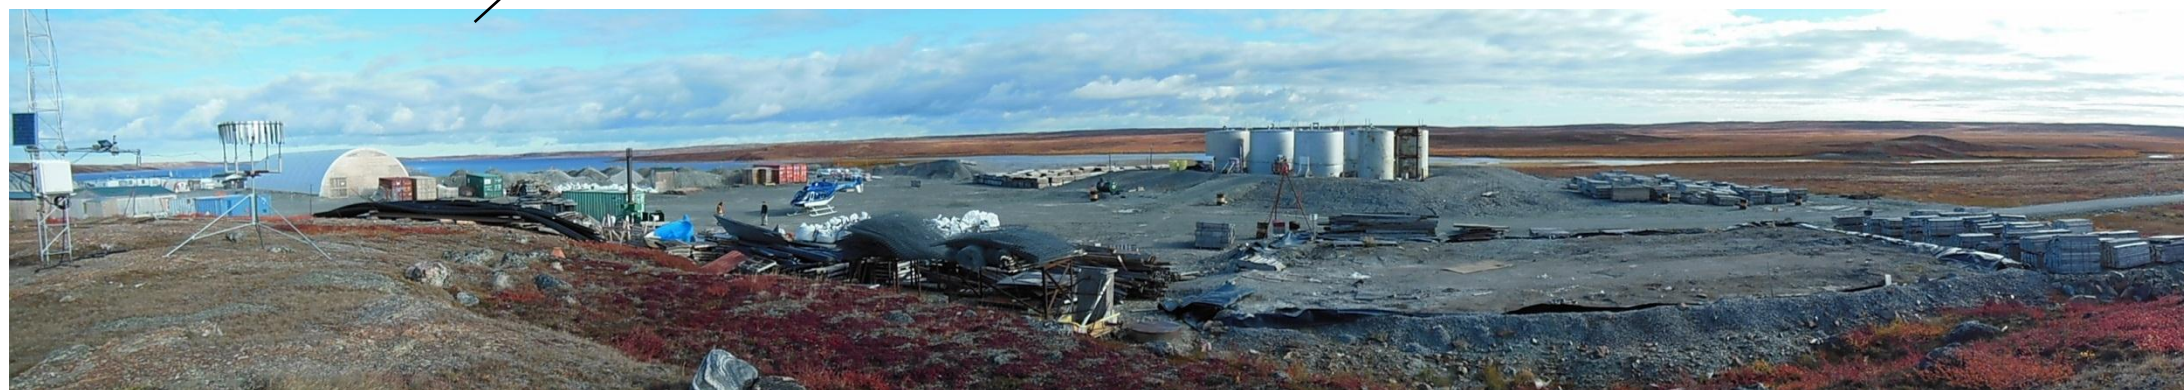
Panoramic view overlooking the bone yard and landfarm towards the fuel tank farm and crusher enclosure. Looking east next to the weather station

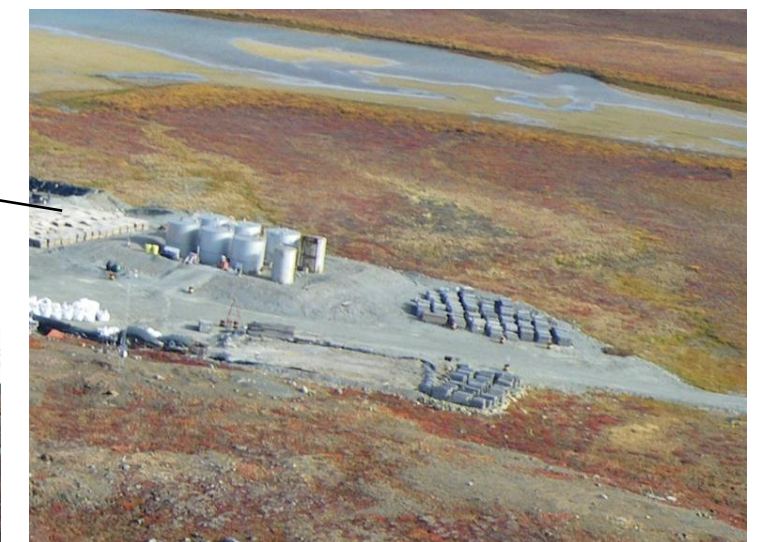
Aerial view looking down on the landfarm, core box storage, bone yard and fuel tank farm – looking west

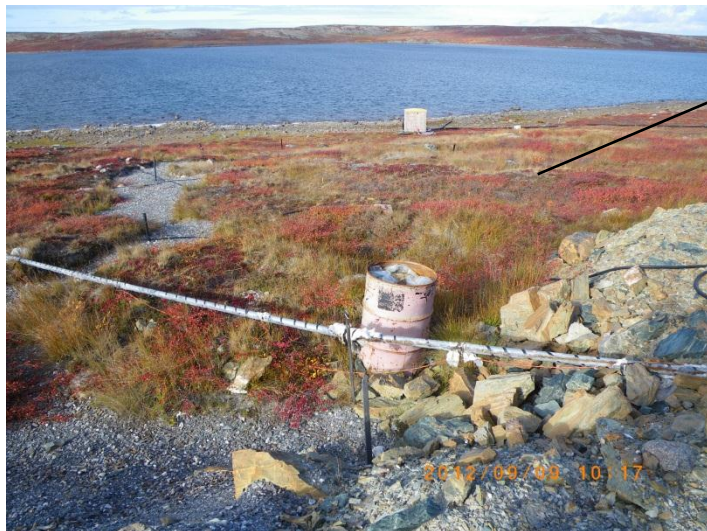
Water Intake and erosion gully – looking west from workshop

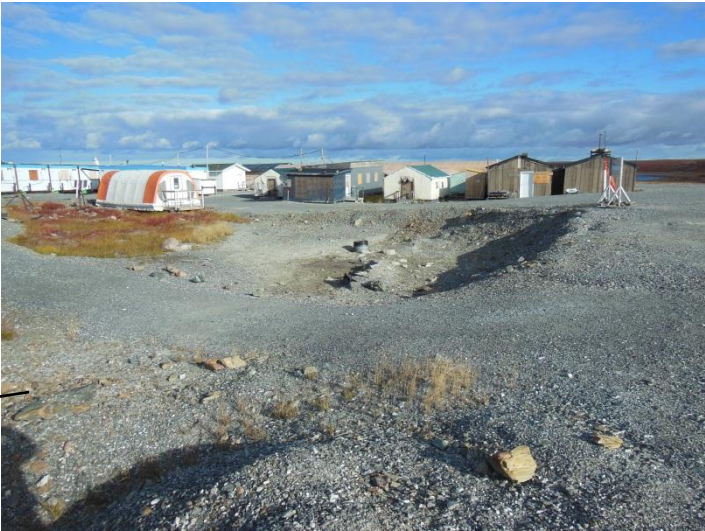
Old hydrocarbon spill area with geology offices and camp buildings in the background

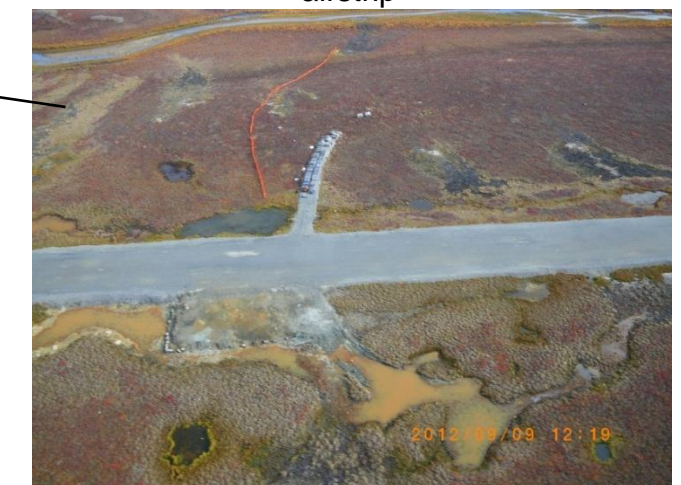
An incident at an exploration drill located due east of the airstrip in 2011 resulted in release of a significant amount of drilling fluid (brine) which subsequently resulted in a substantial salt-burn killing the tundra vegetation (Figure 22). In addition, immediately beneath the drill permafrost degradation occurred leaving an exposed hole with no drainage. Perpetual ponding will exacerbate permafrost degradation at this location.

Aerial view of core box clean-up across core storage road / drill cutting disposal in foreground/ Orbit 25 salt spill at the top of the photo – looking east

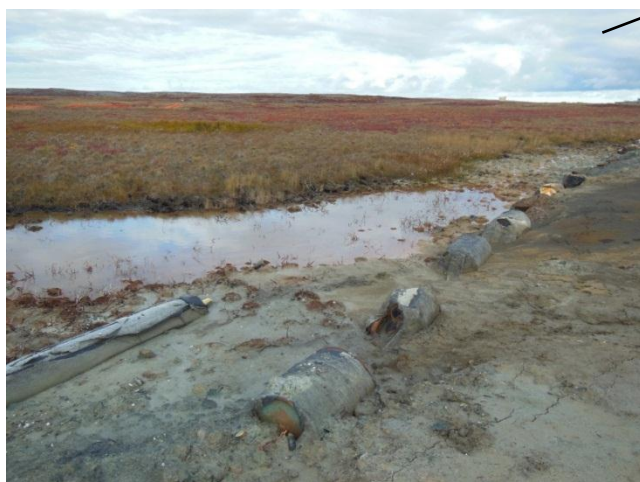
Some drill cuttings have historically been disposed of permanently in a settling pond immediately west of the airstrip (Figure 22). Site staff could not confirm if this pond was intentionally designed for this; if so there are no as-built records, nor could the timeframe for how long this practice has been in operation be determined. Visual inspection suggests that the pond is located at a historic drill hole. Poor control of the drill fluid resulted in permafrost degradation and the subsequent annual thaw created by a pool of standing water resulted in the pool increasing in size. At some stage, the pond started to overflow and silt-laden water started to flow overland towards open water bodies. At that time, drill cuttings were placed in the pond in an attempt to stop further degradation. Geotextile was also installed to control silt flowing from the pond.

West side of drill cutting disposal area showing geotextile drapes over 45 gal. drums – looking northwest while on disposal area

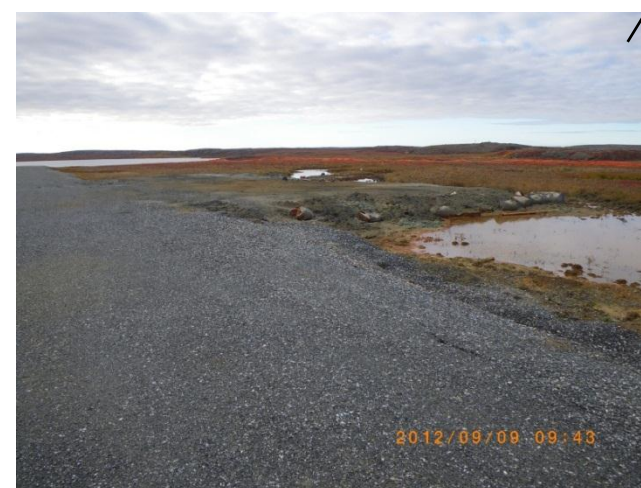
Drill cutting disposal – looking southwest from the airstrip

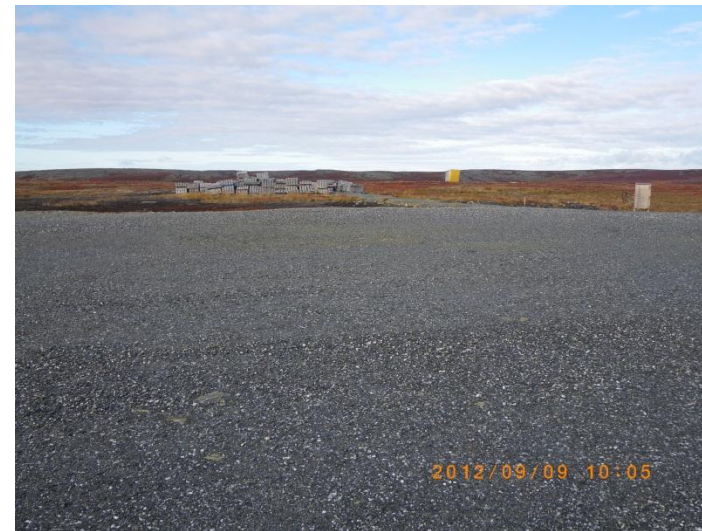
Core storage boxes relocated onto the drill road – looking west from airstrip

Core Storage Area(s)	<ul style="list-style-type: none"> <li>Consolidate core box storage and ensure that no boxes are inadvertently stored on the tundra</li> <li>Develop a long-term core storage plan</li> </ul>	<ul style="list-style-type: none"> <li>Monitor the areas where tundra vegetation damage has occurred</li> <li>Develop long-term re-vegetation plan; involve a tundra vegetation expert</li> </ul>
Grey Water Discharge	<ul style="list-style-type: none"> <li>Implement the new sewage management plan developed for the site</li> </ul>	<ul style="list-style-type: none"> <li>No action required</li> </ul>
Drill Sites	<ul style="list-style-type: none"> <li>Develop remediation strategy to prevent further permafrost degradation</li> </ul>	<ul style="list-style-type: none"> <li>Develop remediation strategy to prevent further permafrost degradation</li> </ul>
Vegetation Dieback Zone	<ul style="list-style-type: none"> <li>Initiate study to determine why dieback continues; involve a tundra vegetation expert</li> <li>Develop remediation strategy to prevent further dieback and permafrost degradation</li> </ul>	<ul style="list-style-type: none"> <li>Initiate study to determine why dieback continues; involve a tundra vegetation expert</li> <li>Develop remediation strategy to prevent further dieback and permafrost degradation</li> </ul>

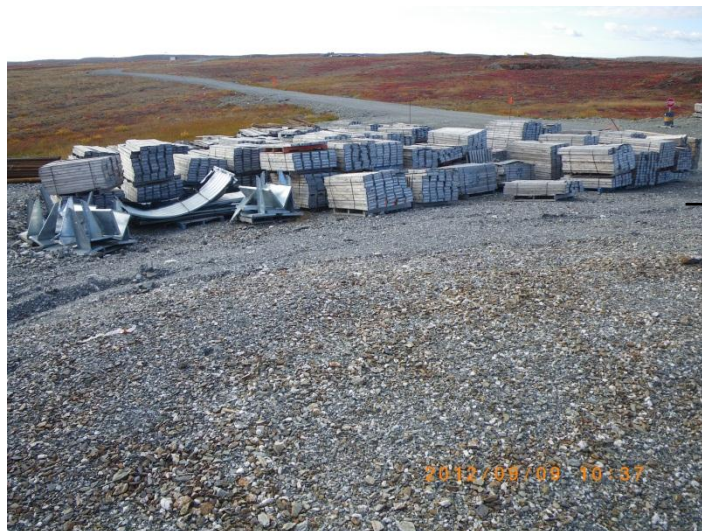
Core boxes stored at south end of camp across from landfarm

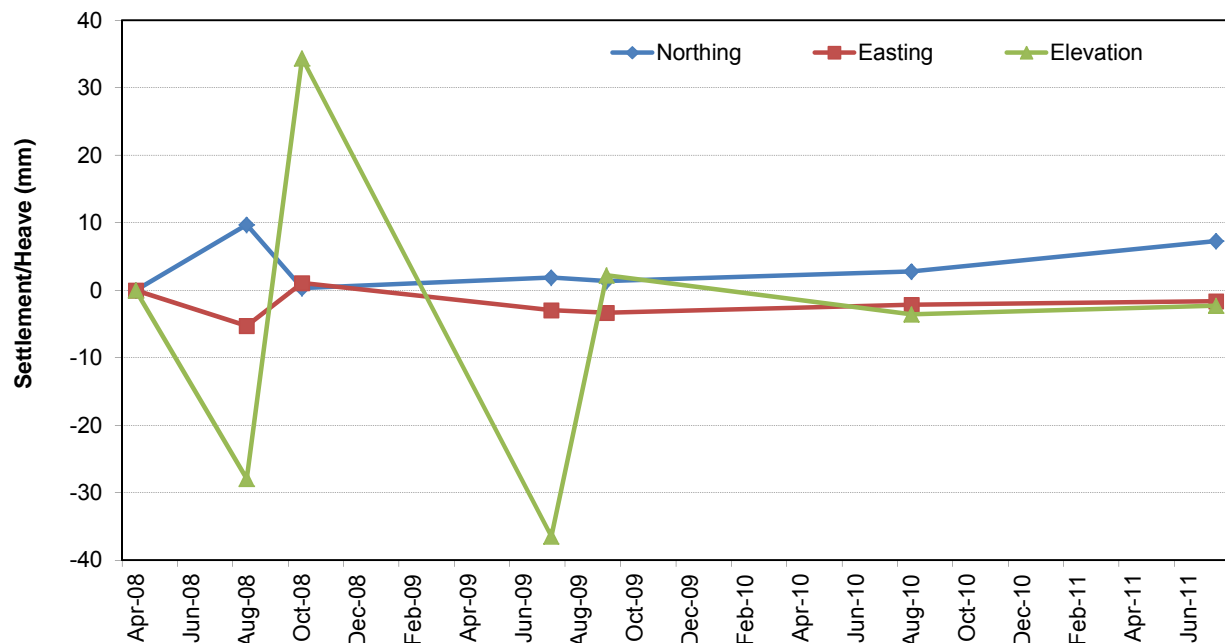
### Tank #8

TANK AVERAGES BY DATE (mm)	22-Apr-08	0.0	0.0	0.0
	8-Aug-08	9.7	-5.3	-28.0
	18-Oct-08	0.3	1.1	34.4
	25-Jul-09	1.9	-3.0	-36.5
	19-Sep-09	1.3	-3.3	2.2
	2-Aug-10	2.8	-2.1	-3.6
	3-Jul-11	7.3	-1.6	-2.3
OVERALL PERIOD AVERAGE (mm)		3.9	-2.4	-5.6
