Re: 2BB-BOS1217 – 2013 Annual Geotechnical Inspection Report

TMAC Resources Inc.

2013 Geotechnical Inspection	
		Containment Pond and Burn Pit	
Job No: 1CT022.000	HOPE BAY PROJECT	Date: March 2014	Approved: LW
Filename: Boston Geotech_Figures_1CT022.000_Rev04.pptx		Figure: 17

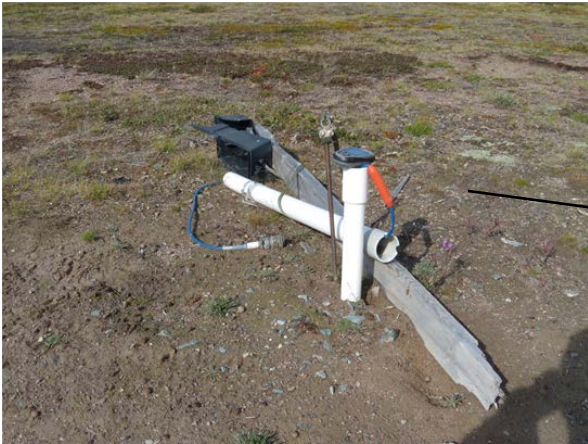
Drill hole 12259-06 (BH6) with thermistor string #1051.

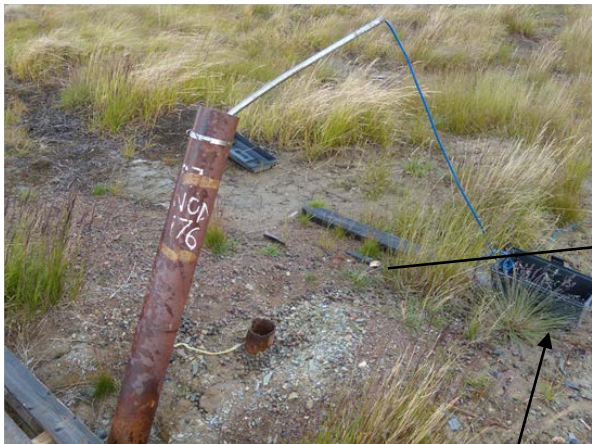
Drill hole 97NOD176 with thermistor string.

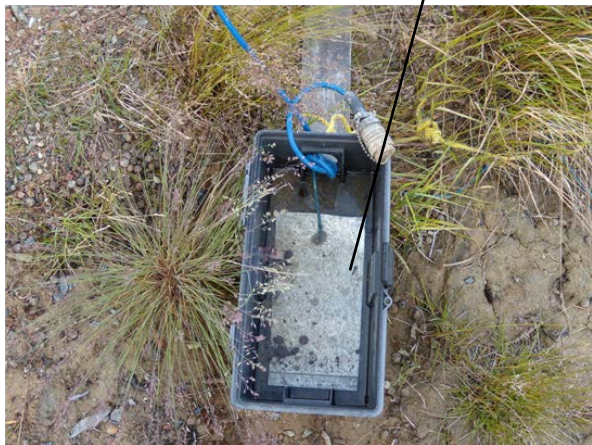
Close-up of the readout box and terminal connector for the thermistor string on drill hole 97NOD176.

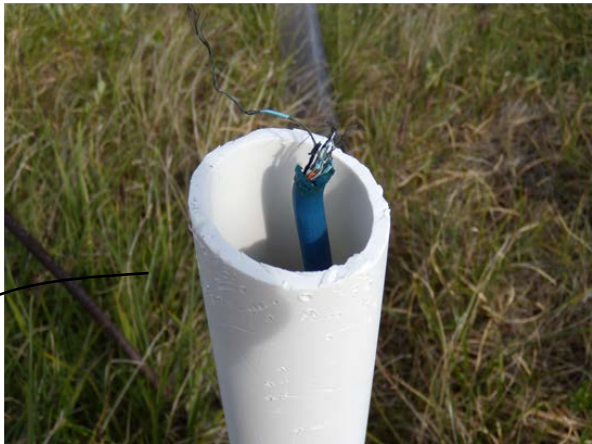
Close-up of the severed cable on drill hole 12259-03 (BH3) with thermistor string #1049.

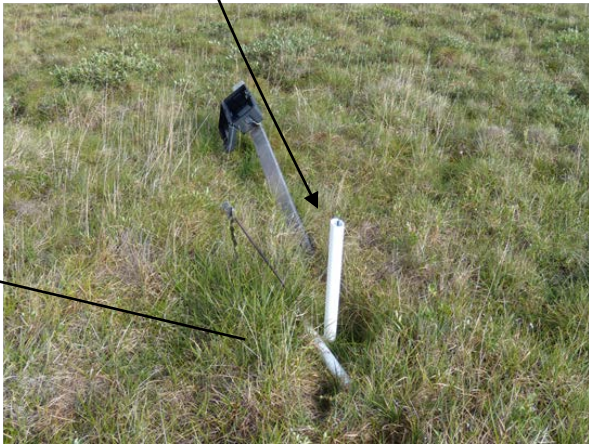
Drill hole 12259-03 (BH3) with thermistor string #1049. The cable has been severed.

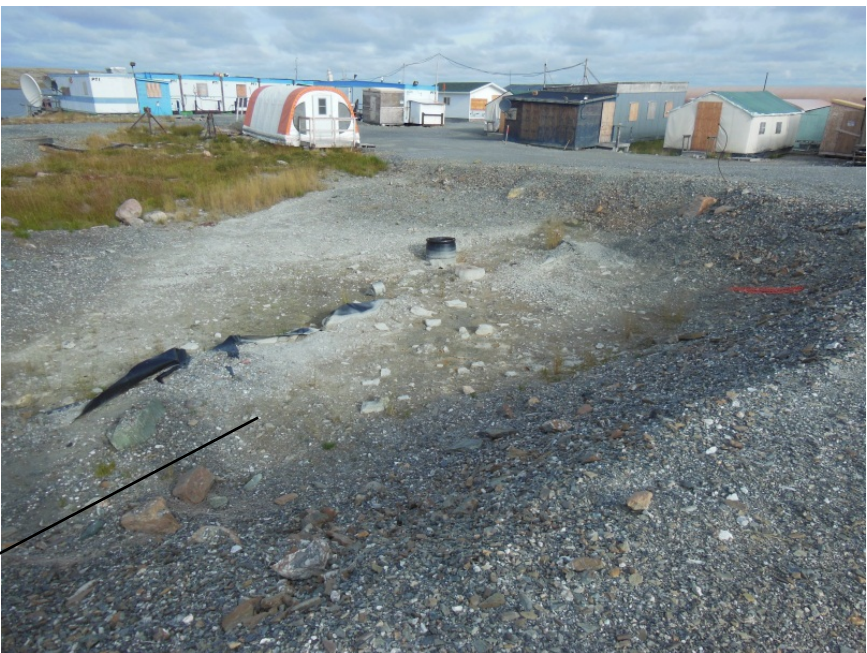
Old fuel spill area

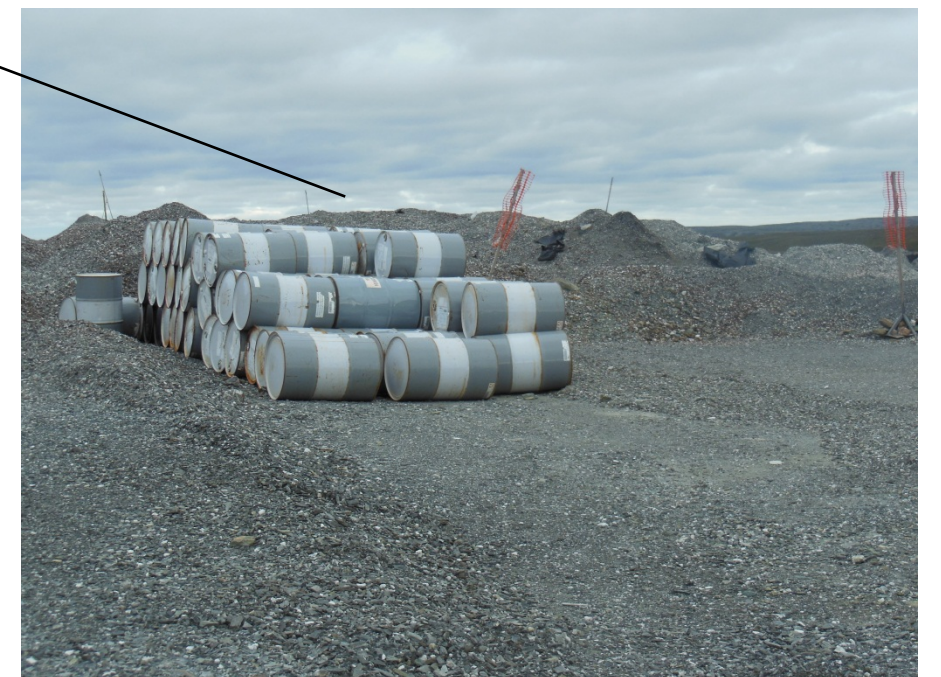
Empty fuel drums stored in the Jet Fuel and Lubricant Storage Area

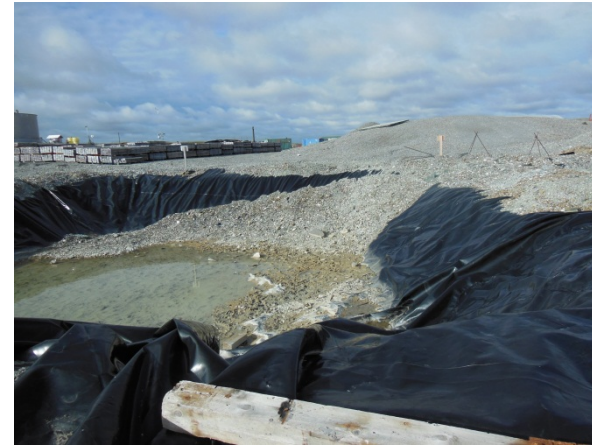
One lined Containment Pond (Figure 17) has been constructed along the eastern perimeter of the camp foundation pad (immediately north of the Burn Pit). As-built records for the construction of this pond are not available. It is understood that this pond was used to contain wash water during the screening and crushing of ore as part of the bulk sampling program.

Containment Pond - looking northwest

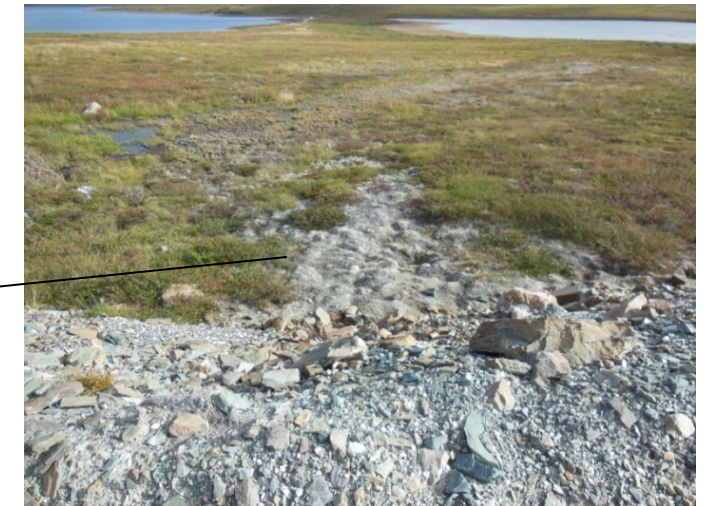
Seepage and vegetation die back at the toe of the rock fill pad at north end of the Ore Stockpiles

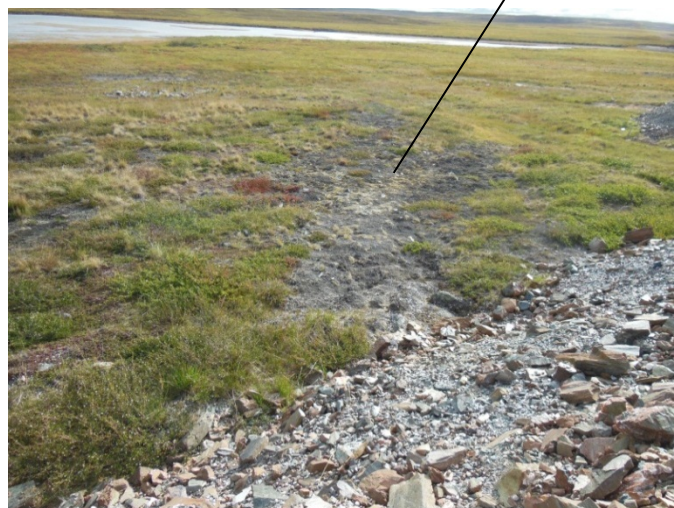
Seepage and vegetation die back at the south end of the Ore Stockpiles

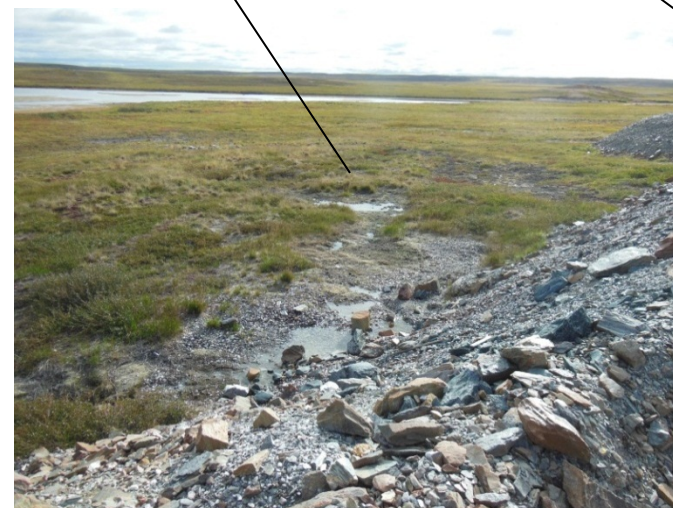
Seepage and vegetation die back at the toe of the rock fill pad by the Ore Stockpiles

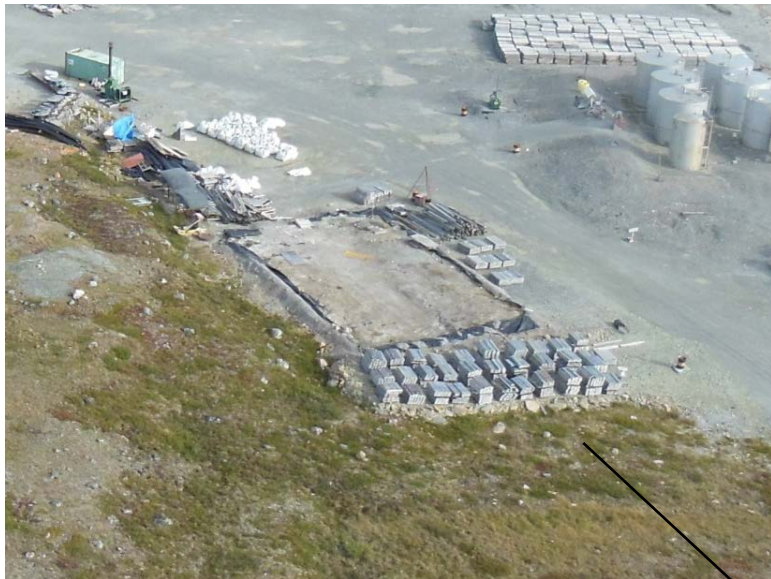
Aerial view overlooking the Bone Yard and Landfarm and the Incinerator - looking north

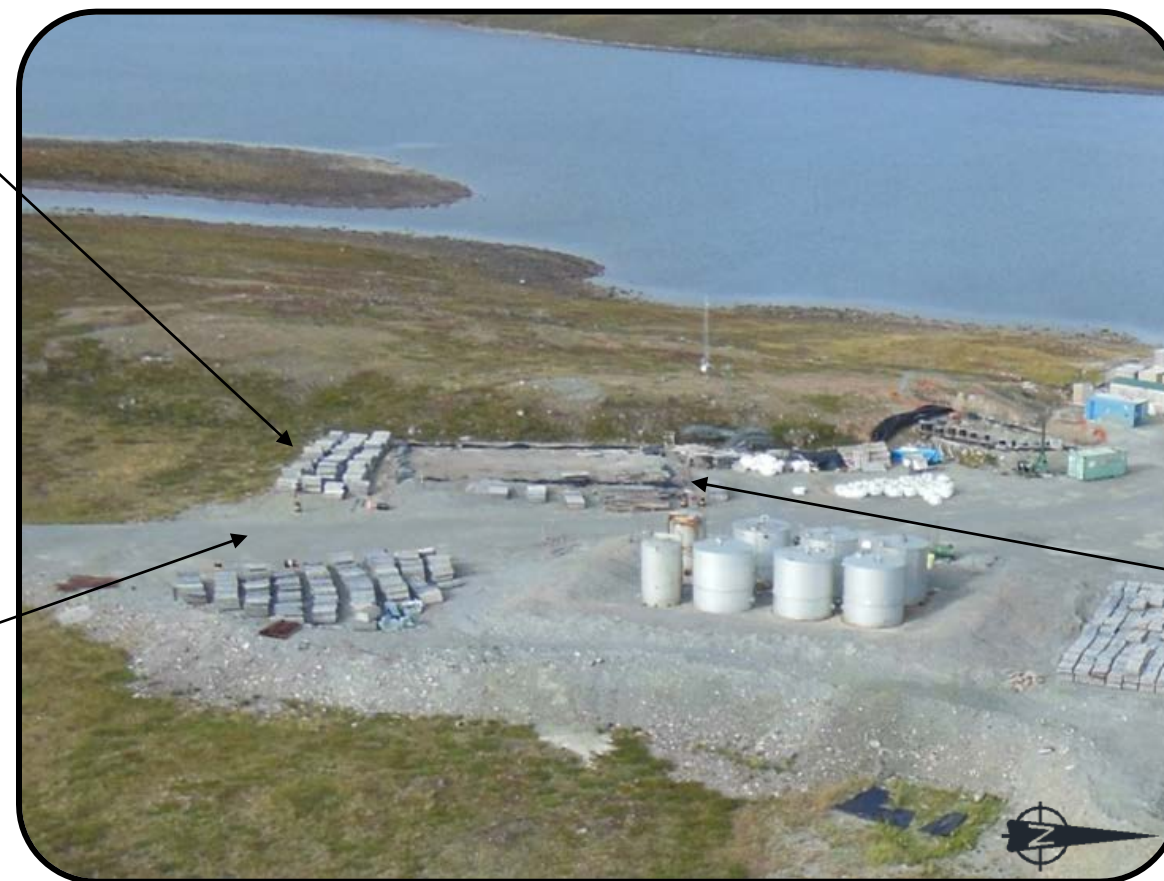
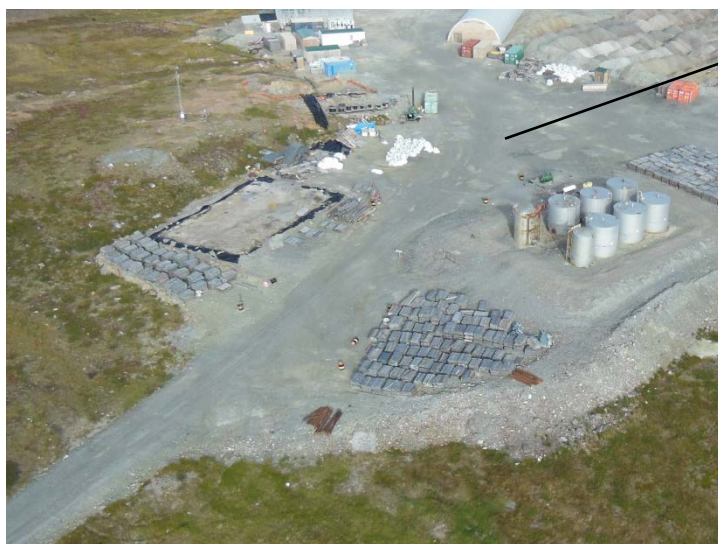
As a result of a historic fuel spill, MHL constructed a lined soil containment facility (Figure 19) within which all excavated contaminated soils have been stored (EBA 2004). SRK reviewed the as-built records for this facility (EBA 2004) and, supported by visual inspection, confirms that it consists of a bermed and lined area in which contaminated soil has been placed in a single lift of about 1 m thick.

Aerial view looking down on the Landfarm, Core Box Storage, Bone Yard and Primary Tank Farm at the south end of the camp pad

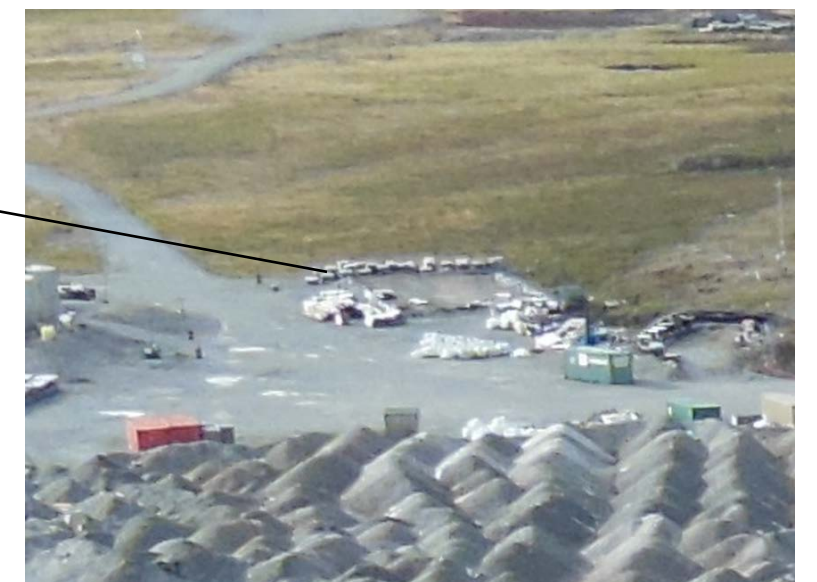
Aerial view looking down on the landfarm, core box storage area and the bone yard – looking south

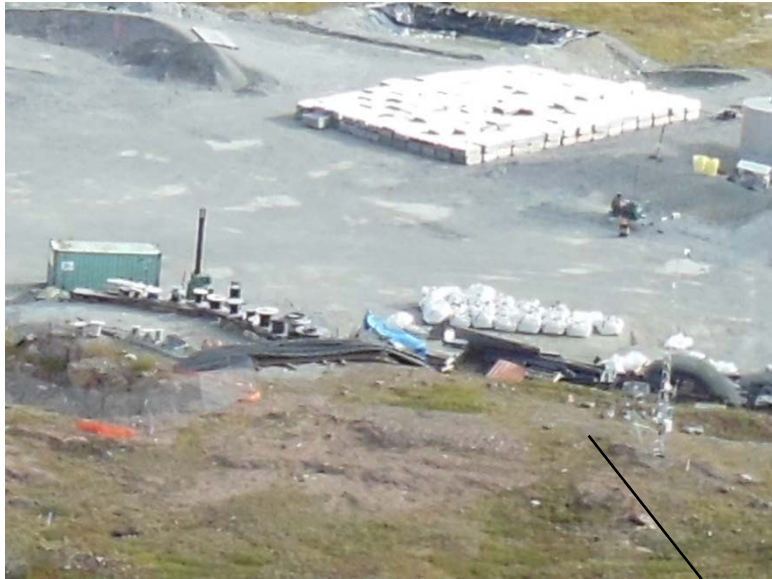
Aerial view of the Portal with the adjacent Incinerator, Weather Station, and Bone Yard – looking northeast

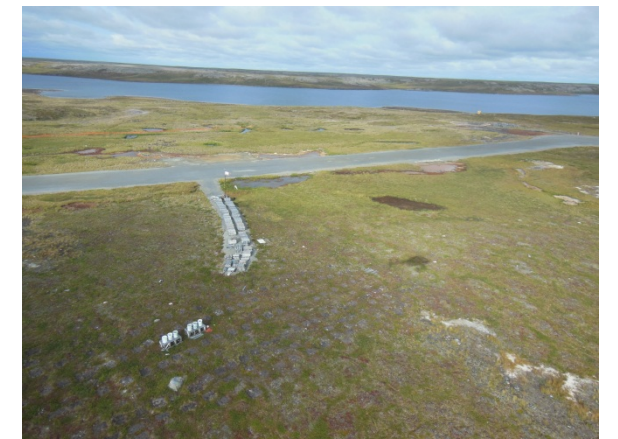
Aerial view of core box clean-up along Core Storage Road. Barrel tests have not been disturbed

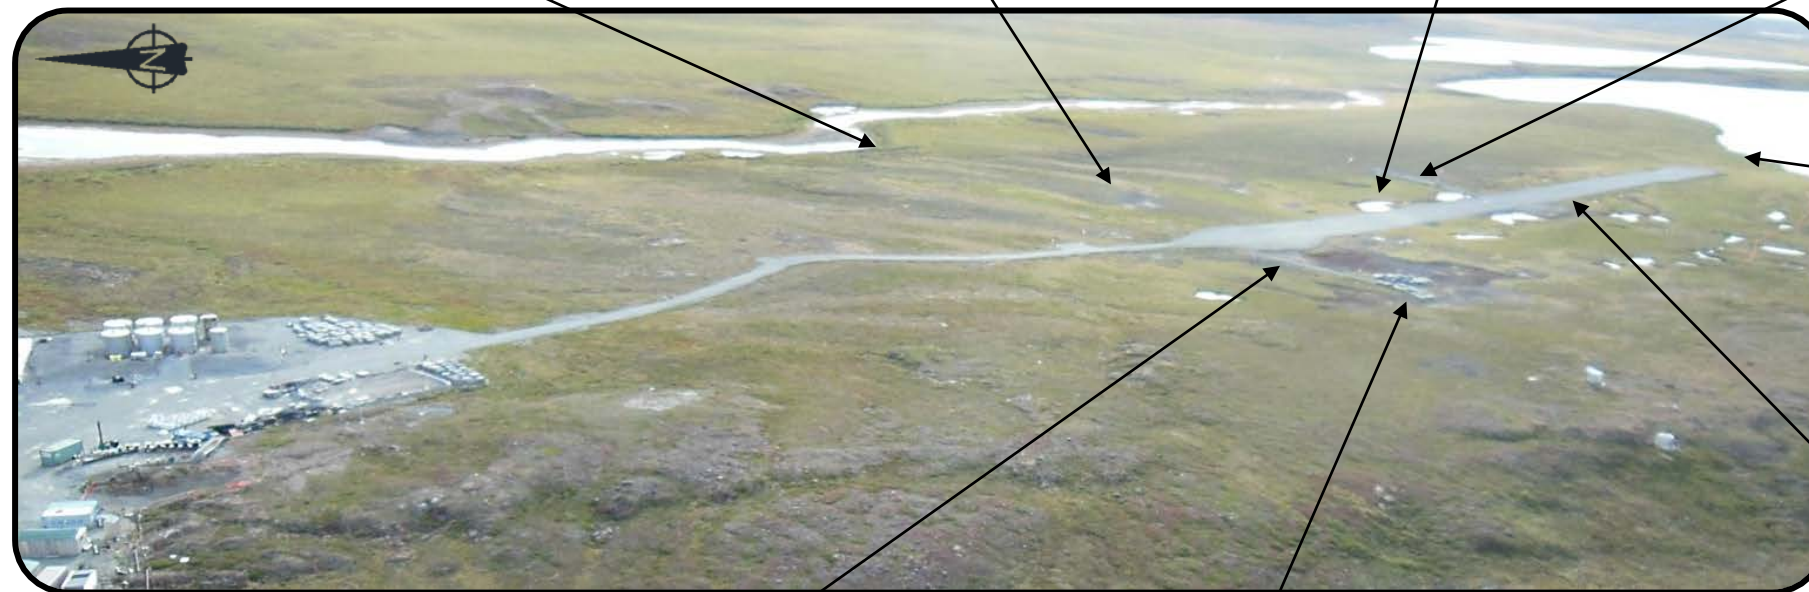
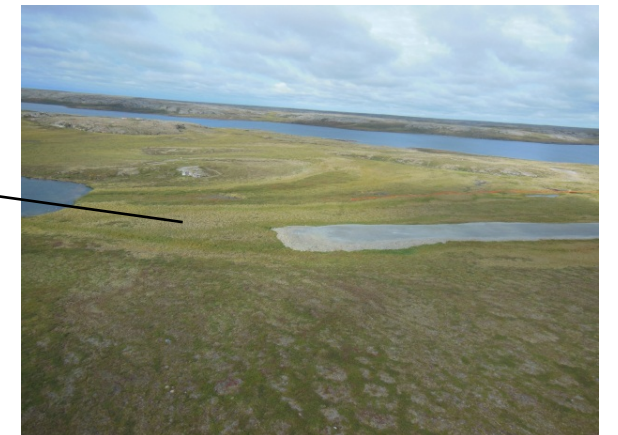
A wooden walkway leading from the southern end of the airstrip to a boat dock in Stickleback Lake (Figure 22) had been constructed as a floating walkway directly on the tundra. The walkway had settled into the tundra hummocks and although there is no lasting permafrost damage at this time, vegetation die back has occurred, which may result in the start of an erosion gully leading to permafrost degradation.

South end of airstrip with the board walk removed

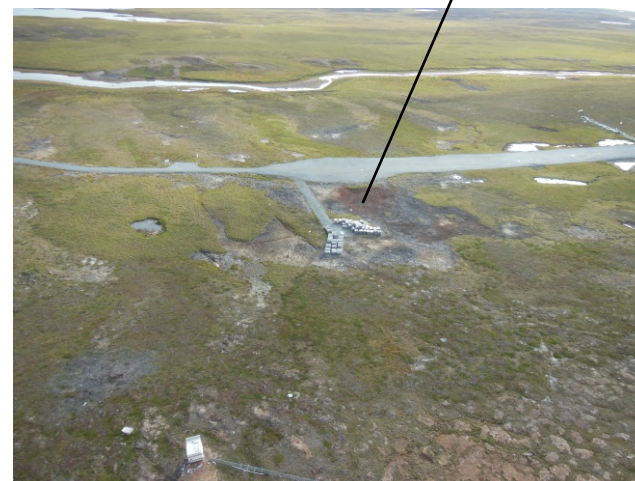
Aerial view of core box clean-up along Drill Road

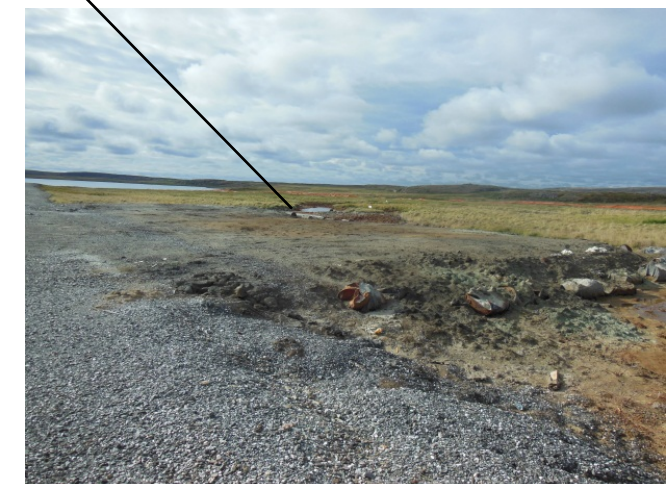
Some drill cuttings have historically been disposed of in a drill cutting disposal area immediately west of the airstrip (Figure 22). It is unknown if this area was intentionally designed for the disposal of drill cuttings. If so there are no as-built records, nor could the timeframe for how long this practice has been in operation be determined. Visual inspection suggests that the drill cutting disposal area is located at a historic drill hole. Poor control of the drilling fluid resulted in permafrost degradation and the subsequent annual thaw created by a pool of standing water resulted in the pond increasing in size. At some stage, the pond started to overflow and silt-laden water started to flow overland towards Stickleback Lake. At that time, drill cuttings were placed in the pond in an attempt to stop further degradation. Geotextile was also installed to control silt flowing from the pond.

Drill cutting disposal area along the west side of the airstrip – looking southwest

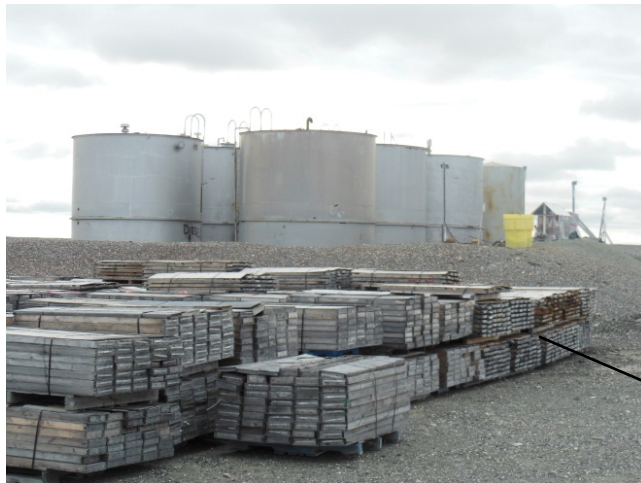
Relocated core boxes by Primary Tank Farm

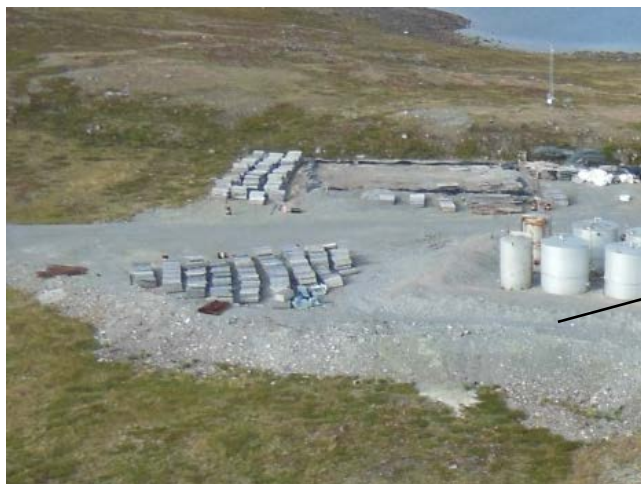
Core boxes stored at the south end of the Camp Complex Foundation Pad

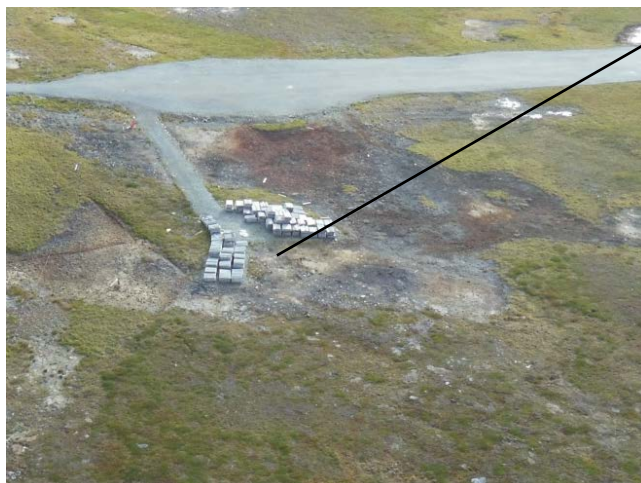
Core boxes relocated onto the Drill Road.

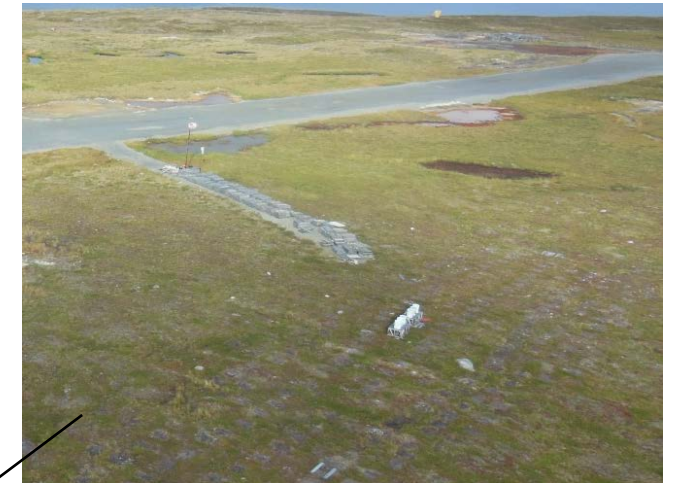
Only the barrel tests remain at the core storage area by the Core Storage Road

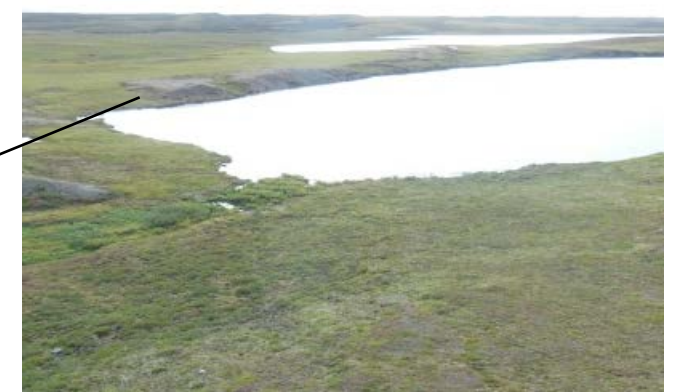
Core storage area at the original camp location

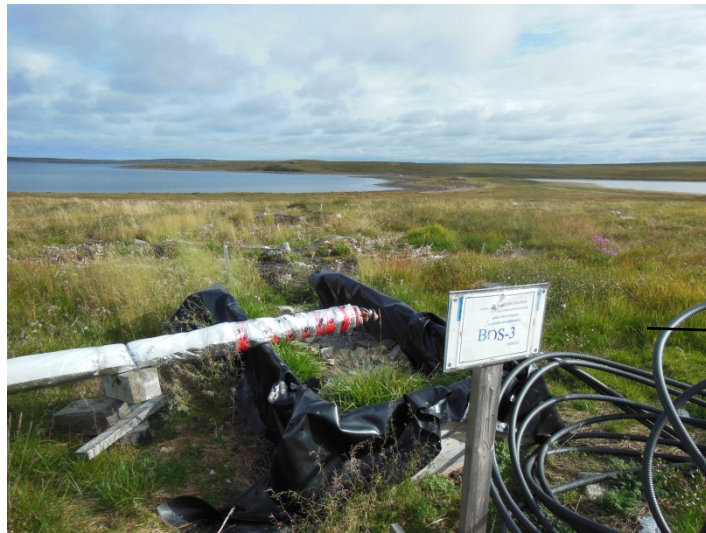
STP discharge location

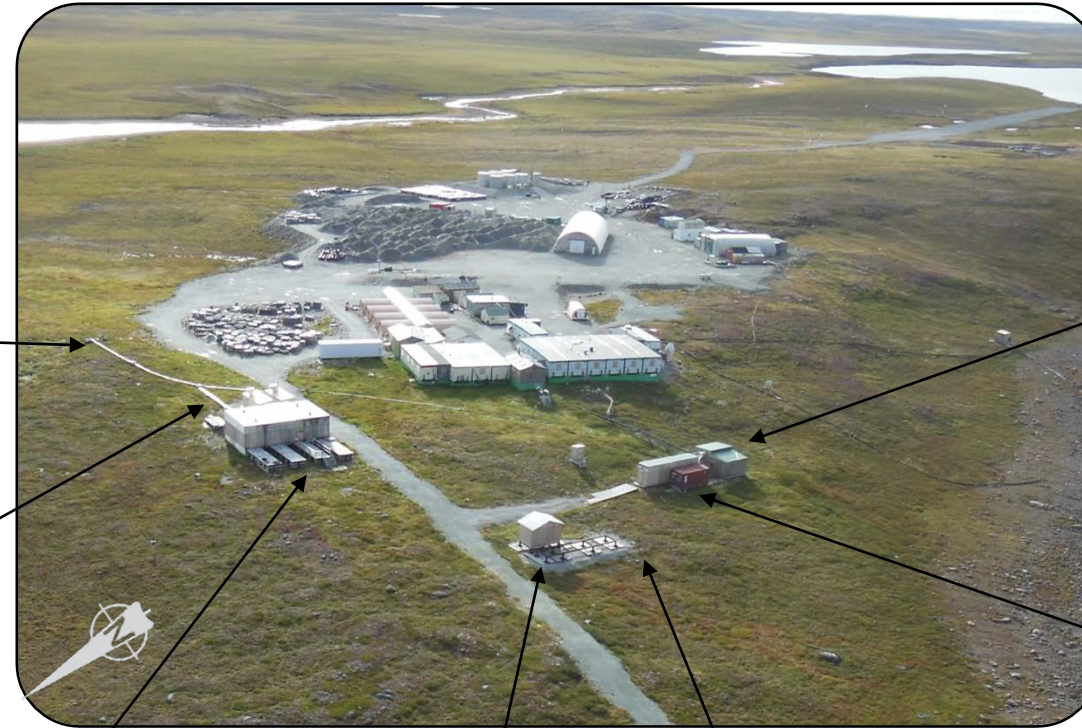
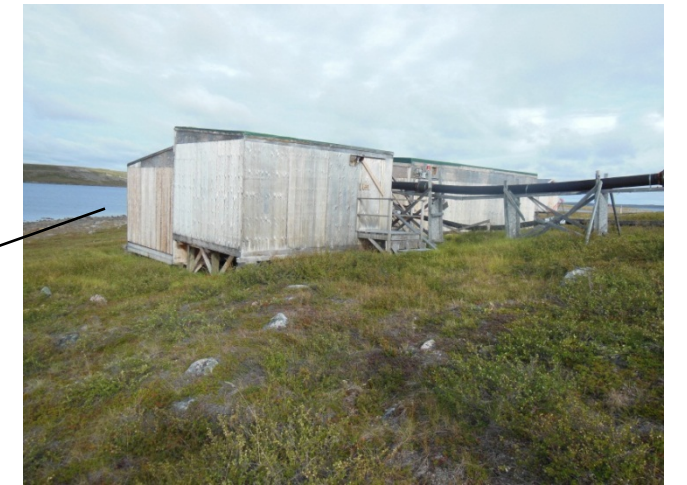
East and south sides of the old STP

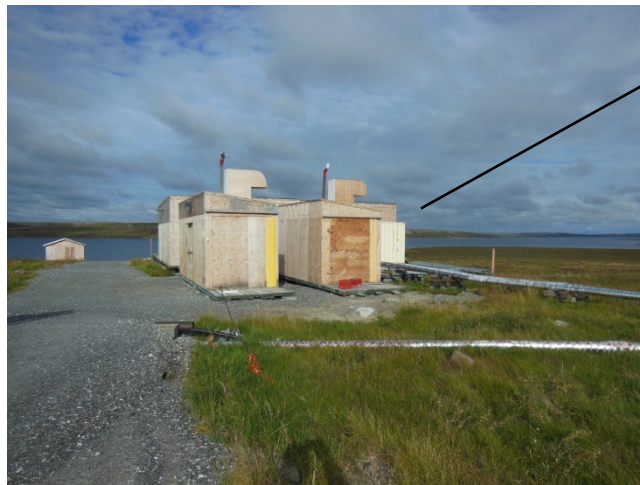
East side of the new STP

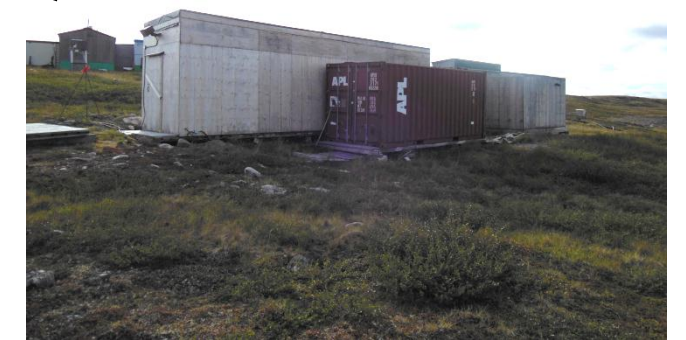
North and west sides of the old STP

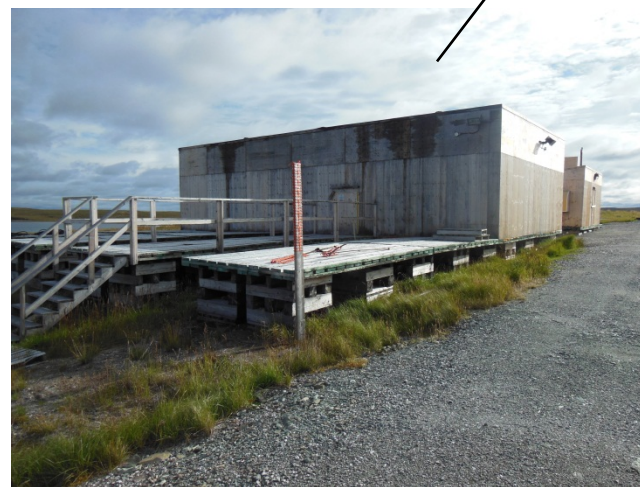
West side of the new STP

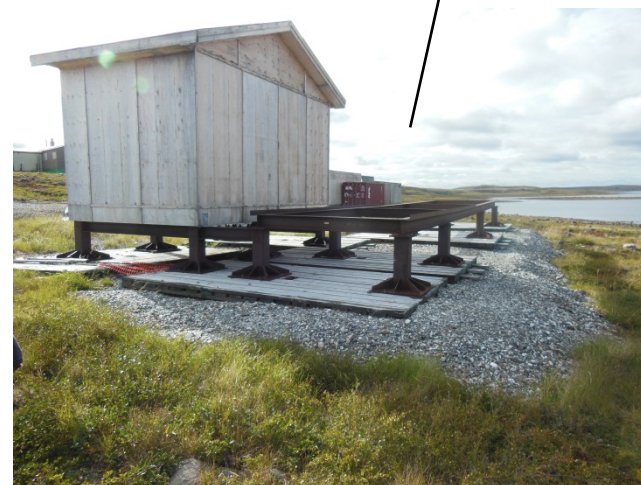
North side of the remaining thermal Pad for new STP

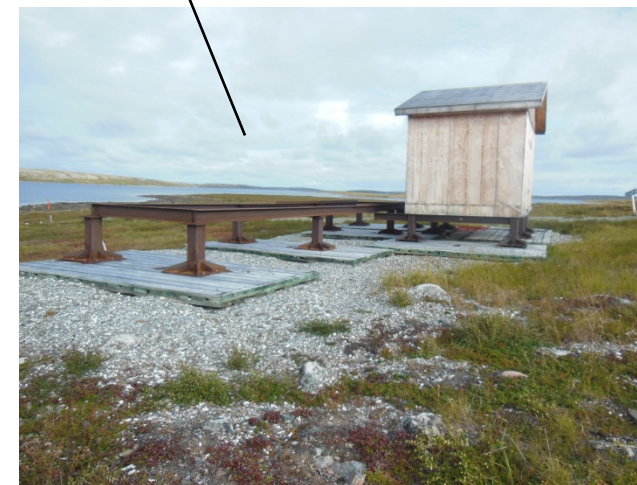
South side of the remaining thermal Pad for new STP
