## **REMEDIAL ACTION REPORT**

Detailing work completed to address  
*2013 Land Use Inspection Report and 2014 Water Licence Inspection Report*

### **COMMITTEE BAY PROJECT Kitikmeot Region, Nunavut Territory, Canada**

30 September 2014

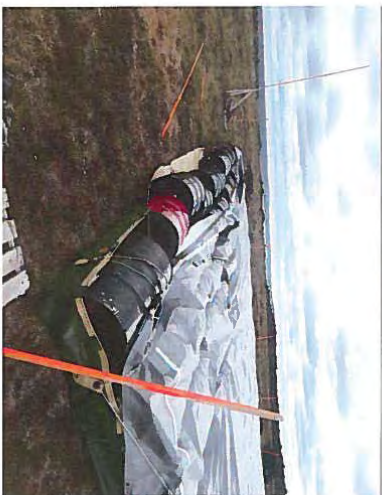
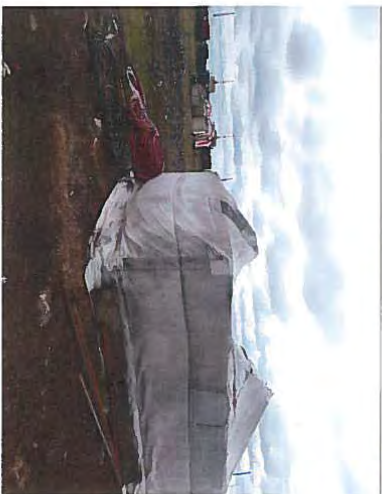
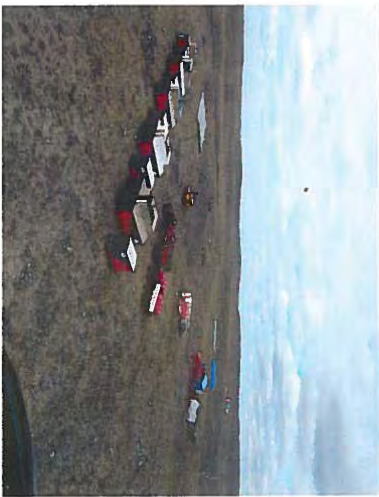
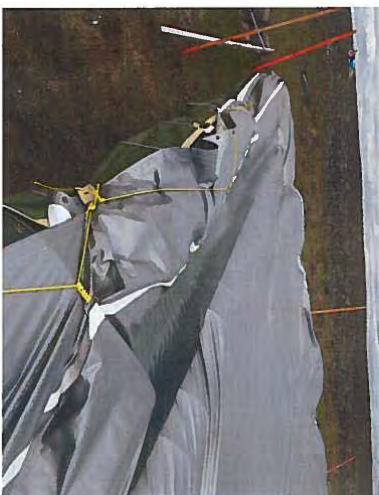
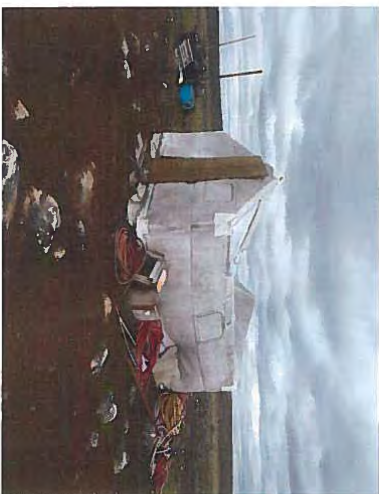
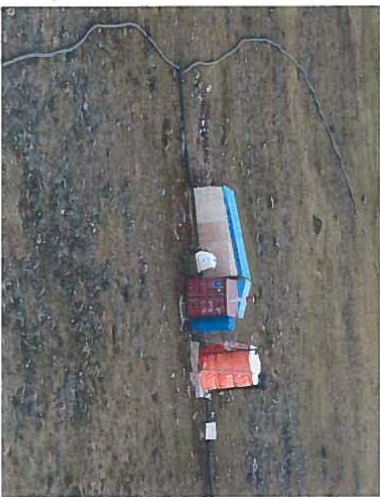
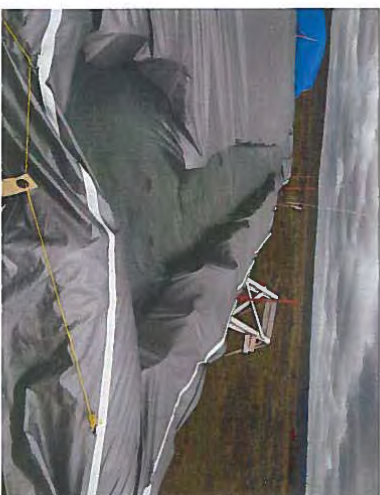
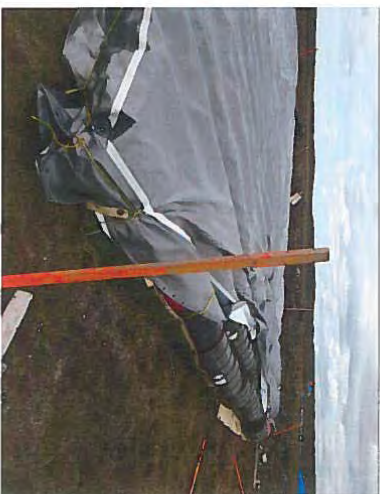
PALE LAYDOWN & FUEL CACHE

As per photo sheet #2 of the Drill Laydown area and Fuel Cache, 1 Tent Frame is weather damaged and needs repairing and 1 Fuel Cache has a large pool of standing water that needs to be drained off and the other Fuel Cache has had part of the cover blown off and a section of the containment wall has collapsed from the support strings coming off.

The above deficiencies need to be fixed and “before” and “after” photos shall be provided to me to show compliance. These sites will be Inspected again in 2014 to ensure compliance.

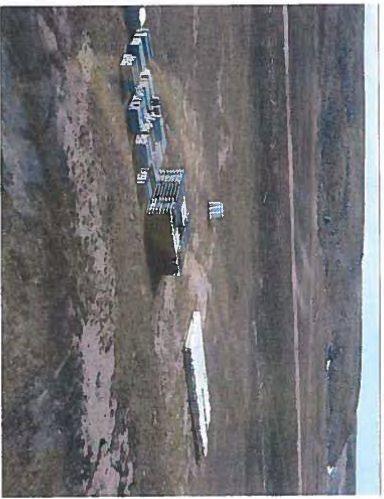
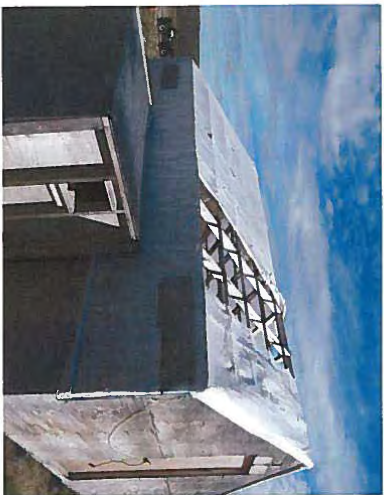
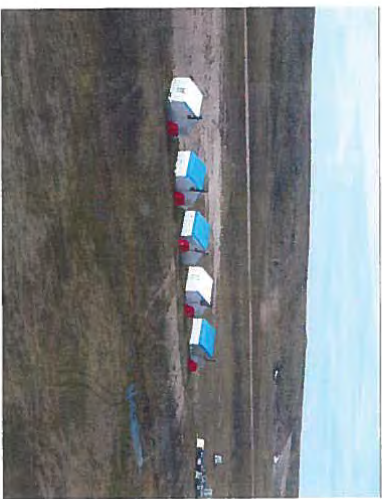
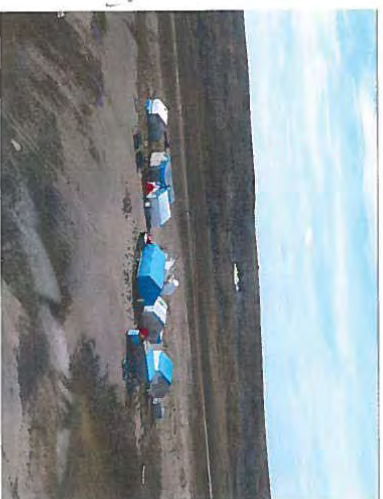
BOULDER CAMP

AT LEAST 6 STRUCTURES HAVE EXTENSIVE WEATHER  
DAMAGE, THESE ALL NEED TO BE REPAIREDPage 2 attached ☐ Yes ☒ No

As per photo sheet #2, at least 6 structures in the camp have sustained extensive weather damage. These must all be repaired and all structures must be secure. You shall provide me with “before” and “after” photos of your repairs to ensure compliance.
