## **REMEDIAL ACTION REPORT**

Detailing work completed to address  
*2013 Land Use Inspection Report and 2014 Water Licence Inspection Report*

### **COMMITTEE BAY PROJECT Kitikmeot Region, Nunavut Territory, Canada**

30 September 2014

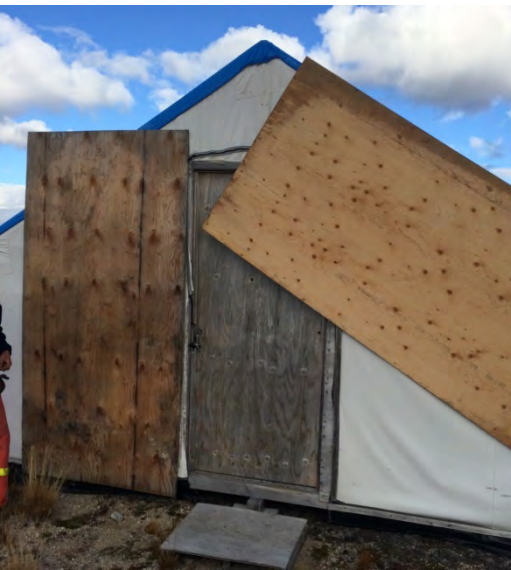
Figure 34 – Repaired tent canvas at Bullion Camp.
