## **Committee Bay Project**

## ***Annual Report***

# **2014**

North Country Gold Corp.  
December 2014

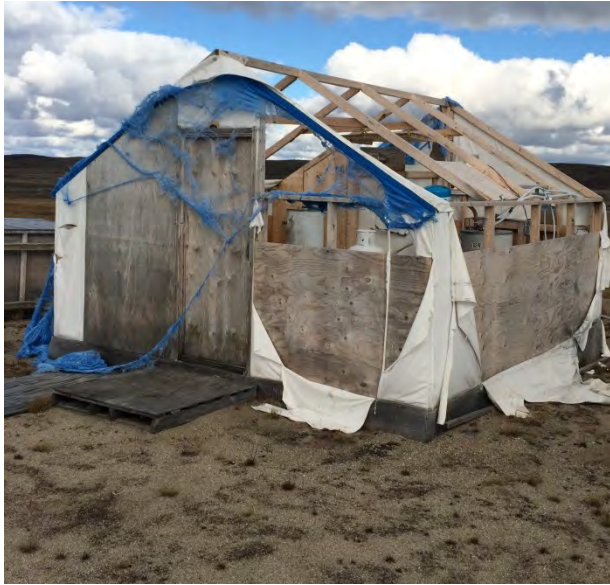
Figure 33 – Repaired tent at Bullion Camp.

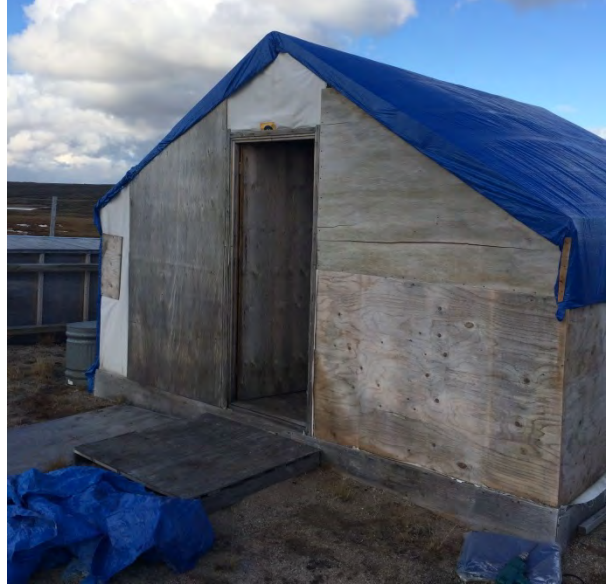
Figure 34 – Repaired tent canvas at Bullion Camp.

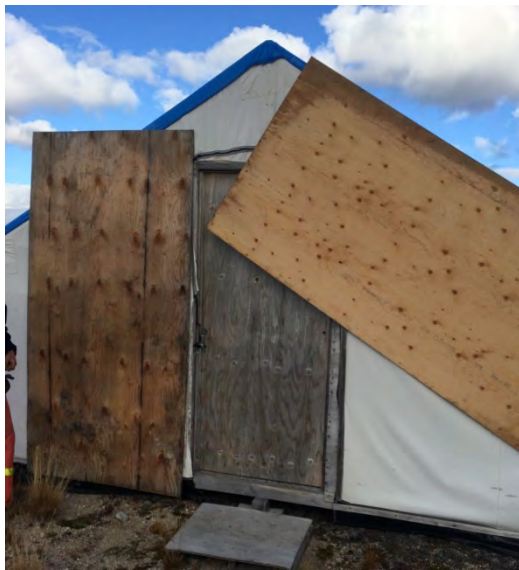
Figure 35 – Bullion Camp after maintenance.

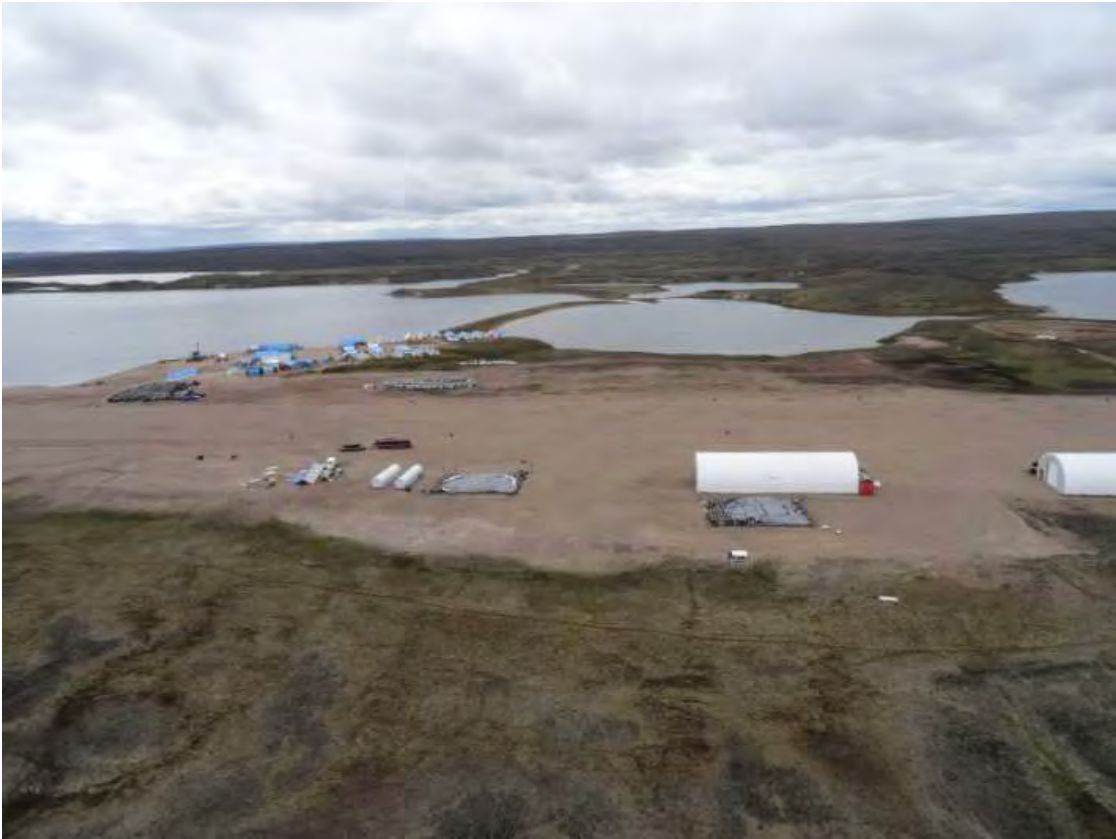
Figure 9. Aerial view of Hayes berms.

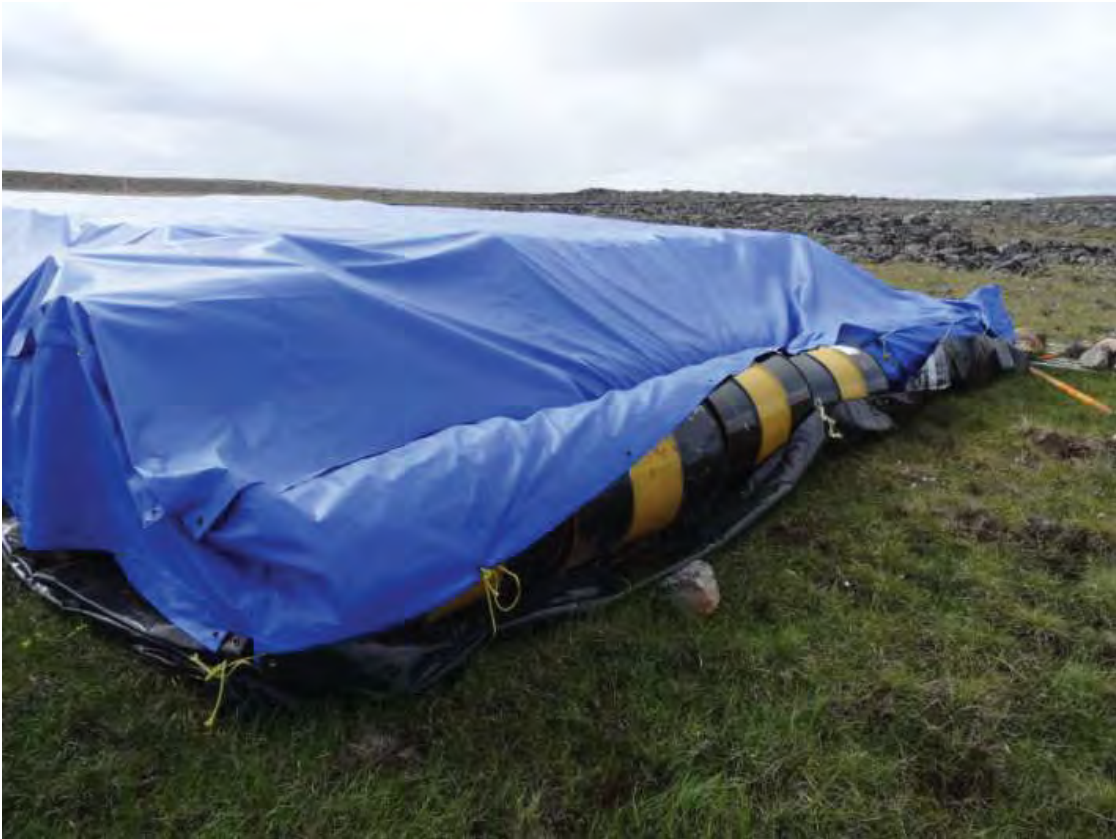
Figure 13. Three Bluffs berm 1.

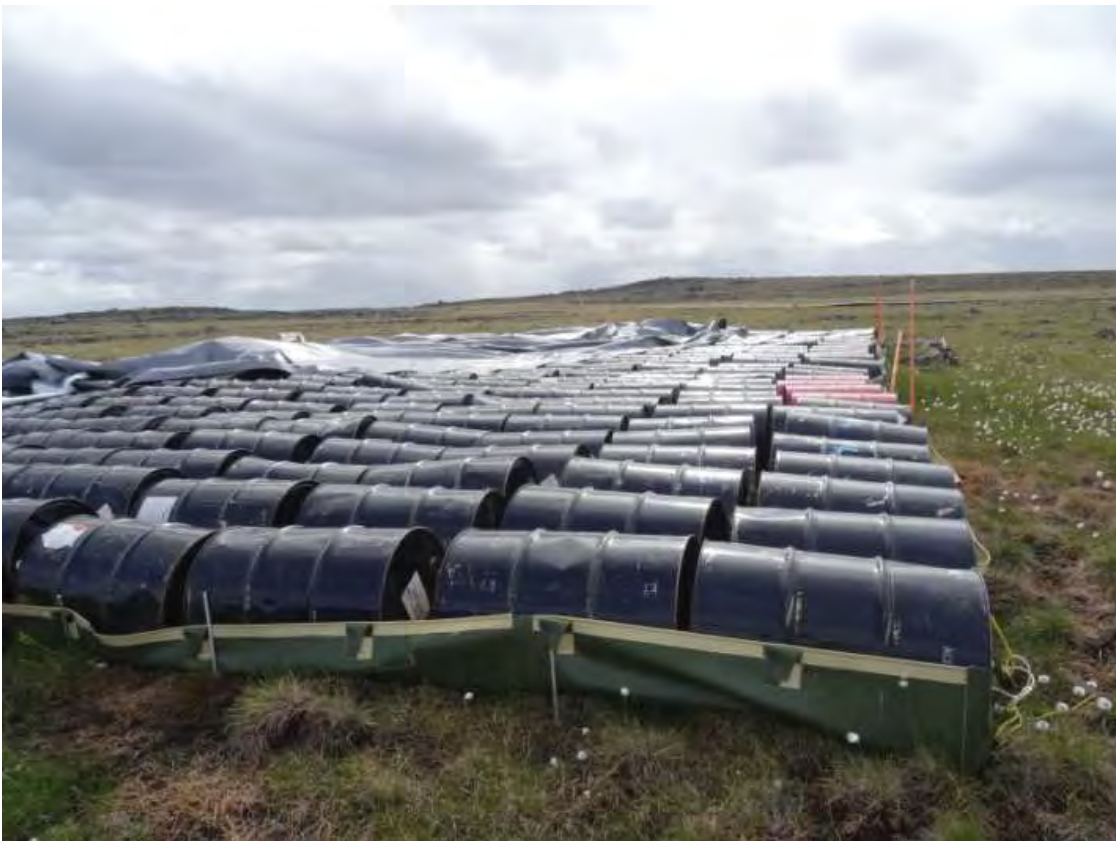
Figure 14. Three Bluffs berm 2.

Figure 23 – Berm 2 at Three Bluffs (2014 Inspection report Figures 11, 14, 23, 24, 25).

Figure 24 – Fuel Berm 1 at Three Bluffs (2014 Inspection report Figures 11 and 14)

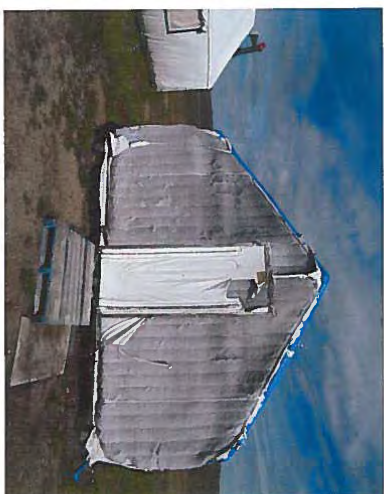
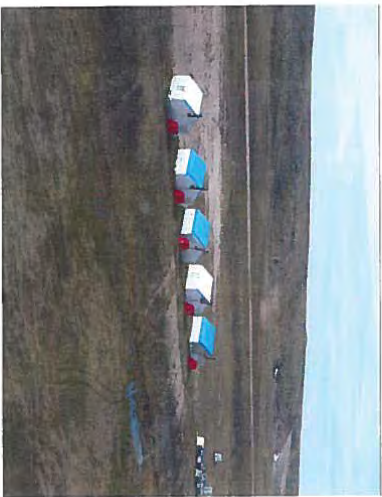
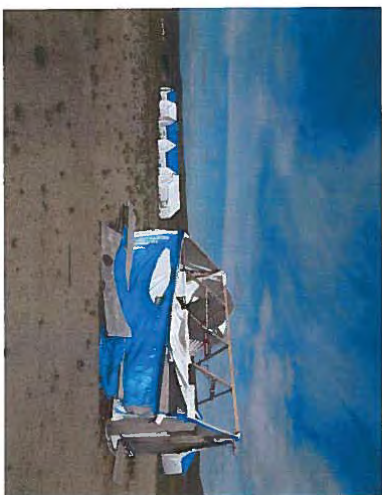
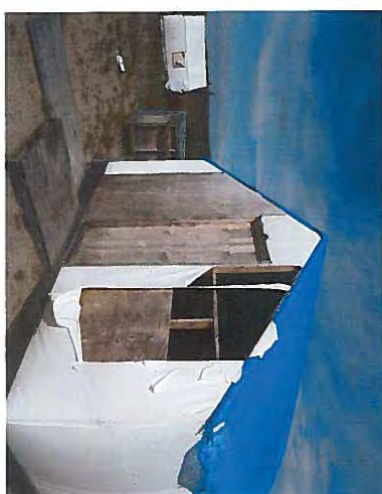
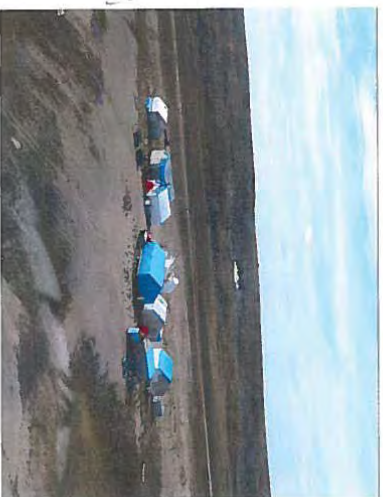
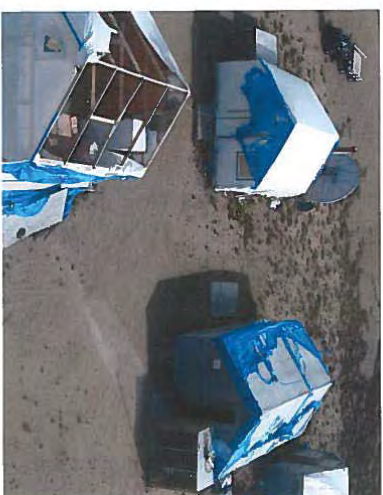
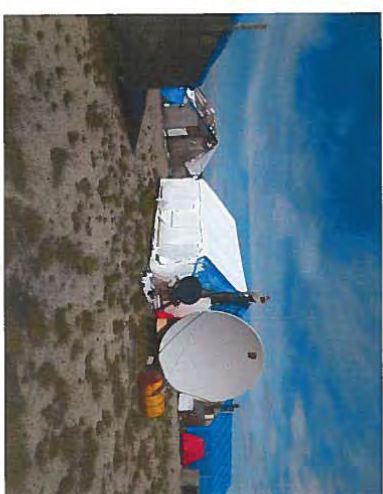
BOULDER CAMP

AT LEAST 6 STRUCTURES HAVE EXTENSIVE WEATHER  
DAMAGE, THESE ALL NEED TO BE REPAIREDPage 2 attached ☐ Yes ☒ No

Issue	Action required	Comments
Six structures have sustained extensive weather damage	Structures need to be repaired and secured	Scheduled for 2014
