SABINA SILVER CORPORATION

HACKETT RIVER CAMP

ABANDONMENT AND RESTORATION PLAN

Prepared by
Scott Burgess, P.Geo.

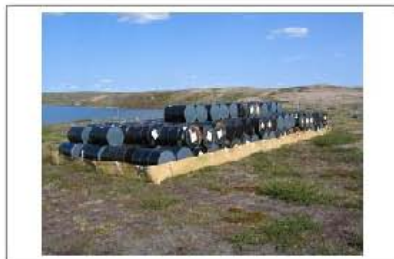
Diesel berm.jpg

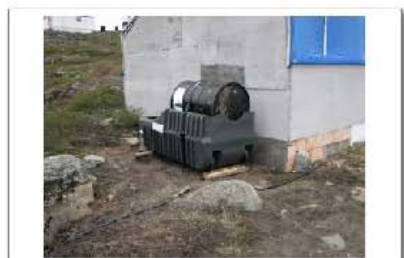
Fuel Caddy at tent, jpg

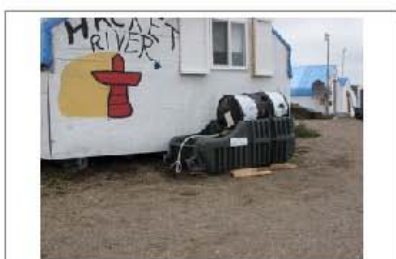
Fuel caddy 2 at tent, jpg

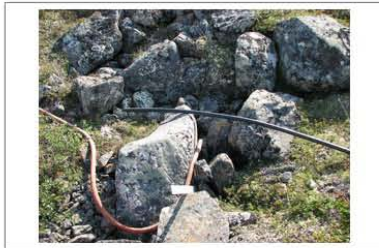
Grey water outlet.jpg

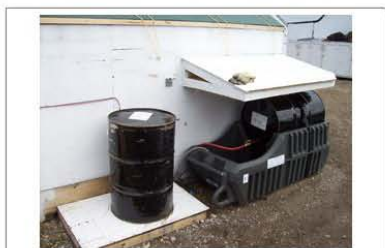
Kitchen.JPG

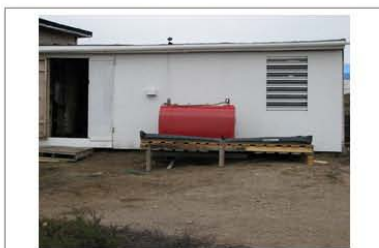
Main Generator fuel tank, and berm.jpg

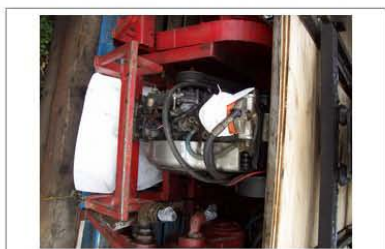
Major Water pump drip pads.JPG

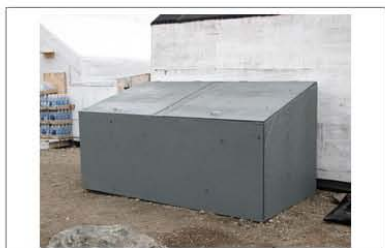
New garbage bin.jpg
