# **Patch Lake Tank Farm Secondary Containment Facility, As-Built Report Hope Bay, Nunavut, Canada**

**Miramar Hope Bay Limited**  
Suite 300, 889 Harbourside Drive  
North Vancouver, BC V7P 3S1  
Canada

**SRK Project No. 1CM014.010**

**October 2007**

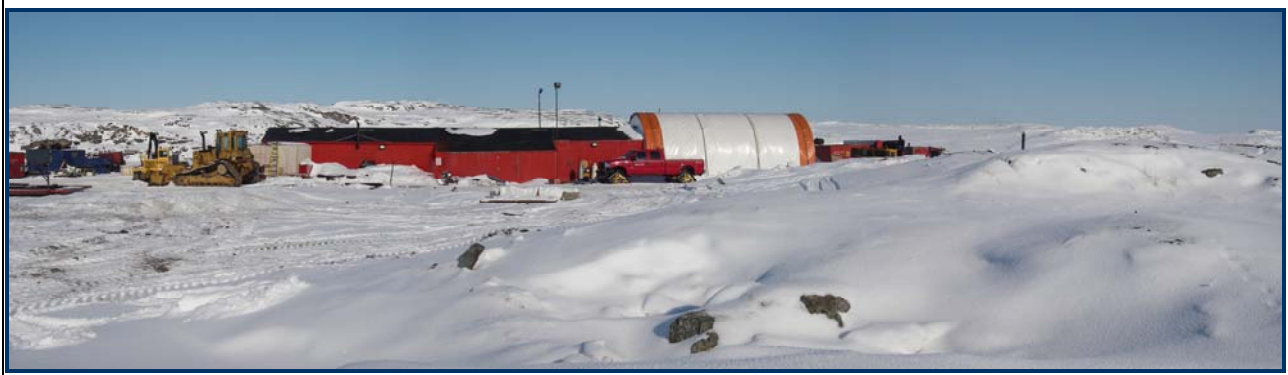
1. Looking east over the tank farm area; Major Drilling's shop facility in the background will be exposed to blasting.

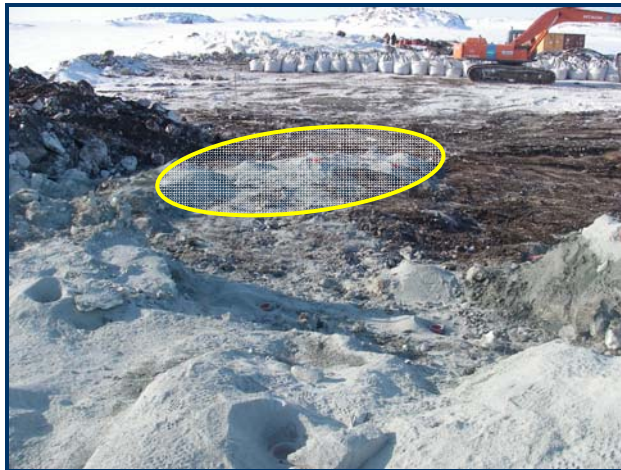
2. Completed drill holes in foreground; outline indicates high area of rock to be trimmed.

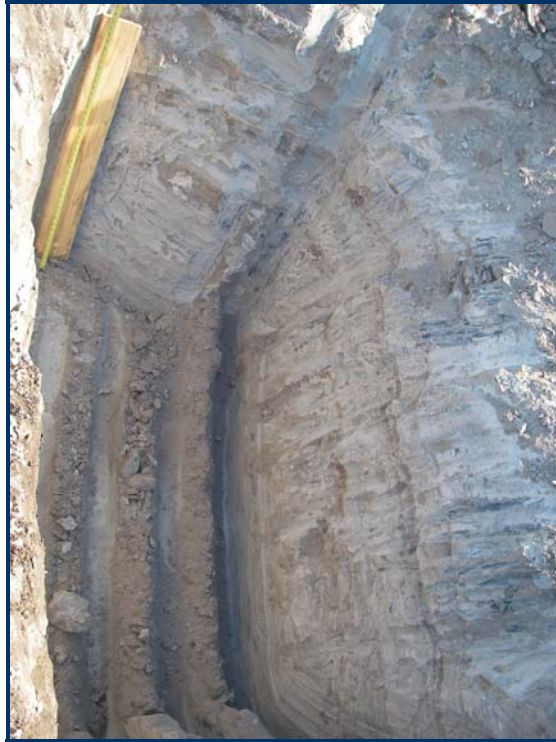
1. View into 1.7 m deep test pit in area sandy silt with 10-15% ice. Extremely tough digging as it took 8 hrs to excavate.

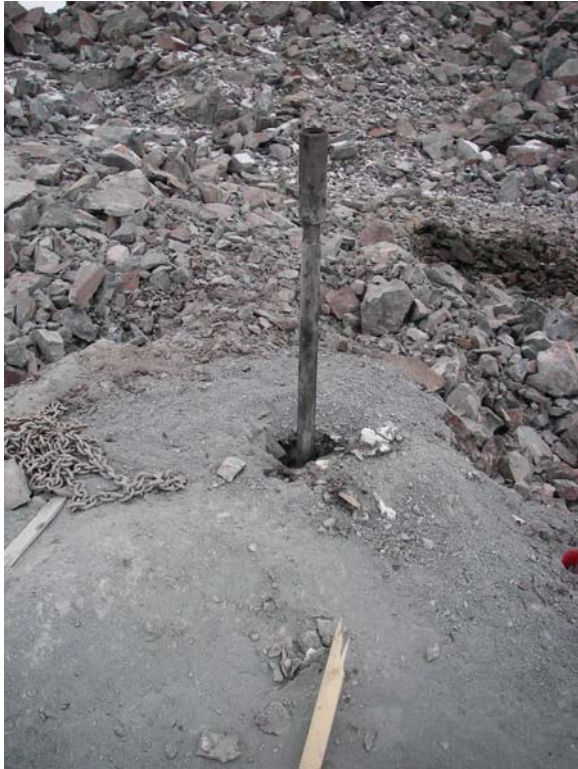
Photo 2: The rod that is stuck in the ground.

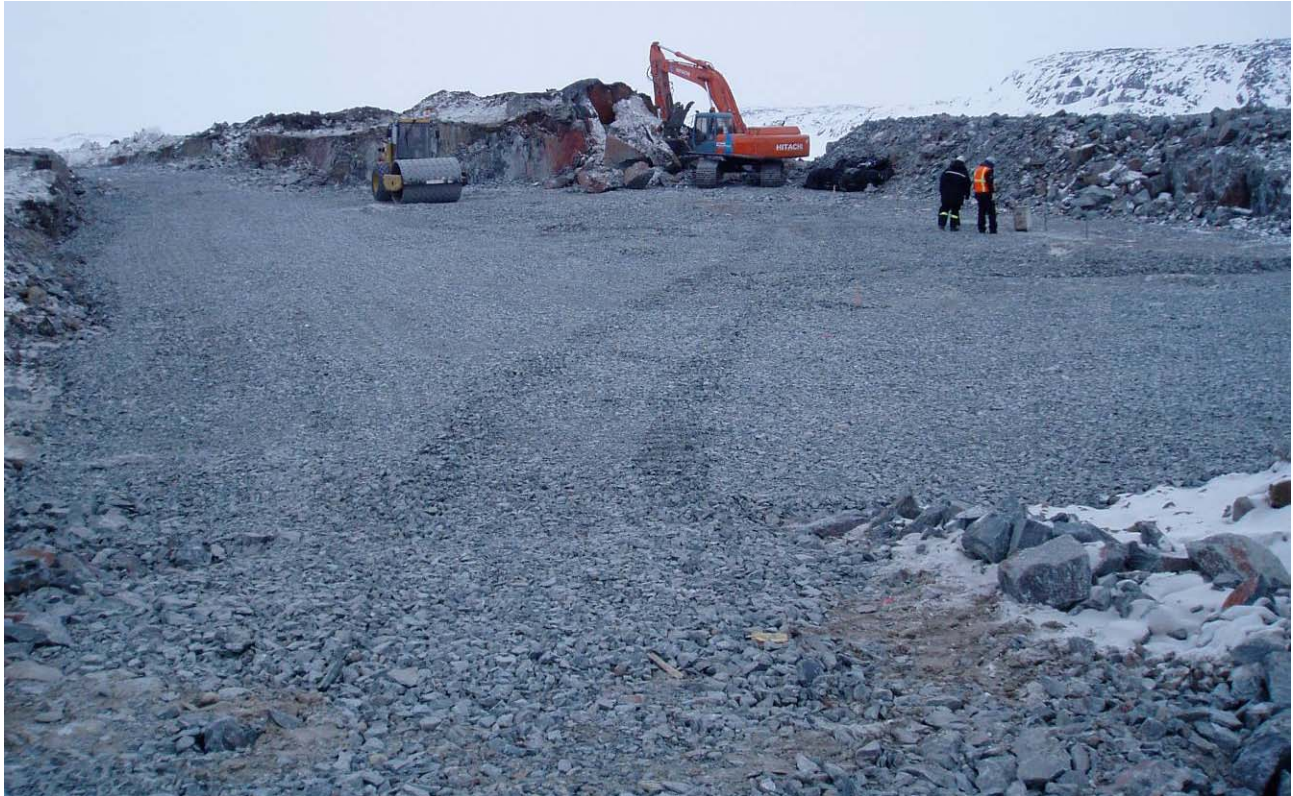
**Photo 1: Nearing grade. Excavator pulling out oversize material from daylight area after blast.**

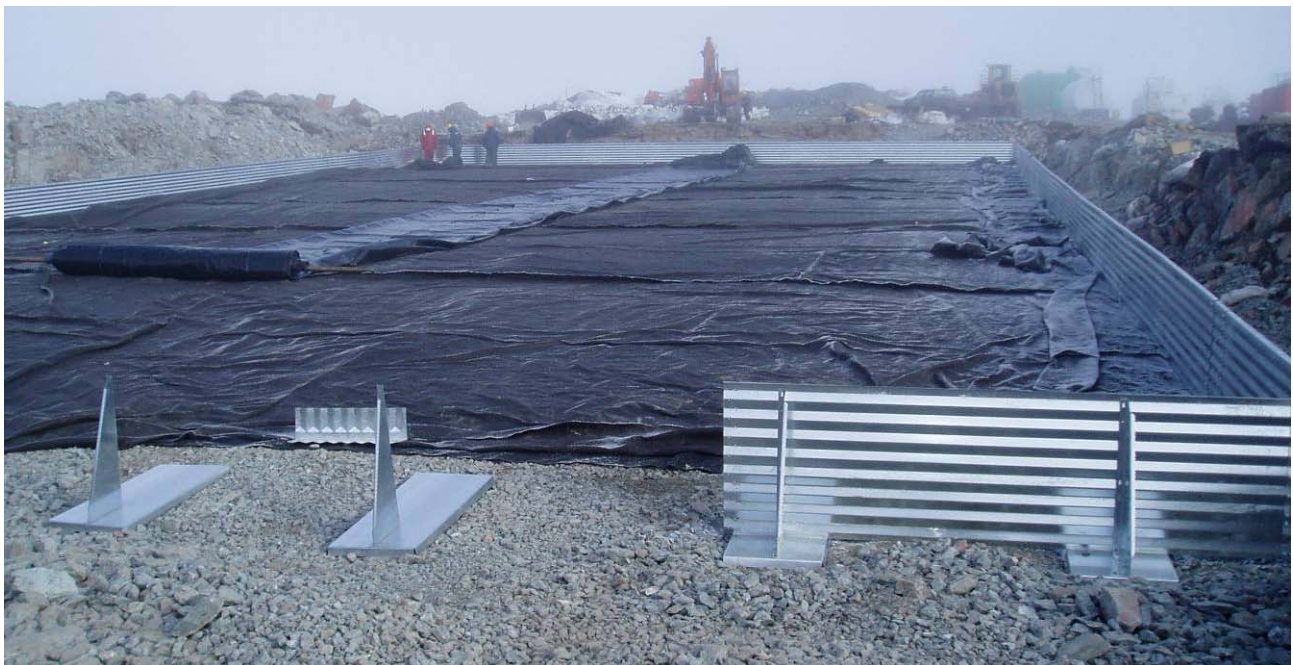
Photo 1: Two layers of geotextile, 80% of the fence, liner is ready to roll out subject to subgrade approval by SRK.

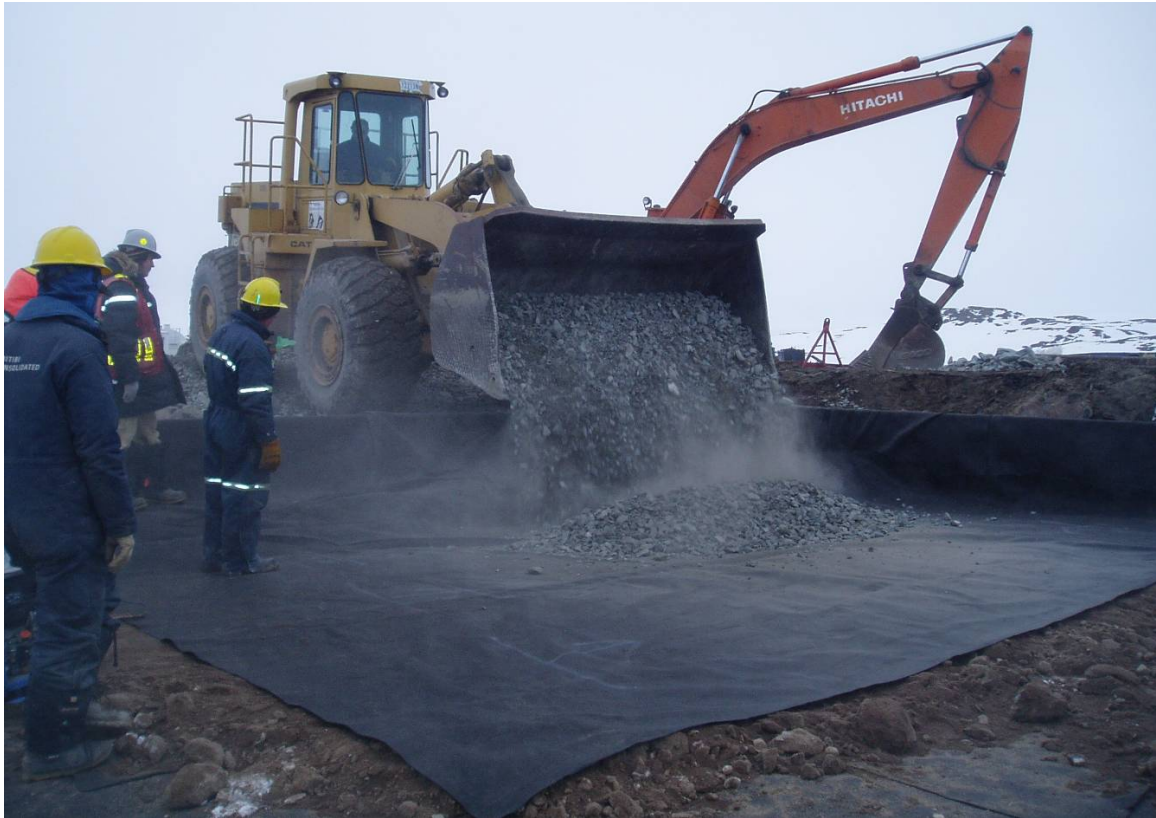
Photo 1: pouring crushed rock over textile, which is over approximately 12 cm of compacted sand.
